Building Pathology and Rehabilitation

Durability of Building Materials and Components

Volume 3

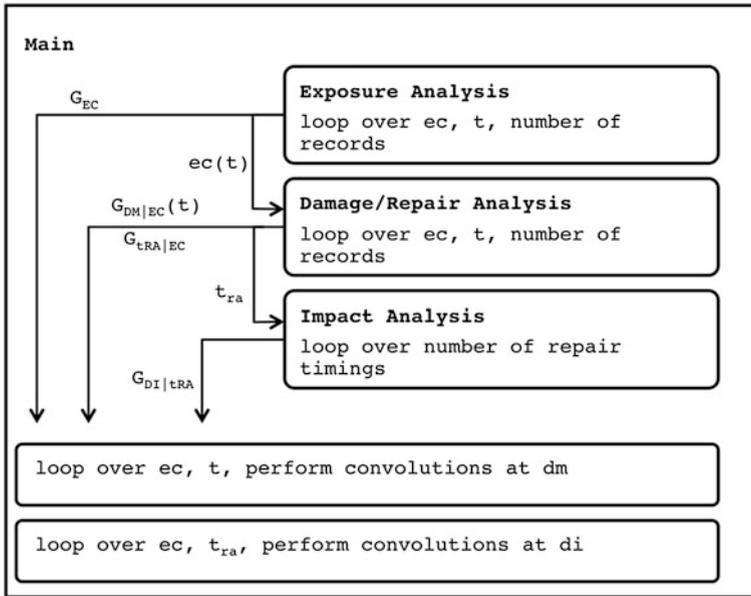
Fig. 8 Implementation of the PBDE assessment in Matlab. The assessment runs as a series of three analysis loops that pass on a limited number of pinch-point variables and two loops to perform the numerical integration of damage over time and decision information. The analyses of the suites of exposure condition (EC) records at a given value are performed in parallel

The example simulation is implemented in a series of Matlab R2011b functions, utilizing the Statistics toolbox. The general structure is shown in Fig. 8. The convolution method of assessment is used, and only the relative humidity and repair timing combinations are passed between the analyses. A bounded kernel-smoothed distribution for the damage measures and repair timing is implemented using the “fitdist” function within the Statistics toolbox. Numerical integration (convolution) of the conditional curves uses the trapezoidal rule. The assessment used 50 exposure condition points, 1,500 time steps, 500 records per exposure, 1,000 damage points and 1,000 decision information points. In general the number of records and discretization required should be assessed to ensure robust results. Use of the Parallel Computing toolbox allows parallelization of the damage/repair records at the conditional exposure level (i.e., simulations were performed in parallel at $ec = ec_1, ec_2, \dots$).

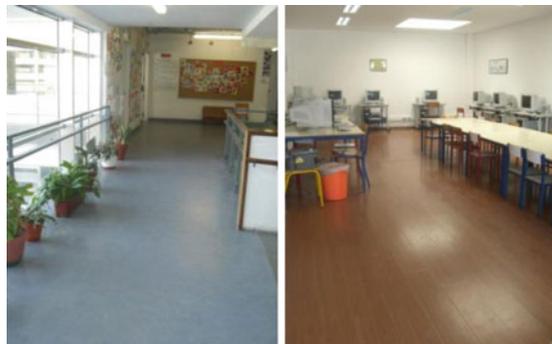
Fig. 5 School n.º 34—Alta de Lisboa. Floor finishes

The flooring currently adopted for the classrooms and corridors is linoleum (see Fig. 5). In the older schools ceramic or wood flooring can be found. The inspection

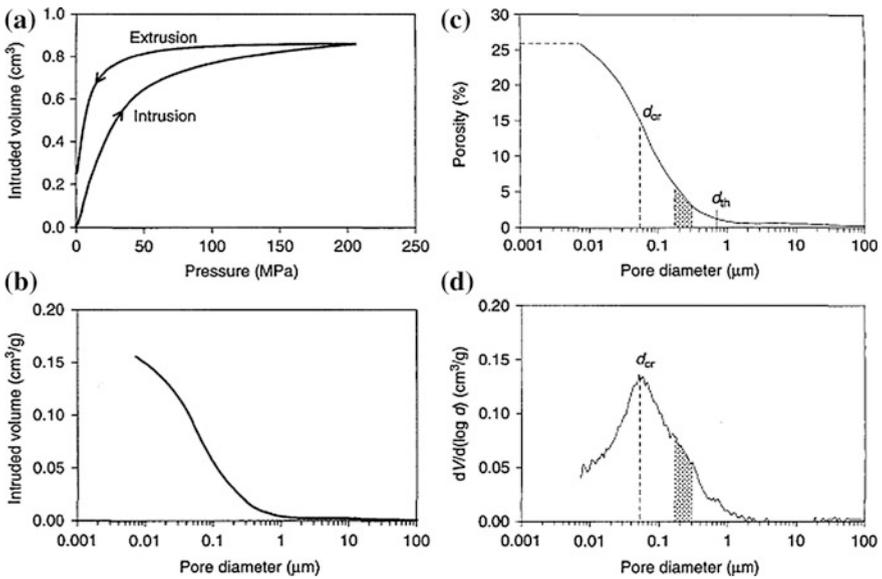
Fig. 2 Plots used most frequently in MIP to report experimental results [1]. **a** Pressurization curve. **b** Cumulative intruded volume curve. **c** Cumulative pore size distribution. **d** Differential pore size distribution

A wide variety of techniques has been used for the characteristics of the pore structure of cement paste. Mercury intrusion porosimetry (MIP) has proven over several decades to be a useful technique in characterizing pore structure parameters of cement-based material [1, 8, 9]. Such parameters include total pore volume, pore size distribution, density of solid and specific surface area of pores. Thus, MIP has become a convenient and fast technique for pore structure characterization. In addition, MIP is the only available technique that is supposed to cover nearly the whole range of sizes that must be analyzed in cement paste. Important characteristics, including total porosity, critical pore diameter and pore size distribution, can be determined from the results of MIP. The schematic drawing is demonstrated in Fig. 2. The total porosity obtained from the cumulative porosity curve corresponds to the point of highest pressure and the smallest equivalent pore size (c). The peak in (d) corresponds to the critical pore size [1].

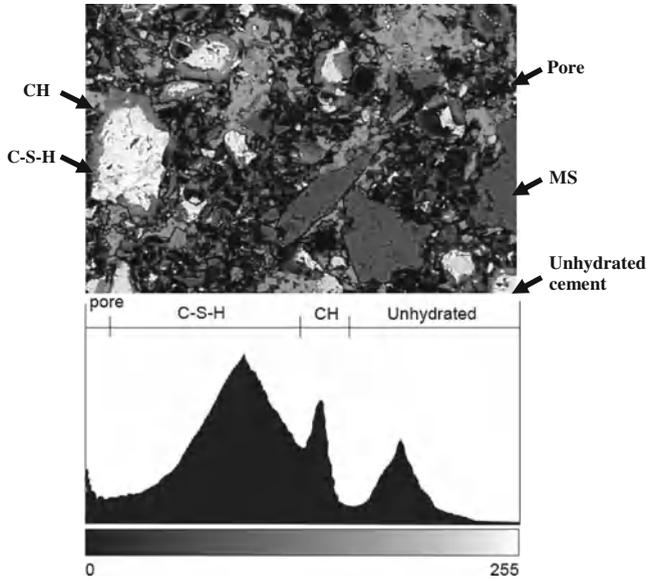
Fig. 3 SEM image of cement paste with 20 % replacement of M6 (coarse) at 7 days curing and the typical grey level schematic histogram [22]

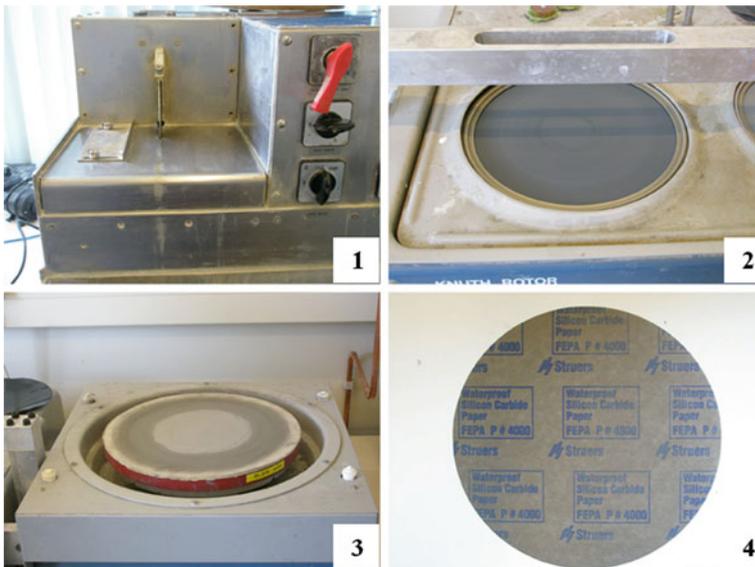
Fig. 5 a Sawing machine. b Grinding machine. c Polishing machine. d Sand paper

A high-quality original image is the prerequisite for accurate segmentation of features and subsequent quantification steps [17]. Proper sample preparation is critical to the successful images of microstructure [19]. In order to view in the SEM, around 30 g of paste samples are selected after stable mass is reached. Epoxy impregnation is applied after the samples are placed in the chamber for evacuation at 0 torr for 3 h. The impregnated samples are cured at atmospheric pressure at 35 °C for 24 h. Then the samples are ready for the cutting, grinding and polishing [19, 22]. The rough surface will be removed by a diamond saw, followed by a delicate grinding procedure. The sample will be ground on a rotating plate with p320, p500, p1200, p2000 and p4000 sand papers. Final polishing is done on a lap wheel with 6, 3, 1 and 0.25 μm diamond paste for 2–3 min each [19, 22]. Then the samples are ready to be observed in SEM. The relevant apparatuses are demonstrated in Fig. 5.

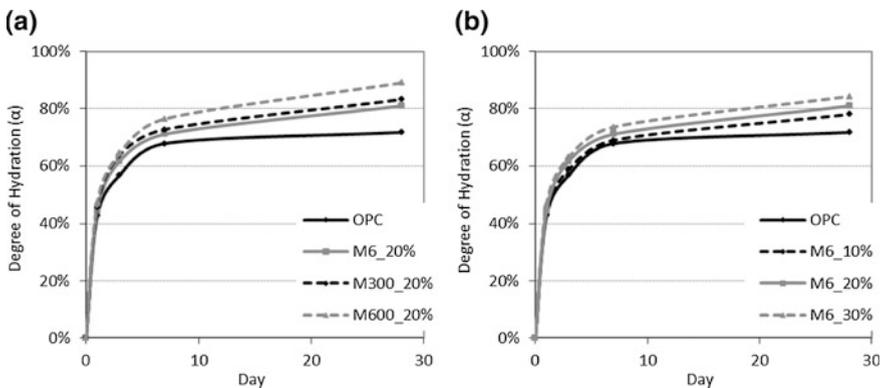
Fig. 6 Degree of hydration of cement in pastes containing micronized sand with **a** 20 % of M6, M300 and M600, **b** 10, 20 and 30 % of M6

The results also show that the degree of hydration of cement in the blended cement pastes increases with increasing fineness of the micronized sand. With the

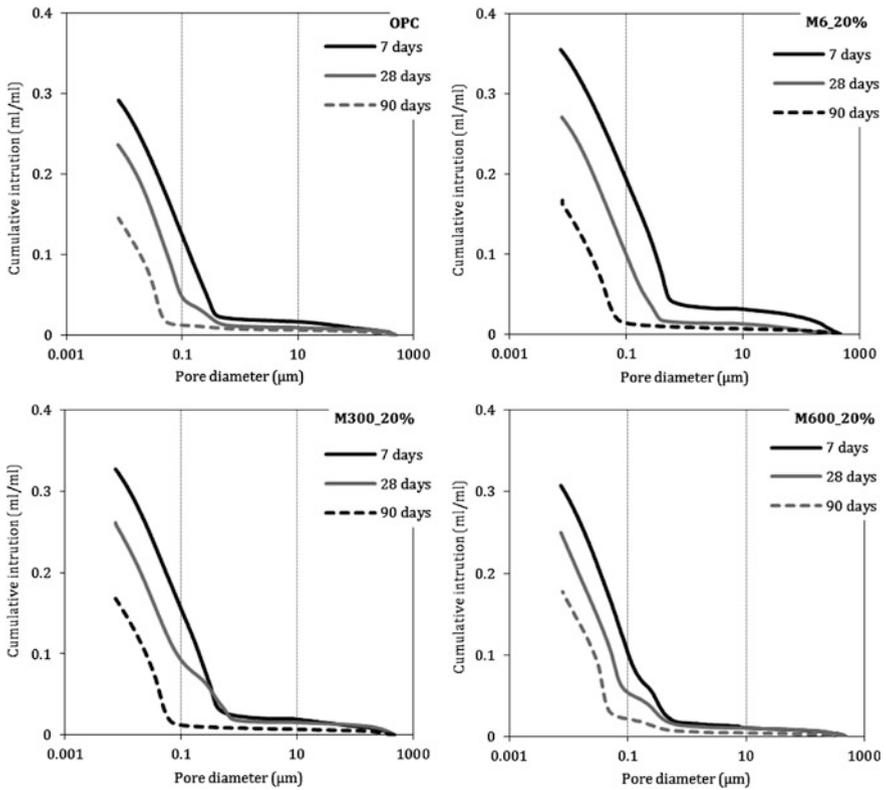
Fig. 8 The cumulative pore size distribution curves of cement blended with 20 % M6, M300 and M600 at the ages of 7, 28 and 90 days

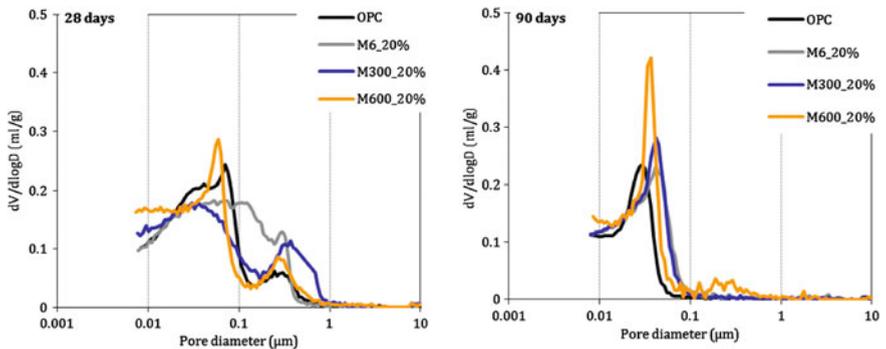
Fig. 9 The differential intrusion curves of cement blended with 20 % M6, M300 and M600 at the ages of 28 days (left) and 90 days (right)

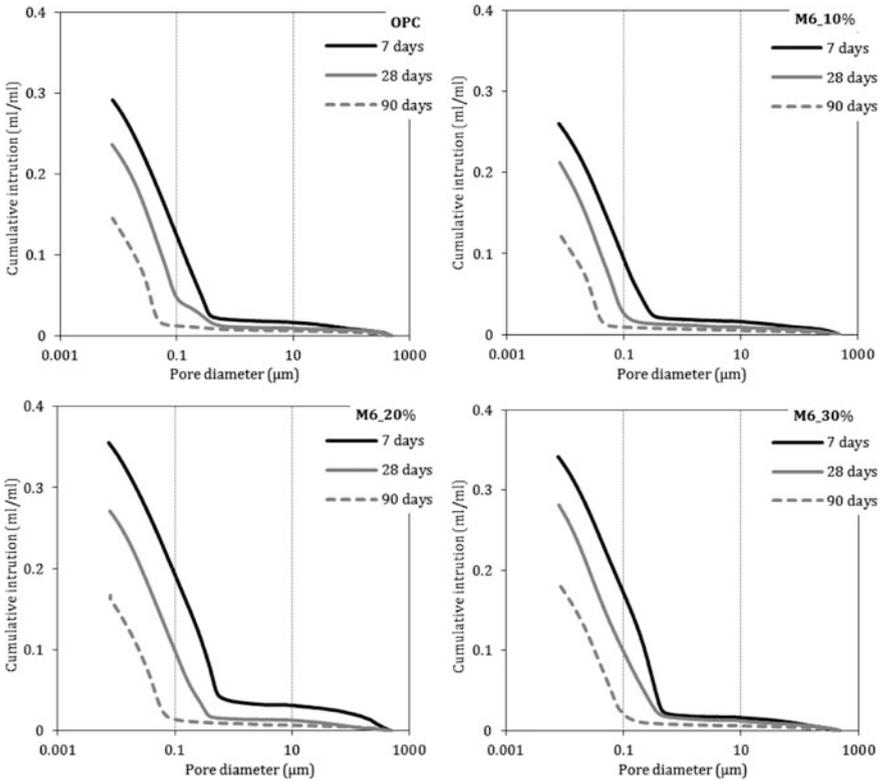
Fig. 11 The cumulative pore size distribution curves of cement blended with 10, 20 and 30 % M6 at the ages of 28 days (left) and 90 days (right)

The cumulative and differential pore size distribution curves of cement paste containing 20 % micronized sand are shown in Figs. 11 and 12. It can be seen that at the age of 28 days, 20 and 30 % coarse micronized sand (M6) results in a higher differential pore volume in the range of pore diameters between 0.1 and $0.5 \mu\text{m}$ compared with the reference and M6_10 % samples. After 90 days the pores larger than $0.1 \mu\text{m}$ are almost vanished in all the samples. The curve of differential intruded pore volume of sample M6_10 % has the same trend as the one of the reference OPC.

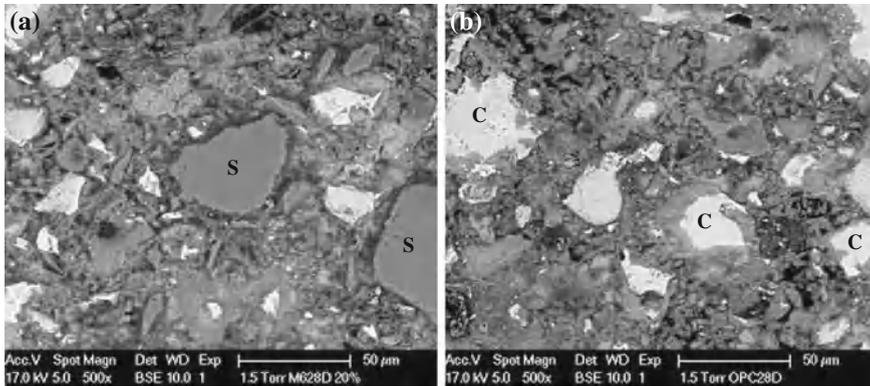
Fig. 13 BSE images of M6_20 % (a), and OPC (b) at the age of 28 days. (C unhydrated cement particle; S micronized sand particle)

In Fig. 13, it can be seen that the morphology of the reaction products around the micronized sand particles is different from that around cement particles. Figure 14 shows more details of the microstructure under the magnification of 2,000. Less hydration products precipitate on the surface of the micronized sand particles forming a clear interfacial zone between sand surface and hydration products. This new interfacial zone is distinguishing from the one between aggregate and paste, since it is in a lower level. The microstructure in this interfacial zone is more porous in comparison with the bulk matrix. It is expectable that this porous interfacial zone caused by the presence of micronized sand will affect the transport properties of the material. In this section, the interfacial zone around micronized sand will be studied by quantitative analysis of the SEM images.

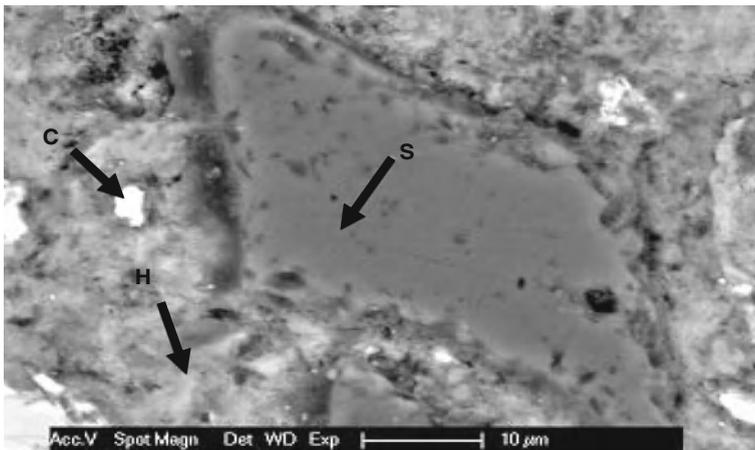
Fig. 14 Microstructure of M6_20 % after 28 days hydration. (C unhydrated cement, H hydration products, S sand)

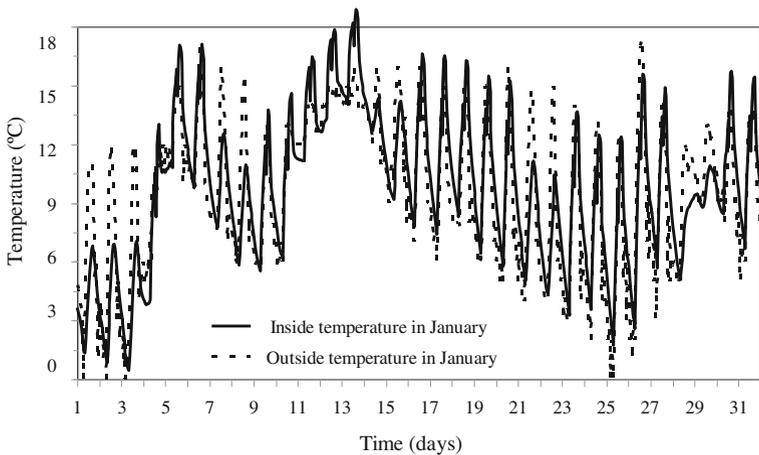
Fig. 9 Temperature variation during January in the pre-retrofit scenario

Figure 9 presents the indoor temperature variation in January. The existence of heat gains due to users and lighting as well as solar gains, provide a rather small difference between indoor and outdoor temperature. This is caused by the very high ventilation rate considered.

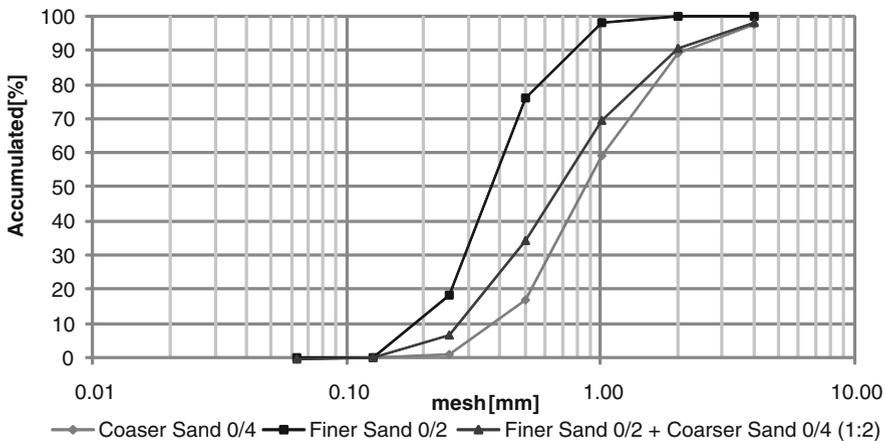
Fig. 1 Particle size distribution curves of the sands and their volumetric mixture

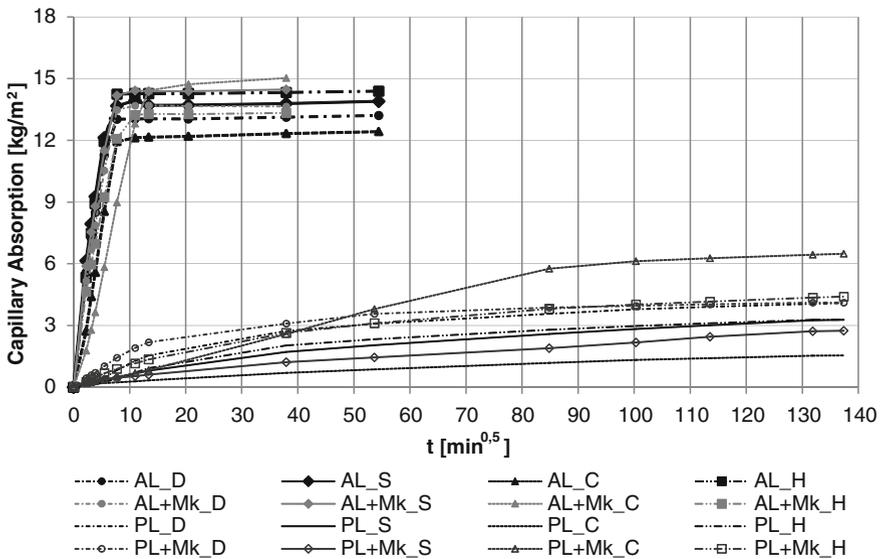
Fig. 3 Capillary absorption curves of mortars

Capillary coefficient of mortars with hydrated lime AL is lower for mortars with metakaolin; for mortars with lime putty PL, capillary coefficient is a little higher

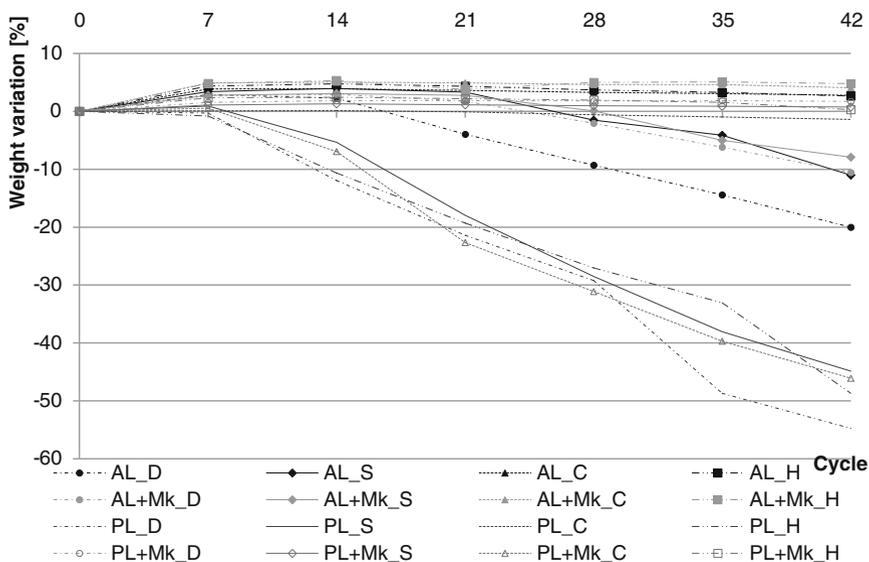
Fig. 6 Weight variation as a function of the number of cycles after chlorides contamination

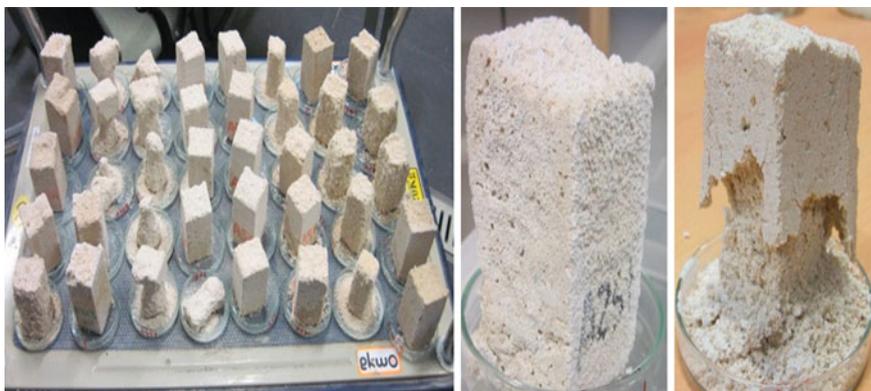
Fig. 7 General view of mortar samples at 42 cycles after chlorides contamination and zoom view of an AL mortar sample only with superficial disaggregation and a PL mortar sample with great mass loss

The deterioration of the samples generally occurred by superficial disaggregation, as can be seen in Fig. 7. But the degradation of lime putty mortars was much more visible and intense than the one that occurred in powder hydrated lime mortars. In Fig. 7 some similarity can be observed between the PL mortar sample

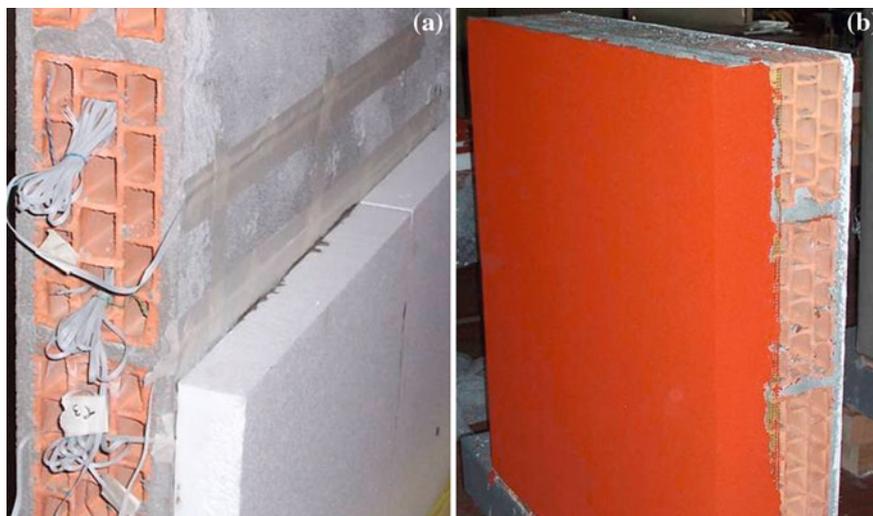
Fig. 3 **a** The aged sample during construction phase and instrumented with temperature and relative humidity sensors between masonry wall and EPS. **b** The sample finished with the top coat. The glass fibre mesh is turned round the edges of the specimen, to provide anchor

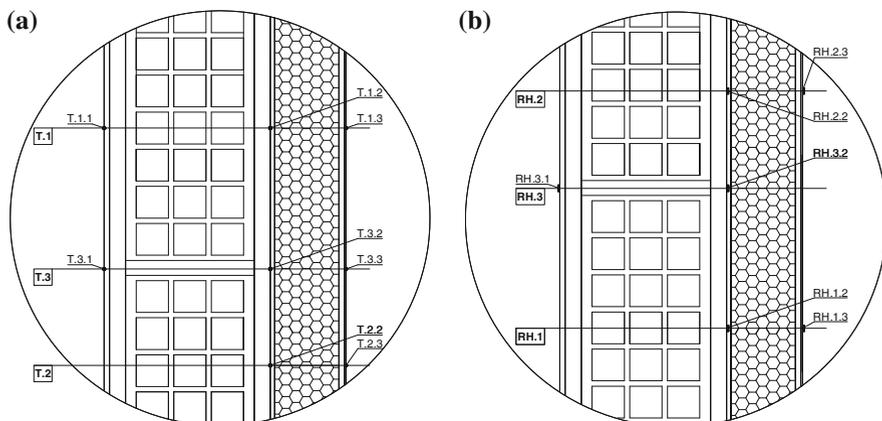
Fig. 4 Temperature sensors profiles in the vertical section (a) and relative humidity sensors profiles in the vertical section (b)

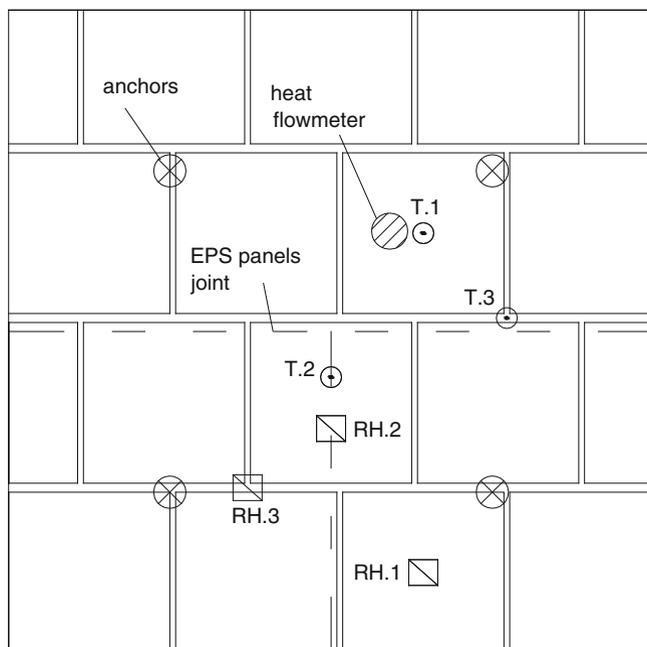
Fig. 5 Positions of the sensors profiles and the het flux meter

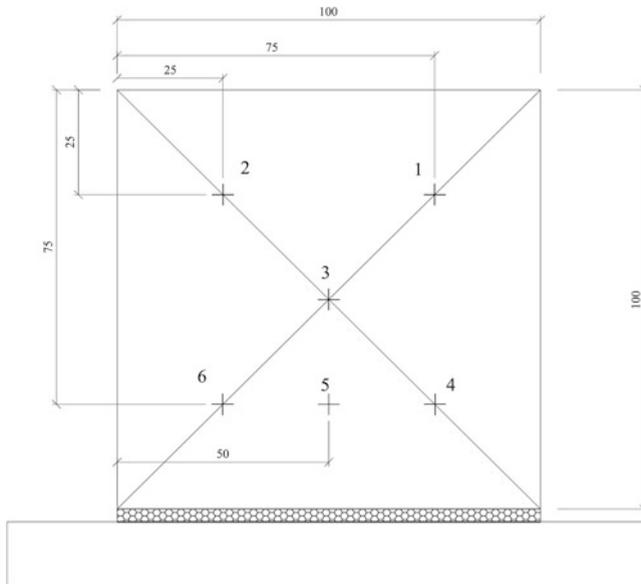
Fig. 8 Photographic survey points (P1 over a fixing; P2 over a fixing; P3 over T joint between insulation boards; P4 over fixing; P5 over vertical joint between insulation boards; P6 over fixing). The measures are expressed in centimetres

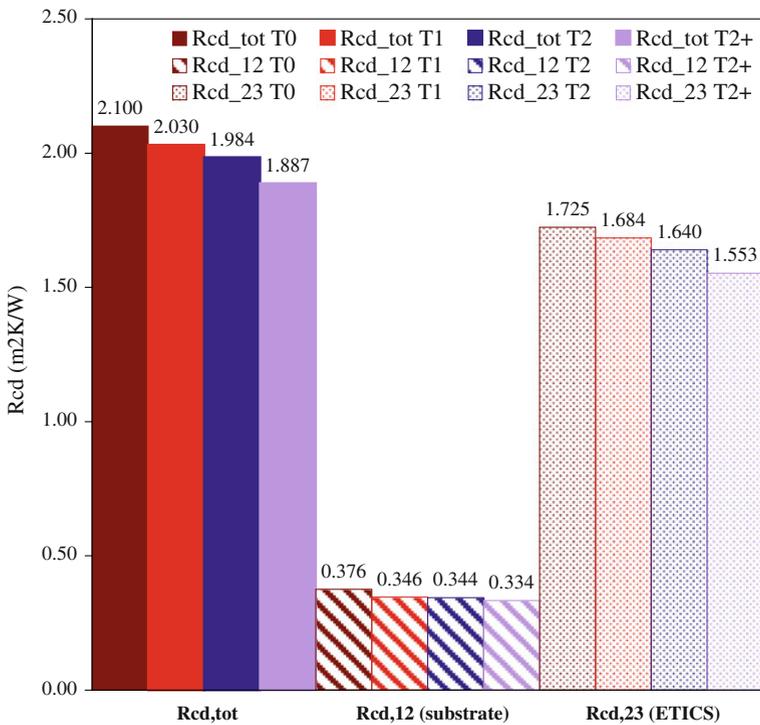
Fig. 19 Total conductive thermal resistance (Rcd,tot), thermal resistance of the masonry wall (Rcd,12) and thermal resistance of the ETICS (Rcd,23) at ageing time T0 (initial condition), T1, T2, and T2+ (the same as T2, but after a rain cycle)

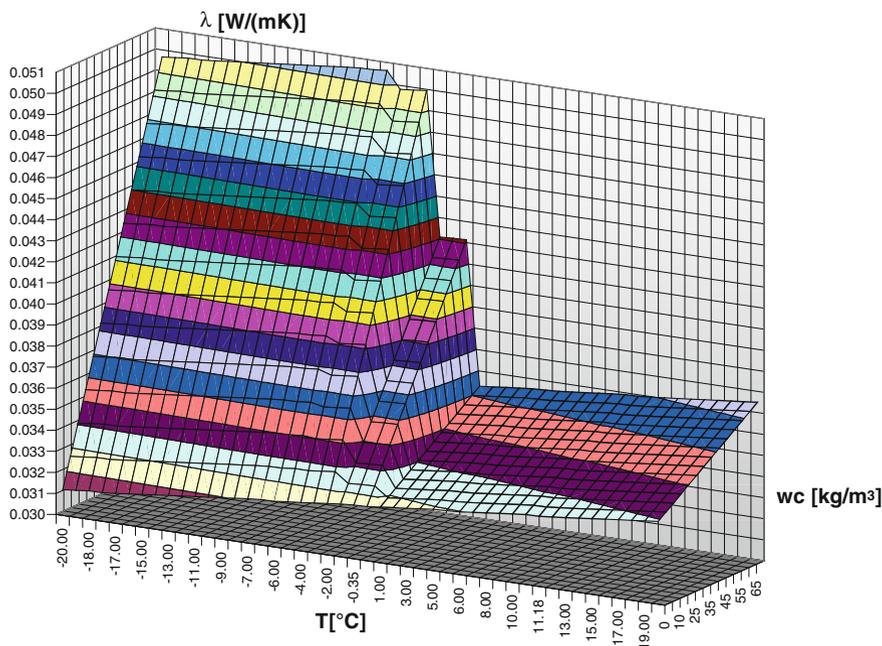
Fig. 20 Thermal conductivity of EPS at different temperatures for different moisture contents (in the figure only the initial part of the curve is presented, for moisture contents up to 70 kg m^{-3}). In the interpolation, we consider water within the pores all in the same phase

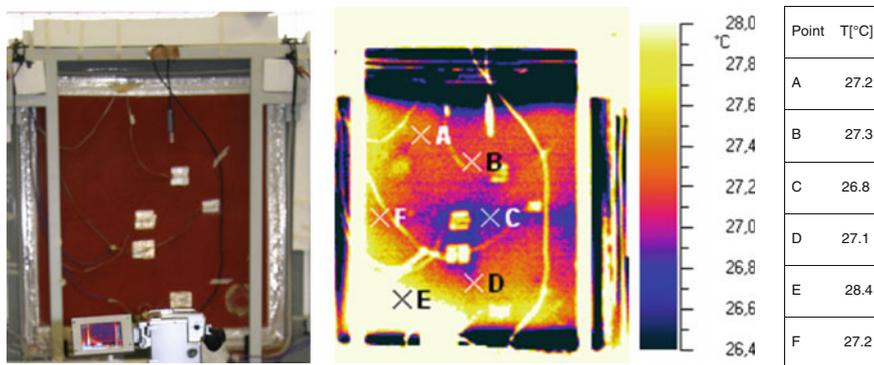
Fig. 21 Infrared thermography at ageing time T2+. Laboratory air temperature $T_{A,LAB} = 29.0 \text{ °C}$. Surface emissivity $\epsilon = 0.90$. Thermocamera distance from specimen: 3 m

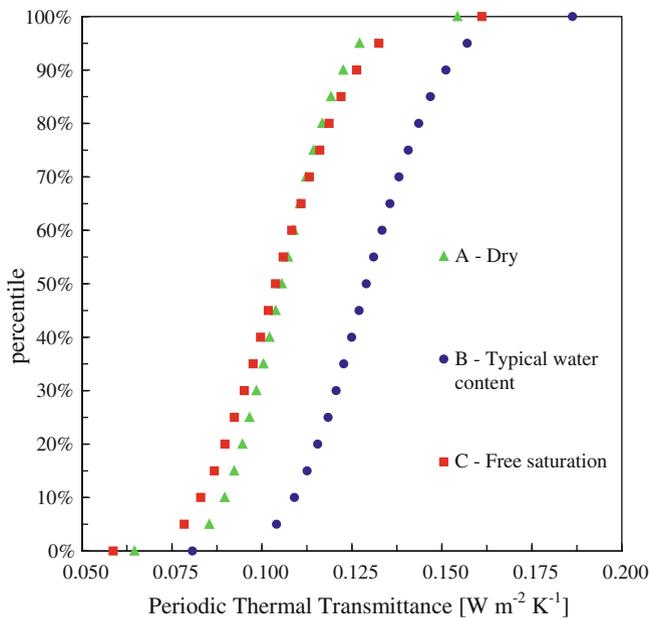
Fig. 24 Periodic Thermal Transmittance when *A* all the layers are dry, or they present *B* typical moisture content (specific for each material), or *C* free saturation water content

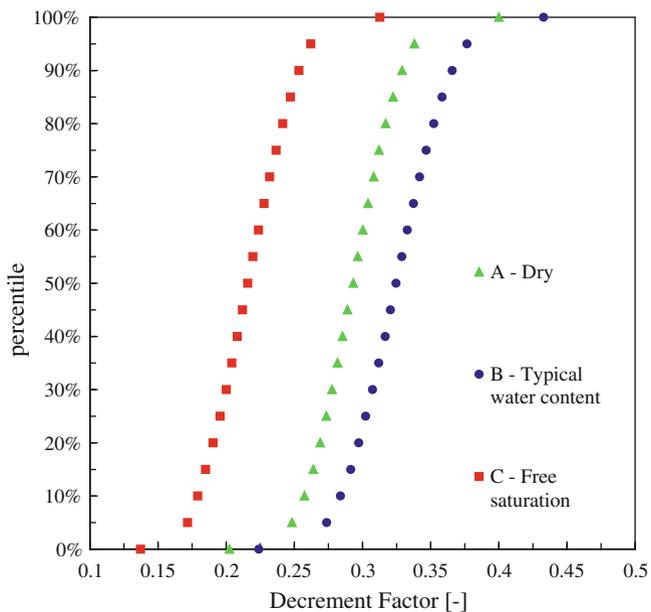
Fig. 25 Decrement Factor when *A* all the layers are dry, or they present *B* typical moisture content (specific for each material), or *C* free saturation water content

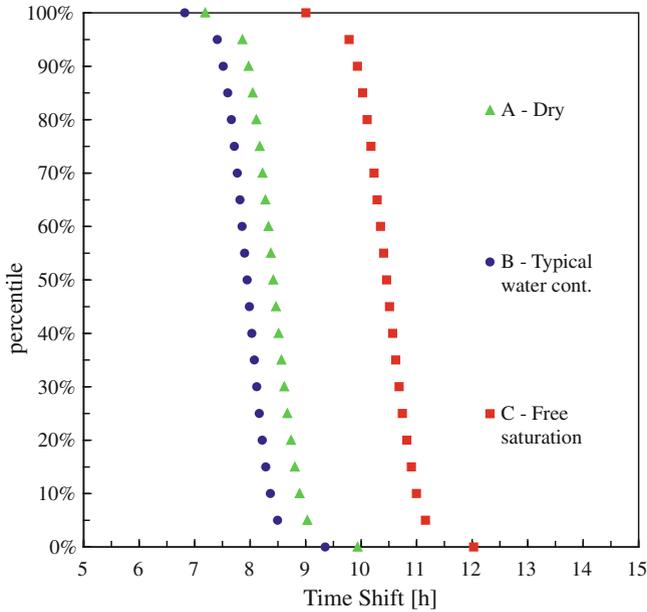
Fig. 26 Time shift for conditions *A* (dry materials), *B* (materials with their typical moisture content), and *C* (materials with their maximum moisture content in free saturation). Typical and maximum moisture content according to Künzel [44]

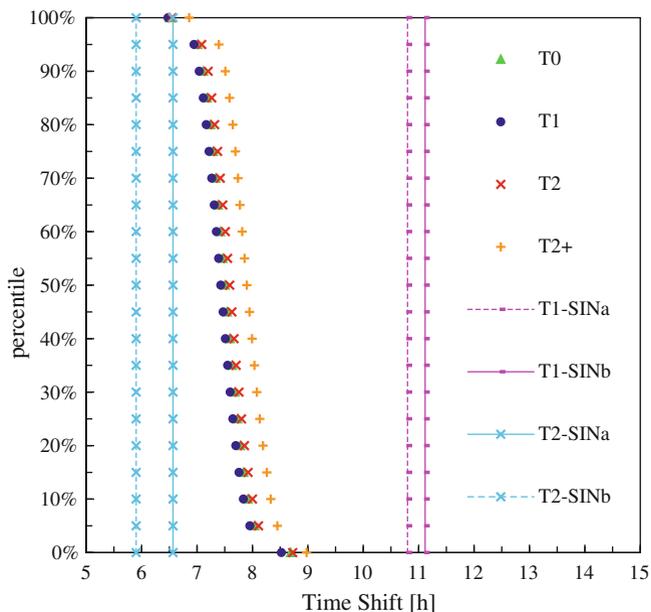
Fig. 27 Time shift for ageing times: measured (*lines*) and modelled (*plots*)

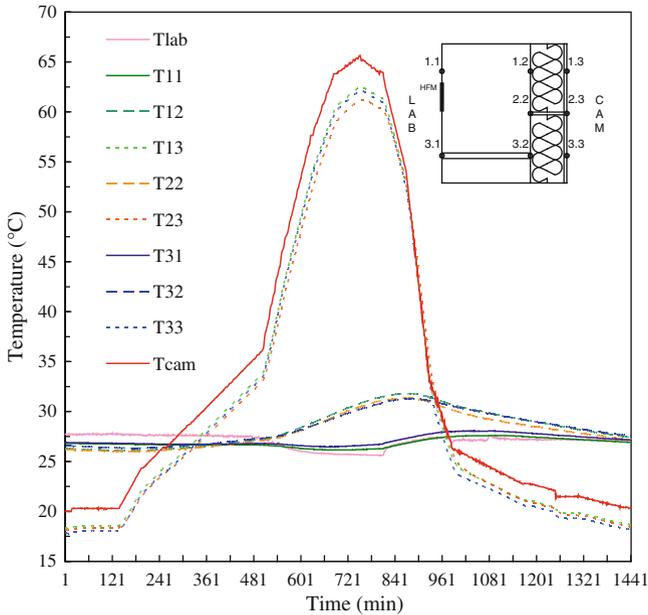
Fig. 28 Measurement of the temperatures within the section during test SINb, at ageing time T2

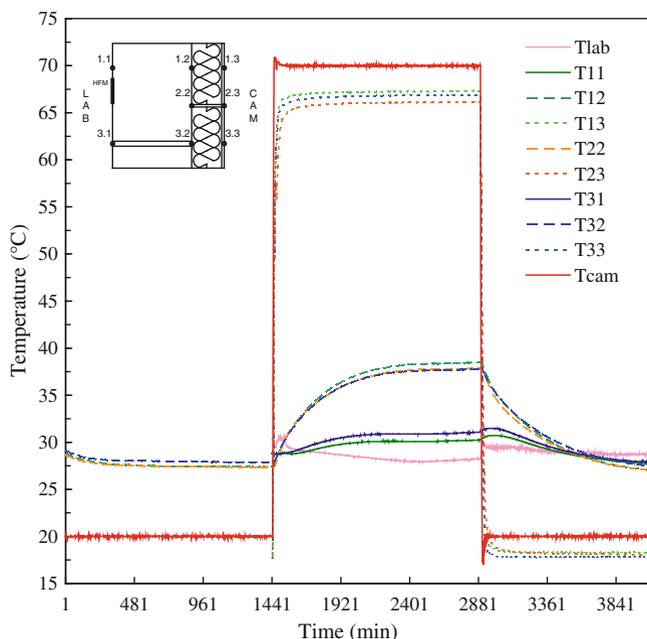
Fig. 29 Measurement of the temperatures within the section during test T1 at ageing time T2

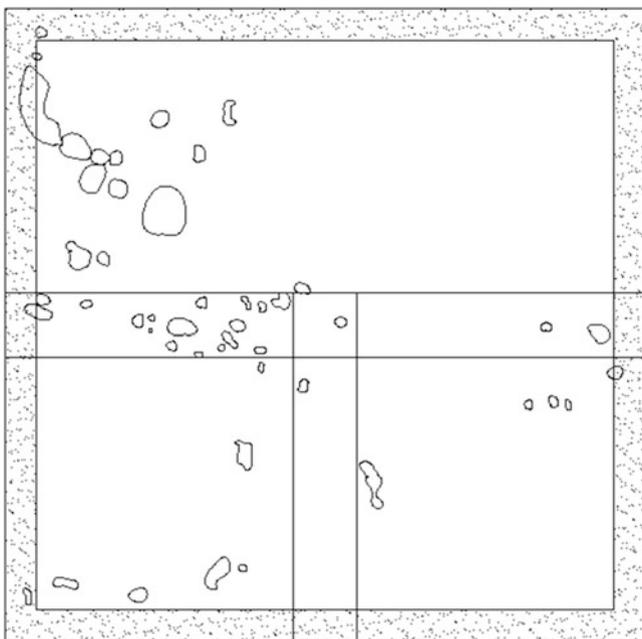
Fig. 35 Distribution of blisters over the surface of the sample at ageing time T2

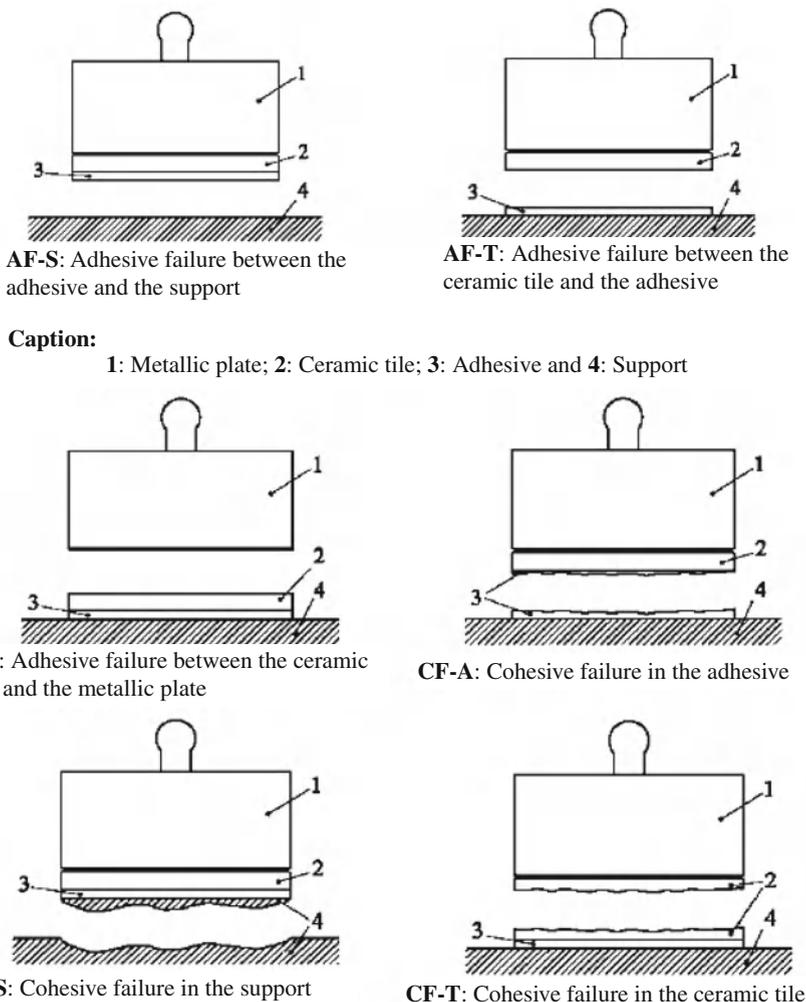
Fig. 7 Types of failures (EN 12004 [2])

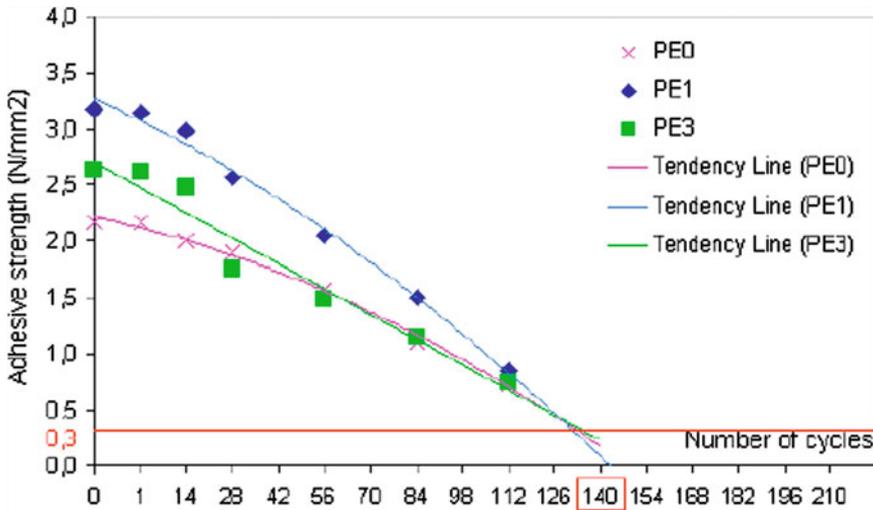
Fig. 8 Service life term prediction for C2 cementitious adhesive

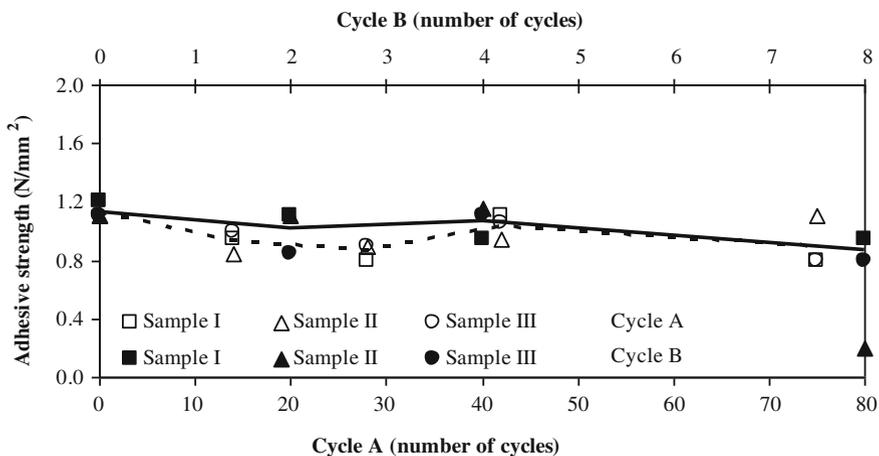
Fig. 15 Pull-off test results for the two ageing procedures (bonding system BA1)

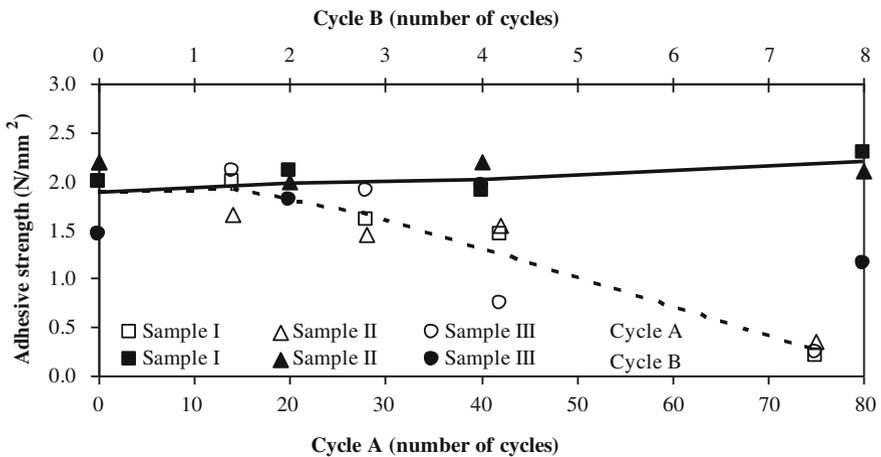
Fig. 18 Pull-off test results for the two ageing procedures (bonding system BA2)

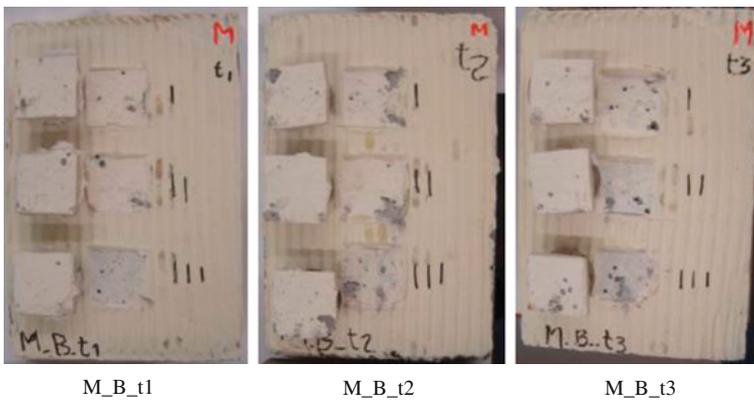
Fig. 23 Type of failure—Cycle B (bonding system M)

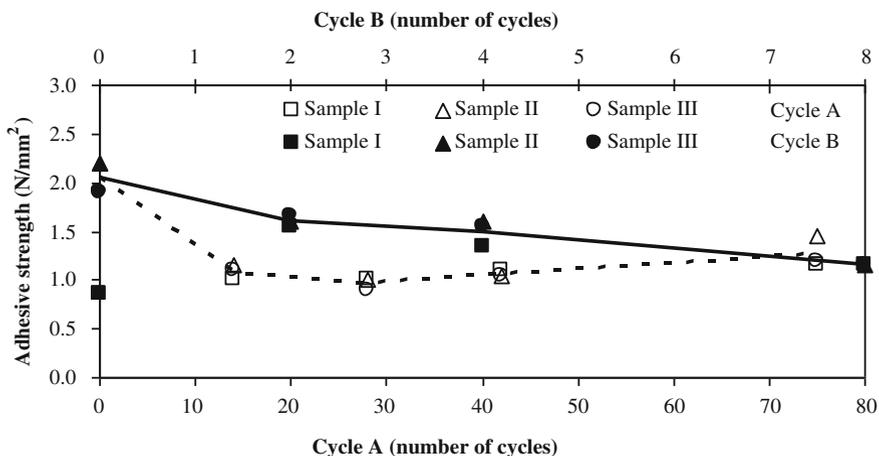
Fig. 24 Pull-off test results for the two ageing procedures (bonding system M)

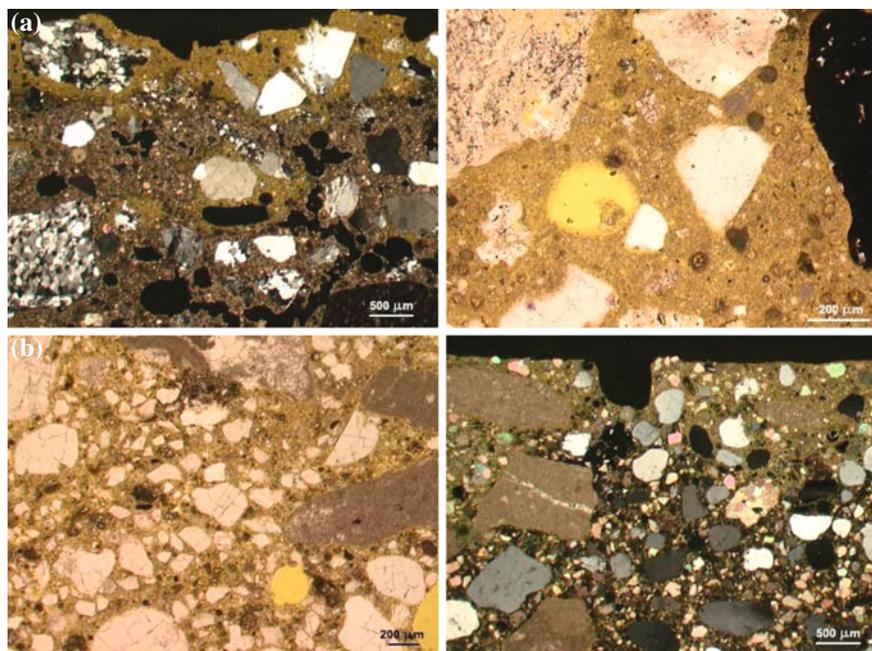
Fig. 1 **a** Mortar MA: carbonation front and irregular shaped porosity (*left*, CPL); not reacted C_2S particles dispersed in the binder's matrix (*right*, PPL). **b** Mortar MD: quartz and limestone aggregate and non homogeneous distribution of C_2S particles (*left*, PPL); carbonation front along the border (*right*, CPL)

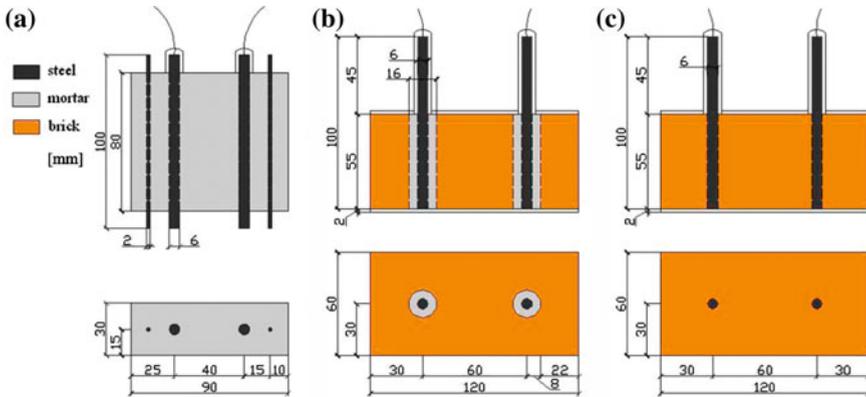
Fig. 2 Longitudinal section (*up*) and cross-section (*low*) of the specimens manufactured in the laboratory: (a) mortar sample (G, LG, LP and LCP) with 2 low carbon steel bars and 2 stainless steel wires; (b) composite brick and mortar sample (B + LG) with 2 low carbon steel bars embedded in a 5 mm mortar layer; (c) fired brick sample (B) with 2 low carbon steel bars. Dimensions in mm

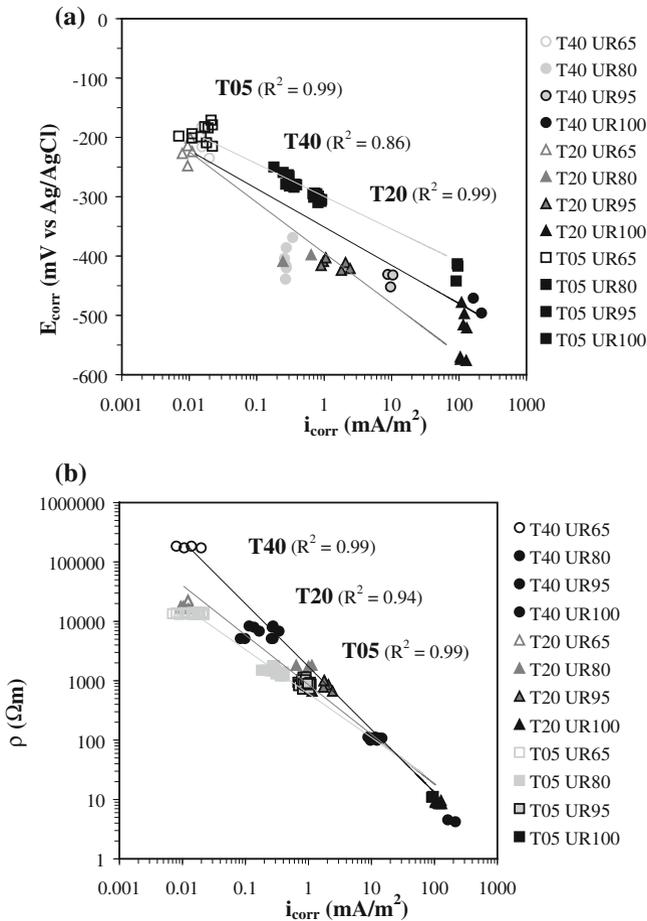
Fig. 15 **a** Relationship between corrosion potential, E_{corr} and corrosion rate, i_{corr} and **b** relationship between electrical resistivity, ρ and corrosion rate, i_{corr} in LG mortar during the exposure to various RH conditions. C2 refers to saturation.

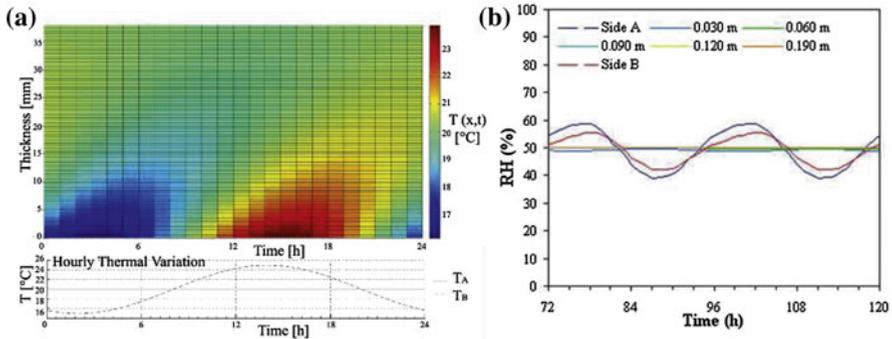
Fig. 18 **a** Thermal response of a 380 mm brick masonry wall to a sinusoidal variation, 24 h period on side A (down), constant on side B (up). **b** Hygrometric response of the same wall to a sinusoidal variation, 24 h period on side A (black curve), constant on side B (grey curve)

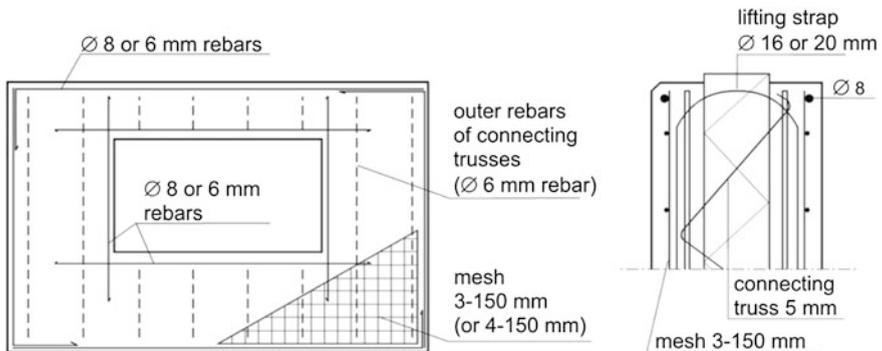
Fig. 1 Typical reinforcement of outer layer of a concrete façade panel

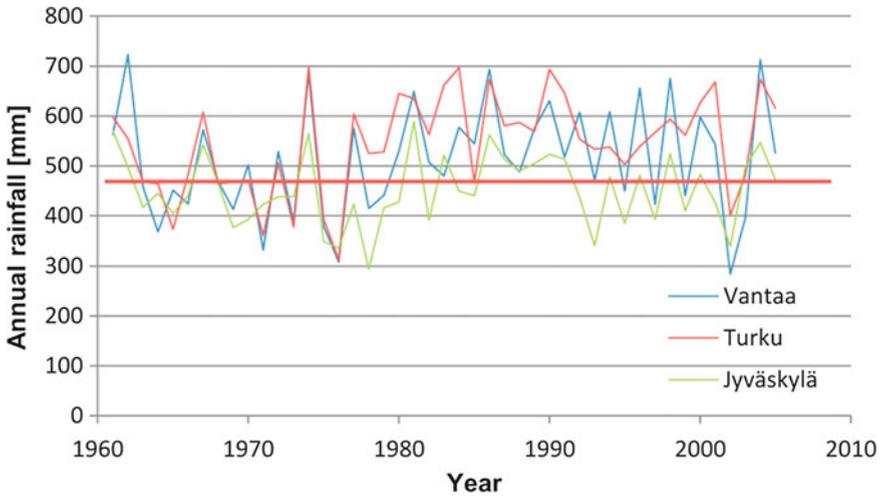
Fig. 6 Annual liquid precipitation in Jyväskylä (inland), Vantaa (south costal area) and Turku (coast line) between 1961 and 2005. The horizontal line expresses the annual rainfall that leads to a faster corrosion rate
