Geological Society Engineering Geology Special Publication No. 20

Coastal Chalk Cliff Instability

Edited by
R. N. Mortimore & A. Duperret

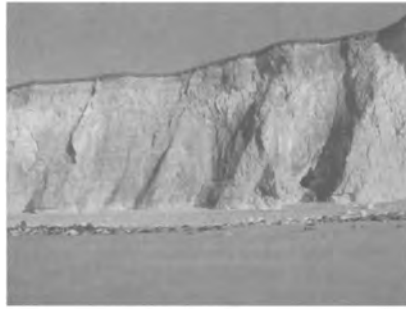
Quiberville, Newhaven Chalk, steeply inclined conjugate joints (pyramidal structure)

Fig. 11. Chalk formations with inclined conjugate joint sets on both sides of the English Channel (photographs R.N. Mortimore).

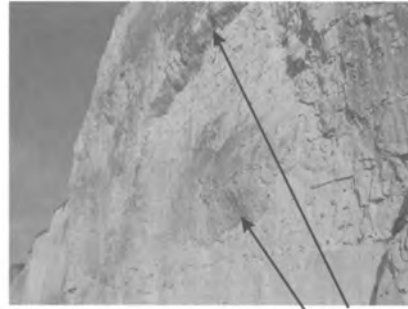
Quiberville, Newhaven Chalk, slickensides on steeply inclined conjugate joints (dip into face)

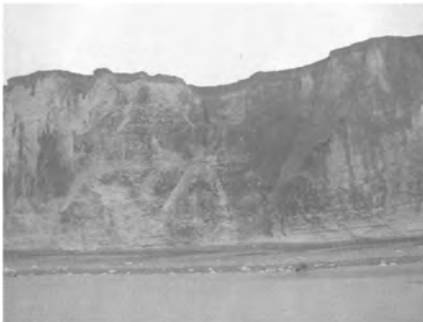
Veules-les-Roses, Newhaven Chalk, steeply inclined conjugate joints (pyramidal structure)

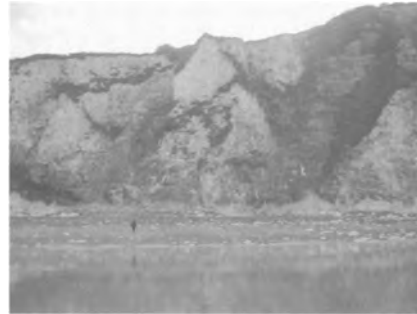
St Martin Plage, New Pit Chalk, steeply inclined conjugate joints (pyramidal structure)

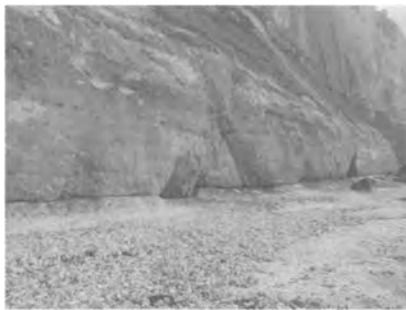
Senneville-sur-Fécamp, uppermost New Pit Chalk, Glynde Marls, steeply inclined conjugate joints and water flowing along Glynde Marl 1

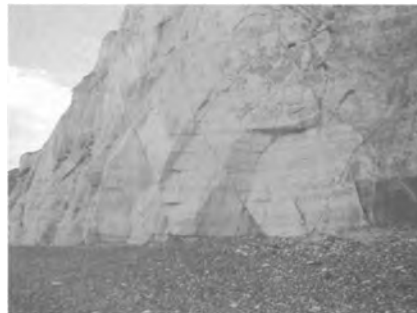
St Martin Plage, Holywell Chalk, steeply inclined conjugate joints. Note dihedral angle and frequency of joints compared to New Pit Chalk above

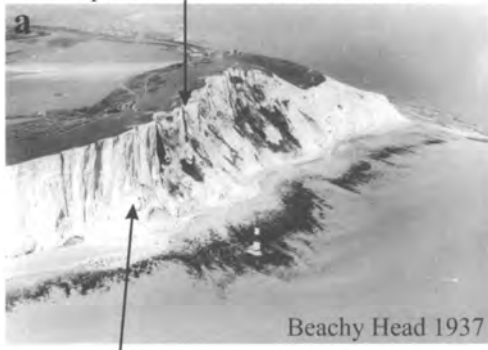
Vertical parts of cliff in Seaford Chalk

Location of cliff failure same as the Jan 1999 collapse

Fig. 14. Frequency and location of large rock falls at Beachy Head. Photographs (a) to (c) published with permission of Simmons Aerofilms. Photo (d) R.N. Mortimore.

Head Lighthouse (Figs 5, 12 & 13) are the highest and geologically most complex along the entire Sussex coastline. Large and small cliff failures are common. Big rock falls with a modest element of flow occurring perhaps once every 10–40 years.

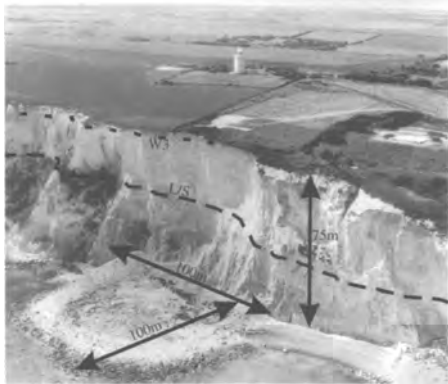
Historical failure 1961 L/H = 1.3 a low chalk flow

Large cliff falls at the South Foreland East Kent are in the same arrangement of Chalk formations, Seaford at top and Lewes at the base, as the Jan. 1999 failure at Beachy Head but in higher porosity (lower density) chalk

Fig. 15. Chalk flows and large rock-falls (geometrical from Hutchinson, 1988a); the Beachy Head (Sussex) cliff collapse, January 1999 and the South Foreland cliff collapse (Kent), 1961.

Large chalk falls close to the South Foreland, Kent, also occurred in a combination of Lewes and Seaford Chalk formations (Fig. 15). However, the behaviour of the debris is different, involving a greater extent of chalk flow creating a surrounding 'ridge' of larger blocks on the seaward side of the run-out (Fig. 15). Mortimore *et al.* (1990) illustrated the consistently lower density of the Chalk in Kent compared with Sussex, supporting Hutchinson's suggestion that the extent of run-out and any flow is porosity dependent.

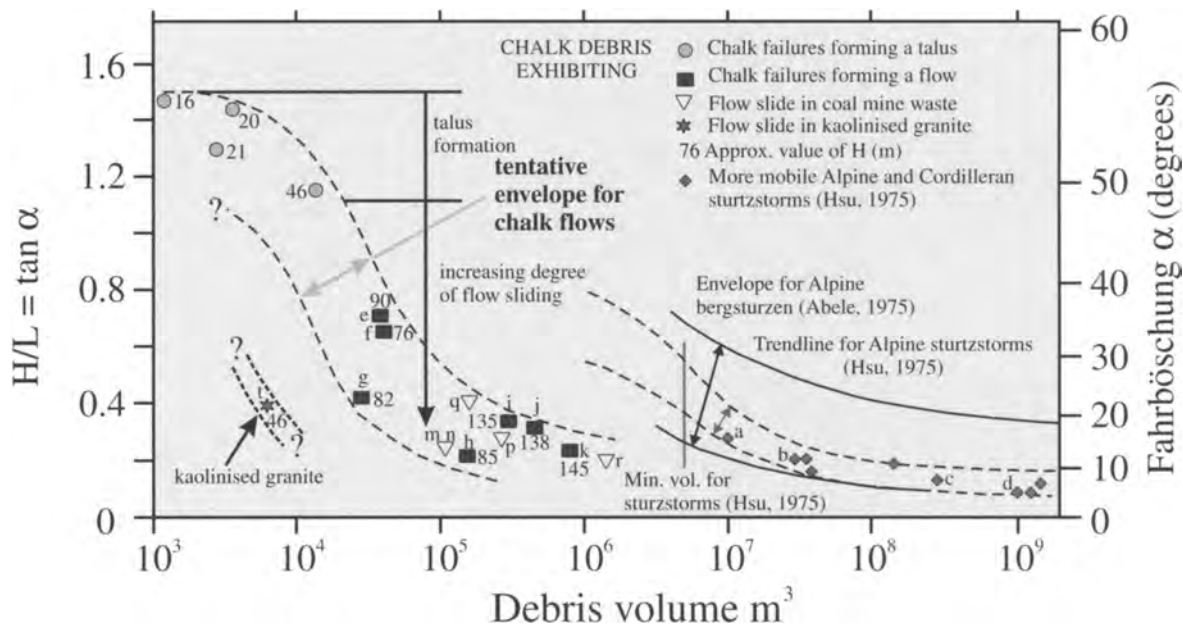
Fig. 19. Chalk flow slides and large rock falls in England. East Kent: Shakespeare Cliff (1909, 1912); f, h, St. Margaret's Bay (1910, 1905); i, j, Abbot's Cliff (1988, 1911); k, Folkestone Warren (1915). Note prior to 1988 no flow slides were recorded in Sussex chalk. Three large rock falls with an element of flow have been recognized: 1, Beachy Head January 1999; 2, between Beachy Head and Belle Tout, 1988; 3, between Birling Gap and Cuckmere Haven, 1914 ($105\,000\text{m}^3$) and 1925 ($266\,100\text{m}^3$) Hutchinson 2002. Several other large rock falls include Beachy Head, February 1813 ($235\,000\text{m}^3$), March 1848 ($105\,000\text{m}^3$) 140 m wide, 15 m encroachment, March 1853, 1862; Summer 1956 at the Head; June 1960 at the Head; Autumn 1960 a large fall east of the Head (Gilbert 1964); Seaford Head 15 July 1986 90 m wide and 15 m encroachment; Friars Bay 1899 (Rowe 1900) 'a great fall of chalk'; February 1891 (10 000 tonnes) broke the cliff-top road between Brighton and Newhaven (Geikie 1893); South Foreland, Kent, 1960 and 2001. Data (supplemented) from Hutchinson (1988a, 2002).

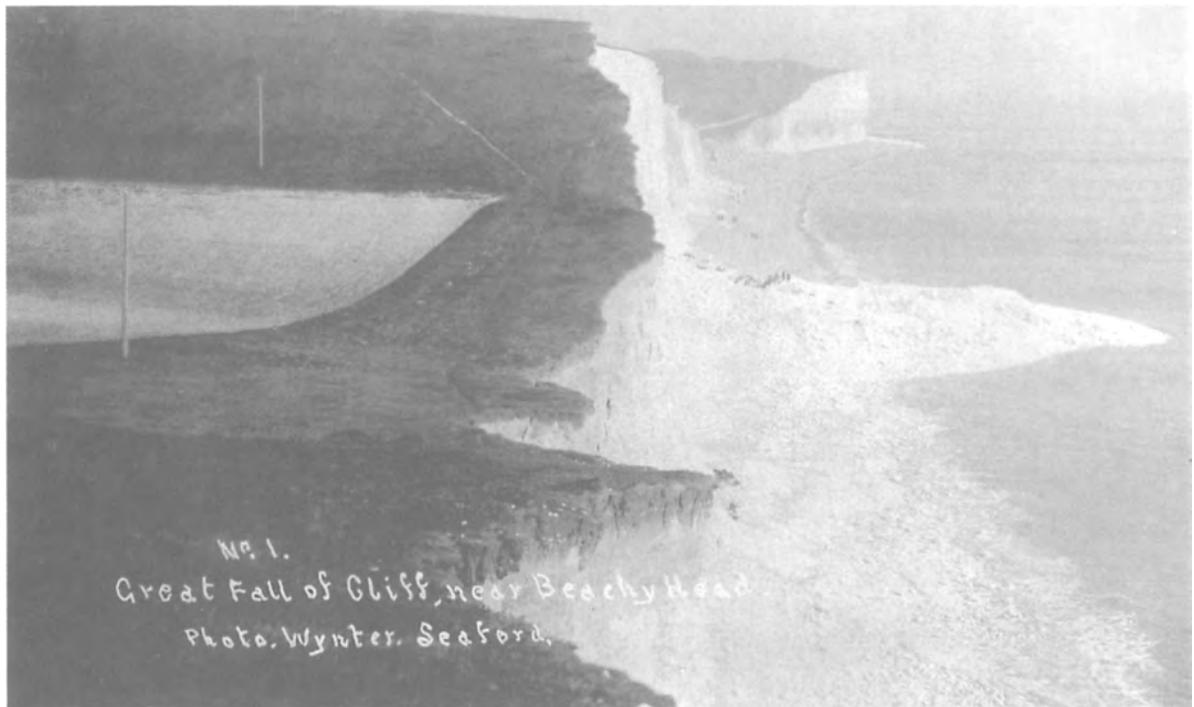
Fig. 2. Distant view of the 1914 cliff fall at Went Hill. The first in a series of at least four contemporary postcards published by Wynter of Seaford.

Contemporary estimates of the length of runout are contradictory. The *Sussex Daily News* reported that 'the fall extended from the base of the cliff sixty or seventy yards out to sea' (55–64 m), whilst the *Eastbourne Gazette* asserted that it 'extended about 150 feet towards low-water mark' (45 m). The Wynter photograph suggests that even the *Daily News* estimate was a little conservative, perhaps because the reporter did not visit the site until after the waves and tide had removed the seaward extremity of the fall. The length of runout can be estimated from the Wynter photograph using as a scale either (1) the height of the cliff, (2) the size of the spectators or (3) the width of the shore platform:

- (1) In 1914 the cliff top at Went Hill was, as today, about 44–45 m high (see the 1909 edition of the Ordnance Survey 1:2500 map, Sheet LXXXII.3). The run-out in Figure 2 appears to be about 1.8 times the height of the cliff or about 70–80 m. However, it is difficult to determine the true position of the base of the cliff because of the awkward perspective and masses of fallen debris. Also, the top of the cliff is ill defined in the photograph.

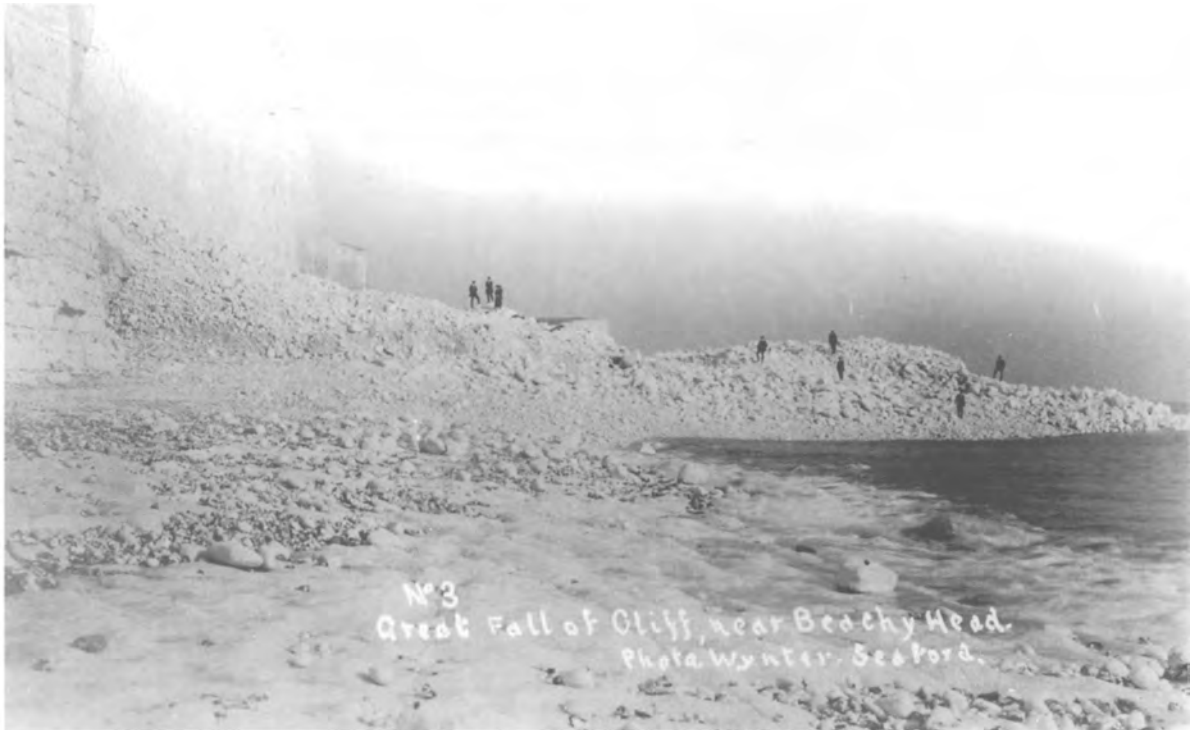
Fig. 3. The third of Wynter's postcards, showing the fall in close up.

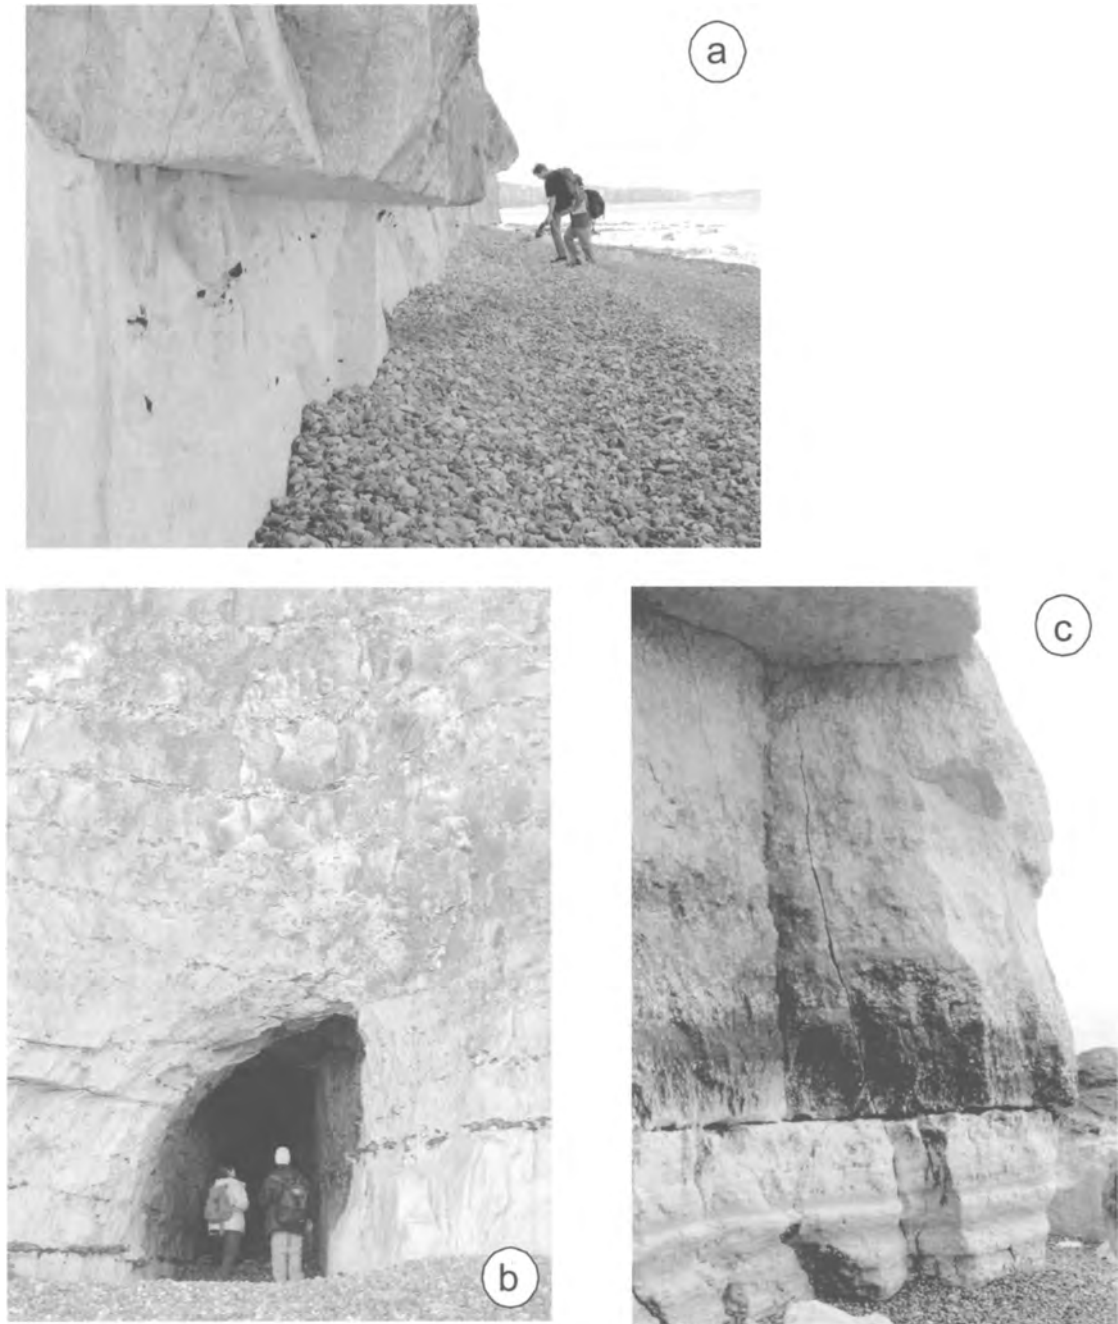
Fig. 3. (a) Basal notching at the toe of the chalk cliff, which is clearly evidenced by the retreat of the cliff and the white colour of the washed chalk. Noted the shingle occurrence. The person gives an approximate scale. Veules-les-Roses, Upper-Normandy, France. (b) Large-scale fracture (Normal fault in-filled by clays) expanding all over the cliff height, ending by an open cave at the toe of the cliff. Note the associate excavation of the cliff face. The person gives an approximate scale. Veules-les-Roses, Upper-Normandy, France. (c) Horizontal and vertical cracks at the base of the cliff. The horizontal fissure is located at the top of a hardground level and the vertical crack is an open joint. Note that the base of the cliff is more white, due to washing by sea-water during high tide. Fécamp, Upper-Normandy, France.

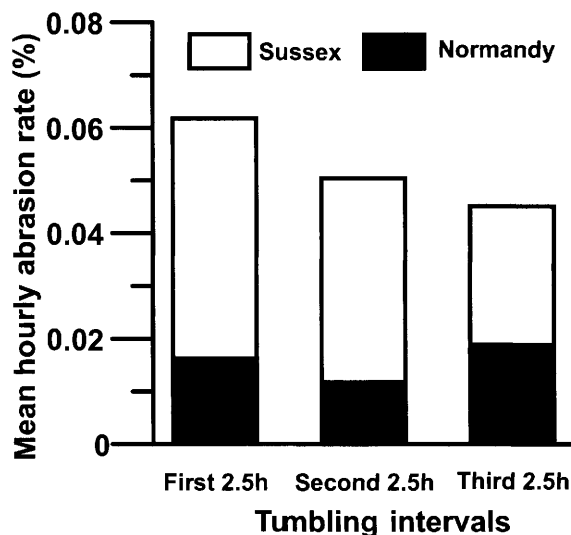
Fig. 7. Abrasion rates for three successive tumbling intervals of 2.5 hours each, averaged over all samples from Normandy and Sussex included in the main experiment.

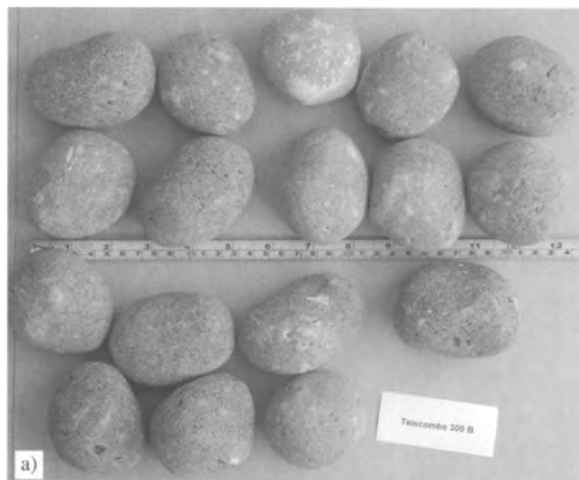
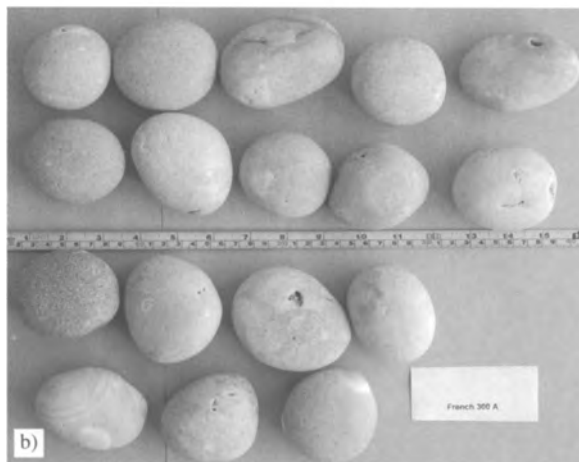
Fig. 8. Visual comparison between the samples (a) Sussex E and (b) Normandy E.
