GEO-VELOPMENT

THE ROLE OF GEOLOGICAL AND
GEOTECHNICAL ENGINEERING IN
NEW AND REDEVELOPMENT
PROJECTS

GEOTECHNICAL PRACTICE PUBLICATION NO. 5

PROCEEDINGS OF THE 2008 BIENNIAL GEOTECHNICAL SEMINAR

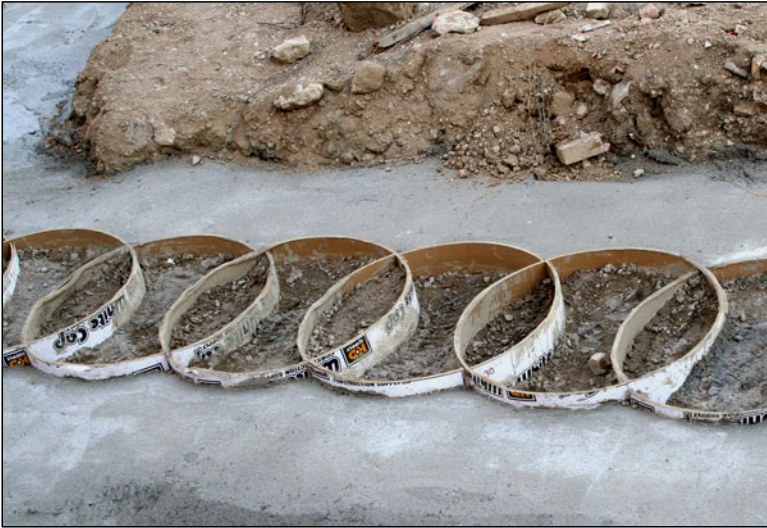
Figure 3: Secant Wall Template

application. A secant wall is constructed by installing a series of overlapping drilled pier foundations. To install the wall, a template is placed on the ground surface (Figure 3), and even numbered piers are drilled through the overburden soil and into

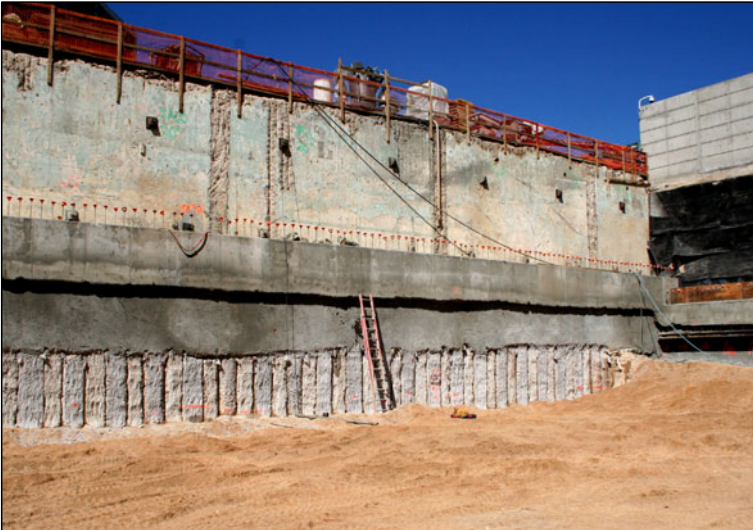
Figure 5: View of postal facility basement and secant walls 3 meters (10 feet) below groundwater elevation (the EPA Building is to the right).

Upon excavation to the lowest basement level, the wall itself was found to be structurally continuous, and relatively impervious, effectively cutting off the majority of groundwater to the interior of the excavation (Figure 5).

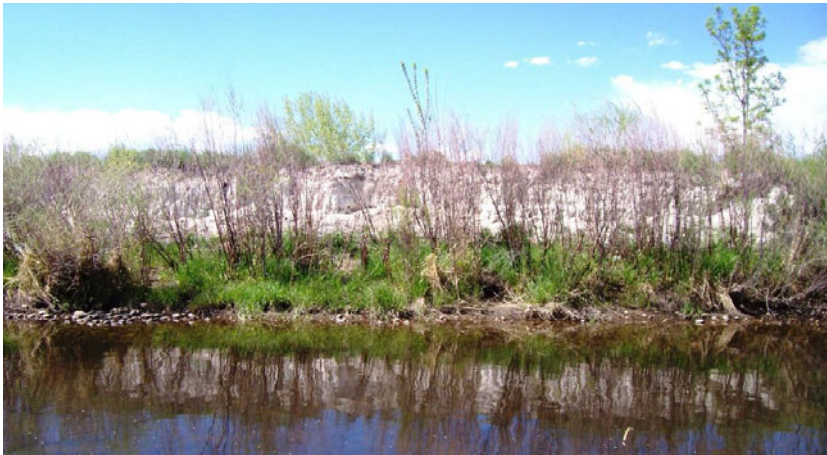
FIG. 3. Beet spoil slurry deposit exposed on the north bank of Cache la Poudre River, Fort Collins, CO.

Spoil piles we observed were fairly clean, white to gray in color, and look like a chalky in appearance. Beet spoils that had been transported away from the processing plants often covered large expanses of ground ranging from less than approximately 4,000 square meters (1 acre) to several square kilometers (100 acres). In the Fort Collins, CO area, beet spoil deposits have been observed within a 6.5-kilometer (4 mile) radius of a processing plant. The spoils are typically distributed in the form of slurry that was flooded onto fields or low-lying areas and allowed to dry. The deposits exposed along the Cache la Poudre River and adjacent areas range from less than 0.3 meter (1 foot) thick up to 4.5 meters (15 feet) thick (Figure 3). The beet spoils that were deposited as slurry range from fairly clean deposits that are white to gray in color to deposits mixed with, or leached into, native soils. The mixed deposits were often gray to light brown in color. Typically, only the lower 0.3 to 1 meter (1 to 3 feet) of beet spoils are mixed with native soils. Vegetation in areas of beet spoils is typically sparse compared to adjacent areas with no spoils.

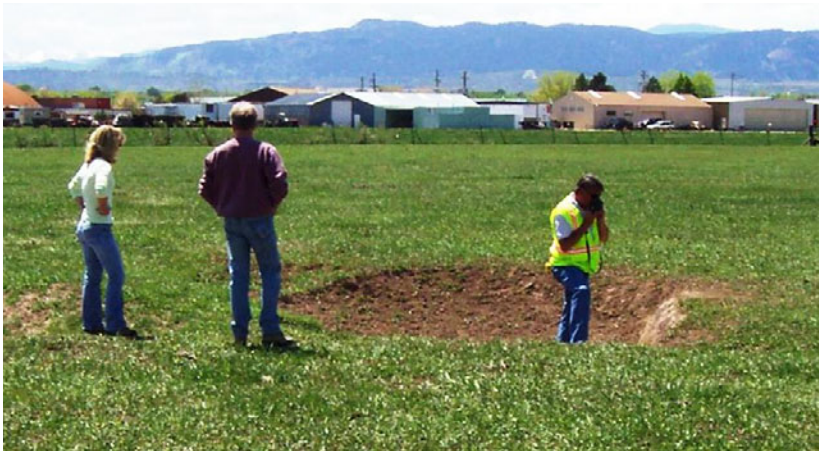
FIG. 4. Large sinkhole features in beet spoil slurry deposit, Fort Collins, CO.

During our investigations, we conducted several site visits to areas with beet spoil deposits. Typically, these areas were relatively flat and often occupy flood plains adjacent to active river systems and lowland areas, prime for distribution of spoil slurries. In several cases, we observed sinkholes and piping features, some of which have significantly affected site improvements. At a location in Fort Collins, CO, we observed conical sinkhole features ranging from less than 0.3 meter (1 foot) to 15 meters (50 feet) in diameter (Figure 4). The depths of the sinkhole features observed ranged from less than 0.3 meter (1 foot) to 1.3 meters (4 feet). The depth of these features appeared to be controlled by the depth of the beet spoil deposit and the depth to ground water. It appears the mechanism for sinkhole formation is removal of beet spoil materials through piping, by solution or transportation (Figure 5). At one location, we observed surface water entering a pipe feature (Figure 6).

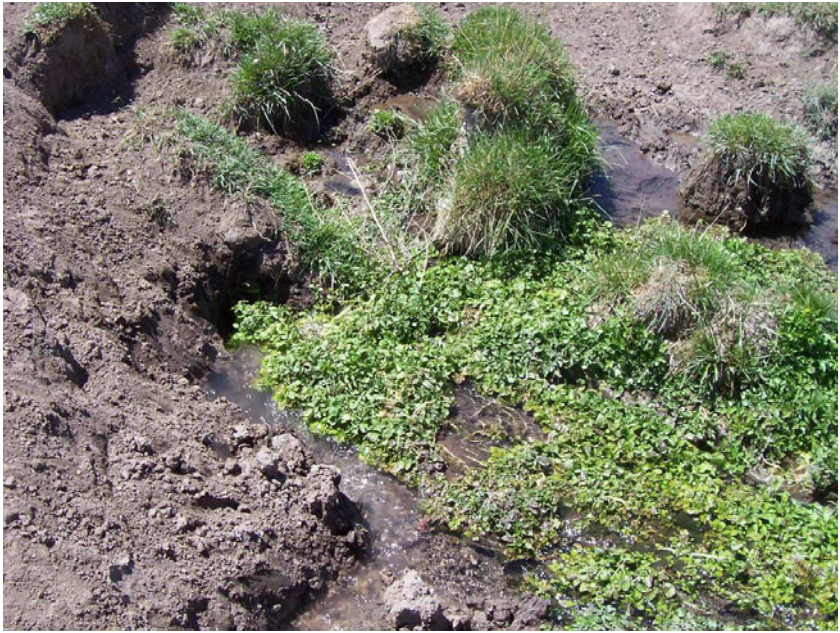
FIG. 6. Surface water entering piping feature in beet spoil slurry deposit, Fort Collins, CO.

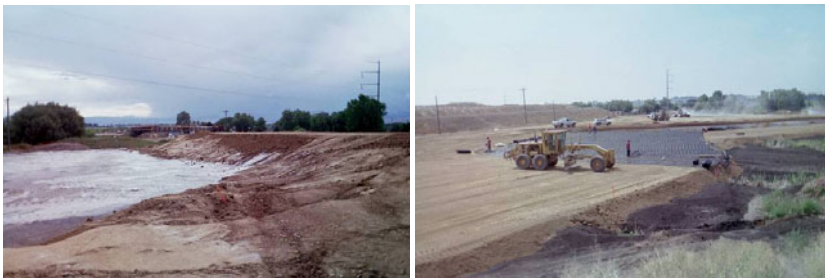
FIG. 7. Construction of roadway embankment over beet spoils and stabilization of subgrade using Geogrid.

occurred in Longmont, Colorado. The Colorado Department of Transportation (CDOT) needed to construct a 4.5 meter (15 feet) high embankment, which would support a rigid pavement. They needed a cost-effective solution that would mitigate differential settlement to avoid excessive pavement cracking. Geogrid was selected for incorporation in the embankment to solve this challenge (Figure 7).

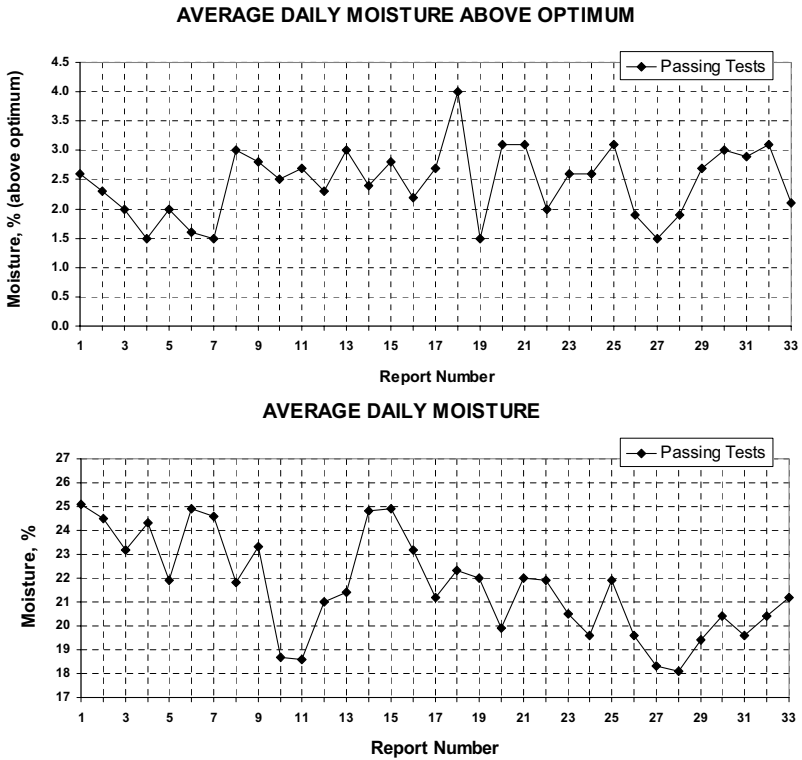
FIG. 1. Daily Moisture Content and Deviation from Optimum

Full time observation and testing by the geotechnical consultant is normally required on over-excavation modification projects. Tracking daily variation in moisture content with maximum variation specified is normal. A graph of variation of average moisture content against compaction report number is shown on Fig. 1. In addition, thin wall tube samples (hand drive samples) are obtained frequently to confirm percent swell and provide a check of nuclear moisture/density tests. The field quality tests are reviewed both daily and weekly to evaluate the likely performance characteristics of the stabilized fill.

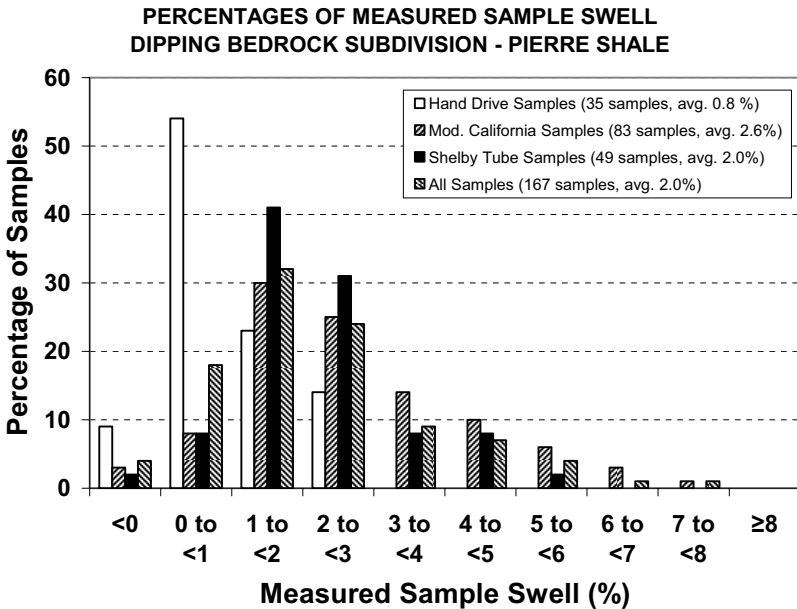
FIG. 3. Comparison of Sample Swell

After completion of the site grading, borings were drilled on each lot. These borings were sampled using both a modified California barrel and 76mm (3.0 inches) Shelby tubes. A comparison of swell test results using the three different sampling methods is shown on Fig. 3.

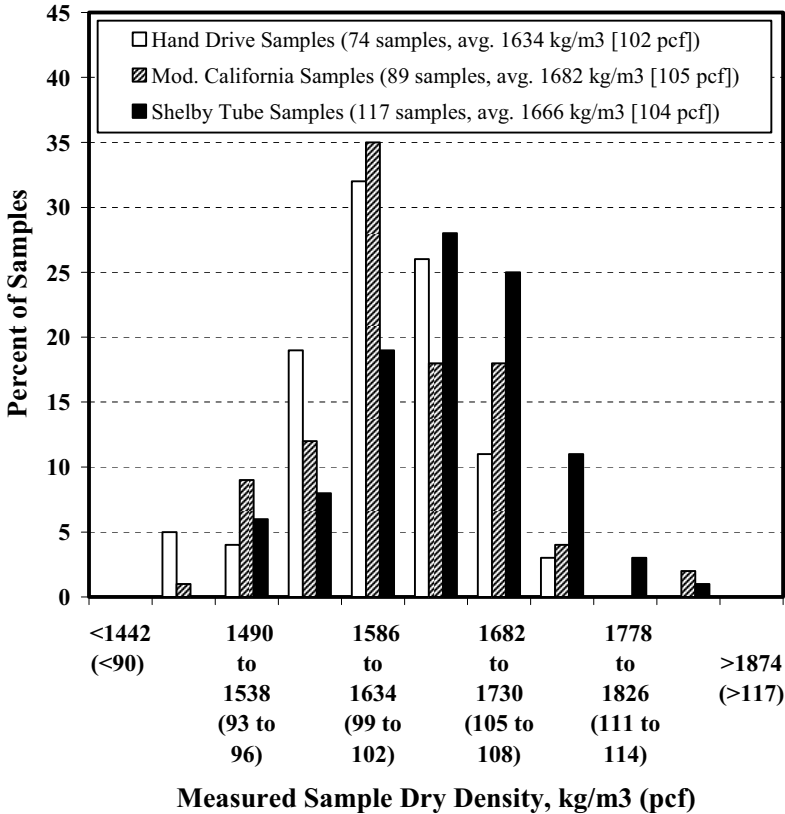
FIG. 4. Comparison of Sample Dry Density

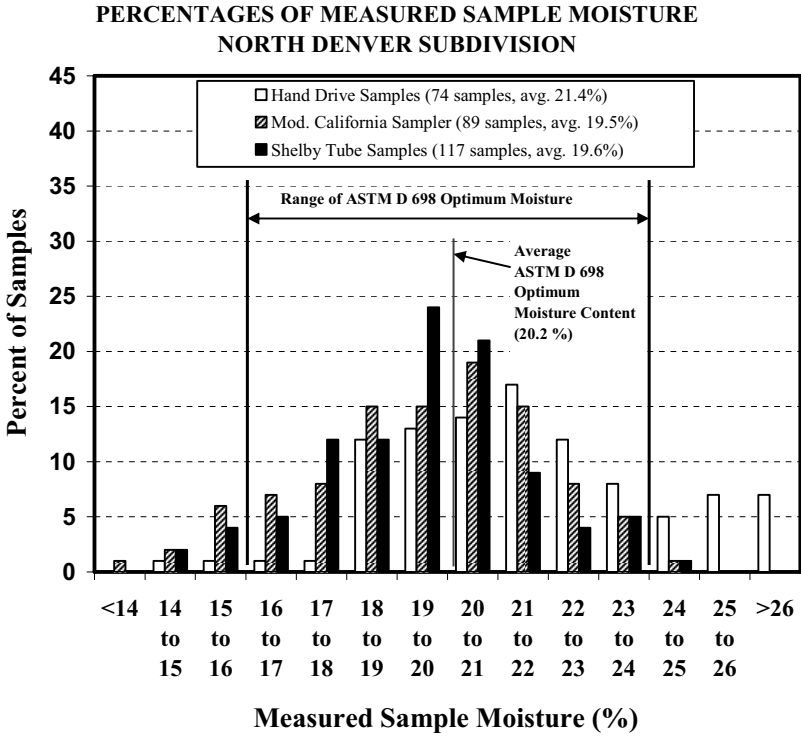
FIG. 5. Comparison of Sample Moisture Content

Excluding the very sandy materials, the average optimum moisture content for the Proctor tests was 19.7 %. Distribution of sample moisture content is shown on Fig. 5. The average moisture content for all samples is 20.2%. The hand drive samples averaged 21.4% which corresponds well with the nuclear field moisture content data.

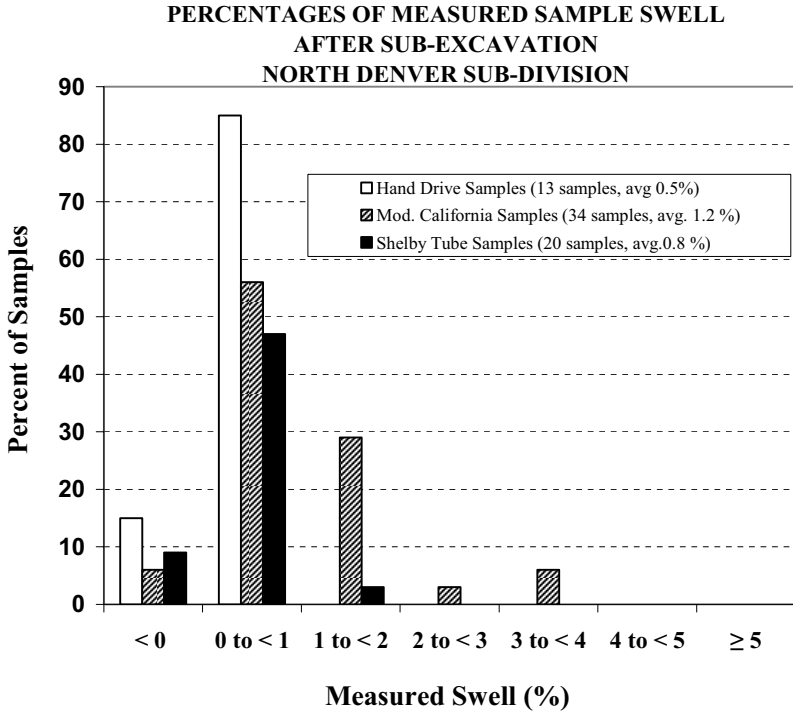
FIG. 6. Measured Swell After Sub-Excavation

Liquid limits for some of the claystone samples were near or above 50 percent with plasticity indexes of 28 to 36 percent. The average optimum moisture content and range for optimum as determined by the Proctor tests is shown on Fig. 5. Distribution of swell test results is presented on Fig.6. Pre-construction swell potential by depth is compared to swell potential by depth after modification on Fig. 7.

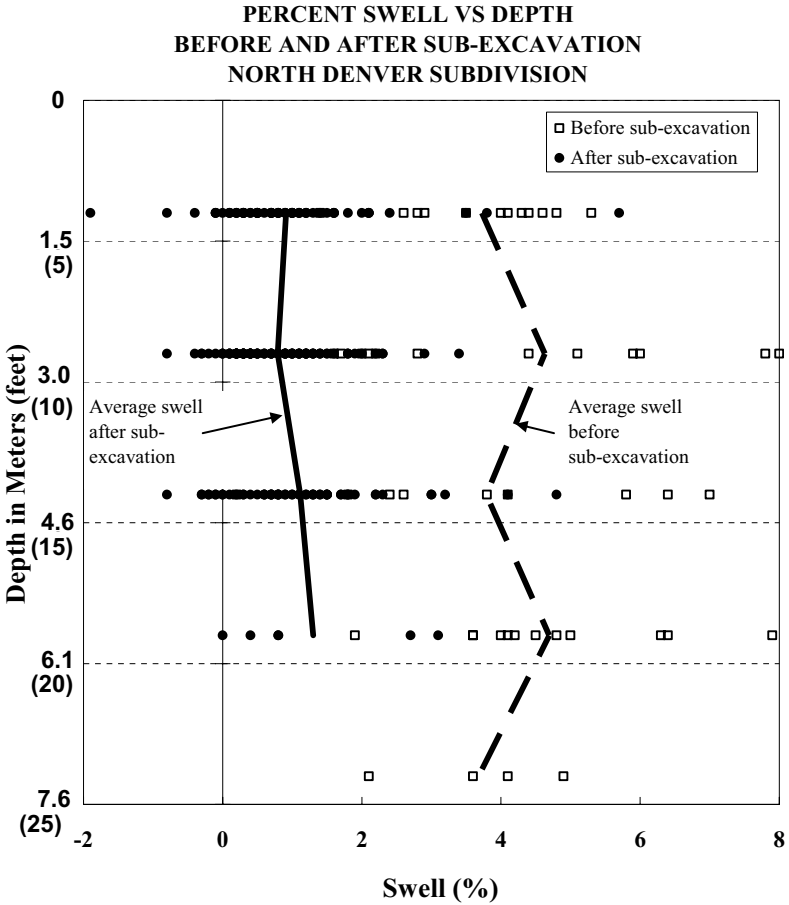
FIG. 7. Comparison of Swell Before and After Sub-Excavation

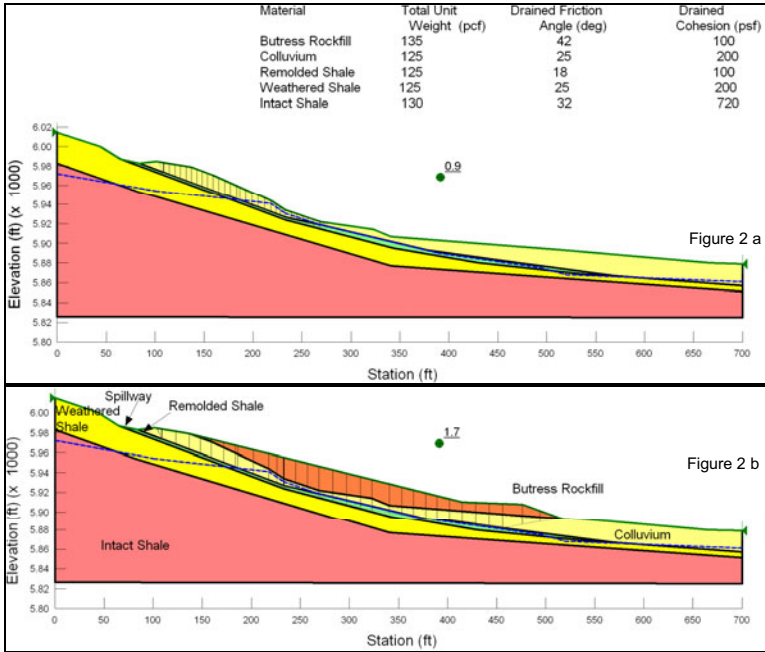
FIG. 2. Analyzed Section of the Slide

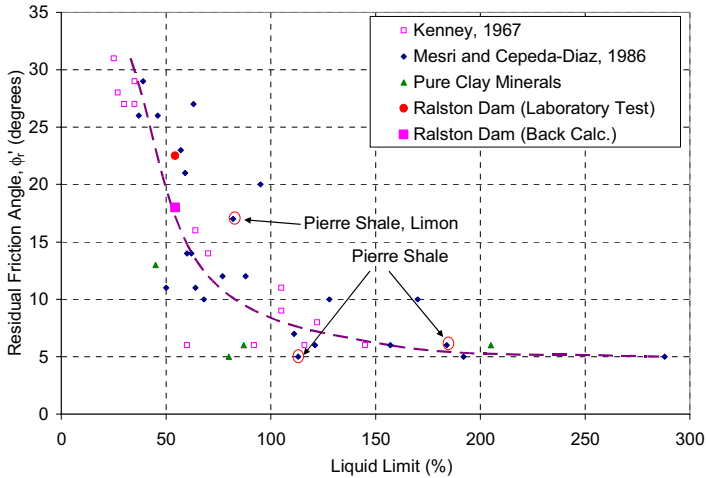
FIG. 3. Relationship Between Residual Friction Angle and Liquid Limit [adapted from Mesri and Cepeda-Diaz, (1986)]

Liquid limit (LL) is a function of particle size, platiness and mineralogy. There is an inverse correlation between residual friction angle and liquid limit as provided in Mesri and Cepeda-Diaz (1986) and as adapted in Figure 3. Ralston Dam foundation laboratory test results generated 42, 54, 56, 57, and 62 as potential values for the LL. The average LL value of 54 is shown in Figure 3 as the representative value for the Ralston Dam spillway foundation.

failure plane. This analysis yielded $\phi_r' = 18$ degrees as the probable residual friction angle and is shown as “Ralston Dam (Back Calc.)” in Figures 3, 4, and 5.

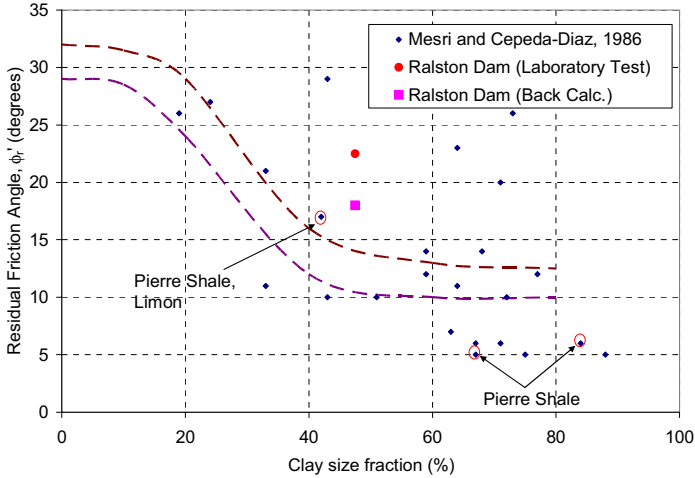
FIG. 4. Relationship Between Residual Friction Angle and Clay Fraction [adapted from Mesri and Cepeda-Diaz, (1986)]

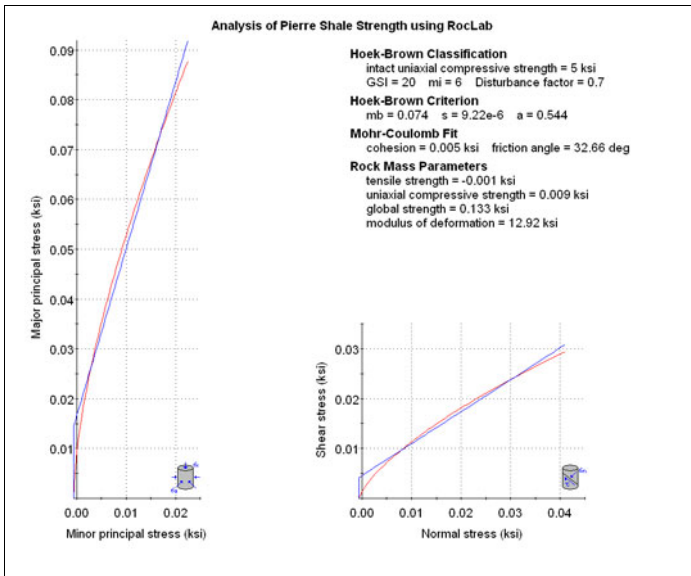
FIG. 6. Pierre Shale Strength Estimate from RocLab.

Finally, based on engineering experience and available literature (Hoek and Bray, 1981) 32 degrees was selected as the peak friction angle of the shale mass for the stability analysis (Figure 5). Additional calculations using the data presented by Mesri and Cepeda-Diaz (1986) indicate that the intact strength of Pierre Shale and Bearpaw Shale reduces 48% to 76% from peak to residual conditions. For Pierre Shale from Limon, Colorado the strength reduction was 48%. Strength reduction observed in the Ralston study was also $[1 - \tan(18)/\tan(32) = 0.48]$ 48%, which is within the expected range of reduction values.

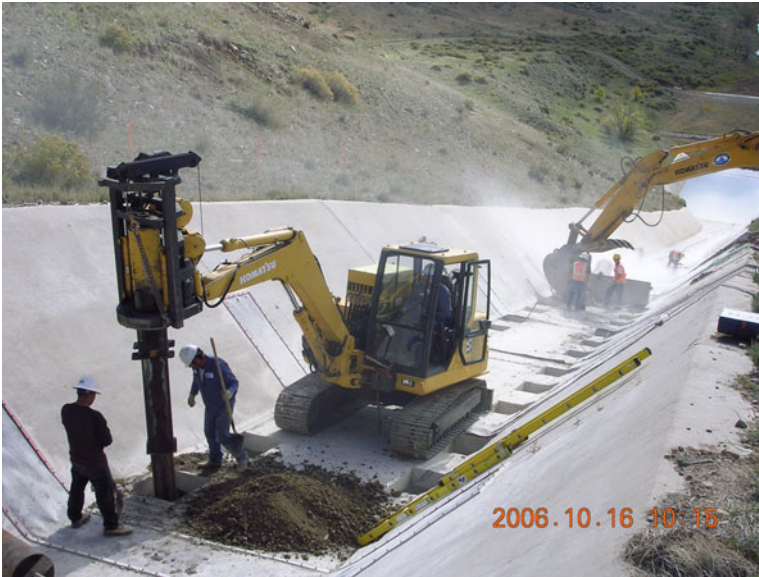
Photo 1. Drilled Pier Installation

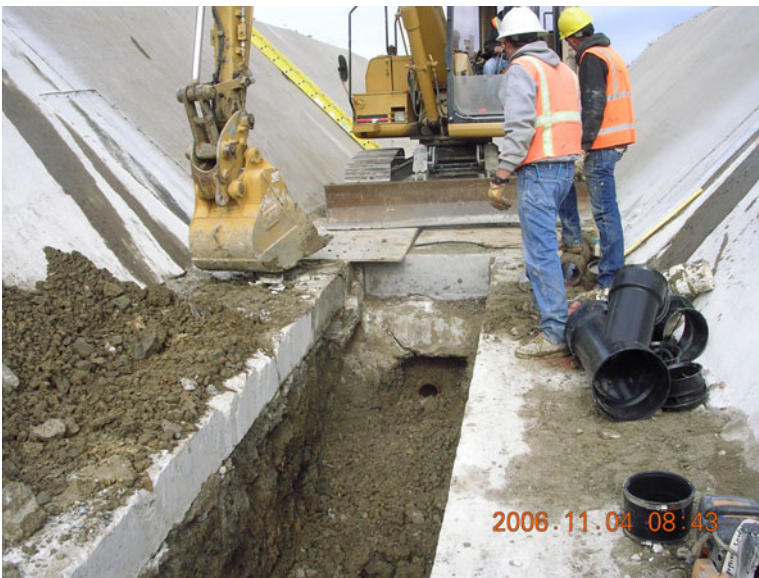
Photo 2. Underdrain Replacement

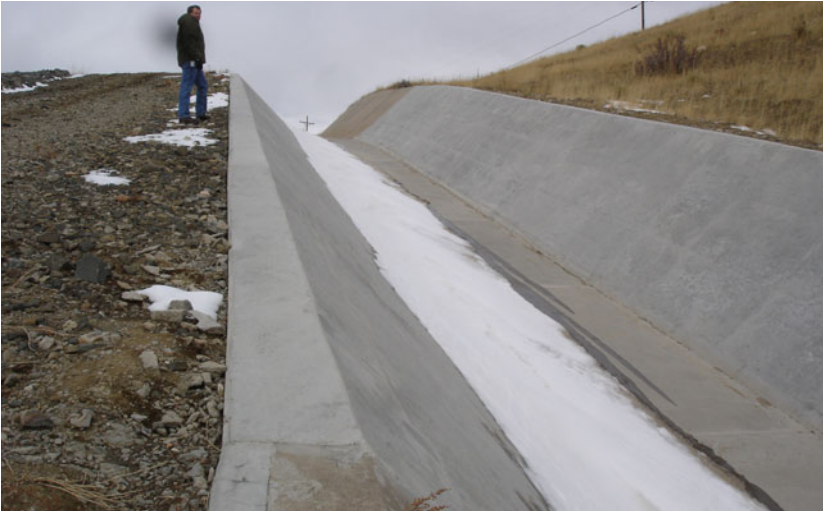
Photo 5. Repair area with no translation or deformation

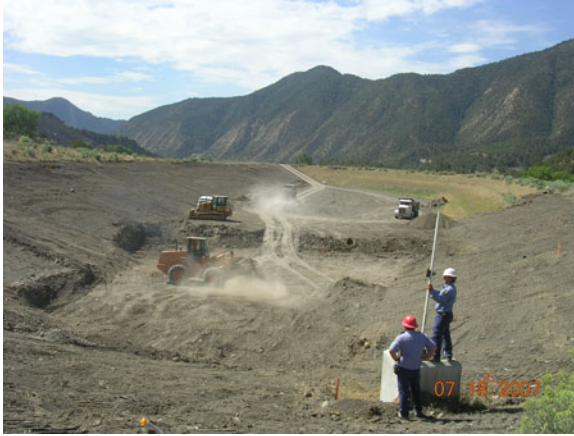
Excavation for Construction of the Soil Filter

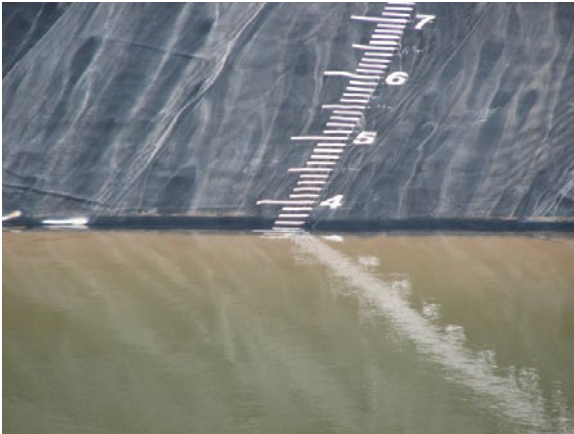
Staff Gauge During Initial Fill of RCC Reservoir No. 1

The original staff gauge installed prior to this project was designed to accommodate 18-inches of riprap that was never placed. The gap beneath the staff gauge and the embankment slope exposed it to damage resulting in reservoir level reading inaccuracies. As part of this project, a new staff gauge meeting SEO requirements, was installed on the geomembrane liner near the outlet works. Numbers and elevation “ticks” were cut out of white Hypalon material and permanently affixed to the black geomembrane liner. Whole numbers and elevation ticks at tenths foot increments were placed based upon surveyed elevations along the exposed liner slope.

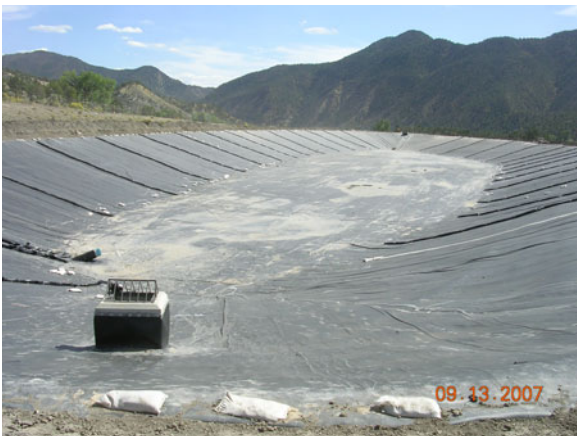
RCC Reservoir No. 1 with Hypalon Liner Installed

Prior to installation of the geomembrane liner, the subgrade of the reservoir basin and upstream embankment slope was prepared by removing sharp rocks, branches and trash prior to rolling with a smooth drum vibratory compactor. A 0.45 kg (16 oz) geotextile fabric between the subgrade and geomembrane liner was installed to help protect the liner from puncturing during construction and reservoir operations.

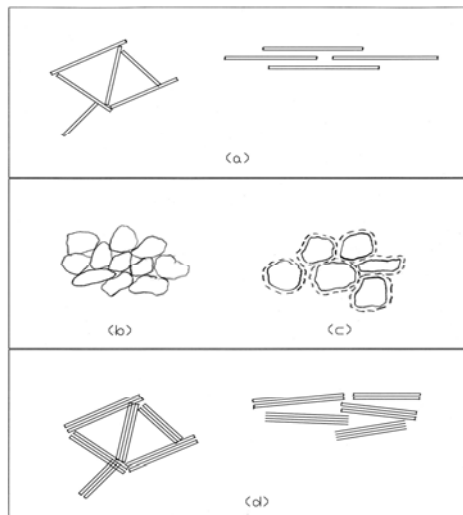
Figure 2 Schematic representations of particle arrangements

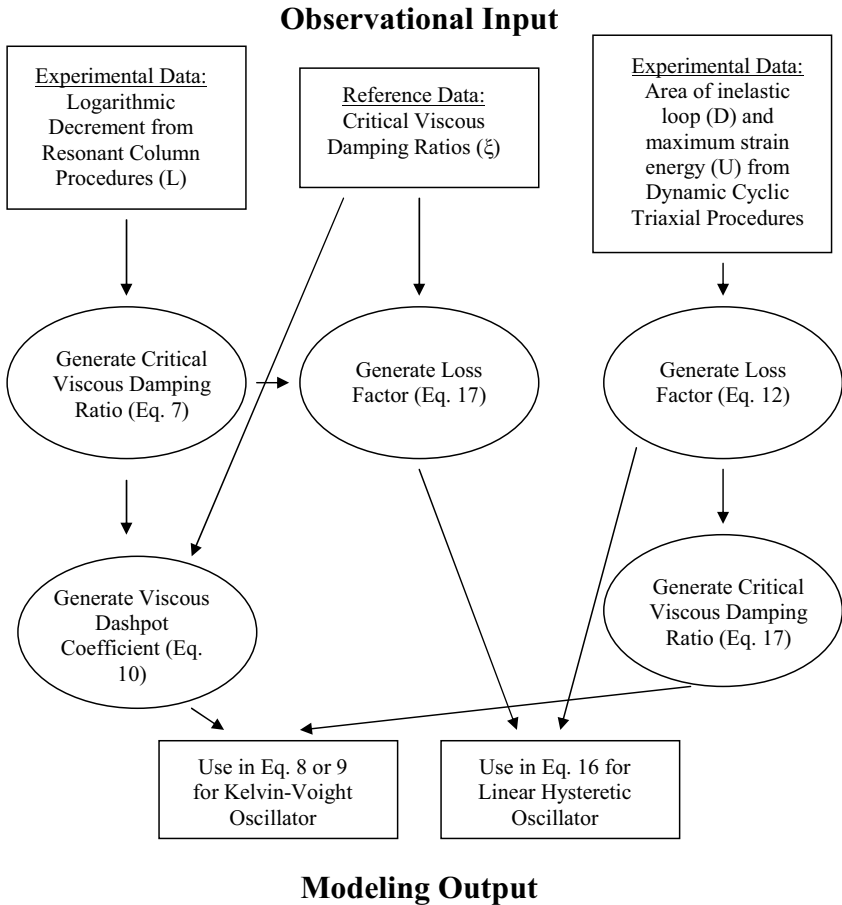
FIG. 2. Flowchart for Using Observed Geotechnical Data in Equivalent Linear Models of Intrinsic Damping.

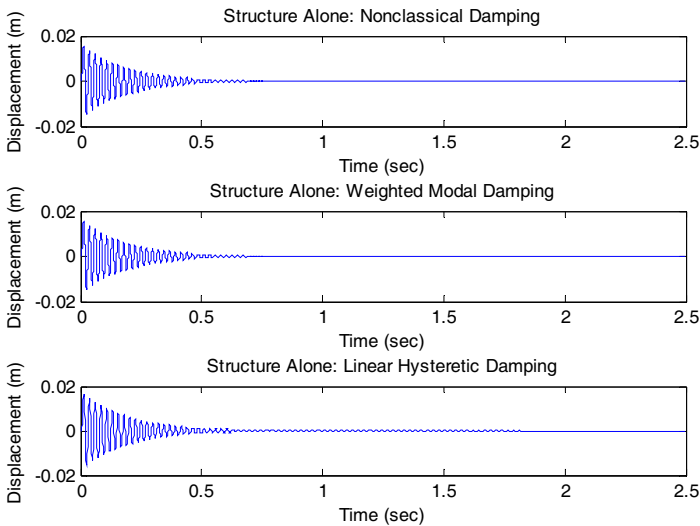
FIG. 4. Comparison of Dynamic Responses for the Structural System Alone.

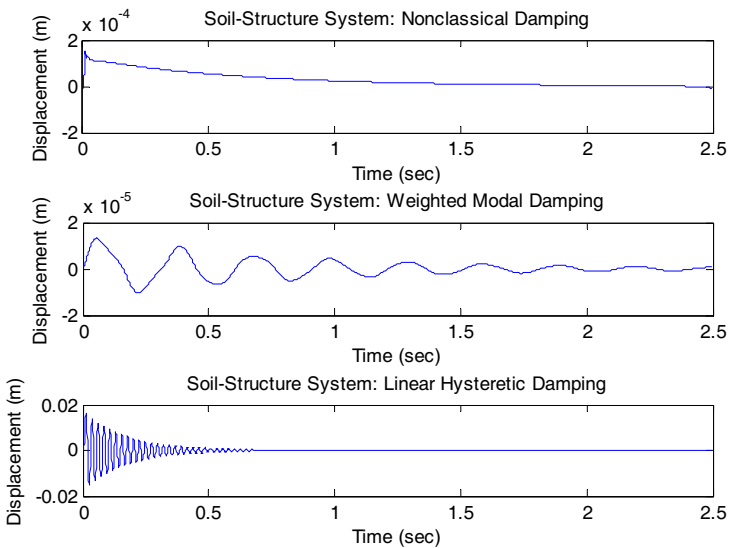
FIG. 6. Comparison of Dynamic Responses for the Soil-Structure System.

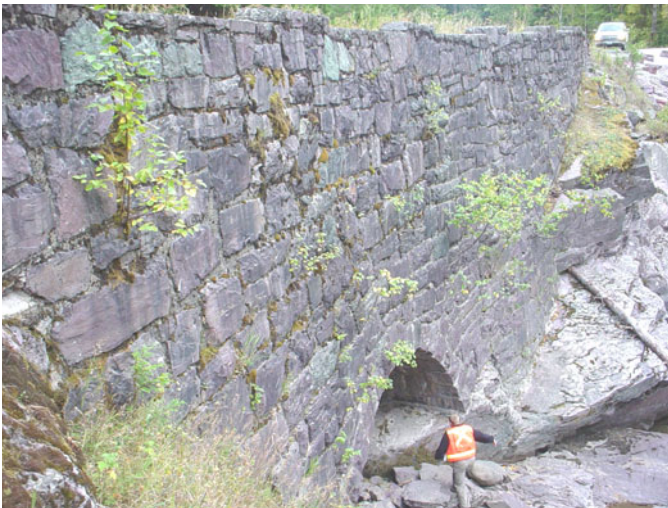
FIG. 5. A retaining wall with dual functions at Glacier National Park.

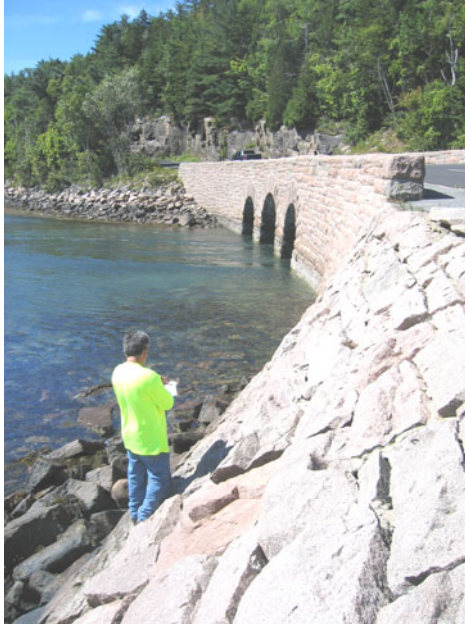
FIG. 6. A structure that grades from slope protection to a bridge approach wall.

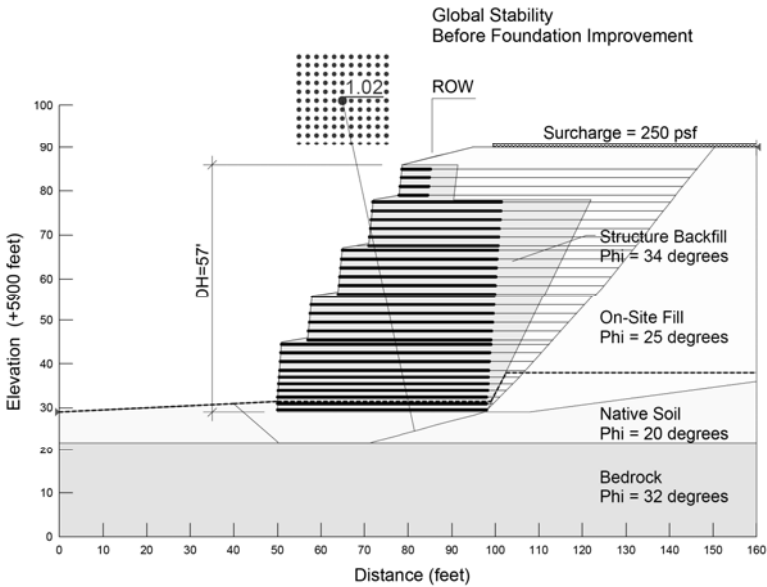
FIG. 6. Global stability before foundation improvement with RAP elements.
