PIPELINES 2007

Advances and Experiences with Trenchless Pipeline Projects

PROCEEDINGS OF THE ASCE INTERNATIONAL CONFERENCE
ON PIPELINE ENGINEERING AND CONSTRUCTION

July 8–11, 2007
Boston, Massachusetts

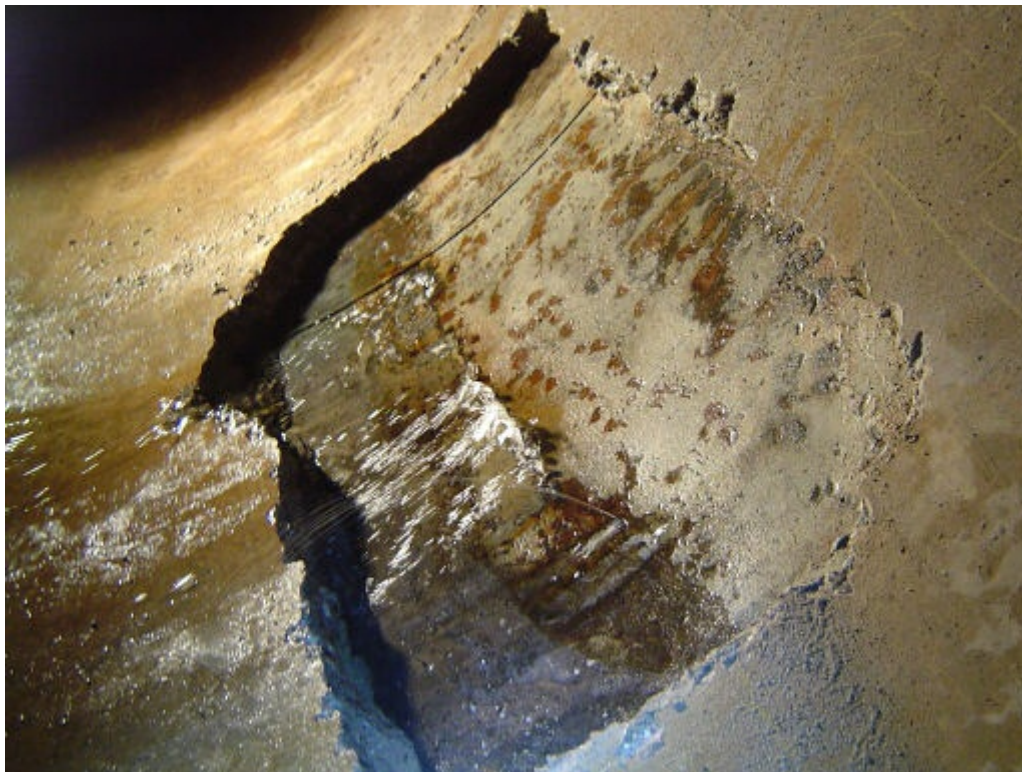
approximately 2-feet. The mortar lining was removed and a 1.5-foot crack in the steel can was located and groundwater was coming back into the pipe (see Figure 1 below).

Figure 1 - Urgent Repair Pipe Mark 543

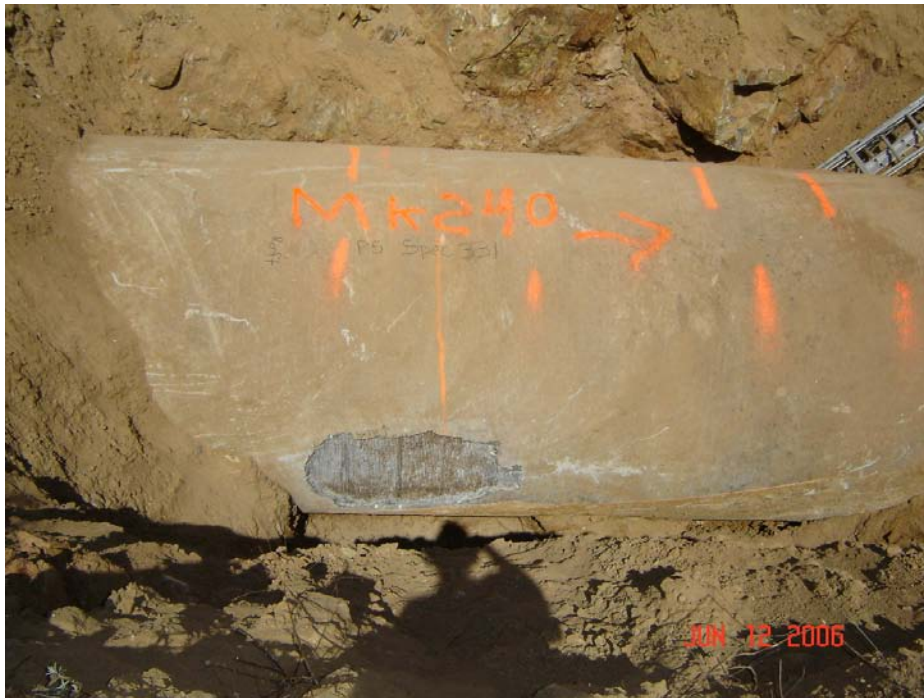
Figure 2 – Post Excavation and Removal of Mortar Lining

In May 2006, the Water Authority had a failure on a section of 66 inch PCCP that caused an unscheduled shutdown of the untreated water pipelines. The information gathered from this failure led to a re-evaluation of electromagnetic data and two sections of 96-inch PCCP located in the northern section of San Diego were selected for further investigations. To perform these investigations, the Water Authority scheduled a six day untreated water shutdown starting on Sunday, June 11, 2006, to visually confirm the corrosion damage. On Monday, June 12, a visual inspection of the exterior and interior of the pipe was performed. A total of 33 wires were broken and 95 wires were corroded (see Figure 2). A structural analysis was performed and showed that the excavated pipe as well as one additional pipe needed to be repaired.

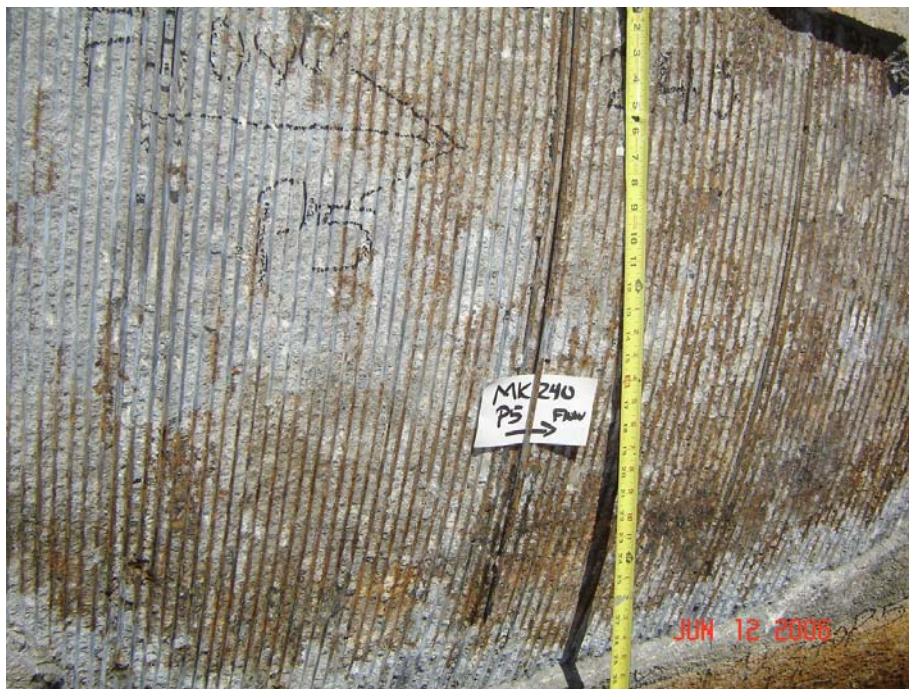
Figure 3 – Damaged wires and corroded area

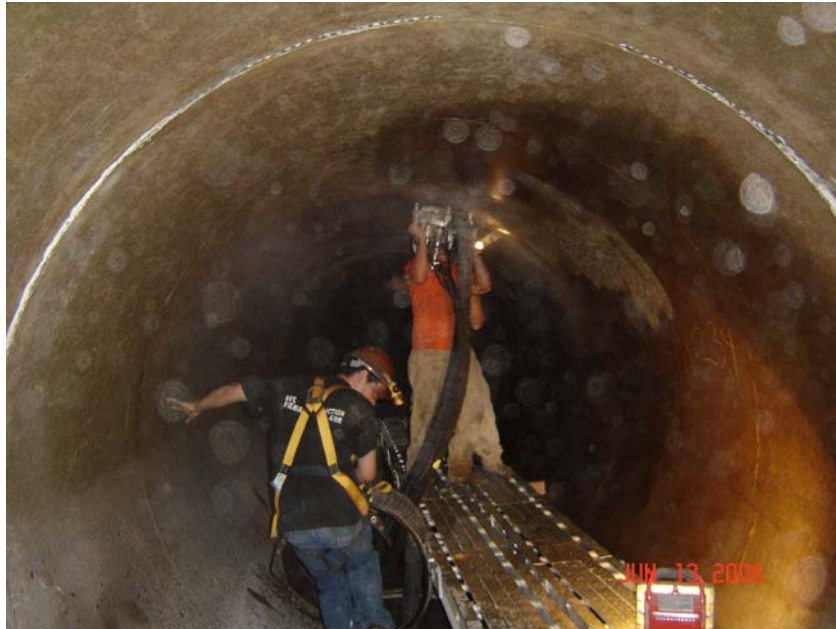
Figure 4 – Interior Cleaning of the Pipe Surface

The contractor mobilized and began work at 6:00 p.m. on Monday June 12, 2006. The work included the interior cleaning of the pipeline, installation of the carbon fiber, curing of the fiber, and installation of a potable water compatible coating. (See Figures 4 through 8)

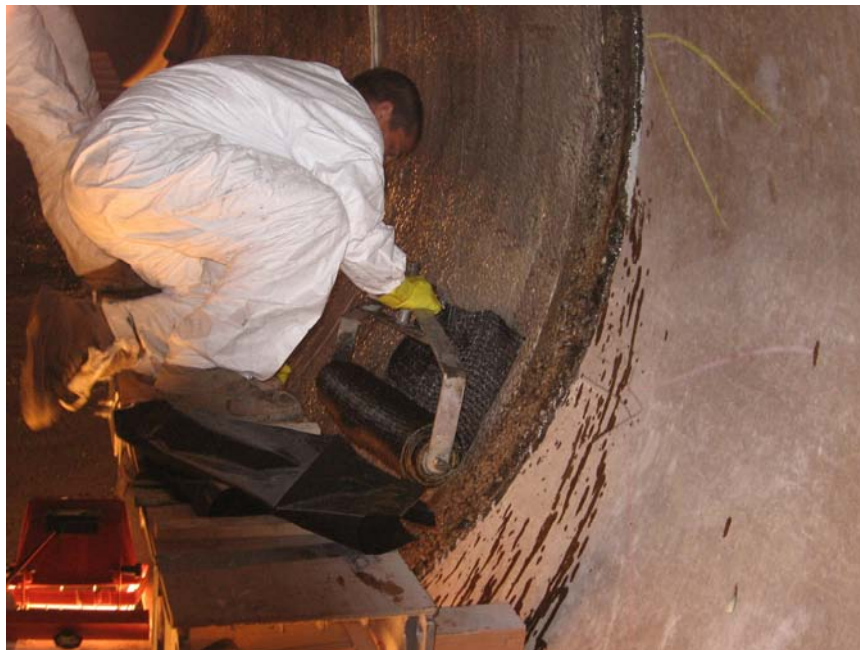
Figure 5 –Carbon Fiber Material Application

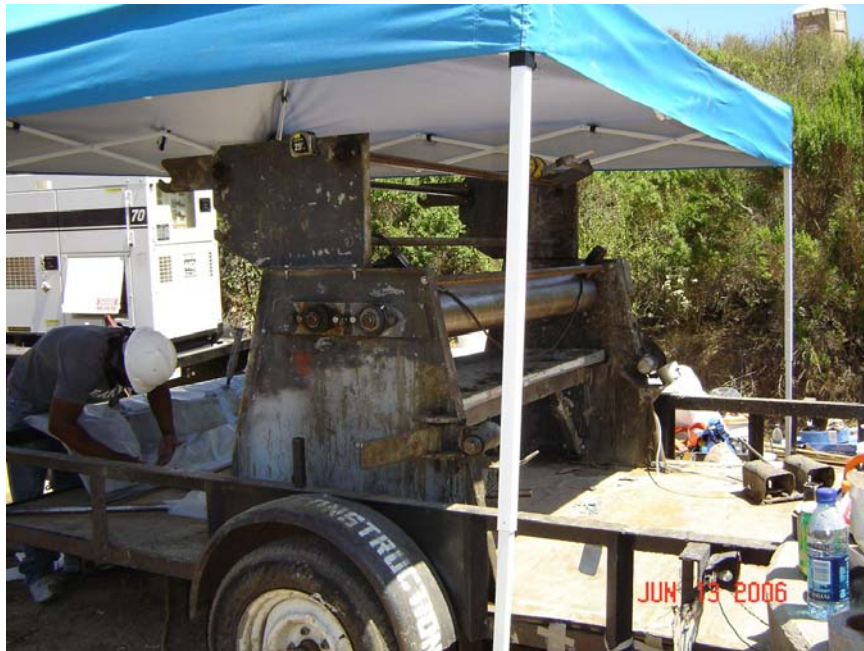
Figure 6 – Carbon Fiber Equipment

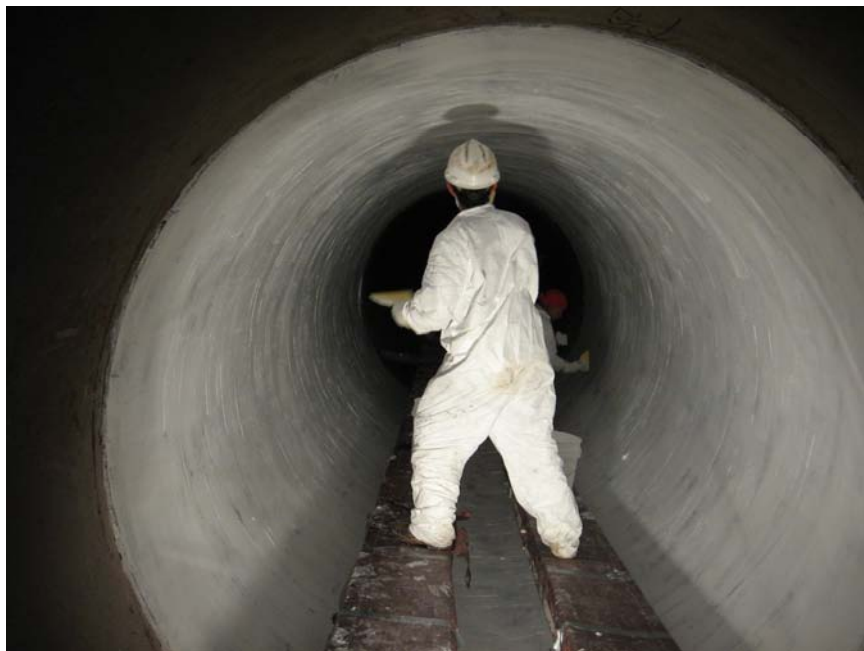
Figure 7 – Application of the Potable Water Coating

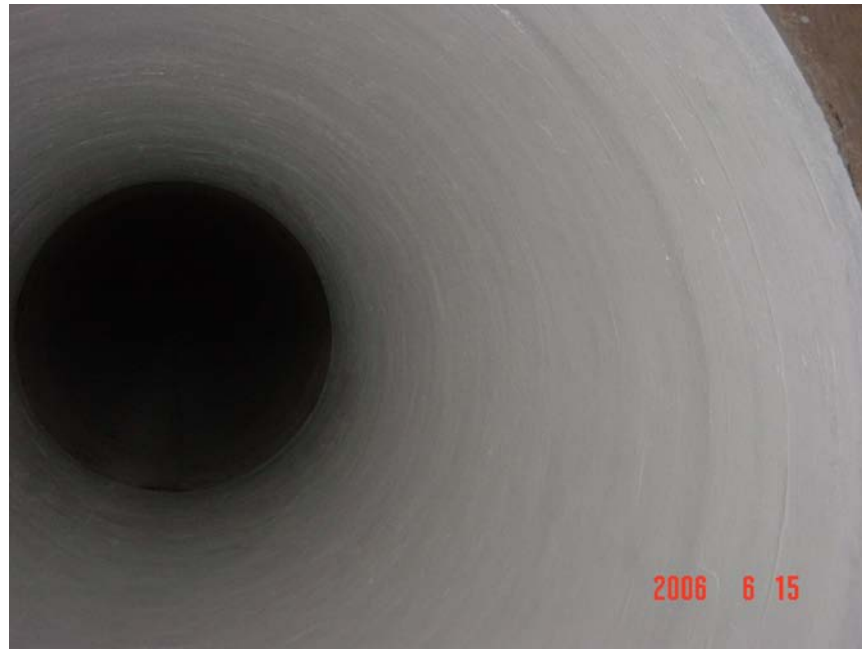
Figure 8 – Finished Carbon Fiber Mark 240

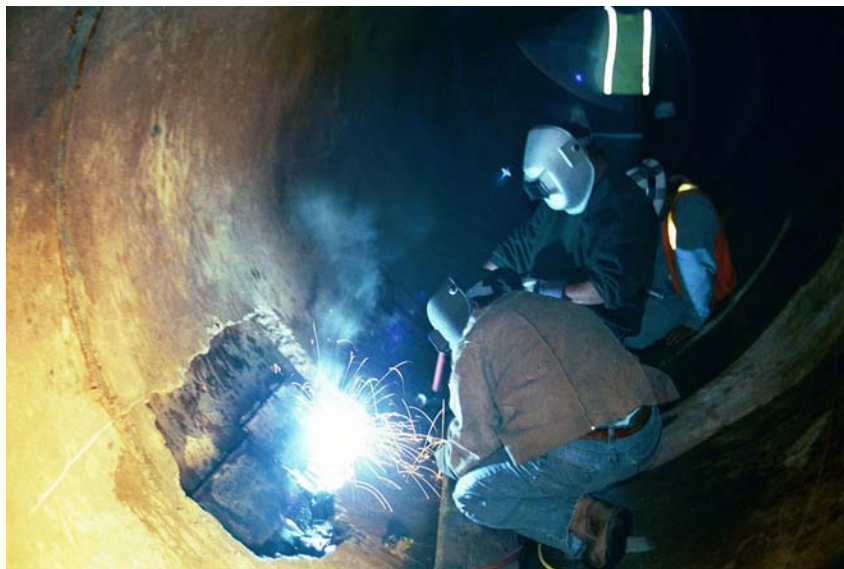
Figure 9 – Welding Repair of Fractured Steel Cylinder

It seems that all projects come with some unforeseen events and/or field complications. The Scripps Ranch project proved to be more challenging than expected with respect to the repairs that were required prior to the wrapping. Exposing the fractured steel cylinder revealed the need to weld the damaged section. The new steel plate was rolled at the shop in order to match the curvature of the existing cylinder. The plate delivered to the site did not fit as planned and field modifications were required to successfully stop the ground water from penetrating the cylinder. The welding process lasted several hours more than the crew expected (see Figure 9) but the project stayed on schedule.

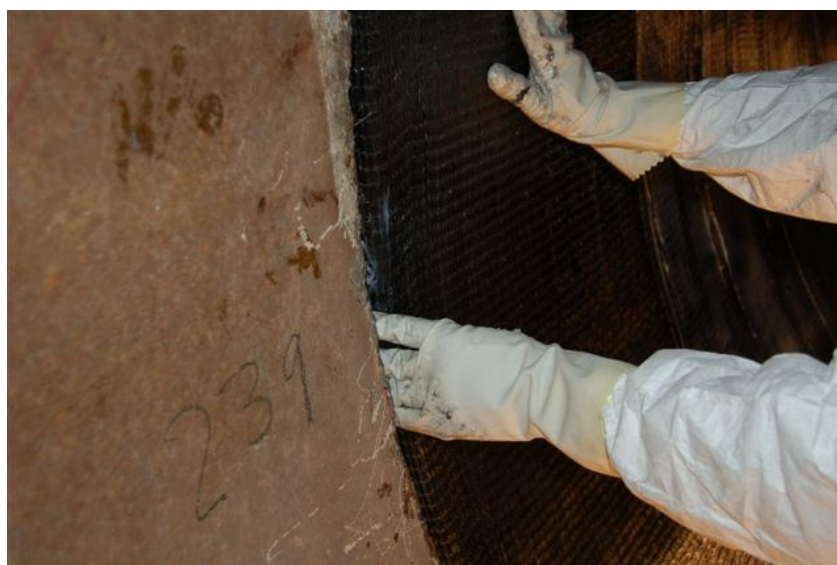
Figure 10 – Sealing of the Liner to the Steel Cylinder

The Twin Oaks Valley project was the first time we had attempted to chip out the end joints and create a watertight barrier between the steel cylinder and the CFRP liner. The chipping process was much more difficult than expected and took more than twice as long as the crew had expected. The new detail caused some initial confusion but the installation was successful (see Figure 10).

Previous installations have shown no sign that there is an issue with the internal water pressure on the steel cylinder due to the presence of the CFRP liner. There is an extra day or more that is required to detail the liner such that it has a watertight seal to the steel liner at both ends of each repaired pipe section. Further testing and/or observation of existing installations may show that this additional work is not required but SDCWA considers it to be worth the additional time and cost to have a more conservative detail.

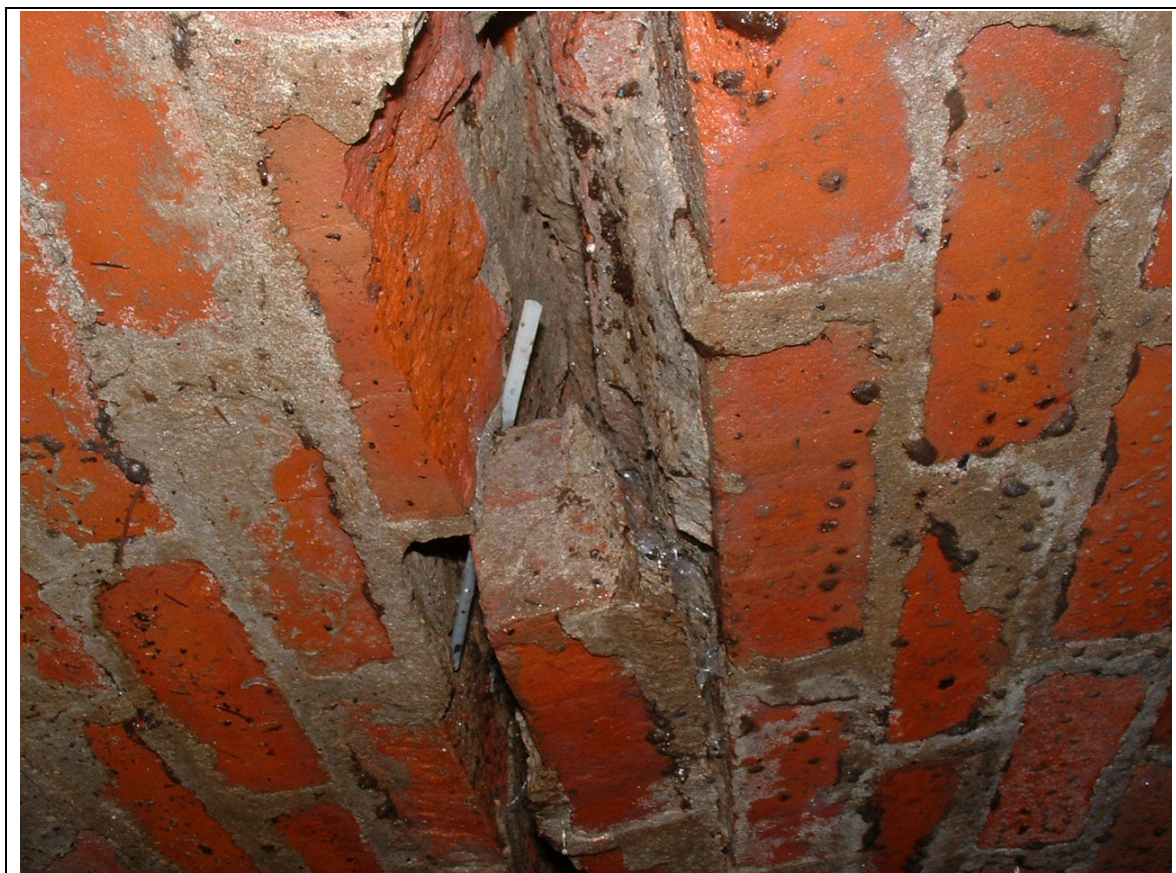
the top of the conduit from the street surface which ranged from 18-inches to 3-feet along the length of the damaged sections of conduit. Figure 2. illustrates the severity of the cracks and the effects of the damage. Most notable is the downward deflection of the crown of the pipe. During the design of the pipe rehabilitation method a crack developed in the street above the crown of the conduit. A second inspection revealed that the crack in the crown of the conduit had become more severe which prompted the Commission to close off a portion of the street with Jersey Barriers. It is evident that this condition required a structural repair or reconstruction of the conduit.

Figure 2 showing a separation at the crown of the conduit

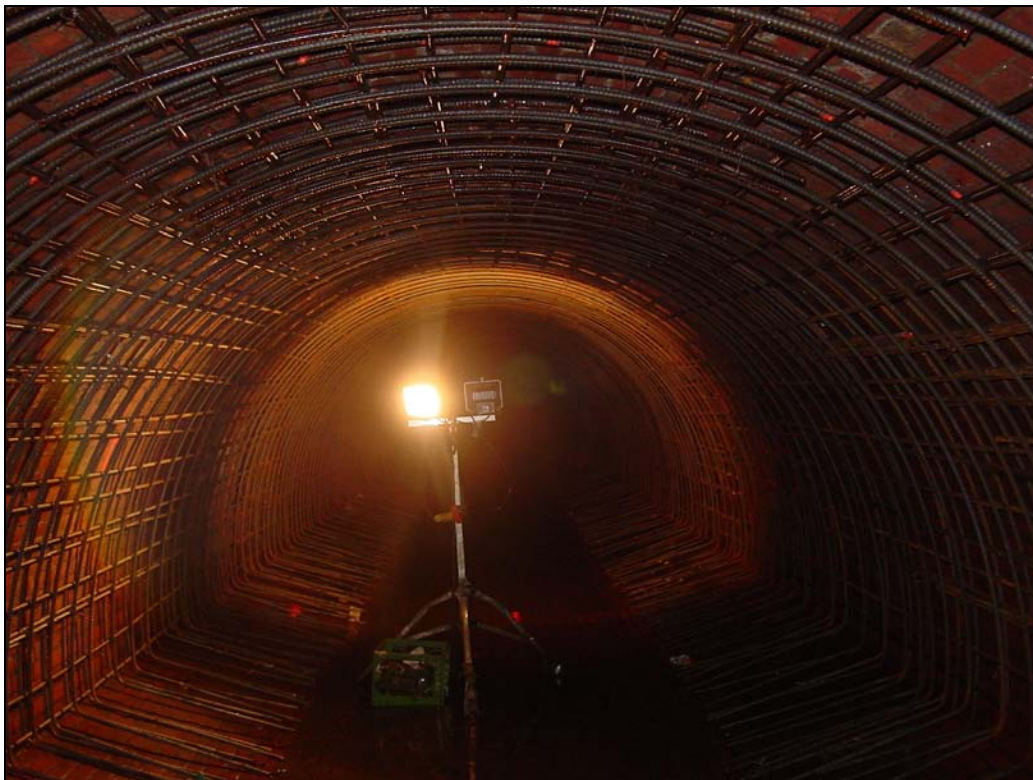
Figure 4 showing the steel reinforcing

After review of the project schedule and the shop drawings the project was allowed to commence. In addition to an onsite inspector the design consultant provided inspection of each major phase of the work including a final inspection of the steel reinforcement before any application of concrete. They also oversaw the core sampling and the field sampling of the concrete mixture. The entire installation including the quality control measures was completed in 65 working days. Figure 4 shows the reinforcing steel installed prior to application of the shotcrete.

The application process involved several application layers of shotcrete. Quality control was maintained to ensure proper placement and installation of the reinforcement. Each application of shotcrete was measured for proper thickness and the concrete mix was inspected for adherence to the specifications. After the final application the shotcrete is troweled leaving solid smooth surface. Figure 5 shows the final stages of the application process. At this time the bottom of the conduit was finished and the brook flow was allowed to continue through the conduit unimpeded.

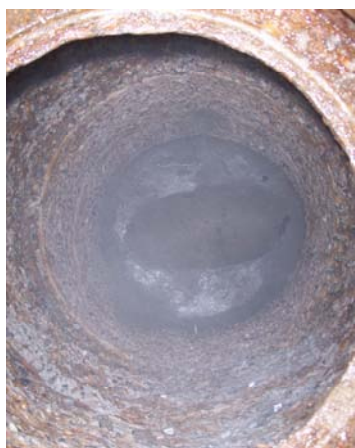
Figure 1
Interior – Deteriorated Manhole

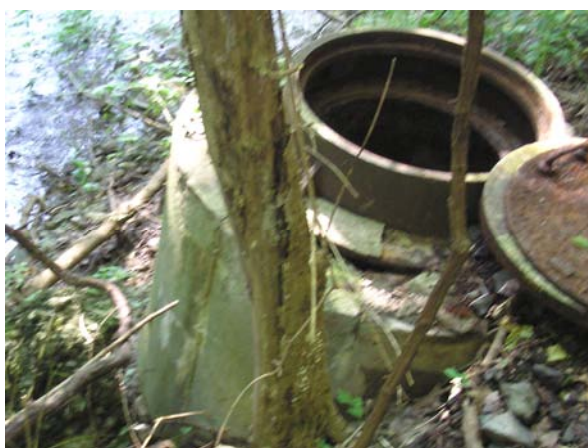
Figure 2
Exterior – Deteriorated Manhole

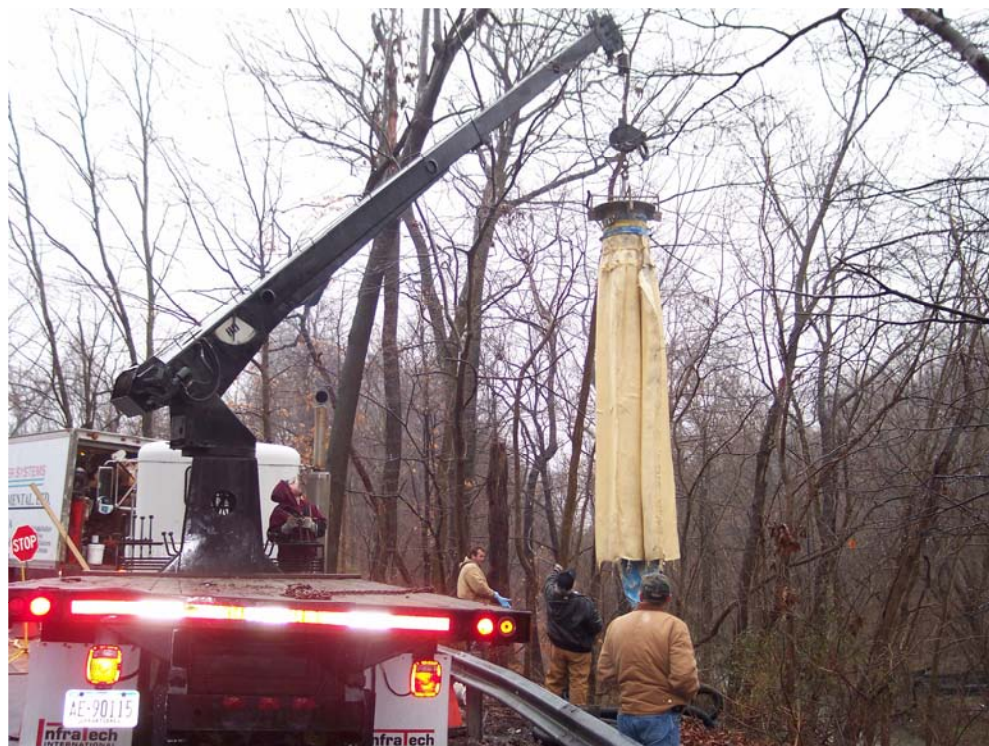
Figure 3
Cured-in-Place Manhole Liner

The selected contractor utilized various trenchless methods to complete the rehabilitation project. The larger diameter sewers [1,300 linear feet (400m) of existing 18 to 24-inch (450 to 600mm) diameter], were rehabilitated utilizing Cured-in-place materials. The smaller diameter sewers [2,100 linear feet (640m) of existing 8-inch (200 mm) diameter], were rehabilitated utilizing Fold and Form materials. Manholes were rehabilitated utilizing epoxy coating and Cured-in-place lining (See Figures 3 and 4).

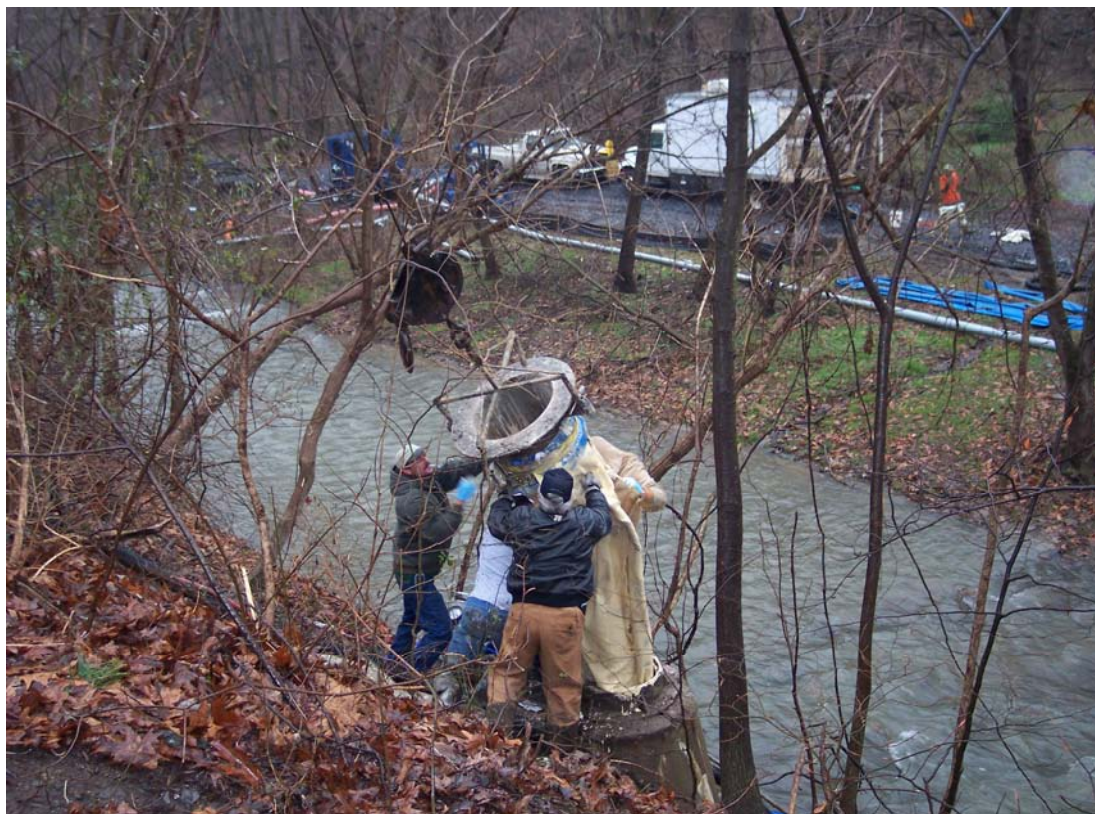
Figure 4
Installation of Cured-in-Place Manhole Liner

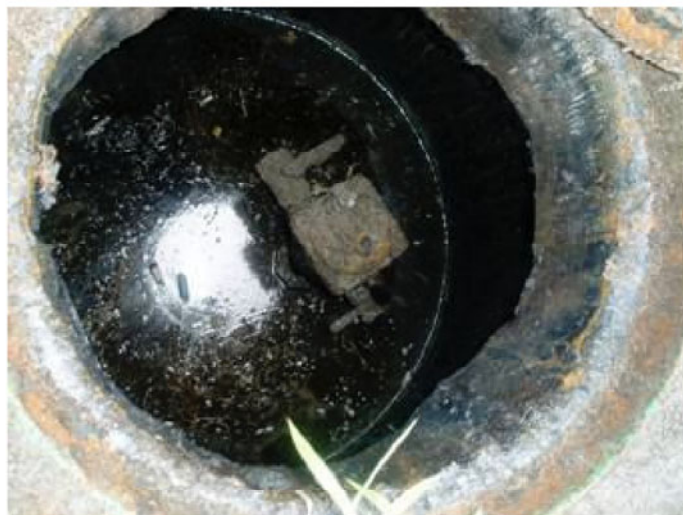
The line was walked and a visual inspection of the air release valves (ARVs) was performed on December 11th and 12th, 2006. The visual inspection confirmed that several ARVs were not operable and proposed a risk to the structure of the pipeline. Air release valves allow air and other gases to escape the pipeline while keeping the fluid inside. When an ARV does not operate properly gasses become trapped in the pipeline. For effluent mains H₂S gas can build up and increase the rate of corrosion of both the air valve and the PCCP pipe. The City will be given a solution to replace the inoperable ARVs while the main is in service.

Picture 1: Typical Air Valve

Since ARVs are often a source of odor as well, some of the devices have been closed to reduce the level of complaints. Because these devices are located at high points in the line to maximize the removal of entrained gases, closed ARVs, particularly in low velocity mains, allow gas bubbles to stay trapped further exposing the interior of the pipe to corrosion. In coastal areas, H₂S measurements, especially in flat collection and pressure lines not flowing full, are typically found at between 300 and 800 ppm in air. Submerged and removed ARVs present the same problem, allowing high concentrations of sulfides to linger particularly around the crown of the pipe. Exposed metal substrate and pre-stressing wires or bars that see these levels of H₂S deteriorate at a much faster rate than comparable exposure in systems with higher velocities and generally lower sulfide concentrations. The size, location, physical arrangement (piping) and volume displacement of ARVs was reviewed to assess whether existing ARV deployment was adequate for current and future flows in the line.

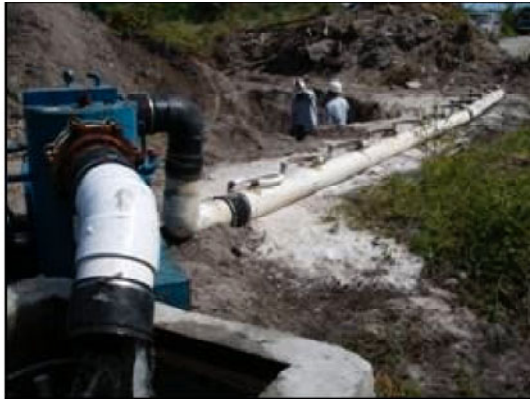
Where the pipeline is under the water table special considerations need to be made. The first step is to well point the area where the pipeline is to be exposed. This involves drilling several small holes around the dig spot and then pumping the ground water away. The pumps will be turned on several hours before digging to lower the ground water level. This allows the excavation crew to dig down to the pipeline and create a

Picture 2: Well Pointing

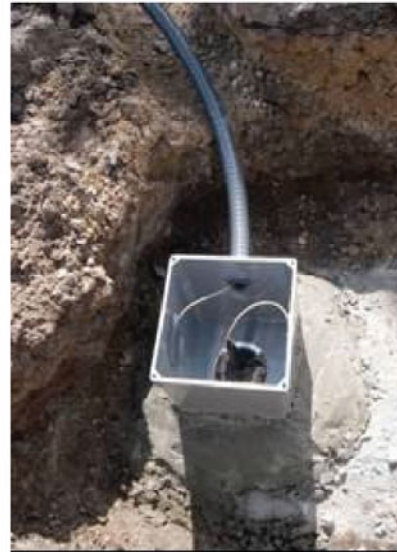
clean dry surface to mount the accelerometer. After the accelerometer is installed it is enclosed in a water proof housing to account for the ground water.

Picture 3: Accelerometer w Housing (no lid)

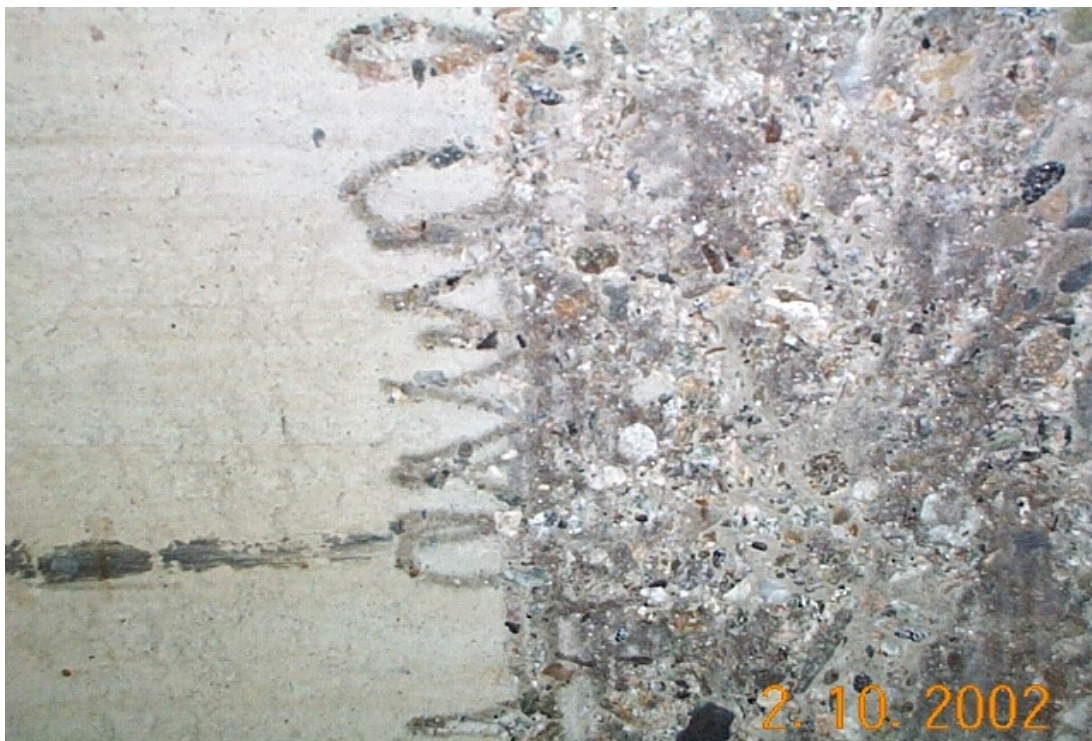
Figure 1 - surface preparation to pipe wall

Therefore all inspection of the surface preparation must be visual. The inspector is looking for a roughened surface with minimum 1/16" amplitude. A visual clue that the surface preparation is completed accordingly is the absence of any smooth surface or other latent still remaining. In most cases the surface preparation will expose aggregate of the mortar lining. Figure 1 shows a concrete surface that has an acceptable surface preparation next to a concrete surface that has not yet been prepared. The surface must also be free from fins or sharp edges that could create voids behind the fiber.

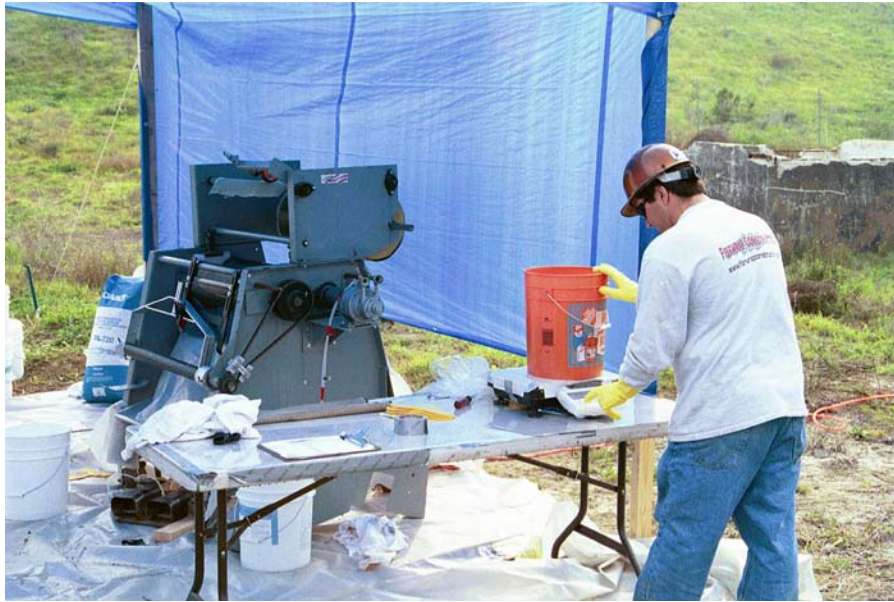
Figure 2 - weighing the saturated material

Fiber saturation is controlled by the saturated fabric test. The saturator's rollers are set at the correct spacing per the manufacturer's recommendations for the material being used. The saturated fabric test is performed to ensure that the gap has been set properly and that the proper epoxy to fabric ratio is obtained. A test piece of fabric, two feet in length, unsaturated, is cut and weighed to the nearest one hundredth of a pound on a calibrated scale onsite, as seen in figure 2.

The test piece is then run through the saturator, seen in the background of figure 2. The now saturated test piece is placed on the scale and weighed. The epoxy to fabric ratio is then calculated and should be within +/- 5 percent of the manufacturer's written recommendation. This test should be performed at the start of each wrapping shift. If the epoxy to fiber ratio does not fall within the allotted variance, then the saturator is to be re-gapped and the weigh test run again until the proper ratio is obtained.

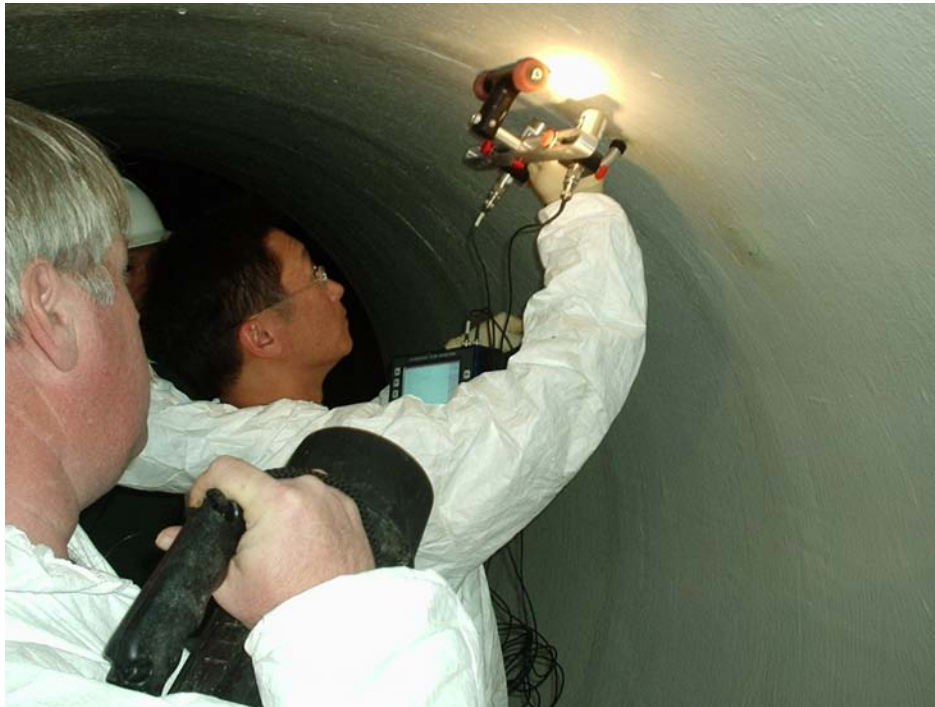
Figure 3 - inspection for “bubble trouble”

Following the installation and cure, the fiber liner should be checked for defects, bubbles, de-laminations, or fabric tears. The inspector has a couple of methods for examining the surface. First, a hard tool such as a quarter or a marble can be hit against the installed composite. The inspector should scan over the surface of the pipe at various locations listening for hollow spots in the liner. The hollow sound implies a void behind the material. A more advanced method of this test is to use a mobile ultrasonic inspection system, like one pictured below in figure 3. The ultrasonic inspection unit is scanned

over the surface of the fiber liner, and the users look for variances in the readings to pinpoint defects.

If voids or de-laminations are found from the test then repairs are recommended. Defects less than three inches in diameter should be injected with resin or backfilled. For large defects, greater than three inches in diameter. The engineer should recommend an alternate repair depending on what type of defect has occurred and where in the composite liner it has occurred.

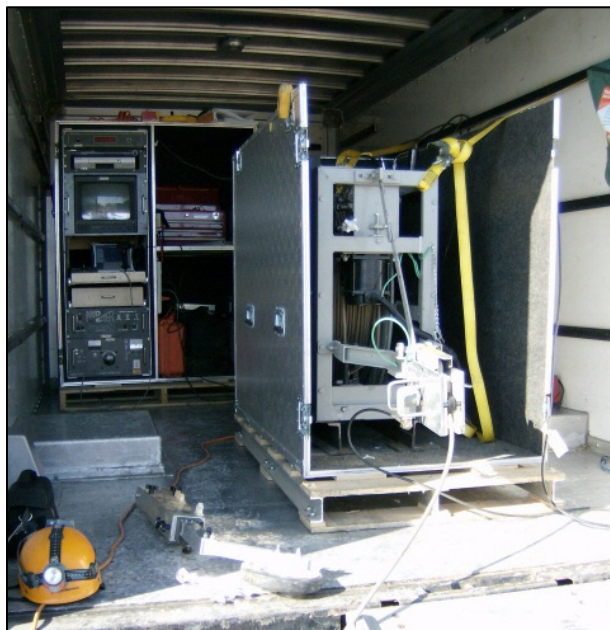
Figure 2. Communication system (left) and umbilical spool (right) stored in van

PipeCrawler is attached to an umbilical cord which supplies power to the tool and is also used to pull the tool backwards. A video camera is mounted to the tool to facilitate driving, particularly when navigating around bends. The footage also shows the visual condition of the internal pipe wall. The video footage as well as the data collected can be viewed in real time via two monitors. The umbilical cord and the monitors are stored inside a van (see Figure 2) which is used to transport the equipment to each pipeline entry point.

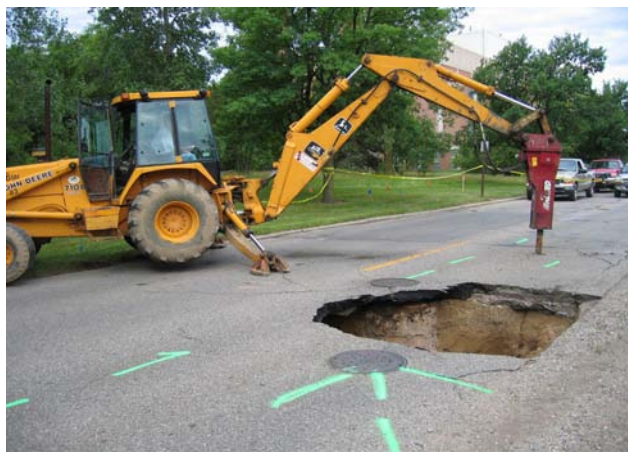
Figure 1 – MSU Service Road Pipe Replacement Construction

A sinkhole appeared just outside of the Power Plant and Laundry Buildings on Service Road on the campus of Michigan State University in June 2004. The main cause of the sinkhole was erosion and structural cracks on the existing clay sanitary sewer pipeline and two manhole structures. The two-foot sinkhole in the manhole structure caused water and sand to be sucked away from the surrounding sanitary structures and created a 25-foot deep hole under the road (Figure 1)

Having inspected the pipe under Service Road and the manhole structure with Closed-Circuit Television (CCTV), it was decided to replace nearly 300 feet of deteriorated 18-inch clay pipe. To handle the existing sewage flow properly, an extensive pumping system was used to bypass raw sewage to a downstream manhole structure.

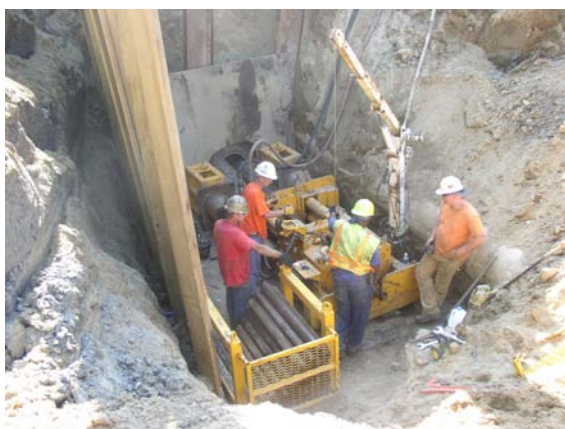
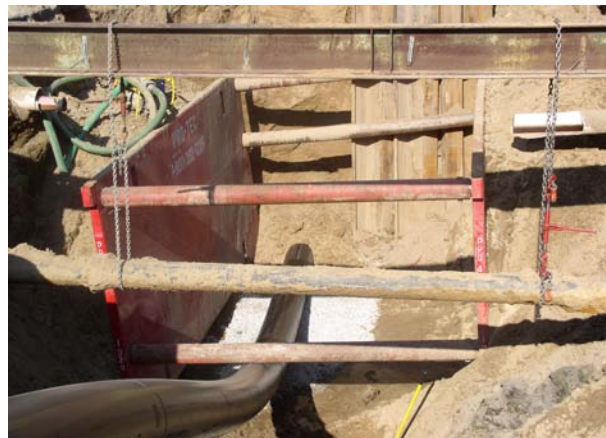
Figure 2 – Pipe Bursting Receiving Pit (Left) and Pipe Entry (Right) Pit

<ul style="list-style-type: none"> • New pipe: DR 17, 18 in. diameter (Iron Pipe Size) HDPE • Old pipe size: 18 in. • Total pipe length: 310 ft • Pit sizes for pipe entry and reception: Approximately 12 ft wide by 25 ft long • Slope for pit wall on the pipe entry side: 1.5 to 1 • Pipe bursting machine used: TRS 225 ton capacity • Installation Speed: Approximately between 0.5 to 1 ft/min • Pipe Bursting Crew: 1 foreman, 1 operator, 3 laborers • Duration: 2 days (1 day for mobilization, 1 day for the bursting)
--

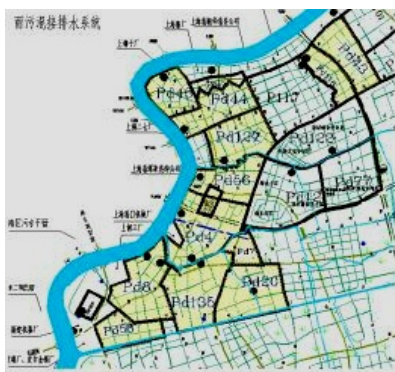
Figure 3. New UPN system in Pudong⁴

The development trend of the existing and future pipelines becomes more and more integrating. In the new developed Pudong District, the “irrigation, water supply, drainage” solution project has been chosen. In the long run, the development trend is to plan and design the underground pipelines system based on integration concept according to the partition of the administrative region. So the safety grade of UPN has great influences on economic development of Shanghai. Establishing safety evaluation system of UPN is a kind of advanced management pattern in the world. Figure 3 shows the new combined system in Pudong District. Figure 4 shows the Shanghai region on the map distinctly. The researchers select Shanghai as the study object for the following reasons.

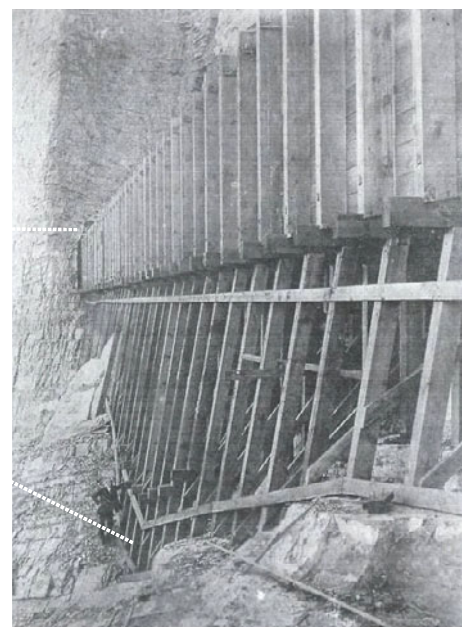
FIGURE 3

Olmsted flume at transition to rock tunnel.

Figure 2 shows the cliff reach of the flume. At the upper left, water can be seen spilling out of the window in the rock tunnel. Figure 3 shows a man standing by the trestle and flume in the cliff reach just before it connects to rock tunnel.

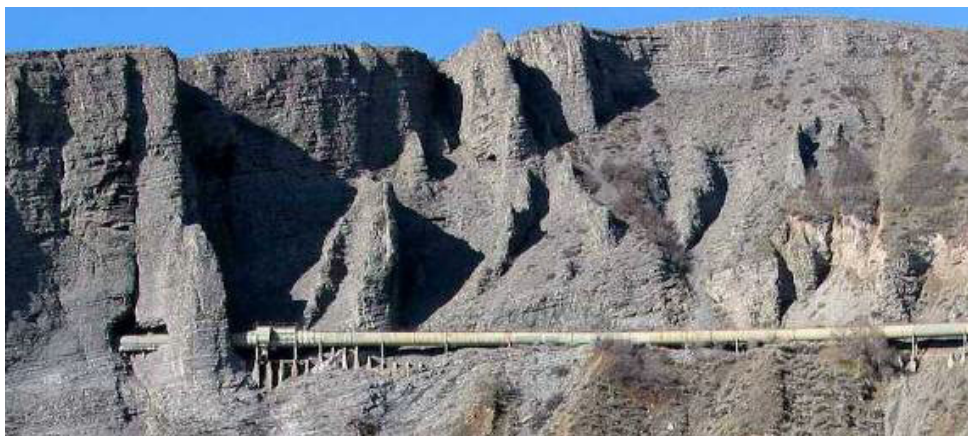
FIGURE 4

1999 photo of the cliff reach pipe and supports. Note the overflow is now on supports upstream of the rock tunnel.

In 1948 and 1952, the wooden flume was replaced with a thin-shell 5 mm (3/16 inch), above-ground 2.6 m (102-inch) diameter steel pipe. Fifty years later, the 102-inch pipe was still operating (seen in Figure 4 at the cliff reach), though with numerous reliability concerns. In the 1950 reconstruction, the overflow was moved 200 feet upstream of the rock tunnel and was redesigned to function as a siphon to accelerate discharge of excess water if the free water surface in the overflow chamber exceeded its design gradient.

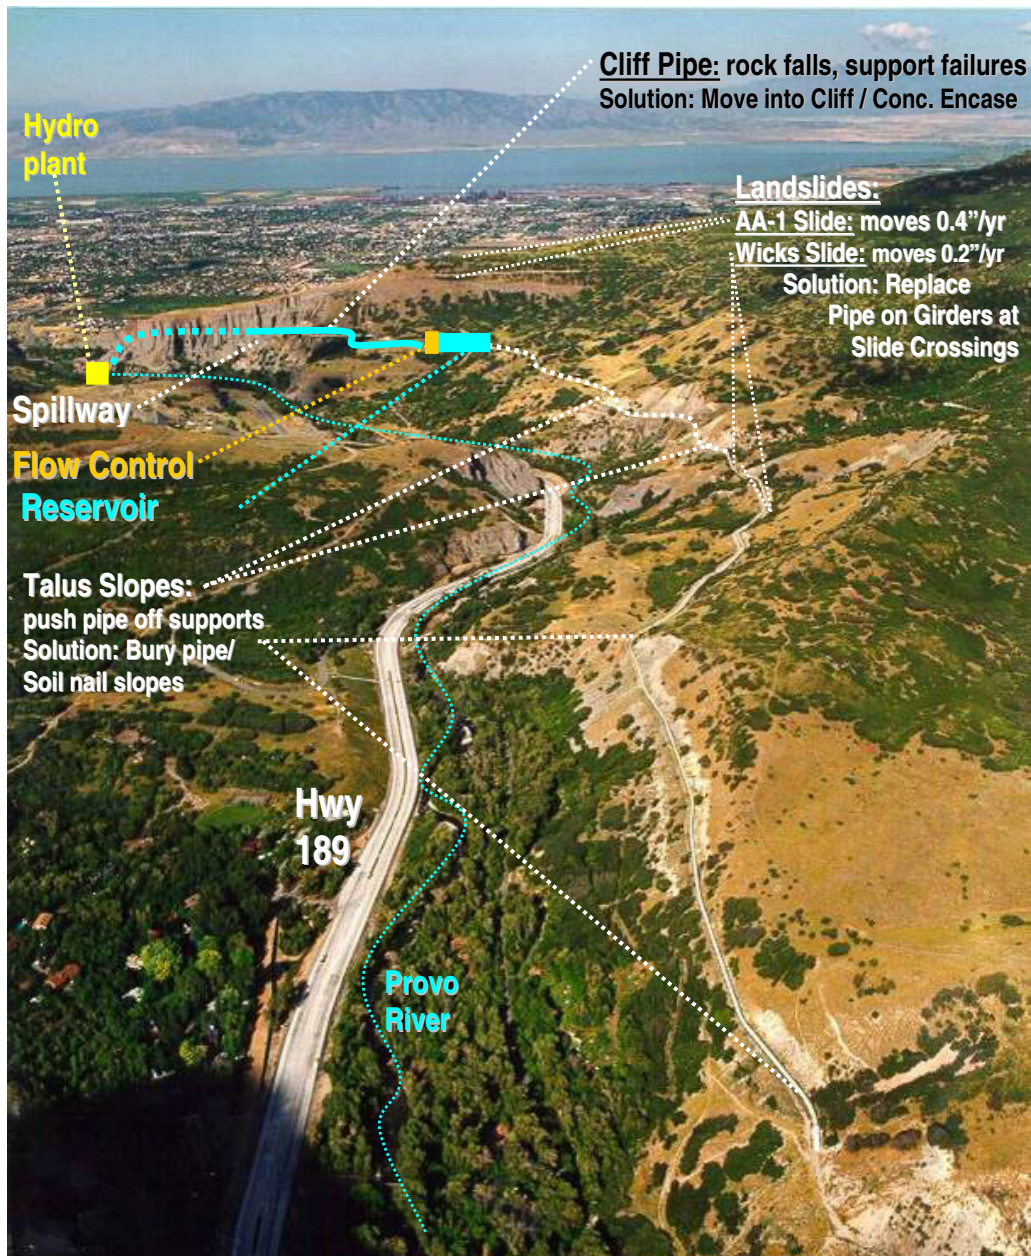
FIGURE 5
1998 photo of the lower 3.2 km (2 miles) of Provo Canyon with pipe reliability issues and solutions noted.

Figure 5 shows the lower 3.3 km (2 miles) of the Flowline within Provo Canyon with the old 102-inch aboveground pipe still in place. The cliff reach where the existing pipe was rehabilitated is in the background. A flow regulatory station and reservoir were added just upstream of the cliff to regulate flows to the cliff reach and M&I system. Upstream of the reservoir are several steep cross slope reaches where talus slope problems (discussed later) were addressed using soil nails to stabilize slopes and old pipes were replaced with new buried pipes. Reaches with creeping landslides (addressed in earlier papers) were improved through above ground replacement pipes.

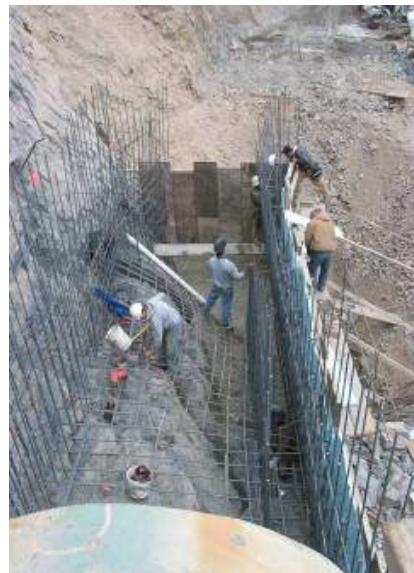
FIGURE 6

Pipe relocated into the cliff. Note earth filled fault zone in background.

Another reason to relocate into the cliff was to increase the rock support at both ends of a 20-foot-wide earth-filled fissure in the cliff (seen at top of Figure 6). The fissure was an inactive fault that had filled with soil. Additional rock bolts were used on both sides of the fissure to support the encasement on the rock and not on the erodible soils.

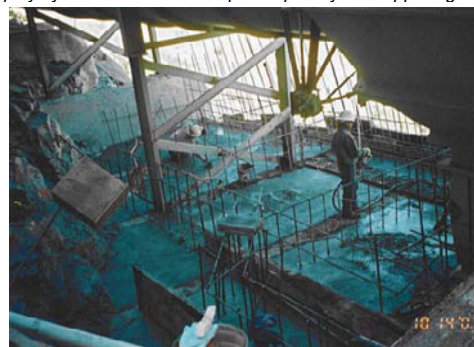
FIGURE 7

Typical room under concrete pipe before it was filled with polystyrene foam blocks. Siphon spillway is at upper right.

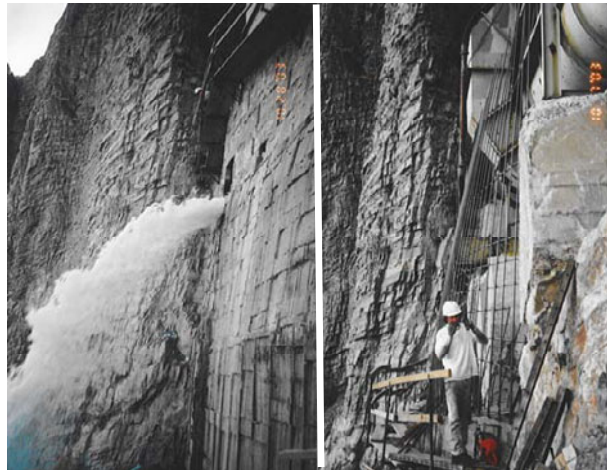
FIGURE 8
Textured concrete face at Spillway after (spilling) and before concrete placing.

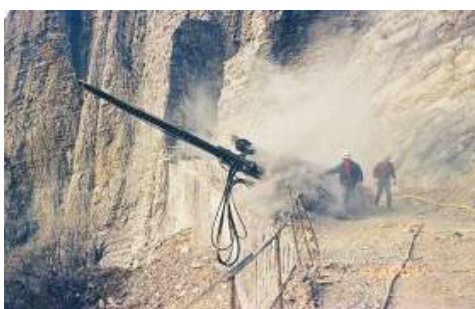
FIGURE 10
Drilling rock bolts with sleeves through encasements.

Near horizontal rock bolts were designed to act in tension to secure concrete masses to the cliff. Bolts tied steel plates, anchored in the concrete encasements, to bolt lengths grouted 15 to 30 feet into limestone bedrock. Rock bolts were designed to be installed first

and cast into concrete, but at contractor request, were placed after concrete encasements by placing steel sleeves and plates through the encasement forms and then drilling rock anchor holes through the sleeves. After encasing pipe, bolts were inserted, grouted pull-tested, and then tightened against steel plates (see Figures 10 to 13) with hex nuts.

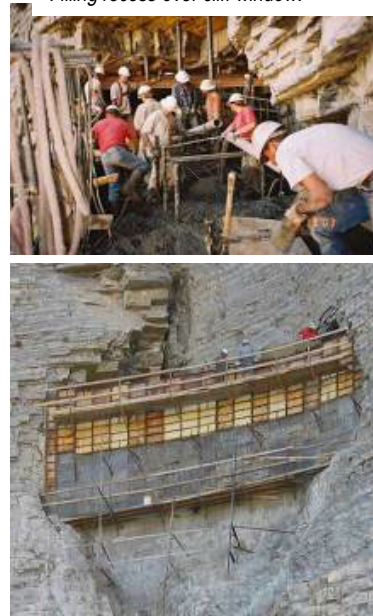
FIGURE 9
Filling recess over cliff window.

Where the existing pipe passed through about 80-feet of rock tunnel, the crown of the tunnel was raveling and large boulders falling onto the pipe. Loosened rock materials at the crown of the tunnel were removed and the concrete encasement was extended past the top of the pipe up to a stable rock crown in the rock tunnel. Fill concrete was also extended to 2 to 3 meters (6 to 9 feet) above the pipe to fill recess in the cliff created for the pre-1950 Flowline spill window (Figure 9).

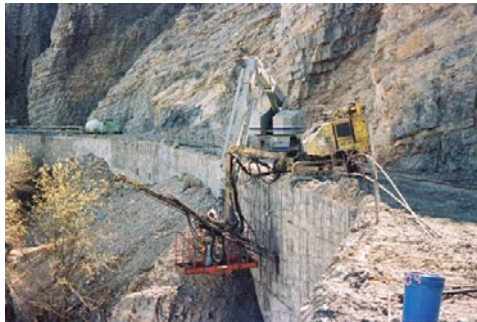
FIGURE 11
Drilling rock bolt under pipe.

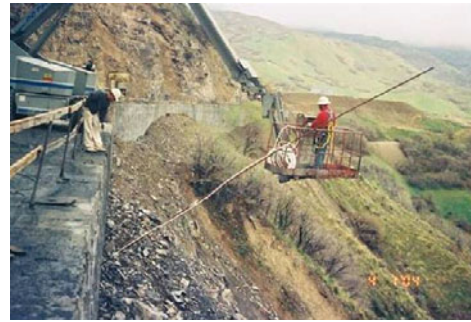
FIGURE 12
Installing rock bolt.

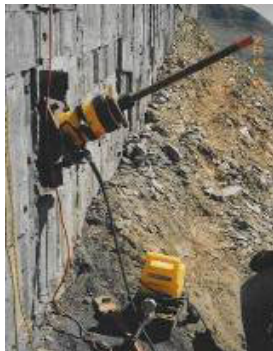
FIGURE 13
Pull-testing rock bolt on steel plate at face of textured wall.
