PIPELINES 2007

Advances and Experiences with Trenchless Pipeline Projects

PROCEEDINGS OF THE ASCE INTERNATIONAL CONFERENCE
ON PIPELINE ENGINEERING AND CONSTRUCTION

July 8–11, 2007
Boston, Massachusetts

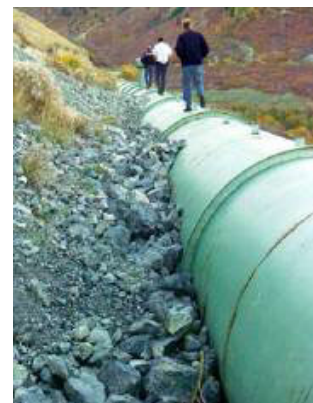
FIGURE 14
Talus buildup on pipe.

Besides cliff reach encasements and rock bolting, a 2 mile reach of 120-inch replacement pipe traverses 1.6 km (1 mile) of steep cross-slopes with raveling talus rocks (see Figure 14) in an inactive ancient landslide. Buried pipeline construction in these areas would require large trench cuts parallel to contours which would weaken these slopes. To prevent construction-induced slope failures near the pipe, uphill trench slopes

Steep cross slopes and a narrow 6-m (20-foot) wide “bench,” formed by the ancient Lake Bonneville shoreline, typify the native slopes over which the Flowline passes. The 1912 flume and 1952 aboveground 2.6 m (102-inch) pipe construction both widened this bench, cutting into the native 2:1 to 1.4:1 slopes above the bench and filling (mildly over-steepening) the slopes below the bench. This caused once stable slopes to ravel. Over the 50-year life of the aboveground steel pipe, over 8 feet of talus rock had accumulated on the uphill side of the pipe in several reaches (including the cliff pipe reach).

Subsequent lifts of excavation, soil-nailing, grouting, testing and shotcreting extended soil nail walls down to the base of the existing pipe. Extra soil nail lengths were trimmed off and a final shotcrete layer was placed to cover nail caps, plates, and nuts. Figures 14 to 17 show soil nail wall placement and testing (in the summer) when the 102-inch pipe was in operation.

After installing soil nail walls with the old pipe in operation (Figure 14), the old pipe was removed and trenching, placement (Figure 15), and backfill (Figure 16) of a new 120-inch pipe ensued over a 5-month winter shutdown.

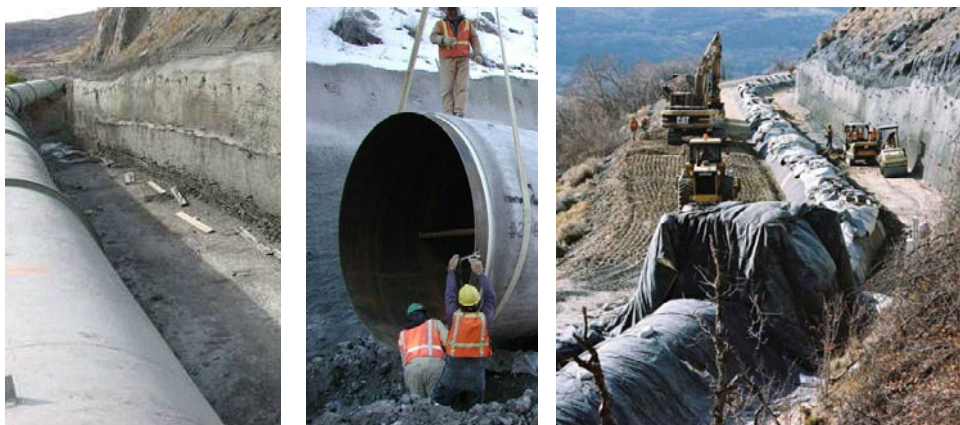
FIGURES 19 TO 21

A completed soil nail wall (Figure 19 at left) reinforces an undercut cross-slope to allow for placement (Figure 20 at center) and backfilling (Figure 21 at right) of a new buried 120-inch pipe.

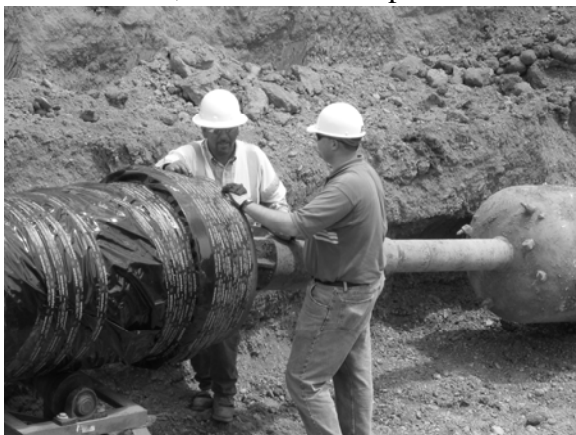
Figure 4 - Flex-Ring Pipe Ready for Pullback

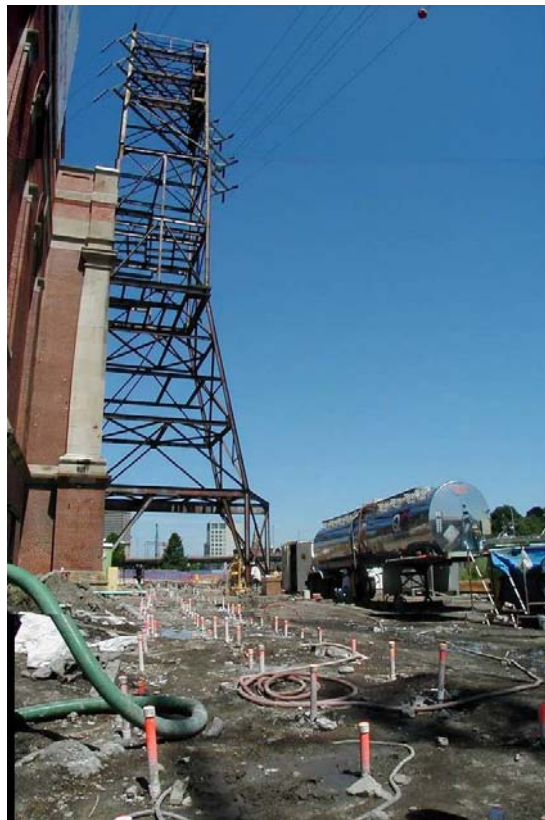
Figure 3. Sleeve port pipe for chemical grout along 54-inch consolidation conduit alignment.

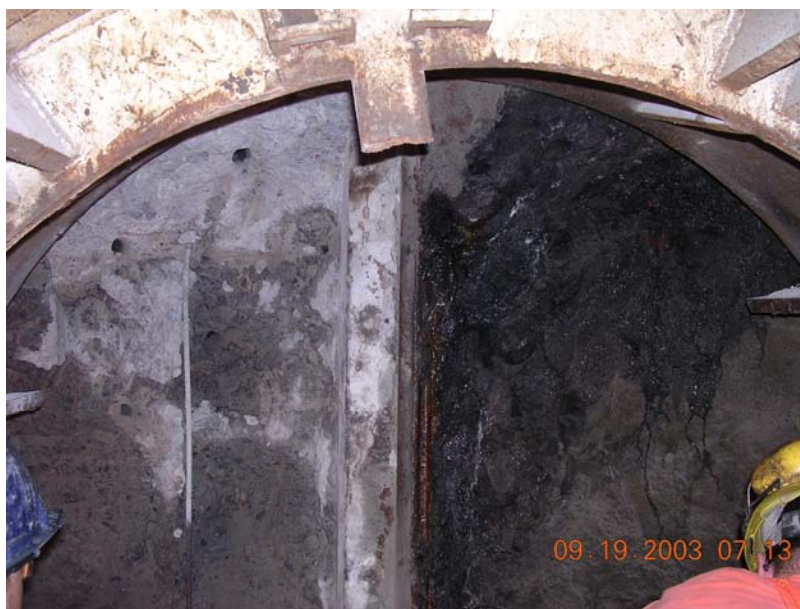
Figure 4. 54-inch shield. On left side, reinforced concrete and concrete-filled sheet pile of abandoned vault. On right side, chemically grouted clean fill.

There were several occurrences that had a significantly higher influence on the overall production rates. These included groundwater inflows discussed below and an abandoned vault constructed of reinforced concrete walls and backfilled with structural concrete. This vault was located along the alignment of the 54-inch consolidation conduit for approximately 15 feet at full face. The Pipe Jacking Timeline shown on Figure 6 demarcates these occurrences and their influence on production.

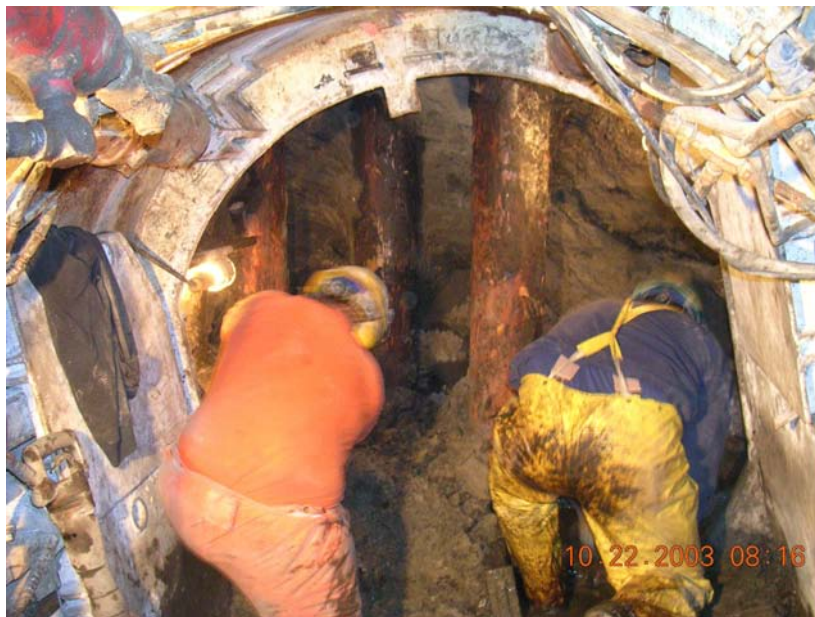
Figure 5. Chemically grouted soil is excavated by hand, and timber piles cut with hydraulic chainsaws and removed. Obstruction removal required some minor excavation ahead of shield.

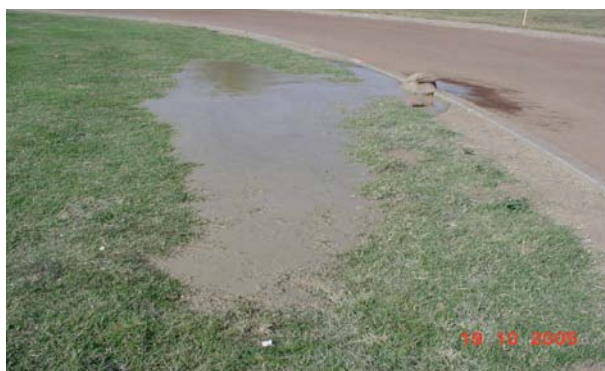
Figure 5 - Typical Slurry Frac-out

The only significant problem started occurring on the fifth day of tunneling when a slurry frac-out was observed adjacent to the running track and additional frac-outs continued on an almost daily basis. Slurry frac-outs also occurred onto the basketball courts and tennis courts. The basketball court pavement also heaved between six and eight inches. The Contractor cut small holes into the tennis court pavement to relieve slurry pressure under the pavement and prevent heaving. The heaving damaged the basketball courts but did not damage the tennis courts. The Contractor cleaned up all frac-outs and repaired the damaged basketball courts. Figure 5 is a photo of a typical frac-out.

Frac-outs had occurred on a previous tunnel under this contract, so it was not unexpected on the High School crossing, but the number of frac-outs was surprising. Although no definite conclusion was reached, it was theorized that mining from a sand layer to a clay layer caused face pressures to increase quickly, although that was not always observed on pressure gauges in the MTBM control room. In addition, the depth of cover was 15 feet and there was likely several feet of fill over the natural layers of soil being tunneled. These imported soils were less dense and more permeable than the natural soil, allowing an easy path to the surface. Oddly, many of the frac-outs occurred between 50-feet and 100-feet behind the machine face. The MTBM itself was also better suited to sandy soil than clay. Progress occasionally became very slow, but water jets on the mining face usually broke up the clay when that happened. The influence of water jets on the frequencies of the frac-outs is speculative. No frac-outs occurred in the crossings with sandy soil.

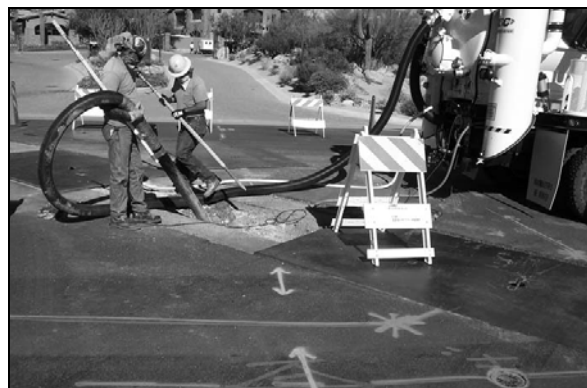
Vacuum Technology is a form of trenchless excavation that utilizes 95% air at a volume of 100+ PSI and 5% water to break up soil in record time. Specialized Services Company (SSC) uses the System 4000, a high-powered vacuum that excavates the material into a 450 gallon rear mounted collection canister. The material is then reused for backfill at the completion of the locating project. Air offers higher performance in most soils, greater efficiency, lower cost, and is less invasive than water. This technology is currently the safest method available to expose underground utilities. The vacuum is 1000 cfm, 15" Hg, with a 4" hose. The compressor has 300 cfm @ 220 psi for the air lance and 300 cfm @ 100 psi for air tools. High pressure water is 0-3000 psi @ 3 gpm and low pressure water is 0-1000 psi for clean-up.

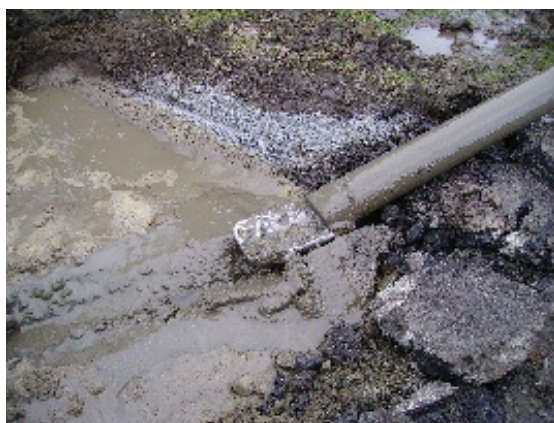
Spoon-style Bit suitable for use in wet clay

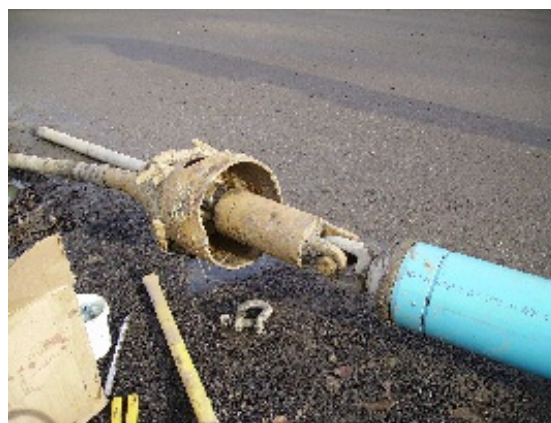
Pullback – Drill rod with reamer attached to swivel in front of lead pipe, ready to commence installation

Pullback - This was followed by a compaction reamer ahead on a swivel which was attached to the pipe to pull in the new Cobra Lock™ Segmented PVC C900 DR18 Water Pipe. No drilling mud was needed because the soil layer was a damp, firm silt

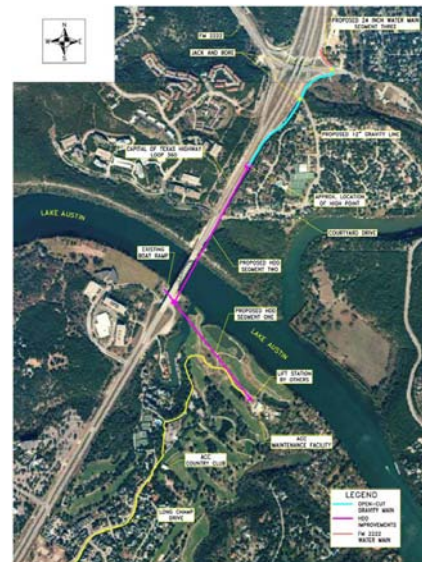
Figure 1 – Davenport Ranch HDD Site: *The two combined Horizontal Directional Drilling (HDD) segments (shown in pink) exceed 4,000 feet of subsurface improvements, installed with no disruption to the golf course, Lake Austin, the public boat ramp, or to Loop 360 and the Pennybaker Bridge.*

Segment 1 parallels the southern shoreline of Lake Austin. The pipeline starts at the maintenance area located about 500 feet south of the Lake shoreline and centrally within the golf course property. Along this alignment, the ground elevation varies between 494 feet and 515 feet above mean sea level (msl).

Segment 2 follows a north/south orientation parallel to the Loop 360 Bridge on the eastern side of the highway crossing below Lake Austin. The elevation near the Loop 360 highway boat ramp is approximately 500 feet above msl. Elevation rises sharply on the north side of the Lake, where the highway was cut through a segment of limestone formation. The Lake is approximately 600 feet wide at this location. At the termination point along Loop 360, the elevation is approximately 602 feet above msl.

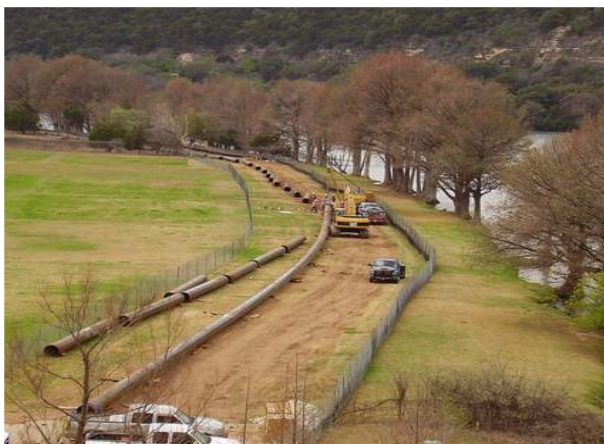
Figure 3 - The lay-down area for Segment 1 extended for 2000 feet between the Lake Shore and the vegetated land. An open, grassy area west of the boat ramp extends approximately 1,000 feet along the shoreline of Lake Austin; the land west of this strip is an overgrown vegetated strip consisting of large trees. Due to vegetation and other constraints the width of the lay-down area was limited to 50 feet.

For HDD installation, a pipe lay-down area that is equal in length to the total installation is most desirable. Stopping during pullback to connect additional pipe greatly increases the risk of pipe becoming stuck in the hole. The need to identify suitable pipe lay-down areas for this project were complicated by the environmentally sensitive Lake Austin shoreline, the heavily traveled Loop 360, and the physical constraints posed by the cliff. Along Segment 1, the vegetated shoreline along Lake Austin, west of the boat ramp provided a good lay-down area. However, the active boat ramp needed to remain open to the public throughout construction. Therefore, the lay-down and pipe assembly area was short by about 200 feet due to difficulties in getting construction easement and a drainage channel separating the boat ramp and the lay-down area. Design and specifications made allowances for the pipe to be assembled in two sections and the final sections were welded during pullback operations.

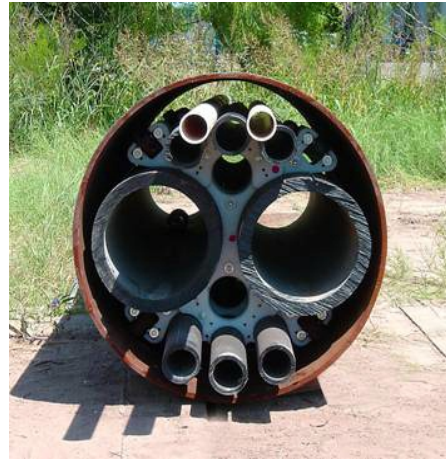
Figure 5 - Based on the mock up results, grouting operations were done in phases. The first two phases consisted of sealing the center sections of each line segment to create a plug. This was followed by grouting at either ends to completely fill the voids. Batch tests of the grout was collected at each phase to determine the Thermal Resistivity of the mixes and verified that grout batches met the specified requirements. Pressure and mandrel testing of pipes were completed after the grout was cured and verified the internal diameter of all conduits met the deflection limits specified.

HDPE pipes were filled with water to avoid any risk of deformation as a result of heat of hydration during setting of grout. After successful mock-up tests the HDPE force mains, electrical conduits and grout tubes were welded and laid out for both the segments.

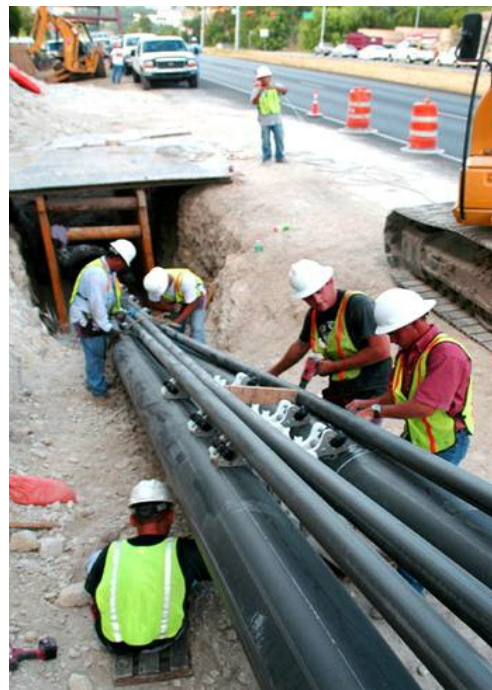
Figure 6 - Bundling our pipes was done in the early morning hours and pipe was pulled inside the casing as the bundles were assembled. A special rack was fabricated to facilitate this operation. Additional tightness was obtained by utilizing a canvas strap to bundle the pipes prior to tightening the steel straps.

HDPE pipe exposed to direct sunlight had very high expansion. These pipes were contracting during the night hours and created loose bundles. Any minor pipe movement during the HDPE pullback operation had to be avoided. It was critical that pipe bundles and casings do not cork-screw and get stuck inside the 30-inch steel pipe.

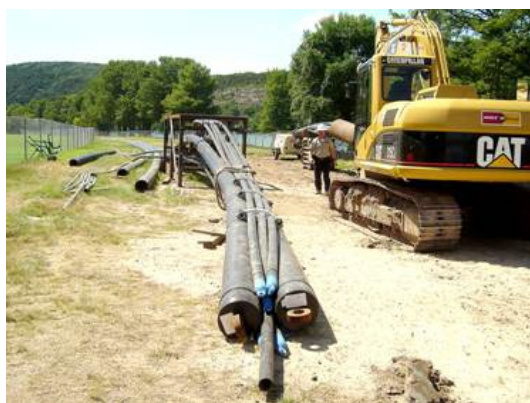
Figure 7 - A special rack was fabricated to facilitate the pullback operation while maintaining correct separation between the multiple HDPE conduits.

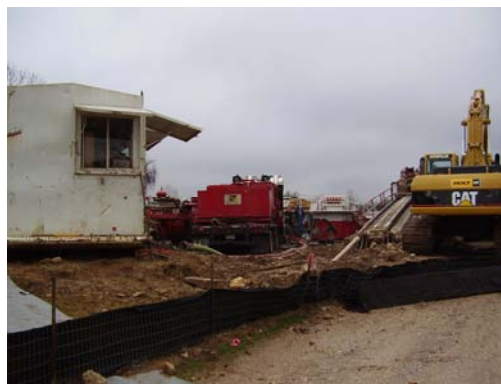
Figure 8 - A DD500 (CMS Rig) and DD140 (American Auger Rig) were used for the operations. 2 MCS-750 mud mixing/cleaning systems along with a combination of mud pumps were used for the drilling operations. A ParaTrack2 MGS Guidance System was utilized along with other equipment consisting of back hoes and trucks. The drilling fluid primarily consisted of fresh water and bentonite, with polymers to optimize performance.

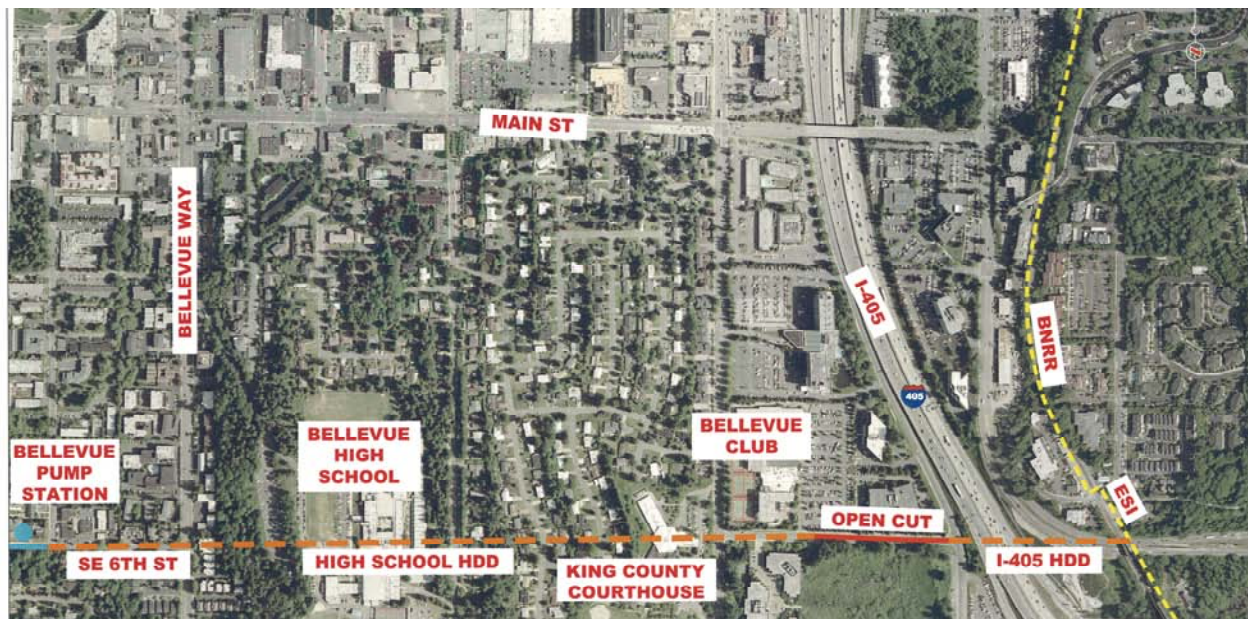
Figure 1. Aerial View of New Force Main Alignment.

The existing Bellevue Pump Station (see Figure 1) is operated by the King County Wastewater Treatment Division and was completed in 1964. Located just south of downtown Bellevue, all flows are currently conveyed through a 20-inch force main and gravity sewer to the Swayolocken Pump Station, which is located a few miles south. In order to upgrade the existing facility and handle the anticipated future design flows, the Bellevue Pump Station peak capacity will be increased from 11.03 mgd to 13.6 mgd, and a new 24-inch (ID), 5,300 feet long force main (see Figure 1) will be constructed from the pump station to the Eastside Interceptor (ESI), a major regional trunk sewer. This paper focuses on the HDD-related elements of the new force main design.

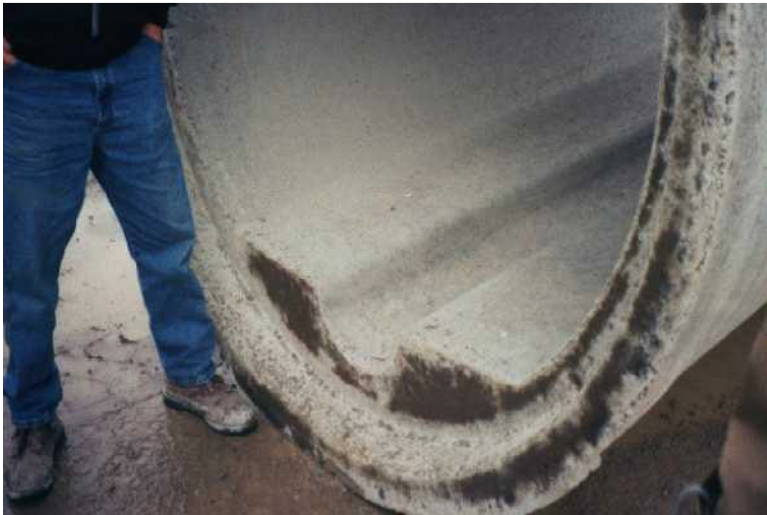
FIGURE 3
RCP with Cunnette

The contract documents offered the bidders two pipe choices: RCP with a cunnette invert or CCFRPMP. The successful bidder selected RCP with an invert cunnette already cast into the pipe sections at the manufacturing facility. Figure 3 shows the pipe with the cunnette section; Figure 4 shows the pipe installed in the tunnel. The bid cost was \$7.5 million for the pipe in tunnel - \$682/lf (shaft and surface construction costs not included).

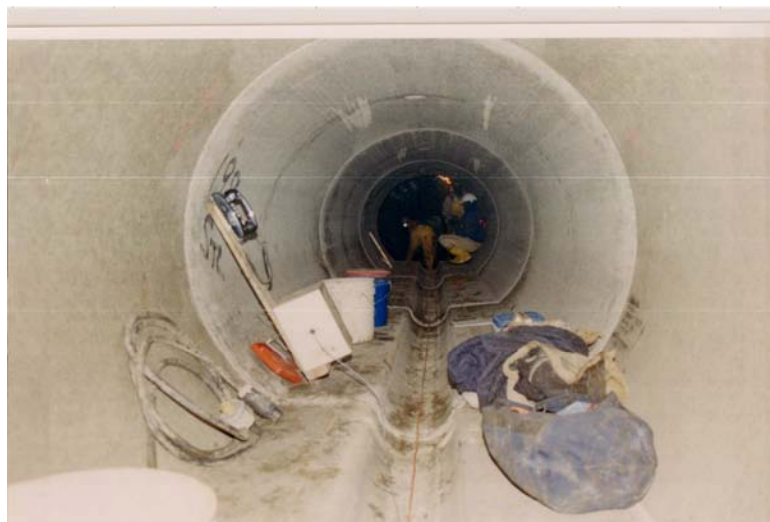
FIGURE 4
RCP with Cunnette installed in tunnel

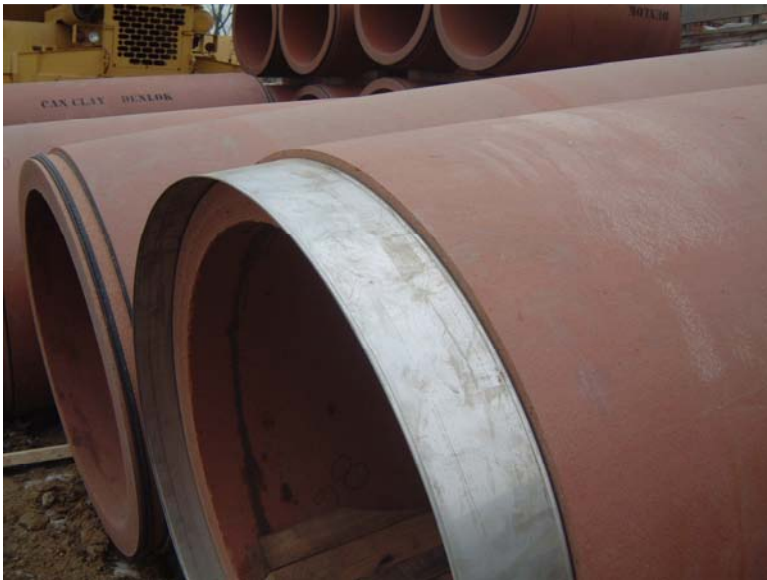
FIGURE 5
VCP Jacking Pipe

The contractor for the project selected the Denlok VCP pipe for microtunneling, as manufactured by Can-Clay with a 36.3" ID and a 44.5" OD to match the selected MTBM.

Figure 5 shows the VCP jacking pipe and Figure 6 shows the VCP pipe being installed in the microtunnel.

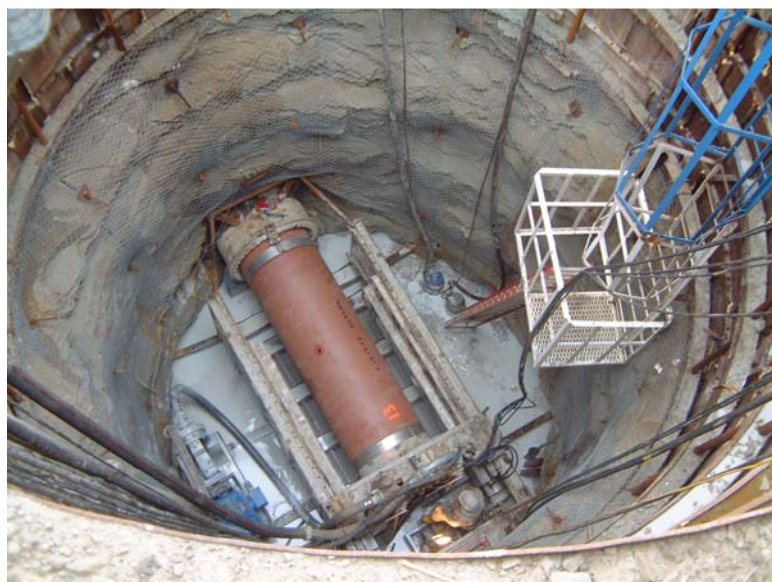
FIGURE 6
VCP Jacking Pipe Being Installed by
Microtunneling in Rock

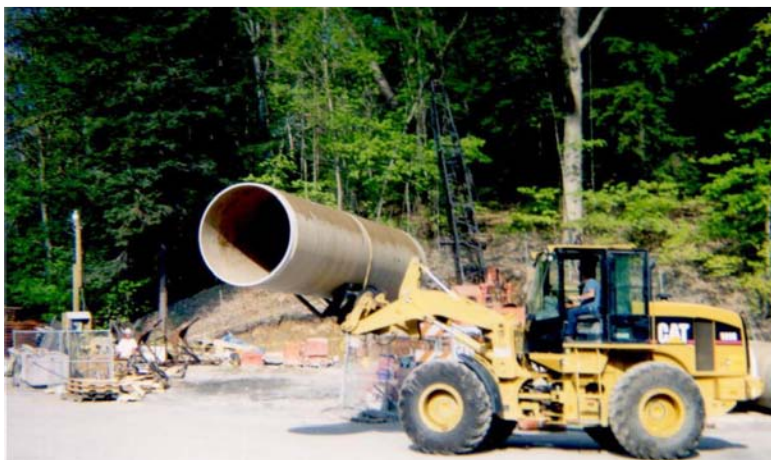
FIGURE 7

Fiberglass Pipe being carried to the tunnel shaft

The Orchard Meadow project was a 1,600 LF long relief sewer designed to eliminate a CSO discharging into Mill Creek within a park in Youngstown, Ohio. The narrow ROW along the creek and concerns regarding slope stability using open cut construction along a hillside resulted in the decision to construct the most downstream 800 LF segment of relief sewer in tunnel. Both RCP and fiberglass pipe (CCFRPMP) were considered for the project. Both were adequate from a hydraulic and a ground load basis. As this was a relief sewer for combined sewer flow (essentially an increase in capacity allowing the elimination of a regulator and overflow), the low flow characteristics of the pipe were a concern. Low flow (dry weather) rates were low enough that deposition of solids and the potential for hydrogen sulfide generation were concerns. As a result, fiberglass pipe was selected for use on the project. A 60-inch diameter pipe was selected as the carrier pipe inside a 114 inch tunnel, excavated by a TBM. The initial tunnel liner consisted of steel ribs and timber lagging or liner plates (depending on the ground conditions to be encountered). The steel ribs and liner plates were considered to be temporary tunnel support as the pipe was selected to carry all of the anticipated long term ground and water loads. After the tunnel was excavated, the pipe was placed in the tunnel and the annular space between the rock or initial temporary supports was filled with grout. As an option, microtunneling with pipe jacking was also specified. The project was constructed using a conventional TBM at a bid cost of \$2.3 million. Figure 7 shows the fiberglass pipe being moved on the construction site. Figure 8 shows the pipe blocked in the tunnel.

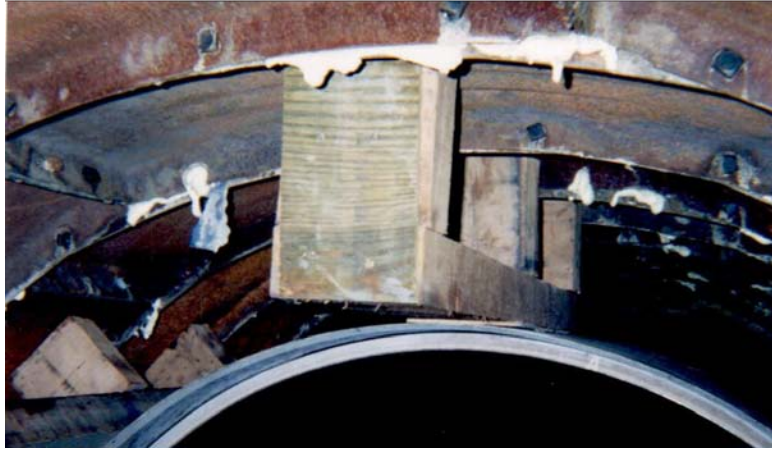
**FIGURE 8**

Fiberglass pipe blocked against the liner plates prior to backfilling with grout.

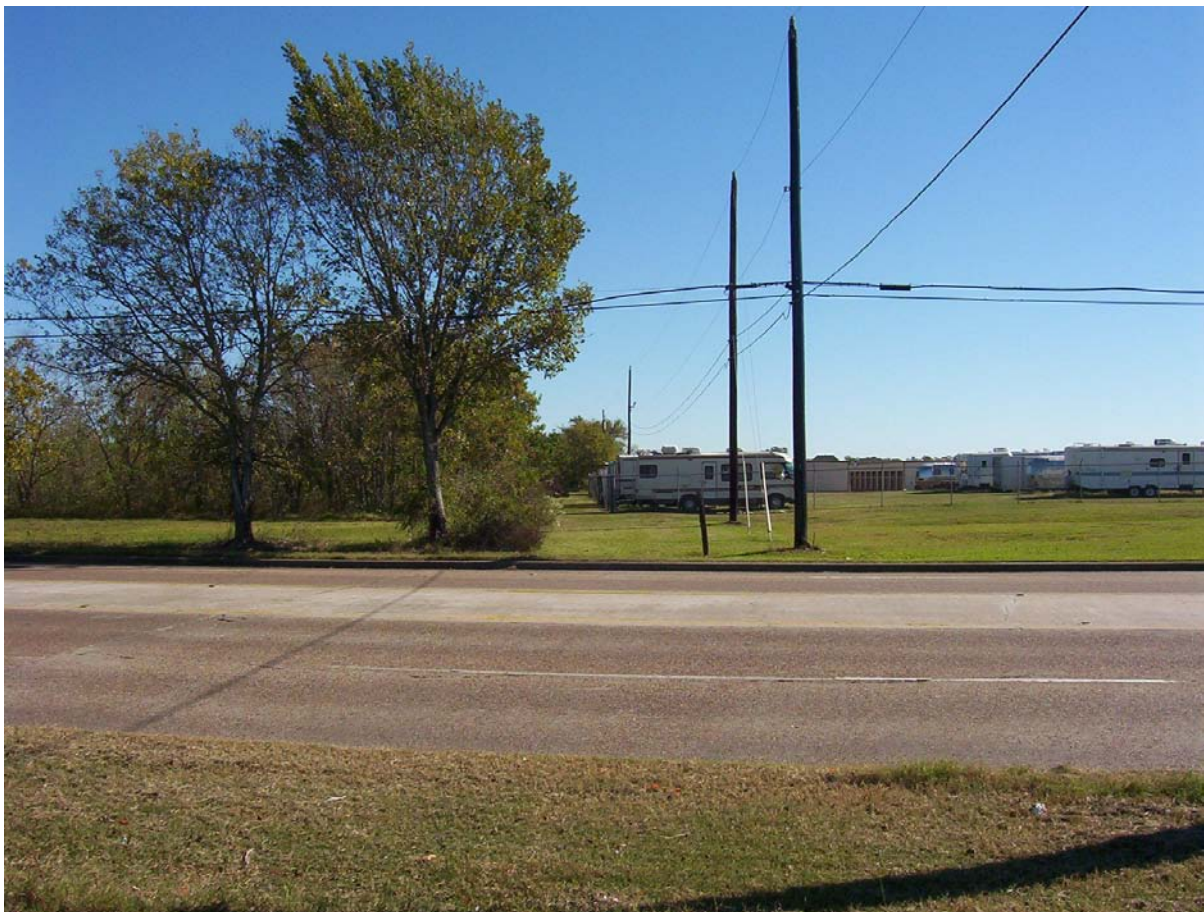
Figure 2: N. Main Street Crossing

A similar layout was designed for the 95-foot portion of the gravity sewer line crossing under N. Main Street. The PVC gravity sewer line will be encased and protected within a 21-inch diameter steel casing pipe. Auguring will commence at the entrance pit on the west side of N. Main Street, and terminate at the exit pit on the east side. Photos of the augur crossings for N. Main Street and one of the existing driveways are shown in Figures 2 and 3, respectively.

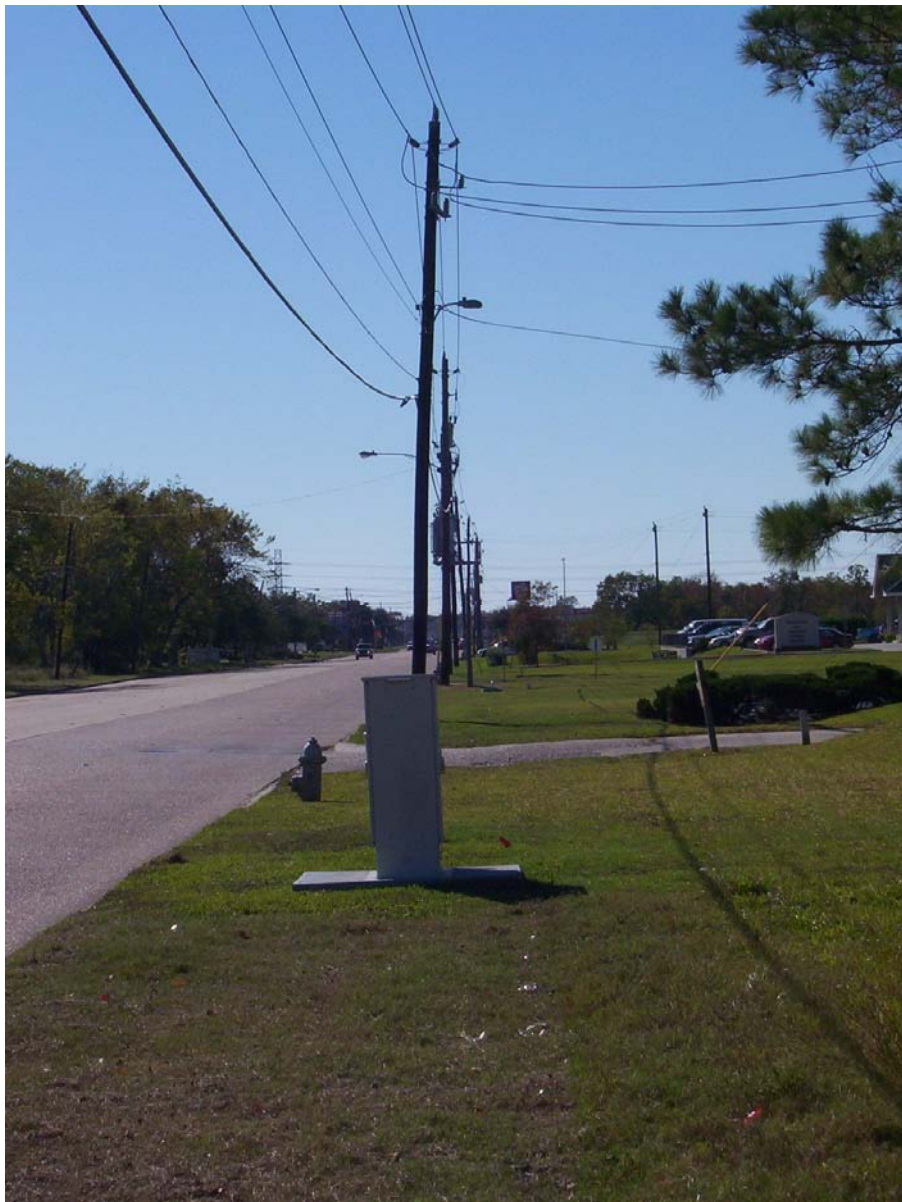
Figure 3: Driveway along N. Main Street

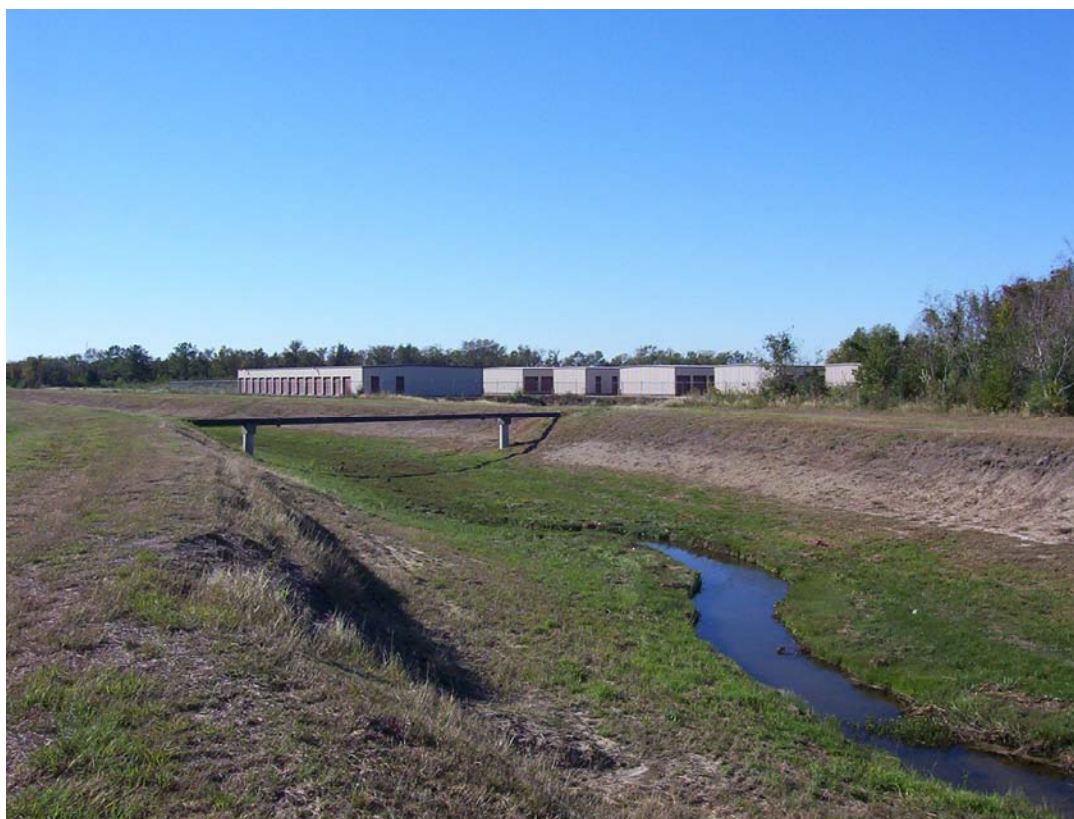
Figure 4: HCFCD with Existing 12-inch Force Main Aerial Crossing

The second option was a design for horizontal directional drilling under the flood control channel, which requires specialized drilling equipment and sufficient above ground open area for placement of piping and heavy drilling equipment. After performing a construction costs comparison, it was determined that the directional drilling method for installing the force main was the more cost effective option. The 6-inch, 215 linear feet force main was designed to have a minimum 10-foot of cover from the bottom of the channel. High Density Polyethylene (HDPE) pipe, SDR 11, was selected for the force main due to its flexibility and durability. Figures 4 and 5 show the HCFCD channel with the existing 12-inch force main aerial crossing.

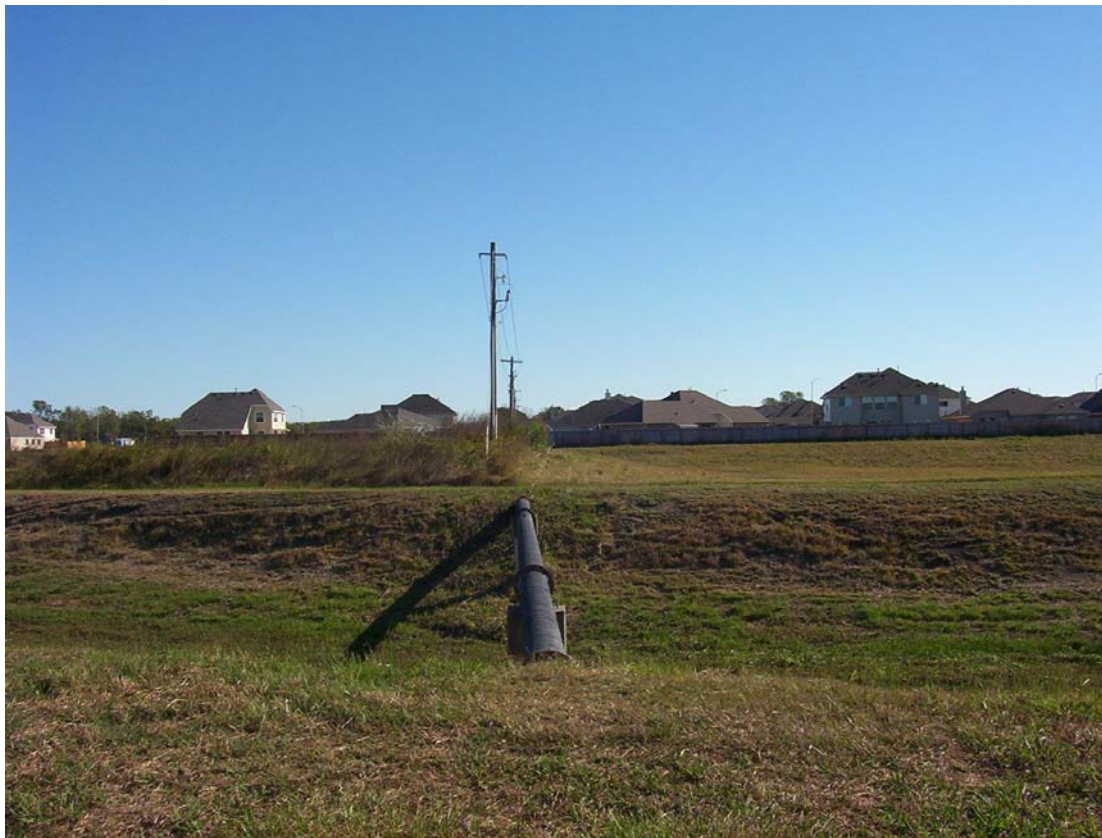
Figure 5: HCFCD with Existing 12-inch Force Main Aerial Crossing

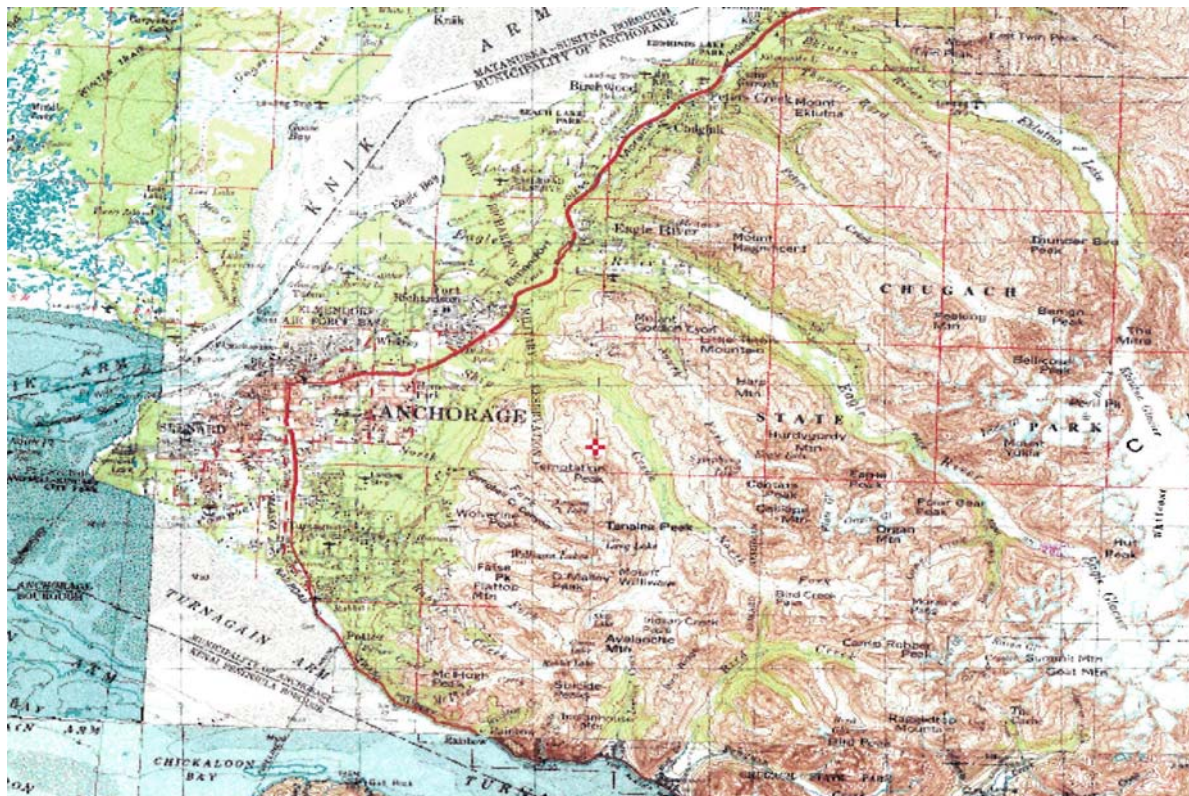
Figure 1 Eklutna Lake and the Anchorage Bowl

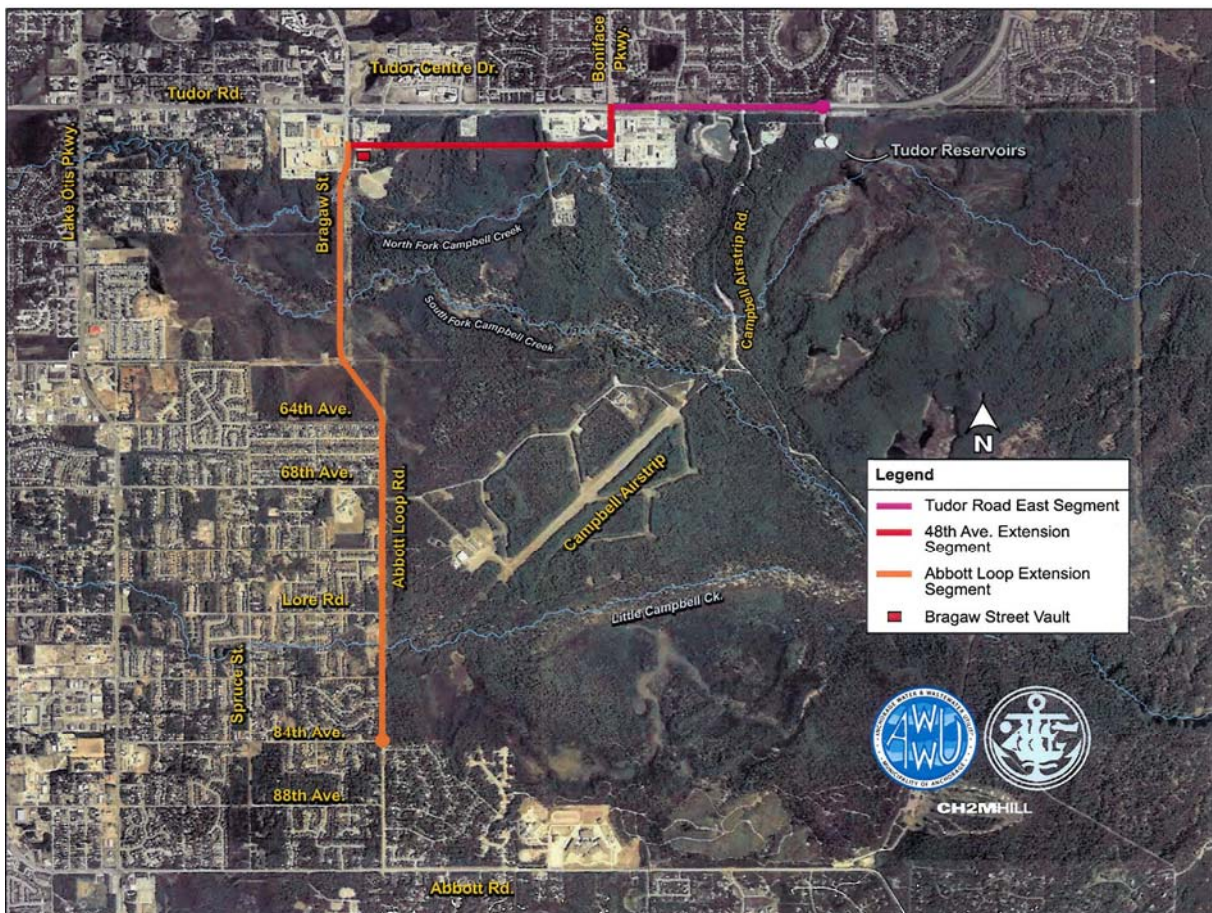
Figure 2 Loop Phase IV Project Overview

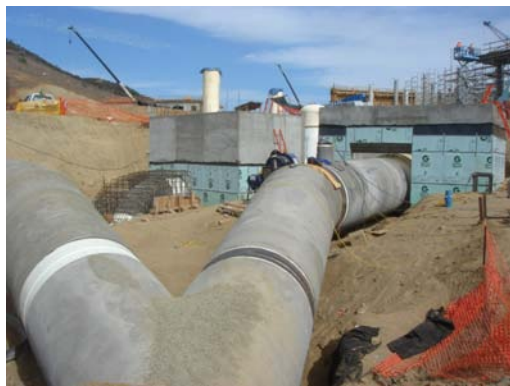
Photo 1 – 84-inch Yard Piping

The constrained site required that sections of yard piping be temporally supported until encased in reinforced concrete or CLSM. Wall thicknesses allowed for unsupported spans of approximately 50 feet. However, the yard piping was supported at 20 to 30-foot intervals during construction and prior to placement of pipe zone material as shown in Photos 1 and 2.

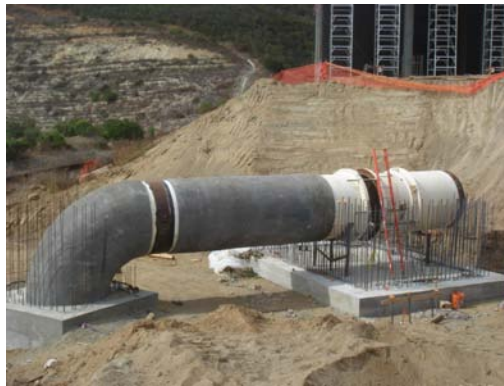
Photo 2 – 72-inch Yard Piping

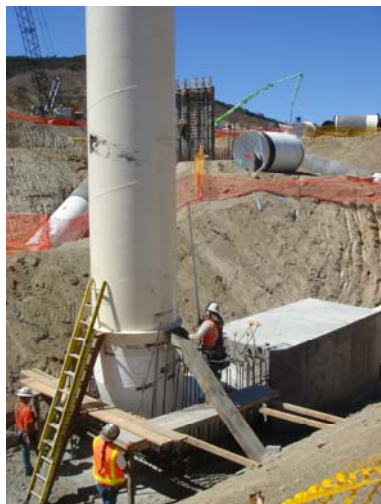
Photo 3 – Tape or Epoxy Coating

In an effort to reduce the cost of steel pipe fabrication and meet a critical early delivery schedule, sections of yard piping initially designed to be concrete encased were tape wrapped without a mortar overcoat as shown in Photo 3. This fabrication method was acceptable according to the contract specifications. However, it became apparent that any savings in fabrication cost were canceled by the extra care and handling of the tape wrapped pipe. Eventually, the construction and design team agreed to apply the mortar overcoat, thereby resulting in less installation time for the encased pipe even where concrete encasement was required as shown in Photo 4.

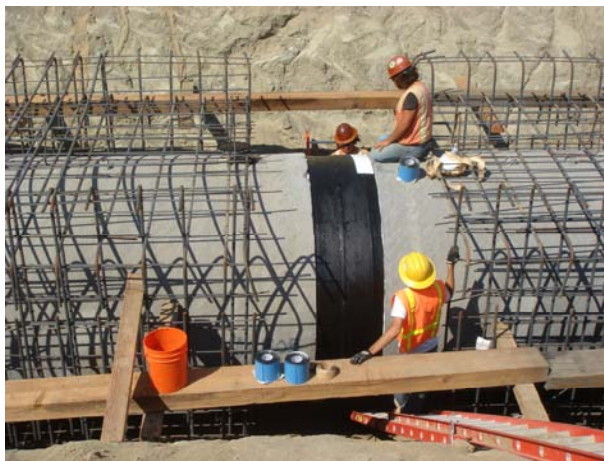
Photo 4 – Tape and Mortar Coating

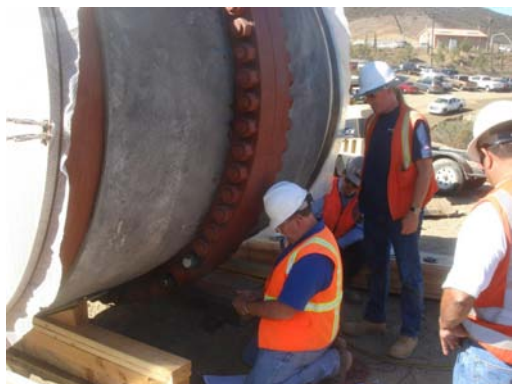
Photo 5 - Bolts Retested at Site

to Water Authority specifications and details. Following assembly, the flange was tested at the NPC plant, then shipped to the site and tested again following unloading (Photo 5). The test indicated that eight bolts failed. The failed bolts, sleeves, washers, and nuts were removed and replaced. The common observed failure was a result of the sleeve compression against the washers and nuts and bolt threads cutting through the sleeve as shown in Photo 6. The damage to the sleeves appeared to be caused by the assembly method that utilized both a static wrench and an impact wrench. Subsequent sleeve, washer, and bolt installation was performed using two impact wrenches.

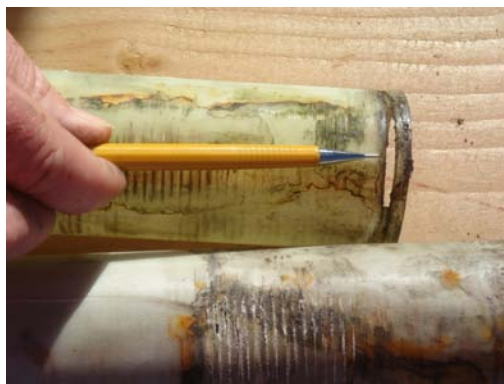
Photo 6 - Damaged Sleeves

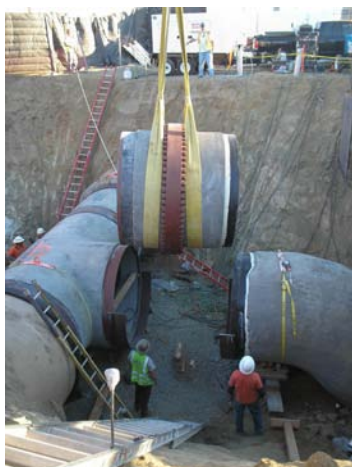
Photo 7 - Insulating Flange Assembly

Photo 7 shows the assembly being set in the 90-inch pipeline. After the assembly was welded in place using two butt straps, each bolt was tested again as shown in Photo 8.

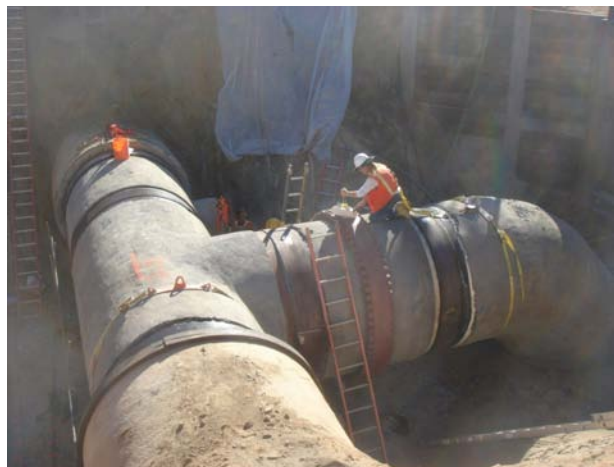
Photo 8 - Testing Of Assembly

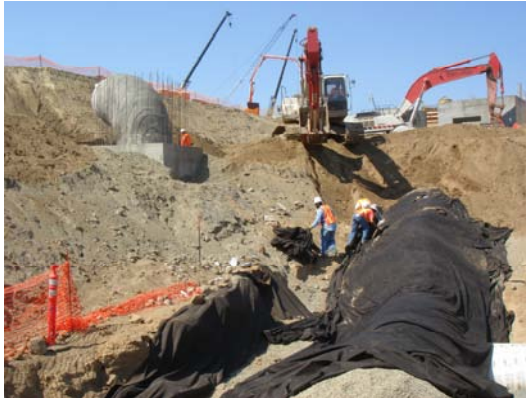
Photo 9 - Granular Embedment

Early critical installation procedures that required filter fabric and crushed rock pipe embedment (see Photo 9) were replaced with CLSM as the pipe embedment material. The construction site had limited opportunity for trench excavation due to structure construction

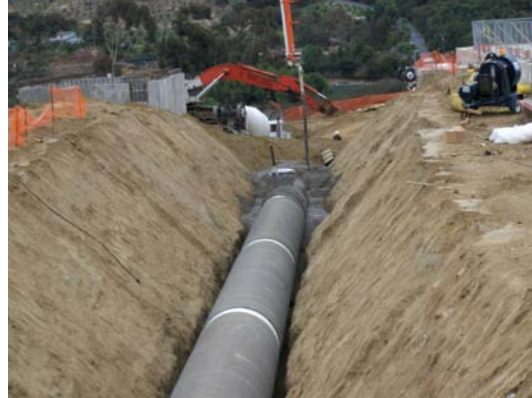
Photo 10 - CLSM Placed In Narrow Trench

adjacent to pipe alignments and construction vehicle circulation needs. Installation of the crushed rock with filter fabric proved problematic because limited trench depths required embankment type pipe installation. The flowable properties of the CLSM reduced the pipe zone installation effort resulting in significant schedule improvements. The mix design had a six-inch slump requirement, and the mix contained cement, fly ash, water, aggregate, Daravair 1000 admixture, and air. Aggregate sizes ranged from 100 percent passing a 3/8-inch sieve to two percent retained on a 200 sieve. The material has a 28-day compressive strength between 50 to 150 psi and resembles a sandstone type material when cured. Photo 10 shows CLSM being placed in the pipe zone.

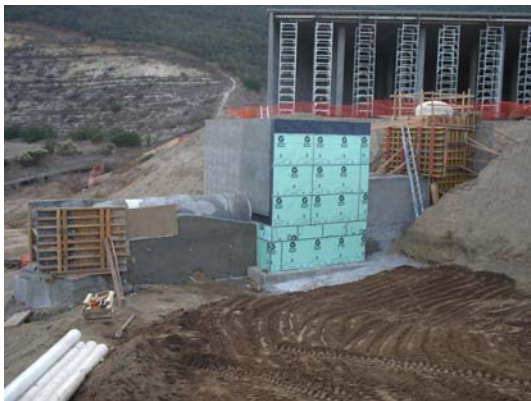
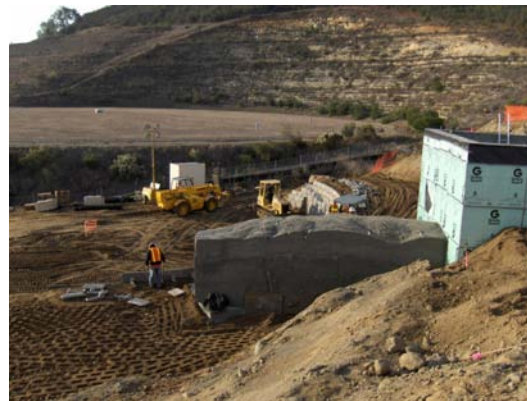
Photo 11 shows CLSM placed around the pipe using formwork and Photo 12 shows vertical sides of the hardened CLSM that encapsulates the steel pipe. Structural backfill was compacted in even lifts around the CLSM.

CLSM Placed with Formwork

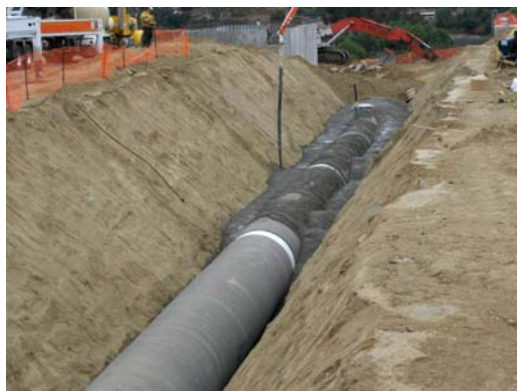
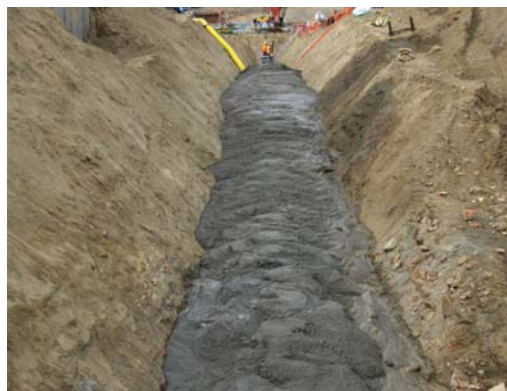
Photos 13 and 14 show CLSM being placed in the pipe zone and the totally encased yard piping.

CLSM Placed in Trench
