PIPELINES 2007

Advances and Experiences with Trenchless Pipeline Projects

PROCEEDINGS OF THE ASCE INTERNATIONAL CONFERENCE
ON PIPELINE ENGINEERING AND CONSTRUCTION

July 8–11, 2007
Boston, Massachusetts

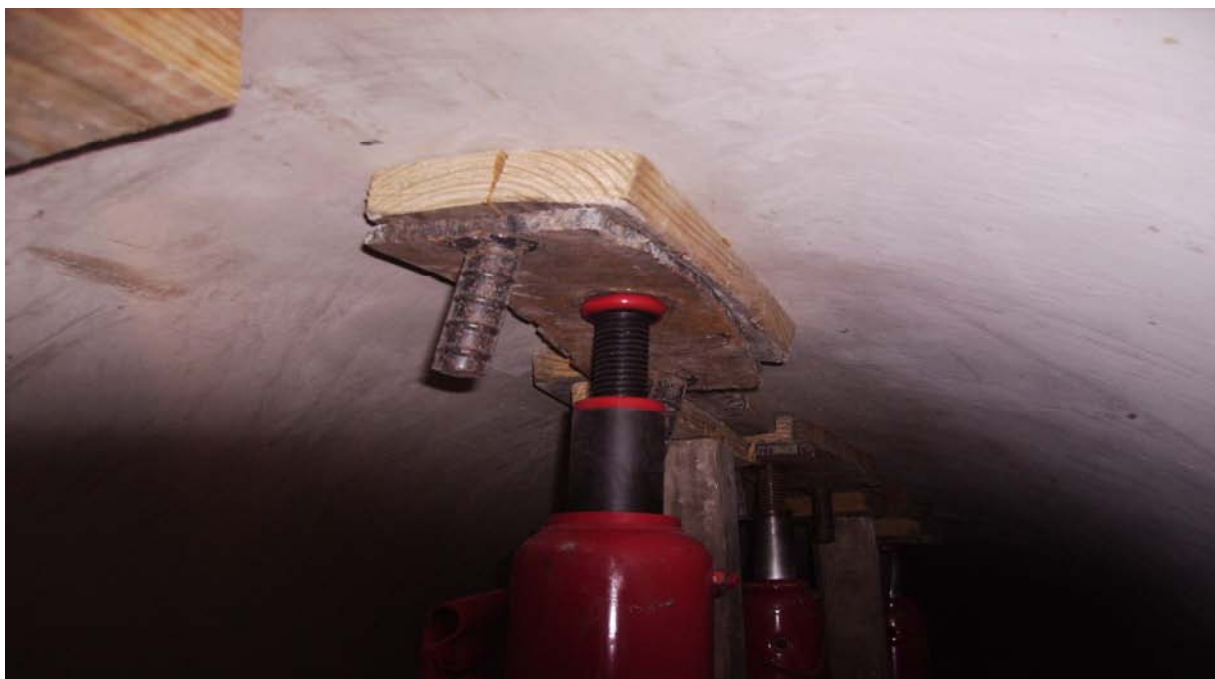
TSC submitted a plan to hydraulically jack the pipe into the designed circular shape after uncovering the deflected pipe and one pipe section on each side down to the haunches, and placing three hydraulic jacks in a pipe segment, one at each end, and one in the middle. This method has been used successfully before by TSC and was also the method recommended by NW Pipe. A mat consisting of a steel plate with either lumber or rubber cushion would be placed in between the jacks and the mortar lining of the pipe to prevent damage to the pipe, as seen in photograph 1. While some of the sections suffered minor damage to the mortar lining due to the jacking, most remained unharmed, and the damaged sections were repaired with grout. The jacks are then manually operated in unison until the pipe is rounded. Once the pipe was re-rounded, 48-inch support stulls were installed at the jack locations, and new sand backfill was compacted in the haunches and up to one foot above the top of pipe in accordance with City Specifications. Depending upon moisture content, the native soil was allowed to be placed above the pipe.

Photo 1: Hydraulic jacks with rubber and steel padding inside MK #35 along Alameda.

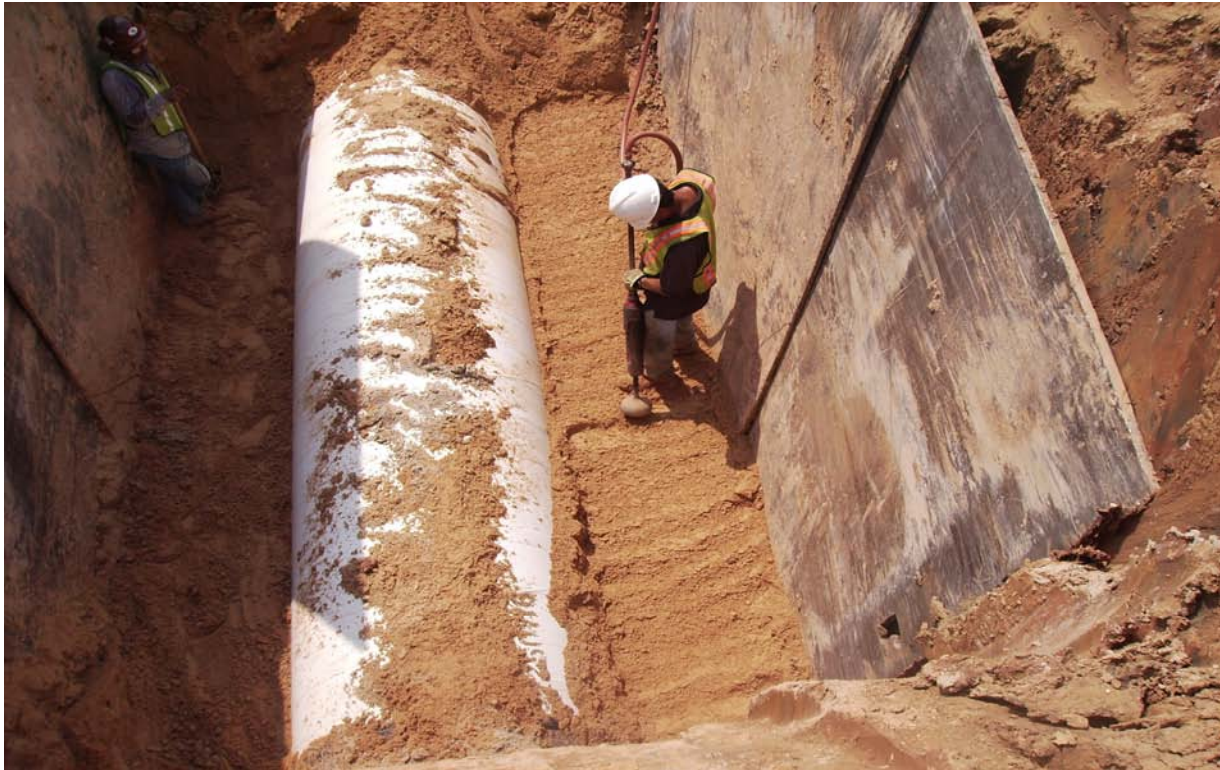
After the rounding of the pipe is complete, the trench is backfilled. Every foot the soil is compacted with hand-held rammers and walk-behind plate compactors, as seen in photo 2. Wooden stulls are in place before, during, and after backfilling is complete.

Photo 2: Worker using pneumatically powered hand-held rammer to compact soil around MK #143 as the pipe is backfilled.

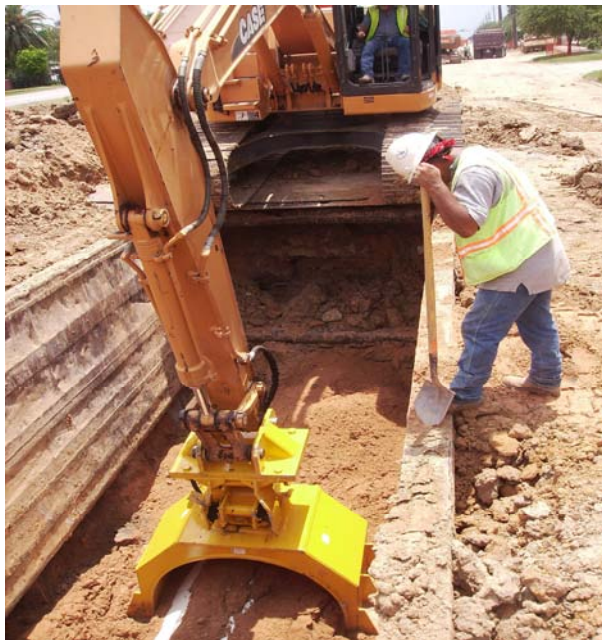
On Friday, May 12, at the request of the surety, Texas Sterling brought an excavator with an attachment to assist with the compaction effort. The machine was used in conjunction with the internal hydraulic jacks and walk-behind plate compactors to re-round the pipe and compact the soil. The horseshoe shaped vibratory attachment is approximately 60-inches wide and designed to fit around the pipe and compact soil on both sides of the pipe simultaneously, as seen in photo 3.

Photo 3: Excavator with vibratory attachment, compacting soil around MK #97.

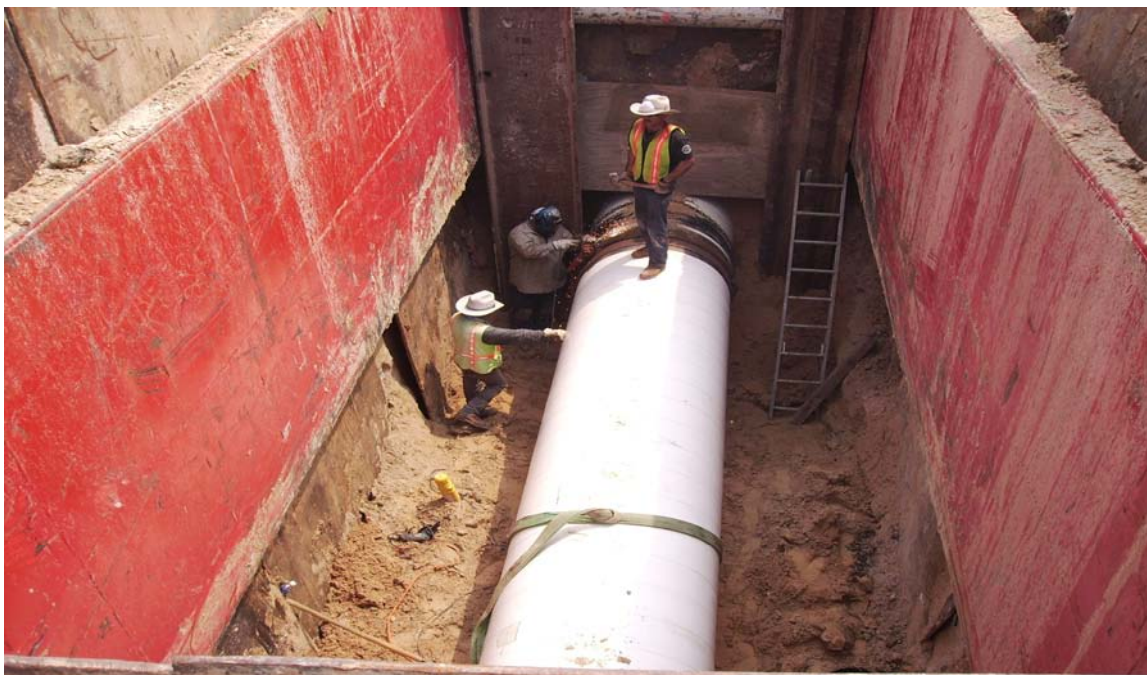
A total of six sections that were beyond repair were required to be replaced. Two contained longitudinal cracks in the mortar lining causing a majority of the lining to delaminate from the steel cylinder. This condition warranted the replacement of the section. The new segments were installed using a butt-strap closure, as seen in photo 4. Four adjacent sections were replaced bell-to-spigot with heat-shrink tape placed over the joints, as seen in photo 5, and did not require the use of a butt-strap.

Photo 4: New segment used to replace MK #23, being installed with the use of a butt-strap between MK #23 and MK #24.

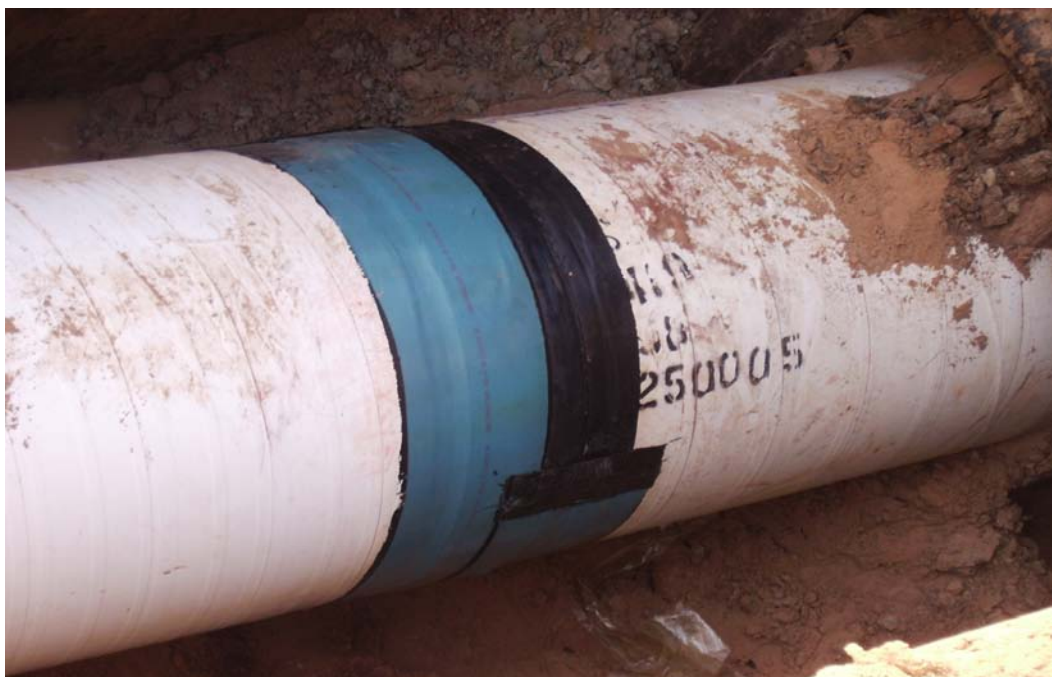
Photo 5: Heat-shrink tape placed at the joint between MK #94 and MK #95.

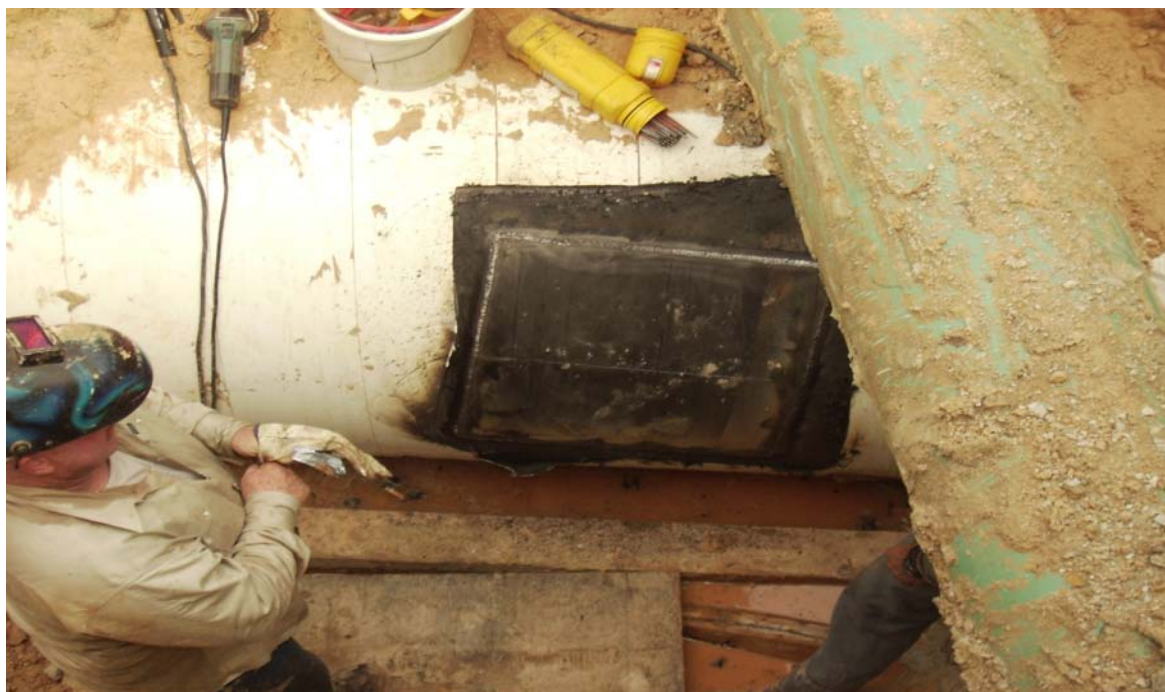
Two more sections contained dents in the steel requiring either replacement or repair. On 10-inch diameter, circular, holes were cut from the steel cylinder, removing the portion of the pipe which was dented. A 36-inch by 36-inch square patch was cut from a removed segment of pipe and welded over the hole both on the exterior and interior of the pipe, as seen in photo 6. Field-applied tape was placed over the exterior of the steel patch after it was welded into place.

Photo 6: Steel patch being welded over removed portion of steel on MK #31

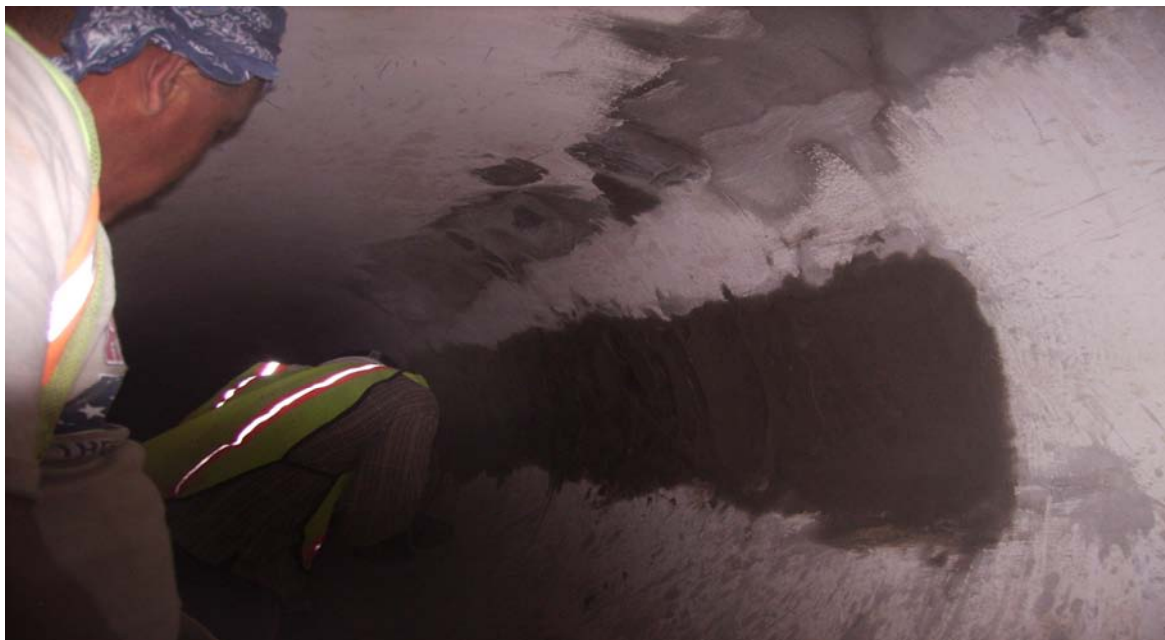
Several of the segments contained either longitudinal or circumferential cracks in the mortar lining. While some were replaced, most were minor enough to only warrant localized mortar replacement. The largest grout repair was made on Mark #33 where a large portion of the mortar lining had become disbonded from the steel, as seen in photo 7.

Photo 7: Grout being used to repair a portion of mortar lining which had delaminated from the steel cylinder in MK #33.

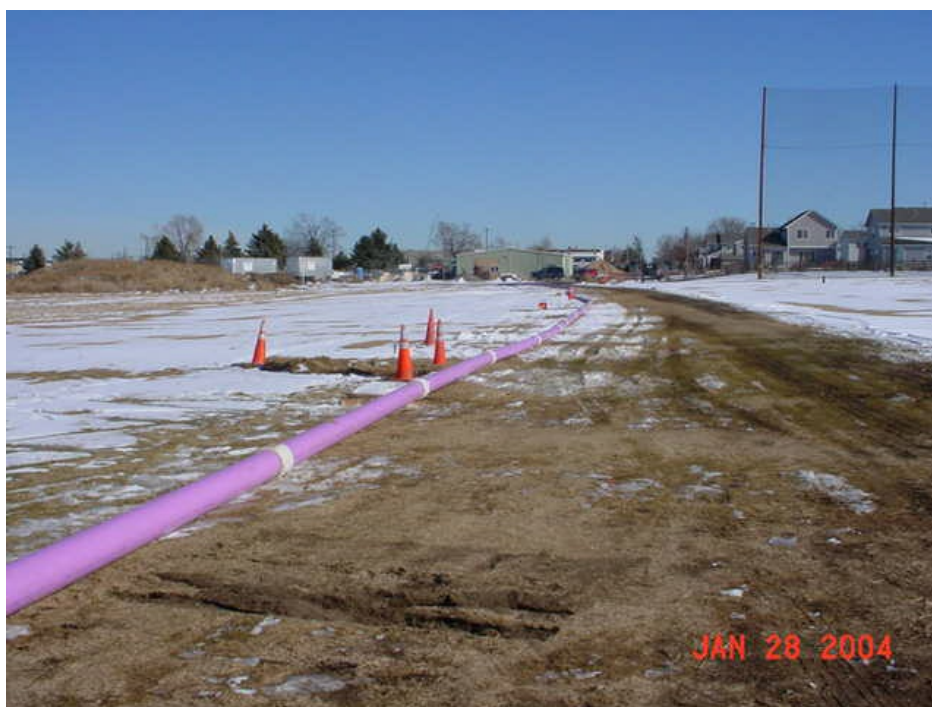
Horizontal Directional Drilling, HDD, was allowed to compete against the traditional open cut method for installation of some of the smaller diameter recycled water distribution mains. HDD was the method of choice in a few instances including a 2000 foot length to cross Park Hill Golf Course in northeast Denver. Certain-Teed Certa-Lok C900 Restrained Joint Pipe 8" diameter was used to cross the golf course in 4 separate pulls. The pits were placed in between fairways so that play could (when weather permitted) continue during construction. Overall, the Contractor saved money versus open cutting when factoring in savings realized because of reduction in surface restoration.

Figure 5 – Pipe laid out in the string method for HDD installation.

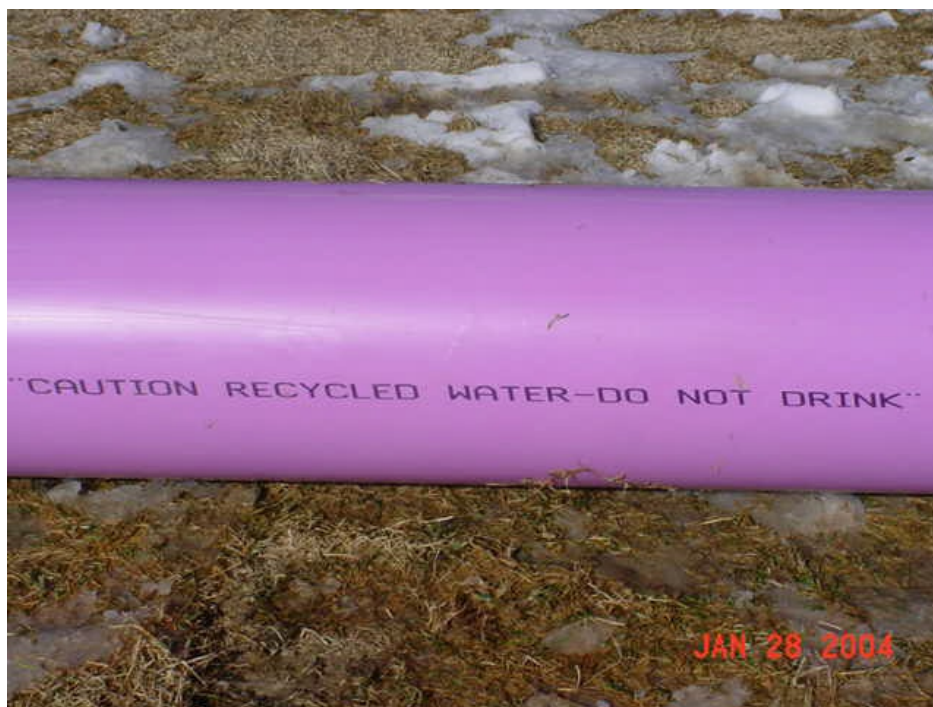
Figure 6 – Photo of purple PVC pipe with warning.

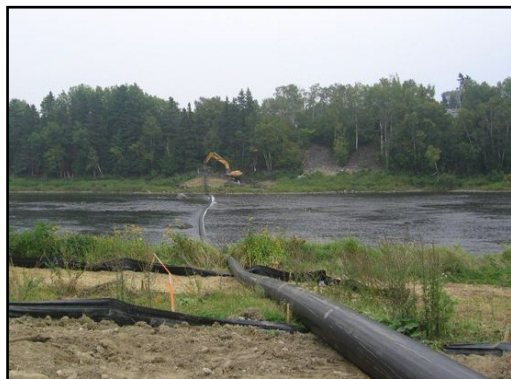
Redesigning the bore to bore to proceed west to east did present several problems, the greatest being that 700-feet of HDPE pipe was on the wrong side of the river. The general contractor contacted a local tow truck service with a long cable and the pipe was towed across the river to the eastern shore (see Photos 1 & 2)

Photo 1: Towing pipe across river looking east

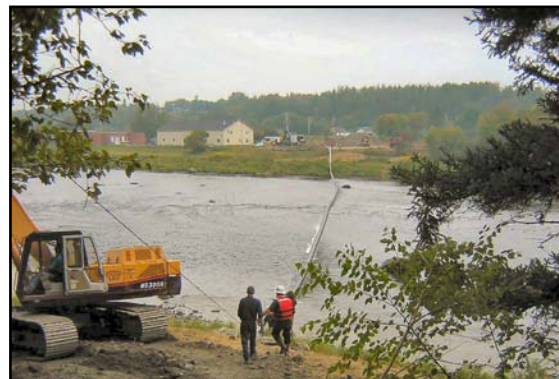
Photo 2: Towing pipe across river looking west

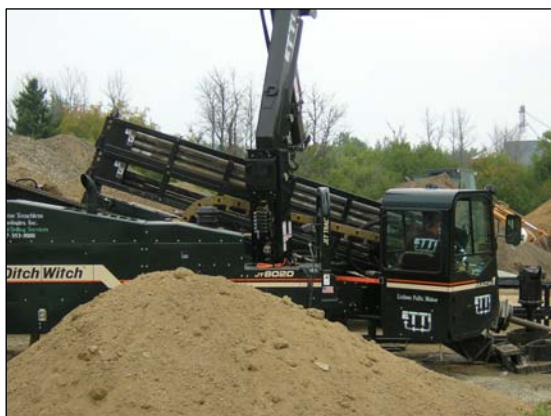
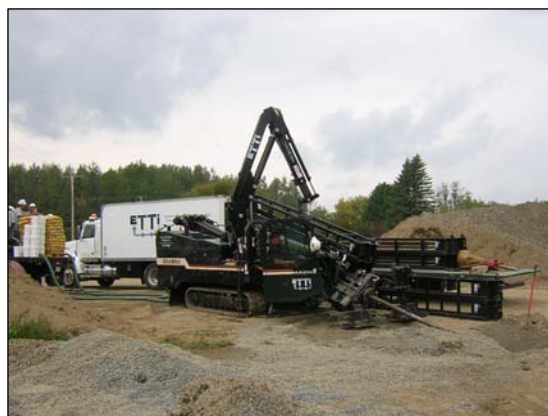
Photo 3

The HDD water main installation proceeded flawlessly. Photos 3 & 4 show the HDD contractor set up on the west shore. The District, MEDEP, and Wright-Pierce observed the installation and were extremely pleased with the final product and the minimal impacts to the Aroostook River.

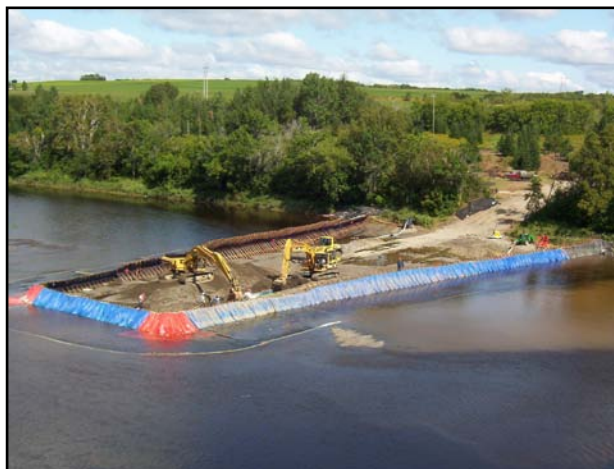
river water level and overtopping the porta-dams and coarse riverbed gravels requiring significant dewatering within the dams. Photo 5 shows this open cut installation with porta-dams.

Photo 5: Aroostook River water main crossing, Presque Isle, Maine

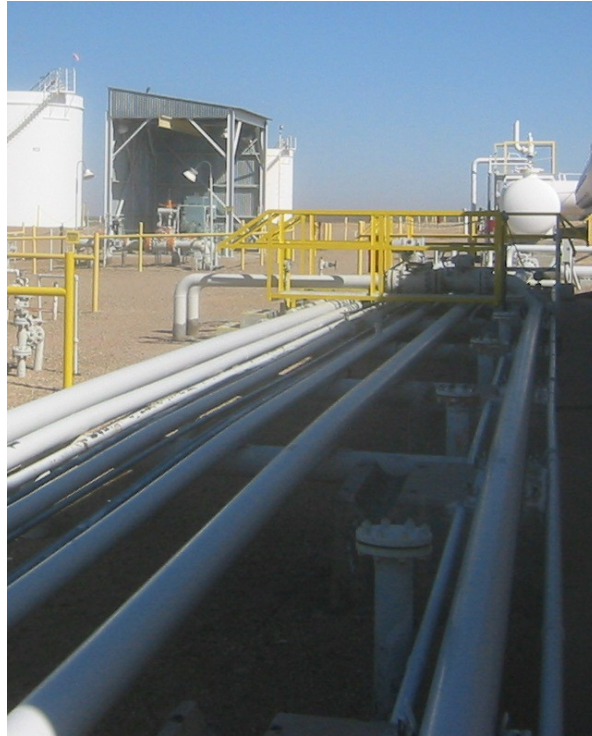
Figure 1 – Petroleum pipeline booster station, Colorado. The petroleum pipeline industry is regulated in planning for risk management (Pipetech International photo)

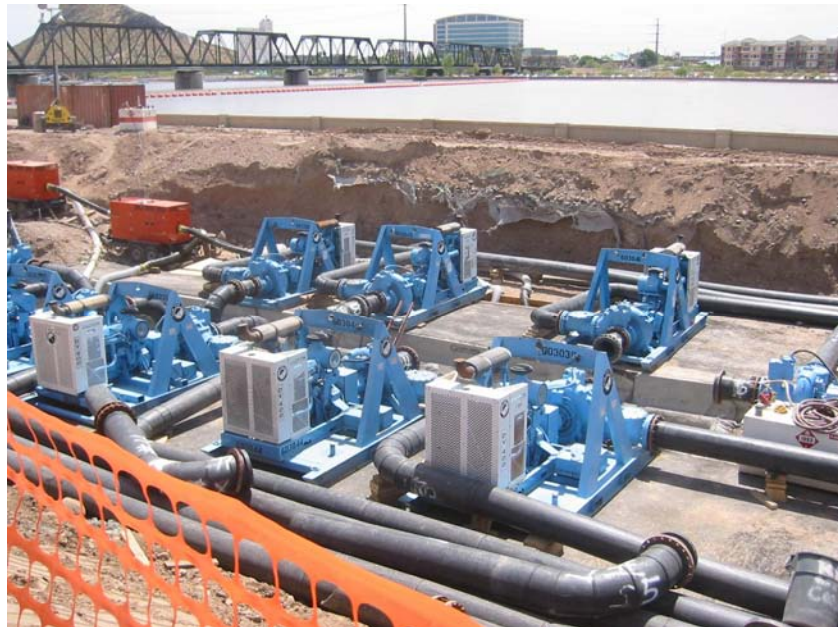
Figure 3 – In this planned outage a temporary bypass of a sewer main allows installation of cured-in-place lining
(Pipetech International Photo)

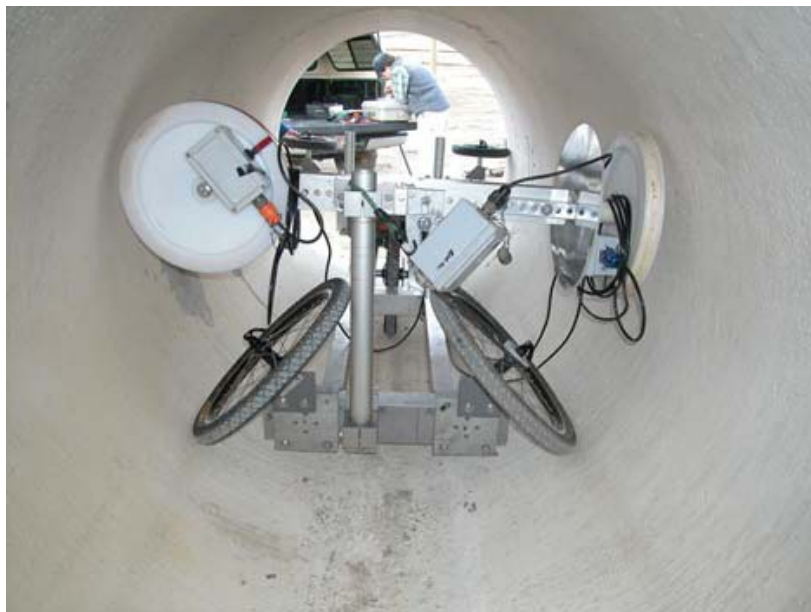
Figure 4 –Magnetic testing introduced in 1997. Manned equipment requires safe pipeline access
(Pure Technologies photo)

The eddy current testing, for example, requires that people and equipment enter the pipeline to perform the test. The rate of testing is several miles per day, and for reasons of personnel safety and efficiency, there should be access manholes about every ½ mile. Unfortunately some pipelines lack the characteristics to facilitate the electromagnetic test, and in some rare cases the test is virtually impossible to conduct for operational reasons.

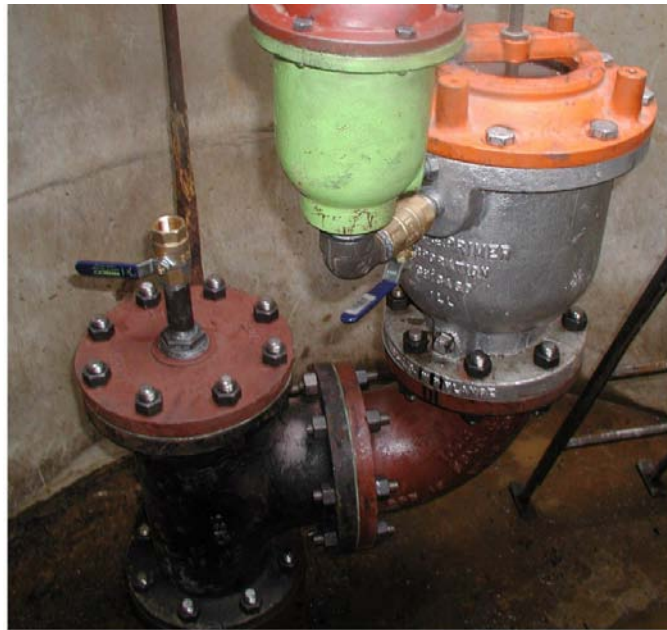
Figure 5 - Acoustic Emission Testing, introduced in 1996 requires insertion of hydrophones at regular intervals
(Pressure Pipe Inspection Company photo)

Another very effective test method for PCCP condition assessment is the acoustic emission testing that is now widely used. This test method enjoys much of its popularity because it is conducted while the pipeline is in operation, however it still requires some preparation for the test to be effective. The test requires the insertion of hydrophones into the pipeline and the spacing of the hydrophones is critical to the effectiveness of the acoustic test. For larger pipelines, spacing of 2000 feet is adequate, while smaller diameters will require spacing not greater than 500 feet. Some existing pipelines have little or no available insertion points within the required spacing, and the performance of the acoustic test becomes quite difficult. Depending on the vendor's methods, the insertion valve will need to be up to 2" full port diameter. This test would be greatly facilitated (and risk management greatly improved) if the design requirements included access manhole spacing not greater than $\frac{1}{2}$ mile; with a 2" ball valve in each manhole, and positioned to facilitate hydrophone insertion.

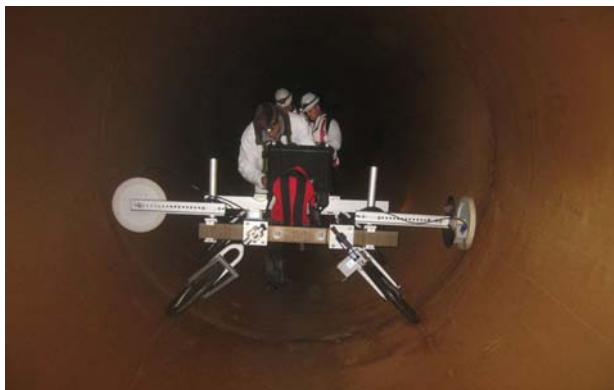
Electromagnetic inspection is a non-destructive testing technique that involves traversing the interior of a pipeline with equipment that can electromagnetically test the condition of the prestressing wire wrapping in a PCCP. An electromagnetic field is induced on the prestressing wire on one side of the pipe. Using the prestressing wire, this field is transmitted to the opposite side of the pipe where it is measured and recorded. The data is then evaluated to identify electromagnetic anomalies consistent with wire breaks in the prestressing. These anomalies are further evaluated, to determine the spatial characteristics of the anomaly and estimate the length of damaged pipe and number of wire breaks.

Figure 2: Electromagnetic inspection of the 102-inch Providence aqueduct

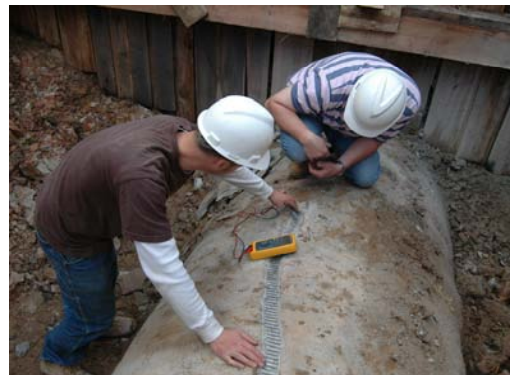
where a loop has an abnormally high resistance value, the loop is broken. This is an accurate method of determining the number of wire breaks on a particular pipe section. Subsequently, the pipe is patched with mortar.

Figure 3: Resistivity testing being performed on a 54-inch pipe

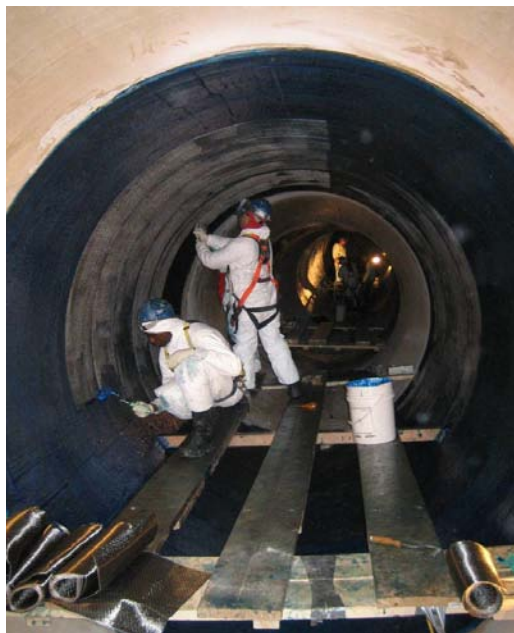
Figure 5: 2006 carbon fiber repairs

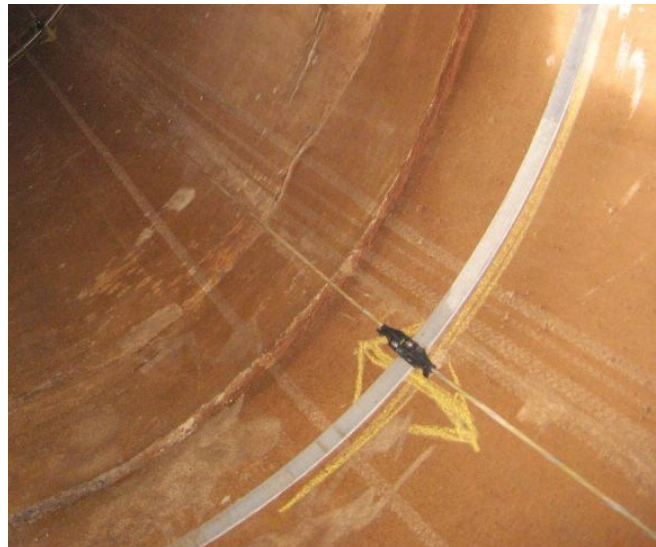
For these reasons a fiber optic sensor was used to monitor the 102-inch aqueduct. The sensor was installed on the invert of the aqueduct and the main was re-charged. The wire breaks recorded by the acoustic monitoring system are now added to the estimated wire breaks determined by the electromagnetic inspection and thus at any point in the future, Providence Water can ascertain an estimated number of wire breaks on each pipe section. This total number of wire breaks can be entered into a structural analysis model and the risk associated with each pipe section can be calculated. If a pipe section deteriorates to an unacceptable level of risk, Providence Water can intervene to initiate a repair of the pipe section thus avoiding pipe failure.

Figure 6: Steel strap and strain relief connection used to attach fiber optic sensor to the interior pipe wall of the 102-inch aqueduct.

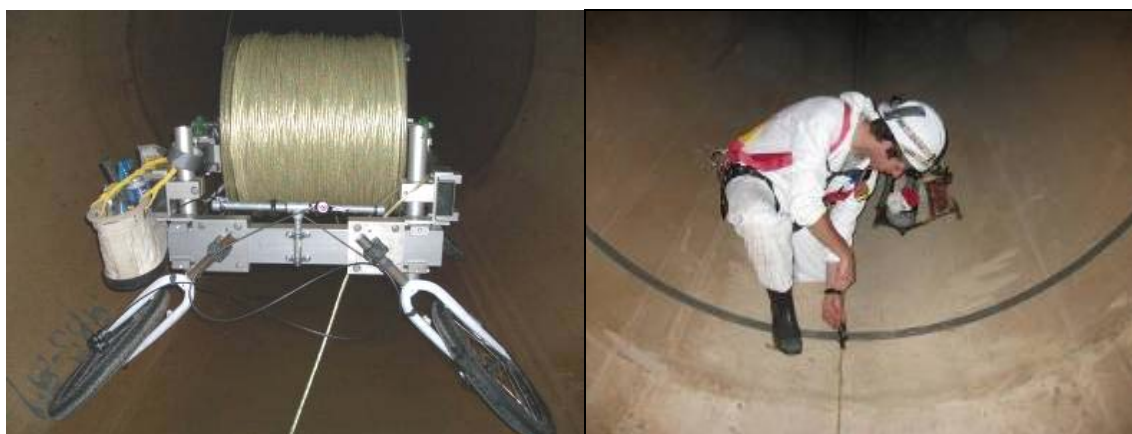
The AFO system is comprised of a specially designed fiber optic cable that is deployed inside a pipeline. The cable is attached to the invert of the pipe at regular intervals using rubber clamps and expandable hoops (Figure 3 & 4). Since cable movement affects the acoustic capabilities of the system, the cable should be secured at points of inflection and in areas of turbulence in the pipeline.

Figure 3 & 4 – Fiber Optic Cable Installation

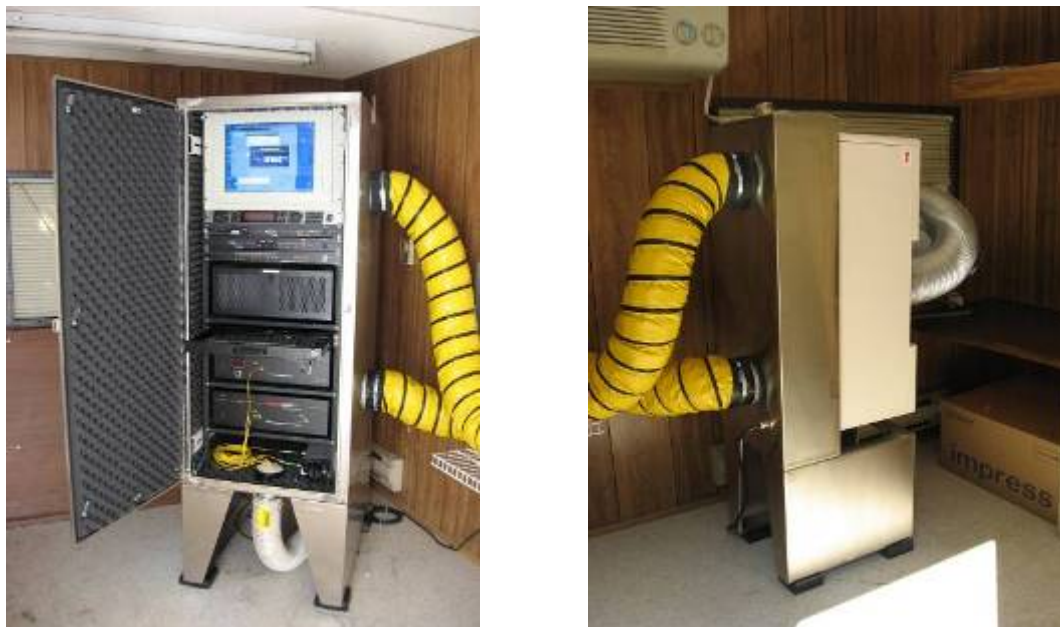
As per standard acoustic monitoring systems, the fiber sensor is attached to a Data Acquisition (DAQ) system that is continuously acquiring acoustic data from the fiber (Figure 5). The DAQ processes the data and rejects any that are outside of the parameters established for an event of interest (e.g., wire break). Conventional telephone lines, wireless or wired internet connections transmit the remaining data to a central processing facility.

Figure 5 – Optical Data Acquisition System

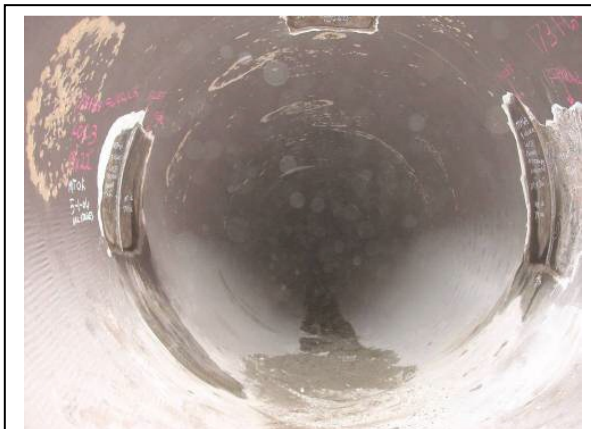
FIGURE 1
Typical Internal Surface Preparation for Non-Destructive Testing

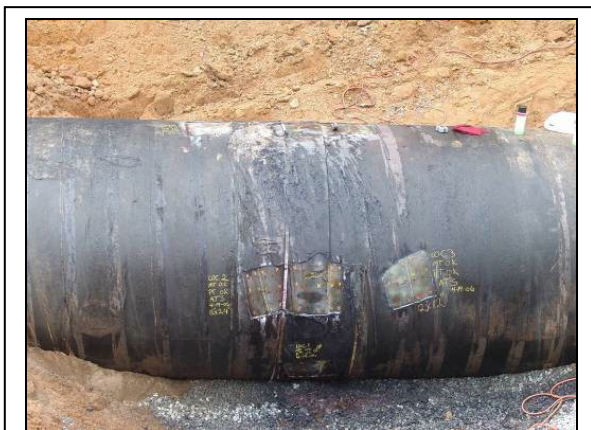
The target surfaces for the internal NDE (figure 2) were the area immediately surrounding the field-assembled bell and spigot lap joint and small sections of the pipe barrel that are traversed by a factory spiral weld. Six to eight sections of external coating were removed at each site, with each removed section varying in size from 0.5 square foot to 3 square feet. Approximately half of these sections exposed the bell and spigot joint.

FIGURE 2
Typical External Surface Preparation for Non-Destructive Testing

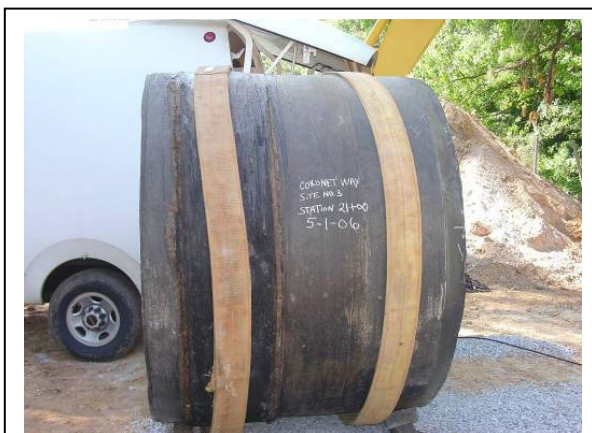
FIGURE 3
4.5-ft Sample (with complete lap joint) cut from 72-inch Pipeline for Lab Analysis

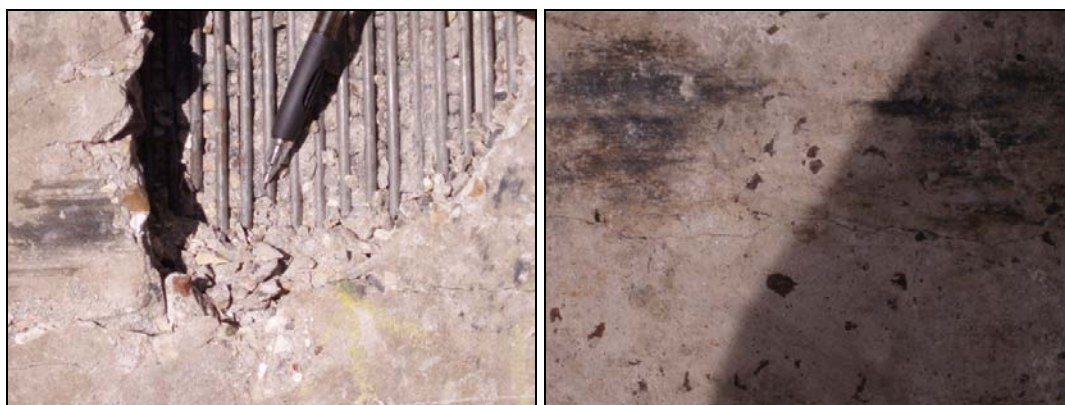
- External longitudinal cracks and hollows were found in the first six feet of R332 (north-south portion of the return line). A small window of mortar coating was broken off to reveal prestressing wires. Several broken wires were identified with no significant corrosion present, and no necking down at the point of failure. Based on the break observations, the prestressing wire failure is likely due to hydrogen embrittlement from stray currents. No cracks in the concrete or hollow areas were found during the internal observation of R332. The electromagnetic survey estimated 120 wire breaks in pipe R332. (Figure 2)

Figure 2 - Broken prestressing wires and external longitudinal crack on pipe R332

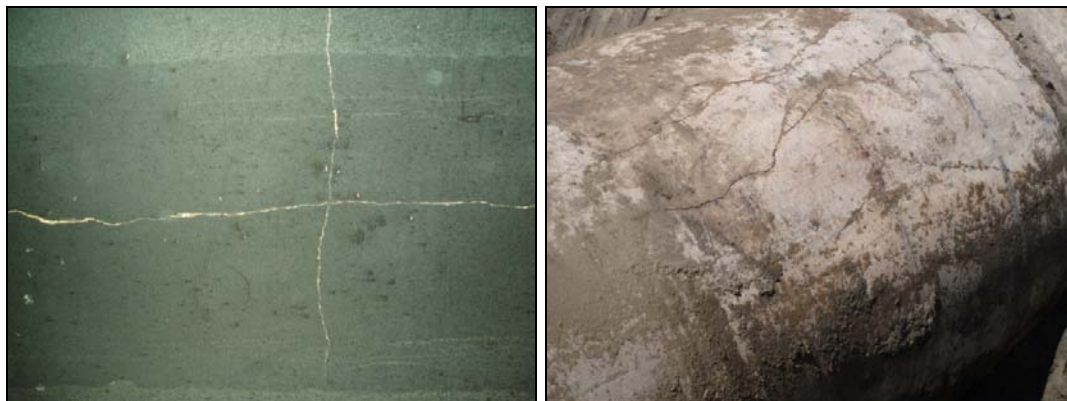
- An internal longitudinal crack in the concrete was found along the length of pipe section R329 (north-south portion of the return line). A circumferential crack crossing the longitudinal crack near the middle of the pipe section had a hollow spot. External longitudinal cracks and hollows in the concrete were found

running across two-thirds of pipe R329. The electromagnetic survey estimated 230 wire breaks in pipe R329. (Figure 3)

Figure 3 - Longitudinal cracks on pipe R329 (internal and external)

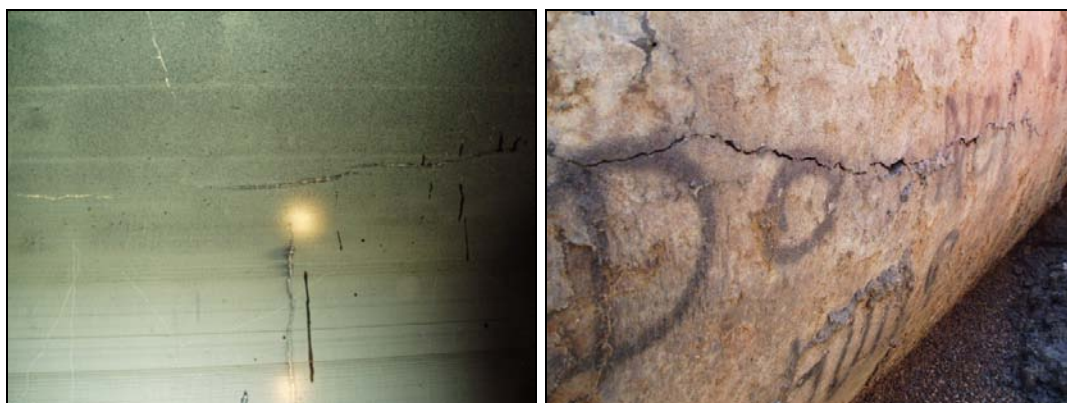
- A five-foot long internal longitudinal crack in the concrete was found on pipe R345 (north-south portion of the return line). No hollows were found around this crack. An external longitudinal crack and hollow in the concrete was observed running across two-thirds of pipe R345. The electromagnetic survey estimated 205 wire breaks in R345. (Figure 4)

Figure 4 - Longitudinal cracks on pipe R345 (internal and external)

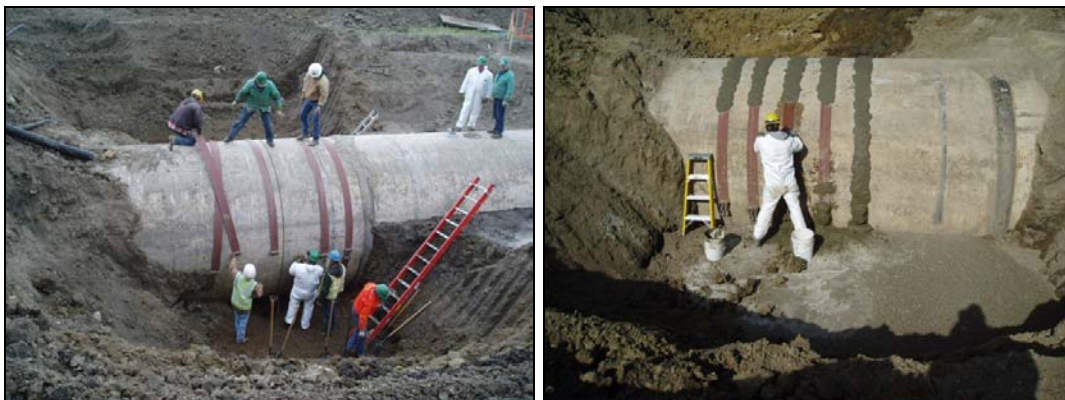
Steel support bands for the 120-inch (305cm) and 96-inch (244cm) PCCP were manufactured by Price Brothers for potential use during the dual-outage. The steel bands were ¼-inch (6.35mm) thick by six-inch (152mm) wide steel bands that matched the outside diameter of the pipes. Results from the physical evaluation identified three pipe sections in distress that warranted installation of these steel bands (Pipe sections R329, R332, and R345). The steel bands act to support the tension capacity of the remaining prestressing wires and to hold the concrete coating in place. The steel bands are a temporary structural support and are not a permanent repair for these pipes. Prestressing wires may continue to break in these pipes, and cracks in the concrete lining will allow corrosion and eventual failure of the steel cylinder. (Figure 6)

Figure 6 - Steel support band installation

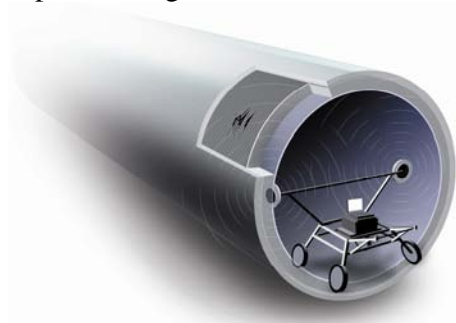
Internal electromagnetic inspection is a state-of-the-art technique used to obtain a baseline condition assessment of all the pipe sections in a PCCP main. The inspections rely on passing equipment through the pipe that senses electromagnetic anomalies caused by broken or deteriorated prestressing wire. The results are recorded on a small on-board data acquisition system. The data is subsequently analyzed and used to estimate the location and quantity of wire breaks in the prestressing wire in each pipe section. The benefit of an electromagnetic inspection is that it provides a direct evaluation of that element that provides the PCCP with its strength—the prestressing wire. The wire break data can also be used to provide a ranking of pipe sections for repair or replacement based on the number of breaks in each section. When this type of data is combined with visual and sounding inspections, a good baseline assessment of a main can be obtained. A conceptual view of the electromagnetic inspection concept is depicted in Figure 2.

Figure 2. Electromagnetic Inspection of Large Diameter Mains

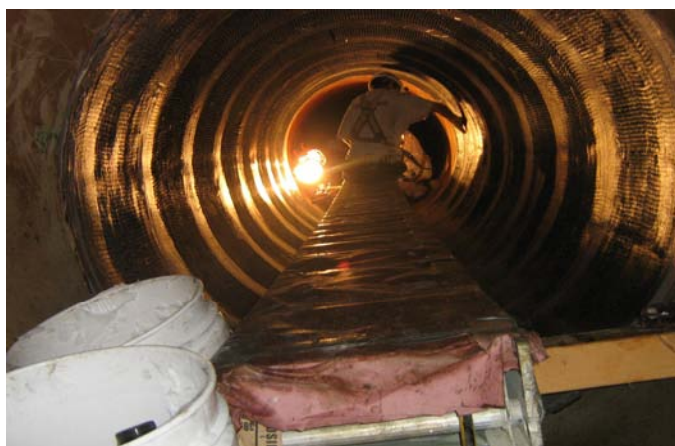
Figure 6. Lining of 54-inch PCCP Main with Carbon Fiber

- Replace approximately 5,000 feet of 54-inch main.
- Slipline 330 feet of 54-inch main.
- Repair twenty 54-inch pipes with carbon fiber lining.

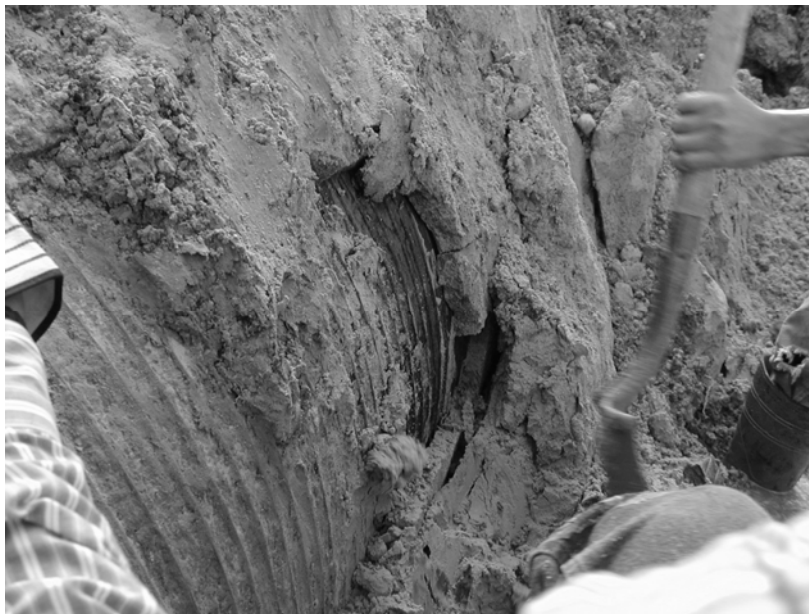
As the surrounding backfill was removed, large sections of mortar coating separated from the pipe with little or no effort (see Exhibit 4). This delamination resulted in corrosion of both prestressing wire and cylinder. The corrosion likely facilitated the onset of failure. Testing performed on wire samples revealed no signs of hydrogen embrittlement or other obvious manufacturing defects.

Exhibit 4. Delaminated mortar coating

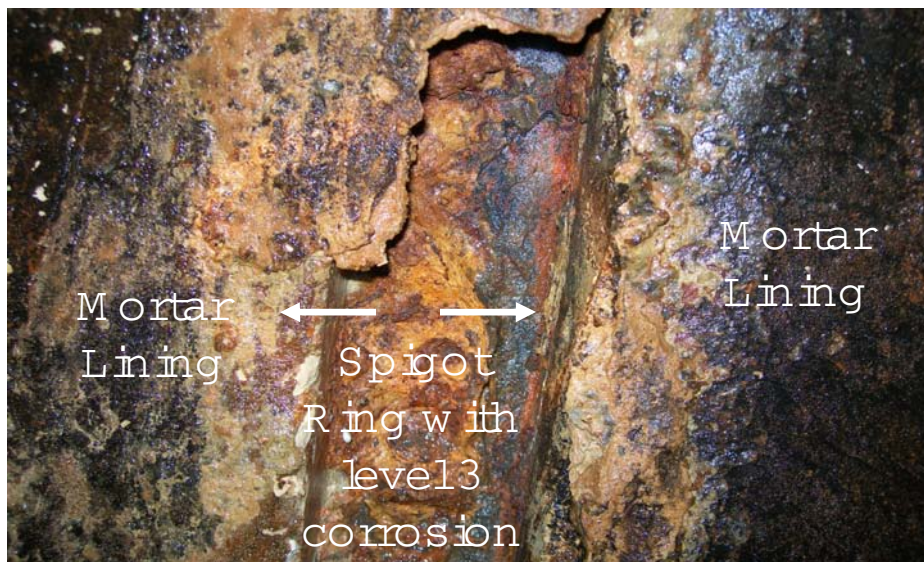
Exhibit 5: Leak location

As a result of the internal observations, the contractor proceeded to fully expose approximately 12 inches of the steel cylinder adjacent to the area of the leak by removing the mortar lining and the remaining joint grout. After removal of the mortar, it was observed that the steel cylinder at the spigot end exhibited severe corrosion and loss of metal at the weld between the spigot ring and the cylinder. The presence of pinholes was allowing groundwater seepage into the pipe, as shown in Exhibit 6 below.

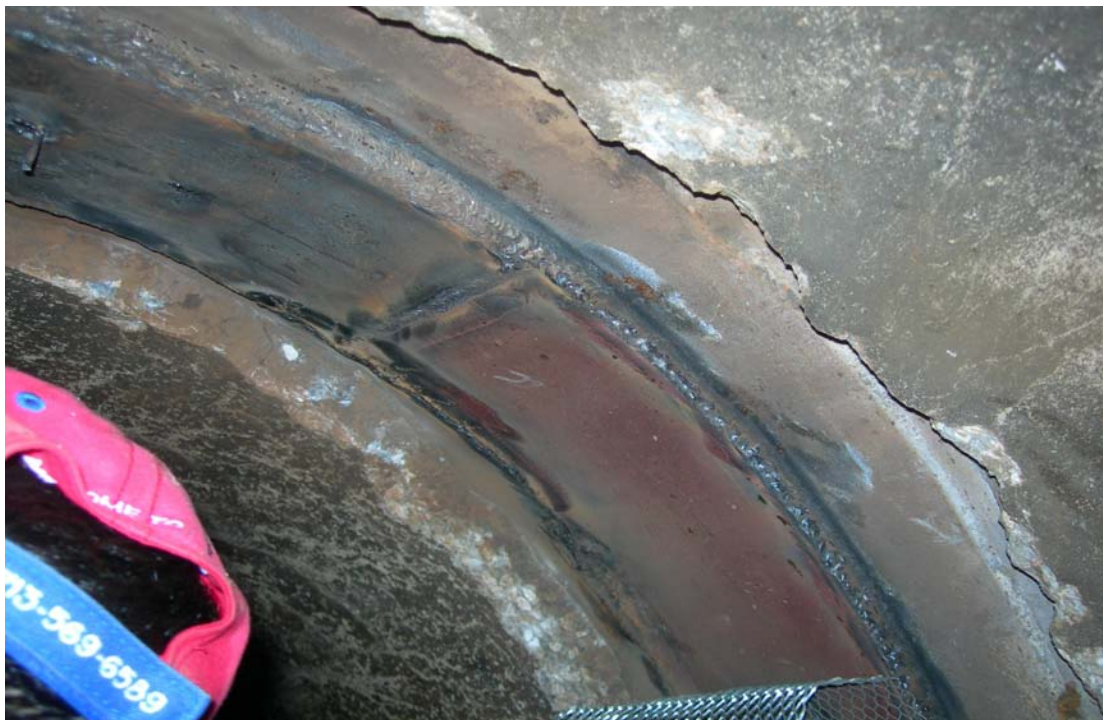
Exhibit 7: Completed internal butt-strap repair

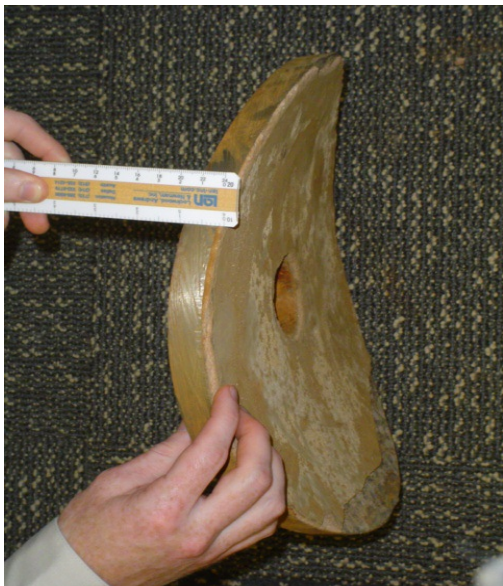
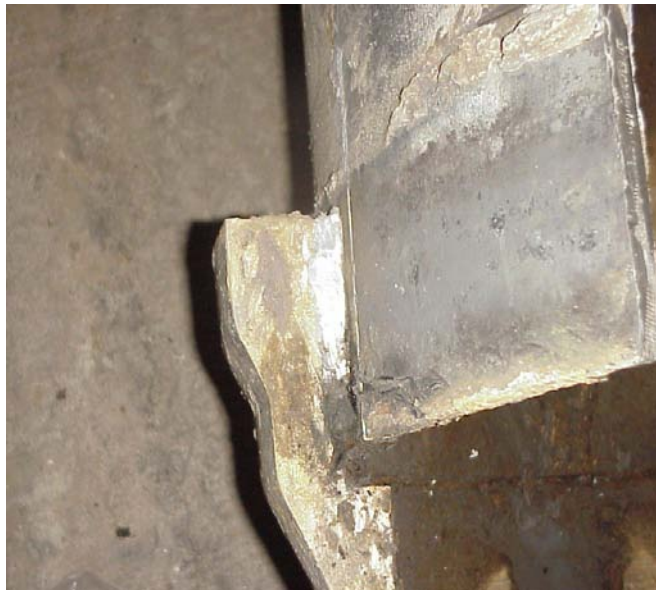
The line was hot-tapped in several locations along the length of the line in order to provide coupons for testing. The coupons indicate the existing pipeline is structurally sound, as can be seen in Exhibits 8 and 9.

Coupon removed from the cast iron water line. Cut-through of bell/spigot joint showing leak caulking

Exhibits 8 and 9: 50+ year old cast iron water line

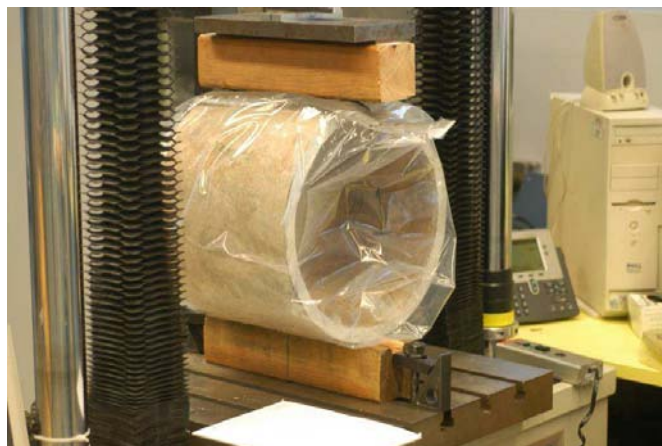
- The three three-edge bearing strength was between 6,621 lb/ft and 7,032 lb/ft, significantly higher than the minimum crushing strength of 3,000 lb/ft specified in ASTM C668 for 14 in. diameter Class T40 pipe.
- The average of the longitudinal flexural strength measured in five flexural strength tests were 4,561 psi.

Photo 3 - Three-edge bearing strength test of 14 in. diameter AC pipe.

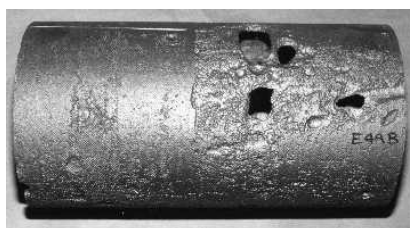
The database consists of 60 examples of DI pipe evaluations. Figure 1 (at the back of this paper) shows a summary of the database. Figure 2 shows one of the pipe segments that is included in the database. The pipe sizes in the database range from 4 inches to 24 inches in diameter. Table 1 shows the number of examples for each of the different pipe sizes included in the database. The DI piping ranges from 5 to 35 years in age. Table 2 shows the number of examples in each age group.

Figure 2
27-year old DI pipe with no protection (after cleaning).
