PIPELINES 2007

Advances and Experiences with Trenchless Pipeline Projects

PROCEEDINGS OF THE ASCE INTERNATIONAL CONFERENCE
ON PIPELINE ENGINEERING AND CONSTRUCTION

July 8–11, 2007
Boston, Massachusetts

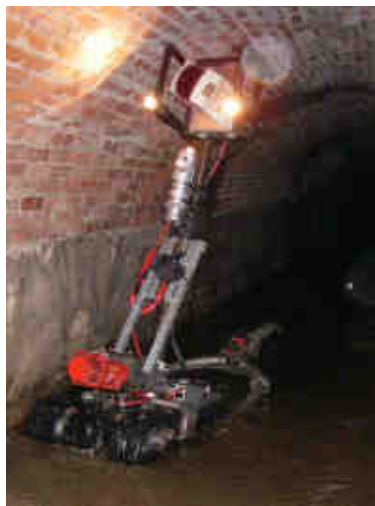
In this paper, we present a unique combination of components for quantitative pipeline inspection: a robust mobile platform, called Responder (Figure 1), a sensor suite that includes a 3-D laser scanner, and 3-D data processing techniques derived from computer vision and computational perception (Horn, 1986) (Russell, 1995). The geometric integration and processing of 3-D point clouds rely on state-of-the-art techniques (O'Neill, 1997) (Hartley, 2000). In addition, using Redzone analytics, 3-D geometric models of pipes can be reconstructed and used to produce quantitative answers to pipe location, integrity, and performance questions.

Figure 1: The Responder Robotic Platform

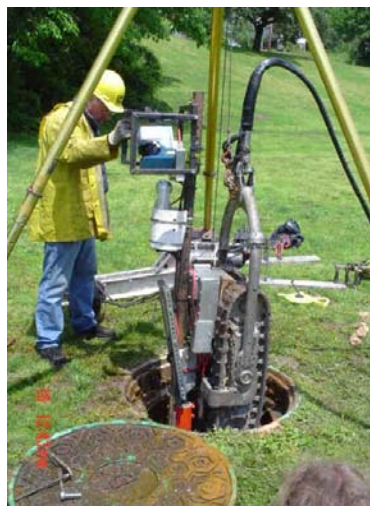
Figure 2: Deployment of Responder Platform

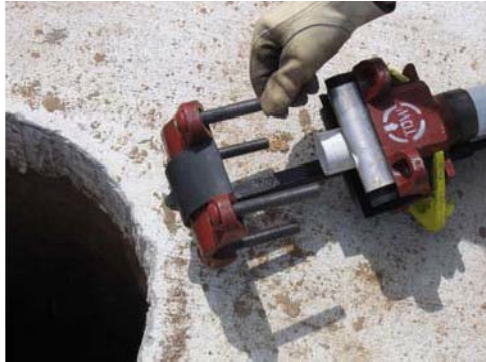
Figure 1

In Keyhole Technology a circular cutout, ranging from 6” to 24” in diameter is cored out of the street and the “core” of pavement is removed and set aside. The pipeline is subsequently exposed by removing the dirt from above it. Once the pipe is exposed, it is cleaned using a scraping or sandblasting device. Long handled tools can then be used to attach a bolt on fitting. Fittings typically

consist of a hinged body or a separate upper and lower half, with o-ring or sheet gasket to prevent leakage once the pipe is tapped into through the fitting's outlet (Figure 1).

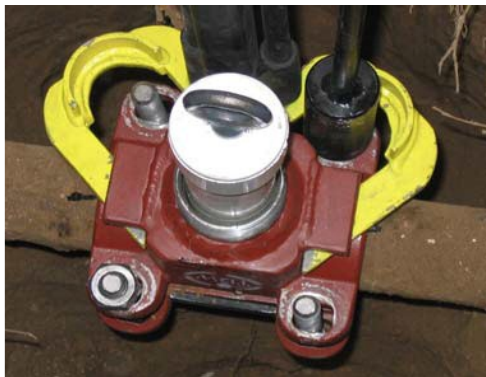
Figure 2

Special long handled tools are then required to attach the fitting, and secure it to the pipe. (Figure 2).

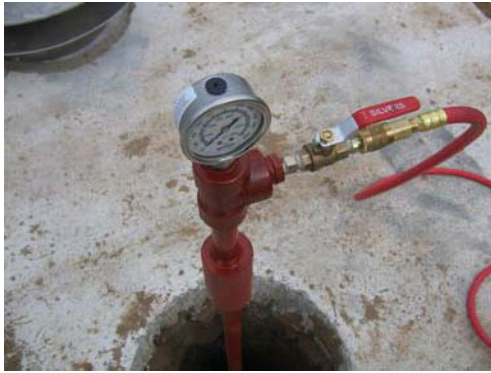
Figure 3

Once installed and pressure tested (Figure 3), an isolation valve is attached (Figures 4 and 5), so the pipeline may be punctured or “tapped” through the fitting without the loss of pipeline product.

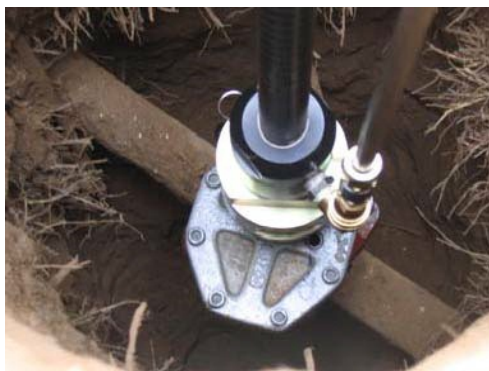
Figure 6

Tapping into the pipe is performed by a drilling or tapping machine connected to the valve (Figure 6).

The machine has an extendable and rotate-able bar that advances and rotates a hole-saw or pilot

drill. The connection to the valve is typically a flange joint or quick connect adapter.

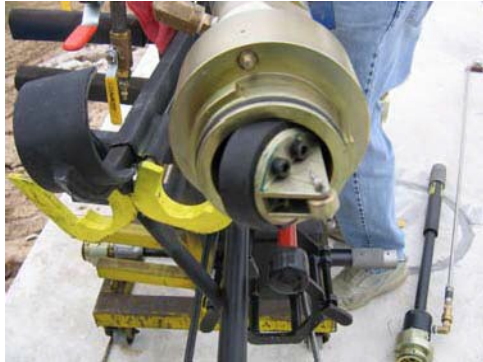
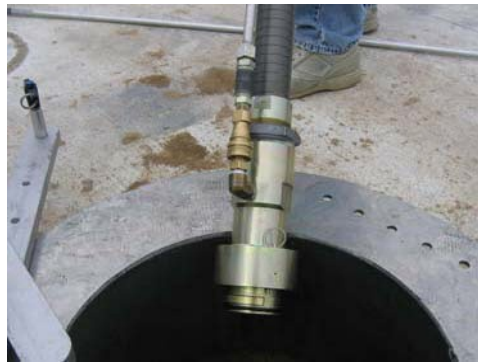
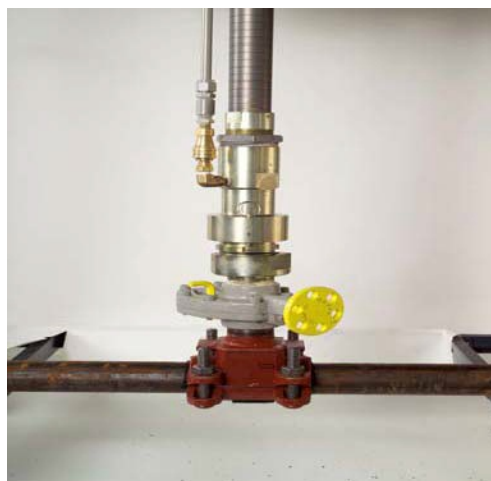
Figure 7

To stop the flow of a broken pipeline, or bypass around a damaged section, make repairs to a valve, etc, a flow stopping device is inserted upstream and or downstream using a machine with an extendable bar. The machines are known as Stopple setting machines or Jackscrews (Figure 7 thru 9).

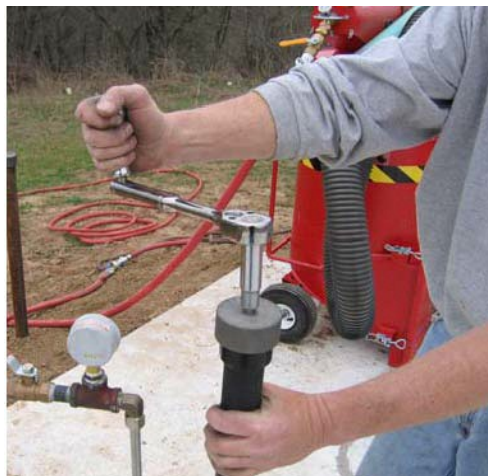
Figure 10

Once the work has been done on the pipeline, the completion plug will be installed into the fitting neck so the valve can be removed (Figure 10).

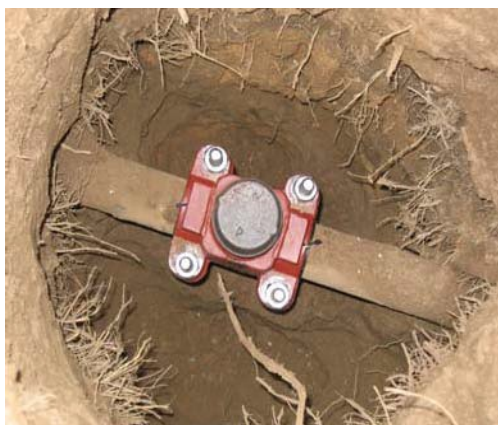
Figure 11

Once the completion plug is installed, pressure can be blown down above the valve and valve removed. The final step is to install the completion cap on the fitting (Figure 11).

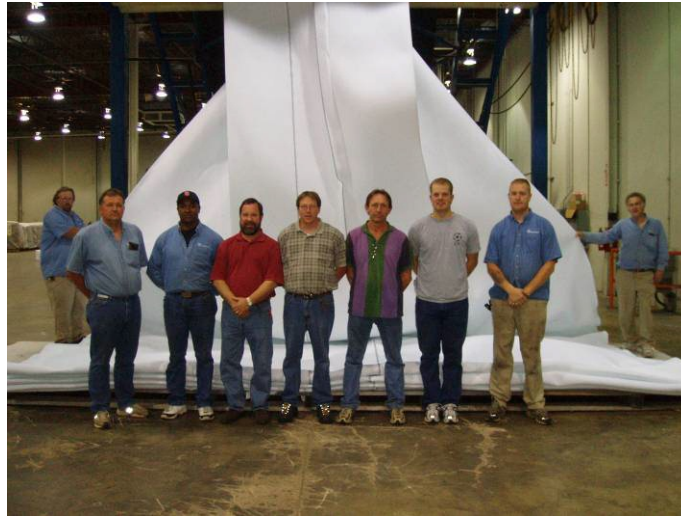
Figure 2

In the case of large diameter pipes, the layers of fabric become so wide that special equipment and processes must be used to handle them. For example, the fabric layers required to construct a tube for rehabilitating a 96 inch diameter pipe, as shown in Figure 2, are approximately 25 feet wide. The extraordinary size and weight of the finished dry tubes requires manufacturing equipment specifically designed to handle these loads.

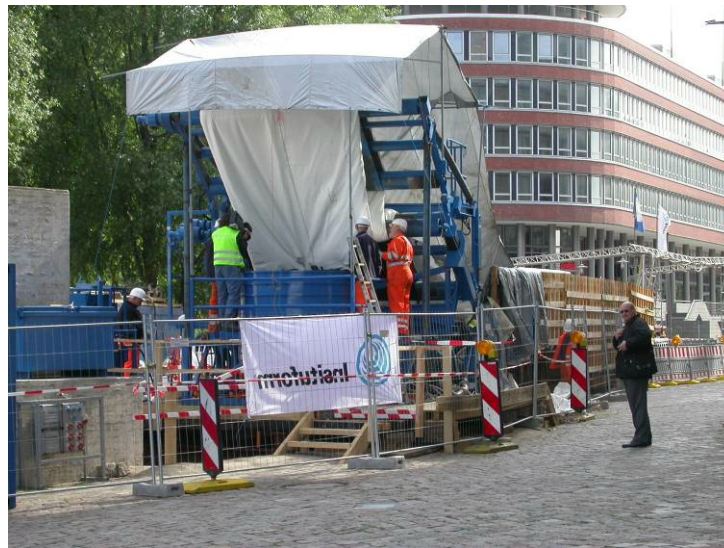
Figure 3

Installation and curing are the final two steps of a CIPP rehabilitation project. Often, the weight associated with large thick-walled cured-in-place tubes requires larger equipment, such as that shown in Figure 3, to be procured for lifting and moving the tube on the jobsite. Handling techniques that work well with smaller CIPP tubes may damage large tubes, simply due to the tremendous forces required to move such a

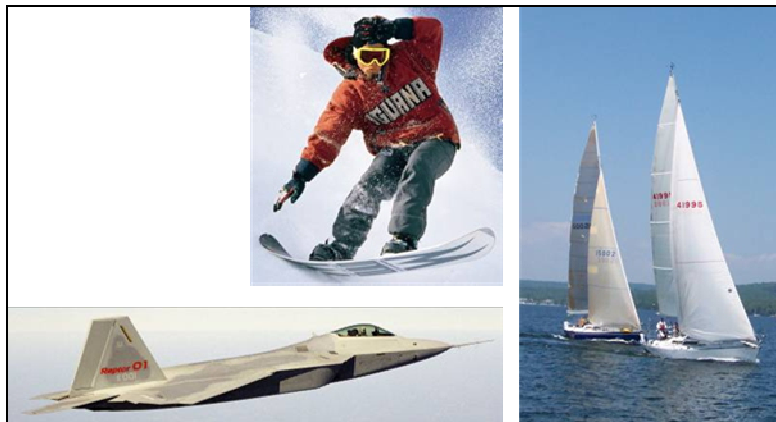
Figure 5

Fiber-reinforced sandwich composites are commonly used in industries such as sporting goods and aerospace to produce structures with high stiffness and low weight. Familiar examples, as shown in Figure 5, include skis and snowboards, military aircraft, and sailboats.

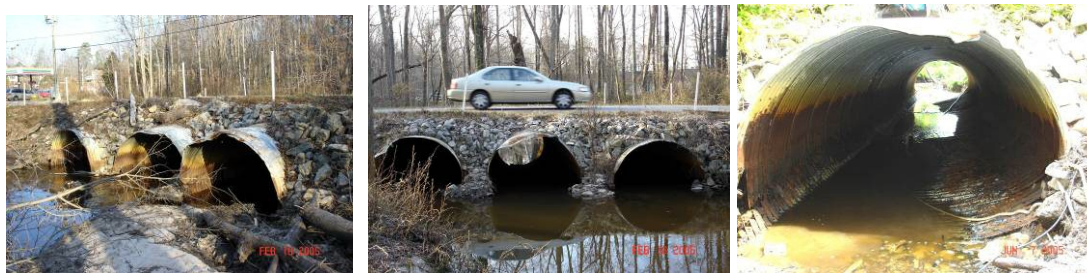
The advantages of fiber-reinforced sandwich composite CIPP technology recently played an important role in the successful rehabilitation of three large culverts under a heavily trafficked road in Chesterfield County Virginia. The owner, Virginia Department Of Transportation (VDOT), did not want to dig-and-replace the culverts because they would have to close the road for an unacceptable length of time. In addition, seasonal flow requirements eliminated rehabilitation technologies that would reduce the flow area of the culverts, so CIPP was the logical choice of rehabilitation technology. However, the design loads on the 87” by 63” arch-shaped corrugated metal pipes shown in Figure 10 required CIPP tubes with a wall thickness of 61.5mm.

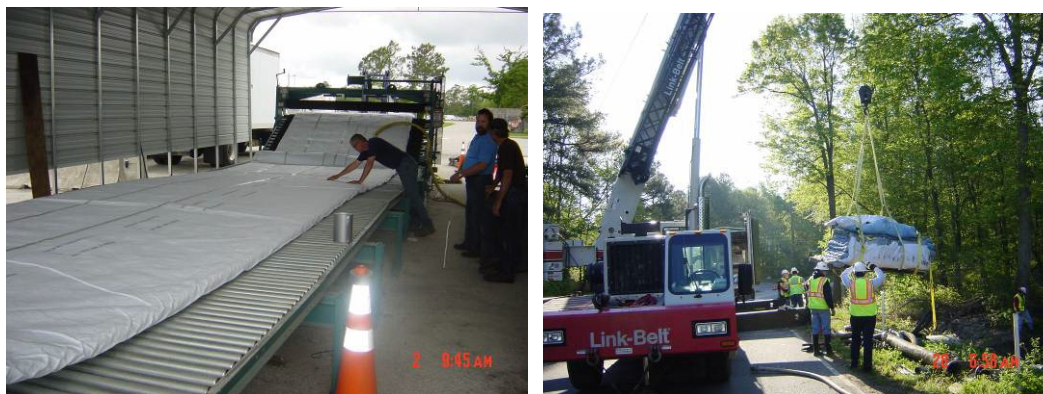
Figure 11

As shown in Figure 11, the fiber-reinforced CIPP tubes were fabricated and impregnated with polyester resin using standard large diameter manufacturing processes and equipment. Upon arrival at the jobsite, the CIPP tubes were pulled into place, illustrated Figure 12, and inflated with air. Steam was then used to heat and cure the resin, as in Figure 13.

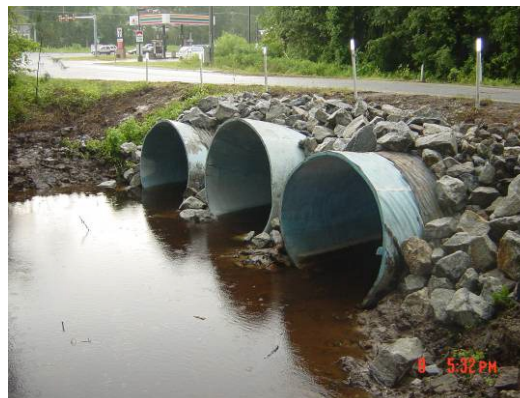
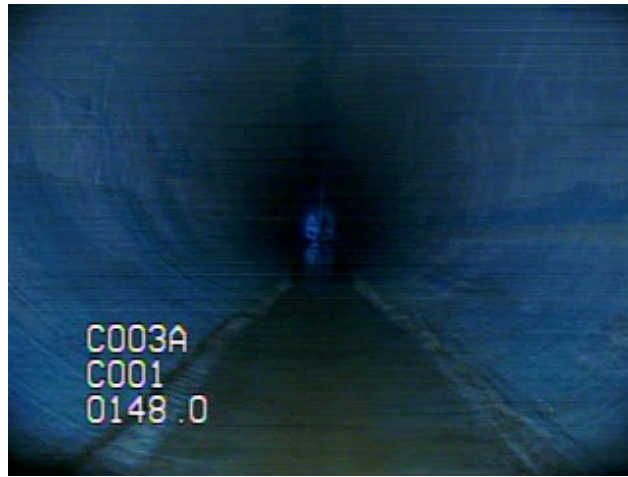
The finished product, as shown in Figures 14 and 15, exceeded the customer's expectations of a fully structural pipeline rehabilitation, with minimum environmental impact and no loss in flow capacity.

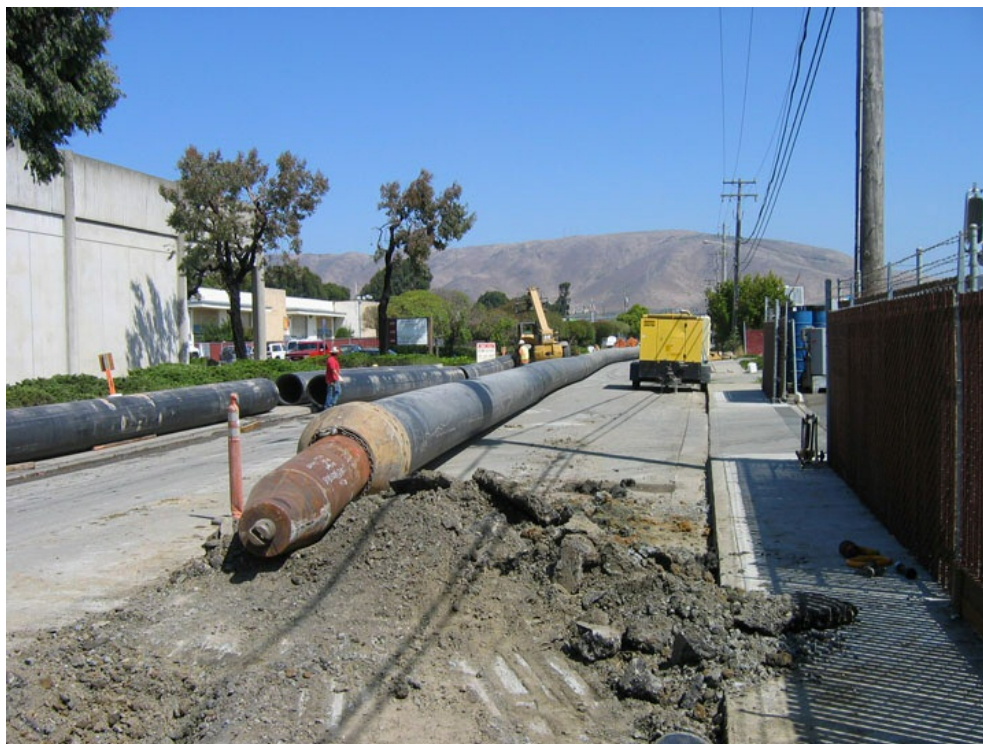
Figure 2 – New 36-inch O.D. HDPE pipe with 24-inch pneumatic hammer and 42-inch diameter pipe bursting expander ready to launch.

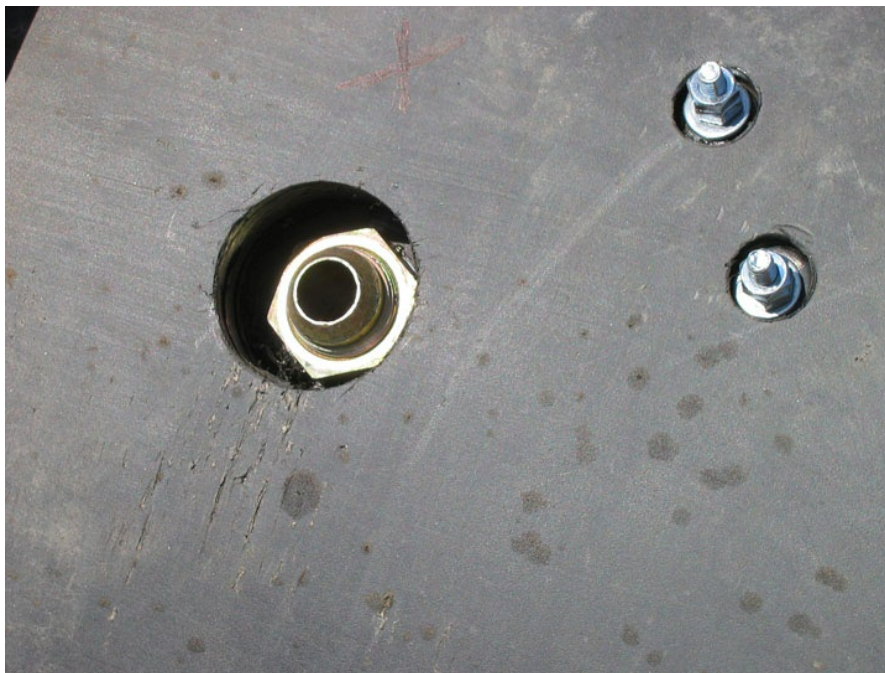
Figure 3 – Typical discharge port for polymer slurry. This assists the new pipe through the sticky Bay Mud during pipe bursting operations. This port is located directly behind the pipe bursting expander.

Bentonite Lubrication. Bentonite lubrication is used in various bursting situations. Due to the weight of larger diameter HDPE, bentonite is used to reduce friction. Friction also increases with the depth of the host pipe. Some soils like beach sand will not remain in the expanded state long enough for the installation of new product pipe. Bentonite lubrication is used in these situations to help maintain the annular space created as the tool travels through the host pipe. Bentonite is pumped through a line that runs inside of the product pipe. A manifold installed behind the tool delivers the mixture to the bursting operation. See Figure 3 & 4.

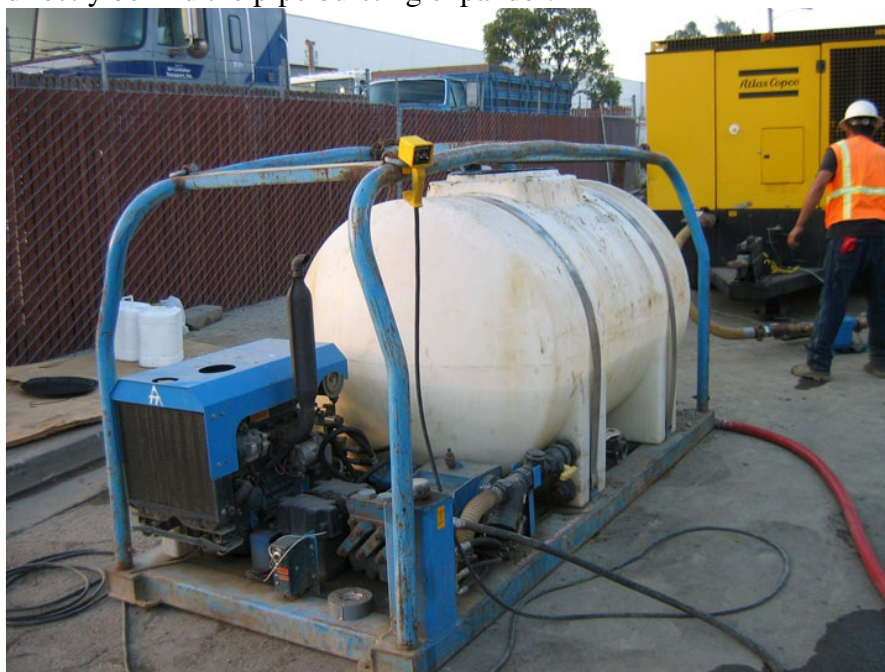
Figure 4 – 500 Gallon mixing and pumping system to supplies lubrication that assists with pipe installation during pipe bursting operations.

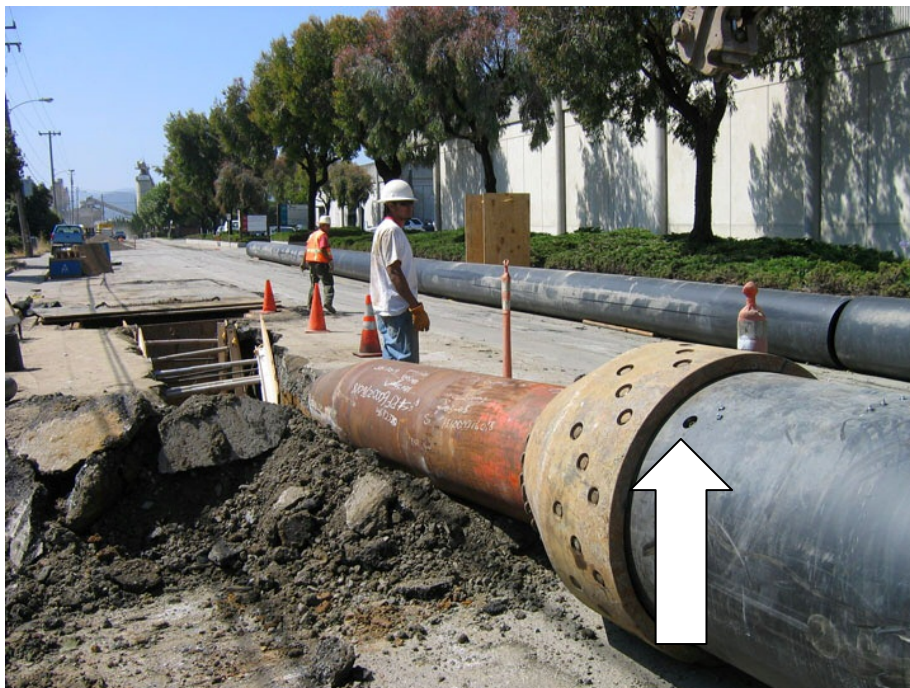
Figure 5 – Note the position of the lubrication discharge port. Also shown are the numerous Grade 8 Bolts securing the HDPE pipe to the pipe bursting expander. Observe that the street is open to traffic.

- Pipe bursting equipment package, included a 24-inch Taurus Pipe Bursting Tool with a 42-inch Rear Expander (See Figure 5), an 18-inch Goliath Ramming Tool (See Figure 6) to push the column of pipe, a 500 gallon Grundomudd system to provide polymer fore lubrication of the new pipe during bursting operations. The use of two 20-Ton Grundowinches, in tandem, to provide adequate constant tension force for this large pipe bursting tool. See Figure 7.

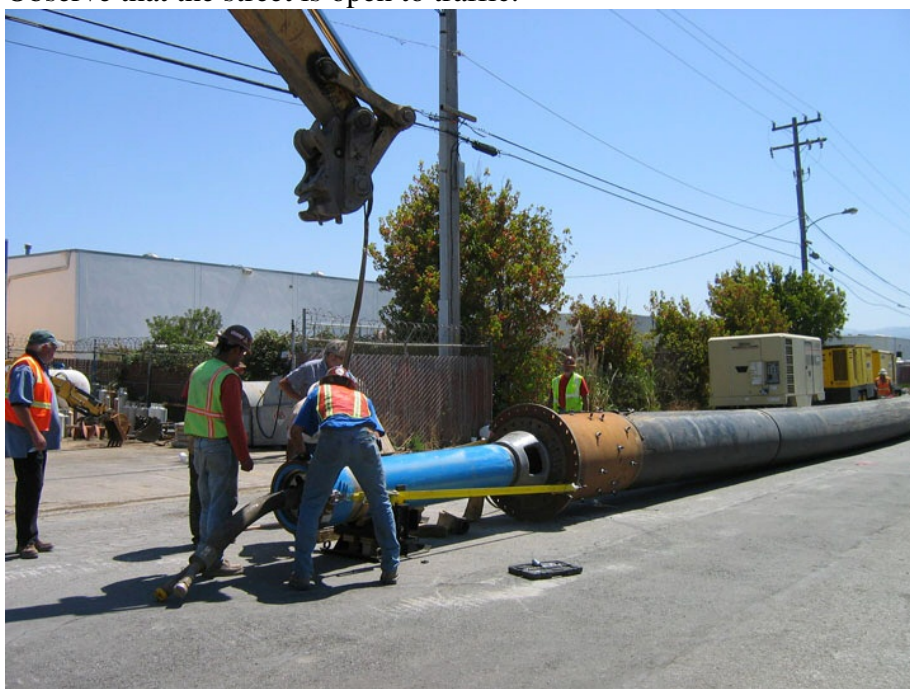
Figure 6 – Setting up the rear dynamic impact pushing tool. An 18-inch diameter pneumatic hammer is setup in a pipe rammer configuration to assist the heavy pipe string along during pipe bursting operations. This added ramming technique improved pipe bursting production over 50% in the Bay mud conditions present. This rear tool was in operation at the same time as the lead tool and lubrication system.

The two pneumatic tools are not synchronized, each operates at 180 blows per minute.

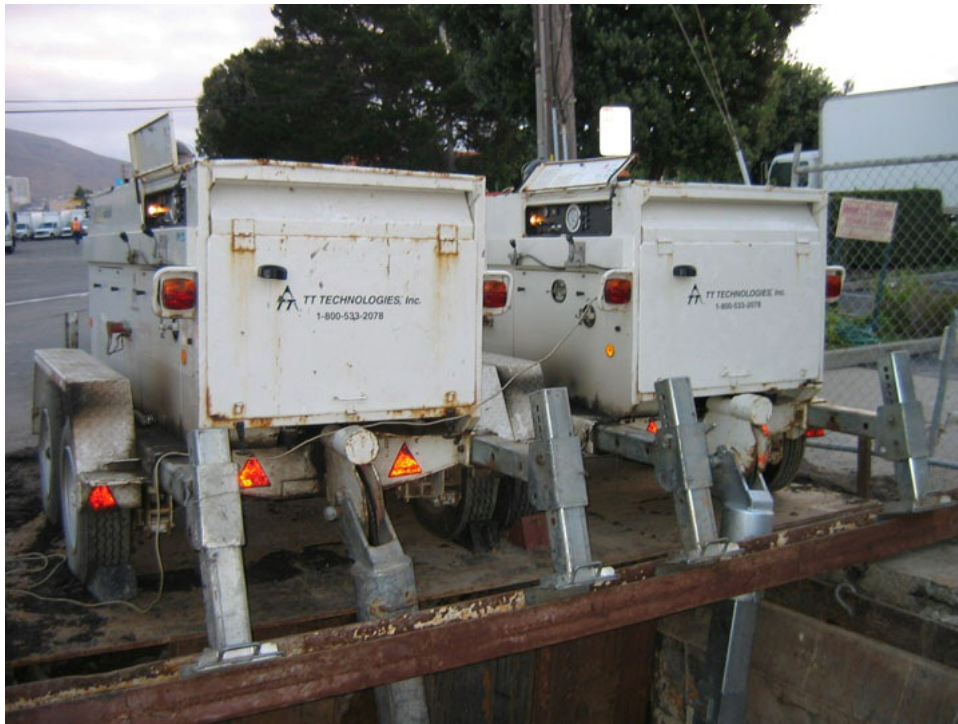
Figure 7 – Dual 20-ton constant tension winches setup over the receiving pit. The added winch tonnage was required because of the overall weight and size of the pipe bursting equipment and the dead weight of the new 36-inch HDPE pipe. Typical winch tension was 30 tons (each winch operating at 15 tons x 2 = 30 tons). Additional tonnage was available as needed up to 40 tons.

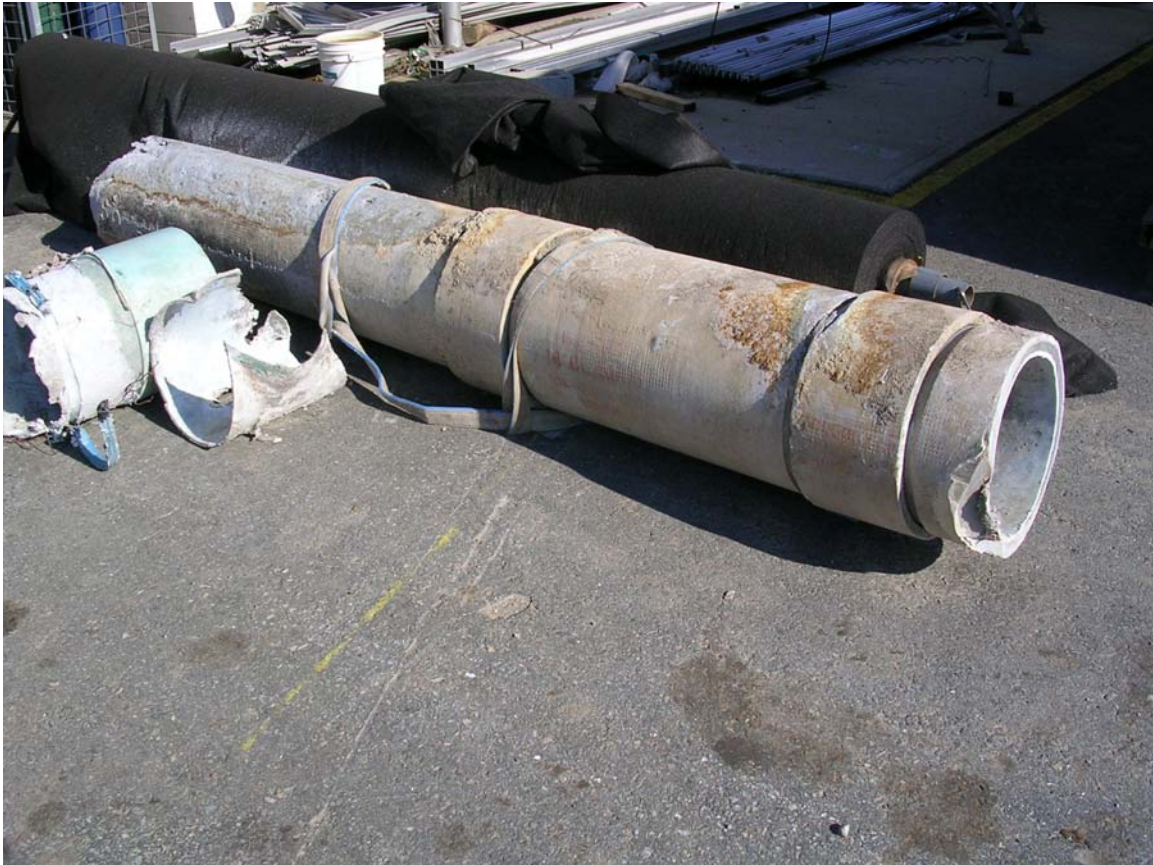
Figure 2: Exterior of removed 356mm (14-inch) diameter Asbestos Cement pipe.

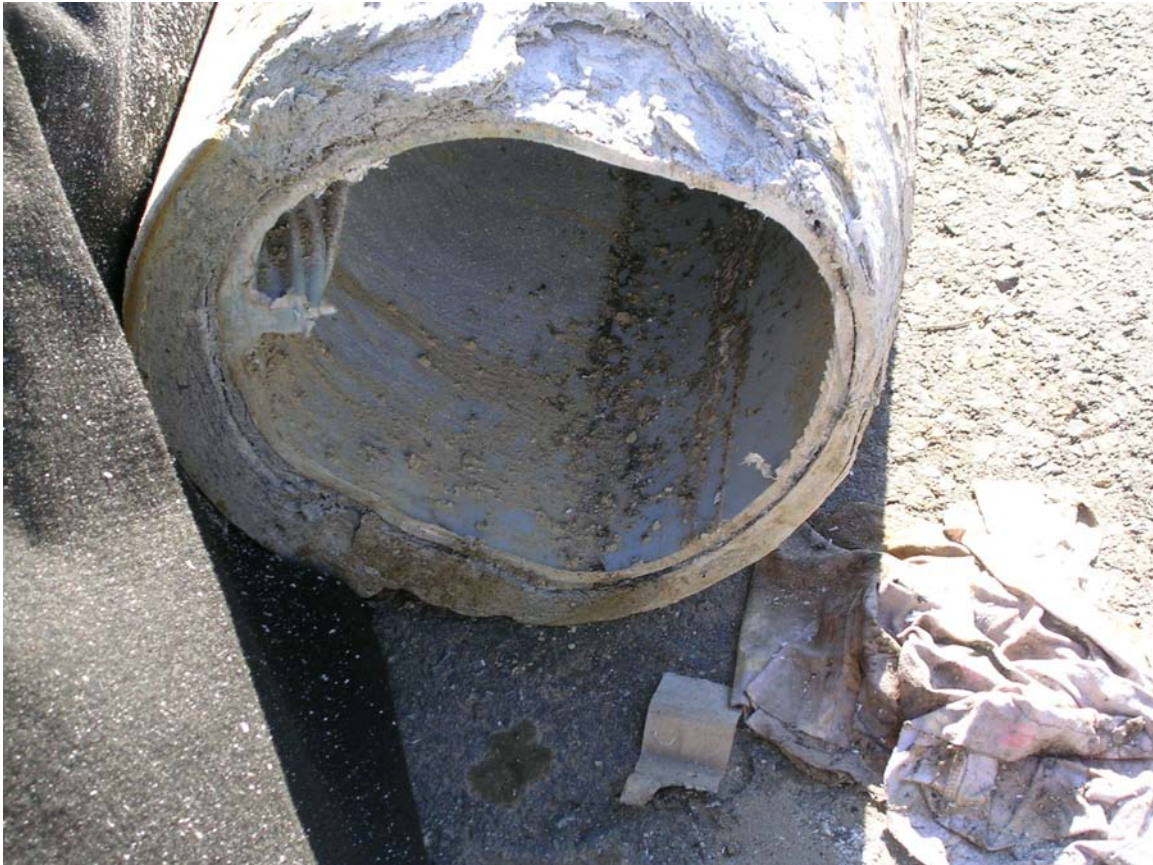
Figure 3: Fold on CIP liner inside AC pipe (9 O'clock position).

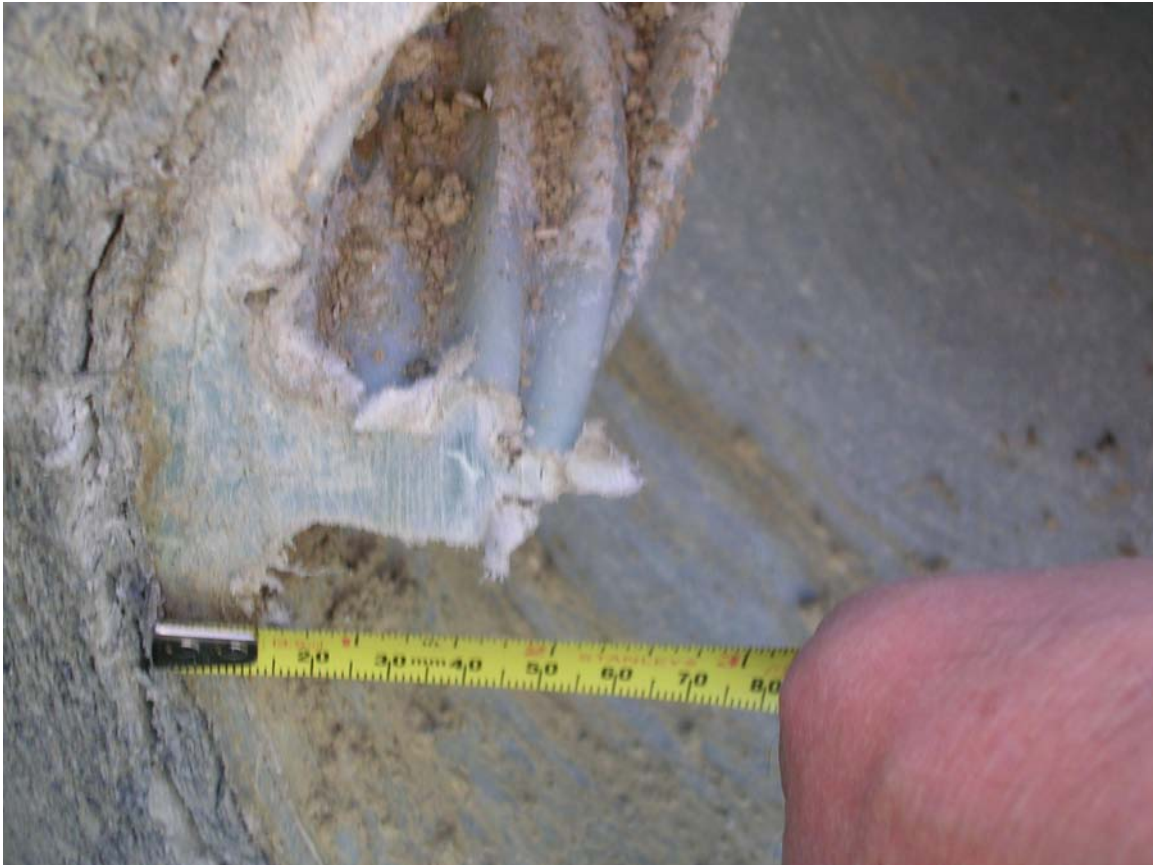
Figure 4: Close up of CIP liner fold.

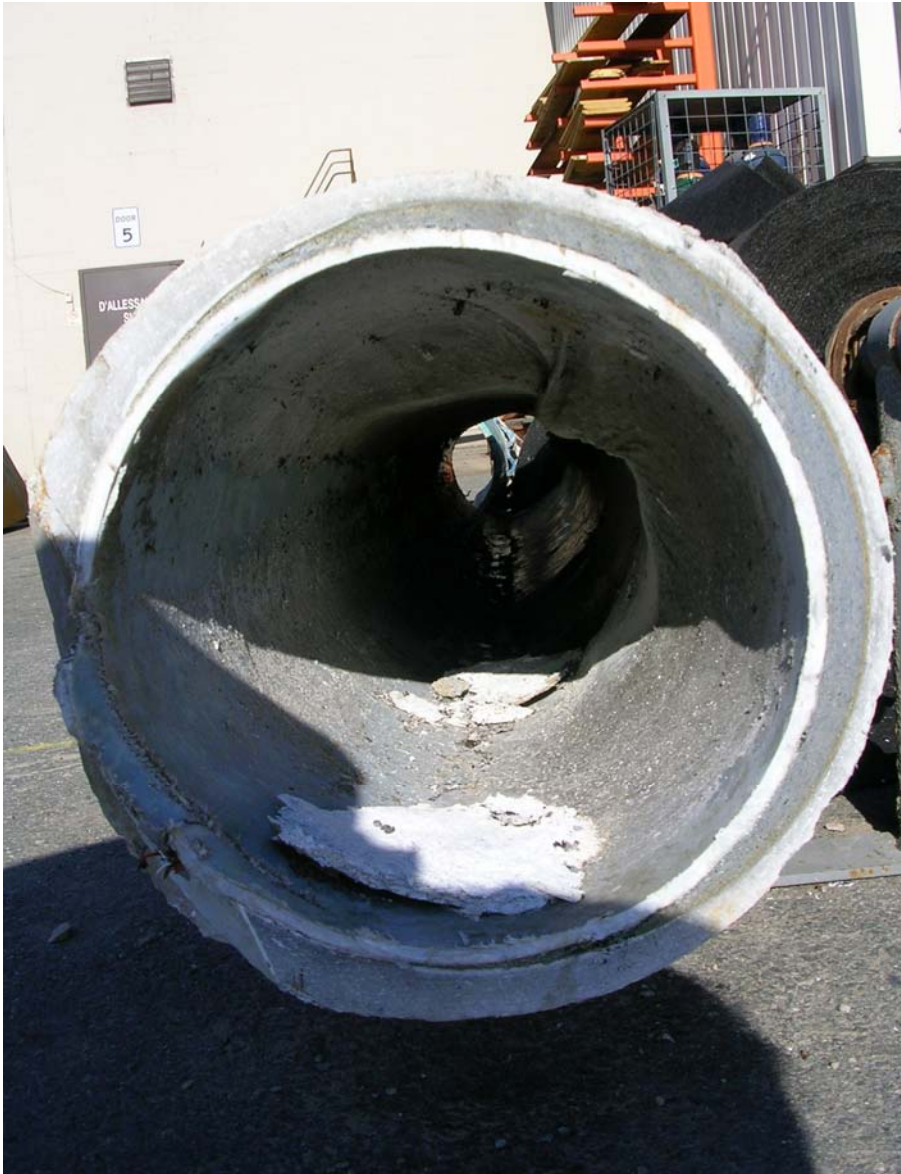
Figure 5: End section of AC pipe showing varying material thicknesses.

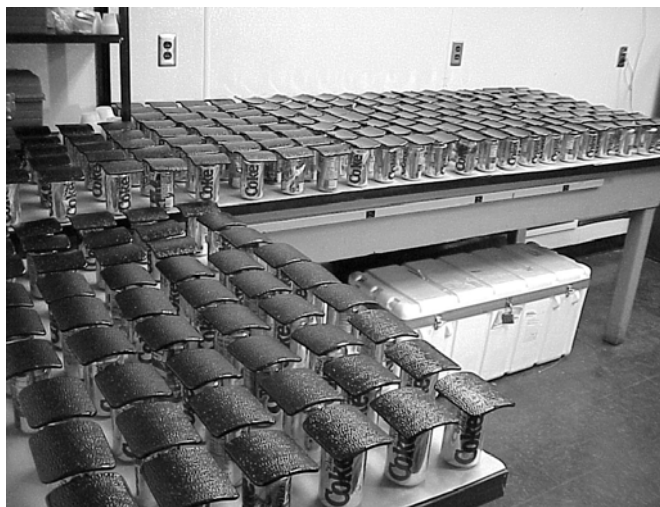
Figure 1 – Photograph of all DIP coupons utilized for the study.

Laboratory corrosion testing was conducted on 222 ductile iron coupons cut from a production 8" diameter ductile iron pipe. Prior to coupon preparation, metallurgical and physical strength tests were conducted on the parent pipe in accordance with applicable AWWA (American Water Works Association) standards to verify the pipe met industry requirements. One half of the coupons (111 samples) were uncoated and sandblasted and the other one-half (111 samples) were coated utilizing standard production asphaltic cutback "shopcoat". The samples utilized for the study are shown in Figure 1.

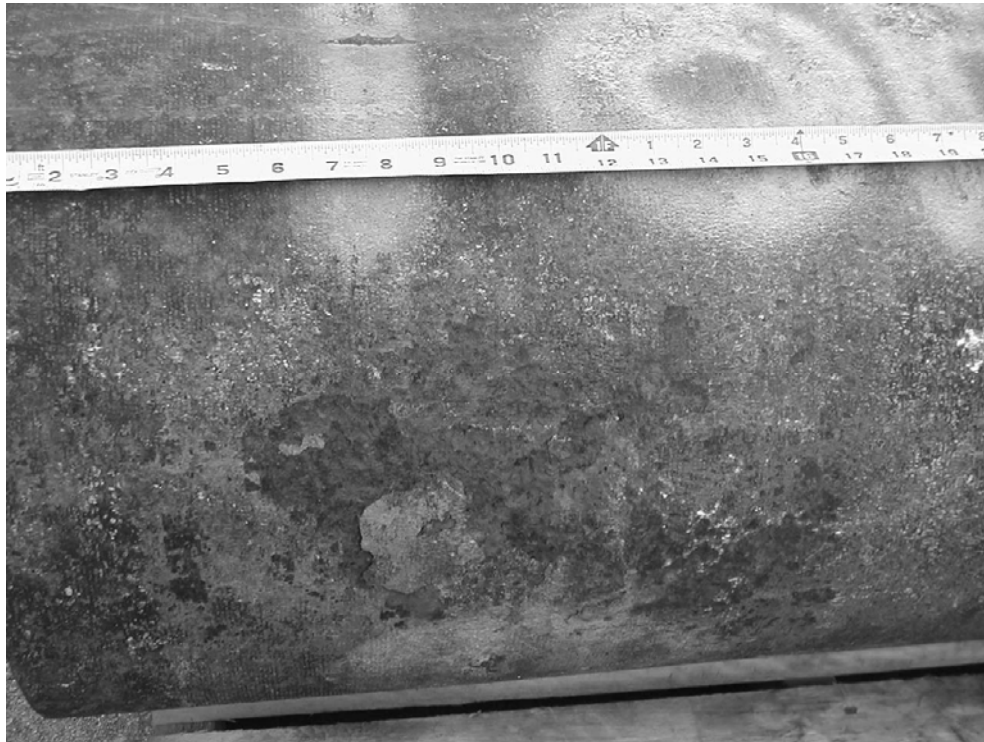
Figure 1 - Corrosive Attack to 16" Ductile Iron Pipe (71% wall max pit depths)

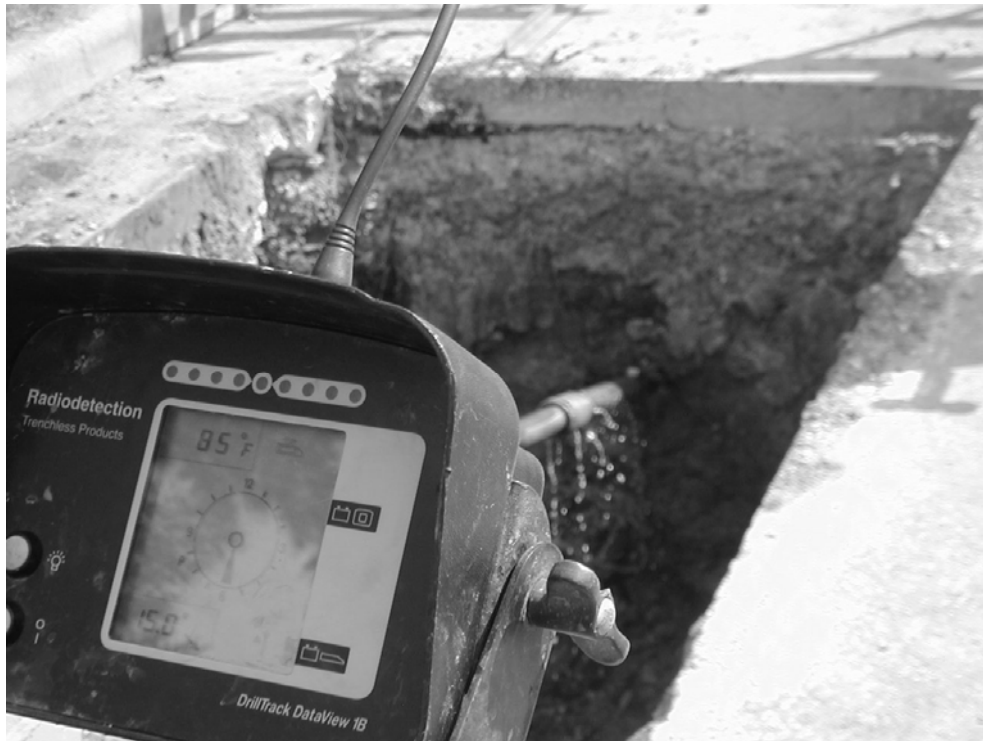
Figure 3 – Horizontal Directional Boring Equipment

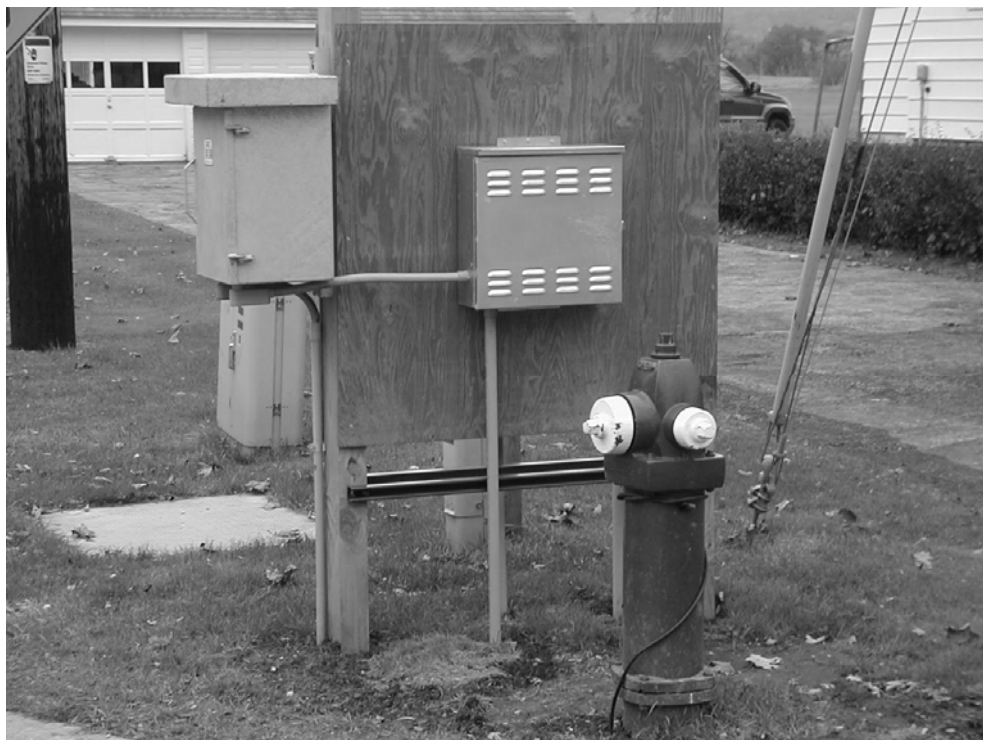
Figure 4 – Rectifier and Anode Box (rectifier negative is connected to hydrant)

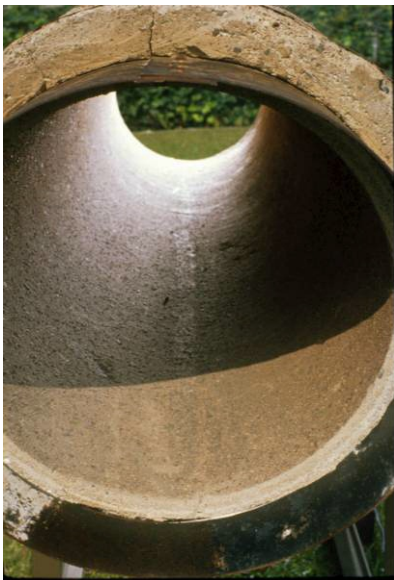
Figure 1. 12-inch diameter riveted steel with concrete lining & field applied conc. coating installed in 1855.

One of the world's first mortar-lined-and-coated steel pipelines was installed in the City of St. John, New Brunswick, Canada, in 1855 (Figure 1). The 16-ga steel cylinder on this pipeline was riveted and lined with cement mortar, and the exterior was protected with cast-in-place concrete. By the 1920s mortar coatings were applied by the pneumatic spray process ("gunite" or "shotcrete") (Figure 2). In the early 1940's impacted mortar coatings were introduced whereby cement mortar is delivered at high velocity against the rotating steel cylinder surface through two counter rotating wheels or by means of a moving belt. The counter-rotating wheels first consisted of wire brushes, but serrated rubber disks are now in general use (Figure 3). Initially the impacted mortar processes were limited to a maximum pipe diameter of 60 inch, and in the early 1950s they were extended to 144-inch diameter.

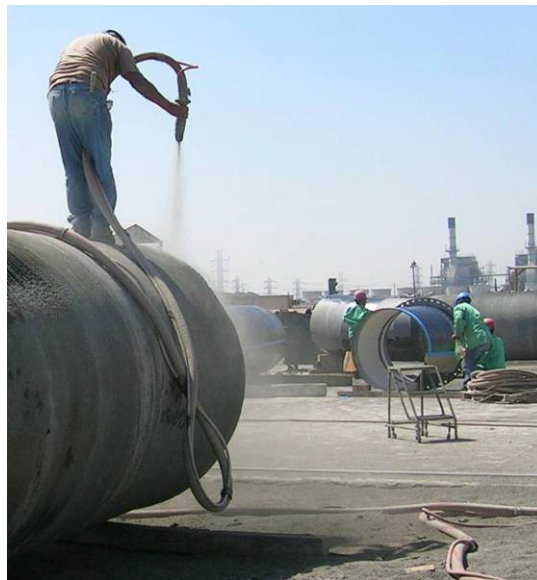
Figure 2. Pneumatic mortar application.

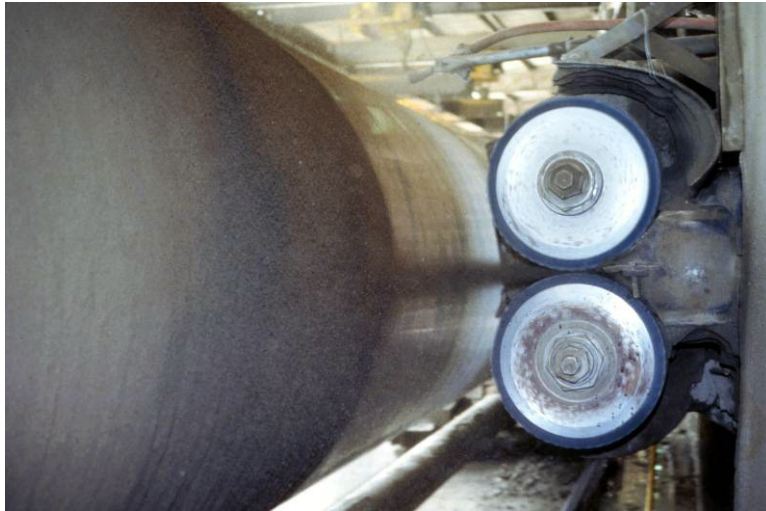
Figure 3. Cement-mortar Coating impaction with two counter rotating rubber brushes.

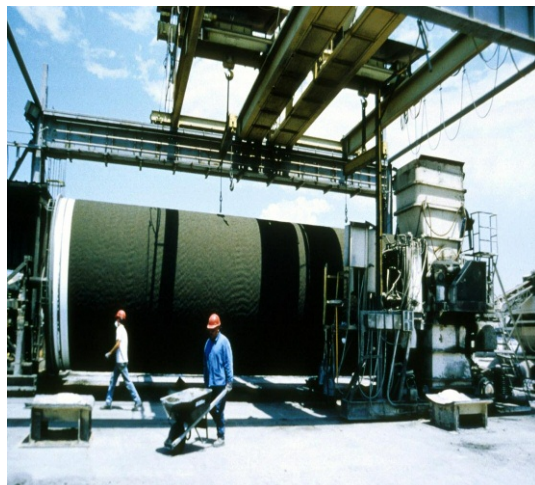
Figure 5. Impacted cement mortar on large diameter WSP.

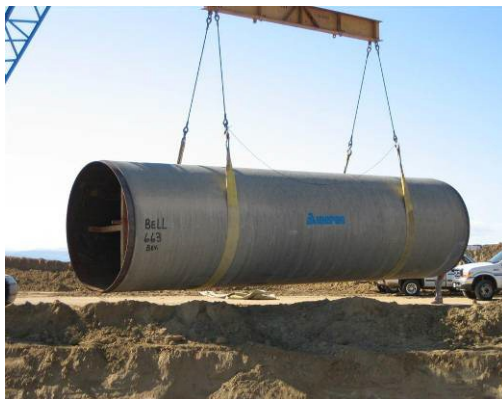
Figure 6. Unloading 120-inch mortar coated WSP for MWD's Pipeline No. 6.

- Although mortar coatings can resist physical damage, the pipe should be handled with two nylon slings and a spreader (Figure 6).
- After the foundation and base bedding is prepared, partial bedding is prepared with holes or discontinuity at the joints to allow for welding and installation of the joint grout bands (Figure 7).

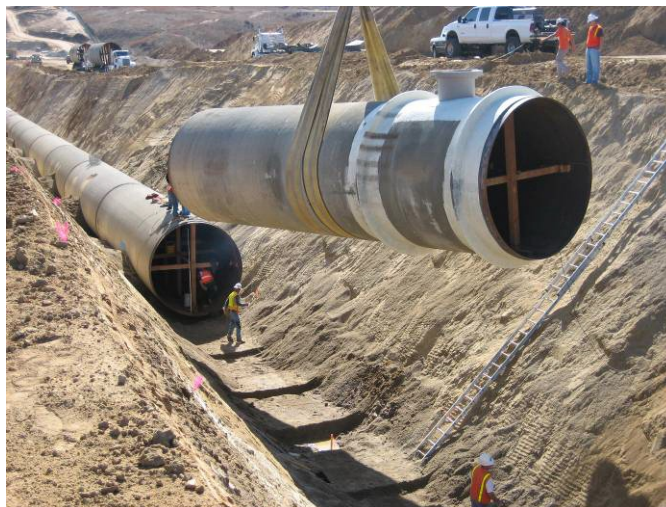
Figure 7. Bedding preparation and installation of 120-inch WSP for pipeline No.6.

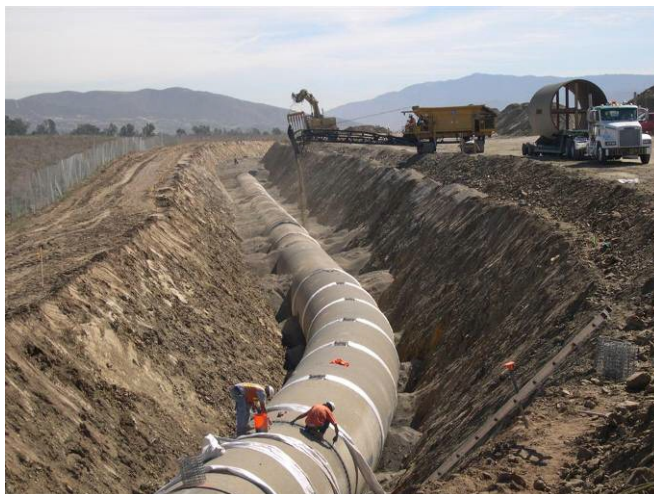
Figure 8. The joint grout bands are filled with cement mortar grout ahead of backfilling with granular material through a Shute.

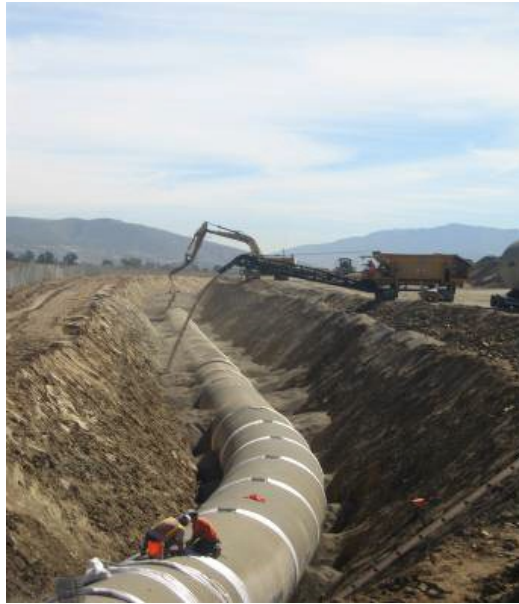
Figure 9. Water jetting of the backfill can be observed in the background.

- The 120-inch WSP, with a cylinder inside diameter of 121.5 inches, had a standard length of 40 ft.
- The steel cylinder thickness varied between 0.50 inch and 0.75 inch. The 0.50 inch thickness was the minimum thickness required for handling.
- The maximum design circumferential stress for maximum pressure was 21,000 psi.
- The shop-applied mortar coating thickness was one-inch applied in two applications reinforced with 2 in. x 4 in., W1.4xW1.4 welded wire reinforcement (Figure 5)
- The field- applied cement mortar lining thickness was 0.75 inch.
- The field joints were single lap-welded joints except in thrust restraint areas it was double lap-welded.
- Backfill material was select granular material compacted through water jetting (Figure 9).

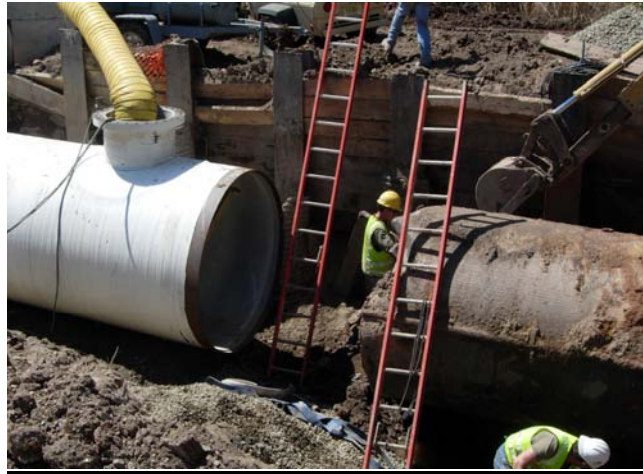
Figure 2. 1906 72” Steel Pipe connected to new Steel Pipe in NJ (National Welding Corporation, 2006)

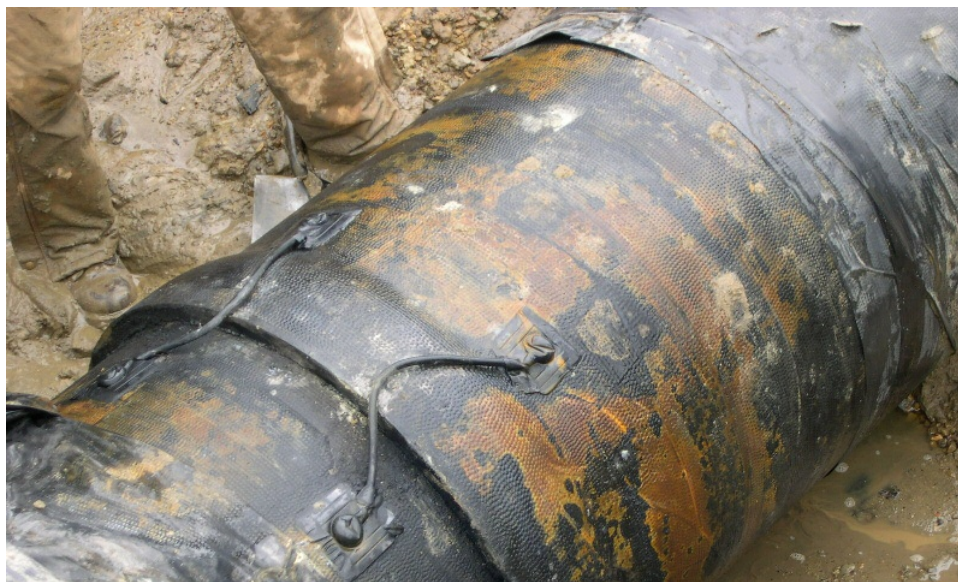
Corrosion monitoring is an economical means of addressing the “what-if’s” of MMTP in non-corrosive soils. The system consists of bonded joints (provides electrical continuity across ductile iron gasketed joints, as shown in Figure 3), insulated joints at connections to existing pipe or dissimilar pipe material, and monitoring test stations. The net result of this inexpensive corrosion monitoring system is that it allows the owner to monitor the pipeline for corrosion in the future and be proactive by taking corrective measures, such as installing buried anodes, long before a pipe break occurs.

Figure 3. Ductile Iron Pipe Bonded Joint (Southwest Pipeline, 2004)

Some discourage making a pipeline (electrically) continuous and instead prefer to deal with corrosion in isolated sections of pipe. Others would suggest that by making the pipeline continuous, corrosion will take place over a much larger surface area and as such will minimize the impact of the corrosive area. It can be argued that continuous pipe does have a positive impact as virtually all ferrous pipelines were electrically continuous prior to approximately 1960 due to the methods of jointing. Lead joints on iron pipe and riveted or welded joints for steel or concrete pipe produced continuous pipe by default. Rubber gasketed push joints for ductile iron pipe (developed in late 1950's) (Bonds, 2003) or steel or concrete pipe effectively insulate between pipe joints as long as there is no metal-to-metal contact between pipe ends. Since all MMTP materials utilize gasketed joints, joint bonding should be a standard practice.

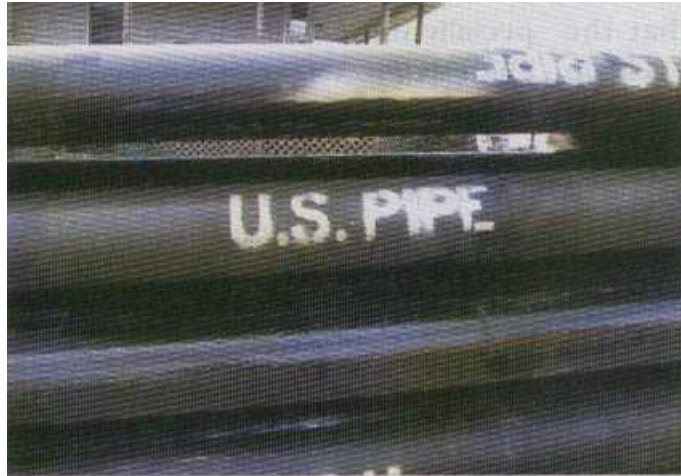
- Polyurethane coating such as US Pipe Polythane™, a product that was produced and sold in USA beginning in 1988 (Horton, 1995). A. M. Horton reports that Polyurethane “cures quickly to form a hard, yet flexible film that is resistant to

chipping, cracking and impact damage.” Horton also reports that on one 31,000’ project shipped over 2,000 miles, “the exterior coating had little or no shipping damage and had an installed coating efficiency of 99.66% when tested as part of a cathodic protection system (Madison Chemical, 1994)” (Horton, 1995).

Figure 4. Ductile Iron Pipe with polyurethane coating (Szeliga/Lieu, 2002)

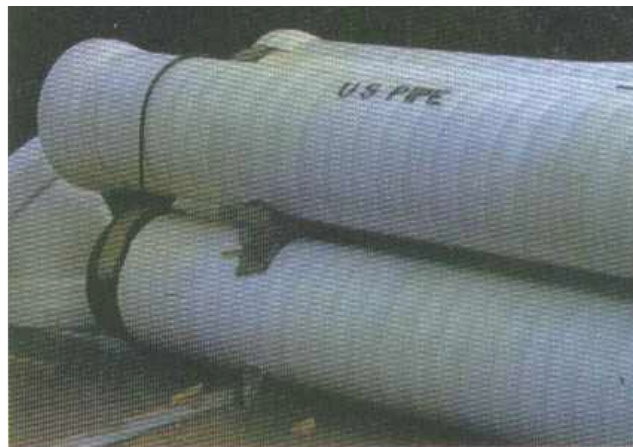
- Coal-tar epoxy coating. A.M. Horton reports “coal-tar epoxy has been used to protect the interior and exterior of iron pipe in excess of 40 years. It has been proven to be an excellent protective coating if properly applied in sufficient thickness” (Horton, 1995).
- Tapewrap coating. Available in two- (50mil) or three- (80 mil) layer systems from tape manufacturers specifically for ductile iron pipe. The tape product is also available in a system that requires no sand blasting and can utilize standard factory shop-coated pipe for tapewrap.

Figure 5. Tape-coated Ductile Iron Pipe (Szeliga/Lieu, 2002)
