PIPELINES 2007

Advances and Experiences with Trenchless Pipeline Projects

PROCEEDINGS OF THE ASCE INTERNATIONAL CONFERENCE
ON PIPELINE ENGINEERING AND CONSTRUCTION

July 8–11, 2007
Boston, Massachusetts

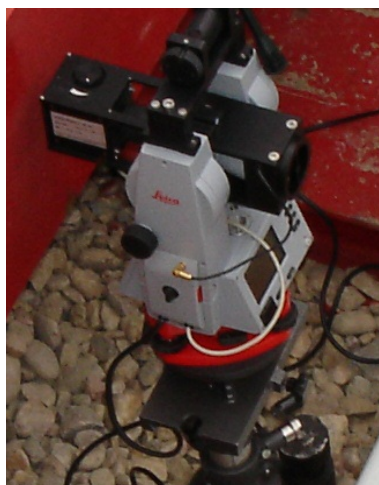
Video camera mounted above the theodolite transmits the image of the battery powered LED illuminated target located in the steering head to the monitor screen. The straight line indicated on the center of the target designates the direction and path the slant faced steering head will follow.

Figure 3- Theodolite w/
electronic video camera

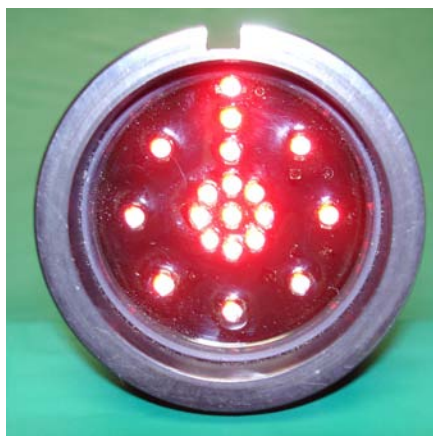
Figure 4- LED Target

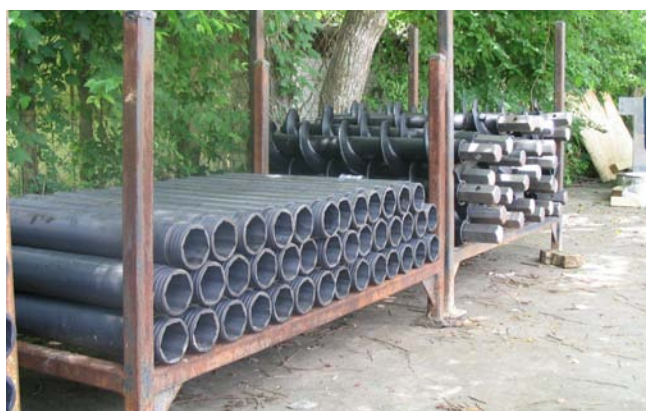
Hollow steel pilot tubes which fasten to each other via threads or clips are available as a double or single wall tube depending on the manufacturer. Only the inner tube

Figure 5- Hollow steel pilot
tubes (4 inch diameter)

on the double wall system will rotate with the steering head during advancement. On some systems a bentonite lubricant may be pumped to the steering head to assist with soil friction. These pilot tubes are typically 1 or 2 meters in length as are the casings and product pipe.

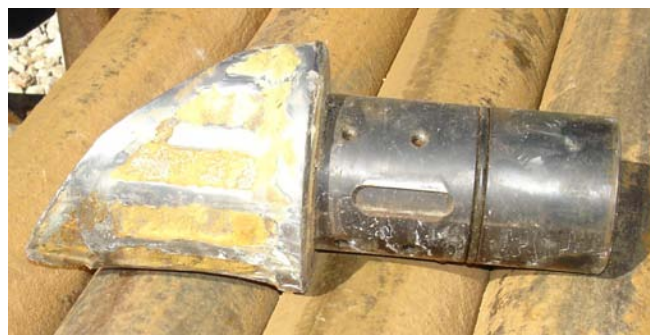
A slant faced steering head similar to that of a directional drill houses the LED illuminated target. Steering heads of different degrees of angle are available for the various types of soil. During the installation process the spoil is displaced by the steering head and pilot tube and directed on line and grade by rotation during advancement.

Figure 6- Slant faced steering head

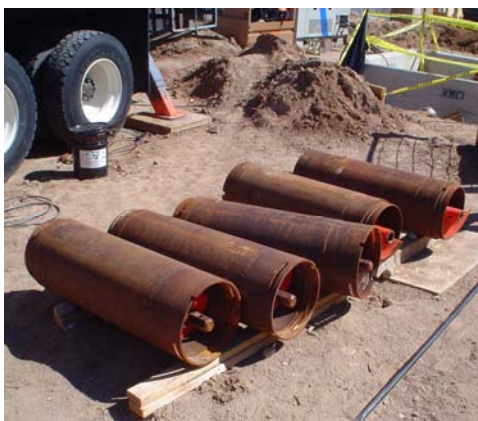
Behind the reaming head follow the auger casings of the same diameter as the head transporting the spoil to the jacking shaft for removal. The spoil can be removed by a muck bucket or vacuum truck depending on the soil type. This step is complete when the reamer and auger casings reach the reception shaft and all spoil is removed.

Figure 8- 1 meter length auger flights and steel casings ready to be lowered and jacked into place for spoil removal on the second step in the three pass method.

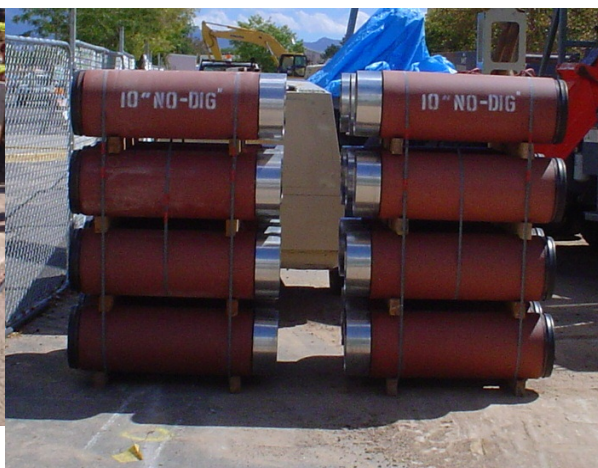
Figure 9- 1 meter length by 10 inch ID product pipe which are installed directly behind the auger casings on the third step in a three pass system. The OD of these product pipes are equal to the OD of the previously installed casings.

The third step (final step in the 3 pass method) is to install the product pipe once the reaming head reaches the reception shaft. The reaming head and auger casings are pushed into the reception shaft and removed. There is no spoil to be removed in this step as the product pipe has the same outside diameter as the auger casings.

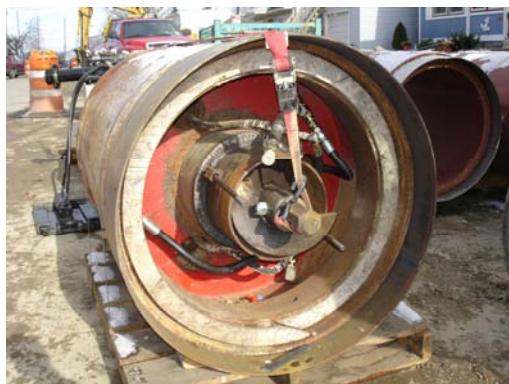
The second step (the final step in the 2 pass method) is to follow the path of the pilot tube with the 2 pass reaming head which funnels the excavated material into auger casings coupled together inside the product pipe and conveyed through to the jacking shaft for removal. These auger casings are then retracted from the inside of the carrier pipe via the jacking shaft. This method has an advantage to contractors as they are able to install multiple sizes of sewer lines while utilizing the same set of auger casings. The disadvantage to this 2 pass system is the decreased diameter auger casings will limit the maximum diameter of excavatable cobbles and hardened material.

Figure 10- 2 step Reaming Head- Rear View (29 inch OD)

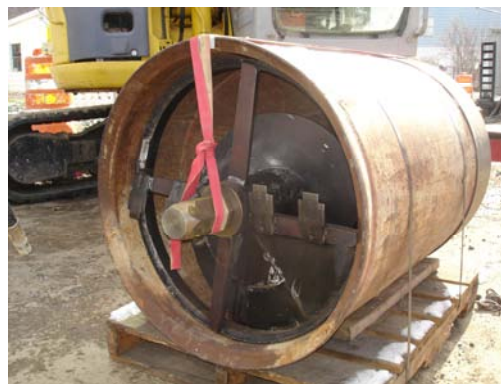
Figure 11- 2 step Reaming Head- Front view (29 inch OD)

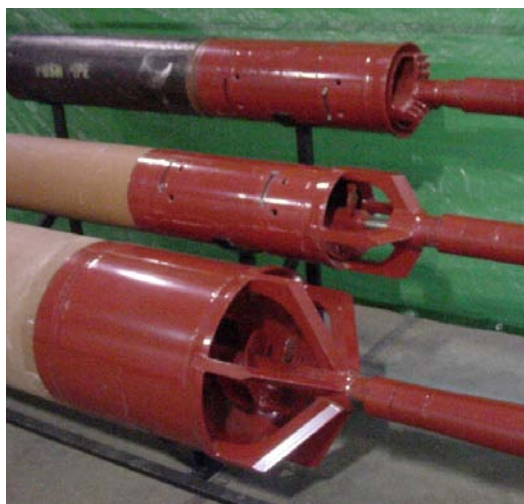
Figure 12- Types of reaming heads.
 Top- Rotating cutter head
 Middle and Bottom- conventional knife style

Different types of reaming heads are available for a variety of displaceable soil conditions as well as heads capable to control flow when working with as much as 10 to possibly 15 ft below the water table (ultimately depending on the soil type). A

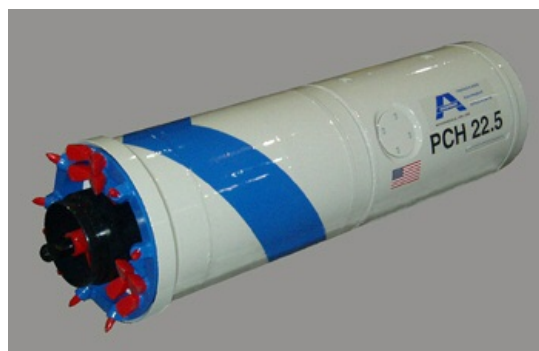
The third step (final step in the 3 pass modified method) is to install a powered cutter head behind the auger casings which is advanced by the product pipe. This method is the newest innovation to the Pilot Tube Methods. The powered cutter head increases the bore to match the larger product pipe diameter. The excavated spoil around the previously installed auger casings is discharged via the reception shaft by reversing the auger direction. This step is complete when the powered cutter head reaches the reception shaft.

Figure 14- Powered Cutter Head

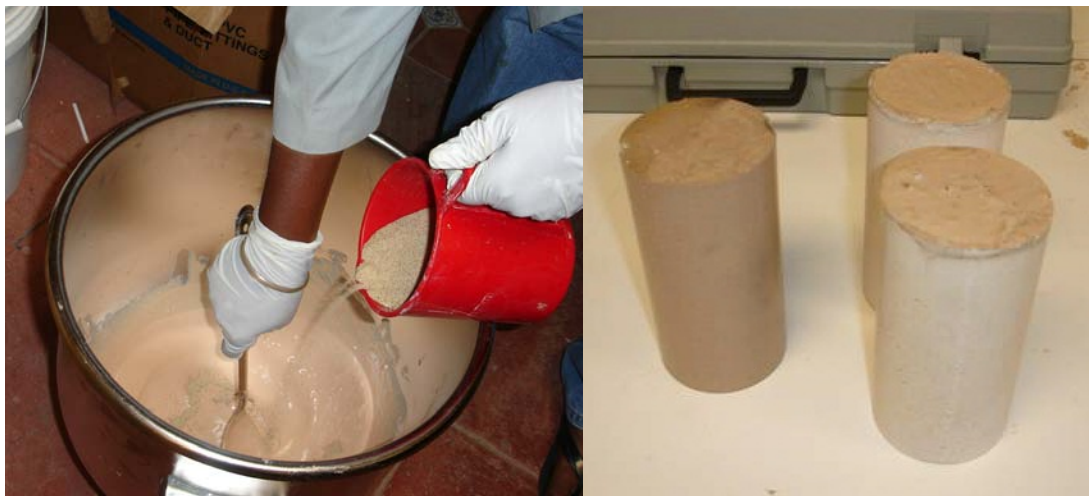
The Trenchless Technology Center at Louisiana Tech University is working with selected industrial partners on the development of mix designs for the fabrication of pre-cast elements such as pipes and manhole components, in-situ casting of geopolymer concrete for the repair of infrastructure components that were damaged due to contact with corrosive agents, and on spray-on coating of buried pipes and tunnels. Geopolymer specimens are shown in Figure 1.

Fig. 1. Metakaolin-based geopolymer paste (left-hand side); Geopolymer cylinders 30 min following casting; notice smoothness of outer surface (right-hand side)

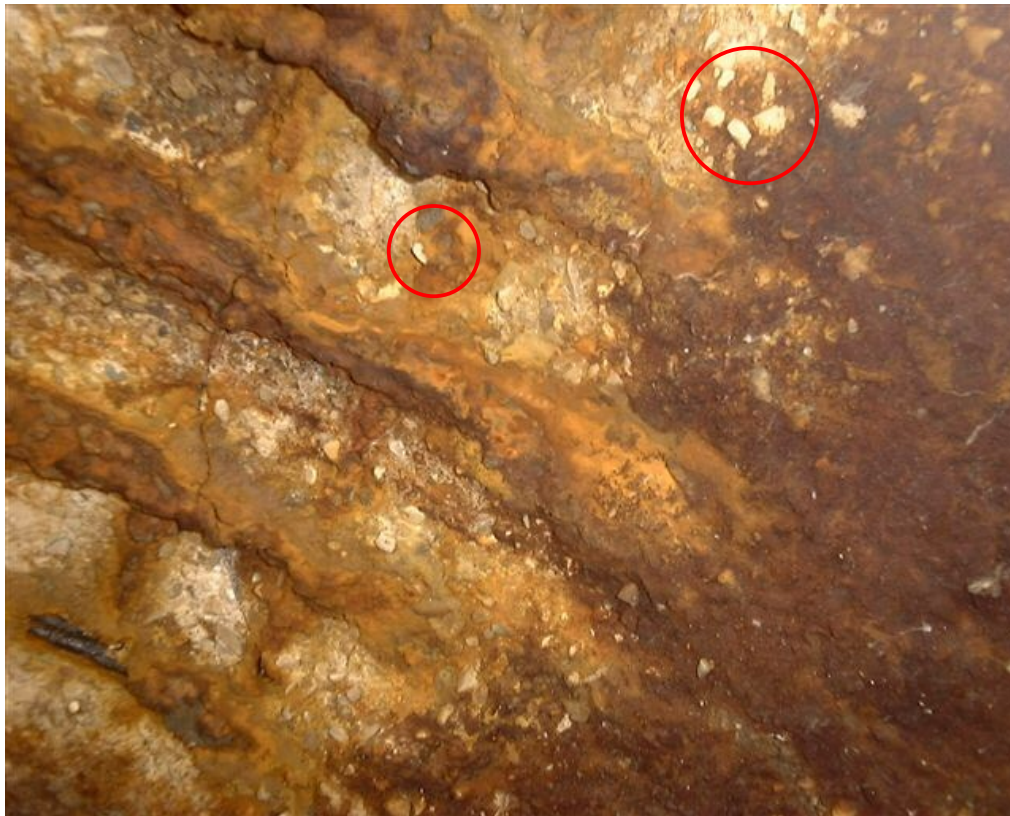
Figure 1. Close-up of a 36 in concrete sewer pipes that experienced severe MIC. The steel reinforcement ribs are either gone or in an advanced corrosion state. The white solids are MIC corrosion products (marked by red circles)

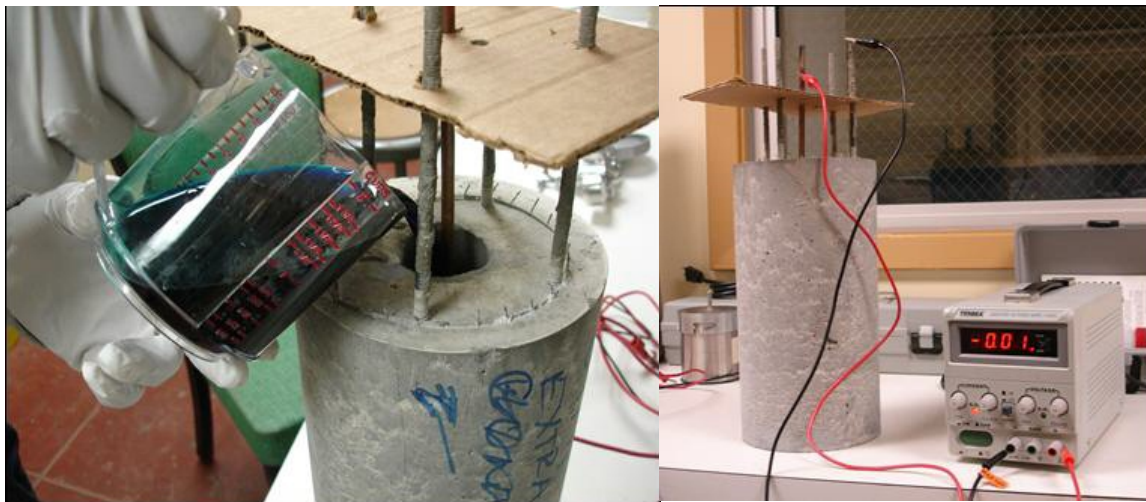
The solution was stirred for 12 hrs prior to being poured into the void in the concrete specimens. A copper rod was placed in the solution to serve as the anode, while the steel reinforcement in the concrete served as the cathode. The electrokinetics process took place by applying 0.3 Amp of current continuously over a period of 5 hrs. The time of application of the electrical current was

Figure 3. cuprous oxide lactate solution poured into the a specimen (left); The electrokinetic coating process underway, note the copper electrode at the center of void (right)

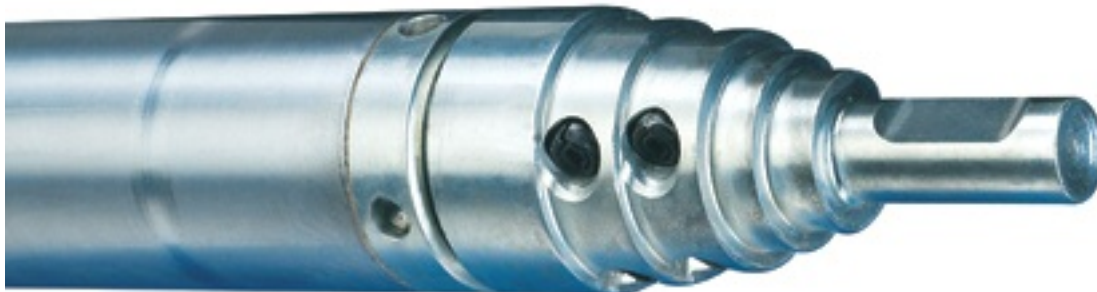
Design improvements improved accuracy. With the introduction of the chisel-head assembly on the certain piercing tool models in the early 1970s, accuracy was no longer an issue. See Figures 1 & 2. The assembly is spring-loaded and pushes forward from the main casing creating a pilot bore for the tool and helping it stay on target. The chisel action and stepped-cone design allow the tool to power through difficult soils and obstructions without being pushed off course.”

Figure 1 Note the chisel tip, the stepped cone and the joint where the reciprocating action of the boring tool head takes place. These parts are designed to be replaceable when significant wear has taken place.

The piercing tool is basically a piston within a casing. Compressed air moves the piston and the impact of the piston drives the tool forward. That was the design of the first tool and it is essentially the same in principal today. The earliest tools, or moles as they are often referred to, were often difficult to handle and hard to restart after stopping. Accuracy was also a problem. Because accuracy was such a problem with most piercing tools, the technology was often thought of as unreliable and was not allowed to reach its full potential. The development of the reciprocating stepped-cone chisel-head assembly changed that.

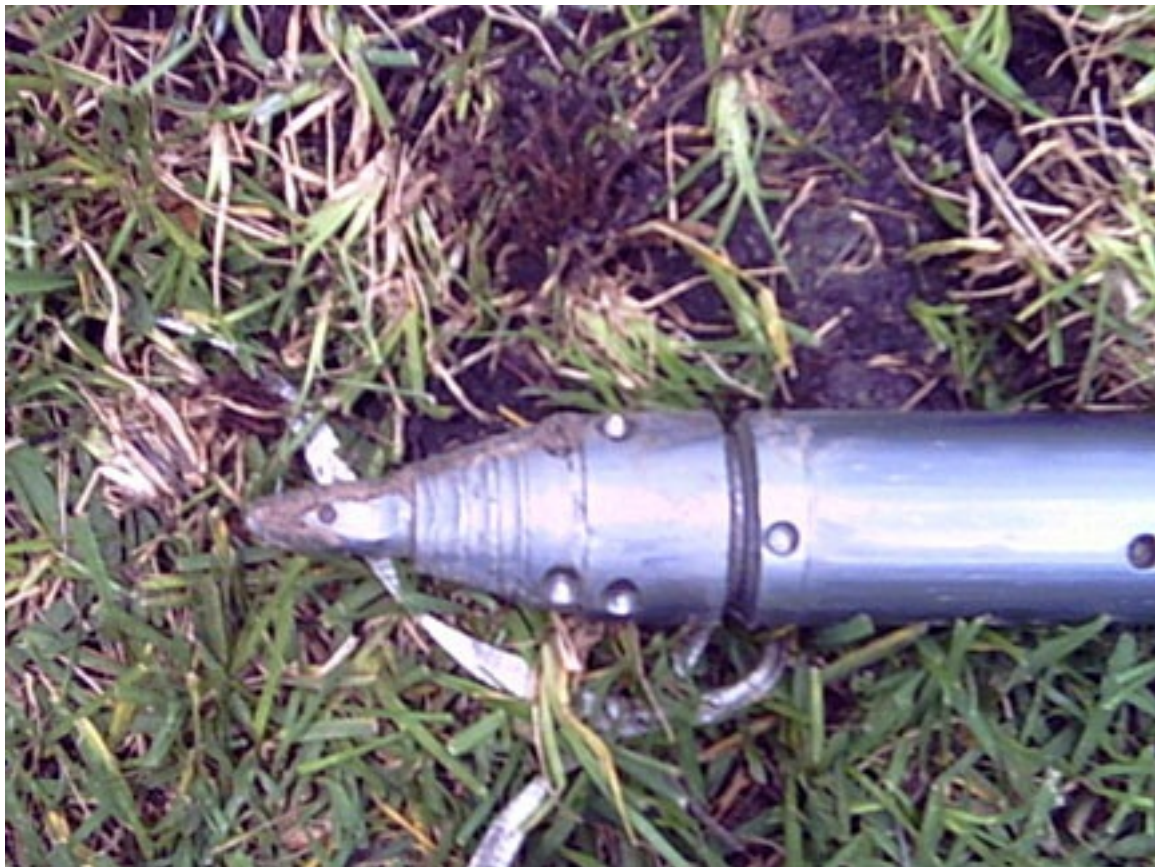
Figure 3 This illustration shows a well-used piercing tool, note the wear on the chisel and stepped cone. These can be replaced at the discretion of the user.

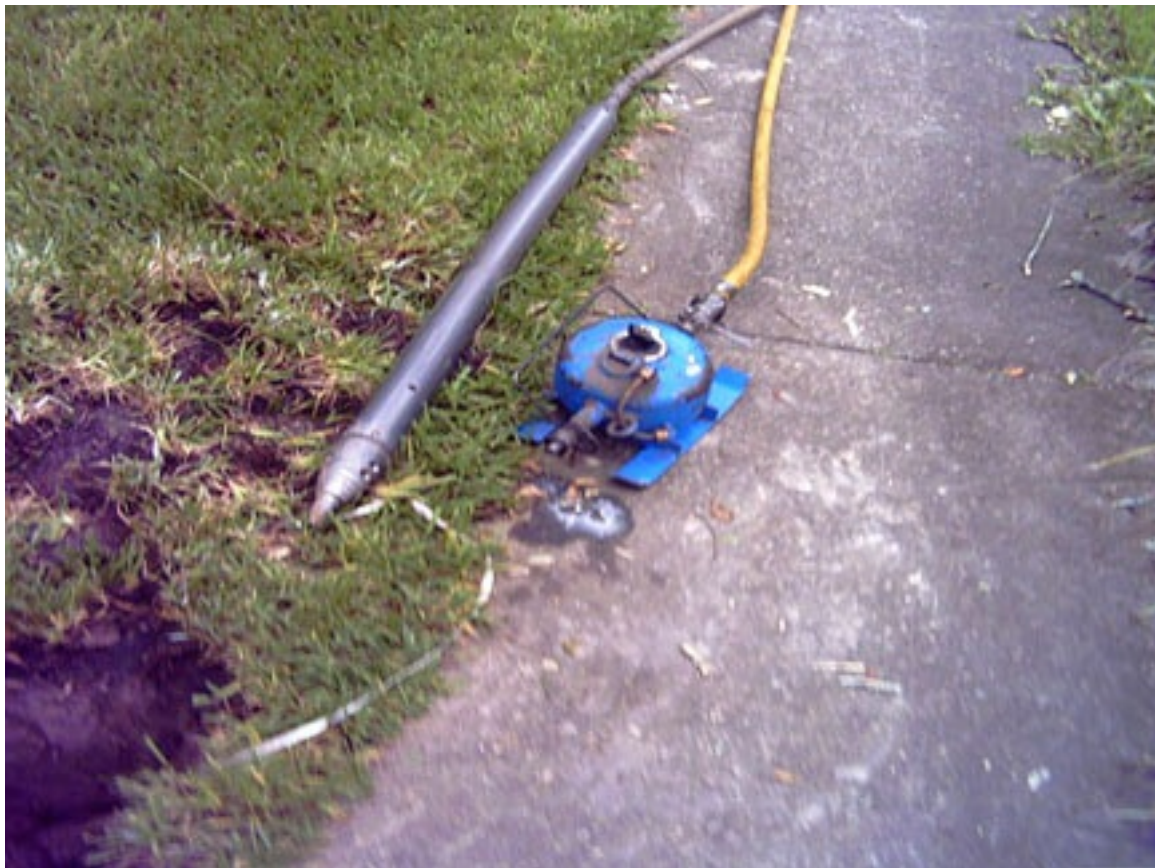
Figure 4 A typical piercing tool setup includes the boring tool, reinforced air hose and lubricator. Compressed air supply is provided by a typical construction air compressor.

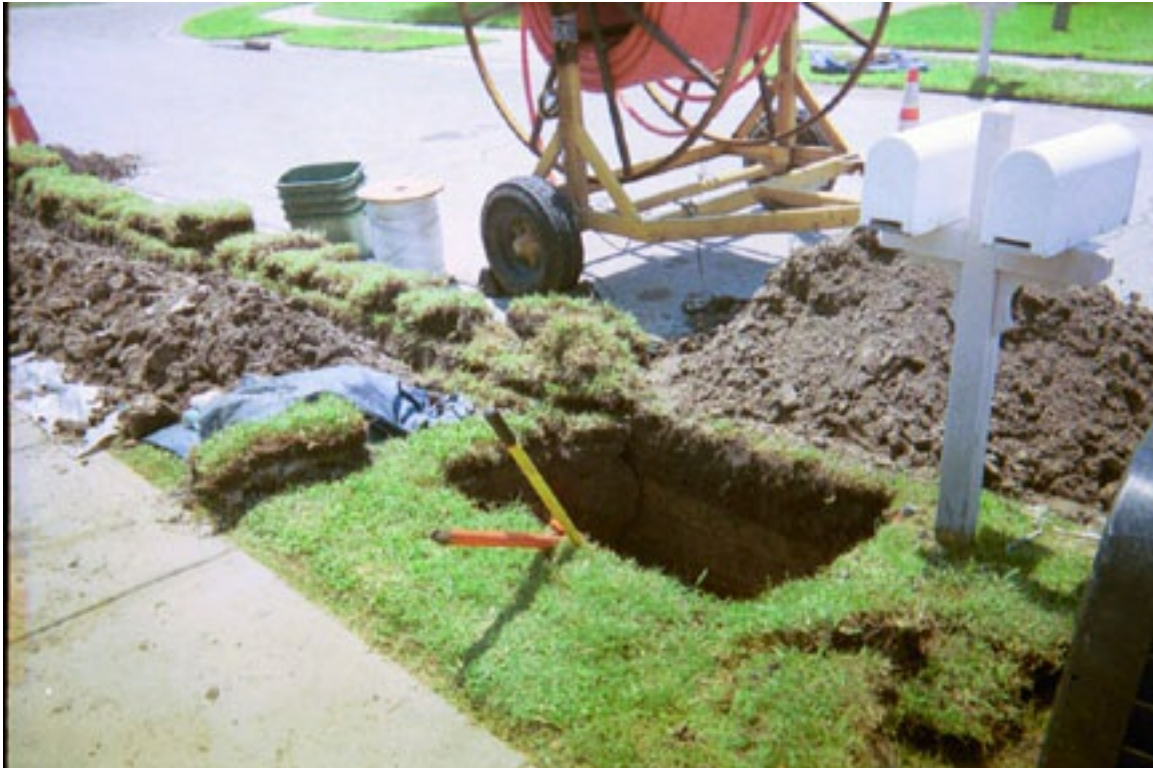
Figure 5 A typical excavation for an FTTH service. This excavation is approximately 2 x 4 feet. Depth is 24-30". Note the reel of conduit, utility boxes, roll of mule tape, turf to be replaced, hand tools and excavated material. Note that the excavated material is placed on plastic sheeting to protect the turf underneath. The mail box was not disturbed.

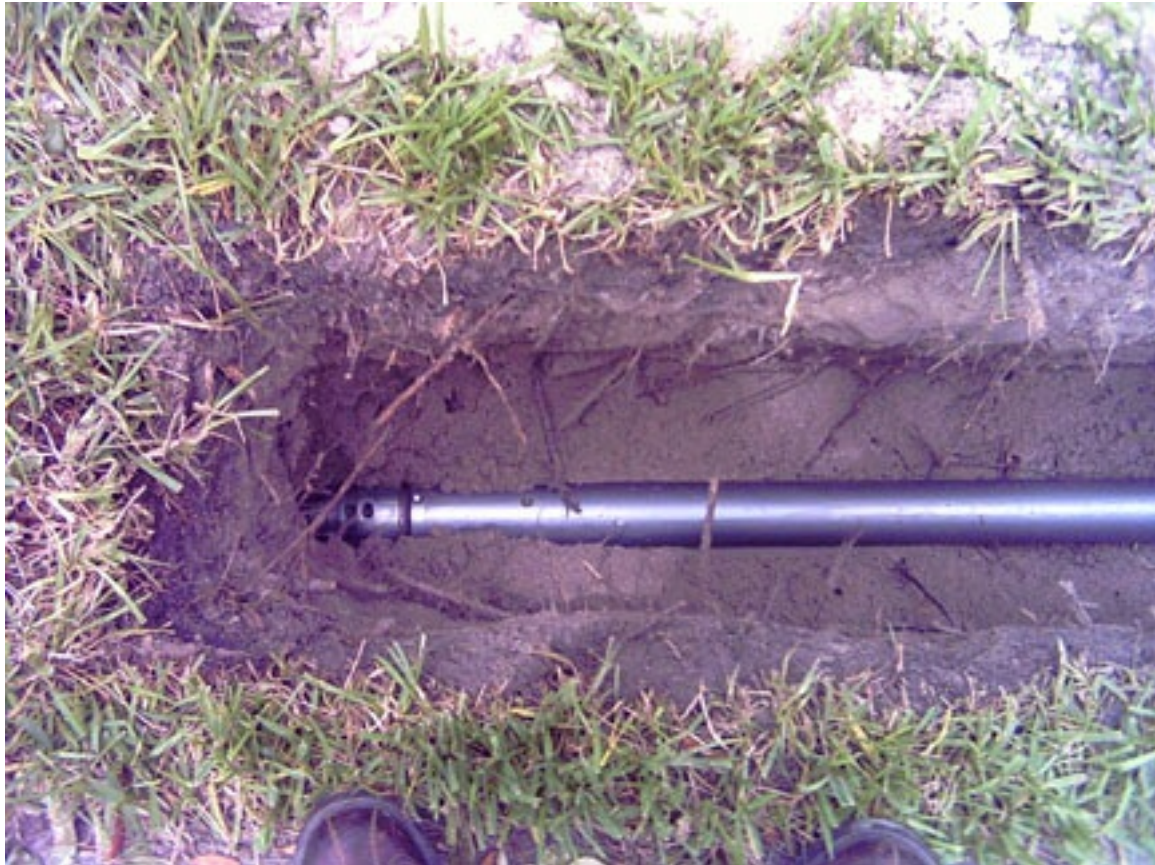
Figure 6 Launch excavations for Piercing tools are normally quite narrow and just long enough for the tool to lie flat on line and grade of the bore.

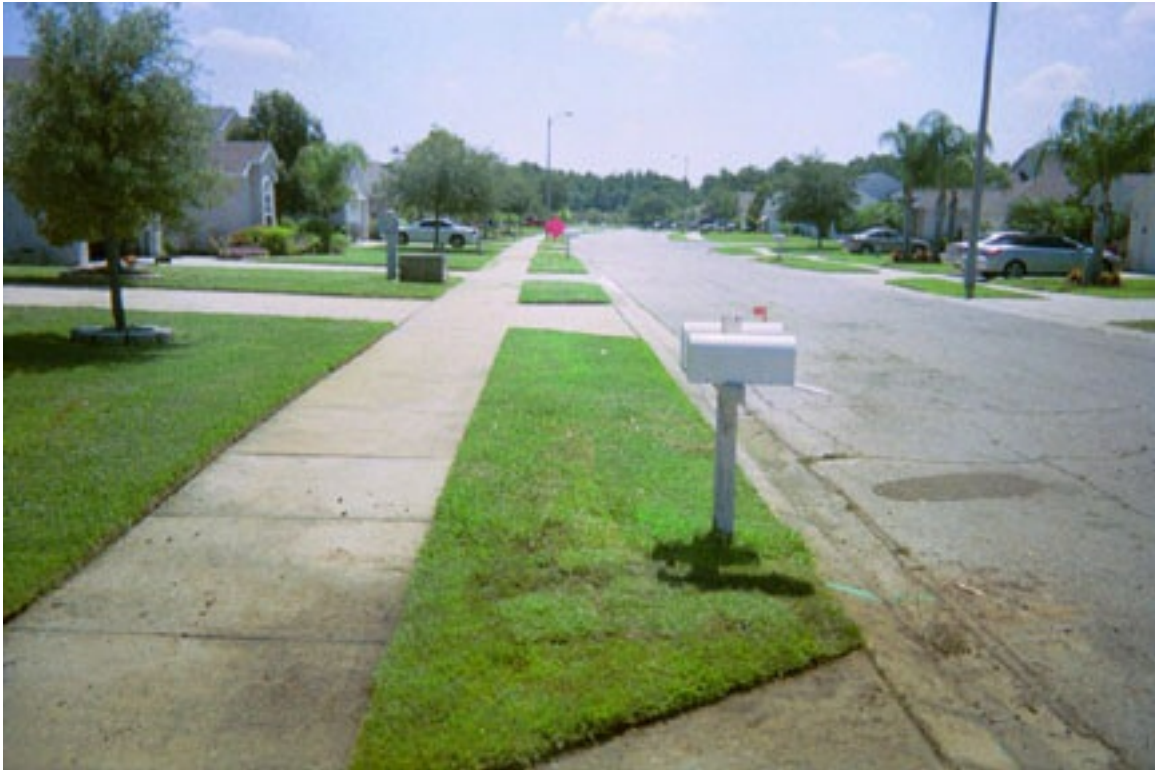
Figure 7

Note the final restoration of this residential street. Minimal disruption allows for reuse of the turf that was removed for the bore pits. This is the same location shown in Figure 5.

In addition to productivity, minimal disruption is a key benefit of the trenchless piercing tool. Restoration is a time consuming and expensive process. It can make up almost 80% of the cost of an installation project. With the cost of restoration so high, trenchless options are extremely attractive, piercing tools especially. Plus the trenchless application is ideal for last mile operations. Arrow Construction crews are working in established neighborhoods with driveways, sidewalks and landscaping. See Figure 7.

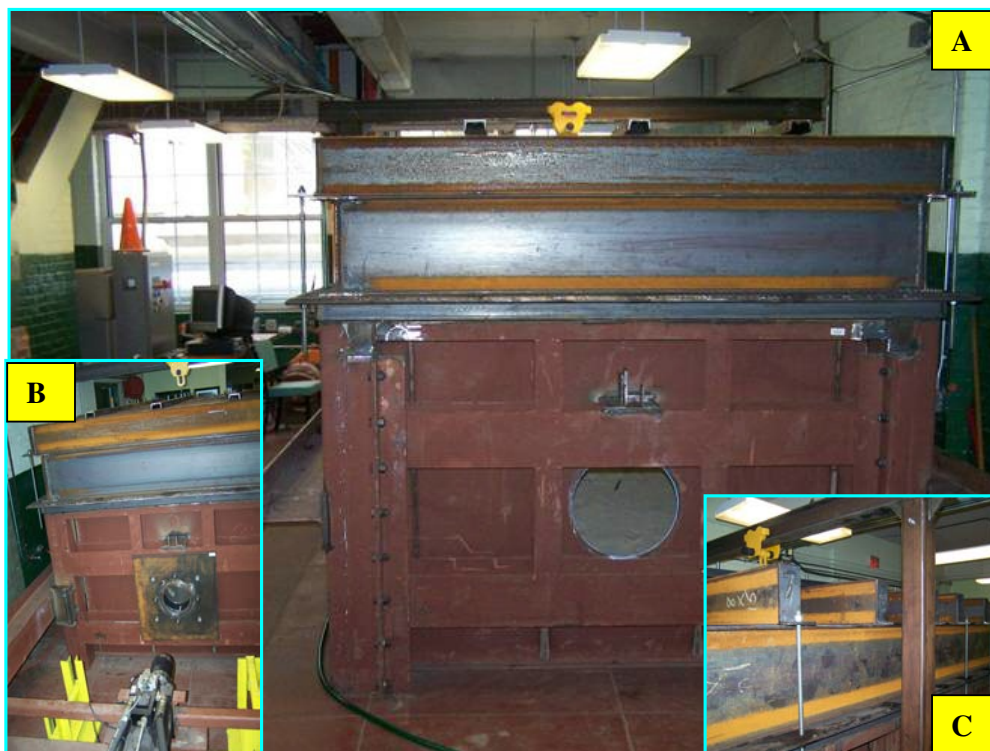
Fig. 7. TTC Soil Structure interaction testing facility; a) View from the rear including control station; b) Front view including servo-control actuator; c) Overhead crane, top beams and tie-down rods

Laboratory tests will be conducted at Trenchless technology Center soil-structure interaction chamber to accurately measure and map ground movement during a pipe bursting operations at different levels of in-situ stresses to further validate and improve the proposed simulation model. This testing facility consisted of a 1.2 m high by 4 m long by 2 m wide steel tank and a 150,000 lb servo-controlled actuator which generates the needed static axial force. An air-bladder capable of producing in-situ pressure equivalent of up to 15 ft of soil overburden will be utilized for simulating various buried depths. Using a grid of 20 LVDTs a 3-D map of the ground surface with respect to the position of the bursting head will be constructed to validate the ArcView model. A snapshot of the facility is given in Figure 7.

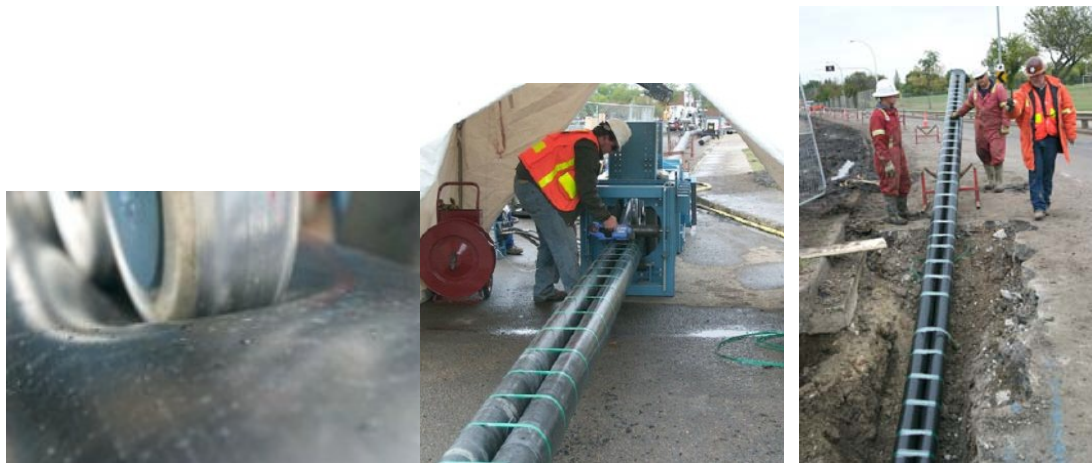
Photos: Process close-up, folding machine and banding, and installation

The liner is then pressurized using a two stage water process. First, restraining bands snap at 10 – 15 psi, then the pipe is pressurized further to re-round the full length.

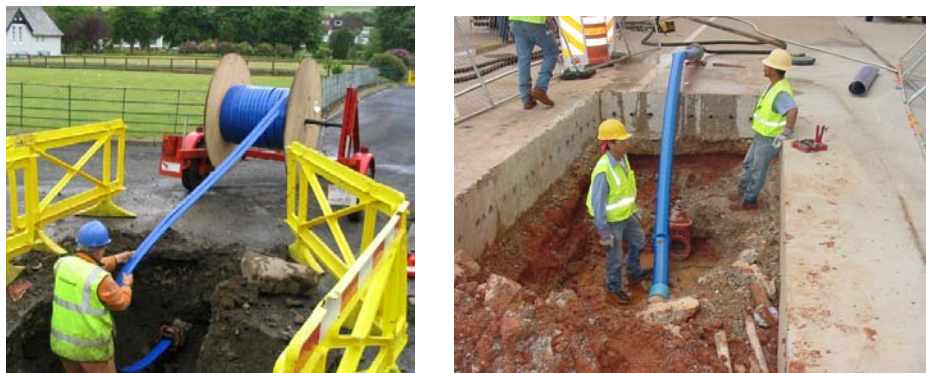
Inserting Folded Liner and Expanding Liner

PRPE can be installed rapidly, through relatively small access pits. Installation of over 1000 feet of liner in one day is possible. The liner is pulled through the host pipe using a small winch and inflated using air pressure. While still under pressure, steam is introduced into the liner for approximately 25 minutes after which the liner is cooled (still under pressure using air). The entire process requires only 15 psi, and does not involve any chemical curing.

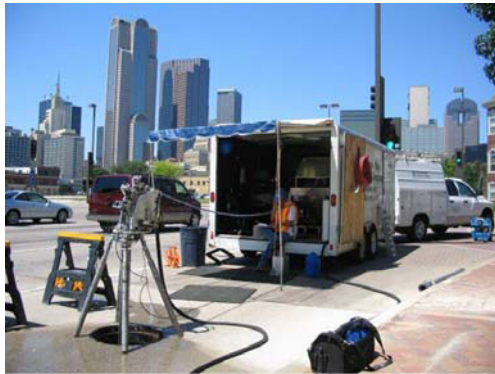
Figure 1: Sahara Leak Detection

DWU staff review the inspection plan prior to conducting a Sahara leak detection survey on a 12” cast iron pipe in the heart of Dallas’s entertainment district, Deep Ellum.

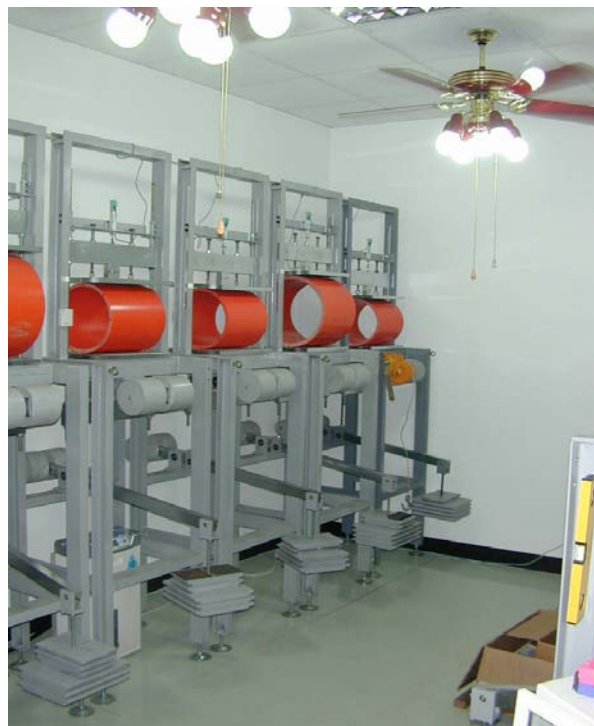
Figure 1 Setup of the long-term pipe stiffness test apparatuses.

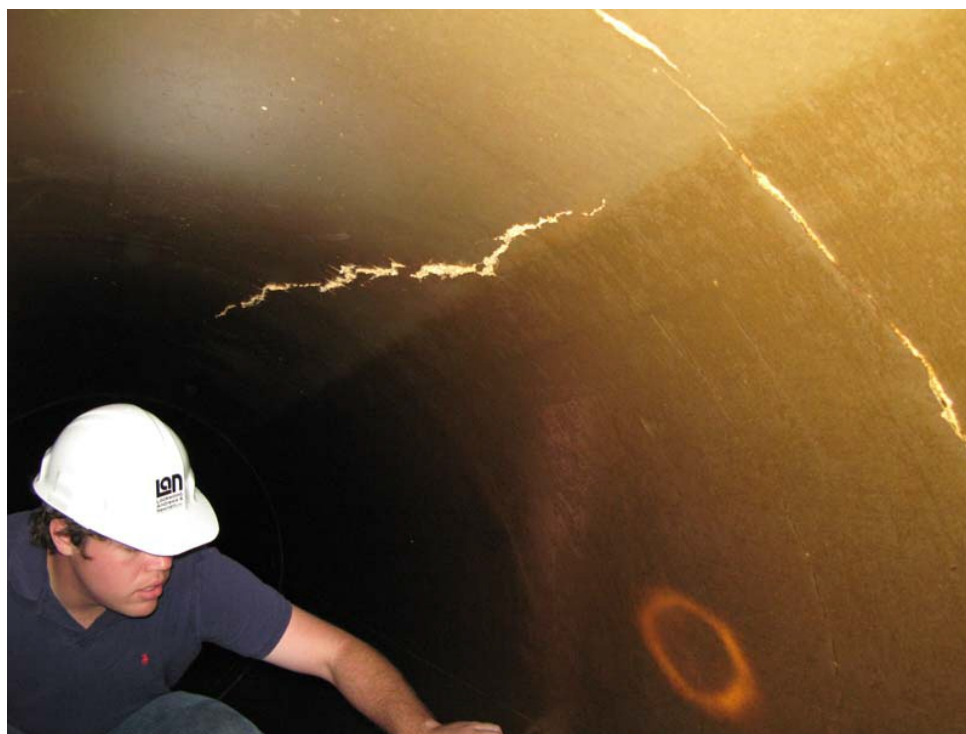
Figure 5. Longitudinal and circumferential damage in PCCP pipe
