Pipelines 2015

Recent Advances
in Underground
Pipeline
Engineering and
Construction

PROCEEDINGS OF THE PIPELINES 2015 CONFERENCE

August 23–26, 2015
Baltimore, Maryland

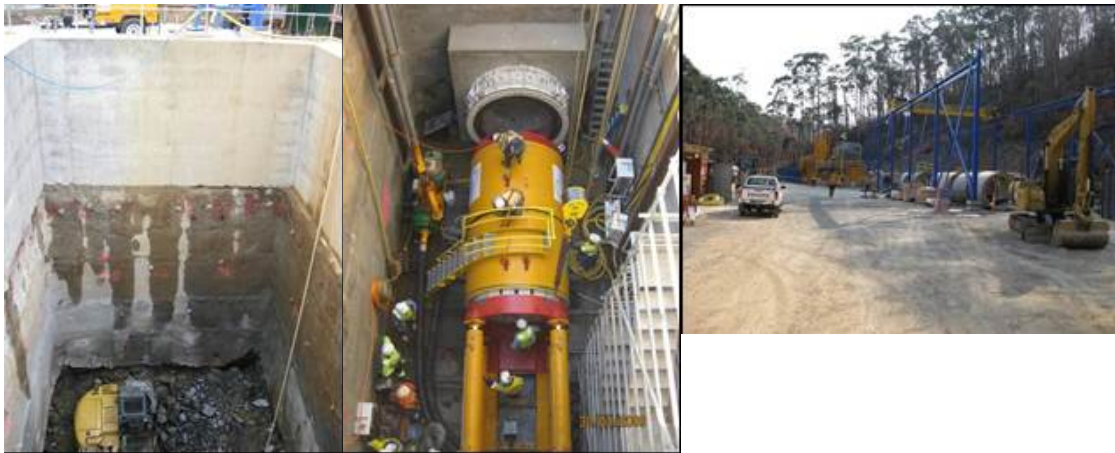
The temporary rock support design consisted of 75 mm (2.95 in) thick steel fiber reinforced shotcrete and 3 m (9.84 ft) long, fully encapsulated, resin anchored rockbolts installed on a staggered 1.7 m (5.58 ft) grid.

Figure 3 (below) presents the temporary support for the shaft and the launch shaft site.

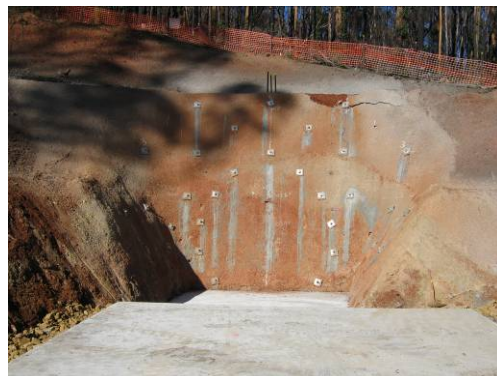
Figure 4. (above) Retrieval portal site and the temporary support

The retrieval portal was located at the north end of the alignment adjacent to the Melba Highway. The geotechnical conditions consisted of colluvial material. The portal was cut into the side of a hill and the temporary support consisted of 150 mm (5.91 in) thick steel fiber reinforced shotcrete and 6 m (19.69 ft) long soil nails.

Figure 4 presents the retrieval portal site and the temporary support for the portal.

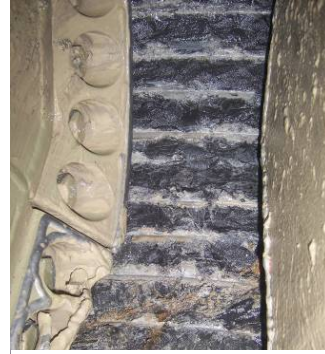
Figure 9.
(above) Tunnel Face
CH 576 m

The tunnel face was inspected once during tunnelling operations at chainage 576 m (1889.76 ft). Joint spacing was in the order of 200 mm to 300 mm (7.87 – 11.81 in), with a maximum of 500 mm (19.69 in) observed. The joints were tight, but showed signs of joint alteration, including weathering and iron staining. Three dominate joint sets were persistent in the rock structure, including two joint sets dipping steeply (70-80 degrees) to the north west and north east, and a third dipping at 45 degrees to the south. A fourth random joint was also observed, and was noticeably more weathered than the three principal joint sets. The jointed nature of the rock mass played an

important role in achieving relatively high production rates as the TBM cutters were able to dislodge rock from the face along existing defect planes much more readily than what would have been able to be achieved in a more massive (unjointed) rock formation. Figure 9 presents the tunnel face at chainage 576 m (1889.76 ft).

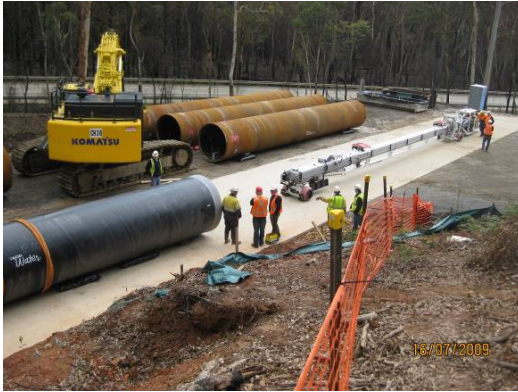
In order to install the 1750 mm (68.90 in) MSCL secondary lining, a pipe carrier was designed to install each pipe section to its nominated location within the tunnel, join it and then return to the retrieval portal to collect the next pipe. The pipe carrier was designed to:

- Lift and place a full length (13.5 m (44.29 ft)) MSCL pipe weighing 11 tonnes (12.13 tons) both on the surface and in the tunnel
- Negotiate the curvature of radius of the alignment by a self levelling/self-steering hydraulic mechanism
- Provide fine adjustment horizontal and vertical movement of both ends of the pipe within the tunnel to allow it to be centralized and supported

Figure 10. (left) presents a view of the pipe carrier located at the Retrieval portal.

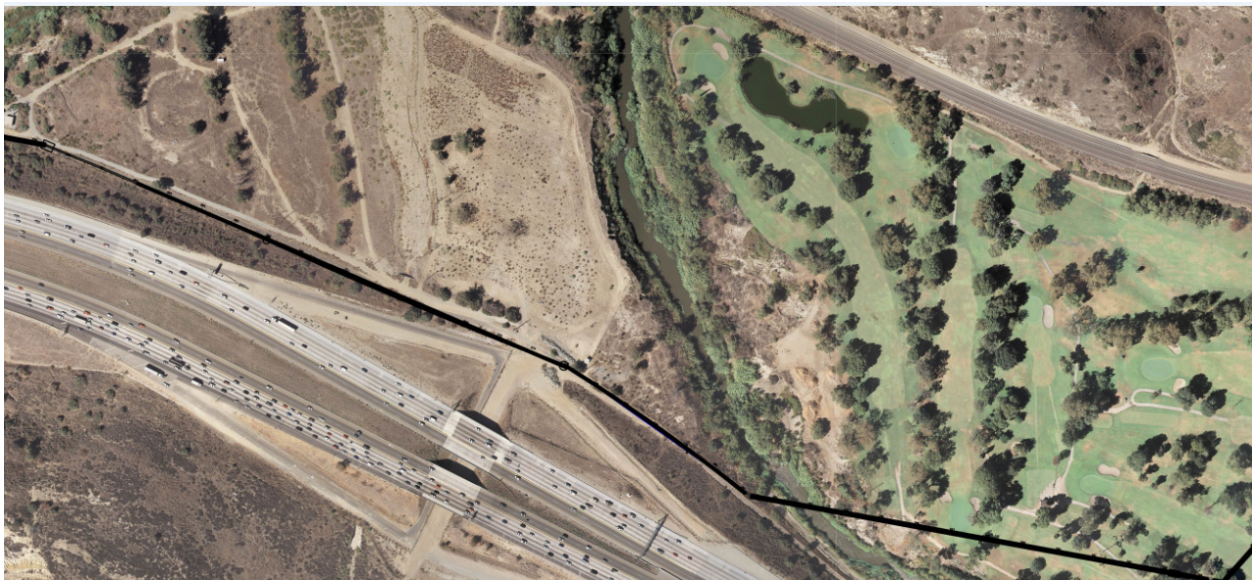
Figure 3
Microtunnel Alignment

The final two drives adjacent to the 91 Freeway fit the profile for adding curves. The third drive, the compound curve, was adjacent to the 91 Freeway and was approximately 1,567 feet. This drive was the first use of the Jackcontrol AG hydraulic joint system with real-time monitoring in North America and set a United States record for being the longest microtunnel compound curved drive and only the second compound curve drive in the United States. The final drive of 622 feet was also adjacent to the 91 Freeway and included a standard curve utilizing the Jackcontrol system (Figure 3).

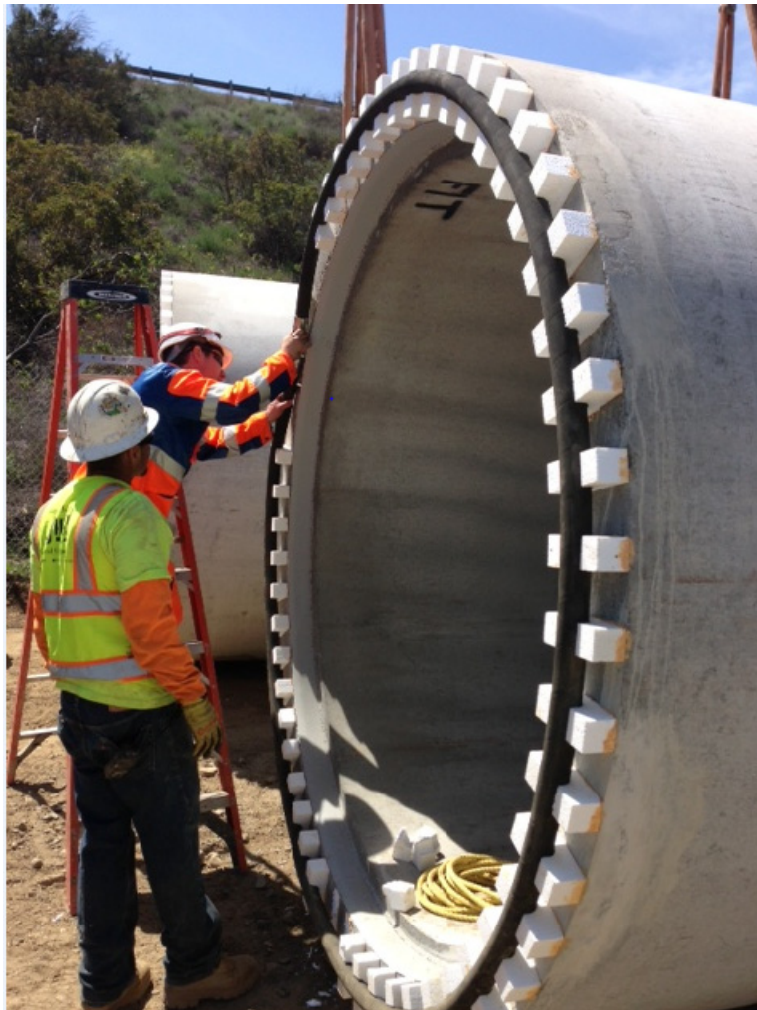
Figure 4
Photo of Hydraulic Joint

Pressure transmission rings made of wood material are widely utilized in microtunneling applications. In curves, the mechanical characteristics of wood material can cause severe damage to jacked pipes. To avoid such damage on the planned curved drive, the contractor partnered with the manufacturer to use a patented hydraulic joint and real-time monitoring system. The joint acts hydrostatically like a fluid-filled hose with a uniform pressure level allowing the curved joints proposed on the project without causing axial stresses that would exceed the strength of the pipe material (Figure 4).

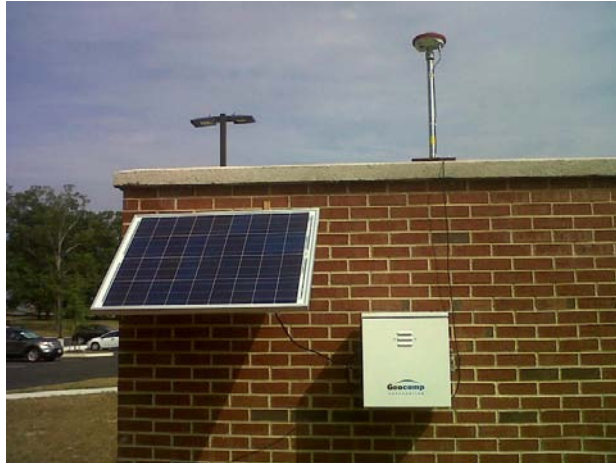
In addition to the settlement and vibration monitoring, a pre-construction survey was completed on specified homes which may be subject to vibration and settlement influence. This information along with the instrumentation data would help address potential damage claims to Fairfax County resulting from the shaft construction or tunneling operations.

Figure 2. Solar Powered GPS Settlement & Vibration Monitoring System

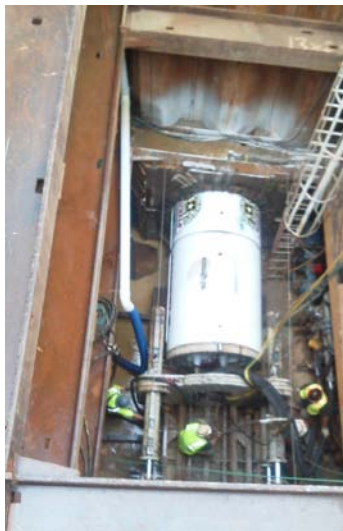
Figure 3. MTBM Launched from Shaft 6

In November of 2011 the tunneling contractor mobilized his crew and they began shaft 5 and 6 construction with the plan to launch the microtunneling boring machine (MTBM) from shaft 6 and have shaft 5 serve as the receiving shaft. On May 8, 2012 the contractor launched the MTBM from shaft 6. Figure 3 shows the MTBM being launched from shaft 6.

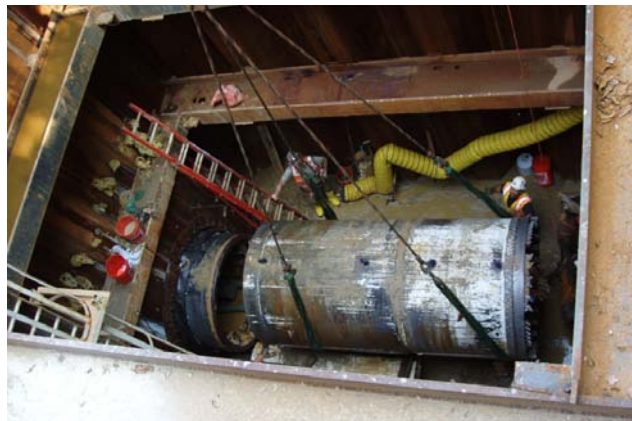
Figure 4. MTBM Received at Shaft 5

and 6 varied from a low of 3.05 m/d (10 ft./d) to a high of 21.3 m/d (70 ft./d) with an average of 10.7 m/d (35 ft./d). The advancement of the tunneling machine was dependent on several factors including subsurface conditions, equipment maintenance and other factors related to the tunneling machine. Generally, clay soil translated into lower advancement of the MTBM while sand or a more granular type soil allowed the MTBM to move forward at a higher rate. As noted there were several ground monitoring points along key locations to monitor settlement. GM-19 which was positioned near the Mount Vernon Highway next to shaft 5 started to show some signs of settlement occurring as the MTBM crossed under the road. The settlement was likely attributed to the sandy conditions near this location. This prompted the tunneling contractor to stop tunneling operations and inject chemical grout into the soil at defined locations to stabilize the subsurface conditions. Once the soil was stabilized the tunneling operations resumed and Figure 4 shows the MTBM being received at shaft 5 and concluding the first tunnel run for the Dogue Creek Force Main.

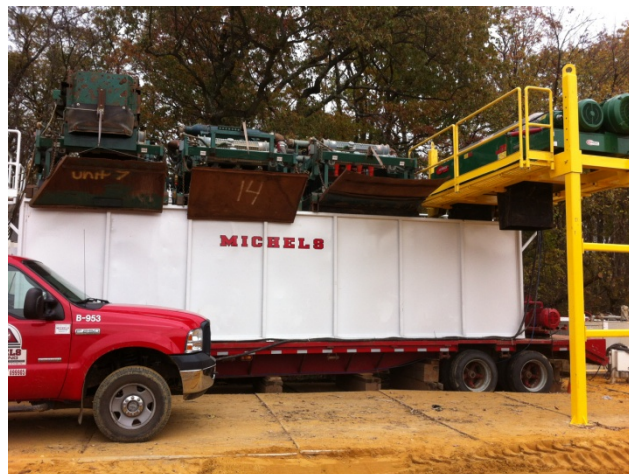
Figure 5 –Tunneling Material Dewatering Operations

Another critical element in the tunneling operations is the need for dewatering the slurry from the tunneling operations. This operation essentially consists of a screening process to remove solids and larger particles then dewatering of the solids with a portable centrifuge. The centrate from the centrifuges is then recycled back to the tunneling operations to the head of the MTBM for lubrication of the cutting head. Figure 5 shows the typical dewatering operations used on this project.

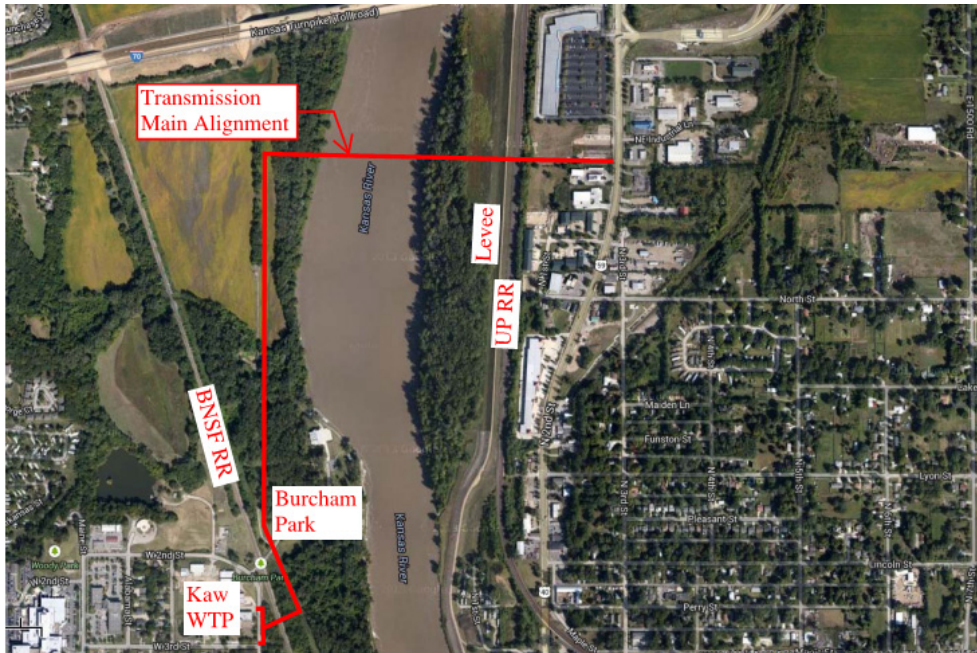
Figure 2 –Water Transmission Main Alignment

As shown in Figure 2 below, the water transmission main alignment runs through Burcham Park. Burcham Park is a highly used park that contains walking trails, playground equipment, and access to the river. The park also includes a boathouse, which is home to the University of Kansas rowing team. The City required that access to the park and boathouse be maintained throughout construction.

As shown in Figure 2, the transmission main alignment crosses two railroad right-of-ways. The railroad requirements called for the transmission main within the railroad right-of-way to be installed by a jack & bore method. This required a bore pit to be excavated. The boring machine and casing pipe were placed within the boring pit. The casing pipe was then “jacked” into place by hydraulic jacks while a cutting head on a rotating helical auger was used to remove the spoils from within the casing pipe. Once the casing pipe was in place, the carrier pipe was installed. The railroads typically require the steel casing pipe to be installed the entire width of the railroad right-of-way. This installation method worked for the BNSF railroad crossing near the Kaw WTP, but not the UP railroad crossing on the east side of the river near the levee.

As shown in Figure 2, there was limited laydown area for the pipe string. The west side of the property is bound by the BNSF railroad, and the north side is bound by the I-70 Interstate. Because of this, the required 2,400 foot river crossing was initially fused in three lengths of 1,100 feet, 880 feet, and 420 feet, which required two intermediate fusions to occur during the pullback process. With the 48-inch bore hole open, the pipe pullback process began. Initial pull back activities began at 6:00 in the morning, with the first section of pipe being pulled through about 9:00 in the morning. Each intermediate fusion processes took approximately two hours. After 16.5 hours, the last section of pipe was successfully pulled into place at 1:30 the following morning.

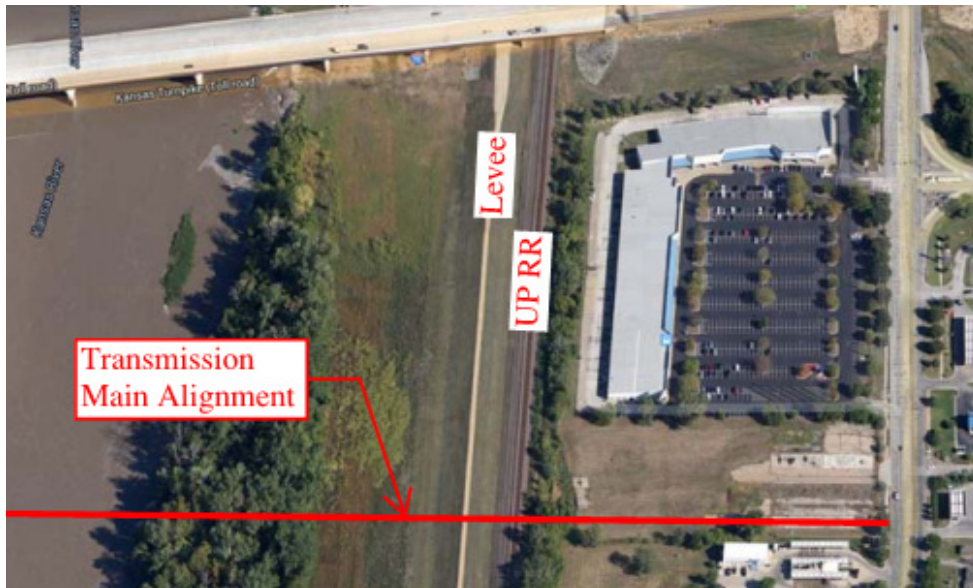
Figure 3 – East Side of the River – Levee/Railroad Crossing

As shown in Figure 3 below, the levee and UP railroad are adjacent to each other. The 30-feet between the levee centerline and the west edge of the UP right-of-way provided insufficient space for a bore pit. It would have been possible to excavate the bore pit on the east side of the railroad right-of-way, but working between the levee and the railroad would have been very confined, so an alternative installation method was considered.

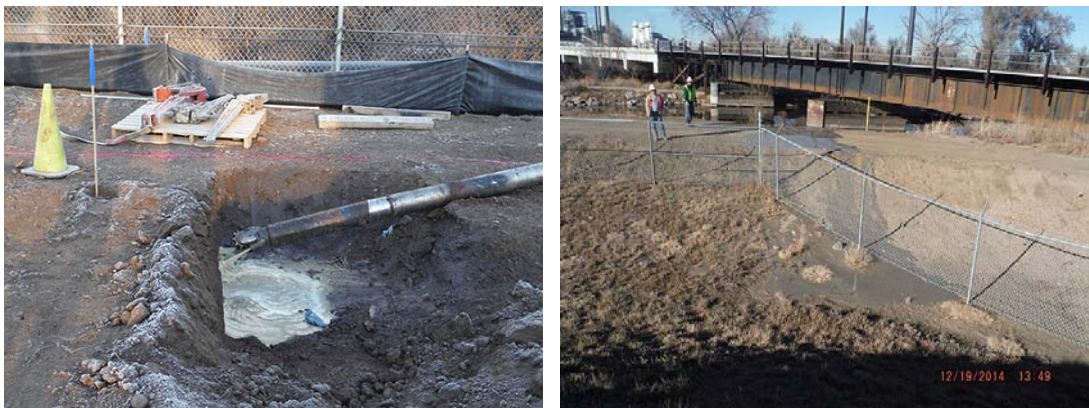
A two degree bent sub and a jetting assembly were used to drill the 8-inch diameter pilot bore (Figure 4, Left). The pilot bore was completed in three days, including delays due to inadvertent drilling fluid returns to the ground surface after drilling approximately 400 feet, or two-thirds of the bore. Drilling fluid was seen escaping to the ground surface at the location of the fiber optic line pothole which had been backfilled with grout (Figure 4, Right). The vacuum excavations performed to pothole the fiber optic line were unable to be offset by any appreciable distance from the HDD bore path centerline due to restraints to surface access. There was no increase in the downhole annular fluid pressure prior to the inadvertent drilling fluid returns reaching the ground surface, only a decrease in fluid returns to the entry mud pit. The drilling fluid was immediately contained and removed with a vacuum truck. Pilot bore drilling resumed with the escaping drilling fluid removed using a vacuum truck. A crew member remained stationed at this location for the duration of the HDD in order to monitor and collect drilling fluid migrating to the ground surface.

Figure 4. Pilot Jetting Assembly with Mill Tooth Bit (Left) / Inadvertent Drilling Fluid at Pothole Location (Right).

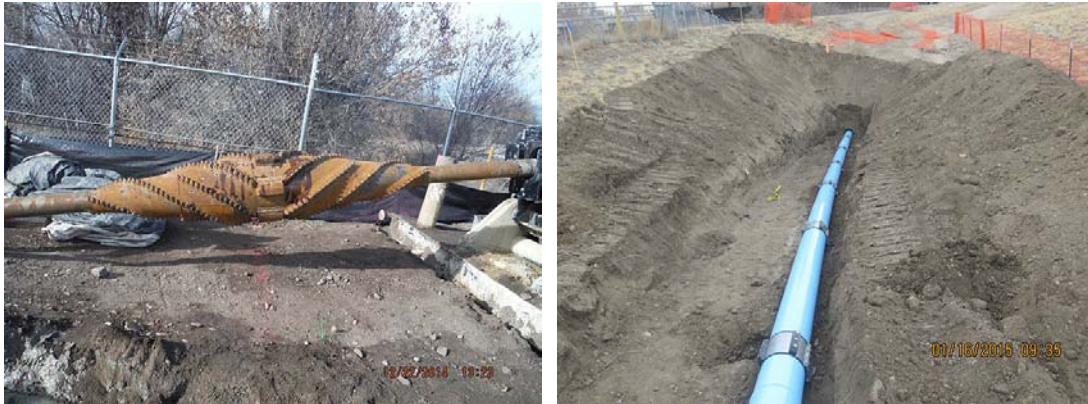
A single 24-inch diameter forward reaming pass (Figure 5, Left), pushed from the drill rig entry side was performed using a fluted reamer that proved very successful in the alluvial soils. Forward reaming was completed in six days without major incident. Severe cold weather interrupted the drilling operation with a decision to postpone reaming for two days while temperatures were well below freezing. Drill pipe tail string was utilized at all times throughout the forward reaming operation, with an excavator used to provide tension on the drill string at the exit site. Drilling fluid continued to flow from the ground surface at the intermediate inadvertent

Figure 5. 24-inch Fluted Reamer (Left) / 10-inch Fusible PVC with Casing Spacers Pushed into the 16-inch Steel Casing Installed via HDD (Right).

The contractor elected to deviate from the initial plan to pull the entire steel casing with FPVC carrier pipe string in one continuous pullback operation. The contractor was allowed to pull the steel casing in two segments with, an intermediate weld performed during pullback. It took just under three hours to perform the intermediate weld, and from beginning of pullback to completion of the casing installation took six hours. After completion of the 16-inch steel casing pullback, the 10-inch FPVC carrier pipe was then pushed into the steel casing with casing spacers used to guide the PVC pipe into place (Figure 5, Right).

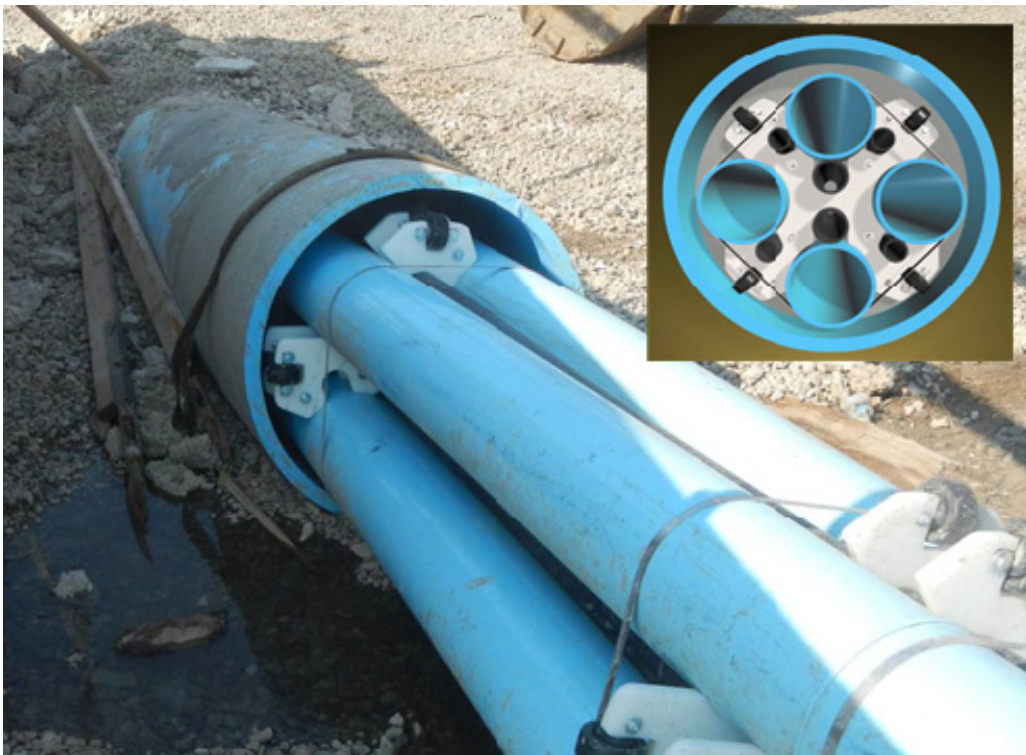
The Carson Corporation elected to use fusible polyvinylchloride pipe (FPVCP) as the casing and primary conduit material for several reasons. First, the tensile capacity of FPVCP provides for a thinner pipe wall for the same buckling and deflection resistance as other thermoplastic pipe options currently available. This means that the overall borehole size could be reduced by using FPVCP, but still provide the required casing and conduit inner diameter for the cable and thermal grout design. Reducing diameter and wall thickness also had tangible value for the HDD process, by reducing the size and weight of both the casing and the conduit, it lowered the risk and cost. The final design for the HDD bores included a 30-inch FPVCP casing, four 8-inch FPVCP conduits, two 2-inch high density polyethylene (HDPE) conduits for the ground cable and a fiber optic line, and two 3-inch HDPE grout tubes. Underground Devices, Inc. custom designed and manufactured casing spacers for the project that held the conduit bundle in the appropriate configuration and also provided wheels for reduced friction of the bundle during installation (see Figure 2).

Figure 2. Final conduit bundle assembly, showing the (4) 8-inch FPVCP conduits, the (4) potential 2-inch HDPE conduits (only two used), the (2) 3-inch HDPE grout tubes, as well as the casing spacers and how the configuration was banded together.

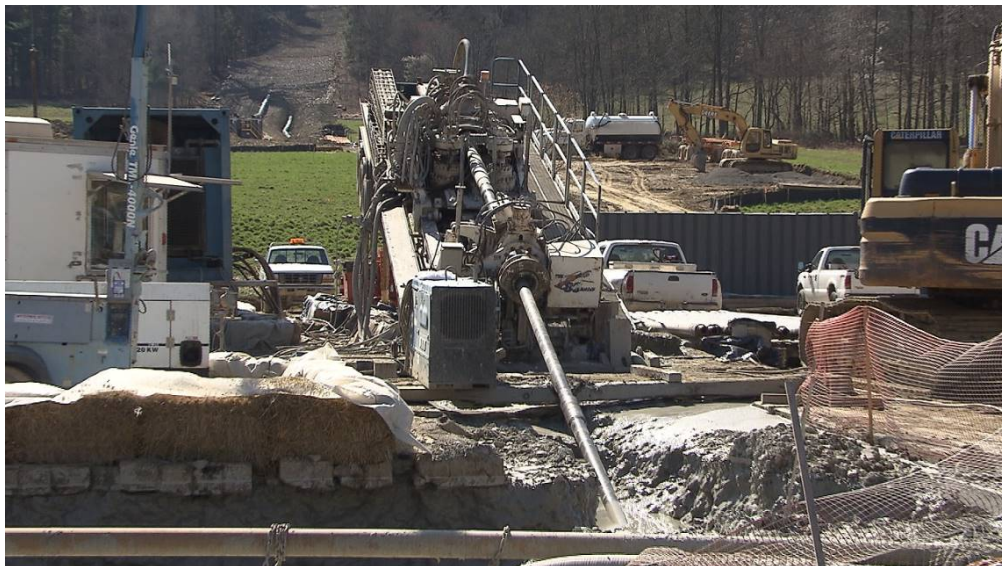
Figure 3. The largest directional drill rig used for the project, an American Augers DD1100.

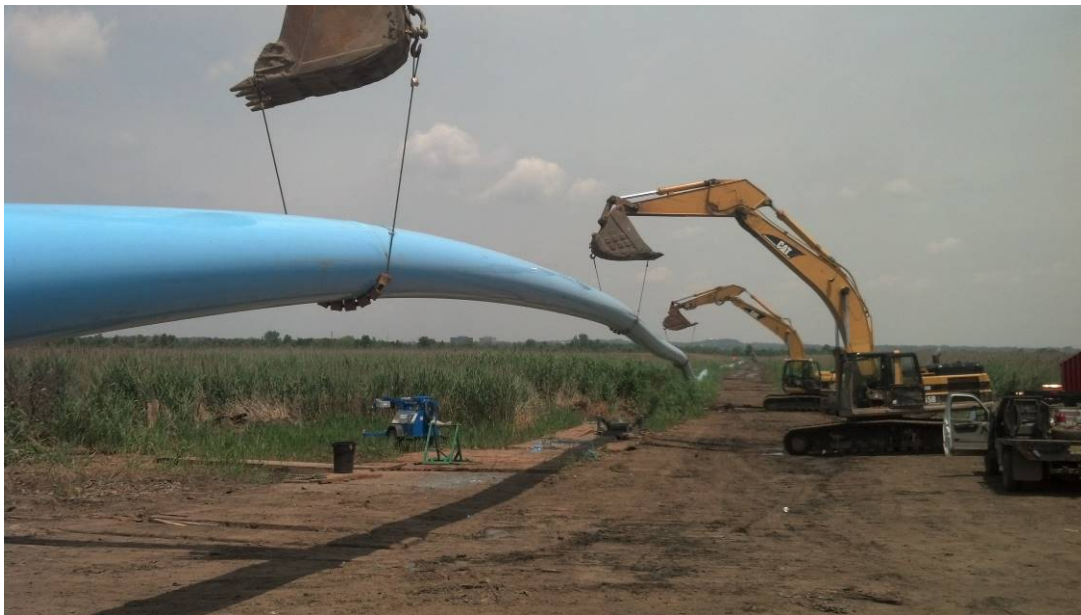
Figure 4. Typical 30-inch FPVCP casing insertion shown with aerial support provided to guide the FPVCP into the required angle of the drill exit.

The timing of the construction was orchestrated so that immediately following the swab pass, the 30-inch FPVCP was ready to be installed. Using a mechanical pulling head attached to the 30-inch FPVCP, installation of the entire string took less than 200,000 lbs of force (see Figure 4). To reduce the amount of pull back force needed, the casing pipe was ballasted or filled with water as it entered the bore hole. This acts to reduce the upward buoyant force created by the pipe as it moves through the dense drilling slurry, reducing the frictional forces generated as it is pulled through the bore. All of the HDD bores were completed in this same fashion.

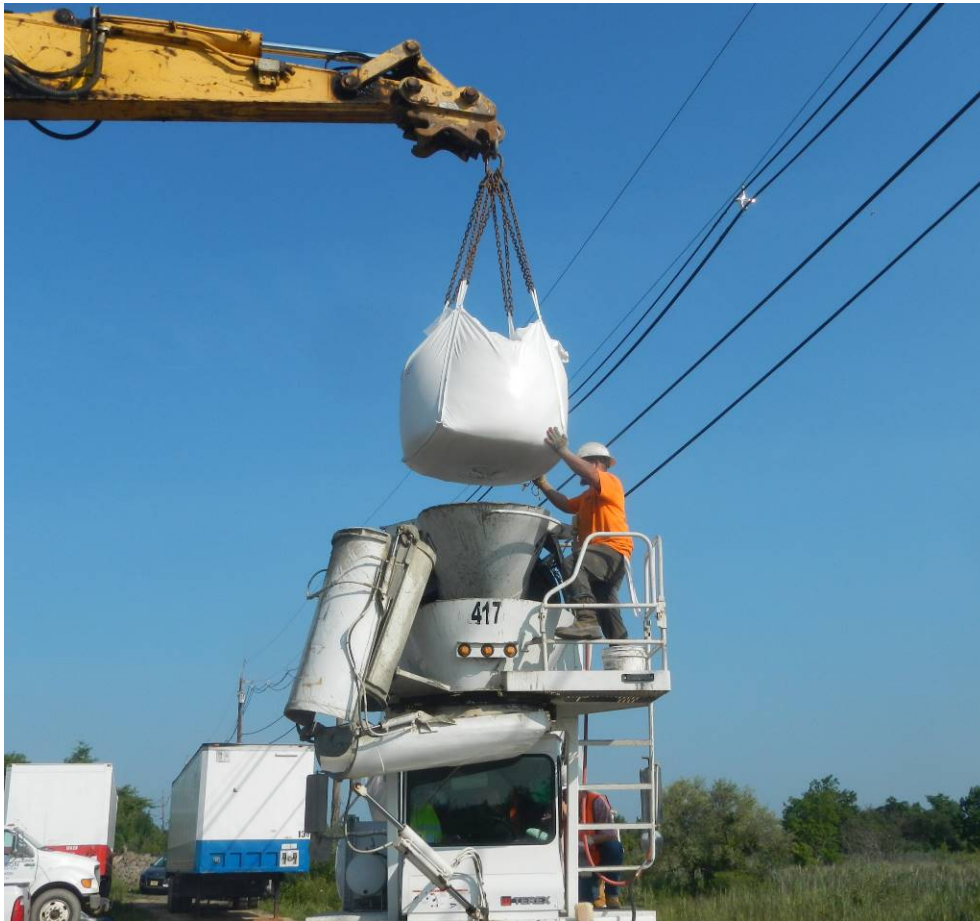
Figure 6. Addition of sand on-site as part of the hybrid grout batching arrangement for the project.

- 2.) When the trucks arrived on site, 15,000 pounds of the specialty fine sand was loaded, along with a final admixture and additional water (see Figure 6).
- 3.) After the truck was fully loaded, samples were taken to ensure the final mix met or exceeded the designed specific gravity of 128 pounds per cubic foot (pcf). Average unit weights were approximately 130.5 pcf as measured.
- 4.) In total, over 2,120,000 pounds of fine sand was handled in this manner.

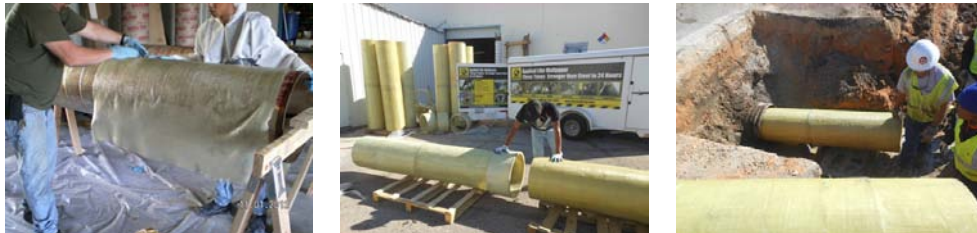
Figure 1. Honeycomb-FRP pipe being made on a mandrel for repair of culvert.

This process is fairly simple and we have used it to build pipe segments for repair of gravity and pressure pipes. A 60-ft (18 m) long 24-inch (610mm) corrugated metal culvert was repaired in Mobile, AL (Ehsani 2013) (Fig. 1). To keep the cost down, this pipe was made with glass fabric only. In another application, shown in Fig. 2, seven segments of 4-ft (1.2m) long 48-inch (1220 mm) diameter corroded steel pipes in Avalon Pumping Station, Carson, CA were repaired with this technique (Ehsani and Parsons 2013). The custom pipe segments were manufactured with an outside diameter of 47 inches (1194 mm), to minimize the loss of flow capacity after the repairs. To meet the operating pressure requirements of the plant, this pipe used two layers of carbon FRP on the inside plus two layers of glass FRP as the outer surface.

Epoxy: The speed of manufacturing a pipe on site is greatly influenced by the properties of the epoxy being used. The pipes shown in Figs. 1 and 2 were made using a QuakeWrap epoxy which is part of a proprietary system that meets the strict NSF-61 standards for potable water pipes. The resin fully cures in 24 hours in ambient temperature (Epoxy A in Fig. 4). While this feature (i.e. requiring no special curing process) is ideal for repair of pipes and large walls or slabs in a building, the long cure time delays the speed of manufacturing new pipes. Typically, it will take less than 2 minutes to wrap the fabric layers around a 10-ft (3m) long mandrel; after which laborers would have to *wait* while the epoxy cures before removing the finished pipe. Epoxy cure time is the major bottleneck in the production process, so any reduction in this time will significantly impact production speed.

While our focus has been on manufacturing the long barrel of the pipe, elbows and fittings can be built by hand using the same technology as we have used to build shorter pipe segments (Figs. 1 and 2). Moreover, steel or fiberglass flanges and fittings from other manufacturers can be inserted into our pipe and secured with the wet layup system; these flanges can then be bolted together by conventional ways.

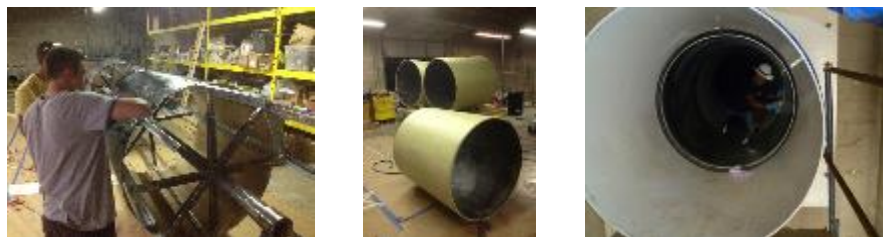
Figure 2. Making and installation of honeycomb-FRP pipe used for repair of pressure pipe.

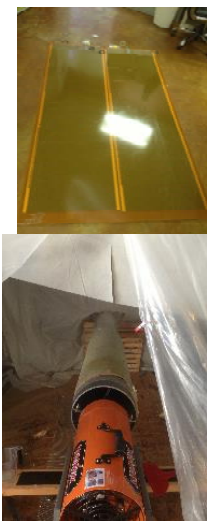
Figure 5. LaminaHeat and propane heater tried in curing the pipe.

Heating Source: As discussed earlier, the epoxy must be heated to initiate the curing process. Several techniques for heating the resin were explored and tested. These included LaminaHeat™ (Fig. 5) which is connected to an electrical circuit and provides a very uniform heated surface. However, because of the time required to raise the temperature in LaminaHeat™ to 300F (150C), it was ruled out. Another promising technology is Variable Frequency Microwave (VFM) by Lambda Technologies (Morrisville, NC) that claims an efficient uniform curing of the resin. Unlike conventional microwave ovens used at homes that operate at a fixed frequency (primarily to excite water molecules), this technique varies the microwave frequencies to ensure that all parts of the subject are heated at the same rate. Samples of fabric and resin were made into a pipe sample cured with VMF in one of Lambda Tech's ovens. The sample looked very good and the epoxy was fully cured. However, a VFM oven based on this technology to fit a pipe would cost around \$100,000. For that reason, this option was ruled out for the time being.

To prevent delays in the project, a decision was made to use gas heaters to heat the resin (Fig. 5). For testing purposes, a temporary enclosure was built and the pipe samples were placed inside this enclosure. The pipe was heated using gas heaters both inside and outside the pipe. While this system worked well, it does require supply of propane on the MMU platform. For some remote sites, this could result in additional challenges. For that reason, the use of propane was ruled out.

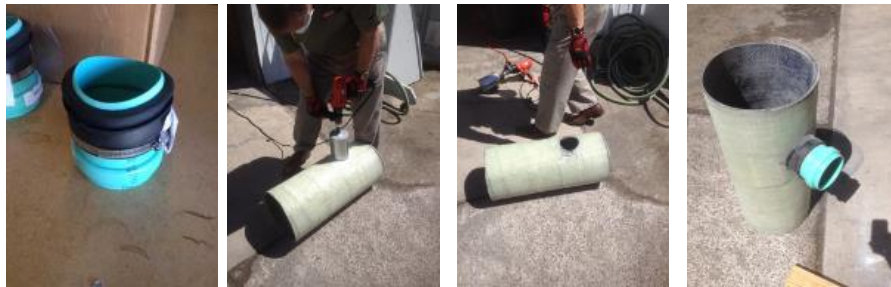
Figure 6. Installation onto InfnitPipe[®] of a lateral connection made by Inserta Tee[®]

For sewer pipe or pipes with low operating pressure, many such products are readily available on the market. As shown in Fig. 6, Inserta Tee[®] provides a three-piece lateral connection consisting of a PVC hub, rubber sleeve, and stainless steel band that can be easily installed on InfnitPipe[®]. The connection shown here uses a compression fitting and is suitable for gravity flow pipes. Connections and fittings for water and other pressure pipe applications require further development. If necessary, the connection can be externally wrapped with FRP wet layup to increase its pressure rating.

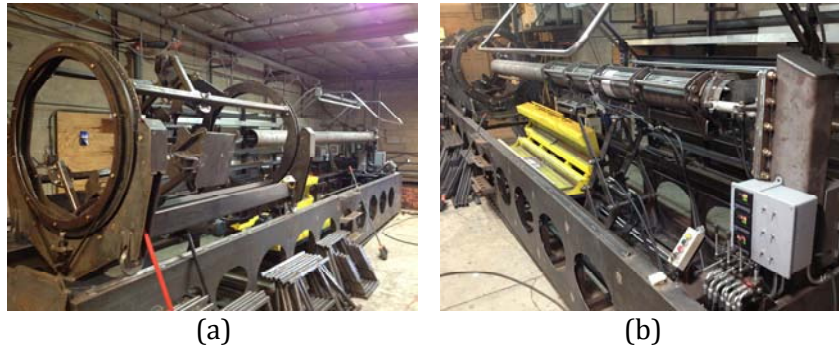
Figure 7. Views from the (a) left and (b) right ends of the first prototype of the Mobile Manufacturing Unit (MMU)

The pitch angle and speed of rotational and translational movement of the hub are set by the controls on the right end. As the hub rotates, layers of fabric are wrapped around the mandrel. The hub then comes to a halt, and the heating oven automatically rises and clamps around the recently wrapped fabric. The oven is heated and within three minutes the pipe is fully cured. The operator then collapses the mandrel, and the finished pipe is pushed out to the left, leaving only a small portion of the pipe on the left tip of the mandrel. The process of wrapping starts again, by continuing at the end of the previously completed pipe. This procedure can continue forever creating an endless pipe.

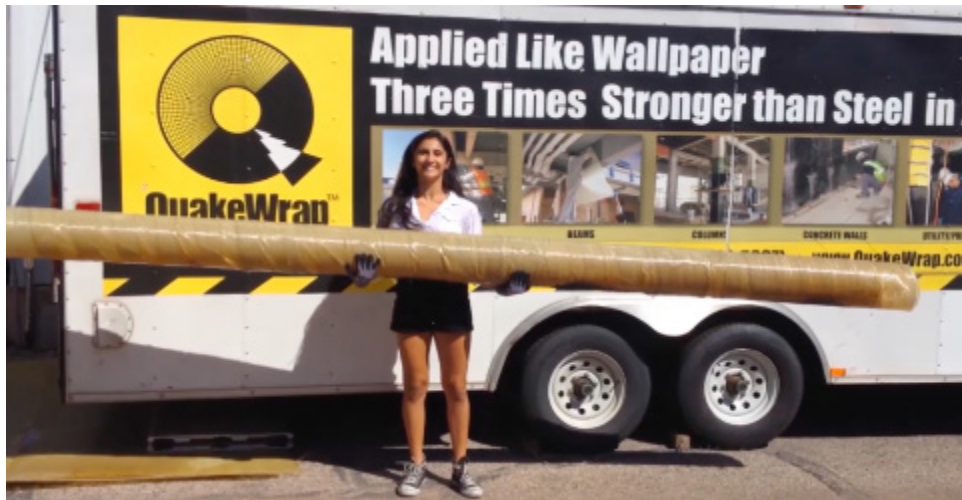
Figure 8. First sample of onsite-manufactured pipe is very light and easy to handle.

video of the MMU is available on YouTube and can be watched at this link (<http://goo.gl/2KAzuD>). In this demonstration video, an 8-inch (200 mm) diameter pipe is being built. The operation is stopped after 12 ft (3.6 m) of pipe has been made. The pipe has a pressure rating of 500 psi (34 bar) and weighs less than 2.5 pounds/ft (3.5 kg/m), allowing for easy handling (Fig. 8). The pipe is rigid enough to allow a truck driving over it without damaging the pipe even when the pipe is not embedded in soil. The MMU can produce pipe at a rate of 2 miles (3 km) per week.

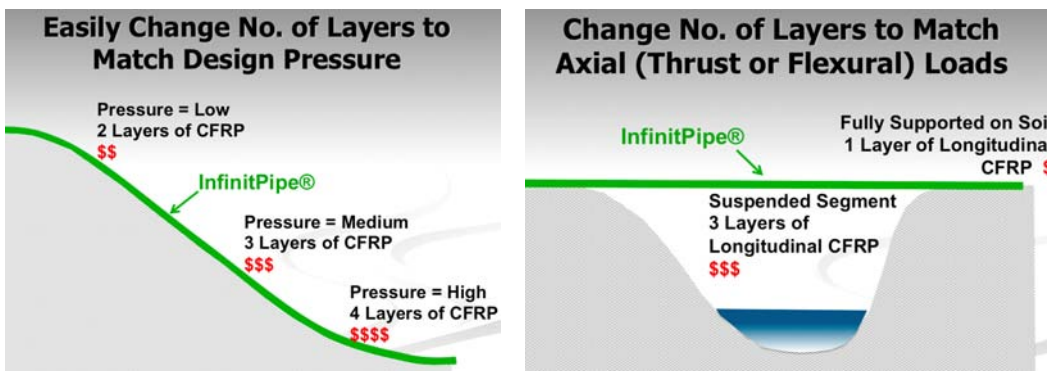
Figure 9. Design of onsite-manufactured pipe can be easily changed to accommodate changes in stresses along the pipeline.

The pipe can be either buried directly in a trench or it can be used to slip-line existing pipes. The method of manufacturing of this pipe is so versatile that allows the designer to change the design along the length of the pipeline. The pressure rating of the pipe is determined by the number of inside layers of carbon FRP fabric that are positioned in the hoop direction. As shown in Fig. 9, for example, when a pipe moves along a steep hill, the number of layers can easily be reduced as the pressure in the pipe is reduced due to change in elevation. Similarly, when a portion of the pipe has to span a crossing, additional layers of carbon can be applied in the longitudinal direction to increase the flexural strength of the pipe – acting as a beam.

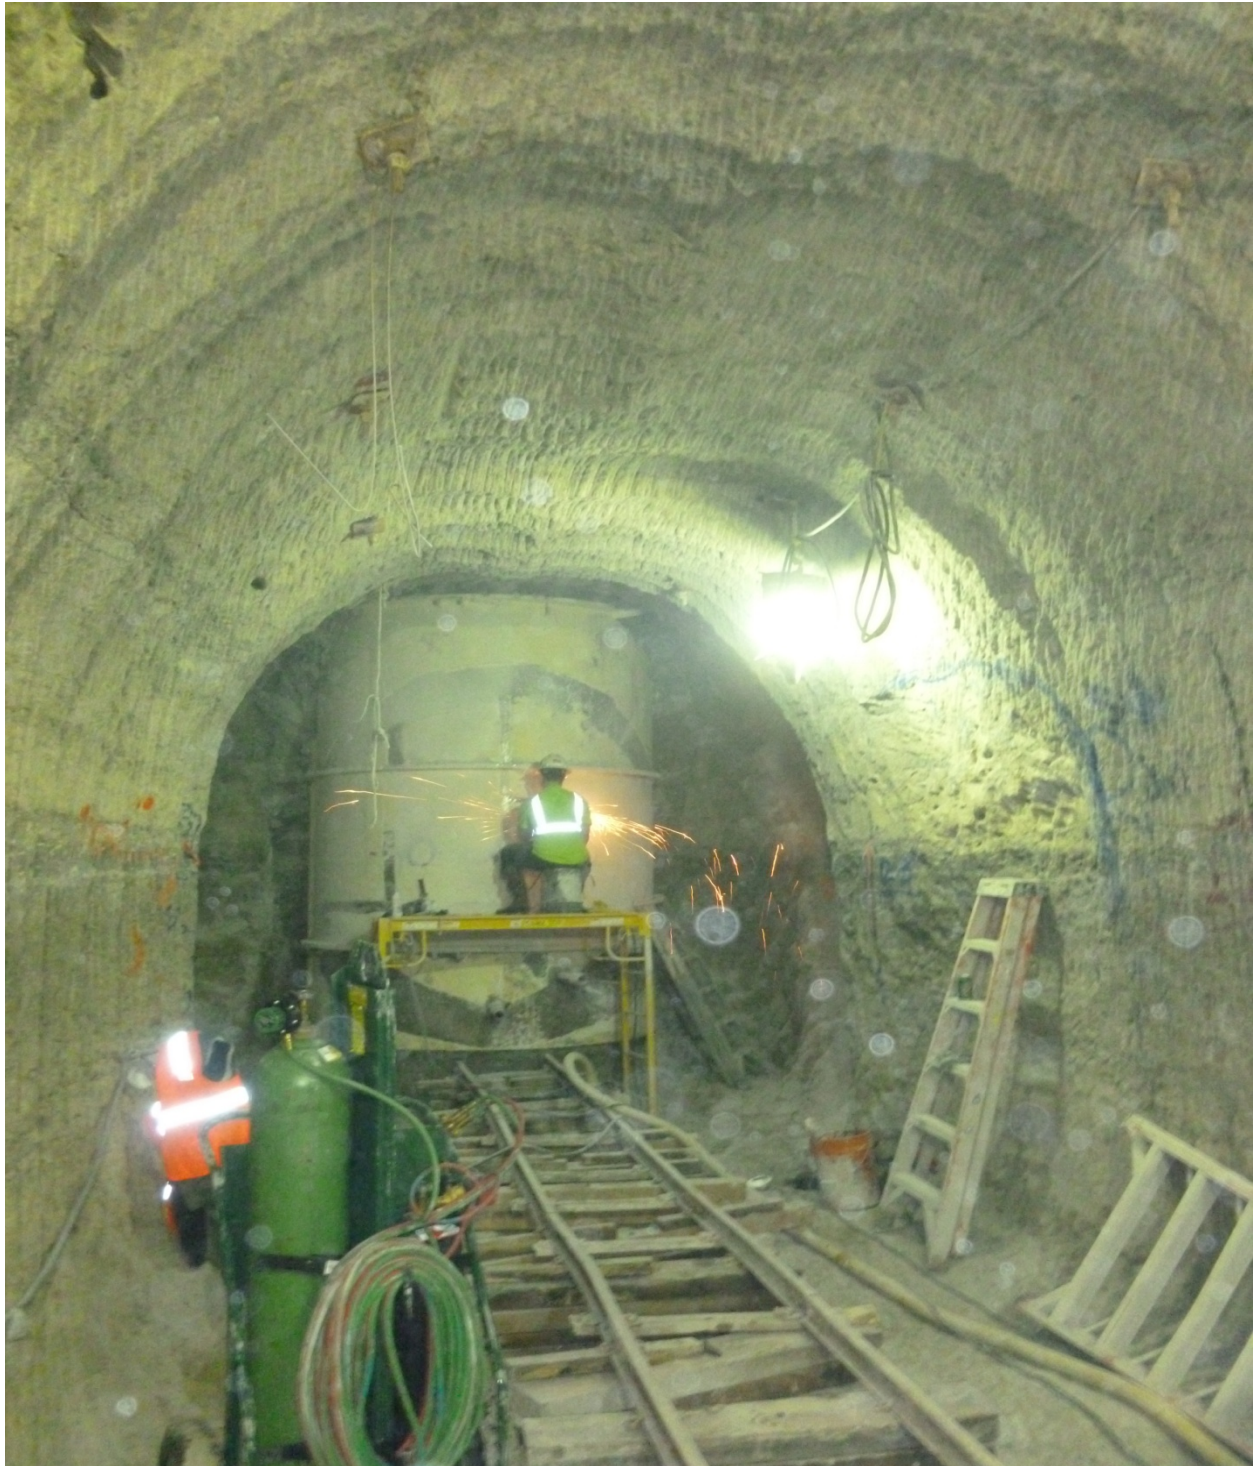
Figure 2. Field Cut-In Outlet Location around Elevation 450 feet.

As can be seen from Figure 2, the work location was quite compact. There would be no room for any layout or welding on a flat surface.

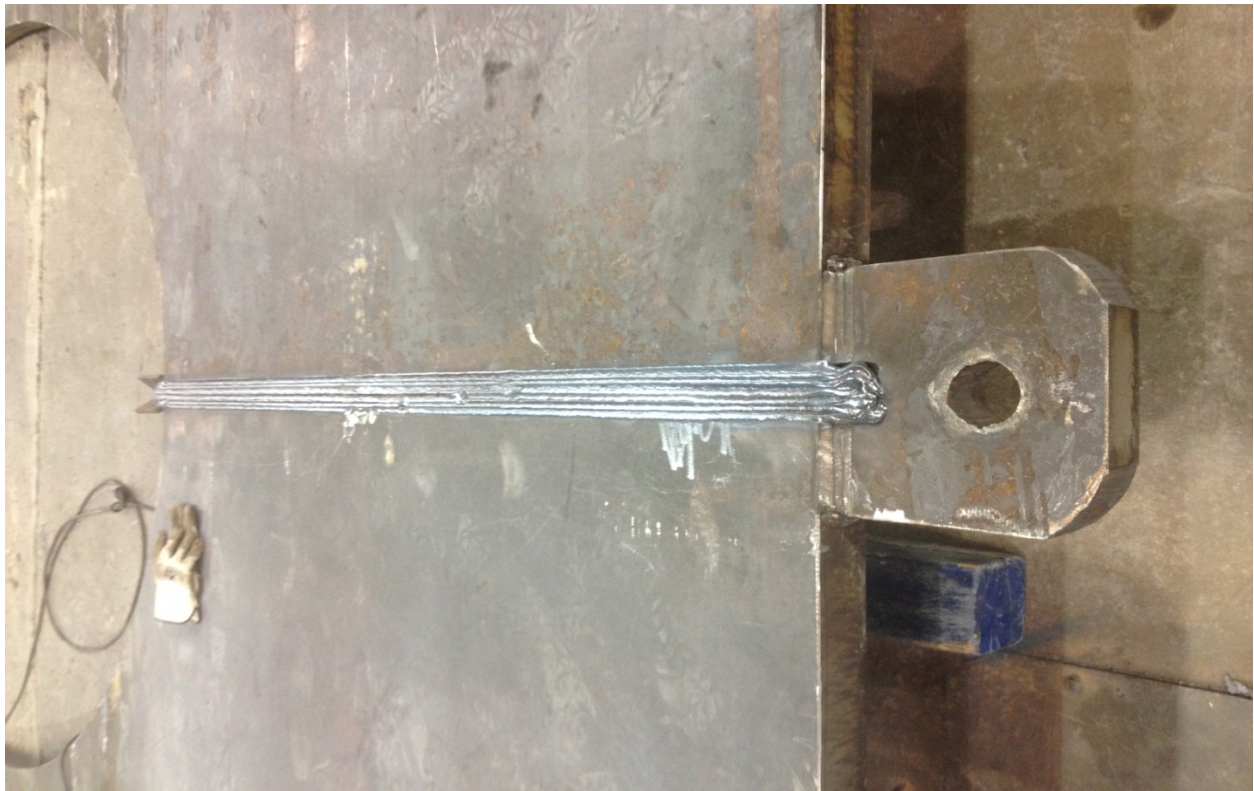
Figure 3. Typical Thick Crotch Plate Seam Weld – Not Chosen for This Project.

contractor confirmed that the Vertical Shaft would be used as the installation shaft for the cut-in tee and all crotch plates would have to pass through the Intake Tunnel and Shaft, which is around 120" in diameter. The dimensions of each proposed crotch plate were over 124" long and 154" wide, which when installed could have required additional excavation around the shaft, which the contractor wanted to avoid. Finally, the Non-Destructive Examination (NDE) of these welds would be difficult based upon the location. X-Ray methods could not be used due to safety concerns. The NDE methods chosen were visual inspection (V/T) and ultra-sonic testing (U/T). For all of these reasons, crotch plate reinforcement was not preferred.

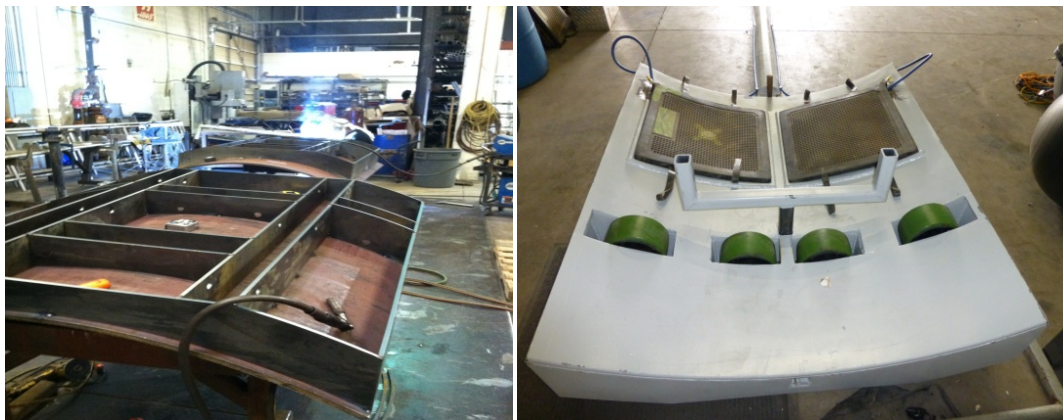
Figures 6a and 6b. Carrier Fabrication and Components.

Polyurethane coated wheels were used to allow for clocking the outlet segments. Kevlar reinforced rubber coated high-pressure lifting airbags allowed pipe engagement and location adjustments, (see Figures 6a and 6b). The polyurethane coated wheels and rubber coated bags would protect the pipe and outlet polyurethane coating during installation. The lifting bags would use the existing high pressure air connections inside the tunnel for lifting power.

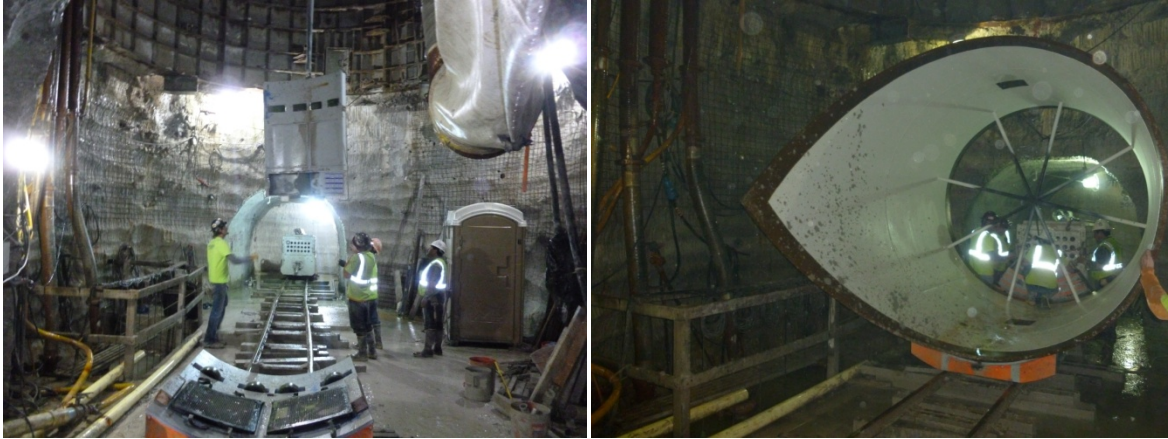
Figures 7a and 7b. Carrier Set-up and Outlet Placement.

The pipe carrier was lowered down the shaft and connected to the locomotive. Once initial carrier setup was complete, the first outlet section was lowered down the shaft and placed on the pipe carrier, (see Figures 7a and 7b).

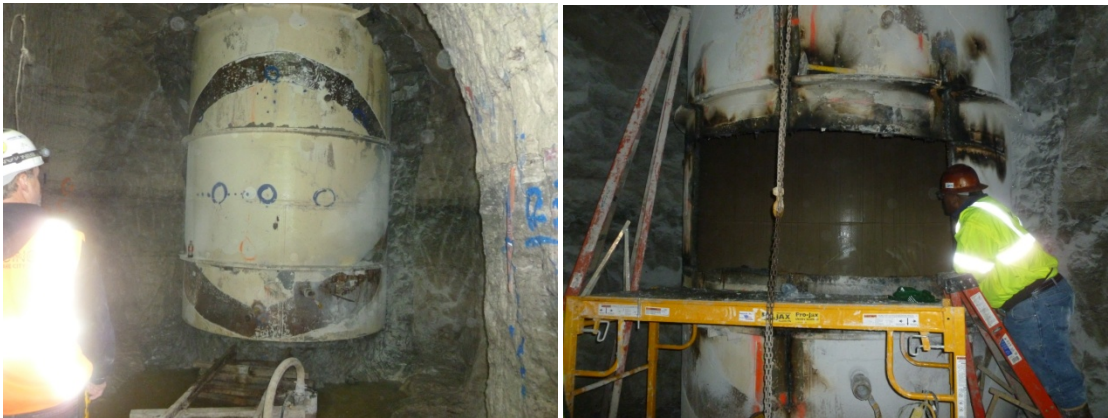
Figures 8a and 8b. Vertical Intake Shaft and Initial Cylinder Cutting.

At the cut-in outlet location the rail was cribbed up to the proper elevation. The extra room around the tie-in location was necessary for welder access, (see Figure 8a). The coating was removed from the vertical intake shaft in a 4' x 4' grid pattern to allow initial steel cutting. The pieces were kept to a small size to allow for easy handling, (see Figure 8b).

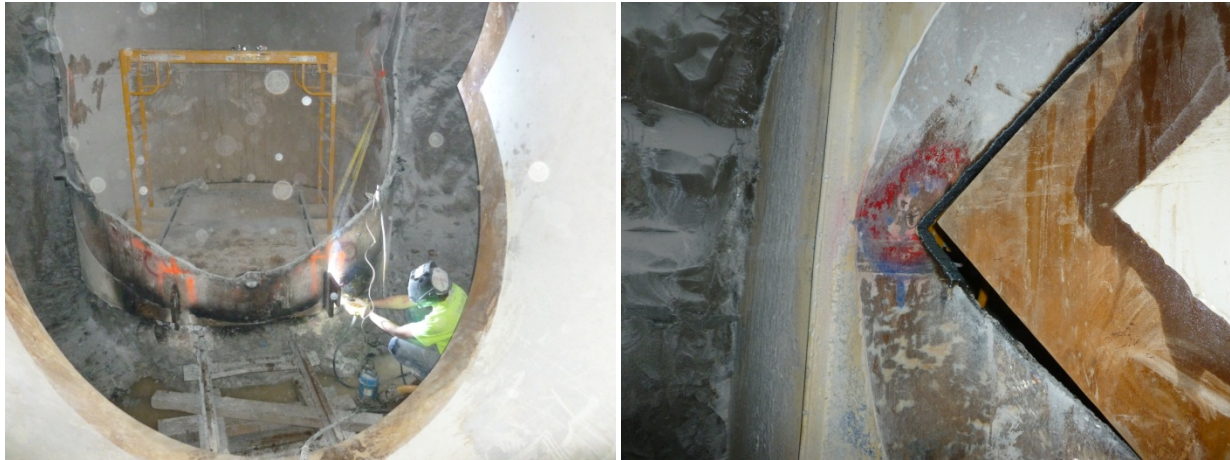
Figures 9a and 9b. Rough Cut-out and Trim Cuts.

With the rough cut-out completed, steel plate dogs were welded to the vertical intake riser. These allowed the outlet to be placed on the side of the intake riser and allowed sliding in and out as needed to trace, cut and refine the field miter preparations without constantly having to adjust the airbags. See Figures 9a and 9b.

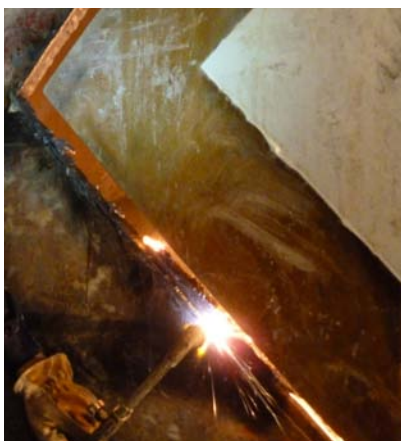
Figure 10. Joint Refinement.

The pipe was fitted to the intake riser numerous times to scribe, cut and refine the field joint configuration. See Figure 10. A 30-ton push-pull cylinder was attached to the intake riser and the outlet to facilitate this motion, which freed the locomotive for movement between the shaft and intake riser to transport personnel and equipment.
