Pipelines 2015

Recent Advances
in Underground
Pipeline
Engineering and
Construction

PROCEEDINGS OF THE PIPELINES 2015 CONFERENCE

August 23–26, 2015
Baltimore, Maryland

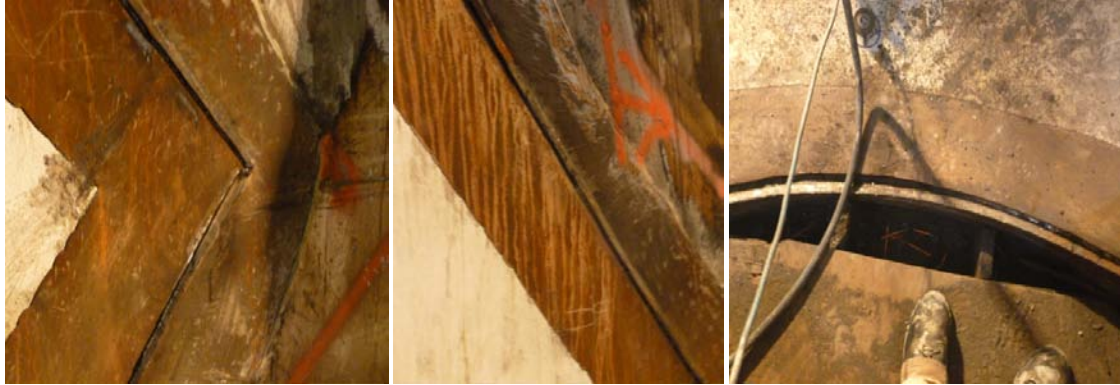
Figures 11a, 11b and 11c. Changing Joint Profile Around Circumference of Outlet.

When an acceptable fit up was achieved between the vertical shaft and outlet segment, the air arc gouging method was used to gouge/cut the acceptable joint profile into the weld location. The joint profile had to be adjusted constantly around the circumference of the outlet to provide proper weld joint geometry. See Figures 11a, b and c.

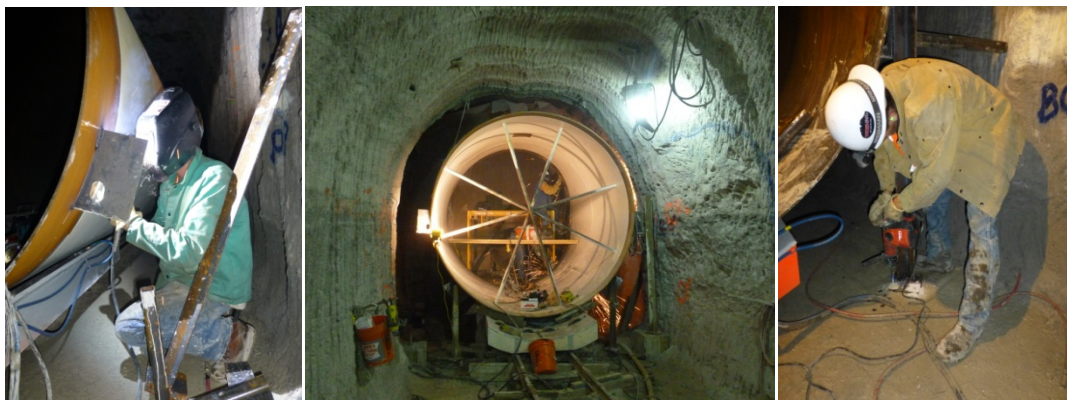
Figures 12a, 12b and 12c. Pipe Bracing.

The liner segments were braced using a combination of 3" x 3" x $\frac{3}{16}$ " angle iron and $\frac{1}{2}$ " plate "ears" that were field welded to the pipe at spring line. The angle iron members were manufactured at an excessive length to allow for variations in tunnel elevation and were attached to the floor via a steel plate and concrete anchors; see Figures 11a, b and c. The steel plates were laser cut with a pick point attachment that was used to attach a come-along for pipe clocking on the carrier. This bracing method sufficiently supported the pipe for installation purposes. Additional 2" x 2" x $\frac{1}{4}$ " square tubing was installed laterally at the spring line location as well as at the flow line and field top locations at Obayashi Corporation's request to resist buoyancy forces during annulus grouting. The square tubing needed to be cut to length at location prior to installation to allow for tunnel width and height variations. The liner location, elevation, and minimum tunnel wall clearance tolerance of 6" was verified and documented. See Figures 12a, 12b and 12c.

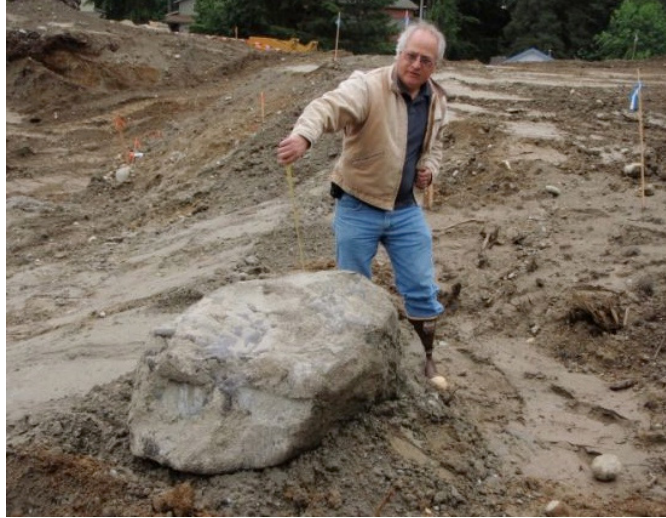
Figure 2. Excavated boulder at adjacent site

In addition to the exploratory borings and test pits, site reconnaissance and observations of excavation activities at an adjacent site near the west end of the I-5 crossing provided valuable information on the presence of cobbles and boulders in glacial till soils similar to those anticipated along both crossings. Eight boulders were encountered in a sanitary sewer trench which was reportedly 1,200 feet long by 4 feet wide by about 10 feet deep. The boulders ranged from 2 to 7 feet in their maximum dimension. Based on this data, it was estimated that one boulder per 222 cubic yards of excavation could be encountered in the glacial till soils. Figure 2 below shows just one of these boulders being measured by the site's excavation contractor.

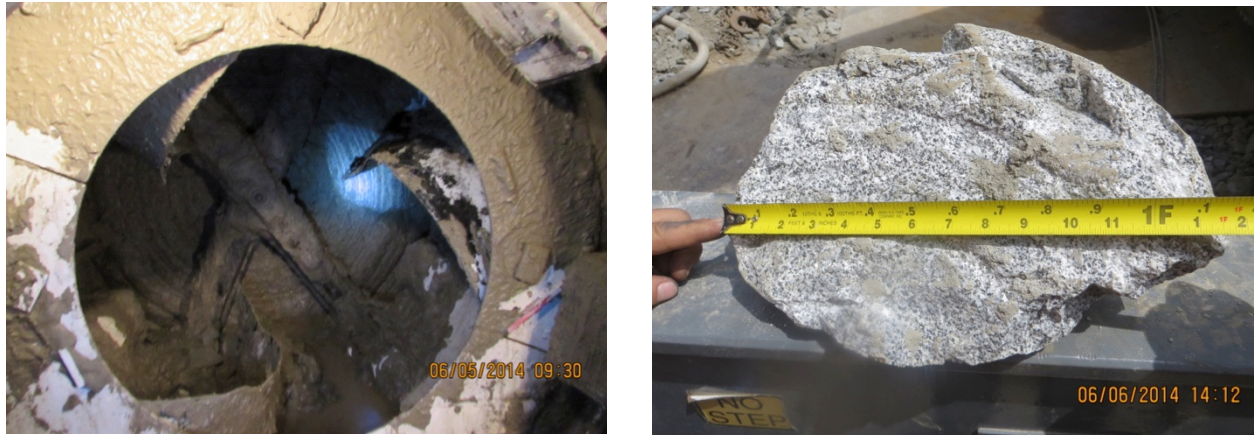
Figure 5. Boulder encountered during pipe jacking

As anticipated in the GBR, both trenchless crossings encountered occasional cobbles and boulders. Figures 5 and 6 below show examples of cobbles and boulders encountered during both crossings as seen from inside the tunneled excavation as well as being measured once they had been removed.

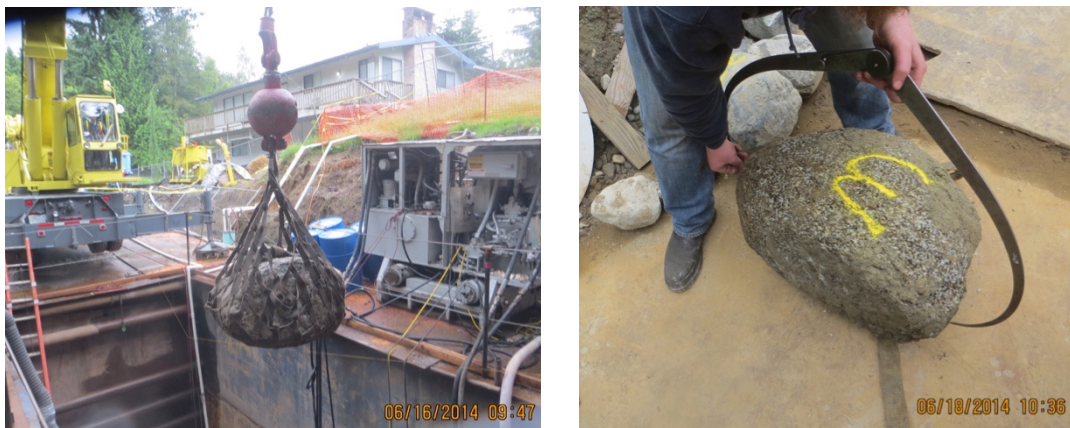
Figure 7. Obstruction (rock #3) being removed and measured

In total, there were four boulders encountered during the I-5 crossing which were determined to be obstructions eligible for additional payment because they exceeded the minimum dimension of 25 inches and stopped forward progress, per the requirements set forth in the GBR. Through the change order process, the contractor negotiated payment for removal of these obstructions. Figure 7 below shows one of these obstructions being removed from the tunneling shaft and being measured on the surface.

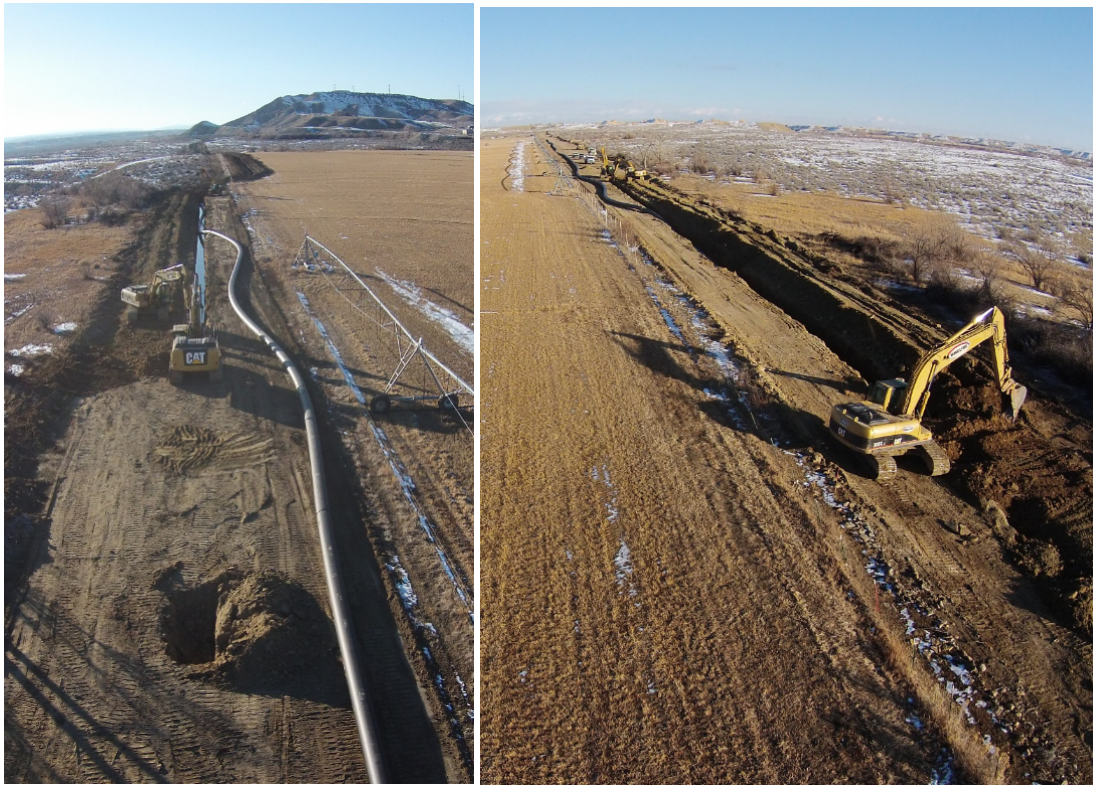
Figure 4. HDPE Pipe Installation

There are many construction/installation advantages to HDPE pipe, such as narrower trench widths. HDPE pipe is fusion joined above ground and then placed into the trench. This eliminates the need to over excavate for trench boxes in order to put people down in the trench safely. This reduced excavation greatly saves time and money, allowing HDPE pipe to be installed quickly and efficiently (Figure 4.).

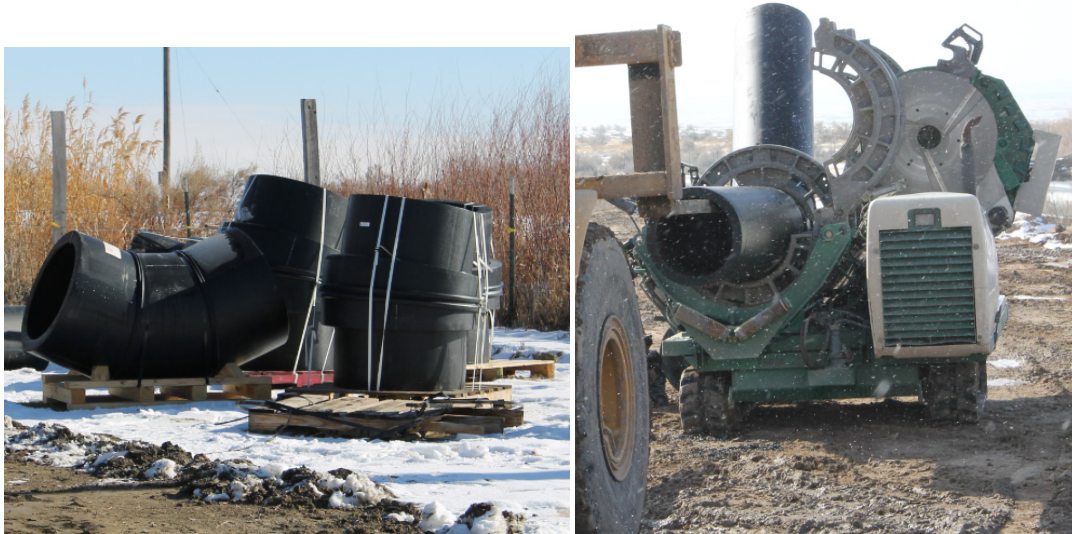
Figure 5. Fabricated Fittings

HDPE pipe has the tightest bend radius of any pipe material, 100 times tighter than other fusible plastic pipe products. Where direction changes need to be performed in a small area, fabricated HDPE fittings are available. These can be pre-ordered or fabricated on site (Figure 5.). Fabricated fittings are fully heat fused and do not require thrust blocks at directional changes like other unrestrained joint piping materials. This saves time and cost during installation.

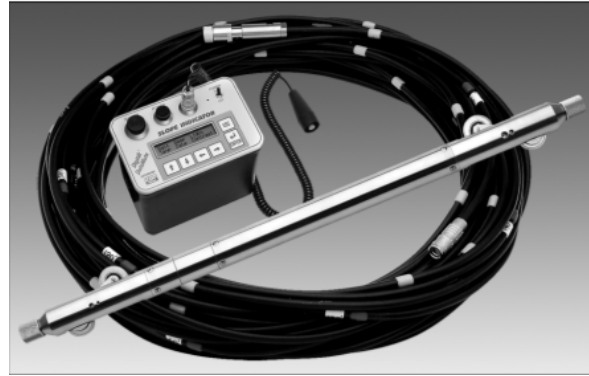
Figure 3. Horizontal Inclinometer Data Collection System (DGSI, 2013)

A Total Station TC407 survey instrument was used to measure the existing pavement surface to record settlement and/or heave at specific shoulder points. Also, a Horizontal Inclinator (HI) system by Durham Geo Enterprises, Inc. was used to monitor settlement and/or heave around existing and new culverts (Figure 3).

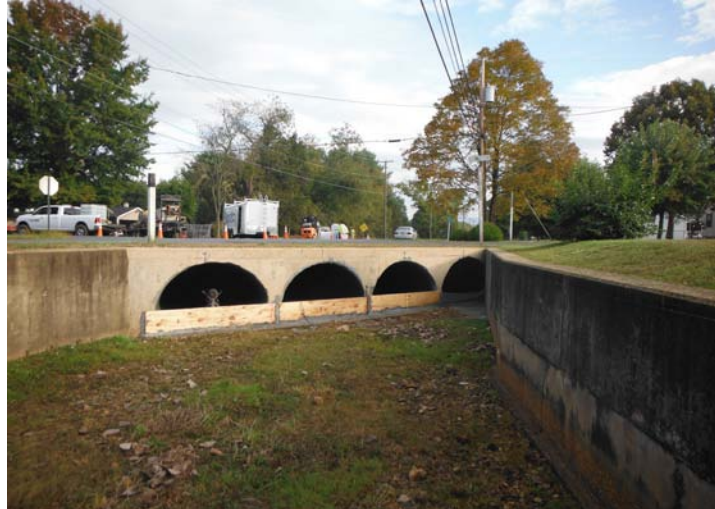
Figure 1: Four parallel culverts under Dogwood Avenue

The Virginia Department of Transportation (VDOT) gives the town funds for the maintenance of streets and stormwater networks, and as part of that arrangement, VDOT requires the town to conduct annual inspections. In the last report, a large set of elliptical CMP culverts didn't pass inspection. The consultant, Schwartz & Associates, told the town their culverts were in poor condition. The consultant informed Grottoes Town Manager, Jeff Nicely that "there was severe corrosion, and that individual sections were failing and misaligned." They recommended replacement.

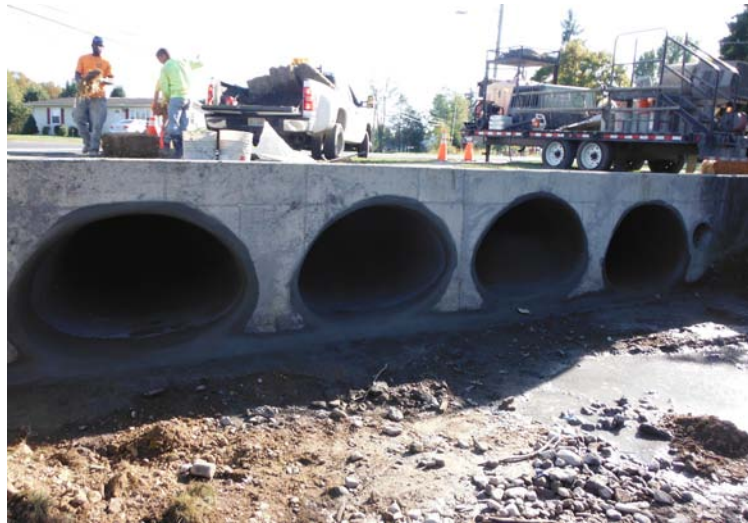
Figure 4: Four large parallel culverts

As noted previously, the Grottoes project consisted of four large parallel culverts 112 feet long, for a total of 448 lineal feet, running directly under a main thoroughfare where traffic disruption would be a burden on the community. The culverts were found to be in poor condition with severe corrosion. Individual sections were failing and misaligned, however the CMP was not falling apart, so spot repairs and a new invert were not required prior to casting the new pipe. And fortunately the work was completed during a dry period so dewatering was not an issue.

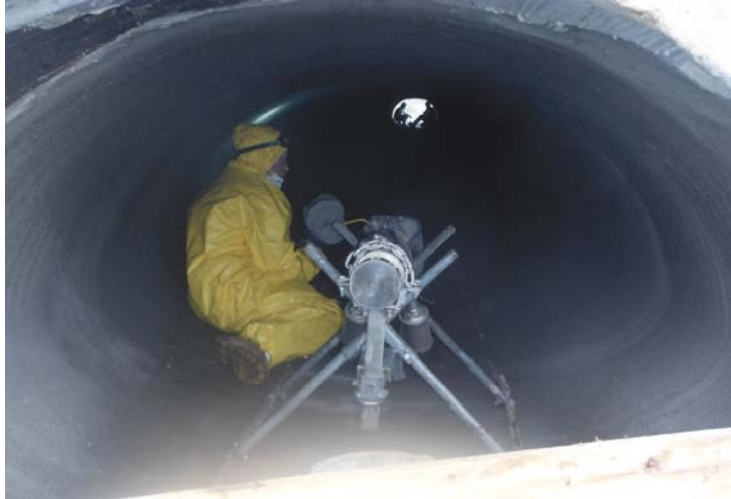
Figure 7: Spincaster and sled

The work was completed in two phases by Mike Shepherd's crew at D&S Contractors, and Arold Construction, both licensees of AP/M Permaform. The crews cleaned the culverts using the CentriPipe spincaster as a high-pressure washer to clear out debris that could affect adhesion.

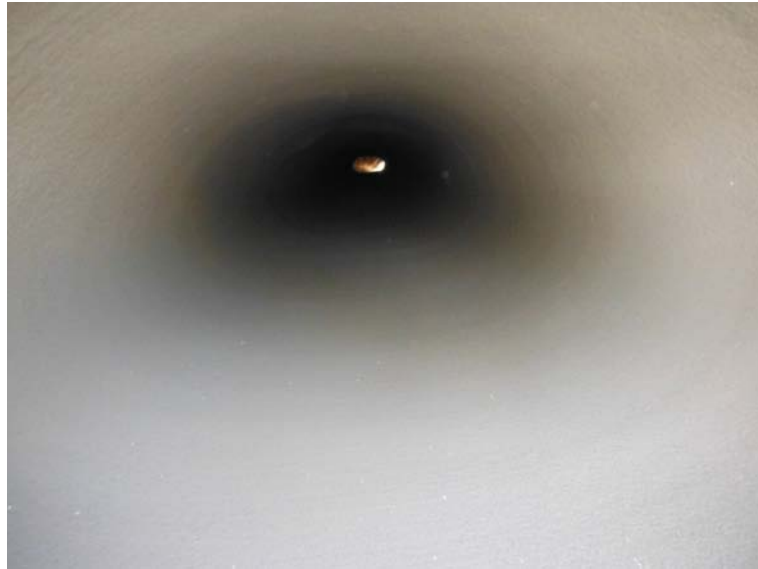
In the case of Grottoes, VA, the town was able to renew existing culverts using the CentriPipe process to make them smooth, seamless, watertight, and structurally stronger than the old CMP, with longer projected service life. Nicely is quite happy with the results, and best of all, traffic never had to stop.

Figure 8: Smooth, seamless, watertight, and structurally sound rehabilitated culvert

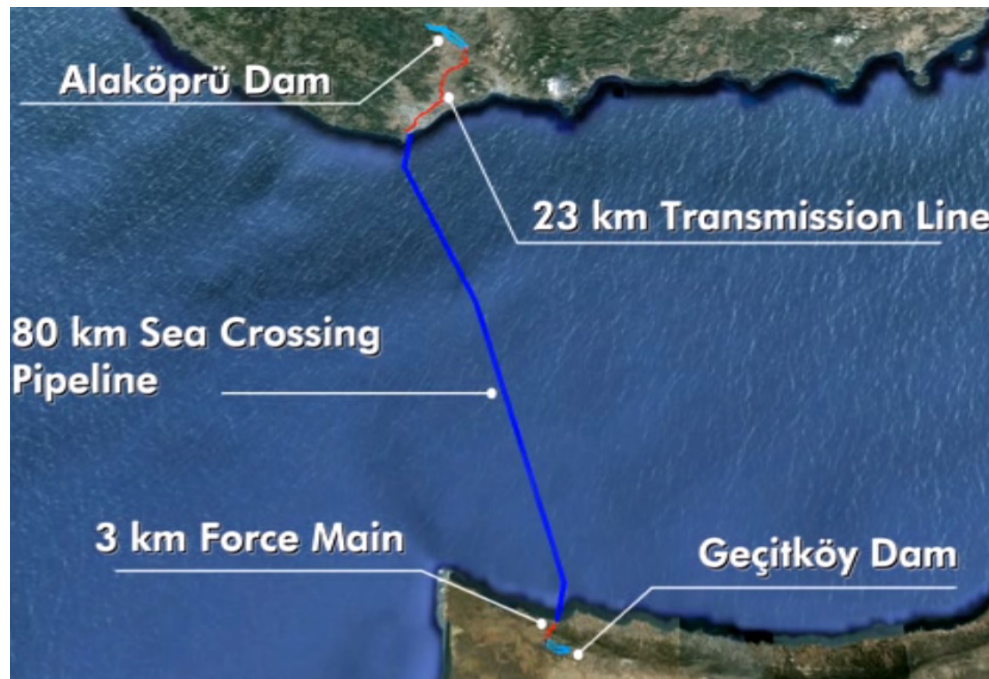
Figure 1: Overview of Construction Stages

The project includes the construction of a dam and a pumping station on both sides of the project, as well as a pipeline of 107 kilometres (66 miles) that mainly runs across the sea. The construction will have five stages:

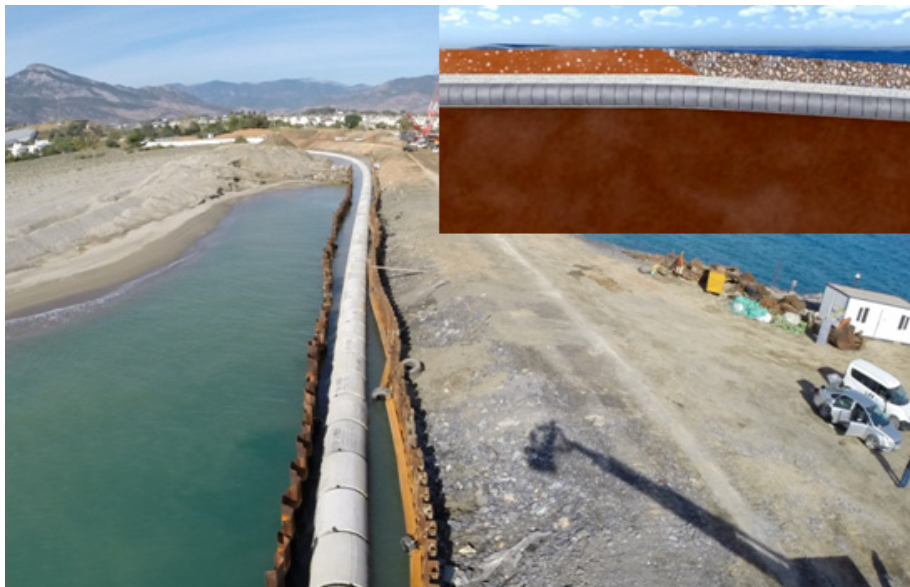
Figure 5: PE 100 Pipe In-Shore Transition

From the valve chambers on the Turkey side runs a 1,600 mm diameter (63 in), SDR 21, PE 100 pipe in a water depth of 20 m (66 ft) below sea level. It is surrounded by round concrete blocks and covered with gravel to resist the effect of buoyancy.

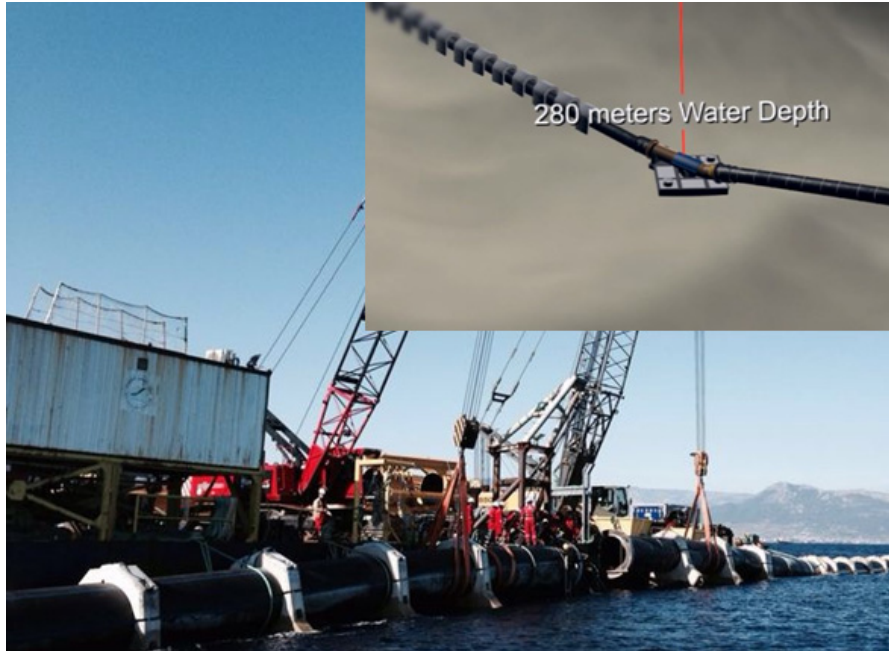
Figure 6: PE 100 Pipe with Concrete Blocks

The next step is to transition from the shallower edge of the sea to reach the deeper, first anchor point from which the PE 100 pipe begins to float in the water. The PE 100 pipe in this and the following section has an SDR of 21. In this section it is fixed to the seabed with concrete blocks.

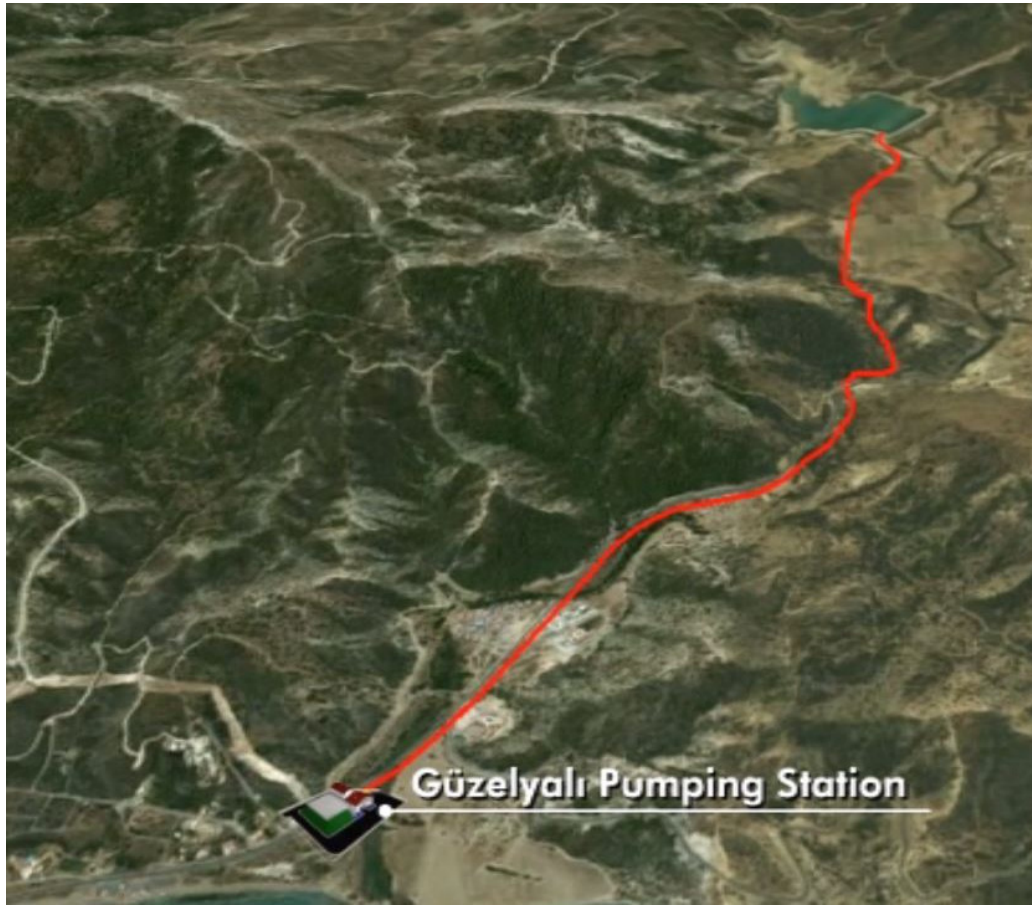
Figure 8: Güzelyalı Pumping Station

From the Cyprus coast, the water is transported by a 1,400 mm (55 in) force main pipeline made of ductile iron to the Güzelyali Pumping Station where it is pumped into the reservoir of the Geçitköy Dam, 3,157 meters (\approx 2 miles) away.

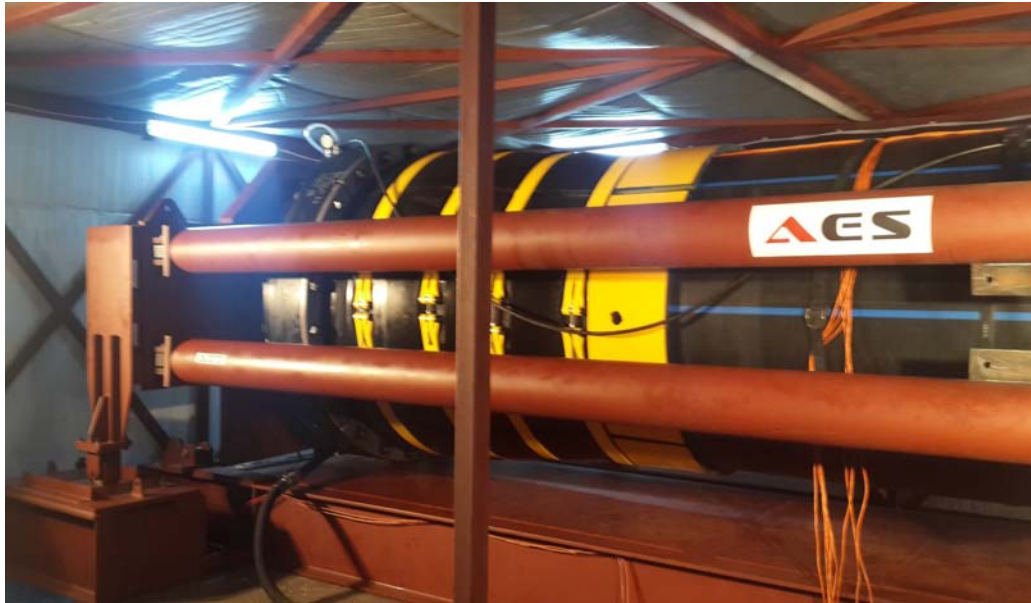
Figure 10: Test for the Whole Flange Connection

On site, the custom made stub ends are welded to the PE pipes and bolted to the steel tube yokes by means of a special flange provided for this purpose. This yoke is then anchored to the seabed by means of steel cables to the securing and anchoring point. The challenge for Reinert-Ritz was to provide a product to join the PE pipes and steel yokes durably and securely so that even the most adverse conditions encountered underwater in the Mediterranean Sea could not impair the connection. At a depth of about 250 m (820 ft), the design has to deal with the following technical challenges: buoyancy forces exerted by the PE 100 pipe, stress due to buoyancy caused by conveying drinking water in a salt-water environment, powerful and dynamic sea currents, high marine and submarine traffic frequency, potential earthquakes and the operating pressure of 7 bar (101 psi). The encapsulated flange connection is additionally supported by a

polyurethane stiffening system. The expected forces were simulated in an approved testing facility.

The extreme dynamic loads to which the flanged connection is exposed in underwater operation were considered during the development.

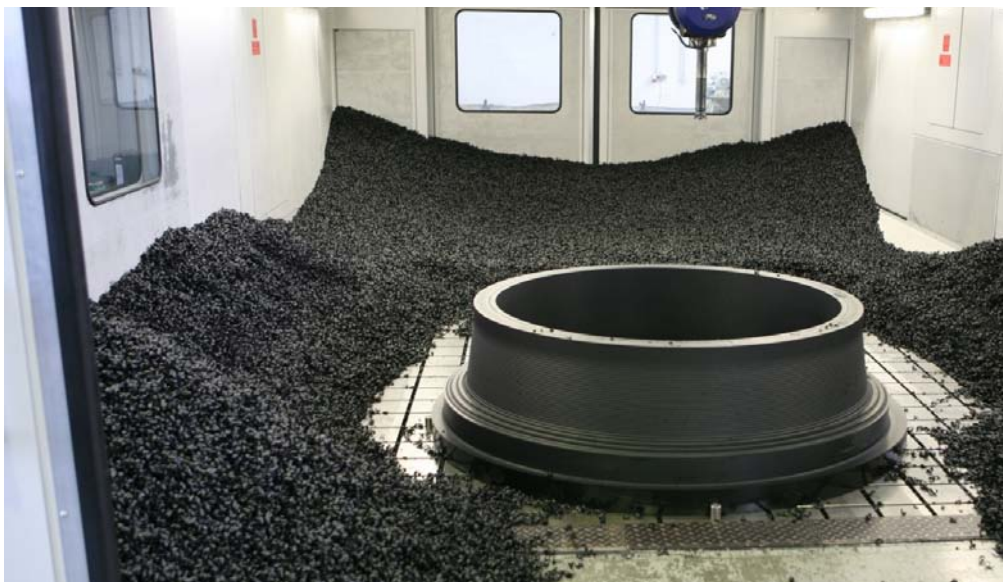
Figure 11: Milling process at Reinert-Ritz

The extrusion of hollow bars of 1,900 mm (75 in) / 1,400 mm (55 in) diameter with a wall thickness of approx. 250 mm (10 in) is the first stage in the fabrication of the special flanged connection. The subsequent machining takes place on a milling machine capable of processing material up to sizes of 2,800 x 1,500 x 4,800 mm.

A particular challenge was presented by the large dimensions of the PE pipeline and the extremely high dimensional accuracy required, with tolerances of -0.0 mm and $+0.5$ mm (-0.0 in and $+0.002$ in). On site in Turkey, the finished PE 100 stub end is secured geometrically in two steel clamping assemblies into which it must fit perfectly.

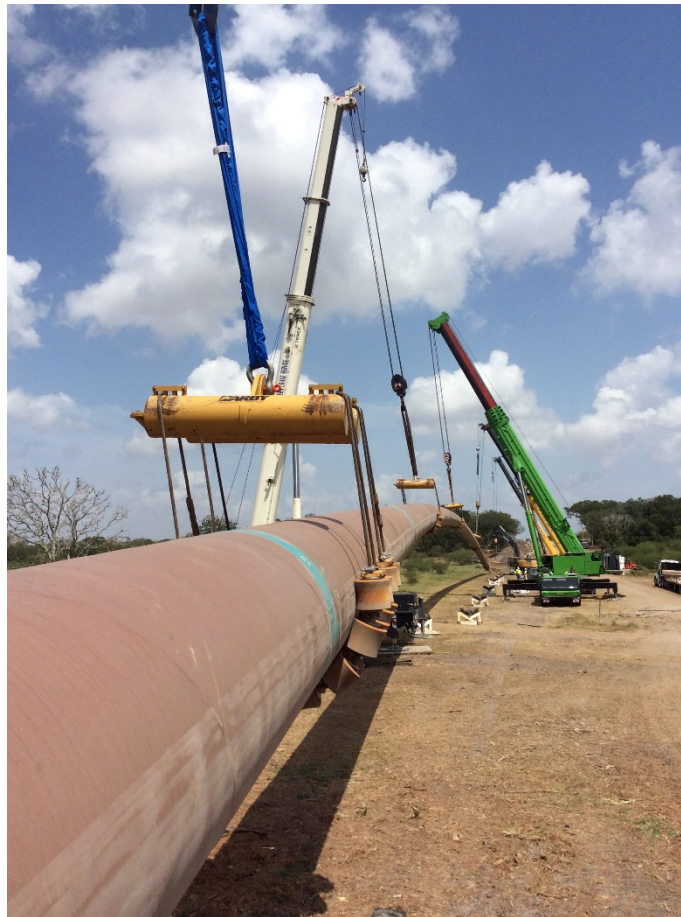
Figure 5: HDD Installation

The installation of the HDD pipe under both the Tres Palacios River and the Navidad River was accomplished with minimal incidents. The steel pipe was strung out along the pipeline easement and field welded prior to pullback. The easement acquisition team secured 2000 linear feet of lay down area for both HDD locations so all pipe

could be welded in place and pulled continuously. The welding of the pipe took approximately 12 days for each crossing. The joints were coated externally and internally with fusion bonded epoxy, with an additional 30 mil abrasion resistant overlay at the external joints. The coating system was a 3M scotchkote system, #6233 with a #6352 abrasion resistant overlay. The lining system was a 3M scotchkote system, #124. The pilot hole was completed in 14 hours for each crossing. For the pullback, the pipe was held up by cranes and utilized foam rollers to keep from scratching the coating as shown in Figure 5. A primary Magnetic Guidance System (MGS) with a secondary Para-Track System was used for the tracking system.

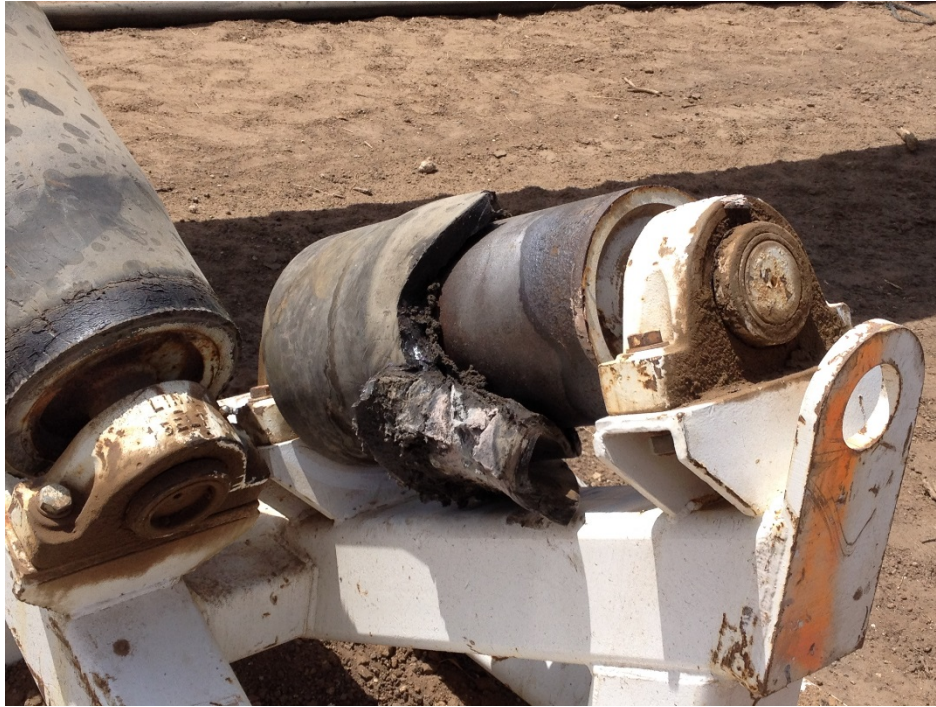
The Contractor and quality control inspectors examined the exterior of all pipe prior to pulling it through the reamed hole. In areas where coating had been scratched, abrasion resistant overlay was on hand to touch up where needed. This pulling through of the pipe was stalled to allow this overlay to dry. The pipe installed at the Navidad River required a large repair due to the foam on the roller support breaking

as shown in Figure 6. This was repaired on site with a large quantity of abrasion resistant overlay before completing the HDD.

Figure 6: Broken Roller Support

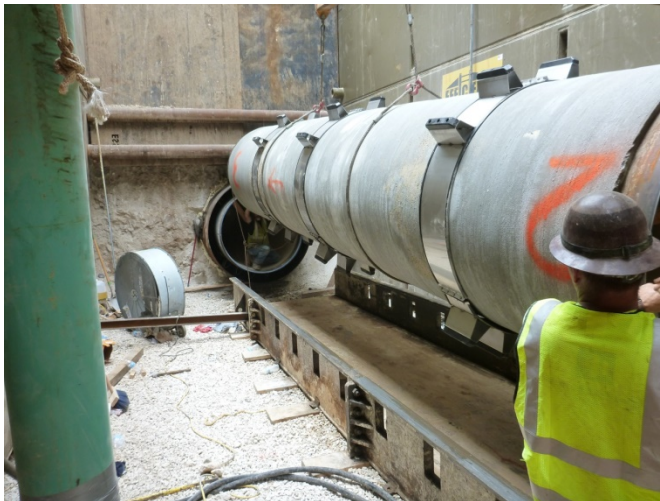
The pipe blocking was specified to be a 6” pipe insulator commonly referred to as casing spacer/ isolators, Figure 2. However this type of spacer created concerns for use in this application including 1) fixed dimensions that cannot easily be changed to accommodate expected variations in tunnel elevation at different stations. 2) The spacers are attached to the pipe as permanent bands which requires a much smaller spacer diameter than the casing inside diameter in order have enough clearance for installation into a tunnel 3) these spacer would not block the pipe from flotation or movement during annular grouting 4) The method for installing this style of blocking is to jack/slide the banded pipe on the tunnel floor while adding each pipe length at the tunnel portal. This becomes an issue due to the tunnel length and the cathodic protection system which includes a full circumference expanded titanium mesh located every 40 feet (at each pipe joint) throughout the tunnel.

Figure 2 Casing Spacer/isolators

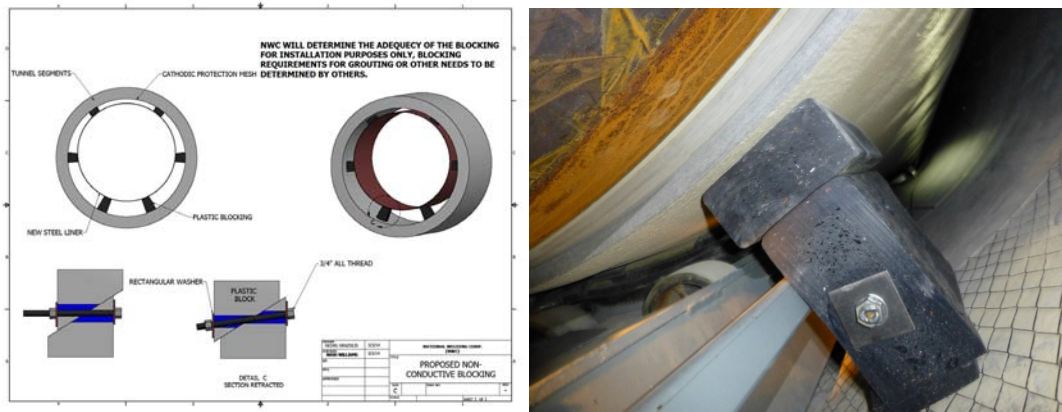
The Team proposed a second alternate blocking method using independent adjustable HDPE (high density polyethylene) blocks set at the end of each pipe joint. This method was designed with a 4 times safety factor for dead load based on the 46,000 pound pipe sections, however it did not provide for axial movement. The cathodic protection mesh was located at every pipe joint including under each joint therefore it would have been damaged by axial movement anyway. This nonorganic, HDPE alternate achieved the isolation, non-welded attachment and adjustability required by the designer which was ultimately accepted and subsequently utilized on the project Figure 4a and b. Intermediate masonry bulk heads were also installed and provided some pipe support but were primarily intended to create separate cells for the grouting operation.

Figure 4a and b HDPE Adjustable Pipe Blocking System

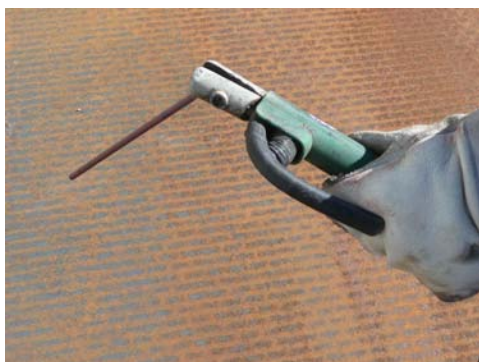
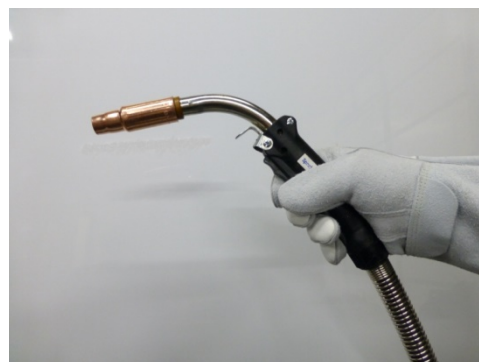
The specified method of welding for this project was SMAW (Shielded Metal Arc Welding) commonly referred to as manual stick welding, Figure 5a. Each pipe seam included over 25 pounds of weld metal which was anticipated to cause substantial delays to the tunnel liner completion. Therefore FCAW-G (Flux Cored Arc Welding with Gas) commonly referred to as semi-automatic welding which is much faster, cleaner and has many superior properties to the originally specified process was submitted, Figure 5b. This proposed change to the Specifications was found to be an unacceptable deviation from the Specification. The SMAW welding was utilized and on the first 2000 feet the welding progress rate lagged several weeks behind the installation. The welding time for SMAW was measured throughout this project and found to be 2.5 to 3 times longer than FCAW welding.

Figure 5a and b SMAW (Stick Welding) and FCAW (Flux Cored Arc Welding)

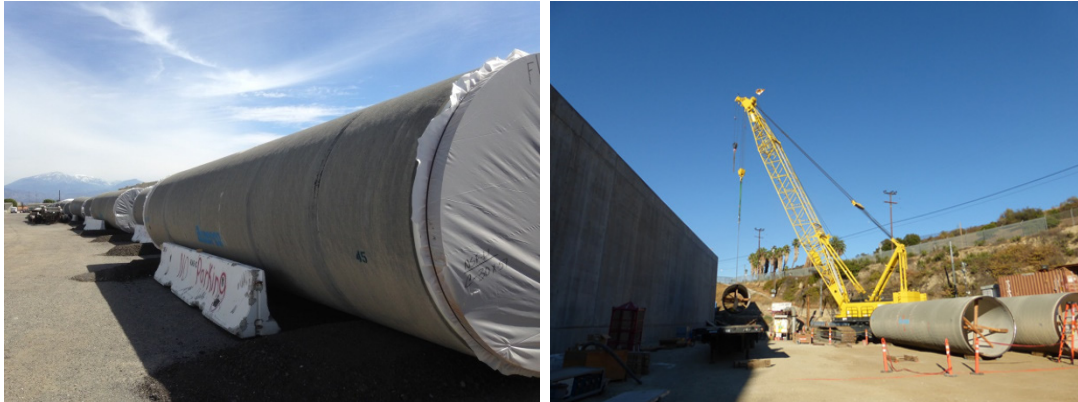
The pipe had been fabricated ahead of time and subsequently stored in the California desert prior to shipment to site, Figure 6a. Due to the limited on site storage only a few day's supply of pipe was delivered to the site as the project proceeded, Figure 6b.

Figure 6a and b Pipe Manufacturers Offsite Storage and Site Storage

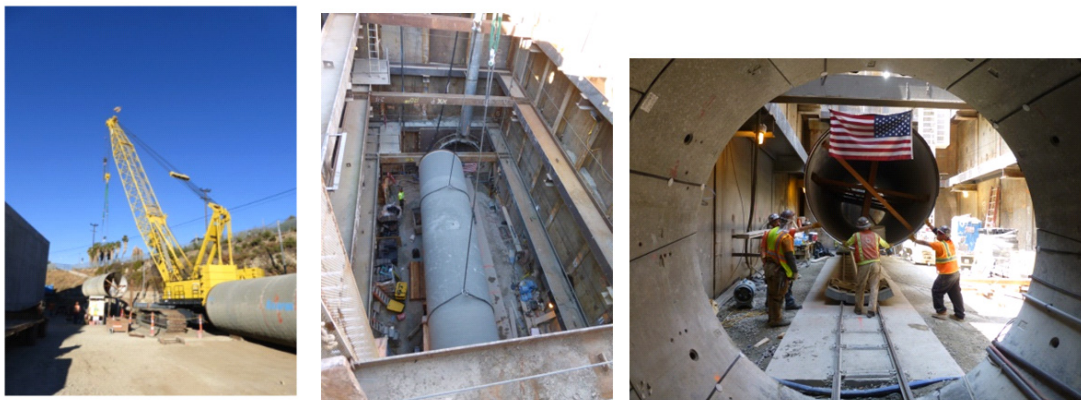
The project was performed during a hot season (August and September) and mandated expedited/around the clock installation due to delays of the preceding work. The pipe was lowered by crane to the installation carrier at the tunnel shaft then transported to the installation location beginning at the far end of the tunnel, Figures 7a, b and c plus Figures 8a, b and c.

Figure 7a, b and c Pipe Installation

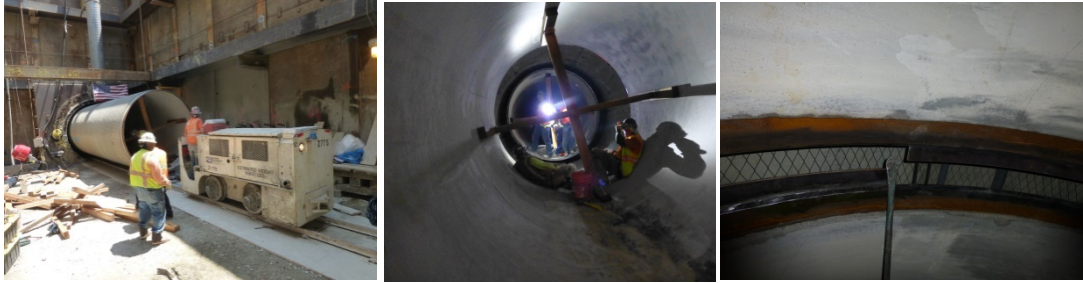
Figure 8a, b and c Pipe Installation and Placement

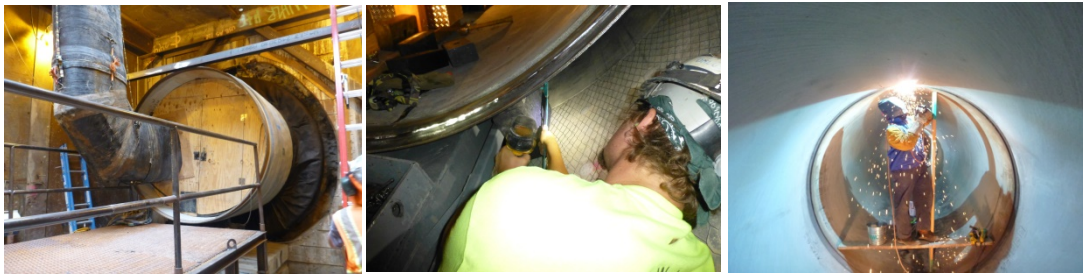
The first pipe was carried down the tunnel to the starting station and positioned against an I-beam in order to restrain movement of the pipe during placement of subsequent pipe, Figure 9a. Additional pipe installation began with stabbing the incoming pipe onto the previously installed pipe utilizing a butt weld with steel backing then adjusting the pipe to the proper line and grade. During this process the butt joint was tack welded or root welded to provide a temporary connection. After adjusting to the final location and performing the initial pipe joint fit-up the pipe was blocked to prevent further movement and secured for final fitting and welding operations, Figure 9 b and c.

Figure 9a, b and c Pipe Placed Against I-Beam, Blocking and Welding

As indicated by the calculations, and while addressing a plan of action, the same 50 joints continued to contract for an additional 8 days and on 8-19-14 virtually all 2000 feet of the installed pipe had contracted to the point of toppling the support blocking thereby dropping the tunnel liner several inches within the tunnel, Figure 13a and b. The pipe had also contracted away from the I-beam (Figure 9a) placed against the first pipe installed by 3.78 inches.

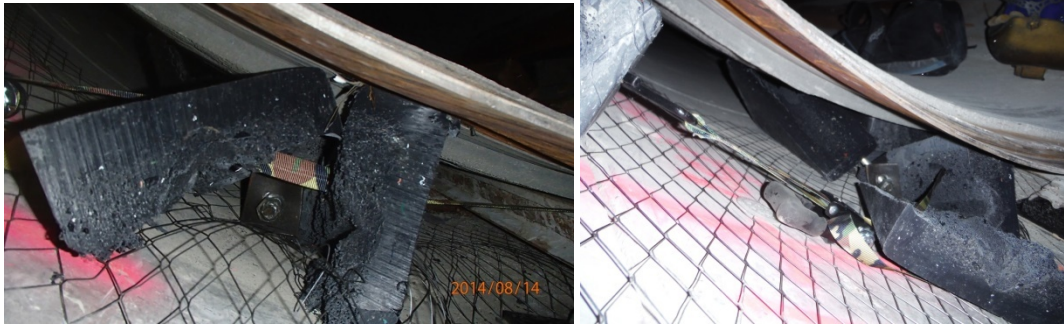
Figure 13a and b Toppled Support Blocking

The axial load was enough to deform a 3” x 3” x .25” square washer and pull the support block steel bolts completely through the block, Figure 13a. Ironically, other than changing the carrier pipe elevation within the tunnel, the only detectable damage to the steel pipe was a deformation found in last pipe installed, Figure 14a and b.

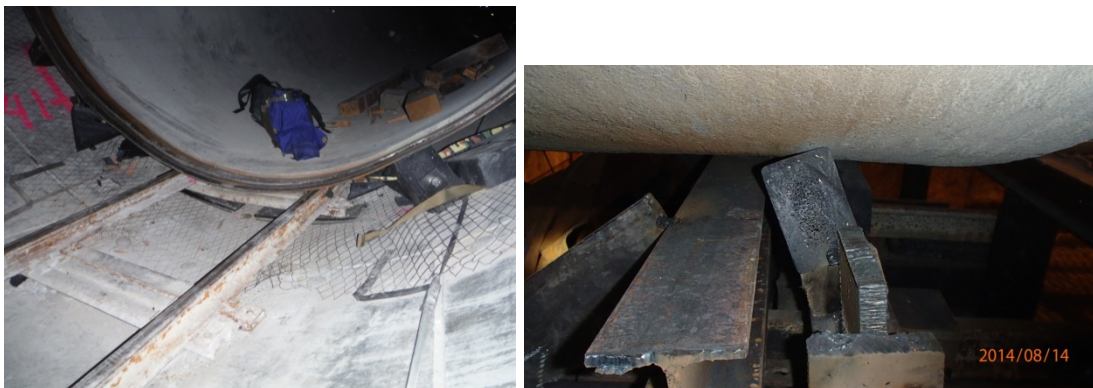
Figure 14a and b Pipe Elevation Change and Pipe Deformation

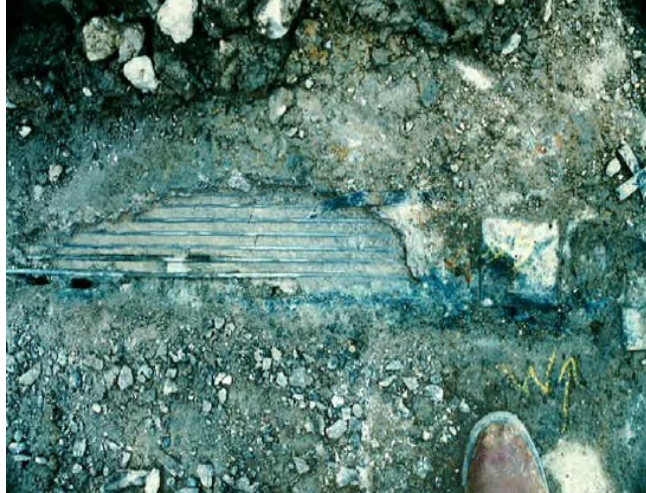
Past experience in Washington, DC, when Metro tunnels were constructed by Washington Metro Area Transport Authority (WMATA) in the 1980s, indicates some damage to joints in the 108-inch Anacostia Force Main (AFM), as shown in Figure 4. Therefore, the potential for similar damage because of shearing of the mortar coating from the impacts of ART and BPT was studied in detail. A parametric study demonstrated that the most critical shearing plane in the lip of either the spigot or the bell would initiate from the mortar coating–concrete core interface at the edge of the spigot or bell and would slope at an angle of 45 degrees until it emerges at the outermost fiber in mortar coating, as shown in Figure 5. An examination of the engineering principles showed that the shear plane is always likely to have a tendency to resemble the shape of one-half of an ellipse, with its major and minor diameters governed by the thickness of the mortar coating and the diameter of the pipe. This is because the existing wire, over the outer concrete core, acts like stirrups in shear and does not afford an opportunity for the shear plane to go any deeper in the lip of either the spigot or the bell, past its presence. The component of the total shear force in the direction of the above shear plane, resulting from the total compressive strain from all

Figure 4. Joint lip shear failure in 108-inch AFM during WMATA tunneling

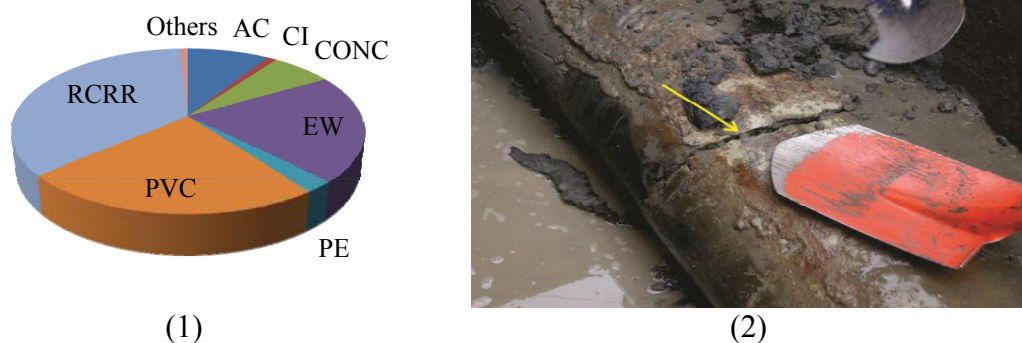
Figure 1. (1) The proportion of the Christchurch sewerage system classified by pipe materials; (2) physical damage to AC sewer pipes caused by the earthquakes.

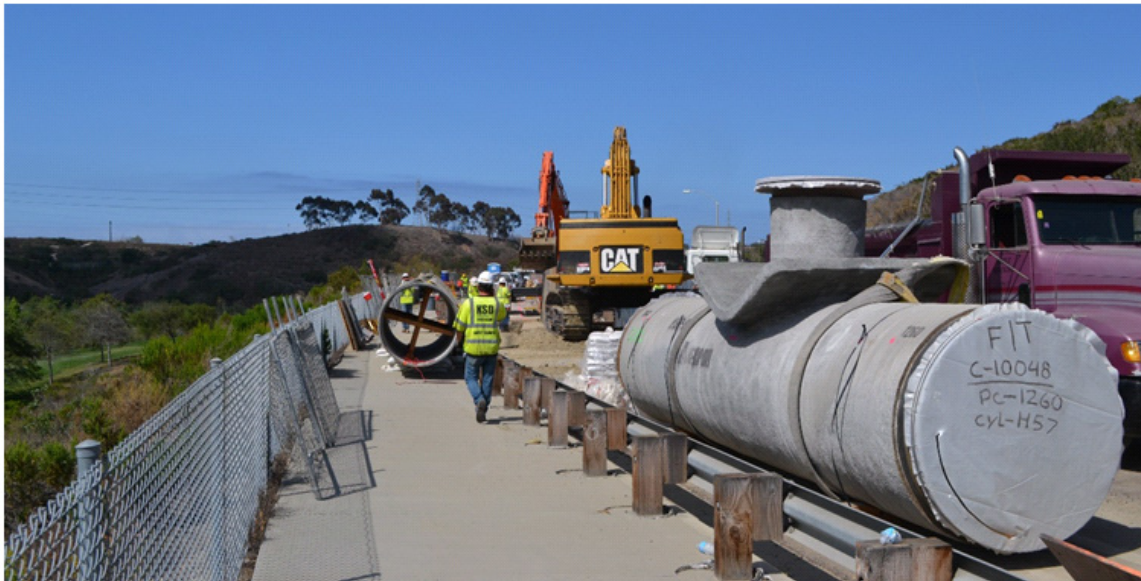
Figure 1 shows the pipeline's construction activity near the pumping station of the desalination plant.

Figure 1. Construction Activity near the Startup of the Pipeline. A 54-inch diameter pipe section with 30-inch diameter outlet and single-plate crotch plate reinforcement is ready for installation.

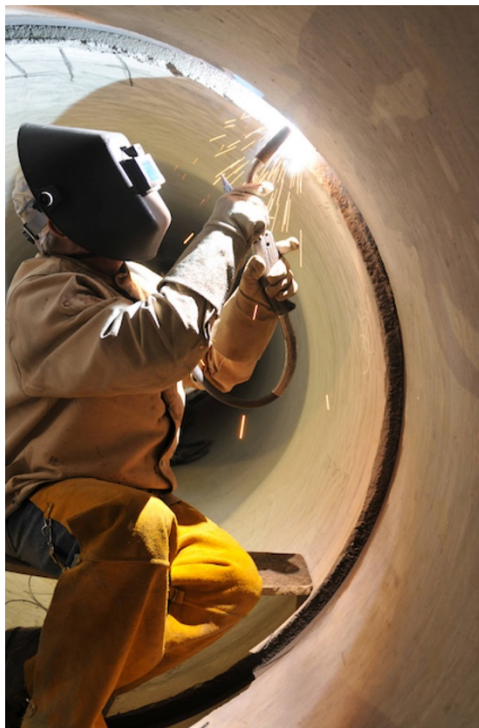
Figure 2. Field welding of interior double lap-welded joint.

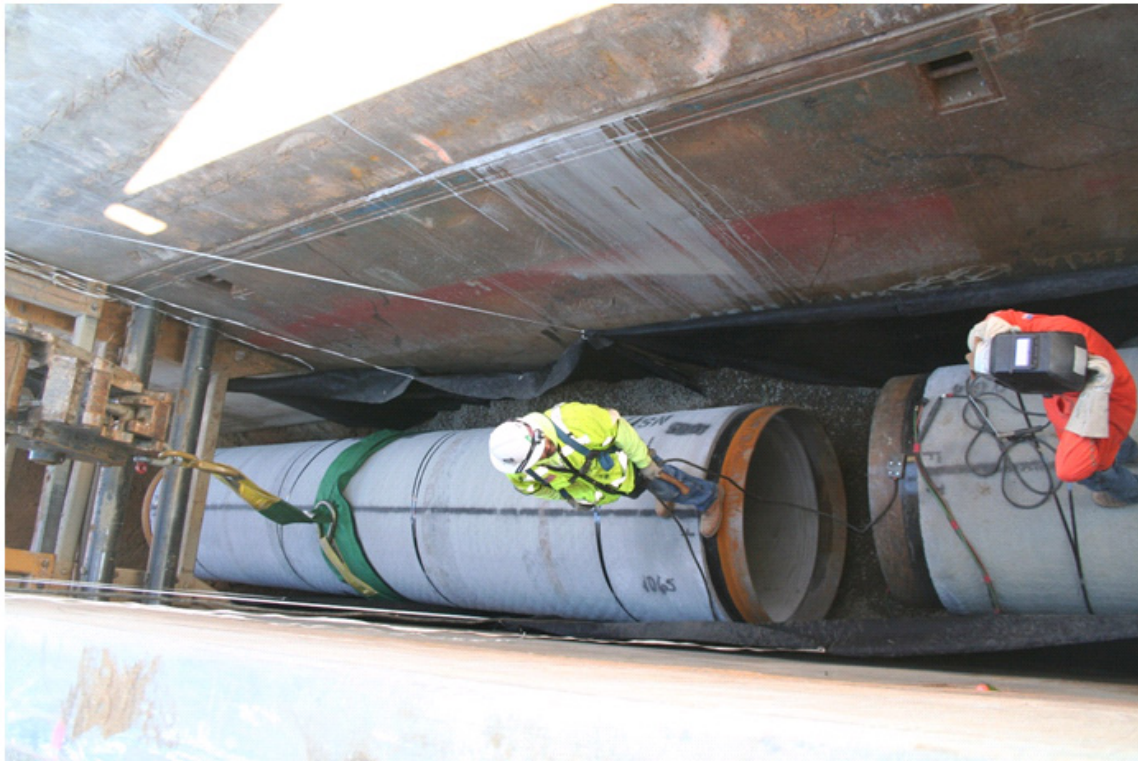
Figure 4 shows a 54-inch diameter pipe section being lowered in a trench box with its bell end being prepared for insertion over the spigot end of an already installed pipe section.

Figure 4. Lap Joint Assembly. The pipe section on the left hand side is being positioned opposite the already installed pipe section for lap joint assembly and welding.

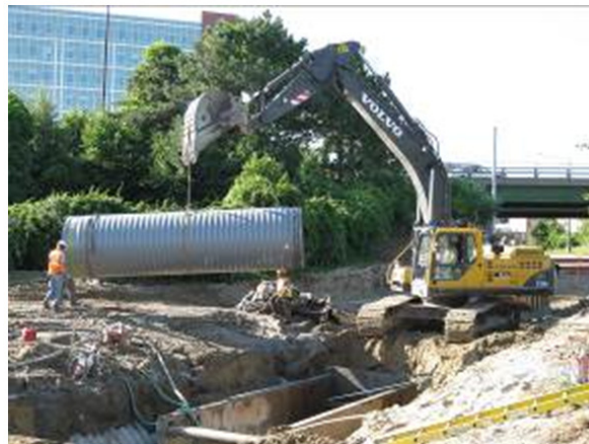
The contractor, R.J. Grondin & Sons, had the choice of selected epoxy coated reinforced concrete pipe, centrifugally cast glass fiber reinforced polymer pipe or polypropylene pipe. From the contractor's perspective, the selection of polypropylene pipe had as much to do with ease and speed of installation, as overall watertight and structural performance. His installation costs were minimized by the ability to use smaller equipment (i.e. backhoes versus cranes (Figure 3)) and longer pipe sections that required fewer joints. The availability of custom polypropylene fabricated manhole sections also made the pipe to manhole connection process seamless.

Figure 3. Backhoe Installation of ASTM F2764 Pipe

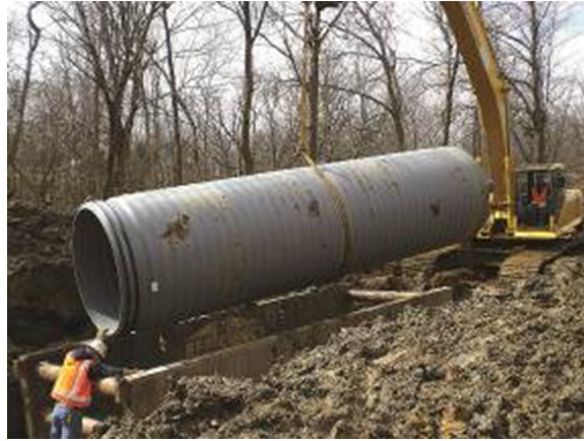
to the long lay lengths and easy joining double gasketed pipe (Figure 4), which supplied superior watertight performance.

Figure 4. Moberly 60-inch Double Gasketed ASTM F2764 Installation
