Pipelines 2015

Recent Advances
in Underground
Pipeline
Engineering and
Construction

PROCEEDINGS OF THE PIPELINES 2015 CONFERENCE

August 23–26, 2015
Baltimore, Maryland

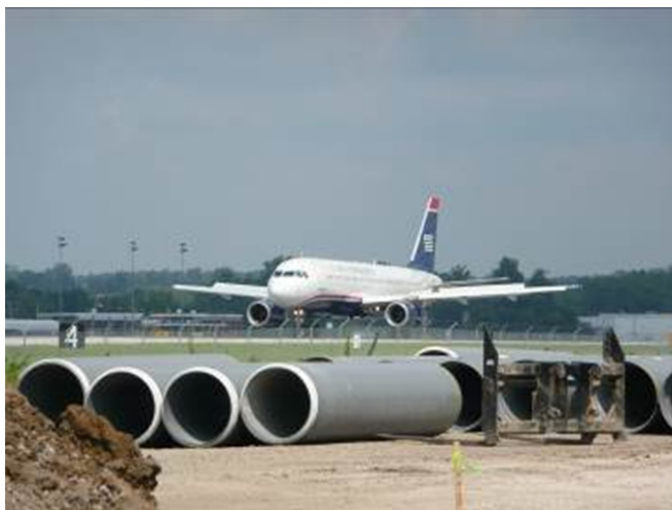
Figure 5. Triple Wall PP Pipe on the Port Columbus International Airport Project

The Port Columbus International Airport in Columbus, Ohio needed to add a new 10,113-ft runway to augment its expansion capacity. The project, designed by CH2M Hill, required a total of 21,580-ft of PP propylene stormwater pipe with diameters ranging from 12-inch through 60-inch. All the small diameter pipe was dual wall PP pipe (ASTM F2736) with all the larger diameters being triple wall PP pipe (ASTM F2764) (Figure 5). As with most airport runway projects, high aircraft live loads are applied to pipe with relatively shallow fills. The high stiffness PP pipe provided excellent resistance to these live loads with the added benefit of meeting high watertight integrity since both ASTM standards are for sanitary sewer pipe. Even given these higher sanitary sewer requirements, the PP dual and triple wall pipe, installed by George J. Igel & Company, was a cost effective alternative to standard RCP stormwater pipe on this project.

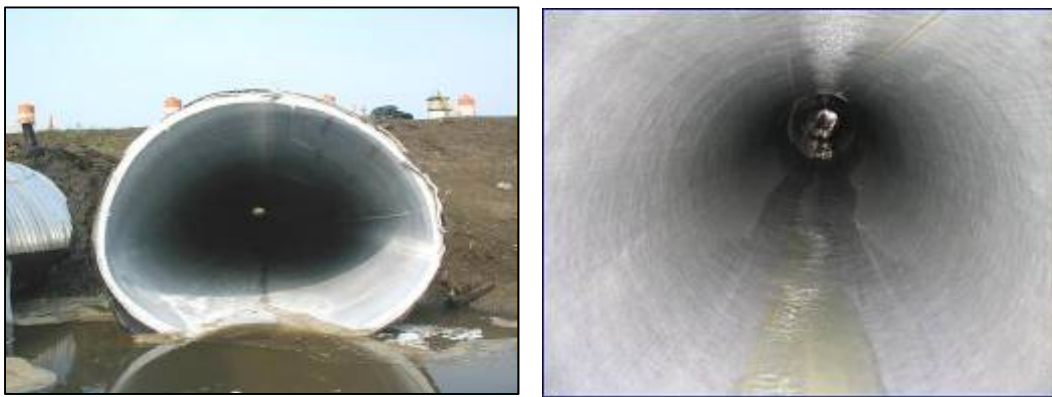
Figure 1. Completed Installation of CIPP

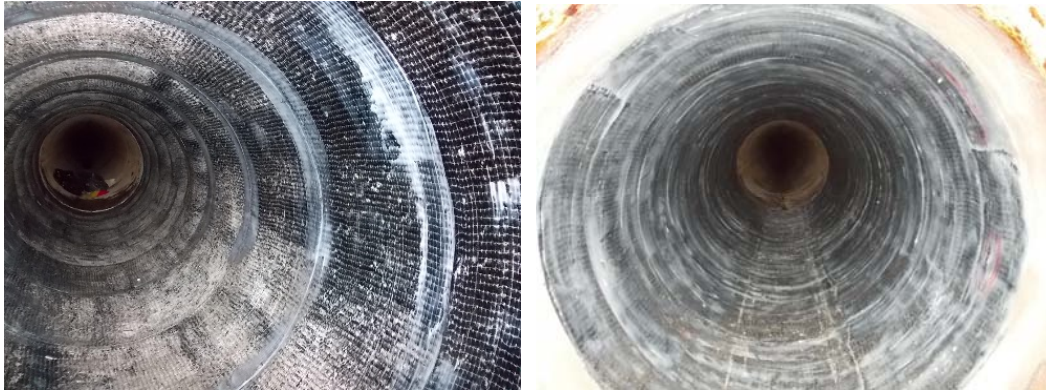
Figure 2. Completed Installation of CFRP on a Buried Pipeline

The use of anisotropic fiber reinforced polymer (FRP) composite systems in different industries, with a trenchless installation procedure, to strengthen steel and concrete pipelines has been utilized for over 20 years, see Figure 2. FRP composite systems are light weight, carbon and glass reinforcing fibers saturated with a polymer matrix. Once applied within the pipe, the system is cured within a given period of time dependent on the environmental temperature inside the host pipe. The end result is the FRP system acting as a tension member for internal pressures and in compression for external pressures. The FRP is utilized to strengthen the degraded steel/concrete by either aiding the host pipe to regain its original strength, providing additional capacity to structural elements forming the existing water infrastructure, or creating a fully structural standalone replacement pipeline. As the global structural engineering industries have adopted this technology, so have the infrastructure industries. However, there are no design standards, including AWWA M28, which refer to pipeline rehabilitation using FRP systems. Due to this ideology, the following will depict some common CIPP rehabilitation design practices used in the municipal pipeline industry, and provide a modified consensus of how to make those common design practices applicable to FRP systems.

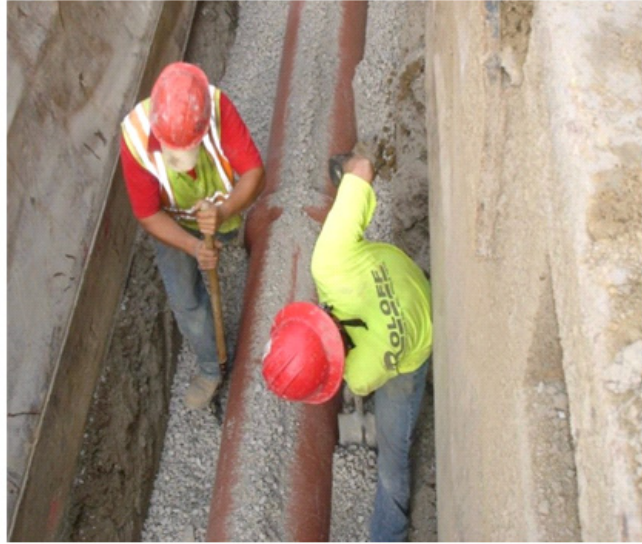
Figure 5: Shovel-slicing the bedding material into the haunches of the pipe is essential.

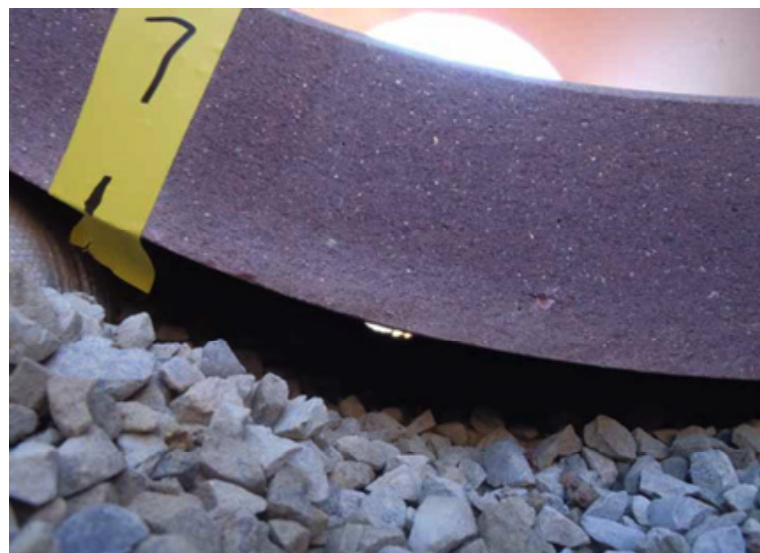
Figure 7: In testing, daylight was visible on the other end of a 7.0' pipe section.

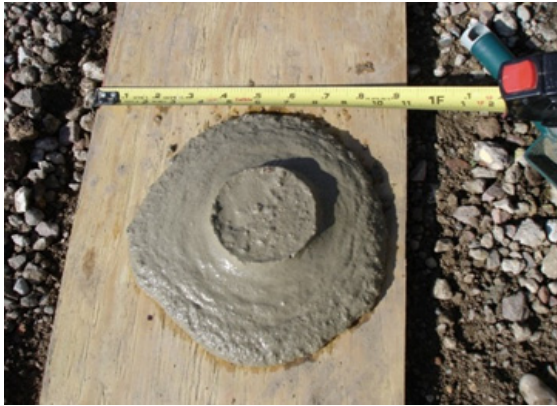
Figure 9: Measuring the spread diameter to determine flowability prior to placement.

Testing for flow consistency should be conducted in accordance with ASTM D6103. When placed, CLSM shall have a measured spread of 7 – 9 inches. A typical test result is shown in Figure 9.

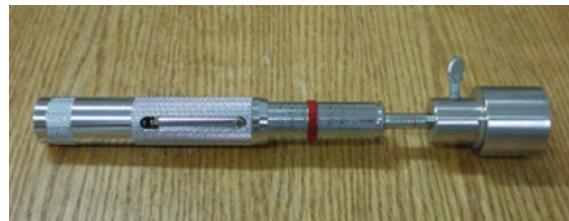
Figure 10: A pocket penetrometer can be used to determine CLSM strength prior to backfill.

Initial backfill shall only commence after a 500 psi minimum penetrometer reading is achieved as determined by Test Method C403/C403M. The penetrometer shall have a maximum load capability of 700 psi and have a 1.0 square inch by 1-inch long cylinder foot attached to a ¼-in diameter pin, as shown in Figure 10. The initial backfill shall be either Class I, II, III, or IV having a maximum particle size of 1½ in (38 mm).

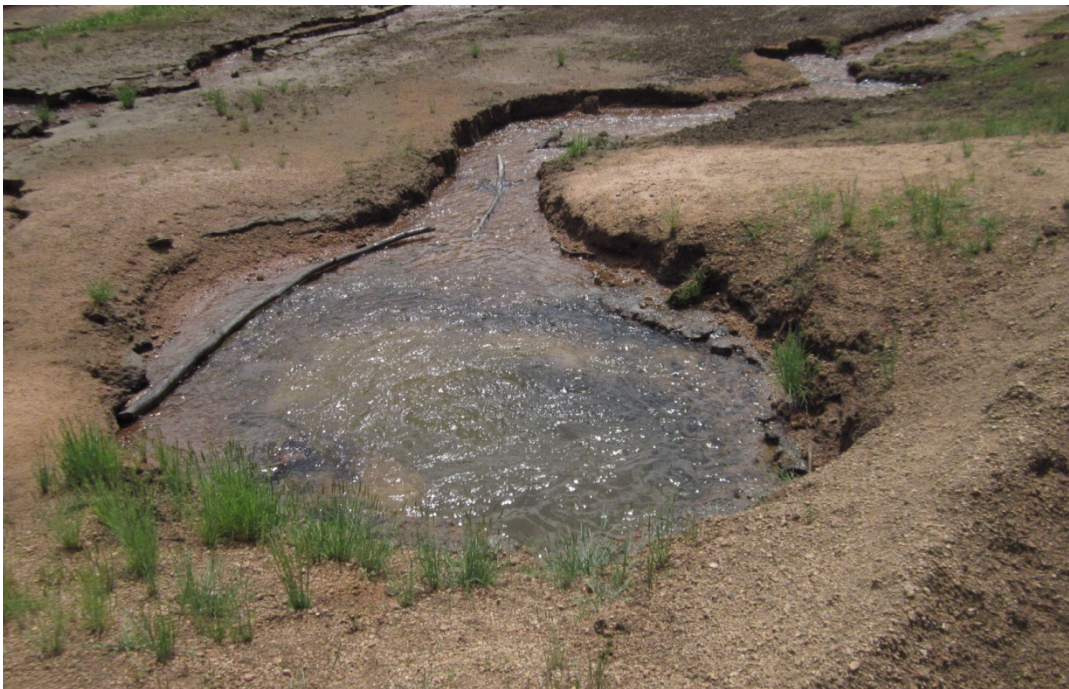
Figure 2 – Flowing water from sinkhole created by leaks in Transfer Pipe

In 1959, a new reservoir was constructed on North Catamount Creek to provide additional terminal storage of the Blue River water. The reservoir inundated the 14-in. and 16-in. South Catamount transfer pipes with up to 75 feet of water. An outfall flume was constructed at North Catamount Reservoir with a set of valves that allowed Blue River water to be directed to either or both reservoirs. This system worked adequately for several decades; however, with time the pipes beneath North Catamount Reservoir increasingly began to leak, until by the end of the 20th Century, Blue River water could no longer be reliably discharged to South Catamount Reservoir, and the majority of the Blue River Water ended up in North Catamount reservoir, either through the outfall flume or through leaks in the pipes. Figure 2 depicts a typical erosion feature found upstream of North Catamount reservoir created by leaks in the steel Transfer Pipes to South Catamount reservoir.

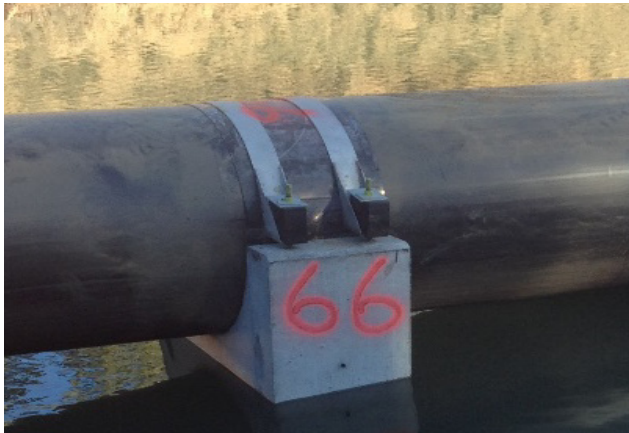
attachment and a neoprene sheet between the pipe and the ballast/attachment for protection. Neoprene compression blocks were placed on the anchor bolts between the straps and the anchor nuts and washers to maintain contact between the strap and the pipe during thermal contraction and expansion. Figure 4

Figure 4 - Typical Precast Concrete Ballast represents a typical ballast. This is a departure from the more traditional two-piece ballast having concrete blocks both above and below the pipe, and proved to be an improvement that significantly facilitated ballast placement, and limited pipe rotation during placement.

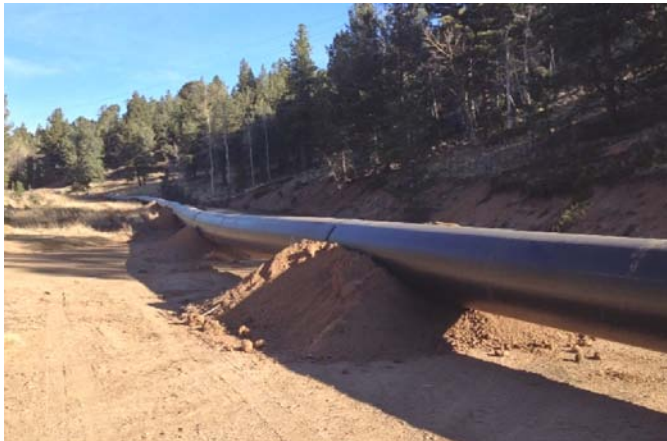
Figure 6- Fused HDPE Transfer Pipe prior to floating

HDPE to be fused as a unit prior to launching. The total length of pipe fused prior to launching was 2,450 feet. The fused length of pipe was supported on rollers to facilitate launching and held in position with mounds of earth. Figure 6 depicts a portion of the total fused length of HDPE

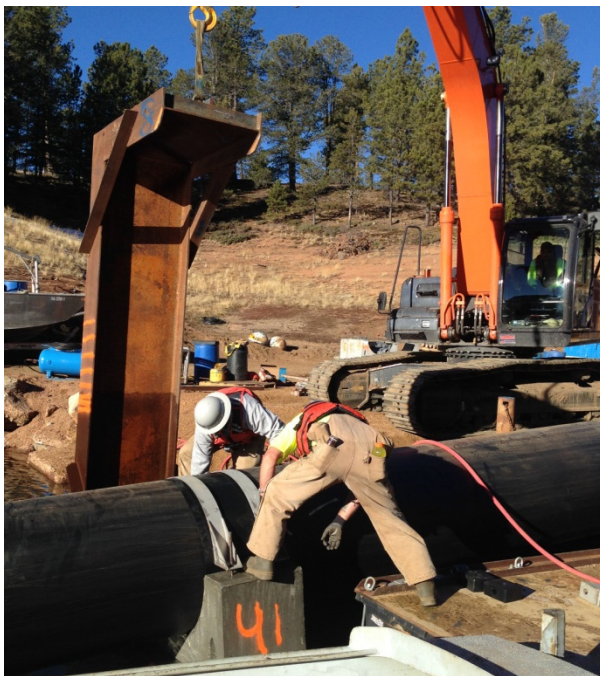
Figure 7 - Ballast block installation.

blocks to be lowered beneath the pipe within the pit, and then raised into position against the underside of the pipe (Figure 7). The steel straps were then installed over the pipe to attach the ballast, and the pipe was advanced into the reservoir to allow placement of the next ballast block. This sequence was found to work well and allowed for rapid ballasting and launching of the pipe.

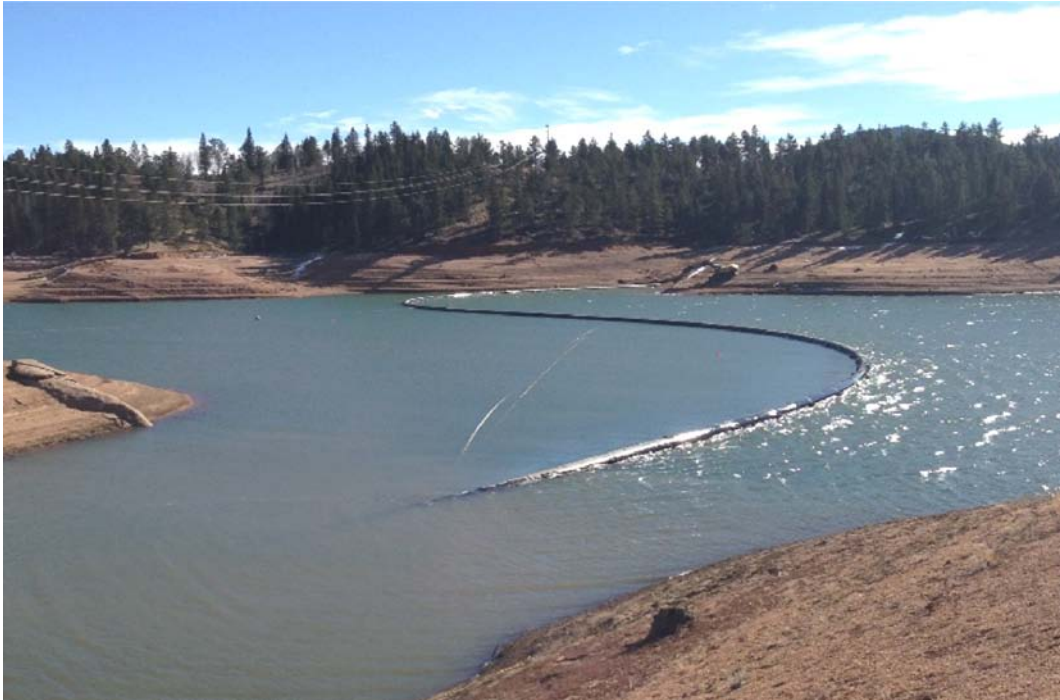
Figure 8 - HDPE Transfer Pipe at the start of the sinking process, floating on the reservoir surface over its eventual alignment

pipe was then sunk into its eventual location by filling with water, beginning from the north end. Figure 8 represents a photograph of the final serpentine alignment on the surface of the reservoir just as the sinking operation began. A common method for sinking the pipe involves creating a loop in the pipe by raising the beginning section of the pipe with an onshore or barge-mounted crane and filling the pipe between the raised portion and the near shore to lower the initial section of pipe. Once the initial section is sunk, the raised section can be lowered back to the surface, and as the pipe is filled with water the lowering will progress from the near shore to the far shore in a controlled manner. For this project, however, an inflatable bladder or “pig” was inserted into the pipe, and water was pumped into the pipe behind the pig. The pig was pushed through the pipe as additional water was added, resulting in controlled sinking of the pipe from the near shore to far, but without the need for a crane or other means to lift the pipe.

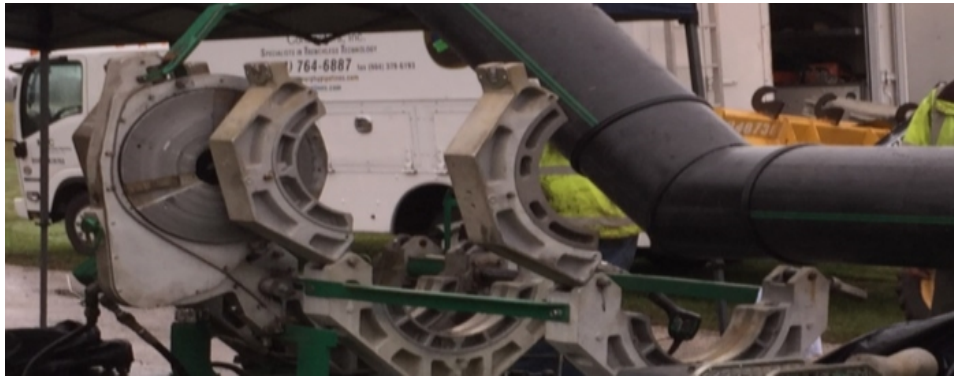
Figure 1. HDPE Fitting

Similar to the HDPE pipe selection, pipe fitting and connections used butt fusion (see Figure 1), fused fittings and electrofusion couplings. HDPE mechanical joint adaptors were used when the new HDPE pipe was connected to the tie-in locations. The ductile iron plug isolation plug valves were the only items in the force main which did not utilize HDPE.

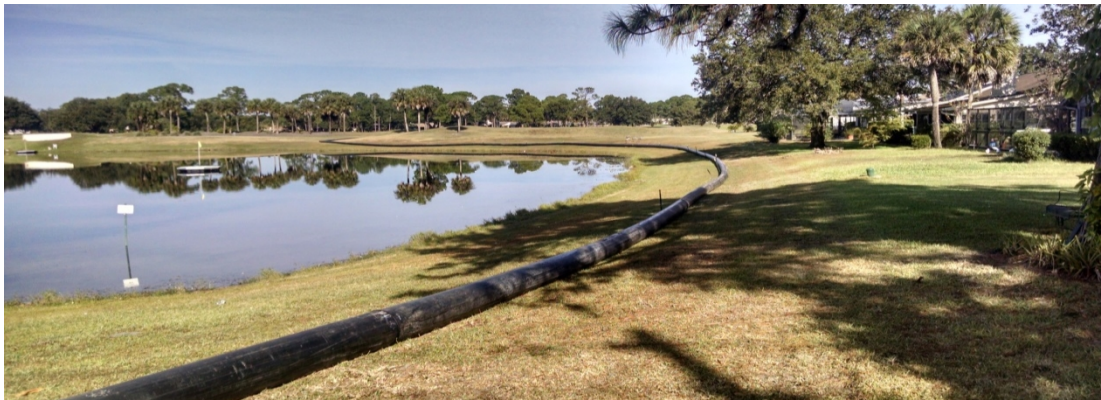
Figure 2. Force main bypassing

The Eagle Circle project used a temporary bypass line (Figure 2) to assist with the new pipeline installation. By establishing a plan early and keeping FDEP informed, the bypass line was installed and removed with few delays. The initial plan of action for the Eagle Circle force main replacement project was to establish a bypass along the 10-inch (250-mm) pipe bursting portion along the golf course of the existing force main. The other 16-inch (400-mm) section of existing force main would be kept in service with parallel replacement. This construction method would have required the use of jack and bore at five locations. While effective, this method involved a large impact on the environment and the public in the surrounding area, and imparted a large cost to the project. In order to reduce the construction impact and cost of the project, REI shortened the required length of bypass piping and completely took the existing pipeline out of service by tying the bypass into a separate force main approximately 2,080-feet (634-meters) away. This alteration to the construction process resulted in approximately \$115,000 of cost savings, helped streamline the project by taking the existing pipeline completely out of service and reduced the amount of jack and bore locations to only one location.

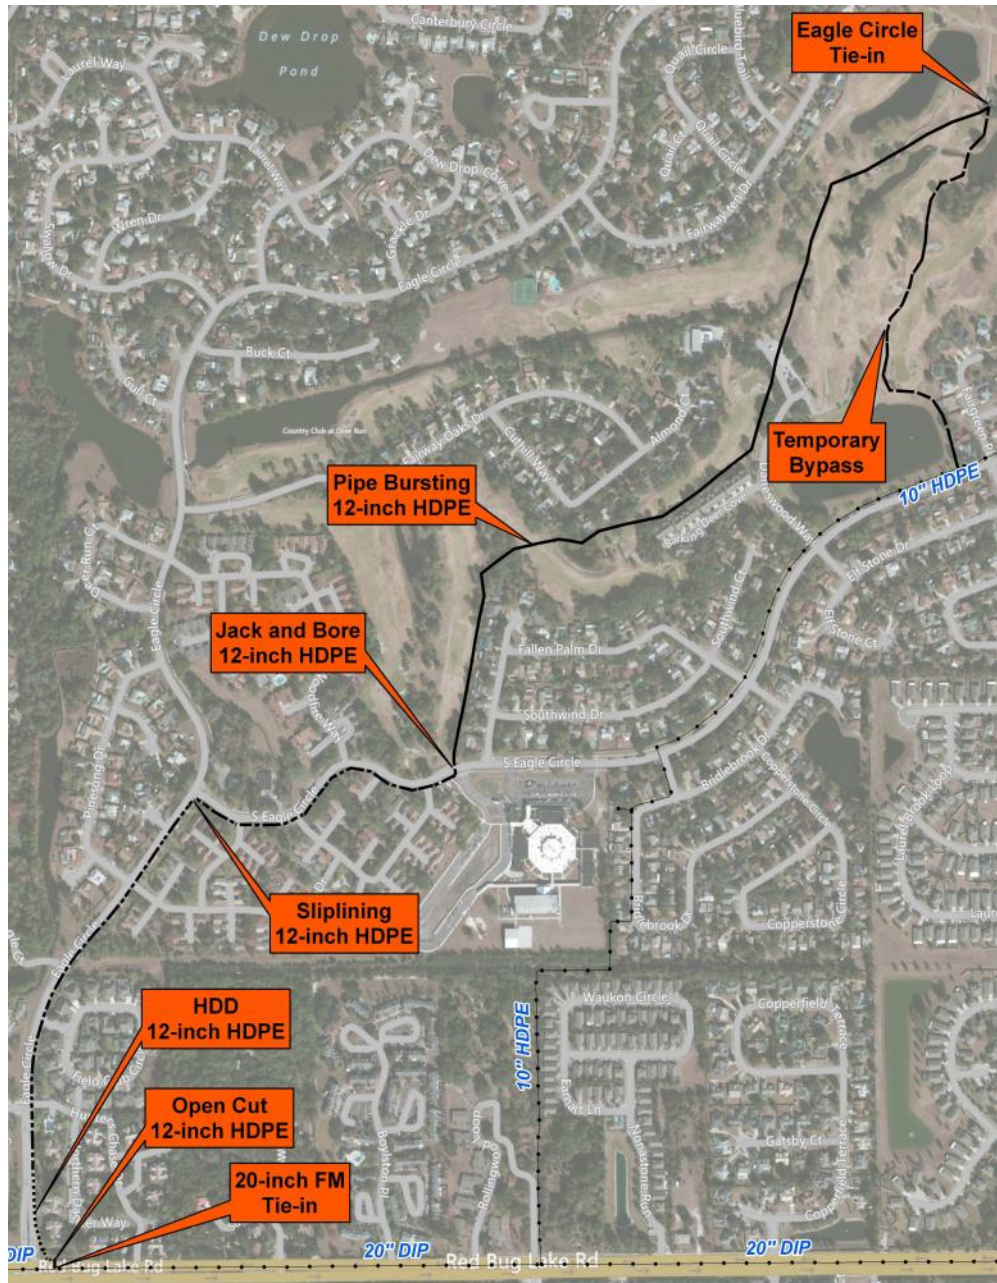
The Eagle Circle force main replacement project used horizontal directional drilling (HDD) as one of its pipe installation methods. HDD was chosen based on a combination of its qualities and the site restrictions. HDD made up 5 percent of the total pipeline length, resulting in a length of 420-feet (128-meters) out of the total 8,350-feet (2,545-meters). The factors that contribute to the decision of HDD versus sliplining and open-cut are the lack of room and easement to work in the specified area, Seminole County requiring no roads be damaged during construction, and the congested utility corridor located in the area.

Figure 3. Replacement Pipe Installation Methods (Microsoft)

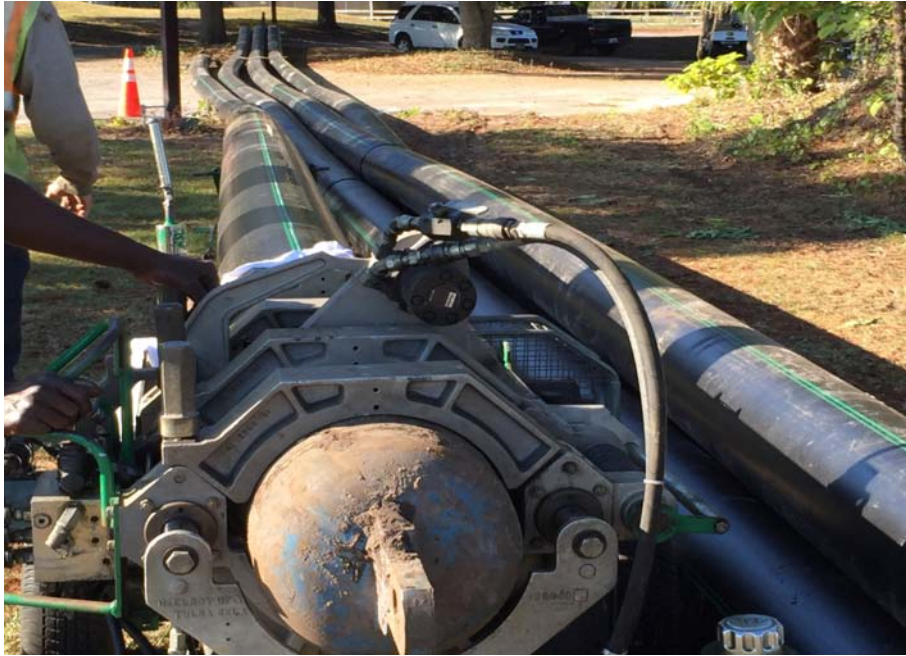
Figure 4. Fused HDPE Pipe

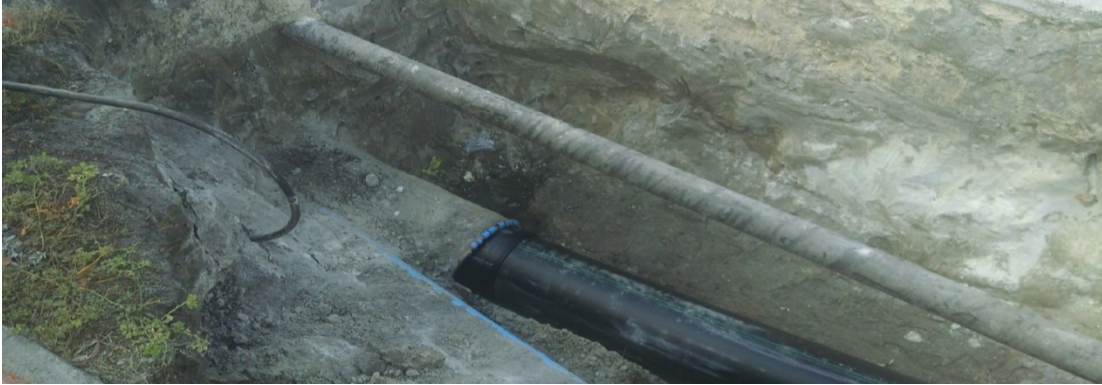
Figure 5. Sliplining

Considerations during sliplining included potential damage to the new pipe imparted by the existing pipe. In order to prevent this, protective linings were applied around the circumference of the existing pipe at both ends during the sliplining process (see Figure 5). A thorough and detailed assessment should be done on the health of the existing pipeline before using it during sliplining.

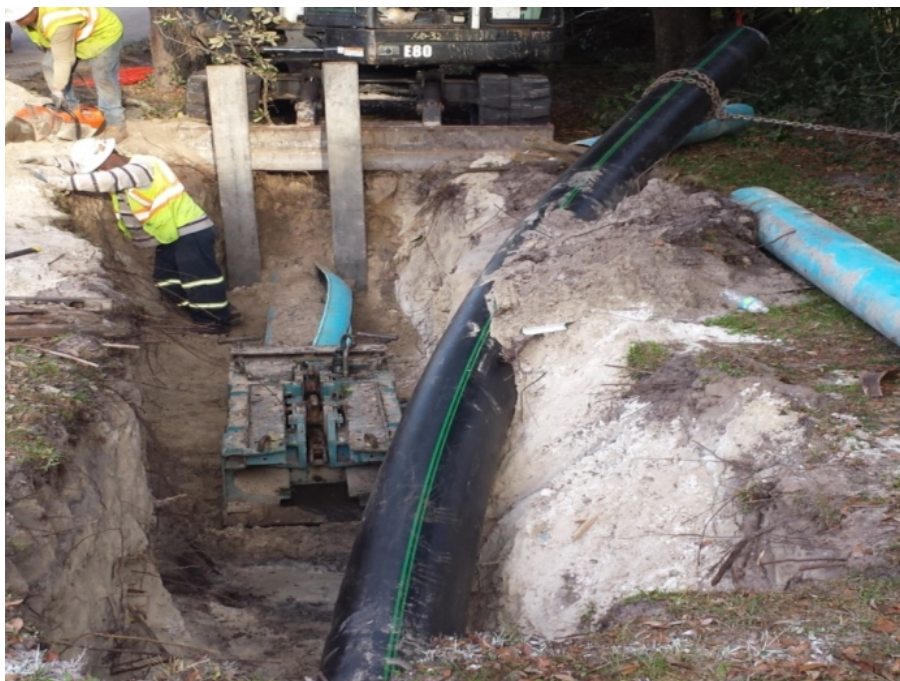
Figure 6. Pipe Bursting

A method becoming more commonly used to install new pipelines is the pipe bursting method. This pipe installation method can be beneficial to the project under consideration; however, the conditions of the project have to be correct for it to be applicable. Static pipe bursting is carried out with equipment known as a bursting machine which operates hydraulically, with rods, and a pipe bursting head. Rods are first fed through the existing pipe using the rig, which is setup in a pipe bursting pit with support columns. The rods are then connected to the pipe bursting head, which is attached to the new pipe to be installed. The new, larger, or same size pipe is then pulled by the rig through the existing pipe. During the process, the existing pipe is “burst” and left in the ground (see Figure 6). For pipe bursting to be possible during the job the existing pipe has to be the correct material, size and location to avoid heaving. The conditions present during the Eagle Circle force main replacement complimented the ideal conditions for pipe bursting with a one pipe size increase.

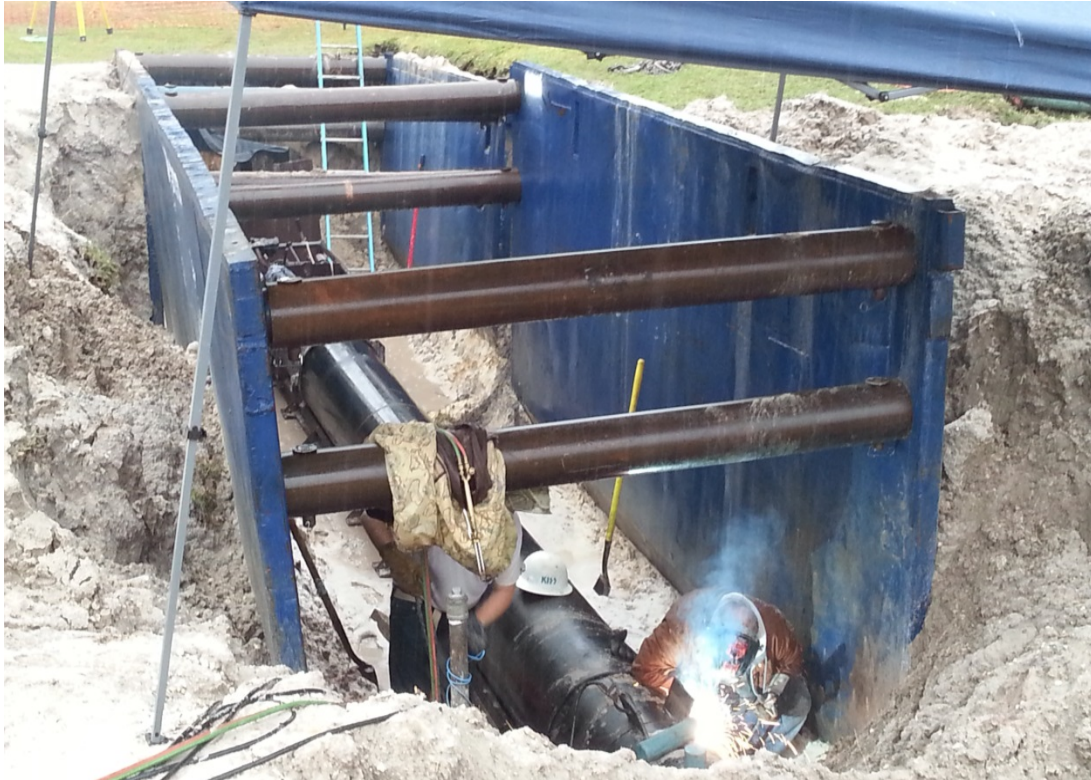
Figure 7. Welding Jack and Bore Casing

A weather condition that is very common in Florida is heavy rain. With jack and bore, the steel casing had to be welded while the casing was being pushed into the ground. The main challenge that utilizing jack and bore faced during the project was making sure the rain did not affect the quality of the welds. Portable canopies were an easy solution to this problem and should be considered if a similar situation arises during a different project (see Figure 7).

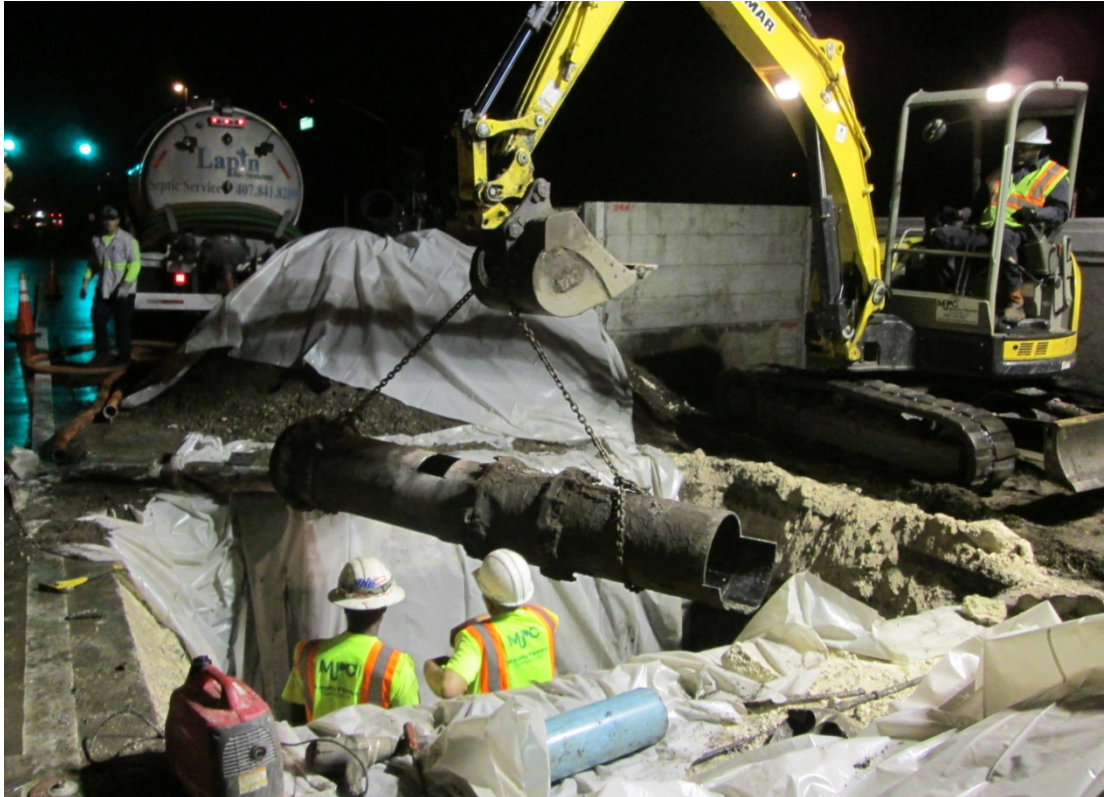
Figure 8. Red Bug Lake Road Existing Pipe at Tie-in Location

Connection to the existing lift station was done through a 12-inch (300-mm) by 10-inch (250-mm) reducer and a section of PVC. Additional underground piping was replaced at the pump station due to a condition observed during excavation. The other end of the new pipeline was tied into an existing 20-inch (500-mm) ductile iron force main located under a heavy flow County roadway. The connection was possible through an existing, operational tapping gate valve positioned horizontally. To

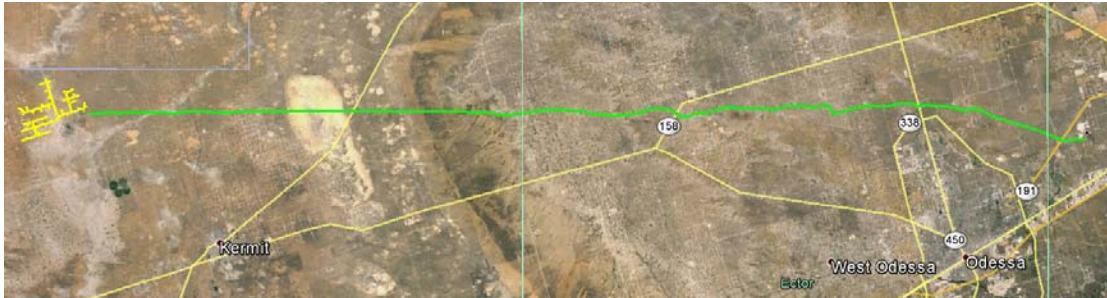
Figure 3. Original Pipeline Route

The Midland County Fresh Water Supply District Number 1 (MCFWSD1), possessing the power of eminent domain, could provide for the shortest route – a straight line from A to B (refer to Figure 3).

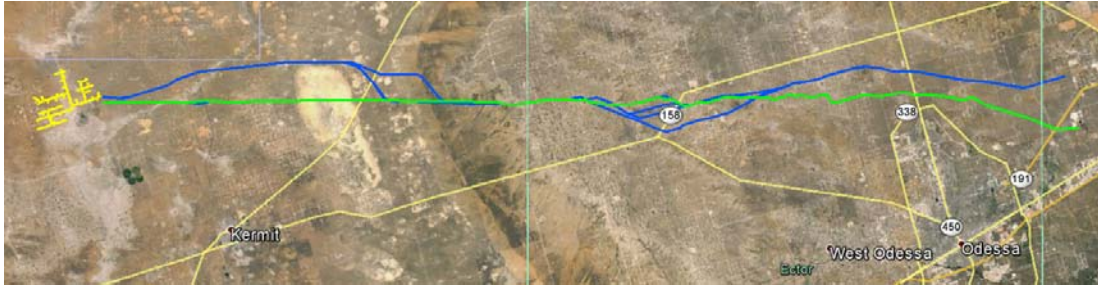
Figure 5. Rerouted Pipeline Alignment Versus Original Alignment

The decisions to route around the permanent oil field infrastructure and immovable sand dunes was cut and dry; the decision to reroute around potentially difficult land owners was not as cut and dry and a heavy responsibility was placed on the shoulders of the land acquisition team to make educated and accurate decisions of what properties to route through and around (refer to Figure 5).

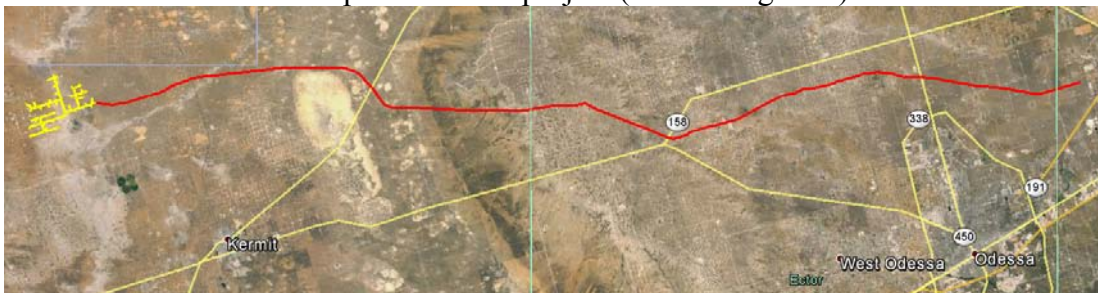
Figure 6. Finalized Pipeline Route

With the final route selected, the acquisition of land, well underway, was now critical to the on-time completion of the project (refer to Figure 6).

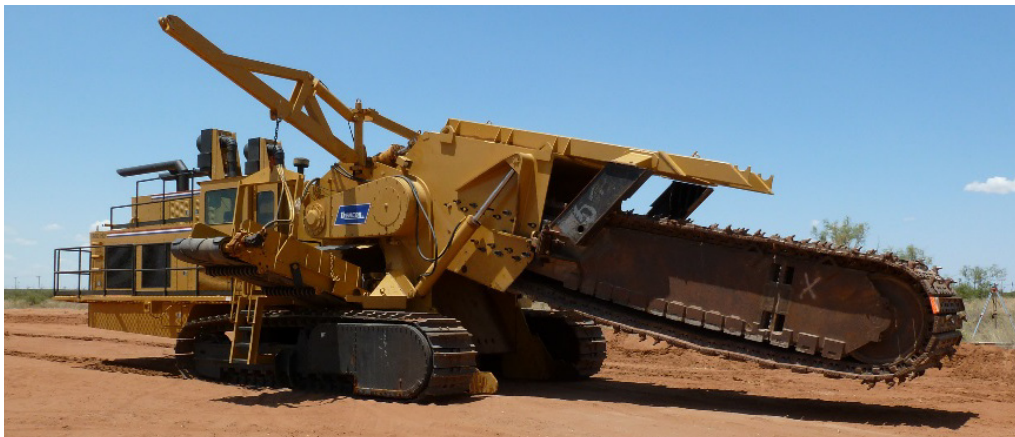
Figure 7. Trenchor 1860 Rock Trencher

Two of eleven of the world's largest trenchers – Trenchor 1860 (Figure 7) – were mobilized on this project along with numerous smaller machines.

These giant trenchers, weighing nearly 226,796 kg (500,000 lbs.) each, limited how close they could operate to the hundreds of petroleum pipelines that the project traversed. The skips the trencher left behind were often 18 to 24 km (60 to 80 ft.) wide which needed to be excavated prior to the mainline crew’s arrival. Smaller crews with hydraulically operated rock hammers on excavators were employed to accomplish this. Tunneling, land clearing, and fencing crews also preceded the installation crews.

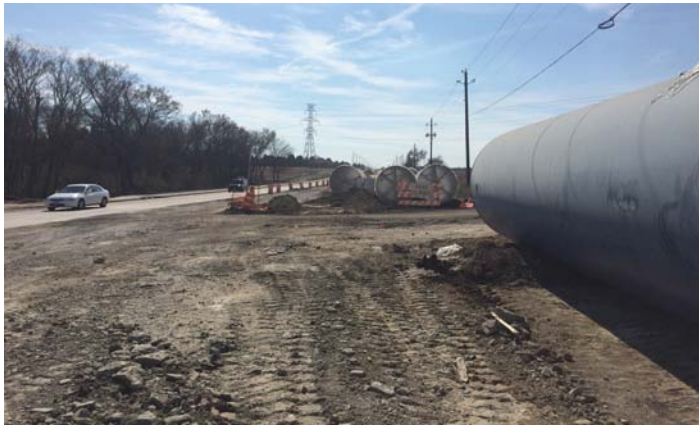
Figure 1. Bonnie View Road Traffic Control

was the case in the Southwest Pipeline project. Figure 1 below shows the construction area along Bonnie View Road. The south bound lanes are closed off while two-way traffic is being maintained along the recently constructed north bound lanes. The design of Bonnie View Road allowed for the two north-bound lanes of the roadway to be constructed while maintaining traffic control on the existing two lane road. Two-way traffic was then moved over to the new north-bound lanes while construction of the pipeline could then occur. During construction of the pipeline along Bonnie View Road, roadway construction was still occurring south of where the pipeline would be installed. This allowed for continual construction of the roadway project while the pipeline was being installed.

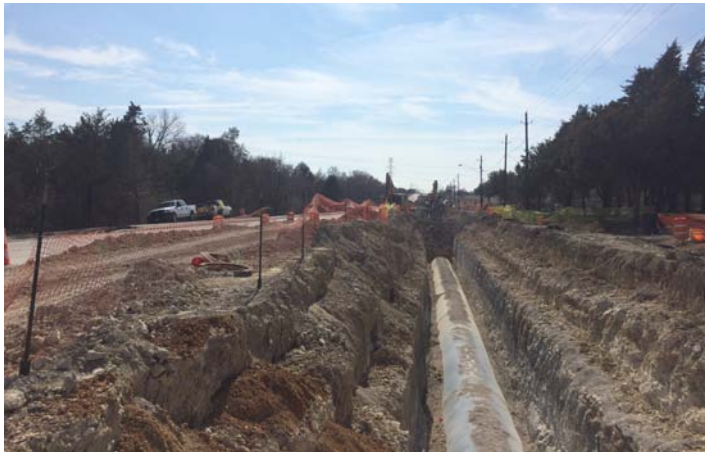
Figure 2. Bonnie View Road Construction Sequencing

After construction of the pipeline, the roadway project would finish up the paving and drainage improvements along the pipeline corridor. Figure 2 below shows the construction of the 96-inch pipeline and pipe trench in the future north bound lanes of Bonnie View Road. The south bound lanes have been completed and are shown to the left of the safety fence.

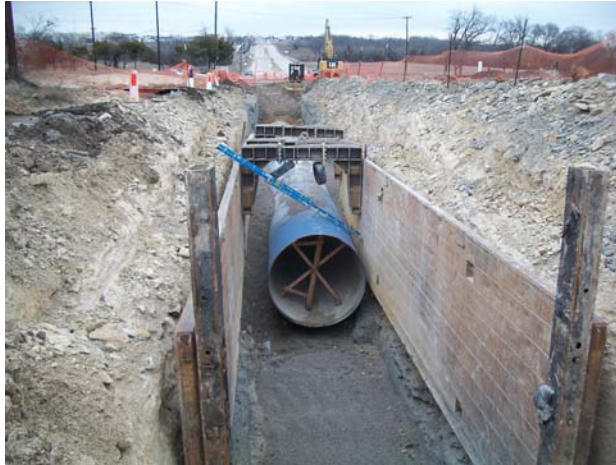
Figure 3. Backfilling Operations on the 96-inch Pipeline

The Bonnie View segment of the Southwest Pipeline project required significant quality control and quality assurance measures on both the roadway and pipeline projects especially on compaction that required the coordination among three different labs. Figure 3 below shows the backfilling operations on the pipeline. Both Dallas County and DWU also had their own testing labs to perform quality assurance for the entire project. This is an important consideration for a joint construction contract, since different entities may have their own guidelines that must be followed.

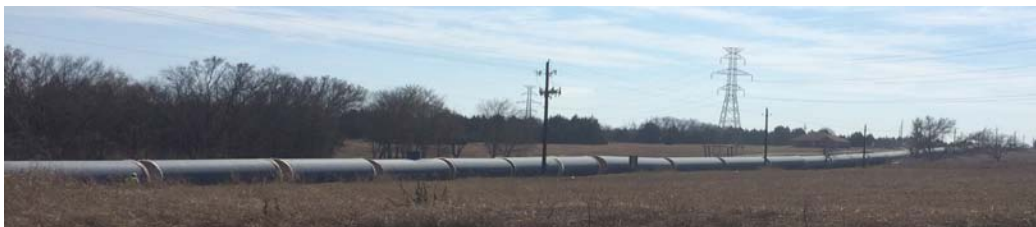
Figure 4. Southwest Pipeline Material Storage

During construction of the roadway and pipeline projects, materials will constantly be delivered after the submittals are accepted by the engineer. Large diameter pipeline projects may require several miles of pipe joints to be delivered to site. In many cases, the pipe may be ready to be delivered but the site is not ready for delivery. This may be an issue that needs to be thought of during design and provisions for pipe storage should be considered. Storing the pipe material at the pipe factory may be an option until site conditions allow for delivery. The opposite scenario may occur depending on the phasing of construction and any milestones that have to be met. The pavement progress may be held by delays in the pipe production and delivery. It is critical to coordinate this early on during construction at the pre-construction meeting. This is especially important if there are two different pavement and pipeline contractors involved in the project. Figure 4 below shows the 96-inch steel pipeline joints being stored along Bonnie View Road prior to installation.

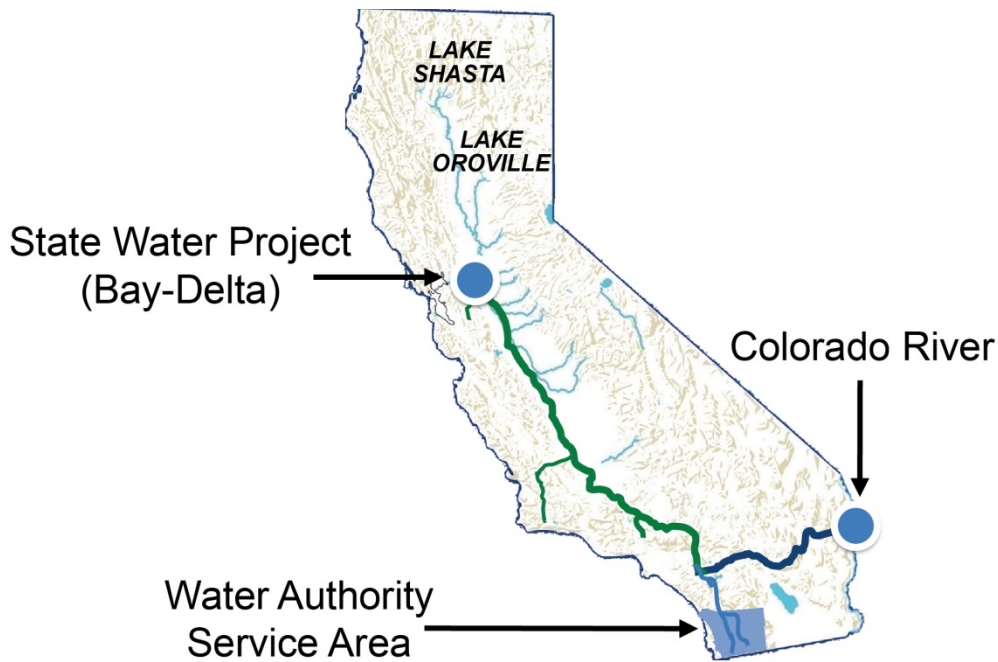
Figure 2. Metropolitan primary imported water sources.

In 1947, San Diego began importing water from the Metropolitan Water District of Sothern California’s (Metropolitan’s) Colorado River Aqueduct (CRA) through a single pipeline to San Diego. To meet the demand of a growing population, the Water Authority constructed four additional pipelines between 1950 and the early 1980s to deliver water from Metropolitan’s CRA and State Water Project Supplies. Metropolitan’s two primary water sources are shown in Figure 2. (SDCWA 2011)

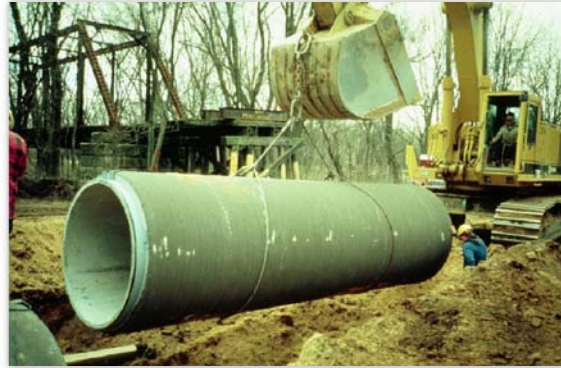
Figure 1 – C303 Pipe

Pretensioned Concrete Cylinder Pipe was introduced by American Pipe and Construction Company, a predecessor to Ameron, in 1942. Today, there is interest regarding the original criteria governing the design. However, the reasons for the distribution of the steel rod to cylinder ratio, established in those early days of development, are lost to 73 years of history, as is the criteria established for the minimum cylinder gage for the various diameters. An argument can be made that the cylinder was established to enable it to resist deformation during the placement of the lining in the long lengths allowed by the C303 criteria. The rod to cylinder distribution could logically be based on an allowable spacing of the rod and the ability, at that time, of drawing and bending the heavier rods; thus establishing a limitation on the maximum area of steel for each diameter pipe. If there was any consideration given to the additional corrosion resistance that a heavier gage cylinder might impart to the water tightness of the product, it should be remembered that there was limited knowledge of the corrosion process in 1942 and the thinking at the time was that a high alkalinity cement mortar naturally protected encased steel. Whatever the reasons, over time, the company migrated to the cylinder controlling the design by requiring a minimum of 60% of the total required steel in the cylinder, with the remainder in the rod wrap. Based on current published literature, Ameron presently maintains this distribution.

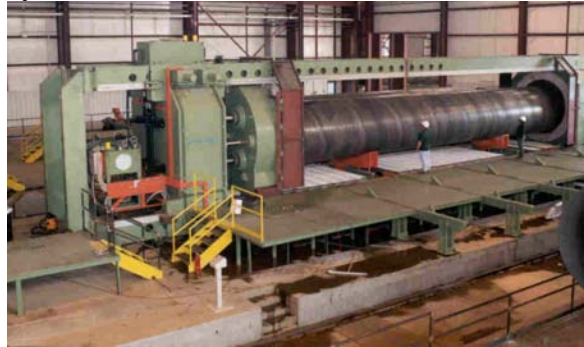
Figure 6 – Shop Hydrostatic Testing

C303 manufacture begins with the rolling of a relatively light gage cylinder to the appropriate external diameter to allow for the placement of 1/2 inch mortar or concrete lining for 16 inch and smaller pipe and 3/4 inch for larger diameters. The cylinder is generally formed by the spiral welding method. A Carnegie spigot and expanded bell joint rings are welded to the ends of the cylinder to provide for gasketed field joining

of the pipe. The individual cylinders with joint rings are then hydrostatically tested to a pressure to induce a stress equal to 75 percent of the minimum specified yield strength of the steel cylinder.

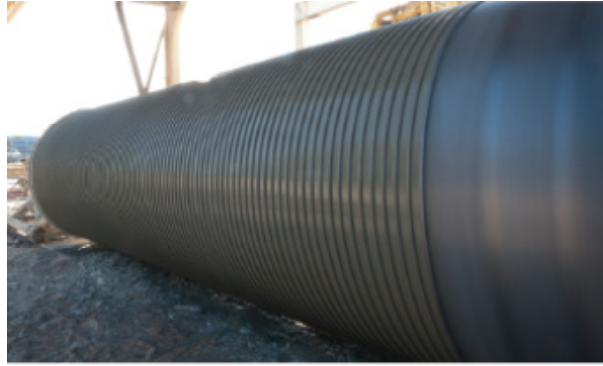
Figure 8 – Bar Wrapping

Following curing, the cylinder is circumferentially wrapped helically with a continuous reinforcing bar at a stress of between 8,000 and 10,000 psi. Pulling the bar around the cylinder at this stress ensures conformity of the bar to the outside of the steel cylinder. As the bar is wrapped around the cylinder, Portland-cement slurry is applied to the cylinder, just ahead of the bar, so that there is a slurry coating between the cylinder and bar surfaces. The bar is anchored by welding to the joint rings, not to the cylinder. See Figure 8.

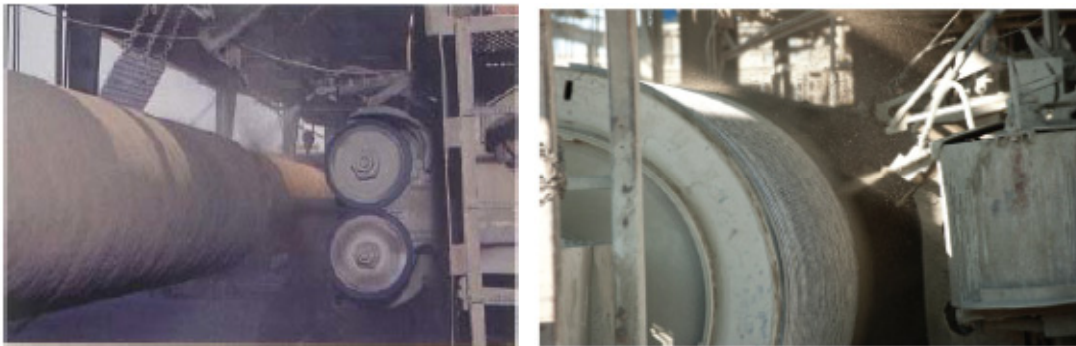
Figure 9 – Cement Mortar Coating

The pipe then receives a Portland-cement slurry simultaneously with the cement-mortar coating to establish a high alkalinity environment to the surface of the steel bar and cylinder. The coating is then steam cured for a minimum of 12 hours prior to shipping. See Figure 9.

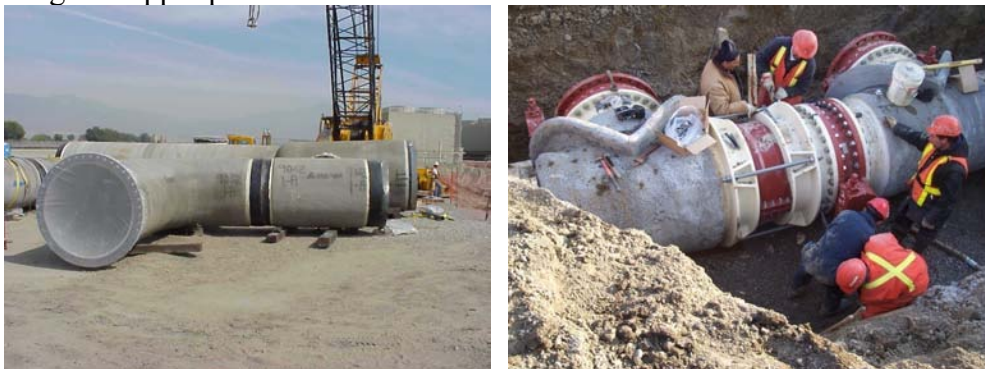
Figure 10 – Typical Fittings

With the exception of beveled pipe ends for minor deflections, as well as outlets in the barrel of the pipe, more complex fittings are produced much like cement mortar lined and cement mortar coated steel pipe, with heavier cylinders than the pipe barrel and no bar wrapping. Two piece elbows are frequently fabricated from finished pipe, requiring a wrapper plate at the location of the elbow seam.

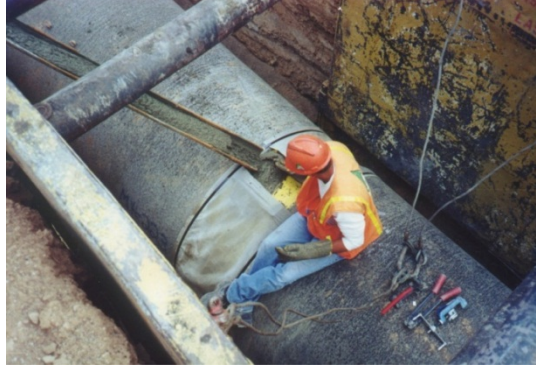
Figure 12 – Exterior Joint Grout

Prior to backfilling the pipe, the exterior joint gap is diapered and filled with a high slump cement mortar mixture. This should be poured from one side of the pipe and allowed to rise on the other side, assuring good distribution under the pipe and at the haunches. See Figure 12.

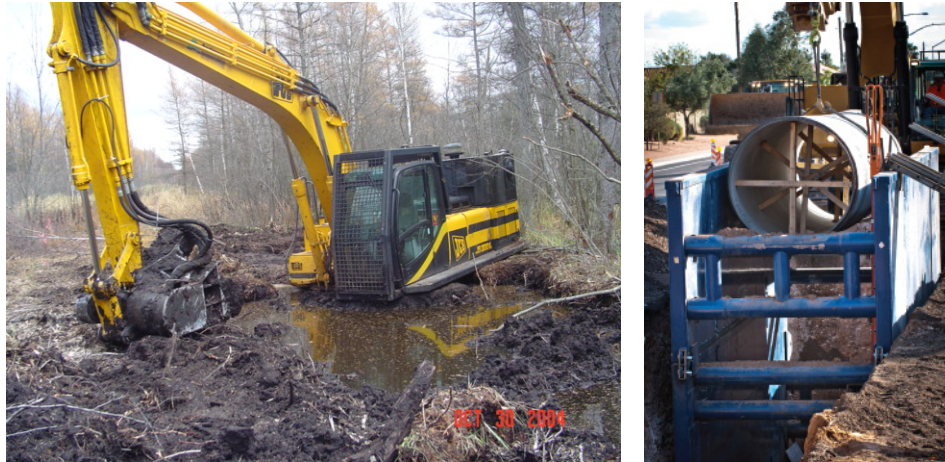
Figure 16 – High Water Table and Trench Box

While C303 pipe has experienced an excellent 73 year history, this history was essentially exclusively in the western states. Conditions in the eastern states are frequently quite different. Heavy population concentrations, a lack of open fields, corrosive clay soils and higher water tables are some of the conditions generally found for an eastern pipeline. (See Figure 16.) Shoring boxes required for trench

safety are more prevalent in the east. These conditions frequently require a limited pipe section length. While all of these issues can be overcome, they can also change the economics associated with the pipe.

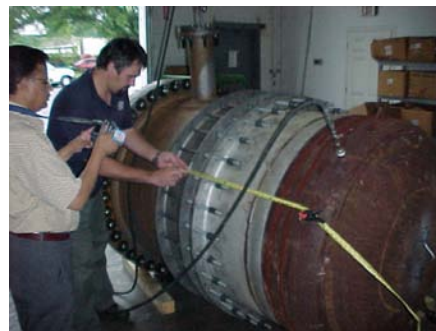
Inspection: Upon commencement of manufacturing for a project, the facility should be visited to assure that all proper procedures and testing are being accomplished. It is generally beneficial if the visit includes any first time users of this pipe, be it designer, owner or contractor. Understanding the nature of a material benefits all involved.

Figure 17 – Plant Inspection

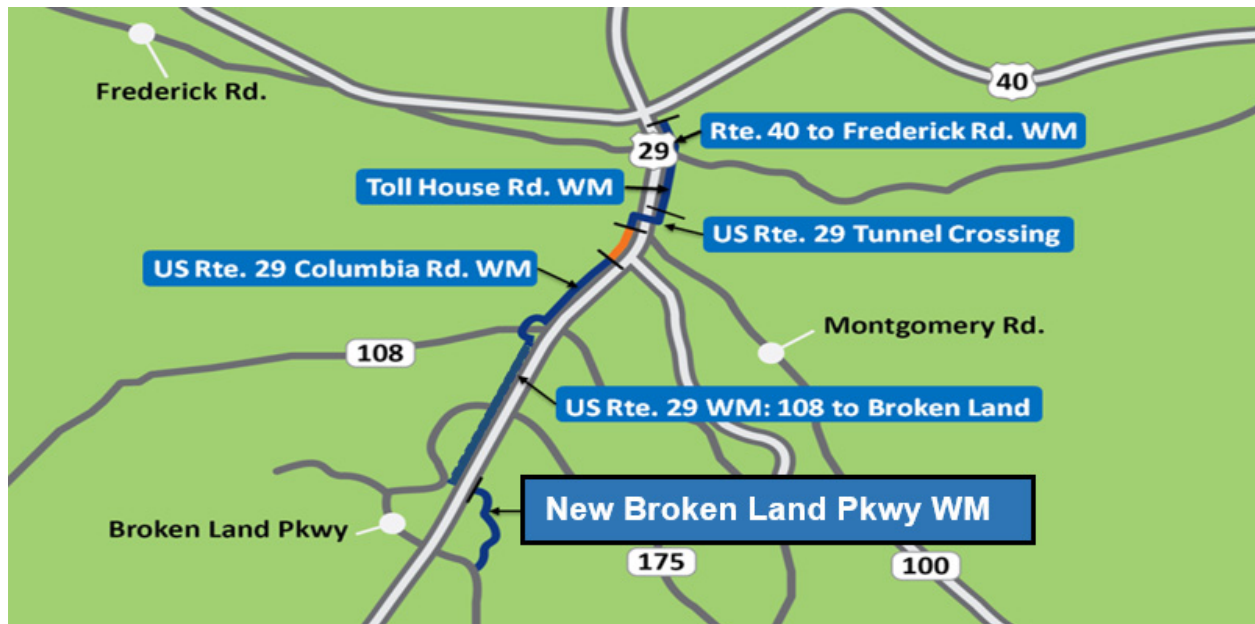
The backbone of their water distribution system is a series of transmission mains that parallel and cross under US Route 29, a highly traveled corridor that connects Baltimore to Washington, D.C. The transmission main that is the focus of this project is part of this backbone system as shown in Figure 1.

Figure 1: Howard County's Transmission Main Backbone
