Pipelines 2015

Recent Advances
in Underground
Pipeline
Engineering and
Construction

PROCEEDINGS OF THE PIPELINES 2015 CONFERENCE

August 23–26, 2015
Baltimore, Maryland

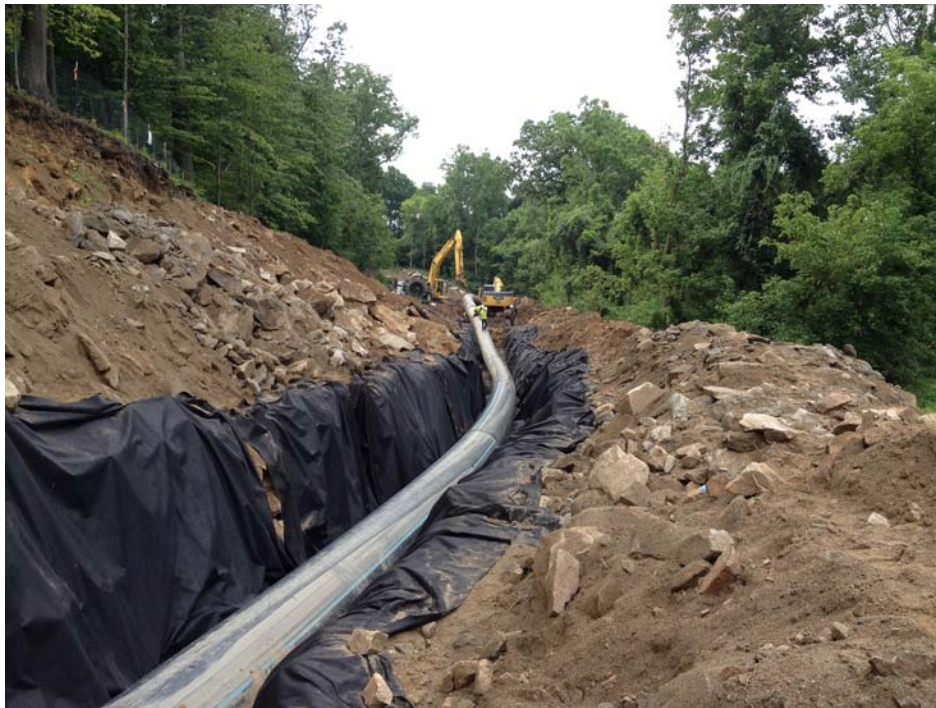
At the initial time of the evaluation, 36-inch diameter (ID) HDPE pipe was not available in the required pressure class. However, based on the initial hydraulic evaluation, it was determined that in lieu of a 36-inch diameter main, a smaller 30-inch diameter (ID) main could be used. It was determined that due to the high coefficient of friction value of HDPE, the reduction in diameter was not an issue from a hydraulic standpoint.

Figure 2: Installation of the winding 30-inch HDPE water main

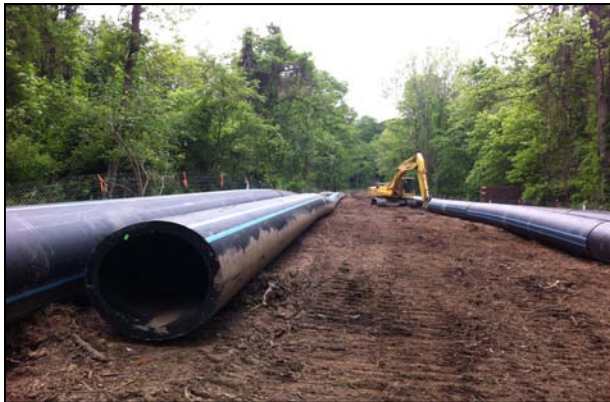
The 30-inch diameter HDPE used for this project has a wall thickness of 3-inches and was delivered in 50-foot lengths. Each length of pipe weighed in at approximately 10,000 pounds. The fusion machine required to join these pipe segments was quite large and it was quickly realized that lowering the machine into the trench to fuse each segment was not an option. As an alternative, the Contractor proposed fusing 400-foot segment of pipe (Figure 4), staging within the LOD, then rolling the pipe into the trench and backfilling, leaving a portion of the pipe above grade that would then be fused to the next 400-foot section. In order to maneuver the larger sections of pipe, a special steel chain-type strap was required, as the normal pipe straps could not support the weight of the fused sections (Figure 5).

Figure 4: Staging of 400-foot sections of pipe

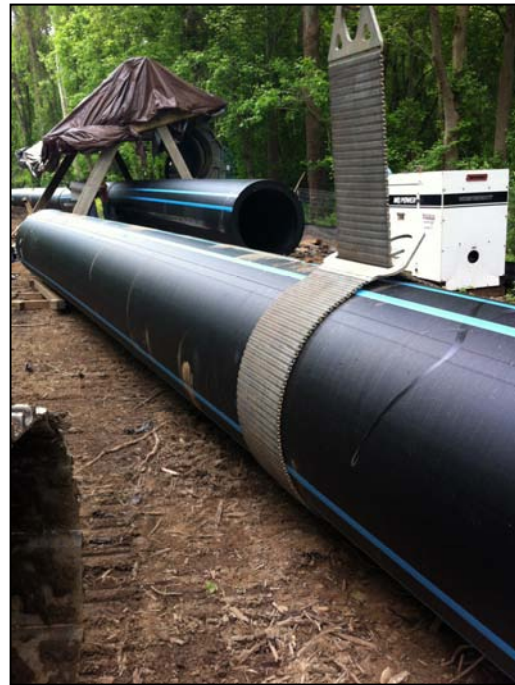
Figure 5: Steel Strap used for lifting the pipe

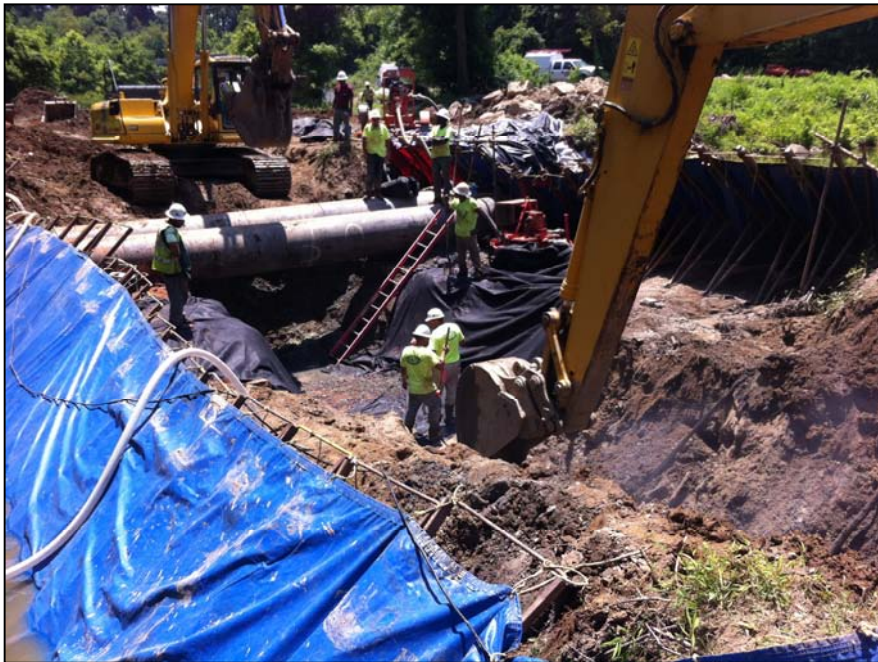
The crossing was originally to include a standard stream diversion; however, due to the nature of the 50-foot HDPE pipe segments, the crossing required multiple segments in order to fully cross the river. This meant that a standard stream diversion, that would typically divert flow from one side of the river at a time, could not be used, as it required half of the river be bypassed at a time in order to facilitate installation. Since the pipe could not be fused in the middle of the river, the contractor opted to use an alternate means of diversion for the river – a PortaDam with a flume bypass (Figure 6). This method allowed for the full width of the river to be diverted through two 36-inch pipes, leaving the channel dry for a 50-foot long section and allowing for the open cut installation of the pipe. The channel was then restored to its natural condition and the bank stabilized using the same rock previously removed from the river bottom.

Figure 6: Open cut river crossing using PortaDam and flume bypass

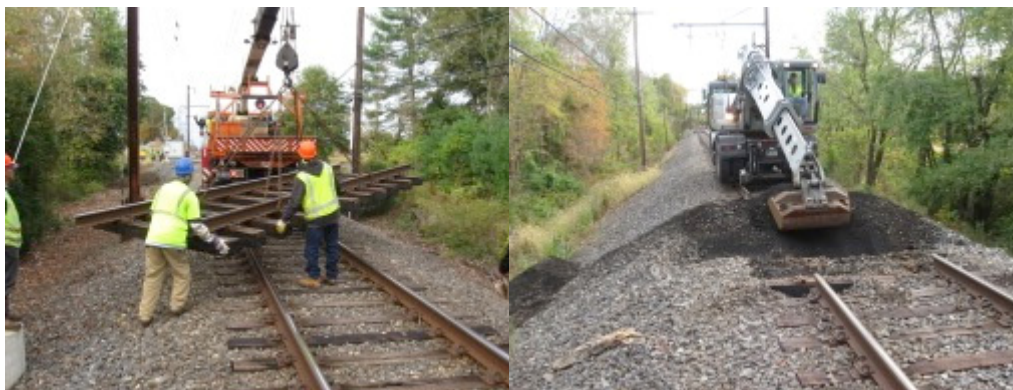
The pipes were installed in accordance to SEPTA installation practices. The existing track was removed and the trench excavated for the installation of the new pipes, as shown in Figure 3. Sloped trench walls were used in accordance to SEPTA practices. The trench width at the bottom of the trench was 8 feet, which allowed 2.5 feet on each side of the installed pipe to ensure adequate compaction of the backfill materials.

Figure 3: Removal of track for pipe installation

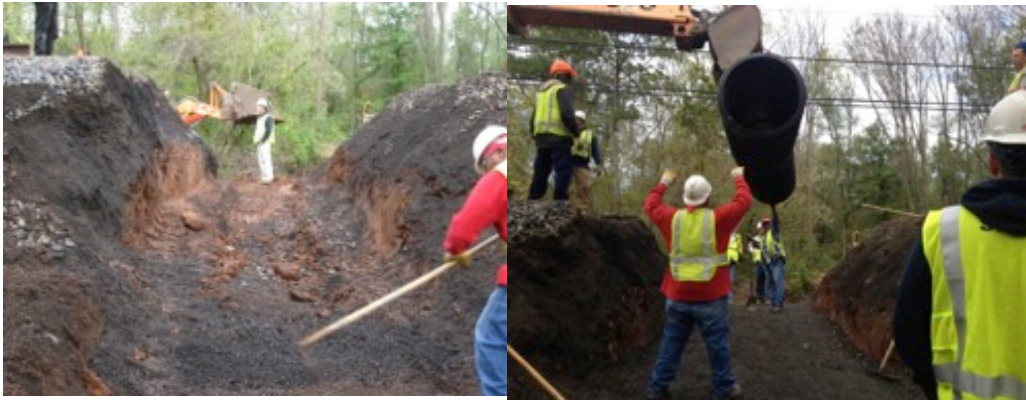
Approximately 1 foot of bedding material was installed in the bottom of the trench. This material was classified as a modified 2-A granular material according to PennDOT specifications (mix of course stone, no greater than 2 in., and fines), and was the same material that was placed in pipe envelope. The backfill was compacted with a Wacker vibratory plate soil compactor in 8 – 12-inch lifts up to the springline of the pipe, then compacted in 12 – 24-inch lifts until the backfill extended to 1 foot

above the pipe. A vibratory rammer was used to compact the backfill materials in the haunches of the pipe, and a Wacker vibratory sheepsfoot trench roller was used to compact the lifts after the backfill material reached the springline. The track ballast material (standard SEPTA ballast) was then placed on top of the modified 2-A granular material. The construction and pipe backfill process are detailed in Figures 4 and 5. We did not verify the compaction level of the backfill materials, but followed standard SEPTA installation practices.

Figure 4: Preparation of trench and lowering of pipe

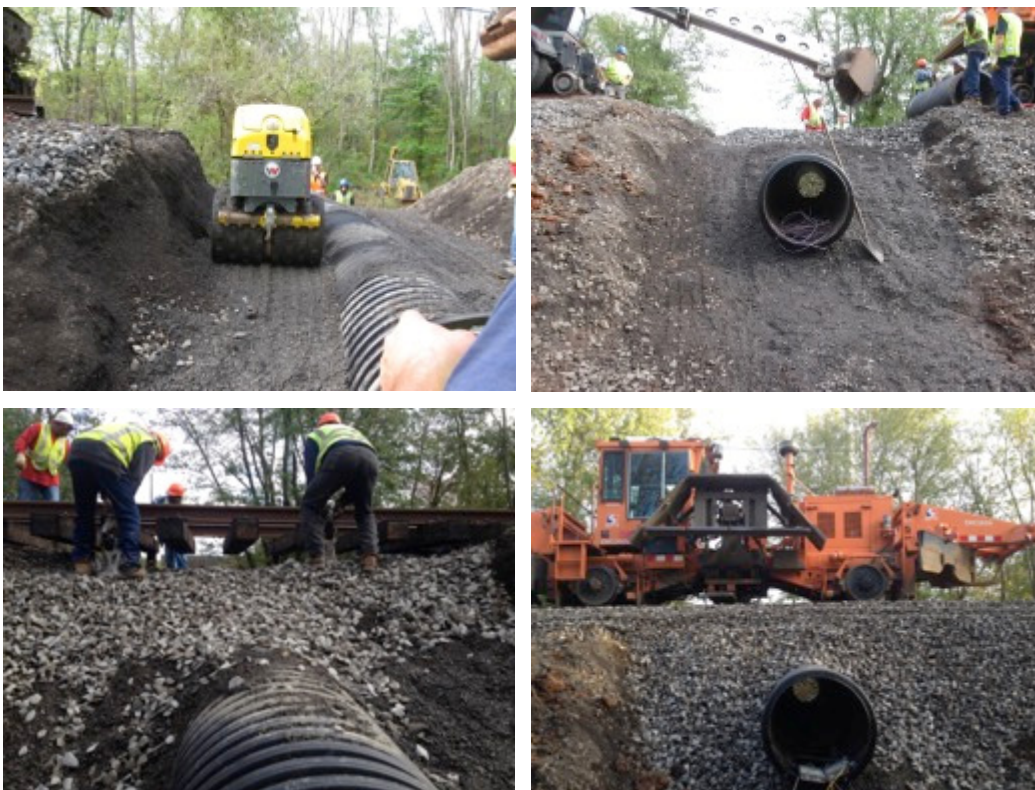
Figure 5: Installation of pipe and railroad track

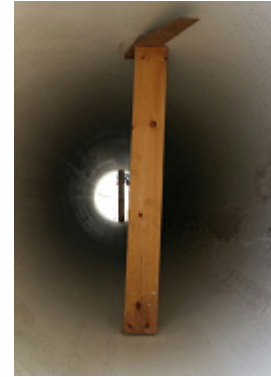
Once the determination is made to include stulls, or stull sets inside the finished pipe cylinder, the next step is to determine the configuration. Often only one stull is required, and as such, the single stull is placed vertically, Figures 1a and 1b.

Figure 1a, b: Single Vertical Stull

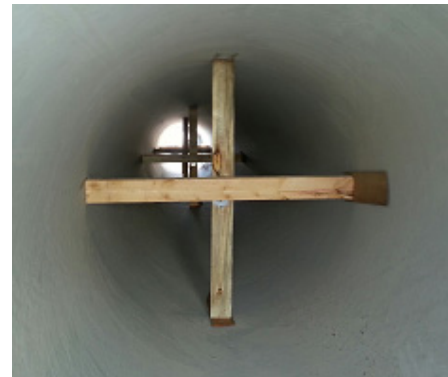
If a 2-stull set is required based on the D/t ratio, a cross configuration is used to provide support in both vertical and horizontal axes. In the 2-stull configuration, one stull is vertical and the other is horizontal, Figures 2a and 2b.

Figure 2a, b: 2-Stull Cross

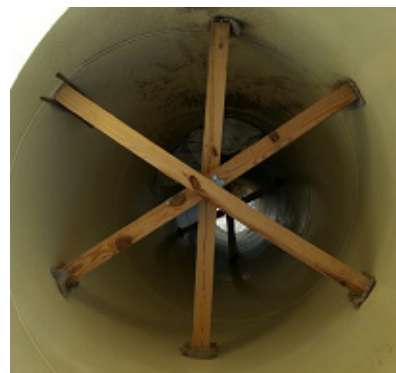
For pipe cylinders with lower stiffness or a high D/t ratio, 3-stull sets oriented in a 60° configuration, commonly called a spider, are often used. In some cases, the vertical stull may be larger than the other 2 stulls in the set, Figures 3a and 3b.

Figure 3a, b: 3-Stull 60° Spider

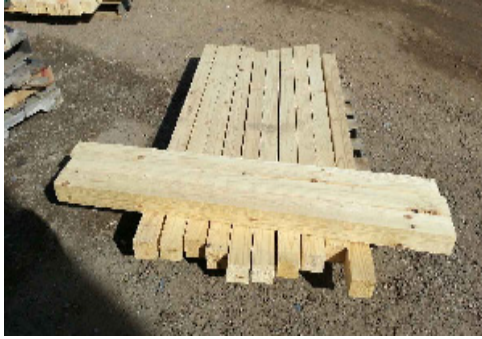
The placement of stulls is a relatively simple process. Figures 5 thru 14 show the installation of a stull set for a 66-in ID steel pipe with polyurethane lining and coating. This particular joint, when complete, will have 4 sets of stulls with 3 legs each. The lumber is first cut to length, Figure 5, typically just shorter than the inside diameter of the finished cylinder with the lining in place. Once the location is identified on the inside of the pipe, Figure 6, the vertical stull is fitted into place, often with a rubber mallet or small sledgehammer to ensure the lining is not damaged, Figure 7. Sometimes wood wedges or shims are used to adjust the length of the stull and to ensure the stull leg is firmly in place and will not fall out on its own if the pipe were to flex upon movement. For polyurethane or epoxy lined pipe, carpet is used on the ends of the stulls to protect the lining during shipping.

Figure 5: A pallet of stulls ready for use

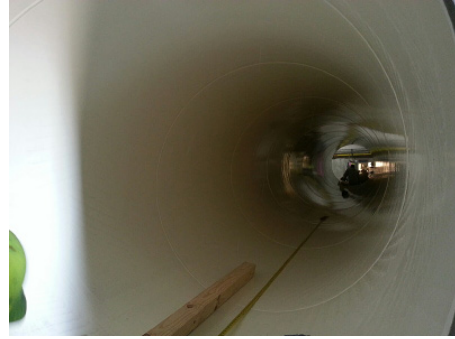
Figure 6: The location of the inside stull is determined

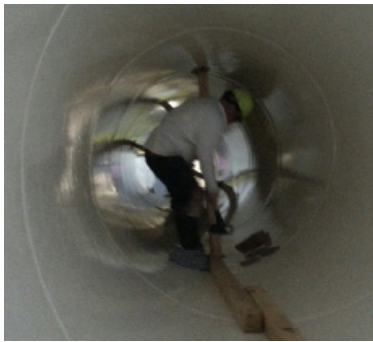
Figure 7: The Vertical stull is fit into place

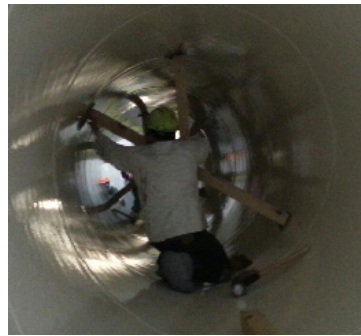
The subsequent legs are then fitted into place, Figures 8 and 9, again with firm contact to the inside of the pipe but not so roughly placed as to adversely affect the shape of the cylinder or to damage the lining in any way. In some cases, these stulls are then connected at their centers with wood screws or using a piece of angle iron and nails, Figure 12. Subsequent stull sets would then be placed inside the pipe in the same manner, keeping the vertical and horizontal orientation consistent throughout, Figures 11 and 13.

Figure 8: 2nd Leg is placed 60° from vertical

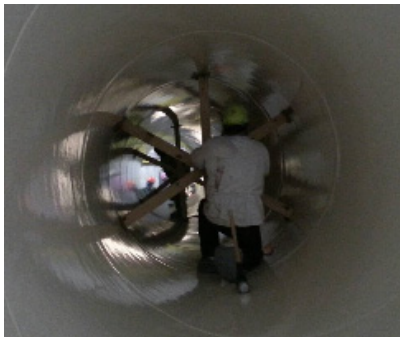
Figure 9: The final leg is placed, supporting the full circumference of the cylinder

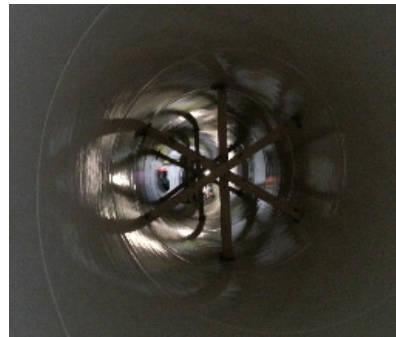
Figure 10: Two inside stull sets are visible

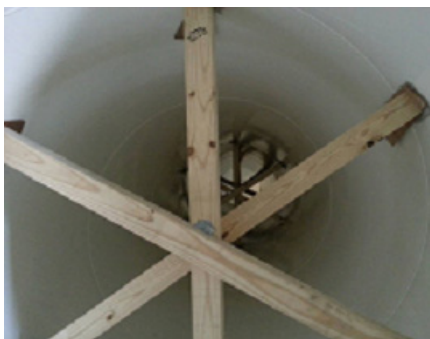
Figure 11: All four sets, with consistent orientation throughout the cylinder

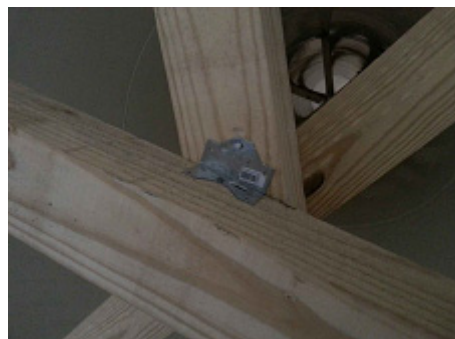
Figure 12: Angle and nails to connect the stull legs

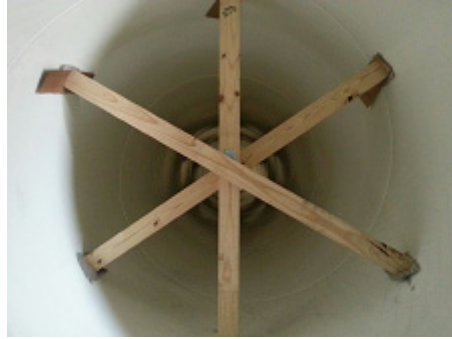
Figure 13: Completed assembly down the length of the cylinder

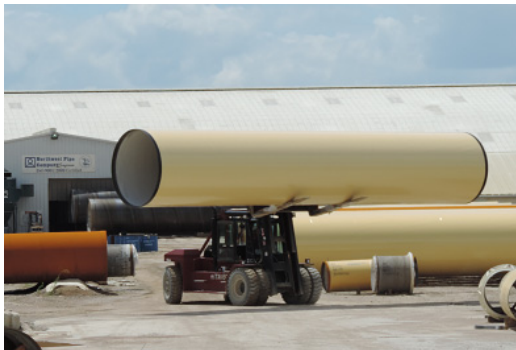
Figure 14 shows 108-in pipe being transported on padded forks. Figure 15 shows the inside of that same pipe joint, just prior to the end cap being installed. Bolts are used in this particular set but simply nailing the centers together has also proven effective. Figure 16 is a close up of the feet used for this particular stull configuration. The stull feet aren't always necessary but they do help ensure proper sizing of the stulls and create a larger bearing surface on the inside of the pipe joint for increased stability.

Figure 14: 108" pipe on padded forks in manufacturing facility

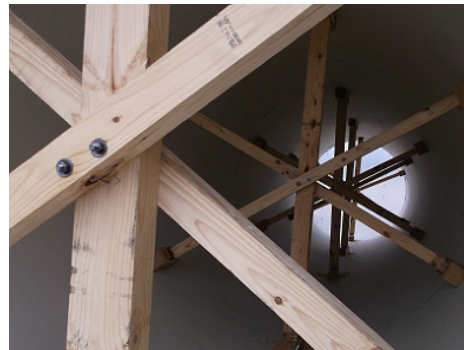
Figure 15: 5 sets of a 3-stull spider configuration

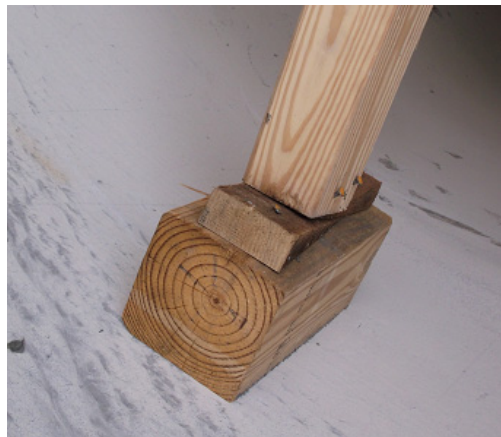
Figure 16: Support feet at the end of each stull

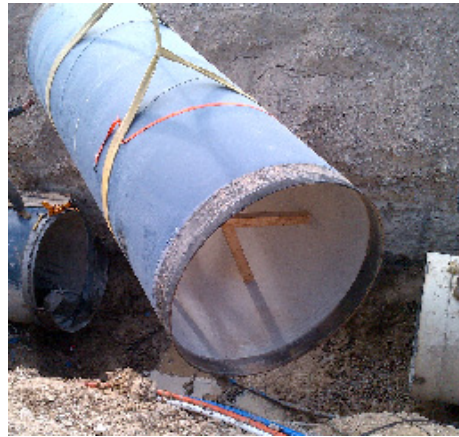
Figure 17 shows a 66-in pipe joint as it is being placed in the trench. In this photo the stull can be seen near the end of the pipe, used to keep the joint within applicable tolerances.

Figure 17: 66-in pipe joint being placed in the trench

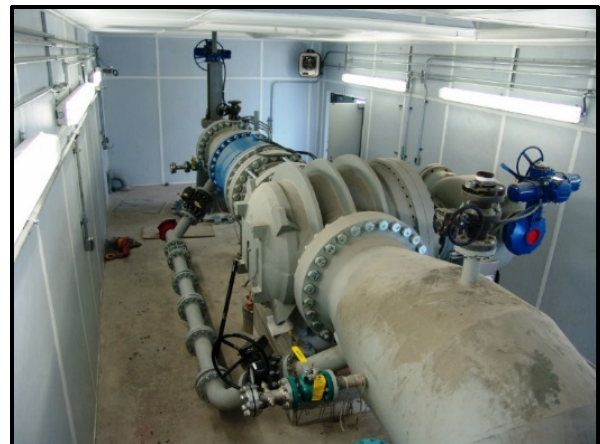
FIGURE 3. Hobbble Creek Station valve room. The sleeve valve is below floor at the back of the photo.

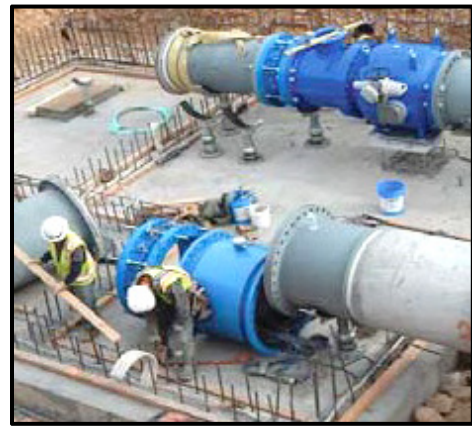
The 400 North, Springville and Upper Hobbble Creek (see **Figure 4**) Stations, deliver 35, 70, 125 cfs respectively, to downstream pipes with low-head (6 to 8 psi). Each has plunger valves to handle high flows and low back pressures. The two Springville Station valves, originally in the Upper Hobbble Creek Station, especially had adverse downstream cavitation which would have required 42-inch plunger valves, so to reduce valve costs, the two valves were moved downstream to a separate vault to increase backpressures and downsize valves to 28-inches.

FIGURE 4. Above right is Upper Hobbble Creek Station valve room being built with 36-inch process lines. The plunger valve discharges up to 120 cfs discharge to a low head basin.

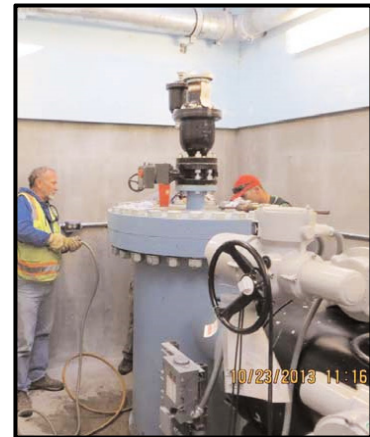
**FIGURE 6.**

Above right is an inside view of one of the 16-inch automated blow-off valve vaults.

Addressing Risk of Pipe Breaks in Cities. The ULS high pressures (330 to 450 psi) in city streets generated comments of concern from the cities through with the pipelines passed. The risk of pipe break is extremely low due to it being well protected by features such as the top of pipe being typically 11 to 18 feet deep (below sewers), and the double welded steel pipe is thick (0.6 to 0.7-inches) with double coatings (mortar and dielectric) with cathodic protection. However to further reduce risk, CUWCD prepared an emergency action plan and added remote controlled 16-inch blowoffs at large storm drains to supplement the 120-cfs draining capacity provided at the Hobble Creek Station. These are located in the hydraulic profile (see **Figure 2**) and in **Figure 6**.

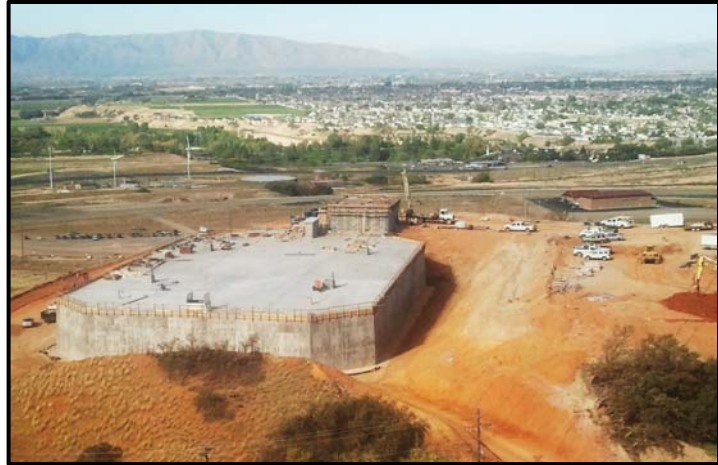
FIGURE 7

The 6.7 MG Mapleton Tank was sited to remain over 50 feet from a splay of an active fault. The active fault runs beneath the row of cars on the right of the tank. This photo was taken just before leak testing and burying the tank. The ULS field office is in the back upper right.

Addressing Fault Risks at Mapleton Springville Tank. As part of the ULS, the 6-mile long Mapleton -Springville Canal was piped. A 6.7 MG regulating tank (see **Figure 7**) was added in between the 320 psi ULS pipeline and the 80 psi Mapleton Irrigation System. A hill by the juncture of these two systems was investigated for the tank site and found to include active faults. However, through literature study, and field geologic explorations (several trenches and holes), the fault locations were well documented and the tank site was located with minimum risk on the uphill side of the located faults.

Several provisions were made to increase the system reliability, and to reduce risks of both the tank and the inlet-outlet piping. These included:

- the tank was designed with an underdrain system with 23 “cells” to monitored drain pipes
- foundation soils which might consolidate were removed and replaced with concrete fill
- a high head shutoff valve was built on the 320 psi inlet pipe upstream of the fault
- the flow control station breaking head to the tank was built monolithic with the tank
- a 42-inch HDPE pipe was built to drain the tank to the pigging pond in an emergency
- remote controlled isolation valves to the 54-inch Mapleton Pipe and 42-inch drain were provided in vaults built monolithically with the tank

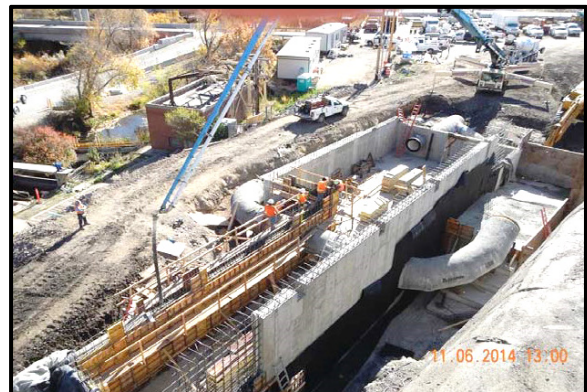
**FIGURE 8**

The Orem 1B Station is the terminal connection station which delivers flows from the 60-inch ULS pipe into the 126-inch PRA pipeline. The station is right beside the Wasatch Fault but is founded on hard bedrock to protect it from significant damage in a fault movement event.

For these reasons, the Orem 1B Station was moved down the hill onto the hard limestone bedrock east of the fault and beside the Provo River and PRA connection. This added more costs for valves but reduced land costs and offsite access costs. More importantly, it put the station on hard rock foundation which would minimize station damage during a fault movement. The Orem 1B Station is shown at the base of the hill in **Figure 8**.

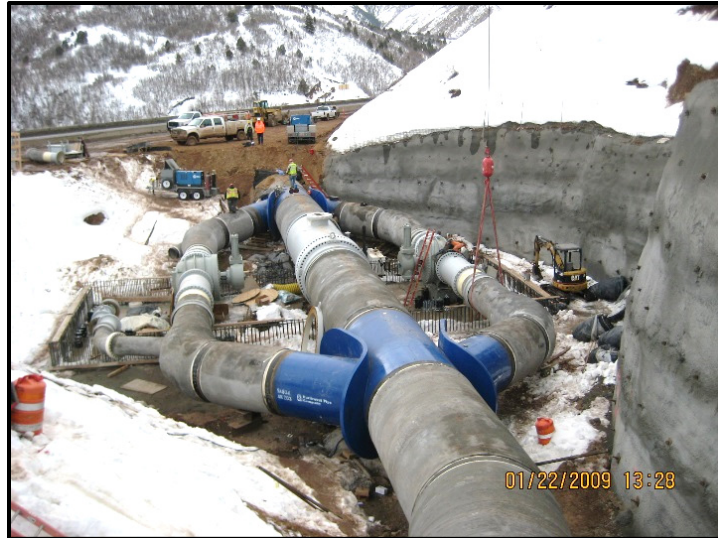
FIGURE 9

The SFFCS valve station at right is shown under construction. This station connects the Diamond Fork and Utah Lake Systems and allows passage of a 96-inch pig through the station.

Addressing Landslide Risks by the SFFCS Station. Due to the need to cross a landslide prone formation at the top of the Utah Lake System, an isolation valve vault (**Figure 9**) was built to allow the system to deliver water through the Spanish Fork River Flow Control Station if the ULS pipeline were to be ruptured due to a landslide.

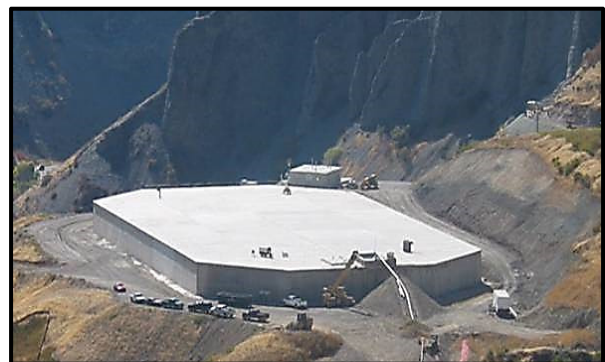
FIGURE 10

At upper right, the 10 MG Olmsted Tank is shown before backfilling. It was constructed as part of the Olmsted System 12 years ago. Because it is at the ULS downstream connection, it is able to provide operating storage for the Utah Lake System also.

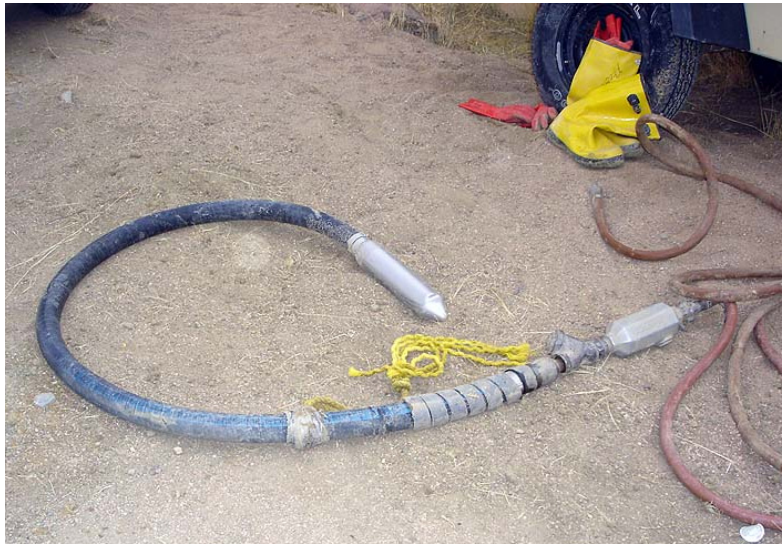
Internal vibrators are also known as stingers, concrete vibrators, or wiggletails. The depth of effective compaction is only limited to the length of the vibrator. A pneumatic vibrator used by a contractor on a Denver Water Board project is shown as Figure 2. Note the solid vibrating head and the flexible shaft.

Figure 2 Internal Vibrator Used on Denver Water Board Project

A concrete vibrator was used as illustrated earlier in Figure 2. The rigid pipe insert is shown in Figure 5.

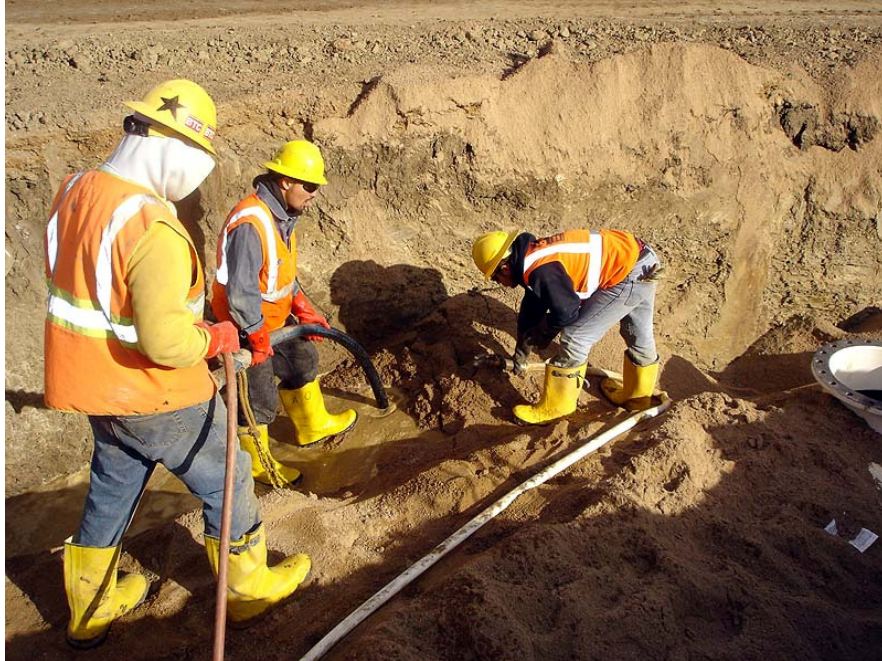
In 1960 Denver Water began to use clean sand around pipe in the pipe zone for pipe with a diameter larger than 24 inches. This embedment was compacted by jetting and vibrating. Denver Water refers to the method as *jetting* because the contractors typically use a separate rigid pipe that is placed down into the sand adding water to facilitate the compaction as the particles of sand were moved around by the vibration. The procedure is illustrated in Figure 4. The inserted vibrator is shown on the left side and the jetting pipe on the right side of the photograph.

Figure 4 Using Jetting Insert and Vibration on Denver Water Board Project

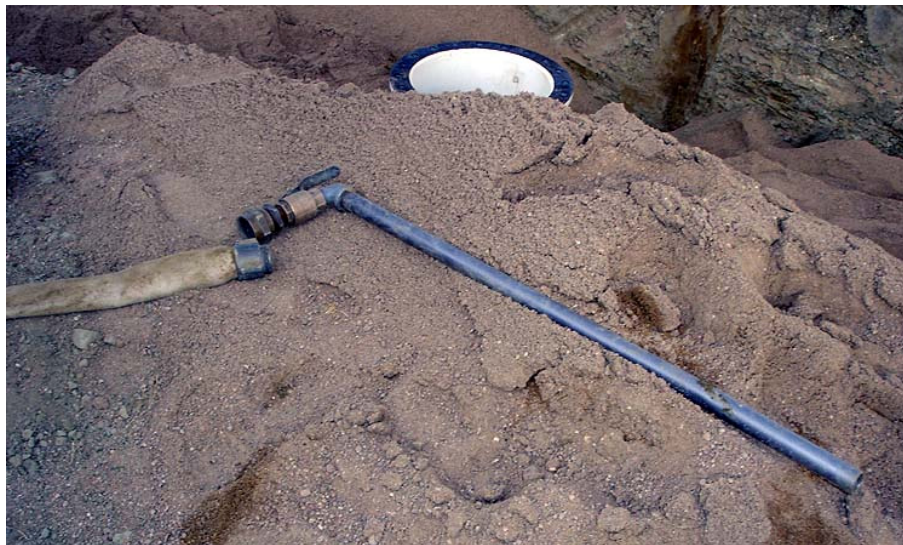
Figure 5 Rigid Insertion Tool for Jetting Water for Denver Water Board Project

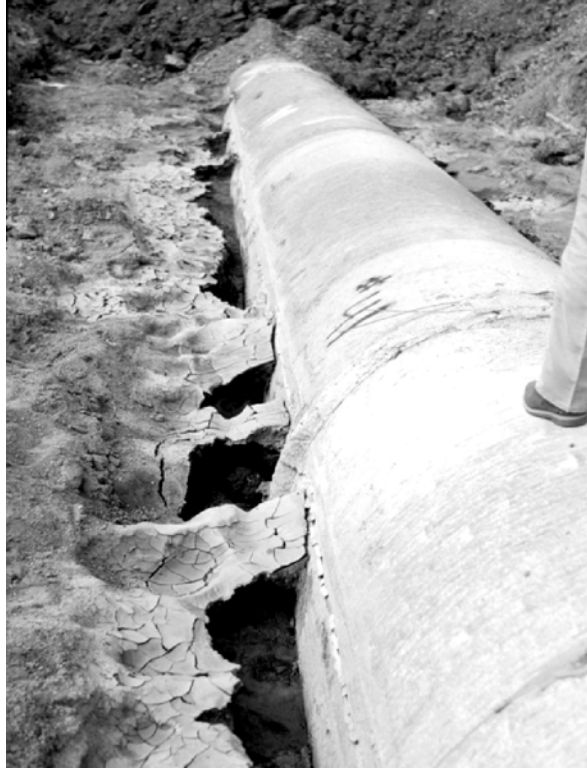
The results of the first attempt by a contractor inexperienced with saturation and vibration is shown in Figure 6. There were too many fines in the soil used as evident by the crust on the surface. The contractor ordered the material appropriately with 5% fines or less. However the aggregate processing plant sent the wrong material. Once the correct soil was being used, he successfully completed the job.

Figure 6 Too Many Fines for Saturation and Vibration

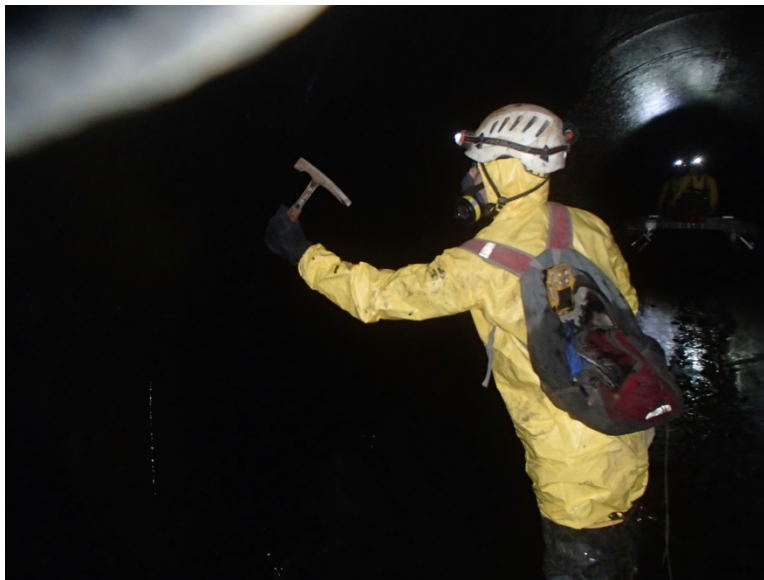
Visual and sounding inspections are used to detect pipes in a state of incipient failure. During the visual and sounding inspections, the interior of the Sayreville Relief Force Main was inspected for cracks, spalls, and other signs of distress. Additionally, a steel rod was used to strike the interior surface of the pipes to detect hollow areas. It has been shown that longitudinal cracks at the springline with carbonate staining, hollow areas, and especially a combination of the two, can be indicators that a pipe is in a state of advanced distress (Lewis and Wheatley). Figure 1 shows an inspector sounding during the 2013 internal inspection.

Figure 1. Inspector Sounding the 102-inch Force Main

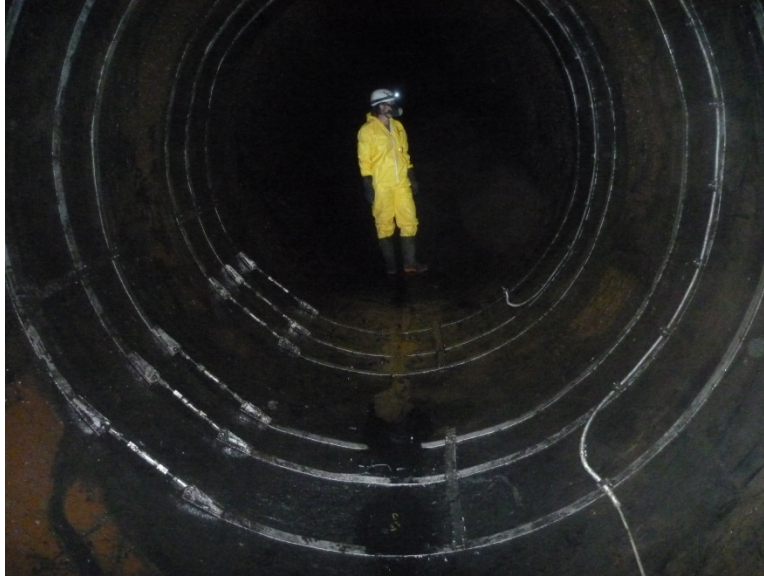
Following the 2008 and 2013 inspections, new acoustic fiber optic (AFO) systems were commissioned in the Sayreville Relief Force Main. Unlike the SMS system, fiber optic cable was installed along the entire length inside the force main. Wire wrap breaks can be recorded at any point along the cable and the information about a particular break is transmitted back to a processing computer along the pipeline. Figure 2a and Figure 2b show internal and external views of a splice point at a manhole in the current MCUA AFO system. At splice points, runs of fiber optic cable from different portions of the pipeline are connected to create one continuous system.

Figure 2a. Internal AFO Splice Point at MCUA

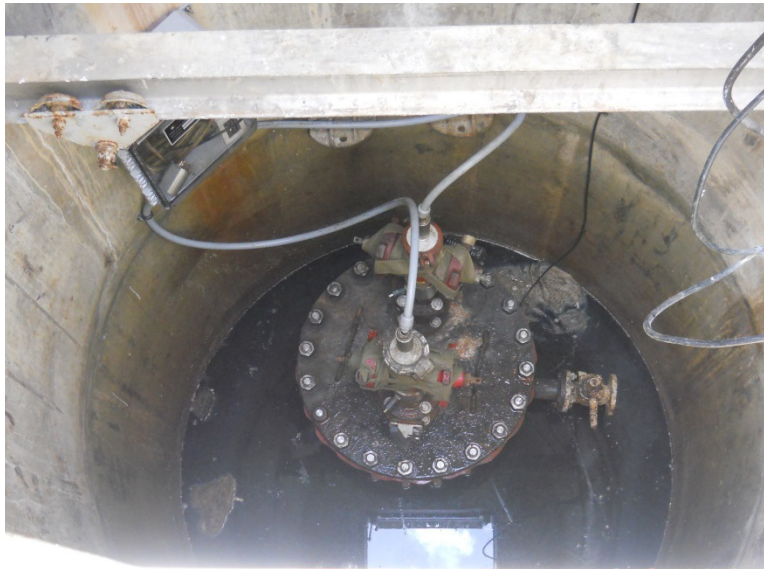
Figure 2b. External AFO Splice Point at MCUA

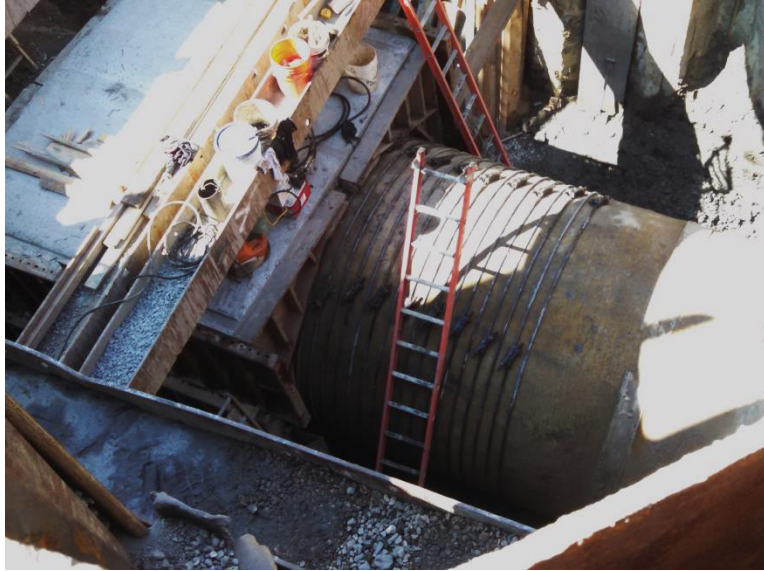
As a result of the assessment program, MCUA has proactively rehabilitated 15 pipes using post-tension tendon repairs. These repairs involved excavating the pipe in question and wrapping seven-strand tendons around the outer circumference of the pipe. These tendons act to keep the concrete core in compression even with broken prestressing wire wraps. The pipes are then encased in concrete to provide an additional layer of protection. Figure 4 shows a tendon repair of a pipe in the Sayreville Relief Force Main.

Figure 4. Tendon Repair of 102-inch PCCP

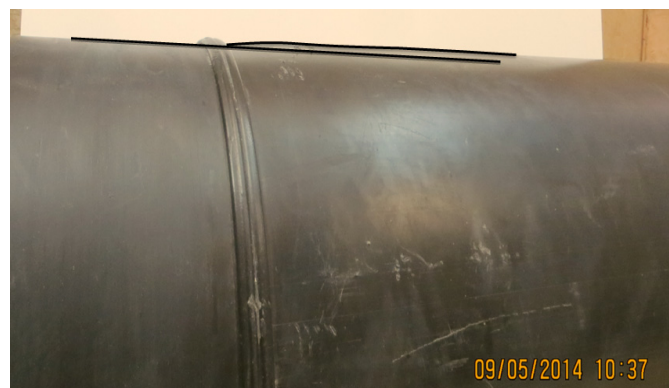
After three months (September 2nd), the pipe sample was no longer expanding along the length, and expansion of pipe sample started to stabilize along the diameter.

Figure 4. Pipe bulge near middle joint.

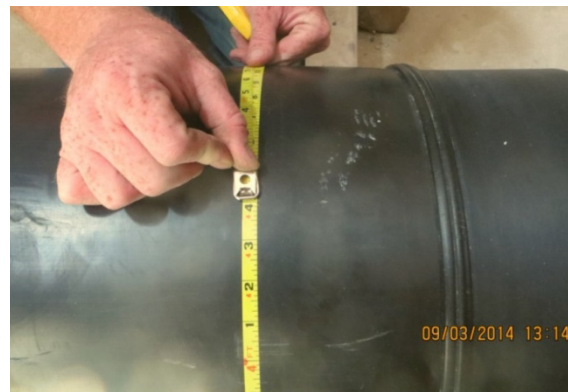
Figure 5 illustrates length measurement locations. Initially, no expansion along the length was observed. After three months, it was observed that as pipe sample diameter increased, length decreased. The length decrease continued until 1.52 million cycles, and after that the pipe length basically remained constant. Figure 6 illustrates the circumference measurement.

Figure 6. Circumference measurement.

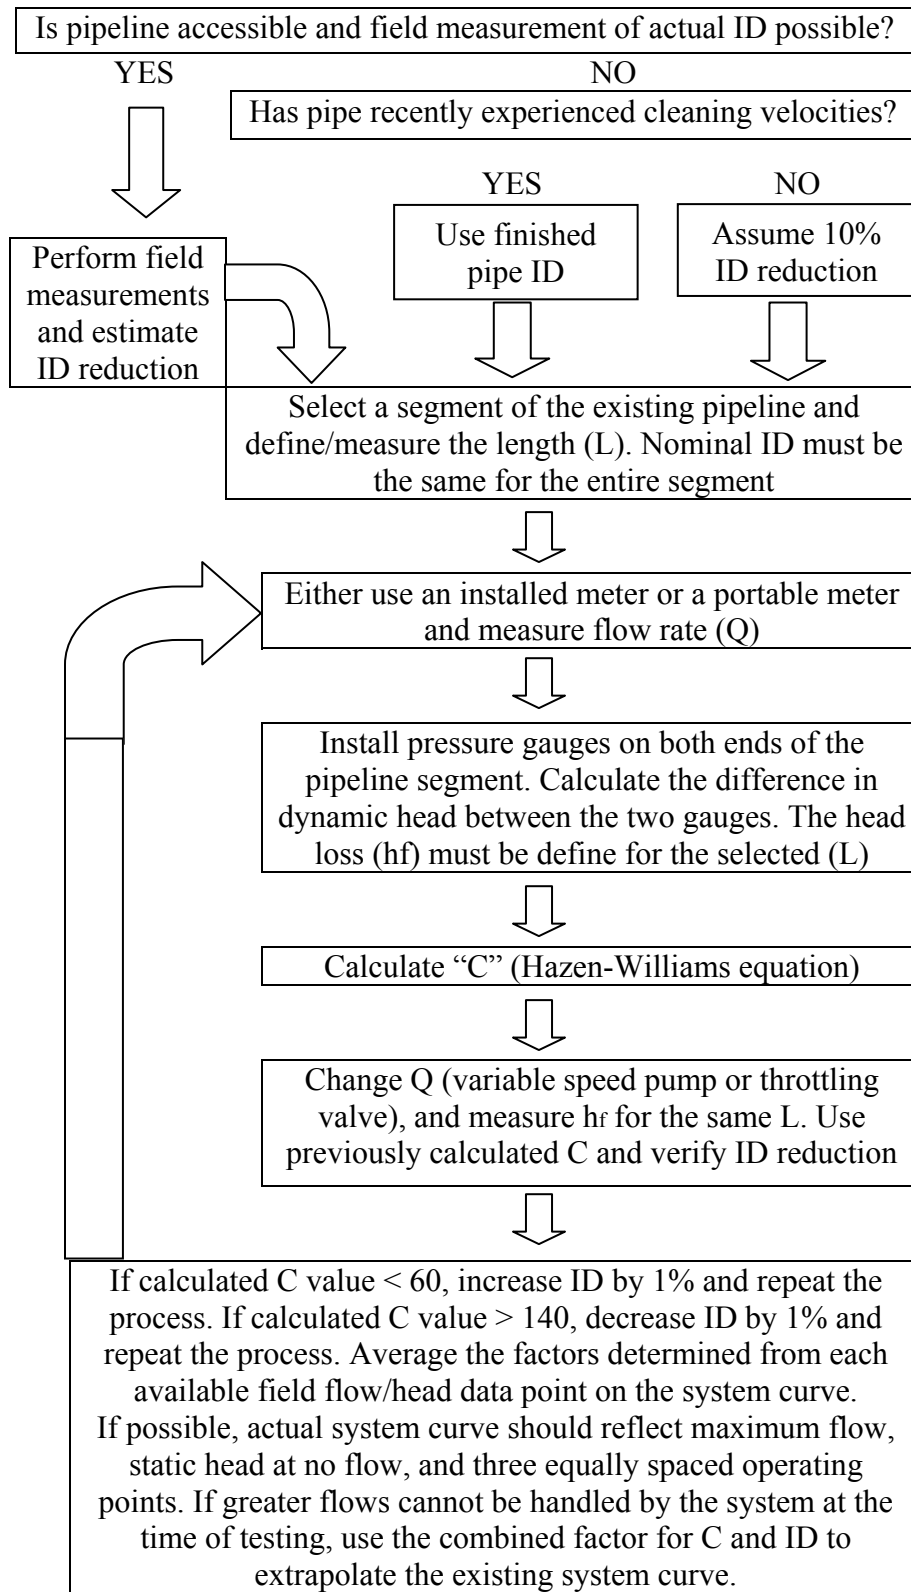
This paper proposes an experimental process shown in Figure 4 for existing systems.

Figure 4. Experimental process flow diagram.

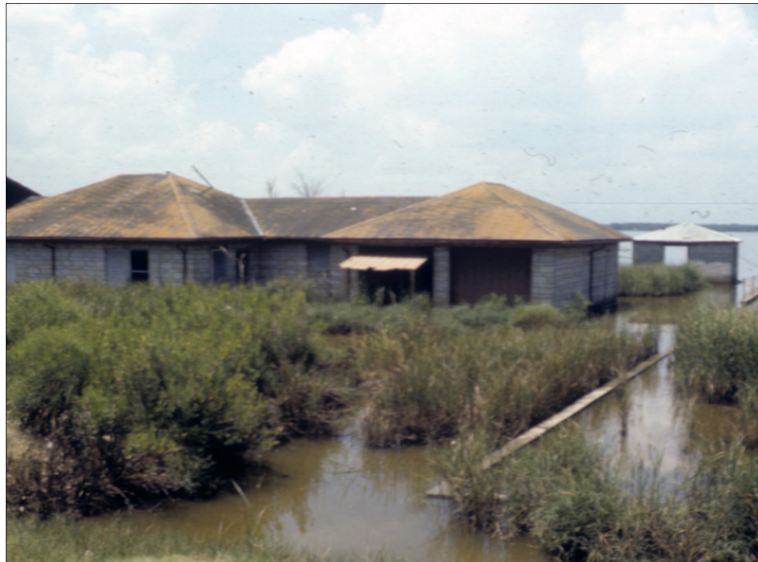
House in abandoned Brownwood development

Figure 5 – Examples of subsidence near Baytown, Texas.

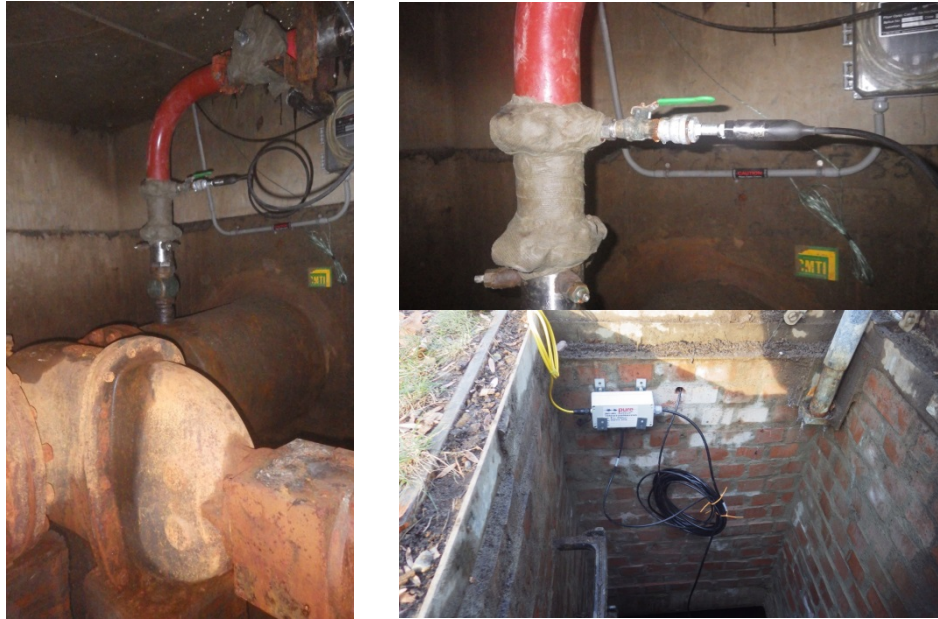
Equipment Installation. The transient pressure monitors were connected to the pipelines via a maximum 76.2 mm (3 inch) tap and then a reduced 19.05 mm (3/4 inch) tee tapped into the approximately 304.8 mm (1 foot) long 76.2 mm (3 inch) diameter spool piece. A ball valve, vent/drain, and analog pressure gauge connection are also provided. The Telog LPR-31i and PR-32iv pressure sensors connect directly to the reduced 19.05 mm tap. The Telog HPR-32iv connects directly to a charged fire hydrant via a 3.5" National Hydrant Thread (NHT) connection. The Syrinix TransientMinder pressure sensor is housed in the transmitter body and connects to the reduced 19.05 mm (3/4 inch) tap via a 2,000 mm long, 19 mm diameter air hose.

Figure 2. Telog PR-32iv Wireless Transient Pressure Monitor Installation.

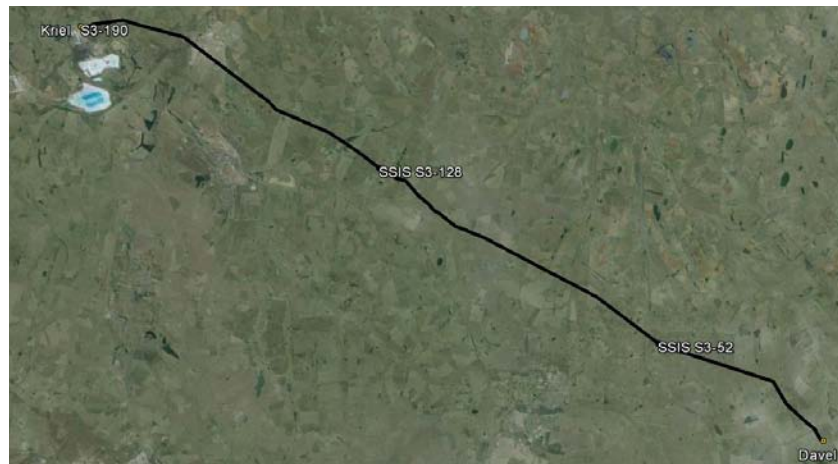
The pipeline starts at the Davel Reservoir complex and discharges into the Kriel Power Station raw water storage reservoir under gravity. Figure 2 shows the layout of the pipeline as well as the location of key points along the route where field measurements were taken.

Figure 2: Davel-Kriel layout and field verification sites

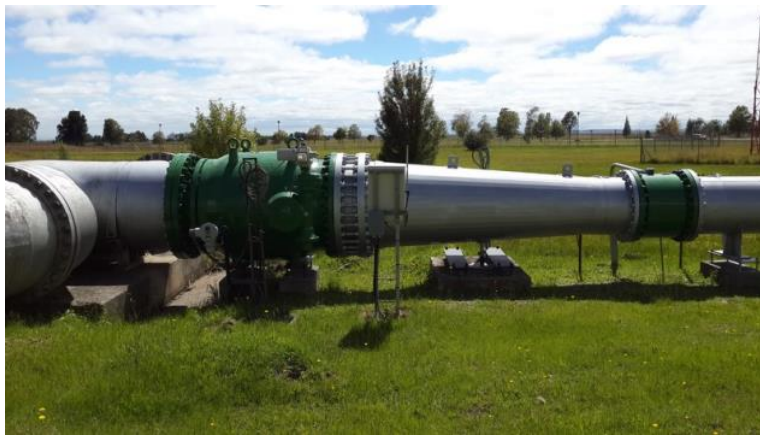
Figure 4: Kriel Reservoir inlet control valve

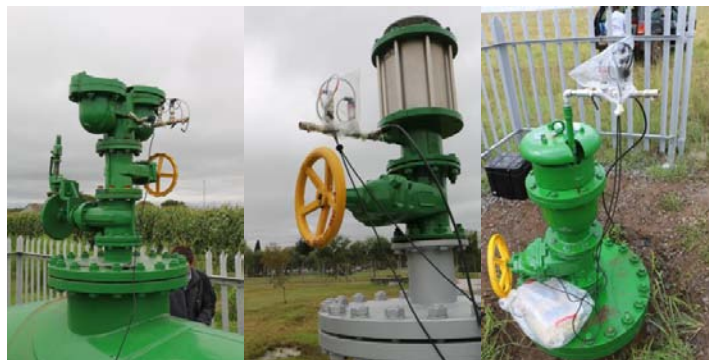
A typical pressure logging site arrangement on the Davel-Kriel pipeline is illustrated by Figure 6.

Figure 6: Typical pressure logging site arrangement

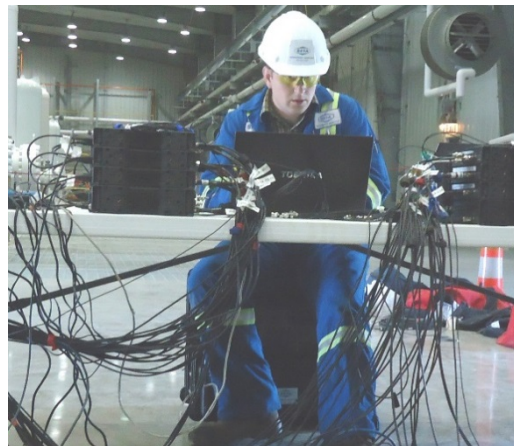
Figure 1. Example of data collection equipment required to measure transients' vibrations on hundreds of simultaneous test points

Figure 1 shows a temporary instrumentation setup to measure transient vibrations at hundreds of test points simultaneously at a pipeline pump facility. A setup like this allows for the collection of many points at facilities with limited transient test opportunities.

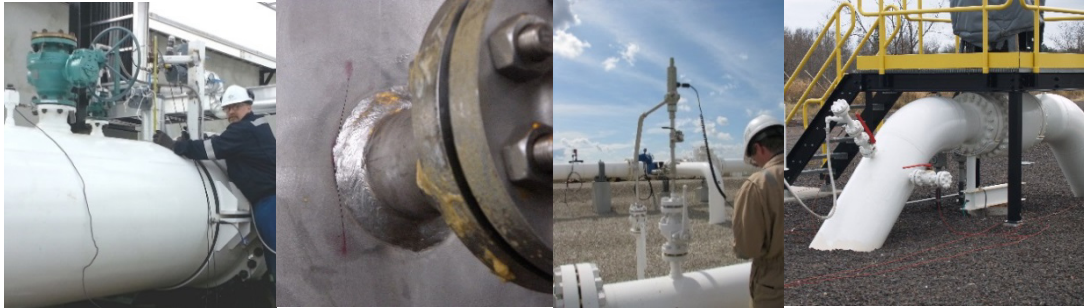
An SBC is defined as a branch connection on the mainline piping that is NPS 2" and smaller. For larger bore pipes (above 24"), connections of up to NPS 4" are also considered to be SBC's. They come in the form of instrumentation ports, vents, drains, inspection ports, and more. Some examples are shown in Figure 4.

Figure 4. Examples of small bore attachments in pipeline systems.

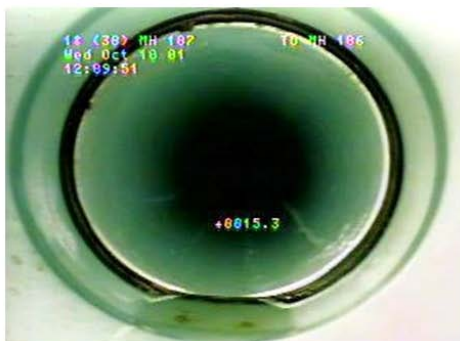
Polyvinyl Chloride (PVC)
Smooth walled plastic generally green or white.

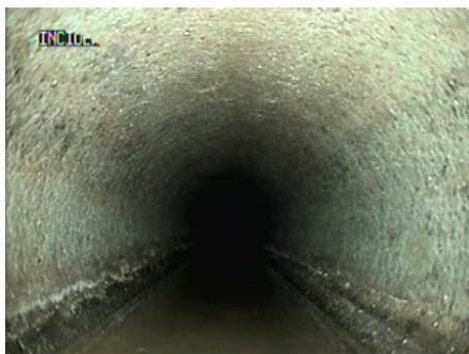
Asbestos Cement (AC)
Can look similar to concrete pipe (CP). However the primary difference is in joint length. AC pipe is comprised of asbestos fibers and cement, while concrete pipe is comprised of aggregate and cement.

Figure 4. Pipe Materials
