Pipelines 2015

Recent Advances
in Underground
Pipeline
Engineering and
Construction

PROCEEDINGS OF THE PIPELINES 2015 CONFERENCE

August 23–26, 2015
Baltimore, Maryland

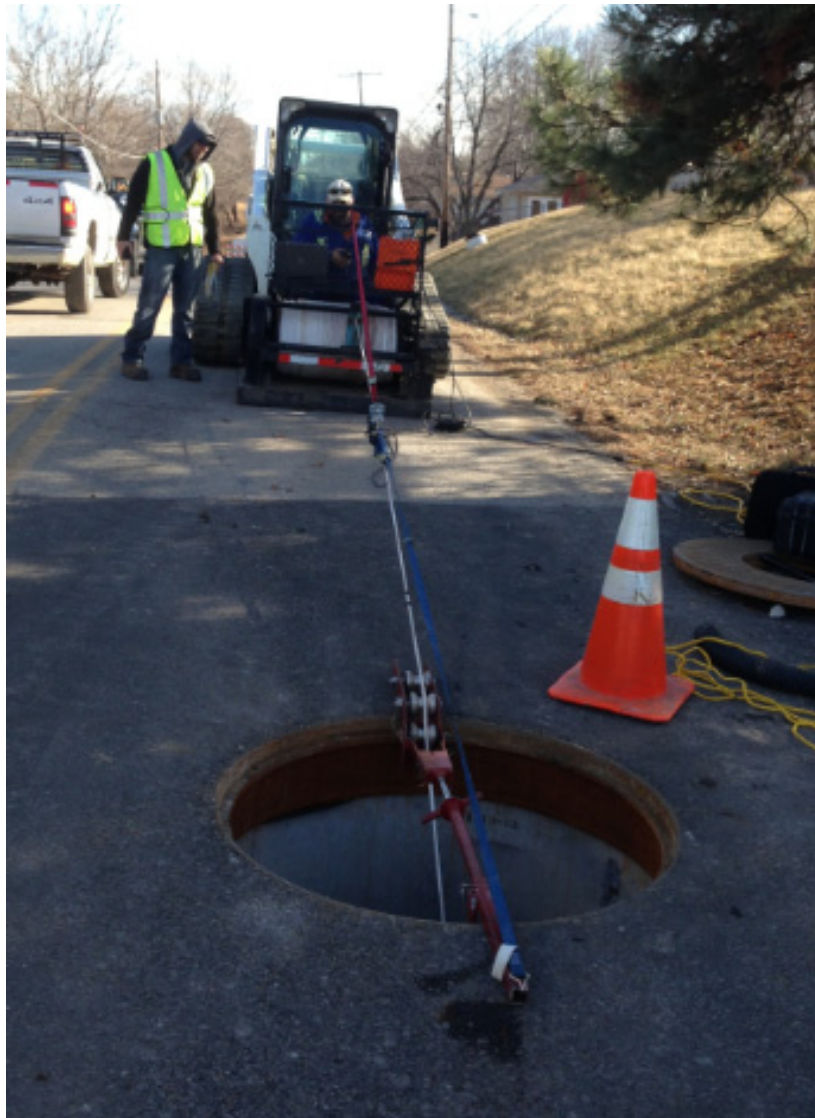
See Figure 3 for the winch configuration. The winch rope was tied to the tag line and pulled back to the insertion point using a truck. Caution was taken in this process because occasionally the tag line would get hot near the fittings and would break from the friction. It is recommended that a heavier tag line be used because the 1,200 lb. line was problematic in a few locations and had to be manually retrieved in the pipe.

Figure 3. Winch Configuration for Inspection

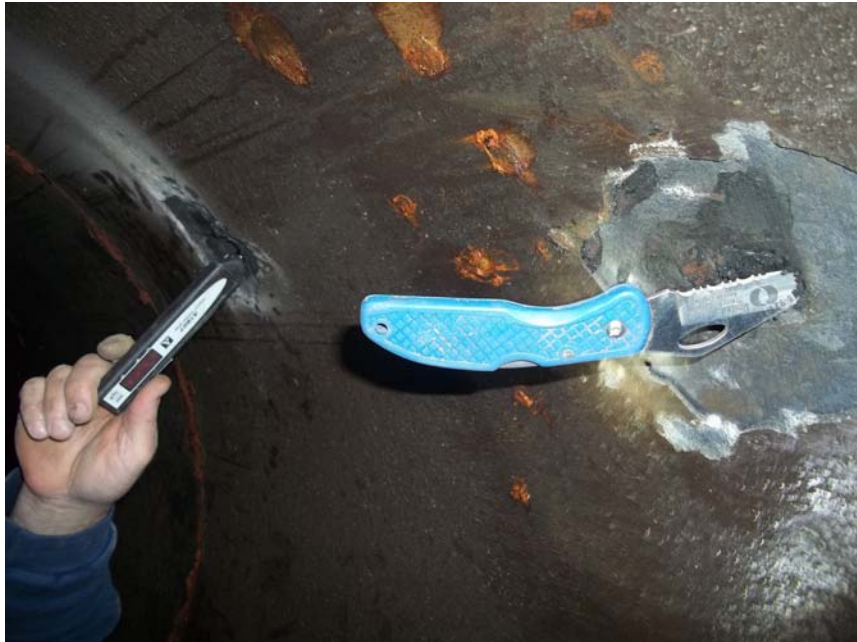
Figure 8. Verification of Remaining Wall Thickness

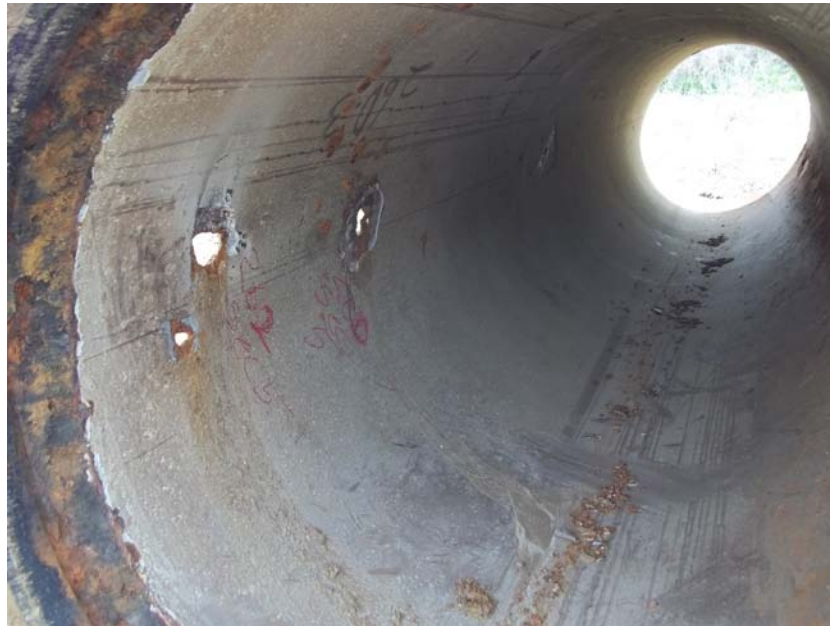
Some observations made during the repairs were: corrosion pits were typically near the 12:00 position on the pipe, approximately one ft. from the end of the pipe segment, and usually under the edge of a road or near the shoulder of pavement. A reason could possibly be the corrosive nature created from the treatment of the roadways during the winter season. This hypothesis seems plausible because in past experiences with other water mains the corrosion locations were usually on the bottom (6:00 position) of the pipe from “hot” soils. Another possible cause of the observed corrosion is a lack of conductivity between joints causing localized electrolysis, but this theory is without a known stray DC current source.

Figure 9. Pipe Section with Multiple Corrosion Spots

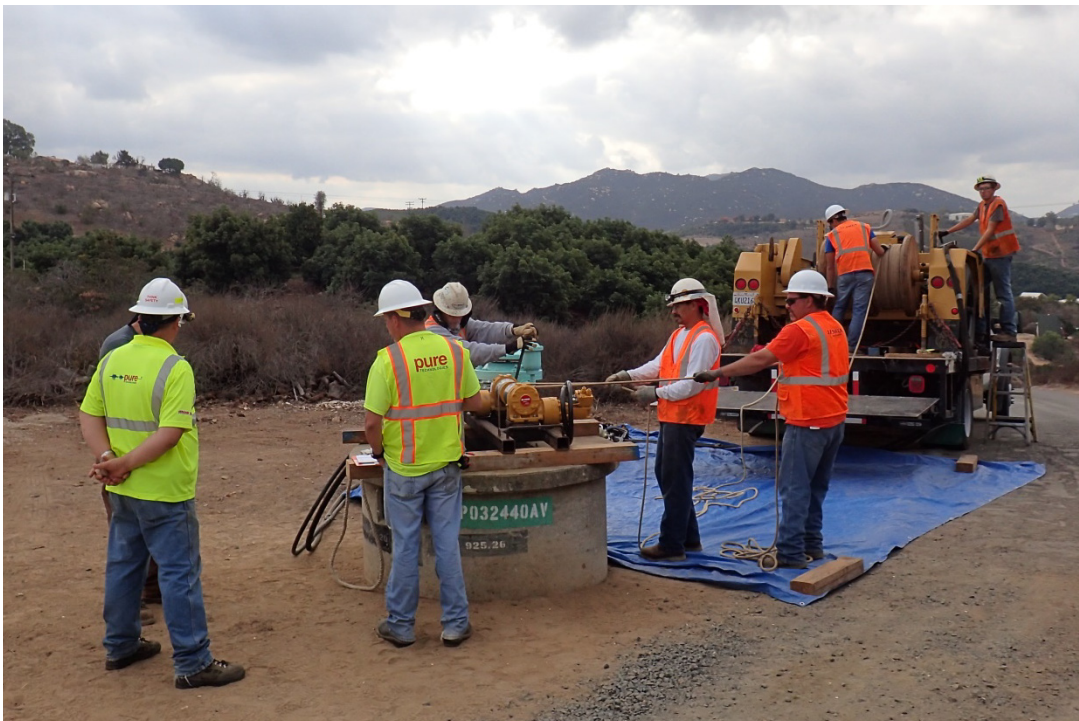
The steep terrain along the alignment of the pipeline was another challenge, overcome by adopting an external winch crew to pull the MFL tool where supporting equipment was unable to be self-propelled. Grades of up to 31 degrees were negotiated.

Figure 3. Winching of MFL tool

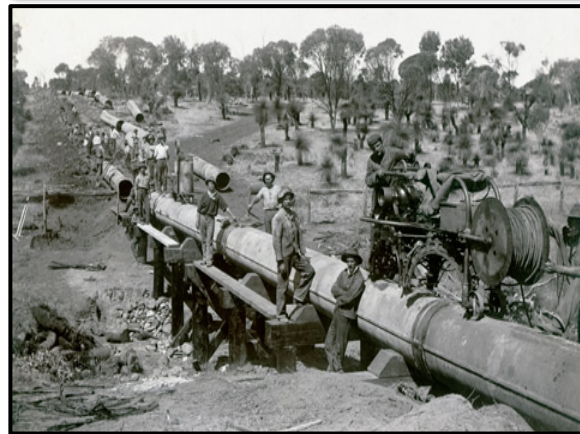
Figure 2.

- A. Fabrication of lock-bar steel pipe.
B. Laying of lock-bar steel pipe.**

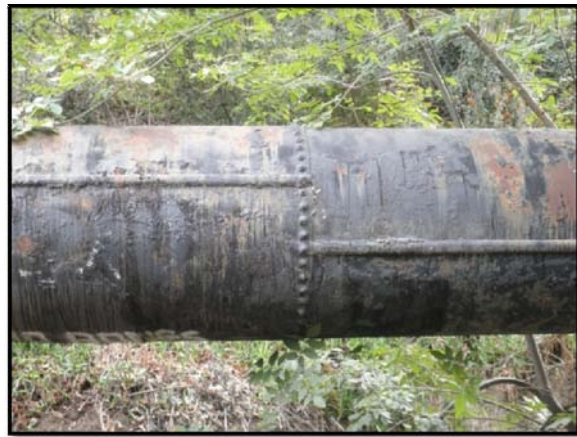
Figure 5. Exposed sections of El Capitan Pipeline lock-bars, riveted joint, and coal tar enamel coating.

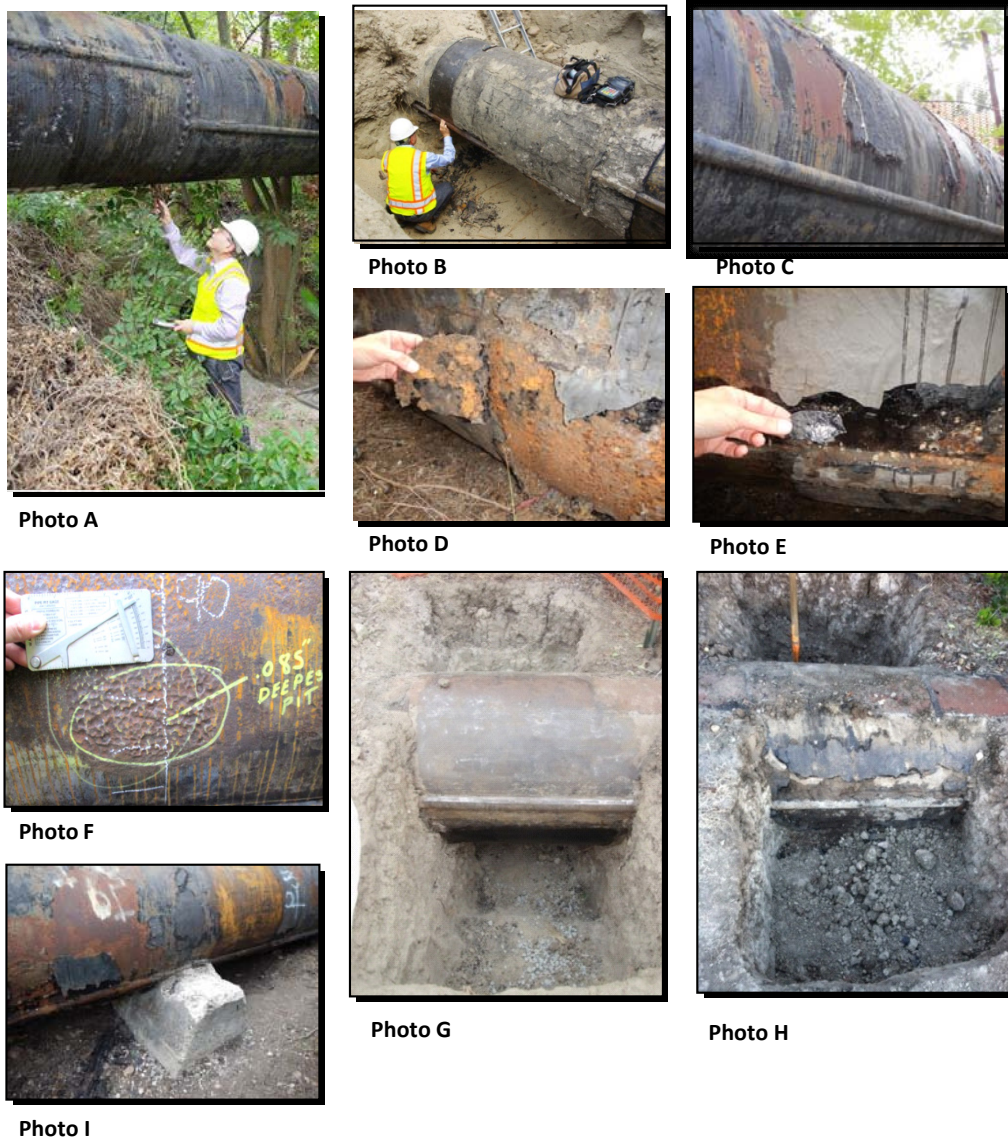
- The steel cylinder was in very good condition at excavated locations. Below are photos of a typical excavated location showing 1) the condition of the coating before removal, and 2) the condition of the bare steel pipe after the coating was removed (see Figure 6, Photos G and H). There was evidence of some minor corrosion, but overall the pipe was in good condition.
- Most of the concrete supports were in poor condition and need to be rehabilitated (see Figure 6, Photo I).
- Wall losses of 5% to 17% of nominal wall thickness were recorded by ultrasonic thickness measurements. However, there was variability in the measurements, and the wall loss is relatively low, considering that the pipe is 80 years old.

Figure 6. Photos of external examination and pit depth measurements.

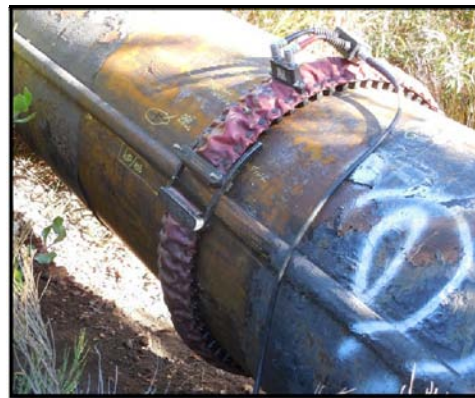
Guided wave testing (GWT) was conducted at three exposed pipe locations. In GWT, a collar of guided wave transducers is strapped on the pipe. The transducers must have direct contact with the pipe wall; hence, the coal tar enamel coating had to be completely removed at the GWT locations. The transducers introduce low frequency ultrasonic guided waves that travel axially along the pipe in either direction.

Figure 8. Guided wave testing on exposed reach near a riveted joint.

When the guided waves encounter changes in the cross-section or stiffness of the pipe (produced by welds, supports, corrosion, or other anomalies), reflections occur that propagate back to the transducer collar. The reflections identify areas of potential degradation that may require additional investigation. Typically, guided wave testing can cover 100-150 feet (30-45 meters) along the pipeline in either direction from the transducer collar, and the wave can also be transmitted through pipe that is buried. Figure 8 shows the guided wave testing in action.

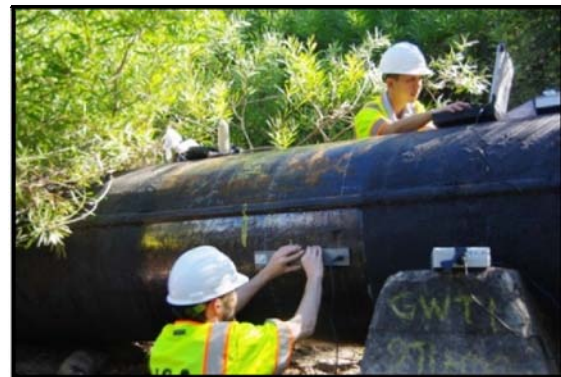
Broadband electromagnetic (BEM) testing was conducted at the same three locations where GWT was performed. BEM testing uses a scan of electromagnetic waves to produce a thickness profile of metallic pipe. The thickness profile is used to detect possible corrosion. The data is obtained using a handheld tool. The operator establishes a circumferential and longitudinal grid of 2-inch (5 cm) squares on the pipe, then moves the antenna around the grid, taking readings which are stored on a computer.

Figure 10. BEM scanning on exposed pipe section.

The results of the BEM testing were consistent with wall thickness measurements taken through UT testing.

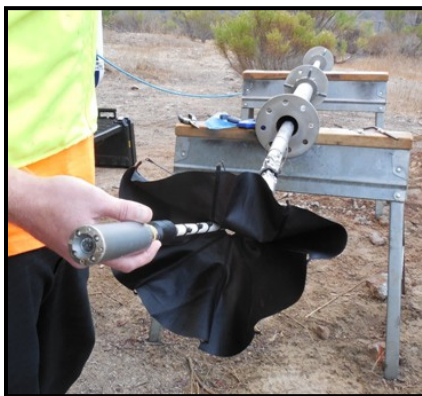
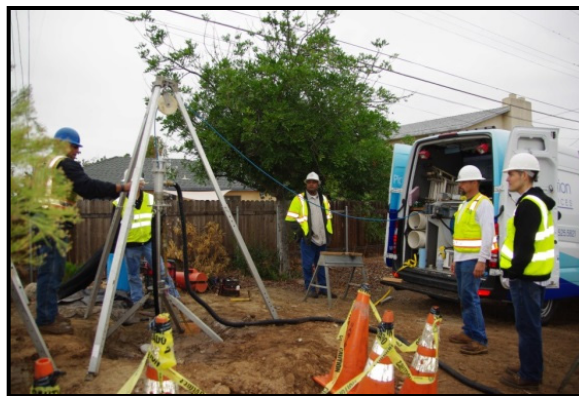
Figure 12. Left: Sensor head and drogue. Right: General setup for inspection.

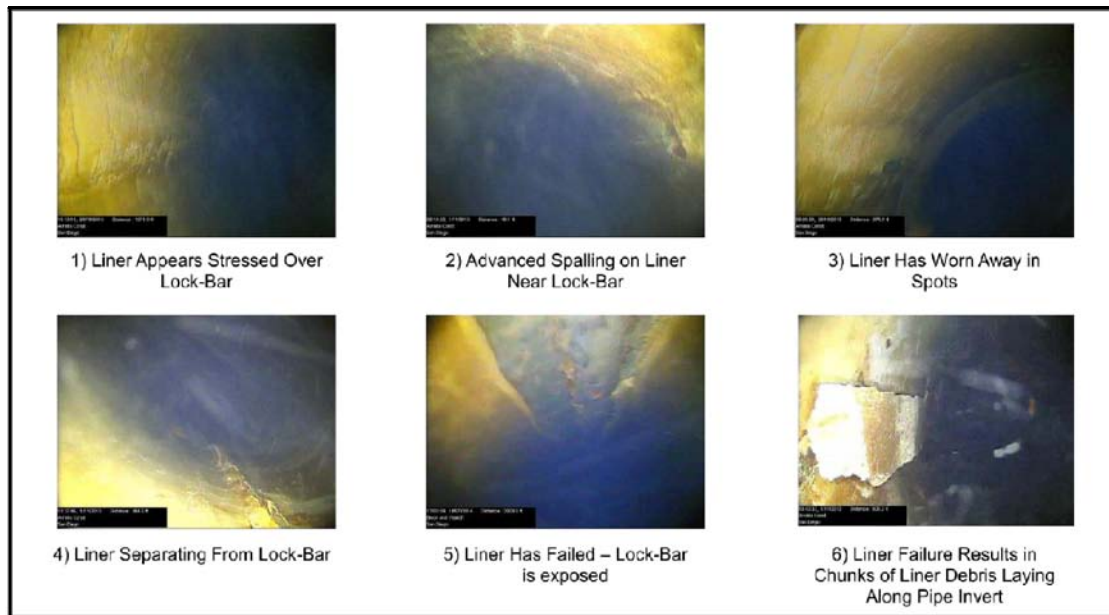
- No leaks were detected in the four reaches inspected.
- There were many minor defects and a few major defects in the lining of the inspected sections. The major defects consisted of large sections of mortar lining falling off the pipe interior, starting at the lock-bar joint.
- There were no joint defects observed in the inspected sections, other than some minor hairline cracks in the mortar lining at the joint.
- Based on the video inspection, the following still images in Figure 13 collectively illustrate the life cycle of liner failure in lock-bar pipe.

Figure 13. Six stages of lock-bar pipe liner failure.

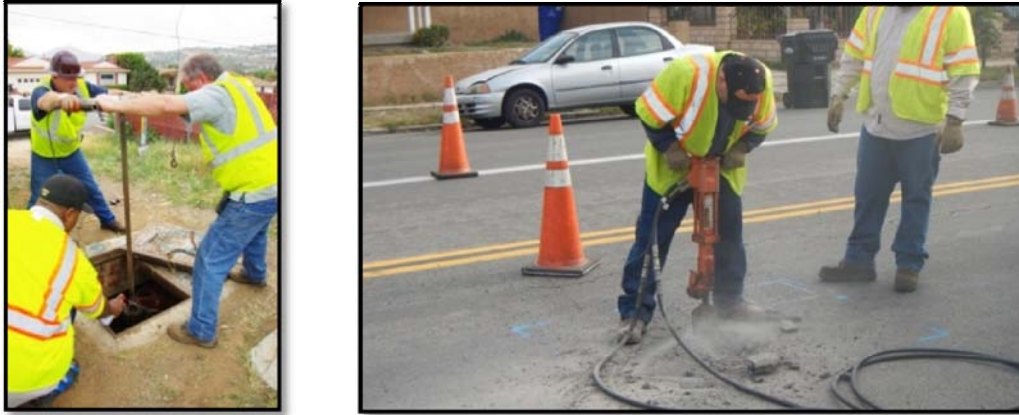
A comprehensive condition assessment of a transmission pipeline would not be complete without an inspection and assessment of in-line valves, side-line valves, and pipeline appurtenances (air valves and blow-offs). A valve assessment program, including exercising valves, documenting their location and condition, and repairing inoperable valves, establishes (or re-establishes) system control for distribution operators, which reduces the consequence of a pipeline failure. Wachs Water Services provided valve assessment, evaluation, documentation, and minor repair services as part of the condition assessment of the El Capitan Pipeline. A total of 96 valves were assessed – 47 in-line valves and 49 smaller side-line or appurtenant valves. Figure 14 contains photos taken during the valve assessments.

Figure 14. Left: Exercising an in-line valve with the help of City crews. Right: Uncovering a paved-over-in-line valve.

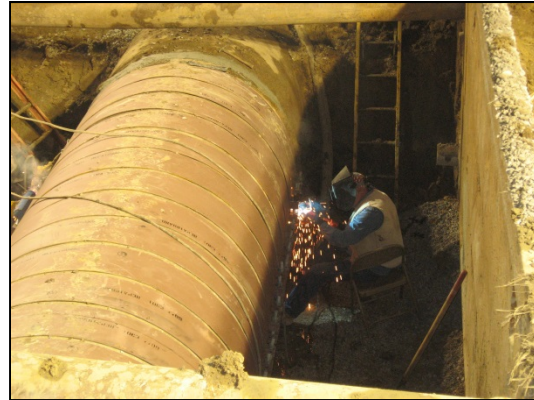
Figure 5 – Installed Repair Bands

There are concerns with the effectiveness of the band repair method. If the corrosion of the PCCP prestressing wires has migrated down to the steel cylinder, there is a chance the watertight barrier may be compromised in the future. In addition, the weight of the flowable fill introduces a new strain on the pipeline at the joints of the repaired pipe section and may cause issues in the future.

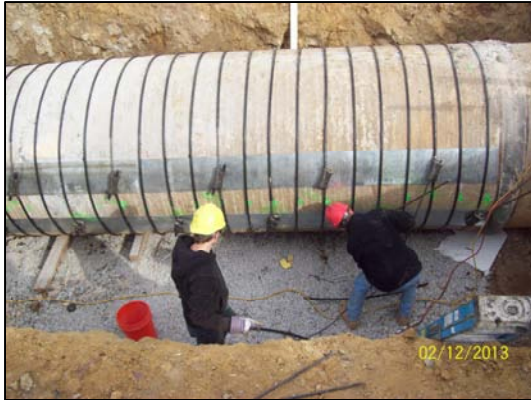
EPT has become the most popular method of rehabilitation at LWC for PCCP pipe sizes greater than 24-inch (600-mm) in diameter. LWC employs a consulting structural engineer to design the EPT system and calculate the necessary tension required. The prestressing of the tendons replaces the prestressing lost with the wire

breaks. Once the tendons are installed, the entire system is coated in shotcrete. To protect the system and encourage the shotcrete to cure at a faster rate, LWC has chosen to cover the rehabilitated pipe section with a double wrapping of polyethylene encasement.

Figure 6 – EPT Tendons Being Installed

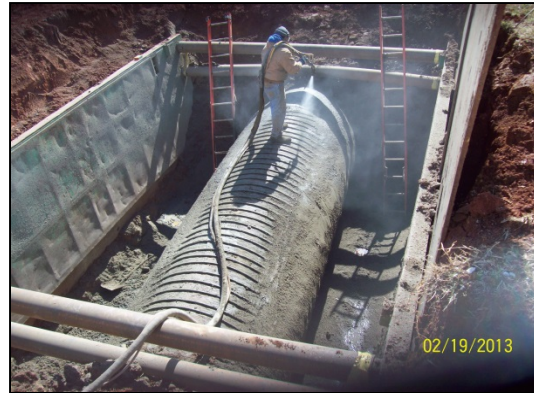
Figure 7 – Shotcrete Installation on EPT

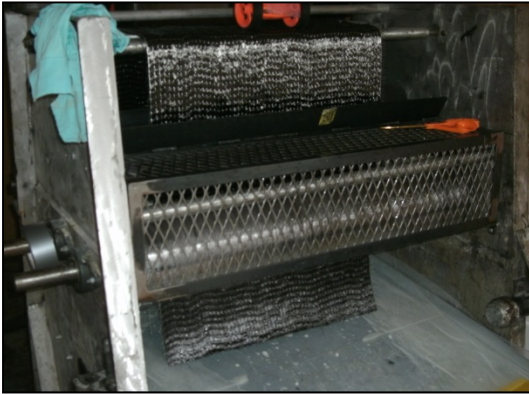
LWC employs a consulting structural engineer to design the CFRP system and calculate the proper epoxy resin, the number of carbon fiber layers, and to perform the necessary quality control testing during installation. Once the CFRP has been installed, a new independent watertight pipe section has been generated inside the existing deteriorating pipe section.

Figure 8 – CFRP Impregnating Machine

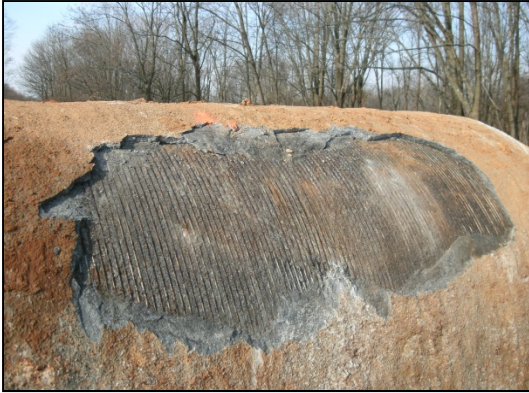
In some instances, a pipe section is damaged beyond repair and requires replacement. All PCCP pipe sections 24-inches (600-mm) in diameter or smaller are replaced if the distress is shown to be in the Repair Priority 1 or 2 by the structural engineer's risk of failure analysis. On larger pipe sizes, the damage to the pipe section must be widespread, have a possibility of negatively impacting adjacent pipe sections, causing the pipe to be out-of-round, or would be cheaper to replace than rehabilitate.

Figure 10 – Wide Spread Corrosion

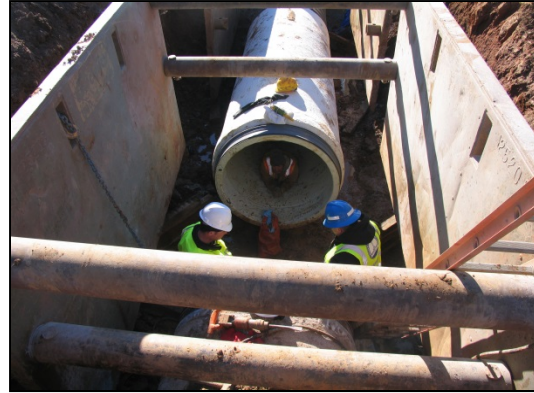
Figure 11 –Pipe Section Being Replaced

As the replacement of a pipe section is a highly intrusive operation that requires excavation, dewatering, replacement, filling, hyperchlorinating, flushing, and testing, the decision to do so is not taken lightly. LWC performs due diligence in determining the appropriate repair and/or replacement method to address distressed pipe sections.

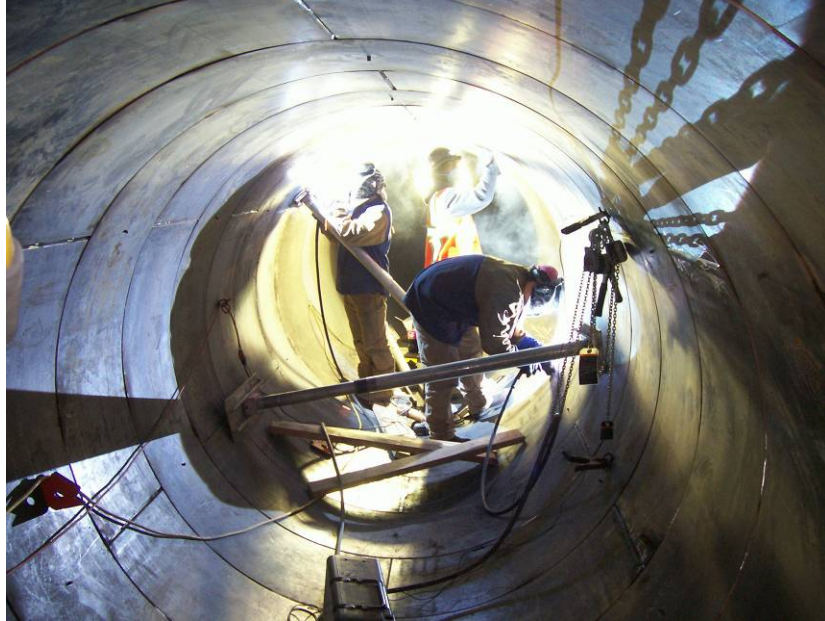
Figure 4: Internal Repair of 78-inch PCCP with Epoxy Coated Steel Lining

Because of the poor access to remove or replace the pipe and the unknown level of deterioration of the pipe cylinder, the District decided to perform a full structural in-situ repair by constructing a full ½” epoxy coated welded steel pipe inside the original PCCP. This in-situ repair was completed in Spring of 2011 and required one short two week shut-down, minimal excavation, and minimal environmental permitting.

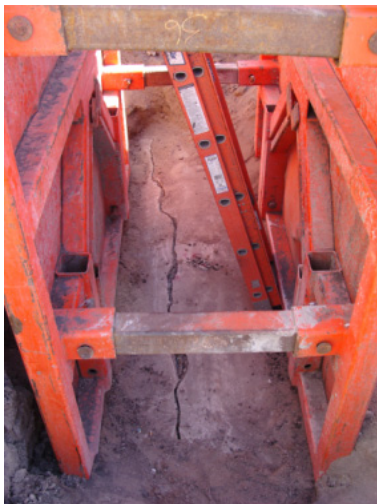
(a) Up to 1.5 in. wide crack along pipe

Figure 1. Observations from external inspections.

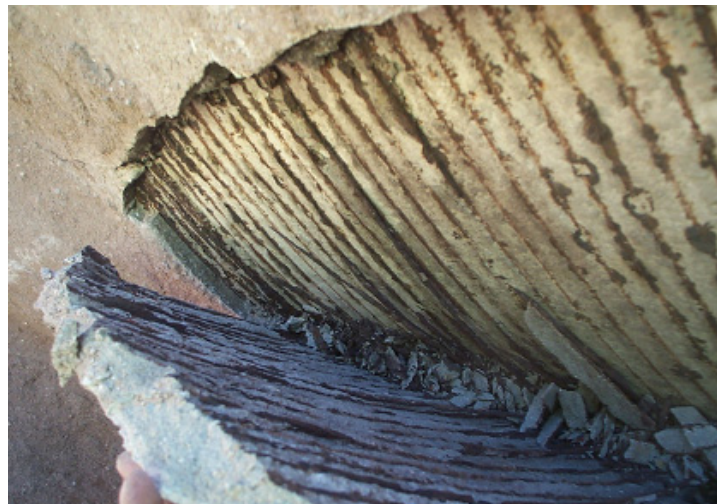
(b) Wire impressions left on concrete core after wires were fully corroded away

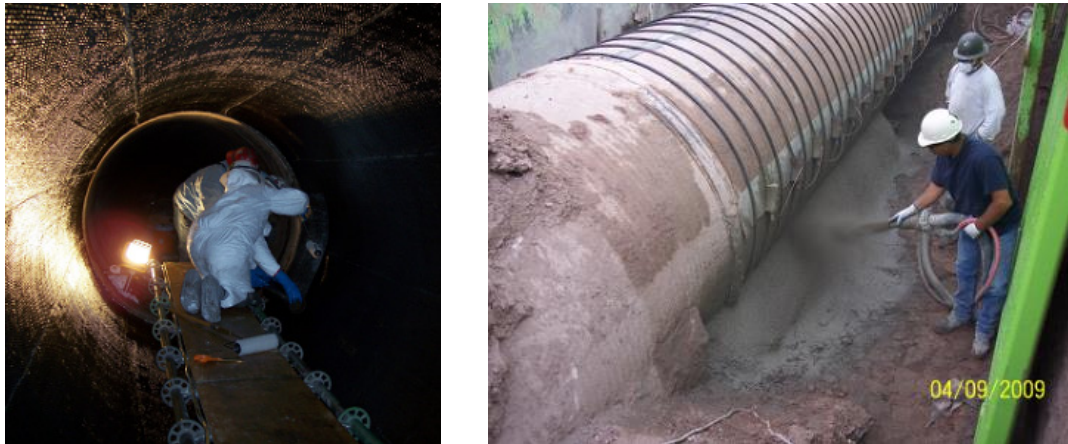
Figure 5. Typical internal CFRP and external post-tensioning repairs.

External post-tensioning repair is designed according to AWWA C304 Standard for Design of PCCP and by using the UDP software to consider the combined effects of internal and external loads.

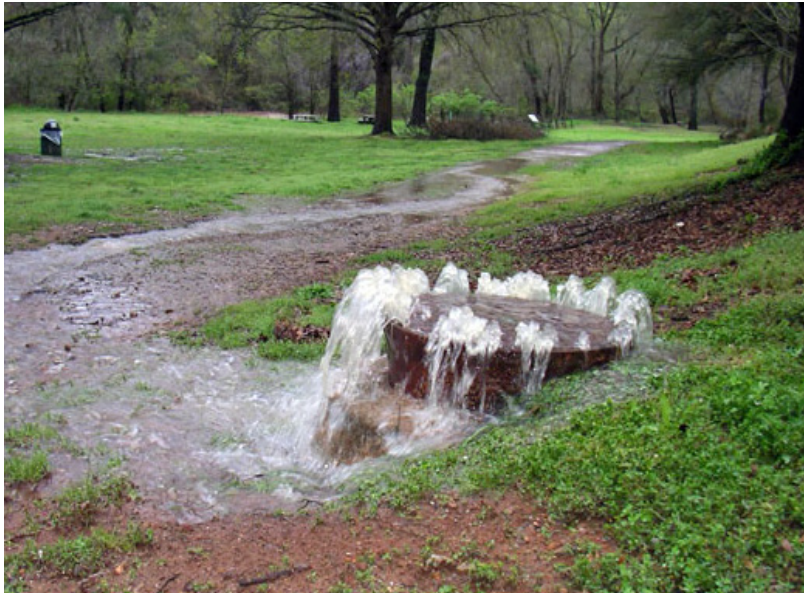
Figure 1. Sanitary sewer overflow frequently caused by undetected blockages

Wastewater utilities face the daunting challenge of maintaining their collection systems in compliance with state and federal regulations. To be effective, utilities must be constantly vigilant in maintaining their collection systems in order to minimize sewer line blockages that push wastewater out of manholes and onto streets, public/private property and waterways (Figure 1).

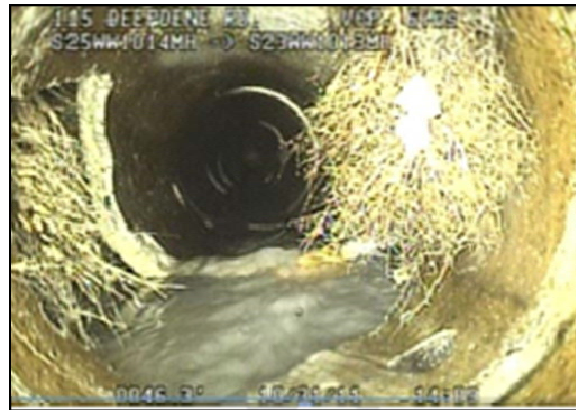
Figure 2: Typical root-intrusion in 6-inch main

This neighborhood is also unique in that it was also one of the first “garden suburbs” in the country (Dickinson, 2014). The developers wanted a natural look and engaged a reputable landscape architect, Frederick Law Olmsted Jr., to be involved with every decision about what type of shrubs and trees to be planted. Wherever possible, mature trees were left in place and the neighborhood was developed around them. While this led to the desirable garden suburb the Roland Park Company sought to achieve, it also led to severe root intrusion in the aging, clay pipes that are still in service today.

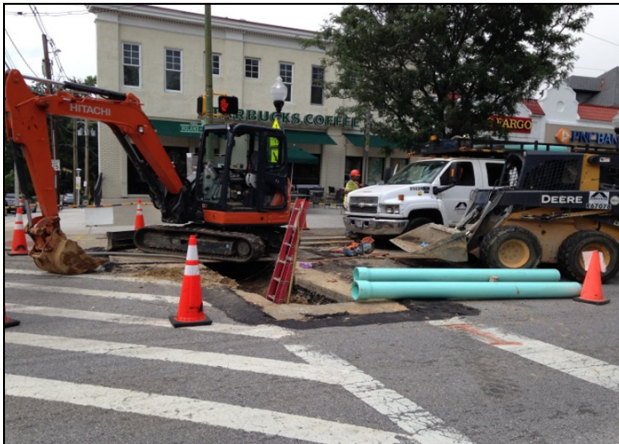
Figure 5: Open Trench Point Repair

There are two recommended methods of renewal: open trench repairs and/or the use of trenchless technology. Open trench repairs include point repairs, typically at least 12 feet in length, and pipe line replacement. If the pipes are recommended for replacement, the 6-inch main will be replaced with an 8-inch main to conform to the standards. In addition, manholes will be installed as needed to increase accessibility to the system.

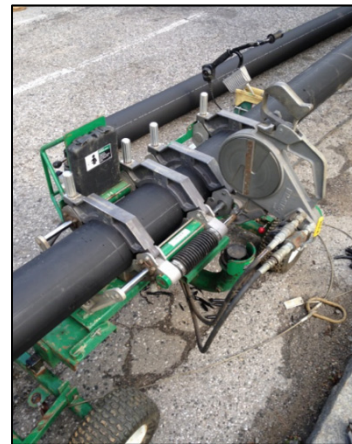
Figure 6: Pipe Bursting Equipment

Trenchless renewal options include pipe bursting and cured-in-place pipe (CIPP). Pipe bursting is another renewal option that will result in upsizing of the pipe to 8-inches in diameter to conform to City standards. Pipe bursting requires only a small excavation footprint for the equipment and entry for the new pipe. The new pipe is pulled through the existing main, which is fractured or displaced in the process. CIPP is a structural liner that is installed on the interior of the existing pipe. CIPP will be utilized on pipes where there is a reduction in capacity due to root intrusion, and the protrusion of structural defects is minimal. The installation typically extends from manhole to manhole along the full length of the main. In cases where a full length CIPP cannot be installed and a localized defect requires a trenchless repair, a sectional CIPP will be used.

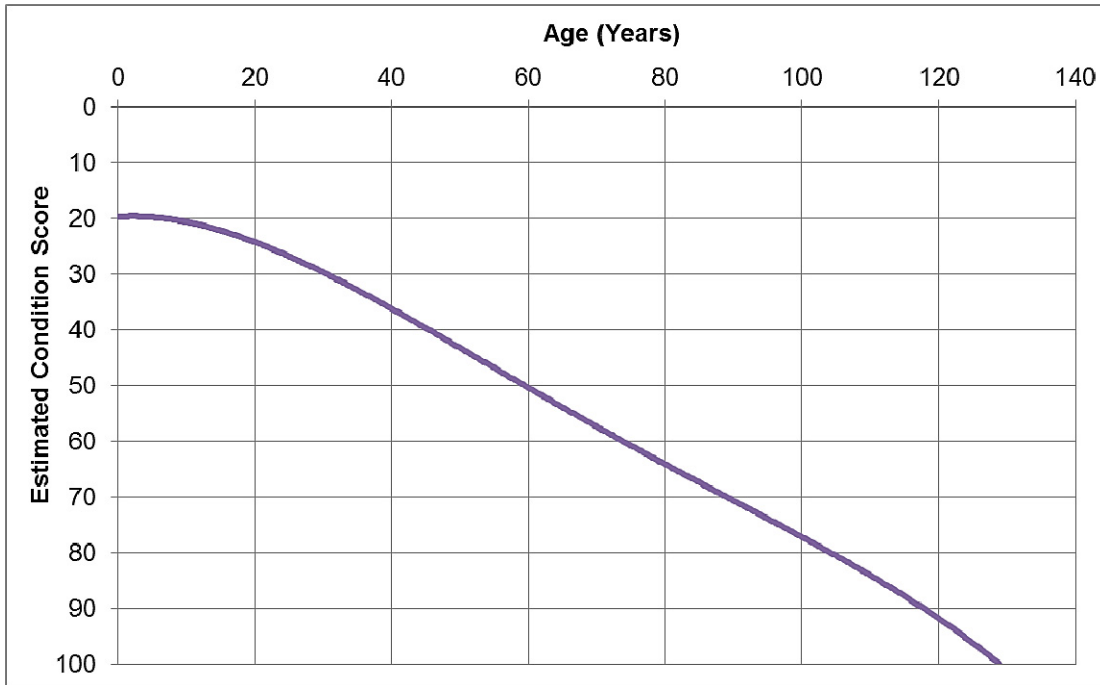
Figure 3. Top Down: Estimated Structural Condition vs Age

Age is generally considered as an indicator of structural condition because it is assumed that degradation occurs over time (Figure 3). Age is used in the Top Down approach to estimate the structural condition in the absence of inspection data – a score of zero indicates good structural condition while a score of 100 indicates poor structural condition. It is expected that the results from the condition assessment, the Bottom Up approach, will result in a similar trend as the Top Down approach. During the project, different ages of pipe were selected for inspection in order to verify the Top Down approach. Out of the pipes inspected, 59% of them were 100 years old or greater and structural issues ranged from minor to major issues indicated by the SCREAM structural score (Figure 4). It can be seen that age is not a good predictor of the structural condition and that an inspection should be performed in order to determine the structural condition.

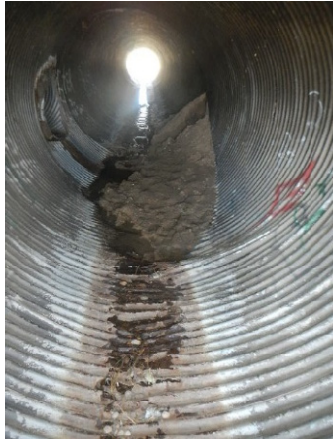
Figure 2. CMP joint failure.

In July 2013, the City of Aurora experienced a significant storm event, which prompted the re-inspection of all culverts with an NBI of 3 or below. The post flood inspection did not reveal any roadway subsidence, but the culvert had deteriorated further with active piping of water under the culvert barrels and some failures at the culvert joints, shown in Figures 2 and 3.

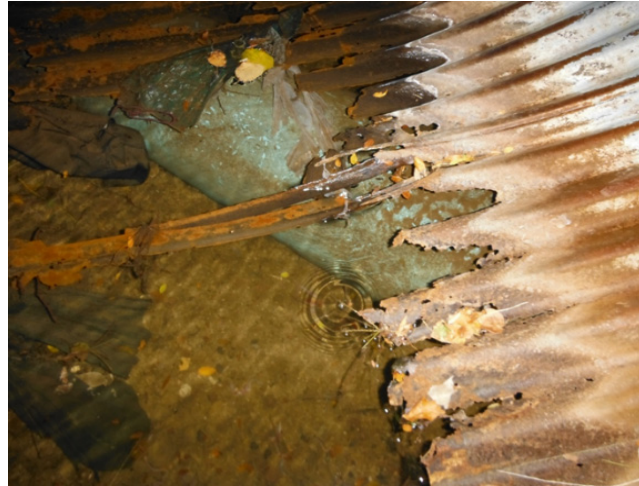
Figure 3. CMP invert deterioration with water piping.

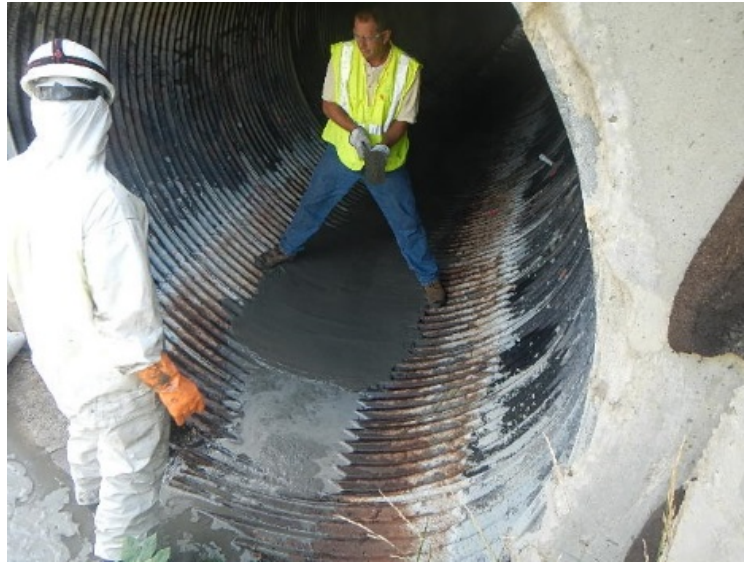
Figure 4. CMP invert repair.

Installation of the liner began by removing all debris from the line using pressurized water. The debris and process water was then impounded and disposed of in an appropriate manner. Once the pipes were fully cleaned, the contractor proceeded with the invert repair along the entire length of pipe, including filling the voids outside the pipe, below the spring line, with low strength flowable chemical grout, shown in Figure 4.

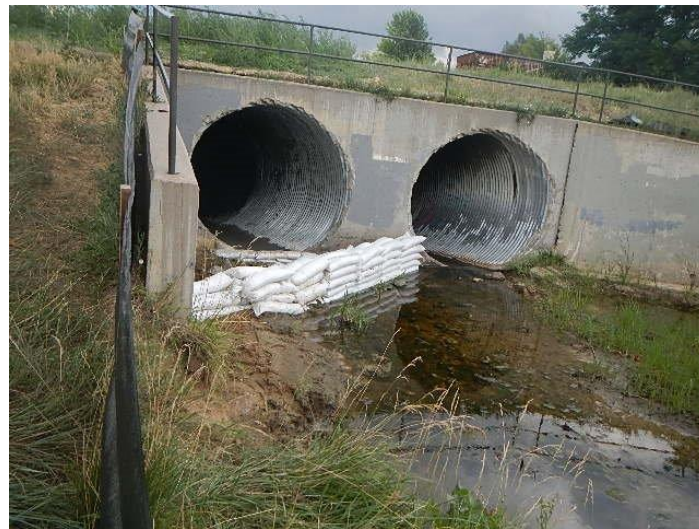
Figure 5. Stormwater control.

Storm flows had to be maintained during the entire repair process, therefore only one of the culverts could be taken out of service at a time. All flows were diverted from the storm sewer being repaired into the one remaining in service until all work was completed and the line could be returned to use. Sand bags mitigated the nuisance storm water diversion so that, if a larger storm ensued, the diversion would be overcome and the nearby neighborhood would not be flooded, shown in Figure 5.

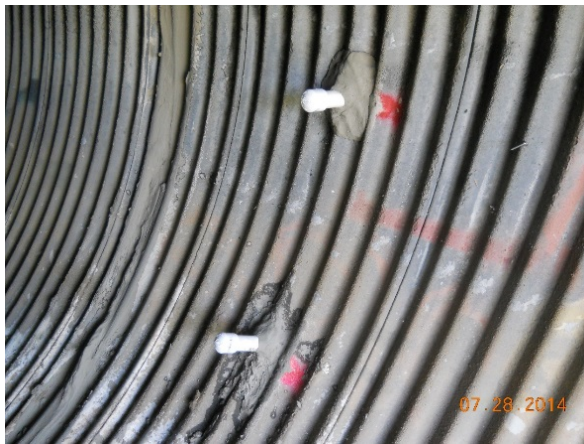
Figure 7. Grout ports.

Low strength flowable grout was pumped into these voids, taking care not to pressurize the grout pump above 30 psi, shown in Figures 7 and 8.

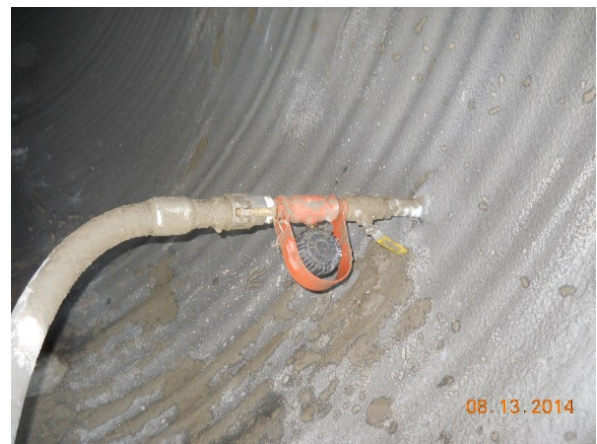
Figure 8. Grout pumping.

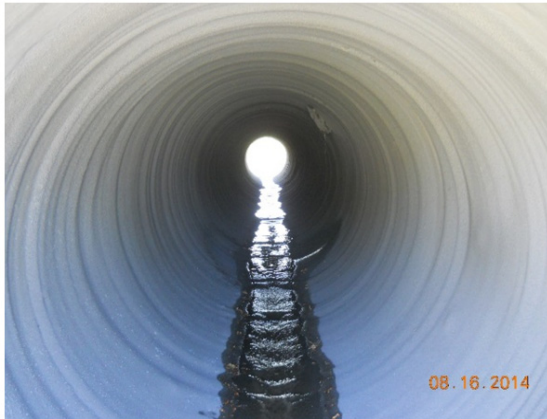
Figure 9. Finished liner.

The liner was sprayed on in passes of approximately 1/2 inch thick. Each pass was allowed to cure overnight before the next pass was applied. The finished liner and liner casting head are shown in Figures 9 and 10.

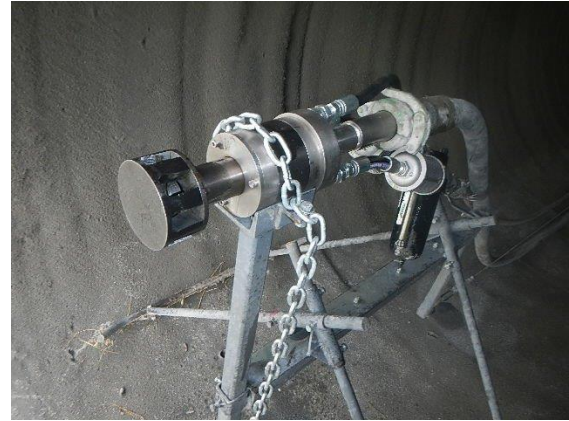
Figure 10. Liner casting head.

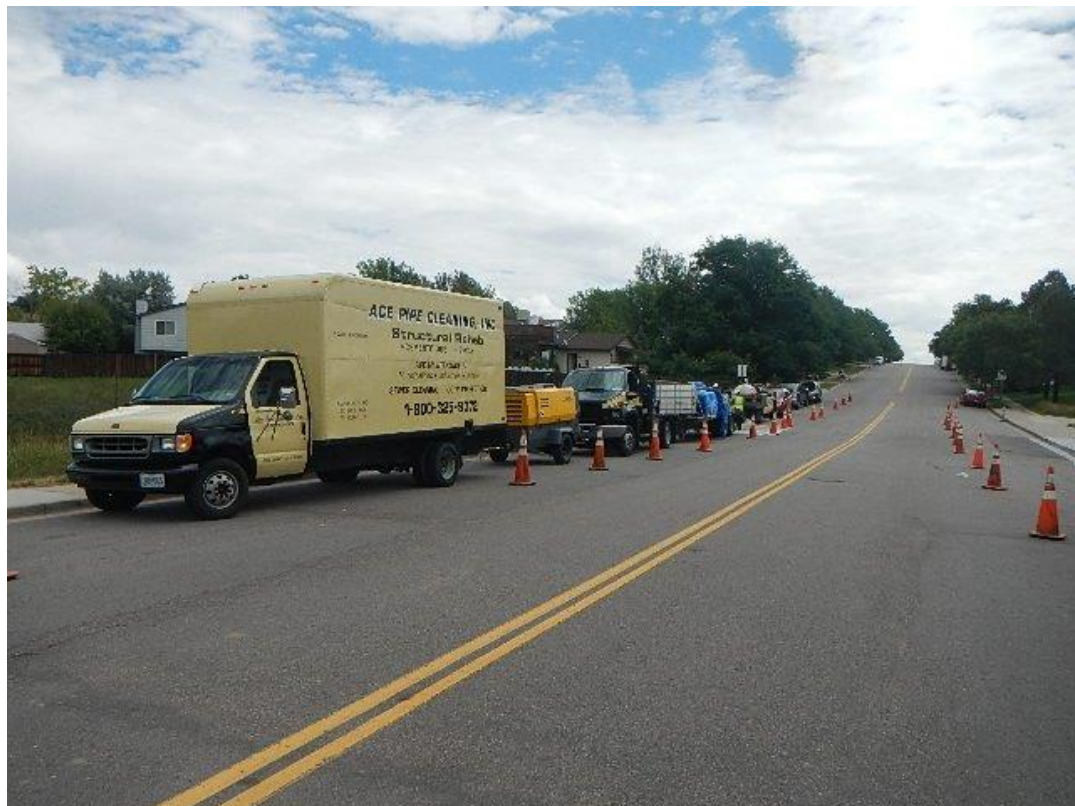
Figure 12. Installation footprint.

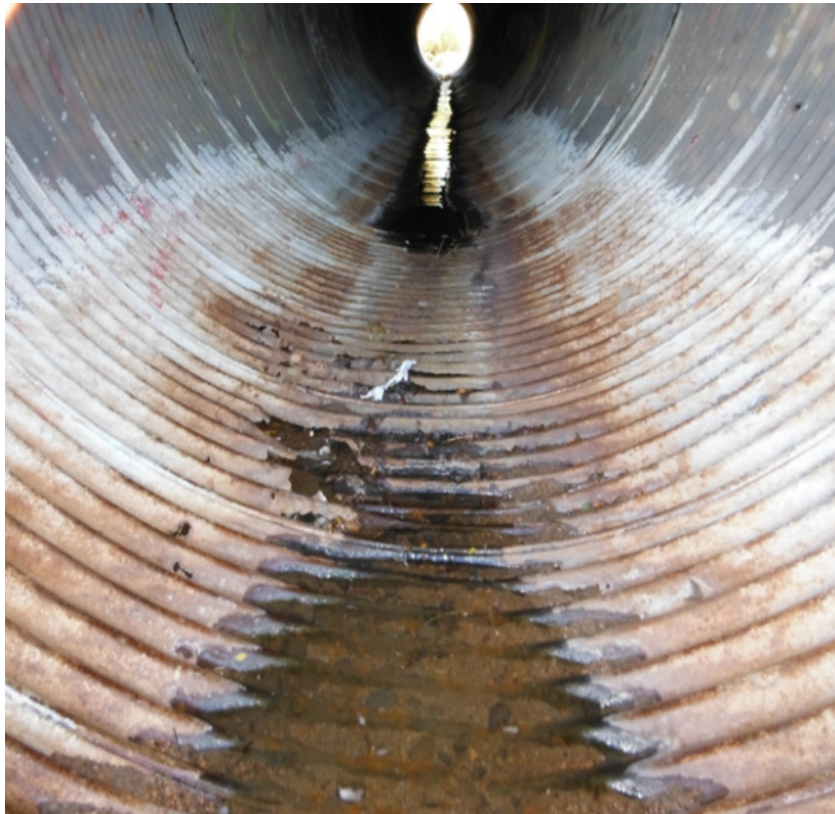
Figure 13. Before CCCP rehabilitation.

Centrifugally Cast Concrete Pipe is a viable and cost effective rehabilitation method for large diameter CMP. However, the industry needs to develop an ASTM so the liner design methodology can be standardized and accepted into the principals and practices of engineering. This would remove ambiguity in the design process and improve efficiencies in the design process. If cubes are going to be used for quality control, care must be taken to ensure they are prepared and cured properly, to avoid erroneous results. The CCCP rehabilitation foot print is minimal, as evident in Figure 12. Therefore, this rehabilitation method can be used in areas where traffic must be maintained. Rehabilitation utilizing the CCCP liner for large diameter CMP is a viable and cost effective option. Figures 13 and 14 show before and after images of the CCCP rehabilitation process.

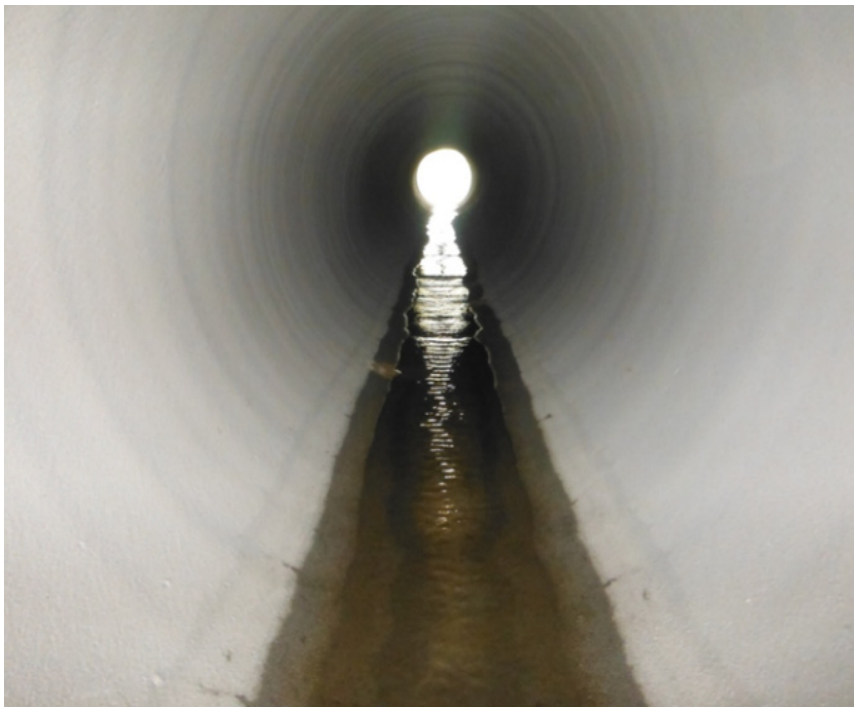
Figure 14. After CCCP rehabilitation.

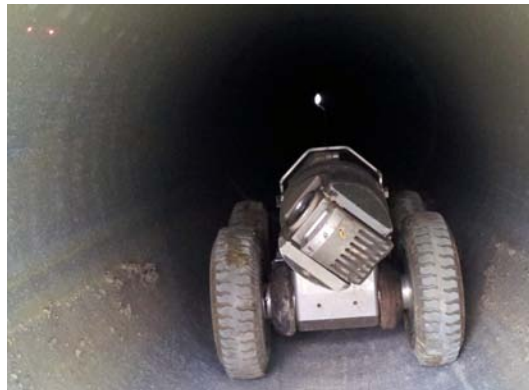
Figure 4. CCTV – Rotational laser diodes camera (from Rausch USA)

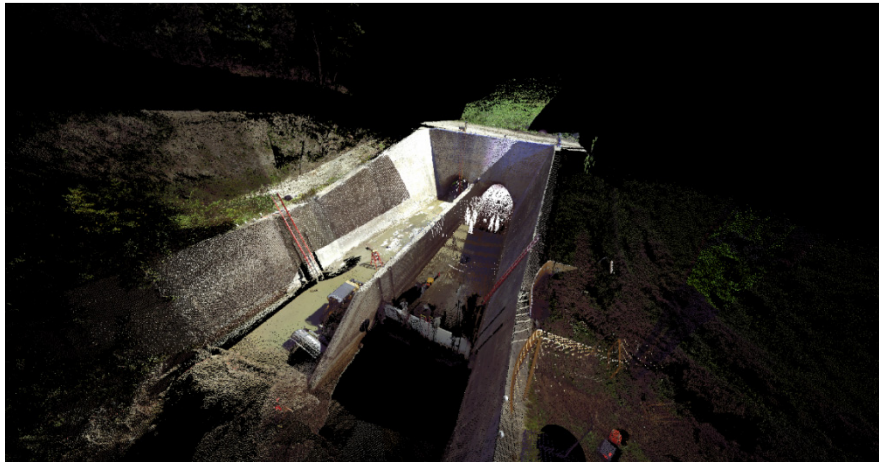
Figure 2. Colored point cloud model developed from 3D LiDAR laser data

Broadly speaking, the other category of lasers are 3D lasers. The most common 3D laser used in wastewater condition assessment is a Light Detection and Ranging (LiDAR) laser. LiDAR refers to the method in which the data is captured by time measurement of light photons, not specifically being 2D or 3D. LiDAR data is precisely accurate, more so than ring laser data, but it is also highly dependent on quality data collection in the field. Depending on the inspection platform, LiDAR data can either be captured continuously and via a stop-and-scan method. With the significant amount of data captured with this technology, there are nearly countless ways to present the data and data processing is often very time intensive. An accurate 3D model developed from LiDAR data is called a point cloud and may be a good starting point for data presentation.

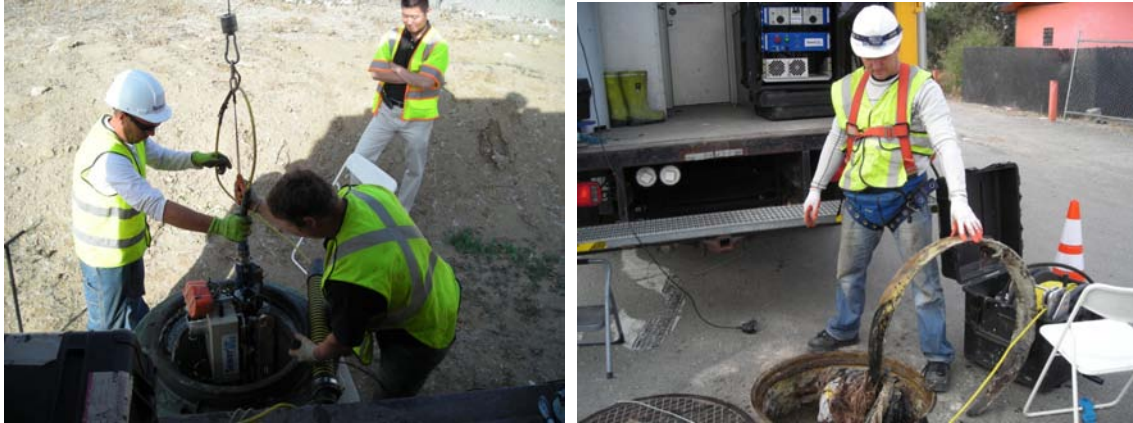
Figure 4a. Deployment of the SewerVUE Surveyor at the Del Norte Trunk Sewer, Stockton, CA. 4.b separated liner.

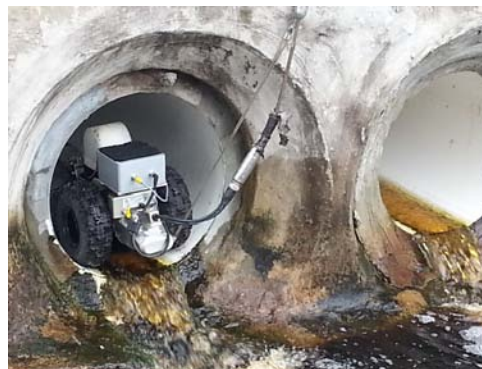
Figure 3: Photograph showing the robot entering storm drain rehabilitated by slip lining method.

After successful completion of the lab test, field trials were carried out during July 2013. Two RCP storm drainpipes (each ~55 m in length) running parallel to each other (shown in Figure 3) were inspected. Field trials took place several days after grouting and this allowed enough time for the grout to set, at least partially. Portland cement based “flowable fill” grout was used in this project. Dielectric permittivity of such a material is influenced by several factors including frequency of the signal, its mineral and moisture contents (Jaganathan et al. 2007). Since the grout’s moisture content gradually varies over time, its permittivity would also change and this would affect the amount of reflection and transmission of radar signals through it. Thus, the radar inspection could be influenced by whether the grout is in a “flowable” state or set, at least partially, with reduced moisture levels. As long as there is a significant difference in permittivity between adjacent layers it would be possible to discriminate them. While the geometry of each layer involved is complicated, for a simple case of normal incidence of plane wave, the co-efficient of reflection (Γ) and transmission (T) at an interface between two dielectric layers with permittivity ϵ_1 and ϵ_2 are given by the following equations (Balanis, 2012):
