Pipelines 2015

Recent Advances
in Underground
Pipeline
Engineering and
Construction

PROCEEDINGS OF THE PIPELINES 2015 CONFERENCE

August 23–26, 2015
Baltimore, Maryland

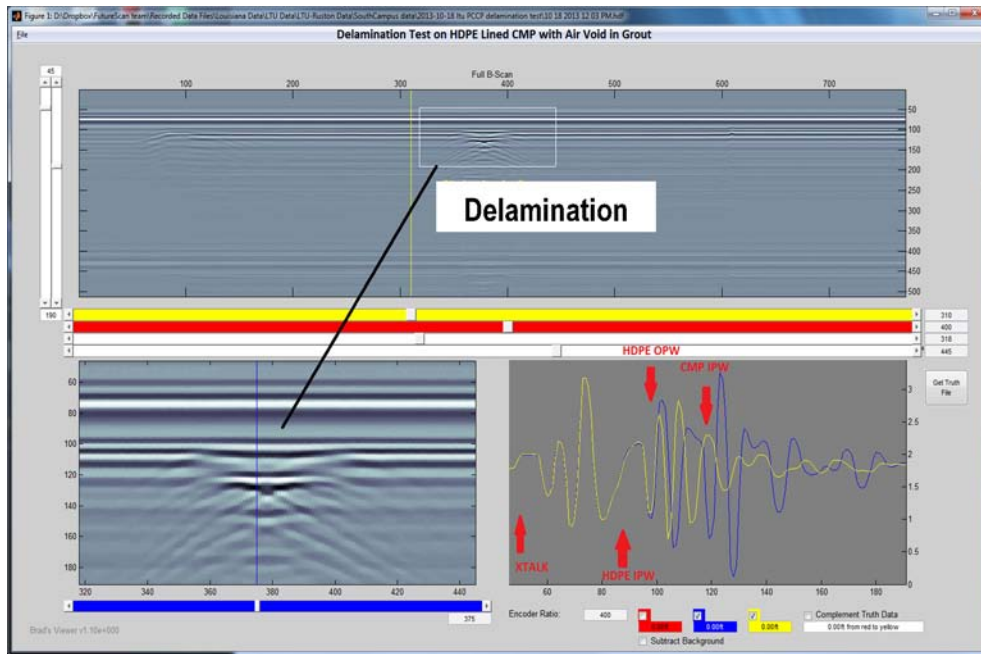
Figure 5 shows a screenshot of the radar data processing software. Three different plots are seen in Figure 5 - a) B-scan plot corresponding to the vertical cross-section near crown for entire length of the pipe (horizontal axis represent spatial increments along the pipe and vertical axis represent time delay in the received signal), b) portion of B-scan plot zoomed-in to show the details near delamination, and c) selected A-scan waveforms showing distinct signatures that are shifted in time indicating various radial interfaces present in the structure. Radar successfully detected the air pocket and a distinct signature was observed in the B-scan. Analysis of individual A-scan waveforms revealed that it is possible to resolve the HDPE and the grout layer. For example, the reflections from inner and outer wall of the HDPE pipe were seen clearly, and the interface between grout and the host pipe were also discriminated. Thus, the laboratory test successfully demonstrated the ability of the radar to detect hidden air pockets and resolve the grout layer thickness. This

Figure 5: Screenshot from radar analysis: (top) 2D B-scan image of the pipe’s vertical cross-section near crown along its entire length; (left bottom) zoomed in window showing delamination; (right bottom) A-scan waveforms (signal strength vs. time delay) showing interfaces between HDPE, grout and the metal pipe.

- c) The interface between grout layer and adjacent pipes were visible distinctly. Using this, grout layer was resolved, and its relative thickness was estimated. The time-of-flight calculations were performed using the A-scan signals (shown in Figure 8) in order to calculate thickness of each layer (Falorni et al. 2007). This calculation requires that the wave velocity through each layer is known which again depend up on their dielectric properties. As mentioned previously, the dielectric permittivity of grout layer depend on moisture content, and it was an unknown value. However, through calibration and by assuming the grout layer to be homogeneous, relatively variation in its thickness was established with reasonable accuracy. As seen in Figure 7, thickness of the grout layer showed significant variations along the pipe. By assuming the grout's permittivity to be constant over the entire pipe, its thickness was estimated to vary by more than 50% (from about 7.5 cm which was the maximum possible height of annular space to about ~3 cm at its thinnest section). More importantly, it was established that the entire annular space was filled with grout and no significant air-pockets

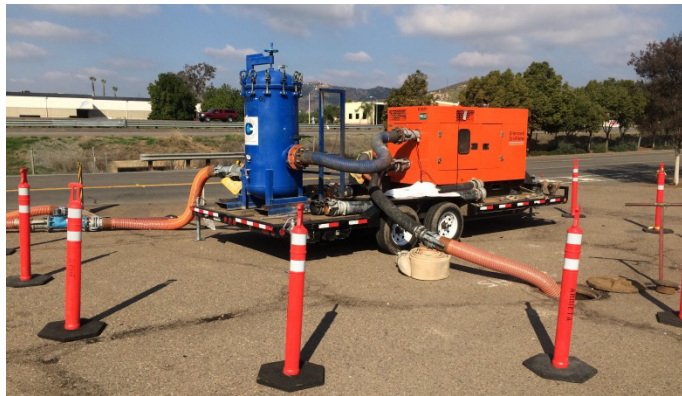
The El Monte Pipeline underwent three separate shutdowns that included dewatering and inspecting the interior of each Section where accessible. The only areas not inspected were those where a blowoff could not be located to adequately drain the pipe, or an unknown dip in the pipe occurred resulting in a pipe full of water. This resulted in 97 percent of the pipeline being inspected over three shutdowns. Dewatering operations included lock out tag out by the City, contractor, and ARCADIS. Each blowoff used for dewatering had suction piping connected from the blowoff to a pump and a Quagga filter which had discharge piping routed to a flood channel, storm drain, or natural ditch as shown in Photo 1.

Photo 1. Typical Dewatering Operation

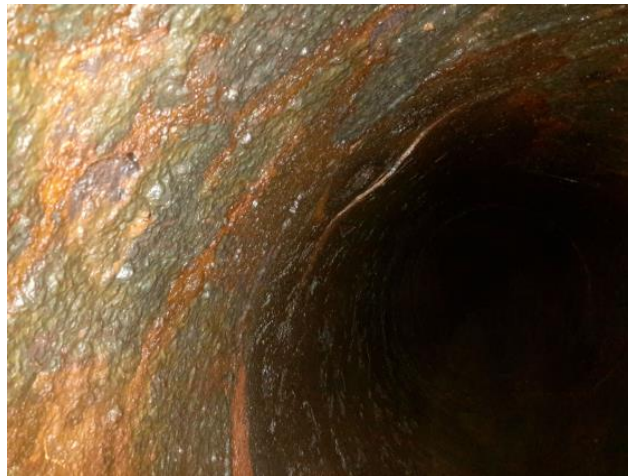
Photo 2. Exposed Steel Cylinder at Joint

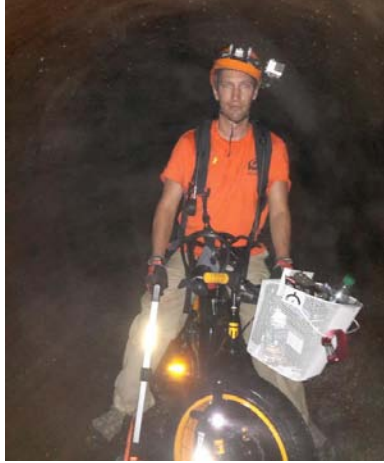
Section II inspection was performed in January 2015 and being a larger diameter, the means of transport was by bicycles taken apart and passed through surface accessible manways, then reassembled inside the pipe. The 68-inch pipe is large enough to walk through, but use of bicycles greatly reduced the inspection time to three days, where six days were expected for the 6-mile long Section, and it was less physically demanding for the team. Lights and baskets were mounted to the front of the bicycles which allowed storage of data collection devices and accessories as shown in Photo 3. SCBA equipment was worn on their backs.

Photo 3. Bicycle Inspection Configuration

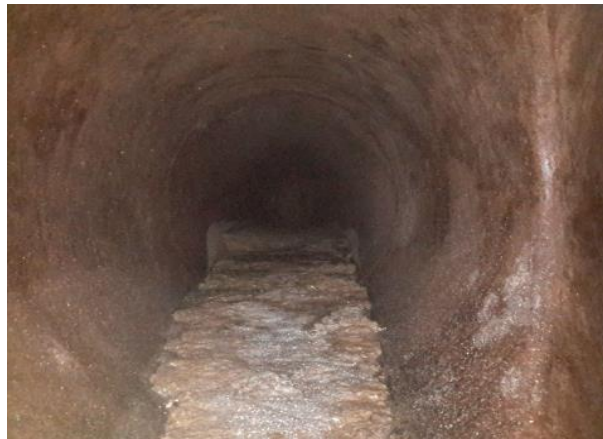
The 68-inch RCSC was found to be in generally good condition except at the El Monte Valve Vault where there are numerous pipe material and diameter changes and the interior lining is nonexistent. A crack was found under the 67/52 Freeways interchange flyover bridges that were constructed in 2011. Large quantities of Quagga mussels were found on the bottom of the pipe downstream of the El Monte Valve Vault as shown in Photo 4.

Photo 4. Quagga Mussels

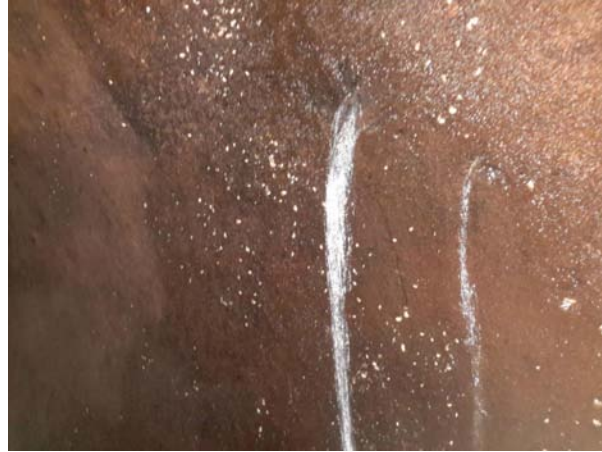
Section III inspection was performed in one day on bicycles in September 2014 and had the most defects of any Section. Leaks were found in the Grossmont Tunnel at more than half of the joints and were mainly located at or just above the pipe spring line as shown in Photo 5. Each leak was assigned a qualitative value of less than 1 gallon per minute (gpm) to 5 gpm based on photo observation. The joint leaks could result from a perched groundwater source or raw water leaking out from the Tunnel when full, and then returning into the tunnel as a result of dewatering. The Tunnel is the high point of the transmission main and watermarks were generally found at the spring line, so the Tunnel does not typically flow full. Quagga mussels were found attached to the circumference of the pipe along the Tunnel's entire length.

Photo 5. Grossmont Tunnel Joint Leaks

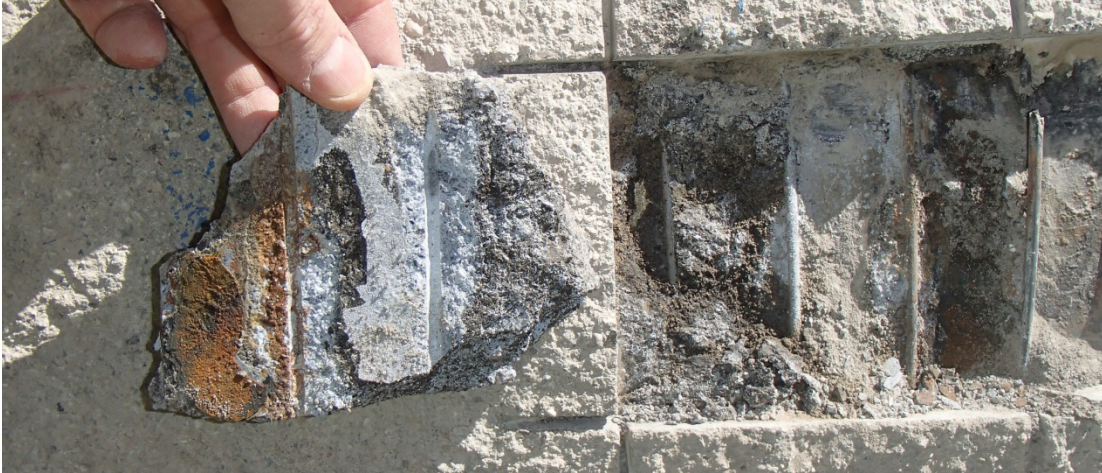
Figure 2 - Corrosion product and poor bond and steel cylinder surface of Pipeline A.

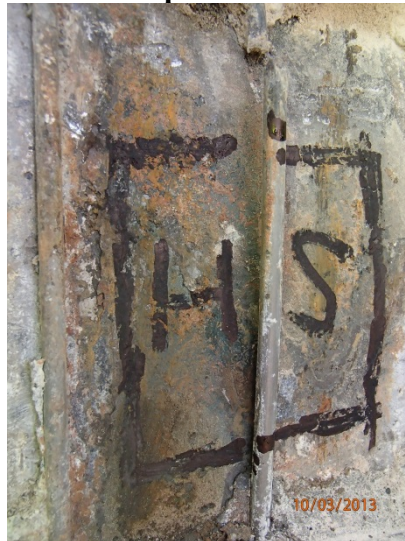
Figure 3 - Brittle broken prestressing wire and 2 in. by 2 in. hollow sounding area of steel cylinder behind wire break in Pipeline A.

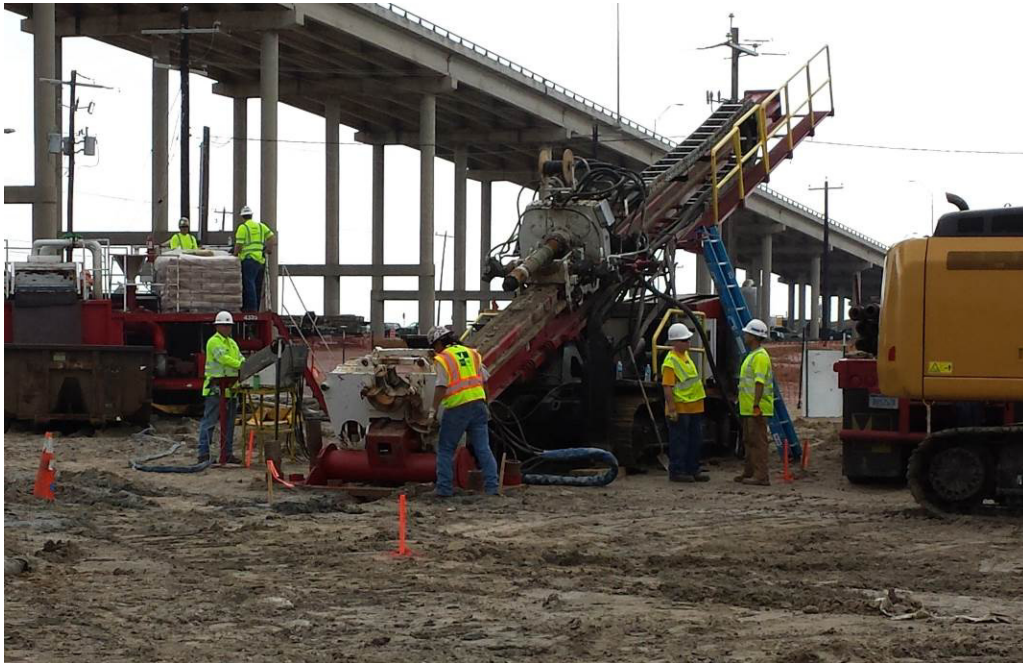
Figure 3. Drill rig set up for the first bore of the GIWW crossing.

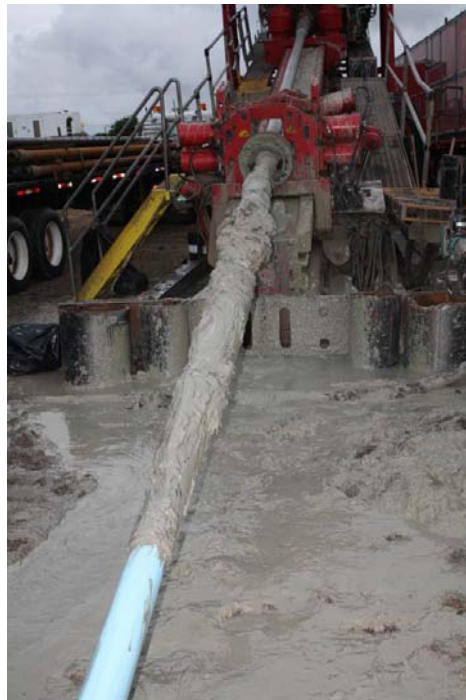
The first installation was the 120 mm (4-inch) FPVCP communications conduit, which was initiated after the pilot bore was completed. The uncased installation of approximately 1,645 m (5,400 feet) of 120 mm (4-inch) FPVCP communications conduit represented the longest known installation of a thermoplastic pipe of this small of a diameter via HDD (see Figure 4).

Figure 4. Completed 4-inch FPVCP conduit installation by HDD.

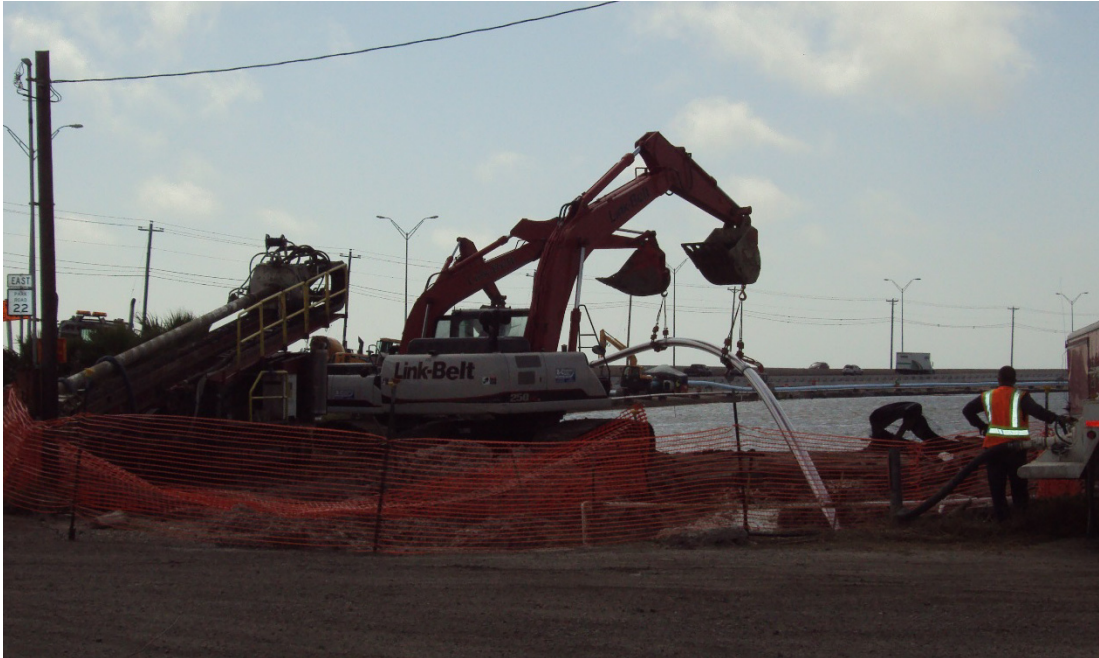
A wireline was installed in the completed 120 m (4-inch) communications conduit to provide accurate guidance for the subsequent bore alignments. The second pilot bore was completed and a single ream pass was used to enlarge the hole and install the 200 mm (8-inch) steel gas pipeline (see Figure 5). Finally, the 495 mm (18-inch) bore was completed using two ream passes and a final ‘swab’ reaming pass to make sure

Figure 5. Insertion of the 200 mm (8-inch) Steel gas line into the Laguna Madre HDD section.

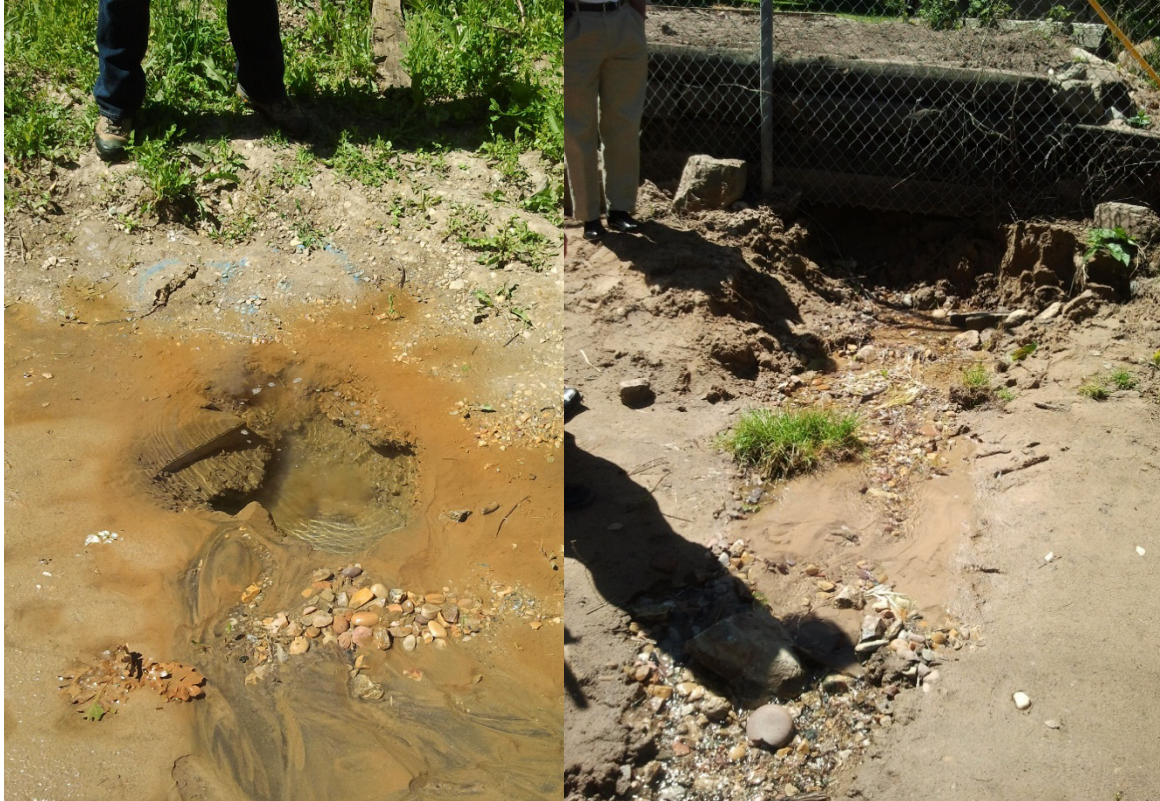
A surge analysis of the existing pipeline was performed to determine the impacts of starting and stopping the Oak Lane Pump Station that is connected to the East Layton Pipeline. The East Layton Pipeline operates at low pressures (less than 20 psi) and is located on the suction side of the Oak Lane Pump Station. The results of the surge analysis showed that the pipeline was experiencing significant down surges when the pump station is shut off and it is expected that many of the leaks at the pipe joints are a result of cyclical negative surge pressures wearing out the rubber gaskets. Figure 3 shows a hydraulic profile of the pipeline during a surge event. The red dots shown on Figure 3 show the location of the discovered leaks. Notice the location of known pipeline leaks relative to the down surges.

Figure 2. Pipeline leaks that surfaced near the Oak Lane Pump Station

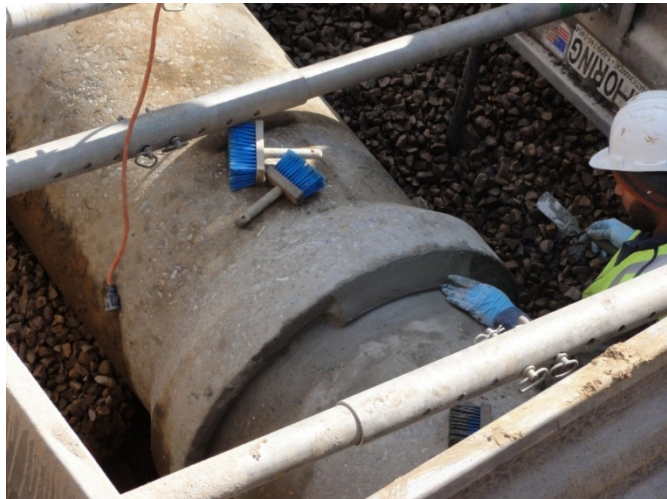
The existing pipeline has been uncovered multiple times to repair leaks. In general the concrete pipe wall and cylinder is in good condition but failure of the pipe is occurring at the rubber gasket joints because of age, suspected pressure surges in the system, and tree root growth into the joints. The leaks have compromised pipeline function and added risk to the system and to the District. Historically temporary repairs have been made to the joints by tightly packing the exterior of the joints with grout or concrete encasing the joints. However this method has not always been successful and often serves only as a temporary fix. Figure 4 shows a joint of the 27-inch RCP being packed with grout during a leak that required repair in the spring of 2013.

Figure 4. Repair of concrete joint with packed grout

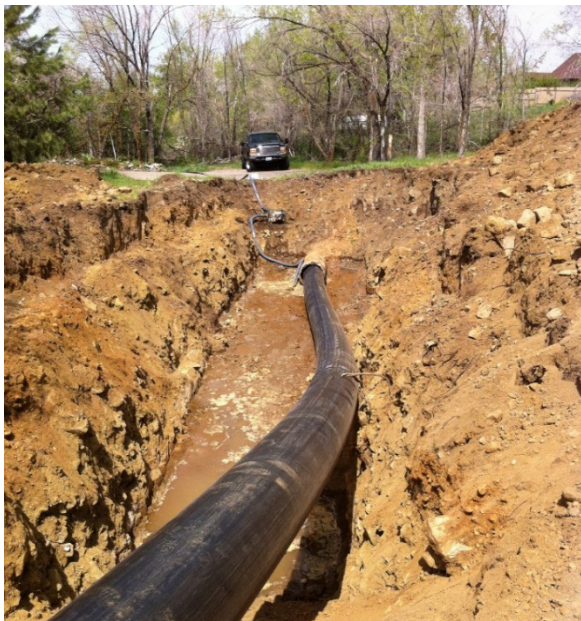
Figure 5- Slip-lining existing 27-inch RCP with 24-inch HDPE

After several unsuccessful attempts at repairing a leaky joint and having other leaks show up in the general vicinity shortly thereafter in the spring of 2013 the District was required to make an emergency repair to the pipeline which included slip lining approximately 1000 feet of the existing 27-inch pipeline with 24-inch outside diameter HDPE pipe. The District was able to install some temporary emergency cross connections with Layton City's distribution system which allowed the pipeline to be taken out of service for about a 5 day time period. This down time put a major stress on the rest of the water system and luckily the repair was made in the early spring when the pipeline was not operating at peak demands. The 1000 foot section eliminated 8 of the 15 leaks found during the leakage test conducted in May of 2012. Figure 5 shows slip lining the existing 27-inch pipe during an emergency repair.

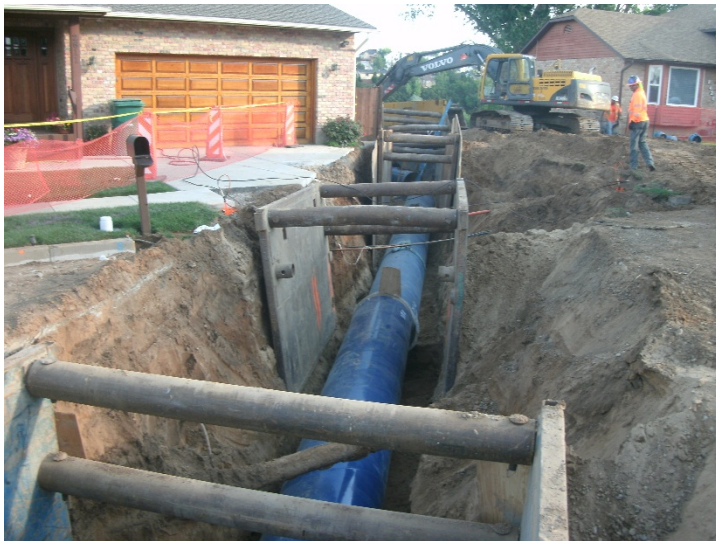
Figure 8. 36-inch Pipe Installation Near Residential Homes

Early and Consistent Public Involvement Team. The CMGC delivery method allowed the engagement of a public involvement team that started during the design phase and carried through construction. As part of the predesign phase the contractor was required to provide a public involvement firm that assisted the District and Design Engineer with several communication efforts including newsletters, brochures, public open house meetings, and one-on-one communication with affected residents. With the construction occurring in residential streets, the District knew that strong communications between project participants would be necessary for successful completion of the project. Being able to start the public involvement effort early prepared the community for the construction impact well in advance of any actual construction taking place. It also allowed the contractor to better understand project constraints such as coordination with school bus routes and residents requiring special needs. During construction the CMGC provided a full time public involvement program that included a 24-hour hotline and a project website where residents could receive important announcements, view detour routes, and track progress of the construction. Figure 8 shows construction between two residential homes. Figure 9 shows construction in a residential street.

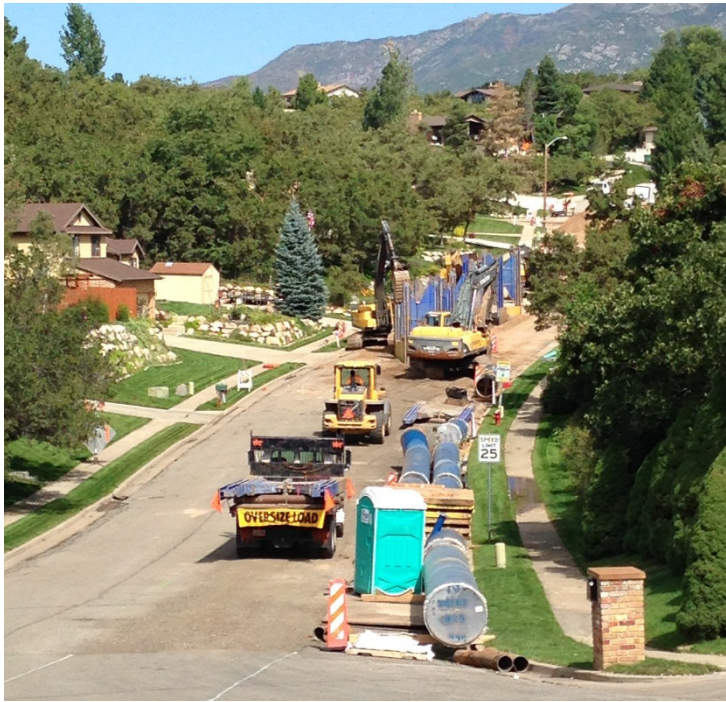
Figure 9. Pipeline Construction in Residential Streets

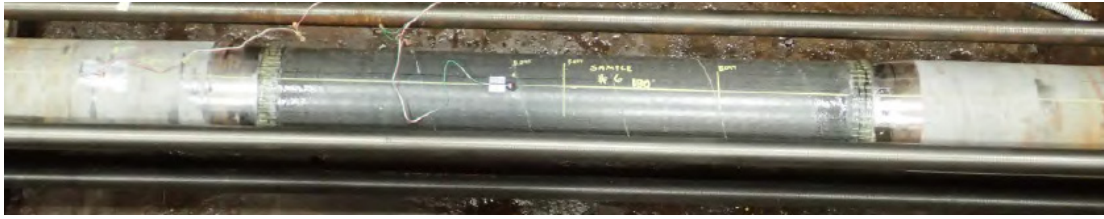
restrained short term burst that mimics worst-case pipeline loading in the hoop direction without any strength of the host pipe. Figure 1 below, shows an image of a test specimen.

Figure 1: 8" diameter CFRP rehabilitation technology test specimen in axially restrained loading apparatus.

Because of the successful short term average burst strength of 1160+/- 90psi for 7 pipe samples installed utilizing the same installation technique and proven cure regime, the manufacturer performed two 300 ft trial runs (Sheets 2014). This full scale installation process was implemented to validate the ability to install the product at the scale required for market use and to test the actual pipe properties during installation. One 300 ft run was installed into Sonotube® (a cardboard tube acting as a mold that could be removed after installation), allowing for testing on the CFRP rehabilitation technology without the host pipe. The second 300 ft install was in 8" nominal diameter ductile iron pipe with and without mortar lining simulating the roughness and variability of a degrading pipeline after cleaning.

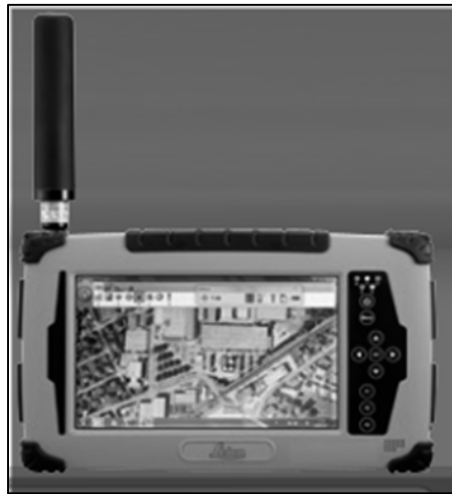
Figure 1. Field GPS Instrument (Leica CS25 GNSS Shown)

Field Inspection and Data Collection. Ruggedized, mobile GPS devices with sub-meter GPS accuracy and user-friendly data collection interfaces and software are vital to accurate field data collection and continual geodatabase updating. With these devices, assets are GPS-located, assessed, and edited in the field. Because condition assessment criteria are different for each asset (i.e. manholes, pipes, and lift stations) in utility infrastructure systems, customized assessment forms developed in GIS are incorporated into the data collection software. Pre-loaded drop down menus created and customized with CartoPac data collection software, are linked with specific asset attribute fields, ultimately reducing the amount of time spent per asset during inspections while minimizing typographical errors. Examples of a GPS device and a mobile data entry form are shown in Figures 1 and 2.

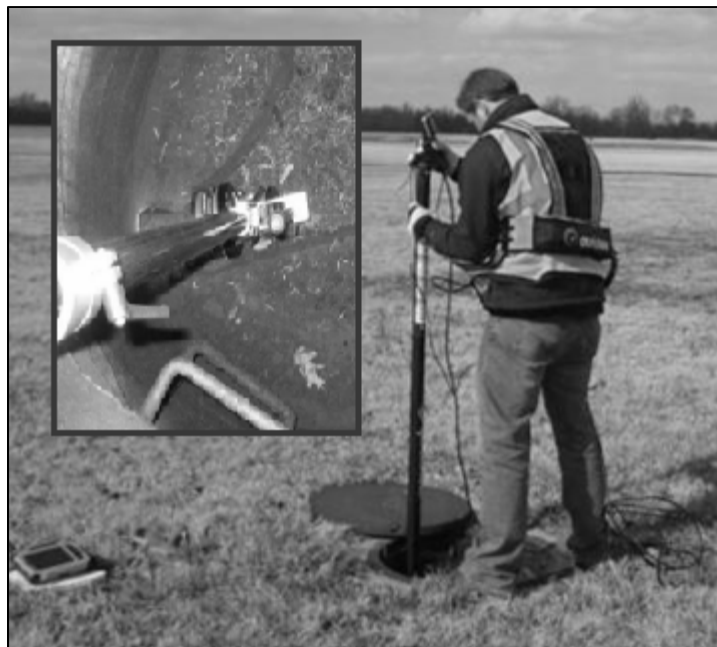
Figure 3. A technician operating the pole camera during a pipe inspection

Parameters required for the asset management prioritization model are those by which assets are assessed. For example, structural deficiencies in a pipe – such as breaks, cracks, corrosion, or deformation – are noted if observed during the field investigation, along with degree of severity. The pole camera utilized in this approach has a reported range up to 400 feet, although field use reports a practical range up to 100 feet in a straight run of pipeline. Ultimately, effective viewing range of the pole camera can be limited by pipe bends, small diameters, and manhole bench construction hindering ease of access. Sample photographs of the pole camera in use during an inspection and a wastewater system pipe taken with the pole camera are shown in Figures 3 and 4.

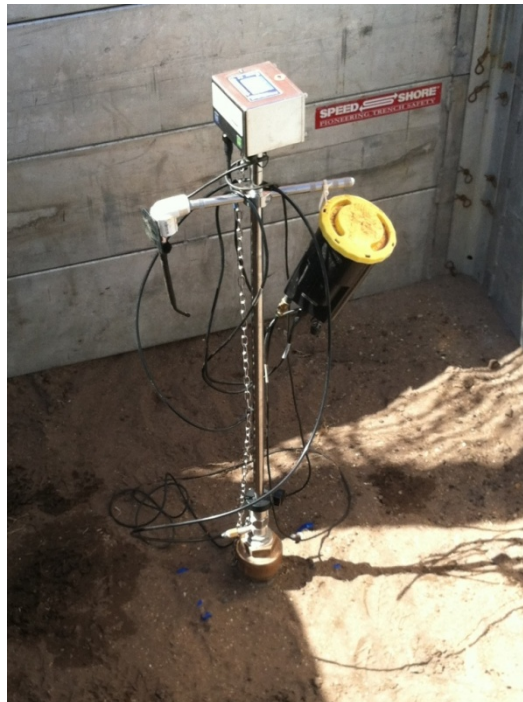
Figure 3. Finished Water Meter Testing using a Temporary Insertion Flow Meter.

One of the most important inputs to the water audit is the water supplied. Therefore, the first thing a water system should do is consider their confidence in the accuracy of this number. Activities to verify this number could include using a temporary, secondary meter to verify the accuracy of the primary flow meter or meters for finished water or testing of bulk water import meters. An example of this is shown in Figure 3 below, using a temporary insertion meter to verify the accuracy of the existing flow meter.

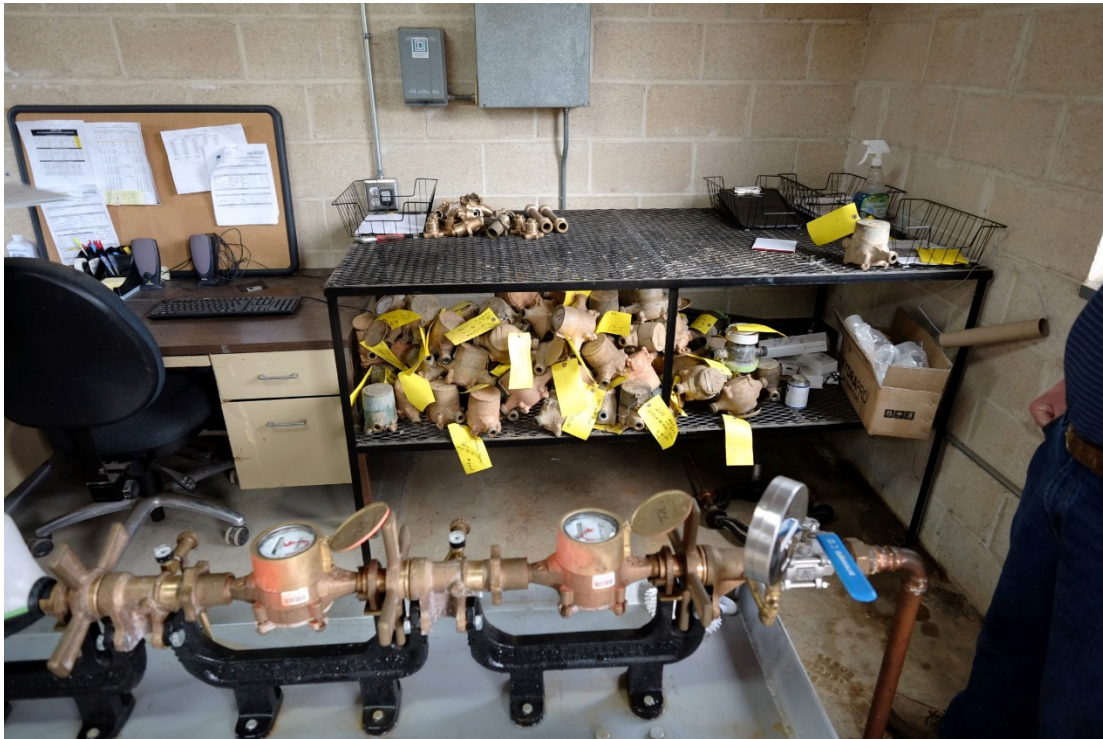
Figure 4. Customer Meter Testing.

analysis of real losses. The first of these is customer meter testing, which is important to understand the rate at which metering accuracy may be deteriorating. For instance, most customer meters in use by water systems are mechanical in nature, and therefore, wear out over time, resulting in reduction of accuracy, especially at low flowrates. A program of testing statistically significant number of meters can help a water system determine their overall customer meter accuracy with a greater degree of confidence. Figure 4 below shows an example of residential-type meter testing. Figure 5 shows an example of the results of customer meter testing.

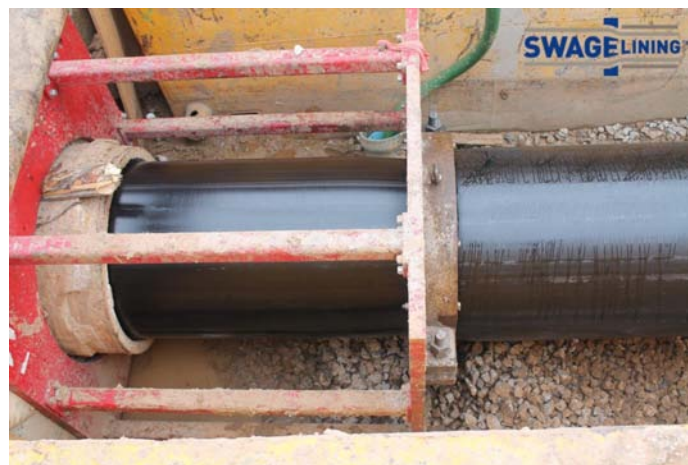
Figure 2: Swagelining™ process as HDPE is pulled through the reduction die.

The Swagelining™ technology specifies a PE4710 High Density Polyethylene (HDPE) pipe with an outside diameter larger in size than the inside of the host pipe to be renewed. After the HDPE is butt fused to correspond to the pull distance, the pipe is pulled through a single reduction die immediately before entering the host pipe. This reduces the HDPE pipe temporarily below the ID of the host pipe allowing it to be inserted (Figure 2). While the towing load keeps the HDPE under tension during the pull, the pipe remains in its reduced size. The HDPE remains fully elastic throughout the reduction and installation process. As the liner pipe is not permanently deformed by Swagelining™, the release of the towing load after insertion is the catalyst for the liner to revert back towards its original size. As its original size is larger than that of the host pipe, the HDPE pipe expands until it is halted by the inside diameter of the host pipe. This produces a residual strain that is locked in the liner and maintains pressure against the inside of the host pipe, even in the absence of internal pressure from the product conveyed.

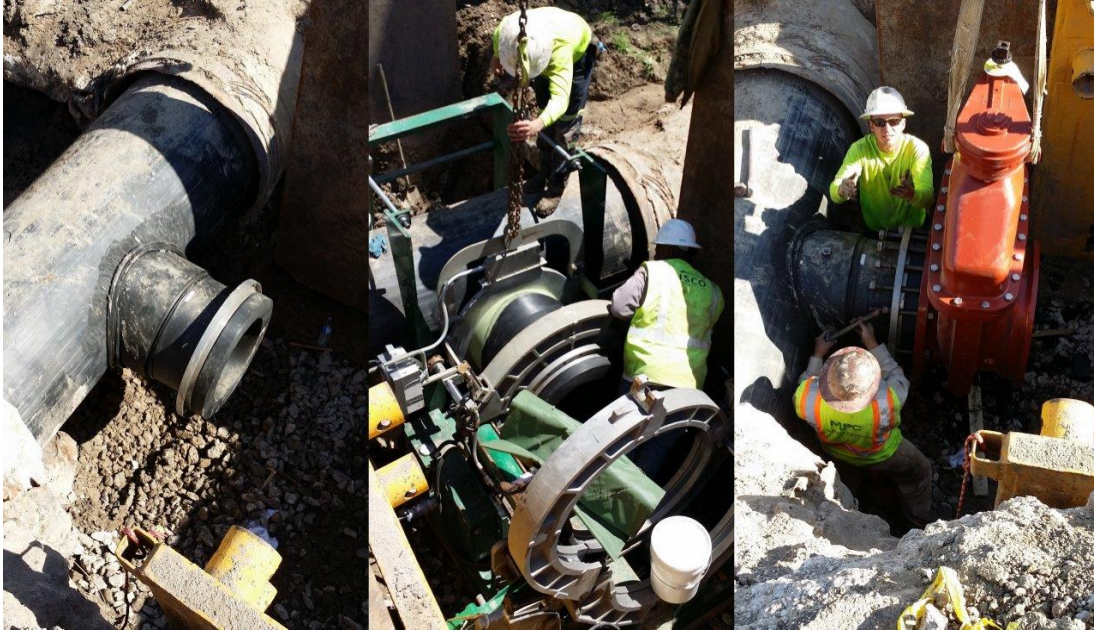
Figure 3: Left and middle picture of 24-inch stub out by sidewall fusion with Flange Adapter connected by downhole butt fusion. Right picture of 24-inch Gate Valve bolted on to Flange Adapter.

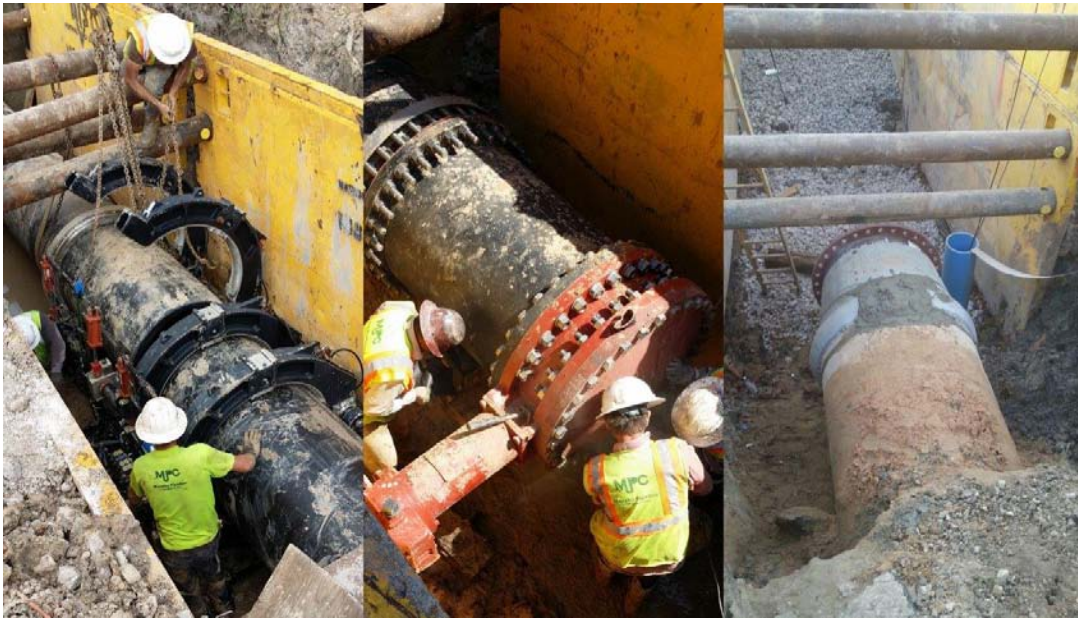
Figure 4: Left picture of downhole butt fusion connecting HDPE in receiving pit. Middle picture of 36-inch side actuated butterfly valve. Right picture of 39-inch by 36-inch PCCP flange reducer.

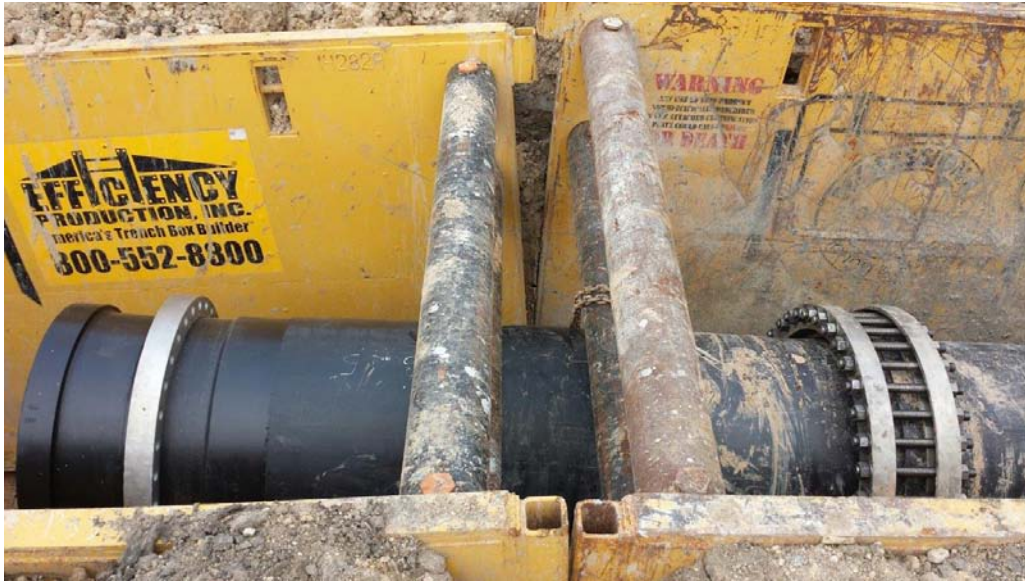
Figure 5: HDPE connections using Flange Adapters with stainless steel back up ring and stainless steel bolts.

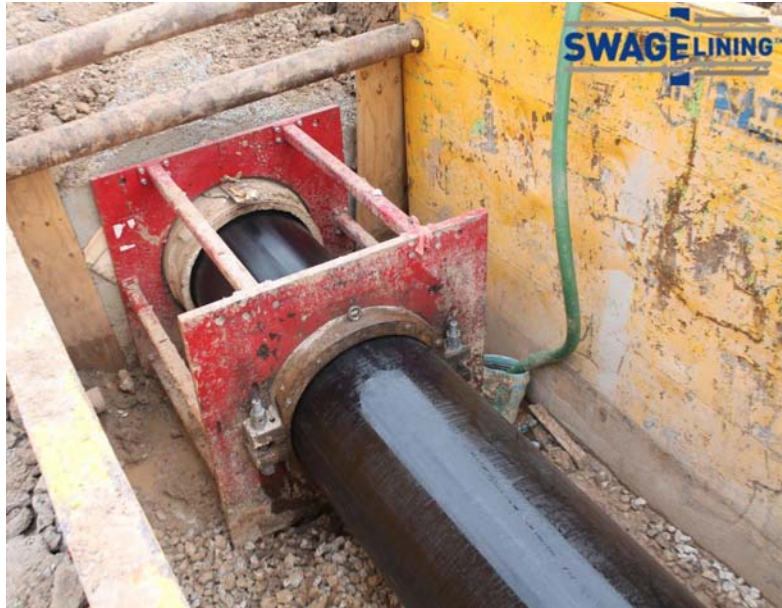
Figure 6: 1000mm (39.4-inch) OD HDPE pipe enters single swage die. The HDPE pipe is temporarily reduced below the ID of the 39-inch PCCP host pipe to allow for insertion.

Once a free bore path is confirmed, Swagelining™ operations would begin (Figure 6). To complete each pull, a specific bank shoring plan was implemented to compensate for the amount of force required to pull the long lengths of HDPE with a wall thickness of 2.32-inches through a single swage die. Two types of constant tension pulling equipment were used for the project; Hammerhead 173 ton pulling machine and a TT Technologies 143 ton pulling machine. Both machines performed well and without incident. As part of the liner system design process, Murphy Pipelines utilized their software program to ensure installation stresses on the HDPE met the ASTM standard for the tensile yield design factor.

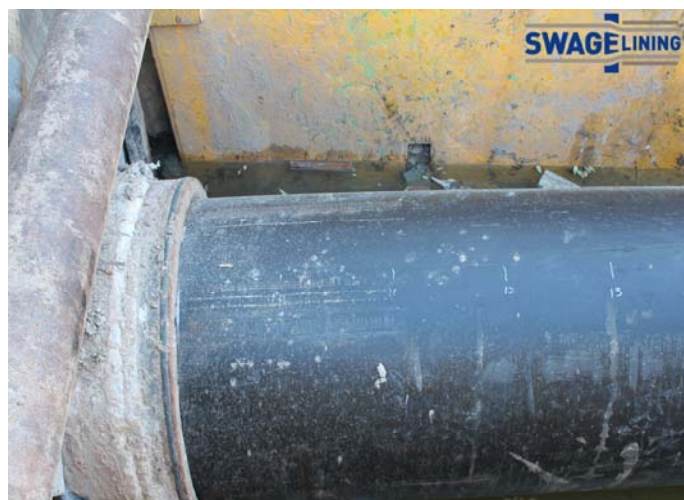
Figure 7: Tight compressive fit of HDPE after reversion.

After the HDPE pipe was completely pulled through the host pipe (with pull lengths of 1,250 to 2,100 feet), the pulling force was removed. This allowed the HDPE to naturally revert back towards its original diameter until halted by the inside diameter of the host pipe forming a compressive tight fit (Figure 7). While dependent on ambient temperatures, the HDPE is typically allowed to relax overnight to regain full reversion for most thin walled and semi-structural Swagelining applications. Due to the thicker wall of this fully structural application, the HDPE needed longer to revert and regain full reversion.

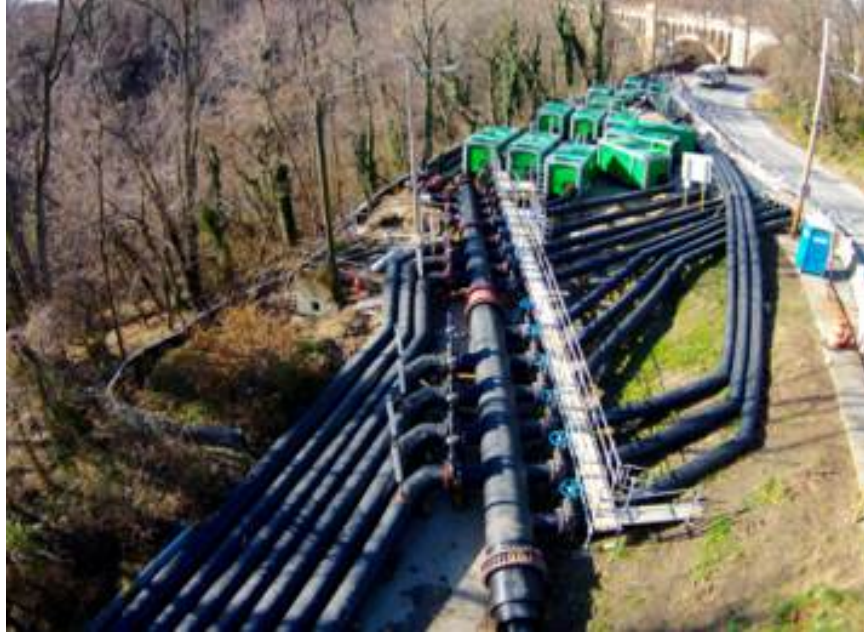
Figure 1. By-pass system installed for the SWDS Project

One of the most challenging aspects of the project was that wastewater flows would need to be diverted for the duration of the repairs using a by-pass/flow control system. With peak flows around 152 MGD, the bypass pumping and conveyance system was extensive and required several carefully planned right-of-entry agreements for routing the eight (8) 24-inch diameter high-density polyethylene (HDPE) bypass pipes in order to minimize disruption to the urban areas in which the project scope was located. The HDPE pipe sections were fused on site to create a continuous and leak-free by-pass system for the project as shown in Figure 1. Flows were intercepted upstream of the repairs, pumped through a series of fused HDPE by-pass pipes, and returned to the SWDS downstream of the repairs.

The by-pass pipes were configured to maintain site, vehicular and pedestrian access through the project by-pass corridor to minimize disruption to the area. This required right-of-entry agreements with several private commercial property owners. Because of the high cost of bypassing the flows, completing the project within the scheduled pipeline shutdown was critical to the success of the project.

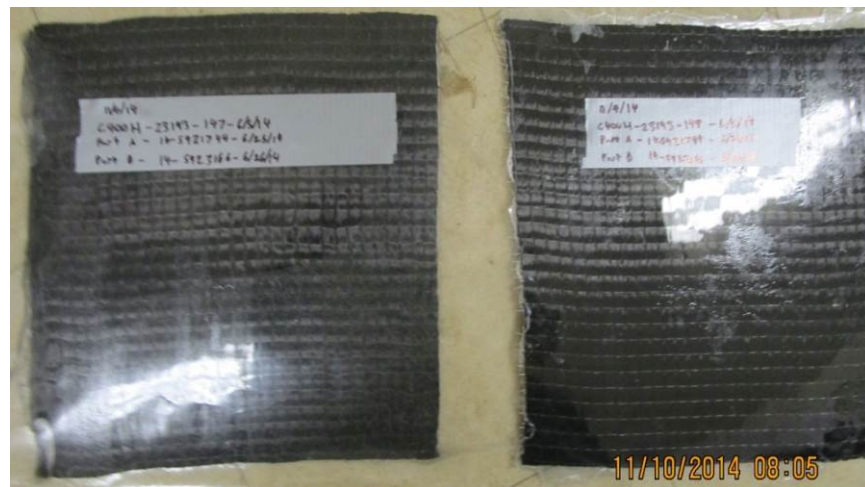
Figure 2. Witness panels utilized to confirm material design values.

One critical verification which takes place is confirmation that the material properties of the CFRP system applied in the field are in-line with the properties utilized in design. To do this, 12-inch by 12-inch test panels were made utilizing the carbon fiber fabric, epoxy, and saturation equipment from the production runs for the field-installed CFRP lining system. These panels were then cured in the pipe to ensure the same curing environment. After curing, these panels were collected by the Engineer and sent to a certified laboratory to be tensile tested in accordance with ASTM D3039 to gather material properties.

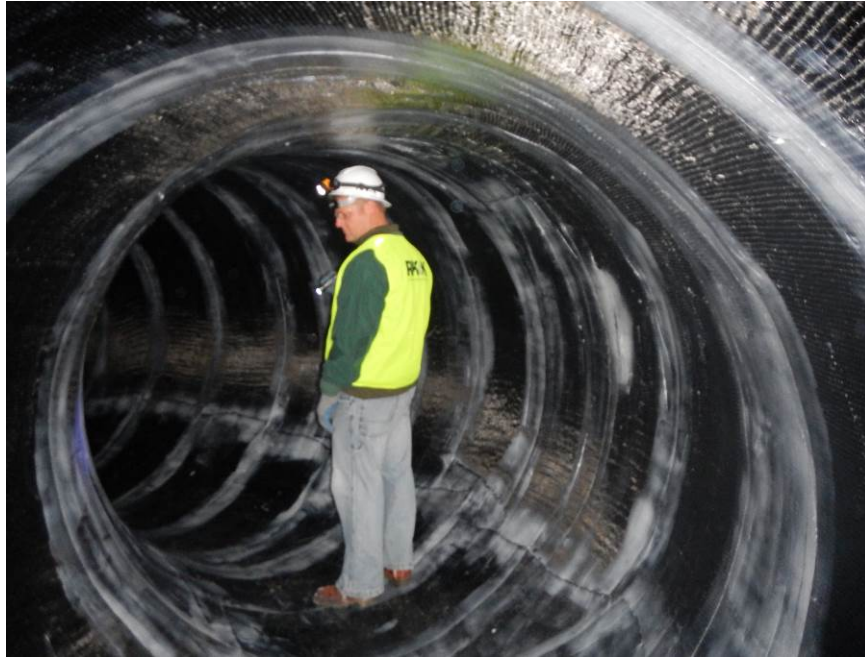
Figure 3. Inspection of the Installed CFRP Lining, prior to Top Coat Installation

- Verification of surface preparation via bond testing in accordance with ASTM D4541 pull tests (Figure 6)
- CFRP post-installation inspection (Figure 3)
- Top coat post-installation inspection (Figure 4)

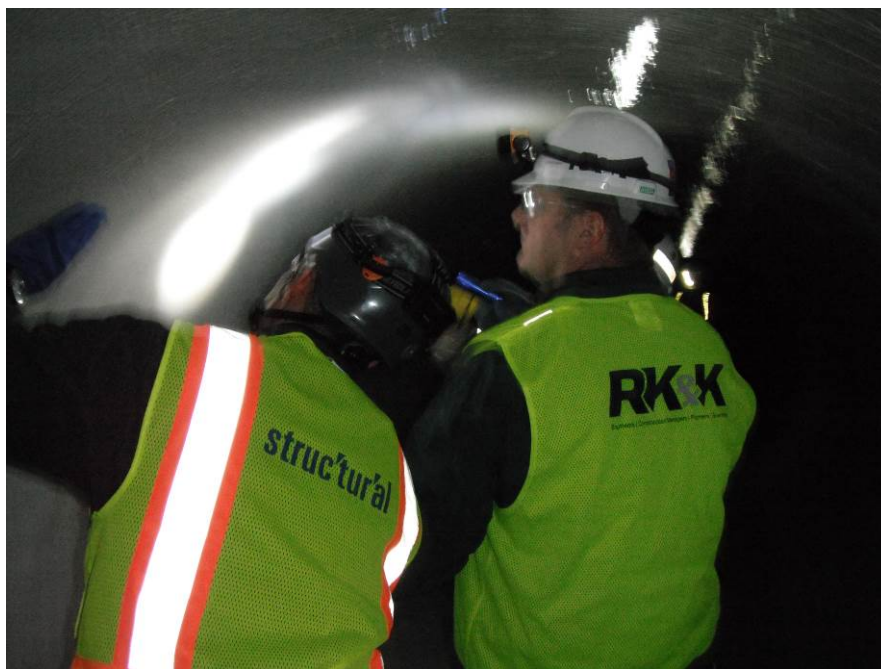
Figure 4. Inspection of top coat

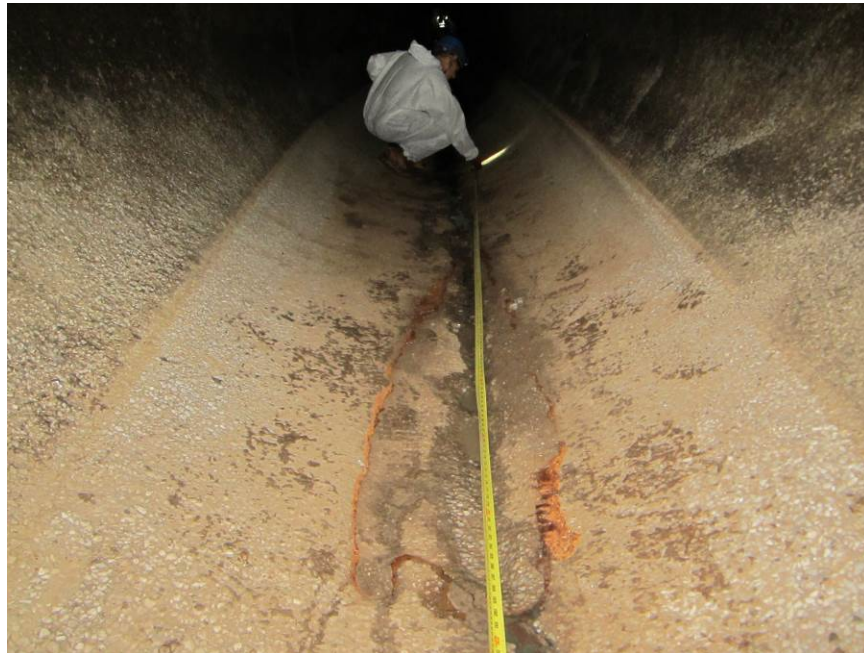
Figure 5. Deterioration observed at the invert of the pipe

After surface preparation was completed, the entire surface of pipeline was inspected by the City's consulting engineer, the CFRP installer, and the CFRP system manufacturer to document any anomalies and address any unanticipated conditions. One region of the pipe, shown in Figure 5, had experienced such severe erosion damage at the invert that the entire inner core, steel cylinder and most of the outer core was missing for a region approximately 16 feet along the length of the pipe. While the CFRP lining system was designed as a stand-alone structural system to take internal pressure and all external loads without reliance on the host pipe for structural integrity, this severe level of distress required special detailing to make sure that water intrusion was stopped during lining installation to allow the CFRP materials to cure properly.

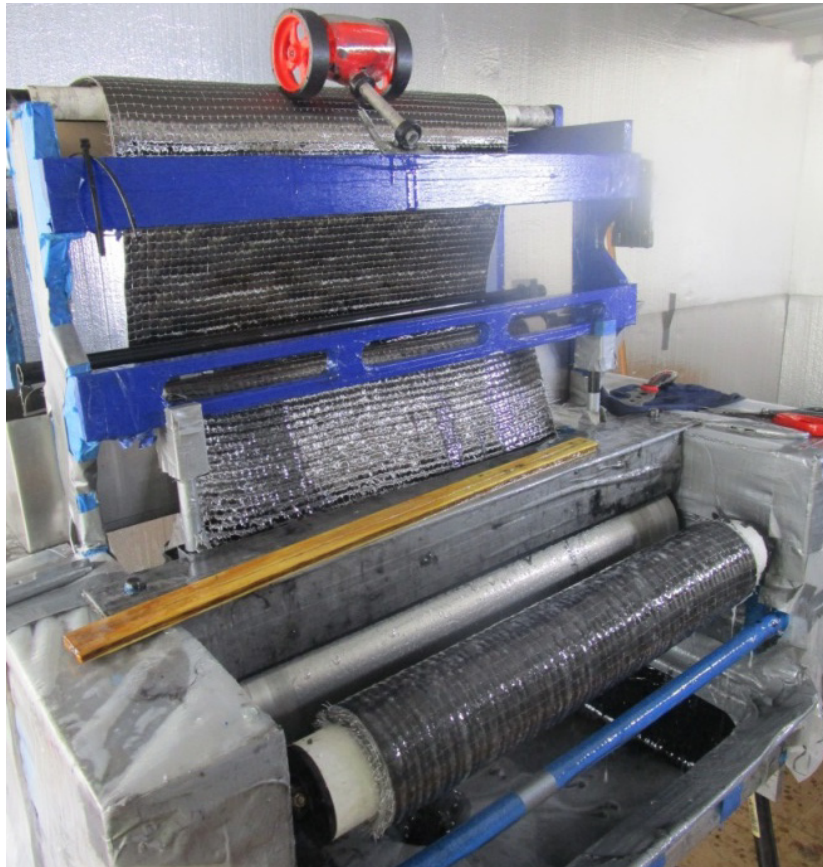
After completion of surface preparation, fabric layers are mechanically saturated with a two (2) part, 100% solids epoxy as shown in Figure 7. The mechanical saturator was calibrated several times per shift to ensure consistency in the epoxy to fabric weight ratio. The application of the CFRP lining system then involved applying a layer of thickened epoxy onto the prepared pipe substrate and applying epoxy saturated sheets of glass fiber and carbon fiber composites to the inside of the pipeline in the orientation designated per the project drawings. Once cured, the CFRP lining system is designed to take all of the internal pressure and external loads acting on the original pipeline without reliance on the host pipe. The design relies on the carbon fiber fabrics for structural integrity and the glass fiber fabrics to serve as an electrical isolation layer in any area where steel surfaces are exposed.

Figure 7. Mechanical saturation of the carbon fiber fabric.

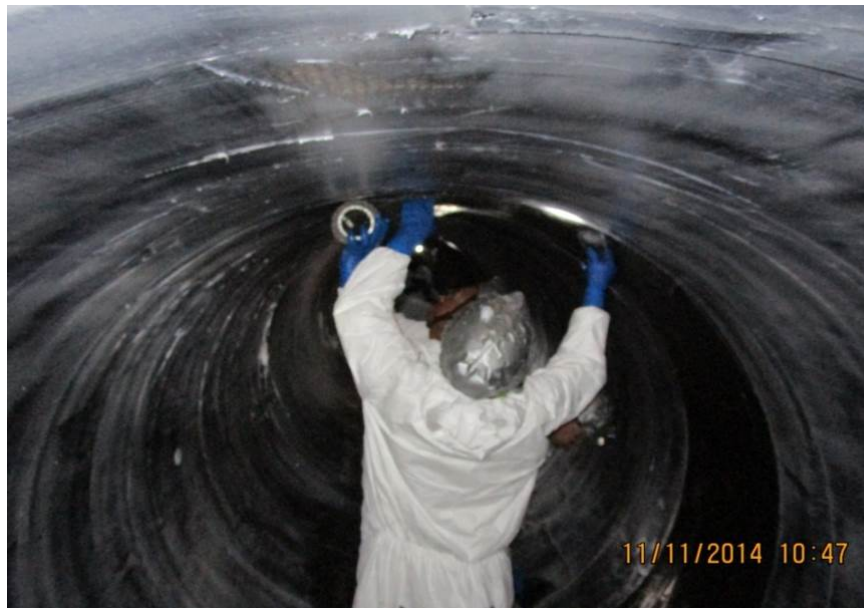
CFRP laminates properties are dependent on the bond between each lamina. The type of bond required is based on the time lapse between which the layers are installed. If a new layer is placed upon a previously installed layer within the epoxy's cure cycle, a chemical bond is established; otherwise, a mechanical bond is required. To establish a chemical bond with the epoxy used on this project, new layers had to be installed within 72 hours of application. Due to the size of the repair, it was necessary to divide the CFRP installation into three (3) distinct construction regions, where each region was treated from an operational standpoint as a separate CFRP installation. The use of separate installation regions, along with careful planning of work sequences, allowed for subsequent layers of CFRP to be installed within the necessary 72 hour window to develop a chemical bond between the layers of CFRP. Figure 8 shows the typical application process for the CFRP layers.

Figure 8. Application of hoop direction layer of CFRP
