Pipelines 2015

Recent Advances
in Underground
Pipeline
Engineering and
Construction

PROCEEDINGS OF THE PIPELINES 2015 CONFERENCE

August 23–26, 2015
Baltimore, Maryland

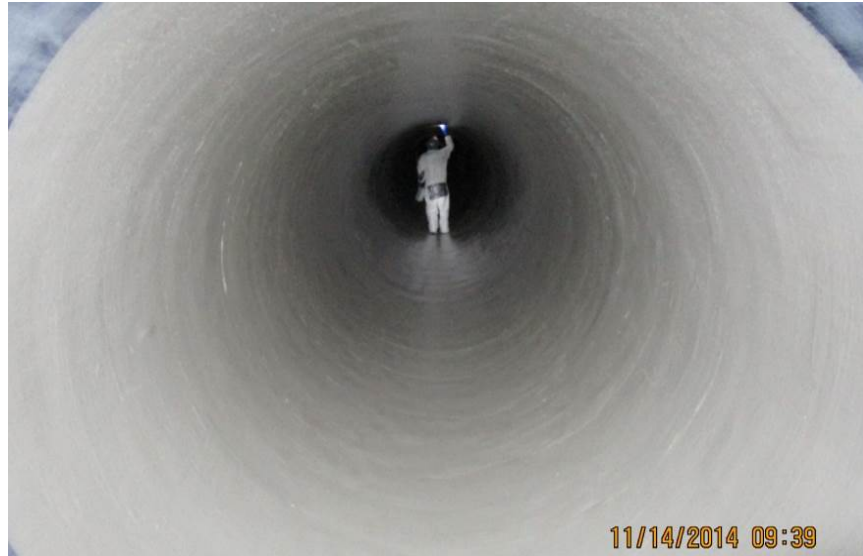
Because the SWDS pipeline transports raw sewage, a chemical-resistant top coat specifically designed for sewage applications was installed over the CFRP structural lining system. Quality inspections were also performed by the Engineer on the top coat layer as shown in Figure 9 to check for any defects that required the application of additional top coats to insure conformity with the project requirements.

Figure 9. Inspection of the CFRP lining top coat

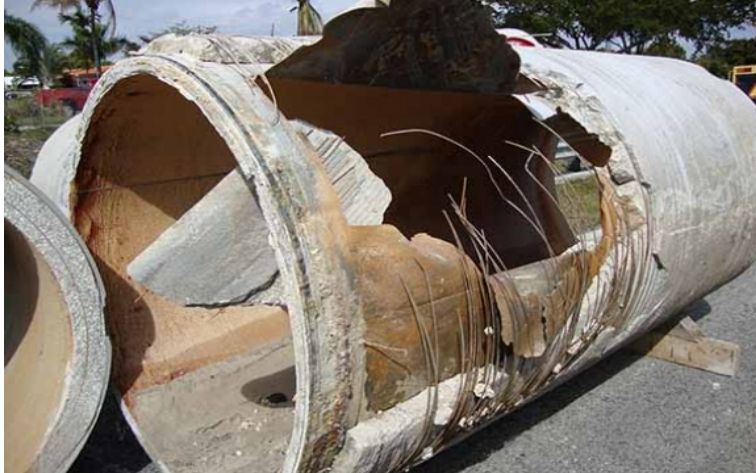
After a series of high profile catastrophic failures in 2010 and 2011, similar to the one shown in Figure 1, MDWASD began to focus on pipeline management and developed a comprehensive asset management program. The objective was to implement a program to minimize disruptions to residents and other customers. MDWASD had to develop a program that balanced upgrading and replacing pipelines to the region's increasing base of customers.

Figure 1 – Ruptured 54-inch PCCP water transmission main

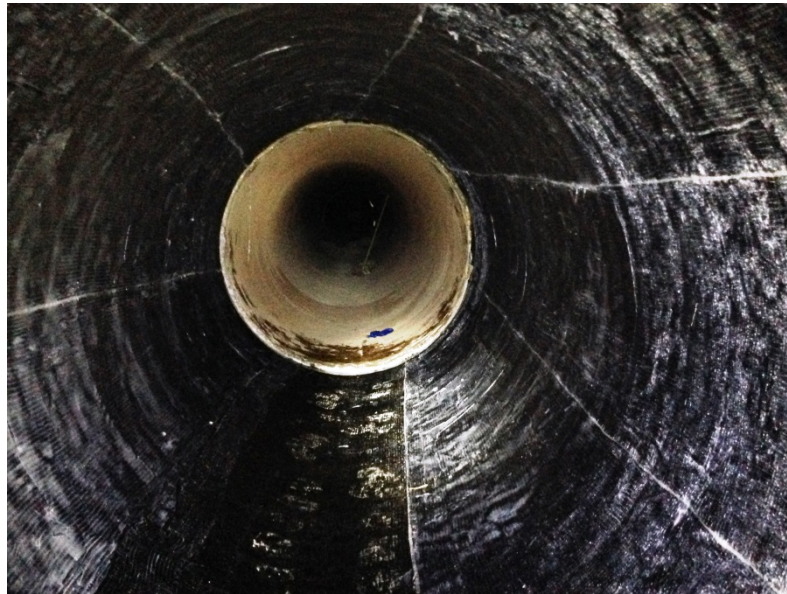
For the past 5 years MDWASD has utilized high-strength fiber-reinforced polymer (FRP) as a method to provide structural upgrade to specific pipe segments identified during inspections and failure risk analysis. Many projects have been completed using FRP for PCCP lines ranging from 48 to 96-inches, and a typical installation is shown below in Figure 2. MDWASD has established an emergency response team (ERT) of prequalified specialty contractors who can perform this work through an on-call process.

Figure 2 – Typical FRP installation

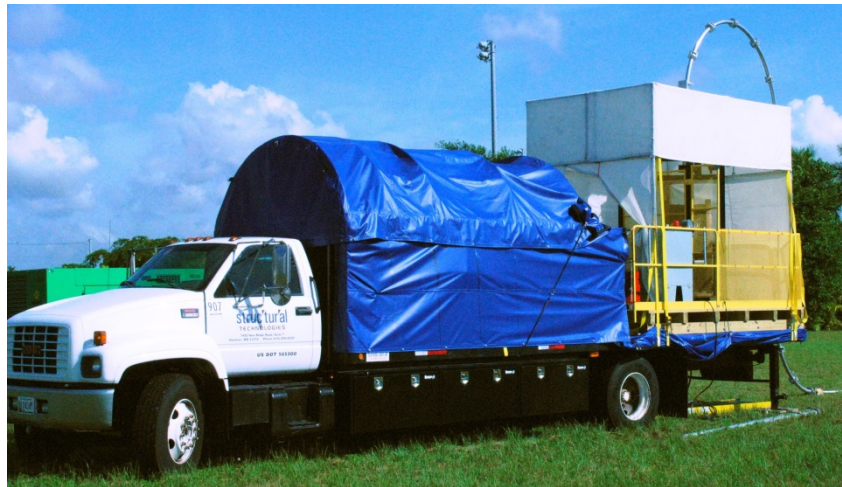
The project set-up for the Hybrid FRP System required a minimal topside footprint which included a truck mounted unit for the steel reinforcement installation. The truck unit is shown in Figure 4 below.

Figure 4 – Truck mounted unit for Hybrid FRP System steel reinforcement installation

The next step in the Hybrid FRP System was the installation of the spirally wound steel reinforcement. The truck mounted unit, shown above in Figure 4, fed the steel reinforcement in a spiral fashion into the pipe where it was placed using automated equipment specially developed for the in-pipe installation. The steel reinforcement installation equipment, shown in Figure 6 below, was dismantled and reassembled in the pipe, allowing for the equipment to fit through the 16-inch by 18-inch manholes typically available for entry into MDWASD's pipelines.

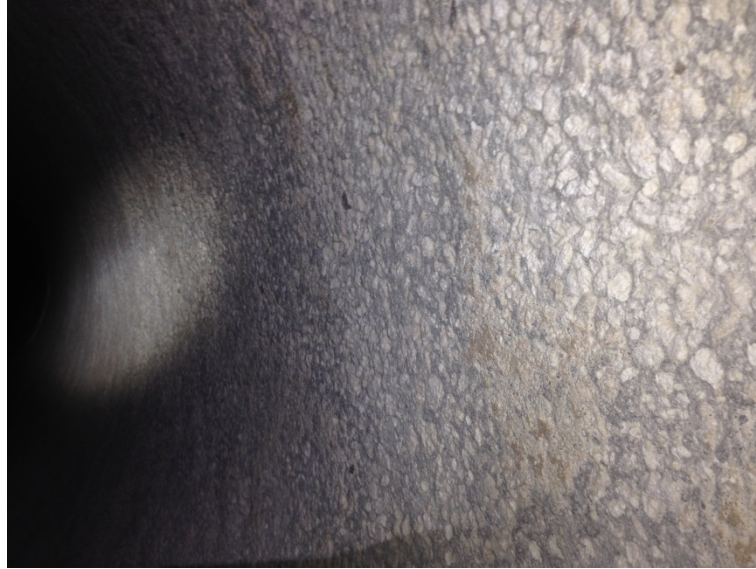
The first step of pipeline operations completed for the Hybrid FRP System installation at the 54-inch PCCP for MDWASD was surface preparation. The inner core concrete was abrasively blasted to roughen the surface to a minimum concrete surface profile (CSP) of 3 as defined by ICRI 310.2 guideline. At the termination of the Hybrid FRP system, the joints of the PCCP were chipped out to expose the bell and spigot steel and the steel substrate in joint areas was prepared to near-white metal condition as defined by SSPC-SP10/NACE No.2. Figure 5 below shows the prepared concrete substrate.

Figure 5 – Prepared concrete substrate – MDWASD 54-inch PCCP

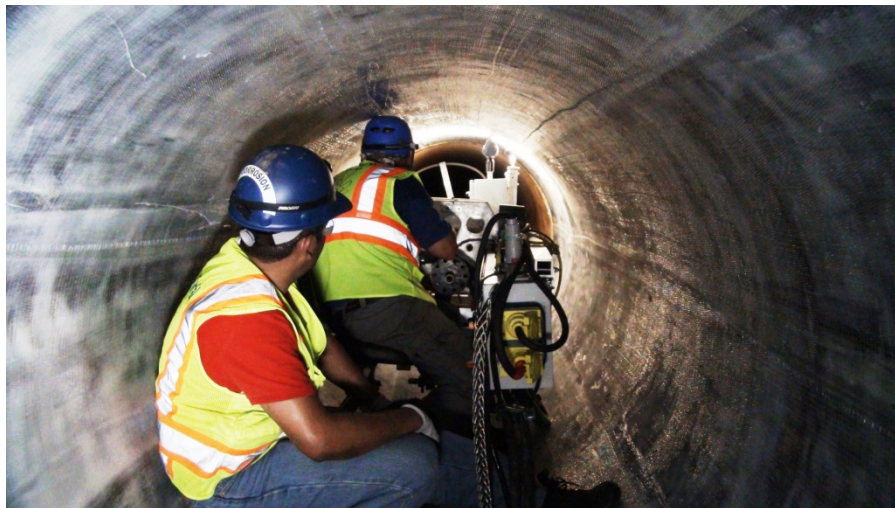
Figure 6 – Hybrid FRP System – Steel reinforcement installation

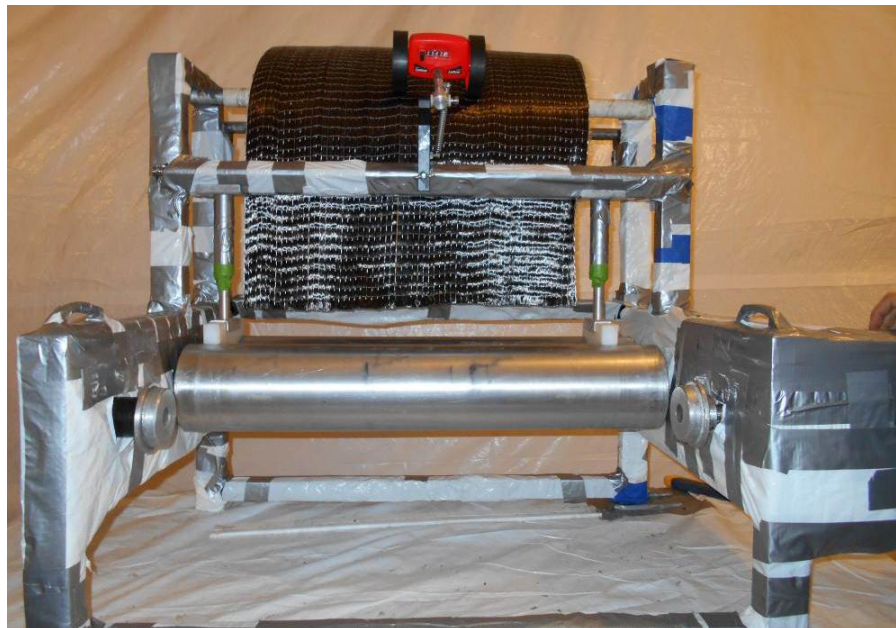
QA/QC for FRP component. During the installation and cure time of FRP, environmental conditions are monitored and tracked. These include temperature and humidity. As materials are prepared for installation there are steps for verification which include confirmation of the mixing procedure for epoxy and documentation of calibration of rollers within the mechanical saturation equipment, shown in Figure 8.

Figure 8 – Mechanical saturation equipment

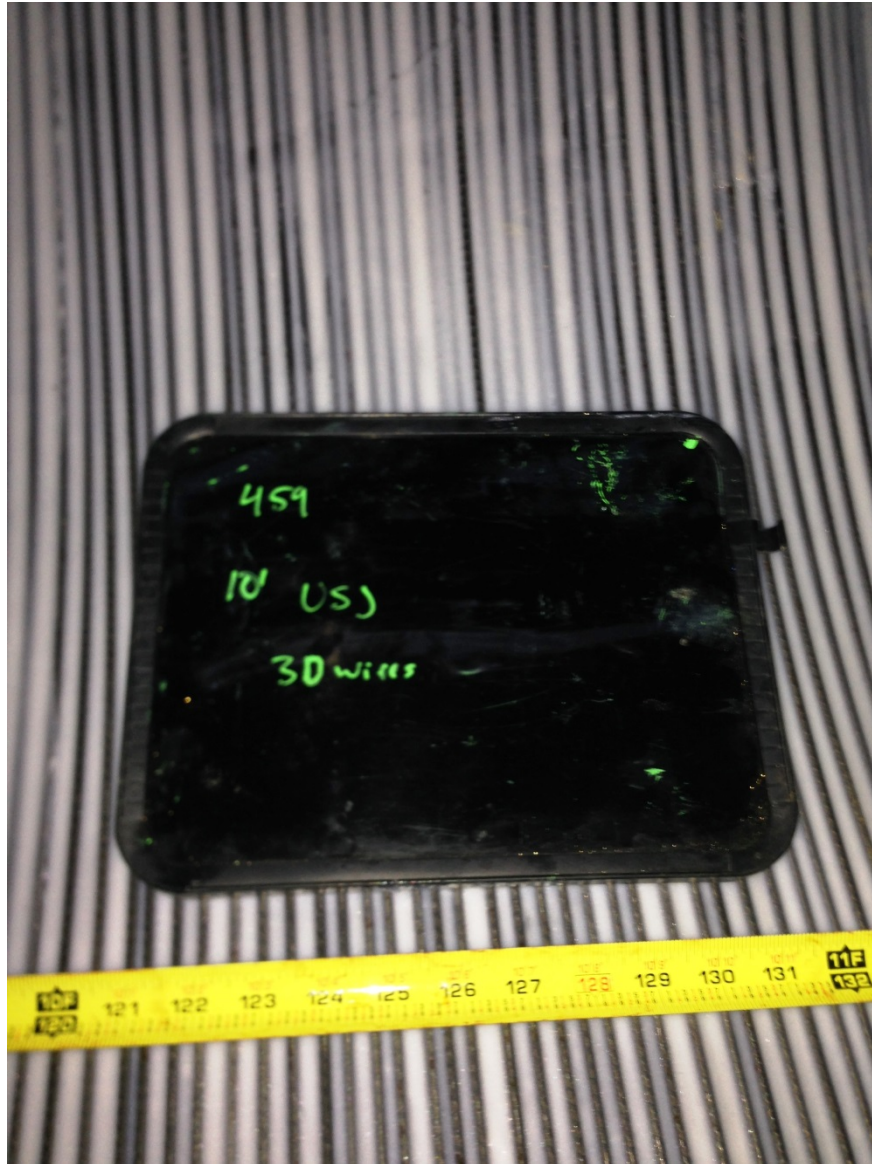
QA/QC for Steel Reinforcement component. The second major component of the Hybrid FRP System is steel reinforcement and there are several QA/QC steps associated with this portion of the installation. As the steel is delivered to the jobsite, the lot numbers of the steel are verified. A visual check of the steel takes place as it is placed onto the pipe surface. In addition, the spacing of the steel reinforcement – confirmation that the correct numbers of steel reinforcement wires are placed within each lineal foot of pipe takes place. There is also a check to determine that the minimum and maximum spacing between each steel wire in relation to adjacent steel meets project requirements. This is shown in Figure 9.

Figure 9 – Verification of steel wire placement

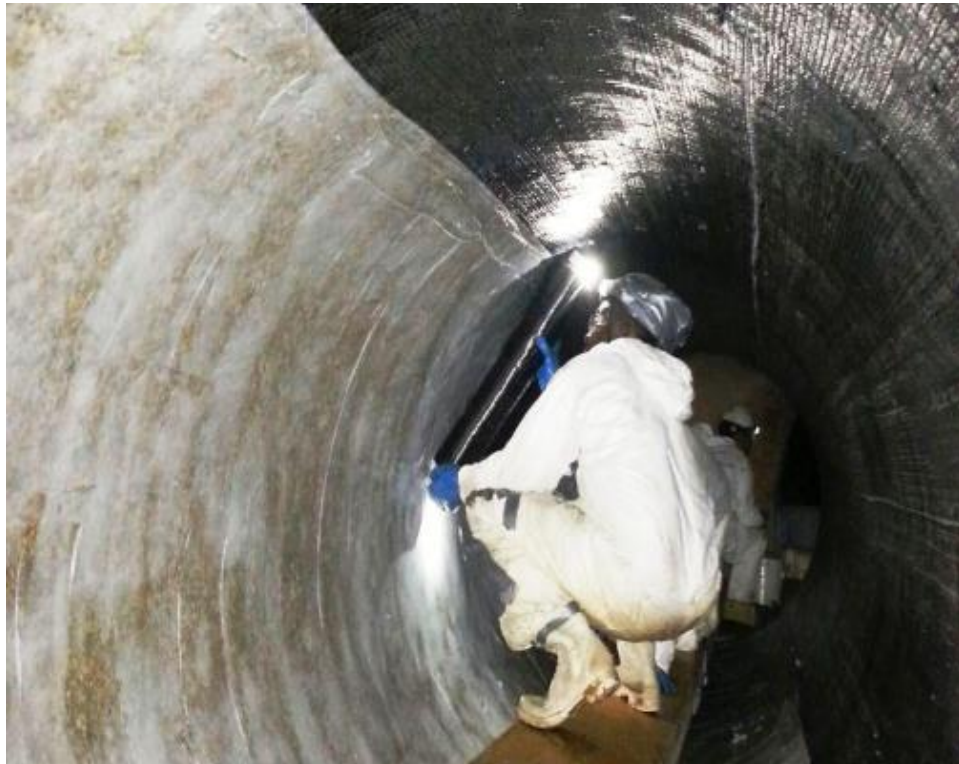
Over the past more than 15 years, Fiber Reinforced Polymer (FRP) composite materials have been utilized with increasing frequency for internal structural rehabilitation and upgrade of pipelines. The overall process involves surface preparation of the internal pipe substrate followed by manual application of layers of unidirectional carbon fiber fabrics (Figure 1) which have been saturated with a two part epoxy directly prior to installation using a calibrated mechanical saturator.

Figure 1. Typical process for Installation of CFRP inside a pipeline

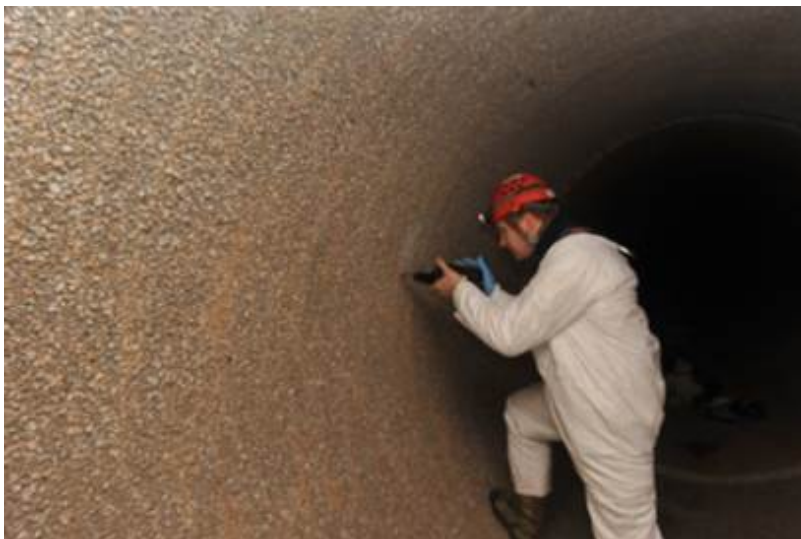
Tests to estimate the compressive strength of concrete include sonic/ultrasonic inspection which can be performed as a part of the structural assessment [8], and the rebound hammer test (i.e. Schmidt hammer test) per ASTM C805 [4] which involves a spring loaded hammer hitting a steel plunger, which is in contact with the concrete as shown in Figure 4. Once the concrete is impacted by the defined energy, the hammer’s rebound distance is measured. This rebound hammer can be used to determine the concrete’s compressive strength using the manufacturer’s conversion chart [9].

Figure 4. Evaluation of Inner Concrete Core via Rebound Hammer Test

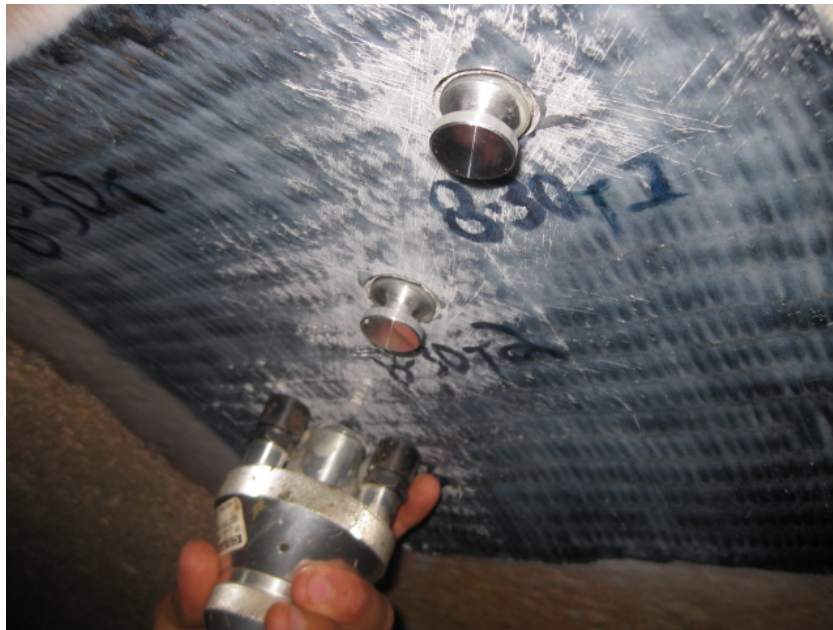
In order to validate design based on the estimated inner core concrete values, adhesion tests must be performed in accordance with ASTM D4541 [3]. Adhesion tests are a part of the typical QA/QC process for the CFRP lining process. A common failure mode observed in the adhesion tests is tensile failure within the inner concrete core substrate so the results from adhesion testing provide a measure of the tensile strength of the concrete core (Figure 5). Since the tensile strength of concrete is approximately 10% of concrete's compressive strength, the compressive strength of the concrete can be approximated through use of adhesion tests on the inner core substrate. The calculated compressive strength for the inner core concrete can be checked against the minimum required values used in the design ($\sigma < R_{\min}$).

Figure 5. Pull Test per ASTM D4541

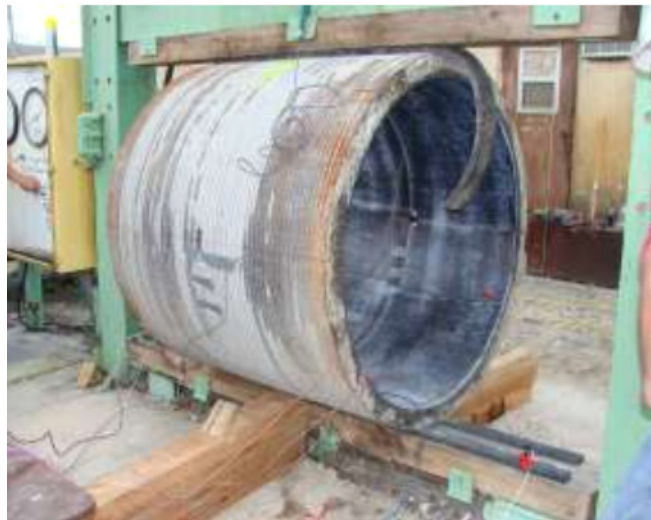
External load testing, such as that recently completed (as shown in Figure 6), assists in better understanding of the CFRP and inner core composite action mechanism and ultimately helped validating the design approach which relies on the inner core for composite CFRP design.

Figure 6. Water Research Foundation Testing Setup (Zarghamee et al, 2013)

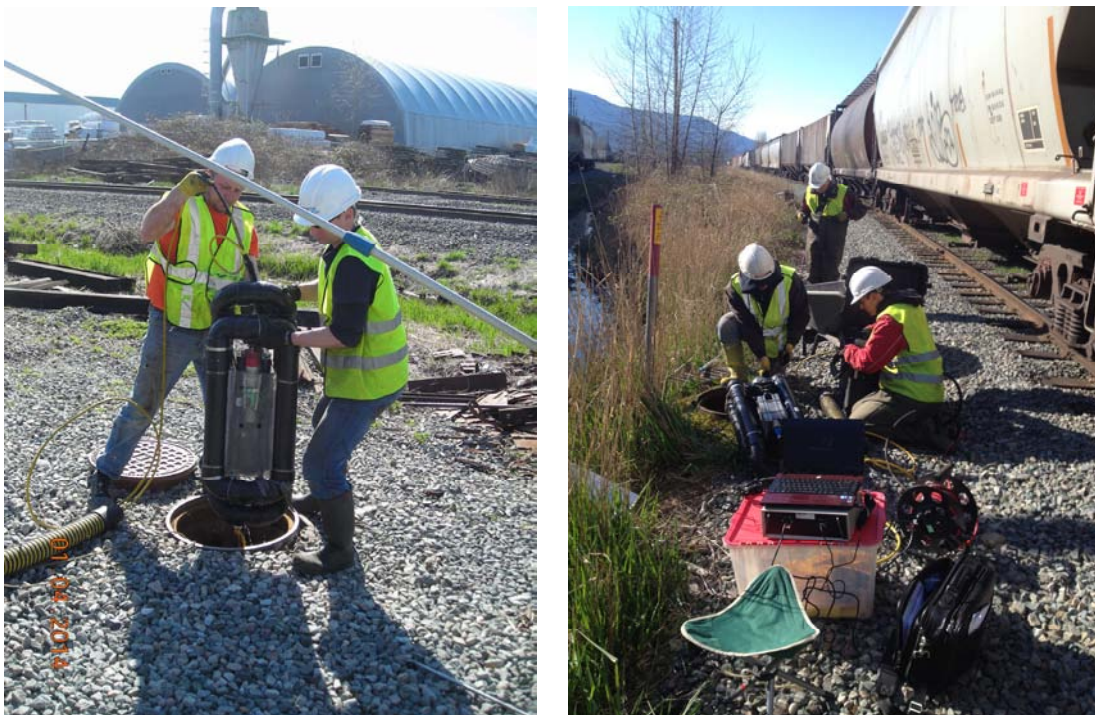
customizable second generation MPIS was attached to a light weight and mobile 500 feet (150 m) long tether cable and reel. This allowed truck independent deployment and operation which was critical for the project since most of the manholes had no vehicle access (Figure 2).

The floating platform was modified to fit through 18" (450 mm) pipe sections. CCTV, LIDAR and sonar data were acquired simultaneously in both in and out directions. The pipe diameter of the inspected sections varied between 18 and 27 inches (450 mm and 600 mm), pipe material was PVC, HDPE and steel. First a guide rope was installed then the inspection platform was winched through. A total of 5589 ft (1863 m) was inspected.

Figure 2. Deployment of and data collection with the second generation SewerVUE Multi-sensor Pipe Inspection System on a railway right-of-way in Abbotsford, BC, Canada.

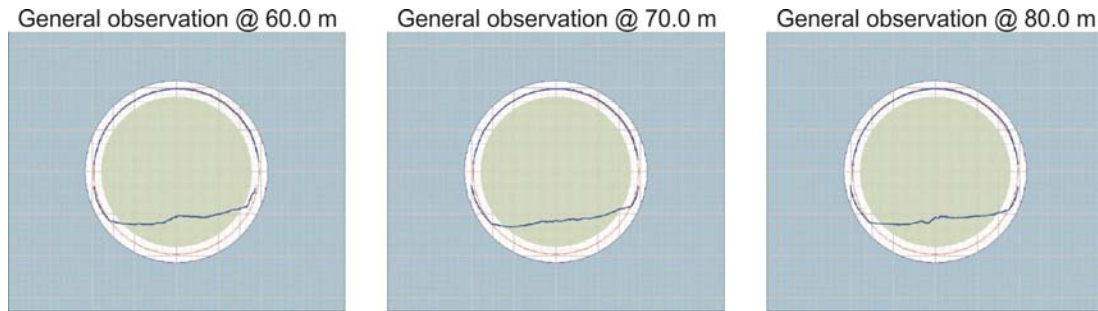
In total, 2,562 ft³ of debris was detected along the 5,589 ft of the Huntingdon Trunk Sewer. The average cross-sectional restriction for the sections of pipe ranged from 3.9% to 28.5% with an overall average of 12.6%. An example of the pipe cross-sections are shown in Figure 3. The cross-sectional restriction did not appear to correlate with pipe diameter or material.

Figure 3. Showing an example of pipe cross-sections from the Huntingdon Trunk Sewer. The line represents sediment level in the pipe. This section had an average cross-sectional restriction of 9.0%.

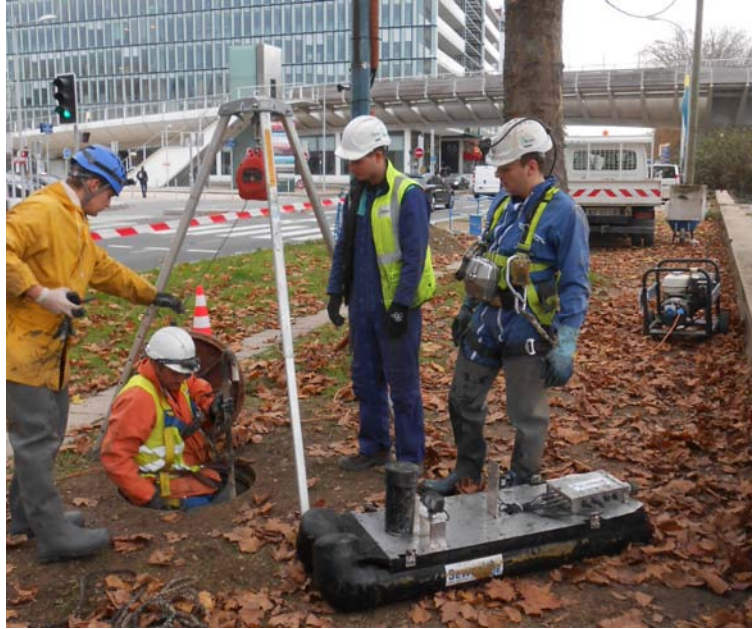
The SewerVUE's long range multi-sensor pipe inspection (MPIS) technology combines state of the art data collection and analysis with proprietary processing and reporting software. The float based inspection platform is outfitted with high definition CCTV, LIDAR and sonar sensors and has a 4000 ft maximum deployment capability. LIDAR measurements determine the exact size and shape of the pipe and provide quantitative assessment of deformation and corrosion. Sonar accurately profiles the pipe below the flow line and calculates the sediment and debris volume in the pipe. The system is customizable and can be deployed through a 18 inch manhole and can inspect any pipe size over 18 inches. Bypass pumping is not required. Inspection reports provide integrated and quantitative corrosion and debris measurements, 180 degree virtual pan/tilt/zoom function, video, laser and sonar flats.

Figure 4. The SewerVUE MPIS and field crew before deployment in Boulogne-Billancourt.

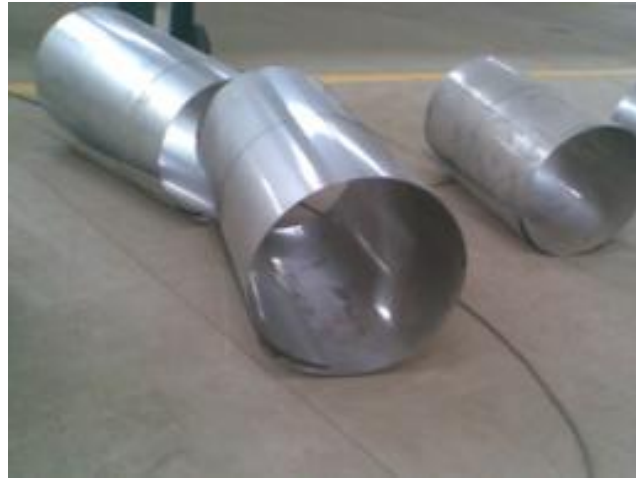
and each plate is curved as showed in Figure 3 by a rounder. The required separation distance of welded joint between each stainless plate is no less than 0.79 inch. And the position of 4 o'clock and 8 o'clock are recommended as welding joints for the adjacent stainless steel plates.

Figure 3. The curved stainless plates

They are manually welded in-situ to form cylinders inside the host pipes to be rehabilitated. Generally, stainless steel liners can be fitted to the host pipes evenly and with a good form-fitting shape using this method. For overlapped and manually welded liners, there would be an inevitable gap adjacent to the overlap point. The first segment of the overlapped liner will cause a gap which is equal to the thickness of the liner, and the second part of liner is welded onto the inner wall of the first liner. And the gap of the second liner near the overlapped part doubles, i.e. $d=2t$, as shown in Figure 4. The welding quality inspection should be conducted after the welding construction based on Chinese national standard GB50235-97, *Code for construction and acceptance of industrial metal pipeline engineering*. Figure 5 shows the stainless steel liners after insertion into the host pipe in practice by in-situ manual welding method.

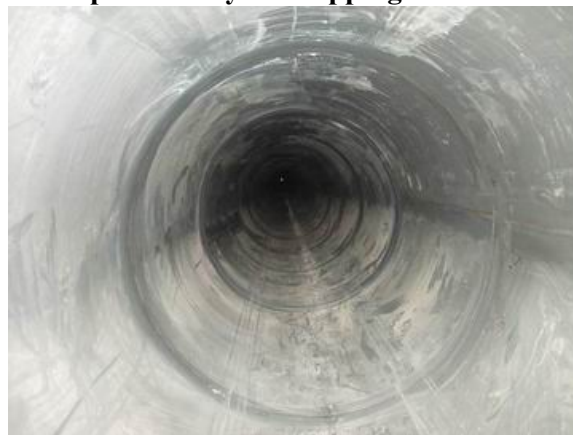
Figure 5. Stainless steel liners after insertion into the host pipe (from BAODING JINDI SCIENCE&TECHNOLOGY DEVELOPMENT CO., LTD)

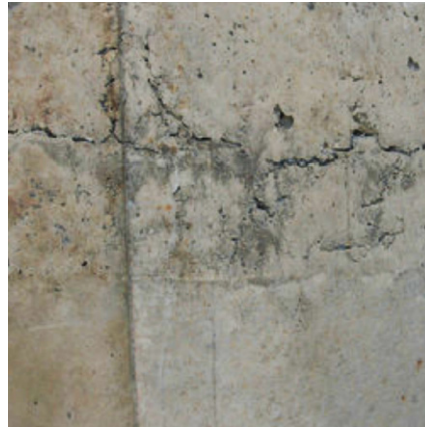
On real world construction sites, unexpected and unanticipated circumstances can result in delays or work stoppages. Additionally, many job sites can be subject to restricted work hours due to local traffic issues or community related ordinance. When working with the placement cement, these types of work stoppages or delays can result in the formation of a cold joint. A cold joint is an undesired discontinuity between two layers of concrete. A cold joint occurs due to the inability of a freshly poured wet cement to intermingle and bind with an already hardened cement. A typical cold joint in a poured structure is shown in Figure 3.

Figure 3: Typical Cement Cold Joint

Cold joints can result in multiple problems ranging from minor to catastrophic. The spectrum of resulting issues include: minor cosmetic visual differences between layers, possible moisture intrusion into the joint resulting in degradation from environmental conditions, and areas of significantly compromised strength within a structure. When water is mixed with Portland cement (OPC) the cement reacts with the water to form a hydrate allowing the cement to harden around aggregates and form concrete. The chemistry of the reaction uses a hydration mechanism to create a hardened solid phase structure. However, once the hydration is complete and the structure is solid, it will not physically or chemically intermingle with additional cement.

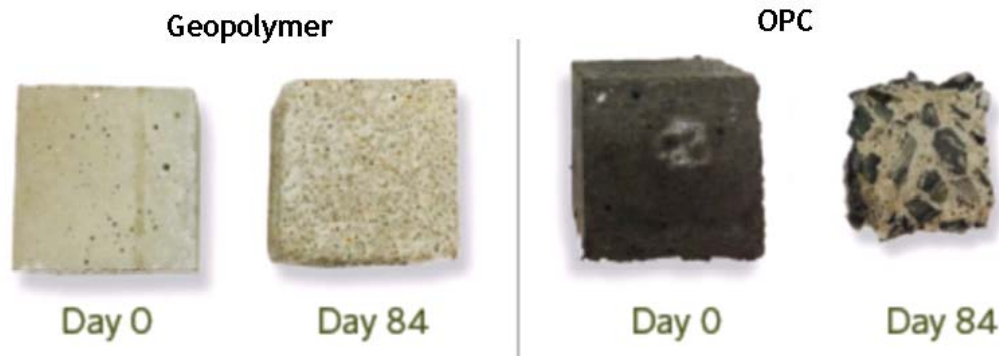
over the same time period. Figure 7 shows samples cubes before and after 84 days of soaking exposure.

Figure 7: Image of cubes before and after soaking in 7% H₂SO₄

Samples were measured for weight and dimensional changes after soaking for 1, 7, 14, 28, 56 and 84 days. 3 samples of the materials were soaked and tested, and the solution volume relative to the cubes was held constant. The chemical solutions were refreshed on day 14, 28, and 56. Geopolymer samples showed only slight loss of mass and signs of surface corrosion through the 84 days exposure to 7% H_2SO_4 (sulfuric acid), while the Portland cement samples lost more than 50% of their weight

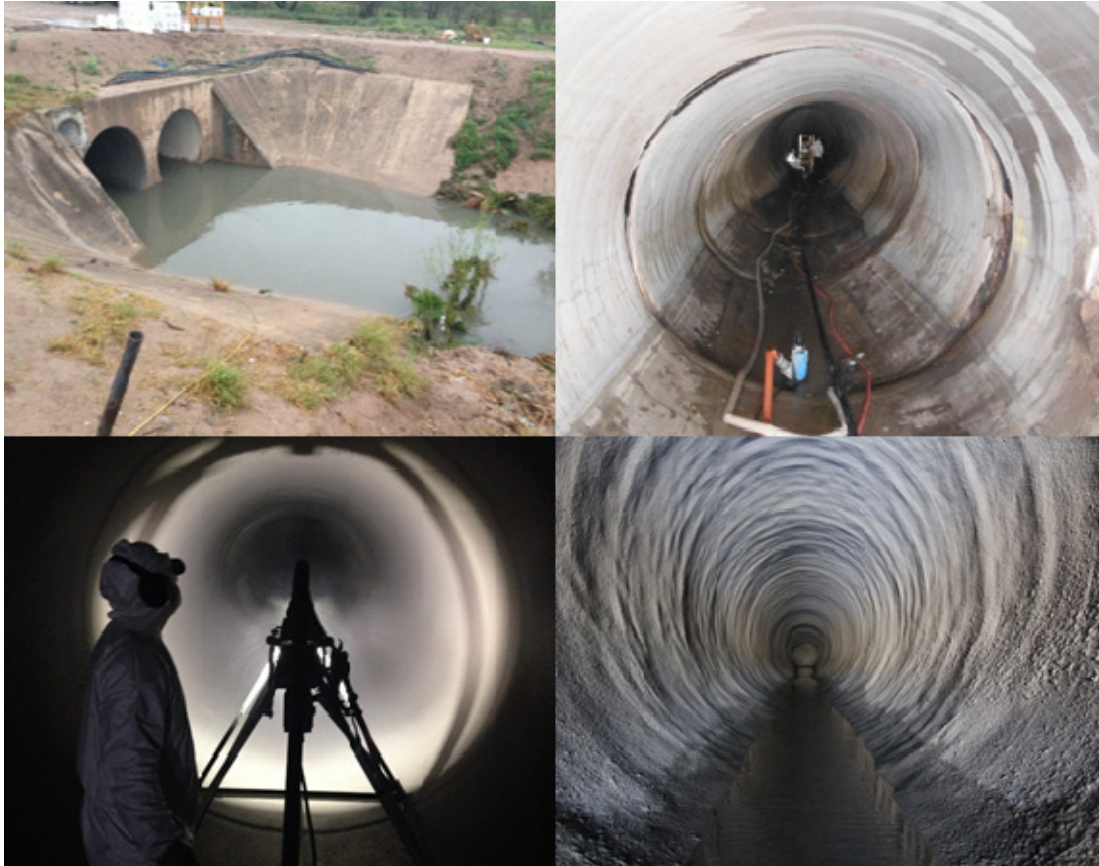
a series of images from the job site, this includes upstream the entrance to the pipes, a view of the joint separation on the shotcrete repaired structure, the geopolymer application and the finished pipe.

Figure 9: Images from the jobsite for the Rado Storm Drain in McAllen, TX

The use of geopolymer to create a new pipe within the existing CMP structure that existed was completed on time and under budget. The new pipe is ready to handle the unpredictable storms of southern Texas for years to come. Figure 9 shows

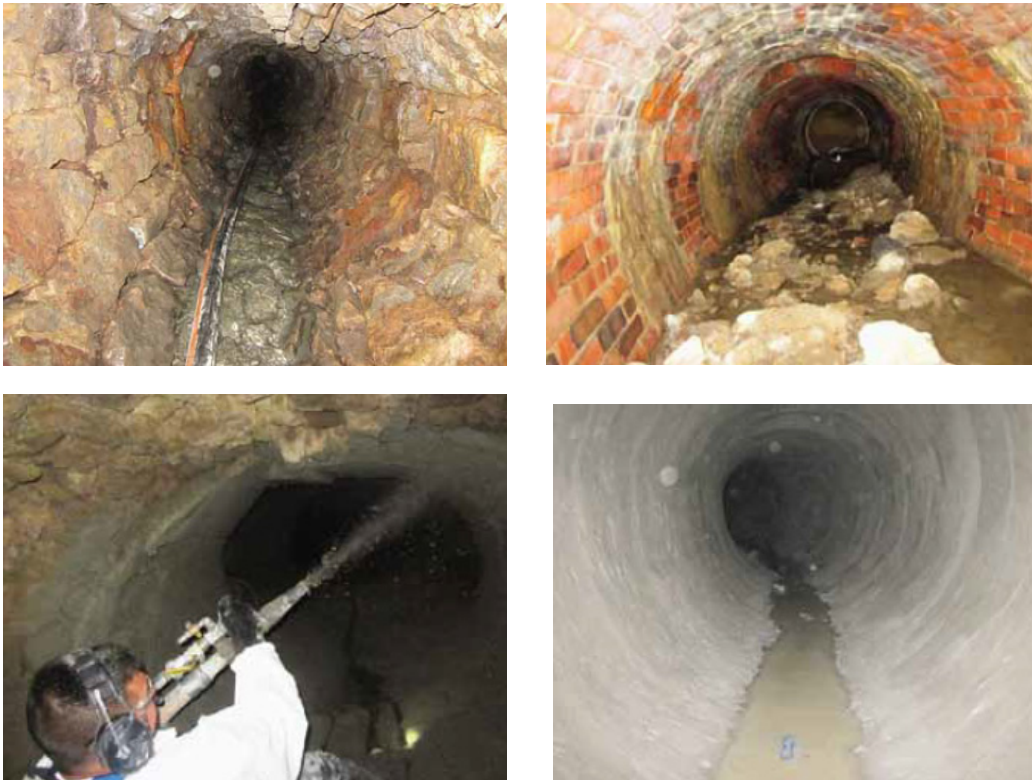
Figure 10: Images from the jobsite for the MSD in Cincinnati Ohio

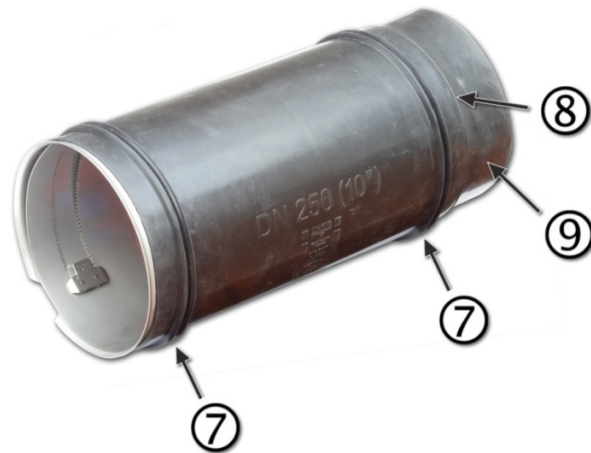
Figure 2. Locking gear mechanism and EPDM rubber seals (Uhrig, 2015)

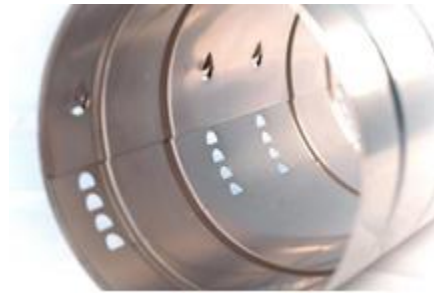
a) Link-Pipe asserts that if during routine inspection damaged pipe is discovered, it takes around 20 minutes to have it repaired using Link-Pipe Grouting Sleeve or SewerSealer, shown in Figure 5. These sleeves must be installed before the resin is cured, usually within 20 to 25 minutes. Spot repairs can be installed in pipe diameters

Figure 5. Sewer seal (Link-Pipe, 2015)

of 6-54 inches. Every Grouting Sleeve, SewerSealer Sleeve and Link-Pipe (PVC Sleeve) carries a manufacture 10-year Limited Warranty and is evaluated to give a minimum 100-year service life. Link-Pipe contains a wide variety of diameters and ranges from man accessible to remote repair products. The sizing of the sleeve that would work needs to be established with precise measurements of the inner diameter of the pipe that is being repaired. At times, this lack of the sleeve's ability to accommodate even minor variations in the diameter of the damaged pipe presents challenges in the field.

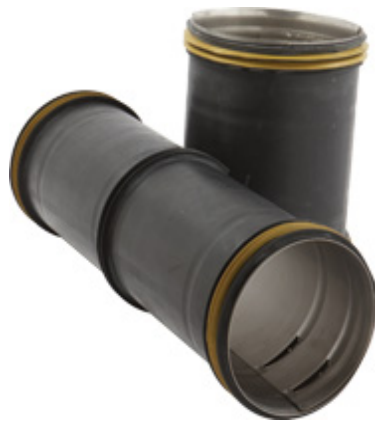
Figure 8. Snap lock system

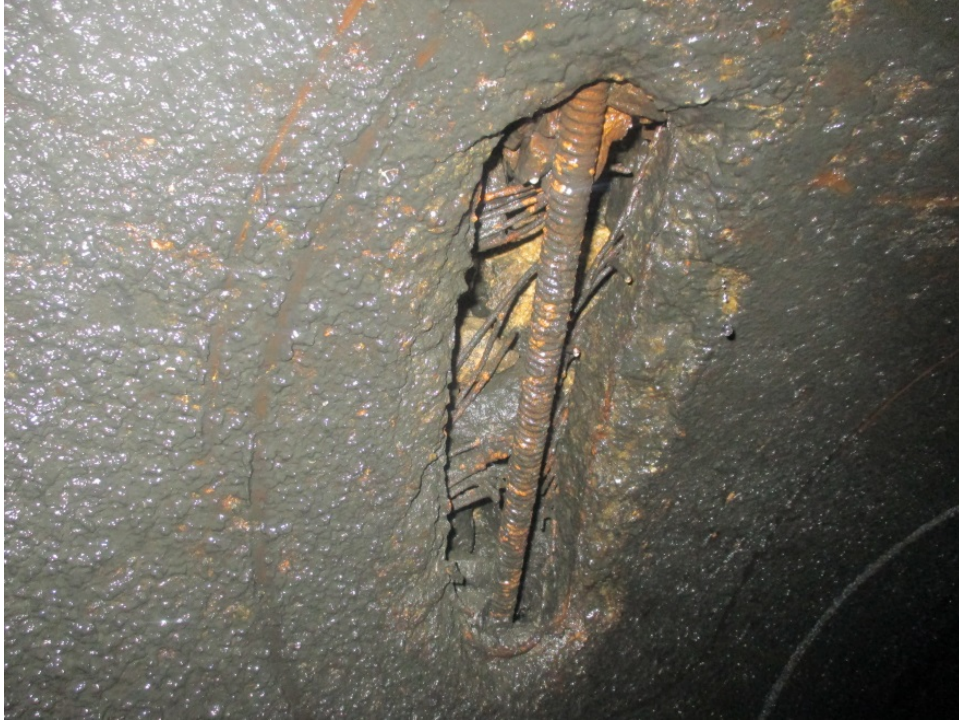
Figure 2. Soil nail going through pipe wall

Based on the damage identified by the video inspection, it was determined the penetrated sections of pipe could not be relied on safely for long term operation. The sections required either replacement or structural upgrade.

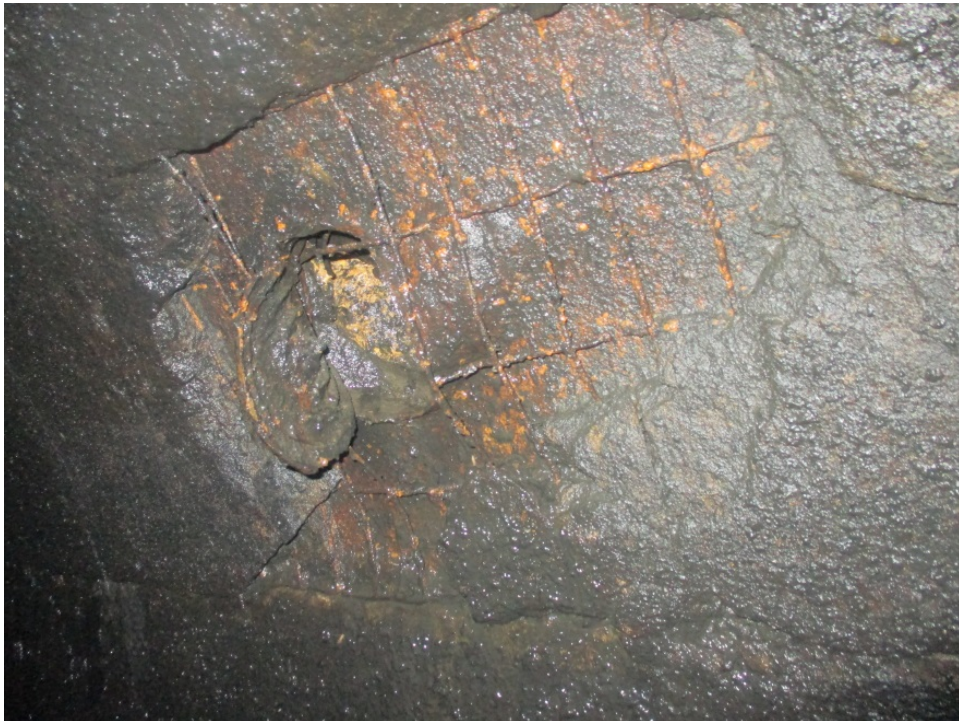
Figure 3. Hole in steel elbow pipe section

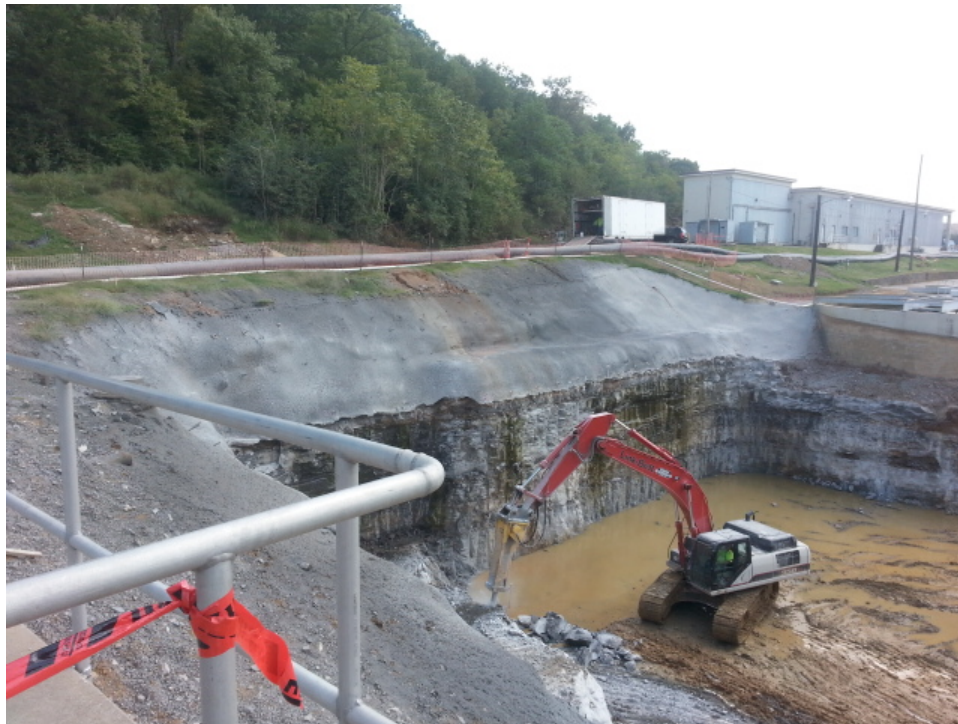
Figure 4. Location of pipeline in relationship to excavation slope

As part of the options analysis, replacement, slip-lining, and stand-alone structural rehabilitation with Carbon Fiber-Reinforced Polymer (CFRP) were considered. The proximity of multiple bends in the pipeline to the distressed pipes ruled out slip-lining as a repair option. Due to the pipeline being positioned adjacent to a 20 foot drop-off, excavation for replacement would have been extremely challenging (see Figure 4). Furthermore, lead time for replacement of the special order steel bend section would have left the pipeline unrepaired for an extended amount of time during the remaining peak summer demand. As the need to repair the line was pressing, the team decided that trenchless repair was the best option. Based on the notable external load carrying requirements and the construction schedule restraints, a CFRP lining system was selected as the repair method for its structural capabilities, trenchless application, and timeliness.

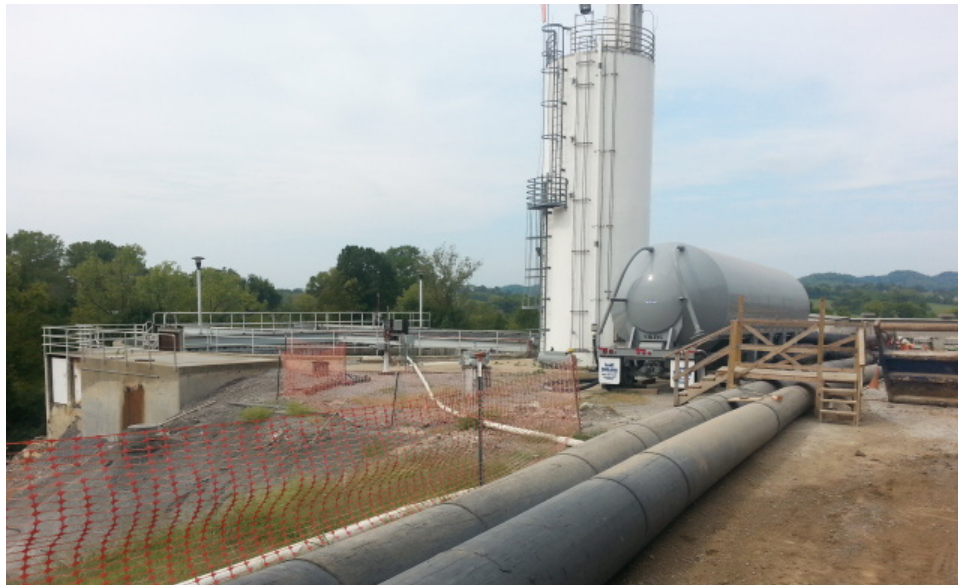
Given the critical nature of the affected 54-inch pipeline, the owner elected to set up a temporary by-pass upstream and downstream of the repair area, so the pipeline could remain operational throughout the repair process. As shown in figure 5, the by-pass system was set up on the Site prior to the repair process moving forward.

Figure 5. By-Pass System

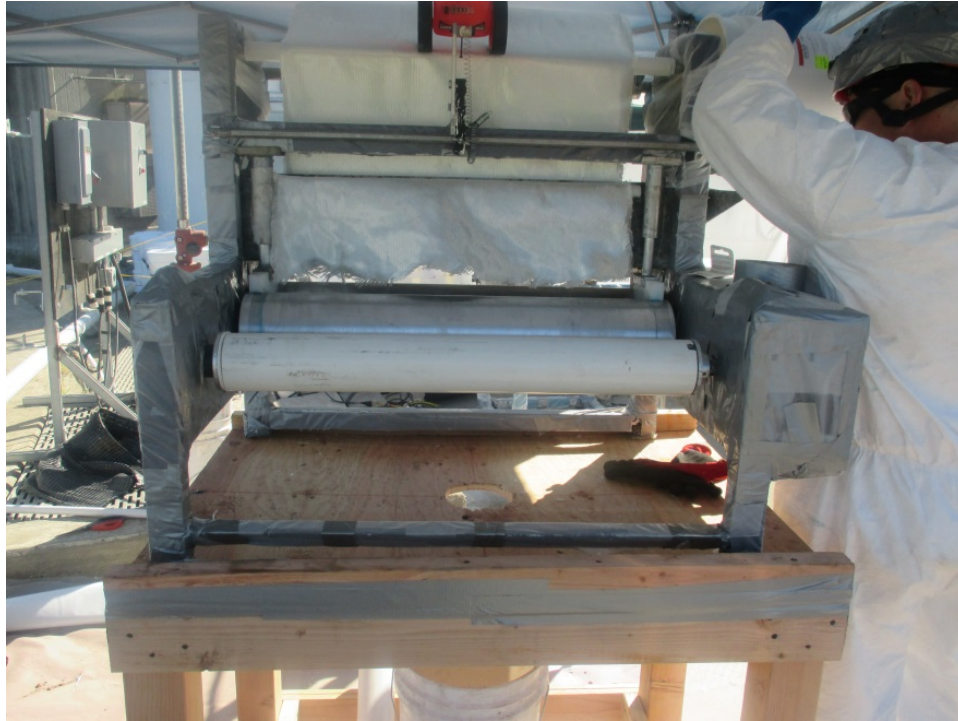
The CFRP repair process involves layers of unidirectional carbon fiber fabric being installed in a pipe longitudinally and circumferentially. In areas with steel substrate such as the joints, a layer of glass fabric was used as a dielectric barrier between the steel and the carbon fiber. Both the carbon fiber and glass fabrics were saturated in a two-part 100% solids epoxy using a mechanical saturator (See Figure 6).

Figure 6. Glass fabric being saturated with a two-part 100% solid epoxy using a mechanical saturator

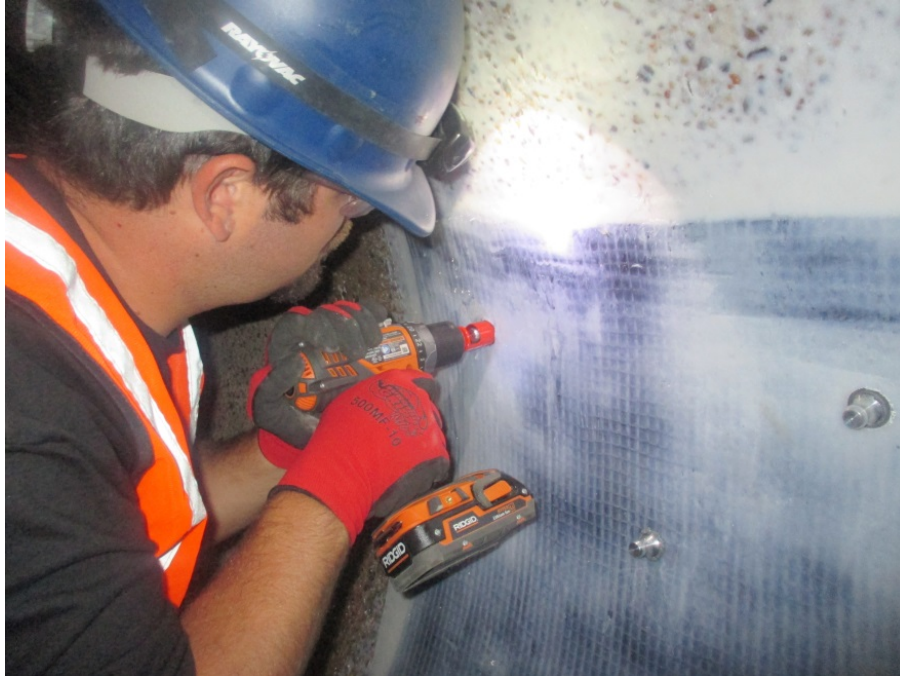
To verify surface preparation, adhesion tests were performed on adjacent substrate per ASTM D4541 to 300 psi minimum (See Figure 8). Once surface preparation was completed, the pipe substrate was covered by a prime coat of epoxy and a layer of thickened epoxy (See Figure 9.)

Figure 8. Pull test per ASTM D4541 being performed to verify surface preparation

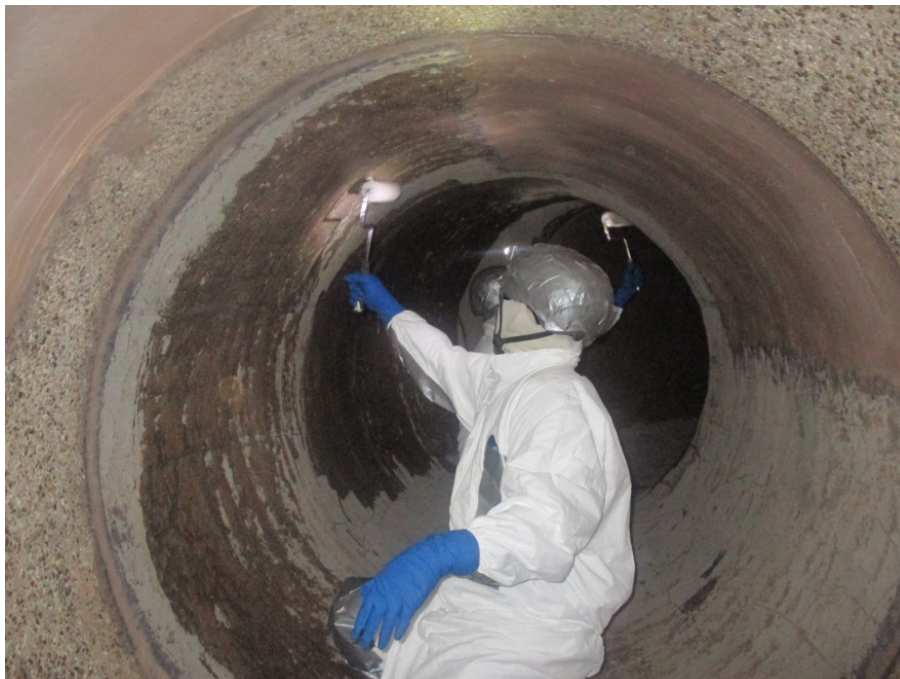
Figure 9. Primer epoxy being applied to concrete substrate adjacent to hole repair

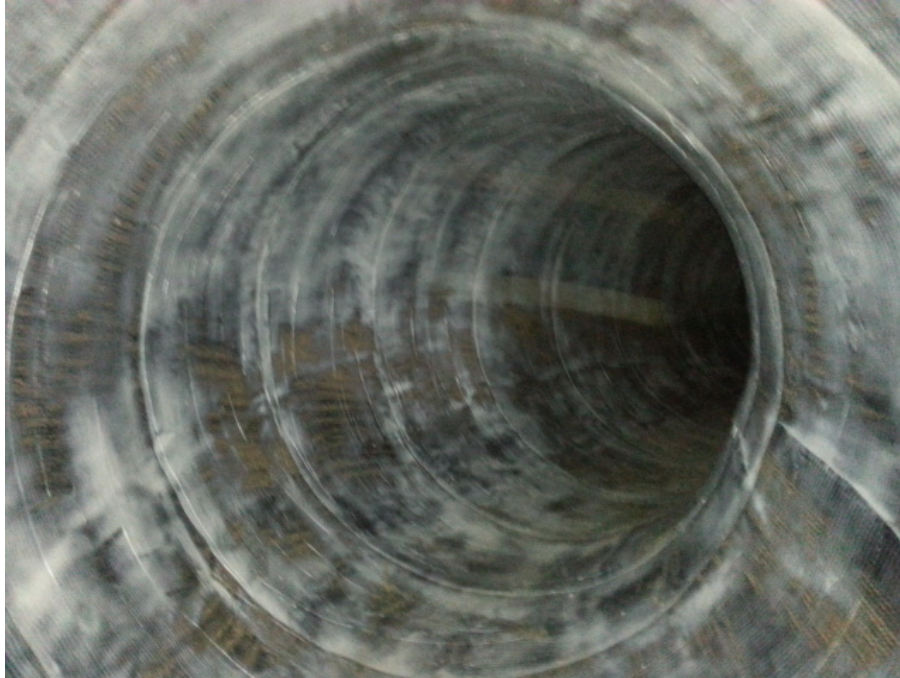
Saturated layers of CFRP were then installed onto the interior of the pipe per the project drawings. The design prescribed that the majority of the reinforcement be in the hoop direction and minimal longitudinal reinforcement in straight regions. Additional longitudinal reinforcement was provided near the two (2) 45° bends, see Figure 10 for completed installation.

Figure 10. Completed CFRP installation at 45° bend

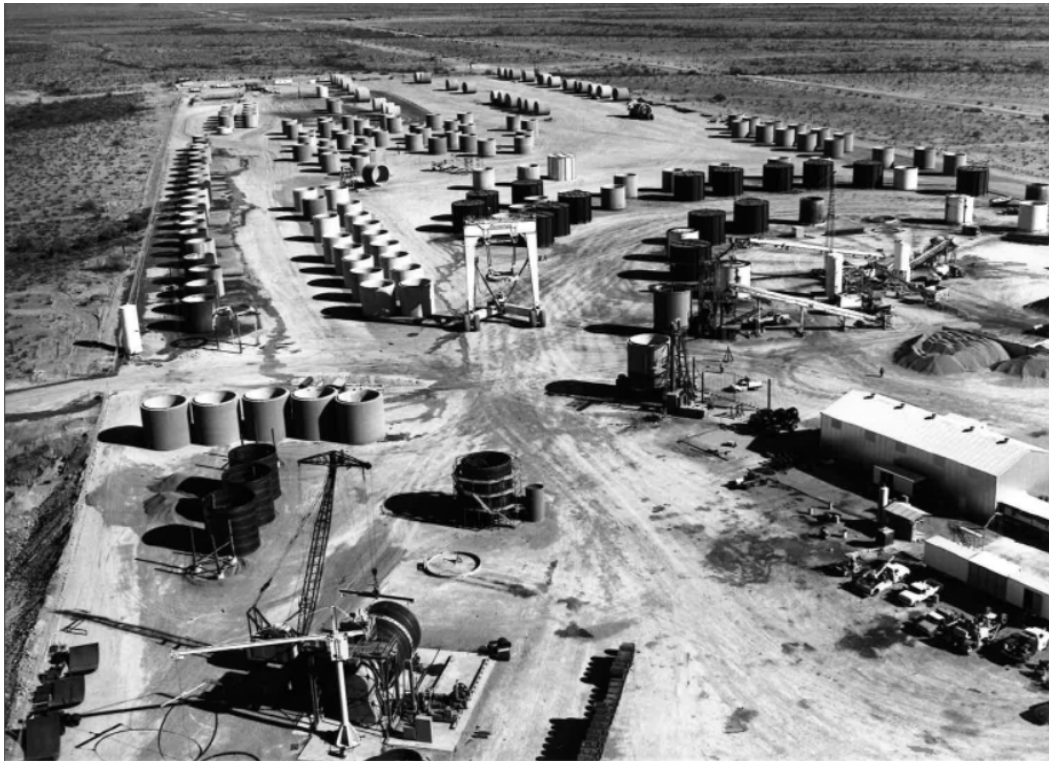
Figure 1 – 1978-79 Onsite Manufacturing Facility

The Centennial Wash Siphon was manufactured and installed in 1978-1979 – the largest prestressed concrete pipe in the world. Results of Reclamation's 1990 investigations resulting from the 1984 pipeline failure lead to the repair of two pieces of pipe on the siphon using post-tension tendons in 1991 and lining the first 1,000 feet of the siphon with an internal steel lining in 1996 – that section of pipeline travels beneath Interstate-10 in western Arizona. Early investigations and attempts to locate distressed pipes were largely unsuccessful; it was not until the early 2000's when the Remote Field Eddy Current Transformer Coupling (RFECTC) Technology was further refined that results became more accurate and reliable, were distressed pipes able to be more accurately identified and located.
