Pipelines 2015

Recent Advances
in Underground
Pipeline
Engineering and
Construction

PROCEEDINGS OF THE PIPELINES 2015 CONFERENCE

August 23–26, 2015
Baltimore, Maryland

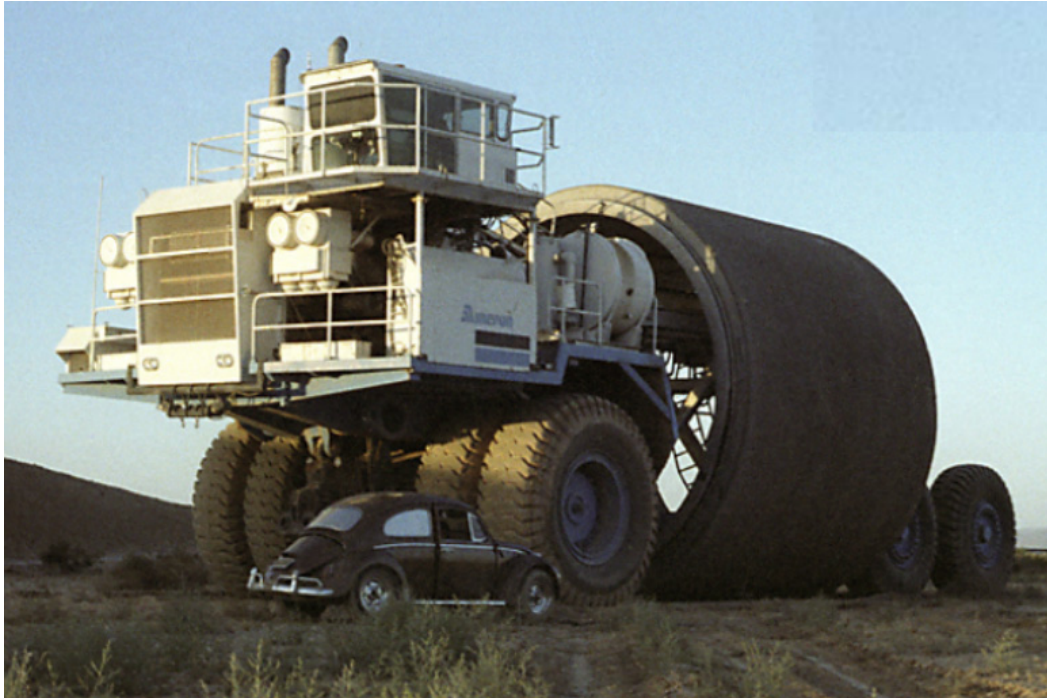
Figure 2 – Pipe Mobile (Note Volkswagen for scale)

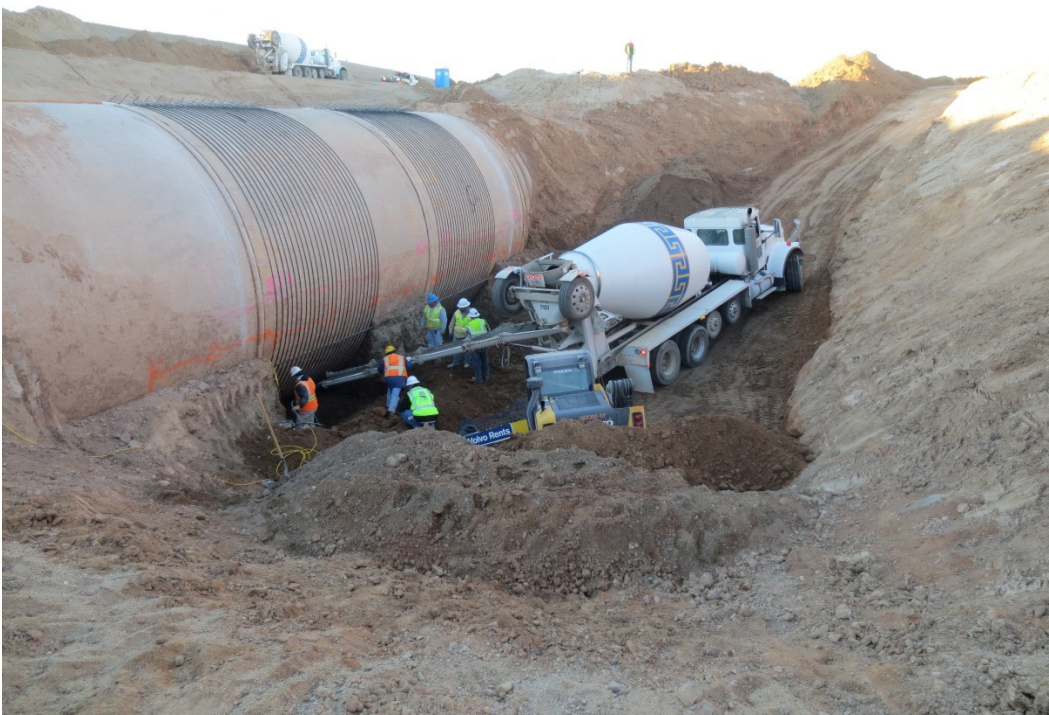
During design, a repair sequence was established that optimized the sequence of repair areas. The repair areas would be excavated, wrapped with tendons, the tendons stressed, and the pipe backfilled with a controlled-low-strength-material (CLSM) up to the 90° bedding angle, see Figure 4. The CLSM is essentially a "one-sack slurry" (flowable fill) to mimic the original bedding of the pipe and provide support to the pipe haunches that was removed to facilitate the repair. The CLSM also provides a higher pH buffer around the pipe and new tendons from the soil. Once the CLSM sufficiently cured, the material adjacent to the CLSM could be removed and repairs undertaken in the new area. There were 17 separate areas for which the following repair sequence was performed (at this point the pipe was only "buried" up to a point of about 3½-feet of soil):

Figure 4 - Placing CLSM Beneath Pipe

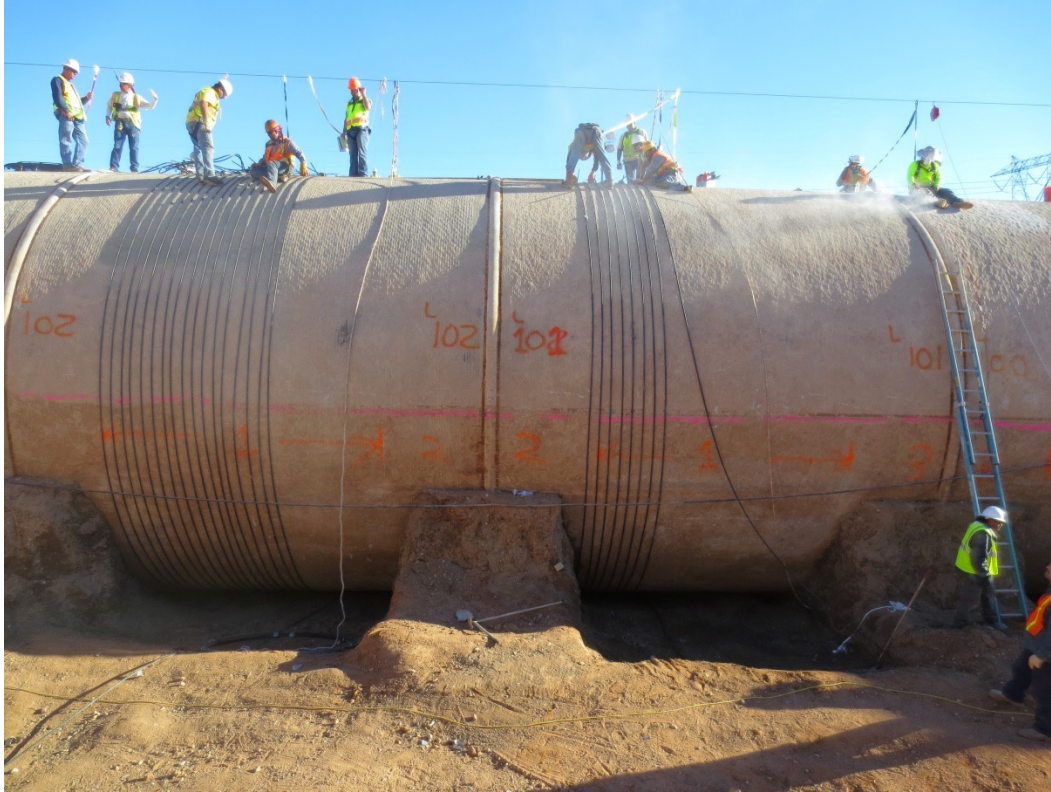
Figure 5 shows two pieces of pipe excavated where the tendons have been installed, some of which have been tensioned. Note the material removed from the mid-span of adjacent pieces and the pipe is supported under the joints.

Figure 5 - Sequencing of Repairs

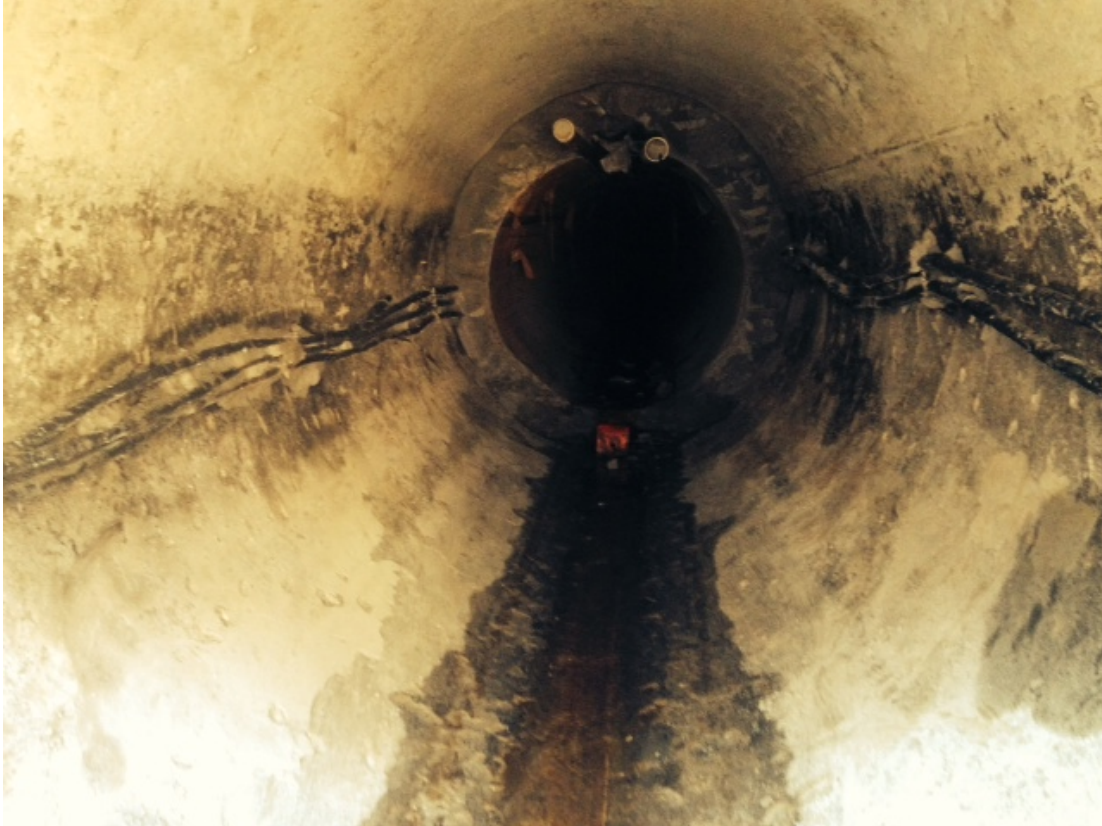
Figure 1. View inside 48 inch RCP after removal of HDPE liner and annular grout

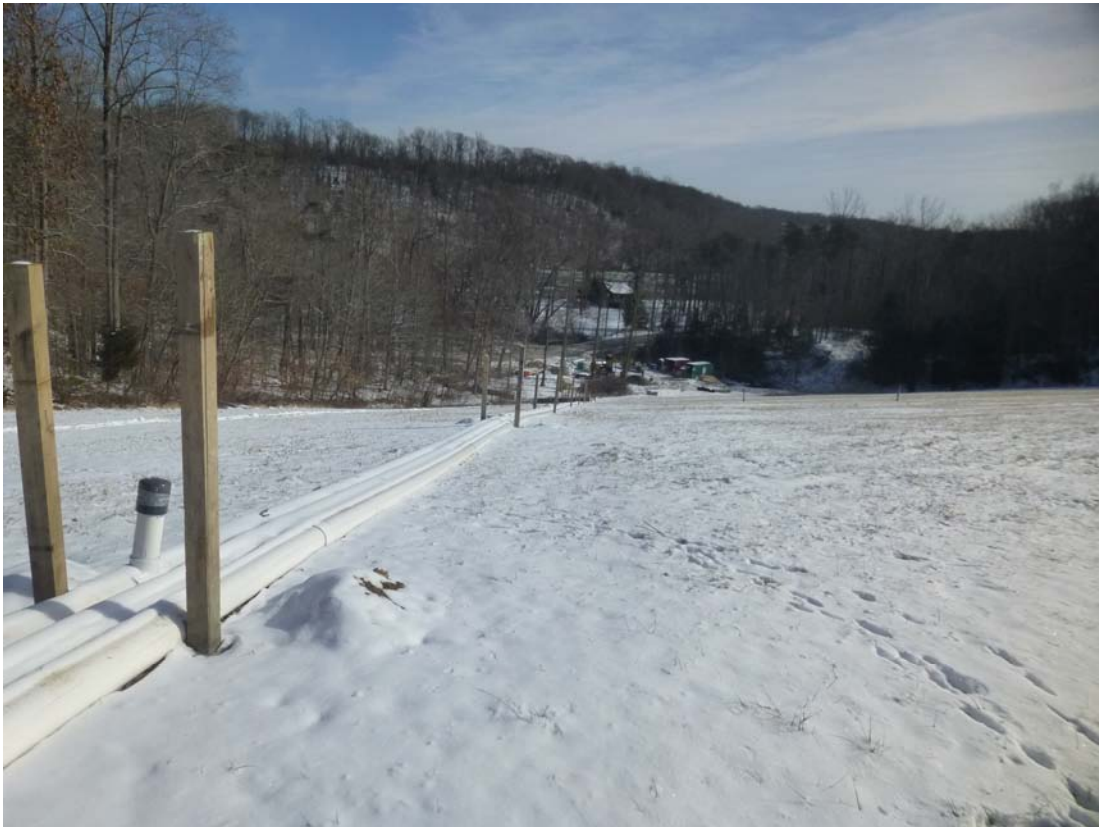
and methods. The approach essentially provided flexibility to the Contractor to size the diversion while offering a maximum limit to the allowable lowering of the lake levels. The maximum allowable lowering was set at 4 feet that could provide temporary storm storage for a 5-year storm event. In addition, optional temporary raising of the weir elevation of the principal spillway by 2 feet (from the existing normal pool) would allow a combined storm storage equivalent to a 10-year storm. The Contractor utilized this approach effectively by using a multi-pipe siphon by-pass system to siphon the desired amount of water from the lake. Once primed by small pumps, the siphons provided flow under gravity on a continuous basis. The number of pipes was adjusted during the course of the construction, depending on the amount of inflow into the lake. During construction several storm events were successfully contained within the reservoir, and gave enough time to the Contractor to vacate the outlet, remove equipment and prepare the site for potential spills through the principal spillway. The specified method of temporary diversion was successful, and proved to be a cost-effective solution for the project. Figure 2 shows multiple siphon pipes used as temporary diversion.

Figure 2. Downstream view from the top of the dam showing siphon pipes

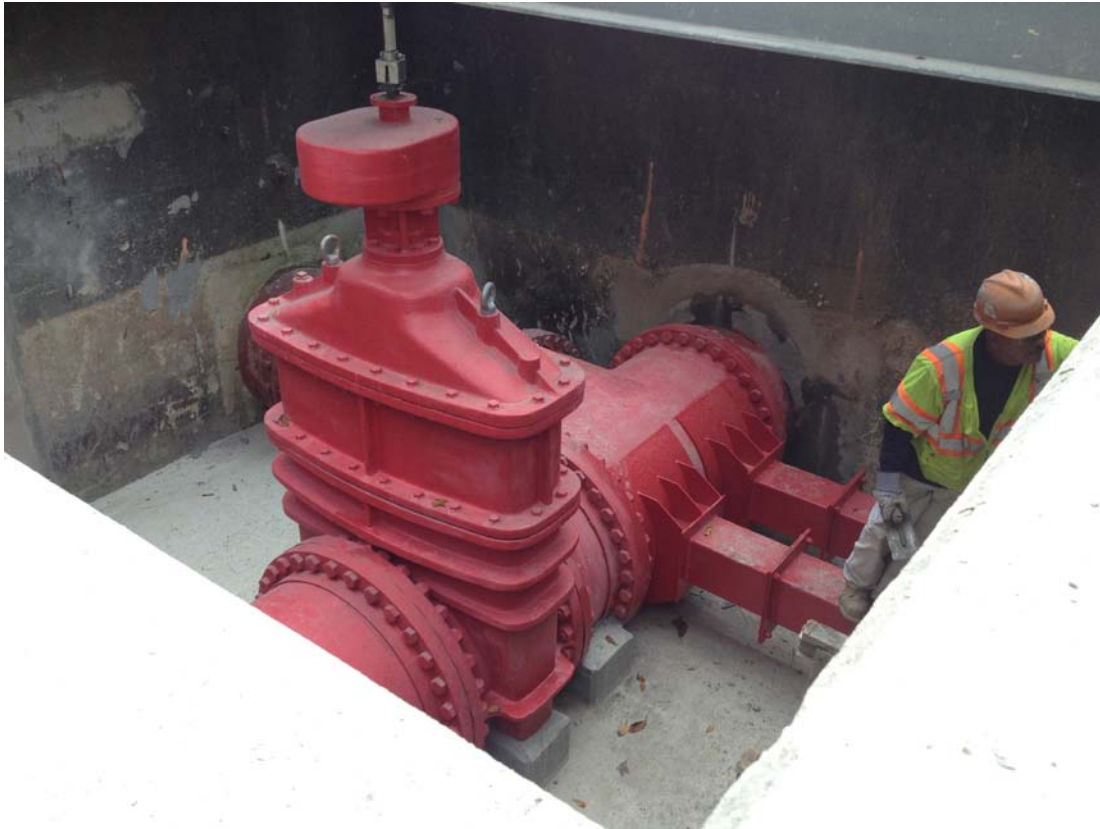
Figure 3. Completed outlet structure with new gate valve and removable thrust blocks

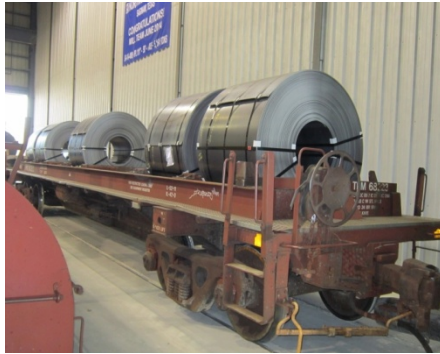
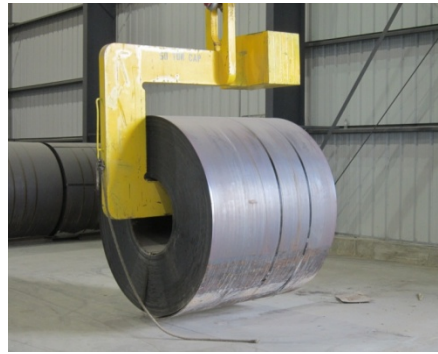
Steel water pipe cylinders were manufactured per AWWA C200 standard and project specifications. The cylinders were made from coil steel, Figures 4a and b that were pulled through buttress rolls, edges prepared for welding, and then spirally free formed into a cylinder that is submerged arc welded both on the inside, Figure 5a, and the outside, to produce full penetration welds.

Figures 4a, b: Coil Steel

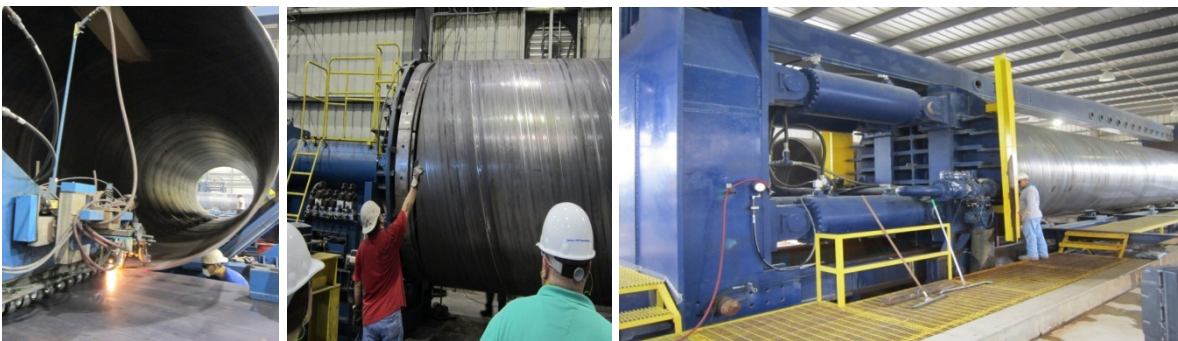
The cylinders were then cut to typical 50-ft sections. Ends were precisely prepared for lap welded field jointing, Figure 5b. Pipe cylinders with prepared ends were then hydrostatically tested, Figure 5c, to a pressure that engaged 75% of the minimum specified yield strength of the steel. For the 108-inch cylinders on Section 15-1, the applied hydrostatic pressure was 267 psi. This hydrostatic pressure is typically equal to the design surge pressure and in effect provides a “proof of design” test against leaks for each section of pipe.

Figures 5a, b, c: Interior Submerged Arc Welding, Expanding Bell-End of Cylinder, Hydrostatic Testing of 108-inch Cylinder to 267 psi

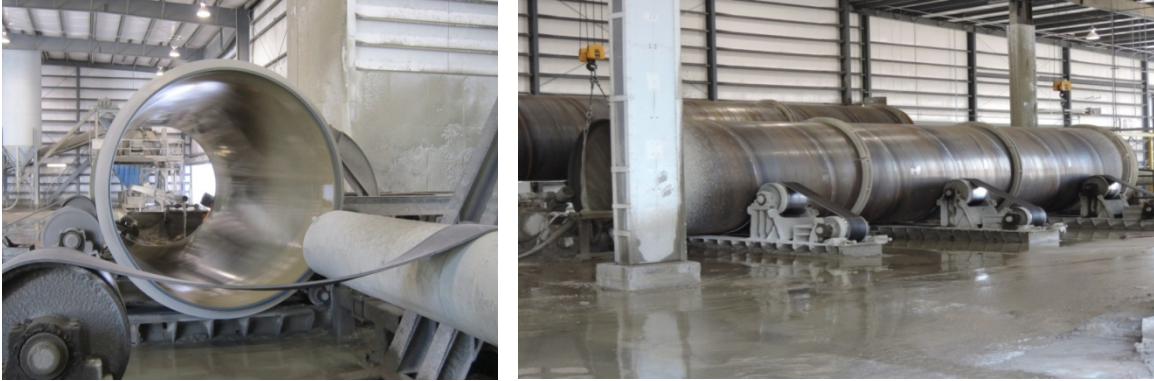
2. TRWD previously built the 108-inch Line J demonstration project where it was shown that a number of experienced steel water pipe suppliers could manufacture, handle and ship 2 miles of 108-inch cement mortar lined and polyurethane coated pipe over great distances. The qualified manufacturers provided considerable competition for pipe material pricing on Section 15-1 as the project that came in approximately 20% under budget estimate. Figures 7a and 7b show the lining of 25-ft and 50-ft sections of cylinder, respectively.

Figures 7a,b: Cement Lining of 25-ft Long Cylinders, 50-ft Long Cylinders

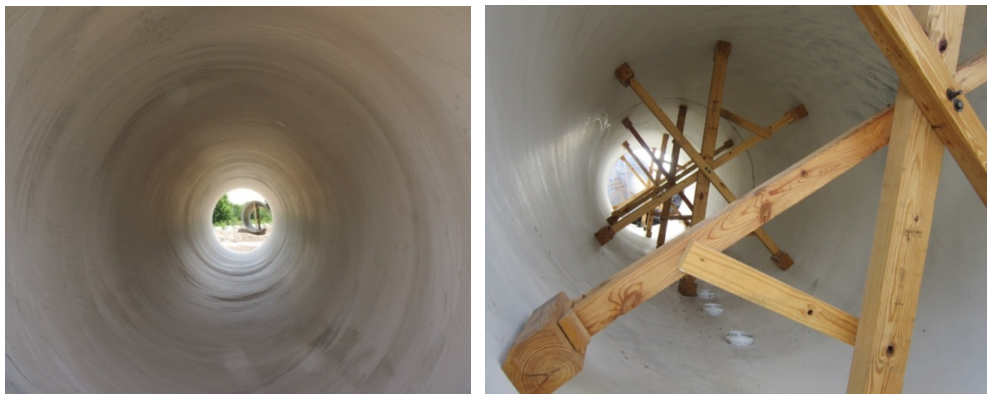
3. Stulling or bracing of the 108-inch cement mortar lined steel pipe received considerable prior study. The primary purpose of the stulls is to keep the pipe and cement mortar lining from excessive "flexing" during handling, shipping and jointing the pipe in the trench. From the Line J project experience, IPL settled on a stulling arrangement for the 108-inch pipe that was in excess of what is typically used in smaller diameter pipe but appropriate for the fact a 50-ft section of 108-inch pipe weighs in excess of 43,260 pounds. The standardized stulling configuration worked well during the installation of the Section 15-1 project. Figures 8a and 8b show the finished interior surface of 108-inch diameter cement mortar lined cylinder prior to stulling, and installed 6-point stulling, respectively.

Figures 8a, b: Finished Interior of Lined Pipe, Installed 6-Point Stulling

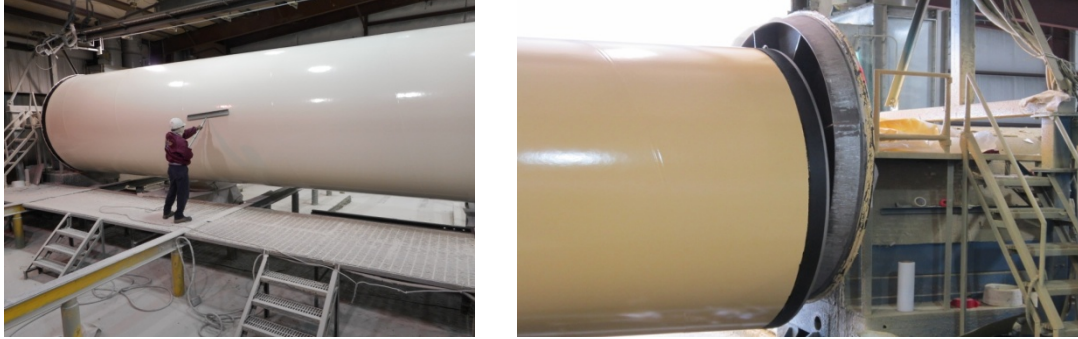
Figure 9a, b: Holiday Testing, Coated Pipe Just Off the Lathe

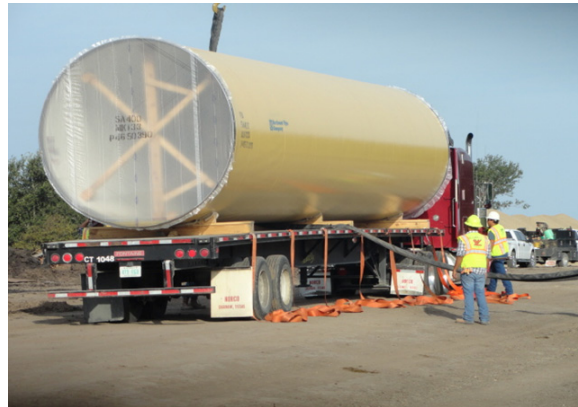
1. 50-ft sections of pipe were shipped with 3 sets of curved and padded bunks on the truck bed that corresponded to the placement of the interior stulls. Ends of the pipe were “capped,” Figure 10, which helped continue the cement mortar lining curing or hydration process, which in turn limited the cracking of the cement mortar during shipping and handling to meet requirements of AWWA C205.

Figure 10: 50-ft Section of Pipe on Truck w/ End Cap

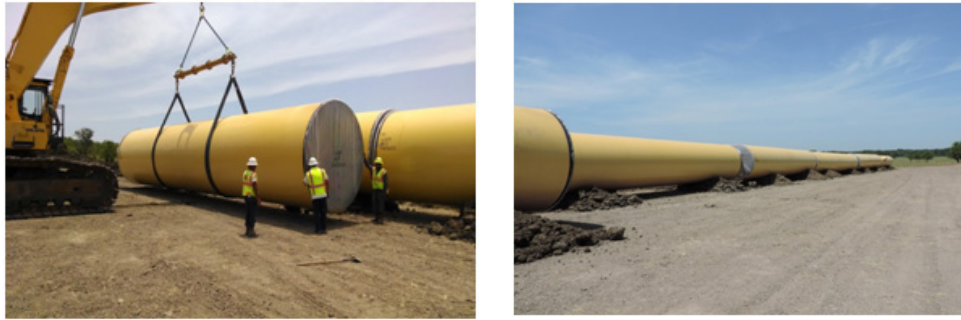
2. Pipe should be unloaded with nylon straps or equal and with two properly placed pick points. This is accomplished with spreader bars, Figure 11a, two pieces of equipment lifting the pipe simultaneously or by other means. Pipe should be placed on earthen berms, Figure 11b, or similar to facilitate picking pipe up to install. End caps should remain on until installation.

Figures 11a, b: Nylon Straps and Spreader Bar to Move Pipe, Earthen Berms for Pipe Placement

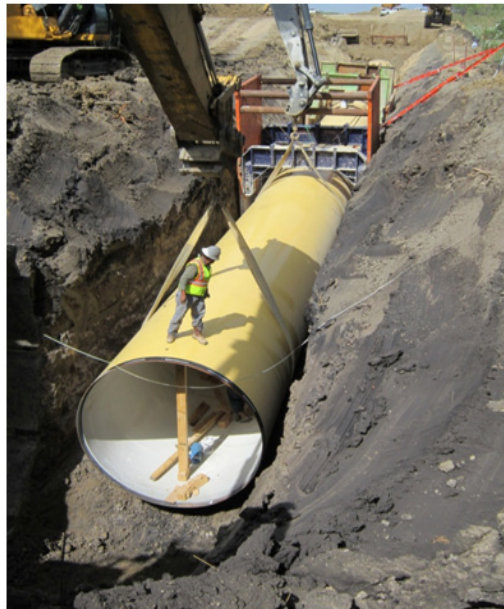
3. Handling the pipe during installation in the trench, Figure 12, again requires nylon straps or equal and again with properly placed pick points. Stulls should remain in pipe during this operation to limit “flex” of the pipe cylinder and cement mortar lining and to aid in keeping pipe as round as possible during joint make up. This facilitates joint fit up and equalization of the gap for full fillet field welding.

Figure 12: Pipe Handling in Trench

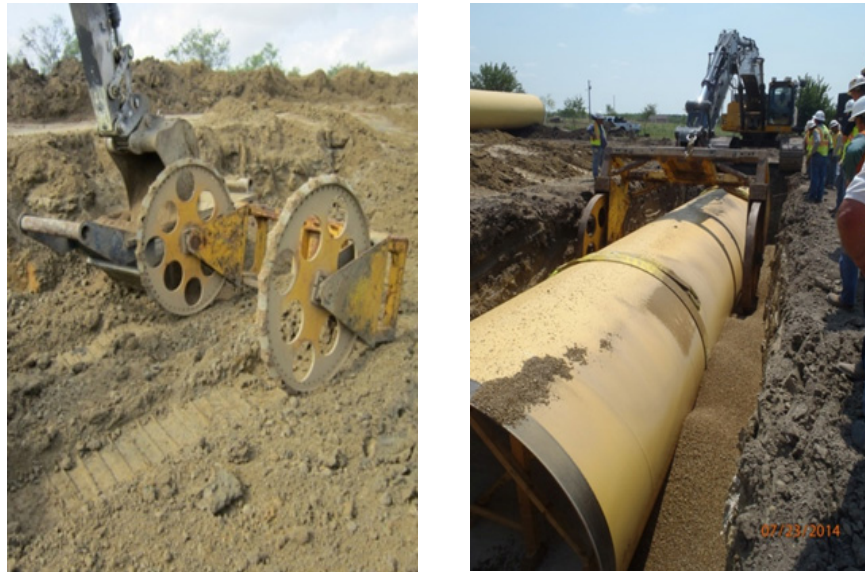
2. Attention should be paid to the haunching of granular material under any large diameter pipe, whether flexible or rigid. It is important that granular material be placed in the “pie shaped” haunch section under the pipe all the way to the invert of the pipe. Voids under the haunches have potential to be problematic for all pipe materials. Use of granular material, placed in controlled lifts combined with suitable compaction such as a “compaction wheel” is producing good results on Section 15-1, Figures 13a and 13b.

Figures 13a, b: Compaction Wheels, Application of Bedding Material in Haunch Zone in Lifts and Using Compaction Wheels

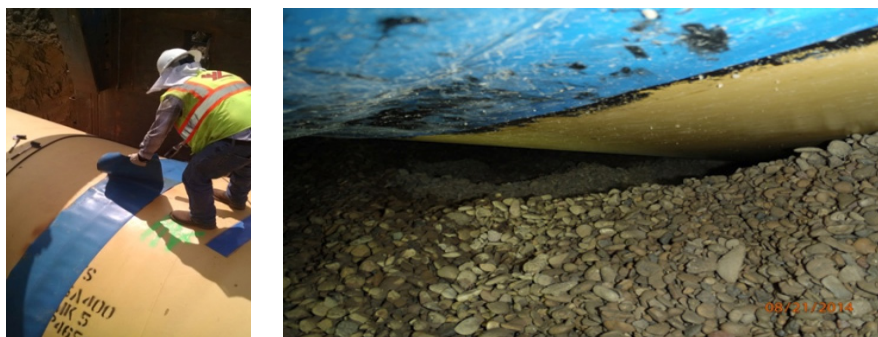
3. Heat Shrink Sleeves are applied after joint is made up when using the specified Weld-After-Backfill (WAB) method, Figure 14a. Heat shrink sleeves are industry standard practice whose installation procedures are well known. Attention should be taken to make sure that during the backfill process, the haunch zone is completely filled in the area of the bell hole (dug to facilitate joint make up and installation of the heat shrink sleeve). It was found that due to the size of the bell hole and the large radius of the pipe, the standard practice for backfill described above would not always completely fill the haunch zone of the bell, Figure 14b.

Figure 14a, b: Application of Heat Shrink Sleeve, Voids in Bell Holes after Completion of Backfilling

Since the bell hole is in the heat affected zone for the WAB process, the haunch zone should be completely filled. It was learned on Section 15-1 that a certain amount of haunch material needed to be placed by shovel or by vibration equipment while the bottom crew was still protected in the trench box. This practice has been proven to work well by excavation of installed and welded joints to inspect material placement under the haunches in the bell hole area and to test the heat shrink sleeve itself for any damage to the outer backing. Results have been good with modified procedure.

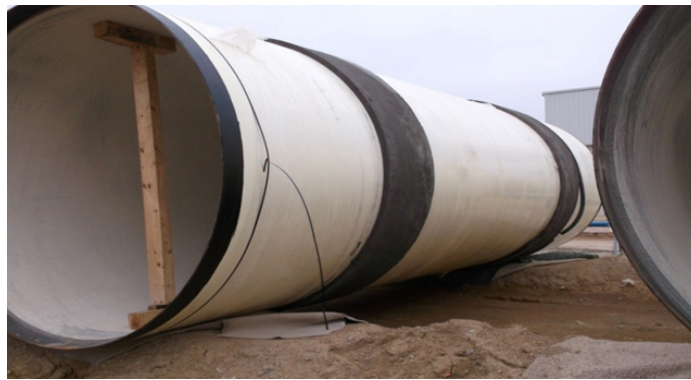
4. 108-inch Polyurethane Coated steel pipe in casings or tunnels --- The Line J project used both commercially available casing spacers and “mortar bands,” Figure 15, applied directly to the polyurethane coated pipe at the shop. Both the casing spacers and mortar bands are designed to act as “sleds” to facilitate pushing and or pulling the 108-inch pipe into the casing or tunnel. They are also designed to keep the casing from contacting (or shorting) to the 108-inch carrier pipe. Shorting of the bare casing pipe or tunnel liner plates would require the cathodic protection system to protect the uncoated casing pipe which will drive up the cathodic protection requirements significantly. Experience on the Line J project and Section 15-1 has shown that both casing spacers and mortar bands require care in the installation of pipe within tunnels to avoid damage to these features.

Figure 15: Two Mortar Bands on 25-ft Section of 108-inch Polyurethane Coated Steel Pipe

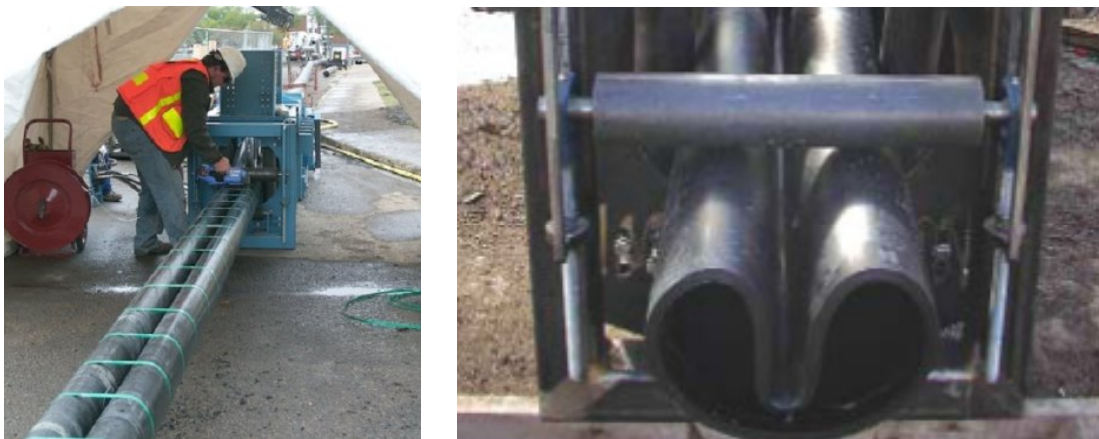
Fold and form. This installation process is similar to cured-in-place but uses a close-fitting polyethylene pipe that is custom designed to match the existing conditions of the pipe to be rehabilitated. The pipe is fused together in length for the project and then held together by bands that are broken after installation into the host pipe, as shown on Figure 4. The polyethylene liner will improve the flow characteristics in the force main and any flow loss from the reduced diameter is typically recovered. The fold and form process using HDPE was considered for the rehabilitation of the force main.

Figure 4. Fold and form process. (Source: Insituform)

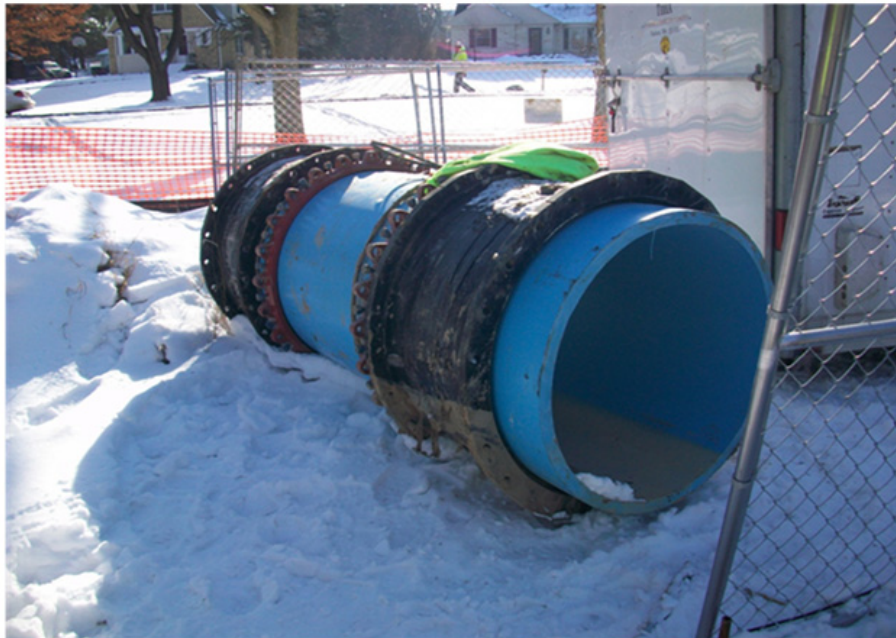
Construction of the pipeline began in late summer 2014 and continued through the winter. The number of access pits required several connections between the CIPP liner sections. The design required the use of PVC pipe to connect the CIPP liner at the access pit as shown on Figure 7.

36" PVC pipe, used to combine sections of lined pipe.

Figure 7. PVC used to combine sections of the pipe. (Source: MMSD)

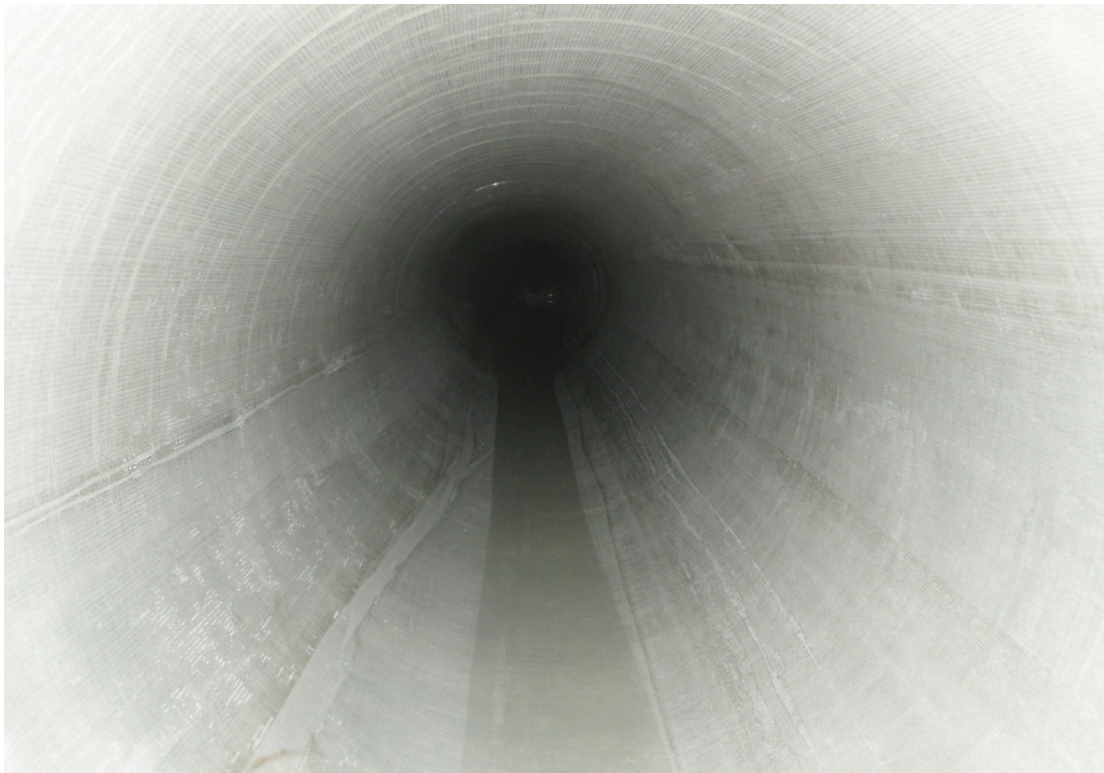
The rehabilitation of the force main required the evaluation of several technologies to address the many challenges and limitations from the location of the alignment. The process from preliminary design through final design and construction included addressing these constraints to provide the liner that would extend the service life of the pipeline and minimize the risk of failure. The CIPP process was successful (as shown on Figure 8), and the pipeline was rehabilitated.

Figure 8. CIPP lining in pipe. (Source: MMSD)

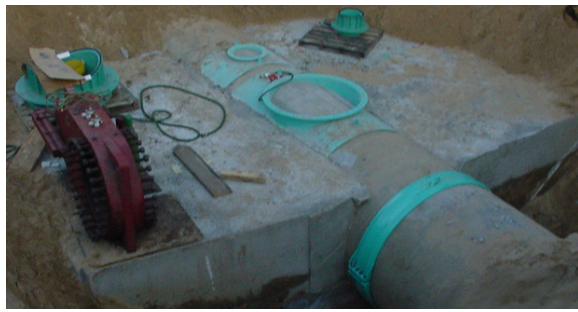
As the first step in the tapping procedure the replacement pipe was installed close to the connection points on the existing line, that would remain in place. The tapping and bypass fittings were installed on the pipe and the concrete thrust blocks were poured (Figure 17). The isolation valves and tapping machines were installed and the taps were performed without incident. During the tapping procedure, the inner core of the concrete pipe was found to be thicker than anticipated, thus requiring installation of a smaller sealing element to achieve the required seal. Once the smaller sealing element was installed, the plugging operation proceeded without incident. The bypass between the new pipe and the remaining prestressed concrete embedded cylinder pipeline was put into operation (Figure 18) and the replacement pipe was connected without interrupting flows or any leakage.

Figure 17 Tapping fittings and thrust block

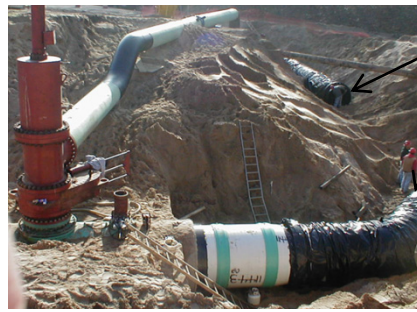
Figure 18 Plugging machine and bypass in operation

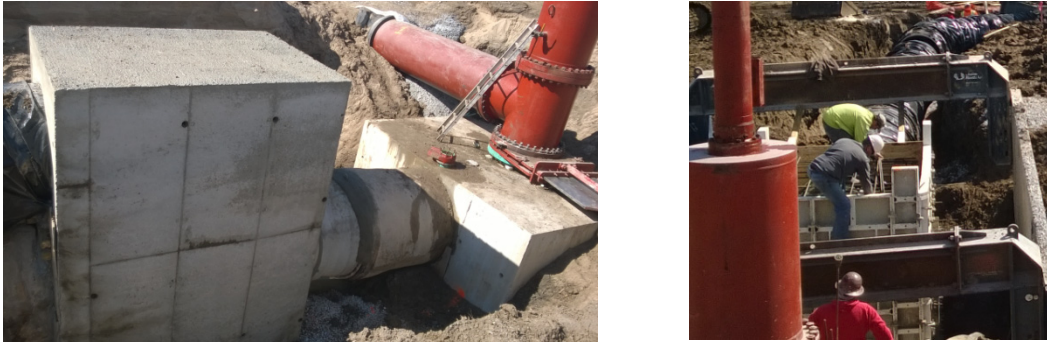
Taps were performed and the plugging machines were installed to divert the flow through a 36-inch diameter temporary bypass line connected to the tapping machine housing using a piping configuration similar to that described in Case Study 1. The new pipeline was connected and made operational (Figure 21) as the plugging heads were withdrawn.

Figure 20 Fittings and connection encased in concrete **Figure 21 Connecting new pipeline**

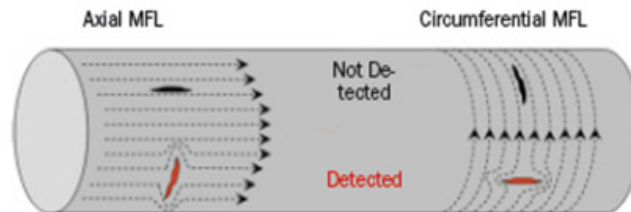
Figure 4 Solid (MFL) Figure 5 Anomalies detected by axial and circumferential flux lines

Solid magnet Magnetic Flux Leakage (MFL) tools (Figure 4) provide high resolution metal loss inspection that locates and sizes external and internal metal loss and other metallic anomalies. This type of tool has a minimum of mechanical parts that require maintenance and repair time. The information provided by these tools is analyzed to determine the location of repairs required to safely maintain specified operating pressure of the pipeline or the acceptable operating pressure of the pipeline if no repairs are made. A balance between the extent of repairs and the desired minimum safe operating pressure can be determined with the information provided by the tool.

Axial MFL tools are better at detecting anomalies and defects that are closer to being perpendicular to the axis while circumferential MFL tools are better at detecting anomalies oriented closer to being parallel to the axis of the pipeline. Figure 5 illustrates that this is because the axial electromagnetic flux lines, generated at 90 degrees to the circumference, are distorted in a greater proportion by anomalies closer to a circumferential orientation and the

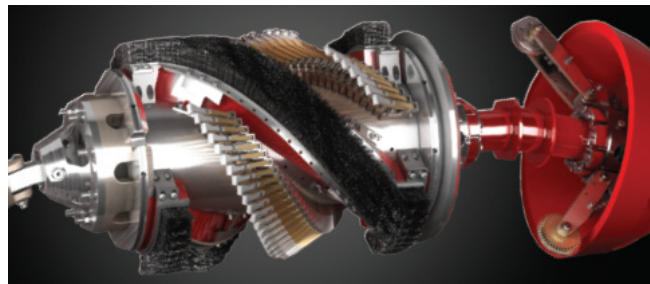
Figure 6 Spiral Magnetic Flux Leakage (SMFL)

Spiral Magnetic Flux Leakage (SMFL) tools (Figure 6) combine the advantage of both axial and circumferential MFL detection abilities. It provides more accurate defect sizing and long seam sizing information, while not significantly adding to tool train length, which may allow passage of a tool train through smaller minimum pipeline curves.

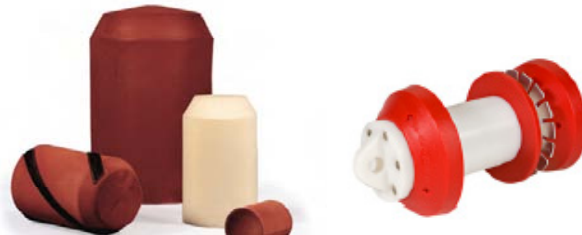
Figure 7 Foam Pigs and Gauge Pig with Lobed Plate

In addition to assuring the bend radii meet the minimum tool configuration requirements, it is necessary to determine if there are any major obstructions within the pipeline line that would not allow the passage of the ILI tool. As a first step, soft foam pigs (Figure 7) slightly smaller than the inside diameter of the pipe are propelled through the pipeline. If these pigs pass through the pipeline without damage, one can proceed to clean the interior surface of the pipe to eliminate any material that might impede the proper functioning of the inspection tools. Dense foam pigs with a hard outer surface with the ability to clean the interior of the pipeline are used for this purpose.

Following the passage of the gauge pig, a brush and magnetic pig, or combination of these two, may be run through the pipe to scrape off additional material from the pipe wall as well as to pick up any stray metallic objects, such as welding electrodes or bits of shavings or parts of tools, that may have remained in the line after construction is completed.

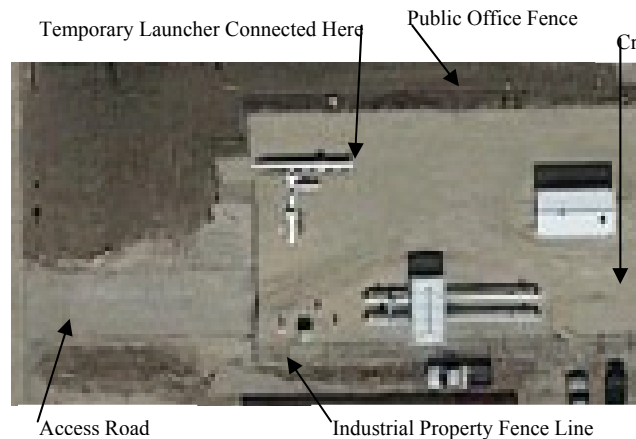
Figure 8 Launch site

The condition assessment was performed in April of 2011 and the final report was delivered in June of 2011. The first step in the process was to conduct a geographic position survey (GPS) along the route of the pipeline starting at the launch site (Figure 8) and ending at the receiver site (Figure 9). During the survey above ground monitoring stations (AGM) were located along the route at distances of approximately one half of a mile and at significant features, such as valves, and bends. Using the times at which the assessment tools pass by the monitors one can estimate their velocity and, if necessary, adjust the rate of flow and pressure of the gas propelling the instruments through pipeline route (Figure 10) so that it is within the correct range to obtain reliable instrument measurements.

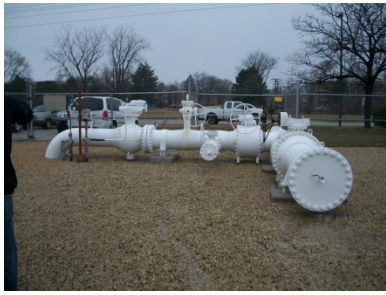
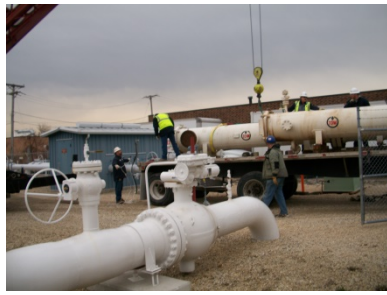
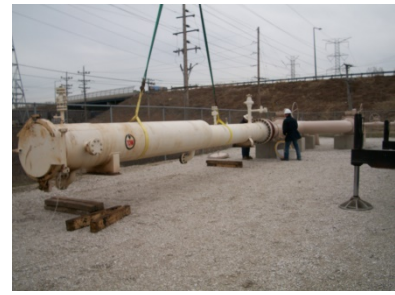
Figure 12 Launch connection point Figure 13 Unloading launcher Figure 14 Installing receiver

The installation of equipment at the launch and receiver sites (Figures 12, 13 and 14) required careful planning due to the weight of the launching equipment and the concern that the weight of the equipment mounted on low riding platform trucks might damage transmission lines under the access road. Wheel load calculations were required to confirm the underground pipes would not be overstressed. Due to restricted maneuver room, a high lifting capacity crane with a long boom needed to be positioned behind a building some distance from the launcher connection point to the pipeline (Figure 8). Once the launcher was installed, the crane required special permits to travel over local roads to the receiver site (Figure 10) to unload and install the receiver.

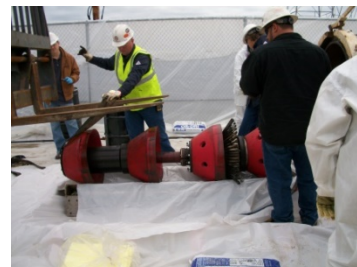
Figure 15 Brush cleaning pig after completing run Figure 16 DEF tool extracted from receiver

The DEF tool was run the day following the cleaning pig runs (Figure 16). The run lasted about four hours and run data was confirmed to be good by the technician. The following day the MFL tool was run within the same approximate run time as the previous day (Figure 17).

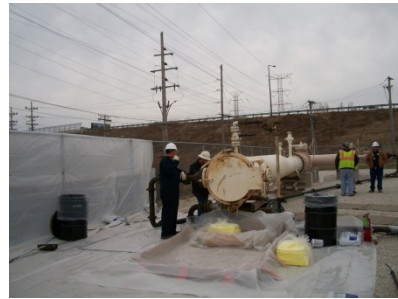
Figure 18 Environmental Containment at Receiver

Liquids produced from the runs was collected, treated and removed from the site by the environmental remediation company contracted by the pipeline company, which also washed the ILI tools (Figure 18). The following day launchers and receivers were disassembled and loaded on trucks for return to their point of origin.

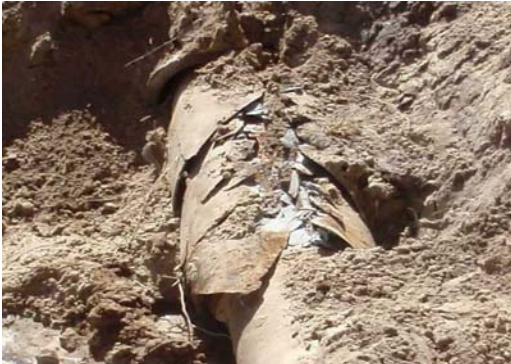
The condition assessment results were reviewed with MMSD and several alternatives were presented. The alternatives ranged from regular leak detection to rehabilitation of the pipeline. MMSD evaluated the alternatives and the associated risks and elected to install a new liner in the pipeline to minimize the risk of exposure from another failure of the pipeline. The next step was to complete a preliminary design to evaluate rehabilitation technologies to determine which methods should be considered.

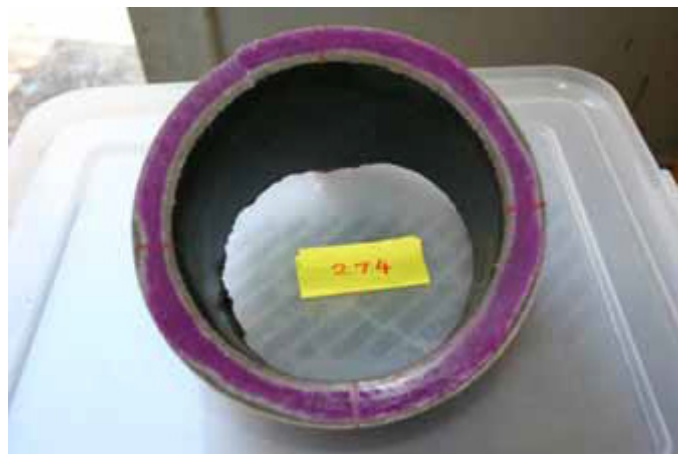
Most approaches at assessing AC pipe life have addressed the loss of strength of the pipeline by assessing the loss of lime from the pipeline. Typically the loss of lime from an AC pipeline is assessed by taking samples of the pipeline, and conducting a phenolphthalein dye test on the pipe, frequently combined with crush tests on the pipe. The phenolphthalein dye test results in a pink stain associated with the pipe wherever there is still adequate lime as shown in Figure 3, which roughly correlate to that part of the pipe with remaining strength, the non-pink areas typically have little strength. These data on remaining wall thickness are correlated with results of crush tests to assess loss of pipe strength. As the amount of lime in the pipe is reduced, the area producing pink color will be similarly reduced, until lack of pink color can be roughly correlated with no residual strength in the pipe – meaning imminent collapse of the pipe – or multiple pipe breaks over a short distance (Figure 4). Based on analyses conducted in the United Kingdom, maximum observed rates of lime leaching in aggressive environments were 0.18 mm/year for internal deterioration and 0.27 mm/year for external deterioration (UKWIR 2005), the maximum noted deterioration rate in less aggressive conditions was 0.09 mm/yr (UKWIR 2005a). The key factors identified in the UK study that could be measured that would predict lime depletion of the pipe were identified as water alkalinity and pH, and soil pH (UKWIR 2005a).

Figure 3: Cross Section of Phenolphthalein-Stained Pipe (Hu 2013a)

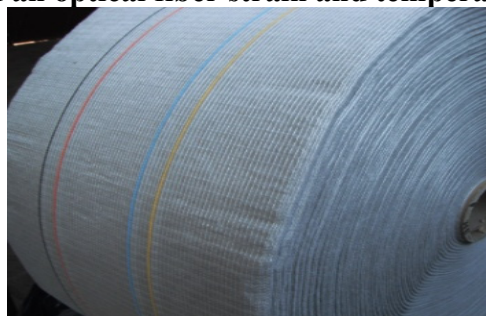
Figure 4. Sensor-enabled geotextile with strain and temperature cables

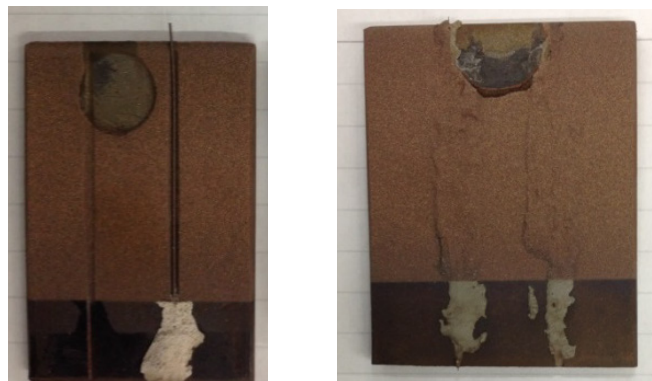
The two test samples (with epoxy and stainless-steel-based adhesive) succeeded the sandblasting were thermal sprayed using copper coating. Figures 6(a~c) show the samples after HVOF spraying process. The stainless-steel-based metallic adhesive successfully survived the thermal spray coating process as shown in Figure 6(b). The copper coating was successfully deposited on top of the adhesive and sensor at the thickness of 0.55 mm. With the successful embedment using stainless-steel-based metallic adhesive as protection on the sensor, all the FBG sensors will use this technique for embedment inside the TS metallic coating for further sensing capability study.

(a) High temperature Minco Epoxy (b) stainless-steel-based adhesive
Figure 6. Sample condition after coating deposition

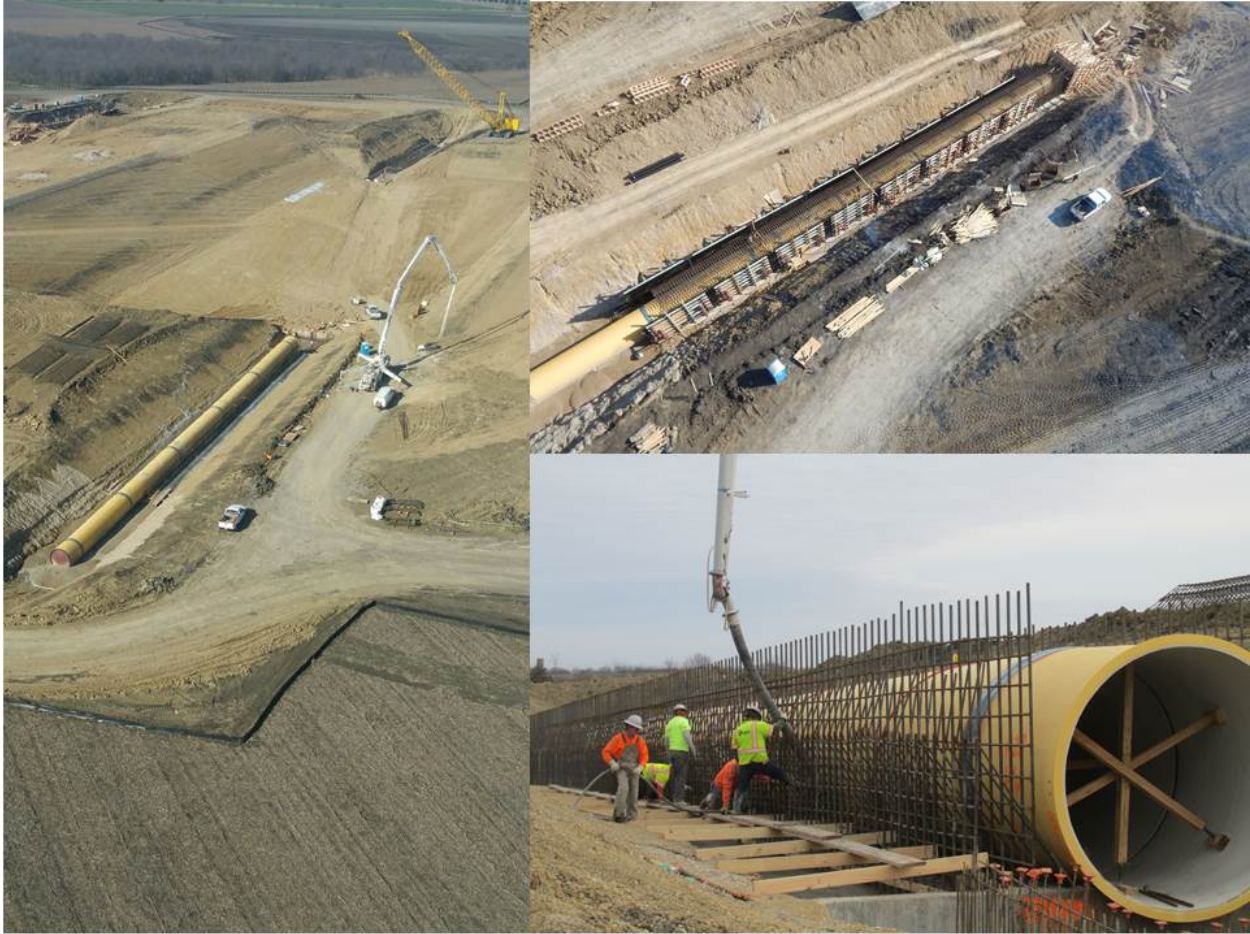
Inlet and Outlet: The inlet and outlet of the reservoir is designed for a maximum capacity of the pipeline. The inlet transitions from the pipeline through a control valve. The pipeline section which goes under or through the embankment includes a concrete encasement around the pipe. The entrance into the reservoir is through a concrete headwall structure at the bottom of the reservoir cell. The outlet pipe is constructed in a similar fashion with a headwall and concrete encasement around the pipe. The outlet has a trash rack installed to prevent introducing any foreign materials into the pipeline and/or pump station suction header. The inlet and outlet are located on opposite sides of the reservoir to create as much turnover of the water as possible. For JB2R and JB3R – the outlet pipe is sized at 114-inch while the inlet is 108-inch diameter. For the MBR, both inlet and outlet pipe are sized at 120-inch diameter. (See Figure 5 below)

Figure 5 - Construction of Encasement on 108-inch Steel Inlet Pipe at JB3R

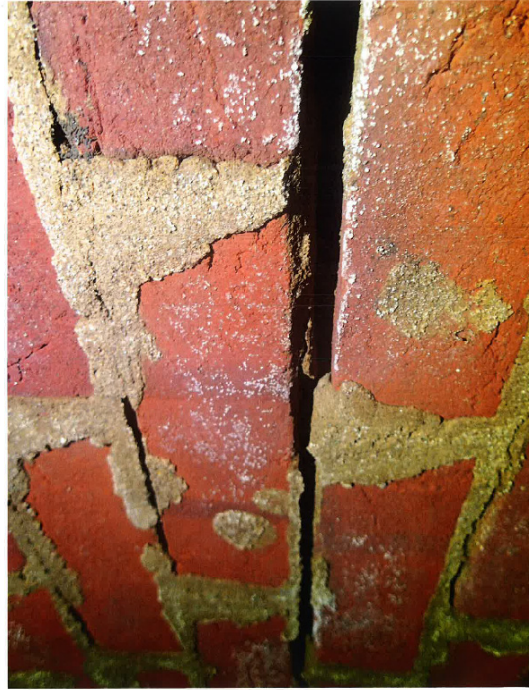
The propagation of the fracture has exceeded our expectation in terms of speed and extent. By the time of completing the scaffolding to deploy a 100-ft CFRP repair in February 19, 2015, the original fracture expanded to 145-ft length and two more localized longitudinal fractures were observed. See typical crack picture in Figure 13.

Figure: 13 - Crack at crown (+/-12 O Clock position)

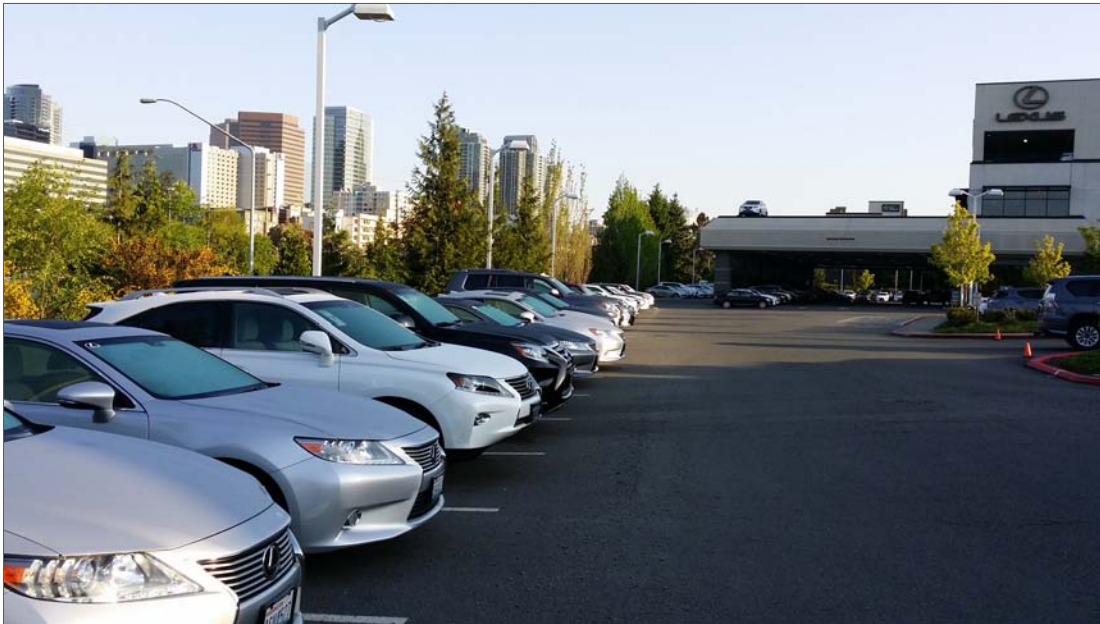
Construction through a Lexus car dealership. After crossing I-405 onto the east side, the new sewer runs along two private properties along an existing sewer easement dating back to 1962. Since the time of the original sewer installation, these properties have been further developed and most recently within the past decade, a new Lexus car dealership had been opened. Construction of the new sewer will require close coordination with Lexus operations, and ensuring their vehicle deliveries, car wash, and service customers are not impacted (Figure 5).

Figure 5. New sewer alignment through Lexus parking lot
