Pipelines 2015

Recent Advances
in Underground
Pipeline
Engineering and
Construction

PROCEEDINGS OF THE PIPELINES 2015 CONFERENCE

August 23–26, 2015
Baltimore, Maryland

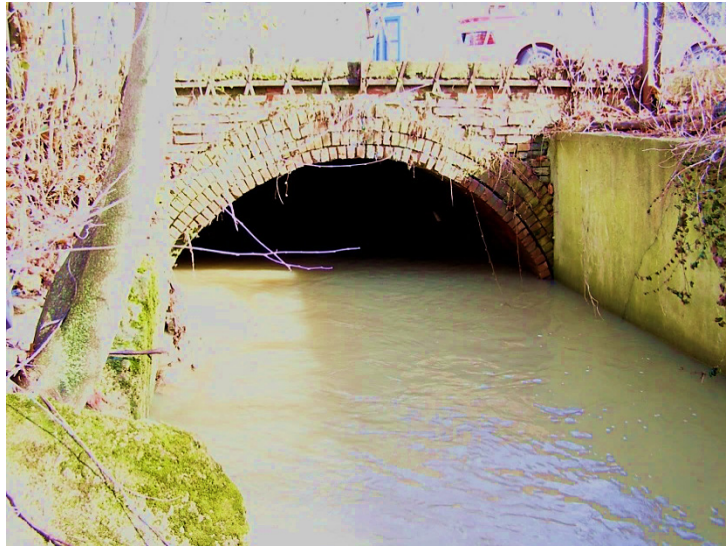
Potts Ditch was originally constructed approximately a century ago of brick and stone arches. A photograph of the original brick arch crossing underneath North Street is included in Figure 1.

Figure 1. Photo of Original Potts Ditch at North Street

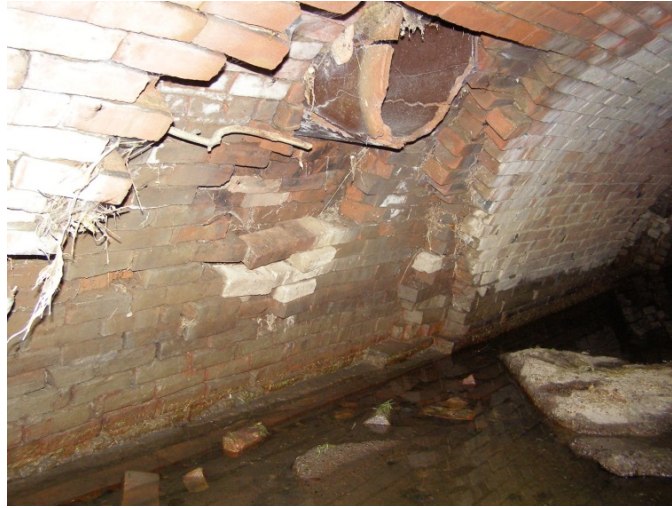
Figure 2. Photo of Missing Bricks in Wall at North Street, Pre-Rehabilitation

In 1990, the City rehabilitated the entirety of the encapsulated Potts Ditch using reinforced shotcrete to repair walls and foundations, many of which were deteriorated and were missing bricks (see Figures 2 and 3). In 2002, Hancock County replaced the portion of the structure from Main Street to the South Street with 14-foot

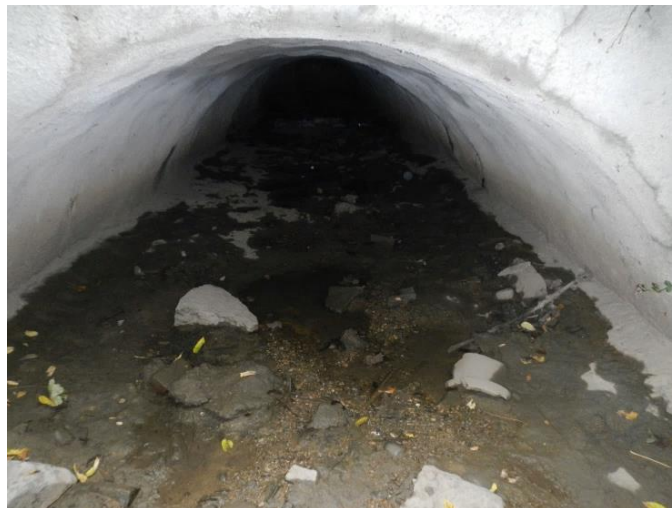
Figure 3. Photo Showing Shotcrete near North Street, Year 2013

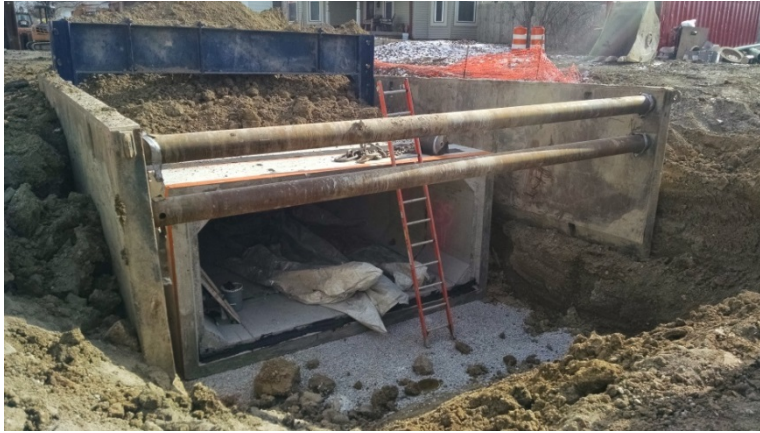
The City awarded the construction contract to Renascent, Inc. (Renascent) in June 2014. American Structurepoint is performing on-site construction inspection. The project is currently under construction, and has progressed from the downstream end onto North Street as of January 23, 2015. The scheduled completion is the end of 2015. Figure 7 is a photo of the precast concrete box installation.

Figure 7. Precast Concrete Box Installation on North Street
