Eric Bird
Nick Lewis

Beach Renourishment

SpringerBriefs in Earth Sciences

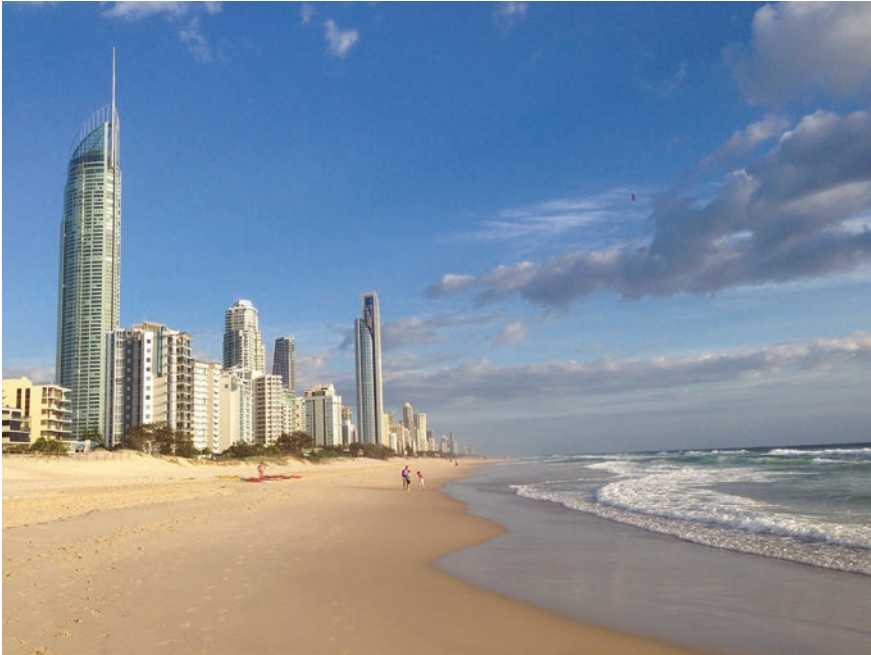
Fig. 1.1 The ocean-facing beaches of Australia's Gold Coast in SE Queensland, renourished over the last four decades with sediment pumped northward past the mouth of the Tweed River in northern New South Wales, as well as local placement. Beach renourishment helps to protect coastal property from erosion and flooding, as well as providing valuable recreation space. © Nick Lewis

Beach renourishment has been most common on marine beaches where the aim has been to counter erosion and protect coastal property (Fig. 1.1). Beaches have also been formed on the shores of some estuaries to provide recreational areas, for example on the Elbe Estuary in Hamburg (Fig. 1.2), in Delaware Bay, United States (Jackson et al. 2010) and beside the Thames at Tower Bridge in London.

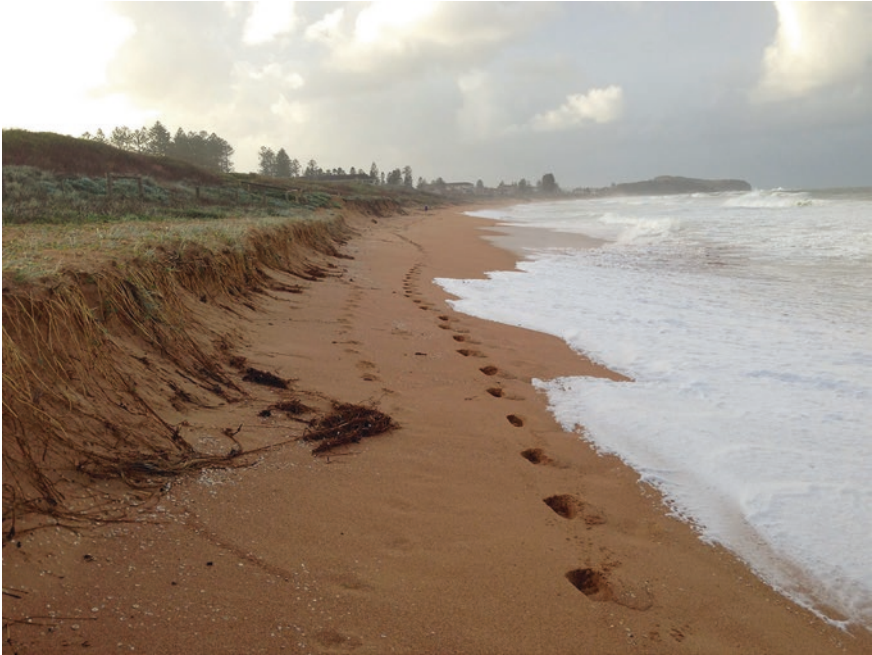
Fig. 2.2 Microcliff (erosional scarp) on Collaroy-Narrabeen Beach, NSW, Australia, cut by a number of late summer storms in 2013. © Nick Lewis

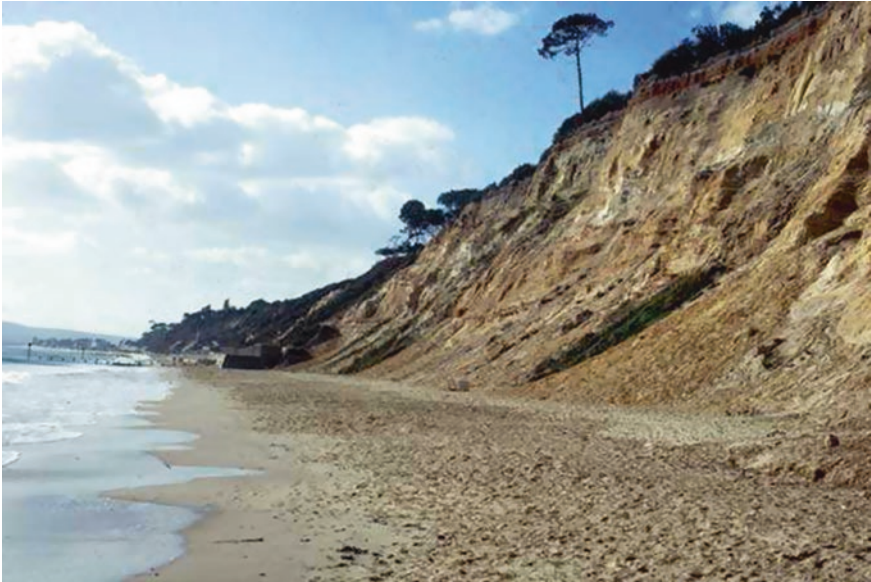
Fig. 2.3 Canford Cliff, Bournemouth, Dorset cut in Tertiary sandstones capped by Pleistocene gravel, as it was in 1950. Sand and gravel eroded from the cliff by runoff and marine erosion was then being delivered to adjacent beaches. See Fig. 2.4. © Geostudies

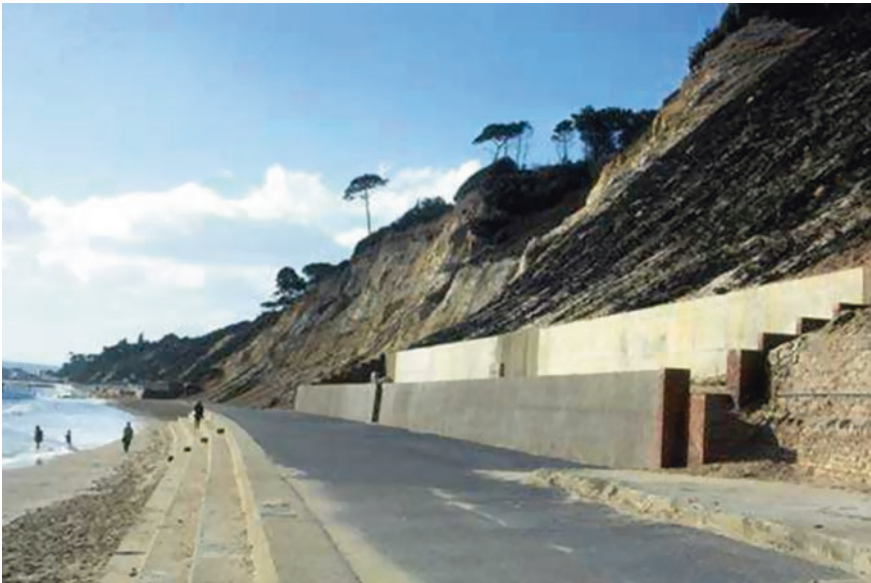
Fig. 2.4 Canford Cliff after the construction of a concrete esplanade along the base of the cliff. This halted marine erosion, but also reduced the supply of sand and gravel to adjacent beaches, which became depleted by marine erosion. © Geostudies

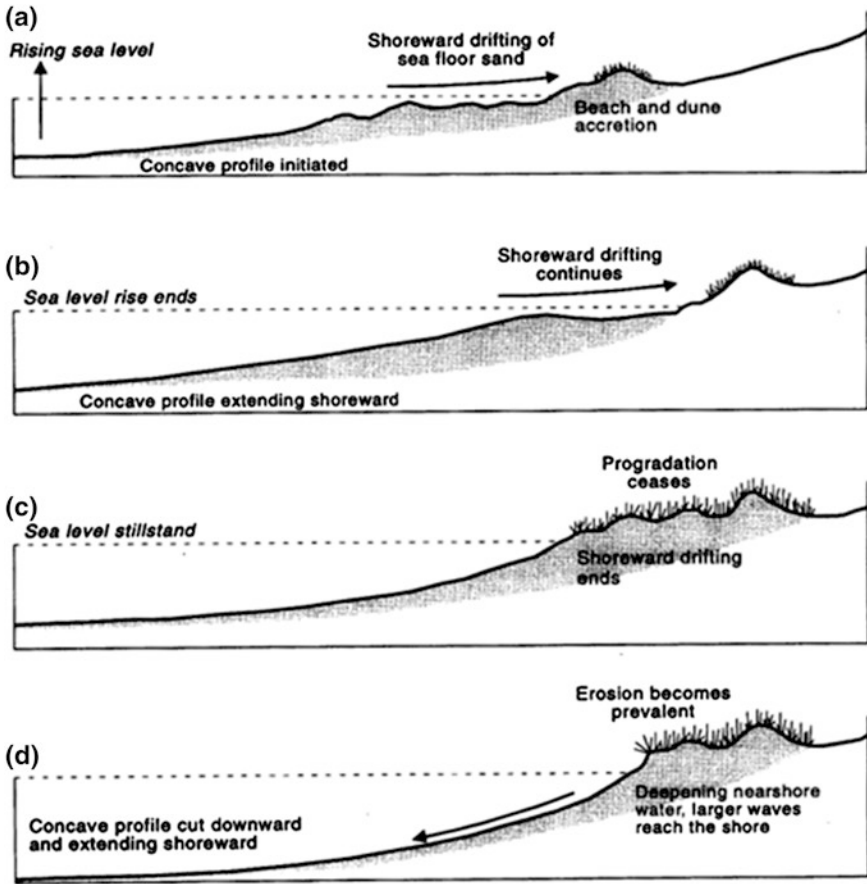
Fig. 2.5 On many coasts sand drifted shoreward from sea floor shoals during the Late Quaternary marine transgression (a), and for a time after this transgression ended (b), so that beaches prograded. With the attainment of a smooth concave sea floor profile progradation ceased (c), and the landward migration of this profile resulted in beach erosion and coastline retreat (d). © Geostudies

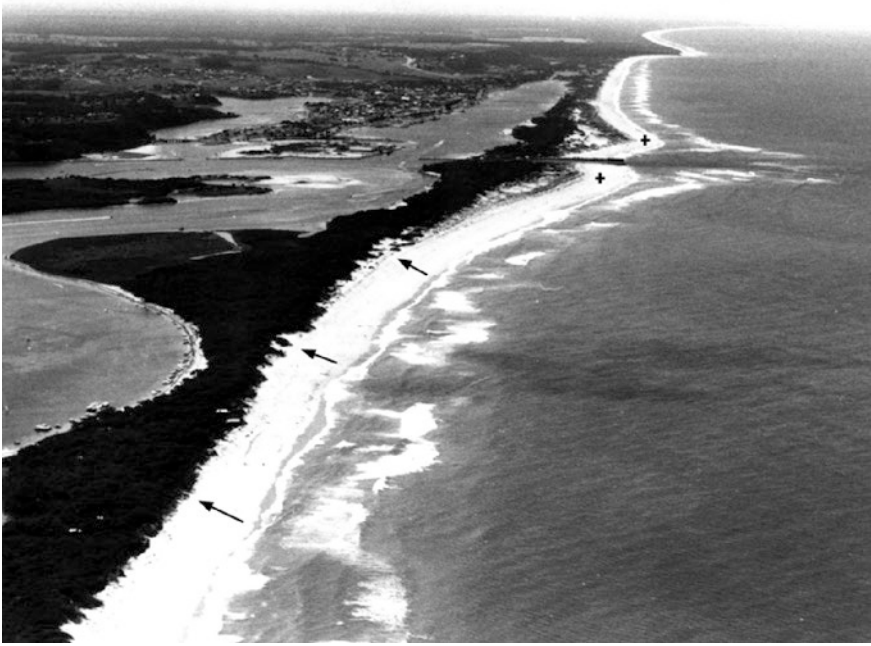
Fig. 2.6 Erosion (*arrowed*) of the Ninety Mile Beach, on the outer barrier of the Gippsland Lakes in SE Australia, with accretion (+) on either side of the Lakes Entrance breakwaters.
© Geostudies

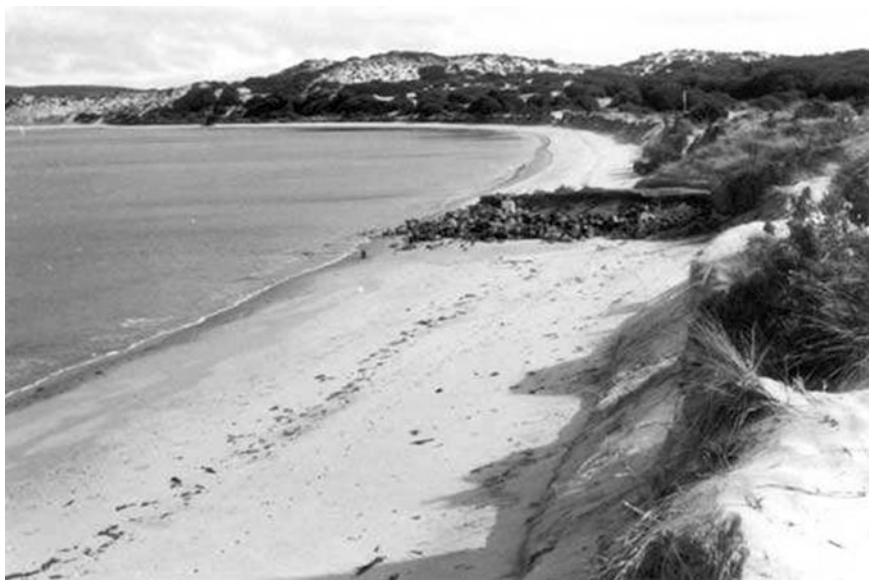
Fig. 2.8 Depleted beach and backshore erosion on the shore of Cleeland Bight, Phillip Island, following the stabilisation of dunes that previously supplied sand to this beach. © Geostudies

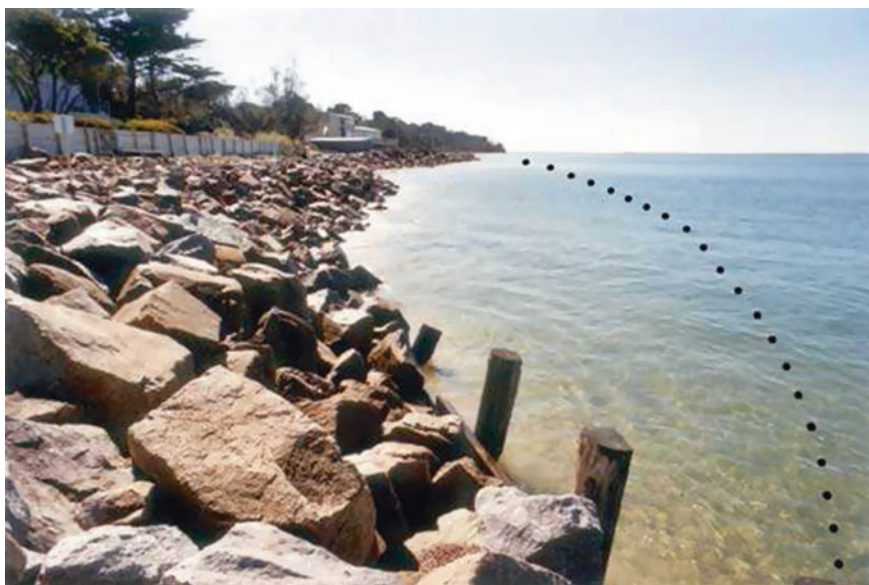
Fig. 2.9 The yacht club at Somers, Western Port Bay, Australia, was built on a sand lobe (out-line: *dotted line*) that had migrated to this position, and then moved on along the coast. A boulder rampart has been inserted to halt erosion here. © Geostudies

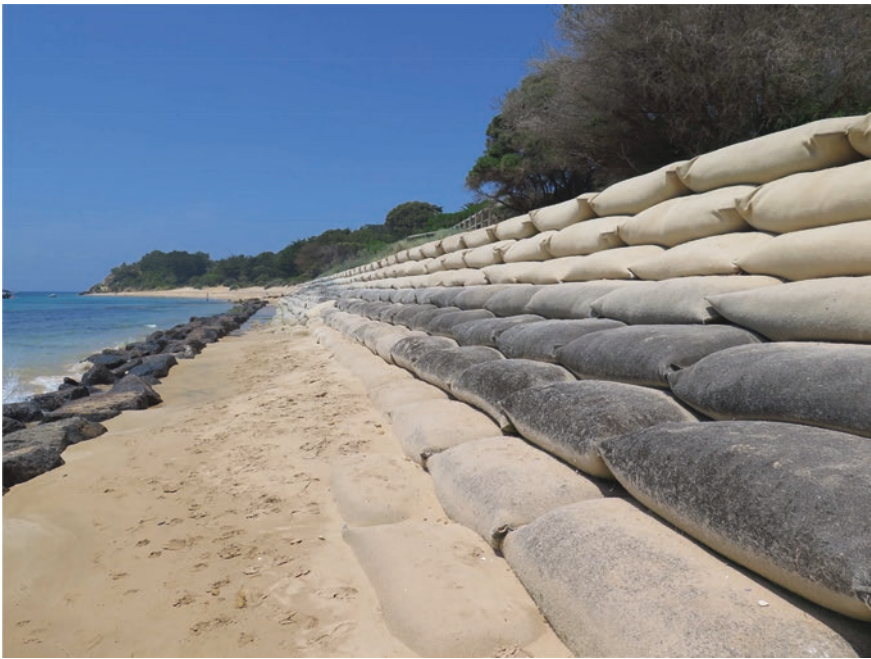
Fig. 2.11 A sandbag rampart marks the site of beach erosion at Portsea, Port Phillip Bay, Australia, in 2013. © Geostudies

Attempts to blame the erosion of Portsea Beach in 2010 on the dredging of a deeper and straighter entrance to Port Phillip Bay in 2008 failed because of evidence that episodes of beach erosion occurred at several times prior to entrance deepening, and because wave refraction diagrams drawn for configurations before and after dredging showed no change in the pattern of waves or wave energy at Portsea (Cardno 2011). The beach was renourished, but the deposited sand quickly drifted away to the east, and the coast at Portsea was then armoured with sandbags to halt recession (Fig. 2.11).

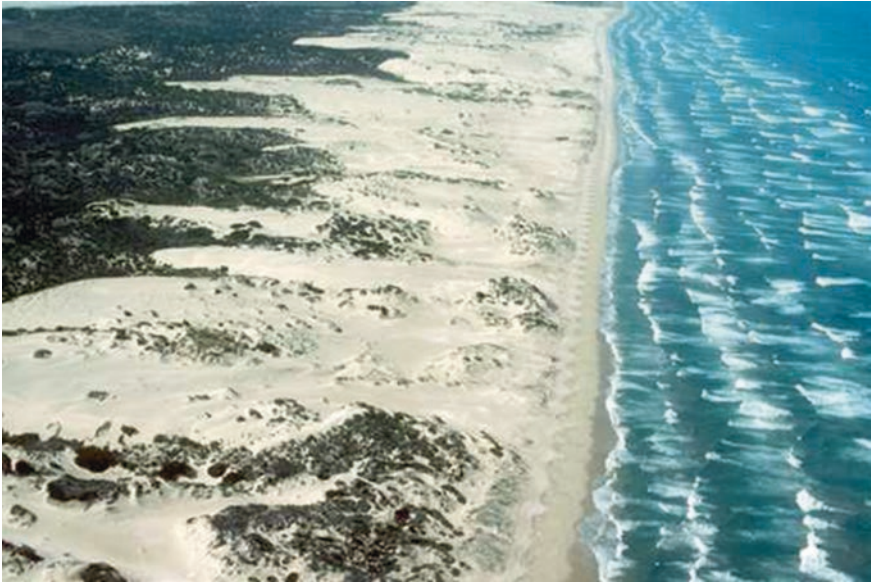
Fig. 2.13 Sand is moving inland from a beach as drifting (transgressive) dunes on the shore of Encounter Bay, South Australia. The lowered backshore is then cut back quickly because of the diminished volume of sand to be removed by wave attack. © Geostudies

Sand is swept from the beach to the backshore by strong onshore winds (Fig. 2.13), or when storms wash beach sediment beyond the back of the beach, or over into lagoons, swales or swamps, or the mouths of rivers. If losses from the

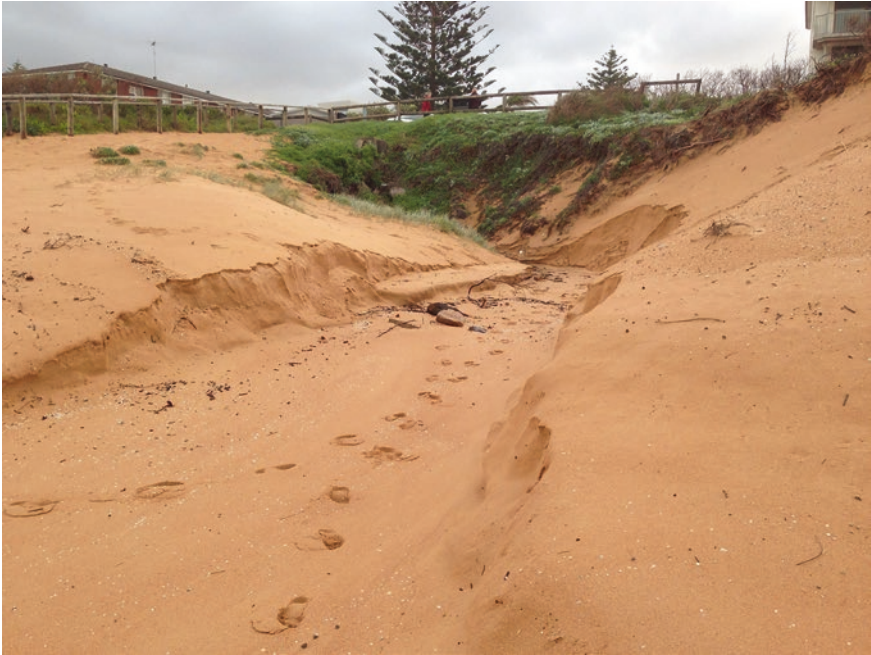
Fig. 2.14 A channel cut through the beach and dune on Collaroy-Narrabeen beach, Sydney, Australia caused by storm water discharging from a drainage outfall. © Nick Lewis

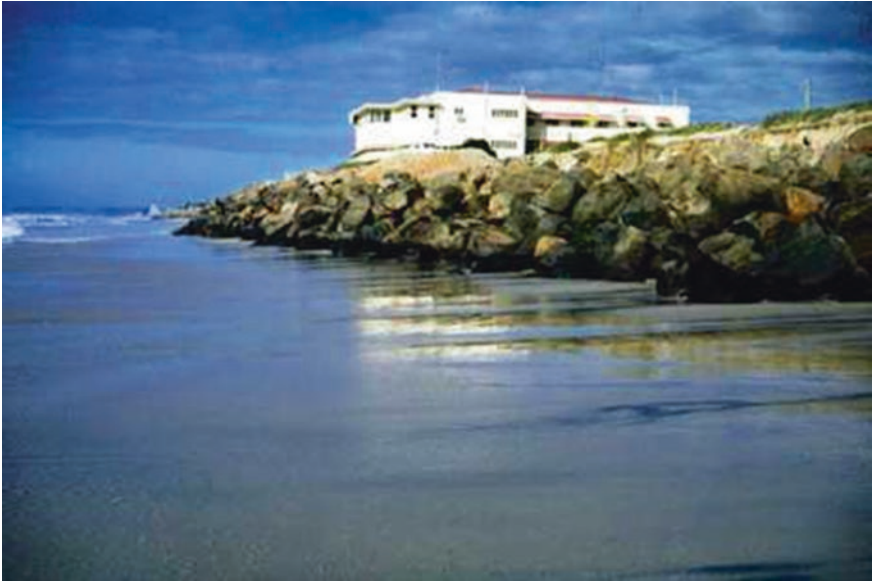
Fig. 2.16 Beach at Surfers Paradise, Queensland, lowered by large waves reflected from a boulder wall during a tropical cyclone. © Geostudies

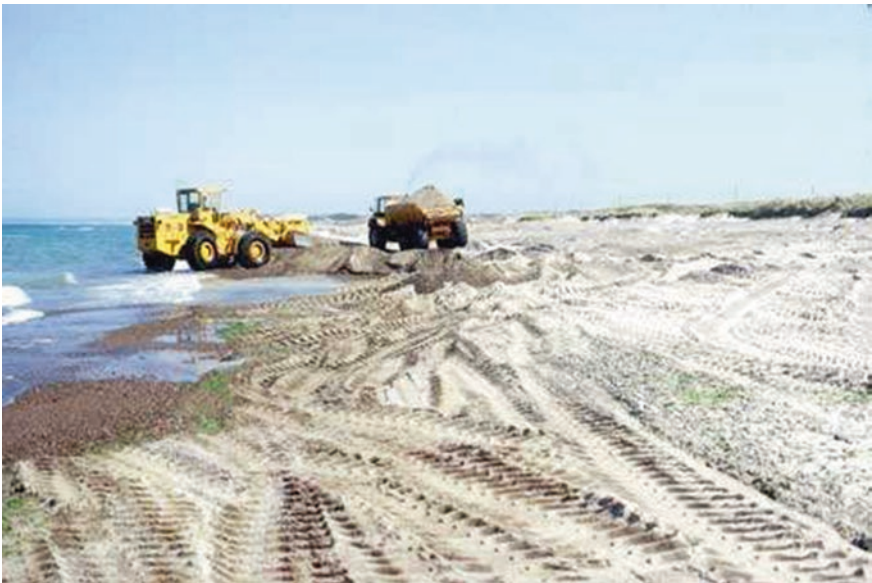
Fig. 2.17 Extraction of *sand* and *gravel* from the beach at Klim in Denmark. © Geostudies

Sand or gravel has been quarried from many beaches for use in road and building construction (Fig. 2.17), and the result of lowering the shore profile is to allow larger waves to attack the beach more strongly during storms. Beaches in Jersey and Guernsey were much reduced by the extraction of sand from beaches by the German occupying forces during the Second World War for use to build bunkers

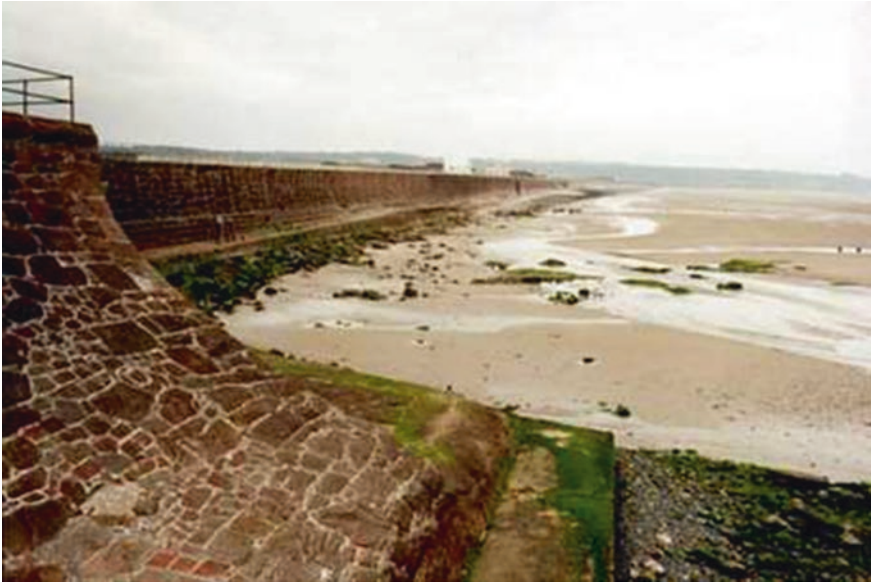
Fig. 2.18 The sea wall at St Ouen's Bay, Jersey, with the beach lowered by reflection scour.
© Geostudies

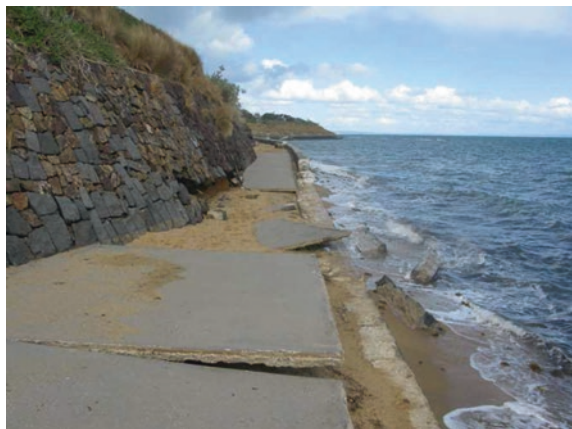
Fig. 3.1 Storm-damaged sea wall at Black Rock, Victoria, Australia. © Geostudies

Sea walls and boulder ramparts are subject to damage by the impact of waves during storms (Fig. 3.1), and by scour due to the hurling of sand and gravel against

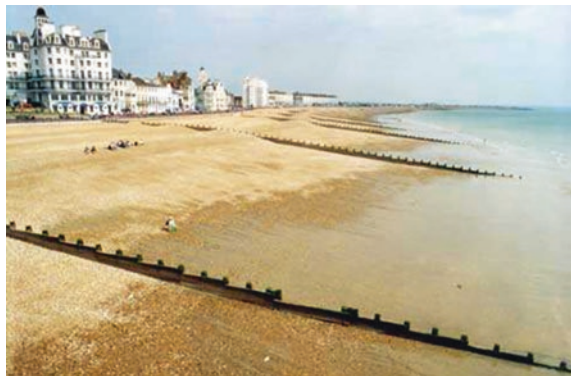
Fig. 3.3 A terminal groyne retains the eastward-drifting beach at Hengistbury Head in Dorset. © Geostudies

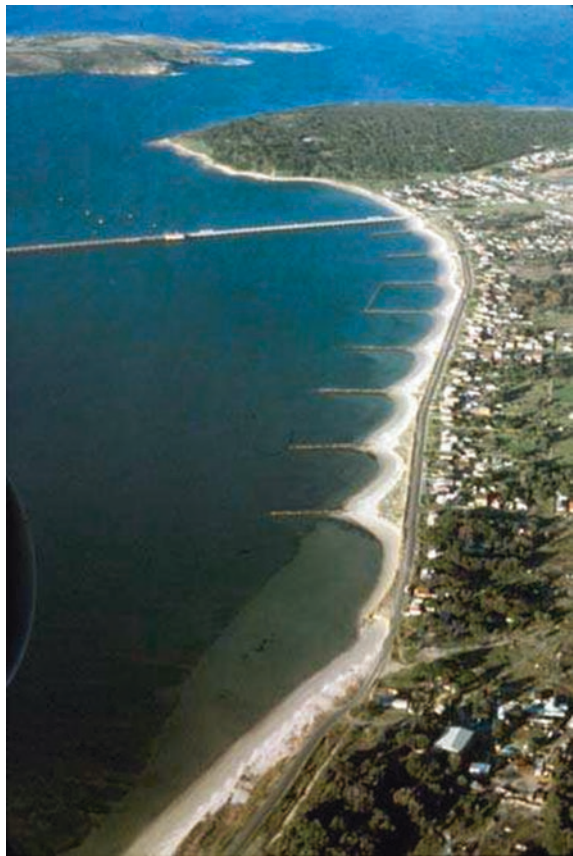
Fig. 3.5 Groynes on the Italian coast at Ravenna have failed to retain beach sediment, which has been withdrawn seaward and lost alongshore. © Geostudies

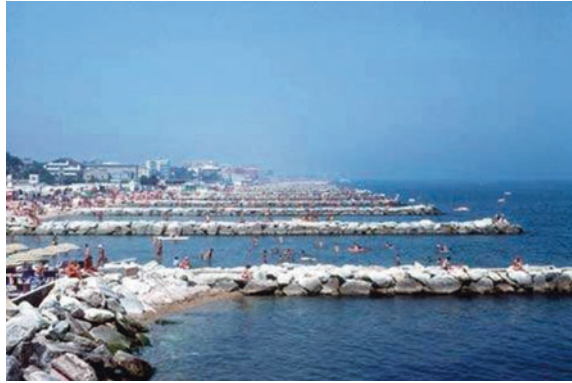
Fig. 3.6 Headland breakwaters separating beach compartments fronting reclaimed land on the south-east coast of Singapore in the 1970s. South-westerly wave action formed asymmetrical beaches between the breakwaters, but these did not remain stable, erosion continuing on the asymmetrical alignments. © Geostudies

compartment (Fig. 3.6). Waves arriving at an angle to the coastline would shape each beach into an asymmetrical ‘half-heart’ or zeta-curve configuration, which would be relatively stable, with minimal losses alongshore. Unfortunately, this procedure failed because erosion continued on the asymmetrical beaches between the groynes.

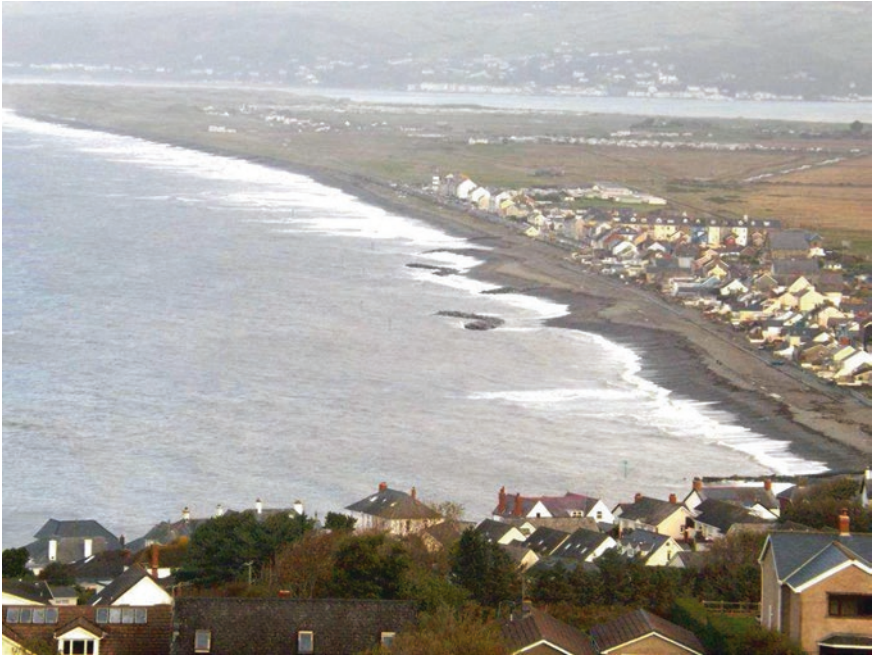
Fig. 3.7 Completed coastal protection works at Borth, United Kingdom. Beach renourishment supplemented a submerged rock berm and two breakwaters. © Royal HaskoningDHV

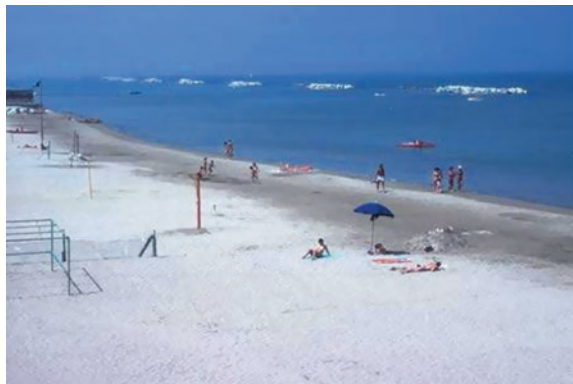
Fig. 3.8 Chain of boulder breakwaters protecting the beach on the coast at Rimini, Italy. © Geostudies

100 m long, and 50–200 m offshore, by stacking large boulders, usually of limestone or granite. Much of the seaside resort coast between Venice and Rimini in NE Italy has beaches lined by offshore breakwaters built of limestone blocks brought from the hinterland (Fig. 3.8). Waves break against them, and are diffracted through the intervening spaces before they reach the beach. This diffraction can lead to the shaping of cusps and shallow zones in the lee of each offshore breakwater, and if there is a sufficient sand supply these may grow into linking tombolos (Fig. 3.9).

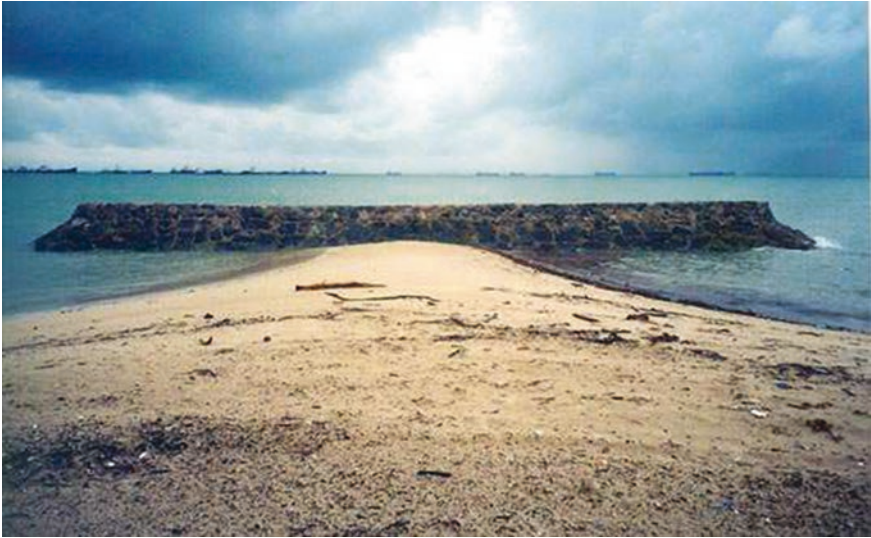
Fig. 3.9 Tombolo formed in the lee of a breakwater on the coast of Singapore. © Geostudies

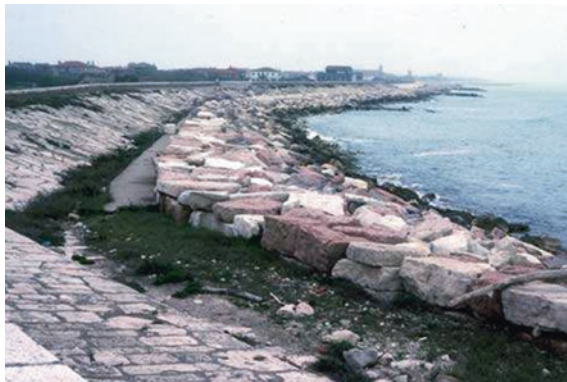
Fig. 3.10 After a sea wall and groyne failed to retain a beach at Litorale di Palestrina on the NE coast of Italy limestone boulders were dumped on the shore. © Geostudies

maintained, and are derelict. On the Lido di Pellestrina, near Venice, attempts were made to retain a wasting beach after a sea wall was constructed, then elaborated and armoured with boulders. Groynes were built, then a chain of offshore breakwaters, but as these defences multiplied the original sandy beach washed away, and has been replaced by dumped boulders (Fig. 3.10).

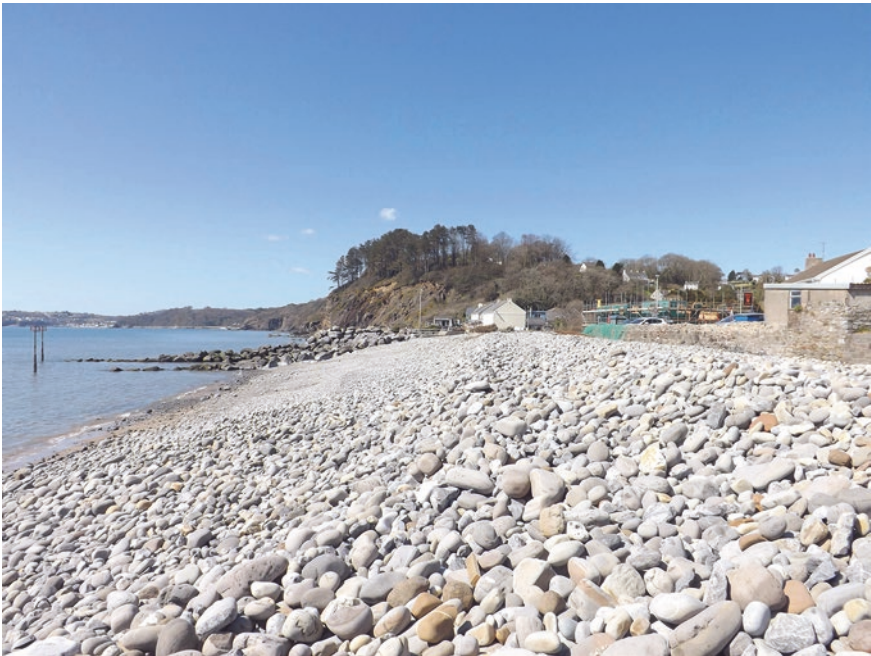
Fig. 3.11 Large cobbles added to the beach at Amroth, Pembrokeshire, to increase the stability of the beach and increase the protection from flooding of hinterland properties. © Greg Guthrie of Royal HaskoningDHV

Dynamic revetments have also been used as an alternative to stone revetments or seawalls (Komar and Allen 2010; Ahrens 1990). Also termed “cobble berms” or “rubble beaches” they involve the construction of a cobble beach at the shore, in front of land or property to be protected. These structures are effective in defending the coastline as the sloping, porous cobble beach disrupts and dissipates wave energy by adjusting its morphology in response to the prevailing wave conditions. Dynamic revetments are therefore a variation of beach renourishment. An example of the introduction of a dynamic revetment was at Amroth in Pembrokeshire, United Kingdom where in the 1990s large cobbles were added to a shingle beach to give it additional stability (Fig. 3.11).

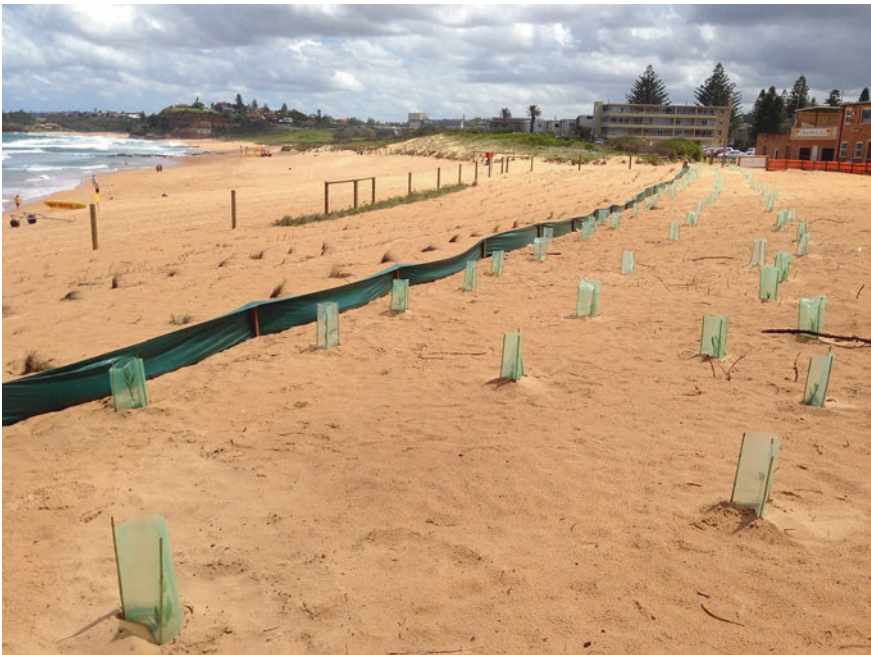
Fig. 3.12 Planting of dune vegetation on Mona Vale Beach, Australia in 2013 in an attempt to halt erosion by restoring and stabilising the dune system. The stabilised dune is intended to protect coastal properties, avoiding the need for structural engineering or other ‘soft’ measures such as beach renourishment. © Nick Lewis

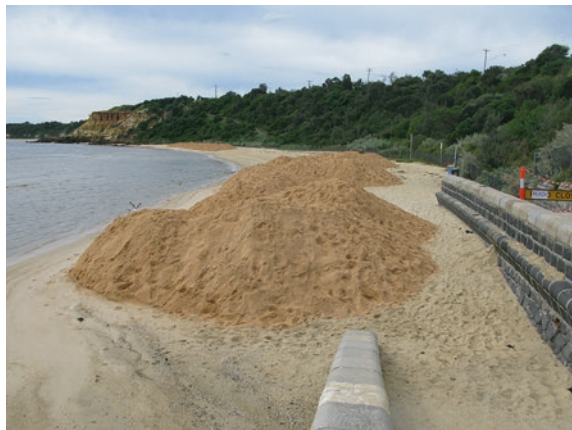
Fig. 4.1 Heaps of sand dumped on the beach at Half Moon Bay, Melbourne, Australia, prior to being spread on the renourished beach © Geostudies

In October 2011 contractors began dumping lorry-loads of sand brought from an inland quarry on the beach at Half Moon Bay. There were protests by local people and the beach nourishment project was halted with about 60 heaps of sand dumped on the beach (Fig. 4.1). The protests were about the renourishment of a

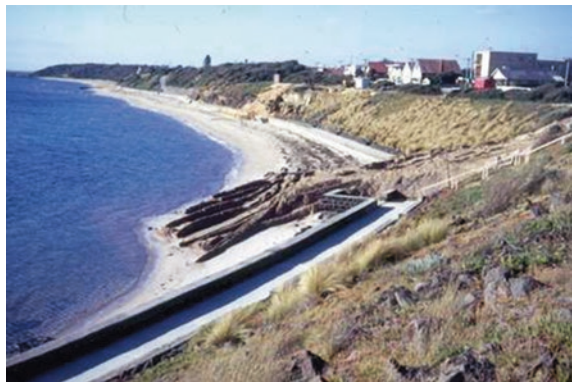
Fig. 4.3 Sand dumped from lorries on the shore at Black Rock, Victoria, Australia.
© Geostudies

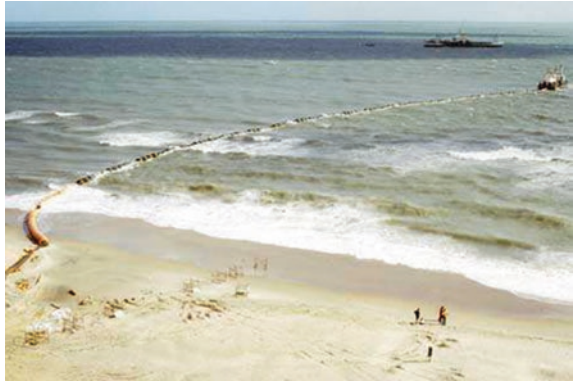
Fig. 4.4 The shore at Mentone, Port Phillip Bay, in 1976 when the beach had been depleted by reflection scour in front of a sea wall. This beach was then renourished by pumping in sand from the sea floor (see Sect. 4.3.1) © Geostudies

Sand dredged from the sea floor was used in a similar way to restore Mentone Beach on the north-east coast of Port Phillip Bay, Australia (Sect. 4.3.1, p. 55), which had been depleted by reflection scour from a sea wall (Fig. 4.4). Sea floor sand immediately offshore was too fine and silty used to be used for this purpose, but between 1.4 and 2.0 km seaward, where the water was 7–10 m deep, there was a deposit of coarser sand up to a metre thick, containing marine shells (Guerin 1984), which was pumped on to the shore to renourish the beach (Fig. 4.5).

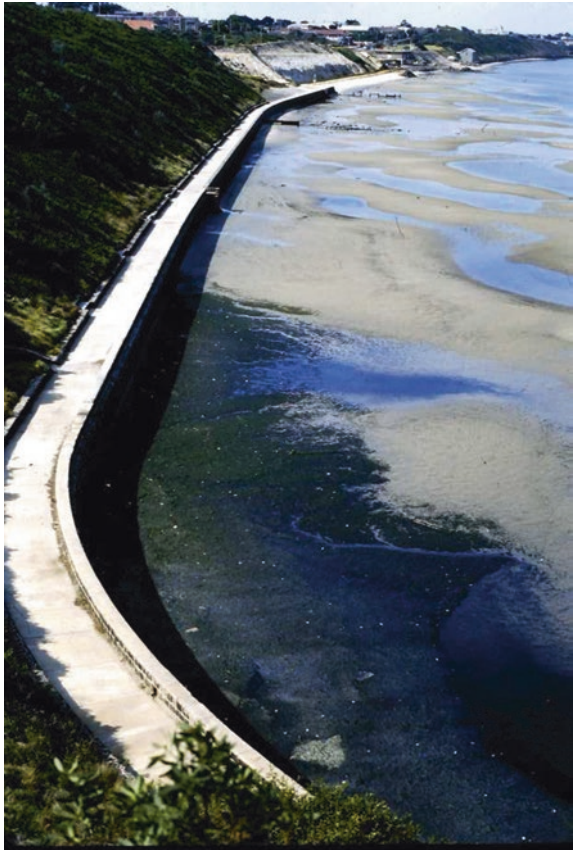
Fig. 4.5 Depleted beach at Mentone, Port Phillip Bay, Australia, after sea wall construction. © Geostudies

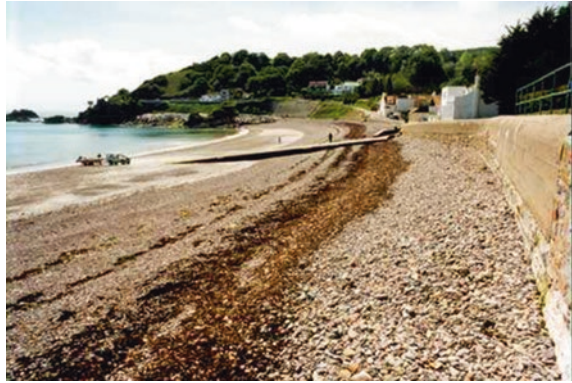
Fig. 4.6 The shingle beach at Anne Port, Jersey, renourished with gravel shipped from Ireland.
© Geostudies

The shingle beach in the bay at Anne Port, on the east coast of Jersey, has a shingle beach that became depleted by reflection scour in front of a sea wall. In 1999 it was renourished with well-rounded pebbles imported from a quarry near Cork in southern Ireland, chosen because of their similarity to the preceding natural beach at Anne Port (Fig. 4.6).

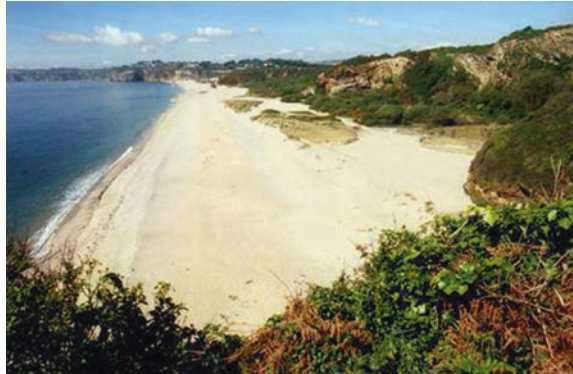
Fig. 4.8 The artificial beach in Carlyon Bay, Cornwall, was supplied with sand and gravel waste from tin mining in the hinterland, delivered through a tunnel cut from the Homebush valley.

Mining waste (sand and gravel) from tin mines in south Cornwall was piped through a tunnel cut in 1842 in a coastal ridge to form an artificial beach in Carlyon Bay (Figs. 4.7 and 4.8) (Everard 1962). The beach was eventually about 200 m wide, with a broad convex profile, but as mining declined in the 20th century the fluvial sediment supply diminished, and artificial nourishment of Carlyon Beach ceased. The beach remains as one of the earliest and most substantial artificially nourished beaches in Britain, but when the supply of mining waste halted the beach began to erode, developing a concave profile. Continuing erosion of this beach is likely to pose a problem for those intent on developing a seaside resort here.

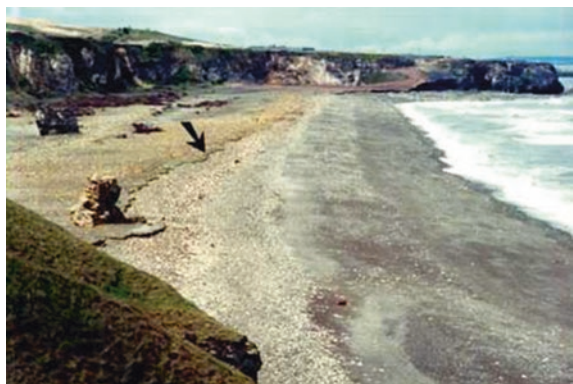
Fig. 4.9 The beach at Ness Point, near Seaham in Durham, was augmented by the dumping of gravelly waste from nearby coal mines. Dumping ceased when nearby coal mines were closed in 1993, and the beach is being re-shaped by wave action. A low clifflet (*arrowed*) marks scarping at the limit of wave re-working.

Colliery waste was dumped on the shores of County Durham, England for more than a century, until the closure of the coal mines in recent years (Hydraulics Research Station 1970; Nunny 1978). Deposits of dumped waste have been reworked and drifted alongshore for several kilometres, augmenting the natural beaches of locally-derived calcareous sand (Fig. 4.9). The added coal and shale have been sorted into gravel and sand, and in some places coal fragments were collected from the shore, mainly for domestic use. Wide, convex beaches formed, but after dumping was halted, the beaches were cut back by wave action, and low clifflets or beach scarps were formed, fronted by a developing concave profile.

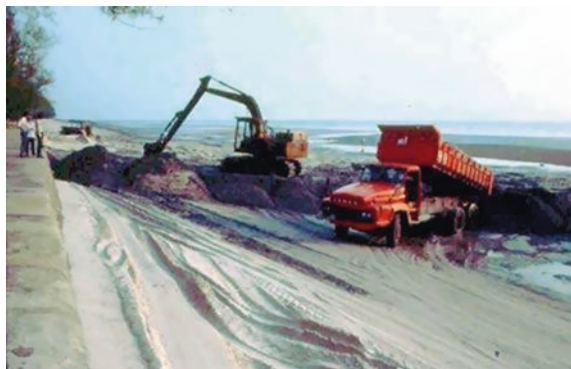
Fig. 4.10 Renourishment of the beach at Morib, Malaysia, by dumping sand from lorries. © Geostudies

Some beaches have been renourished by dumping truck-loads of sand on the shore, as at Morib in Malaysia (Fig. 4.10).

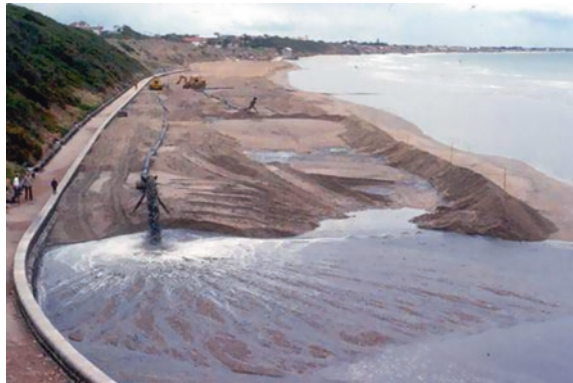
Fig. 4.12 Sand pumped on to the shore at Mentone, Port Phillip Bay, Australia, and deposited as a renourished beach. © Geostudies

Mention has been made (Sect. 4.2.7, p. 49) of the beach at Bournemouth on the south coast of England, which was renourished by pumping sand in from a nearshore stockpile directly on to the depleted beach sector. A similar project was carried out at Mentone, near Melbourne, Australia, on a coast that is much like Bournemouth geologically. Receding cliffs in soft Tertiary sandstones were stabilised by a sea wall and promenade built in 1937–1939, and the sandy beach that had been supplied with sediment eroded from the cliffs then diminished. In 1977 the beach was renourished with about 160,000 m³ of sand dredged from a rectangular zone 1,800 m long and 600 m wide the sea floor (Fig. 4.11) and pumped on to the shore (Fig. 4.12). The sediment supplied to the shore was bulldozed to form a beach terrace, initially about 32 m wide, built 2 m above low spring tide level. The sand was at first dark in colour because of a coating of silt, clay and organic matter, but rain quickly washed this away. There was a problem because the beach had been emplaced across several storm water outfall pipes, and the first heavy rain saw gullies washed out across the beach by outflow. This was remedied by extending the pipes seaward to the outer edge of the renourished beach.

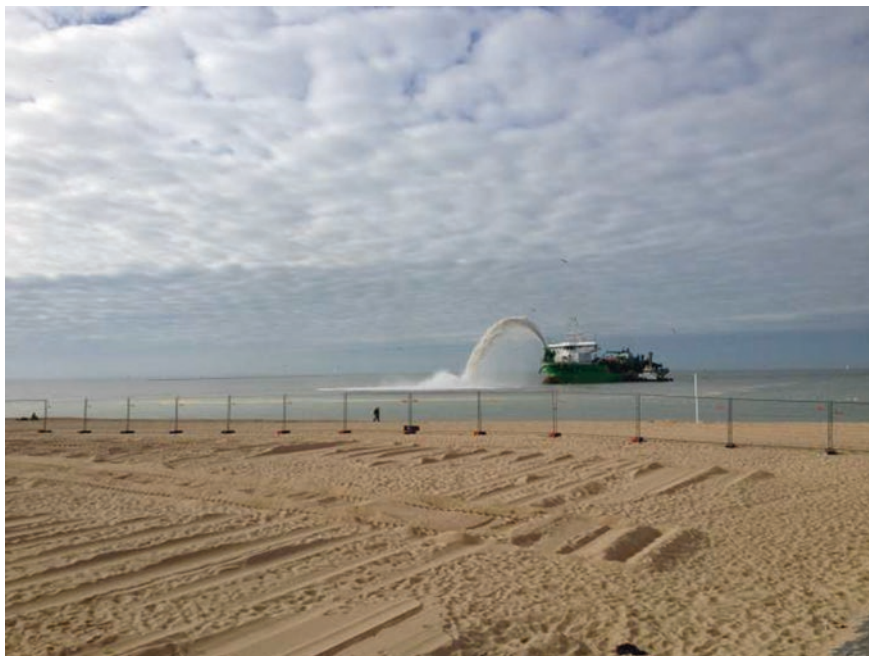
Fig. 4.13 Beach renourishment taking place at Ostend, Belgium in 2013. Sand extracted from the seafloor was pumping directly from the dredge barge to renourish the beach and nearshore areas. © Afdeling Kust

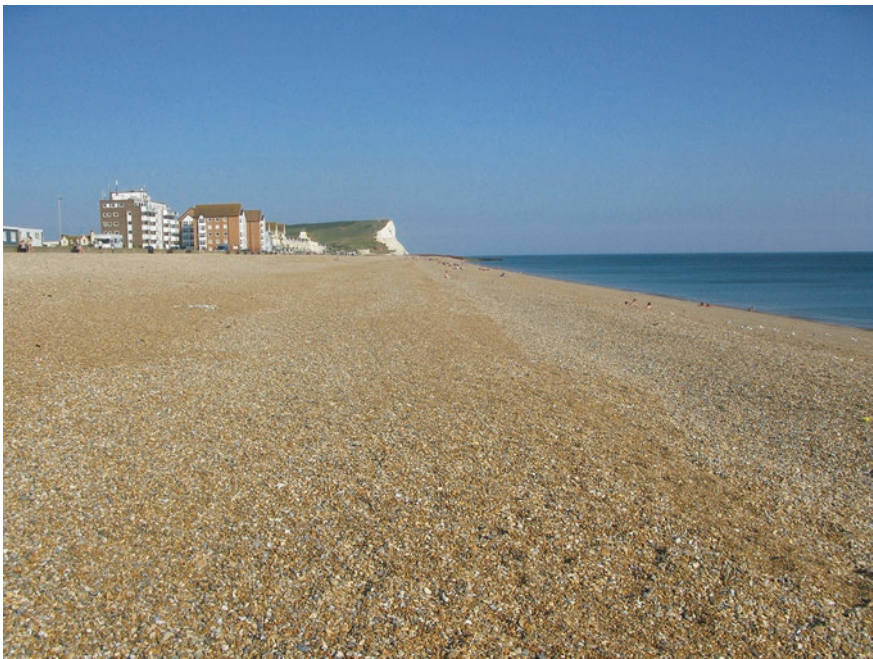
Fig. 4.15 The renourished shingle beach at Seaford, Sussex in 2013. The renourished beach is retained by a breakwater at the eastern (downdrift) end. © Geostudies

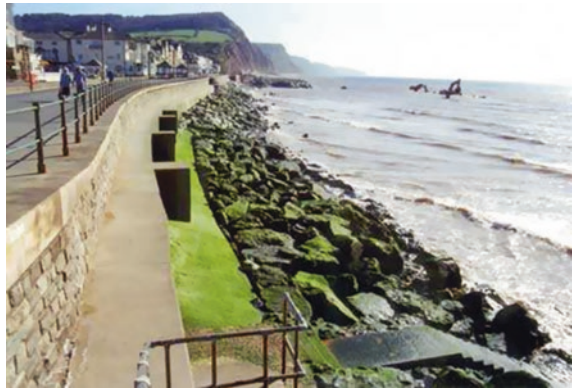
Fig. 4.17 When the shingle beach at Sidmouth in South Devon had been renourished, offshore breakwaters (A, B) were built to protect it from the prevailing SW waves and groynes (G) were inserted to retain it. © Geostudies

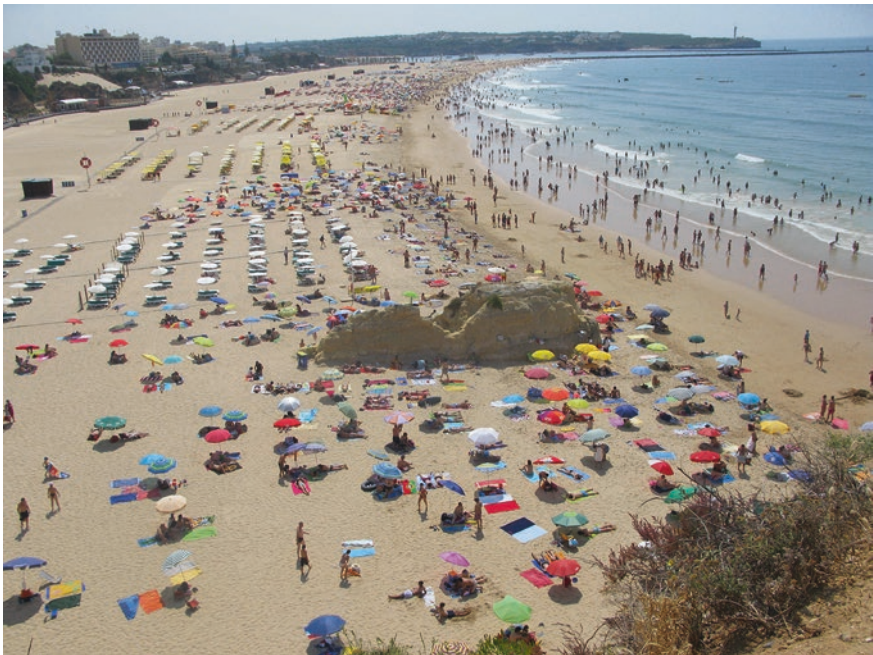
Fig. 4.18 At Praia da Rocha on the Algarve coast of Portugal an artificial beach has been placed in front of cliffs where no beach existed previously. Sediment dredged from the adjacent River Arade was deposited on the shore to the west in 1970 and 1983, forming a very wide beach above normal high tide level, incorporating several stacks. © Geostudies

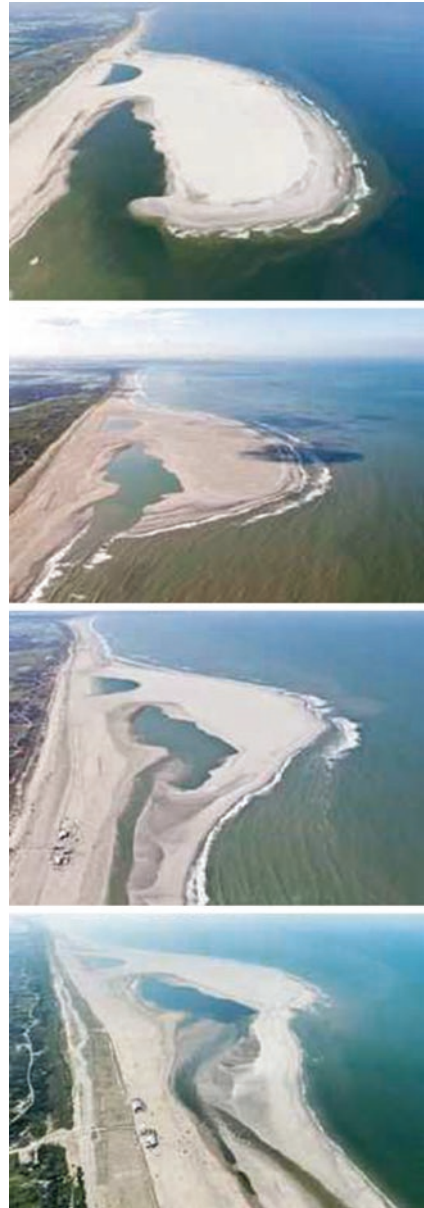
Fig. 4.19 A time series of oblique aerial photographs taken across the ‘sand engine’. Photographs show morphological development since completion in July 2011. From *top to bottom*: 5 July 2011, 13 October 2011, 30 March 2012 and 4 September 2012. © Rijkswaterstaat (The executive branch of the Dutch Ministry of Infrastructure and the Environment)/Joop van Houdt

Results of numerical modelling and observed data from the first year were presented by Stive et al. (2013). This included the stormy winter of 2011–2012, when the shape of the deposited sand peninsula changed considerably (Fig. 4.19). The maximum width decreased from 0.96 to 0.84 km, while its length alongshore increased from 2.4 to 3.6 km. The sediment volume at the location of the initial peninsula decreased during this first year by about 1.4 million m³, while adjacent coastal sectors showed an increase in sediment volume of 0.9 million m³, confirming the longshore distribution.

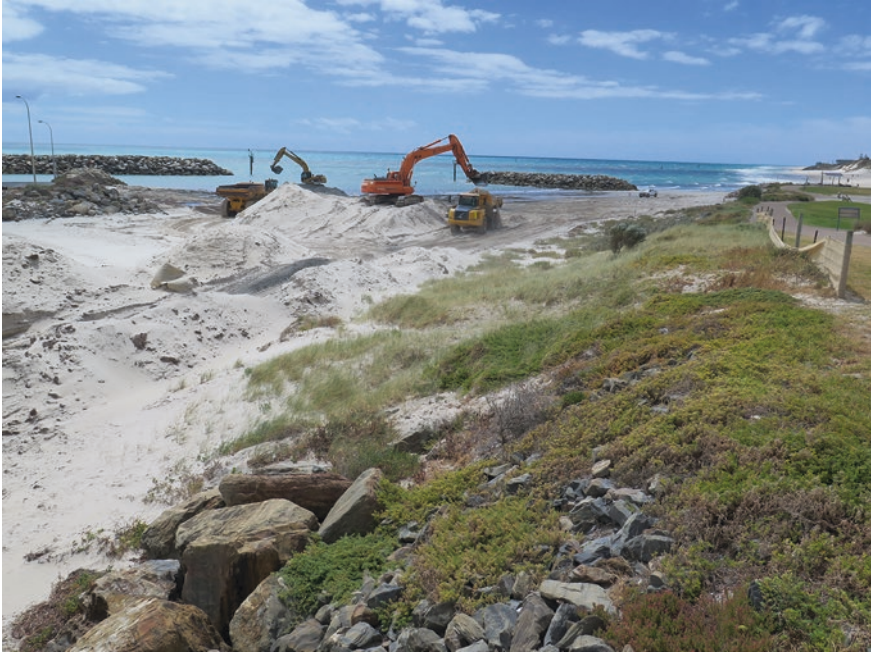
Fig. 4.24a Northward drifting sand on the Adelaide coast trapped by a breakwater near West Beach is loaded into trucks and carried southward along the beach to Glenelg (Fig. 4.24b). © Geostudies

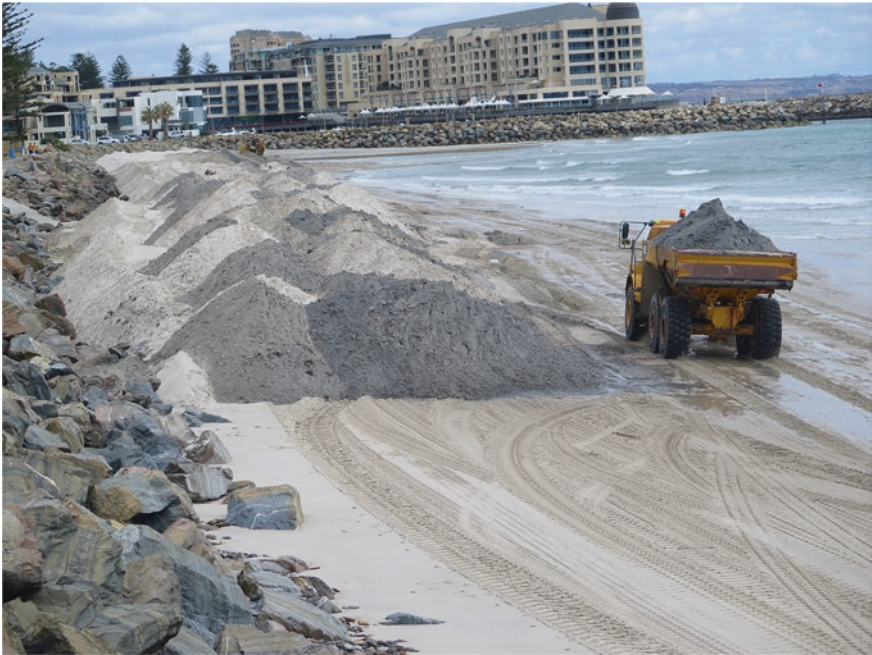
Fig. 4.24b Sand heaps delivered to the depleted southern end of the beach at Glenelg, Adelaide for beach renourishment. © Geostudies

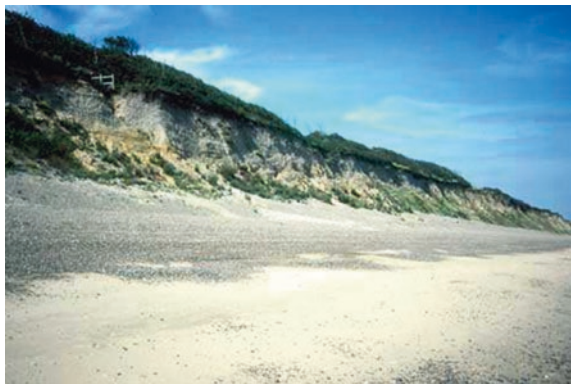
Fig. 4.25 Apron of shingle bulldozed to form an upper beach at Dunwich on the Suffolk coast. © Geostudies

Several beaches on the coast of England and Wales have been modified by the combing of shingle down the beach by plunging waves during storms. This can be countered by bulldozing gravel up to the back of the shore to raise the upper beach profile in front of a sea wall or eroding cliff. This has been effective at Dunwich, East Anglia (Fig. 4.25), as a short-term procedure, where the aim is to increase upper beach protection of soft cliffs cut in glacial drift. Where storm downcombing becomes frequent it may be necessary to add more sediment in order to renourish a higher and wider beach that is more protective.

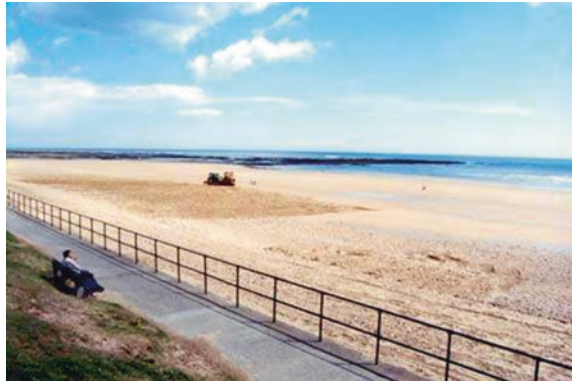
Fig. 4.26 Improvement of the recreational beach at Whitburn Bay, Durham, by dumping sand over shingle.
© Geostudies

More common is the addition of renourishment sediment placed on top of the existing beach material. At seaside resorts the losses of sandy sediment during winter storms may leave a gravelly beach, and it is then necessary to bring back sand to restore the beach for recreational use. At Whitburn Bay on the Durham coast in north-east England the resort beach is improved each spring by dumping sand over the gravelly shore (Fig. 4.26). This is termed a veneer, as when sand is deposited over much coarser (boulders coral rocks) or finer (silt and silty sand)
