Eric Bird
Nick Lewis

Beach Renourishment

SpringerBriefs in Earth Sciences

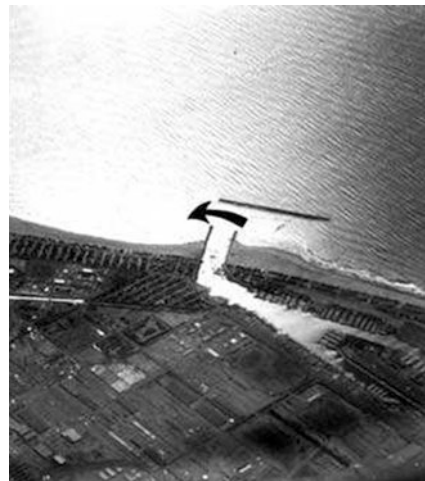
Fig. 4.29 Sand by-passing at Port Hueneme, California.
© Geostudies

At Port Hueneme in California, a breakwater was built parallel to the coast on the updrift side of the harbour entrance in 1940, and the sandy cusp that formed on the beach landward of it (Fig. 4.29) has been excavated at the rate of about 400,000 m³/year by a floating dredge to produce sand which is used to replenish wasting beaches on the downdrift shore (Johnson 1959).

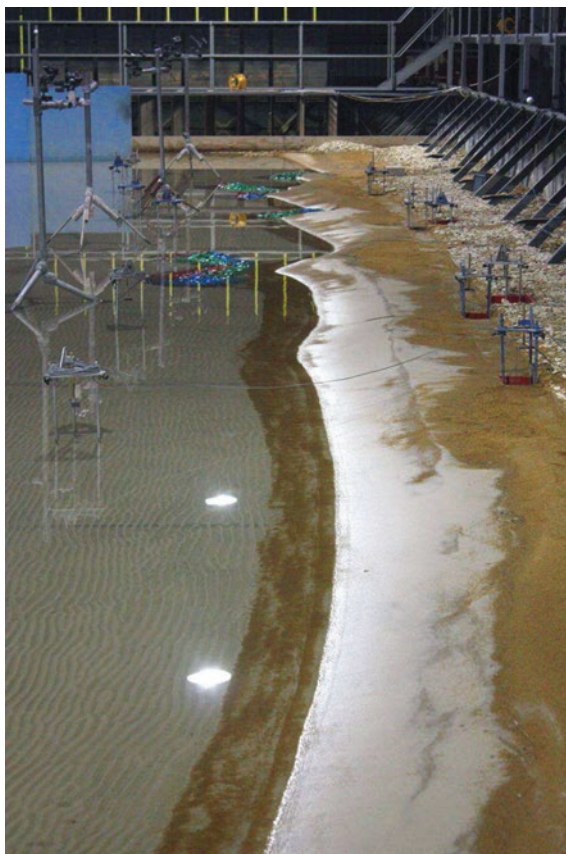
Fig. 4.31 Physical modelling being undertaken to inform coastal protection works in Borth, UK, comprising beach renourishment, offshore breakwaters and submerged breakwaters.

Laboratory simulation of shore processes to help design beach renourishment projects has been attempted with scale models such as water tanks in which waves, tides and currents can be generated and their combined effects assessed. The aim is to test hypotheses concerning the ways in which these processes cause erosion, move sediment and promote deposition on the sea floor and along the coast. Such physical models have limitations because of the difficulty of scaling down materials and processes without modifying their physical properties (e.g. coherence, friability, expansion and contraction of sediments; viscosity and surface tension in water), but they have been useful in exploring potential responses to marine and nearshore processes (Silvester 1974). They are also useful in examining the impacts of structures, as at Borth in Wales (Fig. 4.31), where the future evolution of the beach following renourishment was examined in relation to the introduction of groynes and a submerged breakwater.

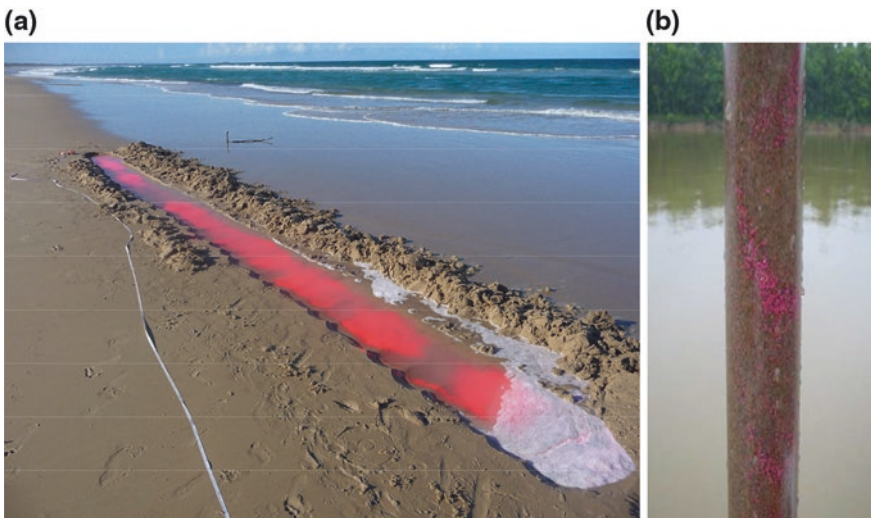
Fig. 4.32 a Indicator sediment (tracer) being released at the start of a study in 2014. b Example of a recovered core including tracer material. © Royal HaskoningDHV/Jon Marsh of ETS Worldwide

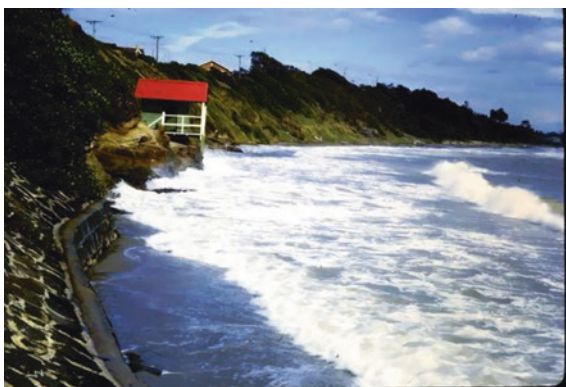
Fig. 5.1 The shore south of Black Rock in 1968, when storm waves at high tide were eroding the base of the backing bluff. © Geostudies

On the north-east coast of Port Phillip Bay, Australia, a sector of natural vegetated bluffs south from Quiet Corner had been stable until the beach fronting them was depleted following the completion of a masonry sea wall at Black Rock, to the north, in 1939. Reduction of the beach allowed waves from the west to generate stronger longshore drift, so that the beach fronting the bluffs gradually dwindled. By the 1960s storm waves were undercutting these bluffs, and erosion was threatening to undermine this part of the coastal highway (Fig. 5.1).

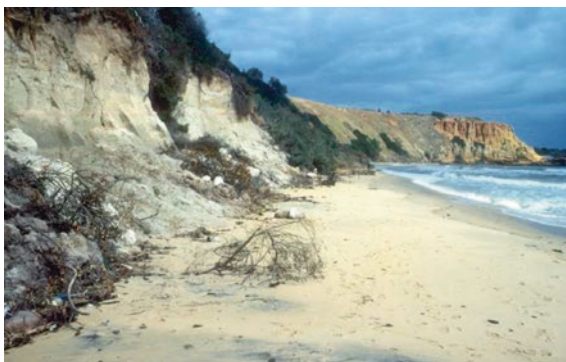
Fig. 5.4 Erosion of backshore bluff on a sector of Sandringham Beach, Port Phillip Bay in 1989.
© Geostudies

become very narrow in winter, when the backing bluff was undercut by storm wave erosion, forming slumping cliffs of sandy clay up to 10 m high (Fig. 5.4). As these were cut back, there was a risk that a segment of the coastal highway, which here runs close to the top of the bluffs, would be undermined.

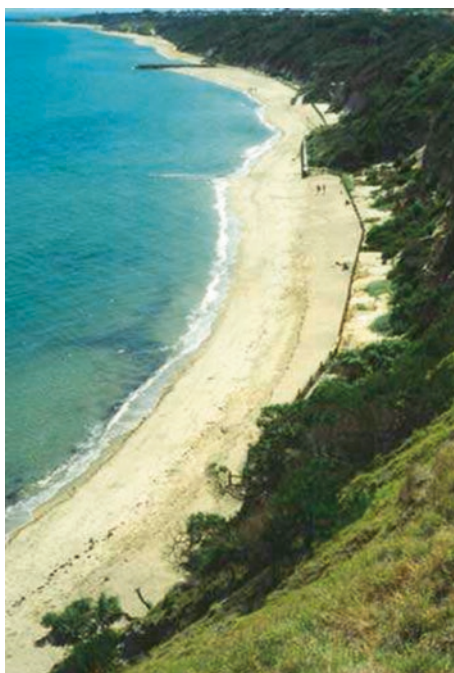
Fig. 5.5 After the renourishment of the of Sandringham Beach, Port Phillip Bay, south of the Edward Street groyne, in 1990, backshore cliff erosion halted and vegetation revived.
© Geostudies

In 1990 a groyne was built at Edward Street and the sector south to Red Bluff renourished to form a beach 25 m wide and 600 m long by trucking in about 35,000 m³ of sand, placed to protect the base of the bluffs from further storm wave erosion (Fig. 5.5). As a result the undercutting of the bluffs ceased (Fig. 5.5). Some slumping continues because of groundwater seepage from the bluff, but by 2004 the cliff base had become largely revegetated. Protection of a cliff base by

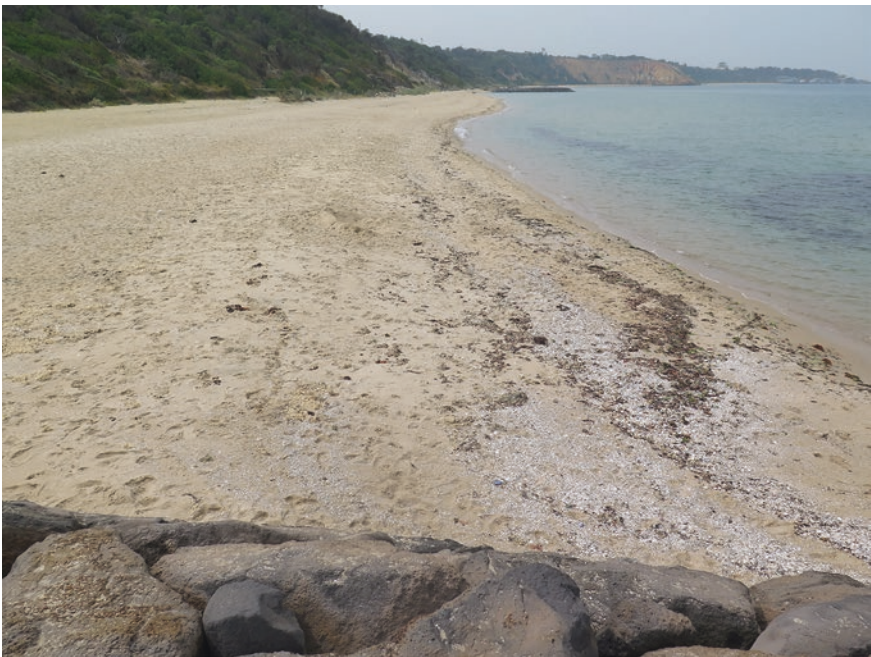
Fig. 5.6 The renourished beach between groynes at Sandringham, Port Phillip Bay, in 2010.
© Geostudies

In 2008 a groyne was built opposite Southey Street at the northern limit of cliff erosion, and sand from Sandringham Harbour was piped a kilometre southward to renourish the beach between the new groyne and the one previously built at Edward Street (Fig. 5.6). This has stabilised the coast in the central part of the Sandringham beach compartment, but the northern part now shows beach depletion and incipient cliffing of the backing bluff, and it may yet be necessary to add a further groyne and renourish this next section.

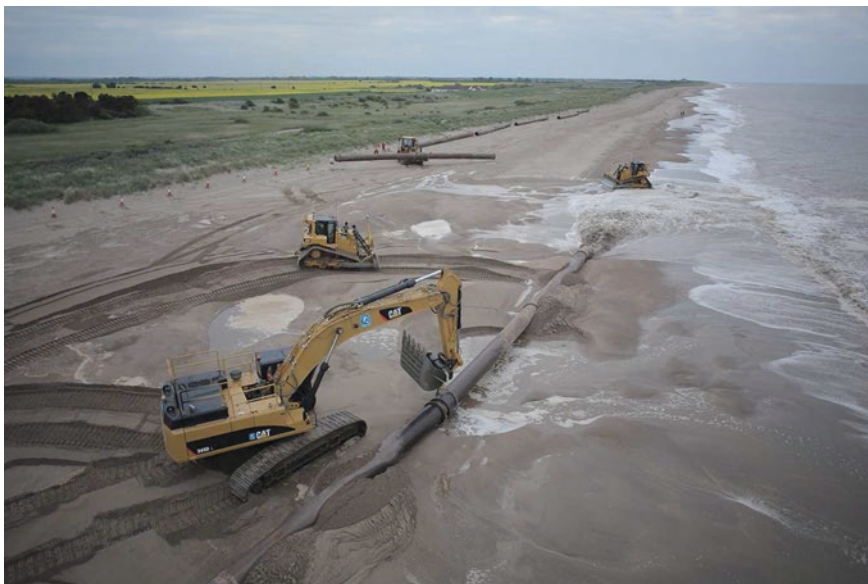
Fig. 6.1 Beach renourishment on the Lincolnshire coast, United Kingdom. Between 2010 and 2015 15,000 m³ of sediment per day was pumped ashore and placed on the beach using hydraulic pipes. Sediment was then spread across the beach using excavators and bulldozers. © Dredging International

Beach renourishment is generally beneficial, and widely regarded as a better alternative to the construction of hard structures (Adriaanse and Coosen 1991; Hamm et al. 2002; Finkl 2002), but it can produce adverse impacts on the environment (Speybroeck et al. 2006). When works are undertaken the activity is often intensive (Fig. 6.1).

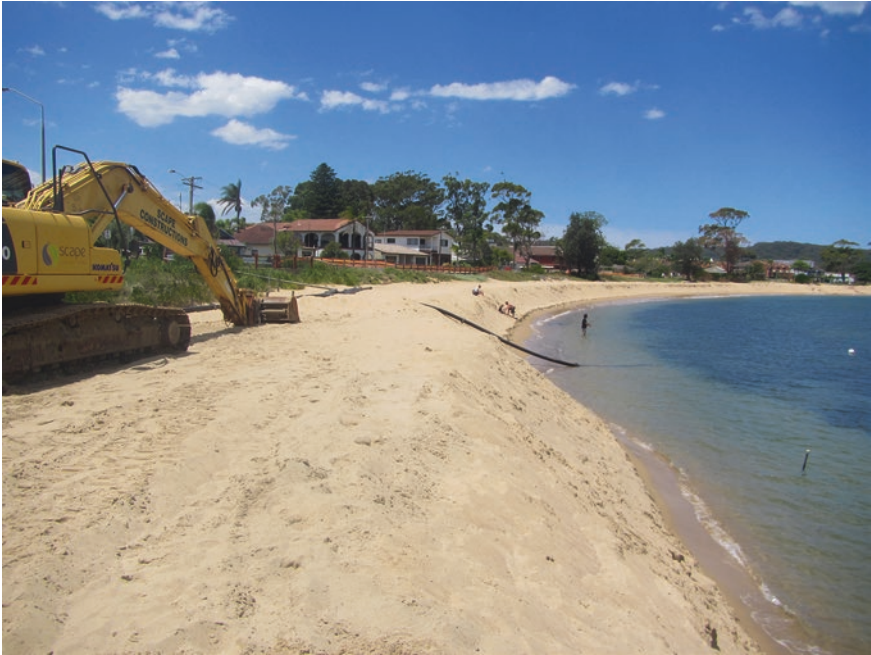
Fig. 6.2 Renourishment of Ettalong Beach, Broken Bay, Australia during November 2013. Sediment dredged from the bay floor 1 km offshore is pumped onshore through a hydraulic pipe and then placed in heaps along the sub-aerial beach by excavator. © Nick Lewis

Costs can be reduced by a number of means. Wellard and Rimington (2013) demonstrated that the unit cost of a beach renourishment could be reduced by 25 % by changing the volume of the dredge vessel. Economies of scale can be realised with greater volumes of material (Hoagland et al. 2012). Simplified placement methods can also reduce costs. Placing renourishment sediment to a selected height on the subaerial beach only, and allowing natural sorting rather than labour intensive re-profiling, can reduce the cost of renourishment (Clarke and Brookes 2008). This was demonstrated at Ettalong Beach, New South Wales (Sect. 4.3.4, p. 68) in 2013, where renourishment sediment was heaped on the beach and left to be sorted by wave action (Fig. 6.2). In Lincolnshire cost efficiencies were made by surveying
