# Engineering Geology for Society and Territory – Volume 8

Preservation of Cultural Heritage

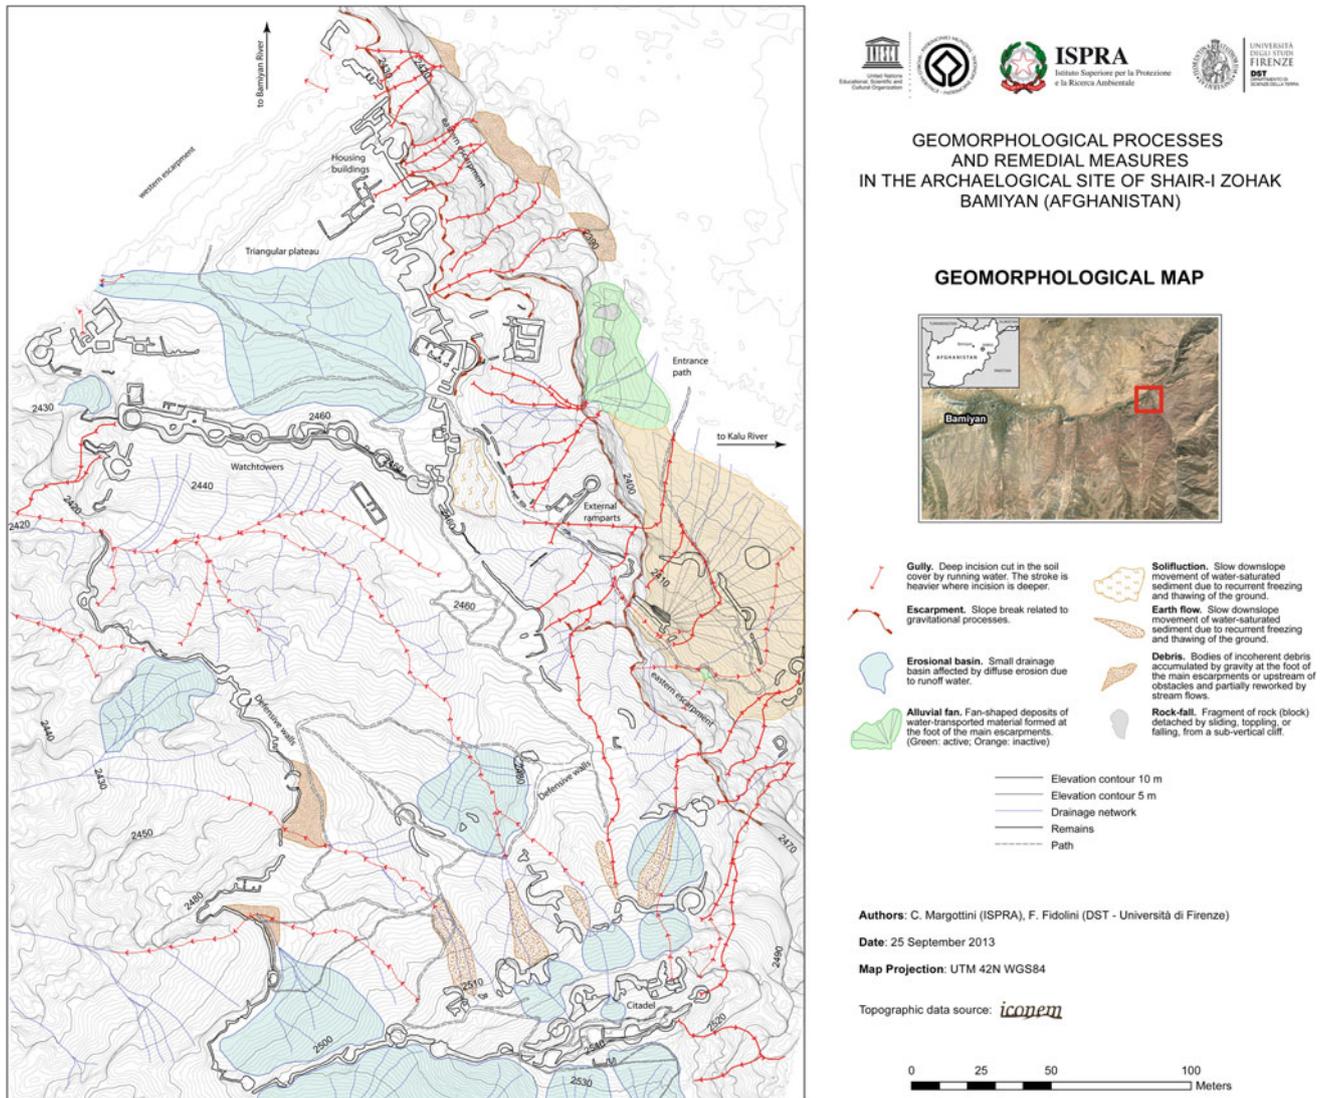
**Fig. 1.5** Geomorphological map of the Zohak site (Margottini et al. 2014)

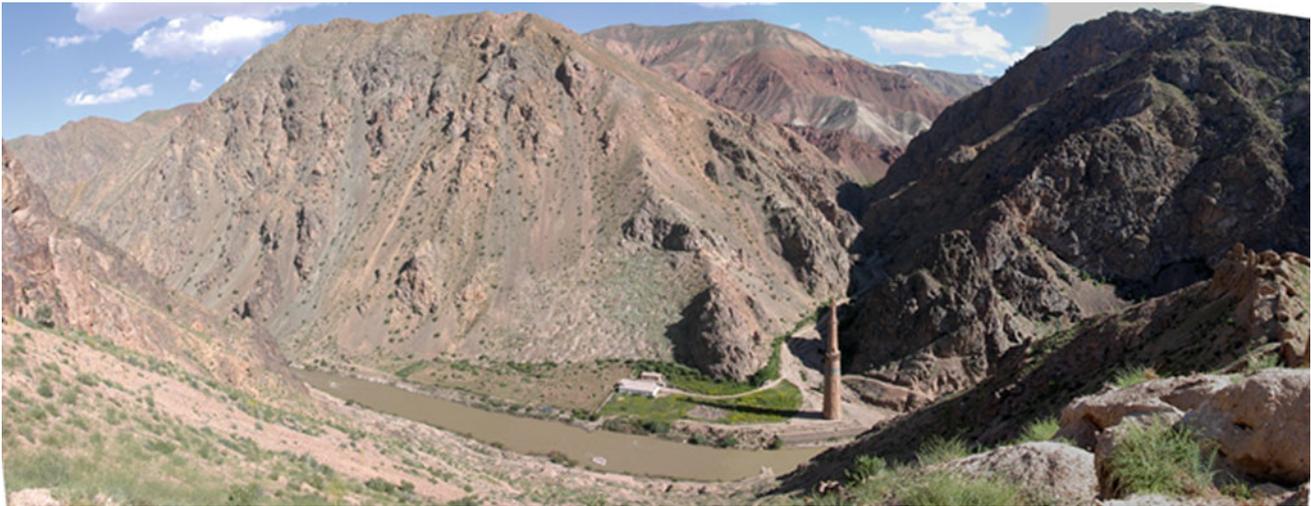
**Fig. 1.8** The Hari Rud and Jam Rud valley with the remain of the minaret of Jam and the floodplain where the city were built, now covered by 3–4 m of alluvial deposits. Some of the settlements were also in the cliff

The following Fig. 1.8 is giving a general view of the Hari Rud and Jam Rud valley.

The minaret was clearly affected by a severe flooding, since the level entrance is about 2.80 m below present day topographic surface, originated by the accumulation of alluvial deposit. Also the minaret, in its recent history, was most likely affected by embankment erosion and under-excavation of the Hari Rud river (Fig. 1.9). Water table rising during flood periods and embankment erosion probably also produced a reduction of bearing capacity in limited period of time. Finally, seismic activity probably also contributed to the present endanger situation.

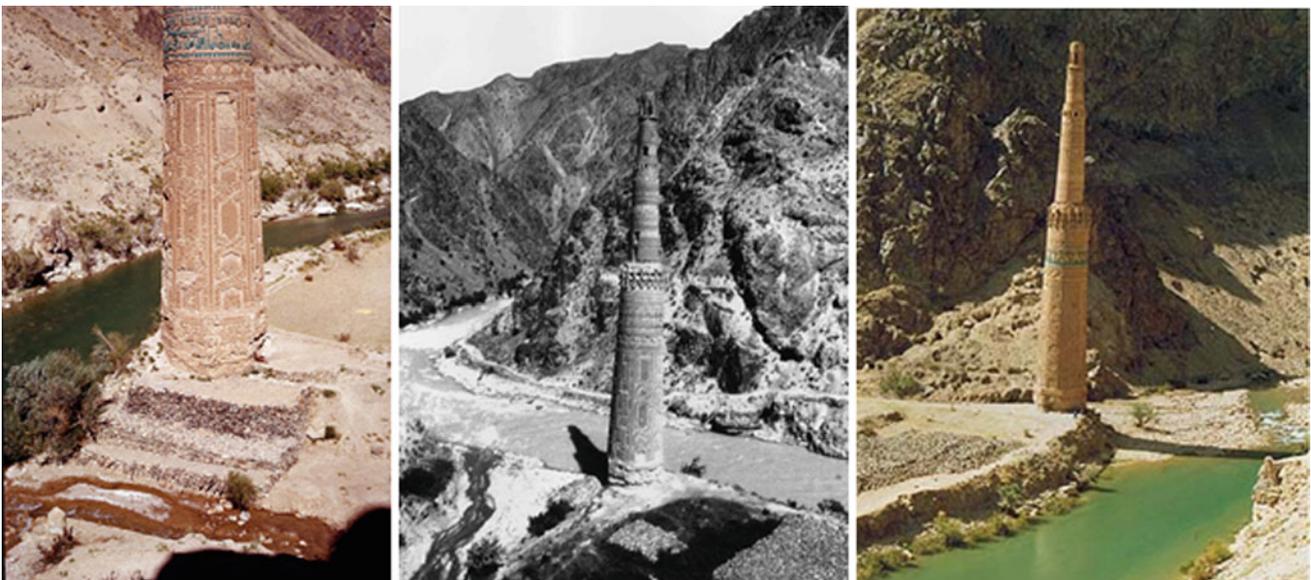
**Fig. 1.9** The embankment in 1963, 1986 and 1999, showing the river Hari Rud quite close to the minaret

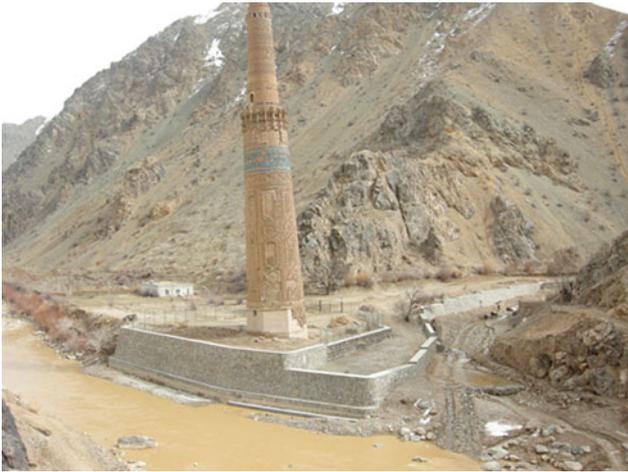
**Fig. 1.12** The emergency restoration work of Jam embankment after the destruction caused by a flooding in 2007

site for security reasons. The following Fig. 1.12 is reporting the final result of emergency intervention.

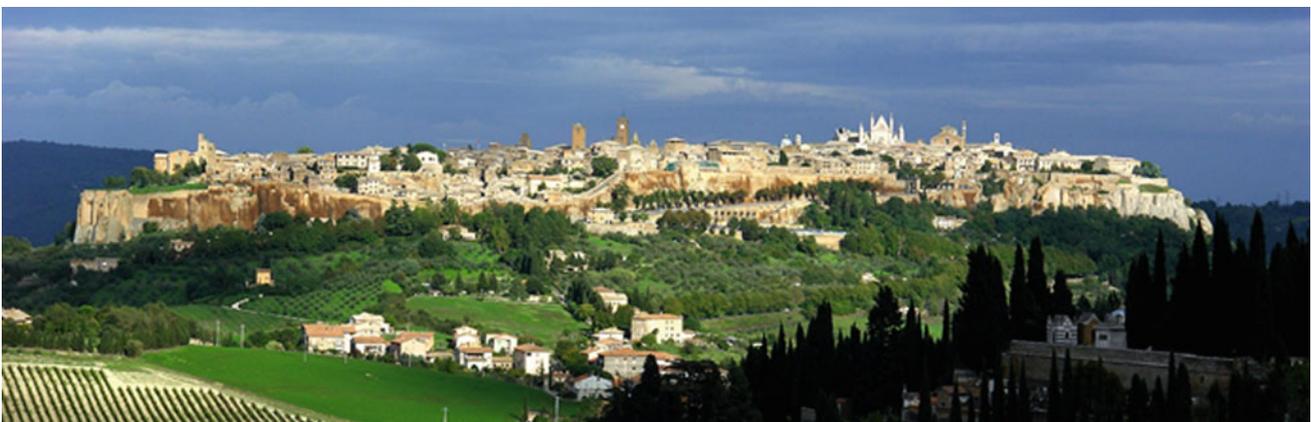
**Fig. 1.13** The settlements of Orvieto, composed by a soft pyroclastic rock overlying low plasticity and over-consolidated marine clay

The peculiar geology of the cliff the town is built on that allowed the inhabitants to excavate the caves that cross and overlap one another under the urban fabric, over the course of Orvieto’s 3,000 years of history. These can be read in close connection with the history above ground, because of the indispensable and complementary services that the underground city assured to the city on the surface. The history of Orvieto dates since approximately 3,000 years, during which different events have happened, peoples and dominations have followed, the city grew spreading and stratifying, changing the allocation of sites and modifying the morphology of the landscape. The present Urban Landscape is the final results of all these events, showing how the history of the town in strictly connected and linked to its geological setting (Fig. 1.13).

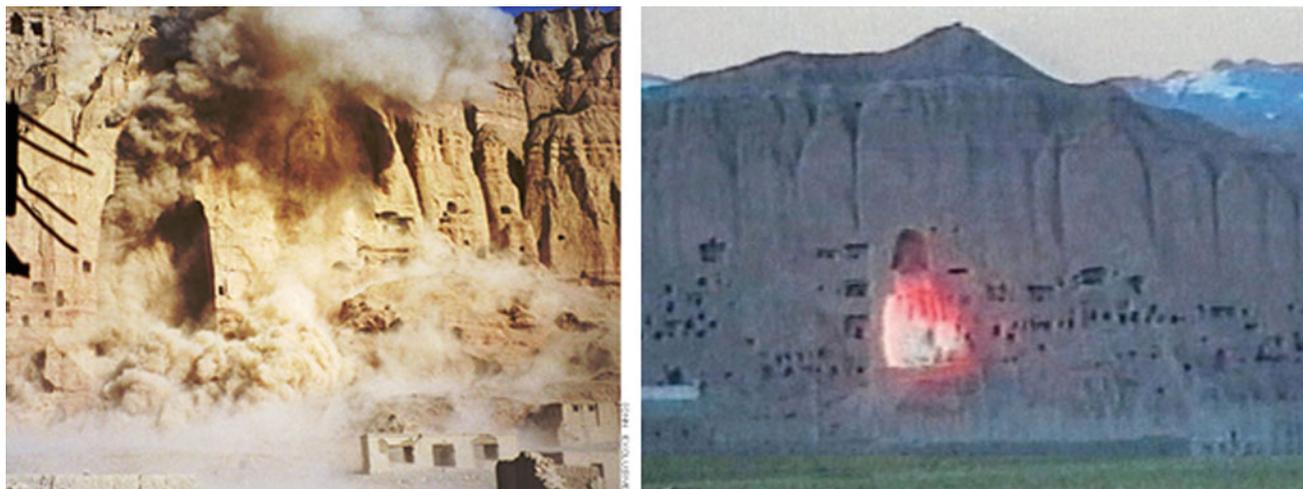
**Fig. 1.19** Explosion and destruction of the Western and Eastern Giant Buddha Statues

The explosion of March 2001 (Fig. 1.19), as well as demolishing the statues, reduced the stability of the slope, mainly in the outer parts of the niches.

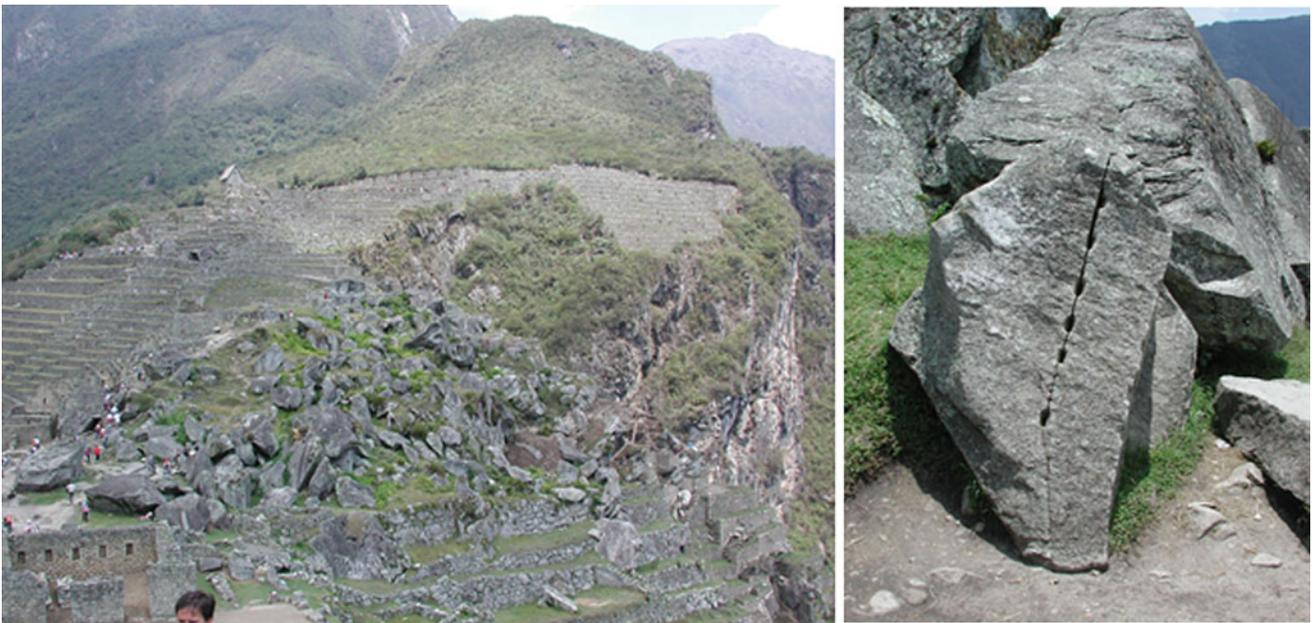
**Fig. 1.23** Possible borrowing quarry/paleo landslide deposit of archaeological site of Machu Picchu (*left*) and methodologies for squared hard rock block production (*right*)

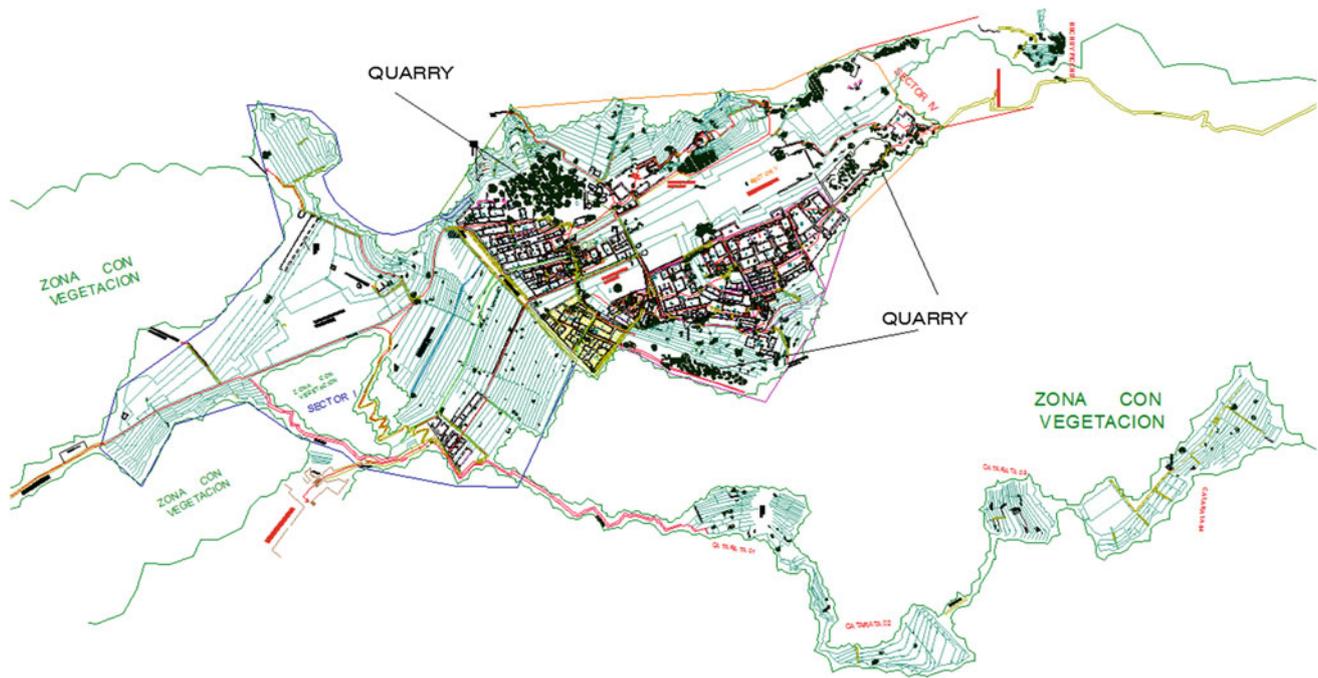
**Fig. 1.24** Location of the quarry (locally “cantera”) for the production of stones to be used in Machu Picchu construction

built. Depending on the particular topographical and morphological situation, the area was presumably used as a borrowing cave for building construction or as a foundation basement of entire neighborhoods of the city (Fig. 1.24).

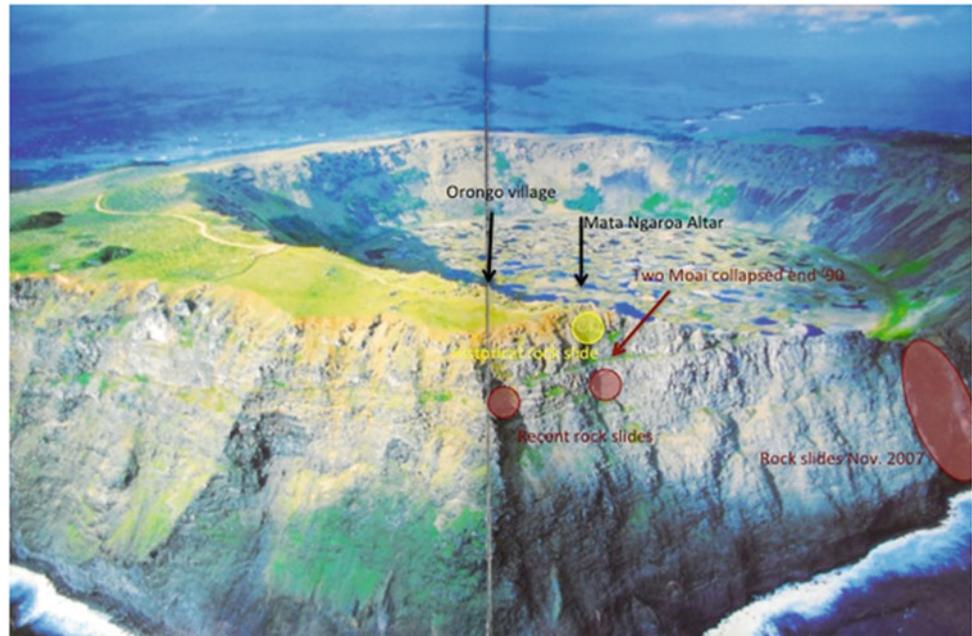
**Fig. 1.31** Detected rock slide on the external edge of Ranu Kau volcanic caldera, below the historical urban landscape of Orongo

The flank of Rano Kau caldera is continuously affected by rock mass movements, as consequence of the important discontinuity pattern affecting the lava and steep slope. Energy of the sea waves in the lower part and chemical alteration in the whole surface are also playing an important role. The flank of Rano Kau caldera was been inventoried (starting from May 2003) in the slope flank located below the archaeological site. From a geomorphological point of view, the landslide can be classified as a rock-slide, initially triggered as a rotational slide in the upper crown area. The following Fig. 1.31 is reporting some evidence of recent and historical mass movement along the cliff below the historical urban landscape of Orongo. Remarkable is the landslide of Nov. 2007 which occurred in a very hazardous slope of the caldera. The rock slide, in highly weathered volcanic material, might affect, in future evolution, the conservation of the lake inside the caldera, located at topographic level higher than the sea. The crown area is localised at approx. 100 m a.s.l. The mobilised material, according to a preliminary morphometric analysis, is about 5,000 m<sup>3</sup>.

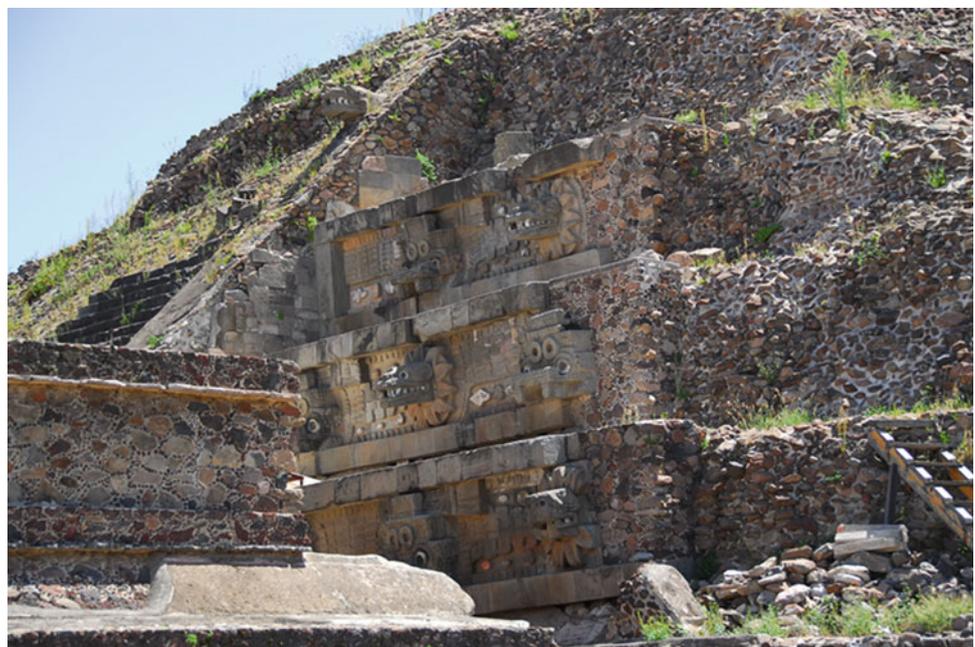
**Fig. 1.33** Some details from Teotihuacan monumental complex (Mexico City) and the rounded volcanic rocks, small size, used as main source for construction

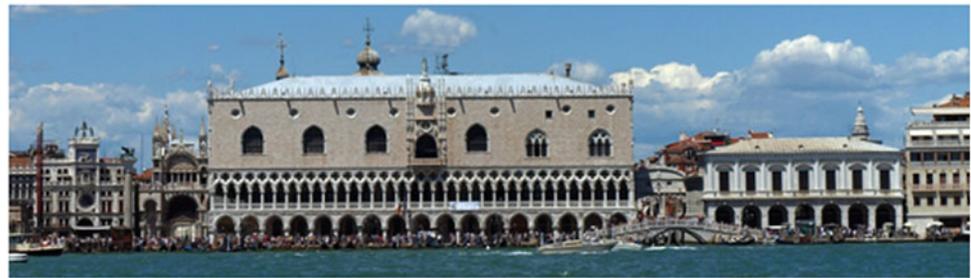
**Fig. 1.34** Example of Venetian buildings and foundations. Wooden piles were mainly used for external buildings walls while, internal wall foundations were mainly executed enlarging the masonry (Colombo and Colleselli 1997)

Venice has a rich and diverse architectural style, the most famous of which is the Gothic style. The style originated in 14th-century Venice, where the confluence of Byzantine style from Constantinople met Arab influence from Moorish Spain. These buildings of grandeur are still very well preserved. Key to its construction is an ancient method of using raised foundations, which effectively elevate ground zero to a height where buildings can be safeguarded from tidal waters (Fig. 1.34). This involves the hammering of thousands of pilings—large wooden stakes commonly made from alder—through the water and into the underlying sand and clay. Each piling is positioned very closely to its neighboring stake, one after the other, ultimately forming a raised wooden platform. Once a certain number of pilings has been driven into the earth, the tops are evened off and a substrate (or foundation layer) of wood and marble laid over the top. A stone foundation is then placed on top of the horizontal timbers. The foundations rest on the piles, and buildings of brick or stone sit above these footings.

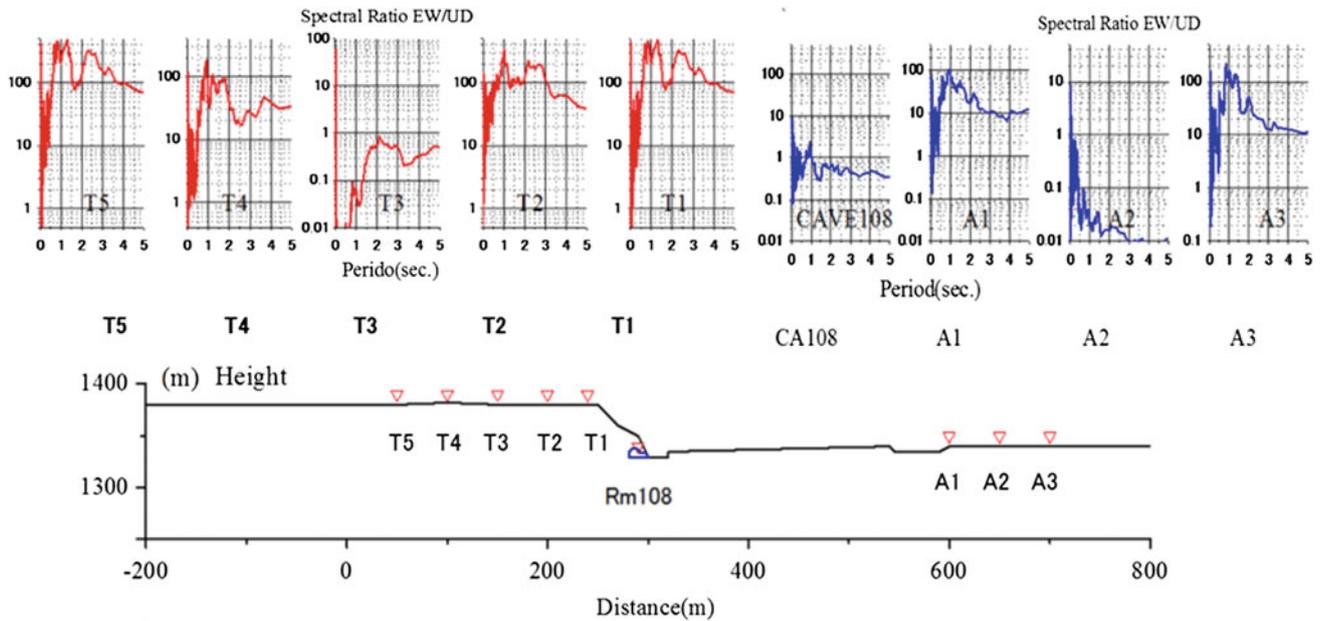
Fig. 2.4 Characteristics of predominant period of spectral ratio

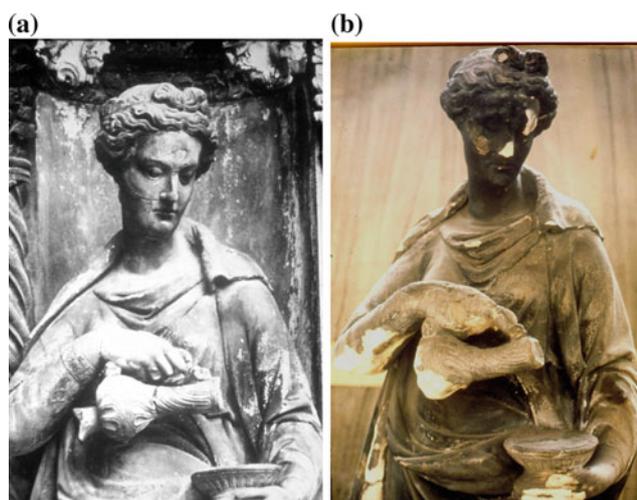
**Fig. 3.1** a, b. Temperance statue, Carrara marble. In 1900 (*left*) the state of conservation was rather good, in 1976 (*right*) some missing parts are visible due to marble dechoesion after heavy atmospheric pollution exposure

To explain better the advantage of a good standardisation in the field of Cultural Heritage we report an example of a Venetian monument which was restored in 1976 as it was strongly decayed. The Porta della Carta, built in XIV century as the entrance door of Ducal Palace, was preserved in a rather good state for four centuries and the only damage observed were ascribed to the natural weathering agents. Comparison between two pictures taken at the beginning of XIX century and after seventy years respectively (Fig. 3.1a, b), shows a sharp increase in the marble decay, ascribed to the contemporary pollution increase occurring in the Venetian district as a result of the industrialization of Porto Marghera, the industrial area, created at the beginning of 1930s (Fassina 1994; Fassina et al. 2002).

In 1976 the conservation work of the whole Porta della Carta started, thanks to a funding of the Venice in Peril fund, and it was completed in a three year period. In 2001 in the framework of the National Research Council Project finalized to the Safeguard of Italian Cultural Heritage in cooperation with the Venice Superintendence for Monuments Care a check of the durability of restoration materials used in 1976 restoration work and of the condition was carried out. The results obtained allow us to conclude that the decay processes, which has caused missing of pieces of marbles and disintegration of carved surfaces (as it is possible to observe from the comparison of Fig. 3.1a and 1b), since the industrialization until 1976, seems to be arrested or slowed down (Fassina et al. 2002; Favaro et al. 2005).

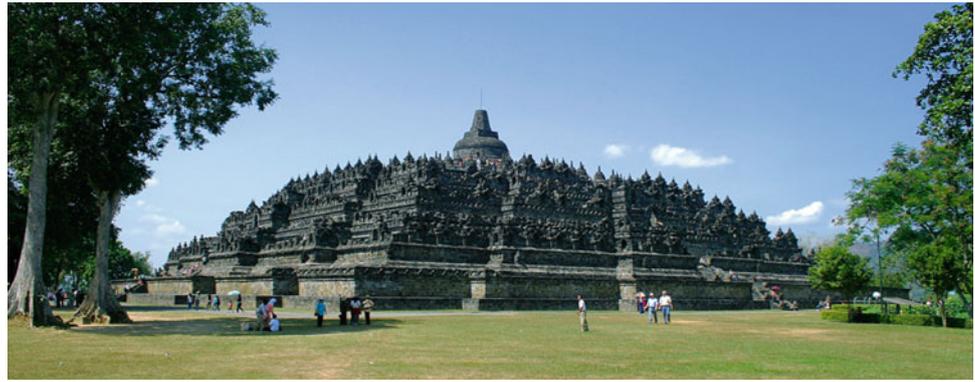
**Fig. 6.1** The Borobudur Temple (after <http://en.wikipedia.org/wiki/Borobudur>)

volcanic rock, above artificial fill on a natural small hill. Length of the foot of this square temple platform is 120 m on a side. The temple consists of six lower square shape stages, three upper round stages and a bell shape stupa on the top. Top most of the stupa was decorated by a finial. The total height of the temple including this finial is estimated as 42 m (however, the conjectural image of this finial is still under discussion and waiting reconstruction) (see Fig. 6.1). A total of 1,460 Buddhist scriptures and 1,212 decorative relief panels were engraved on the wall of the square six stages, and 432 seated Buddha images were installed in each niche. Furthermore, 72 seated Buddha images were covered in the see-through lattice shaped stupas on the upper round stages surrounds the central main stupa.

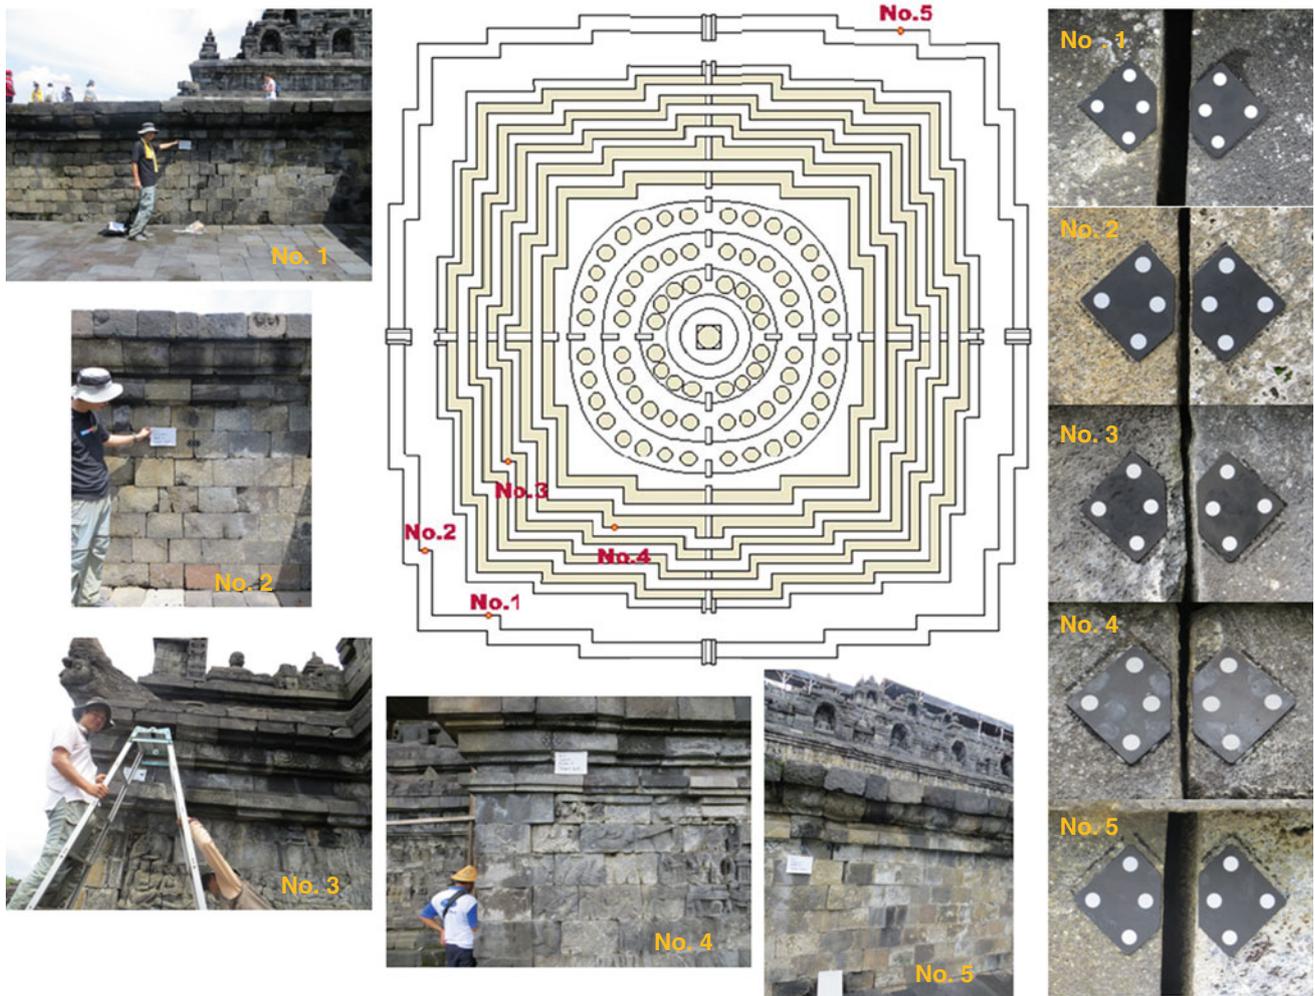
**Fig. 6.5** The location of five different joints along the masonry wall in the Borobudur Temple, Indonesia

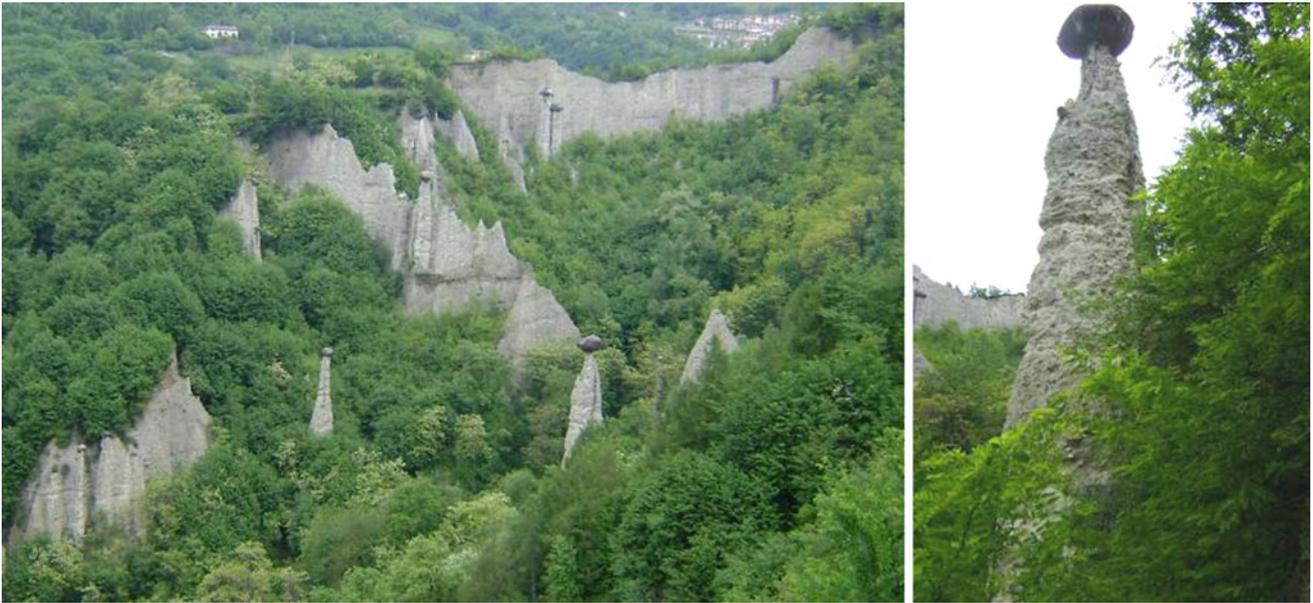
**Fig. 7.1** Location and aspect of the earth pyramids in Zone (BS)

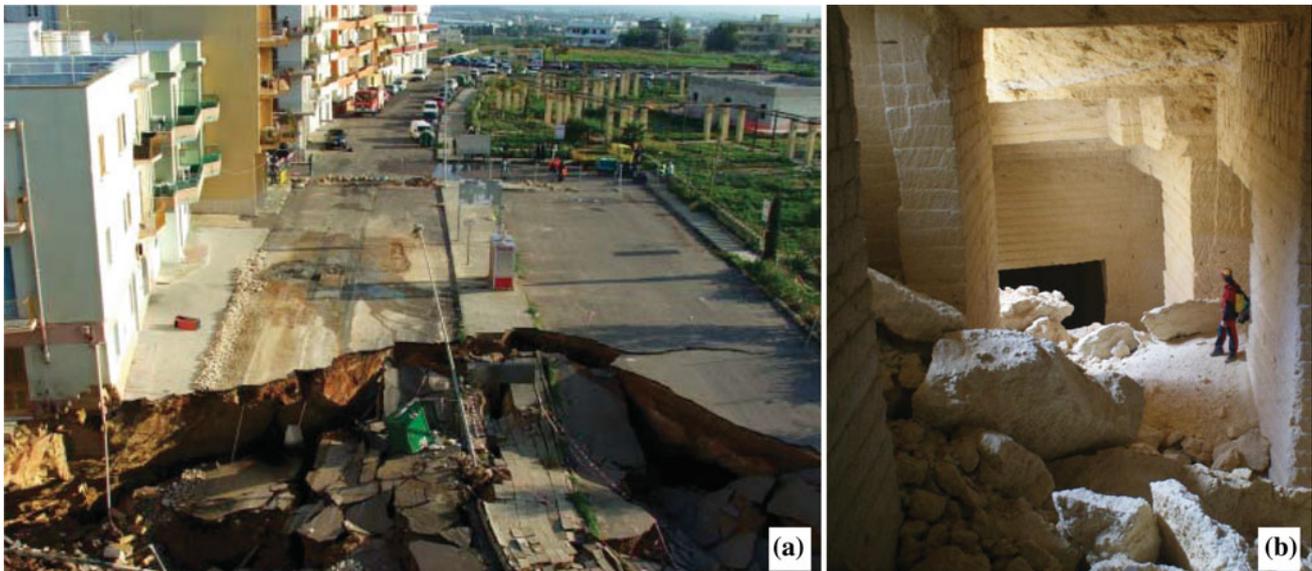
**Fig. 8.1** a Sinkhole in Gallipoli due to the collapse of an anthropic cave (Polimeno 2007), b partial collapse underground cavities in Canosa di Puglia

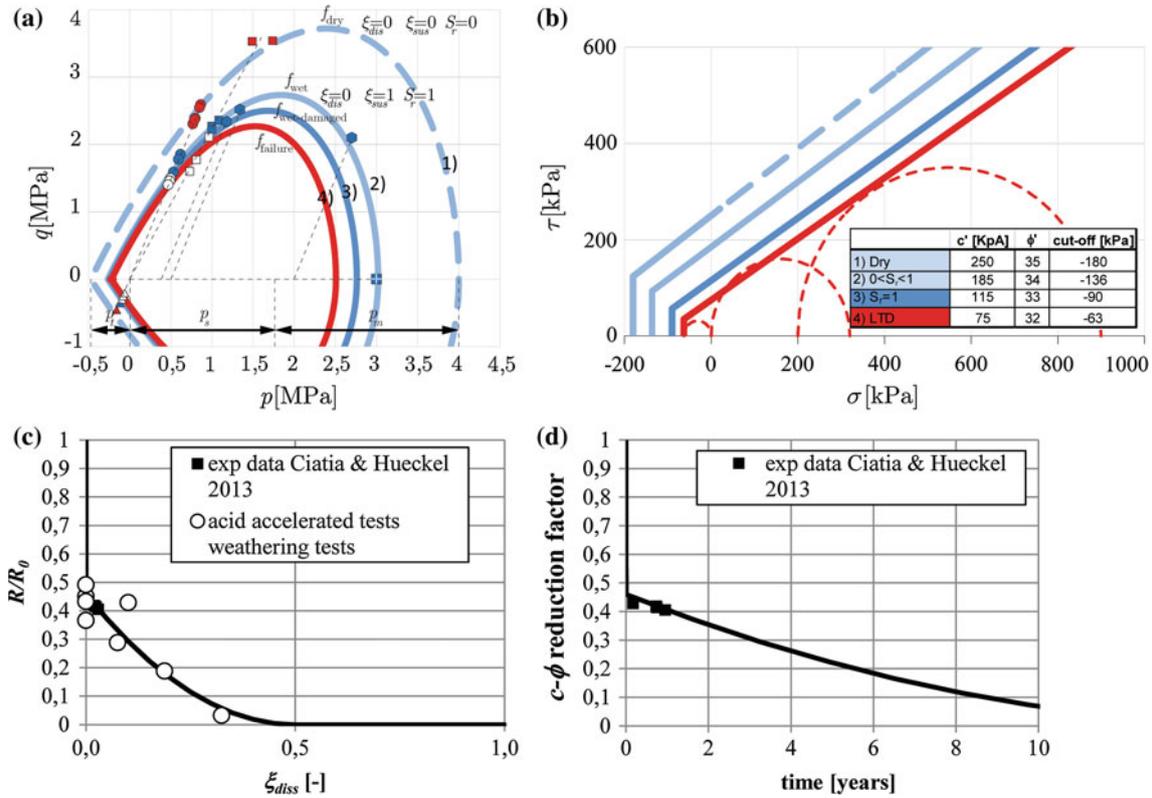
**Fig. 8.3** a Yield locus evolution with  $\xi_{sus}$  and  $\xi_{dis}$  for a closed surface strain hardening plasticity model, b extension of yield shrinkage due to weathering effect to  $c-\phi$  reduction, c evolution of strength with  $S_r$  and  $\xi_{dis}$  and d corresponding  $c-\phi$  reduction factor in function of time

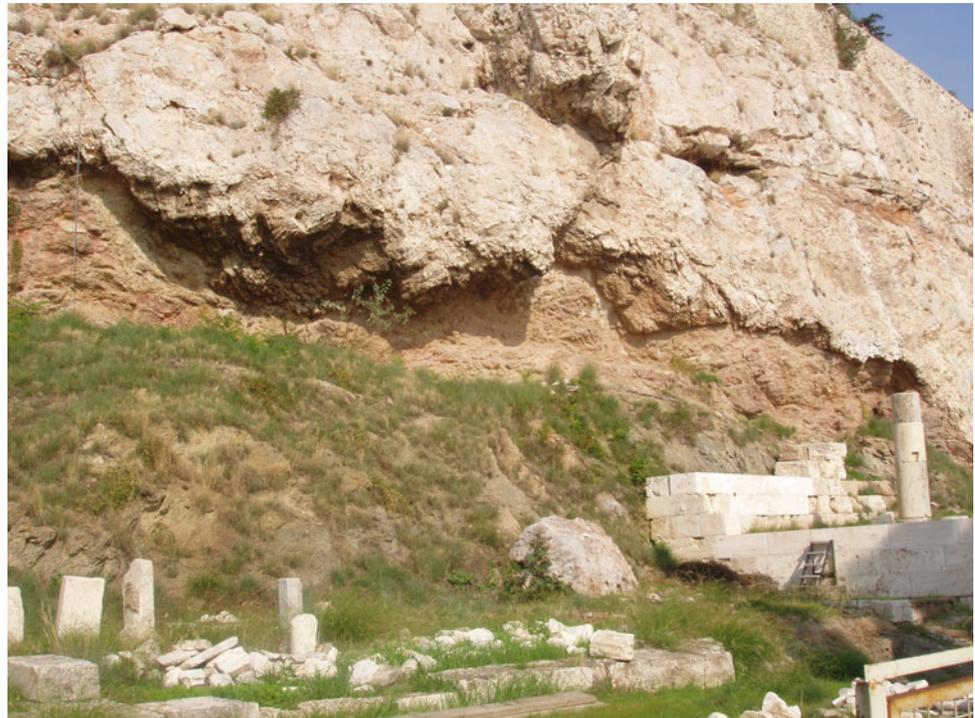
The above sedimentary rocks are folded together in a syncline structure with a fold axis fluctuating around the direction E-W. The differential mechanical behaviour of the schists-sandstones and the limestones (plasticity and inflexibility respectively) explain the observed asymmetric and disharmonic folds, through the exertion of tectonic stresses during the folding (Fig. 12.2).

**Fig. 12.2** South slope of the hill. Contact of limestones and the underlain series

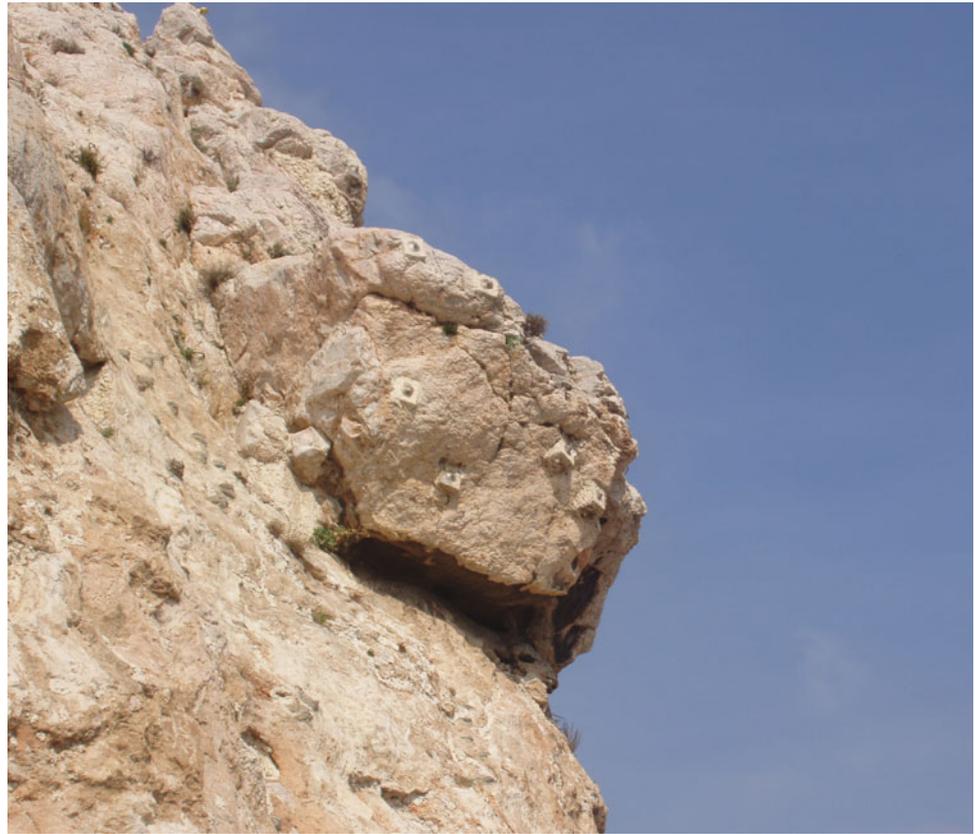
**Fig. 12.3** Eastern slope. Limestone rock after filling of the cracks and joints with cement and with the plates of anchoring

- Securing of the loosened rock masses with the installation of anchors (Fig. 12.3). As the most proper kind of anchoring was judged, out of the studies made, that of combining anchoring at specific points and along the entire length using rods of ribbed steel that adheres two and a half times better than smooth steel. An electrically operated rotating drill is used to open up the holes for the anchors, which can bore to a depth of 35 m.

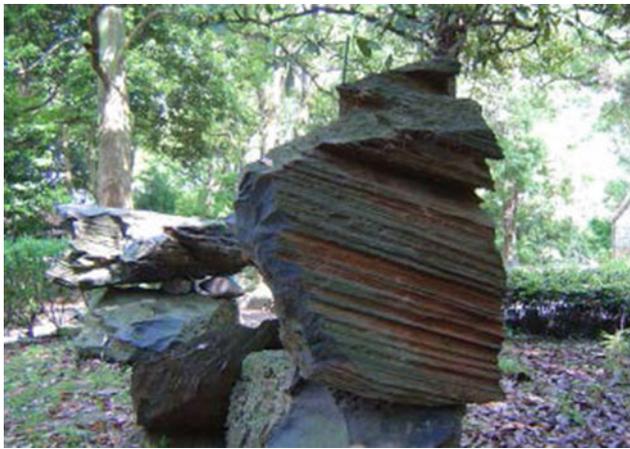
**Fig. 14.2** Weathered surface of sanukite (Modified after Tatsumi (2006))

velocity is unique characteristics of sanukite. Fresh sanukite is black in color. Hydrated white weathering crusts have been formed at the rate of  $4.1 \mu\text{m/ky}$  (Kuchitsu and Iijima 1990).

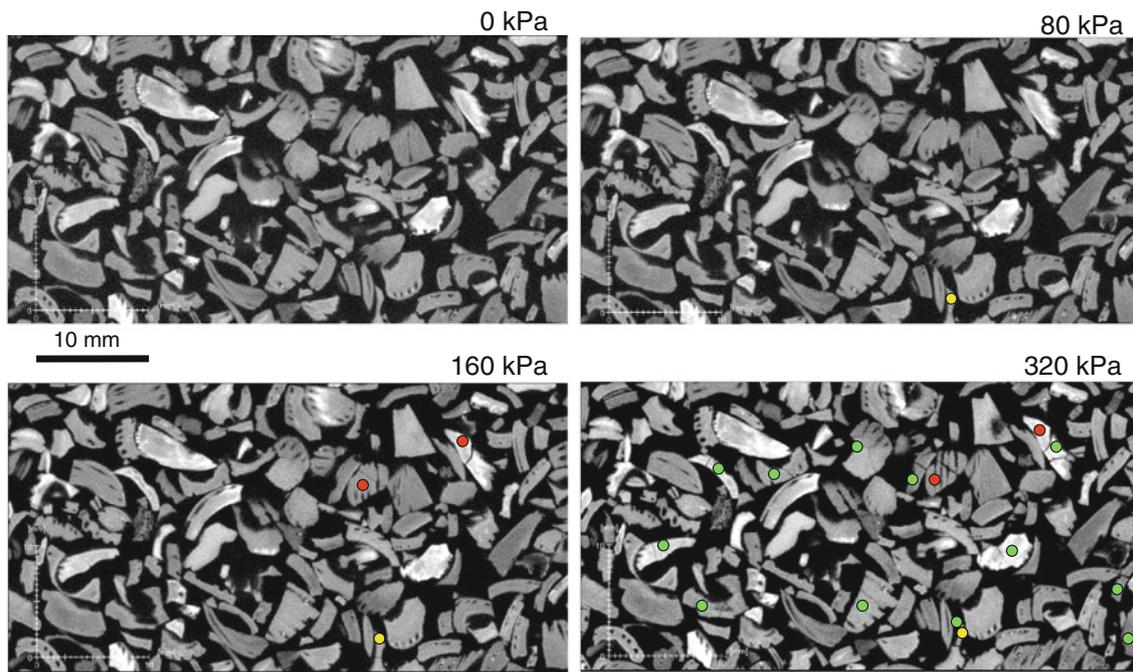
**Fig. 15.1** Zoom on hazelnut shell fragments at the horizontal mid-section of the oedometer sample, at initial state and after 80, 160 and 320 kPa loading. Arrows point at cracks and ellipses highlight crushed

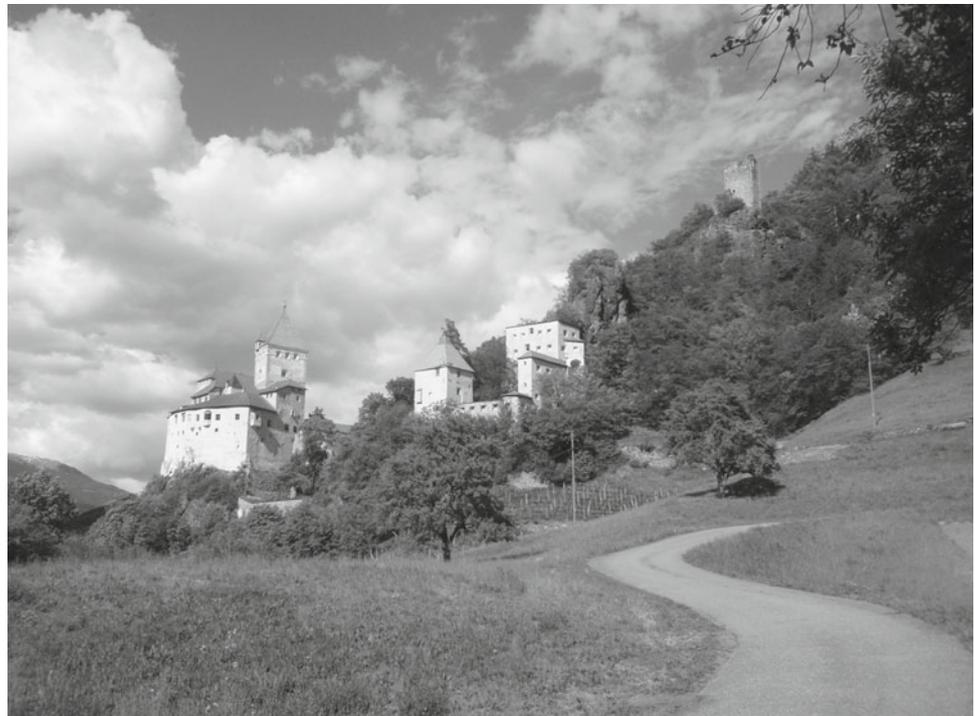
**Fig. 16.1** Trostburg Castle, situated on volcanic rocks of the Trostburg formation (view from the southwest). On the *left* the medieval castle with the rectangular donjon; in the *middle* the outer bailey with a rectangular tower (“Pfaffenturm”) and a gun turret, on the *right* the round tower (“Römerturm”)

One good example is Trostburg Castle (Ital. Castel Forte) (Fig. 16.1), which was mostly constructed during the Middle Ages and remodeled during Renaissance. It has preserved its well-fortified appearance but the walls of Trostburg Castle are crossed by many cracks and there are various possible causes for these damages. On the one hand, there are geogenic causes, such as the curved surface of the castle hill (whaleback), composed of the volcanic Trostburg formation, and the low rock mass strength due to the adverse orientation of some joint sets. On the other hand there are anthropogenic influences.

Trostburg Castle (Fig. 16.1) is situated on an impressive castle hill (627 m s.l.m.) at the eastern slope of the Valley of the Eisack river (Ital. Isarco) around 150 m above the village Waidbruck (Ital. Ponte Gardena) in South Tyrol (Italy), about 17 km northeast of Bozen (Ital. Bolzano). Waidbruck is located at the confluence of the Gröden creek (Ital. Rio Gardena) into the Eisack river.

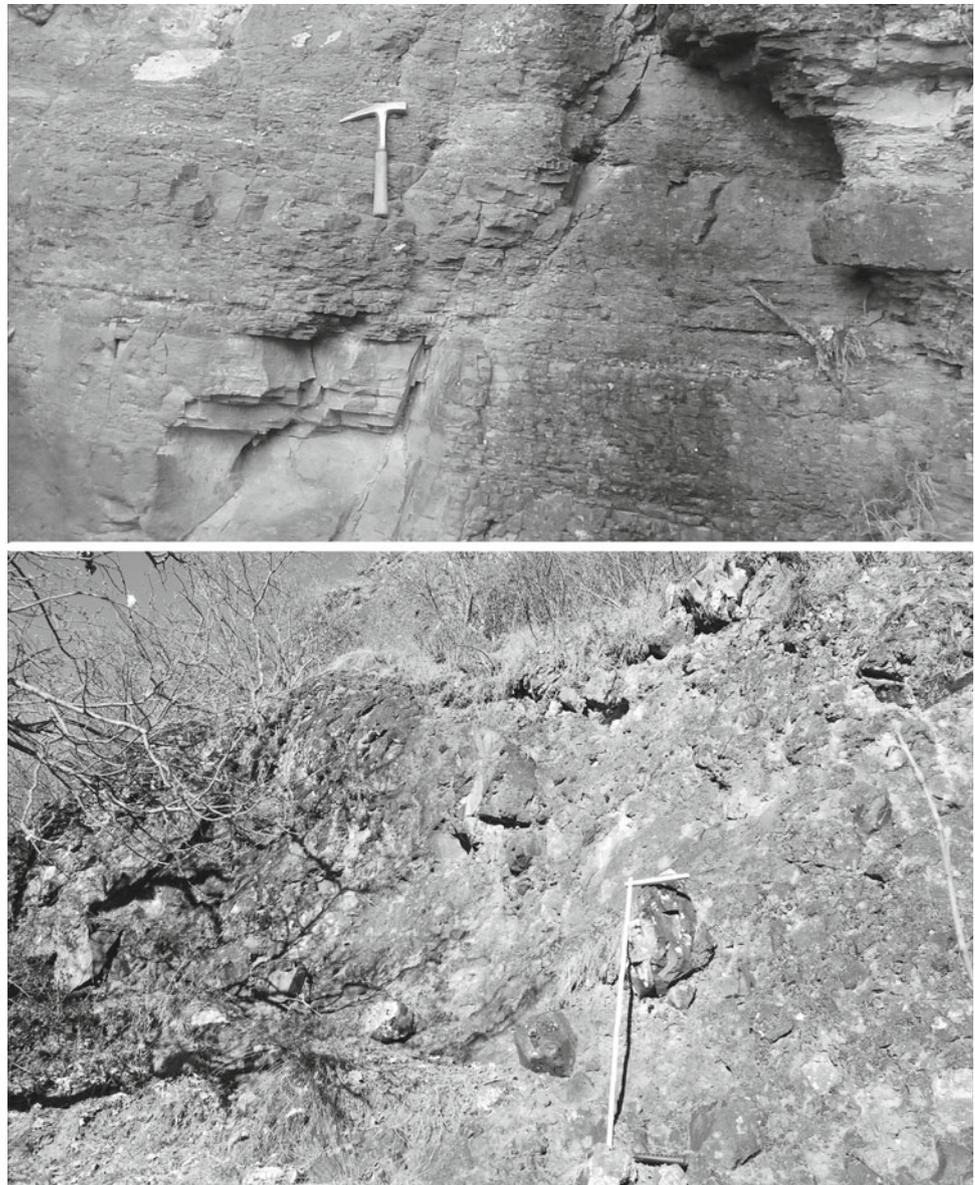
**Fig. 16.2** Typical rocks of the Trostburg formation: well bedded, consolidated ash fall near the outer bailey and rarely bedded agglomerates near the round tower

The Trostburg formation (Fig. 16.2) consists of basic to intermediate volcanic rock series, such as tuffs, lavas and blocky ignimbrites/agglomerates that were deposited in the Permian (300–255 Ma). A thin section microscopy analysis of different tuff and ignimbrite layers of the alternating Trostburg formation demonstrated that there is a typical fluidal texture (Fig. 16.3) in the ignimbrites. Many grains of the tuffs are angular and partially razor-sharp edges of

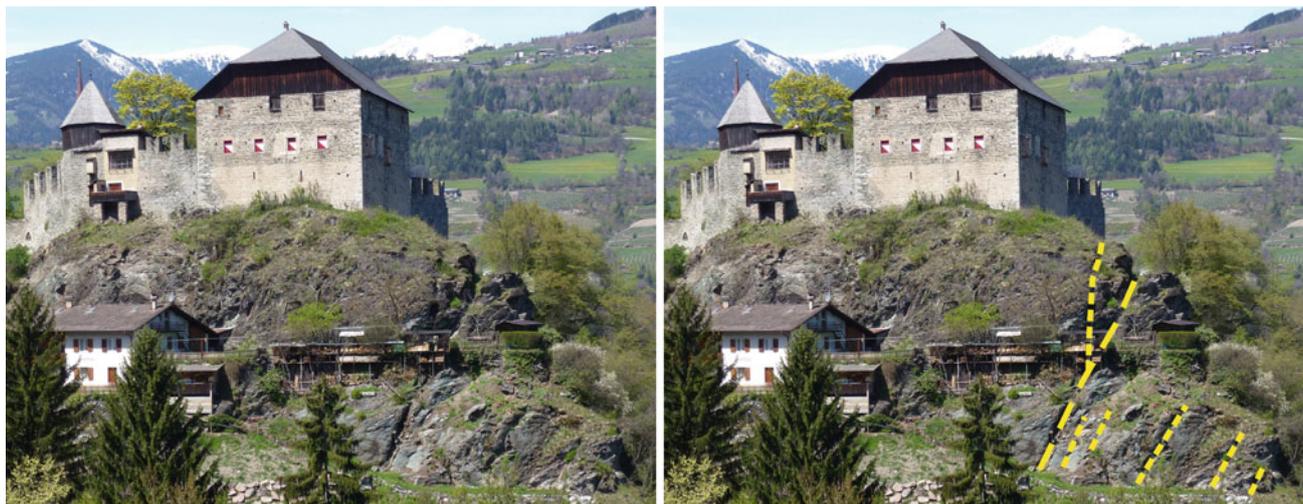
**Fig. 17.1** Eastern Flank of the hill of Summersberg Castle with a clearly visible fault and associated fractures dipping to south. The

spatial position corresponds approximately to the spatial position of the Villnöß-line (Photo 26/04/2012)

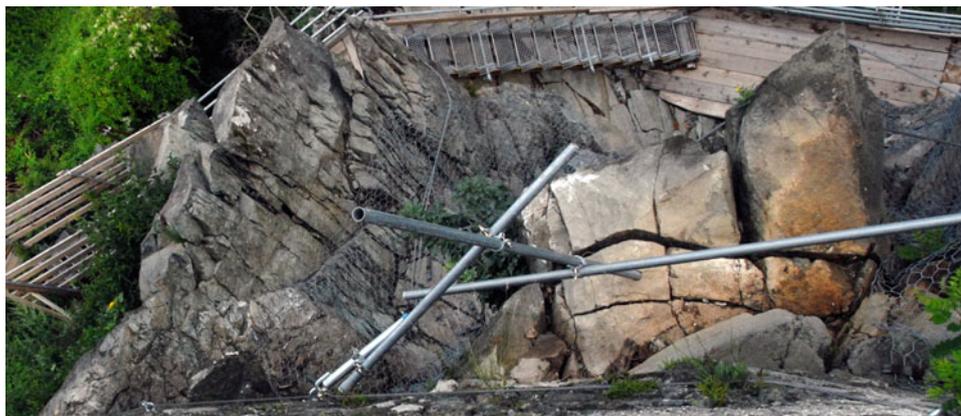
**Fig. 17.3** Rock area below the north tower; clearly visible are the numerous, parallel to the slope and up to 10 cm wide opened fractures that break down the rocks (photo 13/04/2010)

- Area I is located in the northwest of the castle hill. It has an orthogonal fracture system with a plenty of very steep inclined fractures. The generally flat dipping foliation doesn't exist here, respectively isn't effective as a joint set. When comparing Figs. 17.2 and 17.3 it is remarkable that many fractures run parallel or perpendicular to the slope. This is the reason why this area is dominated by rockfalls.
- Area II is located in the northeast of the castle hill. The fracture system here is generally not as steep as in Area I and has less directions. But in this area, the foliation is effective so that an additional flat dipping joint set exists, which dips in right to the valley. This also can cause slidings beside rock falls.
- Area III is located in the southern section of the castle hill. There are only 3 joint sets, which are very steep and

These results show that there is no significant difference between the different rock bodies. The findings indicate that the kinematic freedom offered by the orientation of the discontinuities is responsible for the instabilities (Fig. 17.3).
