# Engineering Geology for Society and Territory – Volume 8

Preservation of Cultural Heritage

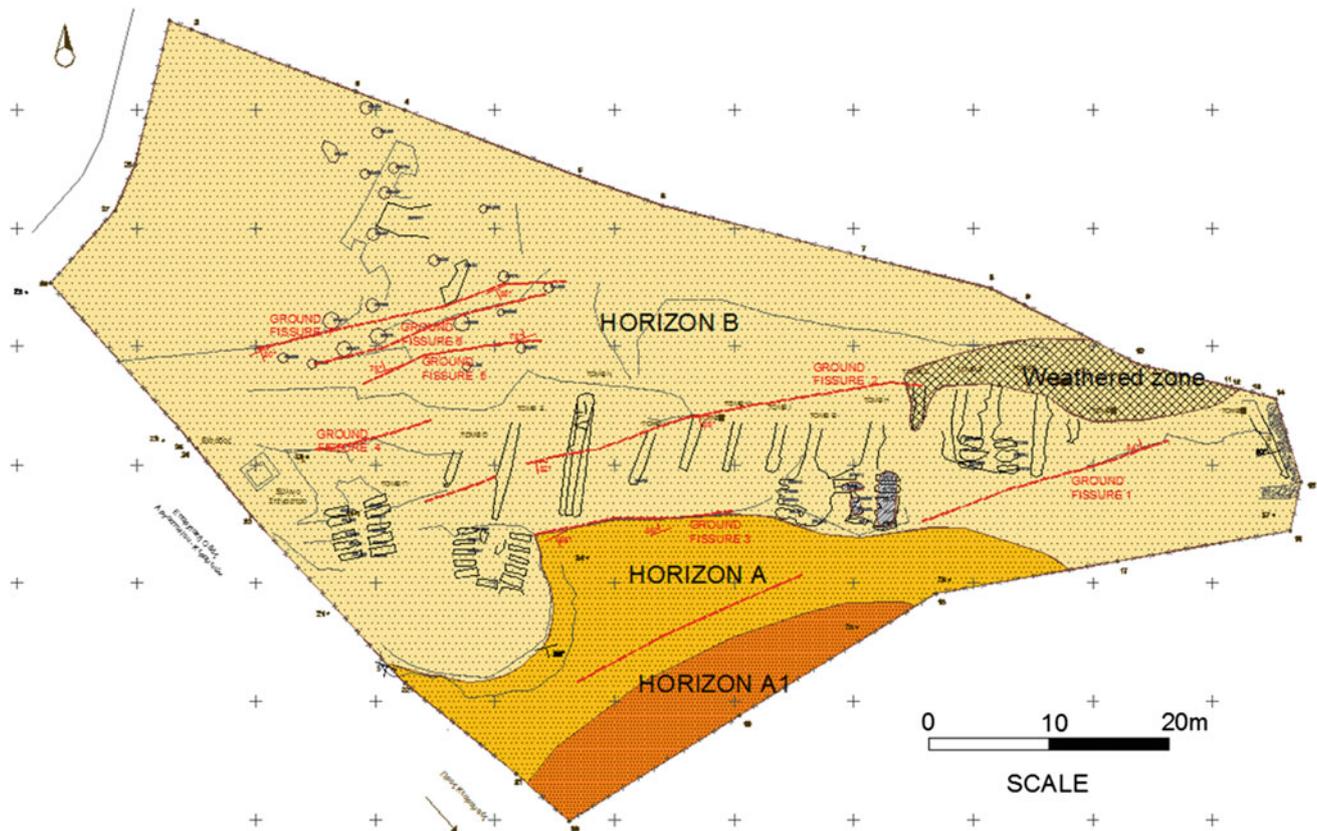
**Fig. 18.1** Geological map of archaeological site (ground fractures denoted with red)

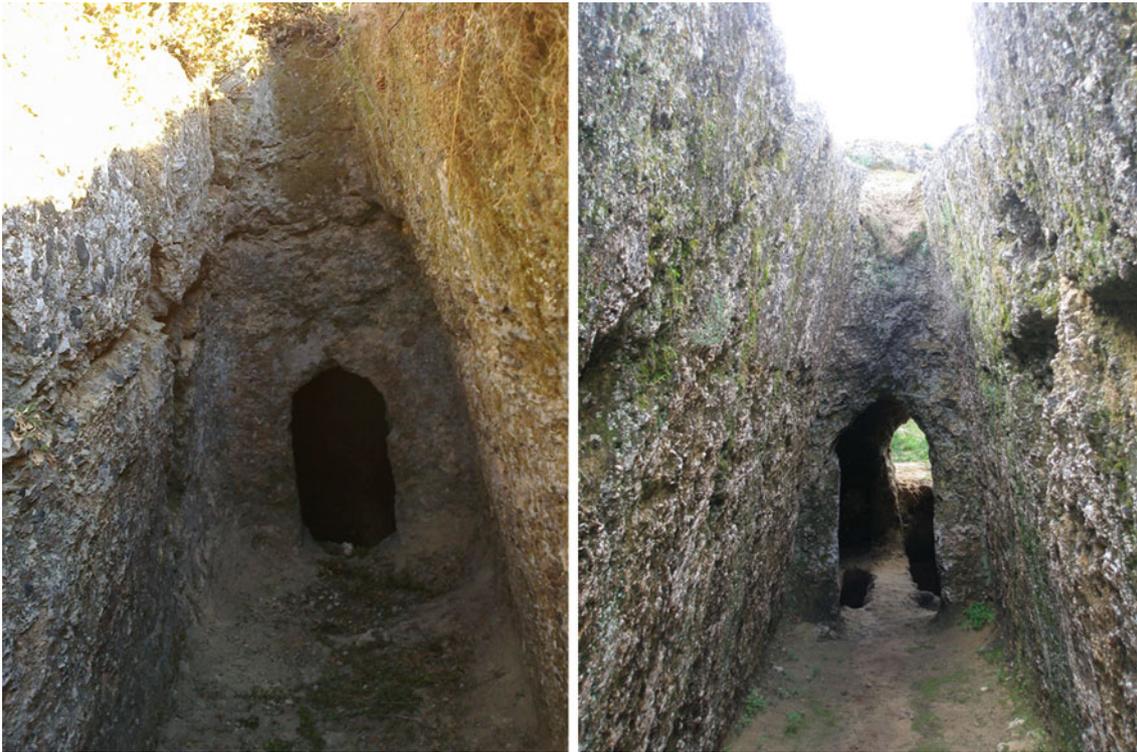
**Fig. 18.4** Entrance of tombs showing the presence of fractures and deterioration of the walls by erosion processes

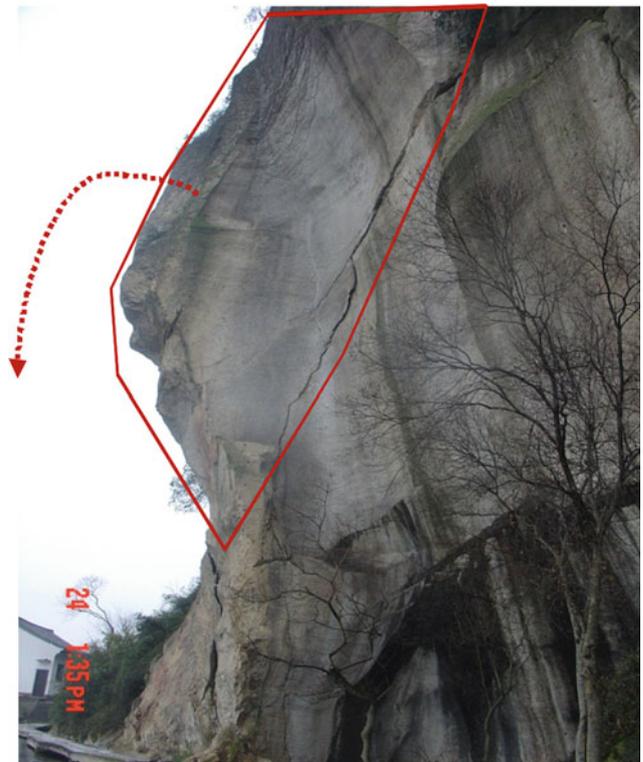
**Fig. 19.5** The risk of rock fall in Donghu

Nowadays, deformations and failure occurred in some of the slopes: wedge failure, pressure shear or tensile crack, slide along the bedding plane or fault. Figures 19.5 and 19.6 give the tendency of the rock fall and block sliding or toppling along structural plane and fault. The deformations or failures are mainly induced by the unreasonable exploiting for tourism. Moreover, the weathering of the rock mass is another reason for the failures. Figure 19.7 shows the cracks and flake weathering of the Yungu in Keyan. The Yungu is an in situ rock pillar left after quarrying. The reason why it was left is a secret, which made it be the most famous scenery in Keyan. However, there are many cracks occurred due to the long-term loading and the weathering. Therefore, thoroughly engineering geology studies should be carried out as soon as possible to ensure the safety of the tourists and protect the ancient sites of quarry.

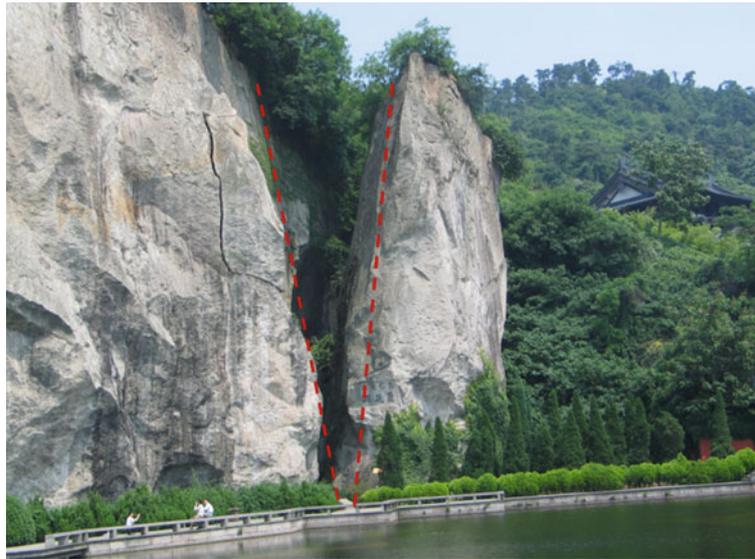
**Fig. 19.6** The sliding of block along fault in Keyan

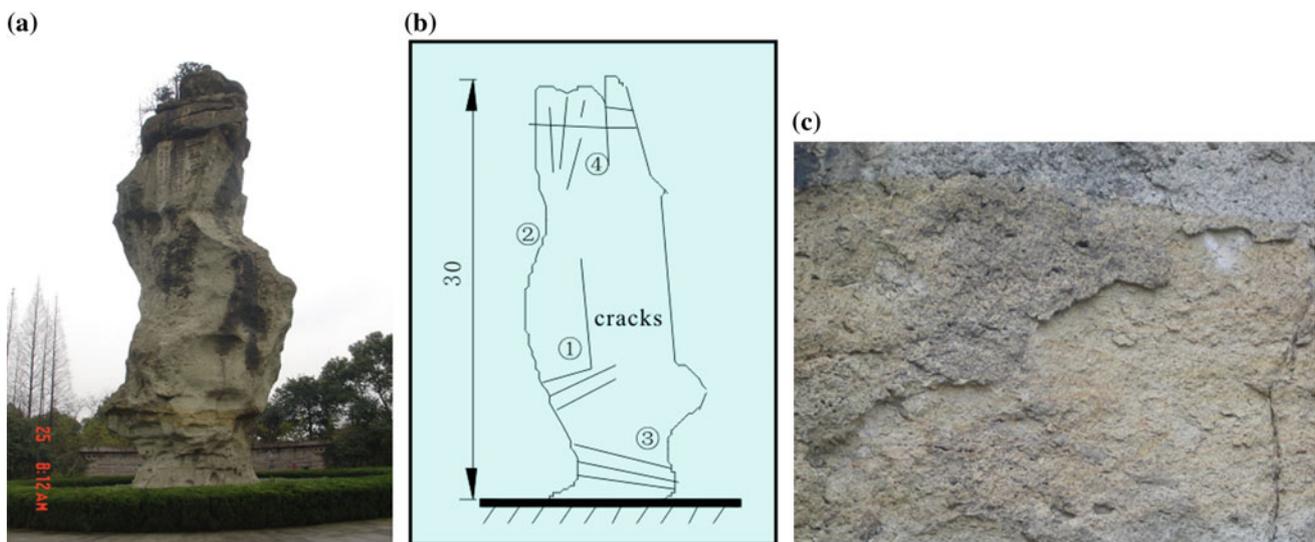
**Fig. 19.7** The cracks in the rock of Yungu in Keyan **a** the front side of the Yungu, **b** the cracks developed in the Yungu, **c** the flake weathering

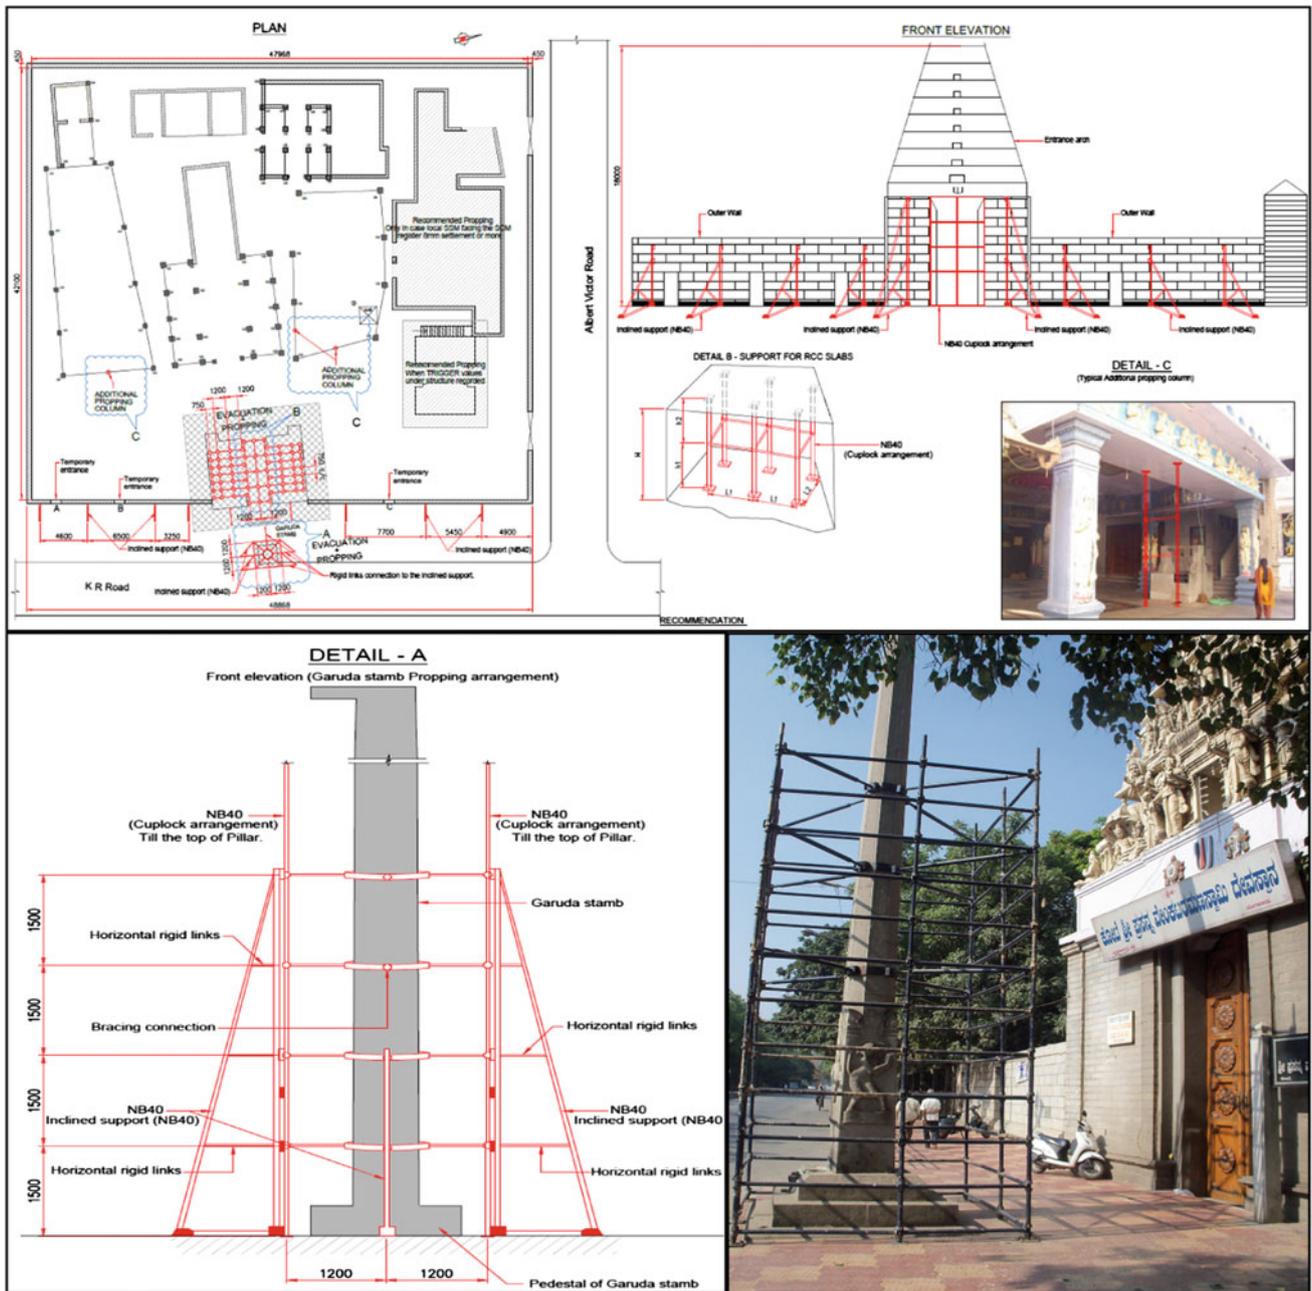
Fig. 20.4 Protective means for the monuments at Kote Venkataramana Temple

Installation of monitoring system both on the structures and on the roads and footpath was followed by a precise plan of evacuation of certain areas of the temple complex according with TBMs advancement and by setting up a propping system on the column and on the main entrances of the area. Collecting and storage of the required material for propping of other portions of the buildings as per plan view shown in Fig. 20.4 was also required, in case assigned figures overpassed limits.

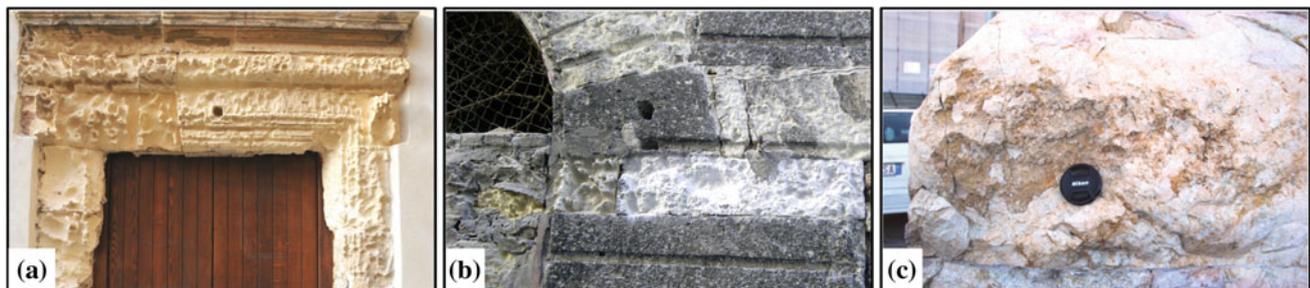
**Fig. 22.1** Different types of degrade: **a** Alveolization of the *Pietra Cantone*, **b** Detachment of material from a wall of *Tramezzario*, **c** Detachment of material from an architectural element of *Pietra Forte*

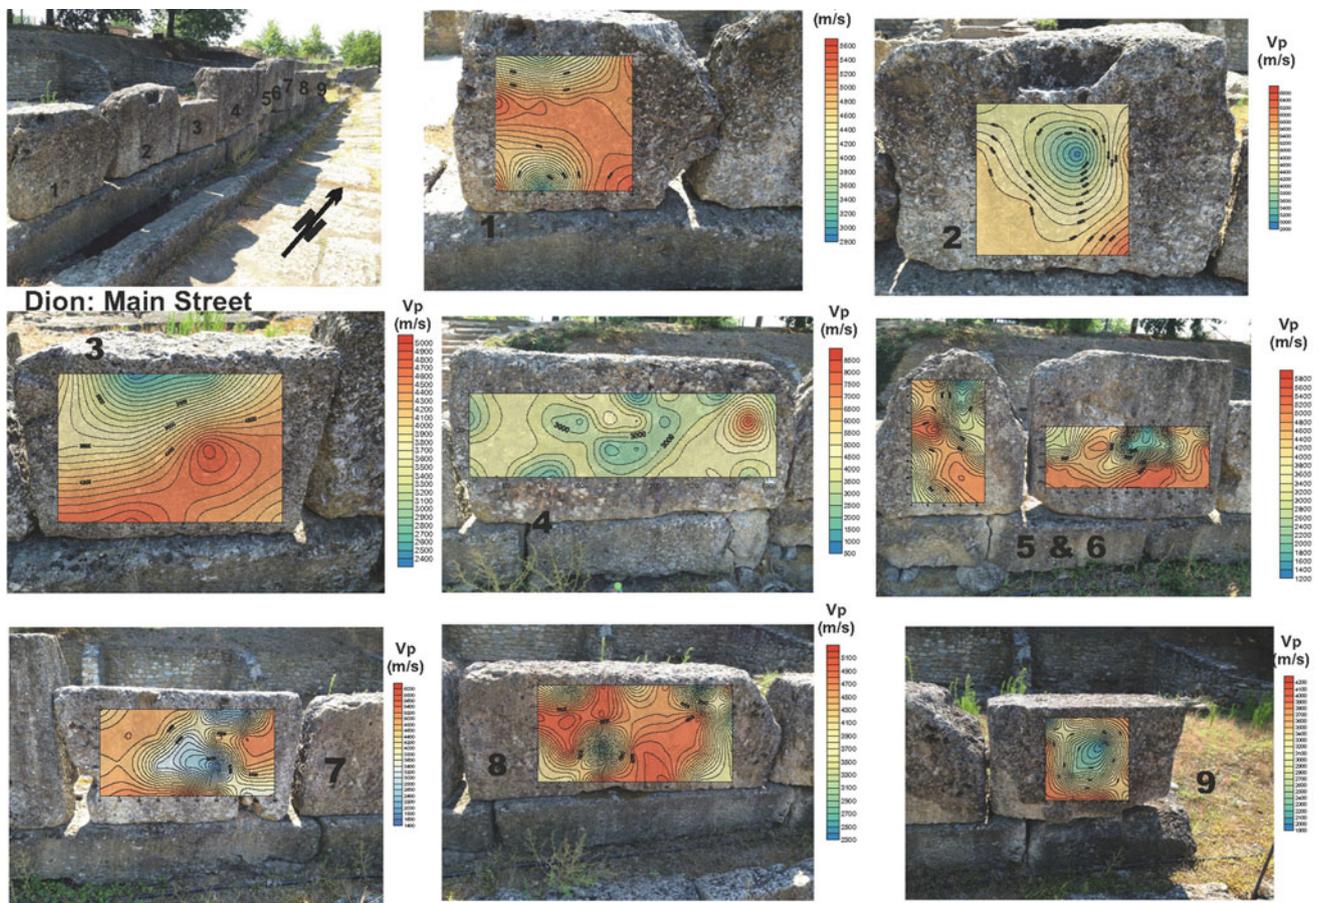
**Fig. 22.4** Ultrasonic velocity mapping related to the surface weathering of stones, along the main street of Dion archaeological site

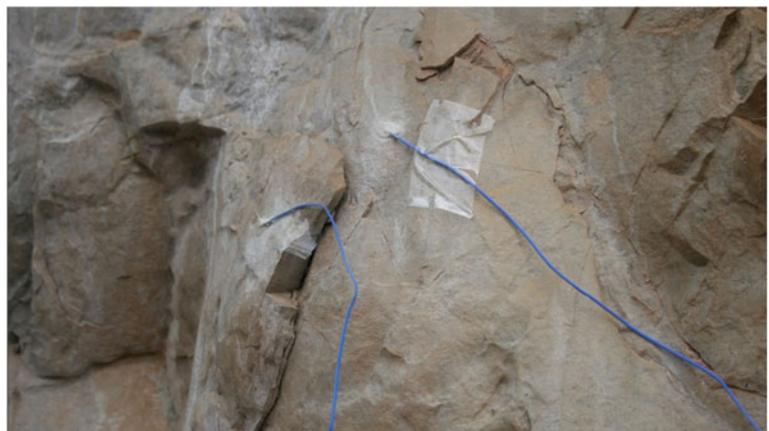
**Fig. 23.4** Temperature curves of air, intact rock mass and cracked rock body from September 20 to October 10

Two temperature probes have been installed on the surface of the cracked rock body and the intact rock mass (Fig. 23.3) separately, at the same time, a probe has been placed in the air to record the air temperature. The monitoring results from September 20 to October 10 have been shown in Fig. 23.4. The temperatures of the three sensors fluctuate synchronously, but the variations of amplitude are different. The peak temperature of the cracked rock body is higher than the intact rock mass, 58 °C for cracked rock but 54 °C for intact rock mass at a sunny afternoon of September 20 have been recorded. The records of two sensors are nearly the same temperature, up to 31 °C, at a rainy afternoon of September 30. The difference between broken rock to intact rock have been obtained by subtracting the two sensor records (Fig. 23.5). The curve shows that the temperature of cracked rock is lower than intact rock when there is no direct sunlight at night and morning but higher when the cliff is shined directly at afternoon. The reason is that the constant temperature mountain provides a good buffer for intact rock mass when the environment change but broken rock is fragile and variable. The thermal stress, between the broken rock and intact cliff, changes highly when the temperature fluctuate which is helpful for the rock crack growth.

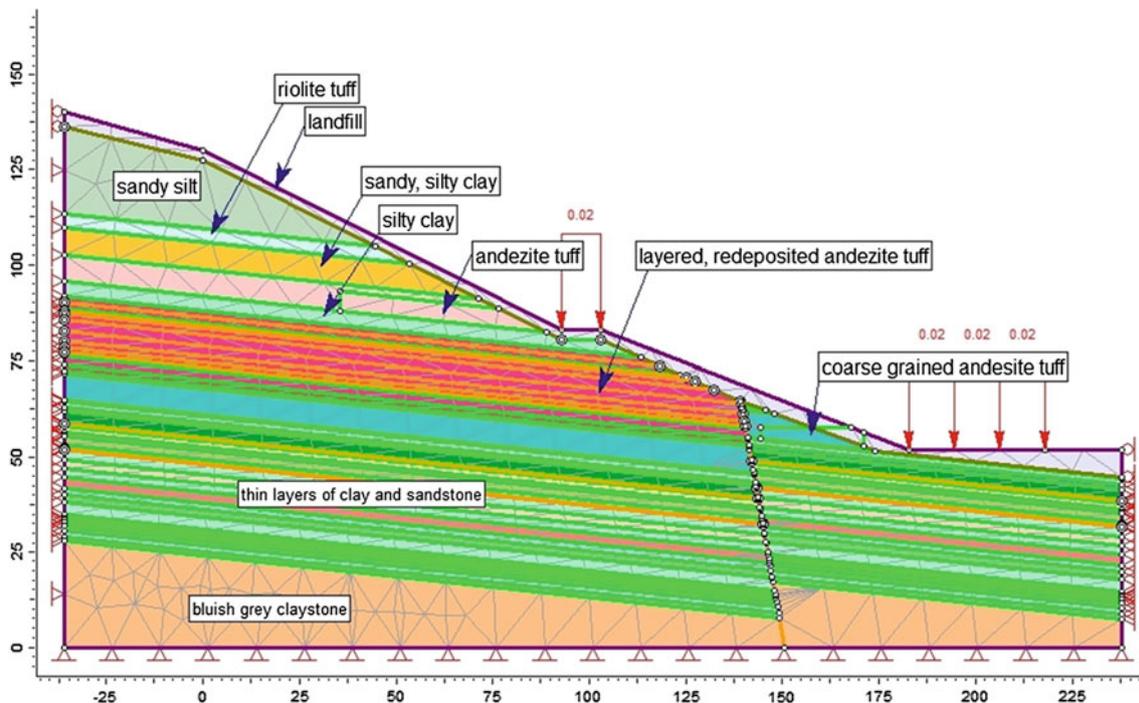
**Fig. 24.5** The strata of the hillside with the names of the most important layers

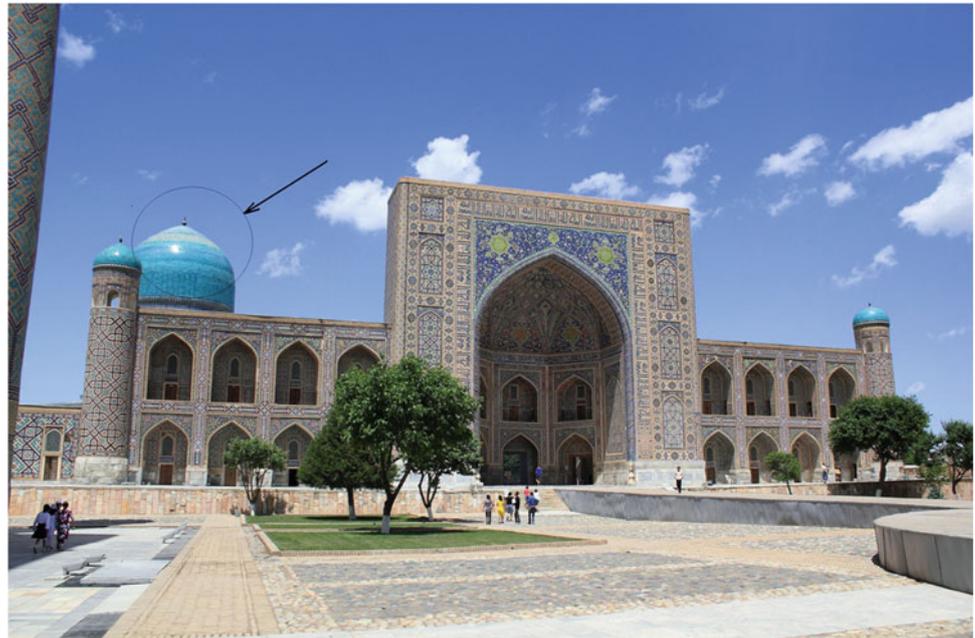
**Fig. 26.1** Tilla Kari madrasah (1646–1660). The *arrow* indicates to the dom was constructed in 1975

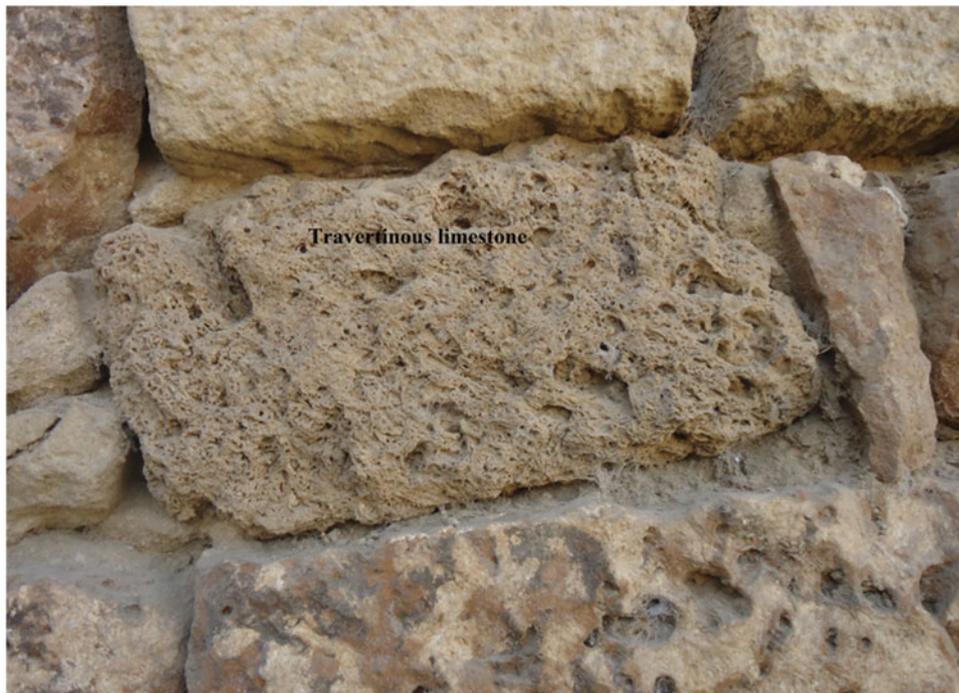
**Fig. 27.2** Travertinous highly porous limestone

In thin section, turonian limestone are biomicritic to bi-osparitic, fine to coarse grained, with varying pore sizes and geometry. Section cut from material of the lower part of the wall are highly discolored and porous. Voids can be seen throughout the section. The purity of the limestone is tested by calcimetry using Bernard calcimeter. For the stones of the wall, the amount of insoluble residue which consists of clay and salts vary from 30 to 14 %. This figure is about 10 % for Ozmor and 25 % for Mizeb. Chemical analysis by XRF method shows that the stones of the wall contain along with the calcium carbonates which is the main component, other secondary constituents such as aluminum silicates and several types of salts (Table 27.1). Aluminum silicates are chiefly clay minerals. Among the salts present one can note magnesium and calcium sulfates, sodium chlorite, sodium sulfate, sodium carbonates, potassium chlorite...etc.

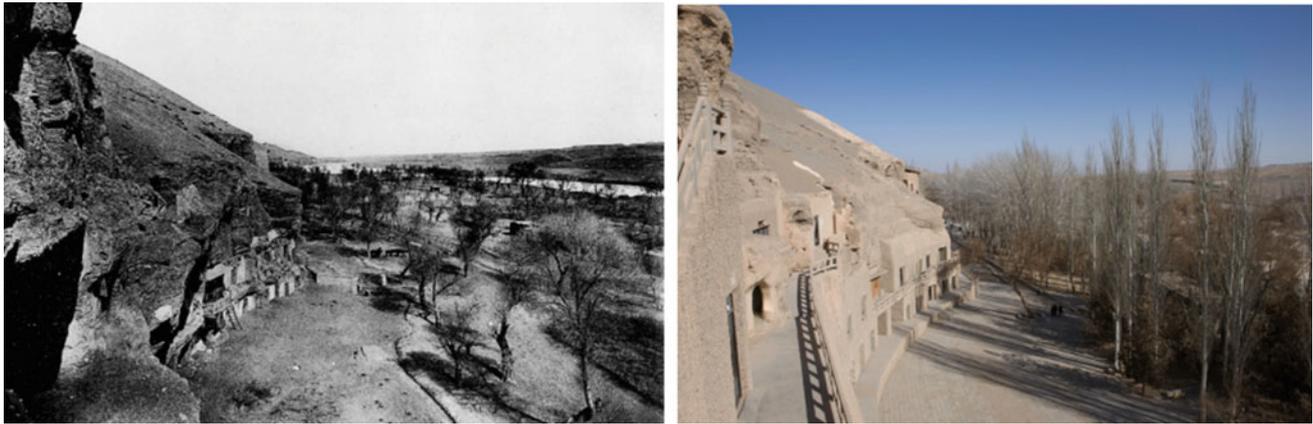
**Fig. 29.3** The Mogao Grottoes Cliff before consolidation in 1907 (*left*) and after consolidation in 2008 (*right*)

Aiming at the main engineering geology problems at the Mogao Grottoes, various engineering measures such as support, retaining wall, fender and removal had been implemented to ensure the stability of most cliff rock in 1950s (Fig. 29.3). During recent 5 years, consolidation measures including cable anchoring, grouting cracks, consolidating thin-topped caves and consolidating the cliff surface against weathering have been taken to effectively strengthen the weathering-resistant and rain erosion-resistant properties of the cliff.

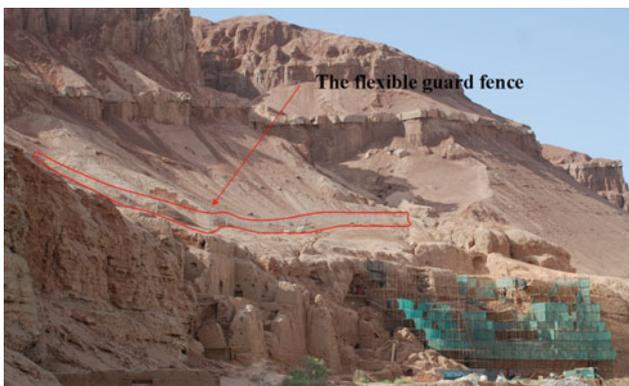
**Fig. 30.3** SNS against rolling stones

Detailed analysis reveals that the rolling stones possess great kinetic energy due to their giant volume and high falling height, just as the roof of Cave 3 have been damaged (Fig. 30.2). Obviously, rolling stones makes both the caves and the visitors into a dangerous situation. Eliminating the risky rocks at the source positions is very dangerous because the falling heavy rock bodies perhaps impact directly the caves at hillside. Also, stabilizing the risky rocks in situ seems not to be economic and feasible in technology because the source area is so high. Practically, a flexible guard fence, namely safety netting system (SNS), was designed at the hillside, upside of the caves, to passively stop the possible rolling stones that falling down from the high mountain area (Fig. 30.3). The net system consists mainly of steel posts anchored to the ground by wire cable, between the posts wire rope net is stretched. When a rolling stone hits the flexible net system, the kinetic energy can be absorbed by the deformation of the high-strength wire net and the steel brake rings connected to the anchoring cables. In fact, this kind of passive guard fence has been successfully used

worldwide to provide protection to railway (MOR 2004) and road etc., against rolling stone from high mountain slope.

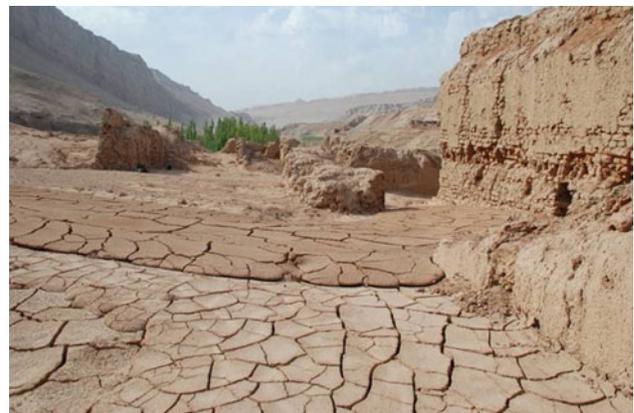
**Fig. 30.4** Mudflow reached the mud-brick temple

Mudflow is another geological hazard threatening the Shengjinkou site seriously, especially to the mud-brick temples (Fig. 30.4). Control of mudflow is a new task that firstly encountered in the conservation projects along the Silk Road in China (Li 2003). Field investigation indicates that mudflow had reached the biggest temple at least 7 times in history, where mud sediments accumulated as deep as 1.3 m. Fortunately, satellite photo in Fig. 30.1 recorded occasionally a mudflow event on July 10, 2011. Figure 30.1 shows clearly the mudflow path across the temple, coincided with that recorded by historical sediments.

When reached the temple, flooded mudflow did not only bury partially the temple buildings, but also made the wall foundation saturated, resulted in differential deformation or even the whole falling down of the walls. A practical way to control the mudflow is to dig a diversion ditch, conducting the mudflow away from the temple. Figure 30.5 shows the diversion ditch under construction in May, 2013, which is an artificial channel with a single concrete embankment at downhill side.

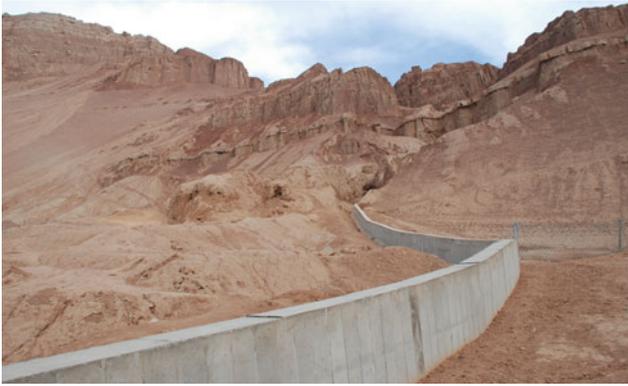
**Fig. 30.5** Diversion ditch for mudflow control

The diversion ditch is designed as a wide, shallow channel, cut into the terrace sediments, with a concrete embankment constructed at the left side. Diversion ditch begins from a gully mouth where mudflow was spilled away from mountain slope, and ended to the main river bed with several steps at terrace edge. The major purpose of the diversion ditch is to introduce the intending mudflow directly to the main Mutougou River, so to prevent the temple to be flooded again by mudflow.

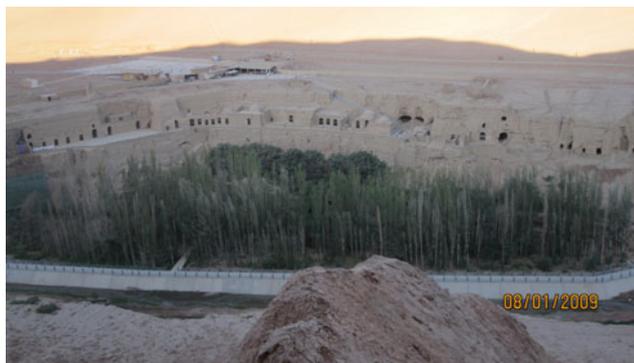
**Fig. 32.1** Distribution situation of the Bezeklik Grottoes

Bezeklik Grottoes distributes above and below of the west cliff of Wood Groove. It can be divided into four zones (seen from Fig. 32.1). Firstly, caves from No. 1 to No. 7 are located in the northern end of the cliff. Secondly, caves from No. 8 to No. 39 are excavated in the middle of cliff with the fine space and appropriate location where there are the mainly existing caves so far. Thirdly, caves from No. 40 to No. 57, with the poor space and severe dilapidation, are

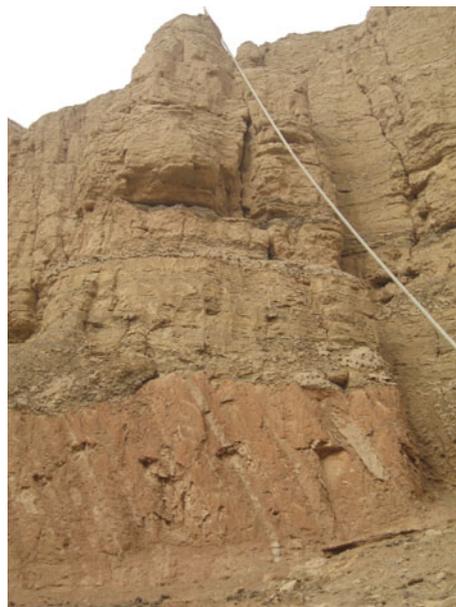
**Fig. 32.2** The typical stratigraphic section of cliff facade

Turpan Basin is a typically continental, temperate and arid desert climate with the characteristic of the scarce rain and dry heat. The Flaming Mountains in the Grotto sites is north-west trend (about  $300^\circ$ ), and wood groove to  $20\text{--}30^\circ$  angle cut through the Flaming Mountains with the intersection to Shengjin ditch. The wind direction is generally from the southeast to the northwest. There is an U-shaped valley with a relative flat, 50–70 m width, 100–110 m height and about 13 % slope, whose sides are substantially straight, with the about 118 m height of debris on the left side of the Flaming mountain. The right bank is alluvial soil cliff (the bottom of soil cliff is the coffee and brown mudstone) and cave is dug in them (seen from Figs. 32.1 and 32.2).

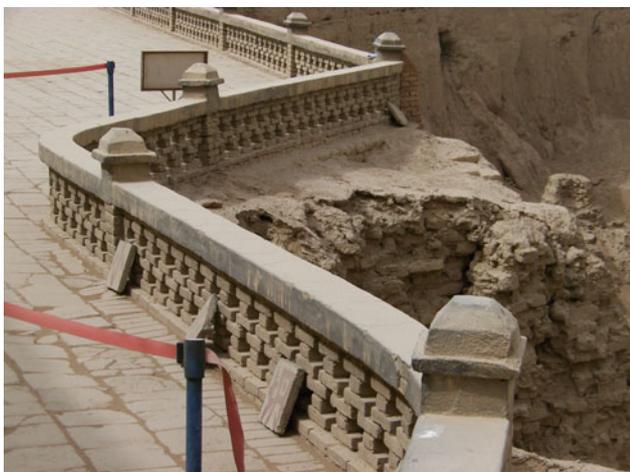
**Fig. 32.4** The top of the dangerous cliff

surface between the quaternary and Tertiary causes the poor slope integrity to easily collapse. Currently, the top of the slope has been suffering the heavy shock from visitors. By investigation, the causes of destruction are the dumping and scattering of the near adobe slope, which led to a further collapse of the upper footway (seen from Figs. 32.4 and 32.5).

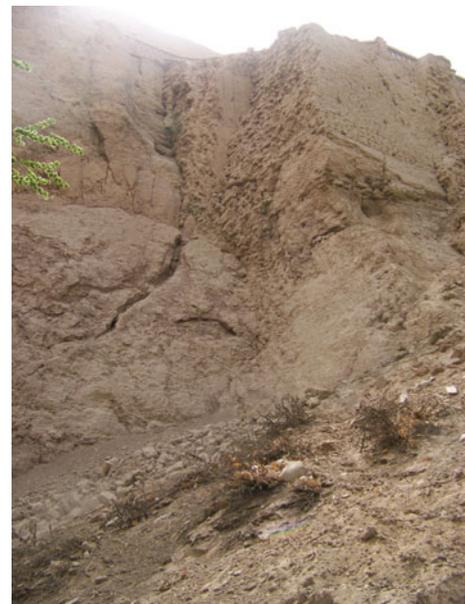
**Fig. 32.5** Façade of the dangerous cliff

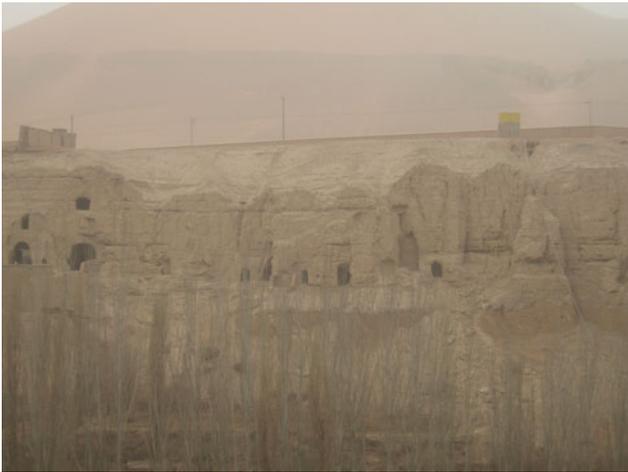
**Fig. 32.6** Façade of No. 1 dangerous cliff

external suspend of outer cliffs, and six large gullies develop on the top with the maximum cutting depth of 2 m. Caves from No. 1 to No. 8 were dug in this section. Therefore, the stability of the cliff body determines the survival of these 8 caves (seen from Figs. 32.6 and 32.7).

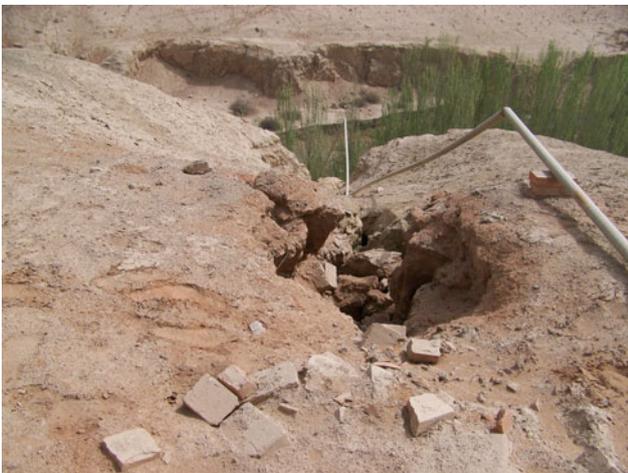
**Fig. 32.7** Gully slump in the dangerous cliff

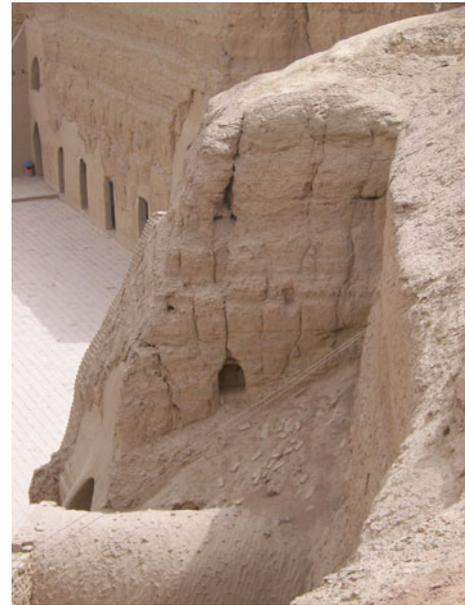
**Fig. 32.8** Facade fissure of the dangerous cliff

The fissure in No. 28 cave cliff body is the most typical one with a nearly vertical body in the Quaternary sandy strata. There are five fissures parallel to the cliff face developing inside the cliff body. With the characteristics of 3–5 cm fissure aperture, straight surface, no ups

and downs, rough walls and the late topsoil filling in the middle, one of which cuts the No. 28 cave completely and forms the channel for rainwater infiltration (seen from Fig. 32.8). The fissures result from unloading of soil mass.

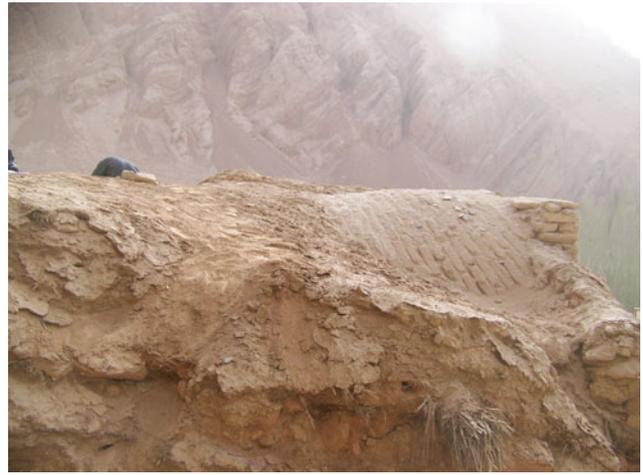
**Fig. 32.11** The cave roof collapsed

The diseases of Bezeklik Grottoes are closely associated to the diseases of the cliff body. After investigations, the major diseases of caves are revealed: (1) cracks are developing among the soil mass and most of them penetrate to the cave and wall painting is destroyed (Fig. 32.9); (2) partial collapse and suspend of the cliff causes the disappear of cave (Fig. 32.10); (3) the fresco is being eroded by the rainwater infiltration due to the collapse of cave roof (Fig. 32.11); (4) Poor drainage of the roof causes rainwater infiltration to pollute the wall painting (Fig. 32.12).

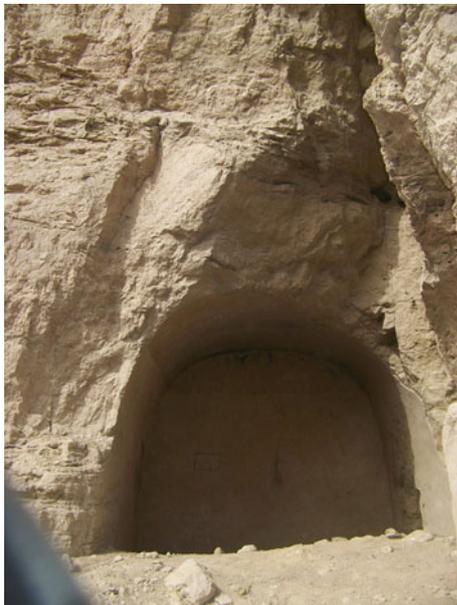
**Fig. 32.10** The current status of No. 6 cave

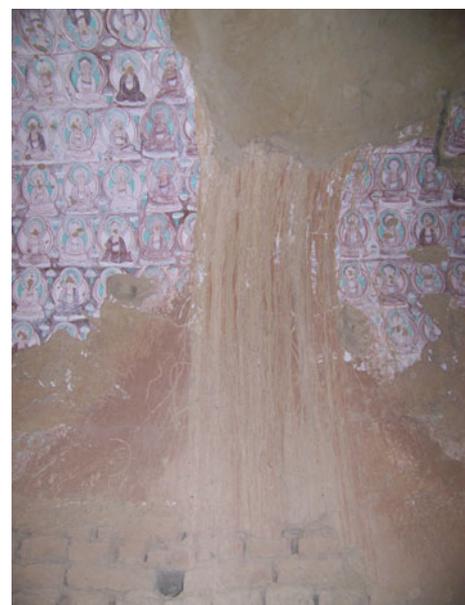
**Fig. 32.12** The cave roof rainwater infiltration induced by poor drainage

erosion of the cliff. Besides, the concentration of rainfall creates a great deal of different-degree gullies among the cliff. Finally, the wall painting will be damaged by the rainfall infiltration.

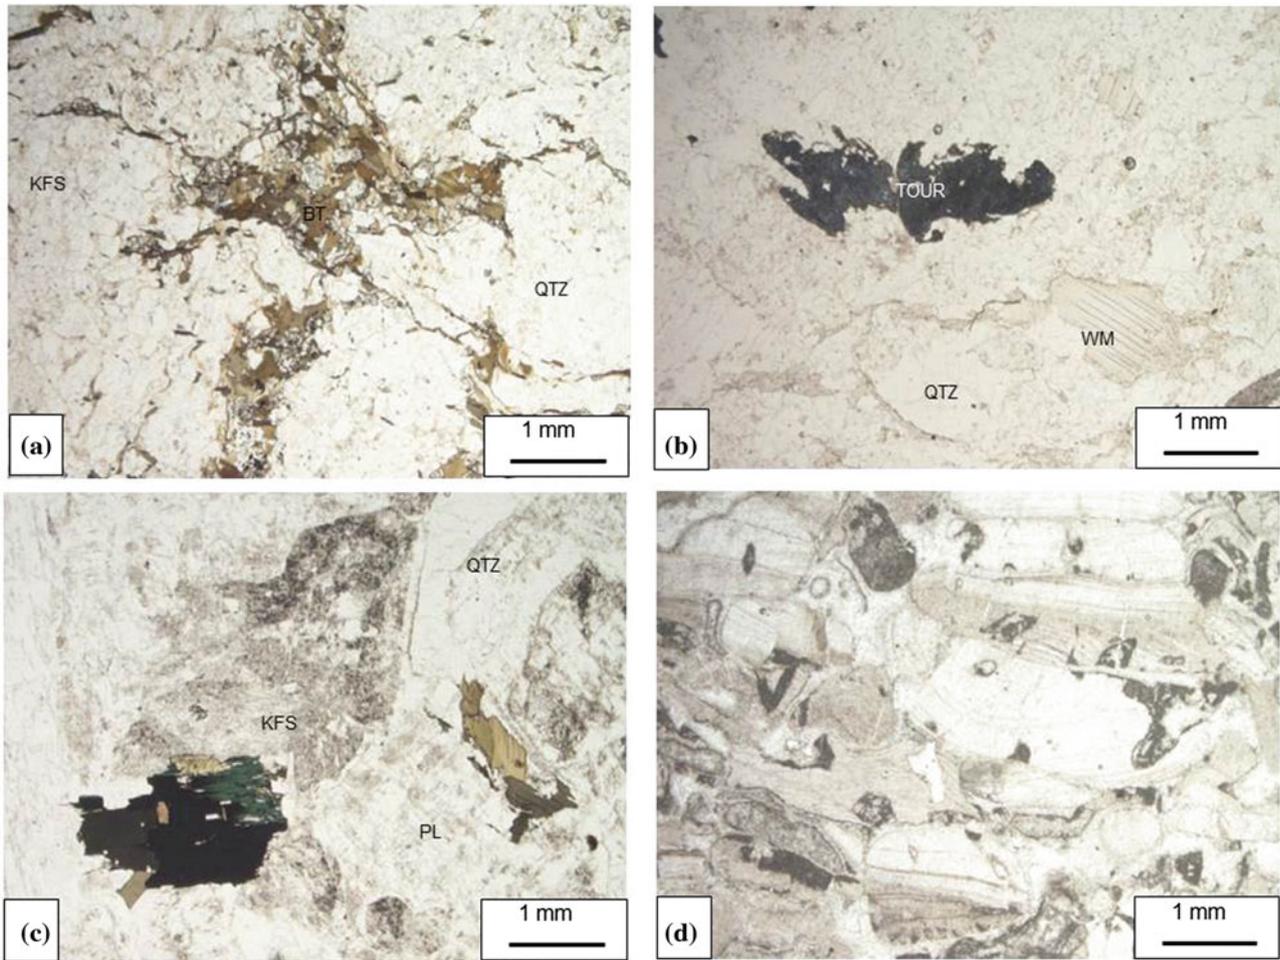
**Fig. 33.2** Representative optical microscope images (plane polarized light) of the main ornamental stones employed in the bridge buildings. **a** Cumiana Stone; **b** Villarfochiardo Stone; **c** Alzo Granite; **d** Aurisina. Mineral symbols according to Kretz (1983)

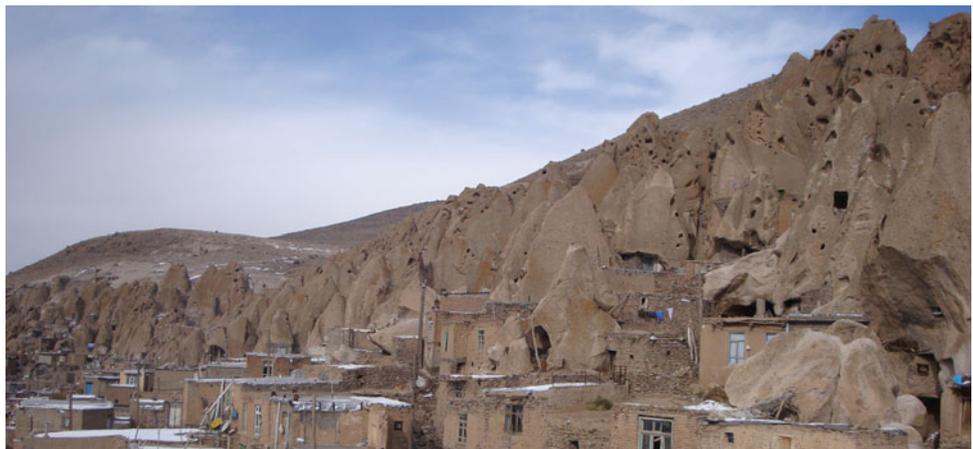
**Fig. 38.2** Schematic steps of formation of *cone shaped* rocks in the Kandovan

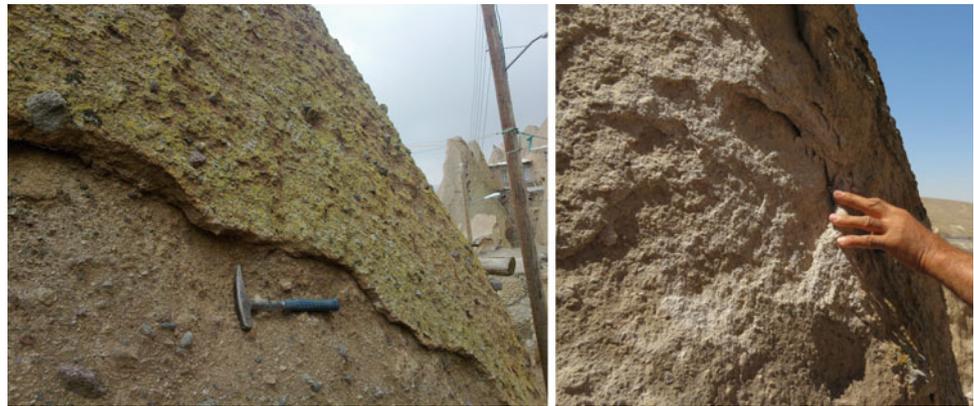
**Fig. 38.4** Typical results of XRD analyses on samples obtained from surface of Kandovan rocks

Chemical weathering is the breakdown of minerals by chemical reactions with the atmosphere or hydrosphere (Eklund 2008). Chemical weathering reactions are largely controlled by access to water, nature of gases and acid components dissolved in water. Minerals of rocks are altered by chemical weathering and converted to new minerals with lower-strength. As a result, physical weathering becomes more severe. The rock chemical weathering and the presence of clay minerals causes weakening of the stone because of the presence of low energy bonds in their structures; therefore, they are more easily affected by mechanical erosion and they are formed when a rock has weathered by the presence of high water and temperature (Garcia-Vallés et al. 2003). Thus, to assess chemical weathering of kandovan rocks X-ray diffraction analysis were performed of 1cm thick of the Kandovan rock surface sample (probably chemical weathered). The typical XRD pattern for a sample is depicted in Fig. 38.4. The results show that there are no traces of clay minerals and chemical weathering in Kandovan rocks.

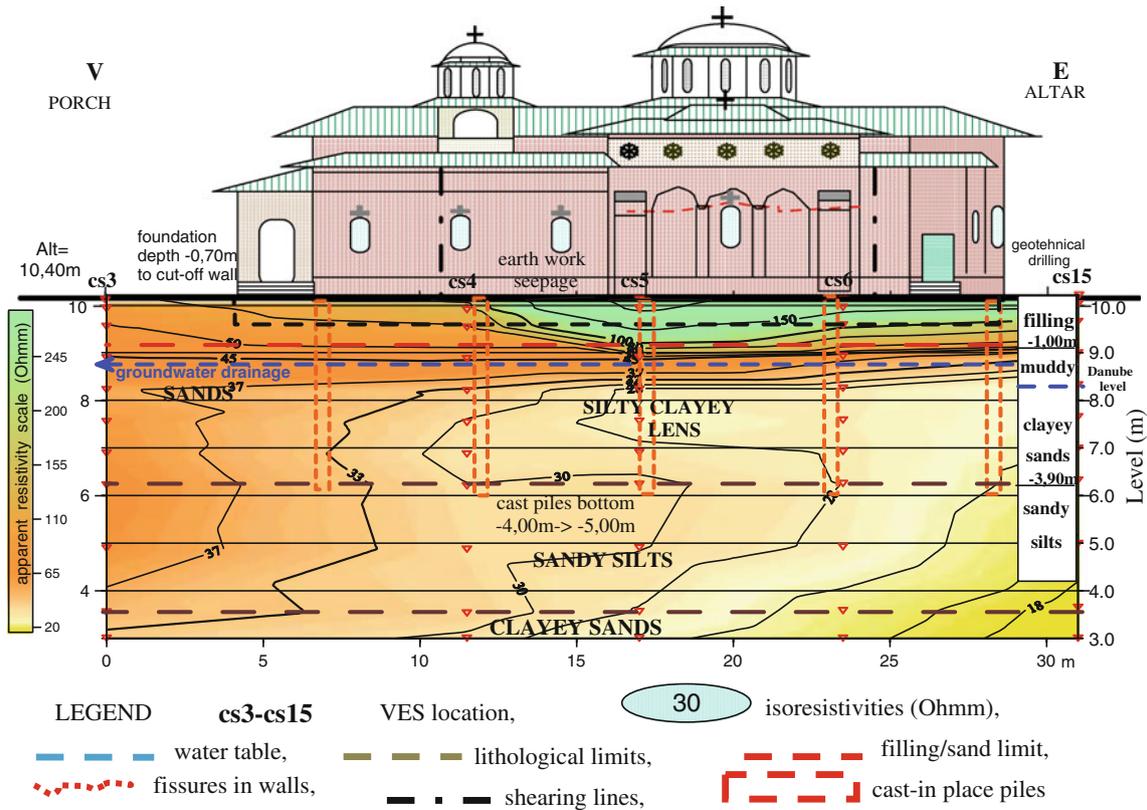
Fig. 49.1 Interpretative geoelectrical cross section—southern front part of the Orthodox Cathedral, Sulina, Tulcea County, Romania

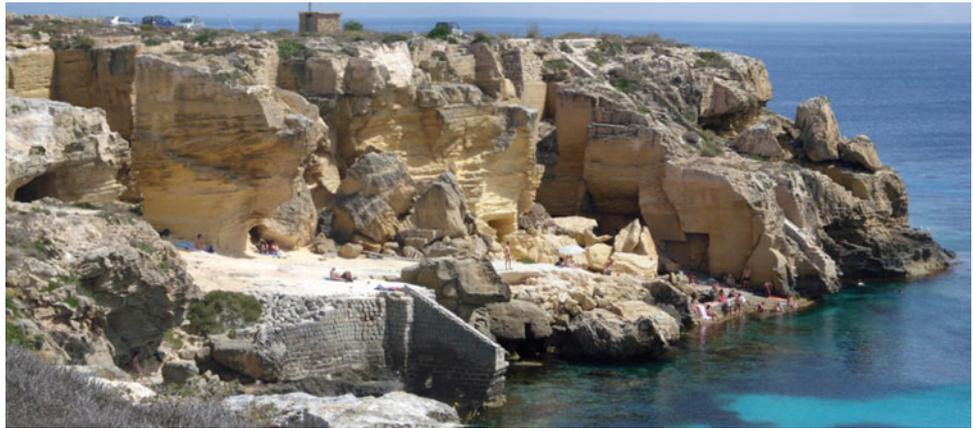
**Fig. 50.1** Rock blocks fallen at Cala del Bue Marino

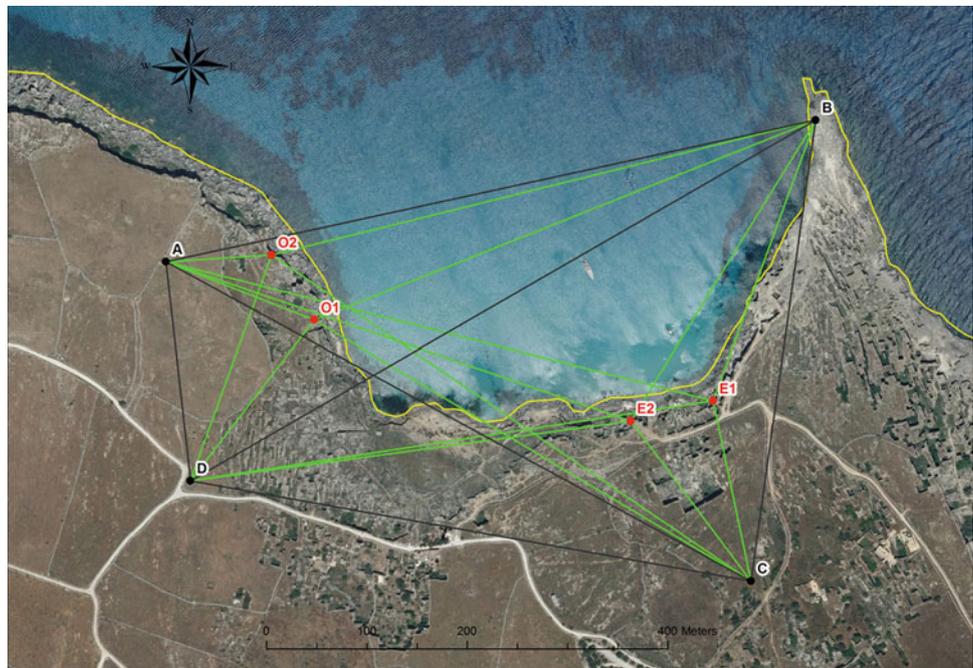
**Fig. 50.3** The GPS network at Cala Rossa (A, B, C and D) and the four measuring points (O1, O2, E1 and E2)

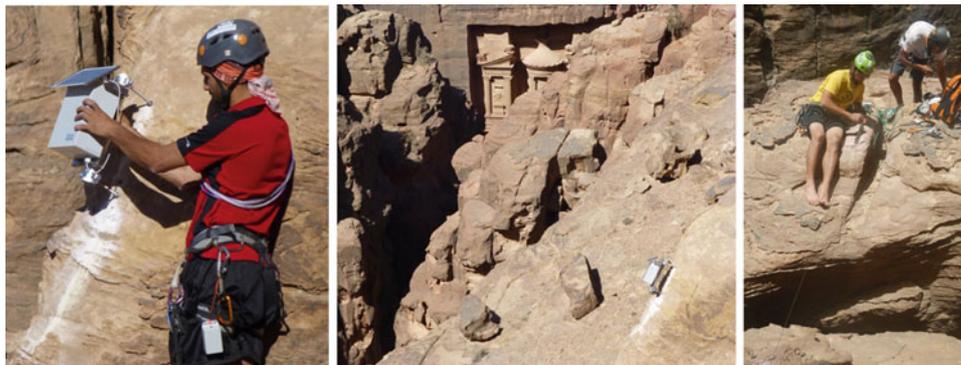
An integrated network composed by 2 wire deformometers, 2 crack deformometers and 2 tiltmeters, 6 air-temperature sensors, a meteorological station, provided by Minteos® s.r.l., with wireless technology sensors for on-time registration and transmission of data, has been installed in the Siq in June 2013 (Fig. 52.4). Displacement of the main fractures,

**Fig. 52.4** Installation of wireless instrumentation network

inclination of the blocks and meteorological parameters are the main data collected by the system.

The general structure of the platform for the storage and management of the collected data from the sensors is based on the following components: field devices, constituted by wireless sentries that measure and send via radio the values of displacement (resolution 0.01 mm) and inclination (resolution 0.01°) to a Short-Range Repeater (SSR); the SSR routes the sentries radio message in the Siq adding temperature and humidity data forwarding these to the Long-range Repeater (LRR); the LLR add rainfall, shielded temperature, humidity and wind direction forwarding all data to the main gateway, located in front of the Treasury (end of the Siq); the gateway collects and send the data to the Minteos server via GPRS and, in turn, to the main Siq Project servers for storage and analysis of results. The sensors will be provided with long-life batteries capable to manage 24 h measures per day per 5 years and further provided with solar cells in order to assure measurements in the event of a breakdown.

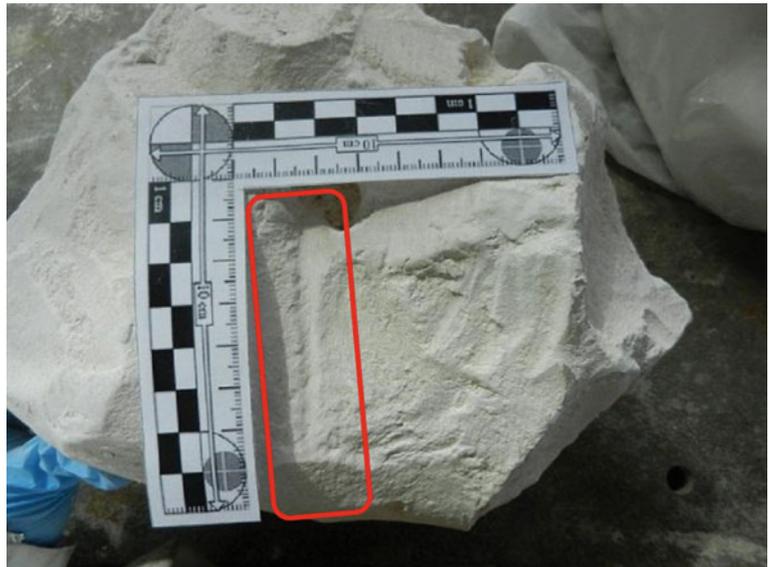
**Fig. 53.4** Chalk block from the Durrington site, with antler tool marking in box

tool marks (see Fig. 53.4) which can be attributed to the use of antler tools during the extraction process (Harris, In press).
