# Engineering Geology for Society and Territory – Volume 8

Preservation of Cultural Heritage

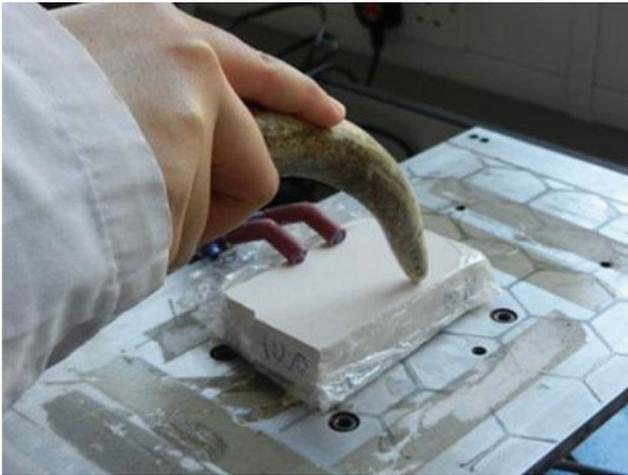
**Fig. 53.5** Forming a groove on a sample of chalk clamped to a force plate

Manual unidirectional one-stroke sliding wear tests were carried out on 100 by 60 by 20 mm thick oblong slabs using a wet diamond saw. So far as possible the slabs were cut parallel to the bedding where this structure was identifiable. Initially the sliding test specimens were clamped to the instrumented force plate (see Fig. 53.5) and the test was performed by holding the antler tine firmly against the rock

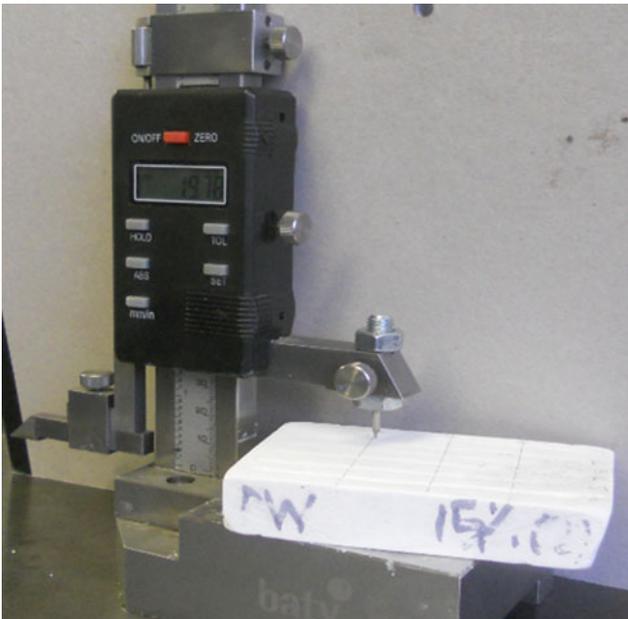
**Fig. 53.6** Measuring depth of surface markings

and drawing it over the surface in a single action. So that the moisture content of the specimen would remain at the required value, the cling film was removed from only the upper surfaces of the specimens immediately before the test was carried out. The average force and the widths and depths of resulting grooves were determined, where the dimensions were measured along 3 transepts, using respectively a vernier caliper and, as shown in Fig. 53.6, a digital depth gauge.

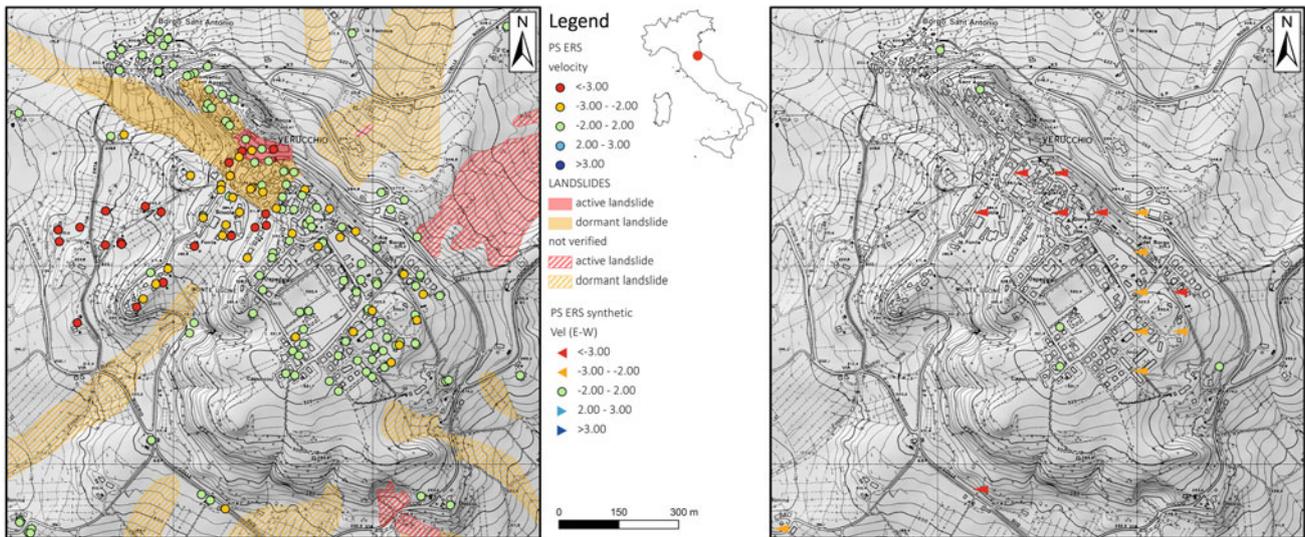
**Fig. 55.1** Velocity class along LOS of ERS PS (ascending and descending geometries) and direction of the movement on E-W axis

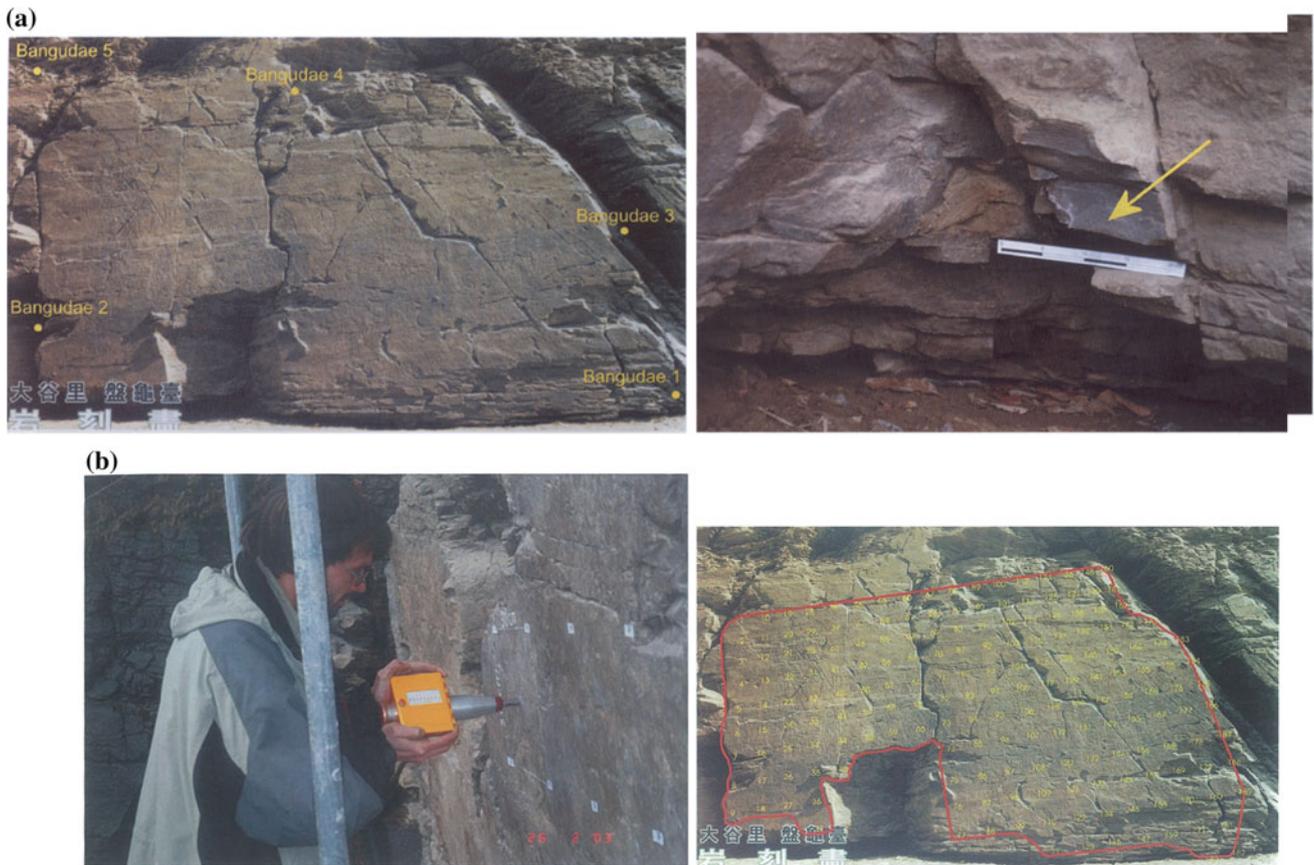
**Fig. 57.6** Damage to rock surface due to **a** rock sampling near the Bangudae petroglyph and **b** Schmidt hammer tests at 189 locations on the rock surface of Bangudae petroglyph (Kim 2003)

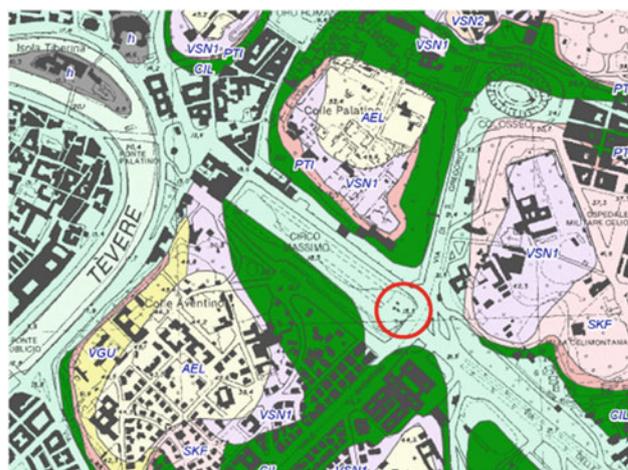
**Fig. 58.2** Geology of area, from Funciello and Giordano (2008)

The area, under a significant layer of backfill, is characterized by the presence of alluvial deposits (a2—Funciello and Giordano 2008) consist mainly of fine silty-clay deposits alternating with sandy levels and levels of peats at different depths (Fig. 58.2).

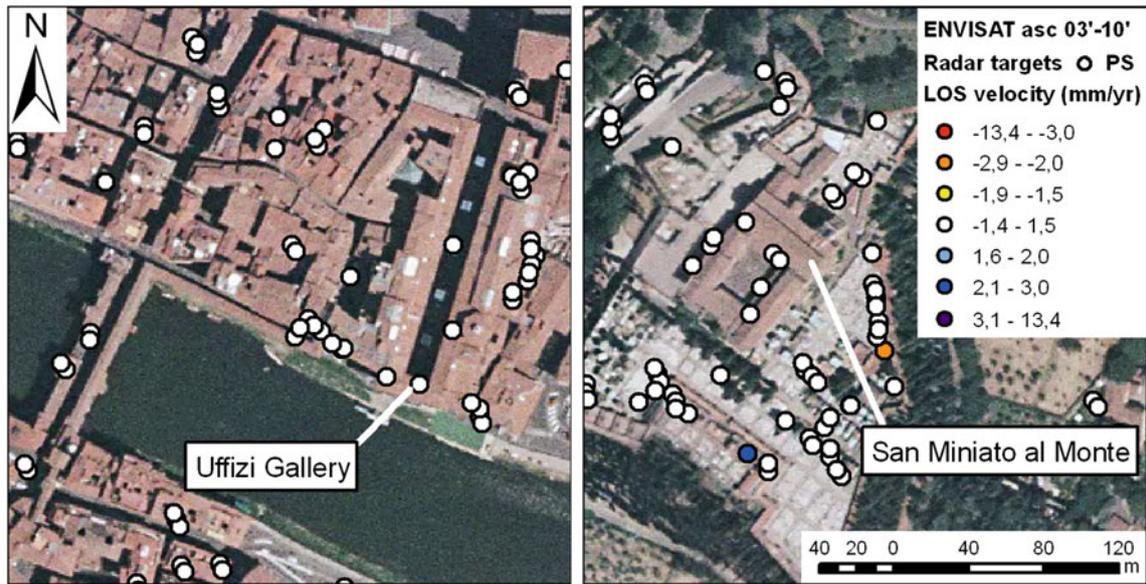
**Fig. 60.2** ENVISAT ascending average LOS displacement rates estimated over the Uffizi Gallery and Vasarian Corridor (*left*) and San Miniato Church complex (*right*) in Florence

Figure 60.2 shows a couple of examples of relatively stable PS over the Uffizi Gallery and Vasarian Corridor in the town centre along the Arno River side, and San Miniato Church complex on the top of the namesake hill over the period 2003–2010. ENVISAT ascending data LOS estimates do not show any critical movements which can warn about the stability of the museum due to possible collapses along

the riverbank, nor structural displacements of the church potentially due to the ground motions historically threatening the hill (cf. Fanti 2006).

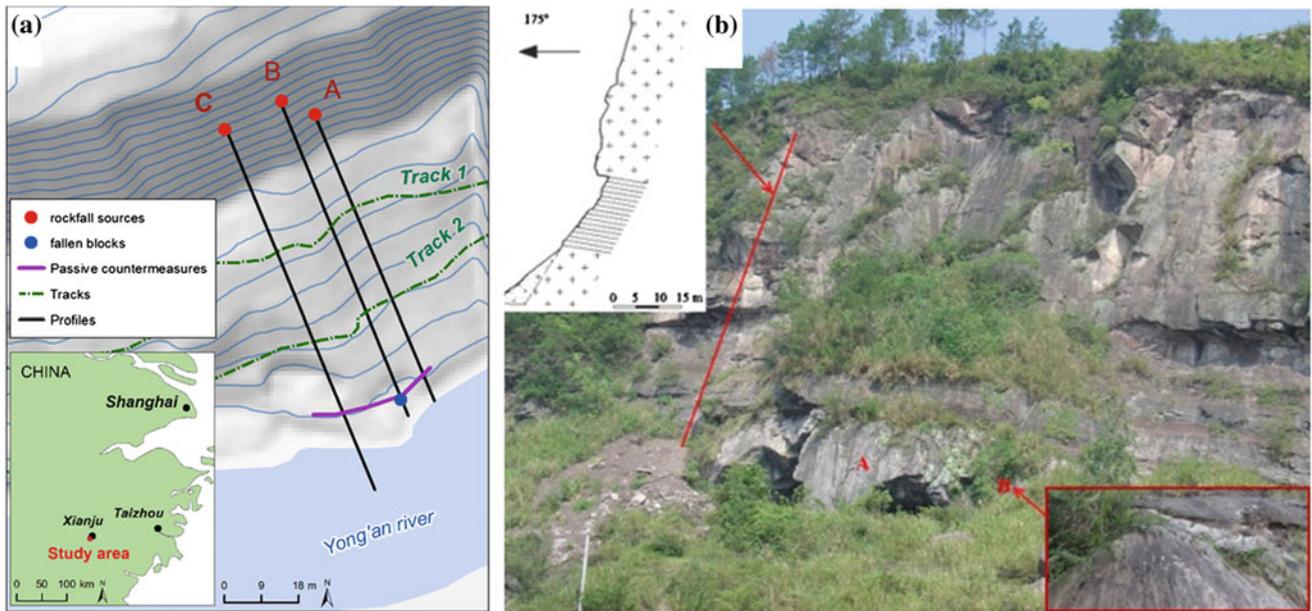
**Fig. 62.1** a The Feifeng Mountain study area, with identified unstable blocks A, B, and C; b picture of the southern slope with a sketch and geological profile and an inset with the main fault (A and B)

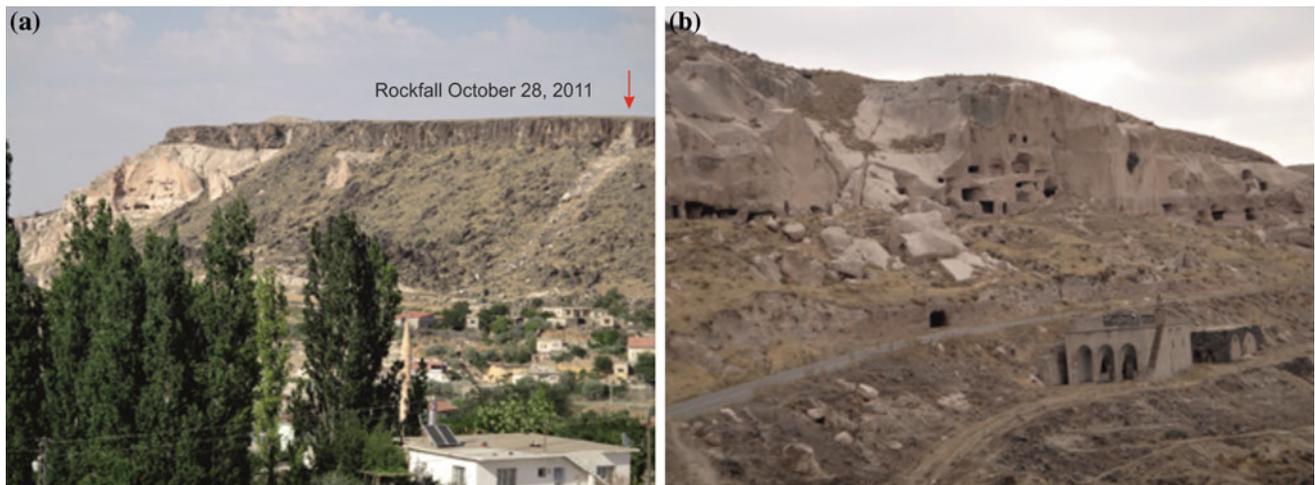
**Fig. 63.2** General views of the slope with unstable basalt layer (a) and Tatlarin Underground City (b)

buildings (Fig. 63.2a). In the past, a number of rockfalls have damaged the underground city (Fig. 63.2a, d), as witnessed by numerous blocks (different volume).

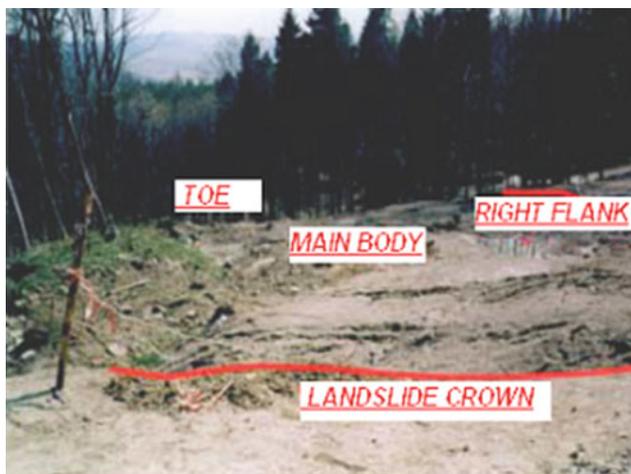
**Fig. 64.2** Landslide crown near the Chapel

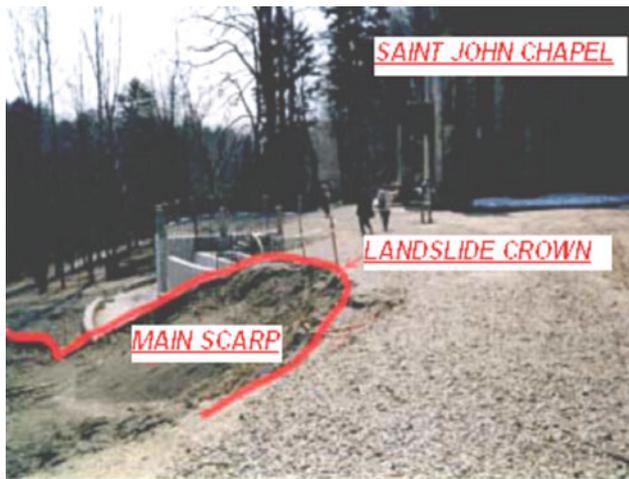
**Fig. 64.4** Initial phase of stabilization, 2006

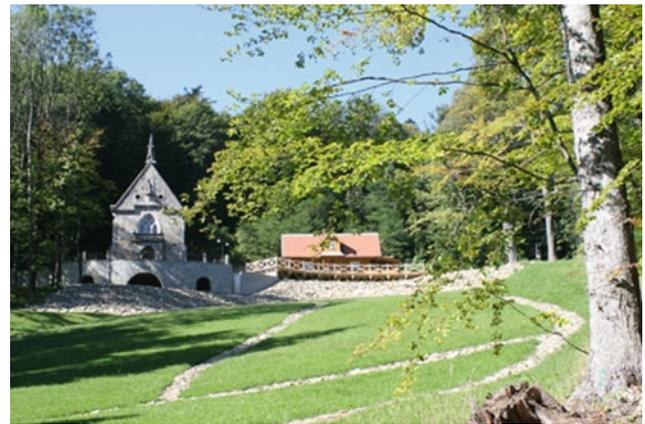
**Fig. 64.5** Landslide after remediation works, 2009

In 2005 the landslide was selected for stabilization realized inside the National Landslide Counteraction Framework Project (SOPO) Component A. Remediation works were financed by a loan from the European Investment Bank and from the Polish state budget. The investment on behalf of the Bernardine monastery, to which the chapel belongs, oversees the Community of Dukla. Design project was prepared by the Building Research Institute ITB Warsaw. It included drainage of the landslide area and construction of retaining wall on the micropiles foundation (Figs. 64.4 and 64.5). Micropiles were drilled to the depth of 10–12 m. Grouted-in-place micropiles were constructed from steel pipe diameter of 305 mm and cement grout. This technology had beneficial impact on slope stability conditions. The construction of retaining wall was founded on this type of foundation in stiffer geotechnical layers. Drainage system was built as a system of trenches filled by drainage stones and geo-textile collecting rainwater downhill. Renovation of the chapel included also building of retaining wall and the cave with two water intakes below the chapel. It contained repair of existing joints on the walls and building of temporary road to the chapel. All the stabilization works improved the stability conditions. The Bernardine order reported no additional movements near the chapel after the remediation works in 2006. However, this conclusion was based only on site inspection and it was unknown if remediation were sufficient enough, because the monitoring system was not implemented the stabilization.

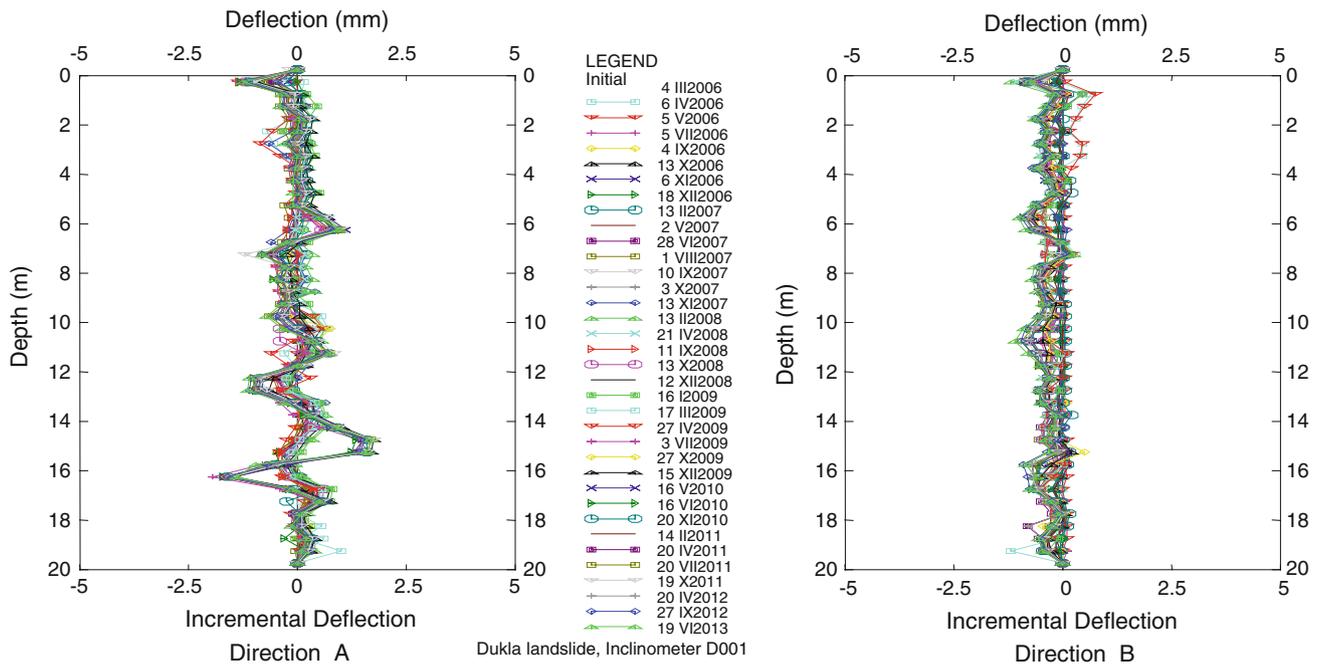
**Fig. 64.8** Incremental displacements 2006–2013

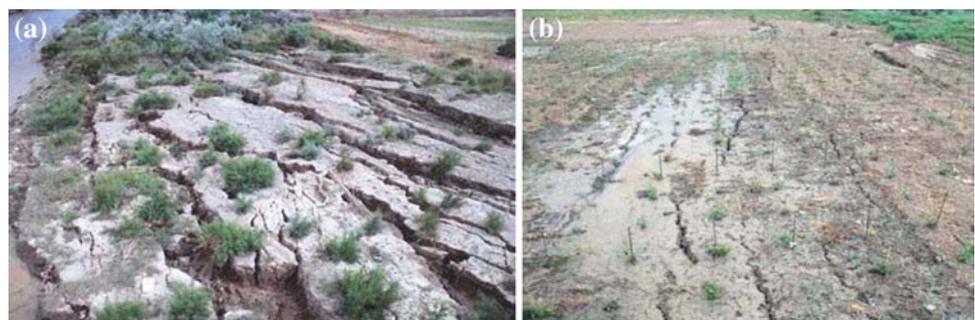
**Fig. 65.4** **a** Total destruction of a building of three floor situated on alluvial site (liquefaction of soil) in the suburb of Boumerdes. **b** Weakness of the stiffness of columns causing collapse (city of Boumerdes)

structures depends of seismic duration. In this vision, the seismic replica can destroy the structures because the original resistance of buildings is very reduced by the strong motion. This case has been reported about the Boumerdes earthquake. One day after the disaster, a replica causes the collapse of many buildings. Many studies are engaged in the United States in this field. This problematic concerns the probability to exceed the duration of a normative seismic peak (Van de Lindt and Gin-Huat 2004). The Fig. 65.4a, b illustrate the lack of building resistance.

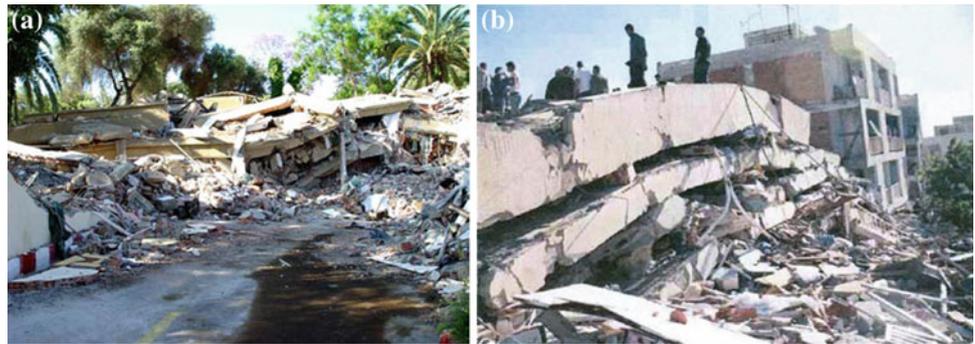
**Fig. 65.5** **a** Lack of ductility and discontinuity of the rebars in the node column-beam. **b** Lack of rebars in the column at the node

The disproportion of geometric sections between the columns and the beams induces plastic deformations on the columns earlier, then in the beams and causes the building collapse. The problem has been recognized during Boumerdes earthquake, as reported in Fig. 65.5a, b.

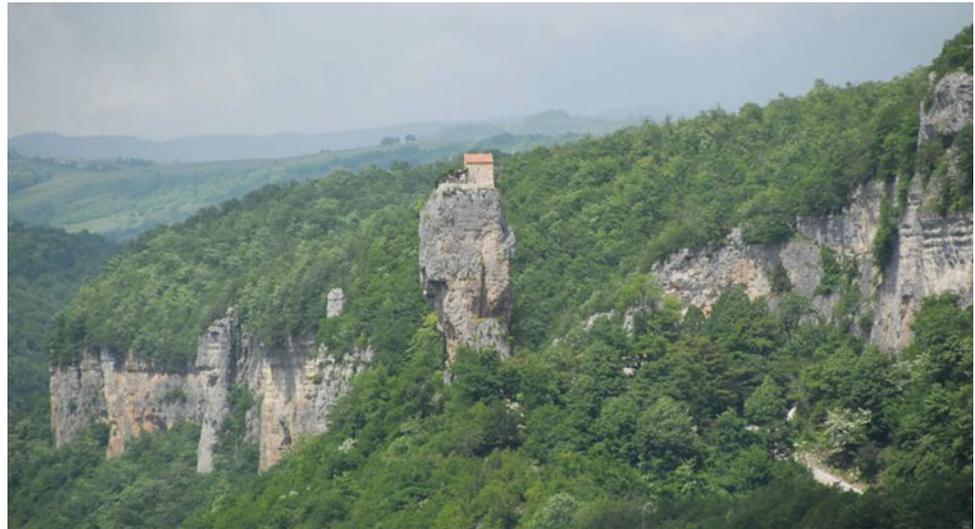
**Fig. 68.1** Panoramic view of Katskhi Pillar in the Katskhura valley. At the top of the calcareous column the small church of the Monastery is located

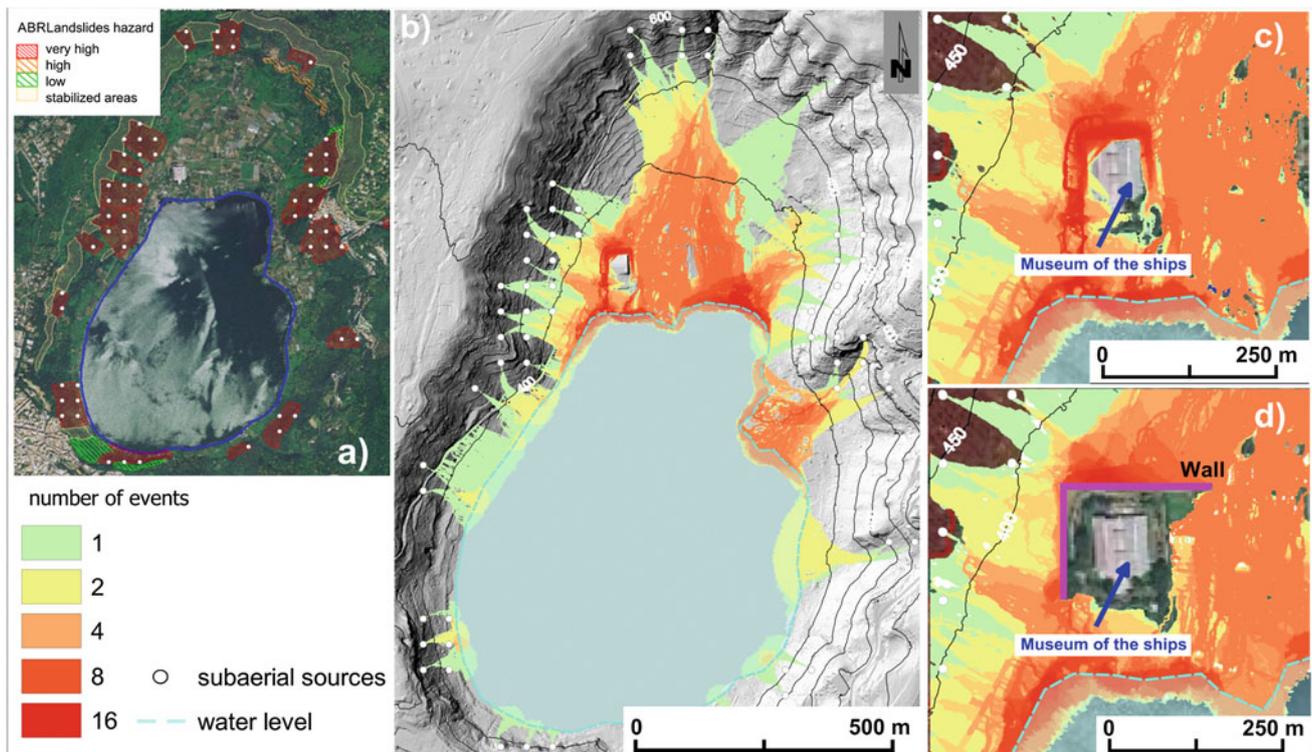
**Fig. 70.3** Nemi Lake a ABR landslides hazard; b susceptibility zonation; c "Museum of the ships" area first and d after placing of wall

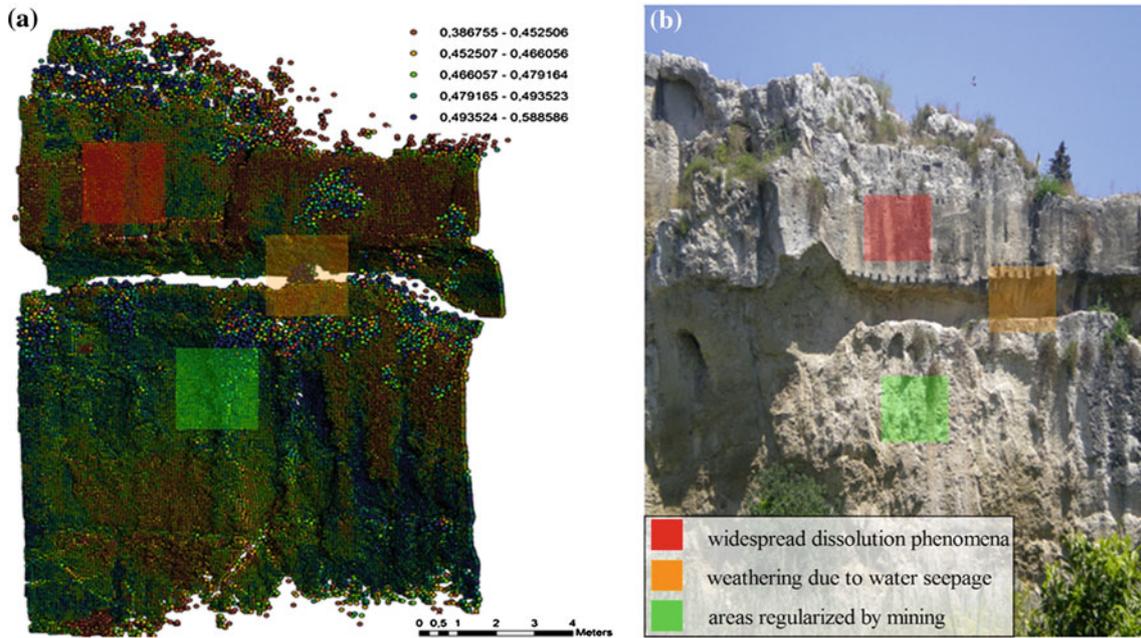
**Fig. 71.4** a Reflectivity values by laser scan. b Photo of the investigated area

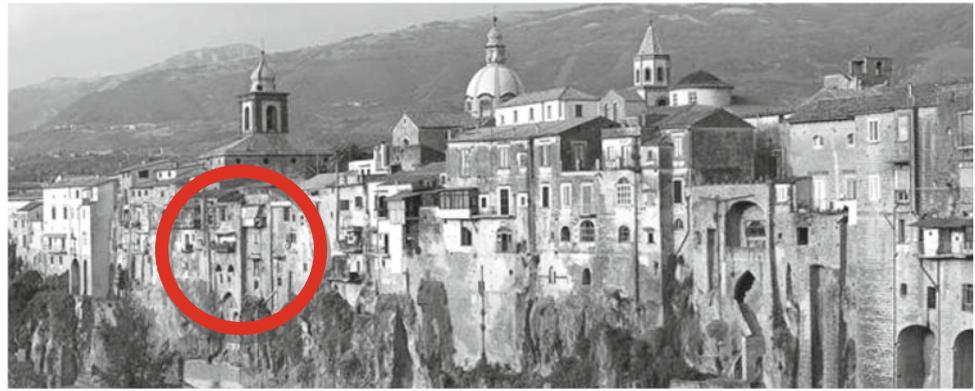
**Fig. 73.1** Western cliff of Sant'Agata de' Goti, along the Martorano creek. The red circle shows the location of the hypogean cavity analyzed in the paper

The historical center of Sant'Agata de' Goti, located in Campania region (Italy), rests on the flat top of a N–S oriented elliptical ridge (Fig. 73.1), about 50 m high, about 170 m wide and 600 m long, and delimited by the Riello and Martorano creeks. Both seismic and landslide hazards are due to the typical morphology consisting of a soft rock slab lying on a thick deformable soil layer, which is frequently detected for

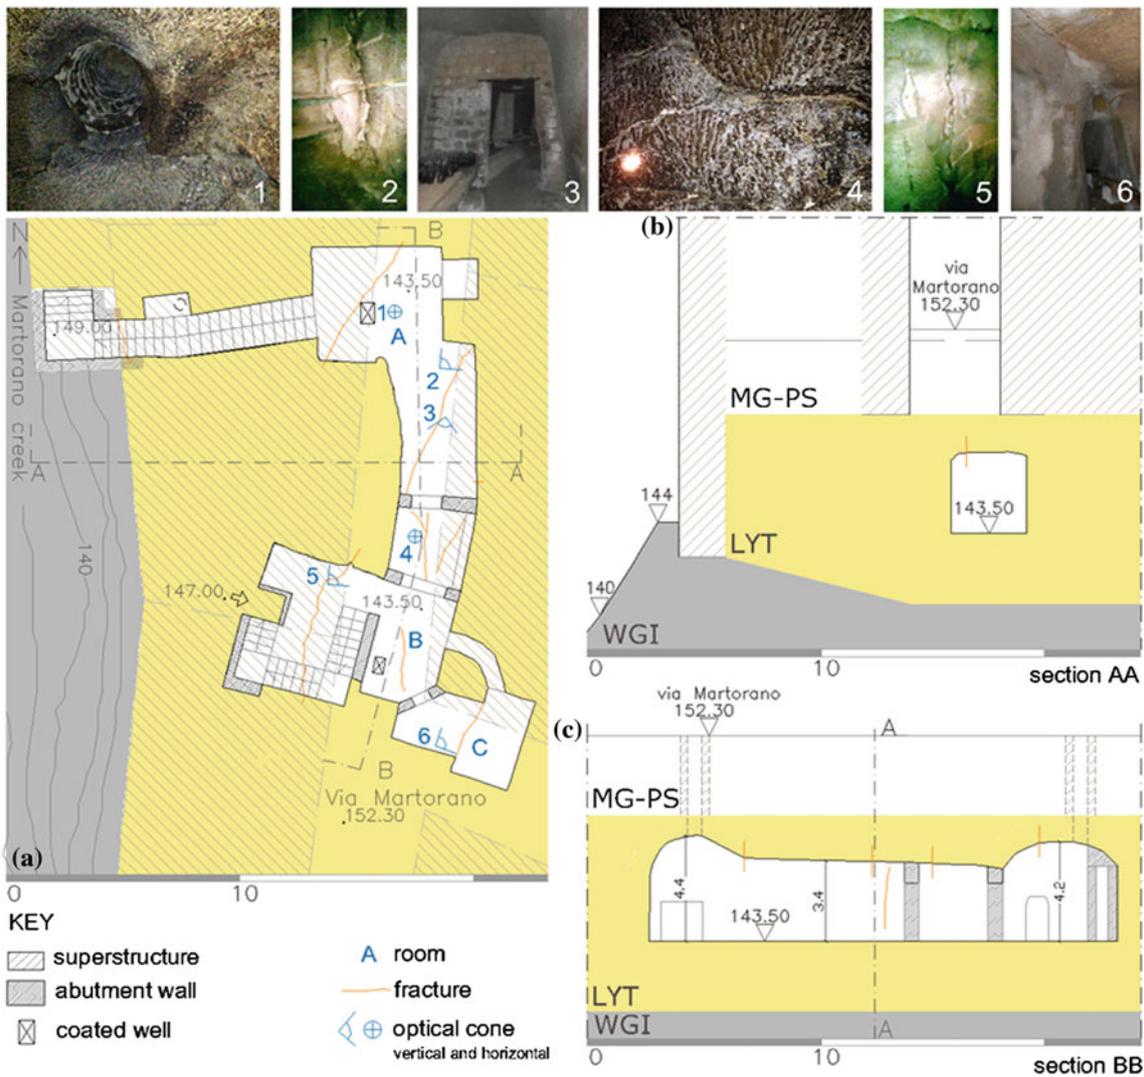
**Fig. 73.3** Plan (a) and sections (b and c) of the studied cavity with the joints observed

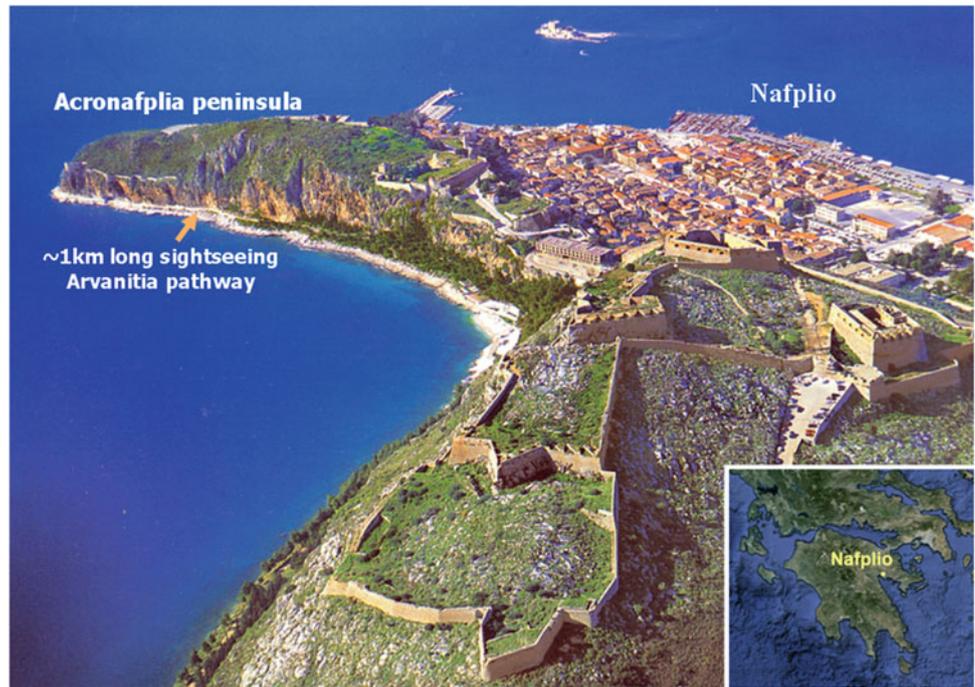
**Fig. 75.1** Aerial view of the Acronafplia peninsula landscape and the archaeological site on top of the cliff. The pathway at the toe of the cliff can also be seen. *Inset* location map of Nafplio, Greece

The Akronafplia peninsula is located in the southern end of the historical town of Nafplio (Fig. 75.1). It consists mainly of Mesozoic blocky limestone exposing 15–55 m high cliffs along the south and west slopes. The Arvanitia site is located at the southern coast of the peninsula, an area of significant archaeological interest and natural beauty that hosts numerous visitors. The popular pathway, used for both walking and cycling, is a paved up to 3 m wide path, running by-the-sea for a distance of about 1 km. It was constructed along the toe of steep high cliff with local use of controlled blasting.

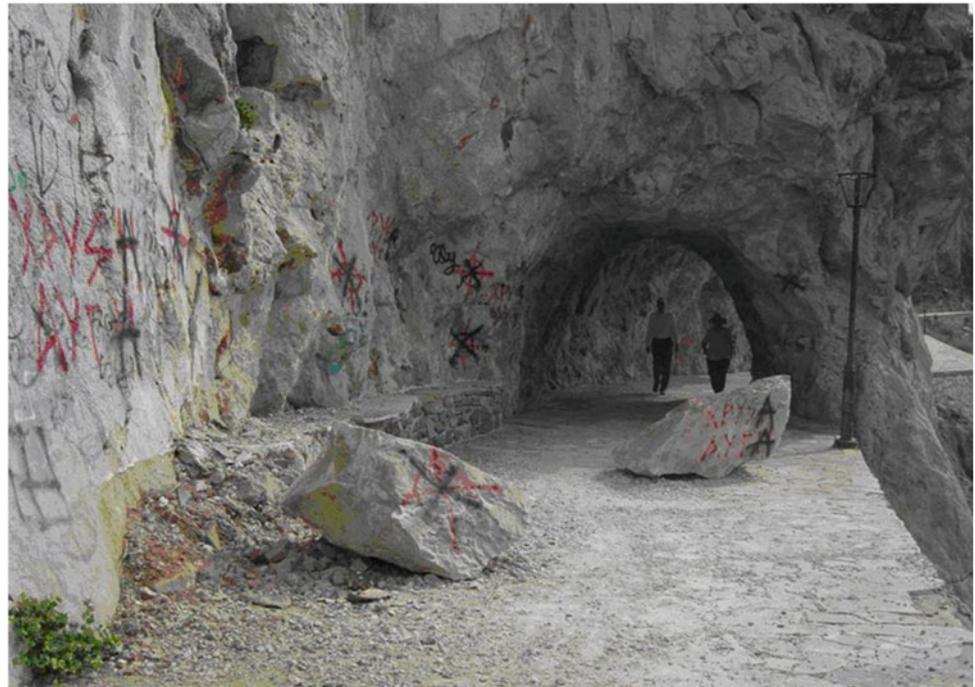
**Fig. 75.2** Two blocks falling on the Arvanitia pathway after the 24 January 2010 rockfall event

The January 24, 2010 rockfall at Arvanitia pathway is the most serious event over the last years, being part of a long series of falls witnessed on the site. Two blocks of about 2 m<sup>3</sup> each detached and fell down the pathway lying at the slope toe, followed by multiple rock fragments (Fig. 75.2). A second minor rockfall event occurred the following July in a

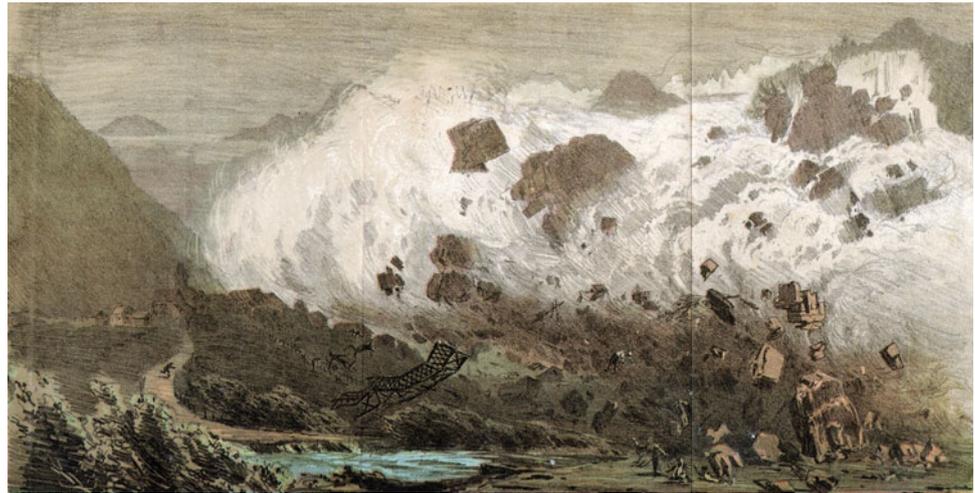
**Fig. 81.3** Impressive and realistic reconstruction of the Elm rock avalanche collapse, portrayed by F. Weber, two days after its occurrence (in Hardmeyer-Jenni 1884)

dramatic moment of collapse: almost a snapshot that, with plausible realism, depicts the breath of the giant debris cloud that fills the valley, the impact of the blocks on buildings, the escape of the survivors (Fig. 81.3).

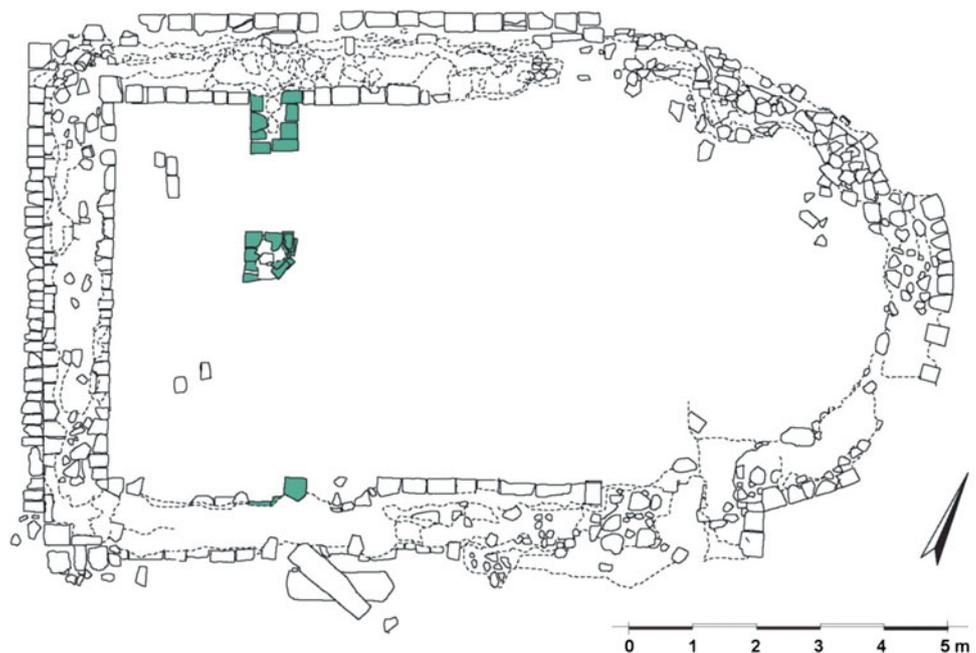
**Fig. 82.3** Ground plan of the monastic church ruin

The crushed stone walls of the church covered with finely cut ashlar on both the inner and the outer side appeared to be clearly different from that of the more irregular stone walling of the surrounding wings (Fig. 82.3). The laser aided

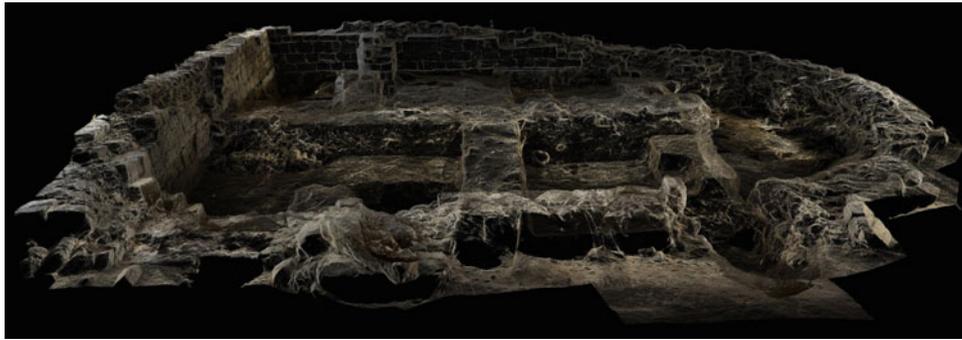
**Fig. 82.4** Laser scan image of the church ruins

reconstruction also revealed that the structures of the internal and external walls are different (Fig. 82.4).

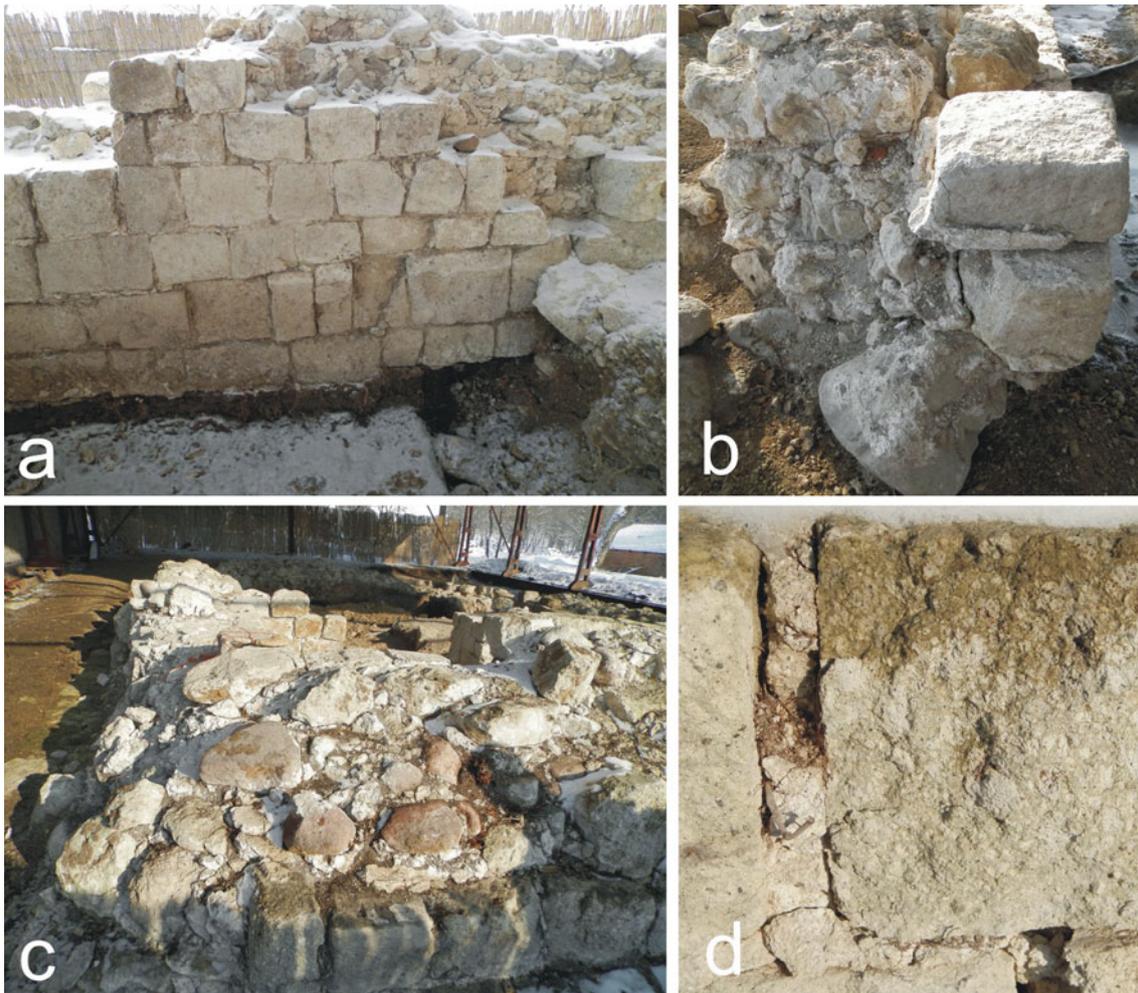
**Fig. 82.5** Stone masonry: **a** finely cut andesite tuff ashlar; **b** cross section of a wall; **c** rounded andesite cobbles at the central part of the wall; **d** lime-based mortar in the joints

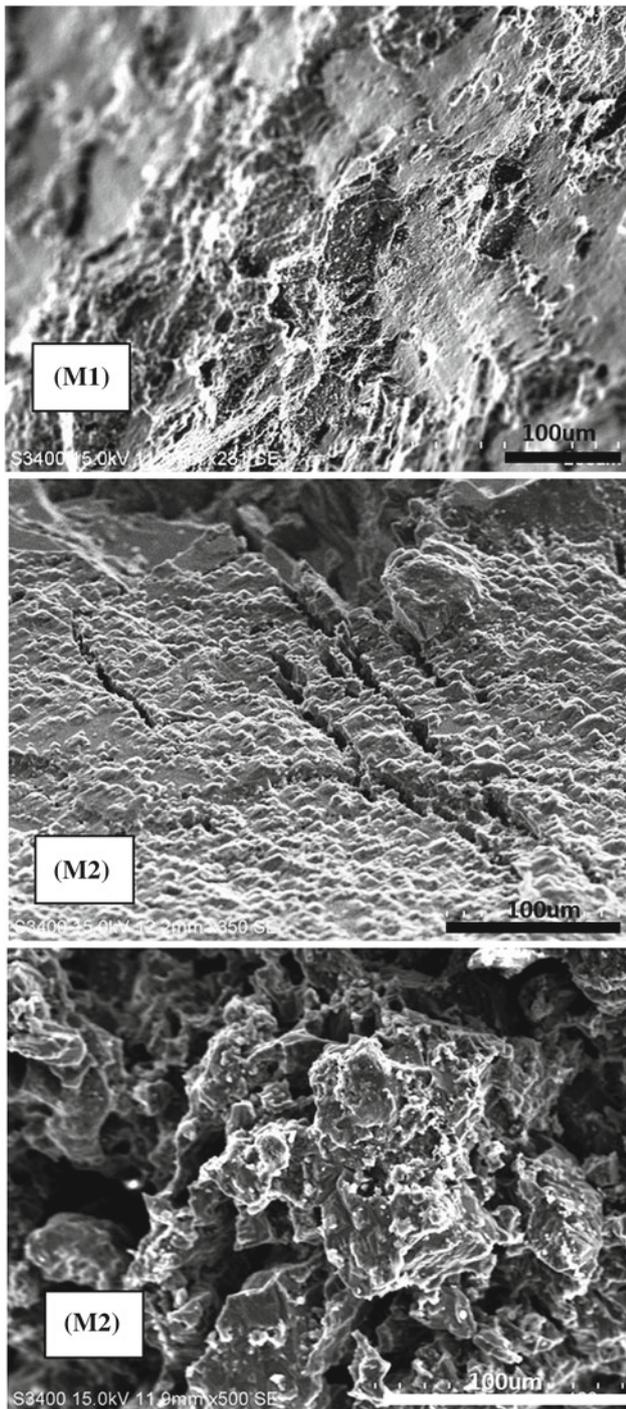
**Fig. 87.3** Marble samples. *Upper*, modern marble (M1), minimal deterioration. *Middle*, parallel cracking in M2. *Lower*, dissolution pitting in M2. 100 µm scale bar in each image

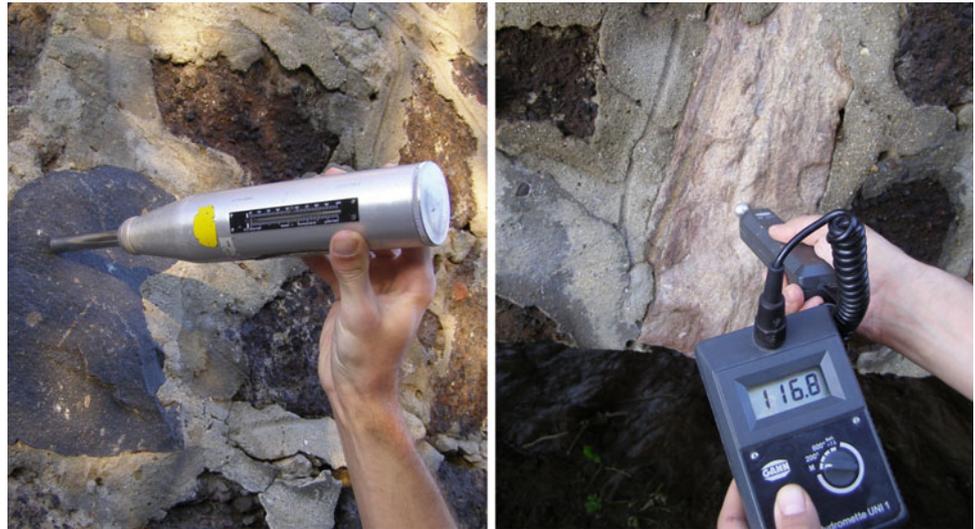
**Fig. 88.1** Schmidt hammer test (left), Moisture content measuring (right)

Lithotypes of the dimension stones also have to be observed on site and the differences between the strength of the blocks could be measured in situ by using Schmidt hammer (Fig. 88.1 left). It is a particularly suitable technique for the diagnostics of national monument structures to estimate the UCS of the rock materials when sampling is not an option. Many literature and research are concerned with this in situ technique (for example: Aydin and Basu 2005; Yasar and Erdogan 2004; Yilmaz and Sendir 2002; Kahraman 2001) because the correlation between the rebound value and the uniaxial compressive strength (UCS) is changing with the rock types (Zhang 2005). The rebound value is depending on more properties, for instance: weathering grade, dry density, porosity, grain size, moisture content and naturally the parameters of the Schmidt hammer (impact energy, plunger tip) (Aydin and Basu 2005). There are several contradictory suggestions about which type of the Schmidt hammer is recommended to be used. According to the International Society for Rock Mechanics (ISRM 1978) the L-type hammer, which has the lower impact energy, should be used for the hardness characterization of rocks between 20–150 MPa UCS. On the other hand some literatures say that the N-type hammer outperforms the L-type, because of the higher impact energy. The American Society for Testing and Materials (ASTM 2001) does not prefer a specific hammer type at all (Buyuksagis and Goktan 2007). Although both types of Schmidt hammers are capable for testing the surface hardness of the blocks, there is no widely used applicable formula or method to estimate the uniaxial compressive strength of stone materials from the rebound value of the Schmidt hammer test.

The moisture has a great influence on the UCS value (Vásárhelyi 2005) therefore moisture content also should be recorded on site (Fig. 88.1 right).

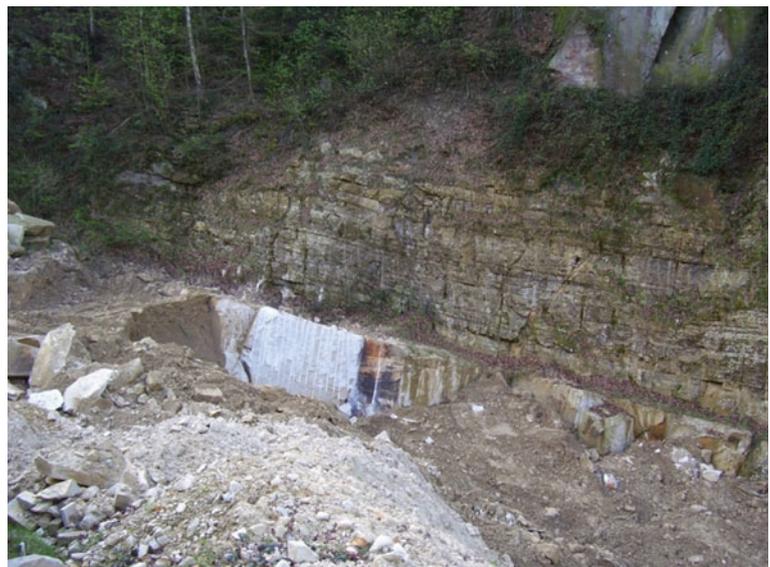
**Fig. 100.3** Romberg Quarry, Gildehaus, 2006. Extracted Bentheim sandstone layer in the center is 2 m in height

Quarry, the Bentheim Sandstone is still being excavated. The limited volume of quarried rock is mainly used for restoration purposes (Fig. 100.3).

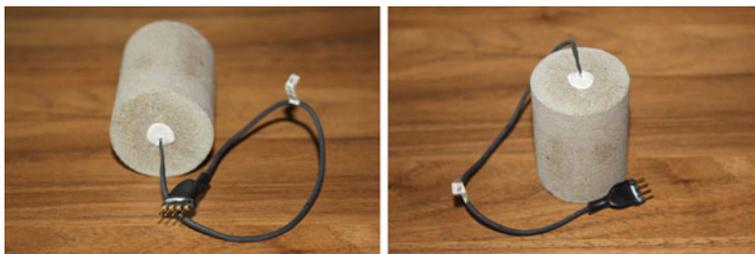
**Fig. 103.3** Photo of moisture sensor with sensing element (*hot ball*) inside it

Body of the moisture sensor(s) is manufactured of the sandstone core drilled directly from the supporting pillars. Sensor body has shape of cylinder in diameter and length of 30 mm. A hole in diameter of 2 mm was drilled in the longitudinal axis of the cylinder in which a sensing element is fixed using epoxy resin (Fig. 103.3). The principle of sensing element is based on the transient hot-ball method for measuring thermal conductivity (Kubičár et al. 2010). The signal of the sensing element is not sensitive to ionic radicals of the pore medium. Sensing element (hot ball) is inserted back into the drilled hole to ensure that the porous structure of both the sensor body and the investigated material are identical and is capable to provide the contact for heat and water transport at the interface surrounding sandstone block and the sensor. Thermal conductivity of the porous material is a function of the pore content (Fidriková et al. 2013b).
