Advances in Natural and Technological Hazards Research

Post-Tsunami Hazard

Reconstruction and Restoration

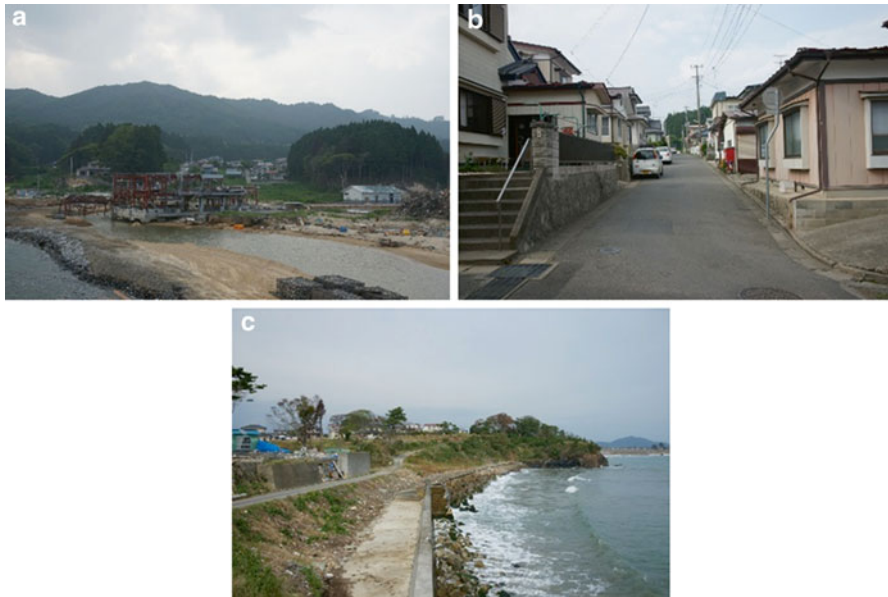
Photo 1.1 Meiji resettled community; (a) Funakoshi, no residential use in low land, (b) Funakoshi community after the EJED; (c) Ootani community (Source: Miyagi Prefectural Government)

Communities remaining at the original resettlement sites and did not expand to lower ground sustained minor damage due to the EJED because the elevation of the resettlement sites were determined based on previous tsunamis. Damage in these communities is very limited, but some houses near the sea were damaged. Two of the resettlement sites from the Meiji and Showa Tsunami Disasters correspond to this type of damage: Funakoshi (Yamada, Iwate) and Ootani (Kesennuma, Miyagi). Photo 1.1 shows damage in these communities.

These two communities resettled on higher ground after the Meiji Tsunami. After the Showa Tsunami, the damage was limited to low land residents (24 housing units at Funakoshi and 27 housing units in Ootani). People have remained on higher ground since the Meiji recovery. Another point about these communities is the location of the community center. These communities face a national highway, which runs on higher ground, and the business area is located along the highway. Business areas on higher ground and residents remaining in the original resettlement sites may have successfully reduced the damage from the EJED.

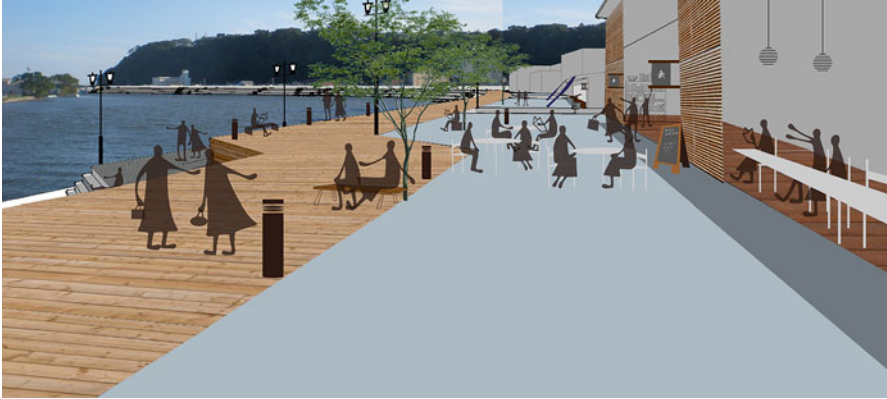
Fig. 2.3 Image of unified plan along Kitakami River (Source: Urban and Regional Planning Lab., Tohoku University and Geospatial Information Authority of Japan)

Therefore, at the moment members of the national, prefectural and local government arrange regular “working-level” meetings with academic experts and consultants to coordinate time, space and budget while explaining the projects to the local residents about the conformation of areas where the city and river will be structurally and non-structurally closely connected with each other (Fig. 2.3).

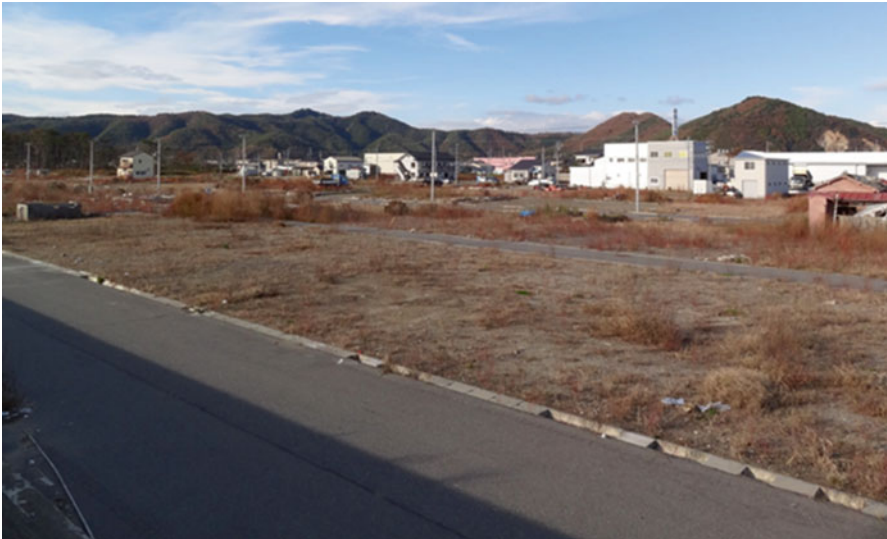
Photo 2.1 Situation of Watanoha district, Ishinomaki city, 2 years after the disaster

Furthermore, the areas severely damaged by the tsunami, for which these reconstruction projects have not been planned yet since the safety measures against tsunami will be ensured by constructing levee and since there is no need to improve urban facilities of the district, are also waiting for problems to be solved: although there is no local regulation for reconstruction of houses, most of the residents are anxious, and not willing to have their houses rebuilt in the same place as before. For this reason, this land is still vacant even 2 years after the disaster as is typically seen in Watanoha district in Ishinomaki city (Photo 2.1). The situation is worsened by the

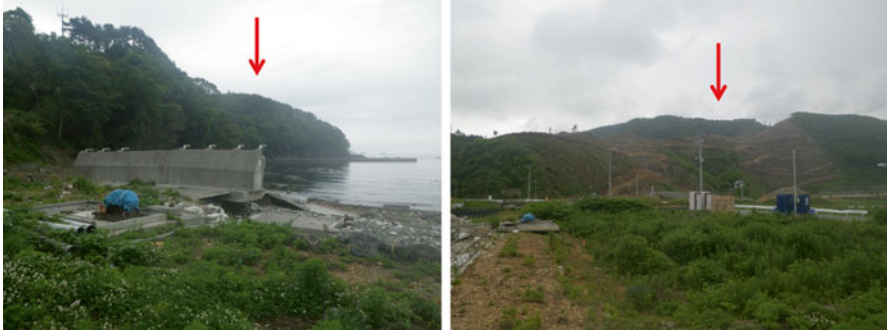
Fig. 4.3 Damaged seawalls and area for relocation in the mountain (*left*). Forests in the mountain that were cut for personal purposes (*right*)

tsunami. Two years after the 2011 tsunami, the village's port is still suffering because of land subsidence as a result of the port being submerged during high tide. Most fishermen still have to anchor their boats at other ports because the fishing port in Tadakoshi is not yet fully reconstructed.

Aquaculture activities of the port have recovered to some extent. For the view of village reconstruction, the villagers realized the level of devastation, and all residents agreed to move their homes to high ground. According to the current reconstruction plan, part of the mountain near the port will be cut and approximately 25 households will be moved by 2015 (Fig. 4.3-left). An example of a new adaptation following the 2011 tsunami in many villages of the Sanriku area is the posting of signs showing the elevation above sea level in many places. This information may help support an evacuation decision following a tsunami warning. There was one problem found in this area during the survey: a large numbers of trees in the forest were cut in a private mountain behind the village (Fig. 4.3 right) and the owner did not agree to see his land for the purpose of the high ground residents (Suppasri and Yasuda 2013). The removal of trees will lead to a high risk of landslides triggered by large earthquakes or heavy rainfall to the lowland area below.

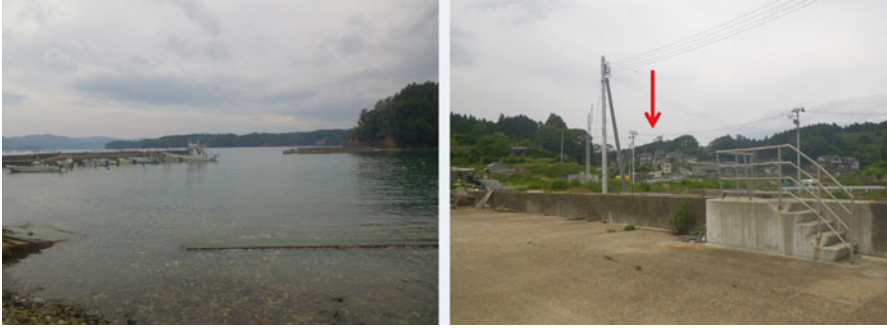
Fig. 4.5 *Left*: A fishing port is submerged during high tide, but some aquaculture activities were observed (*left*). View of evacuation shelters located behind the high ground from the fishing port (*right*) (Source: Cabinet Office, Government of Japan)

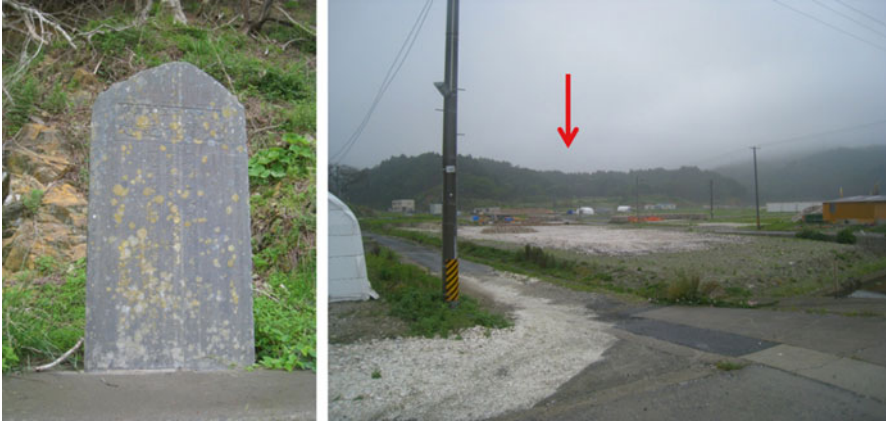
Fig. 4.7 Tsunami memorial of the 1933 tsunami with warning messages (*left*). Relocation area on top of the mountain in Yagawa village (*right*)

Figure 4.7-left is a memorial rock plate of the 1933 tsunami in Yagawa village with three warning messages: (i) Be aware of a tsunami after occurrence of an earthquake; (ii) Go higher than this point if a tsunami comes; and (iii) Do not live in the tsunami danger zone. Despite these measures, the 2011 tsunami was much higher, measuring 18.5 m (Cabinet office 2011b), and the tsunami inundation area was extremely large. As a result, the 2011 tsunami claimed 8 lives from the population of 167, equal to a fatality ratio of 4.79 %—higher than that of Niranohama village. The damage also includes the only house that survived from the 1933 tsunami, which later became one of the relocated houses after the 1933 tsunami but finally washed away by the 2011 tsunami (Suppasri and Abe 2013). Unlike the two above examples, recovery of aquaculture activities in Yagawa is still slow after 2 years. The fishing port is deeply submerged even when the tide is not high as Yagawa is located closer to the earthquake epicenter. This village has a similar reconstruction plan to the others; its residents will move to high ground by excavating part of the mountain (Fig. 4.7-right).

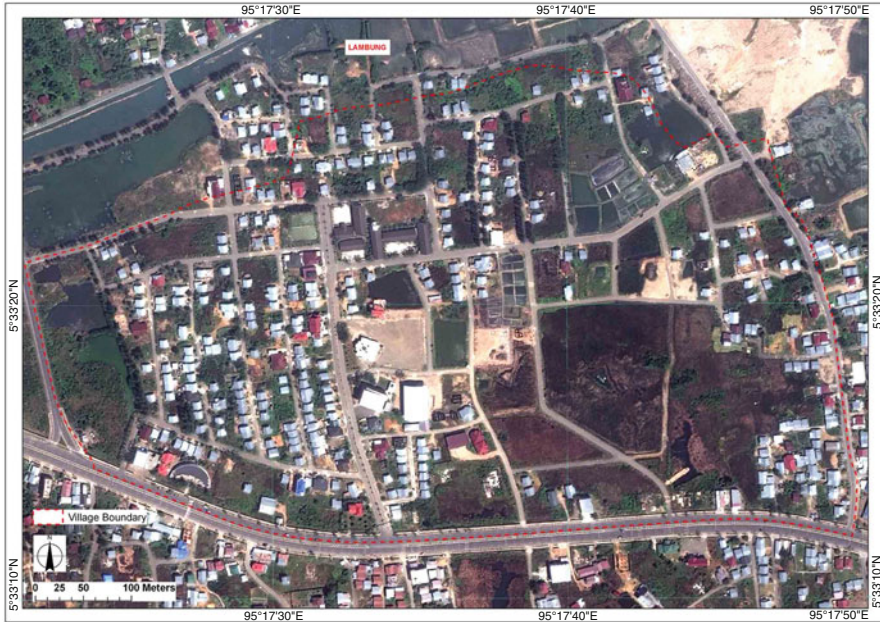
Fig. 5.2 Lambung Village, latest development on 2 March 2011 (Source: Worldview image (BAPPEDA Banda Aceh city))

completed, however, the value of the land increase gradually. In average, the price of the land in Alue Deah Tengoh is cheaper than Lambung’s; yet the successful implementation of LC in Lambung made the new village layout with straight and wide roads more attractive and increased the value of its land. The new layout can be identified from the satellite image of 2011 as shown in Figs. 5.6 1–3 and 5.2.

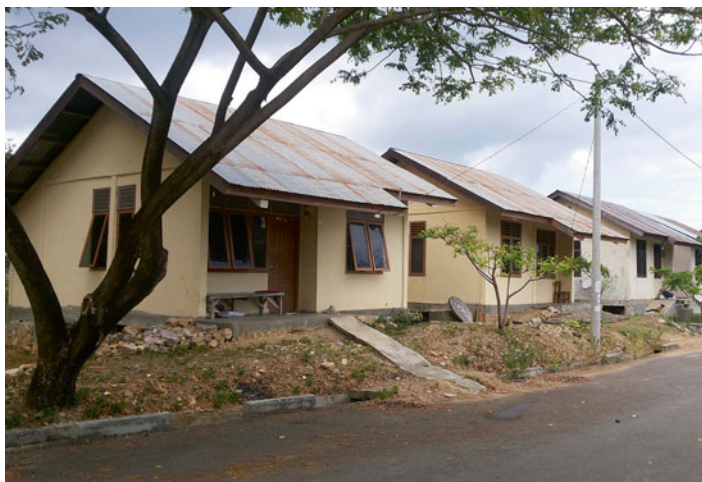
Fig. 5.3 Permanent house built by MDF in the village of Lambung

The Lambung housing reconstruction project started at the beginning of 2005 and finished by the end of 2007. All of the houses provided by MDF in Lambung were of the 36 square meters permanent type with additional terrace (Fig. 5.3). This project helped the villagers to rebuild their houses and revamp the drainage system and public washing areas. During project implementation, the beneficiaries worked hard to plan and carry out the construction works themselves. In this community-driven approach, the villagers worked in groups and everyone was involved at every step of the process, attributing their success to hard work and cooperation (MDF 2011).

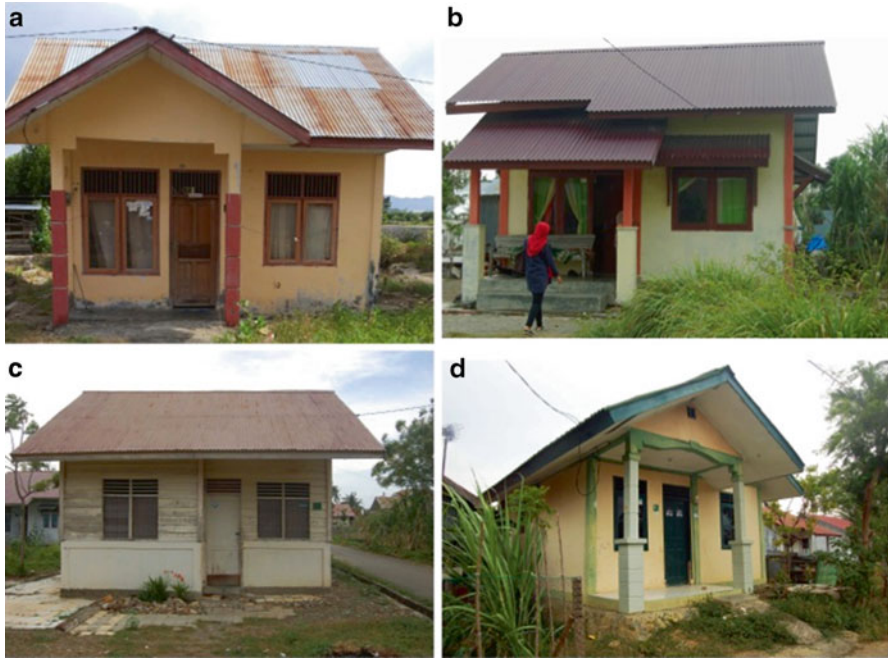
Fig. 5.4 Different type of houses built by different donors resulting different design and quality at Alue Deah Tengoh (a) “Permanent house” built by BRR (b) “Permanent house” built by Caritas (c) “Semi permanent house” built by YBI (d) “Permanent house” built by Oxfam

The approach found in the village of Alue Deah Tengoh was radically different. The housing reconstruction was realized by several donors, namely Oxfam, YBI, Caritas and BRR (Table 5.1). This program resulted in several types of houses with different design and level of quality (Fig. 5.4). Such a donor-driven approach was commonly found in Aceh reconstruction program.

wood and saw the construction of its houses delayed extensively. This situation made some of Oxfam housing beneficiaries become disillusioned until all semi-permanent houses were finally completed in 2005. Later, the beneficiaries of Oxfam’ houses felt at a loss in comparison to their neighbors got permanent houses provided by other donors, i.e. BRR and Caritas. Those beneficiaries then tried to negotiate their upgrading to permanent houses with Oxfam. After many discussions Oxfam agreed to replace all semi-permanent houses with permanent houses (Fig. 5.4d). The modifications and entire project were completed at the end of 2007.

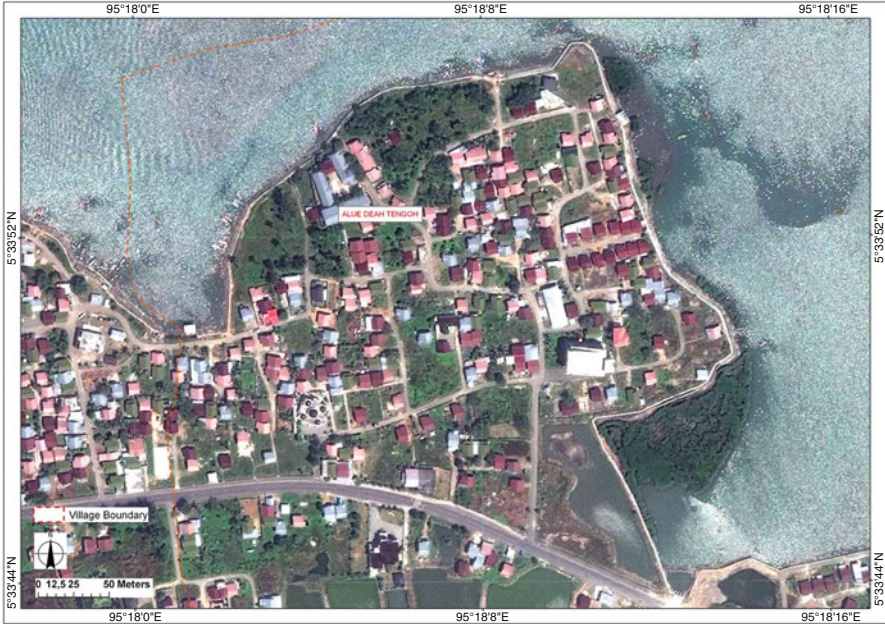
Fig. 5.5 Alue Deah Tengoh Village, the latest development of the village taken on 2 March 2011 (Source: Worldview images (BAPPEDA Banda Aceh city))

This kind of approach without conducting LC prior housing reconstruction had the benefit of providing new house more speedily than other community-based reconstruction programs. In the long-term, however it also resulted in social inequalities as different types and quality of houses emerged randomly within the old layout of the village (Fig. 5.5).

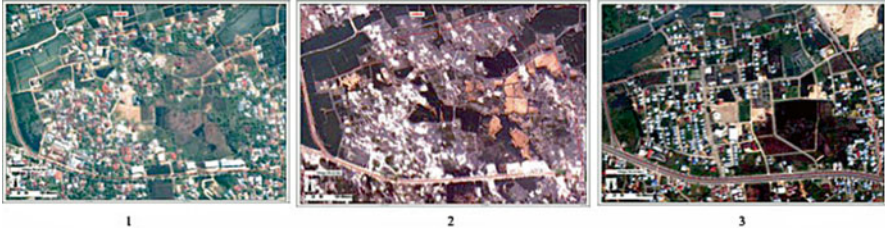
Fig. 5.6 1–3 Lambung Village. (1) Pre-tsunami condition (23 June 2004); (2) Destruction after the tsunami (28 December 2004) and (3) Redevelopment (2 March 2011) (Source: Quickbird and Worldview images (BAPPEDA Banda Aceh city))

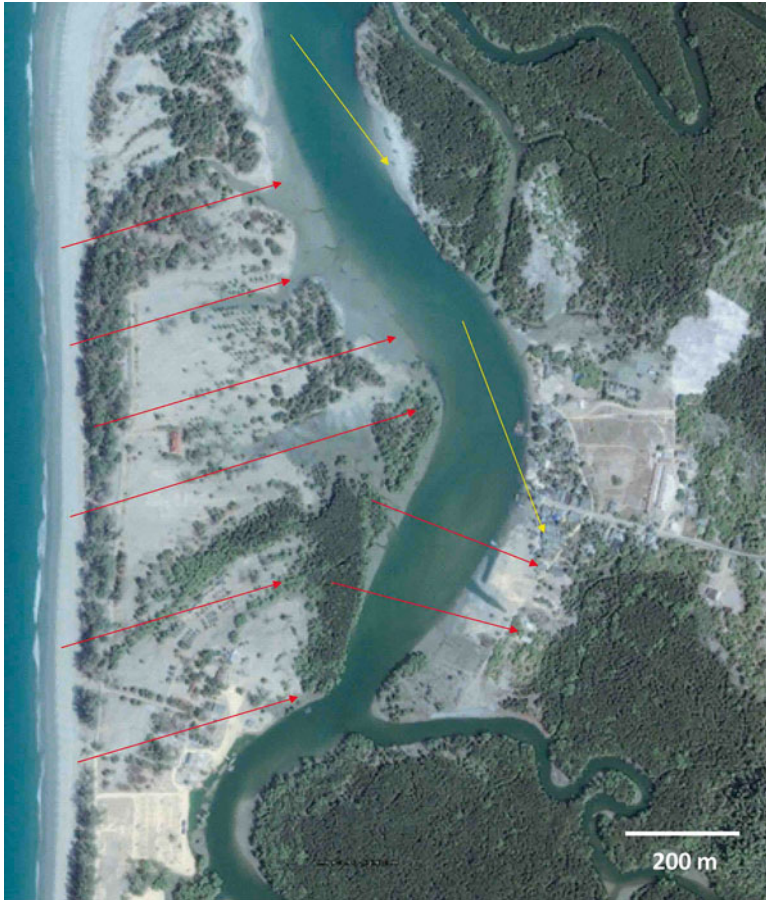
Fig. 6.3 Directions of the tsunami wave hitting the Andaman Coastal Research Station for Development, the Nua and the Hat Sai Khao villages. Note that the tsunami wave travelled both across the Praphat beach (indicated by the *red arrows*) and along the distributary channel, the Kamphuan canal (indicated by the *yellow arrows*) (Source: Google Earth (2/6/2005))

(Fig. 6.3). The witness reported (August, 2013) that the flooding stayed for about 15 min before the water retreated.

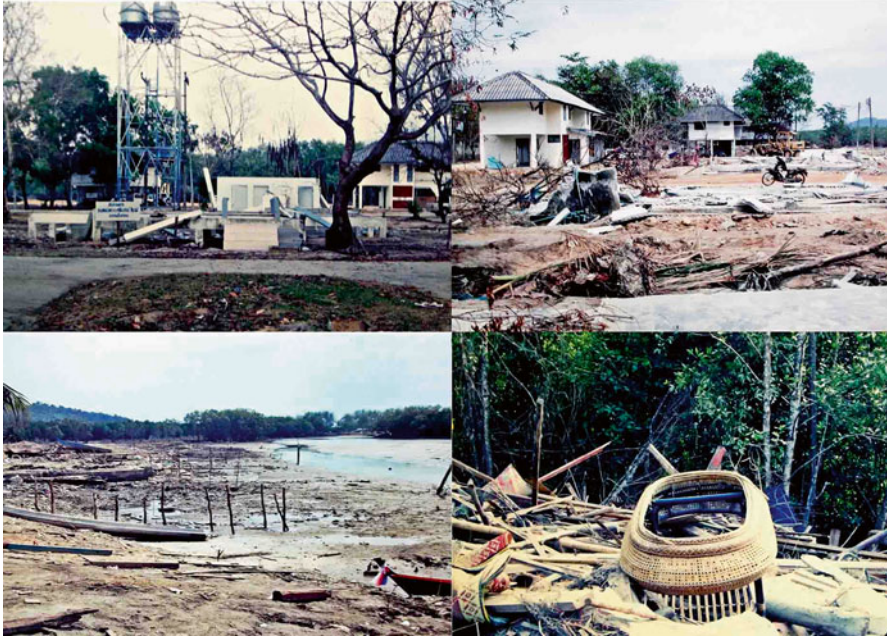
Fig. 6.4 Damages in the Kasetsart University's Andaman Coastal Research Station for Development (*top left*), the Nua village to the east of the center (*top right*), the Hat Sai Khao village (*lower left*) and the mangrove forest that were filled with debris (*lower right*) (Source: Images by ACRSD and Tambon Kamphuan Community Learning Center (between late December 2004 – early January 2005))

The tsunami wave caused considerable damages to the affected areas (Fig. 6.4). Many one-story research buildings at the ACRSD were either completely destroyed or heavily damaged. Many parts of the walls also collapsed. Most of scientific instruments stored on the first floors and vehicles were either heavily damaged or lost. Four employees of the research center were killed on duty (RCRRS 2005). In Nua village, 51 houses were completely destroyed (Recovery and Development Committee 2005). Forty-nine residents and additional 16 tourists visiting the Praphat beach at the time the tsunami arrived were killed (RCRRS 2005). According to the witnesses (August 2013), 10 people were killed in the Hat Sai Khao village.

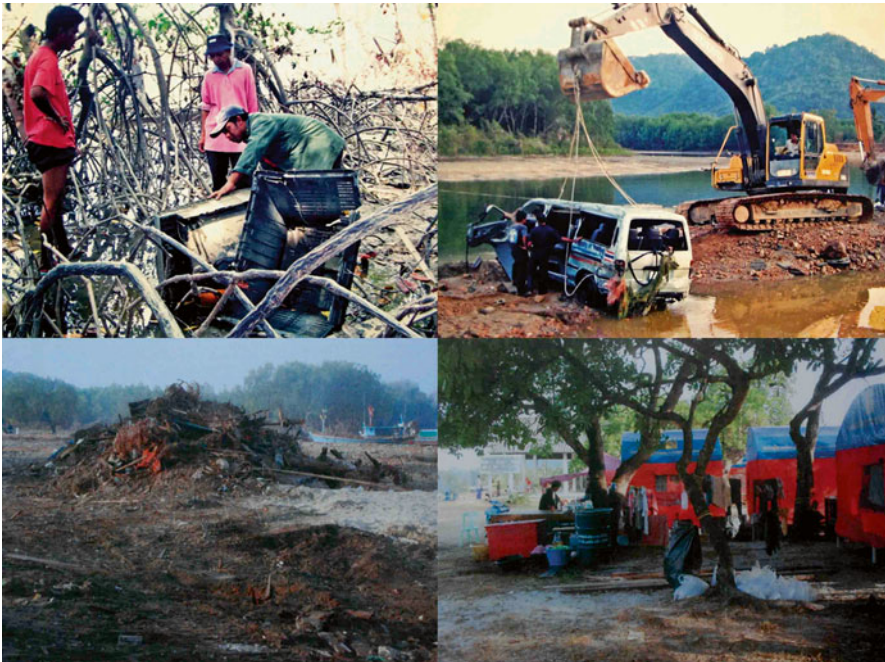
Fig. 6.5 The clean up process in the affected areas. *Top left*: a large television was picked up in the mangrove forest. *Top right*: the backhoe lifted the flooded van at the Kamphuan canal. *Lower left*: a pile of cleaned up debris were waiting for removal at the back of the Andaman Coastal Research Station for Development along the Kamphuan canal. *Lower right*: temporary shelters provided by the Royal Thai Air Force (Source: Images by ACRSD, the Recovery and Development Committee and Tambon Kamphuan Community Learning Center (between December 2004 to January 2005))

For the clean up process (Fig. 6.5), the debris at the Andaman Coastal Research Station for Development were cleaned up by the employees who took about 2 months to complete the tasks. In Nua village, the affected residents were paid daily (about \$6 per day, a typical daily wage in Ranong province during that time) by the World Vision Foundation of Thailand to help clean up debris in the village.

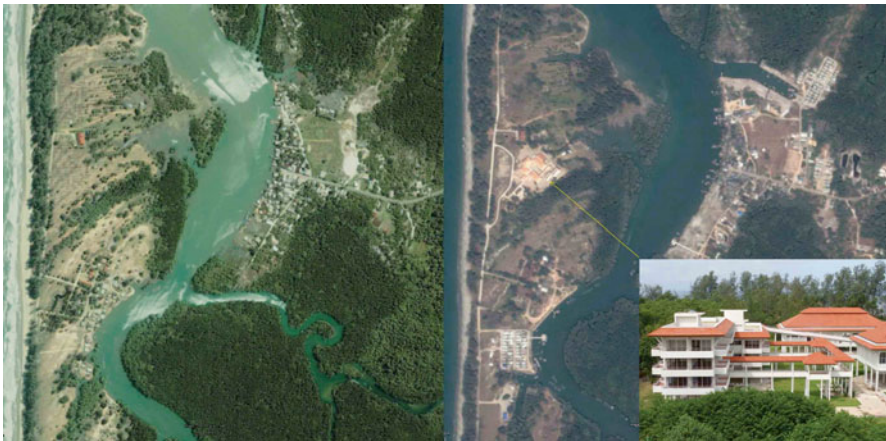
Fig. 6.6 The satellite images of Kasetsart University's Andaman Coastal Research Station for Development before (*left*: image taken on 6/5/2003) and after the tsunami (*right*: photo taken on 2/3/2007). Note the new research building in the center that was designed for additional purpose as an emergency tsunami evacuation shelter (Source: Google Earth)

Many buildings and residences in the Andaman Coastal Research Station for Development were either partially or completely damaged. Some partial damaged buildings were repaired and used as temporary offices. In 2005, the university received the special recovery fund from the government for about 171 million baht to build a new research and development center and to acquire a replacement of scientific equipment that were damaged by the tsunami (RCRRS and ACRSD 2005). The construction of the new buildings in the research center area started in 2006 and completed in 2008. The new complex building was designed to be a tsunami resistant building and could be used as an emergency tsunami shelter for both ACRSD's employees and the residents nearby (Fig. 6.6).

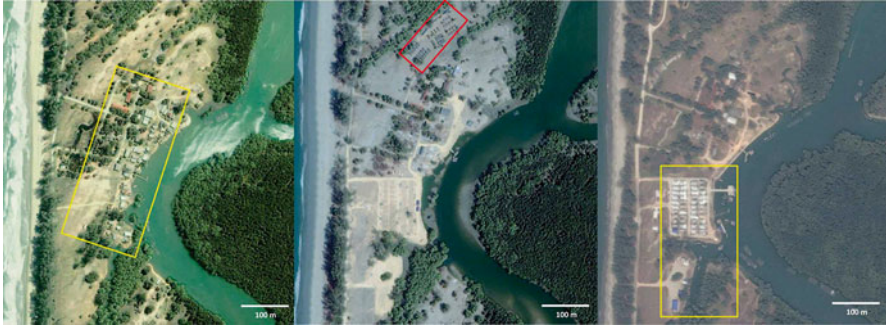
Fig. 6.8 The satellite images of the Nua village before (*left*: image taken on 6/5/2003, after the tsunami (*middle*: photo taken on 2/6/2005) and after restoration (*right*: photo taken on 2/3/2007). Note that the village (yellow boxes in the left and the right photos) was relocated from the overlapping land with the Andaman Coastal Research Station for Development to the separated area to the south of the center. Note the temporary shelters built after the tsunami (the red box in the middle photo). (Source: Google Earth)

At Nua village, the residents used to live in the land properties that overlapped with those of the ACRSD where both pieces of land belonged to the government. The overlapping land use caused some conflicts between these communities in the past. After the tsunami, the ACRSD built fences surrounding the center area, separating the land of the center from the land of the Nua village (Fig. 6.8).

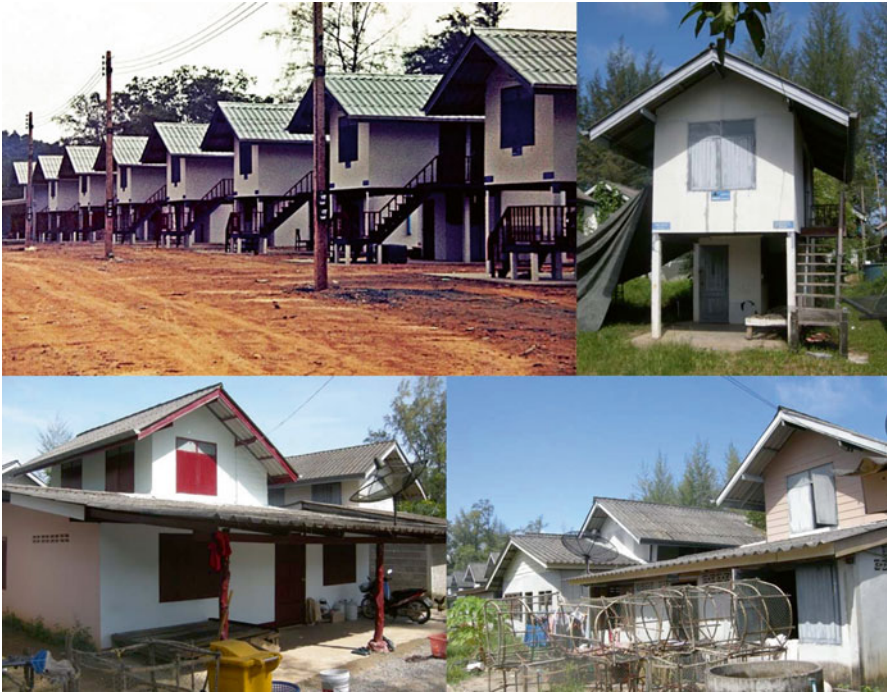
Fig. 6.9 The (then) newly built tsunami resilient houses at Nua village: at the beginning after the construction completed (*top left*: photo taken late 2005-early 2006, image by the Tambon Kamphuan Community Learning Center), house waiting to be renovated (*top right*, photo taken in August 2013) and the renovated houses (*bottom*: photos taken in August 2013)

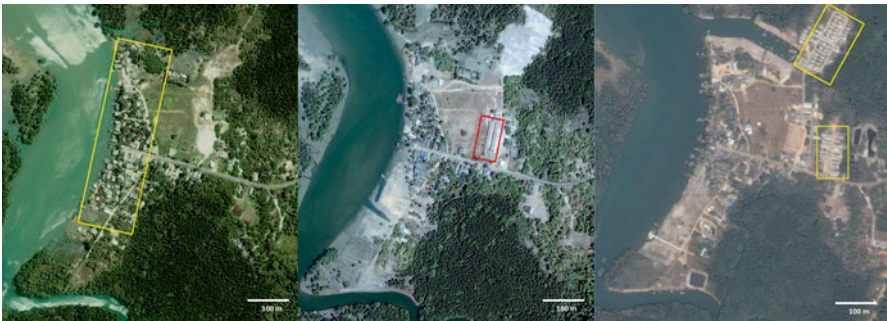
Fig. 6.10 The satellite images of the Hat Sai Khao village before (*left*: image taken on 6/5/2003), after the tsunami (*middle*: photo taken on 2/6/2005) and after restoration (*right*: photo taken on 2/3/2007). Note that the village (*yellow boxes* in the *left* and the *right* photos) was relocated from along the Kamphuan canal to further inland with slightly higher elevation. Note the temporary shelters built at the soccer field after the tsunami (*the red box* in the *middle* photo) (Source: Google Earth)

At Hat Sai Khao village, about 60 houses along the Kamphuan canal were heavily damaged by the tsunami wave that both came from the beach and travelled through the canal. Since the incident, the houses along the Kamphuan canal were relocated further inland away from the canal (Fig. 6.10). The newly built houses were divided into three groups. The first group consists of 50 houses, which were located in a new land bought and built by the Royal Thai Air Force with the donated money. Other necessary supplies for living were also donated along with the houses as those of Nua village. People who did not want to take the new house received 30,000 baht for a compensation of their losses. As there were only 50 houses in this group, residents who wanted this new house had to make a draw and could not choose which house to live in. The second group of the houses was built by using the fund from foreign organizations in a condition that the new owner had to find their own piece of land. Then these organizations would provide the necessary equipment and materials for constructing the new house, which was built by the local residents. This group consisted of ten one-story, moderate size houses locating in the same area. The third group of the reconstructed houses (14 units) was supported by the Nurses Association of Thailand who bought the land from the locals and built the houses at the location nearby the second group. As most of the land in the Hat Sai Khao village was in the National Park boundary, the residents of the new houses were only allowed to live there, but did not own the right of land.

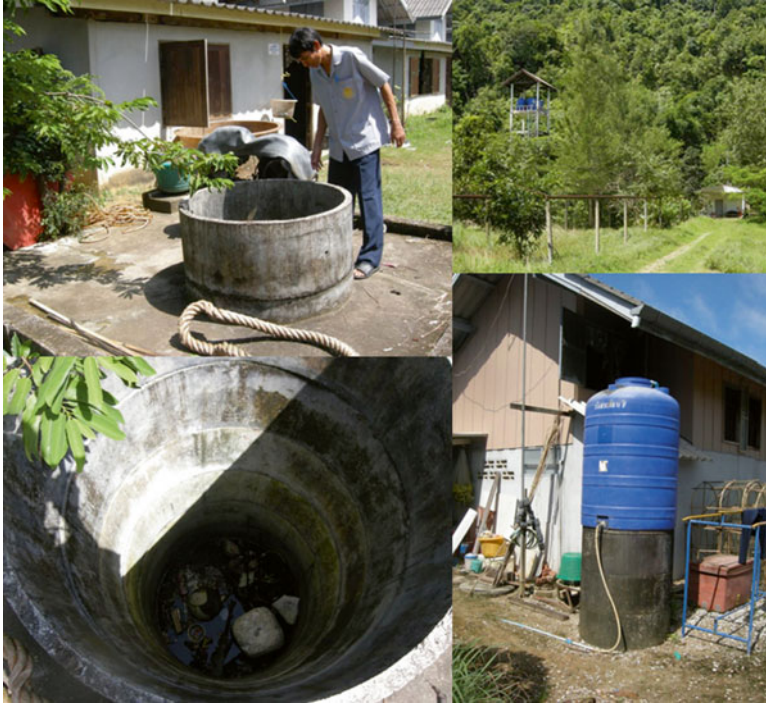
Fig. 6.11 A shallow water wells at the Nua village (*top left* photo). Many wells are abandoned due to intrusion of the brackish water, especially during the dry season (*lower left* photo). The new water storage tank was constructed at the higher elevation nearby (*top right* photo) which released the water to the village occasionally. The released water was then kept in a storage tank at the individual house (*lower right* photo)

For local water supply, the ACRSD had its own water storage tank that was not damaged by the tsunami. The research station just replaced the damaged water pipeline system with the new one. The situation was different for the Nua village that previously shared the water supply with the research center as they lived in the same area before the incident. After the tsunami, as the Nua village was relocated away from the ACRSD and the population in the village increased, the residents in the Nua village had to find new water sources. The water storage tank was built at higher elevation nearby in the National Park property and water was released to the village occasionally, depending on the amount of the stored fresh water in the tank (Fig. 6.11). During the days that the village did not receive water, the residents had to use the surface water from the shallow wells. At many times, there were water shortage problems in the village, especially during the dry season.

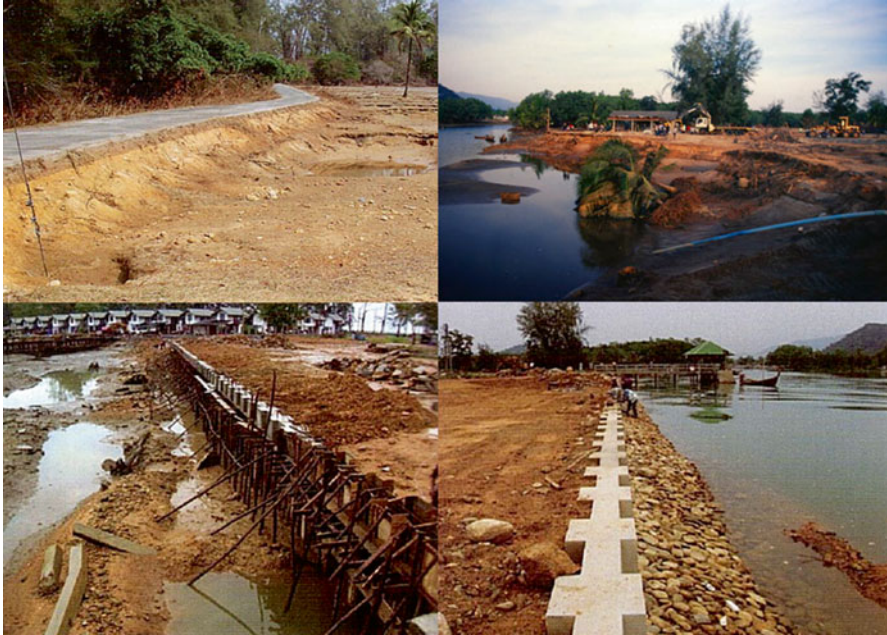
Fig. 6.12 Typical road damages (*top left*; early 2005) and erosion damage due to the tsunami wave along the Kamphuan canal (*top right*; December 2004); rebuilt of the Kamphuan canal's banks (*bottom*; mid 2005) behind the ACRSD (Source: ACRSD)

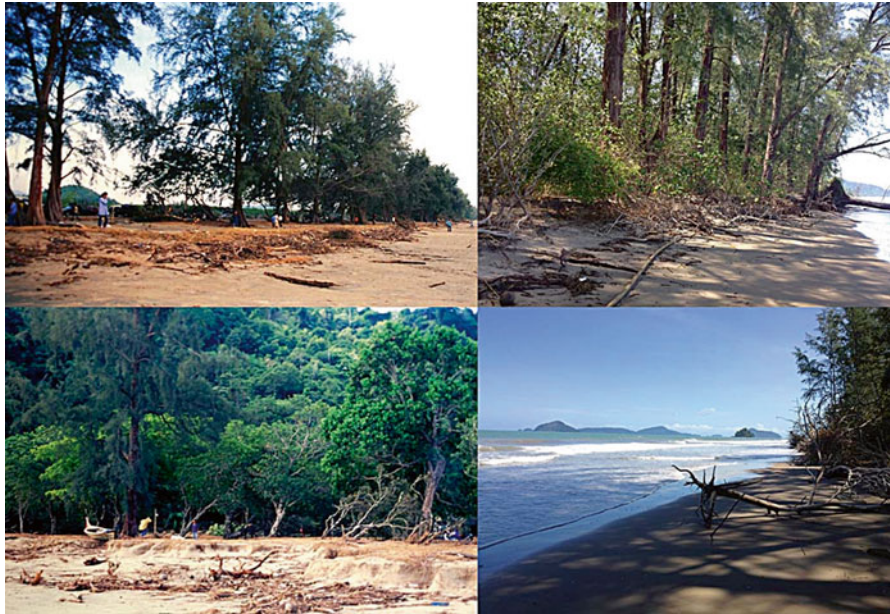
Fig. 6.14 The condition of the Praphat beach after tsunami (*left*: photos taken in December 2004) and the current condition of the beach (*right*: photos taken in August 2013). Note the moderate shoreline erosion problem along the beach

The Praphat beach is one of the famous tourist locations for the locals, especially during the weekend. Many tourists were killed during the incident. After the tsunami, the tourists disappeared due to the bad memories and the ongoing rebuilding of the affected area. The tourists have gradually come back to the beach eventually. The tsunami caused moderate erosion along the shoreline and caused many fallen trees. The eroded beach caused by the tsunami gradually restored (Fig. 6.14). Currently, the Praphat beach still encounters the erosion problem as those of many beaches along the Andaman coastlines.

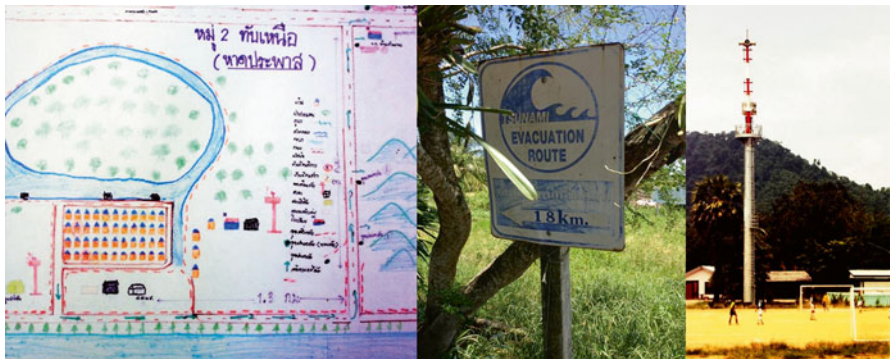
Fig. 6.15 A hand-drawing draft of the tsunami evacuation route map made by the local authority for the Nua village (*left*), the tsunami evacuation sign near the Praphat beach (*middle*) and the tsunami warning tower at the Hat Sai Khao village (*right*) (Source: Tambon Kamphuan Community Learning Center)

After the tsunami, several organizations came into the affected areas to educate people about the hazard of this natural disaster and taught about how to prepare themselves for it. The evacuation procedures were planned. The evacuation routes and signs were designed and built (Fig. 6.15). At the beginning, the ACRSD built a manual system tsunami-warning tower that the commanding officer had to turn on

the warning signal manually. Then two additional warning towers were built in the Nua village near the Praphat beach and at the soccer field in the Hat Sai Khao vil-
lage. The tsunami warning system installed in these new warning towers, were con-
nected directly to the national tsunami warning system and will be alarmed
automatically from the central command office in Bangkok. There has been a

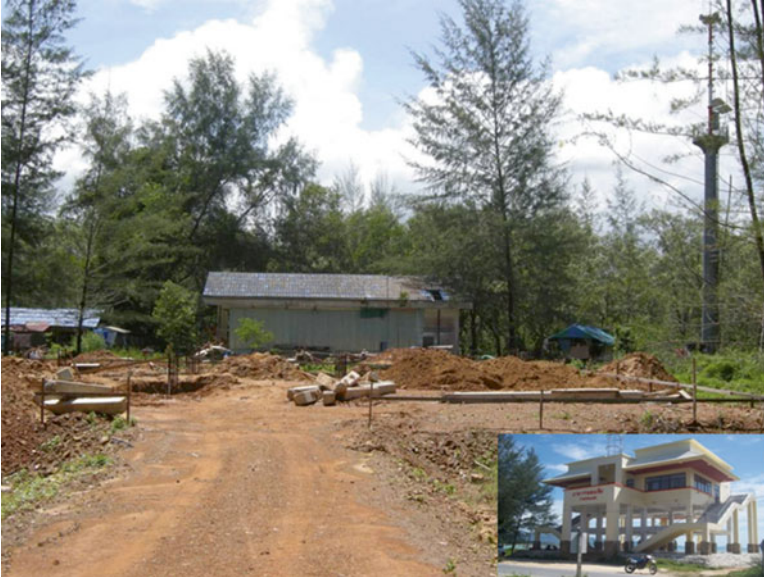
Fig. 6.16 The construction site of the standard emergency tsunami shelter (inset) at the Nua village, Kamphuan subdistrict, Suk Samran district, Ranong province that is funded by the government

MCOT (2013) reported that the government provided 20 million baht to fund the construction of two tsunami emergency shelters in Ranong province. One shelter is being constructed (as of August 2013) in the Nua village (Fig. 6.16). Therefore people in nearby areas can escape to this shelter if the tsunami occurs. The shelter is scheduled to be finished by 2014.

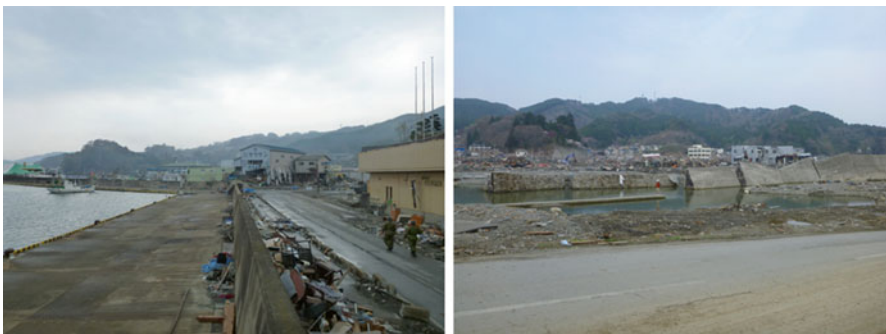
Fig. 9.5 Difference of damage at two different bays (April, 2011); Kamaishi port (*left, a*) and Otsuchi port (*right, b*)

These two locations show large differences as shown in Fig. 9.5. Two pictures of Kamaishi port and Otsuchi port were taken at April 2011. The damage of Kamaishi port is significantly smaller than Otsuchi port, qualitatively. Collapse of small structures can be seen but larger buildings were relatively undamaged on the Kamaishi waterfront. On the other hand, the most of structures and onshore breakwaters near the port in Otsuchi were totally destroyed as shown in Fig. 9.5b. The fatality ratios of Otsuchi area and Kamaishi area are 8.12 and 2.63 %, respectively. Although the damage to Kamaishi port was severe, it was not at the level of destruction observed at Otsuchi, reinforcing the conclusion that the offshore breakwater significantly reduced the extent of damage in this area.

Based on analysis of numerical calculations, it can be seen that the influence of offshore tsunami breakwaters significantly reduced the tsunami impact on onshore damage, in comparison with other similar areas such as Otsuchi. Not considering the cost of construction, effectiveness of tsunami mitigation through the use of breakwaters was verified for the first time by the experience of the Tohoku Earthquake tsunami. The degree of damage to the residential area strongly influence on the recovery of the devastated area. Table 9.2 and Fig. 9.6 show the time history of local tax at Kamaishi city and Otsuchi village based on public release, respectively. Kamaishi city includes the southern part of Otsuchi bay, Ryoishi Bay and

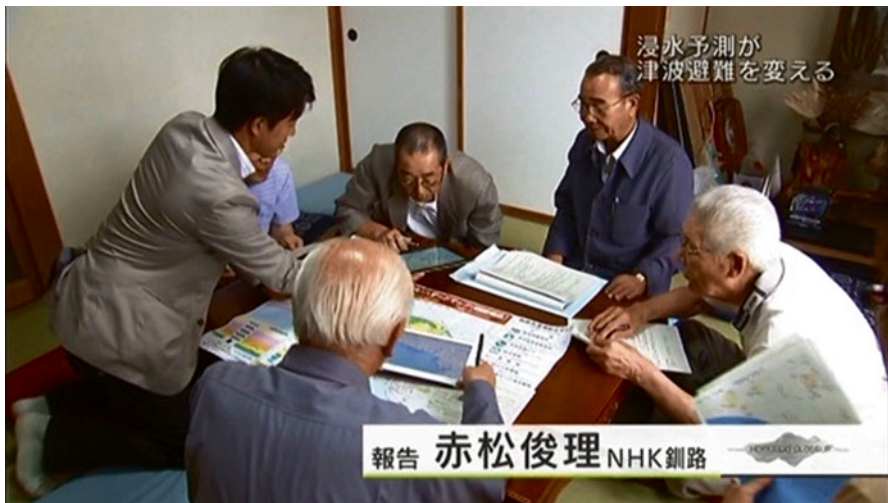
Fig. 11.13 Residents of Kushiro City making an evacuation plan using the tsunami hazard map provided by the Kushiro City Office (Source: NHK Television Network 2013)

The participants were split into different groups that started the evacuation process from two separate locations. The participants studied the tsunami hazard map for Kushiro City to locate the closest tsunami evacuation building relative to their positions (Fig. 11.13). The nearest evacuation building for both groups was a three-stories-tall high school building with a rooftop located approximately 2.5 km from the shoreline and 2.8 m above the mean sea level. Another nearby evacuation

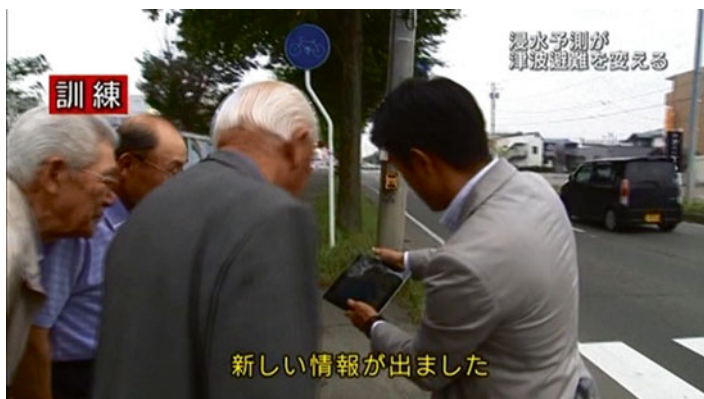
Fig. 11.15 The residents viewing the tsunami inundation forecast map that is available at 10 min after the initial announcement of the tsunami evacuation (Source: NHK Television Network 2013)

In the tsunami evacuation drill, we assumed that the JMA works as it should and delivers the tsunami messages to the residents of Kushiro within 3 min after the earthquake. Upon receiving the announcement of the tsunami warning, the participants immediately evacuated to the nearest evacuation building. At this point in time, they did not know the tsunami flow depth at their exact position or the limit of the tsunami inundation. That information was not given because we preferred to wait until we had more data so we could obtain more reliable earthquake source parameters, and we needed more time to obtain the tsunami inundation forecast map from the NearTIF algorithm. At 10 min after the initial warning, both groups receive new information for the tsunami inundation forecast map. They viewed the map via Google Maps over the Internet on a tablet computer (Fig. 11.15). The two groups made different decisions based on their own situations.

The first group was just in front of the high school building when they received the newly available tsunami inundation forecast. According to the tsunami inundation forecast, the building they were about to use as an evacuation building could be inundated by the incoming tsunami, and the tsunami at that building could be 3 to 4 m high. They considered the position of the evacuation building that is 2.8 m above mean sea level, the height of the building, and the tsunami inundation forecast (Fig. 11.14). They also considered evacuating to another evacuation building that would not be inundated by the tsunami, according to the tsunami inundation forecast. However, their final decision was to go to the initial evacuation building

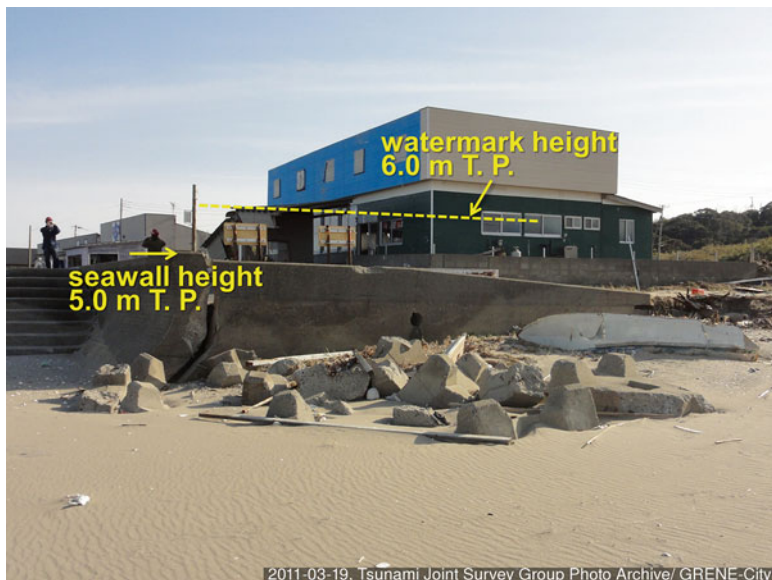
Fig. 13.4 Tsunami watermark measured in Hokota, Ibaraki Prefecture (March 19, 2011); watermark measured at 6.0 m T. P., 55 m from the shoreline (UTMS-0181 in the TTSG database, location marked in Fig. 13.2)

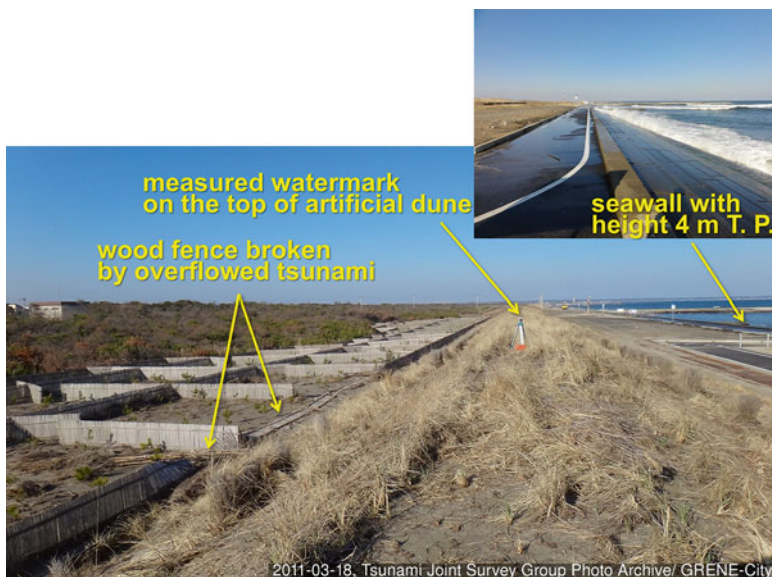
Fig. 13.5 Tsunami watermark measured on Kujuukuri Beach, Chiba Prefecture (March 18, 2011); a watermark was measured on the top of an artificial dune, 6.2 m T. P. and 17 m from the shoreline protected by a seawall with height 4 m T.P. (UTMS-0209 in the TTSG database, location marked in Fig. 13.2)

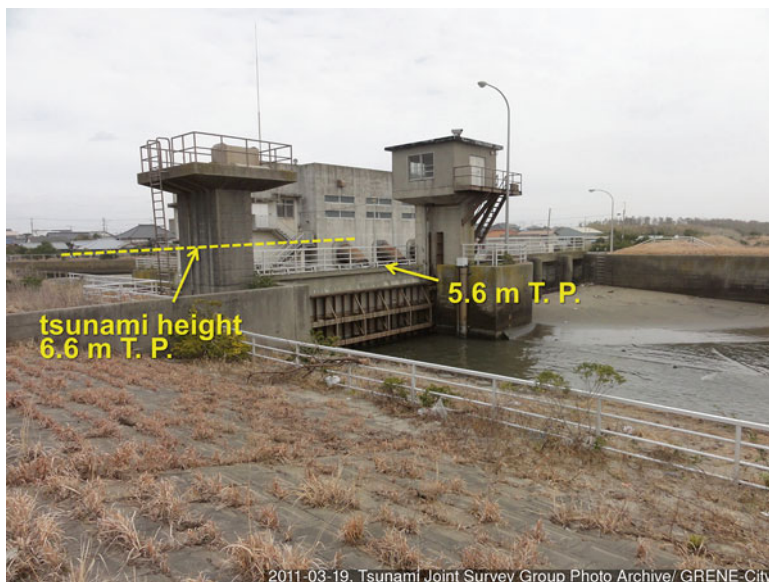
Fig. 13.6 Water gate at the Shimbori River mouth, Chiba Prefecture (March 19, 2011); measured watermark height was 6.6 m T. P. and 1.0 m higher than the top of the gate (UTMS-0163 in the TTSG database, location marked in Fig. 13.2)

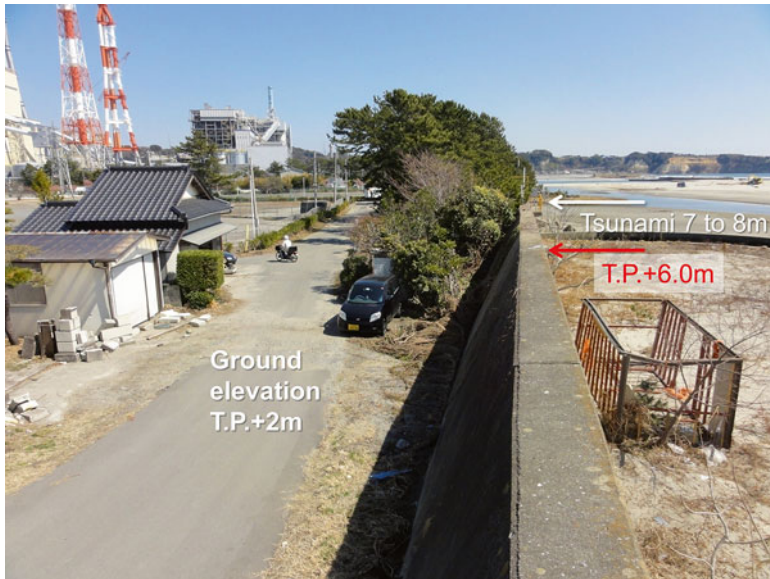
Fig. 13.10 Insignificant damage behind a high seawall in Ooshima District. (March 25, 2011). The location is marked in Figs. 13.8 and 13.14

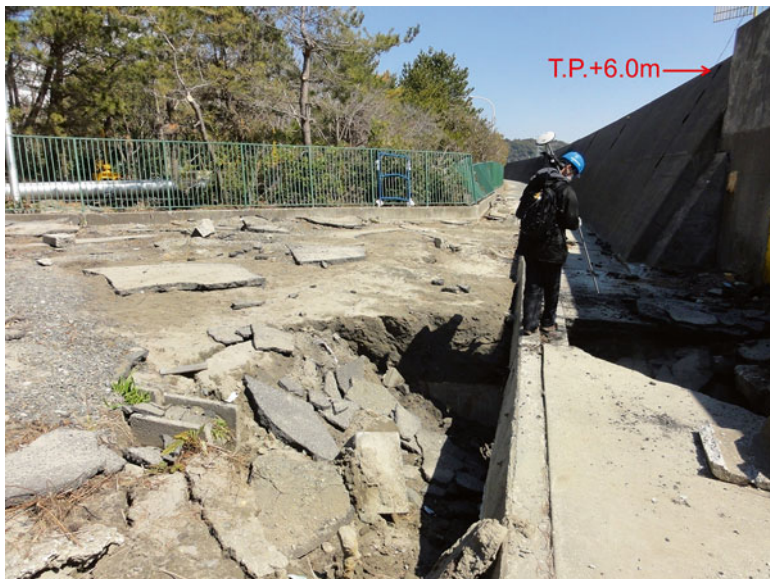
Fig. 13.11 Intact parapet and broken apron concrete with land scoured by overflowed tsunami in Power Plant District (March 25, 2011). The location is marked in Figs. 13.8 and 13.14

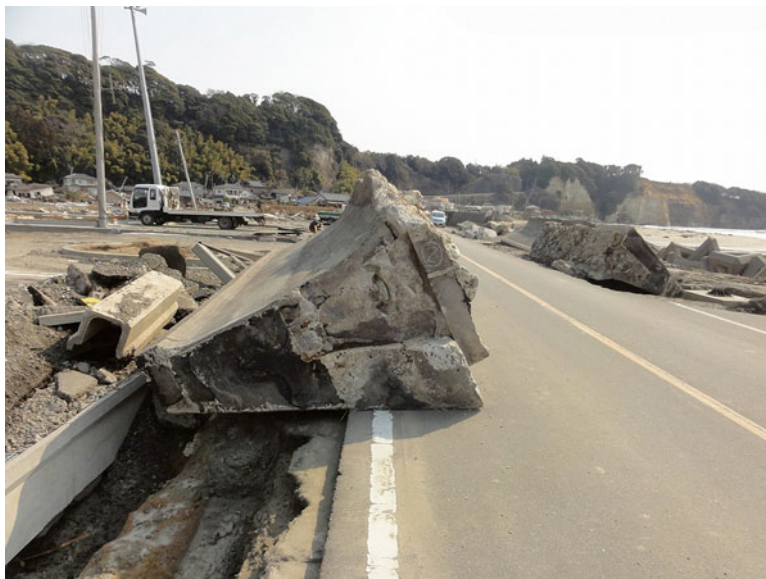
Fig. 13.13 Displaced and Broken seawall block in Iwama District (March 25, 2011). The location is marked in Figs. 13.8 and 13.14

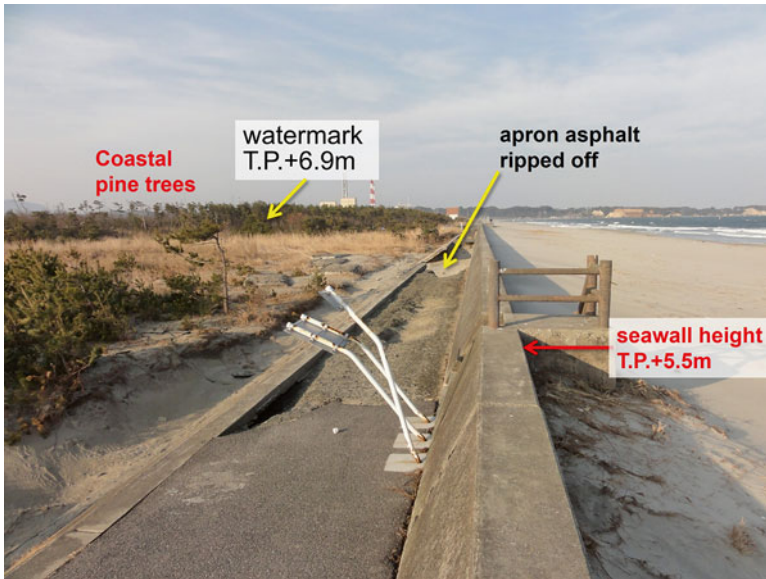
Fig. 13.16 Partially broken seawall and coastal pine trees in Suga District. The photograph was taken at the seawall on the line ‘S1’ marked in Fig. 13.8 (April 1, 2011). The watermark in the pine trees is the most seaward measurement plotted in Fig. 13.15b

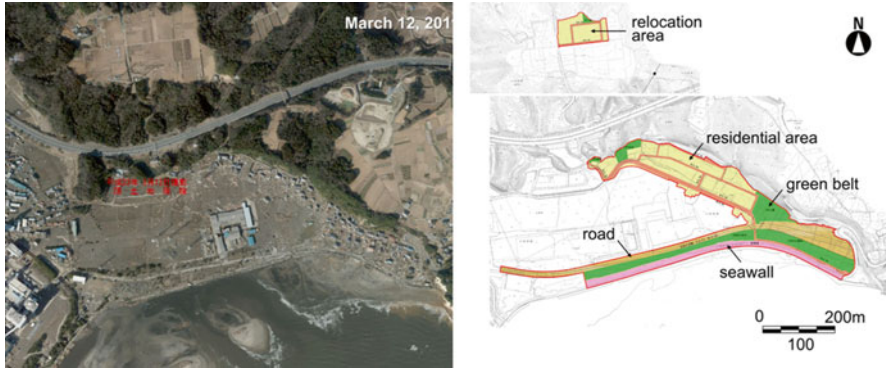
Fig. 13.17 Reconstruction Plan of the Iwama District, Iwaki City, as compared with a post-tsunami aerial photograph

Figure 13.17 illustrates the reconstruction plan of the Iwama District compiled by Iwaki City, Fukushima Prefecture, in February 2013 (Iwaki City 2013). It is composed of the construction of a 7.2 m T.P. seawall, alongshore green belt and relocation of a part of communities to higher ground. The height of the new seawall was determined by the runup height of the design storm waves, considering the significant erosion in nearshore bathymetry as well as the co-seismic land subsidence

which increased the runup height. The seawall height required for the Level-1 tsunami was computed by a numerical tsunami propagation model, which was found lower than the runup height of the storm wave. The shore parallel green belt will be constructed by a landfill with the same height of the seawall, with a purpose of reducing tsunami overflow and thus helping secure evacuation for the infrequent tsunami larger than the design level of the seawall.
