Advances in Natural and Technological Hazards Research

Post-Tsunami Hazard

Reconstruction and Restoration

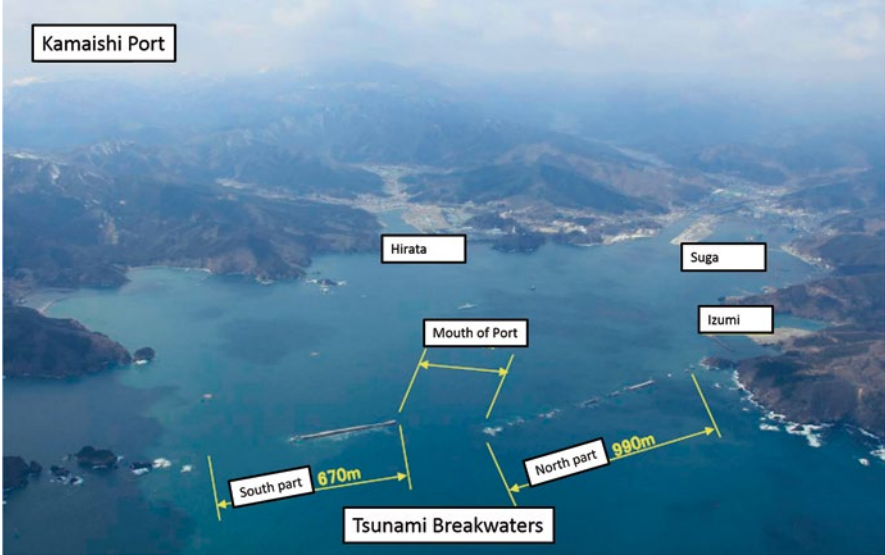
Fig. 14.1 View of the Breakwaters at the Mouth of Kamaishi Port after the 2011 Tsunami (Source: Tohoku Regional Development Bureau; Japan)

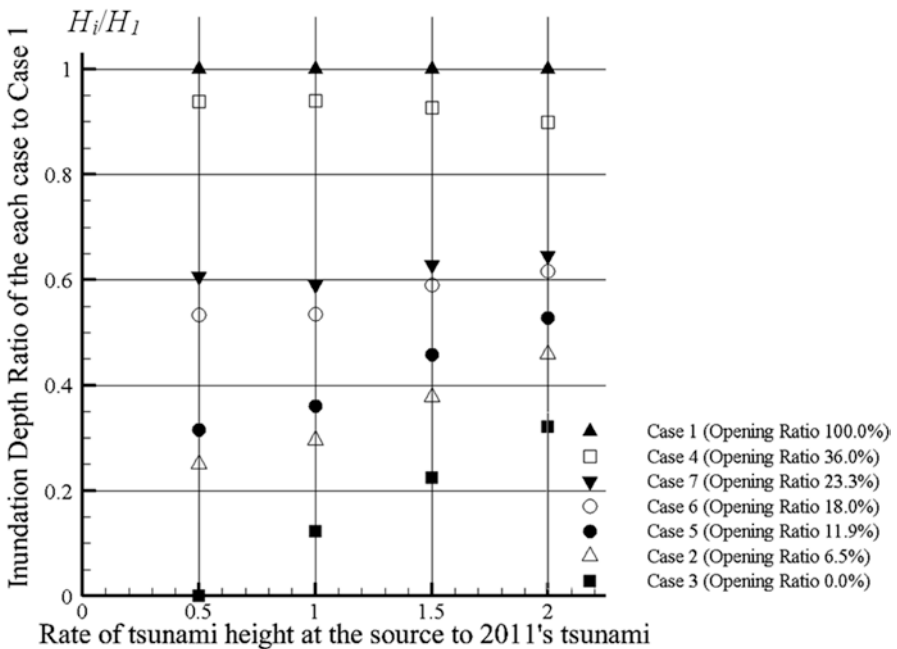
Fig. 14.10 Relation between inundation depth ratio and rate of tsunami height

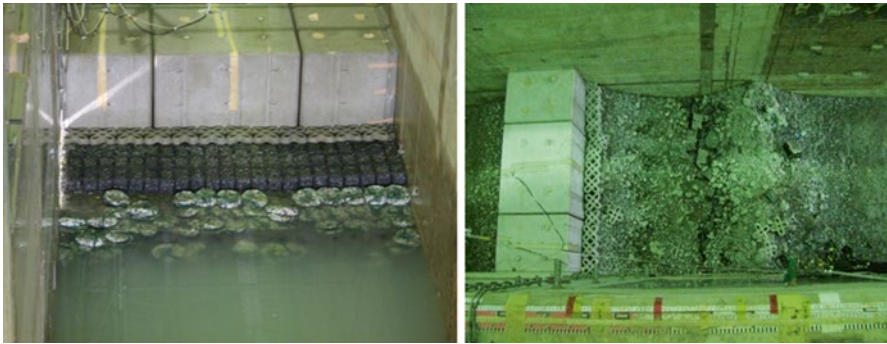
Fig. 14.14 State of widening work against overflow (Arikawa et al. 2013)

the tsunami but prevents scouring of the rubble mound foundation or the seabed. The material for the widening work is riprap, which is used to build foundation mounds. It is feared that if only riprap is used, the widening work will be scoured, so armor blocks are installed on the surface of widening work. Still, if the overflow scale increases, the covering work will be washed away and the widening work will be scoured, so as a countermeasure, scouring prevention work is installed.

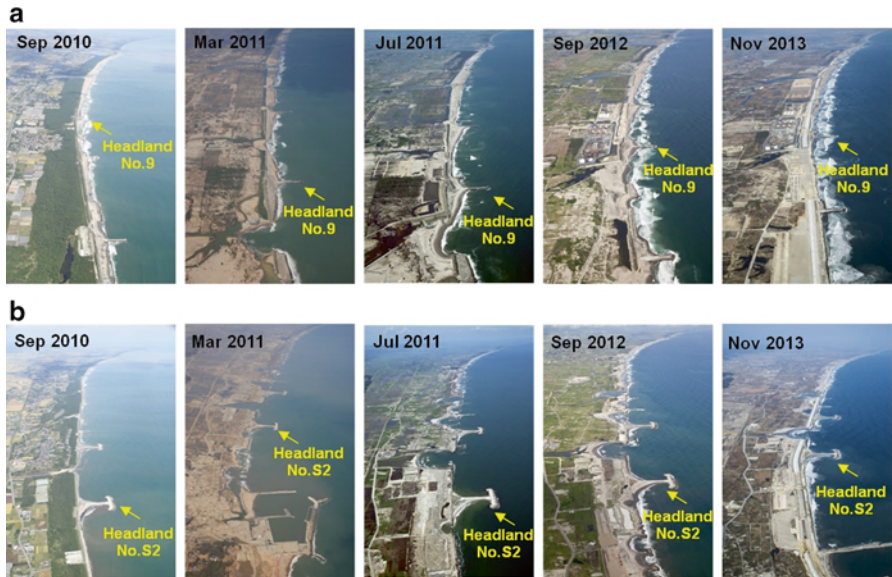
Fig. 15.3 Aerial photographs of coastal areas in September 2010, March 2011, July 2011, September 2012, and November 2013. The locations of (a) and (b) correspond to those of Fig. 15.2c, d (Source: Tohoku Regional Bureau, Ministry of Land, Infrastructure, Transport and Tourism of Japan)

longshore direction behind the seawall and at the same time, sediment deposition was notable just behind the water channels (Figs. 15.1c, 15.2c, and 15.3a). In Area D, the longshore water channels expanded even further compared to Area C and the entire beach disappeared seaward of the seawall crevasse (Figs. 15.1d, 15.2d, and 15.3b). Erosion was severer in the southern coast, especially in Area D where beach erosion was also significant in the past. Further, the old river channel was eroded in Area A (Tanaka et al. 2012; Tappin et al. 2012). In Area B, the sandbanks were eroded (Figs. 15.1b and 15.2b).

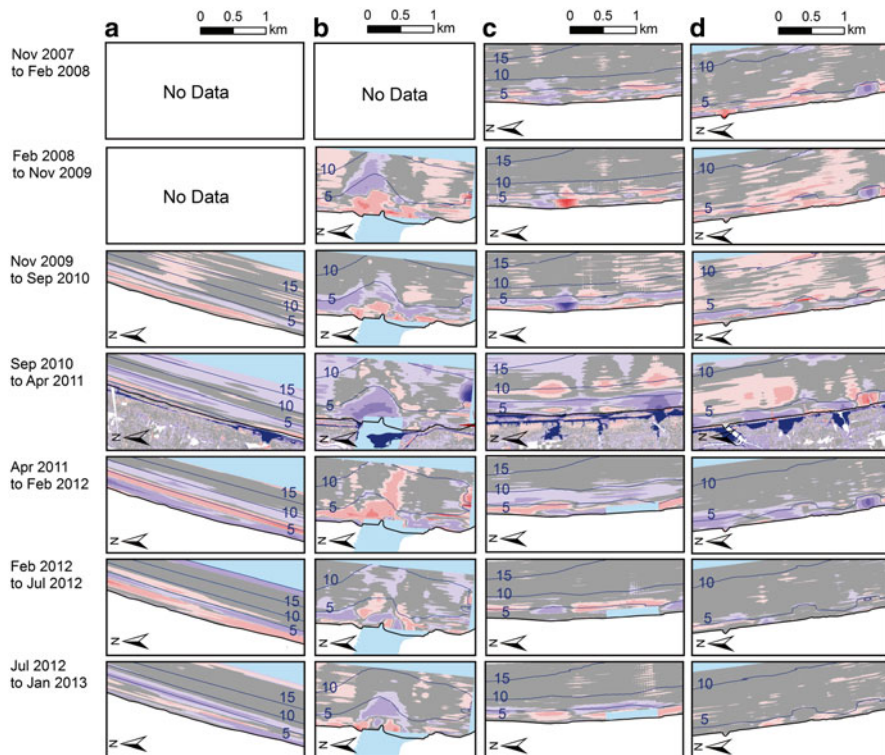
Fig. 15.4 Seabed elevation change from November 2009 to January 2013 (see Fig. 15.1). Land elevation change is also shown only in the figures from September 2010 to April 2011 (Source: Tohoku regional Bureau, Ministry of Land, Infrastructure, Transport and Tourism of Japan)

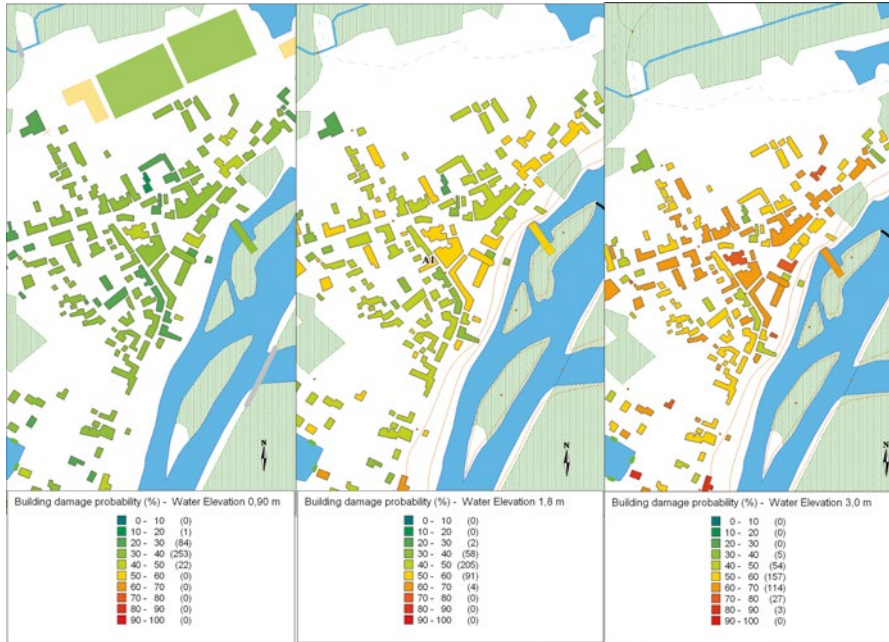
Fig. 16.5 Risk maps: evolution of damage failure in buildings at three different levels of flooding (Source: Mebarki et al. 2012; in Nat. Hazards Earth Syst. Sci)

The Geographic Information System (GIS) maps are adequate tools for mapping risk, hazard and expected socio-economic losses at local or large scales, (Fig. 16.5). They are very helpful when making decisions or analyzing resilience in different flooding scenarios. Adequate solutions can actually be proposed to improve resilience and provide a better capacity to urban systems: building surrounding barriers, dikes, and dams (Mebarki et al. 2012; Schelfaut et al. 2011).

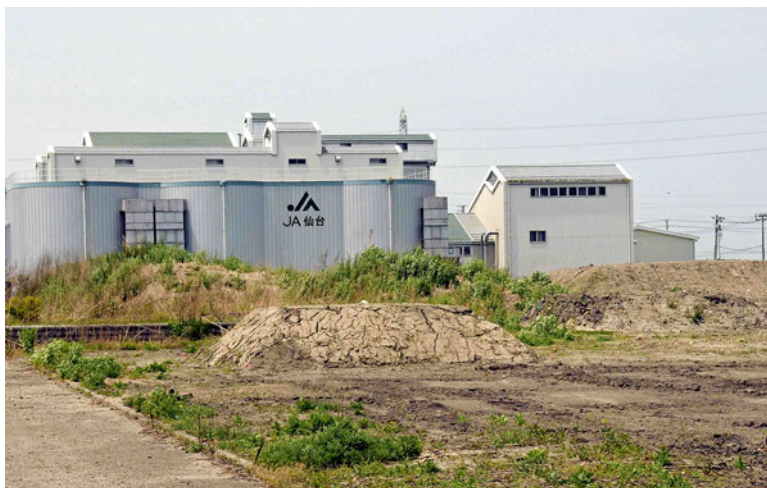
Fig. 17.3 Tsunami mud containing high concentrations of salt removed from damaged paddy fields. Sendai; Miyagi Prefecture

Tsunami mud causes a large increase in sea salt concentrations in the soil, which is mainly due to the presence of sea salt-contaminated terrestrial mud (Chagué-Goff et al. 2012a, 2013) in addition to marine mud brought ashore. As a result, such contaminated soil is rendered useless for rice cultivation therefore must be removed (Fig. 17.3).

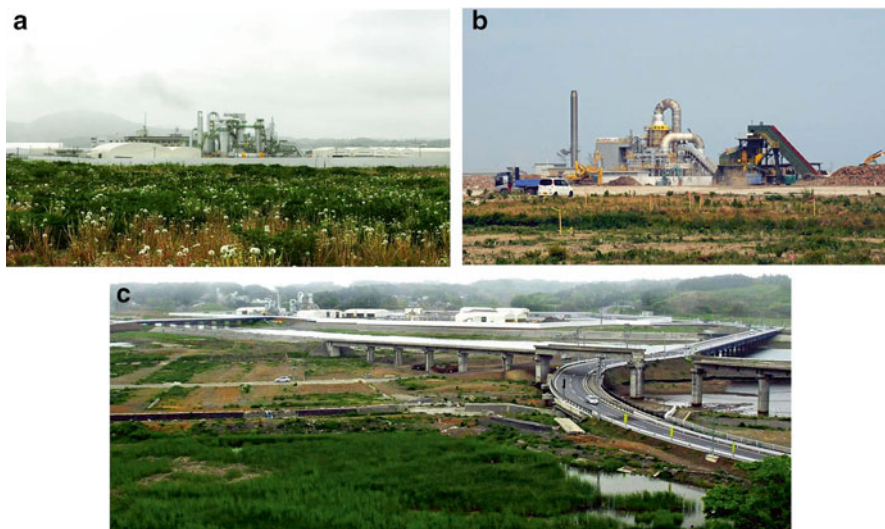
Fig. 17.7 Holding blocks and incinerator complexes at (a) Hajikami; (b) Harahama and (c) Koizumi, Miyagi Prefecture

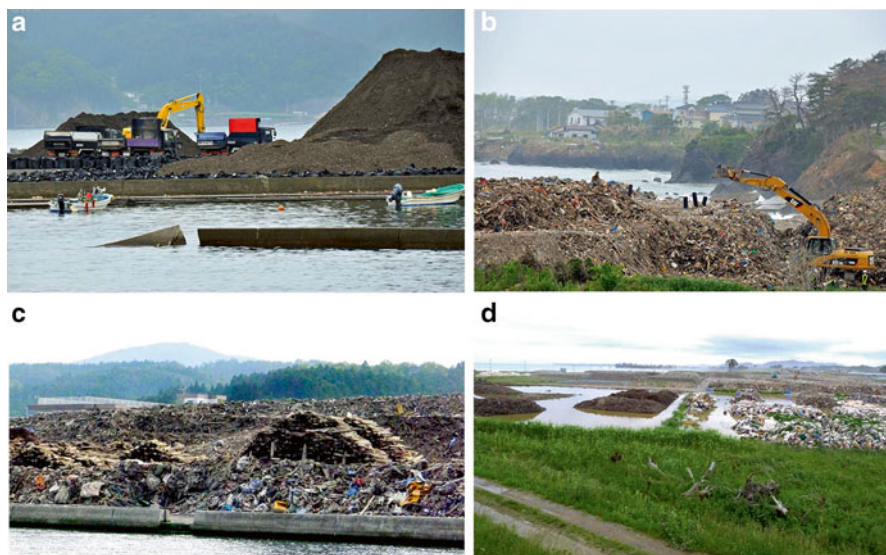
Fig. 17.9 Debris storage sites in lowlands along the coastline (a) shredded; (b) mixed; (c) wooden and (d) composite (partially submerged). Miyagi Prefecture

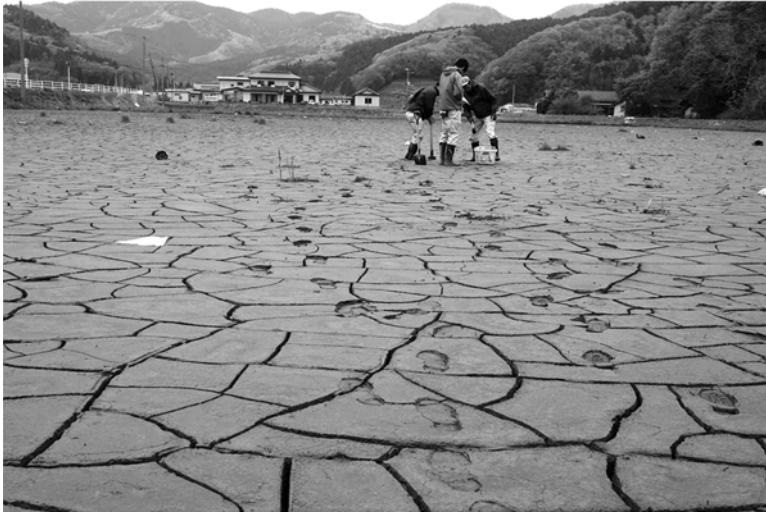
Fig. 18.5 Paddy fields covered by tsunami-deposit (mud). Paddy fields located near the branch of the Kitakami River were covered to a depth of 10 cm by tsunami deposit. The clayey muddy materials are cracked after drying out. Ishinomaki City, Miyagi prefecture; 11th May 2011 (Source Photo: Takehiko Yamamoto)
