Concrete

Building Pathology

Edited by
Susan Macdonald

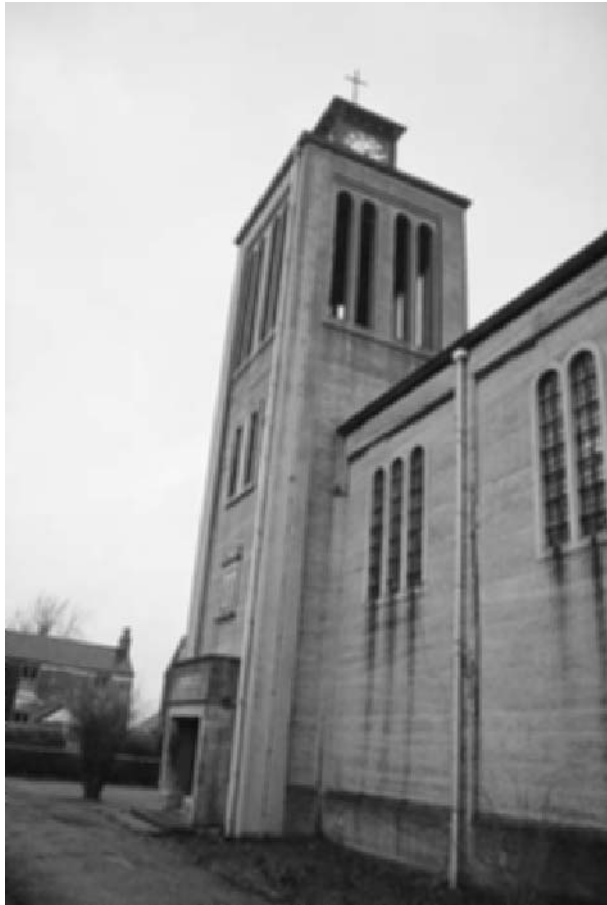
Fig. 1.1 St John and St Mary Magdalene, Goldthorpe, South Yorkshire, 1914–1916, designed by A. Nutt. The problems associated with the reinforced concrete decay in this church are a result of the particular way it was constructed, and are different from problems that have occurred in the building shown in Fig. 1.3.

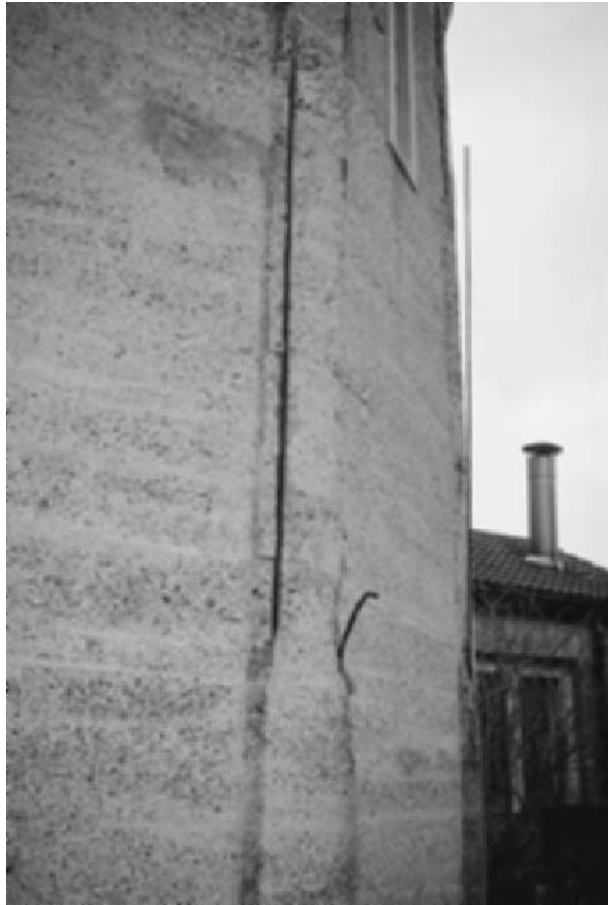
Fig. 1.2 St John and St Mary Magdalene, Goldthorpe, South Yorkshire. Despite the reasonably thick walls, the location of the reinforcement is variable and does not appear to have been well restrained horizontally, as can be seen in the photograph. The concrete is quite porous, and the building is suffering from prolonged deterioration with scant maintenance, which has resulted in some structural problems. Understanding the level of knowledge and types of materials used at the time when it was built is important to an analysis of the problems and may influence the repair decisions.

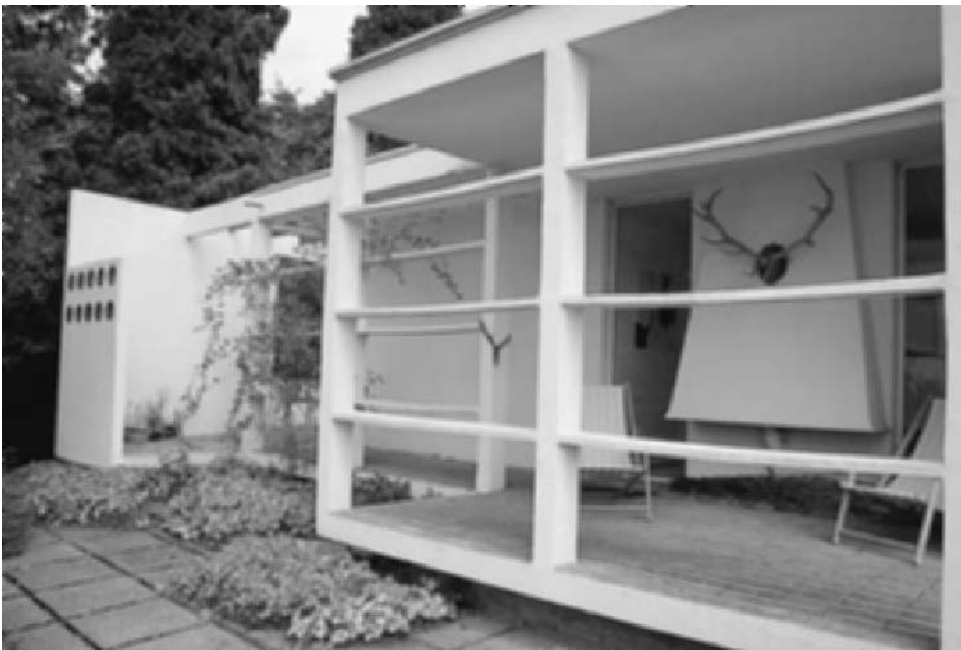
Fig. 1.3 The Loggia, Bungalow 'A', Whipsnade, Buckinghamshire, 1933–1936, designed by Berthold Lubetkin. The thin-walled construction of the architect's own house has suffered problems typical of its era and construction type. The slender precast-concrete members of the loggia and fenestration have sagged. Despite the thin-walled construction, with its minimal cover to the reinforcing steel, the concrete is of a high quality and has therefore survived relatively well. The building was to be repaired using a fairly minimal approach.

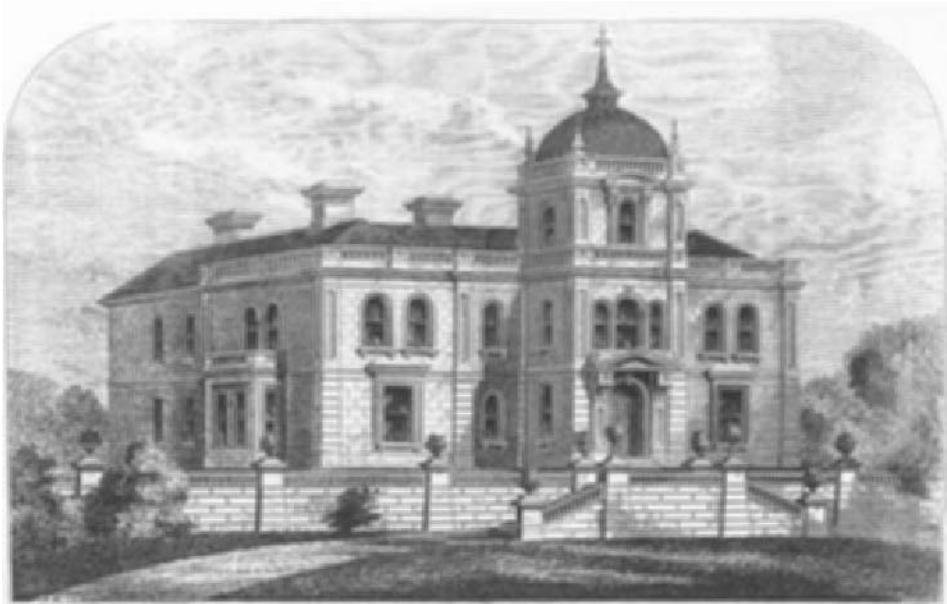
Fig. 2.1 A mass concrete house: Fenlands Villa, Chertsey, Surrey (1870) (from *The Builder*, 12 February 1870, p. 125).

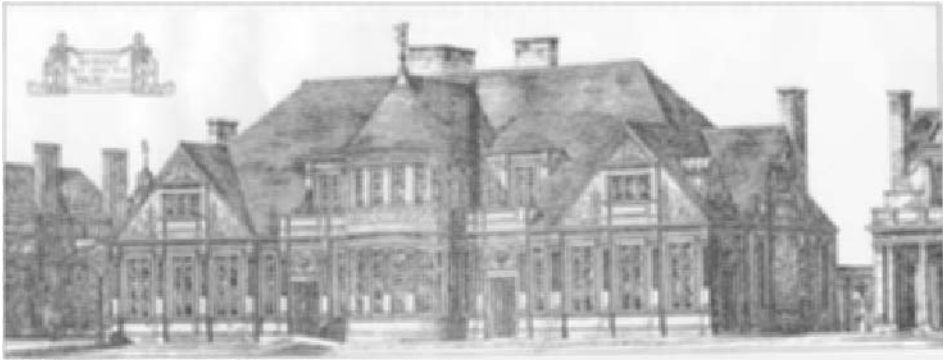
Fig. 2.2 The Buffet at Royal Albert Dock using Lascelles system of precast concrete panels (*Building News*, 19th October 1883).

panels, about $1\text{ m} \times 0.75\text{ m} \times 40\text{ mm}$ thick, was used for many domestic and industrial buildings, and usually featured ornate decoration both for external use in walls and internally for ceilings (Fig. 2.2). As so often happened, the mouldability of concrete was used to disguise the material by giving it the appearance of stone or even brick tiles.

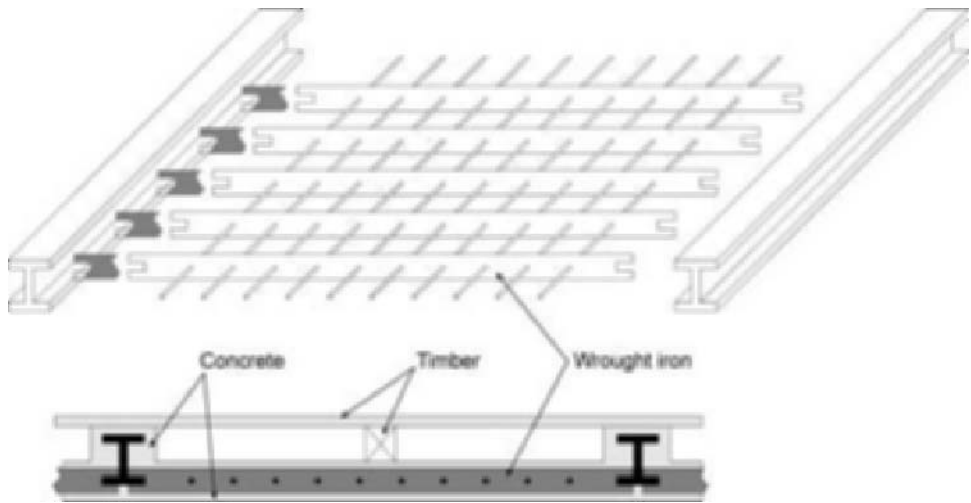
Fig. 2.3 Hyatt's patent reinforced concrete floor system developed about 1877 (drawing Bill Addis).

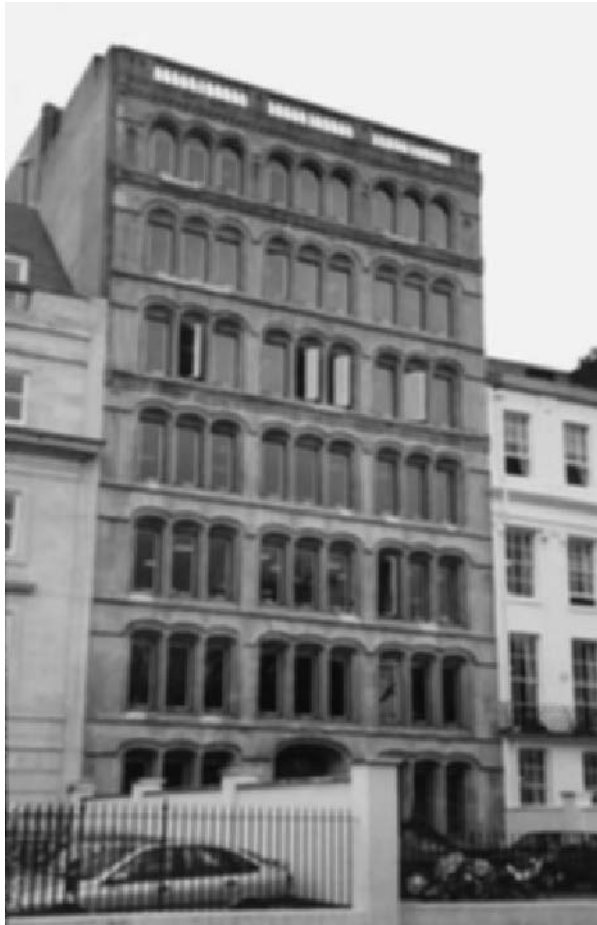
Fig. 2.4 63 Lincoln's Inn Fields, London, with Hyatt reinforced concrete floors (see Fig. 2.3) and walls of mass concrete (photo/copyright Lawrence Hurst).

During the following 30 years many similar patents were filed (de Courcy, 1987; Simmonet, 1992b). In 1877, Thaddeus Hyatt, an American working in Britain, privately published the results of extensive experiments he had undertaken on concrete beams reinforced with iron which had been tested at Kirkaldy's materials testing laboratory in London. A seven-storey building designed in 1886 using Hyatt's patented system of reinforcing concrete survives to this day at 63 Lincoln's Inn Fields in London (Figs. 2.3 and 2.4) (Hurst, 1996). The scene was already set for the development of modern reinforced concrete.

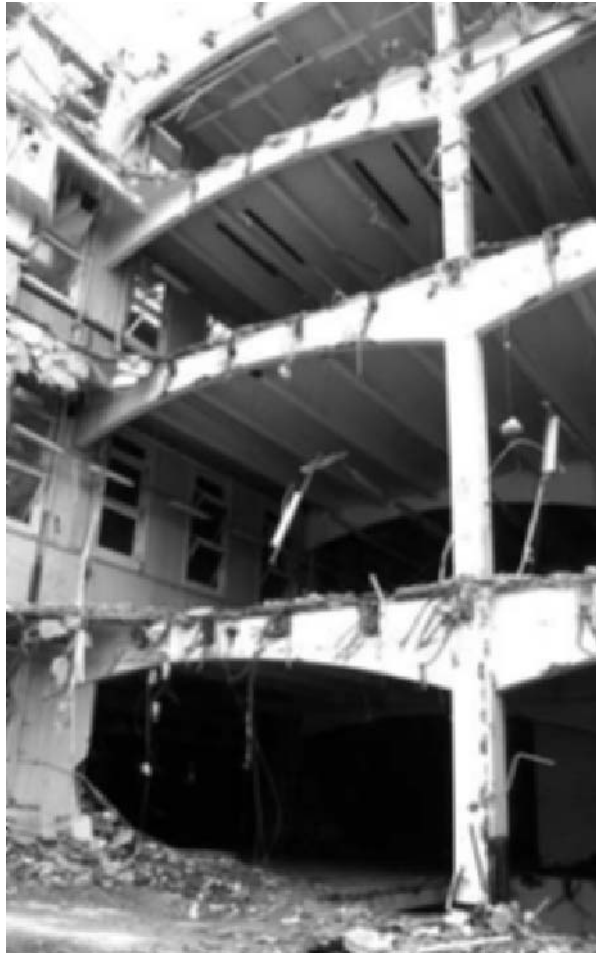
Fig. 2.6 King Edward Street Sorting Office in the City of London, during demolition (photo Michael Bussell).

His patronage of the new material did much to encourage other architects to use reinforced concrete (Port, 1995). As there was no codified view on the design and use of reinforced concrete at the time, local authorities (and particularly district surveyors in central London) were chary about accepting proposals for its use. However, since Government buildings were Crown property they were exempt from local authority building control, and so Tanner was free to use the new material. His sorting office at the King Edward Street building of the General Post Office in St Martin's le Grand (1907–1910) in the City of London was among the largest reinforced concrete buildings yet built in Britain, and the first in central London (Fig. 2.6). It employed long-span haunched beams with

generous storey-heights and floor-loading capacity, with a deep floor plate fed with daylight by lightwells—an early precursor of today’s office block with open-plan layout and atrium (Twelvetrees, 1907). Like Weaver’s Mill, this important early concrete building survived for nearly a century. Regrettably, it was demolished in 1998.

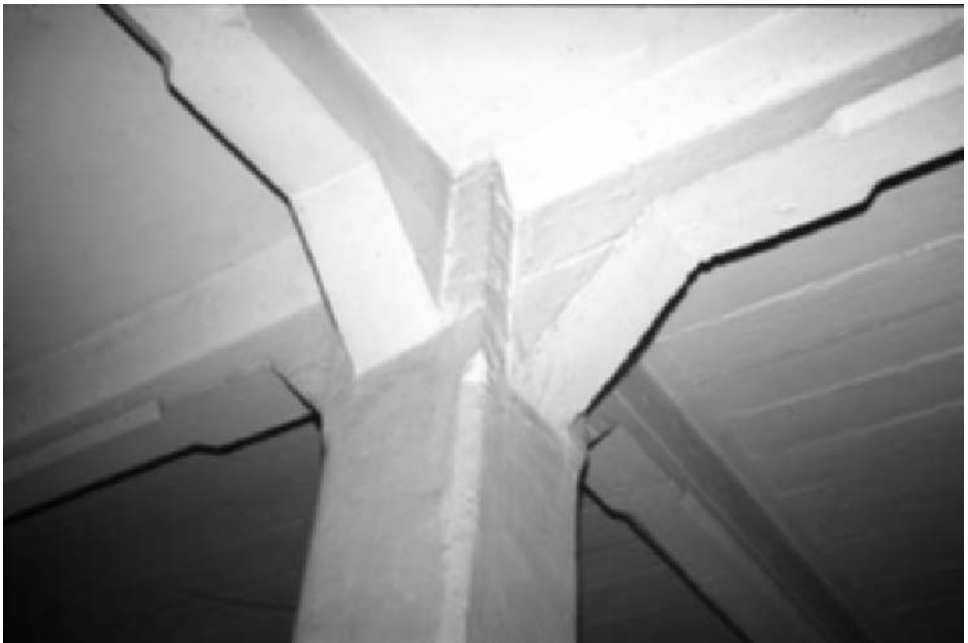
Fig. 2.7 Co-operative Wholesale Society warehouse, Quayside, Newcastle upon Tyne, 1897: detail of reinforced concrete beam-column joint, more akin to that found in an iron or steel frame (photo Michael Bussell).

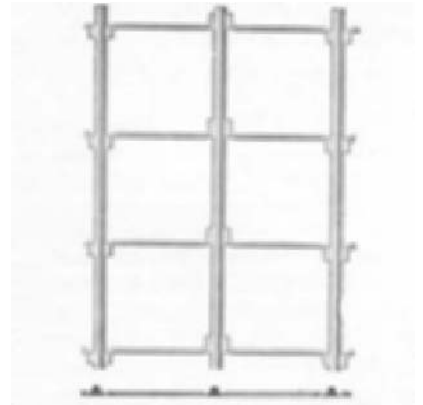
Fig. 377.—Rib Mesh Expanded Metal

Finally, it should be mentioned that other forms of steel were also used in reinforced concrete construction. Expanded metal (known in the USA as 'slashed metal') was introduced in the 1890s and found wide use. Structural steel sections such as I-beams were commonly embedded in concrete as foundation grillages for both steel- and concrete-framed buildings. For purely functional elements, particularly in wartime when steel was scarce, any steel to hand might be pressed into service, including conduit, second-hand cable, gas-pipes and fence posts.

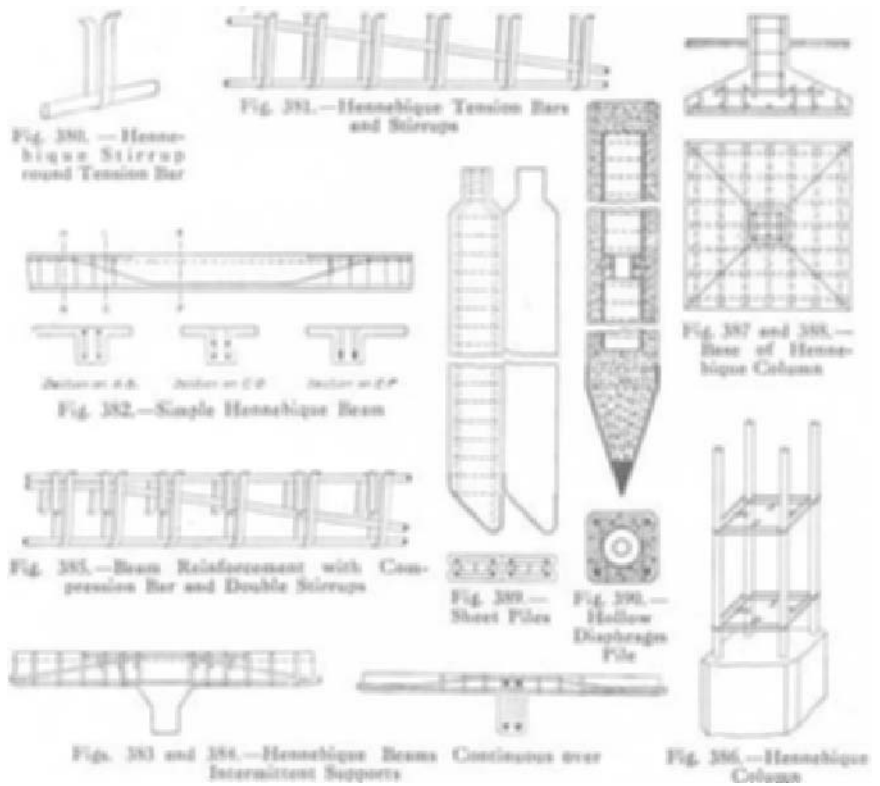
Fig. 2.9 The Hennebique reinforcing system (from Jones, 1920).

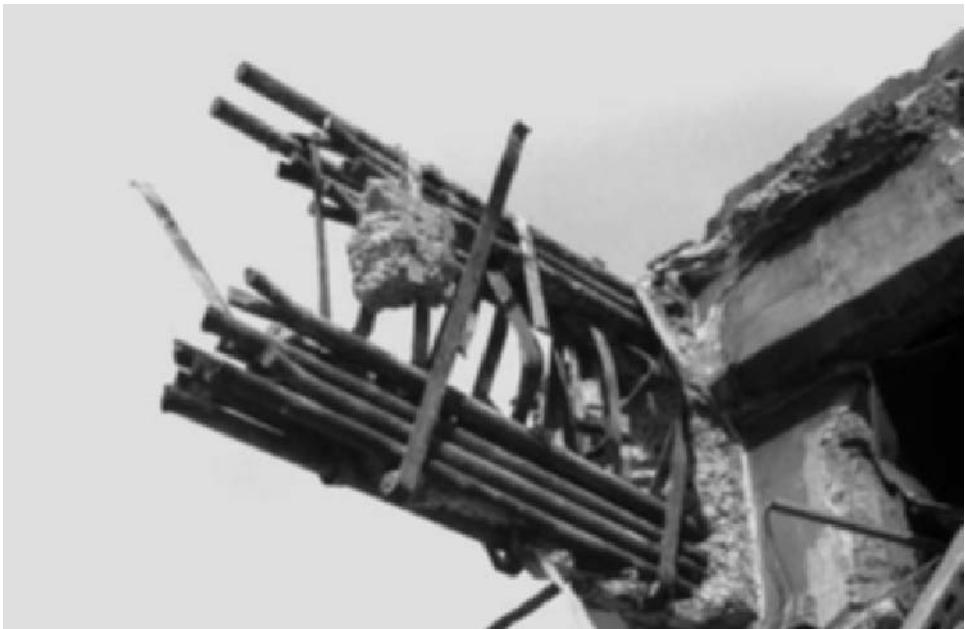
Fig. 2.11 King Edward Street Sorting Office. Column head with congested Hennebique main steel, exposed during demolition (photo Michael Bussell).

A further factor in judging the amount of water was the need to ensure that the newly mixed concrete filled the forms as it was poured. Pragmatically, it was recognised that to produce a sound concrete, it should be as dense and as free of air as could be achieved. In the early years of the century, the methods of delivery available were a chute or wheelbarrow to transport the concrete; it would be lifted to its required level by a hoist and poured into the forms. Here, it would be worked into position by shovel and spade, and then hand-compacted (maybe) using rammers or ‘punning’ tools. To assist compaction, especially with congested reinforcement, it was common to add water to the mix so that it flowed more easily and became, to some extent, self-compacting. Even so, concrete might not be able to penetrate crowded reinforcement, as shown in Fig. 2.11 in a photograph taken during demolition. In 1917, Eugène

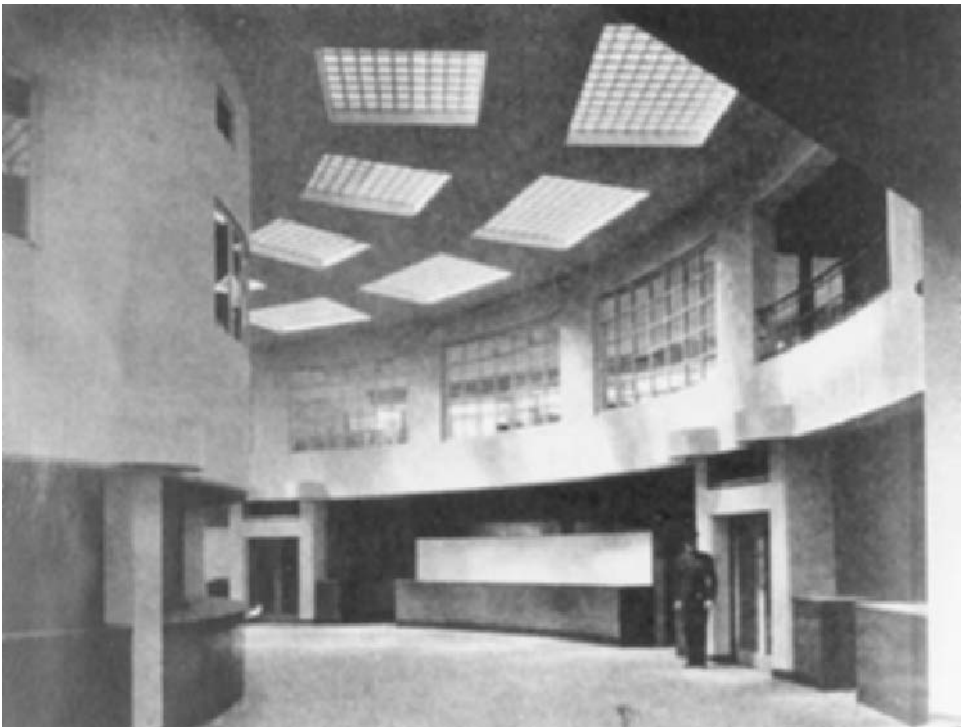
Fig. 2.15 Gatwick Airport terminal, interior. The internal wall at first floor level, supporting the control tower and roof, consists of a circular Vierendeel girder supported at six points (from *Concrete and Constructional Engineering* (1936) 31).

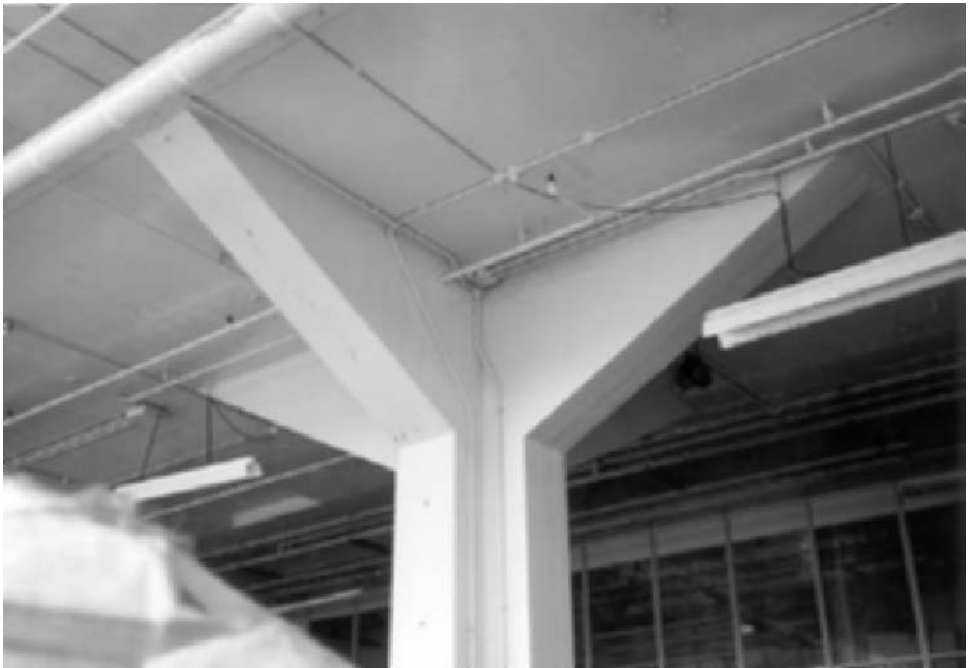
Fig. 2.16 Column detail in Boots packed ‘wets’ factory, Beeston, Nottingham, 1930–1932. Engineer and architect Owen Williams (photo Bill Addis).

- the expression of the function of structural members by shaping them to reflect the stresses and bending they were carrying, for example, the columns and floors of the Daily Express building, London (1929–1931), Boots ‘wets’ and ‘drys’ buildings (1930–1932 and 1935–1956) (Figs. 2.16 and 2.17) (*Architects’ Journal*, 1932, 1938, 1994, 1997), and the later roofs in the BOAC maintenance headquarters building, Heathrow Airport, London (1950–1955);
- the integration of services into his concrete structures, for example, the main columns of his Dorchester Hotel scheme, London (1929–

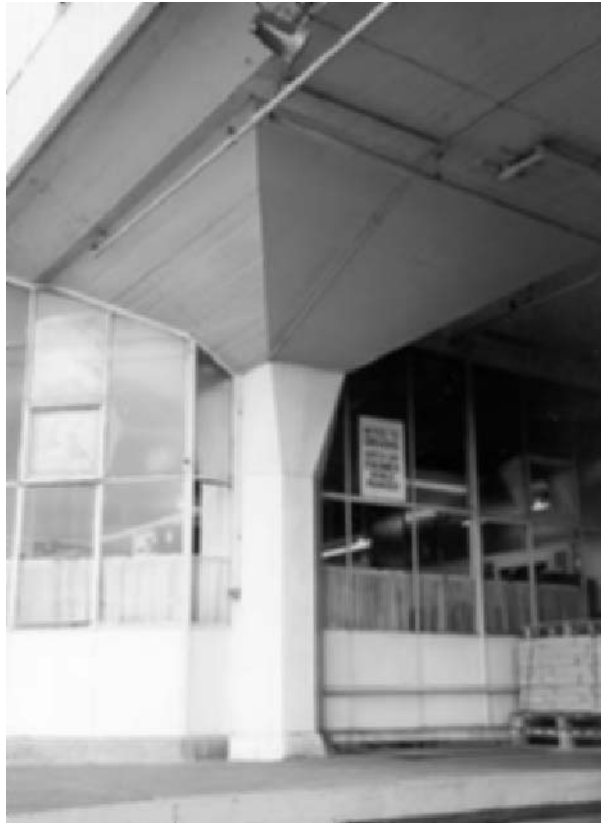
Fig. 2.17 Column detail in Boots 'drys' factory, Beeston, Nottingham, 1935–1936. Engineer and architect Owen Williams (photo Bill Addis).

- the use of the curtain wall, for example the Daily Express building, London, and Boots 'wets' building, Nottingham (1930–1932) (Fig. 2.18);
- sheer structural boldness and ingenuity, for example one roof in the Boots 'drys' building (1935–1936) has 9-foot (2.75-m)-deep valley beams spanning 215 feet (65.6 m) on just two columns, suspended from an adjacent building at one end and with a 48-foot (14.6-m) cantilever at the other, far greater than ever before (and seldom exceeded since).

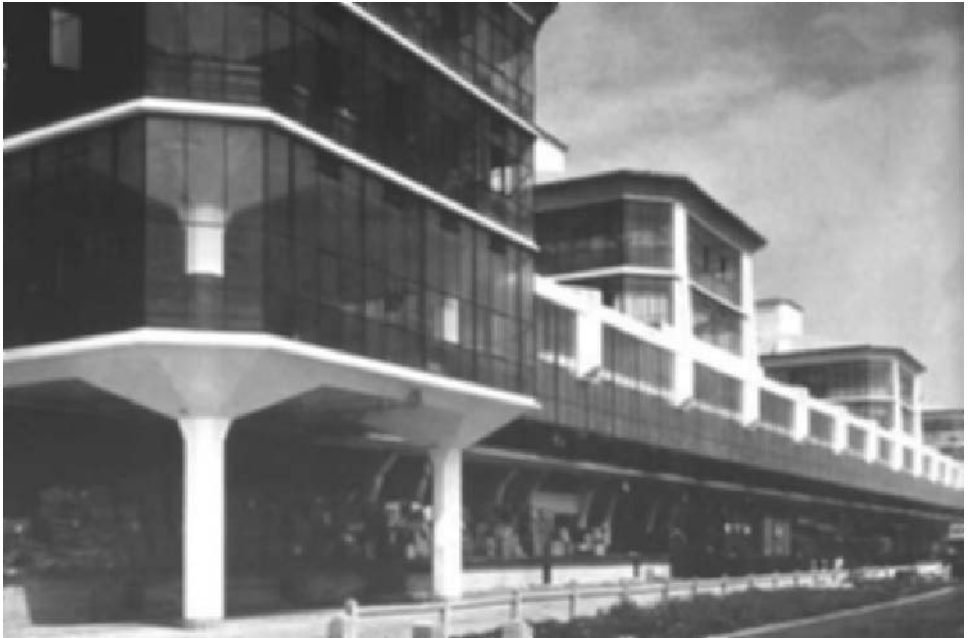
Fig. 2.18 Exterior view of Boots 'wets' factory, Beeston, Nottingham, 1939–1932. Engineer and architect Owen Williams (photo Cement and Concrete Association).

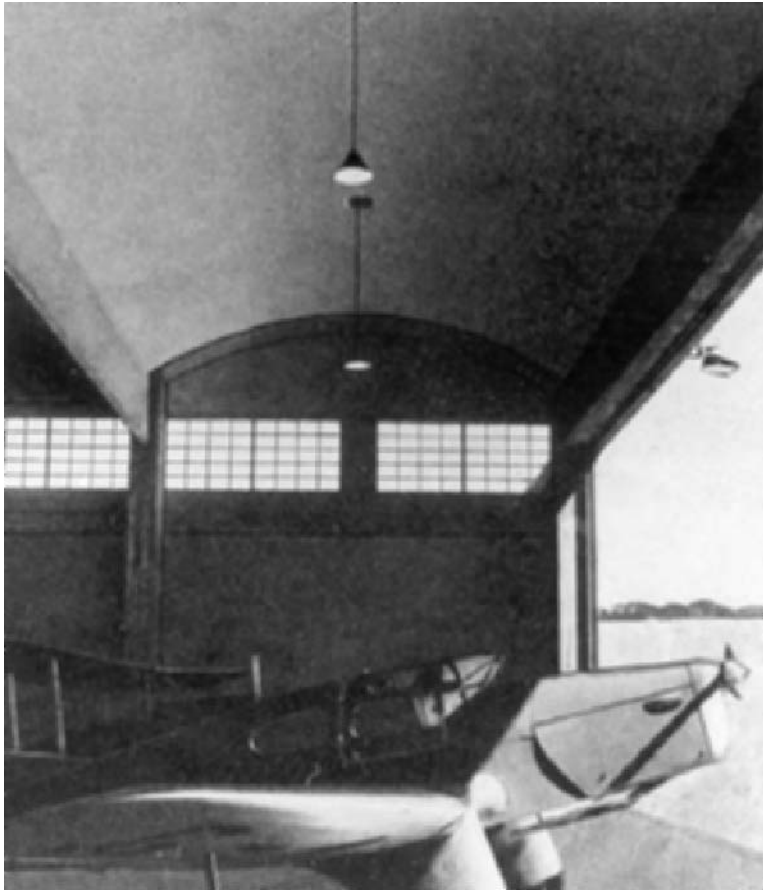
Fig. 2.21 Doncaster Aerodrome hangar, 1936. The concrete shell is approximately 4 in. (100 mm) thick. The building consisted of two bays, each 90 ft. \times 30 ft. (27.5 m \times 9.1 m). It is reputed to be the earliest genuine concrete shell in Britain (from *Concrete and Constructional Engineering* (1936) 31).

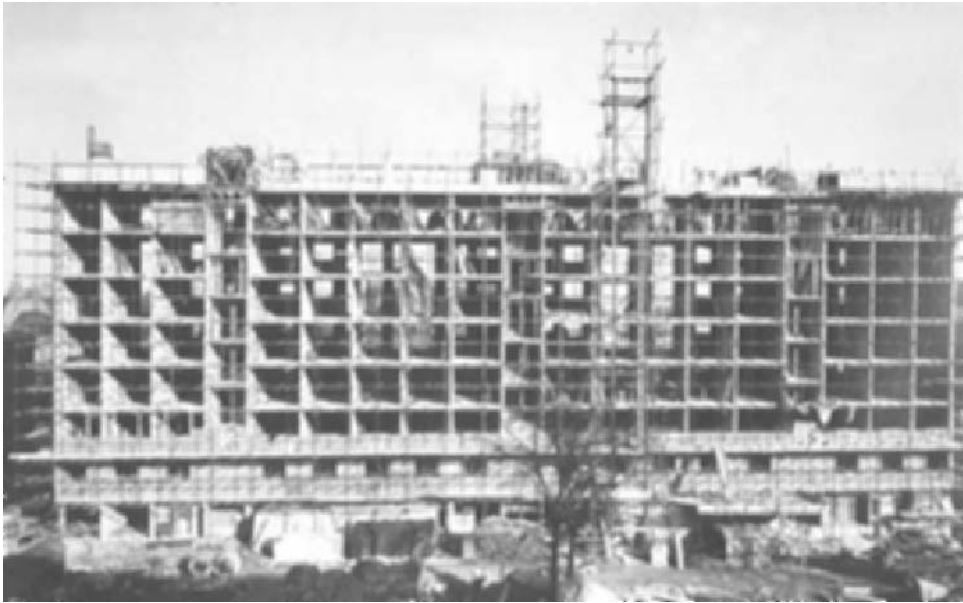
Fig. 2.24 Spa Green Estate, Finsbury, London, 1949, seen under construction (photograph Sydney Newbery, courtesy Ove Arup Partnership).

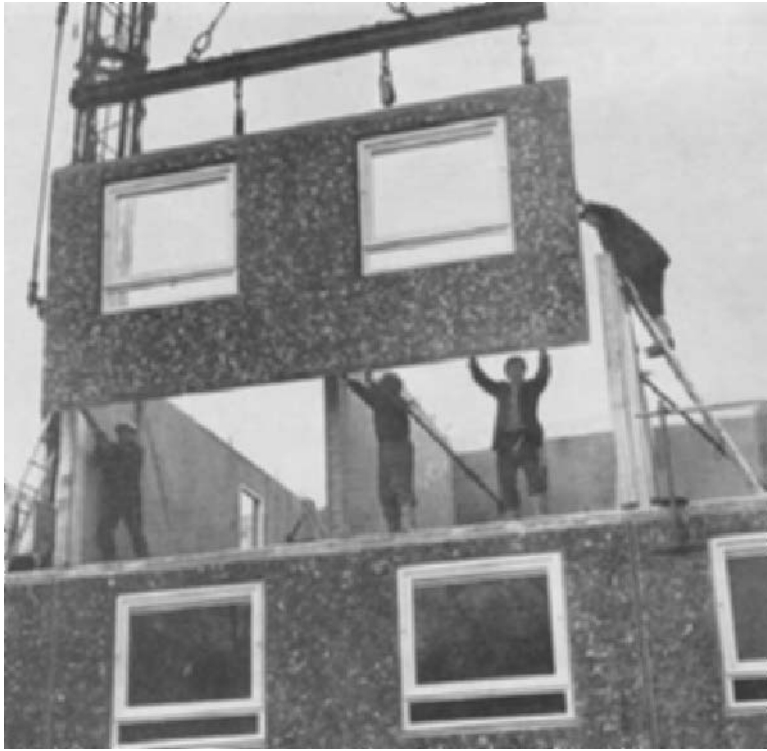
Fig. 2.26 The Taylor Woodrow–Anglian precast housing system, typical of many (from Deeson, 1964).

were rather lost in the rush to build as much and as quickly as possible. Systems proliferated as all the major contractors developed their own patent methods for high-rise flats and other building types (Fig. 2.26). One national survey reported no less than 170 proprietary building systems, mostly non-British, many of which were used in Britain under license (Diamant, 1964, 1965, 1968; Bussell, 1996b).

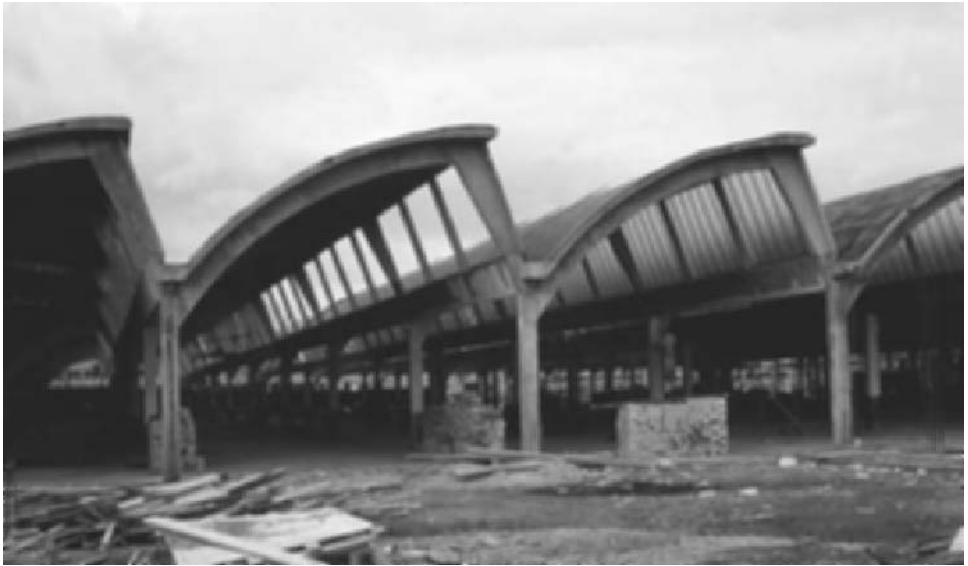
Fig. 2.27 A north-light, concrete-shell factory roof at Cadbury's factory, Moreton, Cheshire, under construction (courtesy Institution of Civil Engineers).

On a smaller scale are the shell roofs that cover many hundreds of markets and factory buildings constructed up and down the land during the 1950s and early 1960s (Figs. 2.27–2.30). They were usually the work of specialist concrete firms, acting as design-and-build contractors to realise an architect's basic layout and scheme. Many of these roofs have lasted well even in our moist climate. As with other reinforced concrete buildings, their life depends initially on the quality of the site personnel and the care with which they checked the placing of the reinforcement, and the quality and placing of the concrete, as well as on the subsequent maintenance regime for the building. Maintenance remains the Cinderella of the building industry; it has yet to go to the ball.

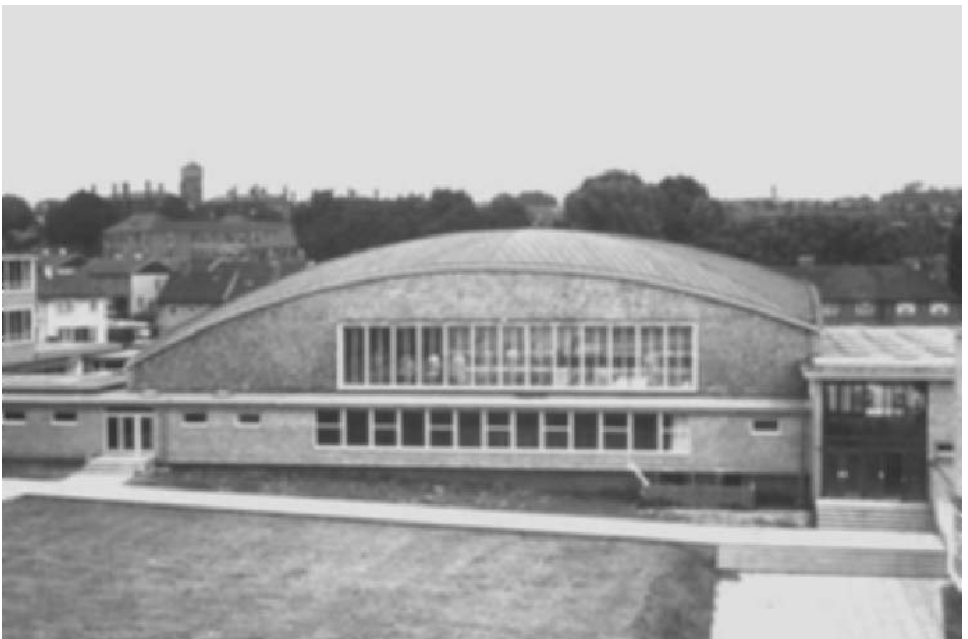
Fig. 2.28 Kidbrooke Comprehensive School, Blackheath, south-east London, 1949–1954, with a shell roof span of 113 ft. \times 75 ft. (34.4 m \times 22.9 m). Architect Slater Wren and Pike, engineer Ove Arup & Partners (courtesy Ove Arup Partnership).

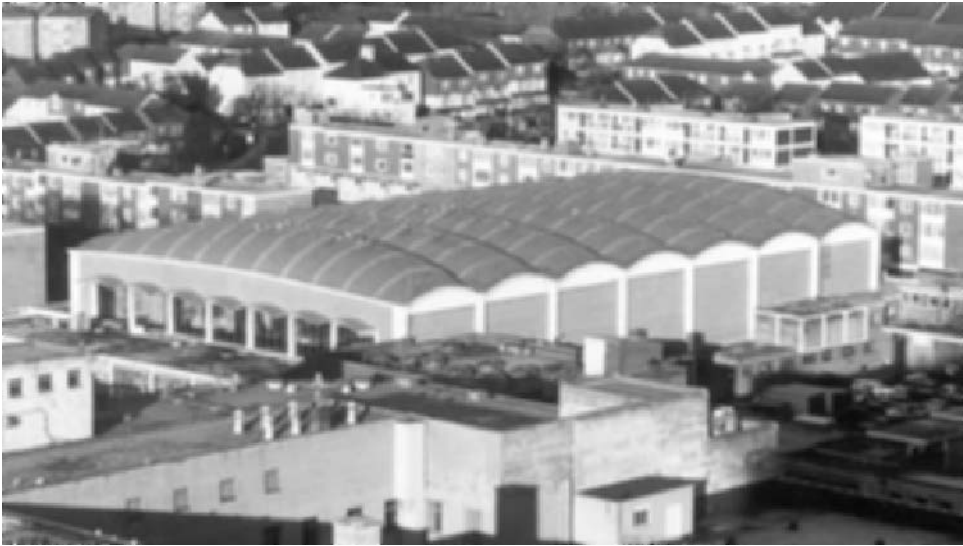
Fig. 2.29 Pannier Market, Plymouth, 1960, exterior view. The north-light shell roof has six bays and covers a total area of 192 ft. \times 76 ft. (58.6 m \times 23.2 m). The market was originally conceived with two trading floors. The upper one was abandoned, but the roof was kept at the original height. The result is a truly splendid interior. The building won a Civic Trust Design Award in 1960. Architect Herbert Walls and Paul Pearn, engineer British Reinforced Concrete Engineering Co. (photo Bill Addis).

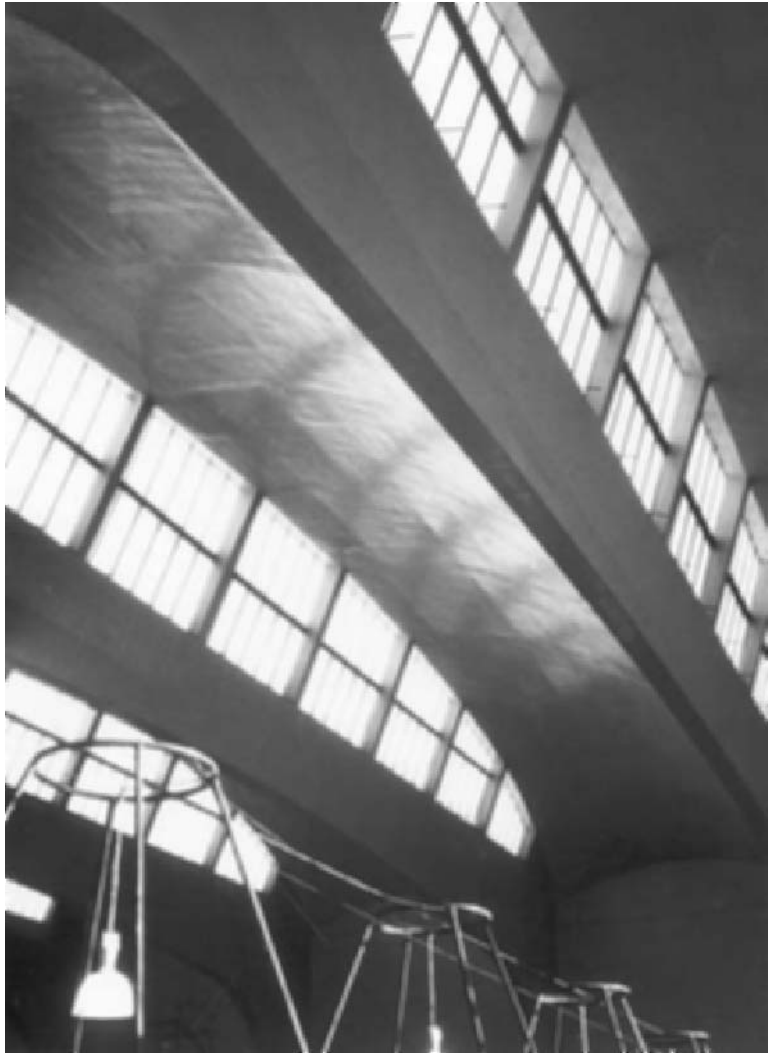
Fig. 2.30 Pannier Market, Plymouth, interior view (photo Bill Addis).

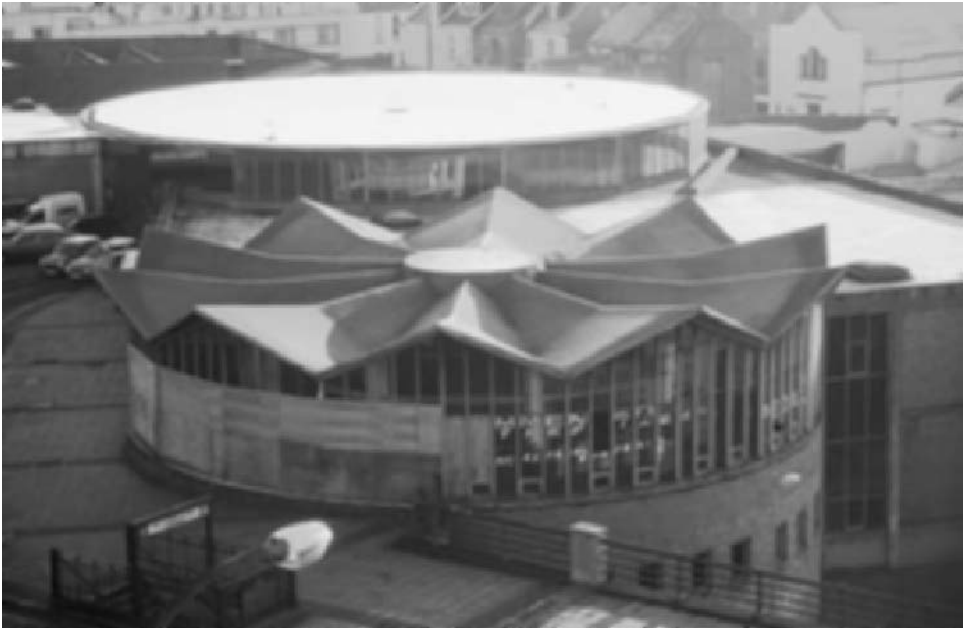
Fig. 2.31 Folded plate roof over car showroom, Turnbull's Garage, Plymouth, 1960. The folded plate roof is supported on ten columns beneath the valley points. The adjacent flat circular roof covered the filling station area of the garage, which was the first self-service filling station in Britain (photo Bill Addis).

Like many of the small, curved shell roofs, folded-plate structures in concrete were used in many small local authority, commercial and factory buildings and, in general, have gone unremarked. One charming example is a garage in Plymouth (1960, architect Roseveare, engineer Felix Samuely and Partners) (Fig. 2.31).

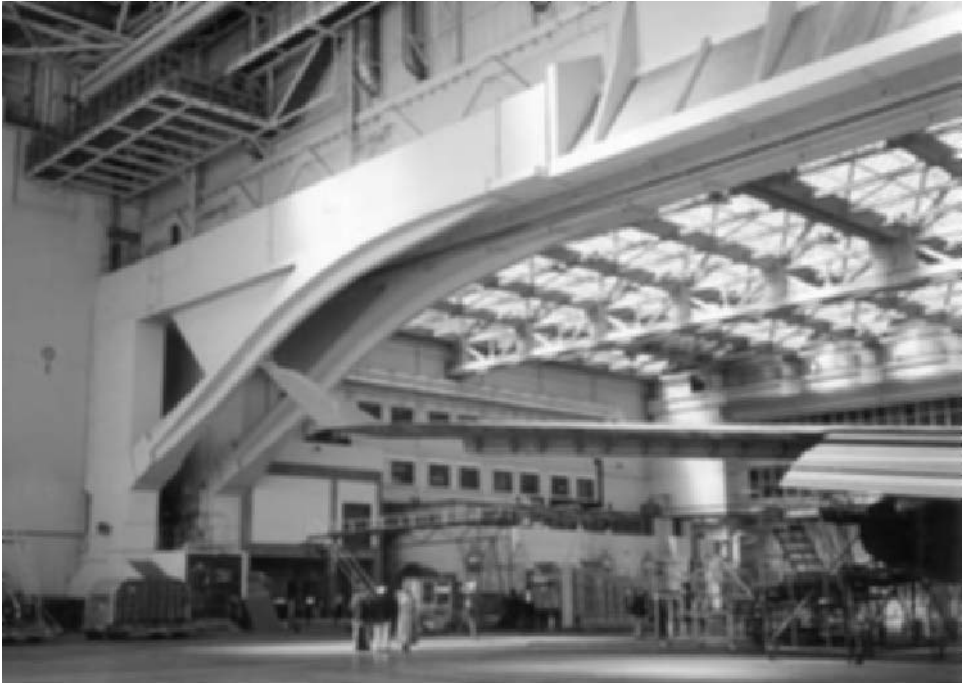
Fig. 2.32 Roof/door detail on British Overseas Airways Corporation maintenance headquarters hangar, Heathrow Airport, west London, 1950–1955. Engineer and architect Owen Williams (photo Bill Addis).

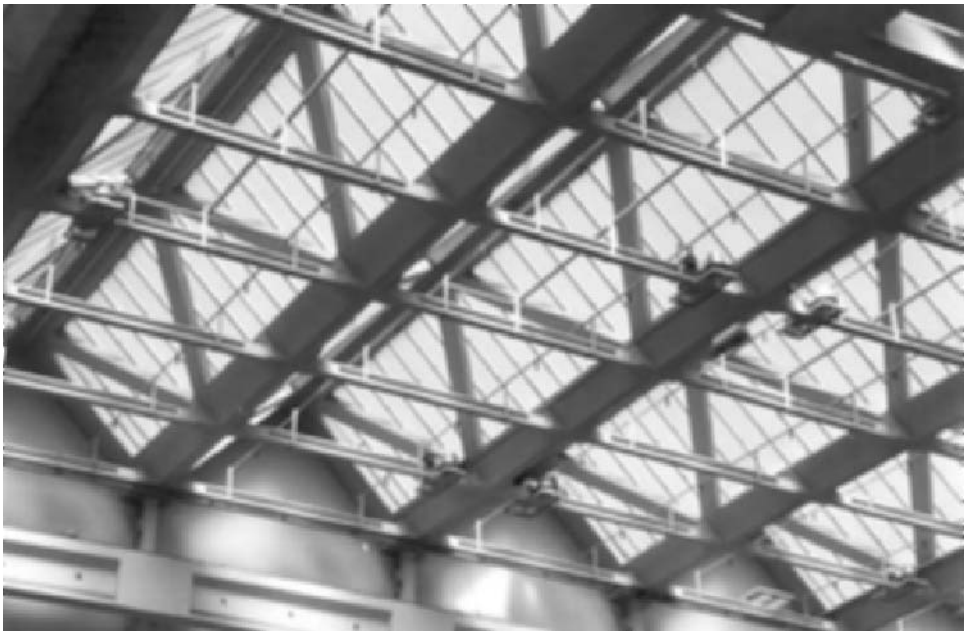
Fig. 2.33 Roof detail on BOAC maintenance headquarters hangar, Heathrow Airport, west London, 1950–1955. Engineer and architect Owen Williams (photo Bill Addis).

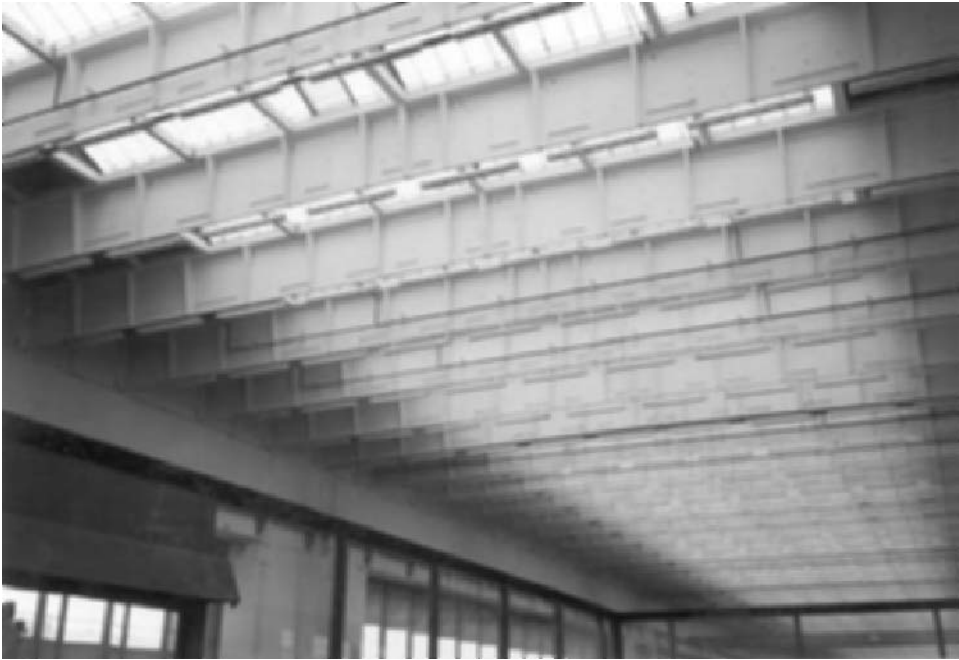
Fig. 2.34 Roof detail on British European Airways maintenance hangar, Heathrow Airport, west London, 1951. Engineer Alan Harris. Part demolished 1999–2000 (photo Bill Addis).

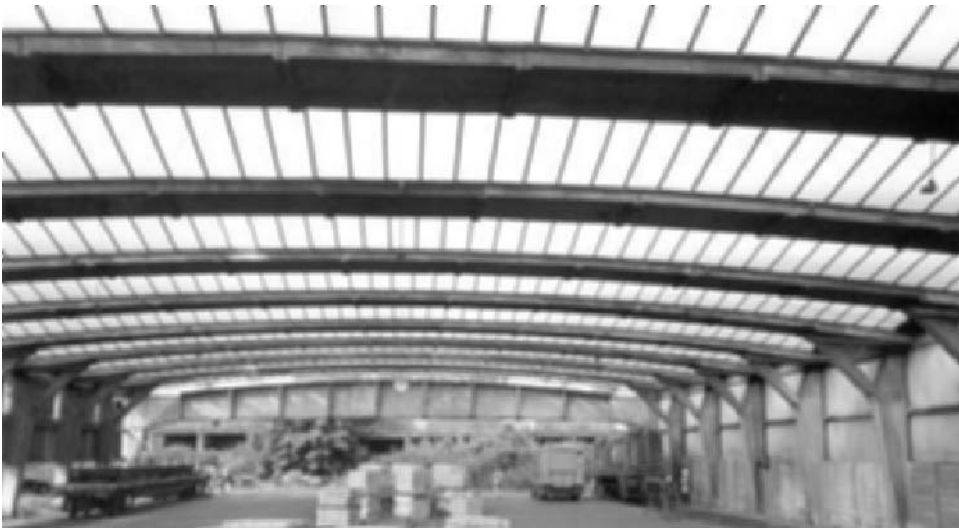
Fig. 2.35 Warehouse at Spekeldands Road Freight Depot, Liverpool. Engineers A.J. and J.D. Harris. The inverted T-beams each comprise 11 precast concrete elements post-tensioned with four cables. They are 6 ft. (1.83 m) wide and vary in depth from 5 ft. 5 in. (1.65 m) at the haunches to 10 in. (0.25 m) at mid-span. The two-pin portal frame spans 102 ft. 6 in. (31.2 m) (photo Bill Addis).

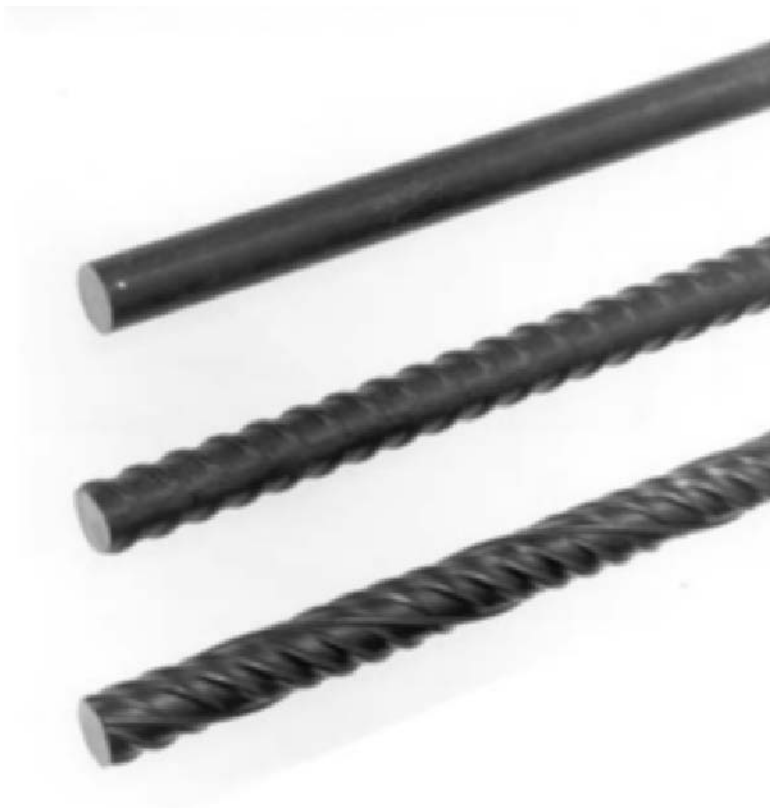
Fig. 2.38 Steel reinforcement used in the late twentieth century. Top, round mild steel; centre, low-alloy, high-yield steel; bottom, cold-worked, high-yield steel (British Cement Association).

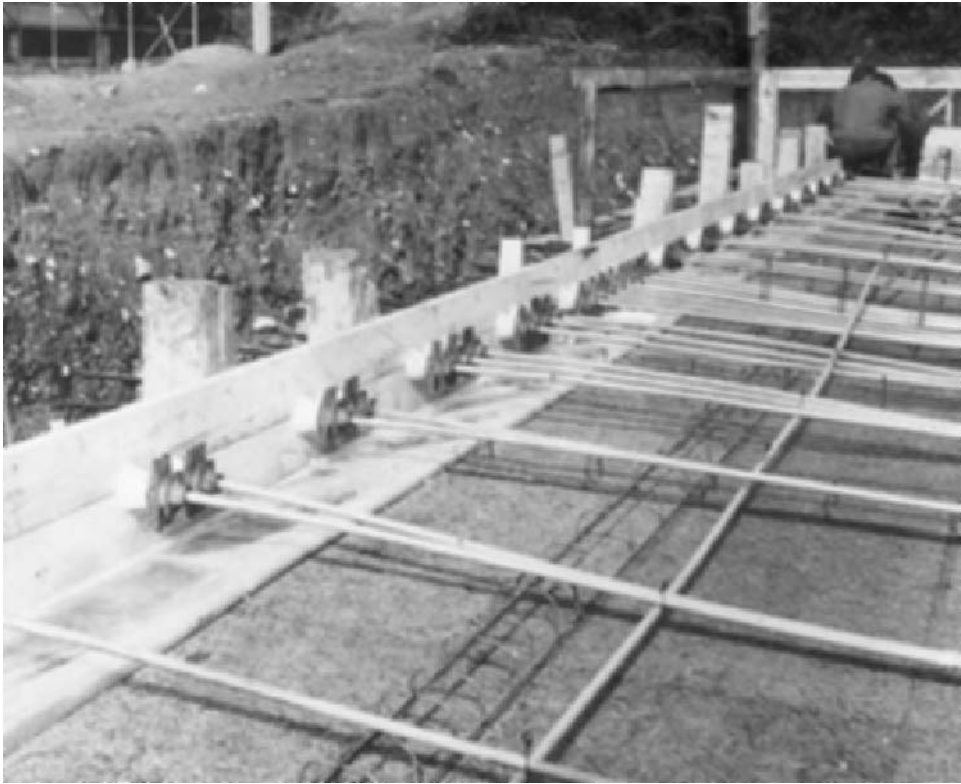
Fig. 2.39 Floor slab with sheaths for reinforcement in place (British Cement Association).

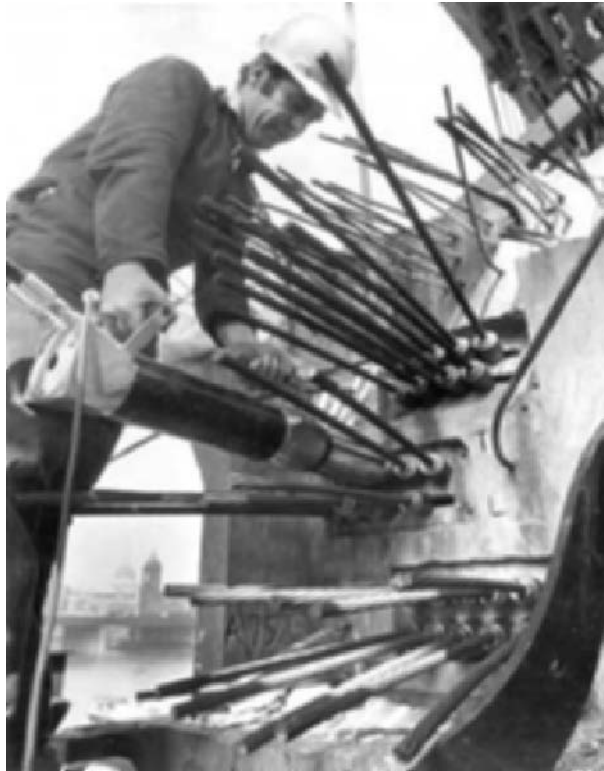
Fig. 2.40 Post-tensioning and fixing cables in a long-span beam (British Cement Association).

The other method of prestressing, post-tensioning, offered a simpler technology, with the additional advantage of being usable for *in situ* concrete work (Fig. 2.39). In this process, the required profile of the prestressing steel was incorporated into the concrete section using oversize sheathing, typically thin-section, flexible, corrugated-steel tubing, to form a duct. When the concrete was of adequate strength, but still supported on falsework, prestressing steel was introduced into the duct. This could be stranded cables, wires or rods. The steel was then tensioned to the required level using jacks with calibrated gauges, and then anchored at the ends using wedges, nuts or another (usually patented) anchorage system (Fig. 2.40). The falsework could then be removed. Finally, the ducts were usually grouted, both to improve the durability of the steel and to provide supplementary anchorage to the steel in the (happily rare) event of anchorage failure or relaxation. Anchorages were usually also encased in concrete (Andrew and Turner, 1985).

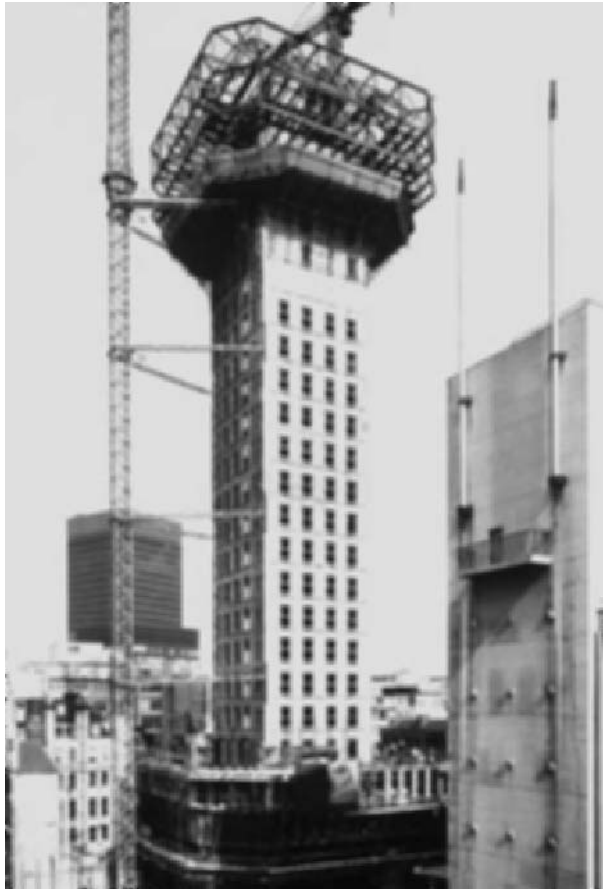
Fig. 2.41 Slipformed concrete core at Barclays Bank Foreign Headquarters on the corner of Fenchurch and Gracechurch Streets in the City of London, under construction in 1968 (courtesy Ove Arup Partnership).

The early use of slipforming was for industrial structures such as grain silos and chimneys. The Post Office Tower was one of the more prominent buildings to have a slipformed core, an obvious application for a monolith such as this, but other buildings also benefited from this technique, which allowed the core structure of an office block (as it usually was) to be built up quickly (Fig. 2.41). This aided an early start on roof-level plant, including lifting equipment, which is always a lengthy task, while the office floors could be built up later around the core. Slipforming has recently returned to favour, and is used in conjunction with steelwork for the framing beams and columns.
