Concrete

Building Pathology

Edited by
Susan Macdonald

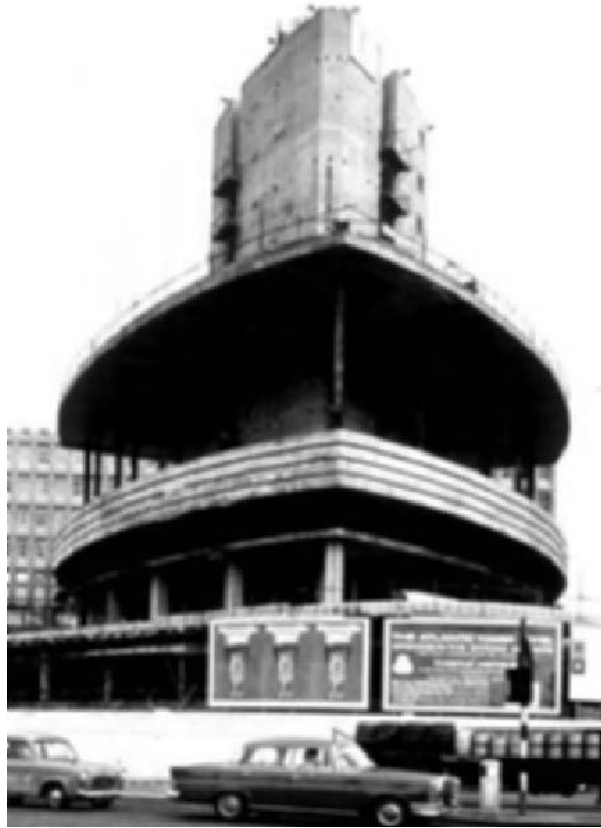
Fig. 2.42 Lift slab construction (British Cement Association).

and then jacking them up into position (Fig. 2.42). A typical vertical structure comprised steel columns and a slipformed core, to which the floors were attached by brackets. Clearly this system imposed repetitive floor layouts, but it eliminated falsework and allowed human activity to be concentrated near ground-floor level, where it is safer and more easily supervised.

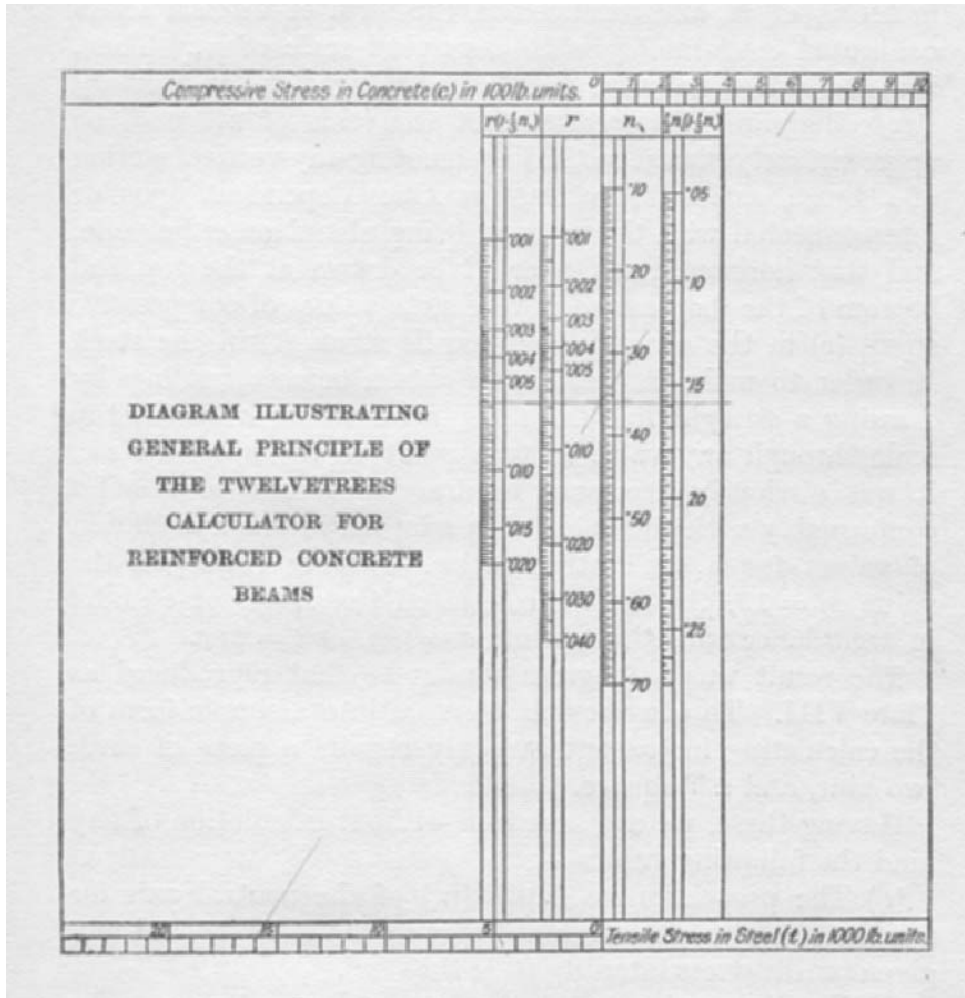
Fig. 2.43 Illustration of an early nomogram for design of reinforced concrete beams (from Twelvetees, 1907).

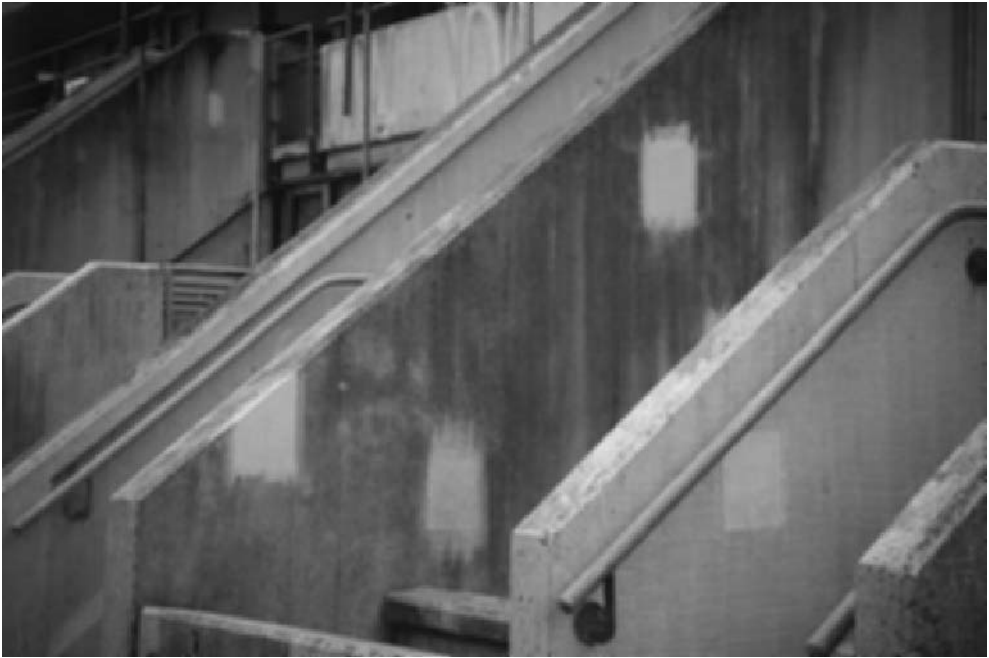
Fig. 2.44 Surface staining in sheltered zone, not subject to regular rainwater washing (photo Susan Macdonald).

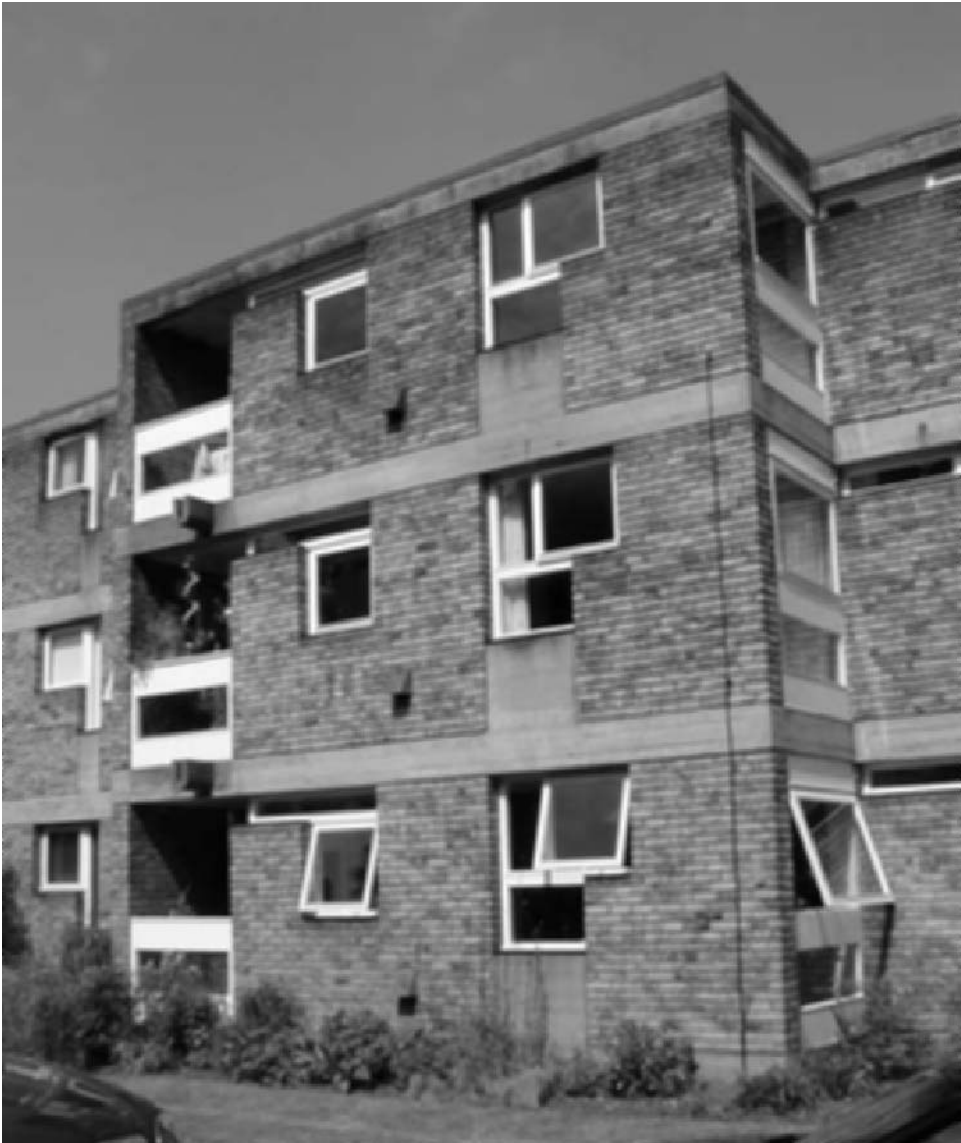
Fig. 2.45 Langham Close, Ham, Surrey (1958) Architects James Stirling and James Gowan (photo Bill Addis).

Theatre in London, its beginnings were very restrained indeed. Three modest blocks of flats by James Stirling and James Gowan dared to reveal in their façade a 400-mm-deep concrete edge beam bearing the imprint of the timber shuttering (Fig. 2.45).

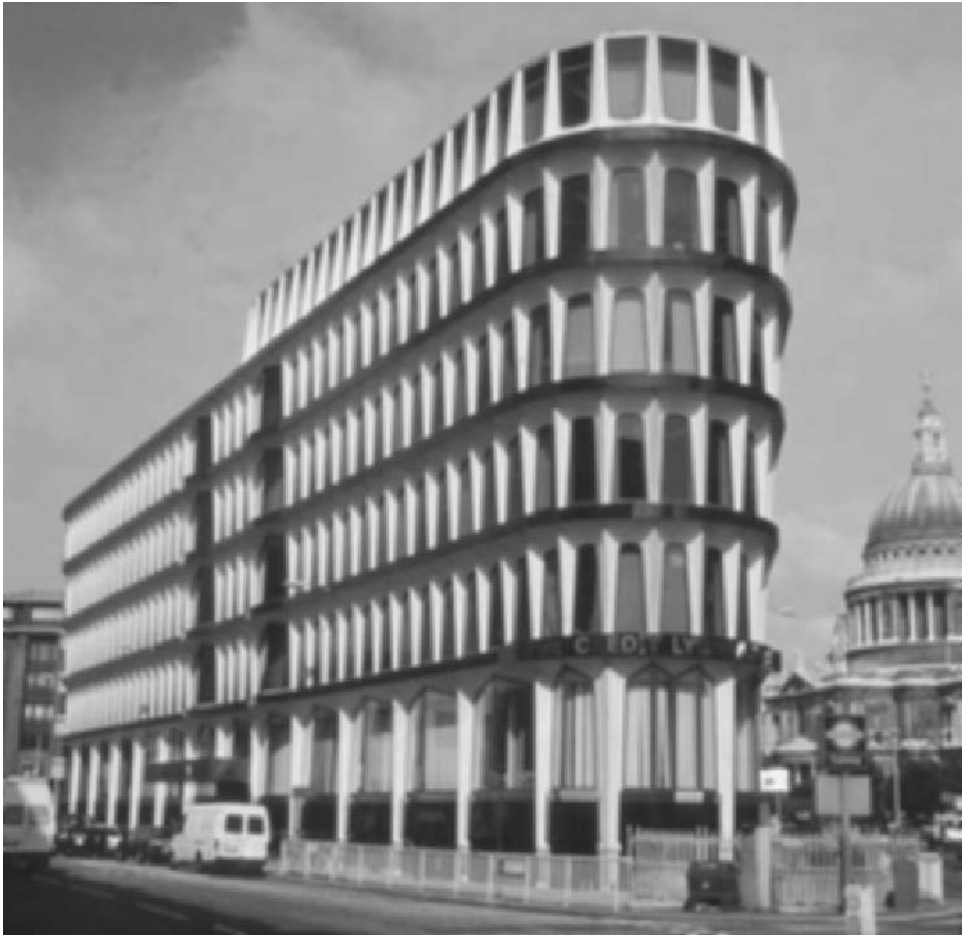
Fig. 2.46 Glass-reinforced cement cladding on the Crédit Lyonnais building in Queen Victoria Street, City of London (courtesy Ove Arup & Partners; photo Mike Taylor).

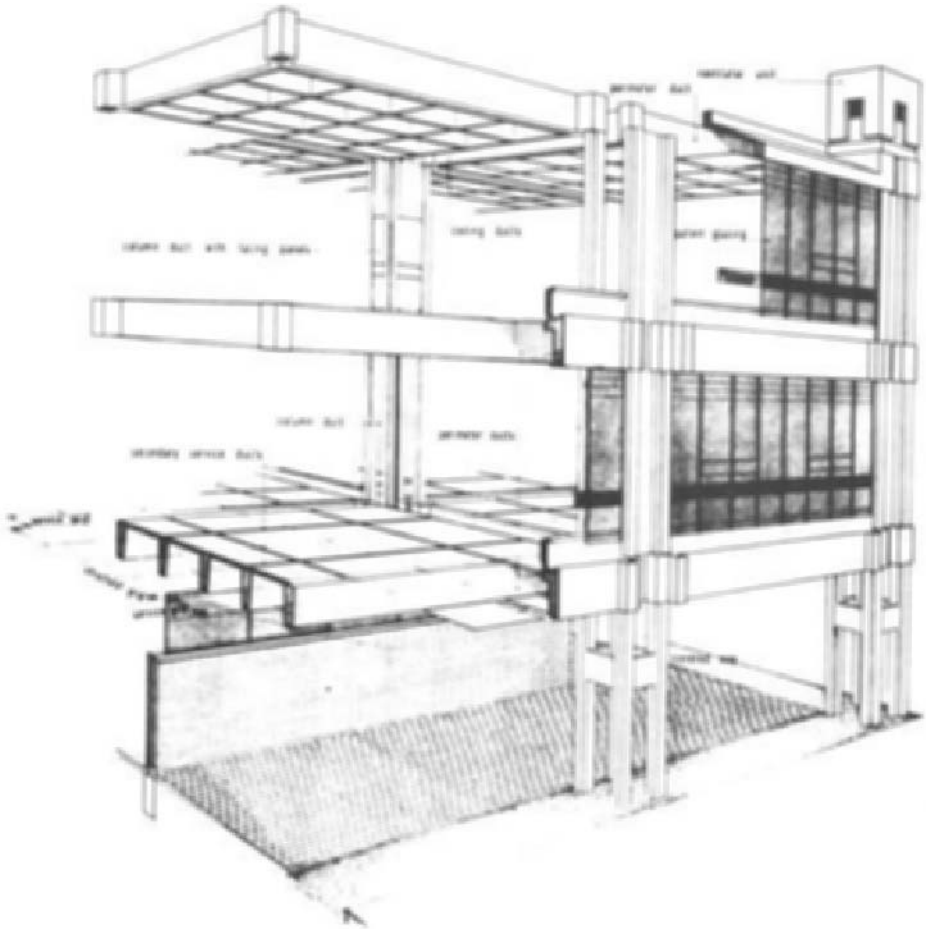
Fig. 2.47 Cut-away isometric of the Mining and Metallurgy Building, Birmingham University (photo Arup Associates).

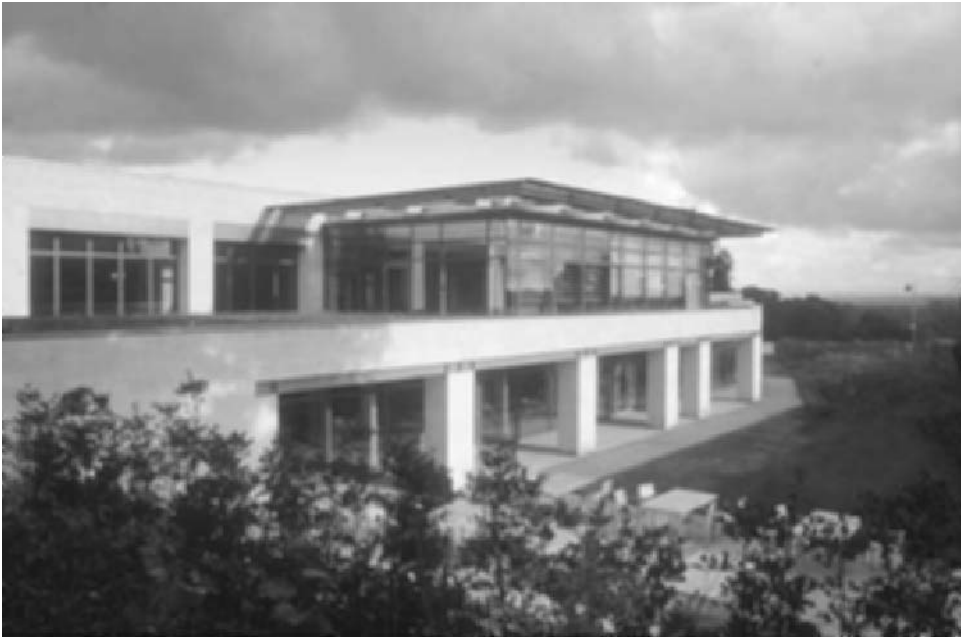
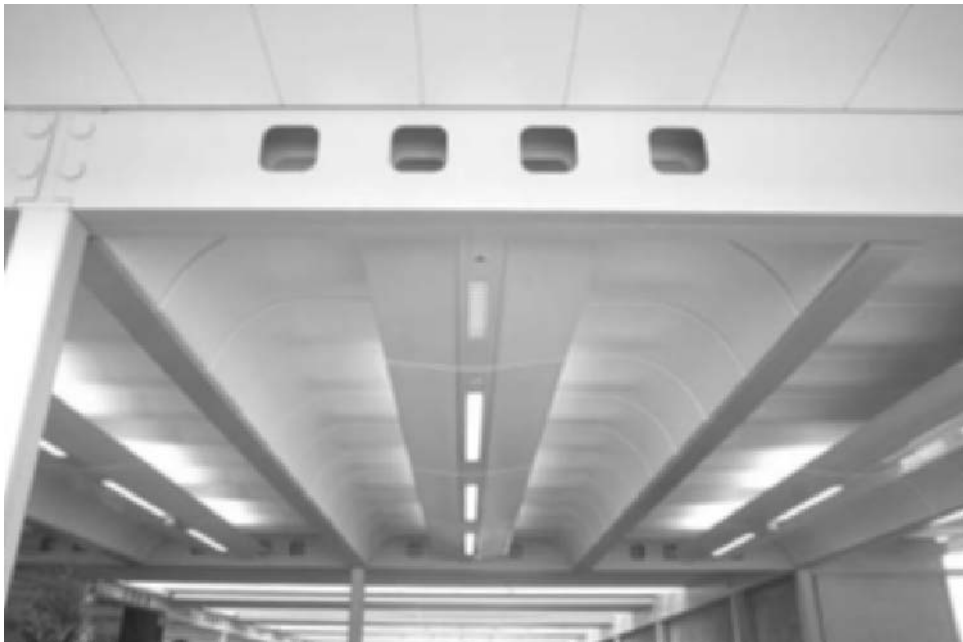
Fig. 2.51 External view of the Wessex Water Headquarters building, near Bath, England. Architect Bennetts Associates; Engineers Buro Happold (courtesy Buro Happold; photo Mandy Reynolds).

Fig. 2.52 Internal view of the Wessex Water Headquarters building. Architect Bennetts Associates; Engineers Buro Happold (photo Mandy Reynolds).

ings with beautifully finished and visually striking concrete ceilings. Just as concrete in the 1950s helped express building structure, so today it can help express the environmental qualities of a building (Figs. 2.51 and 2.52).

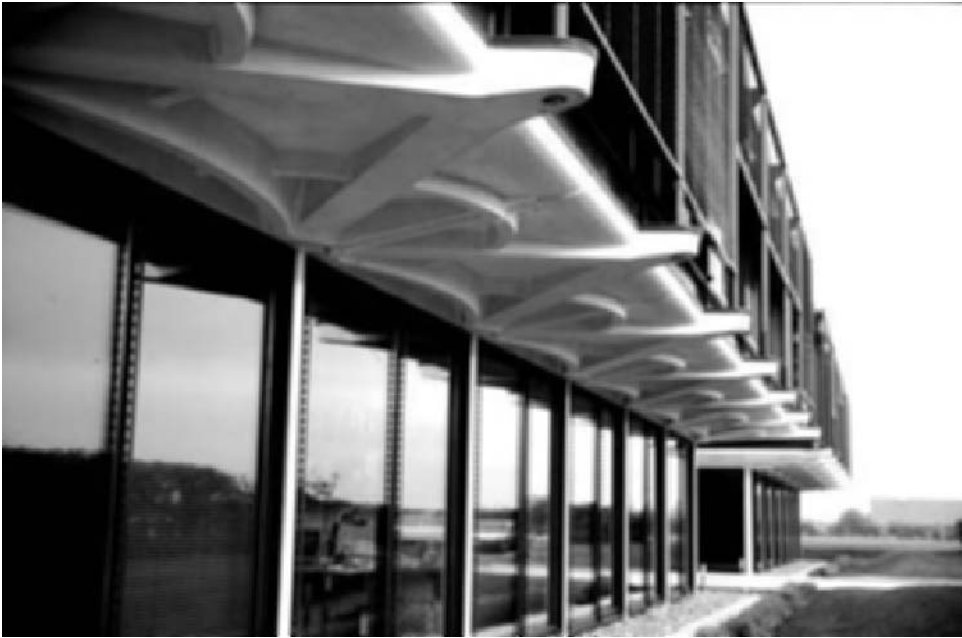
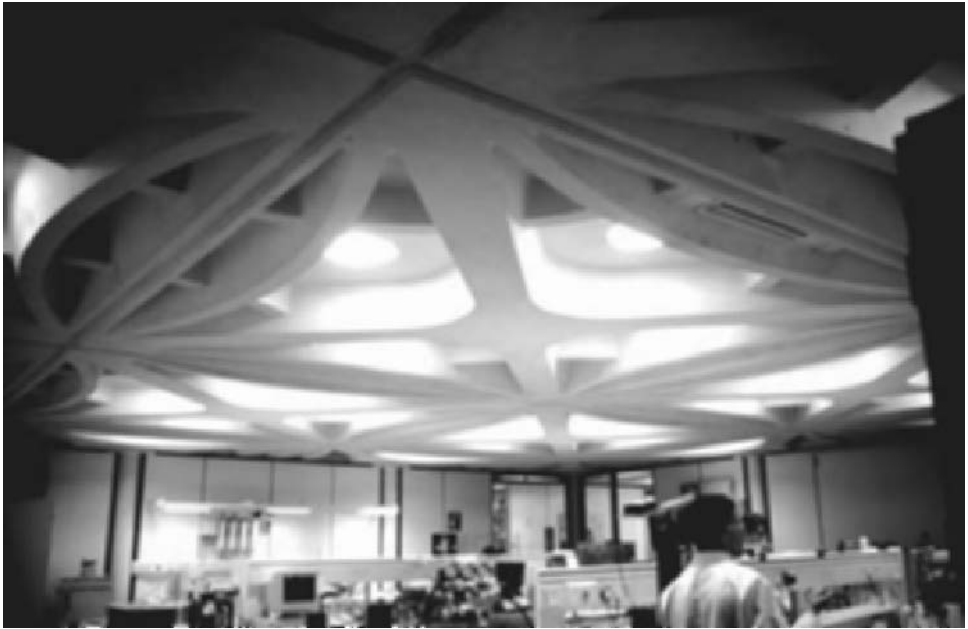
Fig. 2.53 Exterior of the Schlumberger Research Headquarters, Cambridge (Architects Michael Hopkins & Partners; Engineers Buro Happold; photo Bill Addis).

Fig. 2.54 Interior of the Schlumberger Research Headquarters, Cambridge (Architects Michael Hopkins & Partners; Engineers Buro Happold; photo Bill Addis).

The last few decades have also seen a few buildings making use of ferrocement, the material developed by Nervi in the late 1940s and 1950s. By forming it in steel or fibreglass moulds, a shell with a very high-quality surface finish is achieved, which provides a permanent formwork for the primary reinforced concrete which carries the main structural loads (Addis, 2001) (Figs. 2.53–2.55).

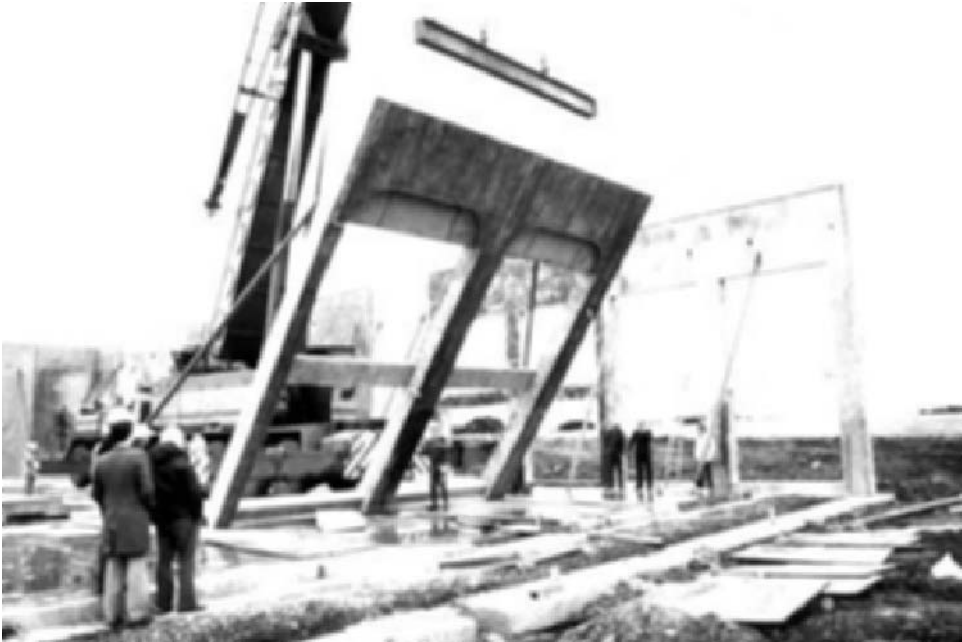
Fig. 2.56 'Tilt-up' construction (photo British Cement Association).

There has been a cautious return to the use of precast large-panel construction. An example is the 'tilt-up' method, in which the walls of a simple building such as a high warehouse can be precast on the ground outside its perimeter, and then rotated into their final locations and secured together (Fig. 2.56).

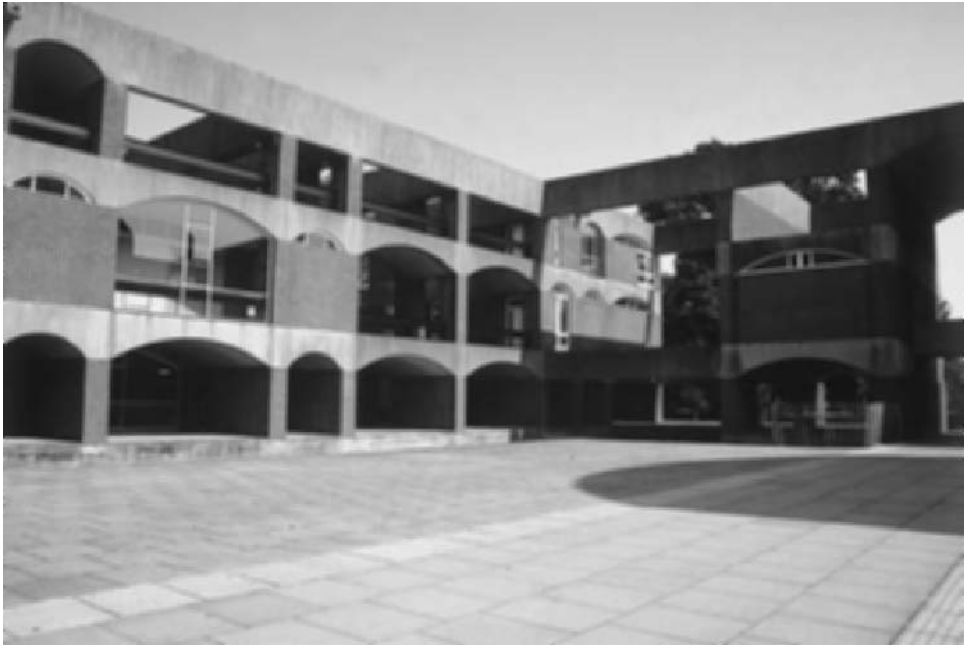
Fig. 3.1 Falmer House, University of Sussex, designed by Sir Basil Spence 1960–1961, is a listed Grade 1 building. Testing can be an invasive process, and when dealing with a listed building special care must be taken to design the testing so that it minimises the effect on the building. In some cases, statutory consent may be required (photo Susan Macdonald).

authority and/or national heritage body (such as English Heritage or Historic Scotland). Listed building consent is needed for any alterations to a listed building that affect its character as a building of architectural or historic interest. Rigorously, ‘alterations’ can be understood to include the removal of even small samples for testing, so it is advisable to obtain consent to such work. Planning permission may be required if any changes are proposed to the appearance of a building that is in a conservation area (Fig. 3.1).

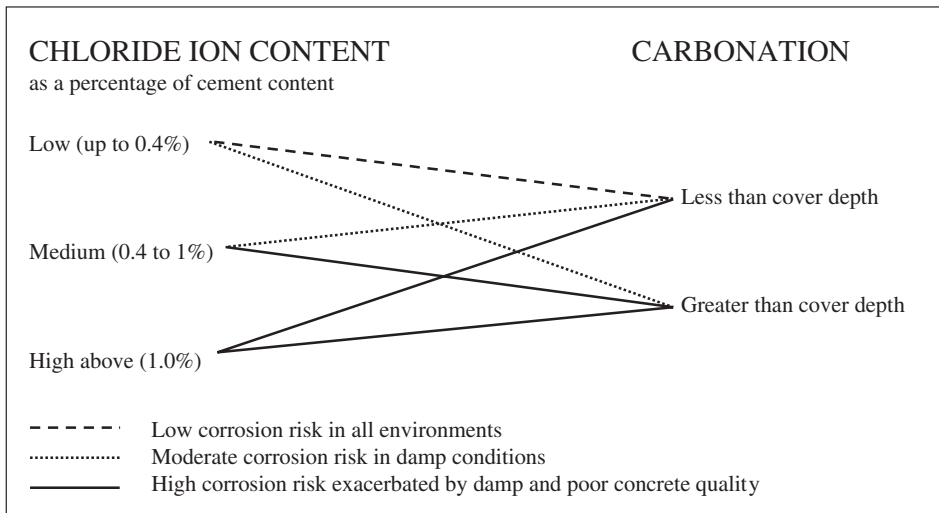
Fig. 4.2 Risk of corrosion in relation to concrete analysis (reproduced from *BRE Digest* 264, 1982).

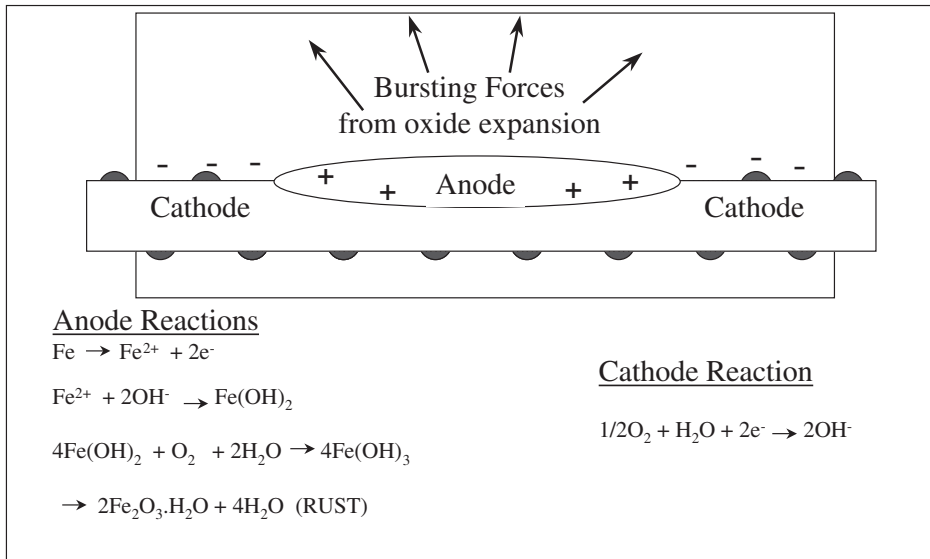
Fig. 4.3 The corrosion process for steel in concrete.

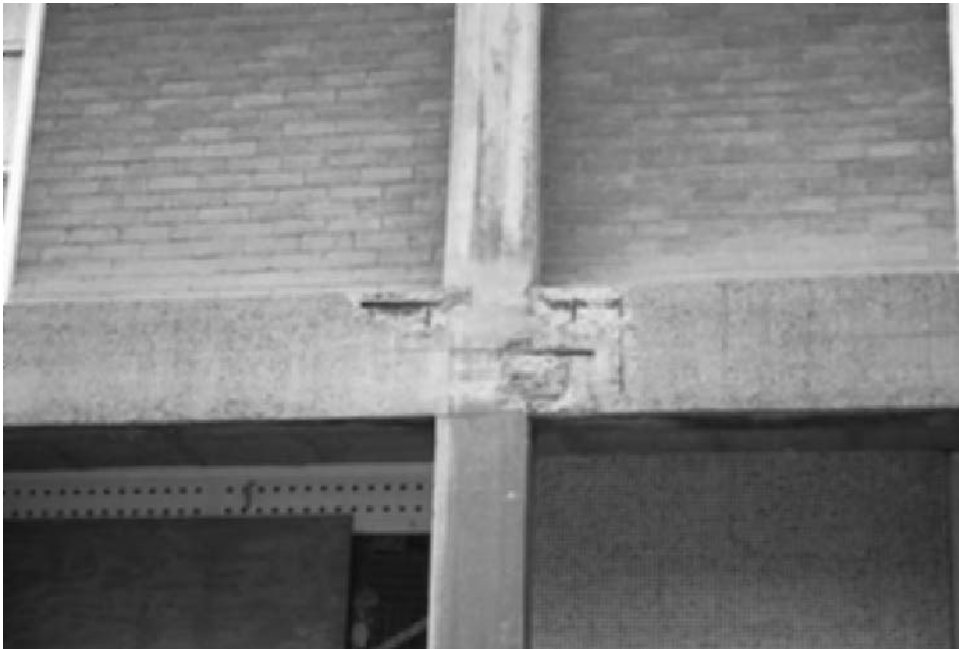
Fig. 4.4 Insufficient cover to reinforcement at Parkhill flats, Sheffield, is one of the most common causes of premature corrosion-induced concrete decay (photo Susan Macdonald).

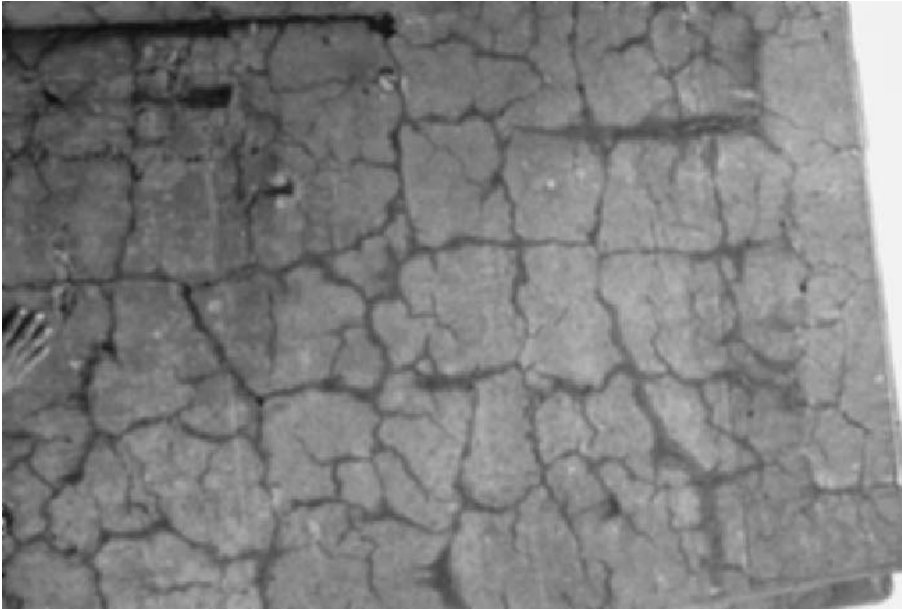
Fig. 4.5 Map cracking due to an alkali–silica reaction.

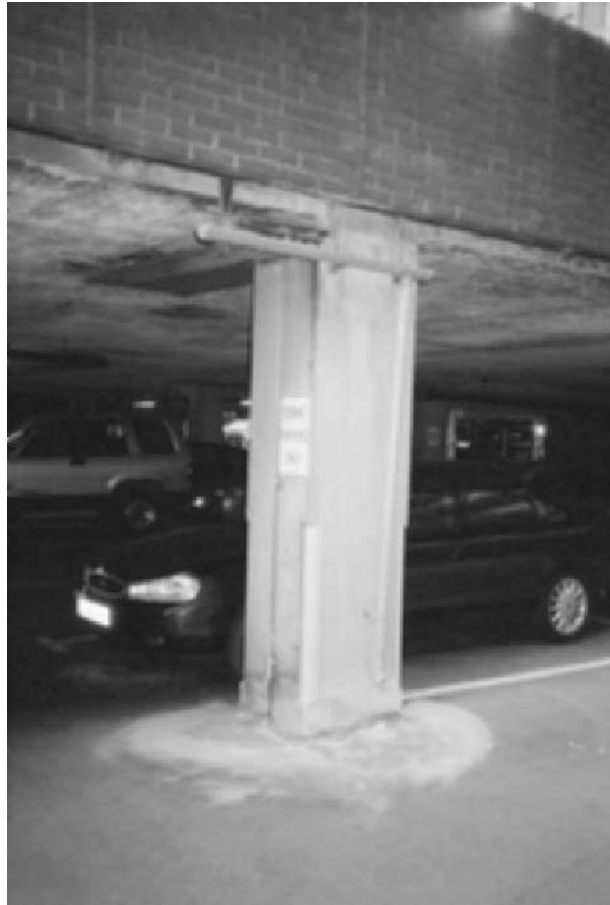
Fig. 4.6(a) Poor maintenance of this car park has led to the formation of a stagmite where the inadequate drainage keeps water off cars but does not cure or control leakage from the floor above.

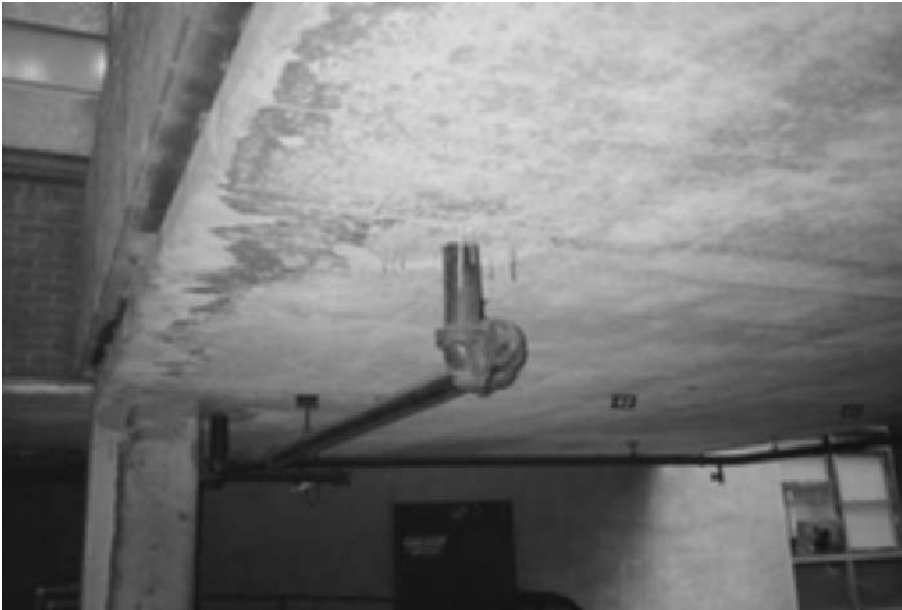
Fig. 4.6(b) In this photograph from the same car park stalactites have formed around a leaking drain.

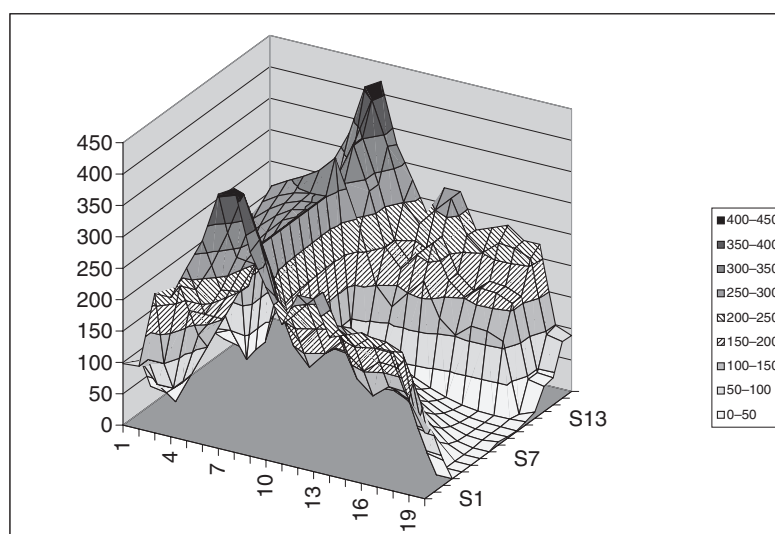
Fig. 4.8 Half-cell potential survey.

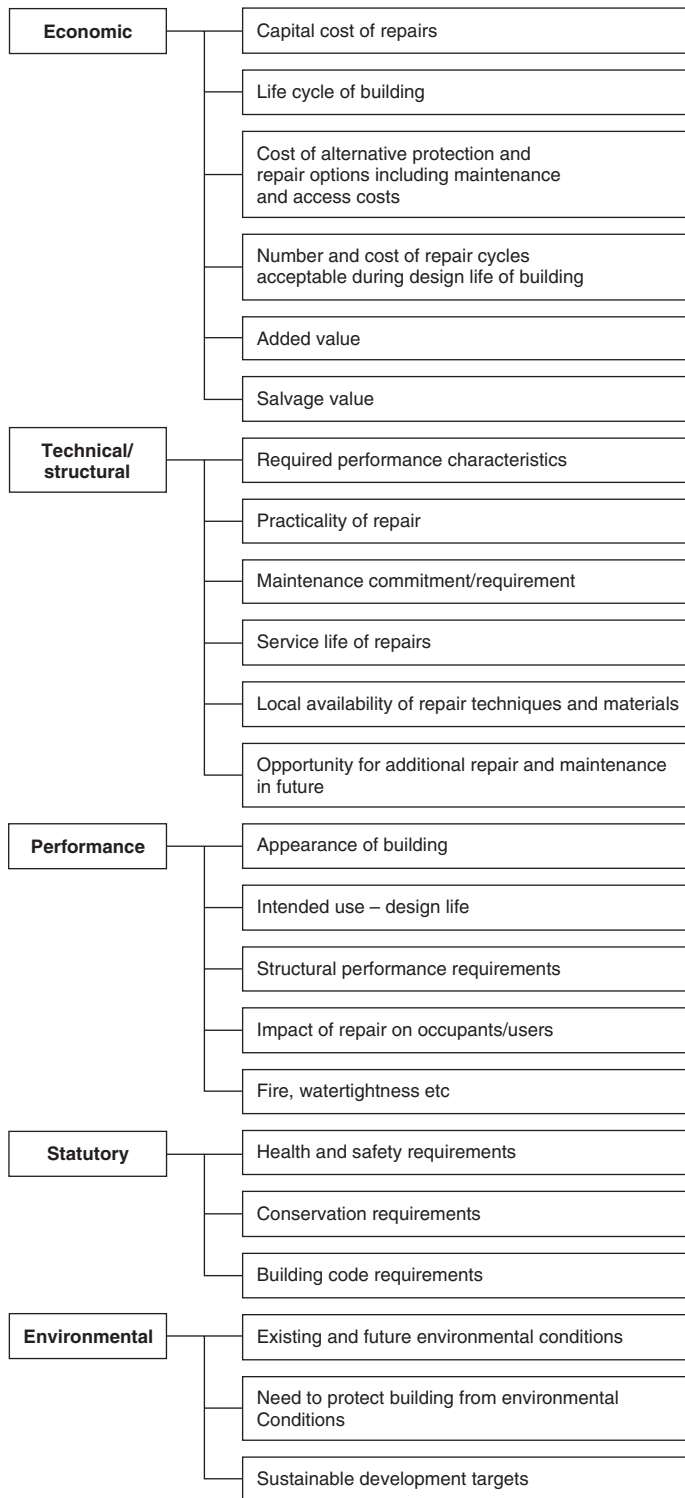
Fig. 5.1 Factors affecting the repair and remediation strategy (Susan Macdonald).

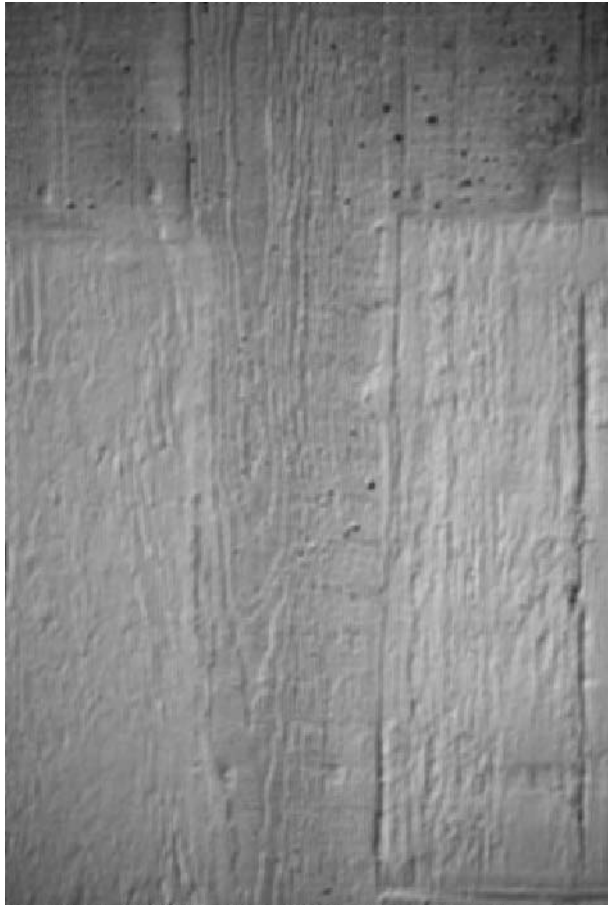
Fig. 5.2 Patch repairs at the Alexandra Road Housing Estate in Camden, London. This is a Grade II* listed building, and therefore it was important to match the repairs as closely as possible to the parent concrete. The high-quality, board-marked concrete finish was an important feature of the architect's design. A latex mould was used to replicate the timber-board-marked finish (photo Susan Macdonald).

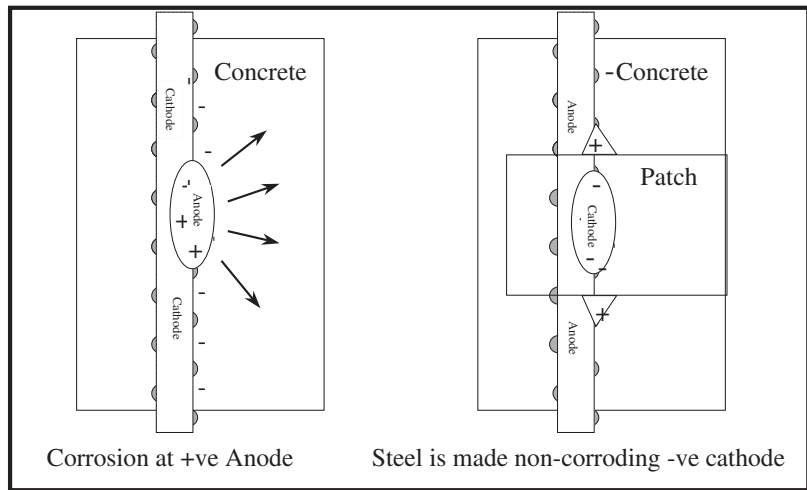
Fig. 5.3 The formation of incipient anodes after patch repairing (John Broomfield).

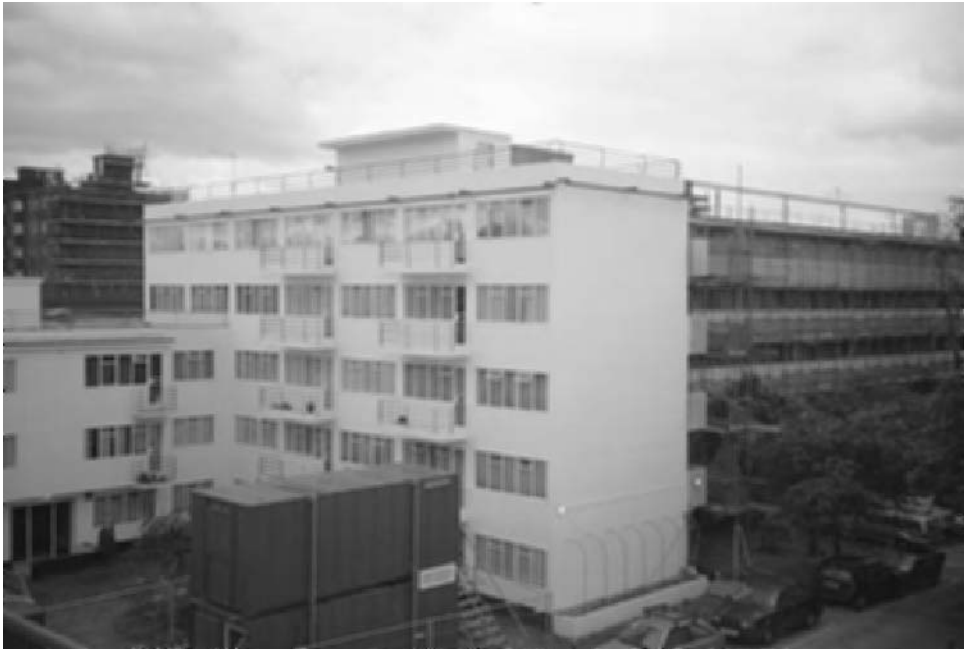
Fig. 5.4 Pullman Court, Streatham Hill, London, designed by Sir Frederick Gibberd, 1936. The concrete was repaired by patching, followed by the application of an anti-carbonation coating to reduce the progress of carbonation (photo Susan Macdonald).

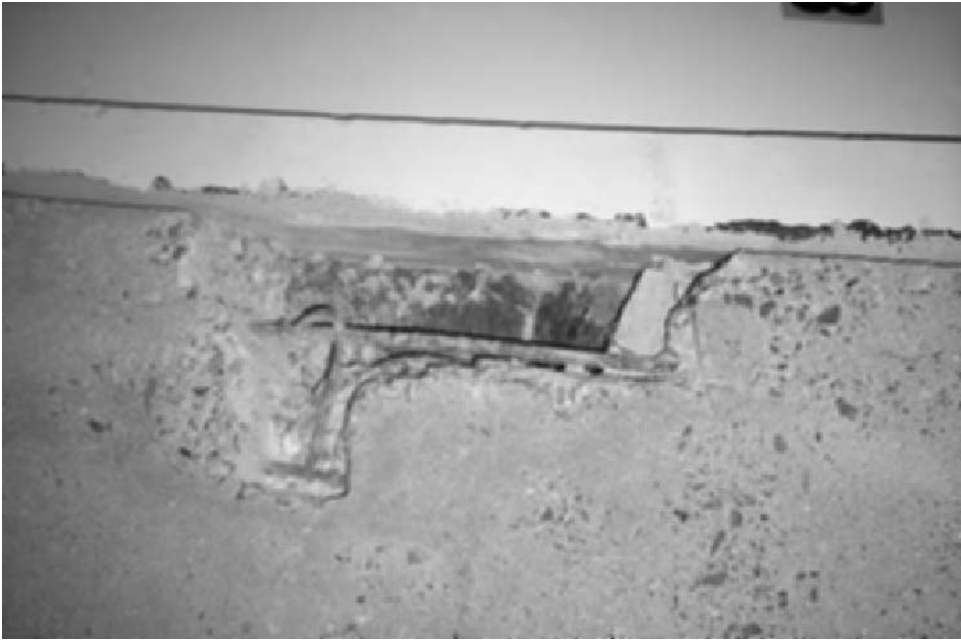
Fig. 5.5 Patch repairs in progress at Pullman Court. Note the thinness of the walls, which is characteristic of early modern architects' work in Britain. The concrete has always been painted (Susan Macdonald).

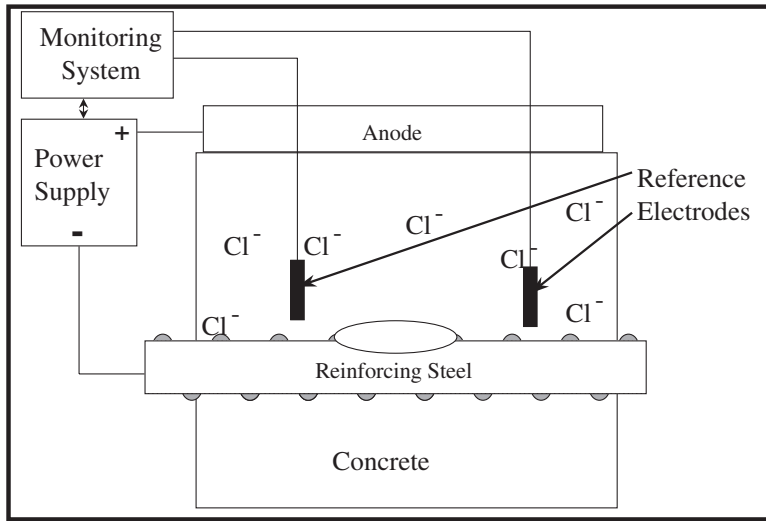
Fig. 5.6 Impressed current cathodic protection (John Broomfield).

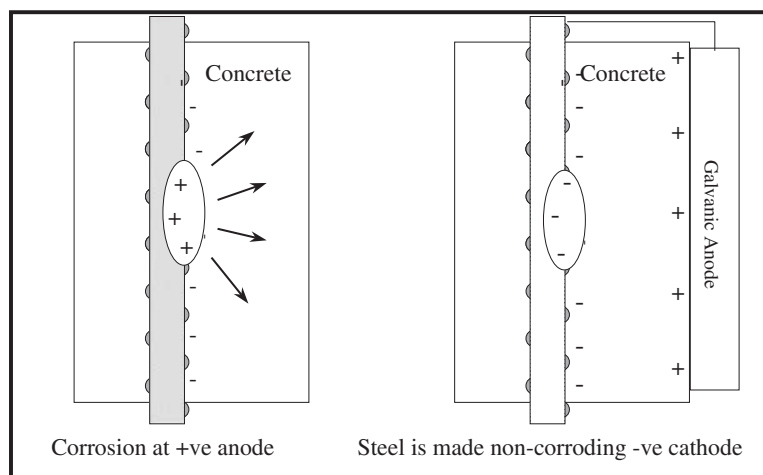
Fig. 5.7 Galvanic cathodic protection with sacrificial anode to stop corrosion (John Broomfield).

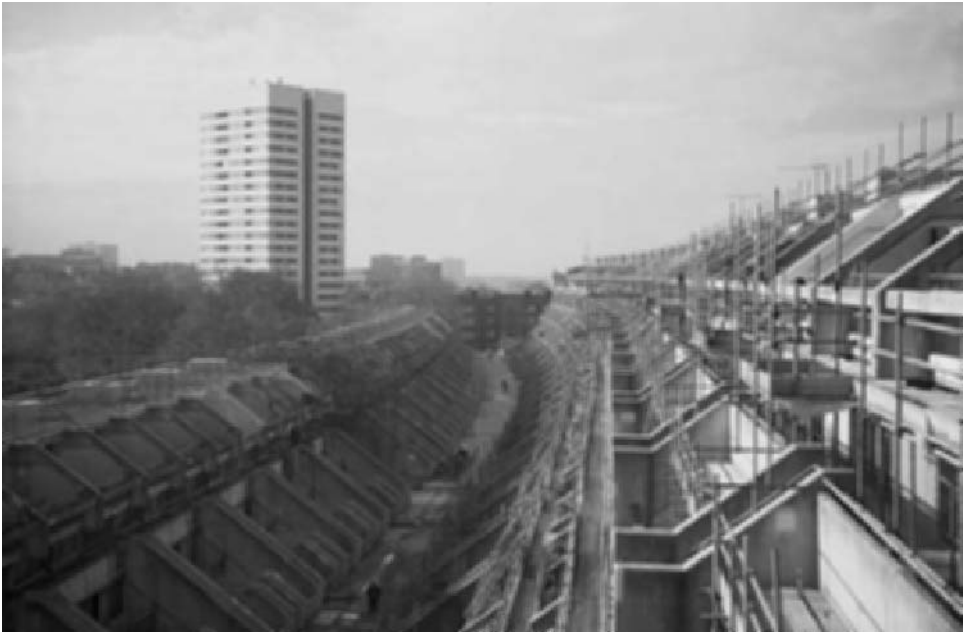
Fig. 5.8 The concrete repairs at the Alexandra Road Housing Estate in Camden were carried out in a manner that attempted to retain the original concrete finish and appearance. Previous repairs had resulted in numerous patches all over the building that were not a good match with the parent concrete (photo Susan Macdonald).

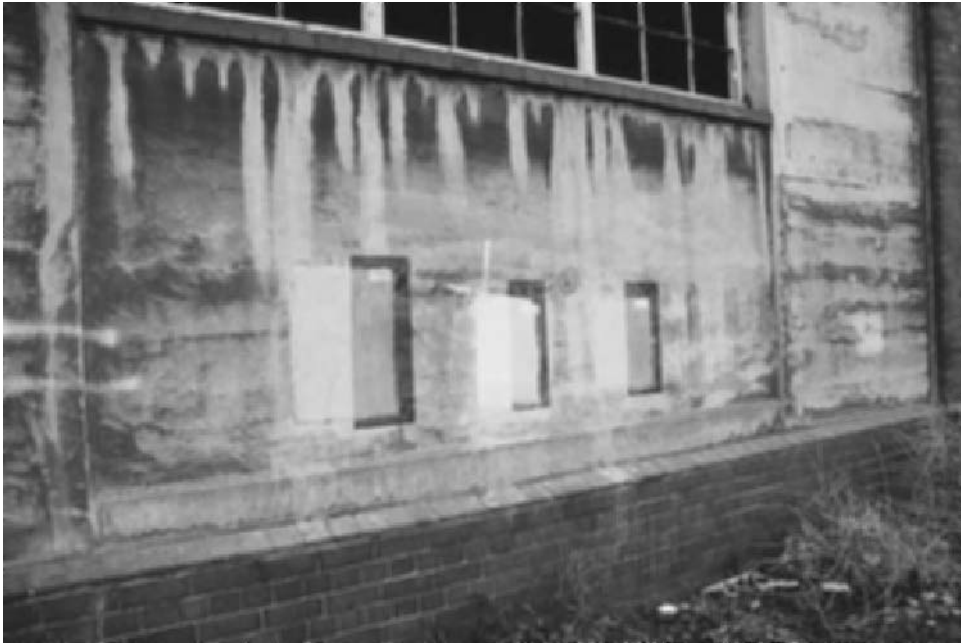
Fig. 6.2 Great Western Goods Shed, Bristol (1910). Note the soiling under the window ledges from environmental pollution in areas that are not regularly washed with water. Trials were an important part of the project during the writing of the specification. The figure shows trial external finishes (photo Susan Macdonald).

Black crusts from environmental pollution can adhere very strongly to concrete (Fig. 6.2). Sometimes it is present on the cement matrix, or it may just be present on the aggregate particles. Care is required to ensure that damage is not done to the concrete surface, the aggregates or the interstitial cement matrix as separate surface components. There follows a description of a number of possible approaches to cleaning pollution-contaminated surfaces.

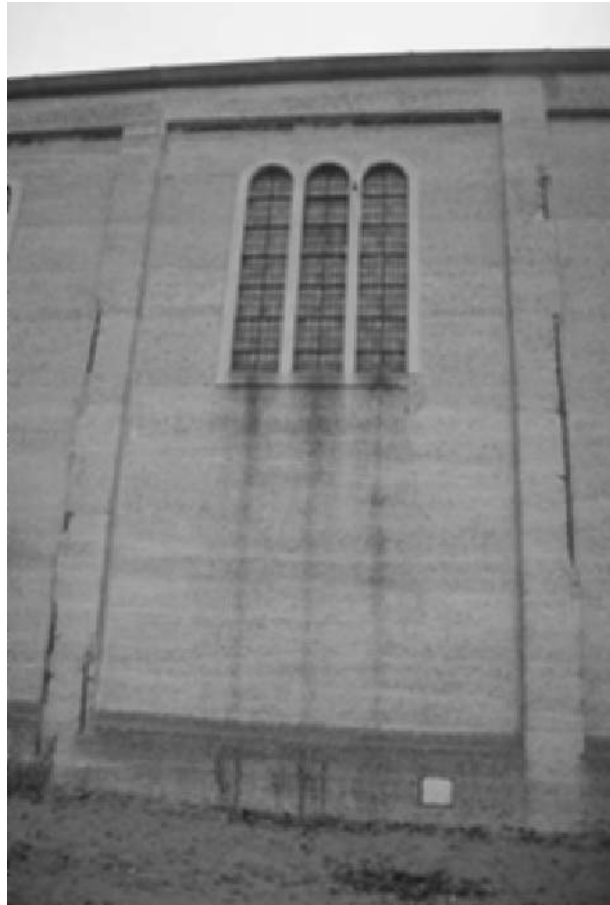
Fig. 6.3 St John and St Mary Magdalene, Goldthorpe, South Yorkshire, 1914–1916. Rust staining of the concrete below the windows due to the corrosion of the metal window guards (photo Susan Macdonald).

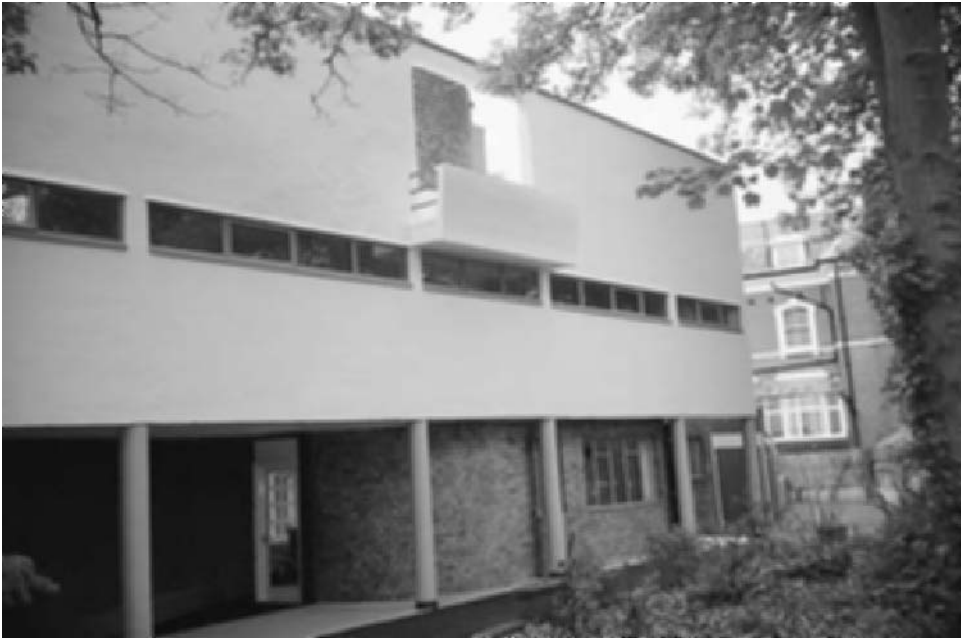
Fig. 6.4 House at Sydenham Hill (architects Hardy and Tecton, 1935) after repairs and repainting. The house was originally finished externally with 'Castex', a spray-applied cement slurry product. The concrete walls were originally cream, with eau-de-nil soffits and recesses (photo Susan Macdonald).

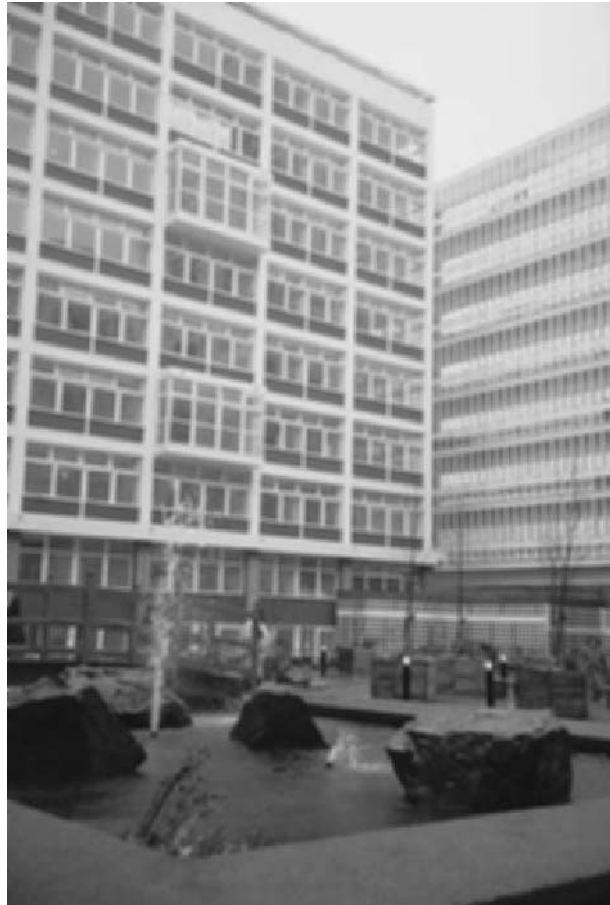
Fig. 6.5 The former Department of National Health building Alexander Fleming House, London (designed by Ernő Goldfinger 1959–1966), after repair and re-use as an apartment block. The repairs included the application of an elastomeric coating over the previously unpainted concrete. The decision to paint the building was the result of a combination of factors: the large number of patch repairs required, the extent of the micro-cracking and an argument that painting would improve the building's appearance (photo Susan Macdonald).

This latter point is of great importance, as a decision to paint previously unpainted concrete will introduce a commitment to regular repainting, if only for aesthetic reasons (Fig. 6.5).

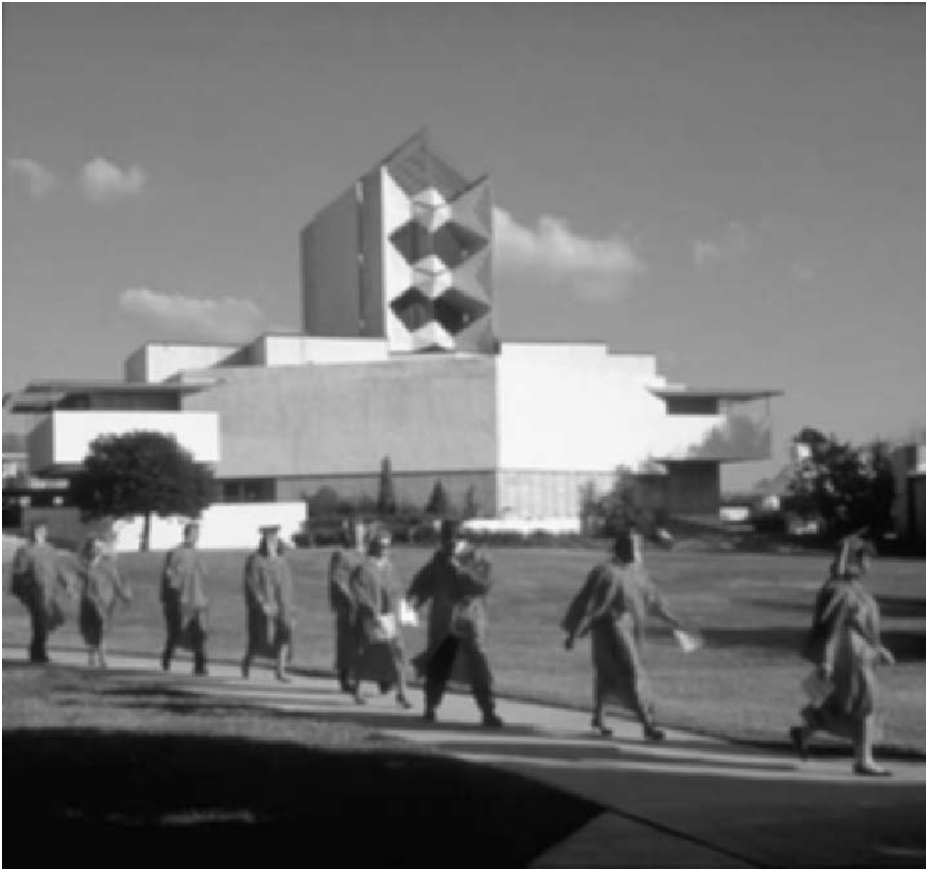
Fig. 7.1 The Polk County Sciences Building at Florida Southern College, designed by Frank Lloyd Wright and completed in 1958 (courtesy Ove Arup Partnership).

The Polk County Sciences building was the largest of 12 buildings within Florida Southern College designed by Frank Lloyd Wright (Fig. 7.1). Completed in 1958, it was suffering from deterioration due to waterproofing inadequacies and/or inappropriate maintenance (Fig. 7.2). Here, rather than allowing repair and remediation to be dictated by circumstance, an alternative approach was developed—planned maintenance (Architects' Journal, 1998). The concept is simple enough—recognising and assessing repair needs in order to develop a staged programme of repairs.

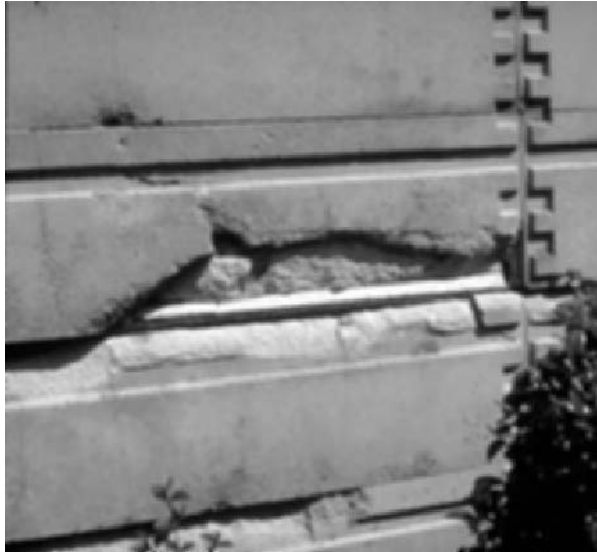
Fig. 7.2 The original precast ‘textile’ concrete blocks were made with fine aggregate, Portland cement and coquina shell. The blocks are highly porous and permeable owing to the absence of coarse aggregate and poor curing. They are therefore susceptible to a high moisture content and subsequent deterioration over successive cycles of wetting and drying. Poor cover to the reinforcement (due to inaccurate steel positioning and insufficient grout and mortar covering) has led to spalling of the blocks (courtesy Ove Arup Partnership).
