Concrete

Building Pathology

Edited by
Susan Macdonald

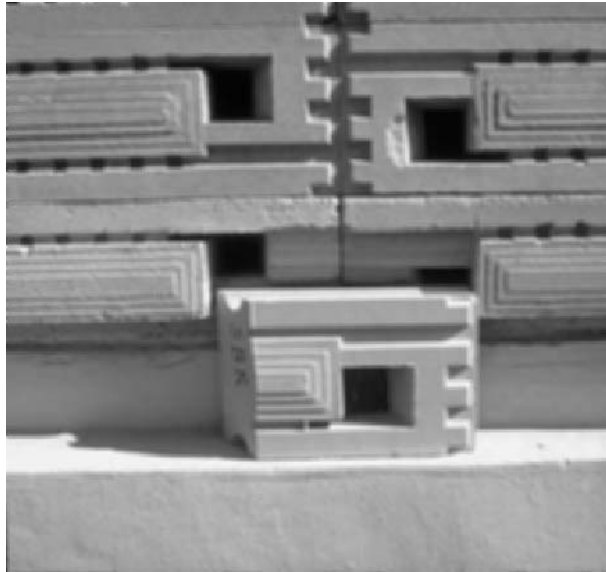
Fig. 7.3 Limited replacement of the ‘textile’ blocks was required as part of the repair programme. Prototype replacement blocks, shown here, included a polymer-modified facing mix with a concrete core (courtesy Ove Arup Partnership).

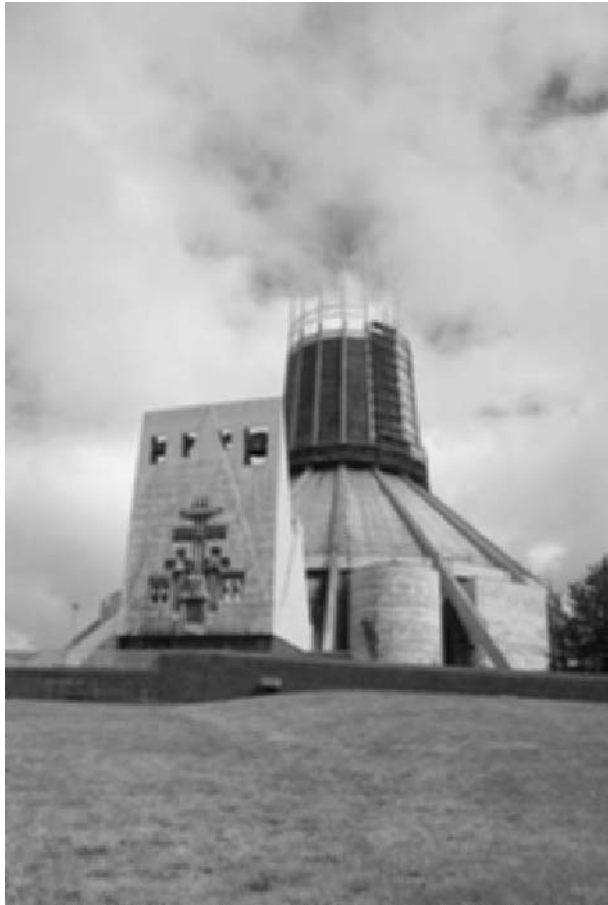
Fig. 7.4 Christ the King Cathedral, Liverpool, designed by Sir Frederick Gibberd and completed in 1967, was built to last 500 years. A major programme of repair in the 1990s addressed a series of problems, including those relating to the mosaic cladding on the concrete ribs (photo Susan Macdonald).

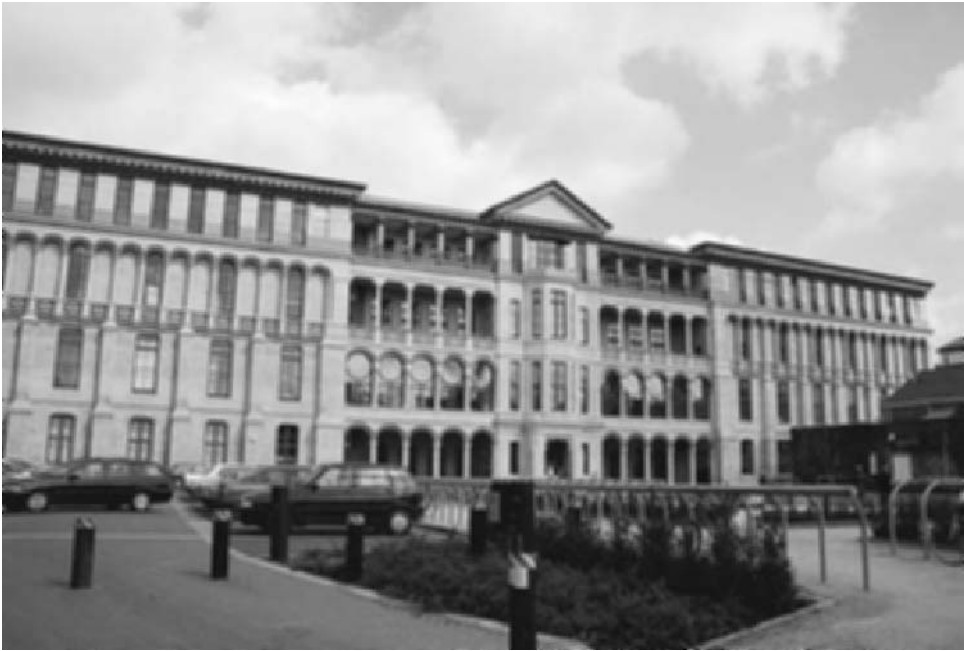
Fig. 7.5 The Judges Institute, Cambridge, designed by John Outram, 1995, utilised pigmented, coloured concrete to create a highly colourful and decorative building (photo Susan Macdonald).

Whilst strength and durability tend to dominate concrete specification at present, the aesthetics are of increasing interest to architects. In recent years, architects have rediscovered the flexibility and variety of form, colour and texture that concrete can provide. The Bilbao Metro (precast concrete), the Judges Institute, Cambridge (pigmented coloured concrete, Fig. 7.5), and the Jubilee Line Extension, London (*in situ* concrete, Fig. 7.6), are recent examples that demonstrate the aesthetic versatility of concrete.

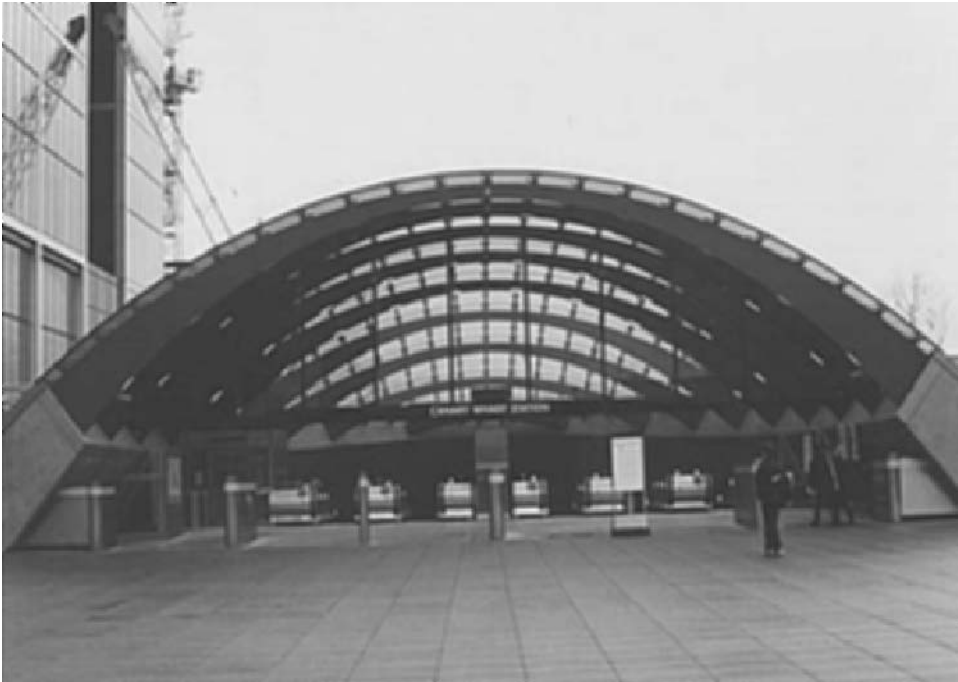
Fig. 7.6 Canary Wharf tube station, one of the new stations designed as part of the Jubilee Line extension, designed by Foster Associates in 1999. The cut and cover technique was used to construct the station, with durability, fire resistance and aesthetics as essential design criteria. Columns and the roof were cast on site, with precast concrete paviers providing the floor finish (courtesy Ove Arup Partnership).

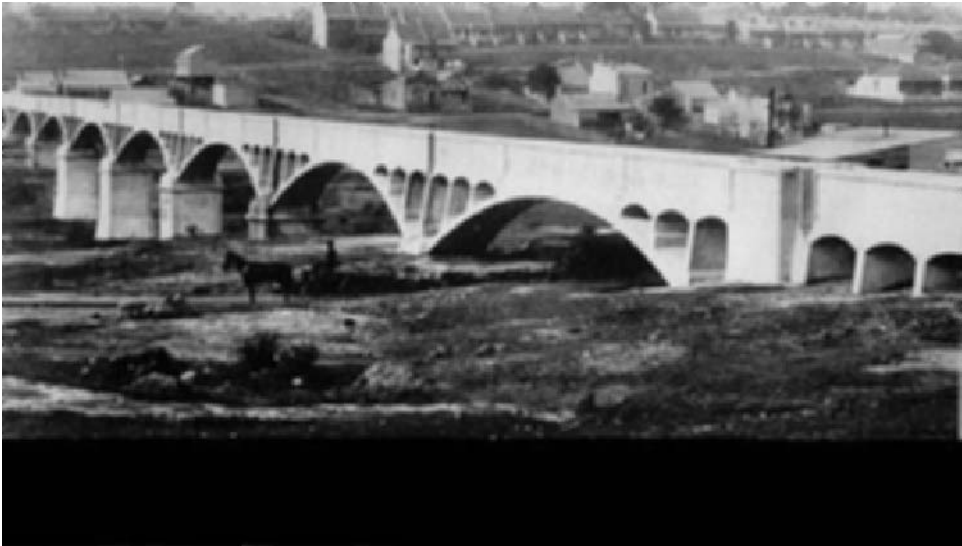
Fig. 8.1 Johnstone's Creek sewer aqueduct, Annandale, shortly after construction in 1897.

Johnstone's and White's creek aqueducts were constructed in 1897, in the inner Sydney suburb of Annandale (Fig. 8.1). They were the first major concrete structures in Australia to incorporate reinforcement, and as such are recognised as being of heritage value and are protected by legislation. The success of this work pioneered the use of reinforced concrete in Australia.

The two aqueducts are each approximately 300 m long, and are almost identical. Effluent is transported through a conduit up to 11 m above ground level and supported by a series of arches each 25 m long. The aqueducts were constructed using Joseph Monnier's technique of reinforcement, and covered with a final coat of cement render.

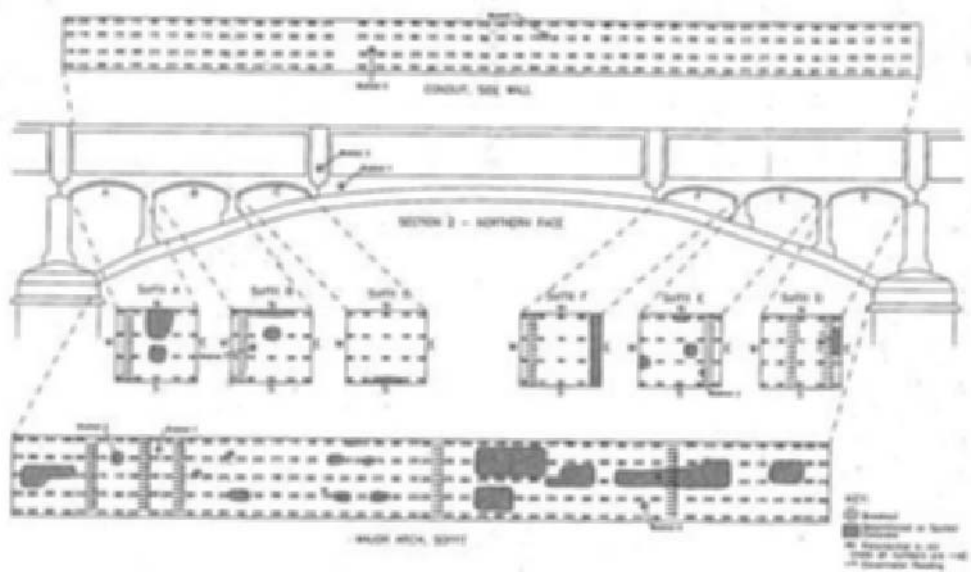
Fig. 8.2 Condition survey of a typical arch at Johnstone's Creek aqueduct, showing cover-meter and electrochemical potential readings, and areas of delaminated or spalled concrete (courtesy Taywood Engineering).

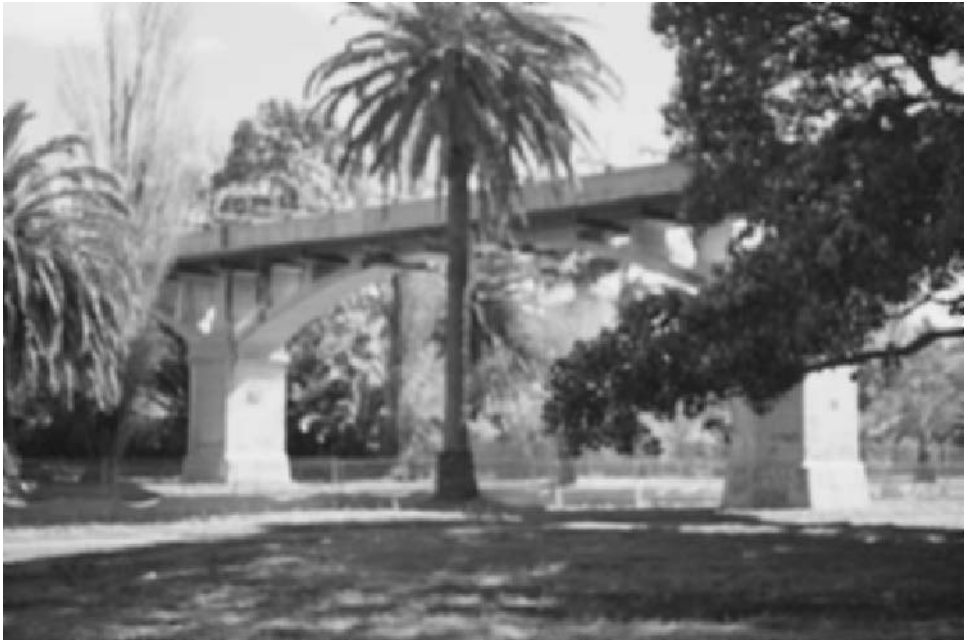
Fig. 8.3 Johnstone's Creek aqueduct after repair (photo: Susan Macdonald).

- In the pylons, minor arches and external faces of conduits, drummy or badly rendered concrete was removed and corroded reinforcement was grit-blasted or replaced. A bonding mortar was applied to concrete and reinforcement in the repair area, followed by application of a high-build repair mortar (both consisting of a cementitious polymer and silica fume-modified mortar). A cementitious polymer modified seal coating was applied over the entire surface area to provide a uniform appearance (Fig. 8.3).

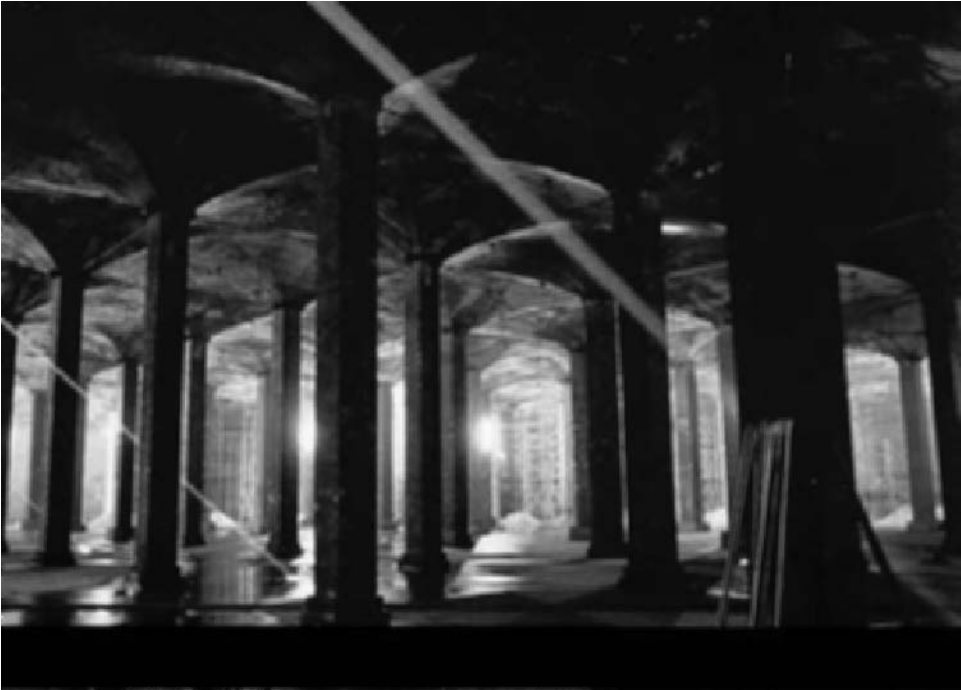
Fig. 8.4 Centennial Park reservoir, showing mass concrete groined arches and brick columns (photo Sydney Water).

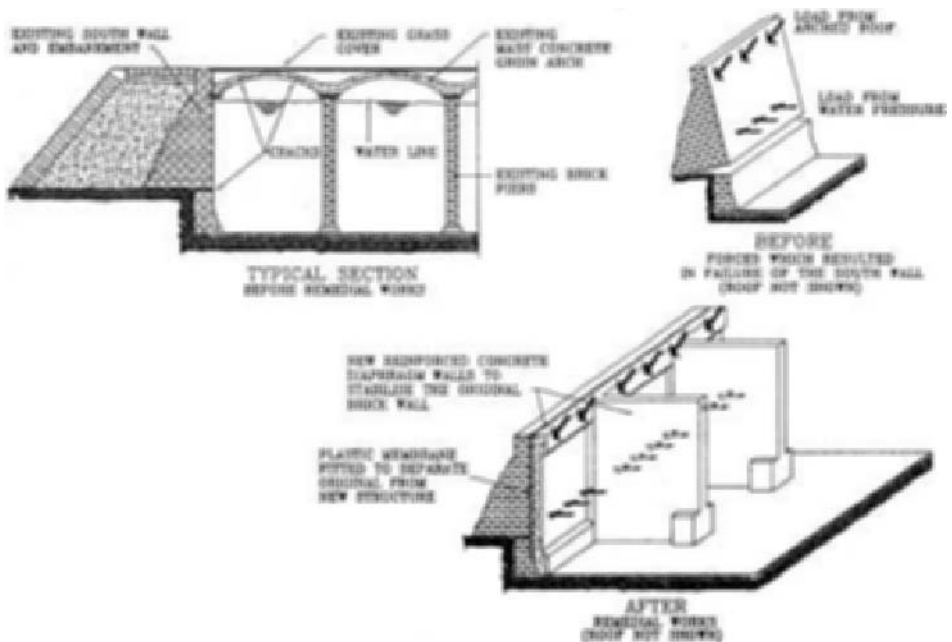
Fig. 8.5 Centennial Park reservoir, showing the strengthening of perimeter walls (courtesy Sydney Water).

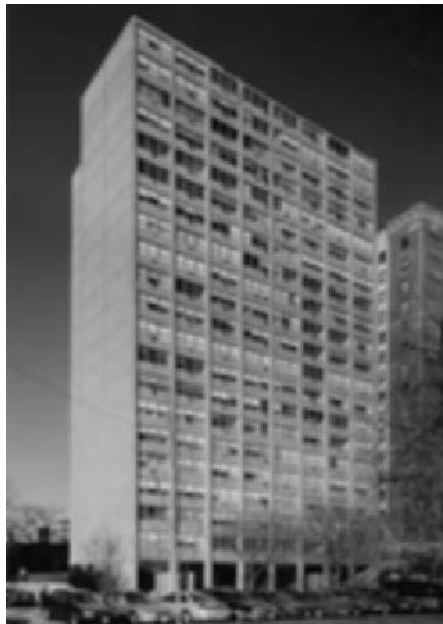
Fig. 8.6 Front and side elevations of the Promontory Apartment Building, Chicago (photo Paul Gaudette).

The 21-storey Promontory Apartment Building is typical of the post-war trend toward straightforward design with an emphasis on efficiency, low cost and a clearly expressed structure. The exposed reinforced concrete frame of the building is infilled with light-coloured brick panels (Fig. 8.6). The concrete frame is emphasised by the projection of the columns beyond the exposed floor slabs. The windows are aluminium-framed. This is an early architectural use of aluminium following the popularisation of this material for wartime aircraft construction.

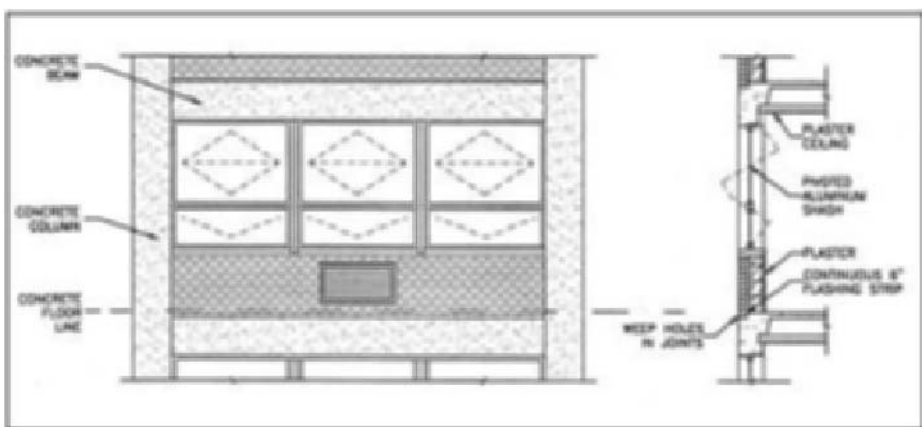
Fig. 8.7 A typical bay. Brick masonry was used as infill between the concrete frame elements. Aluminium pivot, and hopper windows extend from the concrete spandrel beam to the concrete sill above the masonry. This section is excerpted from the original Mies van der Rohe construction drawings.

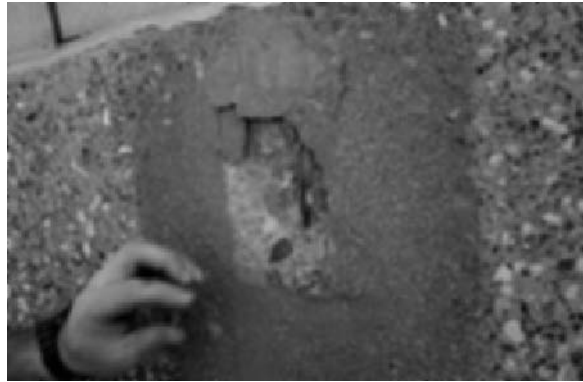
Fig. 8.8 Removal of a delaminated concrete repair: this repair was installed to the level of the reinforcing steel only (photo Paul Gaudette).

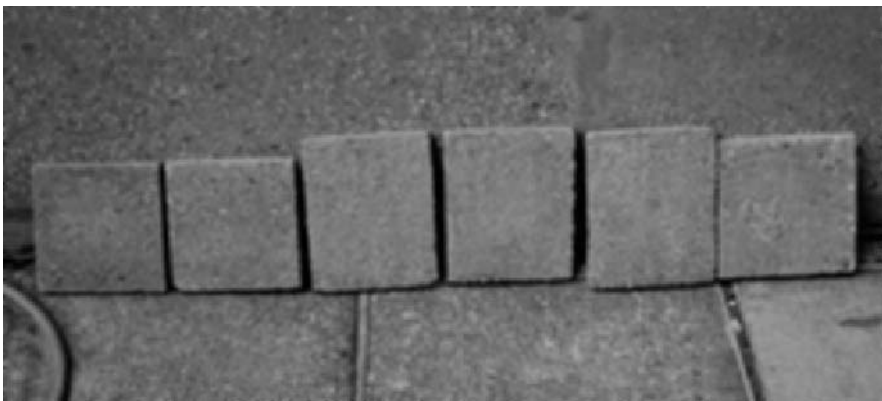
Fig. 8.9 Trial repair mix samples adjacent to the original concrete façade (photo Paul Gaudette).

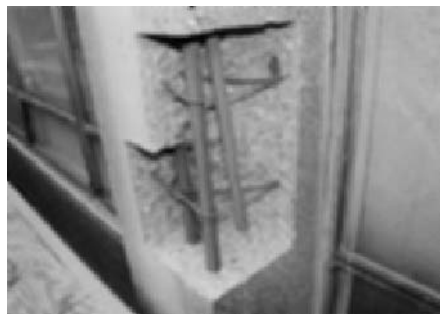
Fig. 8.10 Completion of the preparation works in the repair area prior to the installation of the formwork (photo Paul Gaudette).

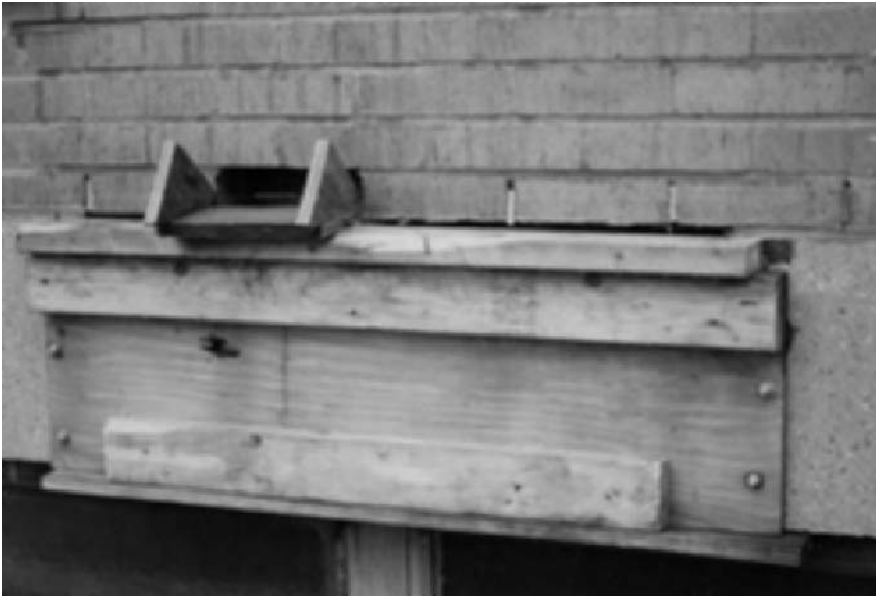
Fig. 8.11 Installation of formwork and a port for ease of concrete placement (photo Paul Gaudette).

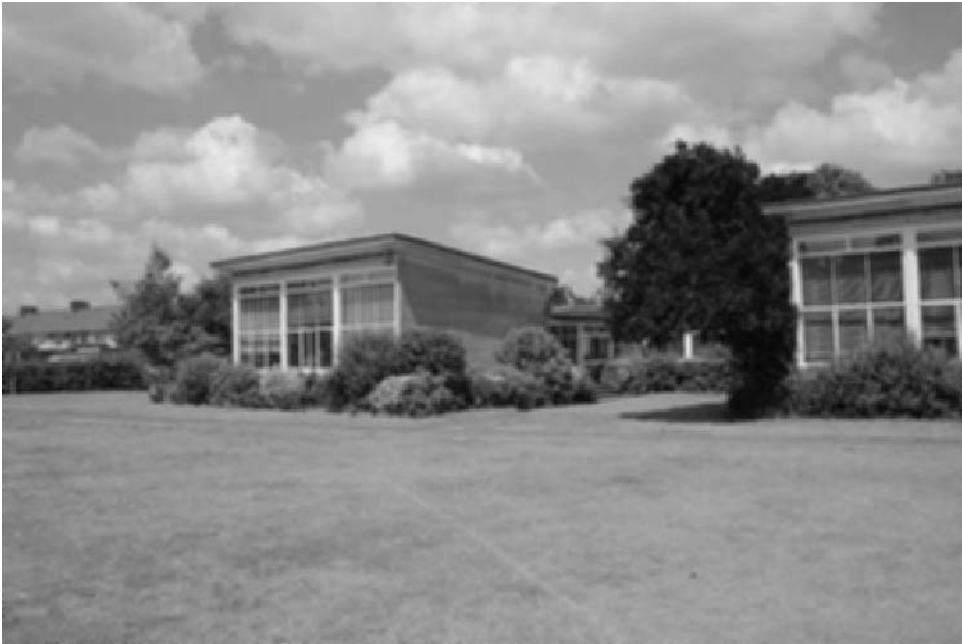
Fig. 8.12 Burleigh School, Hertfordshire, 1947, one of the schools designed by the Hertfordshire County Council Architect's Department, with a design based around child-like proportions. A modular prefabricated construction method was developed to provide this series of small-scale buildings (photo Susan Macdonald).

The now-listed Burleigh J.M.I. School in Cheshunt, Hertfordshire, was designed in 1947 by the Hertfordshire County Council Architect's Department (Fig. 8.12). It was one of the schools built as part of the innovative and extensive school building programme in Hertfordshire immediately after World War II. This programme had a major influence on the design of schools across the country. The architects developed a system of modular, prefabricated components that could be assembled in various ways.

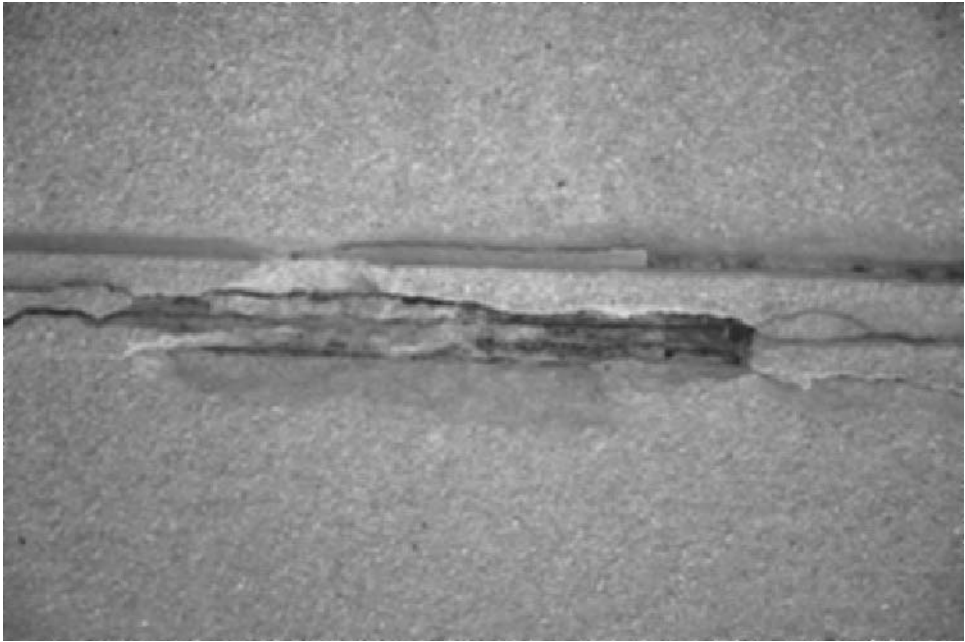
Fig. 8.13 Typical cracking of the concrete panels due to inadequate concrete cover (photo Susan Macdonald).

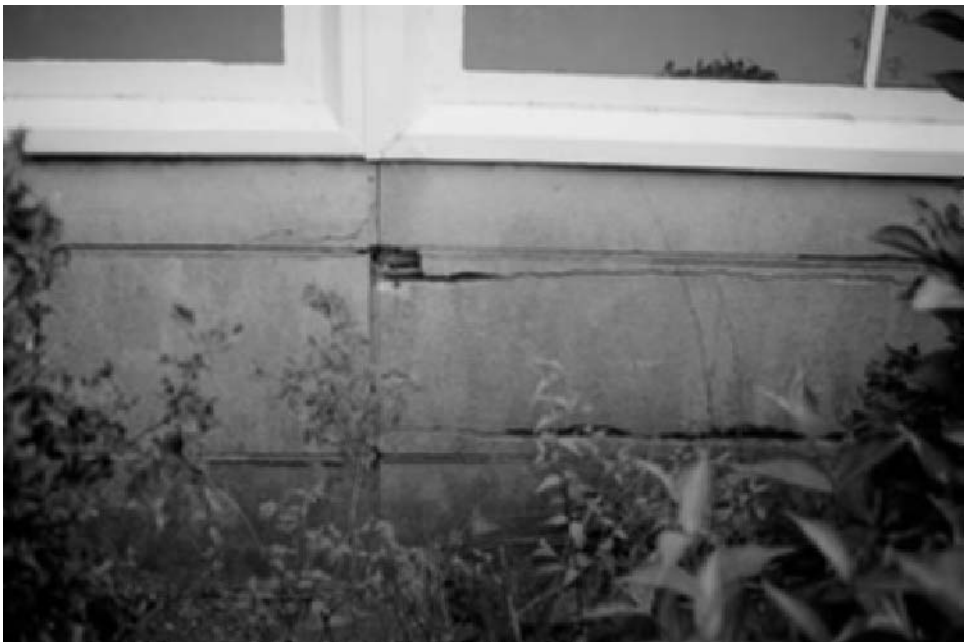
Fig. 8.14 Corrosion of the fixings at the corners and typical corrosion along the top and bottom of the precast panels. Note the junction with the window sill. Increasing the thickness of the panels creates a difficulty at the junction of the panels and the cover of the windows and door frames (photo Susan Macdonald).

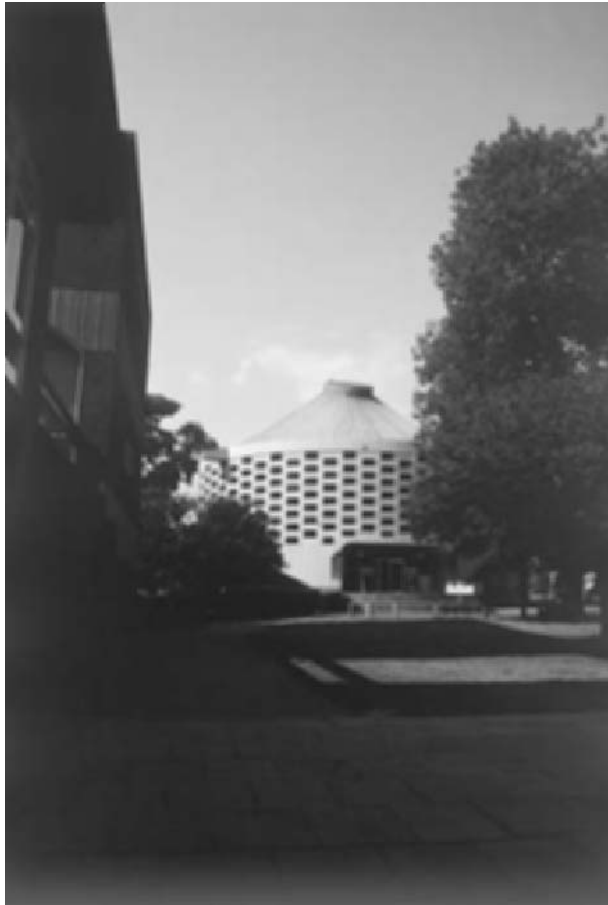
Fig. 8.15 The Meeting House at the University of Sussex following its repair 2 years earlier in 1992. The building was coated with an anti-carbonation coating. Although this attempts to replicate the colour of the concrete, the finish gives a plastic shiny appearance and some of the texture of the board-marking has been lost.

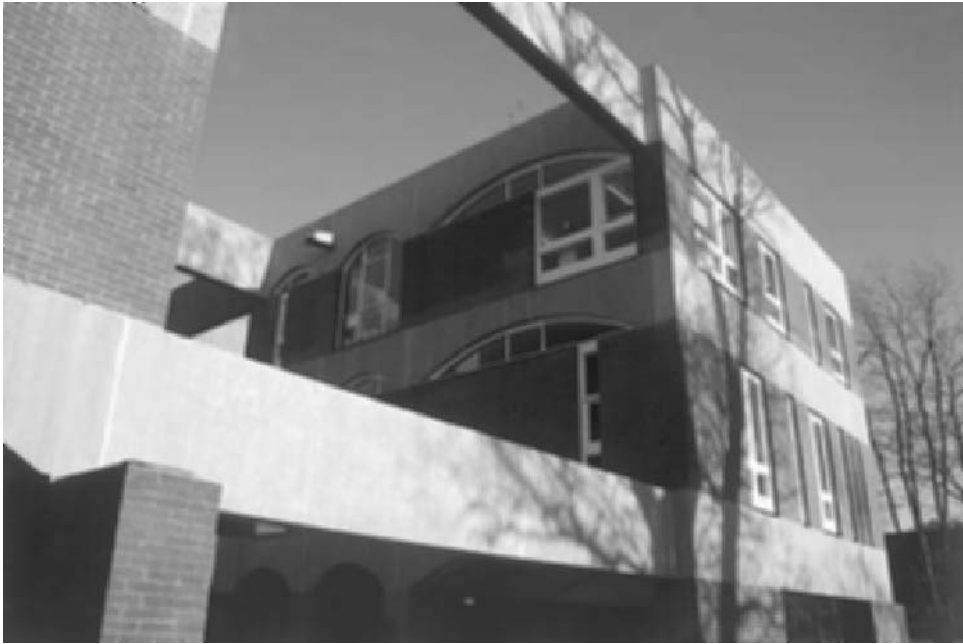
Fig. 8.16 Falmer House after repair. The crack repair through the beam is not particularly successful. The repair could have been improved visually by improved finishing. The other patch repairs to this corner of the building have blended in well with the parent concrete.
