Earthquakes and the Urban Environment

Volume II

G. Lennis Berlin

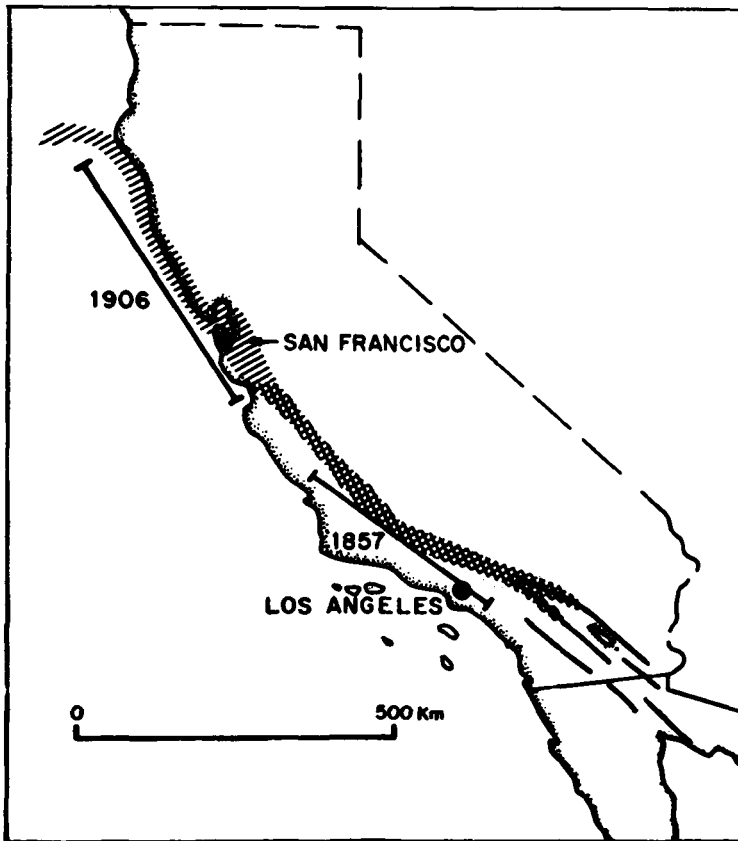
FIGURE 3. Segments of the San Andreas fault system fulfilling initial or initial and supplemental criteria. See text for criteria definitions. Line segments mark the approximate rupture zones of the January 9, 1857 Ft. Tejon and April 18, 1906 San Francisco earthquakes. (From Kelleher, J., Sykes, L., and Oliver, J., *J. Geophys. Res.*, 78, 2578, 1973. Copyrighted by American Geophysical Union. With permission.)

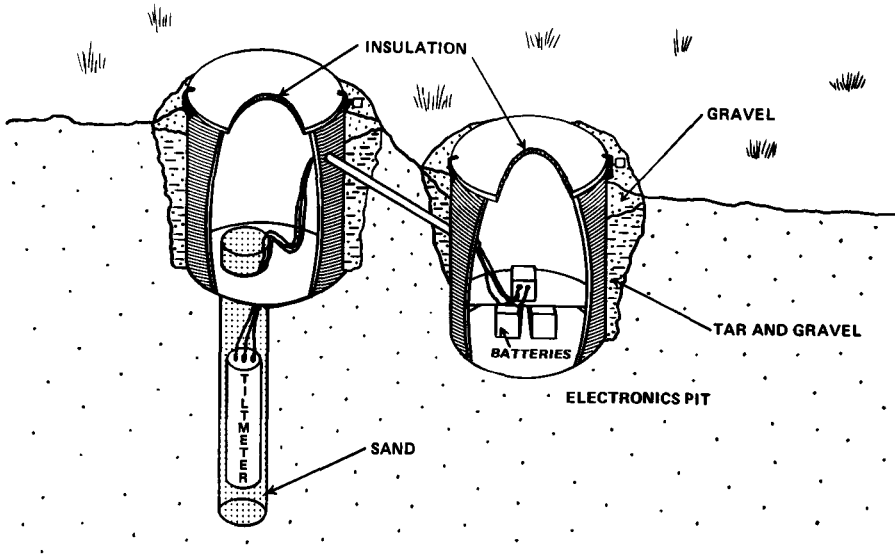
FIGURE 8. Typical U.S. Geological Survey *tiltmeter* installation. Pit at left is 1 m in diameter, 2 m deep, and lined with a fiberglass culvert surrounded by a layer of tar and gravel to prevent seepage. The tilt sensor is packed in a fine-grained silica sand near the bottom of a 15-cm diameter, 2 m-deep borehole lined with steel tubing and closed at the lower end. The recording and transmission electronics are located to the right in a similar pit. (From U.S. Geological Survey, *Earthquake Inf. Bull.*, 6, 17, 1975.)

These instruments have a 10^{-7} to 10^{-8} radian sensitivity and are installed in shallow boreholes to minimize the effects of temperature, moisture, and atmospheric pressure variations (Figure 8).

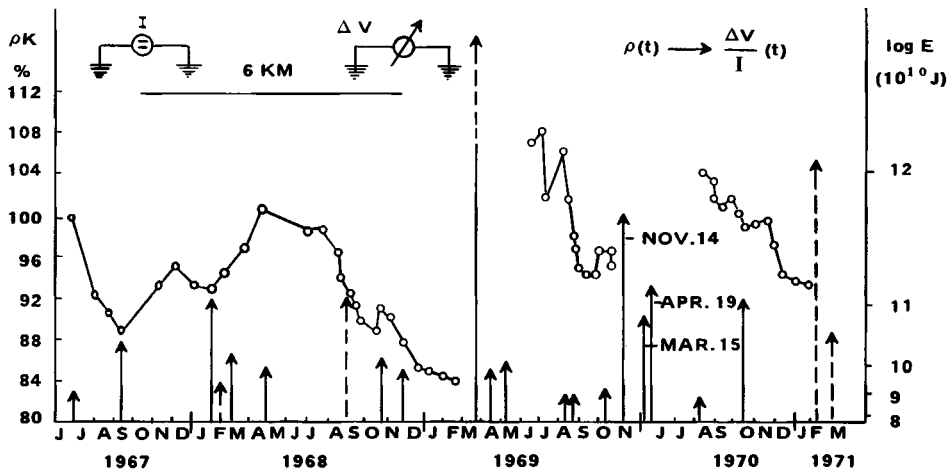
FIGURE 12. Variation of electrical resistivity and the occurrence of large thrust-type earthquakes in the Garm region of the Soviet Union. The ordinate represents values of resistivity as a percent of the initial value. The vertical arrows show the moments when earthquakes occurred while the right-hand scale shows the logarithm of their energy. (From Barsukov, O. M., *Tectonophysics*, 14, 274, 1972. With permission.)

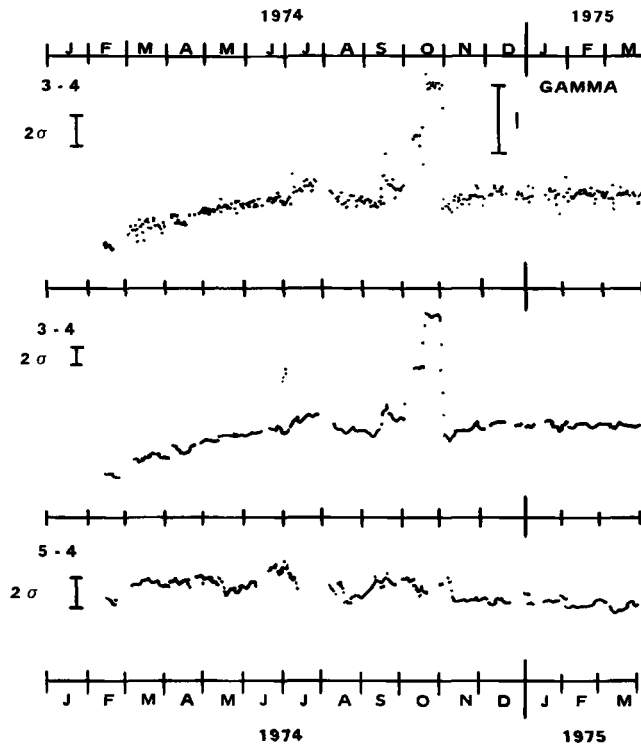
FIGURE 13. Plots of 1-day means (top record) and 5-day running means (bottom two records) of the total magnetic field differences for station pairs 3 and 4 and 5 and 4 from the U.S. Geological Survey's seven-station proton precision magnetometer network in central California. The error bars represent 2 SD calculated by using the 1- or 5-day mean values from March through July 1974 after removing the long-term trend. This period of time includes the largest ionospheric disturbances observed during 1974. The $M_L = 5.2$ Hollister earthquake occurred on November 28, 1974. (From Smith, B. E. and Johnston, M. J. S., *J. Geophys. Res.*, 81, 3558, 1976. Copyrighted by American Geophysical Union. With permission.)

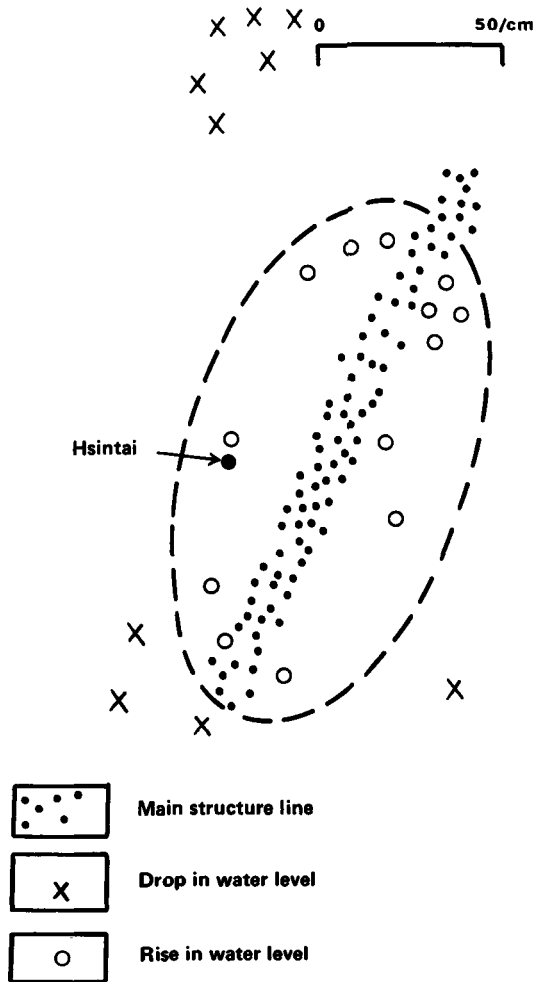
FIGURE 14. Changes in the ground water level near Hsintai, People's Republic of China before the 1966 Hsintai earthquake. (Adapted from Kuo, T.-K., Chin, P.-Y., and Feng, H.-T., *Acta Geophys. Sinica*, 17, 99, 1974 by Bolt, B.A. and Wang, C.-Y., *CRC Crit. Rev. Solid State Sci.*, 5, 140, 1975. With permission.)

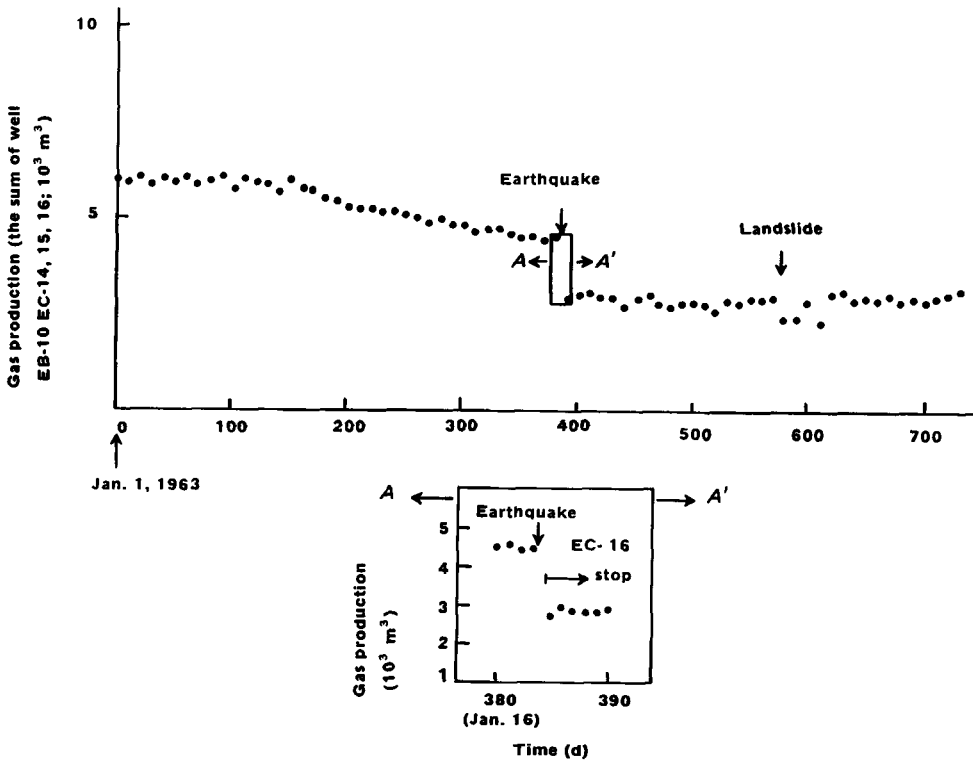
FIGURE 18. Gas production-rate data for four wells in the Chutouchi gas field, Taiwan, before and after the January 18, 1964 earthquake ($M_s = 6.75$). Note the more rapid drop in production beginning in March 1963. The drop in total production after the earthquake was caused by a coseismic disruption of one well (inset). (From Wu, F. T., *Nature (London)*, 257, 663, 1975. With permission.)

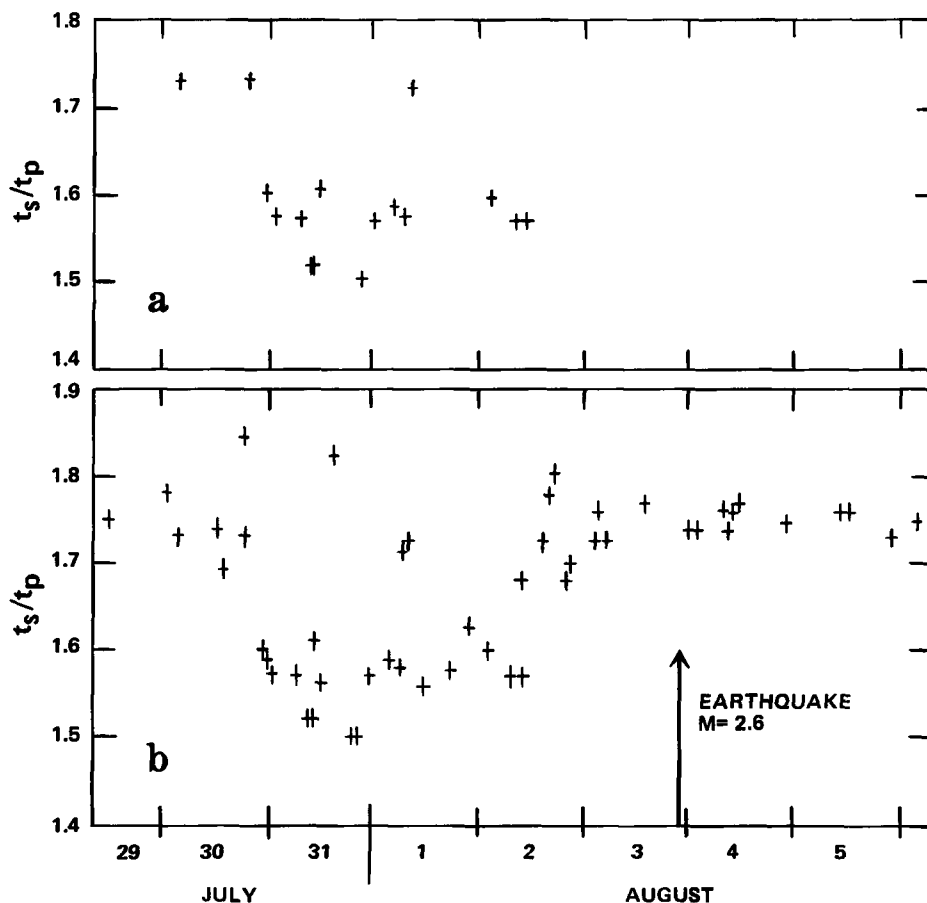
FIGURE 21. Travel/time ratios of secondary to primary waves (t_s/t_p) as a function of time before and after the occurrence of the predicted earthquake of August 3, 1973 at Blue Mountain Lake, New York. Arrow indicates the time of occurrence of the earthquake. A. Data were reduced in the field before the August 3 earthquake and used to predict the event. The anomalously low t_s/t_p values observed on July 31 and August 1 were interpreted as a precursor to an impending earthquake. B. Data in part A combined with the results of data reduction after the occurrence of the earthquake are shown. Note that, in B, t_s/t_p apparently returned to normal before the earthquake. (From Aggarwal, Y. P., Sykes, L. R., Simpson, D. W., and Richards, P. G., *J. Geophys. Res.*, 80, 722, 1975. Copyrighted by American Geophysical Union. With permission.)

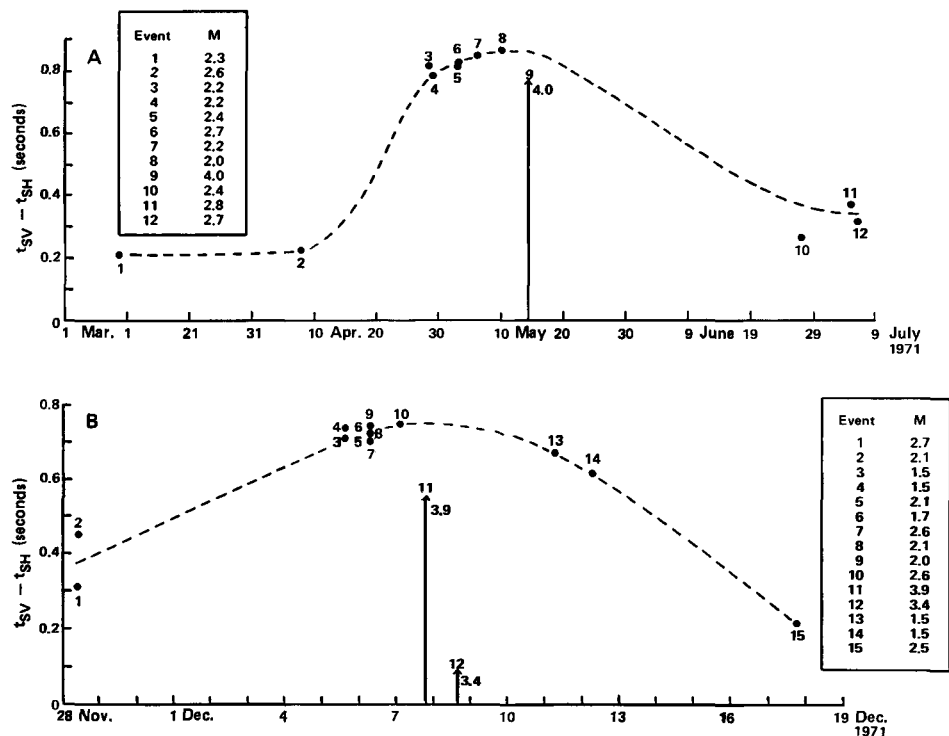
FIGURE 22. Observed temporal variations in S-wave velocity anisotropy ($\Delta t = t_{sv} - t_{sh}$) for earthquakes in (A) the Slate Mountain region and (B) the Mina region, Nevada. The maximum difference in the SH and SV velocities in the two regions amounts to only 2.3 and 2.5%, respectively. The insets show magnitude for each event. The S-waves from the largest events (Event 9 from Slate Mountain and Events 11 and 12 from Mina) could not be examined because of signal clipping. (From Gupta, I. N., *Science*, 182, 1130, 1973. Copyright 1973 by the American Association for the Advancement of Science. With permission.)

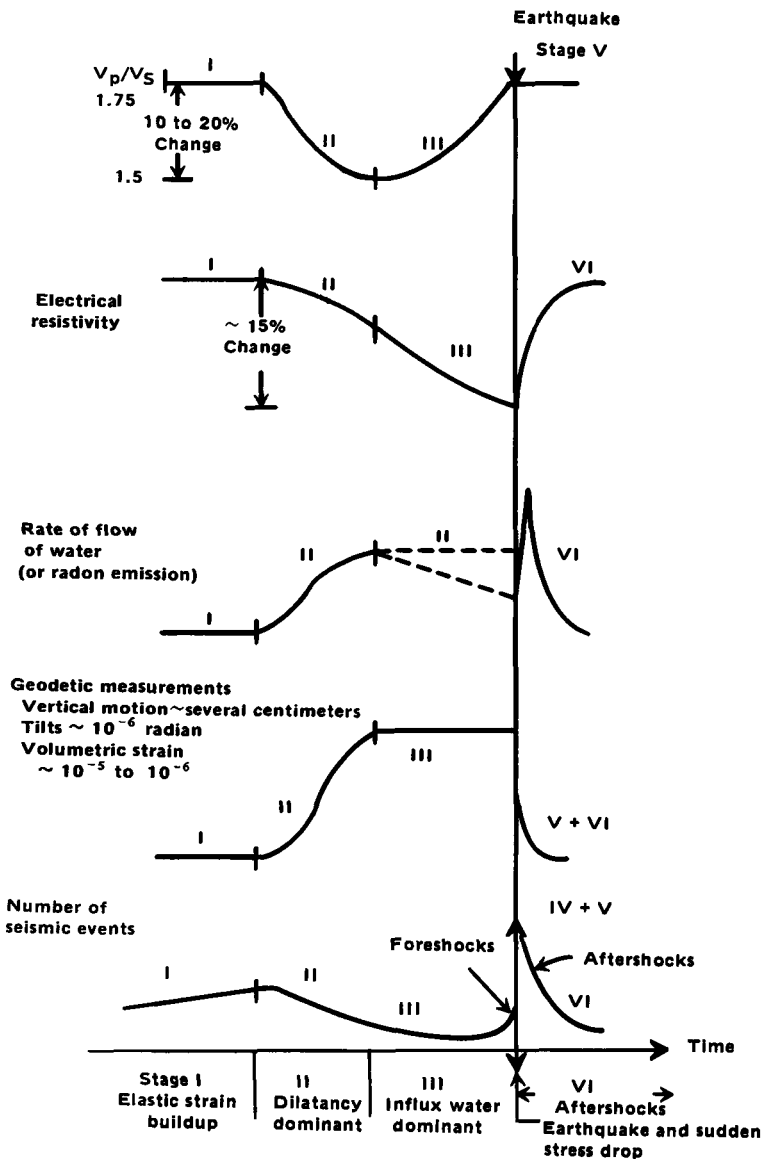
FIGURE 25. Predicted changes in various precursors as a function of time during the earthquake cycle for the Scholz et al.⁴² dilatancy-diffusion model. Roman numerals indicate various stages in the cycle. Short-term fluctuations (Stage IV), which are observed before some large earthquakes, are not indicated on the sketches. The rate of water flow may vary as indicated by the dashed lines. Radon emission may be a function not only of the rate of water flow but also of the rate of creation of new surface area by the growth of cracks. (From Scholz, C. H., Sykes, L. R., and Aggarwal, Y. P., *Science*, 181, 803, 1973. Copyright 1973 by the American Association for the Advancement of Science. With permission.)

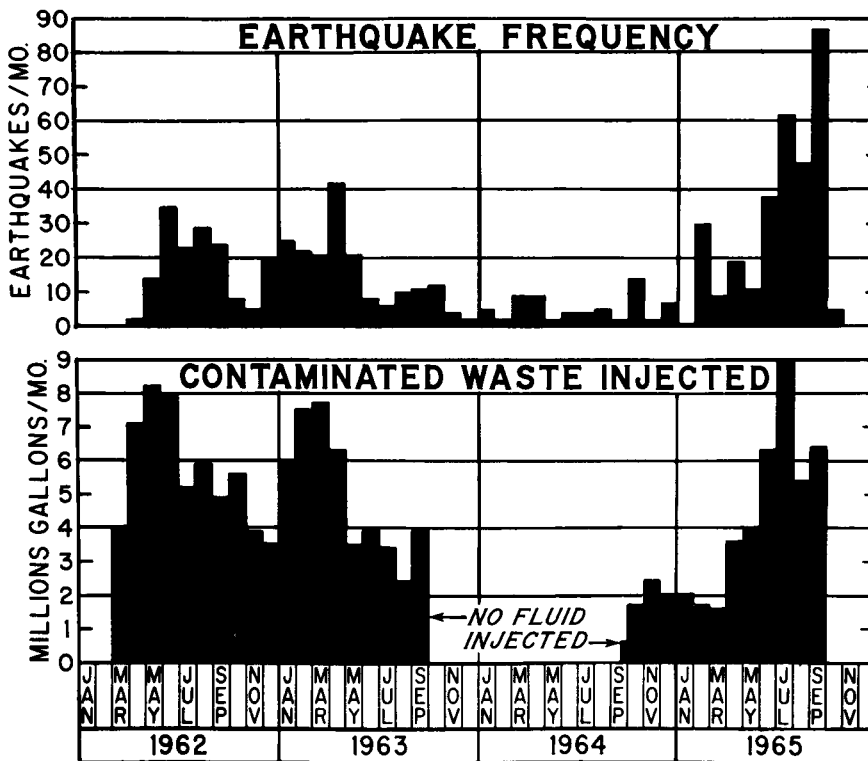
FIGURE 1. Earthquake frequency compared to fluid injection rates at the U.S. Army's Rocky Mountain Arsenal well, Colorado. (From U.S. Geological Survey, *Earthquake Inf. Bull.*, 5, 6, 1973.)

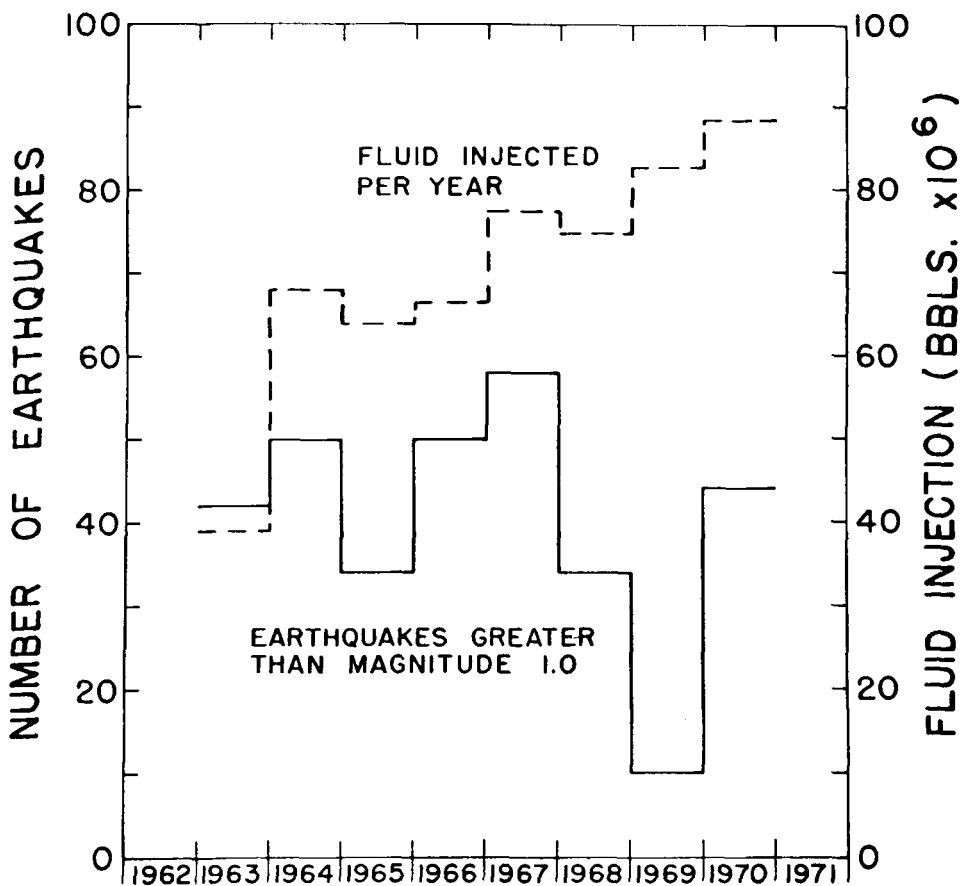
FIGURE 4. Total yearly fluid injection and number of earthquakes per year occurring in the Rangely oil field, Colorado and vicinity. (From Gibbs, J. F., Healy, J. H., Raleigh, C. B., and Coakely, J., *Bull. Seismol. Soc. Am.*, 63, 1569, 1973. With permission.)

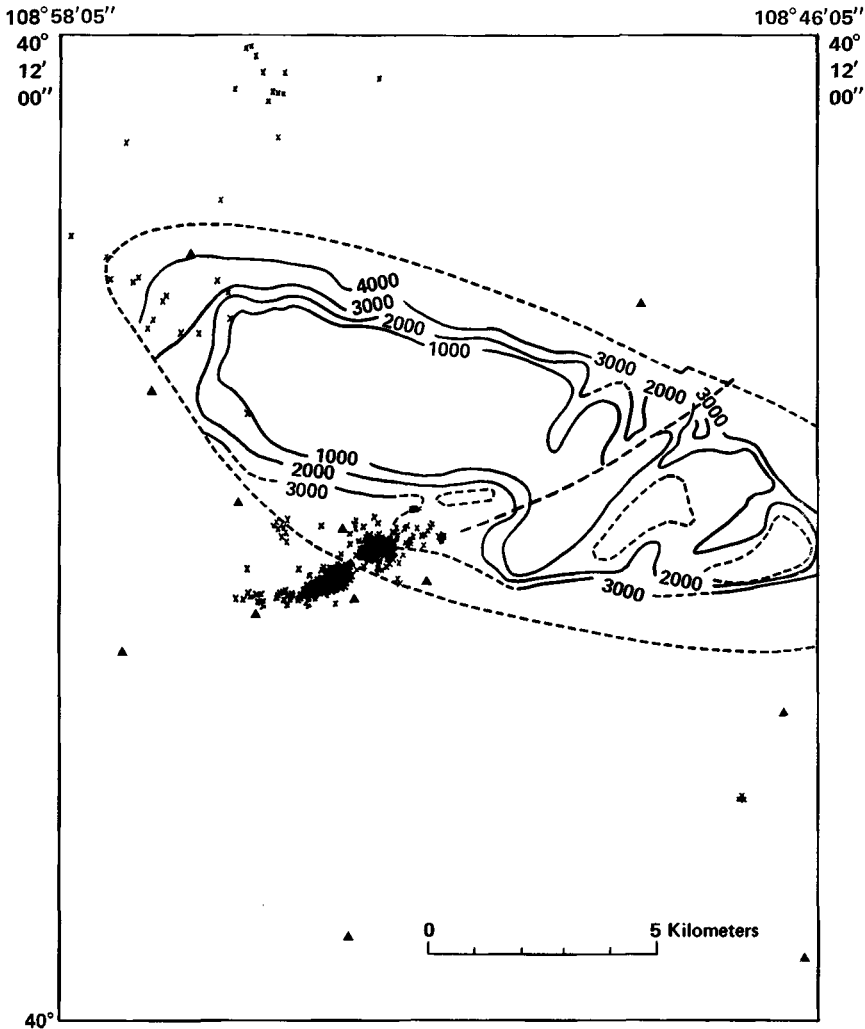
FIGURE 5. Earthquake epicenters at the Rangely oil field, Colorado between October 1969 and November 1970. The heavy dashed line is a subsurface strike-slip fault. Contours are bottom hole 3-day shut in pressures (per square inch) as of September 1969 and are typical of recent pressure distributions in the field.¹⁵ Triangles represent seismic stations and the rectangle represents the well used to measure *in situ* stress. The four injection wells used in the earthquake control experiment are located between the field boundary and the mapped fault. (From U.S. Geological Survey, *Earthquake Inf. Bull.*, 5, 7, 1973.)

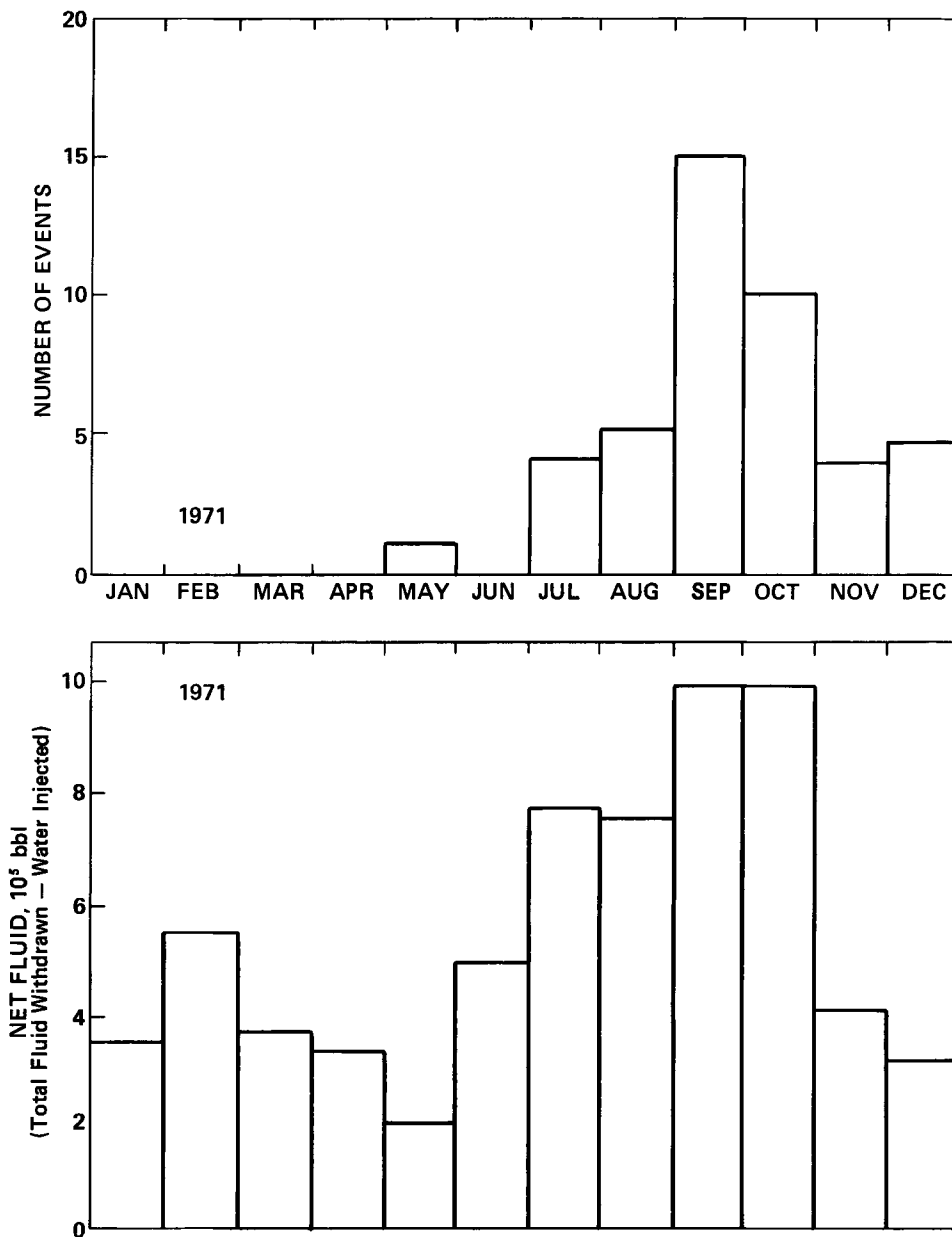
FIGURE 7. Correlation of earthquake occurrence and the net amount of fluid replacement, Inglewood, California oil field. (From Teng, T. L., Real, C. R., and Henyey, T. L., *Bull. Seismol. Soc. Am.*, 63, 874, 1973. With permission.)

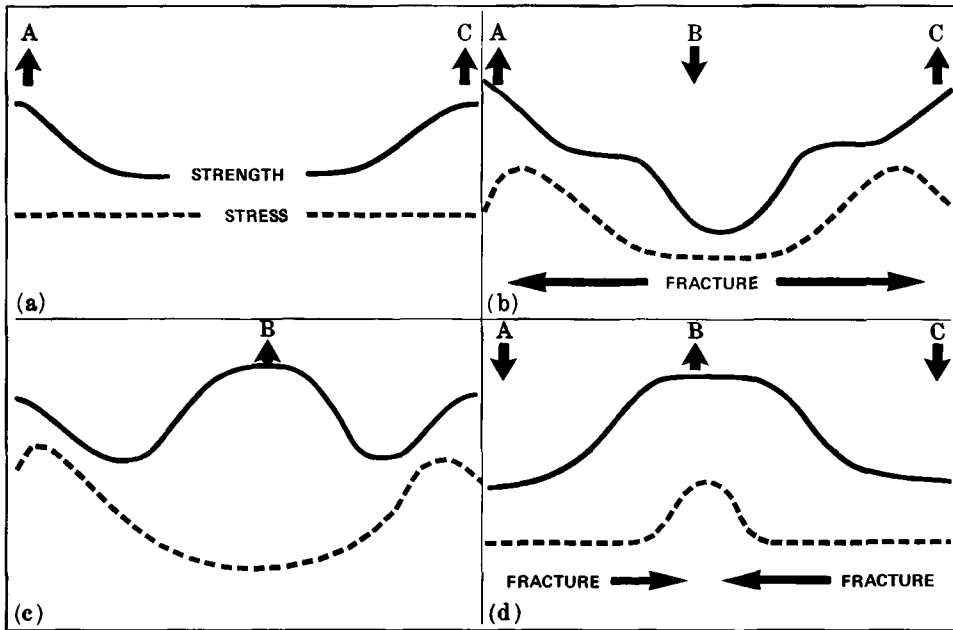
FIGURE 8. Hypothetical scheme for controlling earthquakes. (a) Fluid is removed from wells A and C, with an increase in frictional strength along the fault. (b) Fluid is injected into well B, triggering an earthquake; the stress drops at B and increases at A and C, where the fracture is arrested. (c) Fluid is removed from well B, resulting in an increase in strength at B. (d) Fluid is injected at A and C, producing earthquakes and the fracture is now arrested at B. (From Raleigh, C. B., Healy, J. H., and Bredehoeft, J. D., *Science*, 191, 1236, 1976. Copyright © 1976 by the American Association for the Advancement of Science. With permission.)

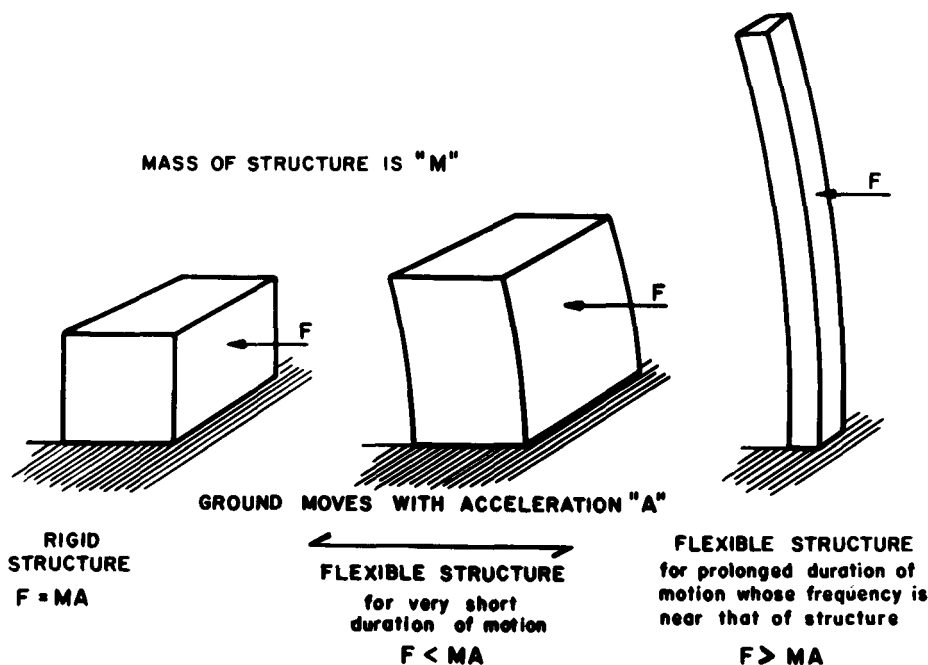
FIGURE 1. Earthquake-induced ground motion setting up *inertia forces* in three types of buildings. F = inertia forces, M = mass of the structure, and A = acceleration of the ground motion at any instant. (From Degenkolb, H. J., *Earthquake Forces on Tall Structures*, Booklet 2717A, Bethlehem Steel Corporation, Bethlehem, Pa., 1977, 3. With permission.)

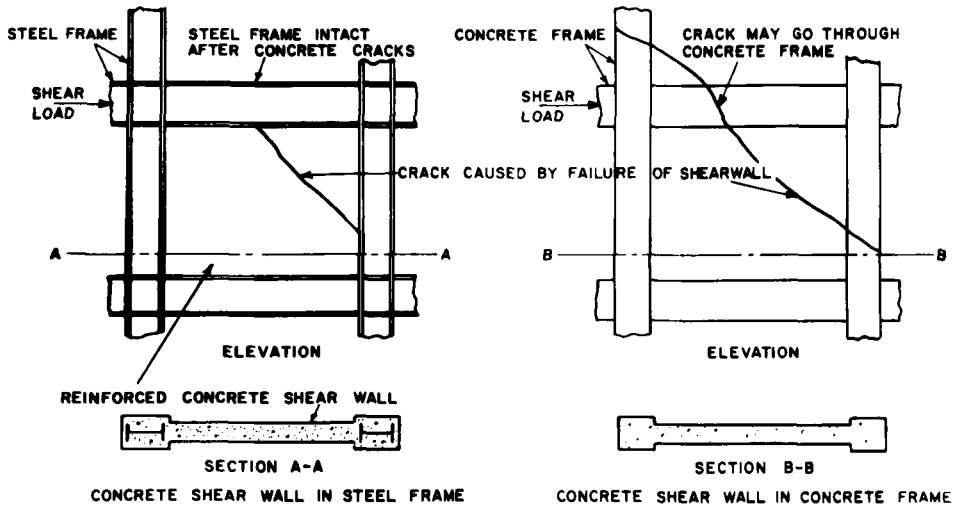
FIGURE 2. Advantage of using a *ductile material*, such as steel rather than concrete, for the basic frame of tall structures. Note that failure in a concrete *shear wall* can penetrate and damage the concrete frame. (From Degenkolb, H. J., *Earthquake Forces on Tall Structures*, Booklet 2717A, Bethlehem Steel Corporation, Bethlehem, Pa., 1977, 23. With permission.)

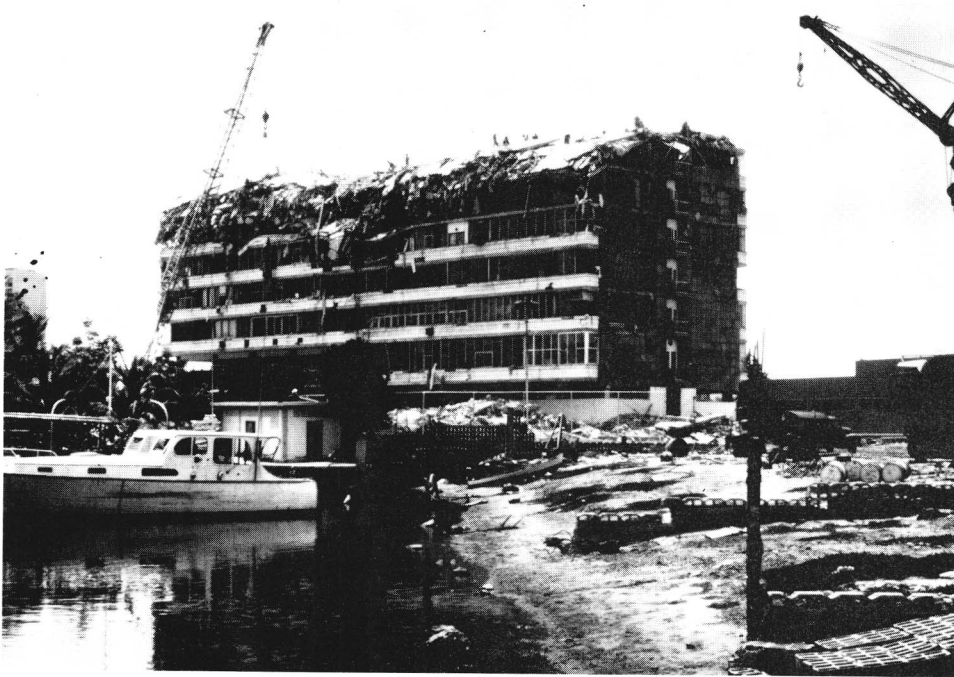
FIGURE 6. Reinforced concrete Mansion Charaima Apartment building in Caracas, Venezuela following the July 29, 1967 earthquake ($M_L = 6.5$). The top four floors “pancaked” causing 42 deaths.⁹³³ (Courtesy of the National Oceanic and Atmospheric Administration, Environmental Data Service.)

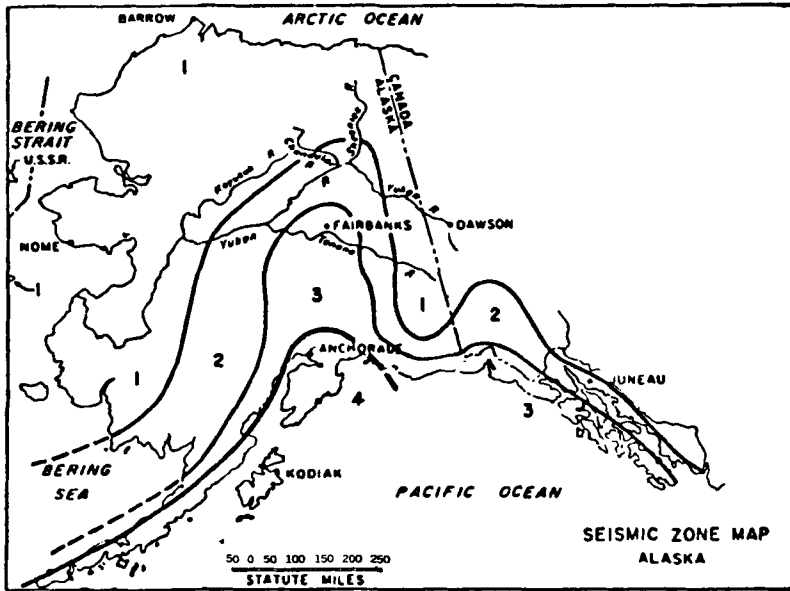
FIGURE 8. Seismic risk maps of Alaska and Hawaii used in the *Uniform Building Code — 1976 Edition*. (Reproduced from the 1976 edition of the *Uniform Building Code*, copyright © 1976. With permission of the International Conference of Building Officials, Whittier, Calif.)

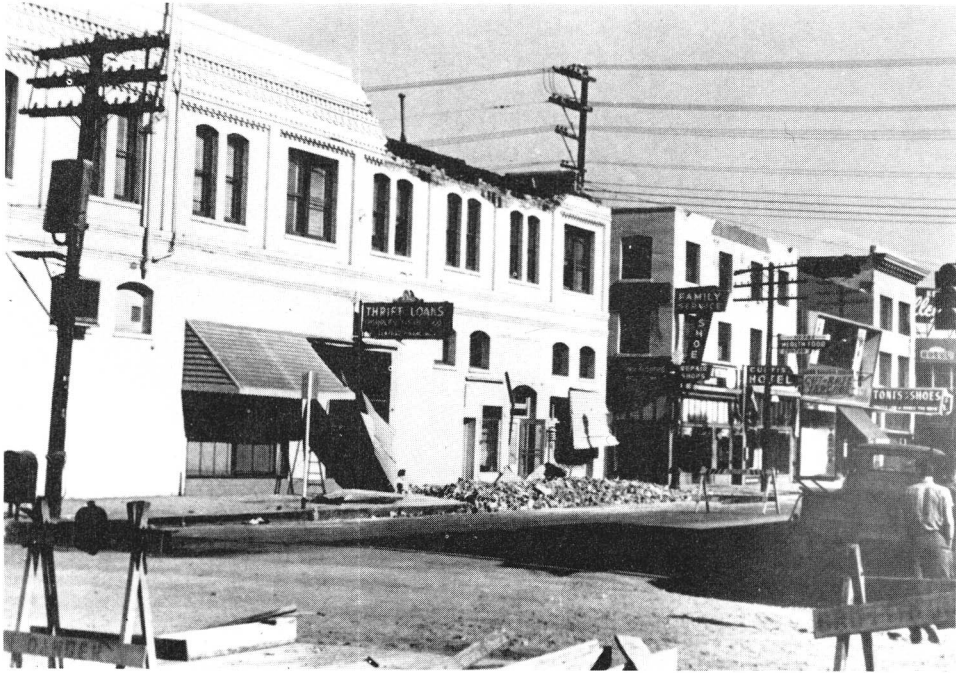
FIGURE 10. *Parapet damage* to structures in Bakersfield, California following the July 21, 1952 Kern County earthquake ($M_L = 7.7$). (Courtesy of the National Oceanic and Atmospheric Administration, Environmental Data Service.)

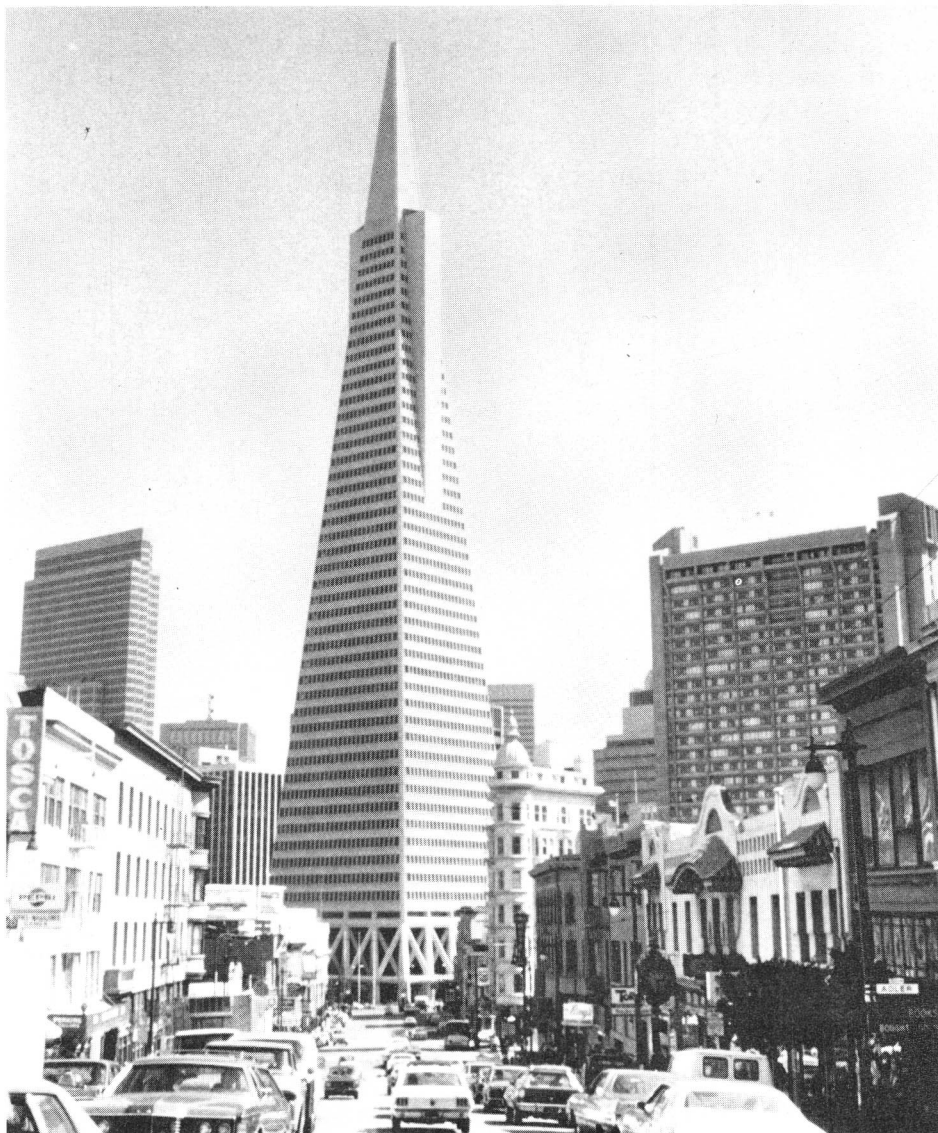
FIGURE 11. The 48-story (plus 65-m spire) Transamerica Pyramid in San Francisco. The establishment and distribution of lateral forces for this structural steel frame building were determined by *dynamic analysis*. The windowless protrusions rising from the 29th story house elevators on one side of the building and a stair well and smoke tower on the opposite side. (Courtesy of Dale Honeycut, Northern Arizona University.)

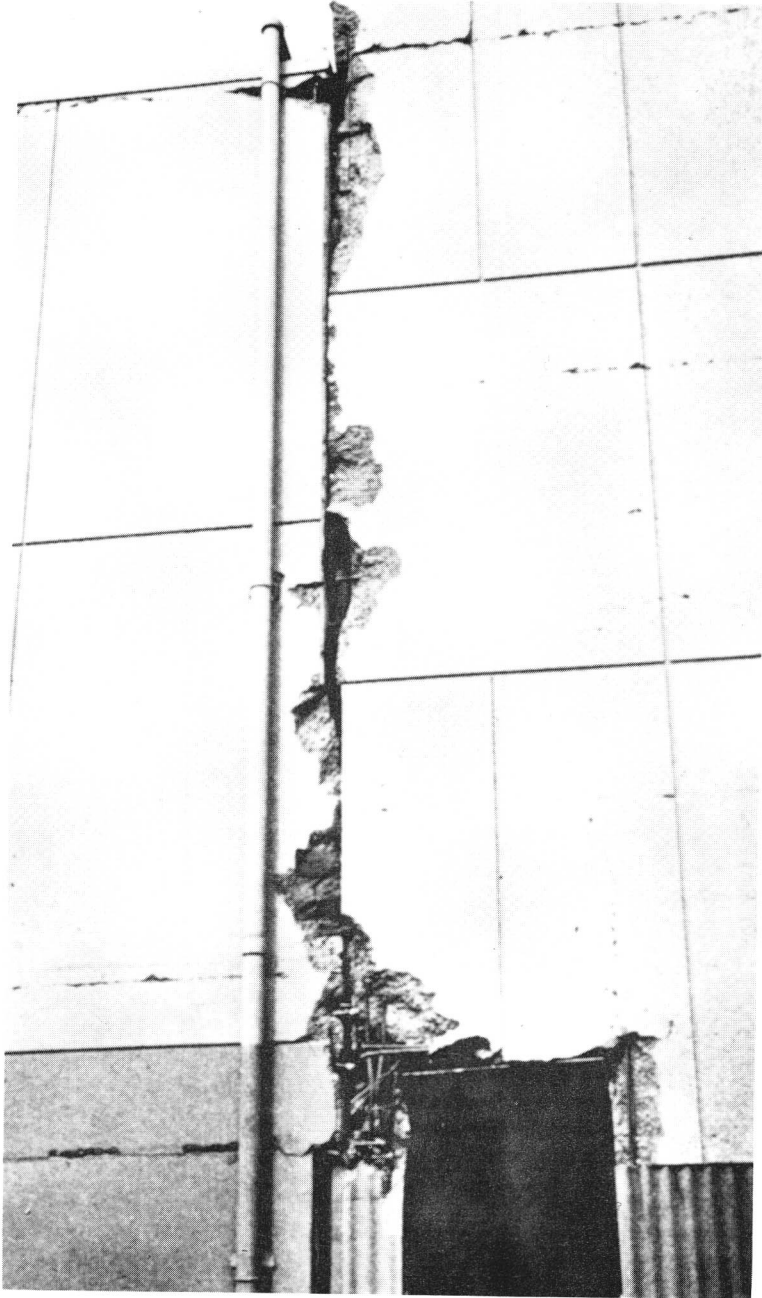
FIGURE 12. *Pounding or hammering damage between the ballroom (left) and the 14-story Anchorage-Westward Hotel following the March 27, 1964 Alaskan earthquake ($M_s = 8.5$). (From Berg, G. V. and Stratta, J. L., *Anchorage and the Alaska Earthquake of March 27, 1964*, American Iron and Steel Institute, New York, 1964, 30. With permission.)*

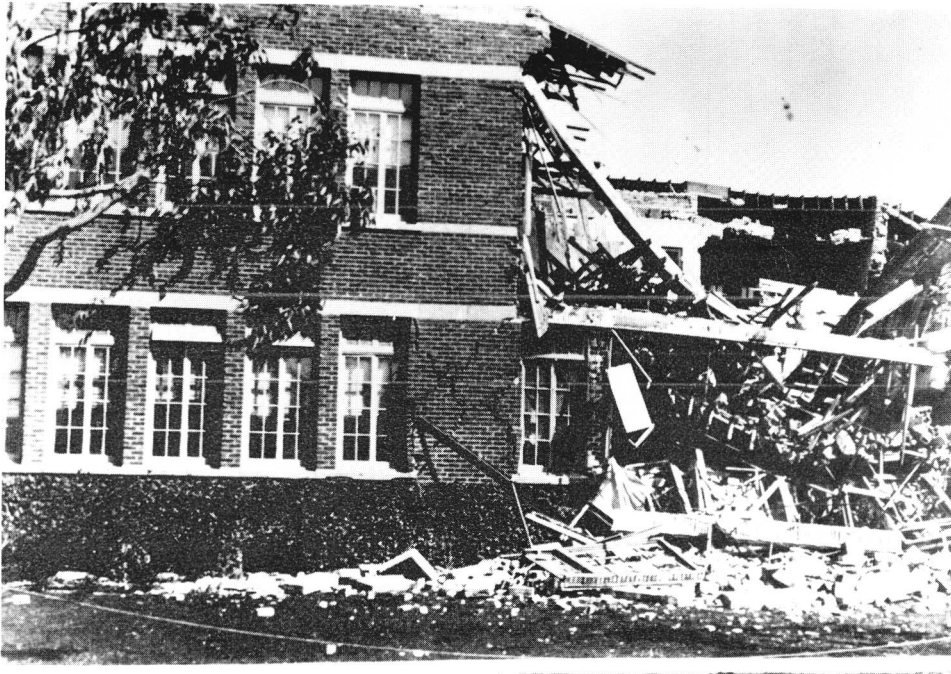
FIGURE 14. Collapsed roof and walls of Jefferson Junior High School building following the March 10, 1933 Long Beach, California earthquake ($M_L = 6.3$). (Photo by Captain T. J. Maher. Courtesy of the National Oceanic and Atmospheric Administration, Environmental Data Service.)

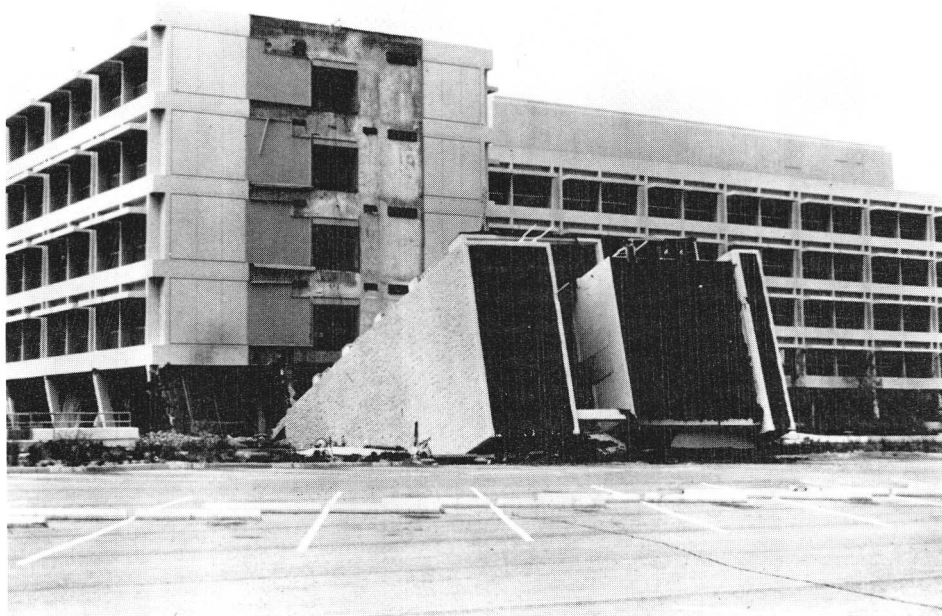
FIGURE 15. The Medical Treatment and Care Unit of the Olive View Community Hospital complex in Sylmar, California following the February 9, 1971 San Fernando earthquake ($M_L = 6.4$). Three of four stair well and recreation towers overturned and pushed into the basement. Note the damage to first-story columns. There were three casualties at this facility. One person was killed as a direct result of the earthquake, and two people under intensive care died when an earthquake-caused power failure severed the operation of all electrical life-support systems. (Courtesy of James L. Ruhle and Associates, Fullerton, Calif.)

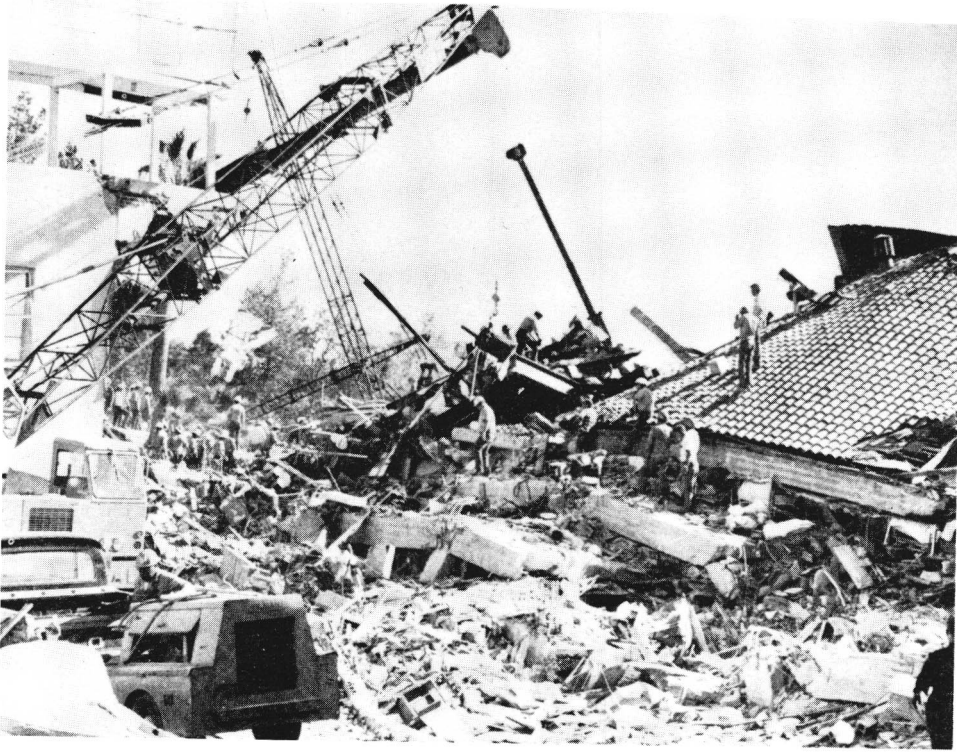
FIGURE 16. Rescue operations at the San Fernando Veterans Administration Hospital complex following the February 9, 1971 San Fernando earthquake ($M_L = 6.4$). The collapse of four pre-1933 unreinforced masonry buildings was responsible for 44 deaths. Newer buildings and additions in the complex that were designed and constructed in accordance with earthquake-resistant provisions did not collapse. (Los Angeles City Department of Building and Safety photograph. From Brugger, W., *The San Fernando, California, Earthquake of February 9, 1971*, Geological Survey Professional Paper 733, U.S. Government Printing Office, Washington, D.C., 1971, 218.)

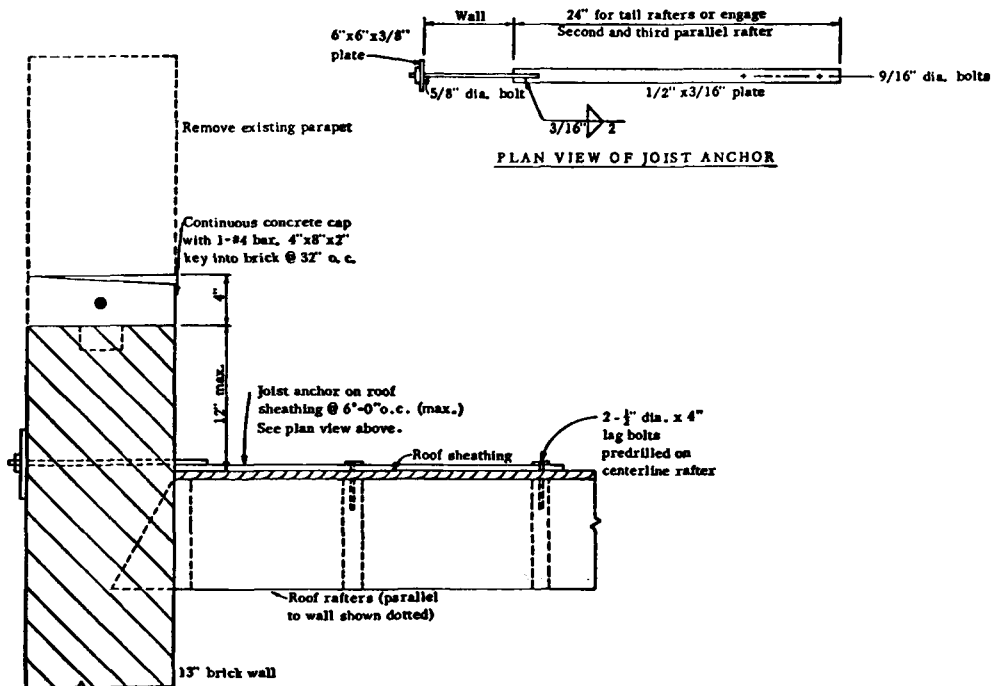
FIGURE 17. Typical *parapet corrective measure* for a pre-1933 masonry building in Los Angeles. In general, the parapet (1) height was reduced to 30.9 cm (12 in) above the roofline and (2) anchored to the roof framing by steel straps and bolts.⁹⁷⁰ (From Abel, M. A., San Fernando, California, Earthquake of February 9, 1971, Vol. 1 (Part B), Benfer, N. A., Coffman, J. L., and Dees, L. T., Eds., U.S. Government Printing Office, Washington, D.C., 1973, 639.)

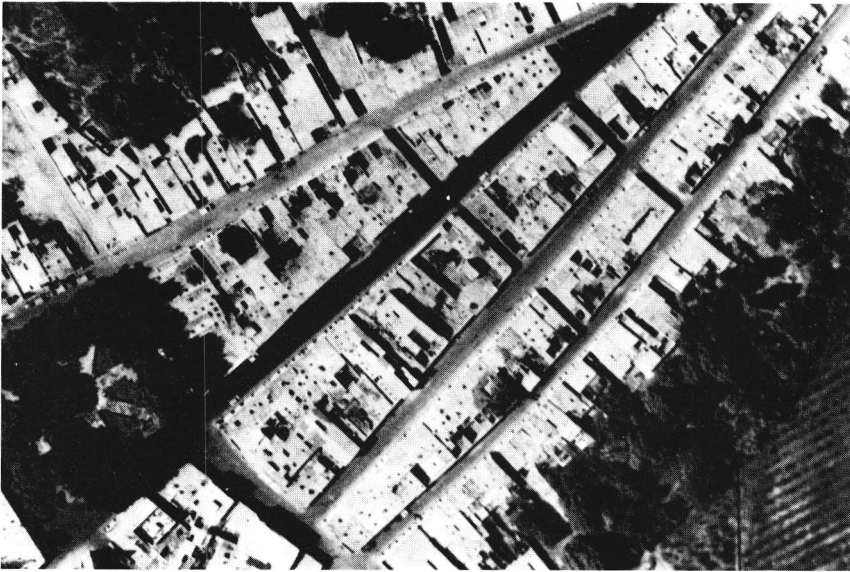
FIGURE 1. Vertical aerial photograph showing a portion of Casma before the May 31, 1970 Peru earthquake ($M_s = 7.7$). (From Cluff, L. S., *Bull. Seismol. Soc. Am.*, 61, 529, 1971. With permission; photo courtesy of Lloyd S. Cluff, Woodward-Clyde Consultants, San Francisco.)

Because the failure of unreinforced masonry buildings has been repeatedly responsible for a large part of the loss of life and property in earthquakes, this type of construction has been called the *dead hand of tradition*.²⁷ The devastating effect of ground motion on unreinforced adobe construction is depicted in Figures 1 and 2.

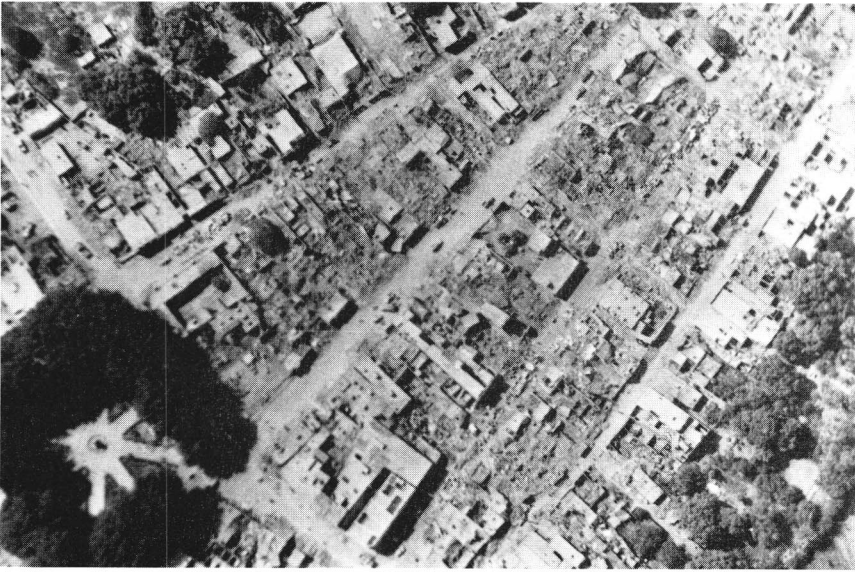
FIGURE 2. Vertical aerial photograph showing a portion of Casma following the May 31, 1970 Peru earthquake ($M_s = 7.7$). According to Cluff,⁹³⁵ Casma, located about 61 km from the epicenter, was almost completely destroyed as a result of the strong ground shaking. Nearly all of the buildings were of adobe construction. (From Cluff, L.S., *Bull. Seismol. Soc. Am.*, 61, 529, 1971. With permission; photo courtesy of Lloyd S. Cluff, Woodward-Clyde Consultants, San Francisco.)

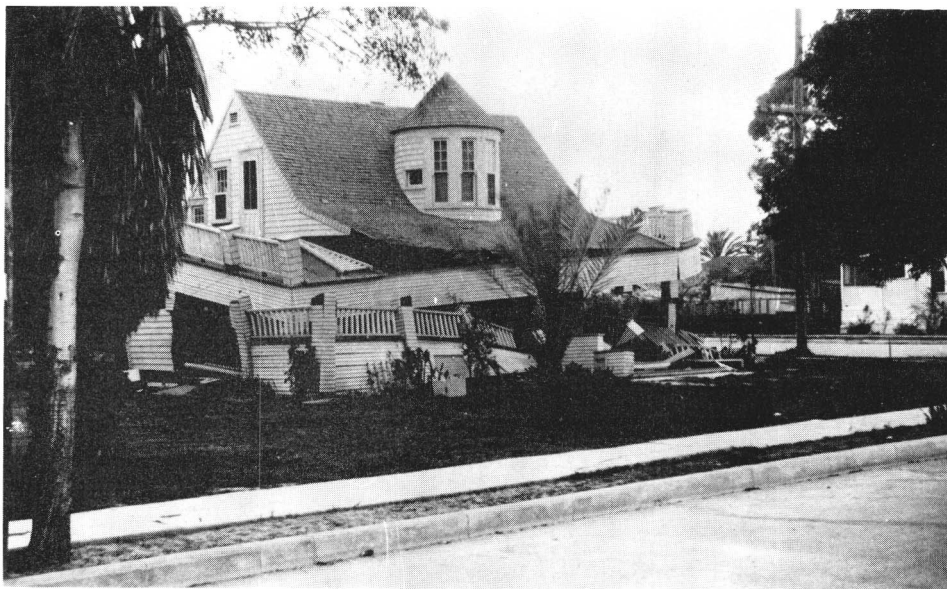
FIGURE 3. Wood-frame house severed from its foundation as a result of March 10, 1933 Long Beach, California earthquake ($M_L = 6.3$). The studding had been weakened by termites. (Photo by Mr. Merritt; courtesy of National Oceanic and Atmospheric Administration, Environmental Data Service.)
