Earthquakes and the Urban Environment

Volume II

G. Lennis Berlin

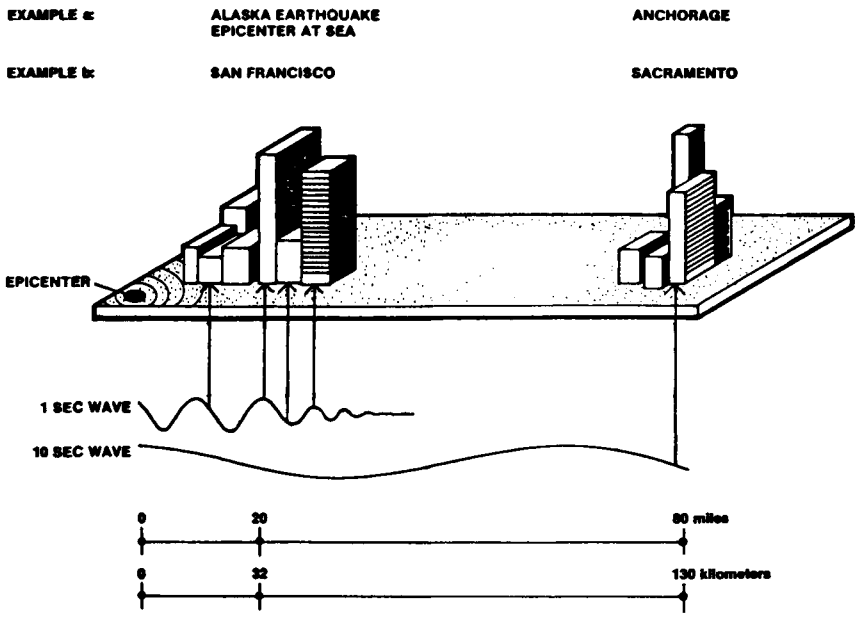
FIGURE 4. Relative wave motion effects at different epicentral distances. Note that the shorter period waves tend to die out more rapidly with distance than do longer period waves. Shorter period waves oscillate in the same frequency range as lower buildings, affecting such structures close to the epicenter. Longer period waves, which oscillate in the same frequency range as taller buildings, travel farther and can affect such buildings at relatively great distances from the epicenter. (From Botsai, E. E., et al., *Architects and Earthquakes*, AIA Research Corp., Washington, D.C., 1977, 23. With permission.)

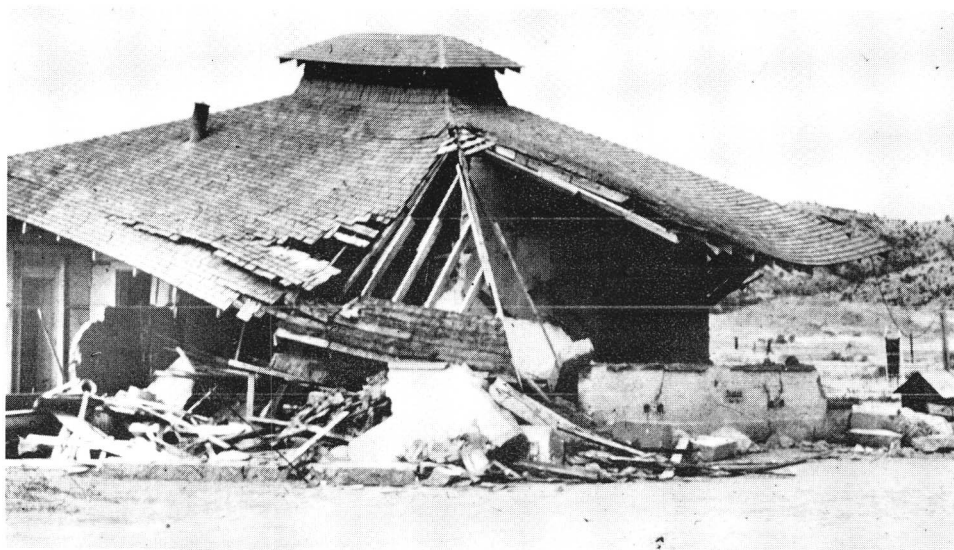
FIGURE 5. Collapsed Cummings Valley School following the July 21, 1952 Kern County, California earthquake ($M_L = 7.7$). The school, built about 1910,⁹⁴⁸ was constructed of reinforced concrete walls and wood roof. (Courtesy of National Oceanic and Atmospheric Administration, Environmental Data Service.)

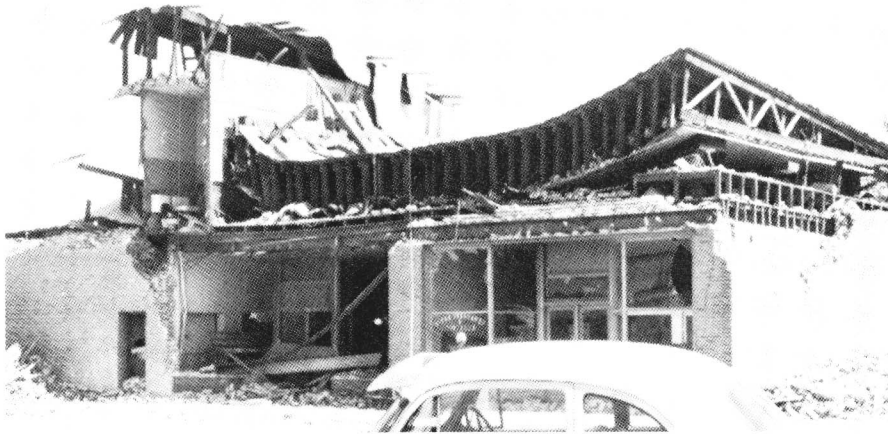
FIGURE 6. Unreinforced brick Lodge Hall in Tehachapi following the July 21, 1952 Kern County, California earthquake ($M_L = 7.7$). Wood partition at left shows original roof height of this two-story structure. The roof collapsed after supporting walls failed. (Courtesy of National Oceanic and Atmospheric Administration, Environmental Data Service.)

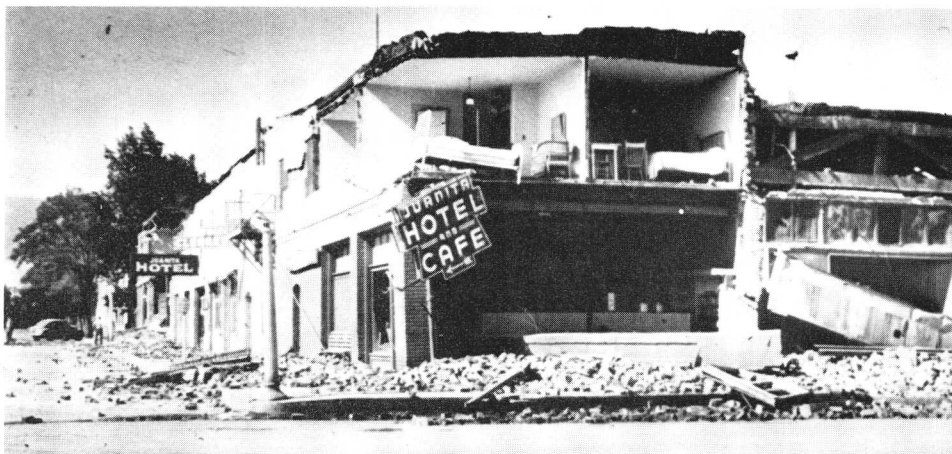
FIGURE 7. Collapsed unreinforced brick bearing wall of the Juanita Hotel in Tehachapi following the July 21, 1952 Kern County, California earthquake ($M_L = 7.7$). Note support given by the nonstructural wood partitions after collapse of exterior bearing walls. (University of California, Berkeley, photograph; courtesy of National Oceanic and Atmospheric Administration, Environmental Data Service.)

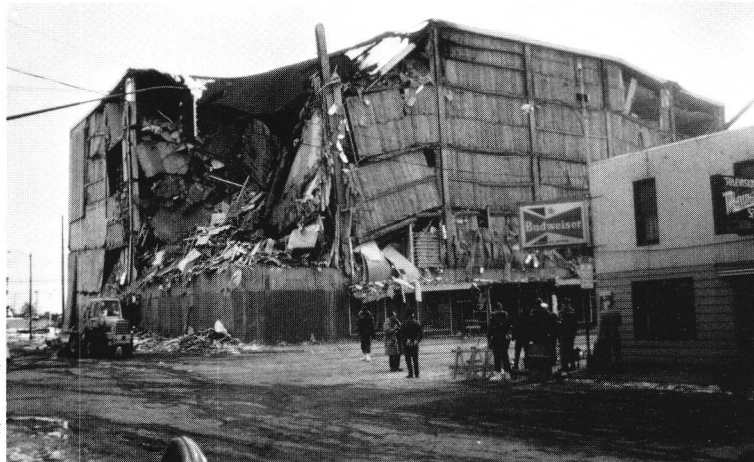
FIGURE 8. Northeast corner of the five-story reinforced concrete J.C. Penney building in Anchorage following the March 27, 1964 Alaskan earthquake ($M_s = 8.5$). Most of the rubble has been cleared from the streets. (Courtesy of George Plafker, U.S. Geological Survey.)

- The J.C. Penney building was constructed in 1962 under the Zone 3 earthquake provisions of the Uniform Building Code.⁹⁸³ It was a five-story reinforced concrete structure, nearly square in plan, with shear walls on three sides. The north and east walls were covered with 10-cm-thick precast reinforced concrete panels from the second floor to the roof. No lateral bracing system was used in the north wall above the first story. The floors were 25-cm-thick reinforced concrete flat plates supported on 129 cm² reinforced concrete columns.^{550,978}

Earthquake-induced torsion was the triggering mechanism for the catastrophic failure of the building (Figure 8). Torsional forces were not initiated in the first story because the shear wall bracing system was constructed along all sides. However, because the north wall was structurally open above the first floor, the center of rigidity was near the south wall, far from the center of mass. Consequently, large torsional forces were produced when the U-shaped shear wall system was subjected to east-west horizontal loading.^{978,983} Examples of damage were (1) the west wall failed at the second floor, (2) most of the precast panels were shaken loose, dropping to the streets, (3) the floor slabs along the north elevation were sheared at their connections to one column at all floor levels above the second,

and (4) the northeast corner of the building collapsed⁹⁷⁸ (Figure 8). The building was torn down shortly after the earthquake.

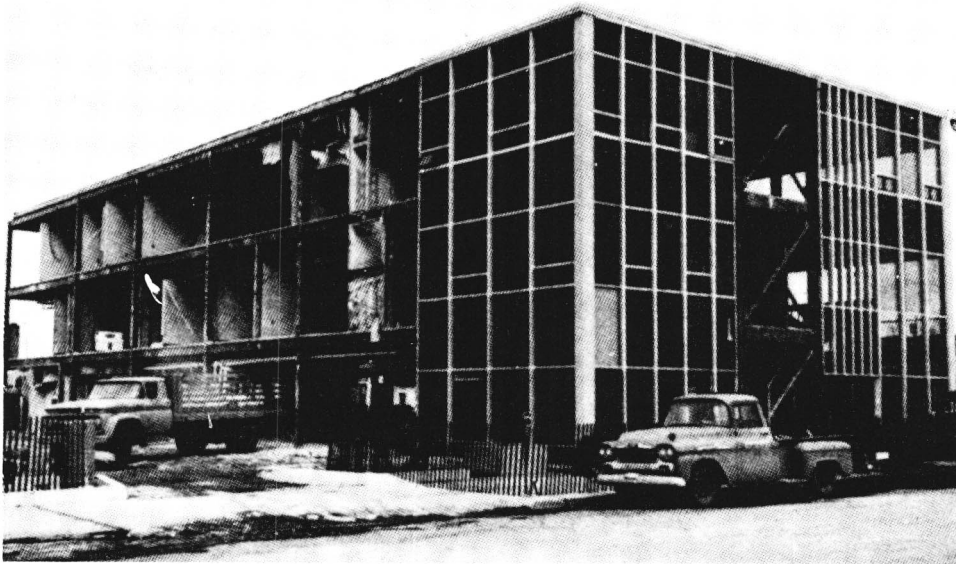
FIGURE 9. Three-story steel-frame First Federal Savings and Loan building in Anchorage following the March 27, 1964 Alaskan earthquake ($M_s = 8.5$). Demolition of masonry exterior walls has been completed enabling repairs to be made. Note the X-bracing in the south wall and the limited amount of glass breakage on the south elevation. (From Berg, G. V. and Stratta, J. L., *Anchorage and the Alaska Earthquake of March 27, 1964*, American Iron and Steel Institute, New York, 1964, 36. With permission.)

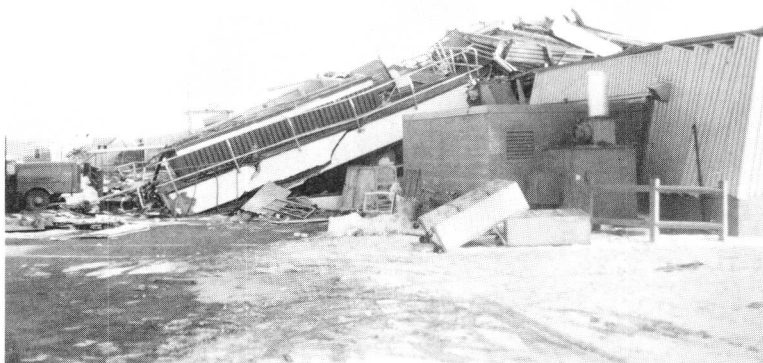
FIGURE 10. Collapsed six-story reinforced concrete control tower at Anchorage International Airport following the March 27, 1964 Alaskan earthquake ($M_s = 8.5$). (Courtesy of George Plafker, U.S. Geological Survey.)

According to Berg and Stratta,⁹⁷⁸ the two cores were unable to resist the horizontal forces, and they fractured in the first story. More specifically, George et al.⁹⁸⁶ state that the cores failed because of an inadequate overlapping of reinforcing bars at their bases, allowing them to rock, and thereby severing the core and floor slab connections. Ayers et al.⁹⁸⁷ pointedly describe the end result.

. . . The only recognizable elements remaining after the earthquake were stair shafts and the elevator hoistings . . . it is obvious that the only place where anyone could possibly have survived would have been in the elevator car.

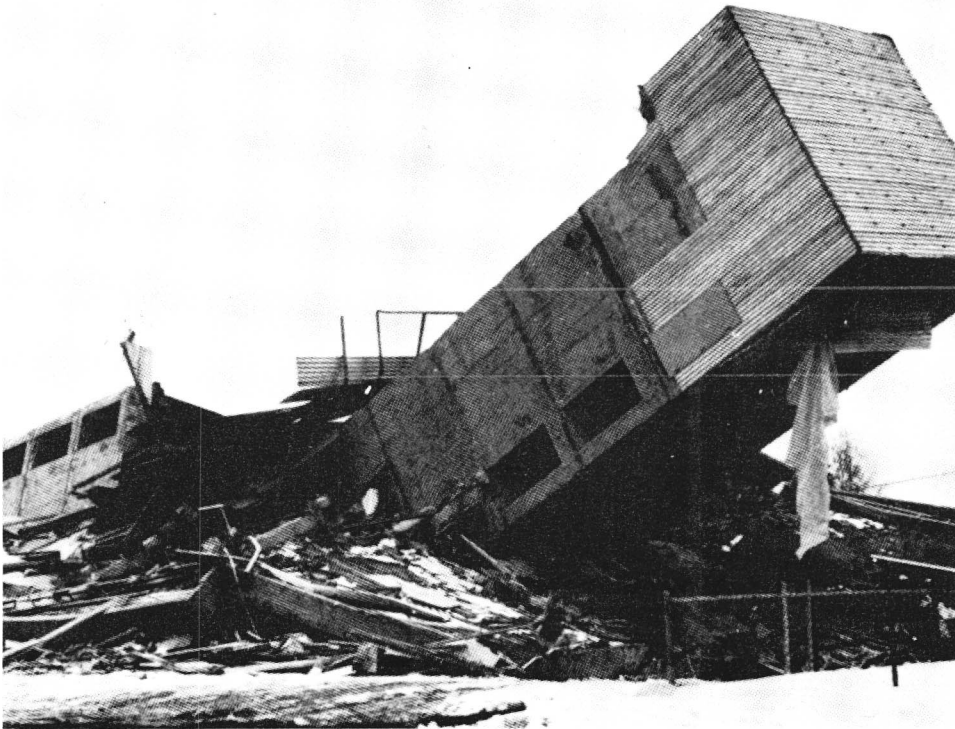
FIGURE 12. Collapsed Four Seasons apartment building in Anchorage following the March 27, 1964 Alaskan earthquake ($M_s = 8.5$). An adjacent two-story wood-frame building was undamaged.⁹⁴⁷ (From Berg, G. V. and Stratta, J. L., *Anchorage and the Alaska Earthquake of March 27, 1964*, American Iron and Steel Institute, New York, 1964, 20. With permission.)

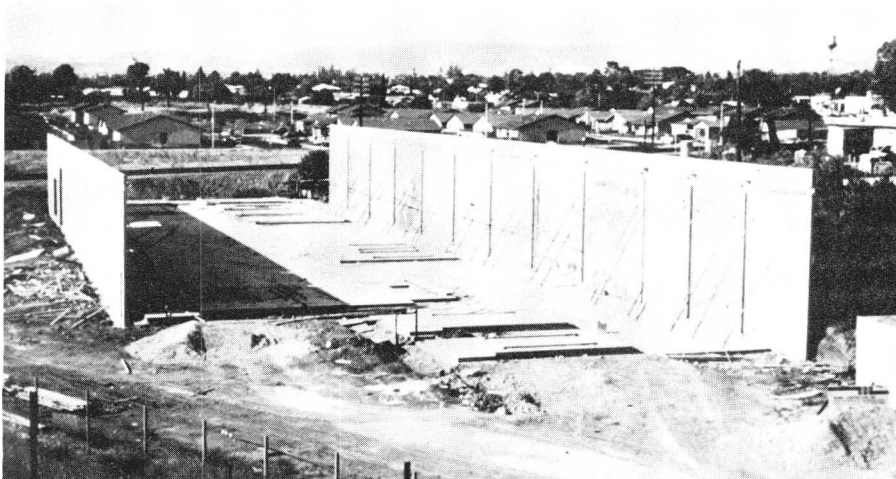
FIGURE 14. Precast, tilt-up concrete building under construction in Los Angeles, California. (Courtesy of James L. Ruhle and Associates, Fullerton, Calif.)

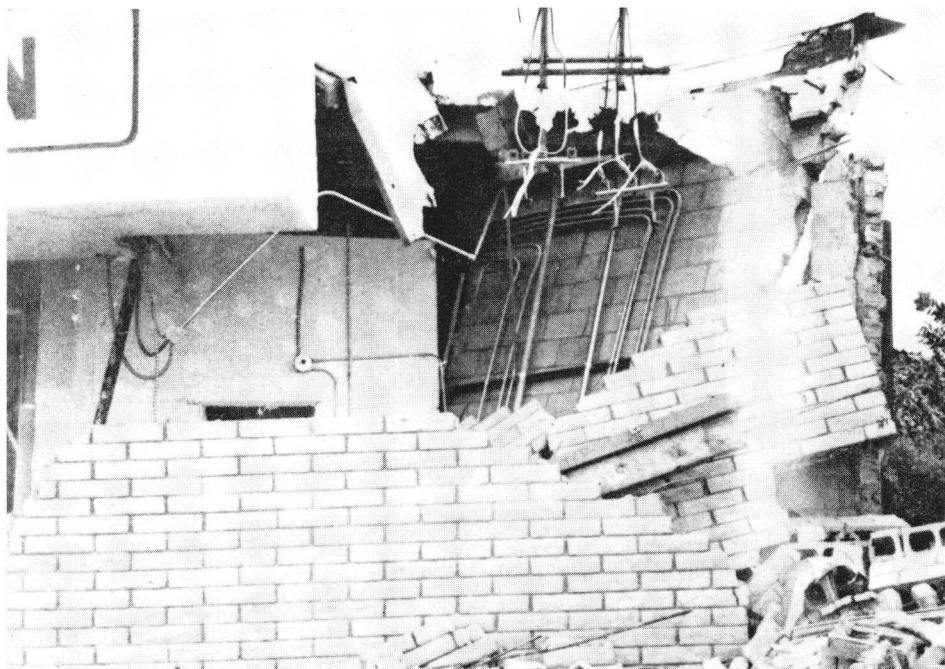
FIGURE 17. Collapsed southeast corner of Stone's Liquor Store in Sylmar following the February 9, 1971 San Fernando, California earthquake ($M_L = 6.4$). The building was constructed in 1969; it had a plywood roof and reinforced hollow concrete walls. Structural failures could have been caused by a severing of the roof-to-wall connection when the bearing walls were subjected to ground accelerations normal to their planes. The ability to resist lateral loading along the south elevation may have been further impaired because the vertical reinforcement did not appear to extend more than 1.8 m above the floor, thus leaving the top portion of the wall unreinforced. Portions of other walls with reinforcing steel did not appear to contain grout. This building, valued at \$35,000 prior to damage, had to be demolished shortly after the earthquake.⁹⁷⁷ (Courtesy of National Oceanic and Atmospheric Administration, Environmental Data Service.)

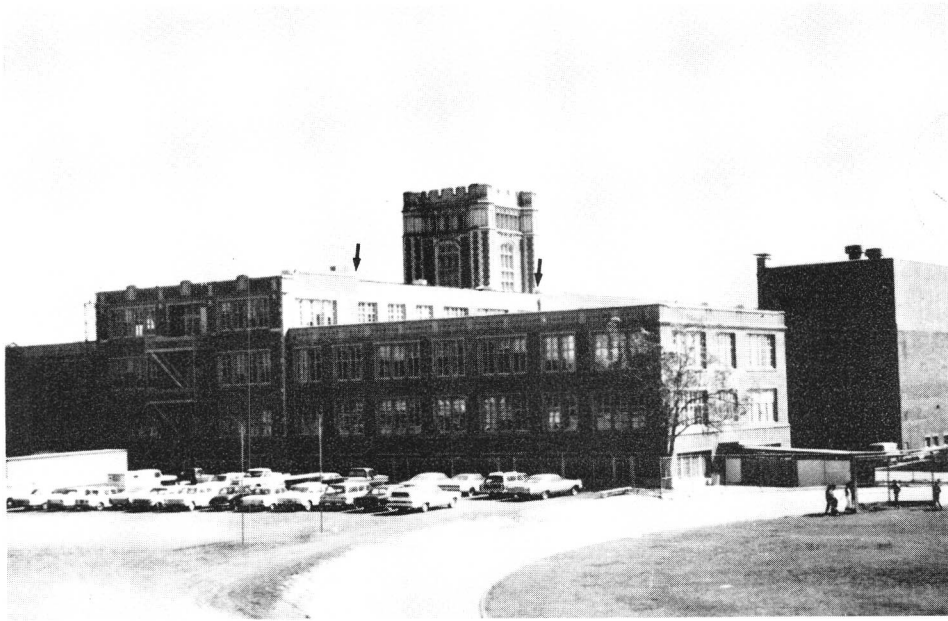
FIGURE 19. Los Angeles High School classroom building following the February 9, 1971 San Fernando, California earthquake ($M_L = 6.4$). A portion of a masonry parapet wall fell off this pre-Field Act building (between arrows). The building was demolished shortly after the earthquake. (Courtesy of National Oceanic and Atmospheric Administration, Environmental Data Service.)

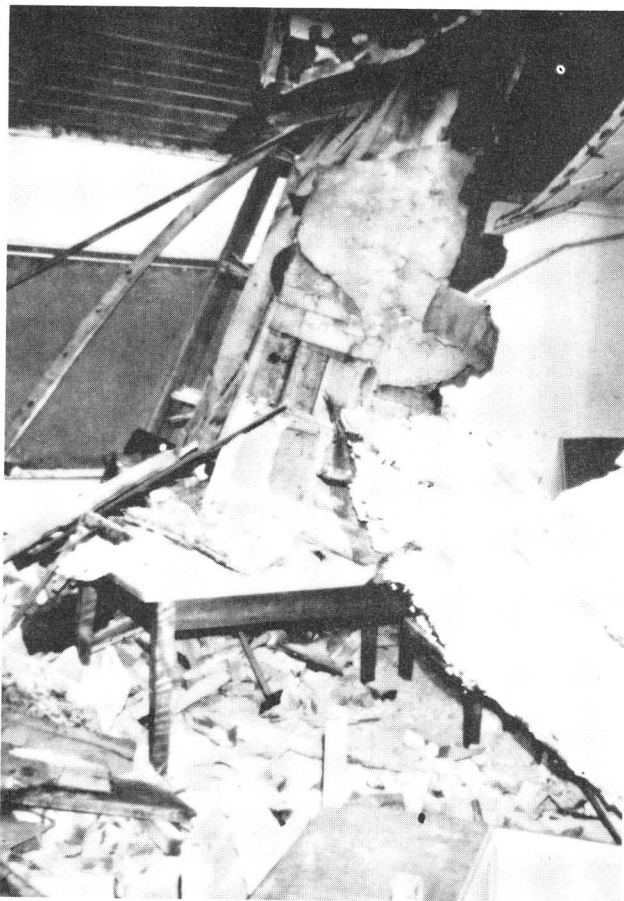
FIGURE 20. Classroom at Los Angeles High School following the February 9, 1971 San Fernando, California earthquake ($M_L = 6.4$). Portion of a parapet wall fell through the classroom roof. (D. K. Jephcott photograph; courtesy of National Oceanic and Atmospheric Administration, Environmental Data Service.)

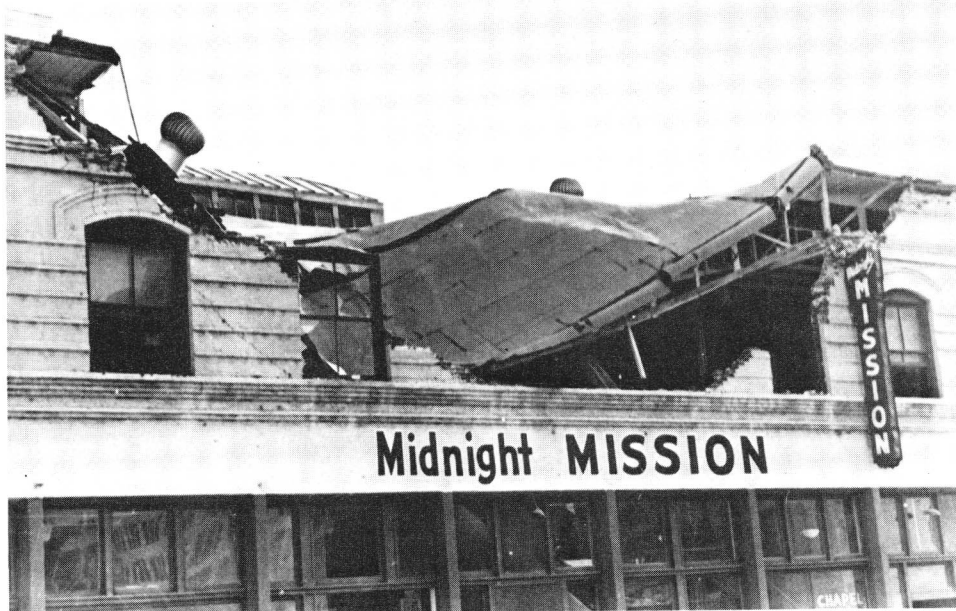
FIGURE 21. Front elevation of the unreinforced masonry Midnight Mission building in downtown Los Angeles showing partial collapse of a room and second-story wall following the February 9, 1971 San Fernando, California earthquake ($M_L = 6.4$). Although only a 6.1-m portion of the second story wall fell, the remainder of the wall was displaced outward from 2.5 to 5.0 cm; further movement and collapse probably were prevented by the joist anchors installed as a part of the Los Angeles parapet correction program (described in Volume II, Chapter 3). One resident ran from the building at the beginning of the earthquake and was killed by falling bricks.⁹⁷⁰ (Los Angeles City Department of Building and Safety photograph; courtesy of National Oceanic and Atmospheric Administration, Environmental Data Service.)

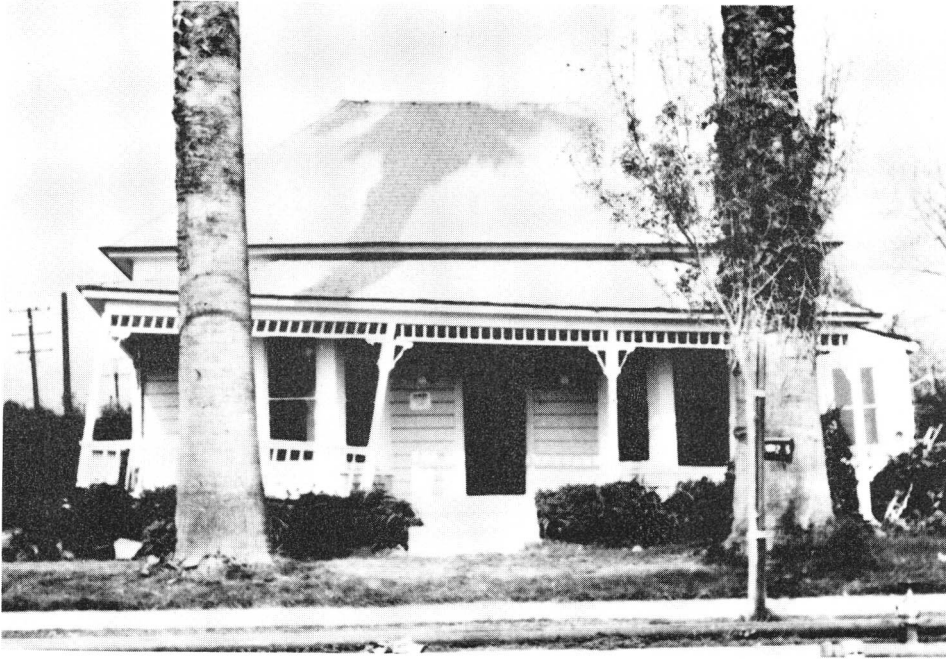
FIGURE 22. Older wood-frame dwelling in San Fernando damaged during the February 9, 1971 San Fernando, California earthquake ($M_t = 6.4$). (Courtesy of National Oceanic and Atmospheric Administration, Environmental Data Service.)

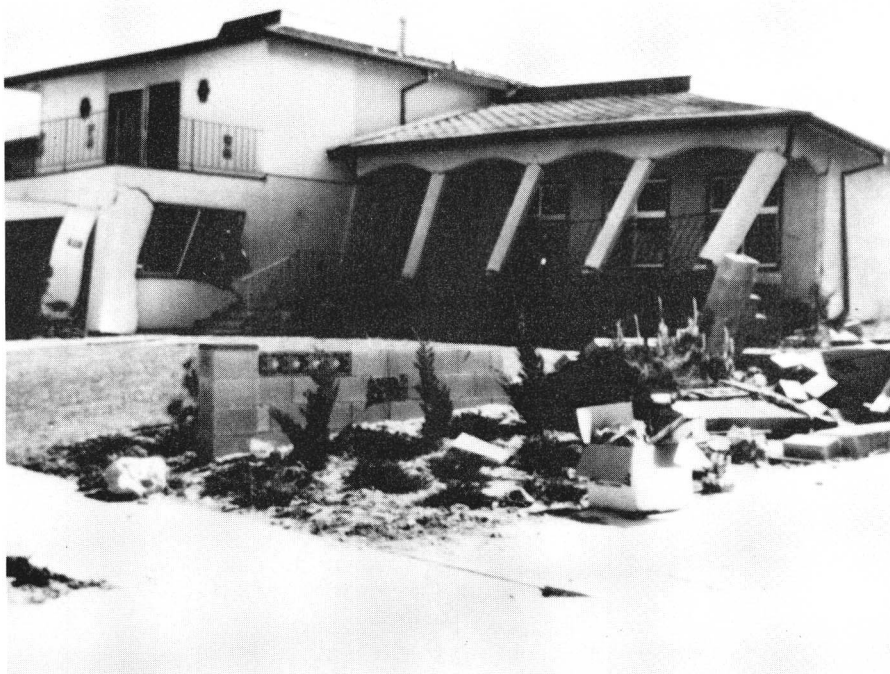
FIGURE 23. Partially collapsed garage section of modern split-level dwelling in Sylmar following the February 9, 1971 San Fernando, California earthquake ($M_L = 6.4$). (Courtesy of National Oceanic and Atmospheric Administration, Environmental Data Service.)

2. One-story houses performed substantially better than either two-story or split-level dwellings with garages at the ground level. According to Yanev,¹⁰¹⁸ the latter two types of buildings were especially susceptible to vibration damage because they are structurally weaker than one-story structures (subject to greater deflections caused by the weight of an upper story) and the presence of a large opening for the garage door produces, in effect, a bracing system with only three shear walls. Consequently, large earthquake-induced torsional forces were produced because of the U-shaped wall system. With the generation of torsional forces, the buildings tended to twist and because of an inadequate resistance to this type of motion, especially with the weight of a second story, walls of the garage often failed partially or totally (Figure 23). Torsional resistance was aggravated if the garage walls were inadequately braced (i.e., lack of plywood sheathing along vertical studs) for earthquake loads.¹⁰¹⁸ According to Foth,¹⁰¹⁹ split-level homes

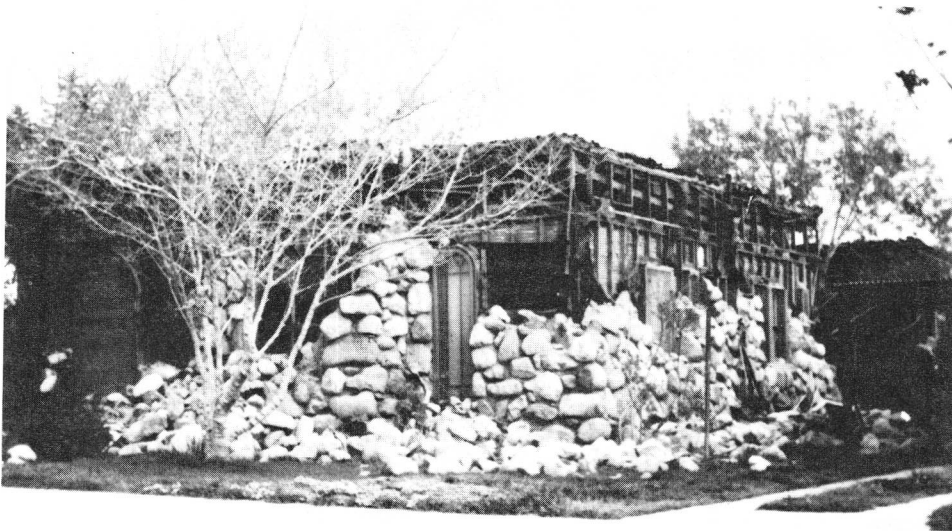
FIGURE 24. Severely damaged older wood-frame dwelling with unanchored stone veneer in San Fernando following the February 9, 1971 San Fernando, California earthquake ($M_L = 6.4$). (Courtesy of National Oceanic and Atmospheric Administration, Environmental Data Service.)

3. Although not a common type of house, masonry veneered wood-frame dwellings were seriously damaged (Figure 24). This type of structure is highly susceptible to earthquake damage because the additional weight of the facing material produces larger inertia forces that can cause serious structural damage and the spalling of the veneer itself if not properly anchored to the walls.

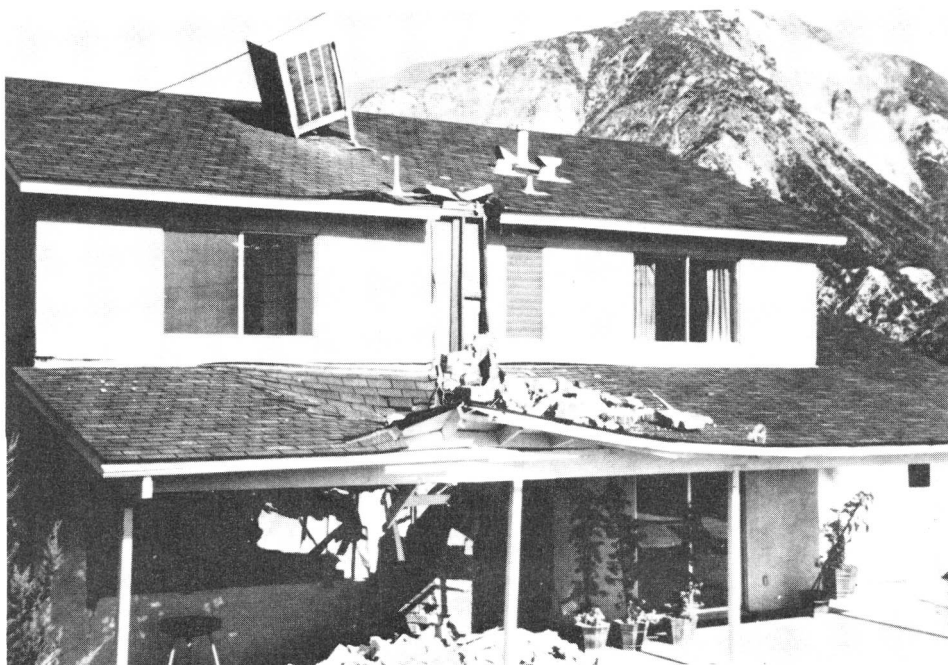
FIGURE 25. Severely damaged chimney and roof-mounted evaporative cooler at a residence in the San Fernando Valley following the February 9, 1971 San Fernando, California earthquake ($M_L = 6.4$). (Los Angeles City Department of Building and Safety photograph; courtesy of National Oceanic and Atmospheric Administration, Environmental Data Service.)

4. Severe masonry chimney damage occurred principally in older dwellings and two-story structures⁹⁴⁴ (Figure 25). Many chimneys built prior to 1960 did not have adequate ties to the building or reinforcing steel bars.¹⁰¹⁸ Two-story chimneys tended to suffer more damage than one-story chimneys because of greater deflections in the second story of a dwelling with subsequent hammering against the chimney. Yanev¹⁰¹⁸ observes that although most of the houses in the heavily shaken area were less than 15 years old and their masonry chimneys were reinforced in accordance with local building codes, approximately 32% of the chimneys suffered damage.

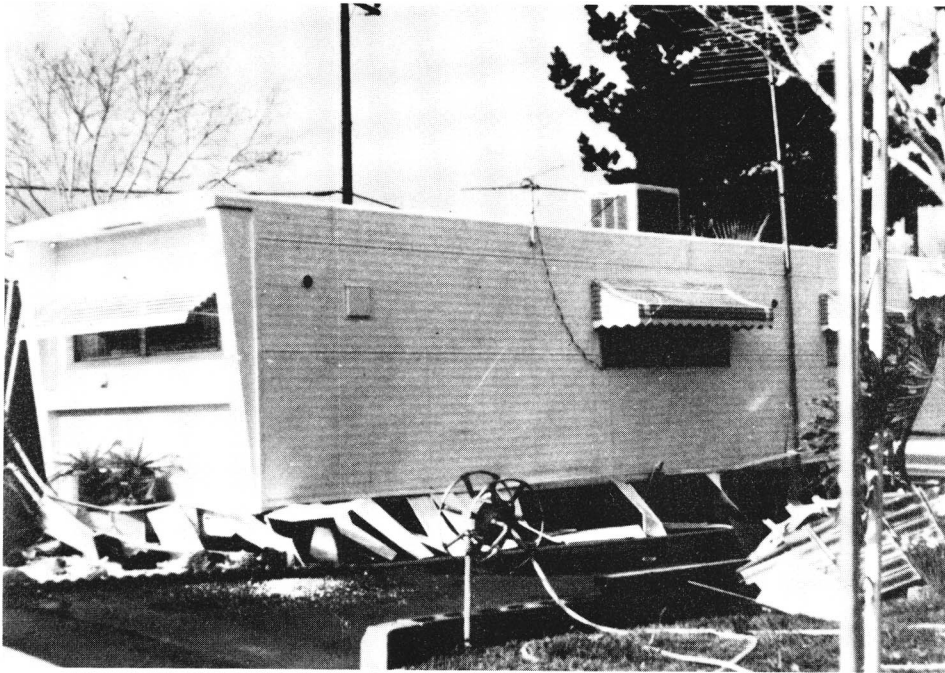
FIGURE 26. Mobile home in the San Fernando Valley shifted off its foundation by the February 9, 1971 San Fernando, California earthquake ($M_L = 6.4$). Note damage to the aluminum skirting. (Photo by Drew P. Lawrence; courtesy of National Oceanic and Atmospheric Administration, Environmental Data Service.)

The typical setup technique is to roll the coach into place and use one of several types of piers (such as precast concrete pyramid-shaped piers) placed at intervals of about 6 feet (1.8 m) along the main frame. A screwjack on the top of each pier is then brought up into contact with the undercarriage and positioned until the coach is level and steady on the mounts. When soft soils are encountered, concrete block masonry or flat (cement) patio-type blocks are used to spread the load and prevent settling. Utilities are next hooked up, an aluminum skirt is finally applied around the base, and stairs are placed at the doorway . . . If the yolk-tongue at the forward end of the trailer is left on, . . . it is vertically supported and skirted.

Because the piers were not anchored to the ground and the screwjack levelers were not attached to the coach frame, the support technique was very unstable. During the earthquake, there were numerous cases in the meizoseismal region where coaches were shaken off their supports (Figure 26). For example, in two mobile home parks in Syl-

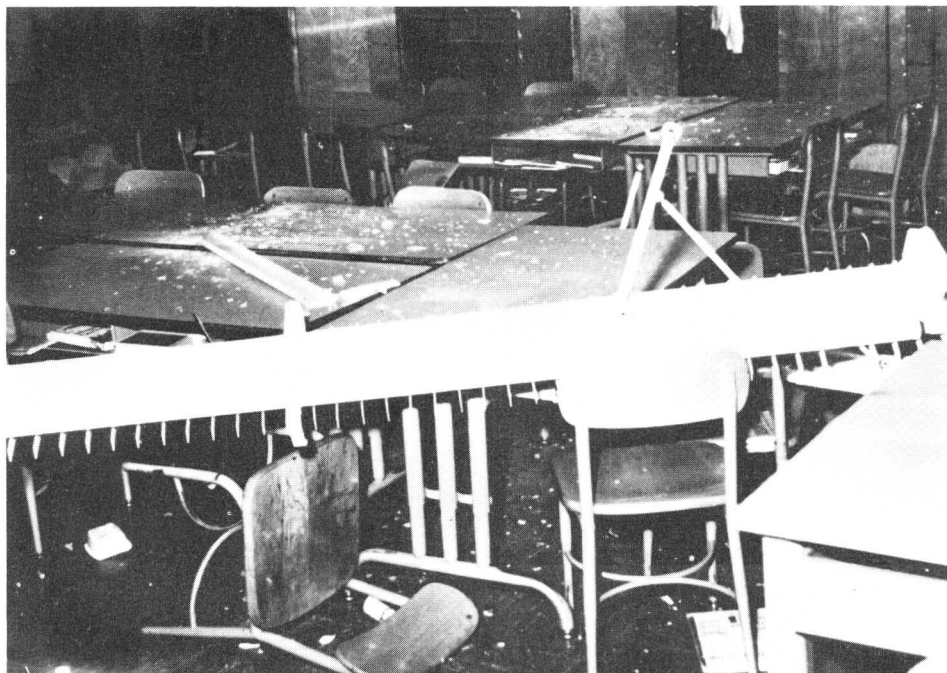
FIGURE 28. Pendant-mounted light fixtures that were torn loose from their ceiling support base plates at the Herrick Avenue Elementary School during the February 9, 1971 San Fernando, California earthquake ($M_L = 6.4$). (Los Angeles City Department of Building and Safety photograph; courtesy of National Oceanic and Atmospheric Administration, Environmental Data Service.)

2. Suspended light fixtures were heavily damaged because they were free to move under the earthquake forces. Failures occurred in supporting stem hangers and chains or at ceiling connections (Figure 28). Some of the fallen fixtures weighed between 18.1 and 36.3 kg and would have been a serious life hazard had the affected buildings been occupied. Light fixture failures were very common in school buildings.

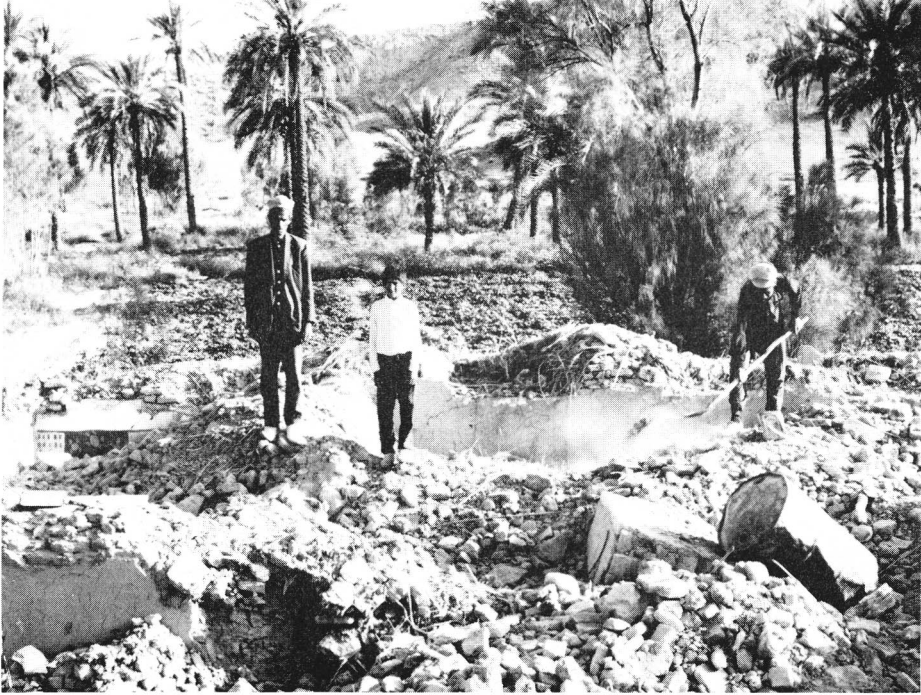
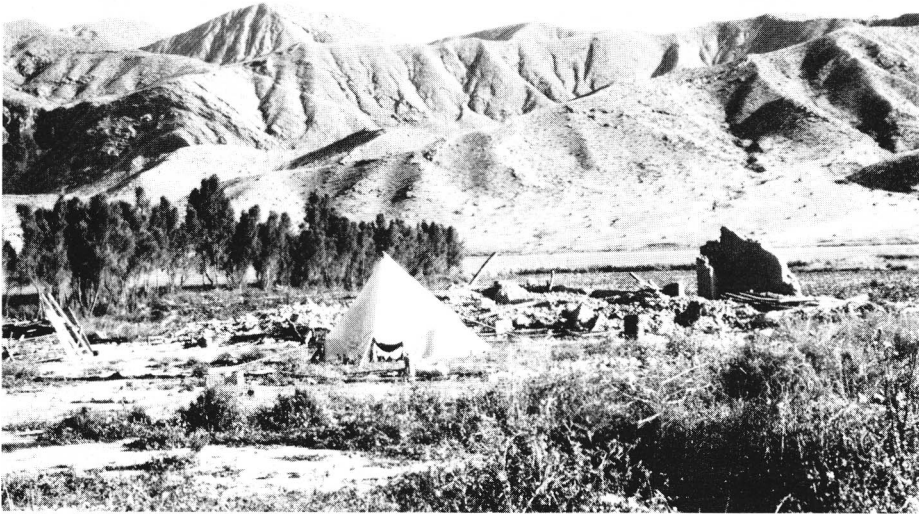
FIGURE 30. Collapsed traditional dwellings in the villages of Tang Rudeh (A) and Shar-e Pir (B) following the April 10, 1972 Fars Province, Iran earthquake ($M_s = 6.9$). (Courtesy of James W. Dewey, U.S. Geological Survey.)

Most of the traditional houses were one-story high with adobe brick or stone set in mud-mortar bearing walls. The flat roofs were composed of wood poles covered with sticks and straw and veneered with 30 cm or more of mud. The wood beams were only 10-to 12-cm thick and were spaced every 30 to 40 cm atop the bearing walls; the beams rarely passed completely through the thick walls. Total roof thickness varied from 30 to 60 cm, resulting in a tremendous weight.^{1026,1027} According to Dewey and Grantz,¹⁰²⁶ the combination of weak bearing walls and heavy roofs in these structurally stiff dwellings made them especially vulnerable to damage from strong, high-frequency accelerations. Such ground motions were responsible for wall failures or the unseating of the support beams and consequent roof collapse in virtually every traditional structure in the most severely shaken area (Figure 30).¹⁰²⁷

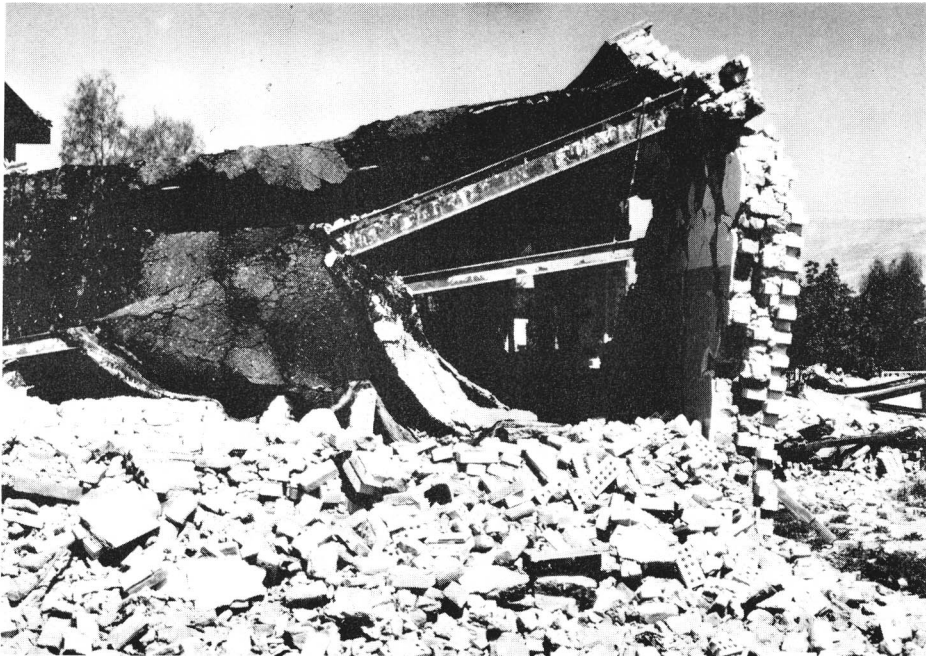
FIGURE 31. The steel beam masonry Malaria Eradication Center building in Ghir following the April 10, 1972 Fars Province, Iran earthquake ($M_s = 6.9$). Note the absence of reinforcing steel in the bearing wall. (Courtesy of James W. Dewey, U.S. Geological Survey.)

ment mortar and roof systems comprised of steel I-beams, spaced 80 to 100 cm apart, with interbeam slabs formed by shallow brick arches.¹⁰²⁷ These buildings fared little better than the traditional structures (Figure 31). The primary types of destruction were the collapse of bearing walls that failed because little or no reinforcing steel was used and roof collapse caused by the separation of the roof beams from the bearing walls. Separation occurred because of inadequate ties to the walls.^{1027,1028} McEvelly and Razani¹⁰²⁷ note that the structural inadequacies were created largely because the local, unskilled workers were unfamiliar with modern materials and construction techniques.

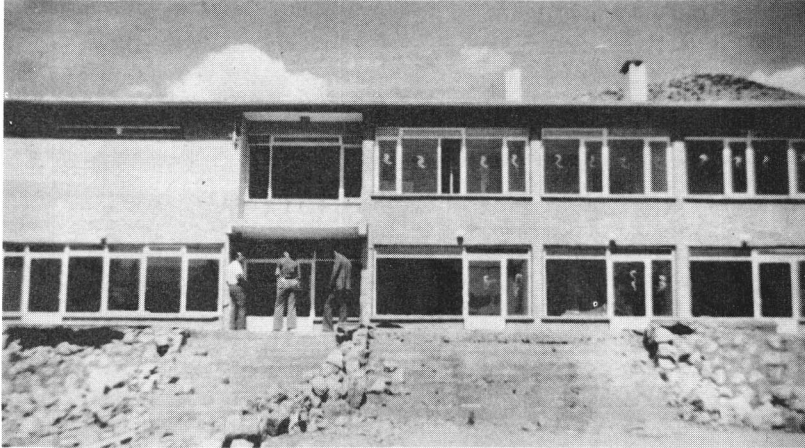
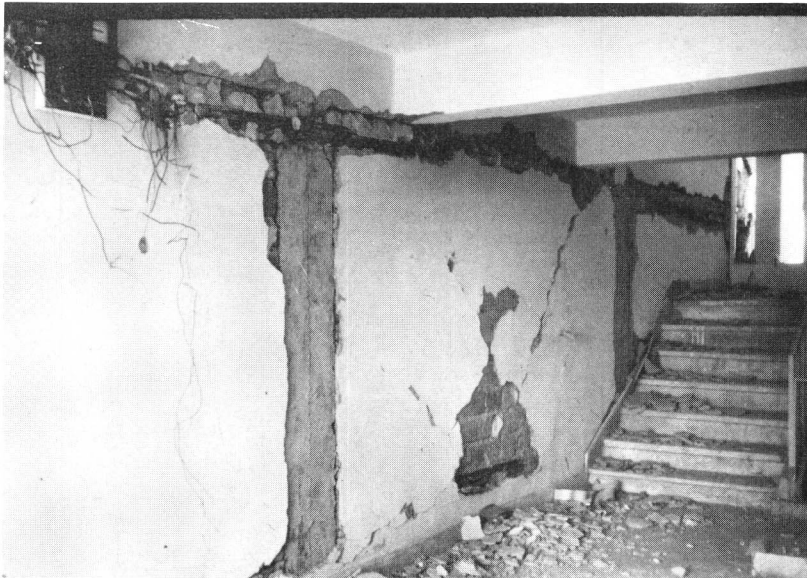
FIGURE 33. (A) The new reinforced concrete municipal building in Lice following the September 6, 1975 Lice, Turkey earthquake ($M_s = 6.7$). The building suffered moderate damage to the frame and significant damage to brick infill walls. (B) Interior of the entrance hall of the municipal building showing damage to the reinforced concrete frame and brick infill walls. (Courtesy of Peter I. Yanev; URS/John A. Blume & Associates, San Francisco.)

1. Yanev was able to examine two damaged reinforced concrete buildings in Lice (Figures 33A and B and 34). Both structures had reinforced concrete frames and stiff, unreinforced brick infill walls. The brick walls represent nonstructural elements, and their principal effect is to increase the stiffness of the surrounding concrete frame (i.e., frame is less able to absorb earthquake forces by bending). With the presence of infill walls, seismic loads become concentrated at the infill bays, and within a bay, the total shear force must be resisted by each column and not divided between the two columns as would be the case if the lateral load was resisted by frame bending.¹⁰³³ Frame failures in the two buildings were most common at the tops and/or bottoms of the columns where an infill wall had failed in shear. This type of reinforced concrete building has performed similarly in several other contemporary earthquakes,¹⁰³³⁻¹⁰³⁷ and emphasizes how non-structural elements can drastically alter the predicted behavior of the structural frame.¹⁰³³

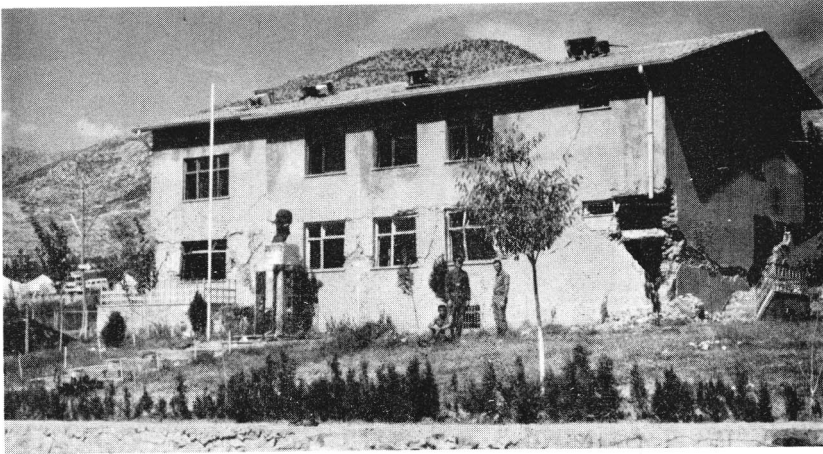
FIGURE 35. Unreinforced masonry police building in Lice following the September 6, 1975 Lice, Turkey earthquake ($M_s = 6.7$). Note the severe damage to the first floor corner of the building, the shear failure of the piers between the windows, and the toppled brick chimneys. (Courtesy of Peter I. Yanev; URS/John A. Blume & Associates, San Francisco.)

Lice suffered severe damage, and several experienced partial collapse. The police station and two high school buildings suffered spectacular vibration-induced damage and were declared total losses (Figures 35 and 36). The external bearing walls of these three structures sustained severe shear failures. Yanev speculates that the buildings did not collapse because they were being held up by interior unreinforced brick walls (interior inspections were not possible for safety reasons). In several cases, portions of corner walls were destroyed by torsion and pounding between the floor slabs and walls (Figure 35). Unreinforced masonry chimneys were commonly broken off at roof lines, often falling through the wood and tile roofs (Figure 35).

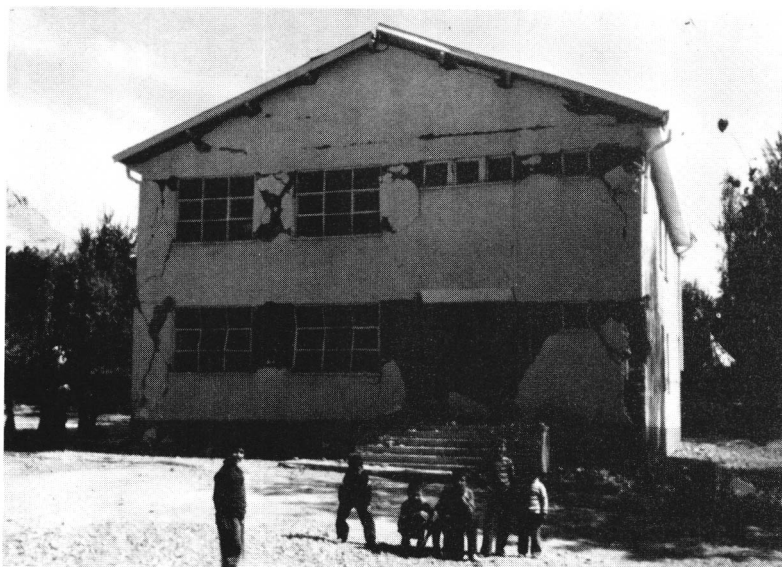
FIGURE 36. West-wall view of an unreinforced masonry high school building in Lice following the September 6, 1975 Lice, Turkey earthquake ($M_s = 6.7$). All lateral resisting elements were shattered. Similar damage occurred to an adjacent high school building of identical construction. (Courtesy of Peter I. Yanev; URS/John A. Blume & Associates, San Francisco.)

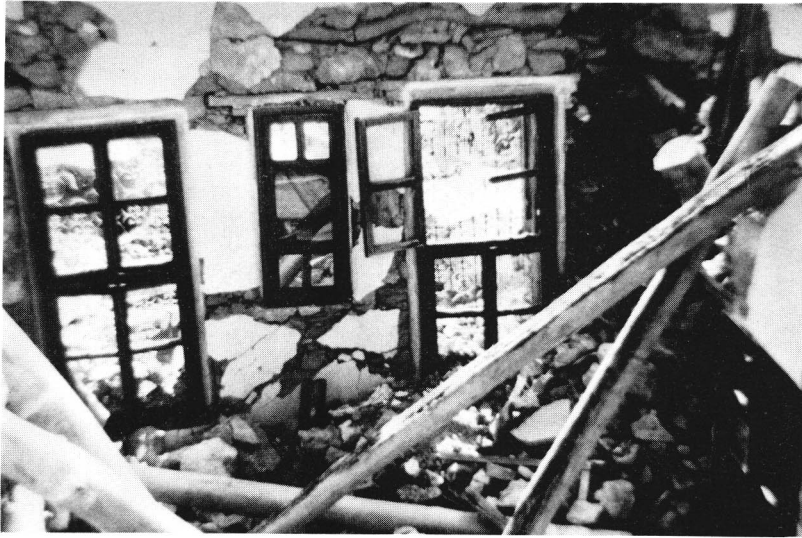
FIGURE 38. Interior view of a traditional stone dwelling in Lice showing collapsed timber and mud roof following the September 6, 1975 Lice, Turkey earthquake ($M_s = 6.7$). (Courtesy of Peter I. Yanev; URS/John A. Blume & Associates, San Francisco.)

3. Most of the buildings damaged or destroyed by the earthquake were stone dwellings of a style common to eastern Turkey. The walls are typically comprised of broken pieces of stone held together with mud, or less commonly with cement mortar. Small stones are often keyed in between larger stones. The flat roofs are composed of about 20 support timbers and 40 to 60 cm of mud. This type of roof is very popular because it provides good insulation against the hot summers and cold winters of Anatolia, is watertight with regular maintenance, and serves as a platform for storing firewood and hay. However, the roofs may weigh as much as 1000 kg/m^2 , and their collapse appears to have been responsible for most of the casualties (Figure 38). Roof failure was usually caused by the with-

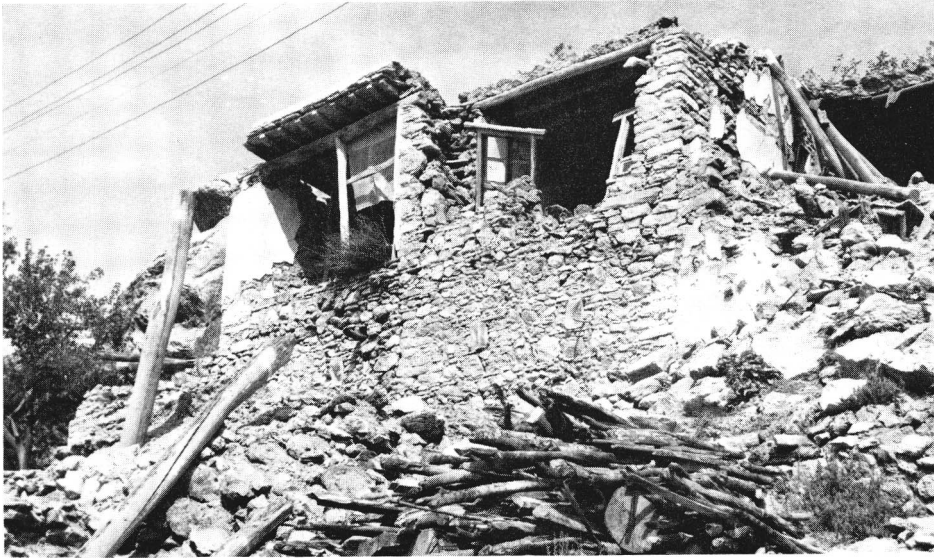
FIGURE 39. View of a traditional stone dwelling in Lice following the September 6, 1975 Lice, Turkey earthquake ($M_s = 6.7$). Total roof collapse is evident at photo (right); note pile of roof support timbers. (Courtesy of Peter I. Yanev; URS/John A. Blume & Associates, San Francisco.)

drawal of support timbers from the walls. These stone houses, which make up 92% of all dwellings in the Lice-Hani region, were usually total losses in areas having Modified Mercalli Intensities of VIII or higher (Figure 39).

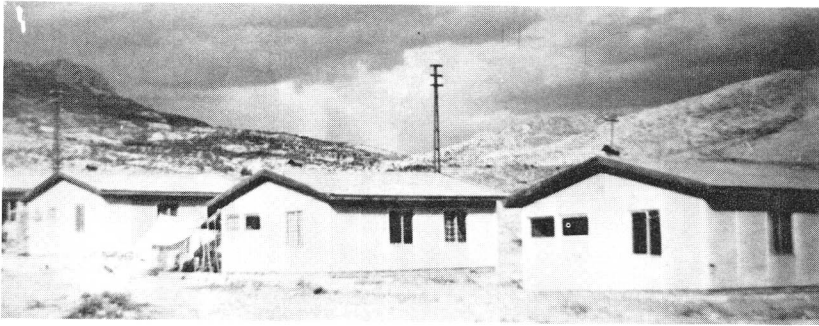
FIGURE 40. Undamaged earthquake-resistant dwellings in Hani following the September 6, 1975 Lice, Turkey earthquake ($M_s = 6.7$). (Courtesy of Peter I. Yanev; URS/John A. Blume & Associates, San Francisco.)

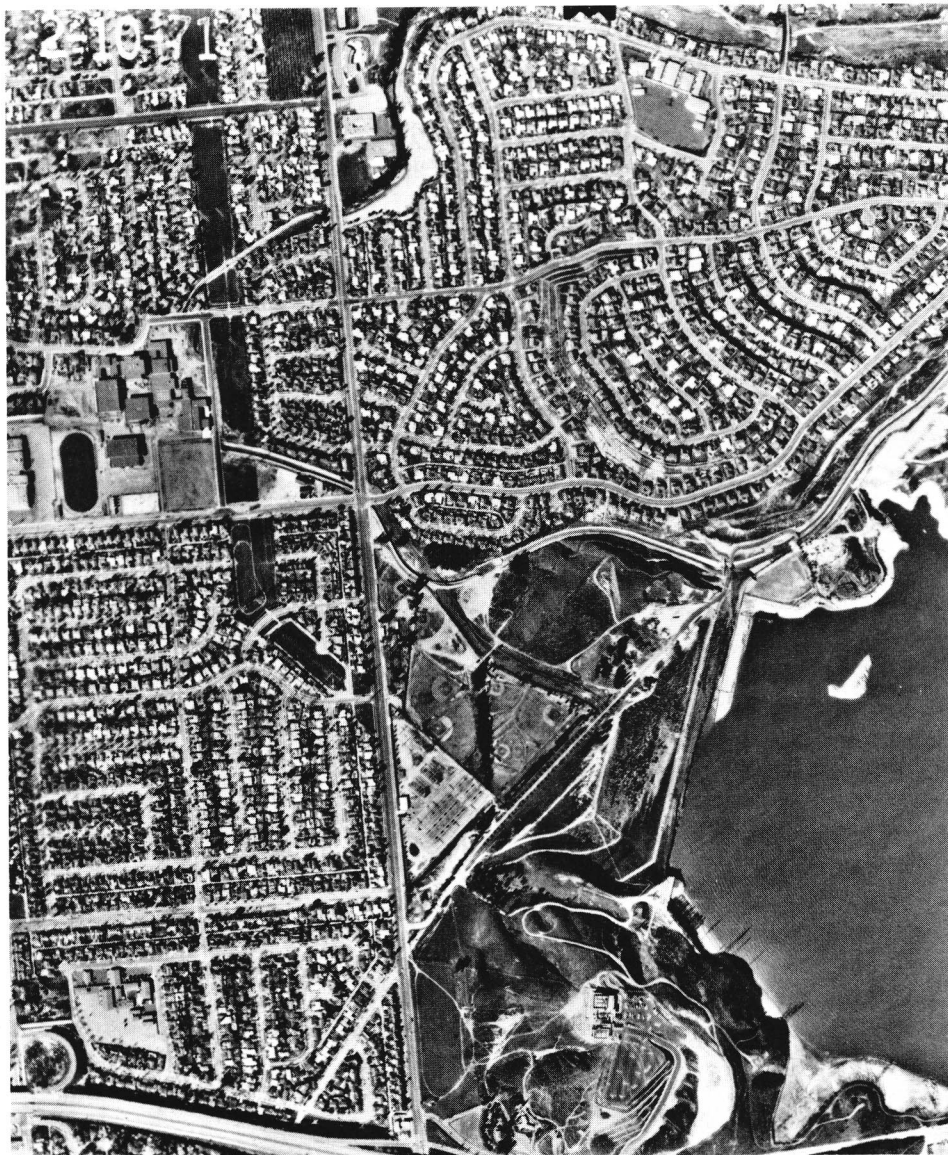
FIGURE 43. Damaged Lower San Fernando Dam one day after the February 9, 1971 San Fernando, California earthquake ($M_L = 6.4$) and its relation to the densely built-up area downstream. The complex at the left edge of the photograph is a school. (National Aeronautics and Space Administration photograph; from Rush, M., Holguin, A., and Vernon, S., *Potential Role of Remote Sensing in Disaster Relief Management*, School of Public Health, University of Texas, Houston, no date, 49A. With permission.)

The principal damage to the Lower San Fernando Dam was a spectacular upstream slope failure that dislodged a major portion of the embankment and concrete dam face, depositing them on the reservoir floor (Figure 5 in Volume I, Chapter 1). The length of the slope failure was approximately 550 m. The slope failure reduced the dam height by 9 m. Had not the reservoir level been 10.7 m below the crest at the time of the earthquake, the dam would have been overtopped, with the likely loss of the dam and a residential area of 80,000 people would have been inundated¹⁰⁵³ (Figure 43). According to Youd and Olsen,⁴⁹⁵ the slope failure could have been caused by “seismically induced inertia forces alone or in concert with liquefaction of the embankment materials, tectonic deformation, or foundation soil failures.” Some 80,000 residents below the dam were evacuated for 4 days while the reservoir was lowered to a level that would preclude flooding if the dam was further damaged by aftershocks.⁴⁹⁵ The dam was permanently taken out of service.¹⁰⁵²

Because the earthquake nearly caused the total failure of Lower San Fernando Dam, a dynamic type of analysis was developed by scientists at the University of California, Berkeley for portraying the potential performance of earthen dams during earthquakes. By this procedure, the dynamic response of a dam is carried out by using accelerograms of real and simulated earthquakes as input for time-dependent analyses; it more accurately depicts the performance of earthen dams than the earlier pseudostatic method of analysis. Under the jurisdiction of the Division of Safety of Dams (DSD) of the California Department of Water Resources, all earth dams under state jurisdiction must be analyzed by the dynamic analysis technique. Dams found to be incapable of resisting certain earthquake forces must be rehabilitated or abandoned.
