Earthquakes and the Urban Environment

Volume II

G. Lennis Berlin

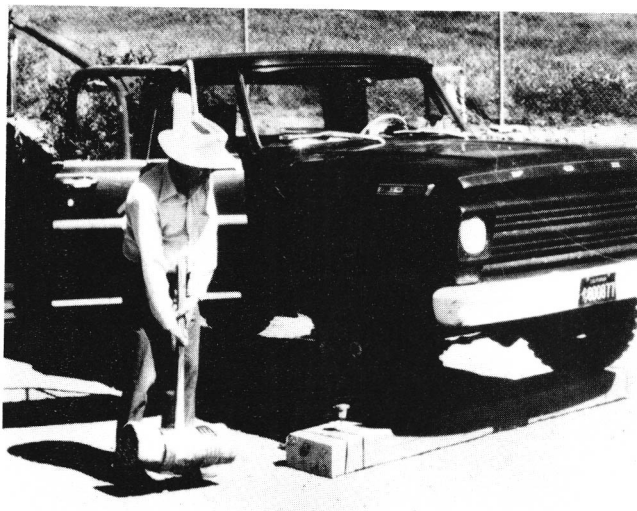
FIGURE 49. *Horizontal traction or plate and hammer method* used for identifying subsurface layers of rock or soil plus their configurations and elastic properties. Mechanics of the method are described in the text. (Courtesy of Jay H. Power, California Division of Mines and Geology.)

In order to gain an understanding of the influence of a site’s geology in affecting ground motion, Power and Real¹¹⁰² report that site investigations for accelerograph stations in the California network include field measurements of horizontal shear wave velocities to identify subsurface layers of rock or soil plus their configurations and elastic properties. This is accomplished by the *horizontal traction or plate and hammer method* (Figure 49) that was developed by the Earthquake Research Institute, Tokyo University. The mechanics of the method are as follows:

1. A large horizontal plank, held firmly against the ground by the front wheels of a truck, is hit on one end with a large wooden hammer (Figure 49).
2. The horizontal hammer blow imparts a traction or shearing stress tangential to the surface of the ground, thereby producing a ground motion rich in horizontal shear energy.
3. The waves are detected by geophones emplaced at increasing distances from the energy source along an axis parallel to the plank.
4. By plotting the first-wave traveltime to each sensor vs. source distance, distinct seismic layers are identified that normally correspond to different geological units.¹¹⁰²
