# Safety and Reliability of Bridge Structures

Edited by Khaled M. Mahmoud

*Bridge Technology Consulting  
New York City, USA*

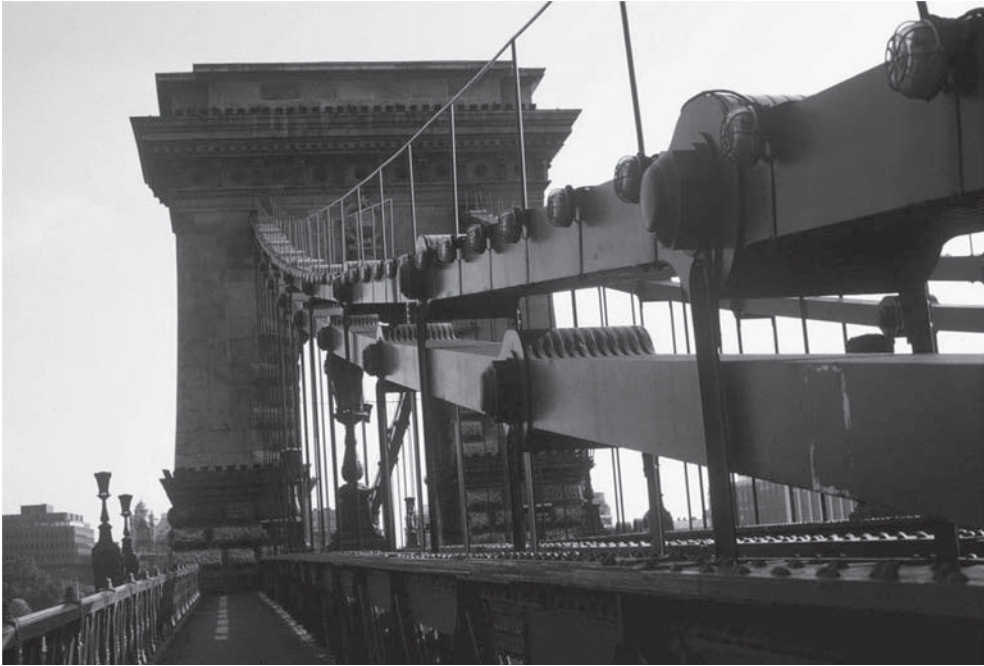
Figure 3. Eyebars of the Budapest Chain Bridge.

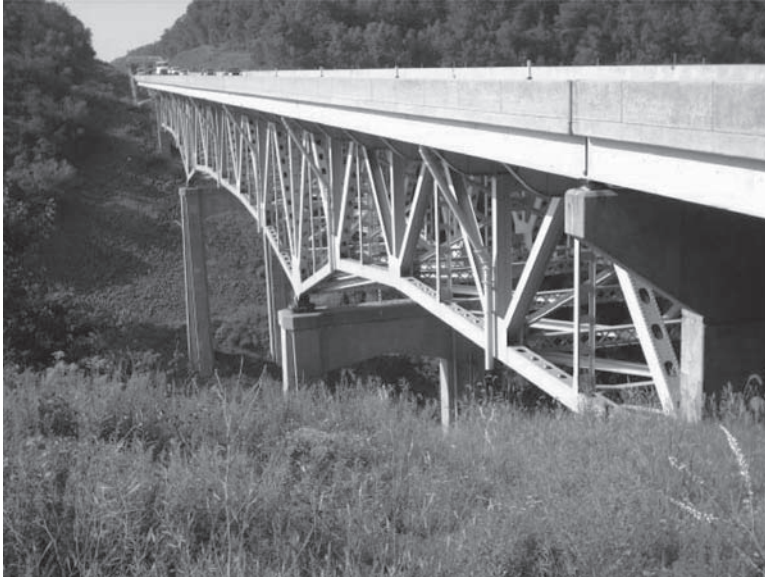
Figure 1. Elevation of the Hawk Falls Bridge.

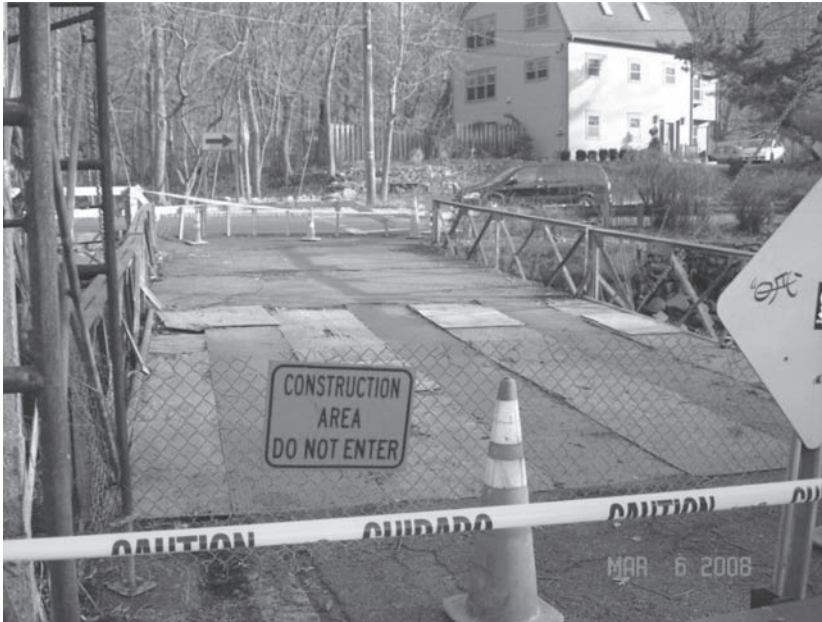
Figure 5. View looking south across the deteriorated timber deck on the bascule span at the start of construction. Also note the asphalt overlaid concrete approach deck and lateral deformation of the approach truss.

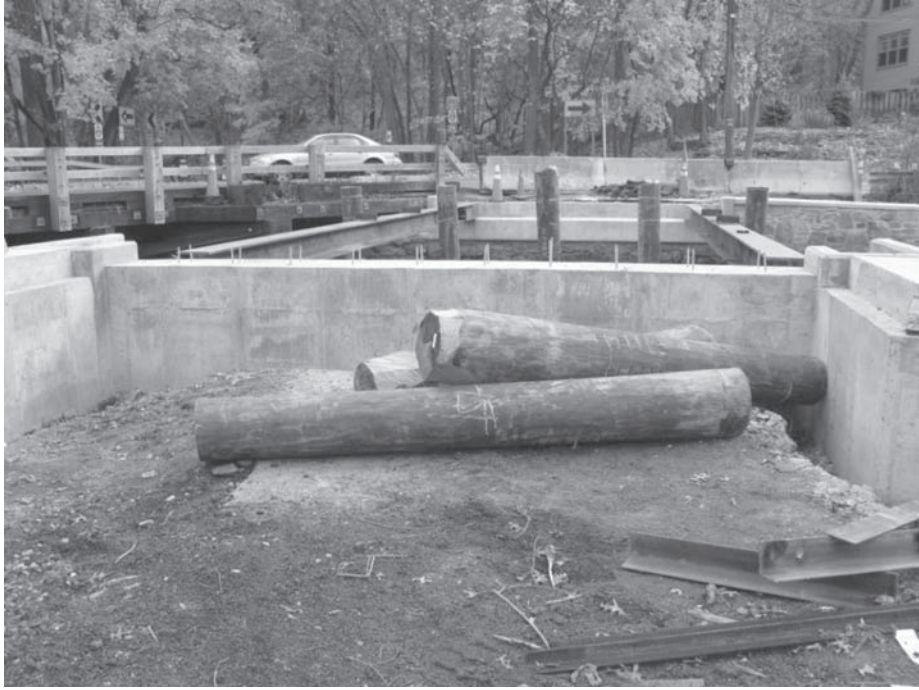
Figure 14. View looking south from behind the north abutment. Note new timber piers and the reconstructed southwest wingwall.

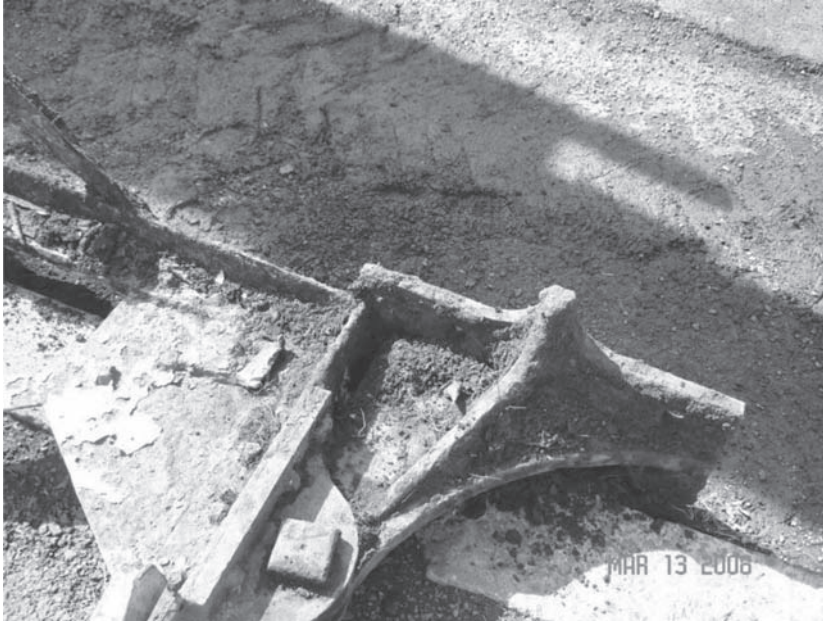
Figure 17. Existing movable bridge bearing uncovered during the removal of the existing draw span.

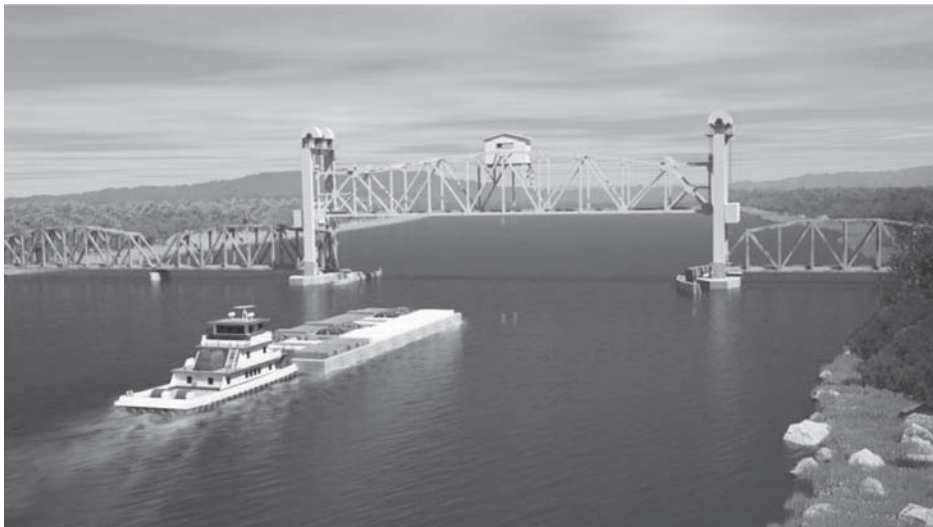
Figure 6. Rendering of HNTB proposed final design alternate (HNTB, 2009).

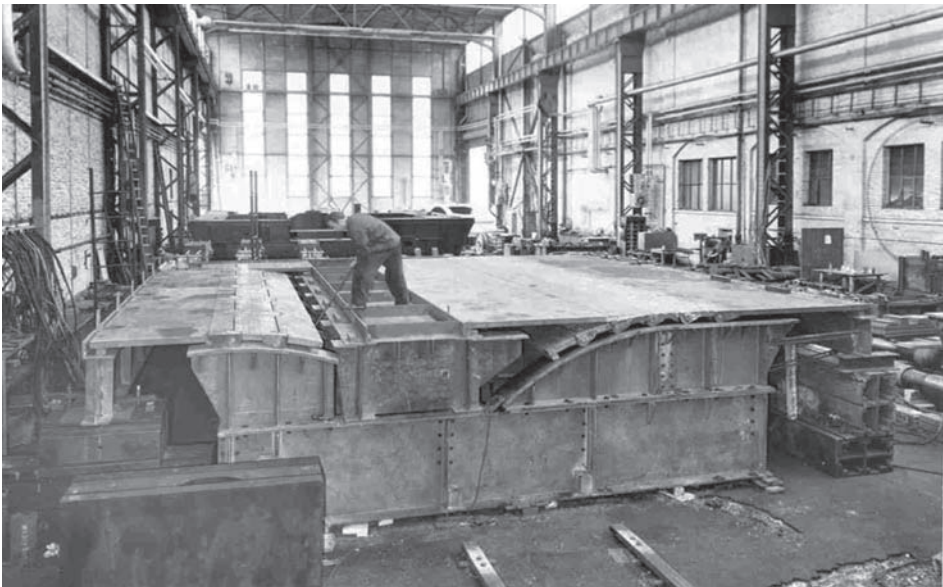
Figure 4. Trial erection.

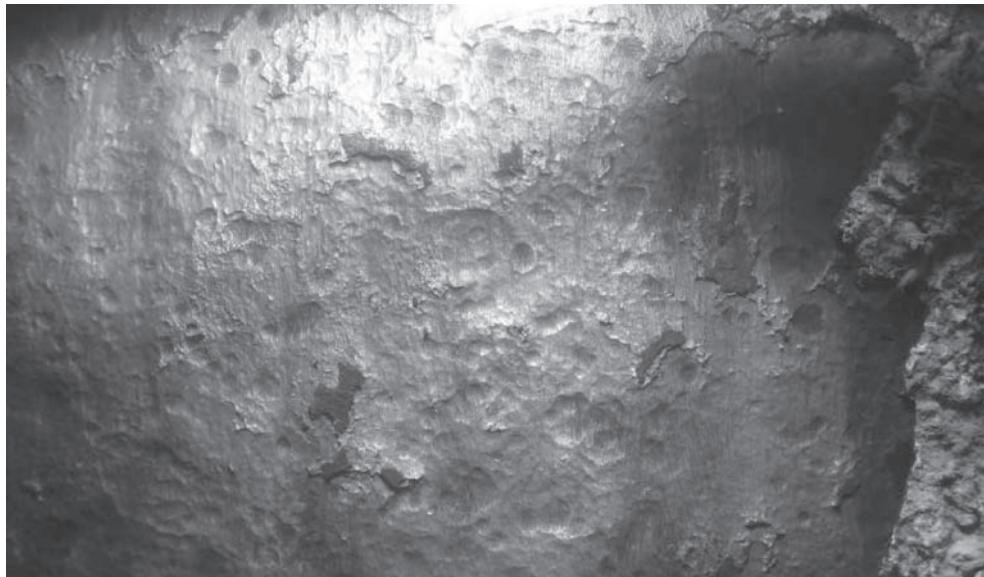
Figure 5. Dumbarton pier 6, Northwest caisson, SE Quadrant, 9.5-ft below MLW. Typical steel in 1-ft above to 10-ft below MLW, typical condition of steel shell.

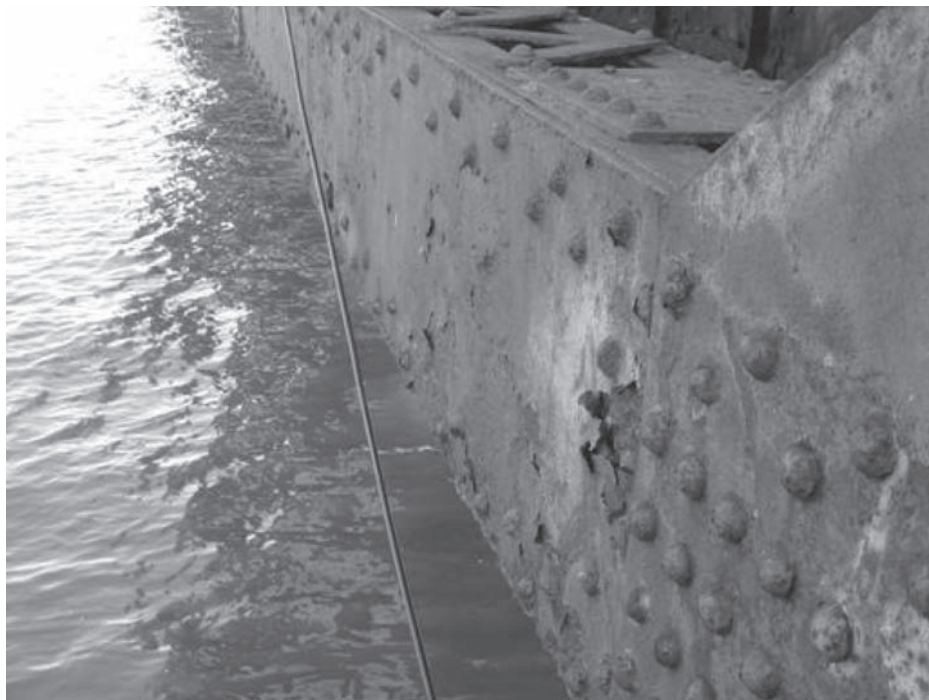
Figure 8. Dumbarton bridge—typical failed paint on truss member.

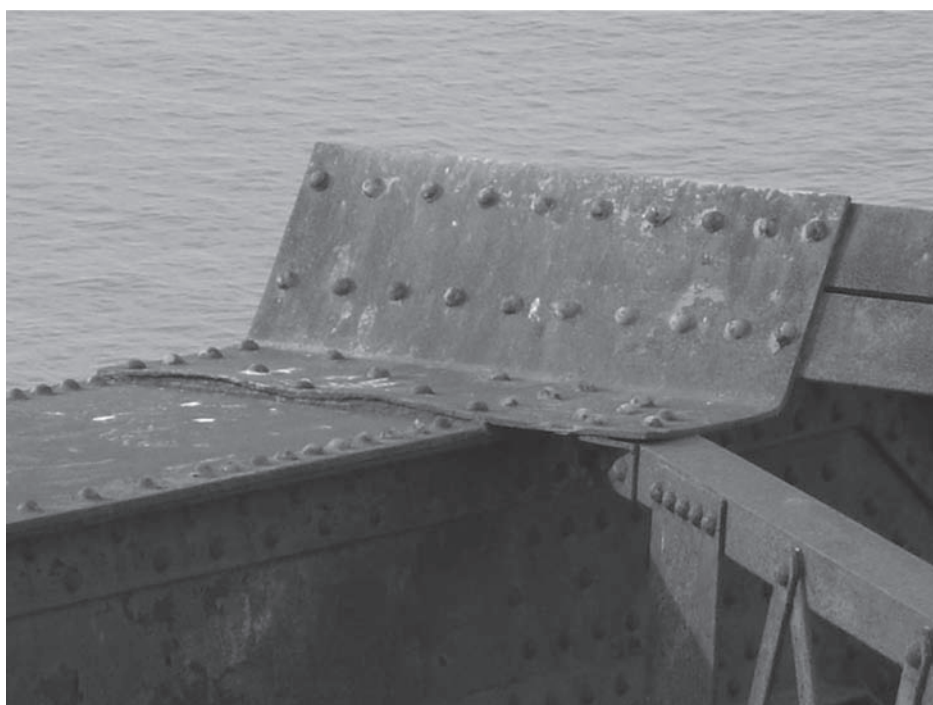
Figure 9. Dumbarton bridge—typical corrosion and pack rust of steel truss member.

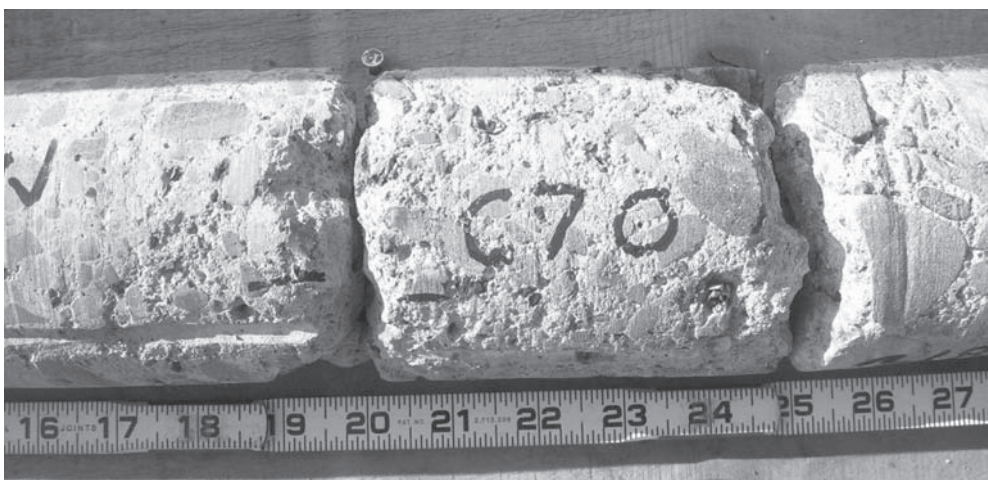
Figure 13. Typical concrete sample from tidal fluctuation zone.

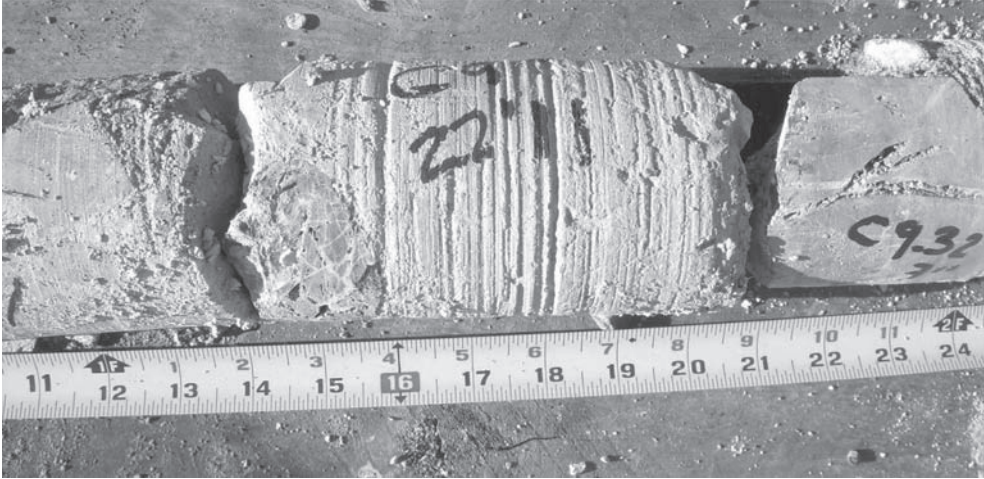
Figure 14. Concrete sample showing high level of cement paste.

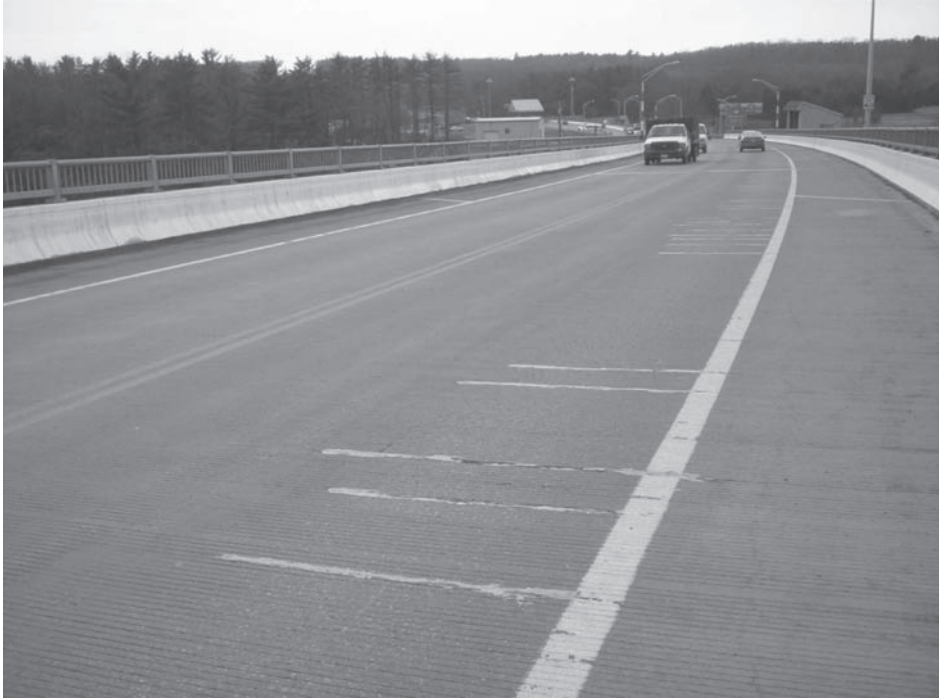
Figure 5. Cracks, sealed and unsealed, forming above the main steel in grid panels.

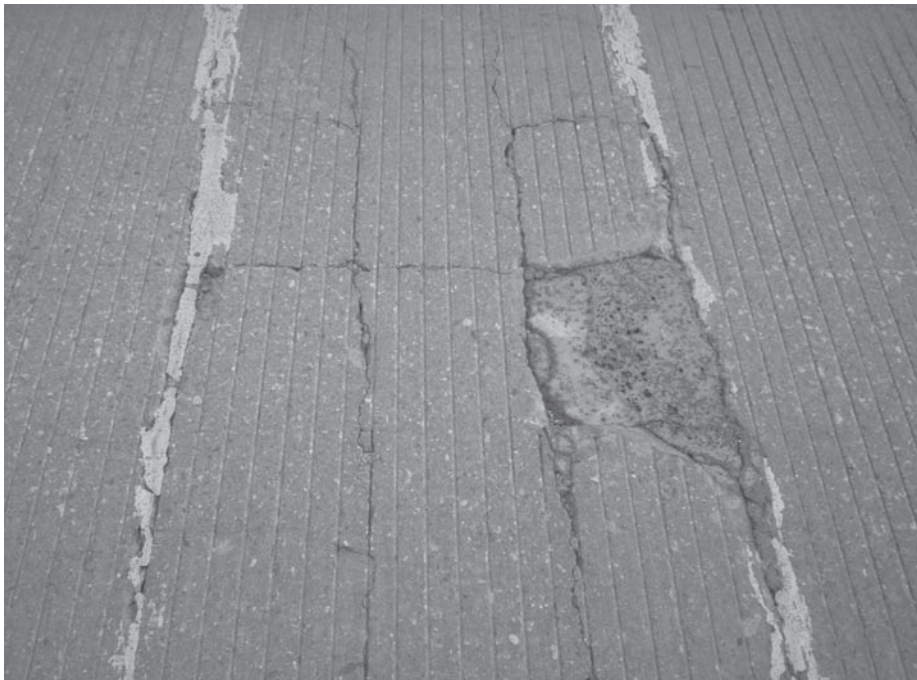
Figure 6. Failed area of deck panel.

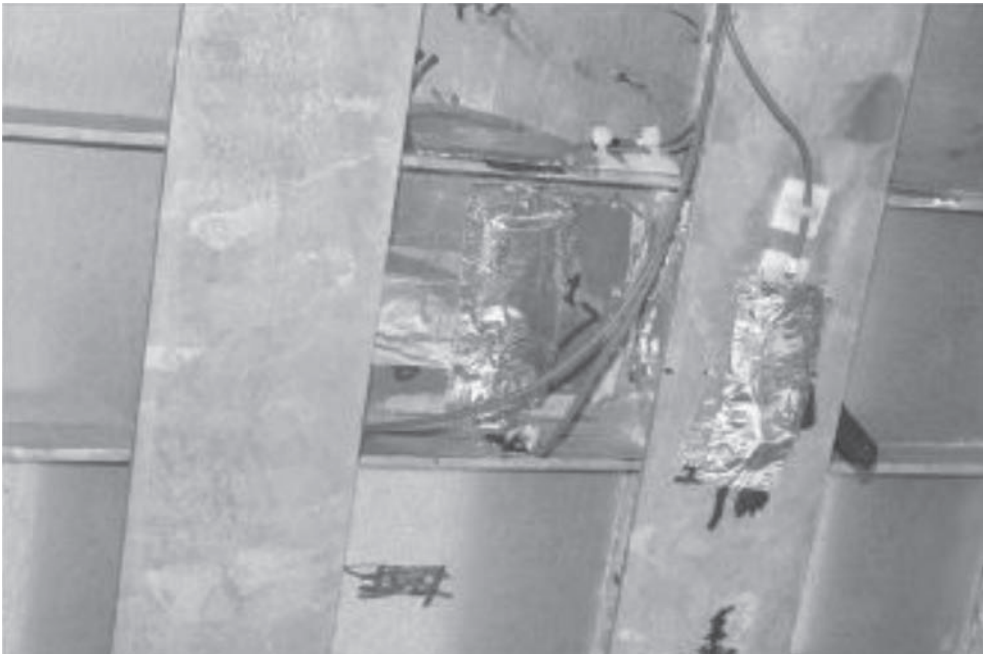
Figure 7. Strain gauge placement.

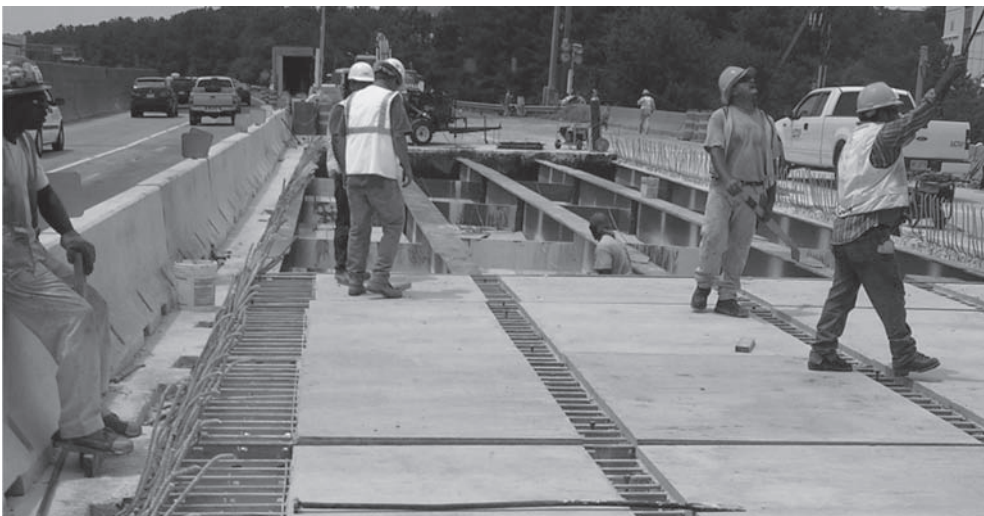
Figure 4. Precast panel installation on I-285 near Atlanta, GA (Photograph courtesy of L.C. Whitford).

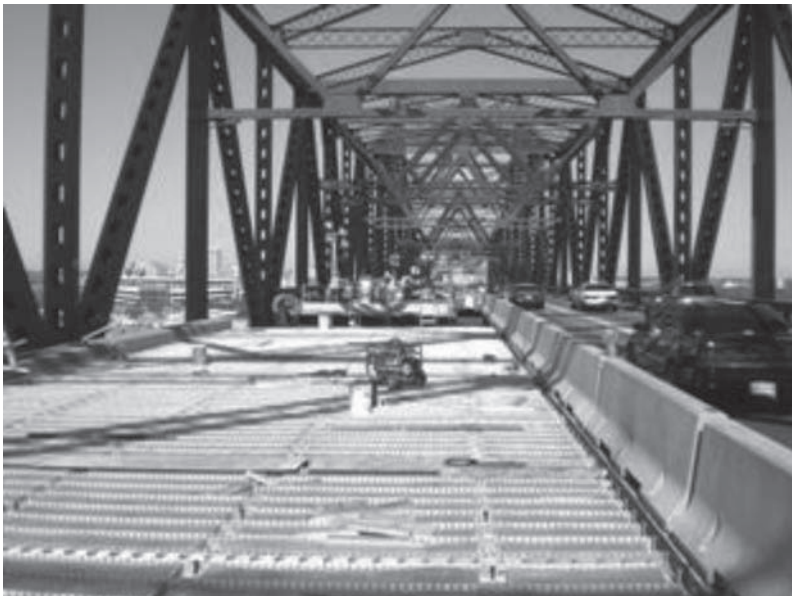
Figure 5. Bare Exodermic™ panels placed on Mathews Bridge (Photograph courtesy of RS&H).

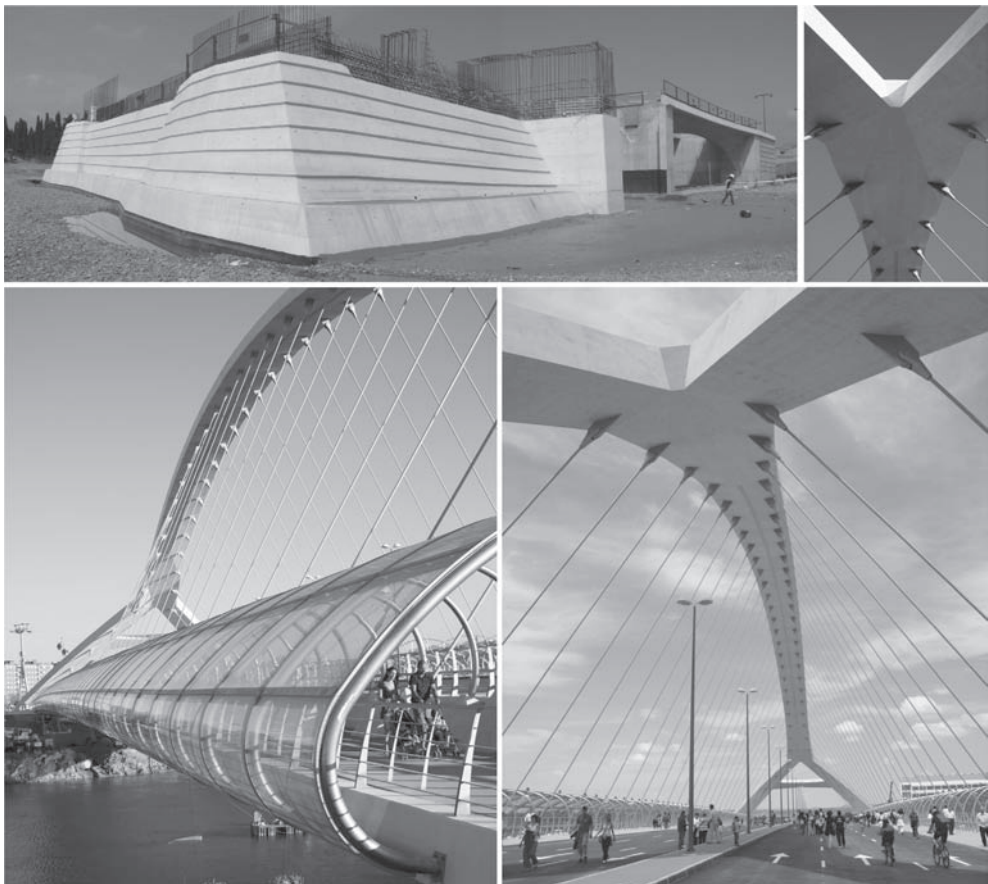
Figure 6. From left to right and from top to bottom, left bank abutment, detail of the transition between pure arch and inclined legs, one of the side glazed balconies and perspective of the three dimensional space inside the bridge.
