Site Characterization in Karst and Pseudokarst Terraines

Practical Strategies and Technology
for Practicing Engineers,
Hydrologists and Geologists

Richard C. Benson • Lynn B. Yuhr

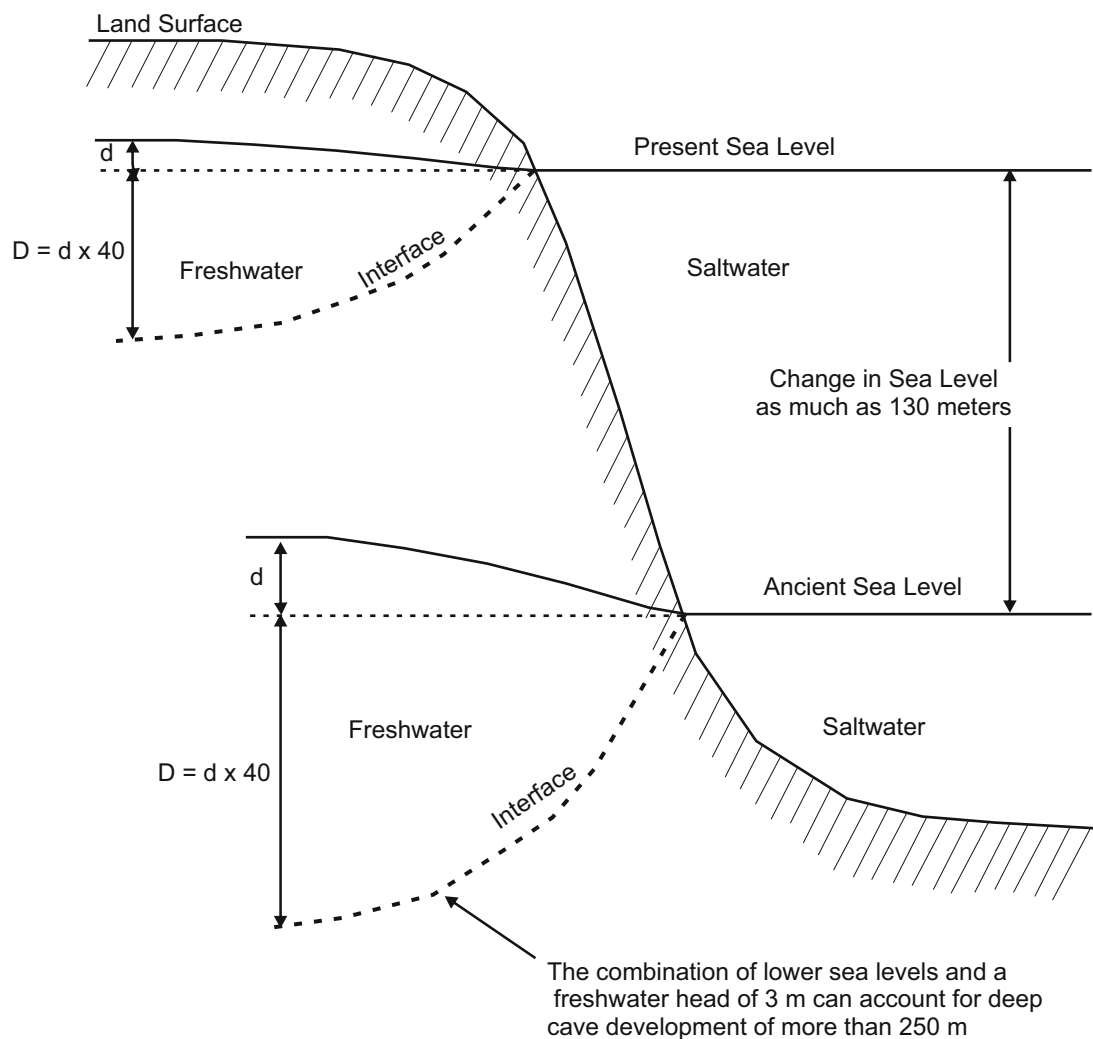
Fig. 2.3 During periods of lower sea level stands, with a thick freshwater lens, there can be extensive dissolution deep within the limestone

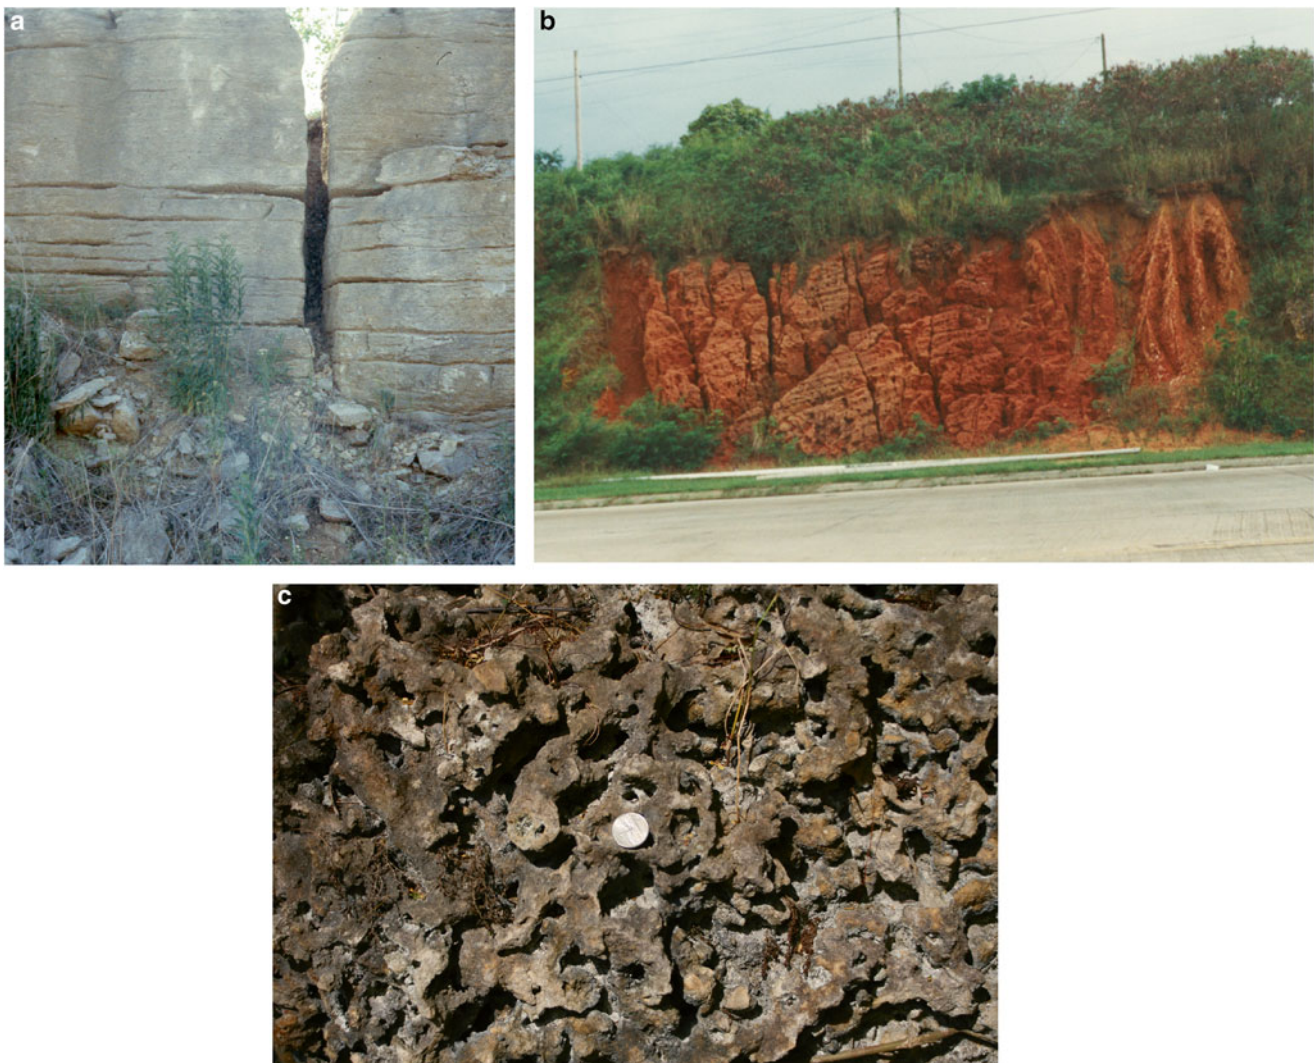
Fig. 2.5 Variations in limestone range from an older, massive strong limestone Kansas City, Kansas (a), a younger, highly weathered weak, almost friable limestone, in Puerto Rico (b) and a very young weaker, porous, Miami limestone (c) in south Florida

- The Bethany Falls limestone from the Kansas City area is an older (Pennsylvania Period), massive, low porosity and hard limestone (1,229 psi, 139.3 MPa) (Fig. 2.5a),

- The Aymamon Limestone from Puerto Rico is a younger (early Miocene), and at some surface exposures it is highly weathered and almost friable limestone (Fig. 2.5b), and
- The Miami Limestone from Southeast Florida is a very young (Pleistocene age), extremely porous and relatively weaker limestone (Fig. 2.5c).

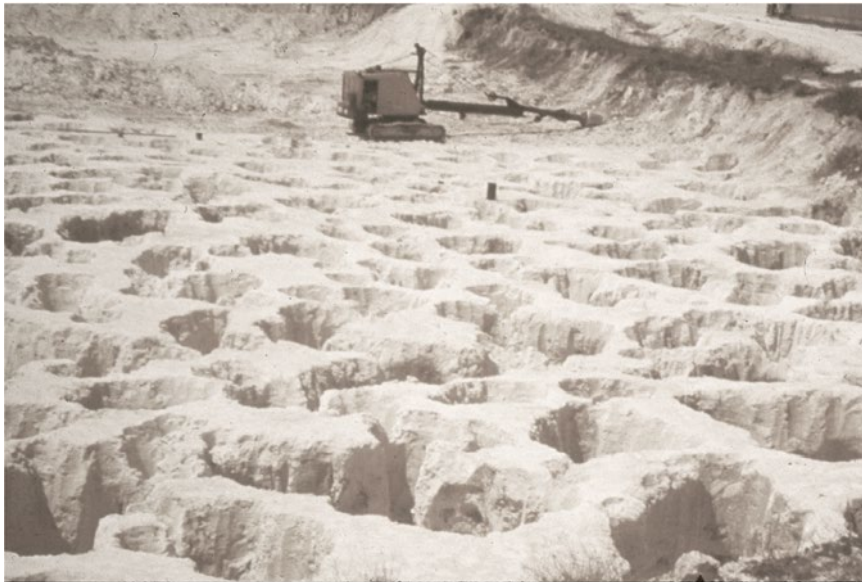
Fig. 3.4 The top of rock in a North Florida quarry was cleared of sediments exposing extensive small pits (Photo courtesy of B. Wisner 1972 Florida Department of Transportation)

remediated using a small amount of backfill material. Figure 3.4 shows a quarry in northern Florida where the rock surface has been exposed. These numerous small diameter pits were created by dissolution due to vegetation. Similar pits are seen along canal banks in south Florida and in the easternmost Everglades. When these small local voids are present and soil cover is thin, material easily settles into the voids and small sinkholes develop. These conditions often result in small nuisance-

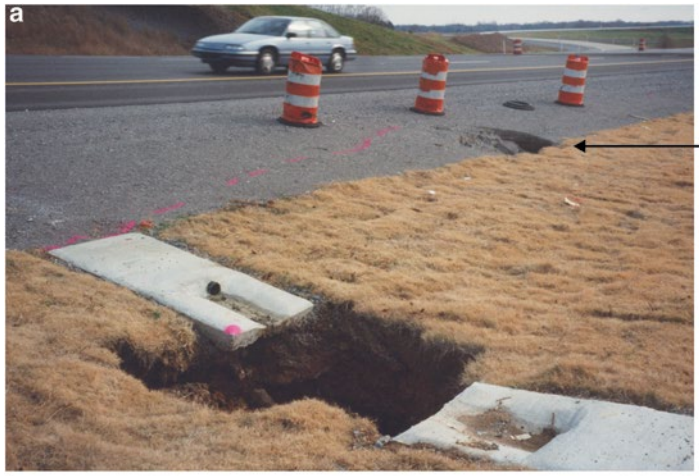
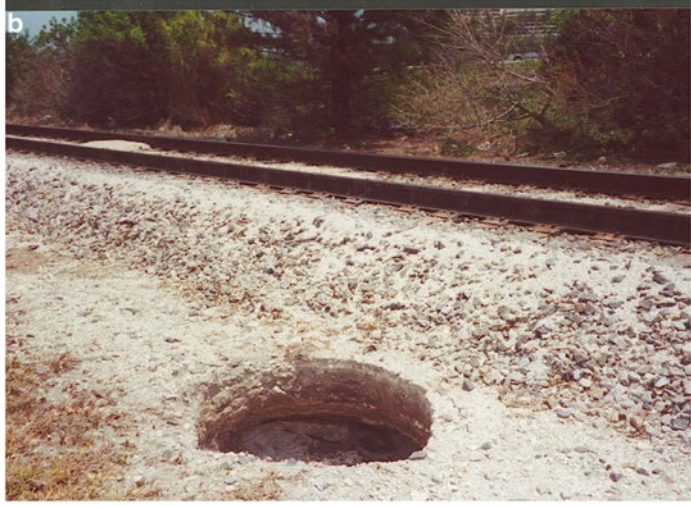
Fig. 3.5 Examples of small sinkholes are due to small pits or isolated cavities at or near the top of shallow rock (a) Sinkholes along roadway in Tennessee (b) Sinkhole along railroad in south Florida

type sinkholes. Figure 3.5 shows two examples of small nuisance sinkholes that are generally backfilled for remediation.

Nuisance sinkholes are typically small (Fig. 3.5) don't necessarily have a large impact on structures or possess a high risk for injury. They can often be "managed" by simple back-filling measures. This type of sinkhole is often common in surface water retention ponds, parking lots, roads, etc.

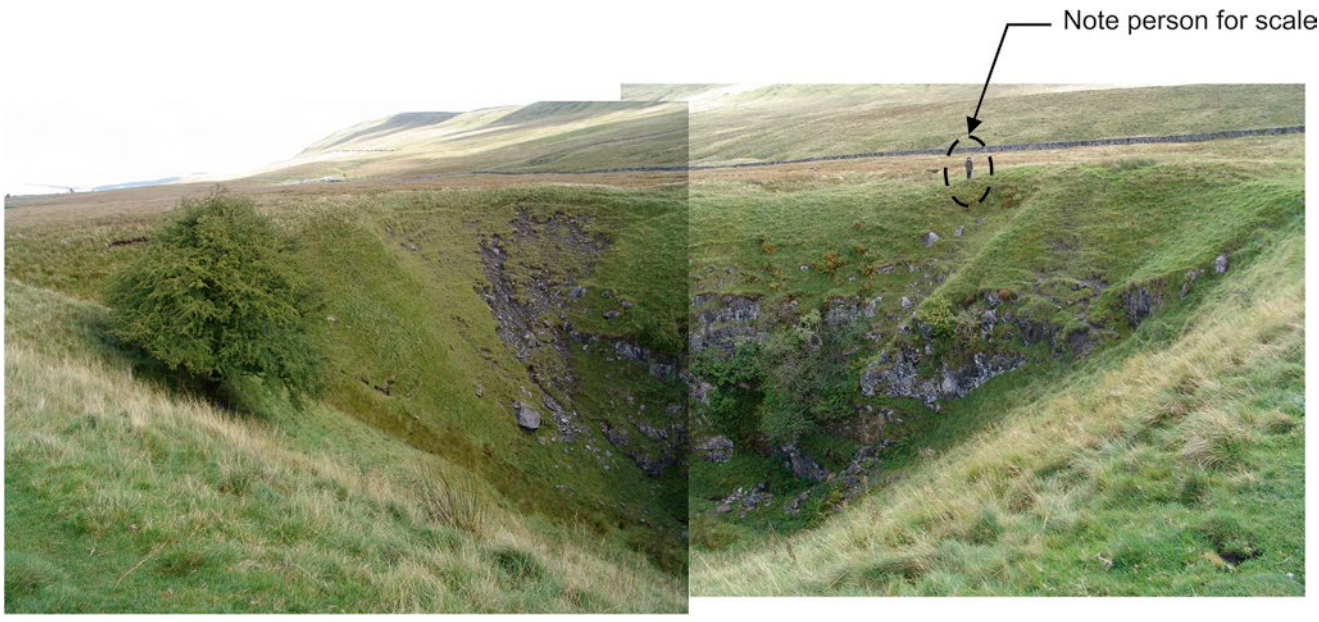
Fig. 3.6 A very large sinkhole in England estimated to be 100 m in diameter (note person for scale)

When the sediment cover becomes thicker, (6–15 m or more) the sinkholes become larger and can reach tens of meters across with losses up to 100,000 m³ or more. Figure 3.6 shows an old large sinkhole in England. Note the person in the photo for scale reference. New sinkholes in thick soil mantle constitute the most wide spread karst hazard (Waltham et al. 2005) and become a major hazard when they occur in populated areas.

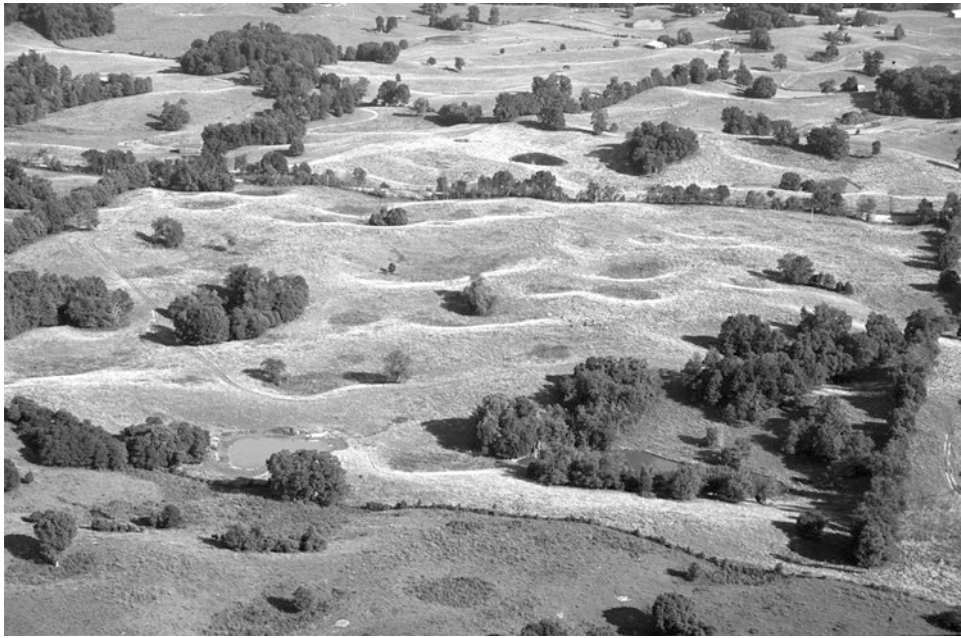
Fig. 3.8 Sinkhole densities can be quite high such as the Mitchell Plain in southern Indiana (Courtesy of T Waltham Geophoto)

Mitchell Plain showing the pervasiveness of sinkholes (closed depressions) throughout the area. However, sinkholes may be rare to absent in many karst areas.

The number of sinkholes present and their densities are tied to site-specific geologic conditions such as thickness of soil cover, type of underlying rock, depth to water table, the degree of dissolution or karst maturity. In many cases, where sinkholes are present they tend to line up as a linear trend or other geometric patterns. These linear trends or other geometric patterns often follow main joints that control groundwater flow resulting in preferential dissolution.

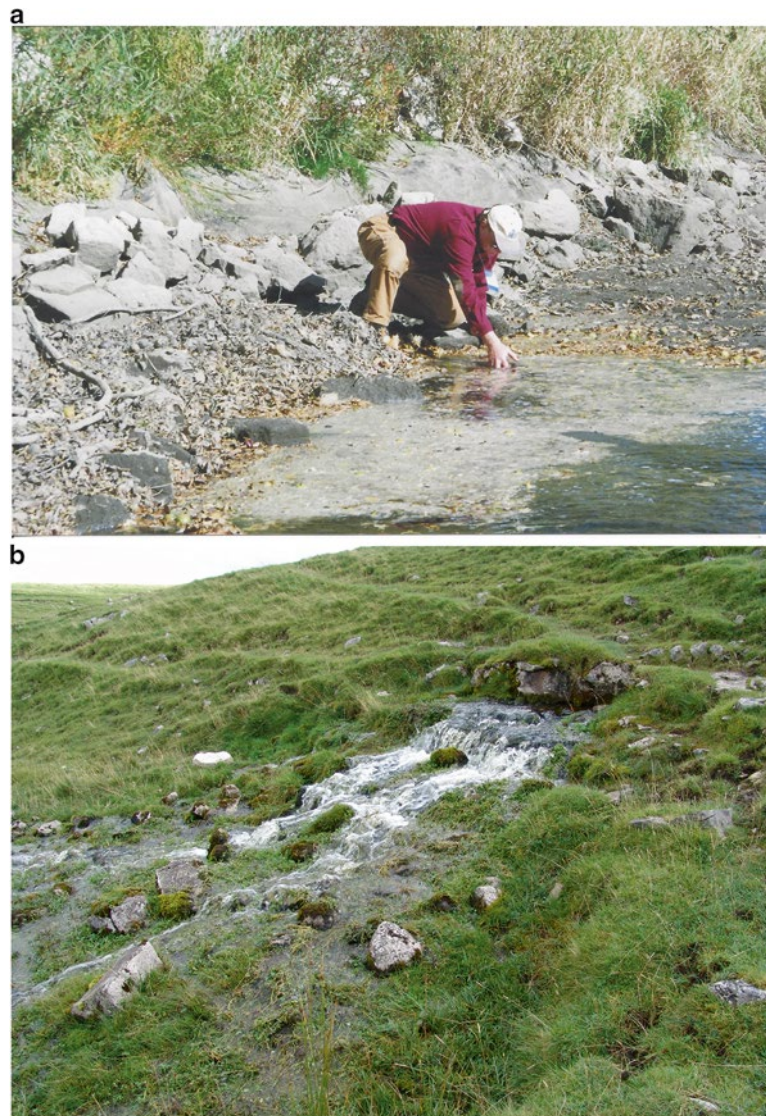
Fig. 3.11 A small sinking stream in southeastern Minnesota (a) and a moderate spring flowing from a hillside in England (b)

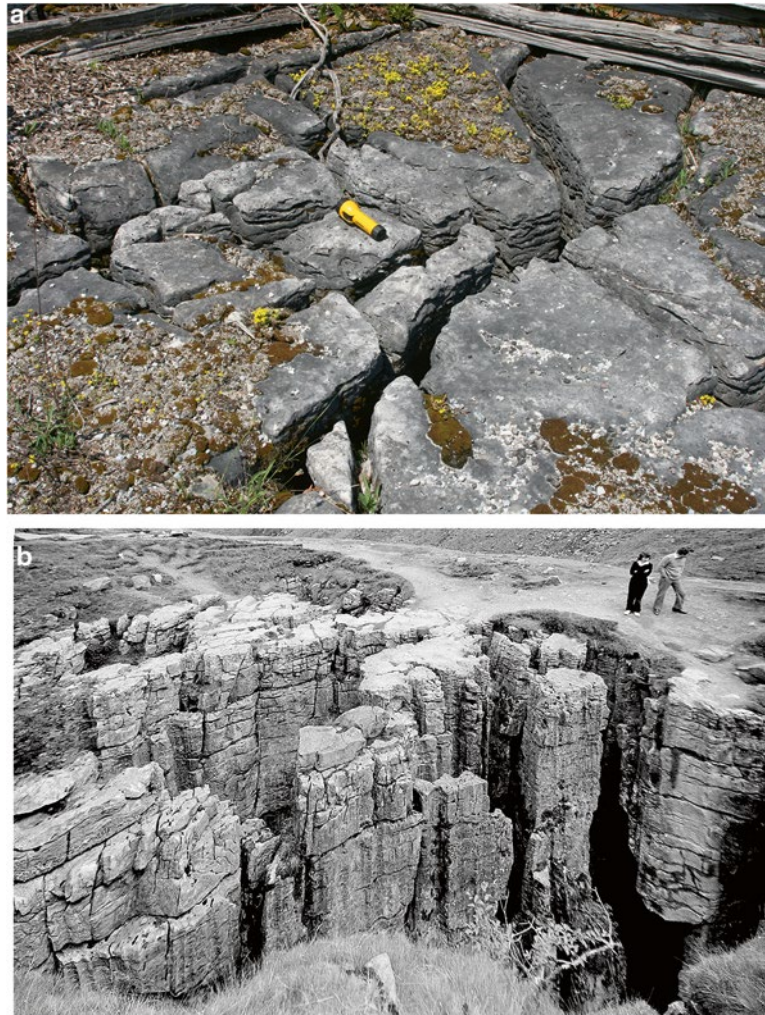
Fig. 3.12 Exposed limestone with extensive dissolution along secondary fractures is referred to as limestone pavement or karren fields (a) Karren karst in Manitoulin Island, Canada (b) Extreme karren karst in England (Photo courtesy of T Waltham Geophoto)

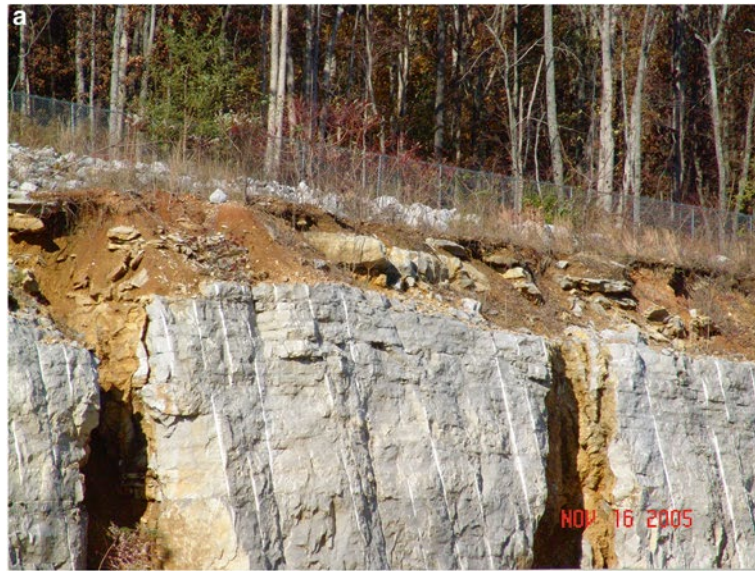
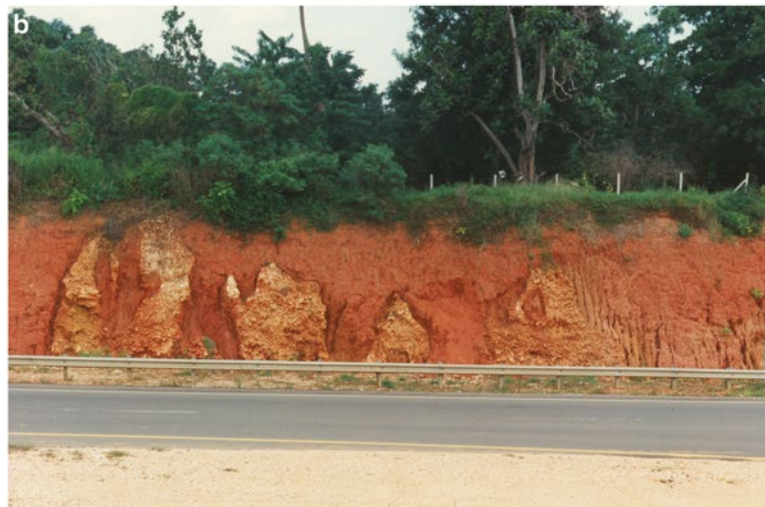
Roadcut in northeast Alabama showing epikarst over a more massive limestone

Roadcut in Puerto Rico showing highly weathered epikarst

Fig. 3.13 Epikarst, top of rock or rockhead can range from massive rock (a) to highly weathered rock (b)

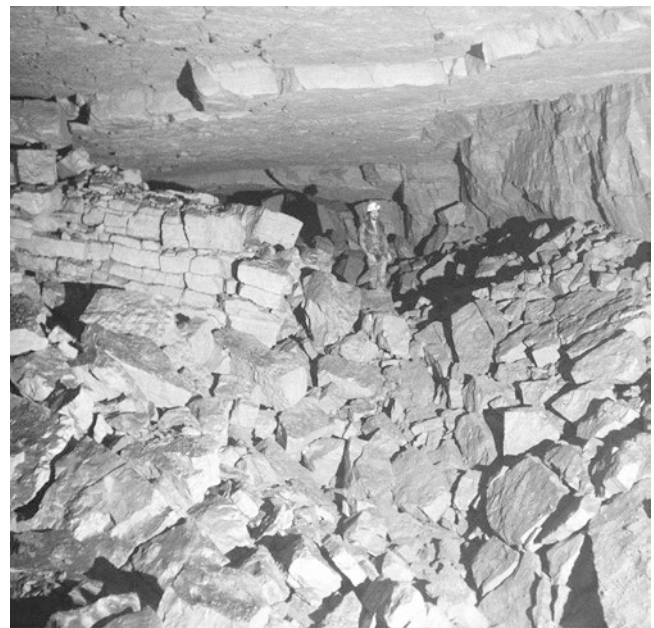
Fig. 3.15 Piles of fallen rock can nearly block off access in a cave and in some cases will completely block off access (Courtesy of T Waltham Geophoto)

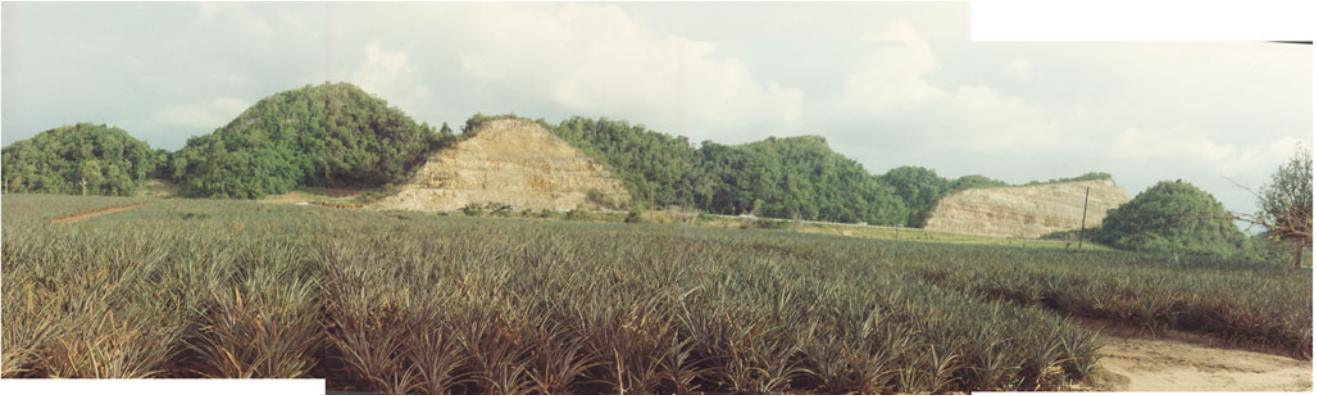
Fig. 4.2 The karst of Puerto Rico is likely a Mature Karst. Note two of the magotes (the term used in Puerto Rico to describe these features) have been cut away for road development

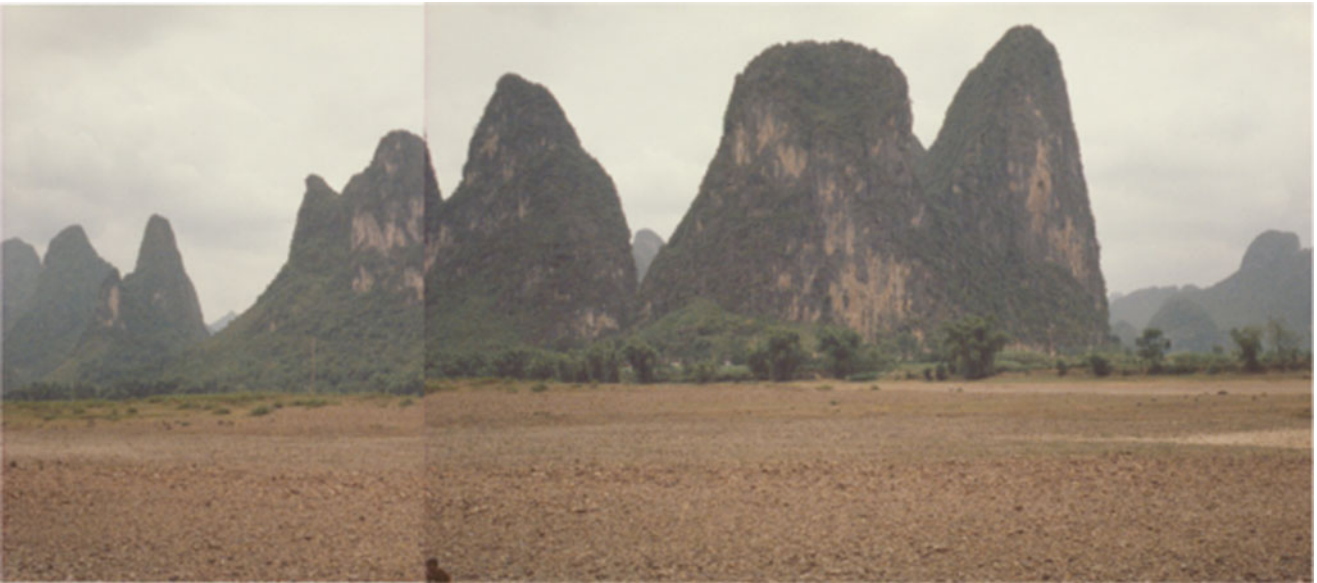
Fig. 4.3 The karst of Guilin, China is likely Extreme Karst

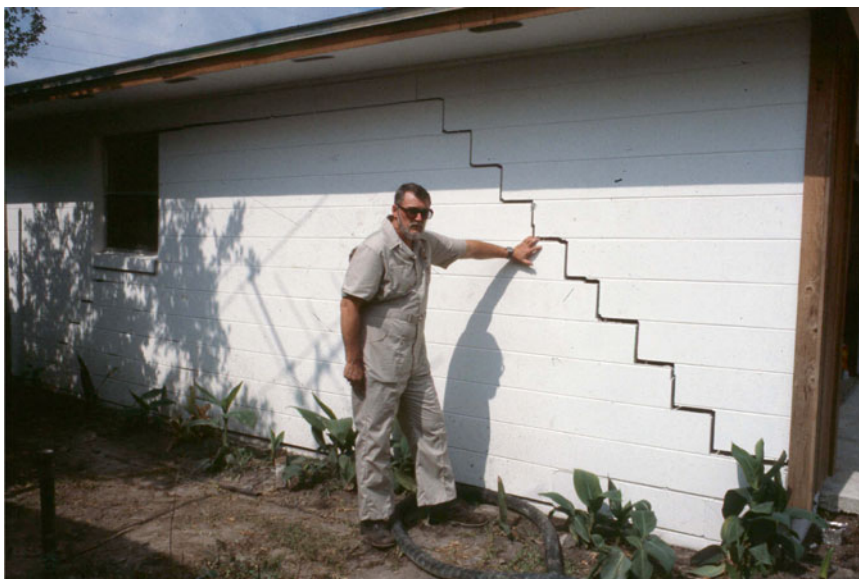
Fig. 7.1 In some cases the structure may be impacted by settlement resulting in cracks

When there is an obvious sinkhole collapse present, such as a house about to disappear (Fig. 3.2a) or the Winter Park sinkhole (Fig. 3.7), there is little dispute regarding insurance coverage. However, if the evidence of a sinkhole is simply cracks in a walkway or the house walls (Fig. 7.1) without the obvious presence of a collapsed sinkhole there can be considerable differences of opinion as to the cause. Many factors may cause small differential settlement of a structure such as: shrink/swelling clays, post construction settlement, ero-

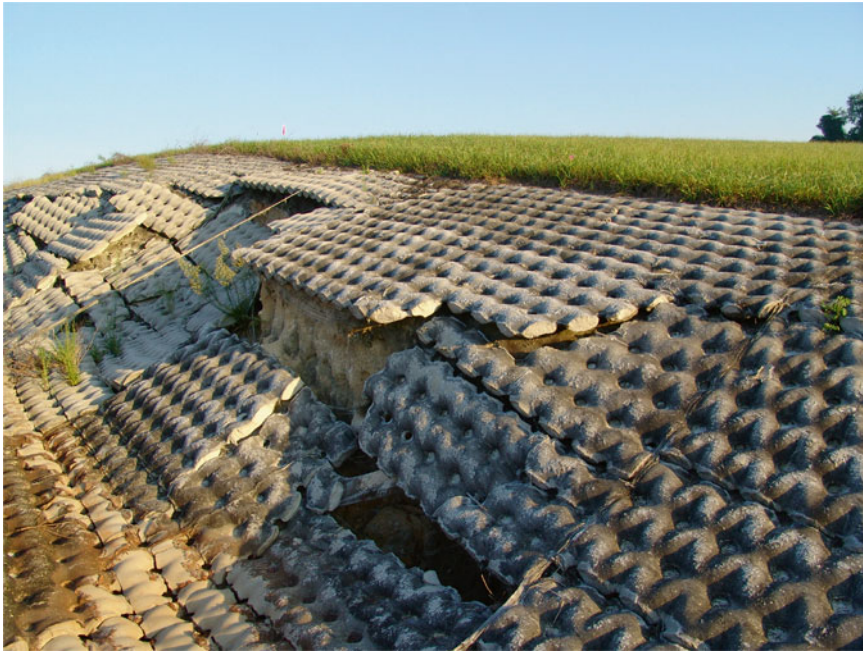
Fig. 7.2 Seepage of water through a concrete lining used to transfer surface water away from a landfill resulted in washing away of sediment and ultimately the collapse of the lining

The management of surface water runoff at a landfill included a concrete liner to guide waters off of and away from the landfill into a retention pond. Small leaks in the liner resulted in sinkholes developing beneath the concrete lining impacting and eventually breaching the concrete liner. Once breached, the surface water runoff was concentrated into these locations rapidly enlarging the sinkholes and extending the damage (Fig. 7.2).

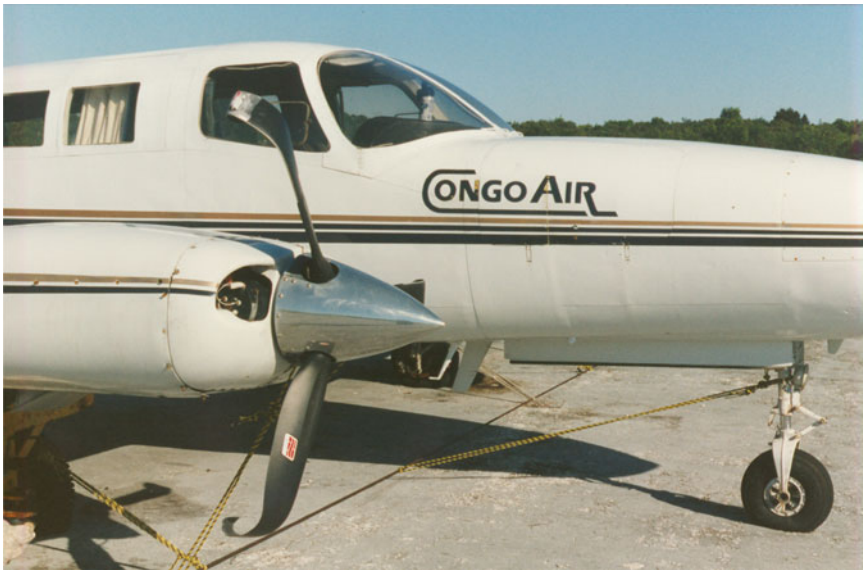
Fig. 7.3 Damage to an airplane propeller that encountered a small sinkhole (banana hole) on the runway at Congo Town airport, Andros, Island Bahamas

began to decay, local collapse features occurred along the runway. Their frequency of occurrence increased after a major storm had gone through the islands. Upon landing, an aircraft encountered one of these small sinkholes. Figure 7.3 shows the damage to the propeller of the aircraft after encountering a small sinkhole.

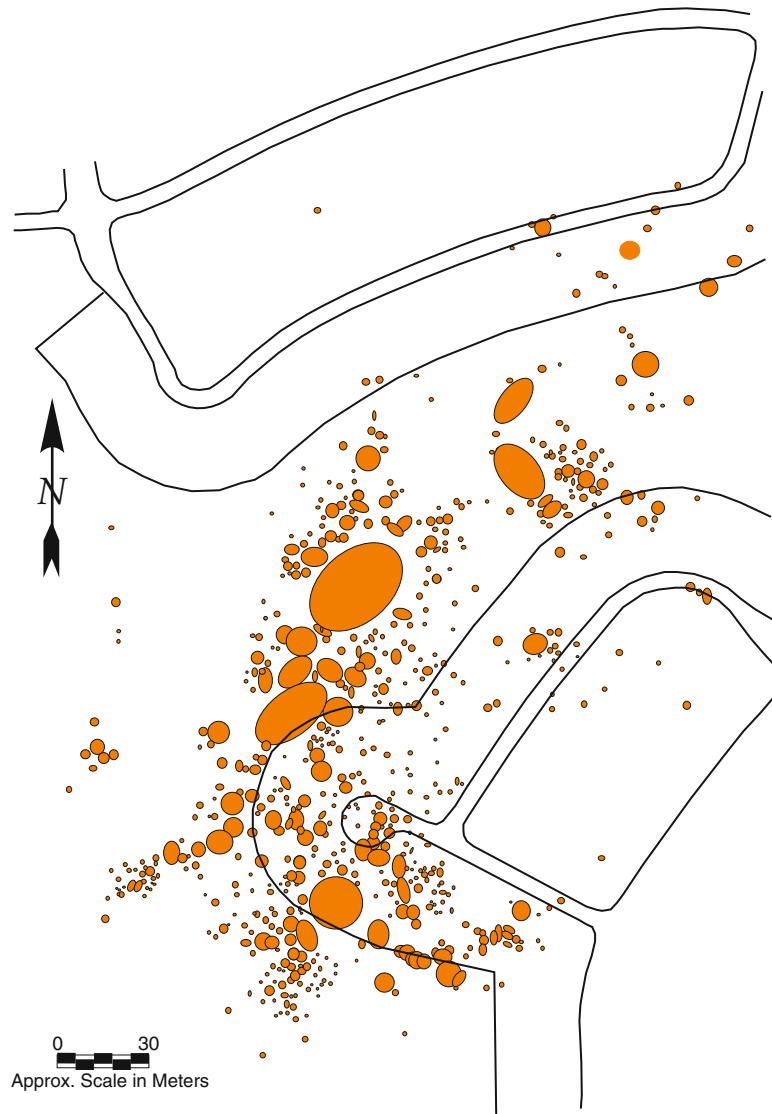
Fig. 7.4 A new housing development in west central Florida 760 sinkholes occurred within 24 h as a result of drilling and completing a well for irrigation purposes

A new housing development in west central Florida (Hernando County) experienced the formation of 760 sinkholes in less than 24 h over an area of approximately 8 ha (Fig. 7.4). This may be the greatest number of sinkholes to occur in a limited area within this short period of time. The sinkholes ranged from 1 m (Fig. 7.5a) to more than 30 m in diameter (Fig. 7.5b), with the majority of them smaller in size. There was no loss of life or equipment in this case and the incident occurred prior to housing construction.

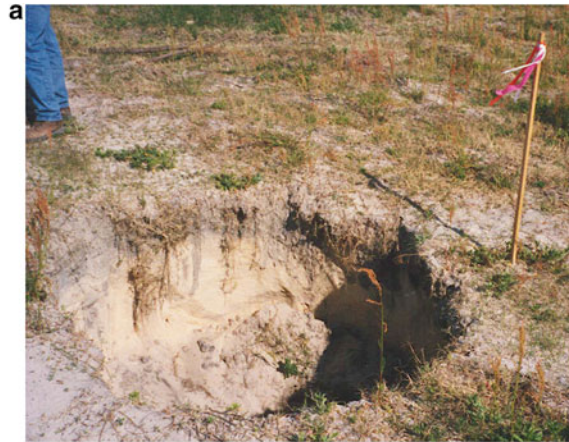
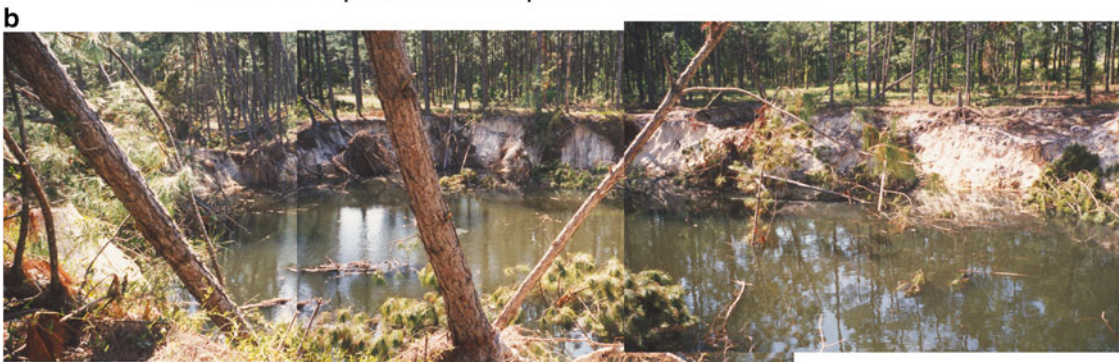
Typical small collapse feature associated with voids within the epikarst at a depth of about 12 meters

One of the large collapse features associated with caverns within the limestone at depths of about 30 to 60 meters below grade

Fig. 7.5 The majority of the 760 sinkholes in Fig. 7.4 were 1–3 m in diameter (a) along with a few larger ones of 15–30 m in diameter (b)

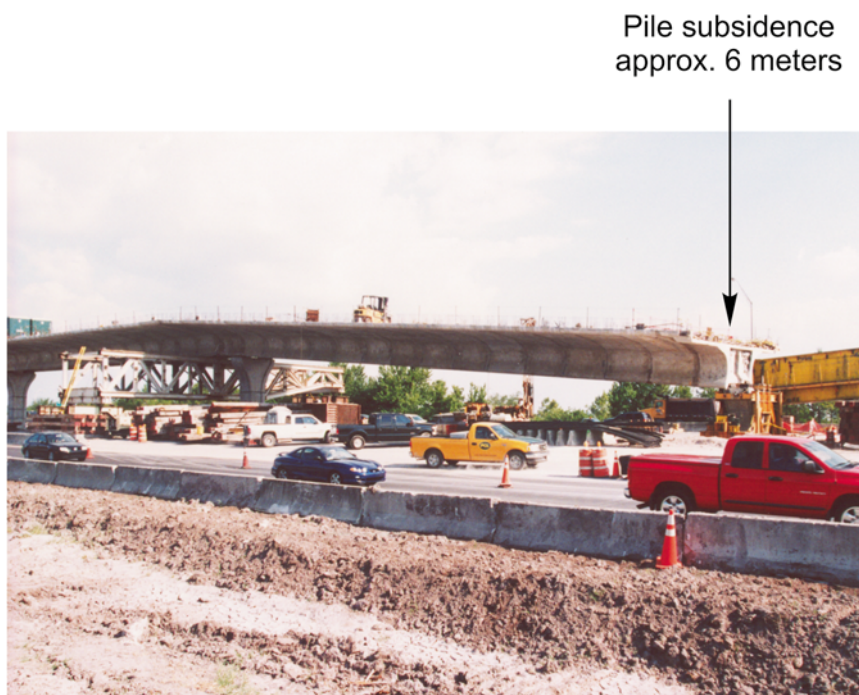
Fig. 7.6 Damage occurred during construction of the Crosstown Expressway in Tampa, Florida when one pile slowly sunk about 6 m

A pile failure occurred during the construction of the new, elevated Tampa Bay Crosstown Expressway on the west coast of Florida in April of 2004. A single massive column supporting a three-lane road over a 30-m span, sank into the ground about 5 m over a 10 s period along with the newly constructed roadway resting on top of the column (Fig. 7.6). The other 60 piers that were in-place showed no signs of any problems.

The columns extended down into a caisson that was founded on strong limestone about 18 m below the surface. Prior to construction, the geotechnical investigation included drilling 22 m deep to test subsurface conditions (Stein et al. 2004). The fatal flaw in the limestone was obviously deeper than the test borings.

Expressway officials and road builders said the collapse has as much chance of happening again “as someone getting hit by a meteor”. Other comments in the press included; “A sinkhole as deep as this is undetectable”, “It was just a bizarre event”, “A small problem with the soil, something 1–6 m across, is easy to miss. If you try to find everyone, you could never afford the project”, and “It was an act of God”. These comments showed a complete lack of understanding of karst conditions, (Waltham et al. 2005). The cost of this single catastrophic event was estimated at about \$100 million, but the cost of additional investigation (deeper initial borings or employing other methods) prior to construction is negligible in comparison when dealing with possible karst conditions at such critical structures.

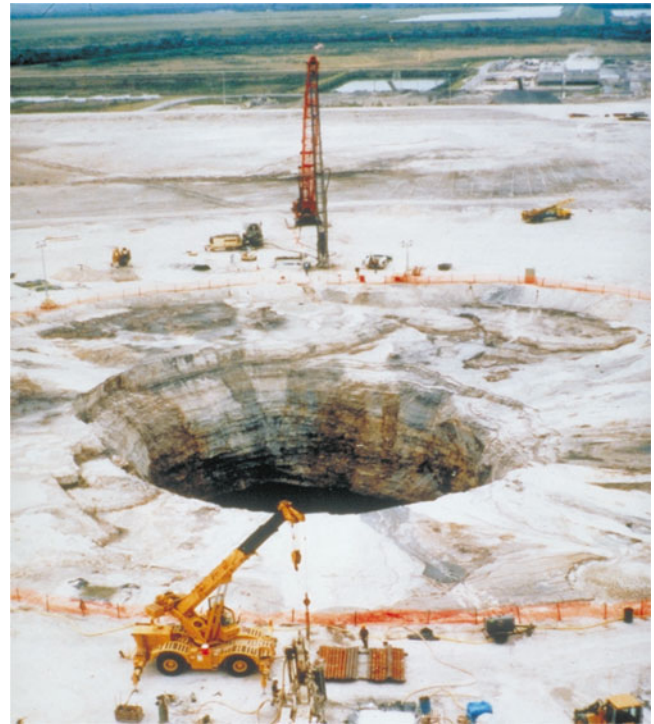
Fig. 7.8 A large sinkhole developed in a gypstack, a waste material from the phosphate industry in Florida (Tihansky 1999)

Gypstacks have had sinkhole failures (Sowers 1996), the most recent formed in June of 1994. A major collapse occurred at a 168 ha, 60 m high gypstack at the New Wales plant of IMC-Agrico Company. During a routine morning visual inspection, an elongated erosion feature was seen in the surface of the gypstack. That afternoon a sinkhole developed which was approximately 48 m in diameter and tapered to 32 m wide at the base of the gypstack (Fig. 7.8), (Fuleihan et al. 1997).

Six borings including four angle borings along with piezometers were used to determine the dimensions of the collapse and assess hydrologic conditions. Figure 7.9 shows a conceptual cross section of the conditions at the failed gypstack. The nearly vertical shaft tapered from 48 m diameter at

the surface to about 32 m diameter at a depth of 18 m and then extended vertically to a depth of 55 m where blocks of gypsum were encountered. The sinkhole extended more than 122 m below the top of the stack. An estimated 113,000 m³ of phosphogypsum and an undetermined amount of contaminated water disappeared down the sinkhole (Fuleihan et al. 1997).

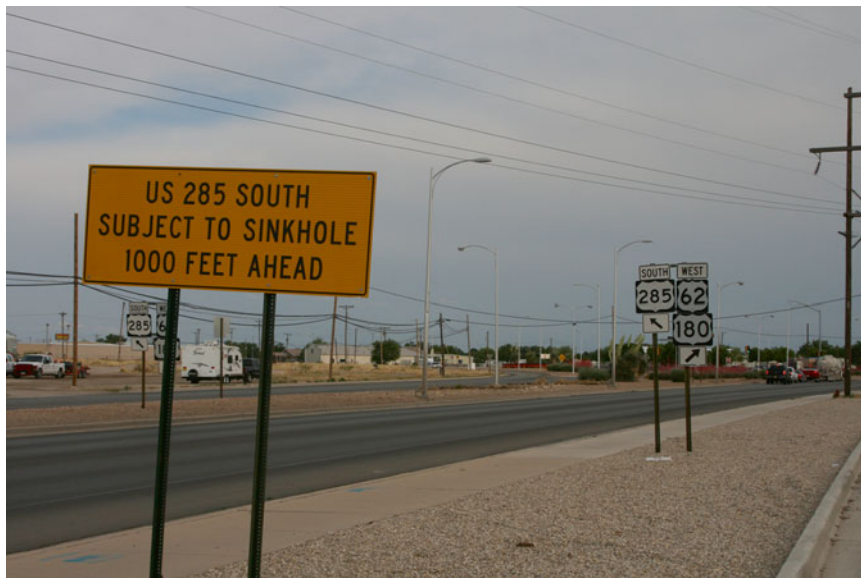
Fig. 7.12 Another site within the city of Carlsbad, New Mexico where salt was dissolved for drilling purposes has created a large cavity and a road sign alerts drivers to potential of sinkhole occurring in this area

adjacent mobile homes, a drainage canal and a church. Signs along the roads warn of the potential danger (Fig. 7.12). Surface geophysical surveys were made to determine the lateral extent of the cavern and the site is being monitored by inclinometers installed within the boreholes with their outputs sent to critical emergency staff phones (Land 2013).

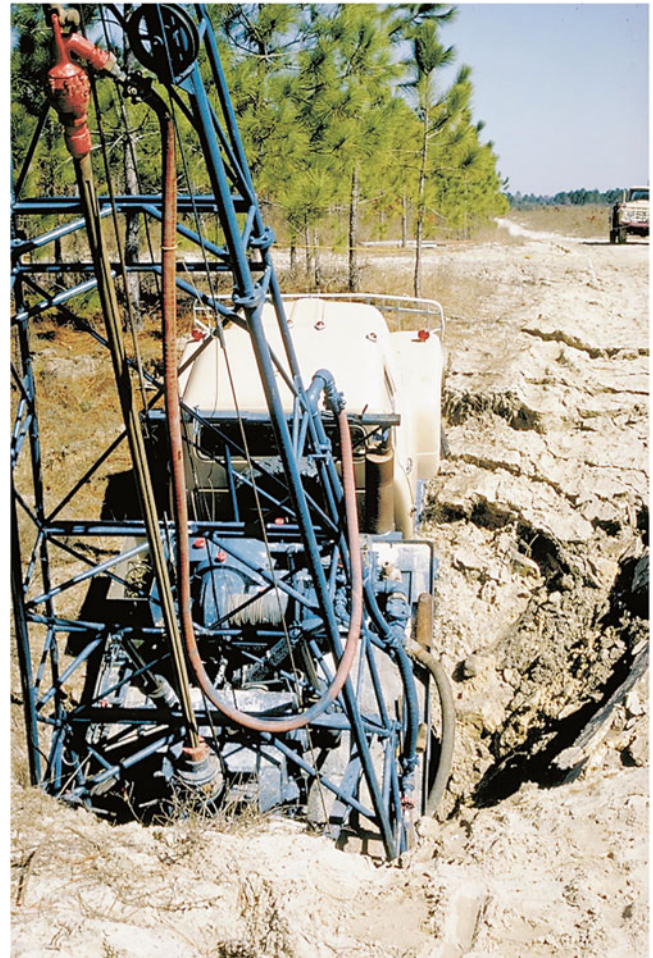
Fig. 8.2 The Guest Sinkhole in west central Florida triggered by drilling a monitor well (Tihansky 1999)

was down about 62 m on the third day of drilling when the ground began to give way. Within minutes, the sinkhole swallowed the well-drilling rig, a water truck, a trailer loaded with drill pipe and a 12 m pine tree. Figure 8.2 shows the beginning of the collapse around the drill rig. The sinkhole was about 91 m in diameter and 7.5 m deep (taking about 200,160 m³ of sediment). As the sinkhole formed, it was originally dry, however, within 24 h it had filled with water seeping into the sinkhole from the surficial aquifer. Ten small satellite sinks as much as 6 m in diameter formed along a NNW-SSE trend through the main sinkhole (Scott 2009, personal communication, Tihansky 1999).

The process of air rotary drilling had probably loosened the clayey sediments within the epikarst zone due to air pressure from below. The repeated flushing pressures during well development continued to aggravate these conditions. The combination of these two activities was sufficient to initiate collapse. As the collapse process continued the head difference between the surficial aquifer and the deeper Floridan aquifer aided in sinkhole development.

- On the west coast of central Florida, the Guest Sink consumed a drill rig and two support trucks, within a matter of 10 min (Fig. 8.2) (Scott 2009, personal communication).

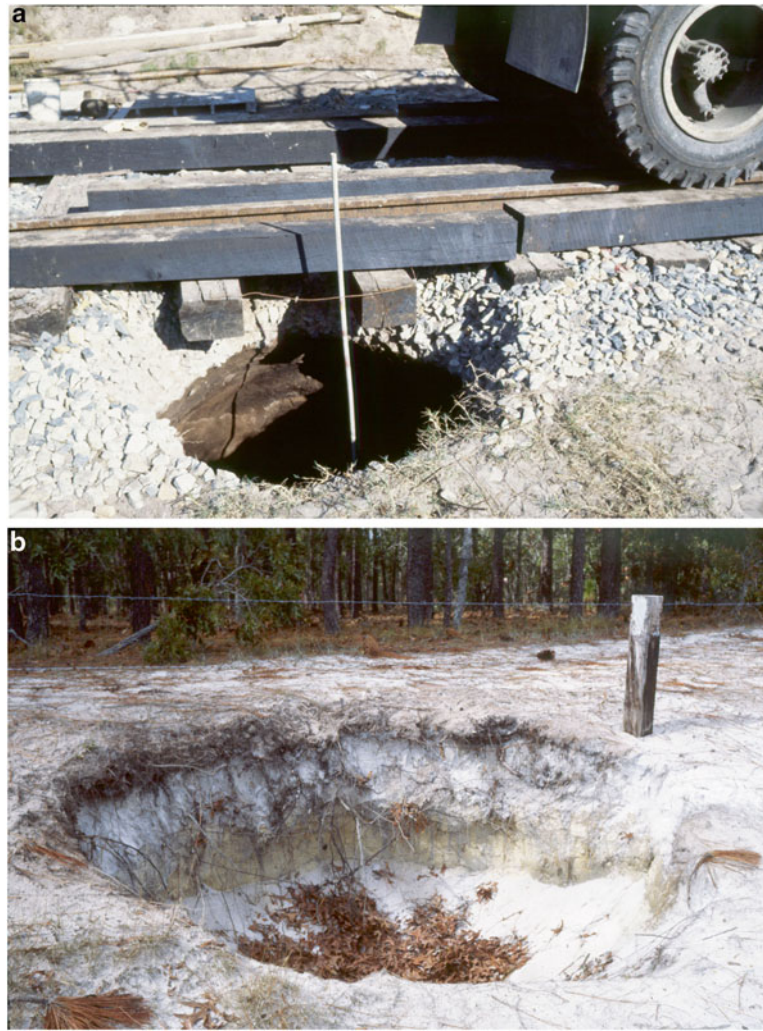
Some dropout sinkhole or cover collapse sinkholes may initially be quite small but commonly enlarge with time. At a site in North Carolina where sediments were about 12 m thick, small (0.3–0.6 m diameter) soil piping sinkholes would slowly migrate to the surface (Fig. 8.3a). Then a slow process of raveling of sediments would take place resulting in a funnel shape sinkhole of a 3–6 m diameter within weeks (Fig. 8.3b). The sinkholes in Figs. 3.5, 7.5a, and 8.3 are all related to small isolated voids within the epikarst.

Fig. 8.3 Initial sinkholes at a site in North Carolina were quite small (<1 m in diameter) as a result of piping in sandy soils (a). Within a few weeks, these sinkholes would slowly enlarge to 3–6 m in diameter as the sandy soils continued to ravel (b)

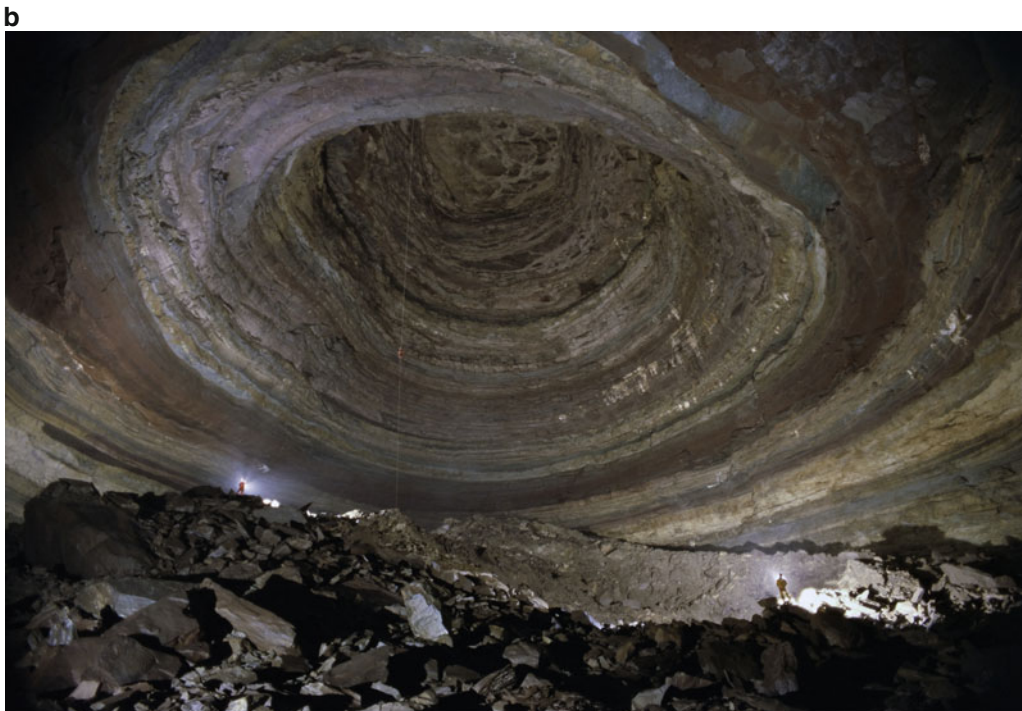
Photo of large cavern Rumble Room in Rumbling Falls Cave, Tennessee (courtesy of Chris Anderson)

Fig. 9.1 Huge caverns can develop arched domes that can be inherently strong and stable for long periods of time (a). An example is seen in the Rumble Room of Rumbling Falls Cave, Tennessee

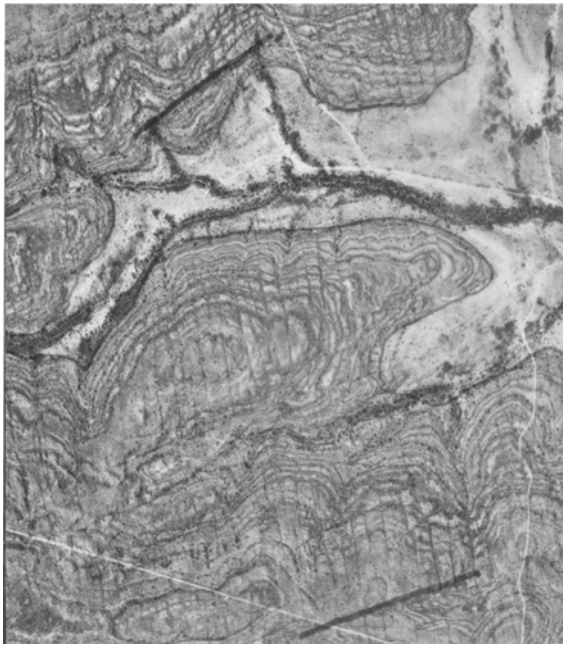
Fig. 14.4 Aerial showing fracture patterns and landforms in southwest Texas

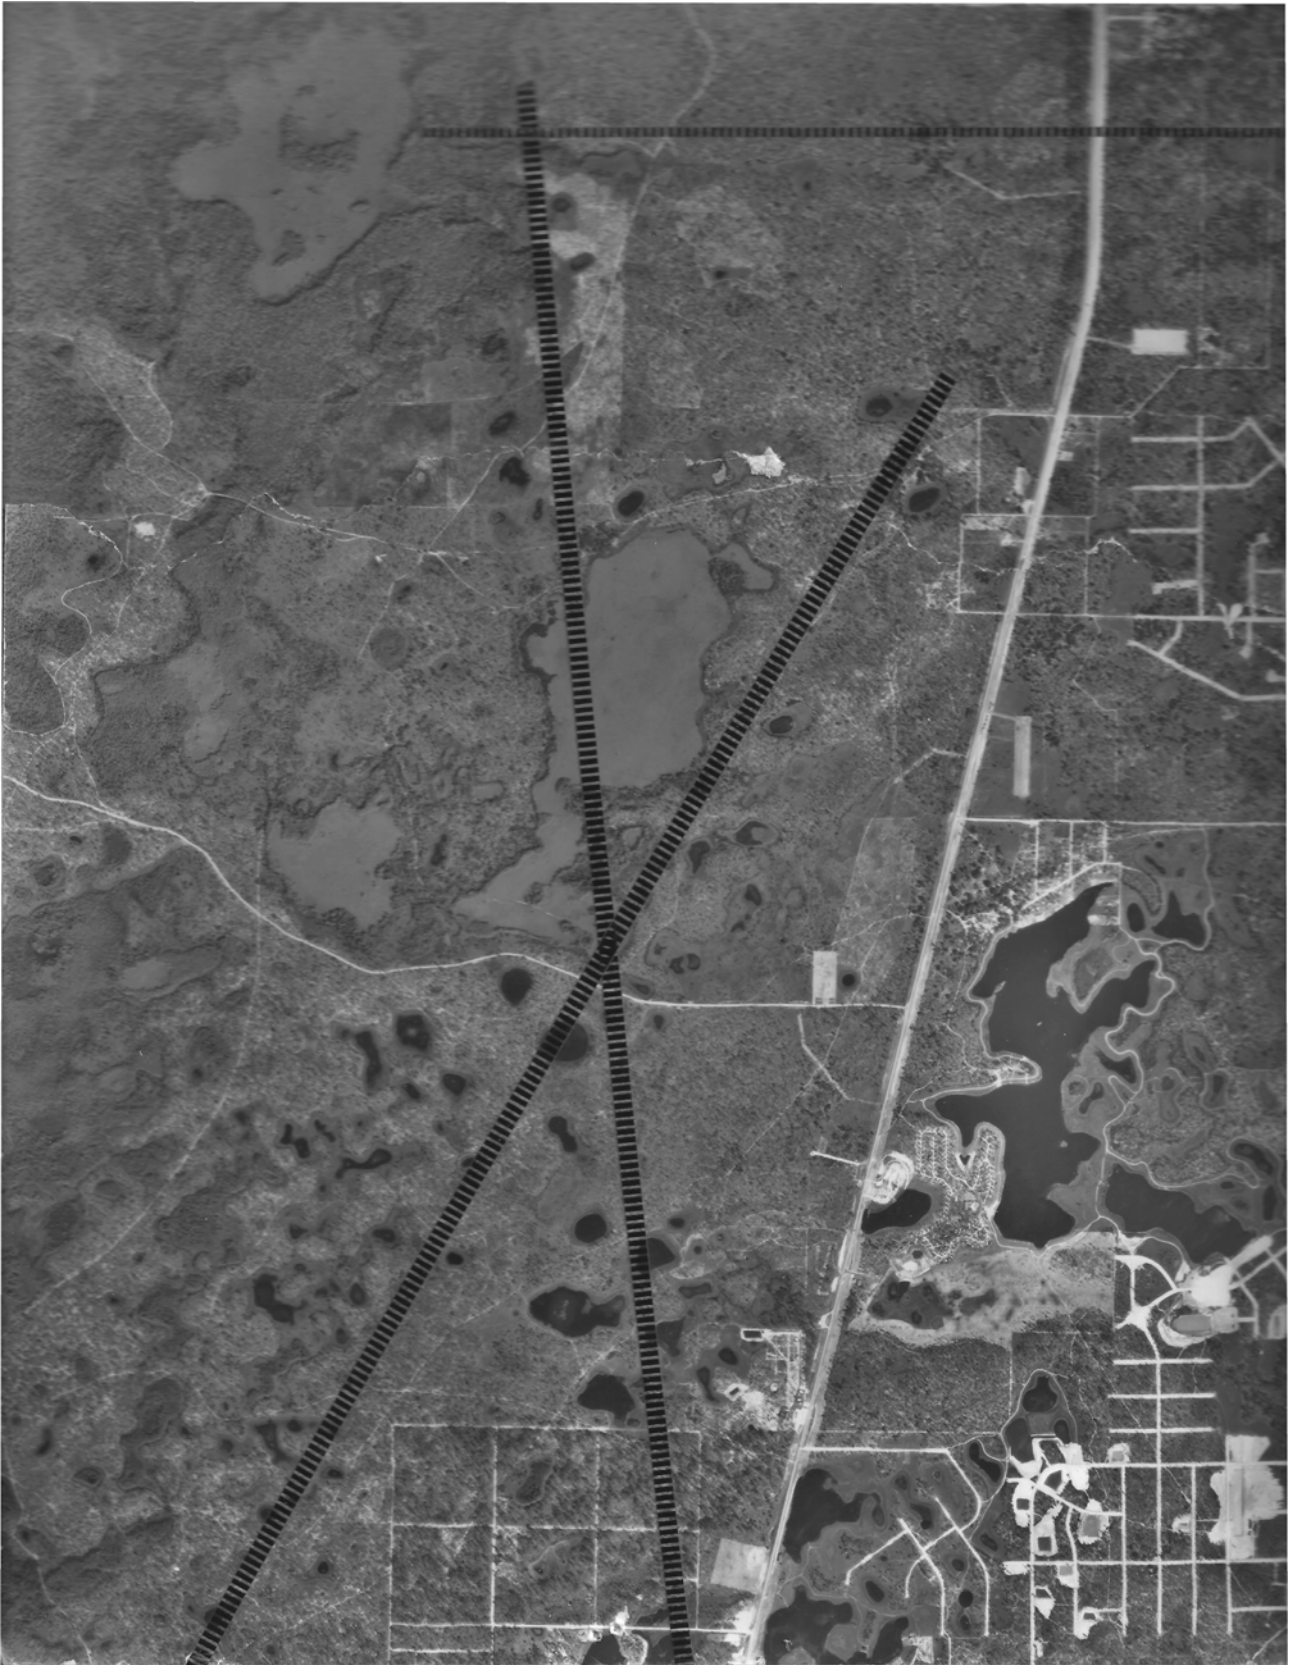
Fig. 14.5 Linear trends associated with in sinkholes along a portion US19 in west-central Florida

Water resource development has utilized fracture trace and lineament analysis to locate wells in fracture zones to optimize water recovery. Sinkholes often tend to occur along linear patterns of fracture traces or lineaments (Fig. 14.5). Littlefield et al. (1984) have suggested that sinkhole probability increases at major lineament intersections and decreases as the location moves further from a lineament. Short-term sinkhole development is most probable along the largest photolinear features.
