Site Characterization in Karst and Pseudokarst Terraines

Practical Strategies and Technology
for Practicing Engineers,
Hydrologists and Geologists

Richard C. Benson • Lynn B. Yuhr

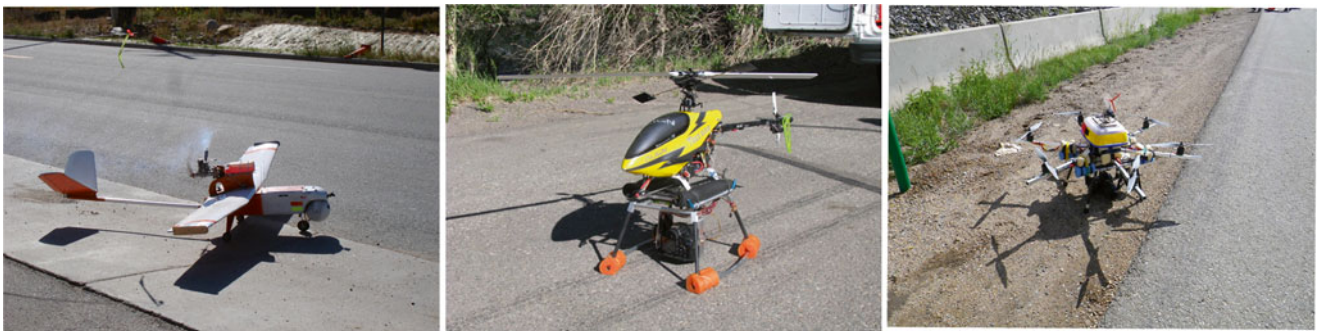
Fig. 14.7 Unmanned aerial systems (UAS), fixed-wing aircraft, a helicopter and hexa-copter used to obtain aerial photos and video (Photos courtesy of the Colorado Department of Transportation)

(Fig. 14.7). The UAS's have two cameras; one mounted for a pilot's view and another one to take the photographs. Photos can be vertical to almost any oblique angle needed for the project.

A fly over is commonly completed using a small fixed wing aircraft or helicopter. A slow speed aircraft with an overhead wing is the best choice for visibility and obtaining oblique aerial photos. The senior author has used a two seat Piper Cub with an overhead wing to provide the best visibility and with the window open to improve photographic quality. Helicopters are quite maneuverable but are also noisy and have a fair bit of vibration. The senior author has utilized the Goodyear blimp a number of times in the 1970s to monitor dye traces from sewerage outfalls in the ocean and to track dye traces of tidal flow in coastal waters and inlets. Today however, we will be seeing more unmanned aerial systems (UAS) (Fig. 14.7) being used for such reconnaissance.

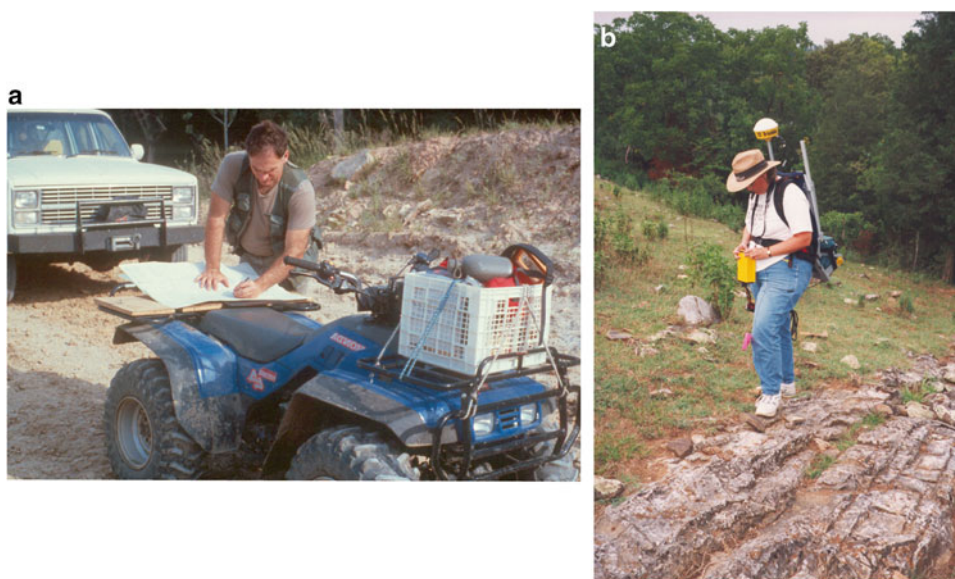
Fig. 15.1 An ATV is used to cover a large site (a) and field mapping has been aided by the use of GPS and digital field notebooks (b)

There are obvious tools such as topographic maps, aerial photos, rock hammer, a field notebook, camera and a compass. Limited sampling of soil and rock may be obtained for initial analysis and reference. On a new site development, the initial area in which a project is to be located can be many km^2 . While a site walkover is done mostly on foot, larger sites may require an ATV (Fig. 15.1a) or a 4×4 pickup truck as a means of transportation. A GPS unit and topographic

sheets are a must in wide ranging reconnaissance of 100's–1,000's of hectares particularly over areas with few landmark or reference points. With the wide-spread use of GPS one might think that pacing would be a lost art, however, pacing remains effective for field reconnaissance in wooded areas, underground or in structures. Distances by pacing can be better than 2 % on flat smooth surfaces, but will be less in rough, hilly, or vegetated terrain. Field mapping can be improved by the use of a GPS system, hand-held computers and digital topographic maps and aerial photos (Fig. 15.1b).

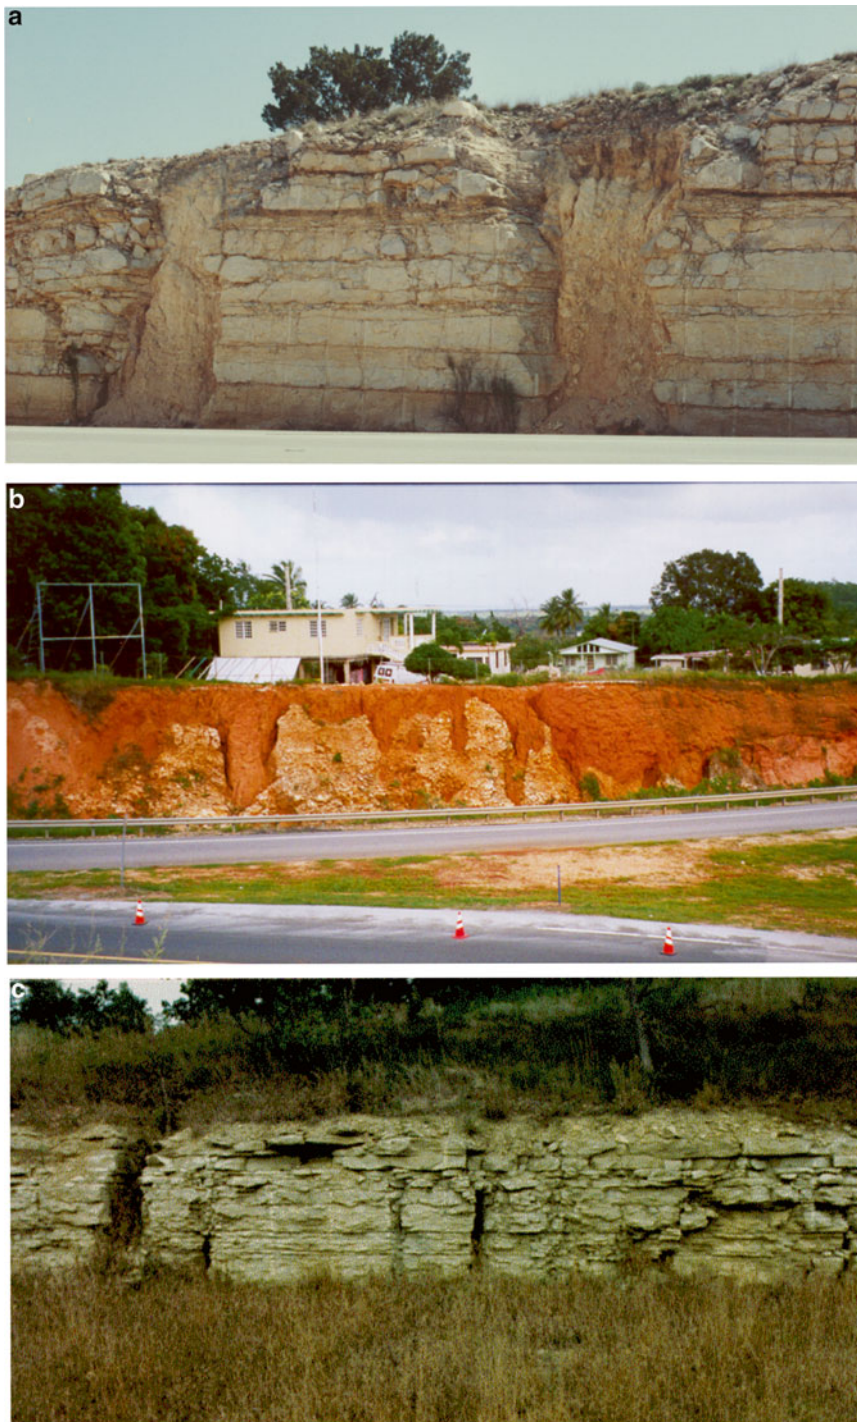
Fig. 15.3 Three road cuts illustrate the valuable geologic information available from these geologic windows. (a) Southwest Texas. (b) Puerto Rico. (c) Kansas City, Kansas

A road cut along Highway 90 in southwest Texas (Fig. 15.3a) shows two smaller areas of in-filled collapse.

These features are relatively close to one another and they extend from the surface to the roadway indicating that the feature extends deeper well below the road. A road cut in Puerto Rico (Fig. 15.3b) shows a highly weathered and irregular limestone profile. In the Kansas City area, the uppermost Argentine Limestone (Fig. 15.3c) is commonly exposed along road cuts showing extensive fractures and weathering.

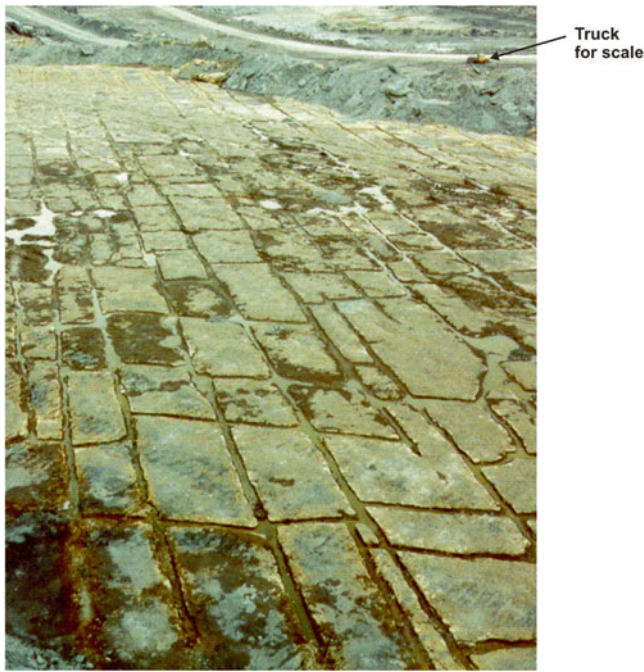
Fig. 15.4 The floor of the Missouri Portland Cement Quarry in Independence, Missouri reveals the extent and spacing of fractures in the Bethaney Falls Limestone

A limestone quarry floor adjacent to a site under investigation in Missouri revealed the extent and spacing of vertical fractures in the Bethaney Falls Limestone (Fig. 15.4). This plan view of the rock fracturing was unique and would not have been as readily perceived from any other data or observations.

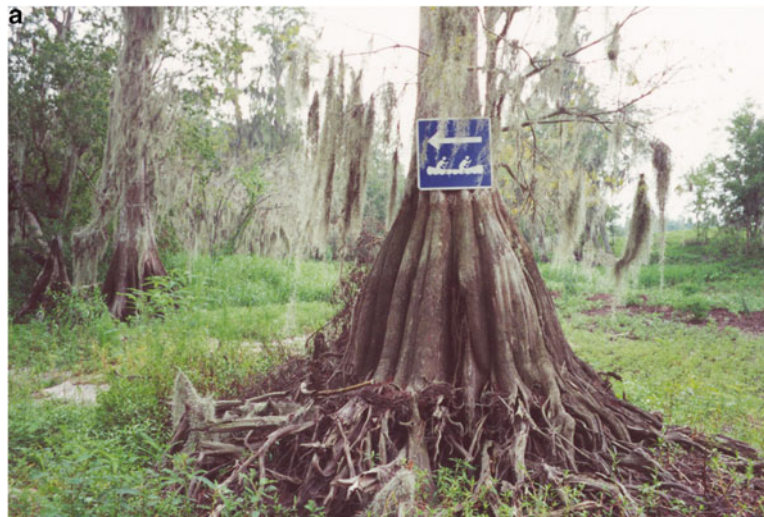
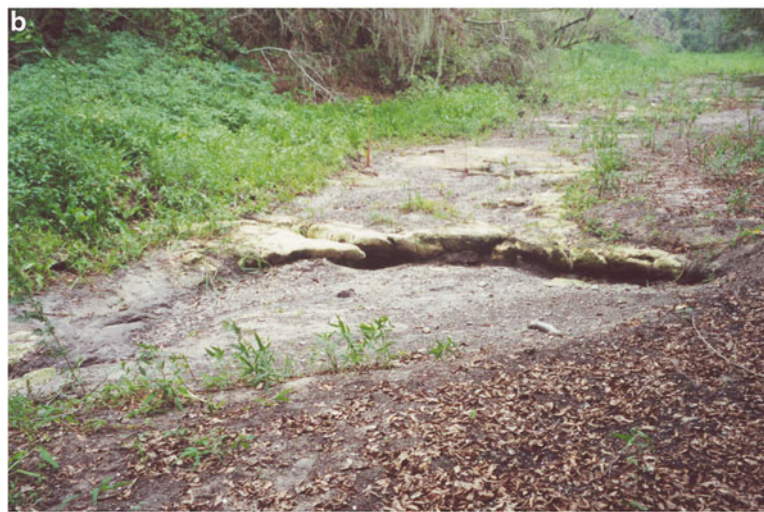
dry creekbed usually active with canoeists

open fracture found in dry creekbed

Fig. 15.6 The Peace River in west-central Florida is normally a small quiet stream used by canoeists. However, during periods of low rainfall the river will dry up completely (a), note the sign on the cypress tree indicating direction for canoeists. When dry, open joints in the rock are exposed (b)

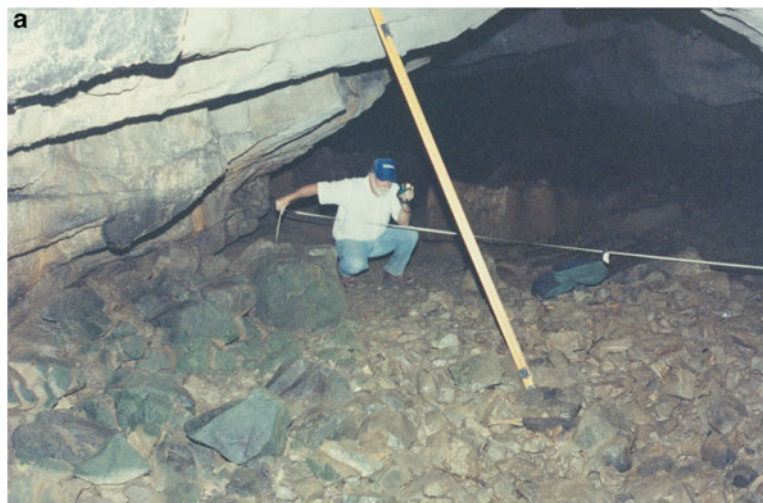
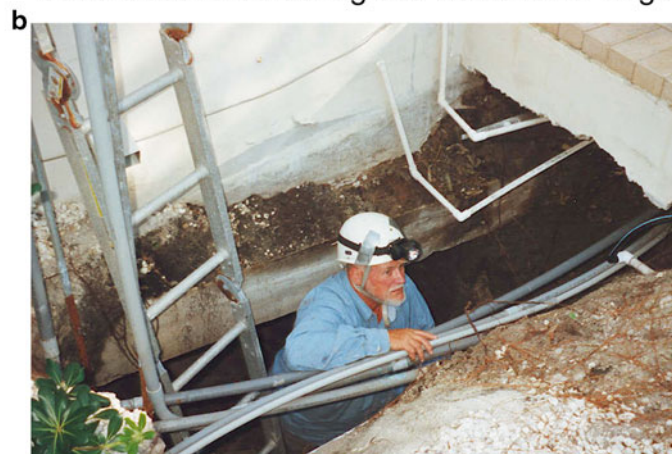
Cave discovered during site walkover in Virginia

Inspection of collapse reveals cave under house along east coast of Florida

Fig. 15.7 Caves can be encountered during a site walkover. Measurements of a cave were made to establish the cave's height and span in West Virginia (a). A small collapse was found at the edge of a house. A quick inspection indicated that this was a small cave (b)

At a proposed federal prison facility in Virginia, a small cave was encountered during the site walkover (Fig. 15.7a). This large property had not been previously developed or surveyed so there was no existing information on this cave. Documentation included basic dimensions and geologic formation along with evidence of collapse or presence of

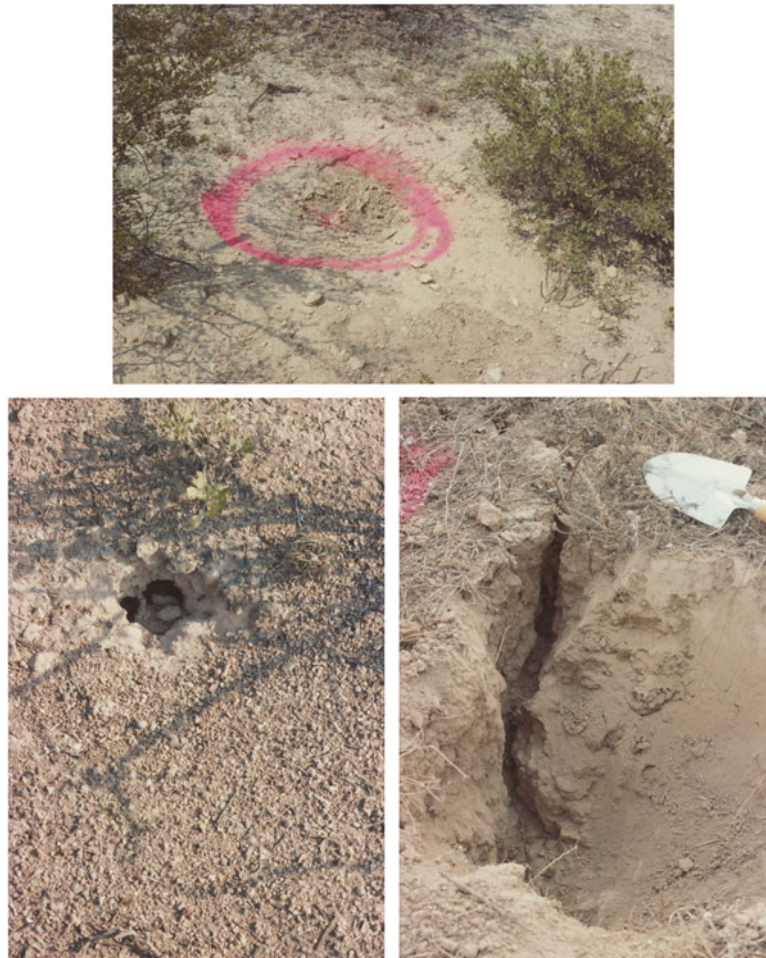
Fig. 15.8 Three examples from a total of 42 localized features and fissure found during a 100 % site coverage walkover. Excavation of these fissures by shovel and backhoe revealed that they extended at least a meter below grade

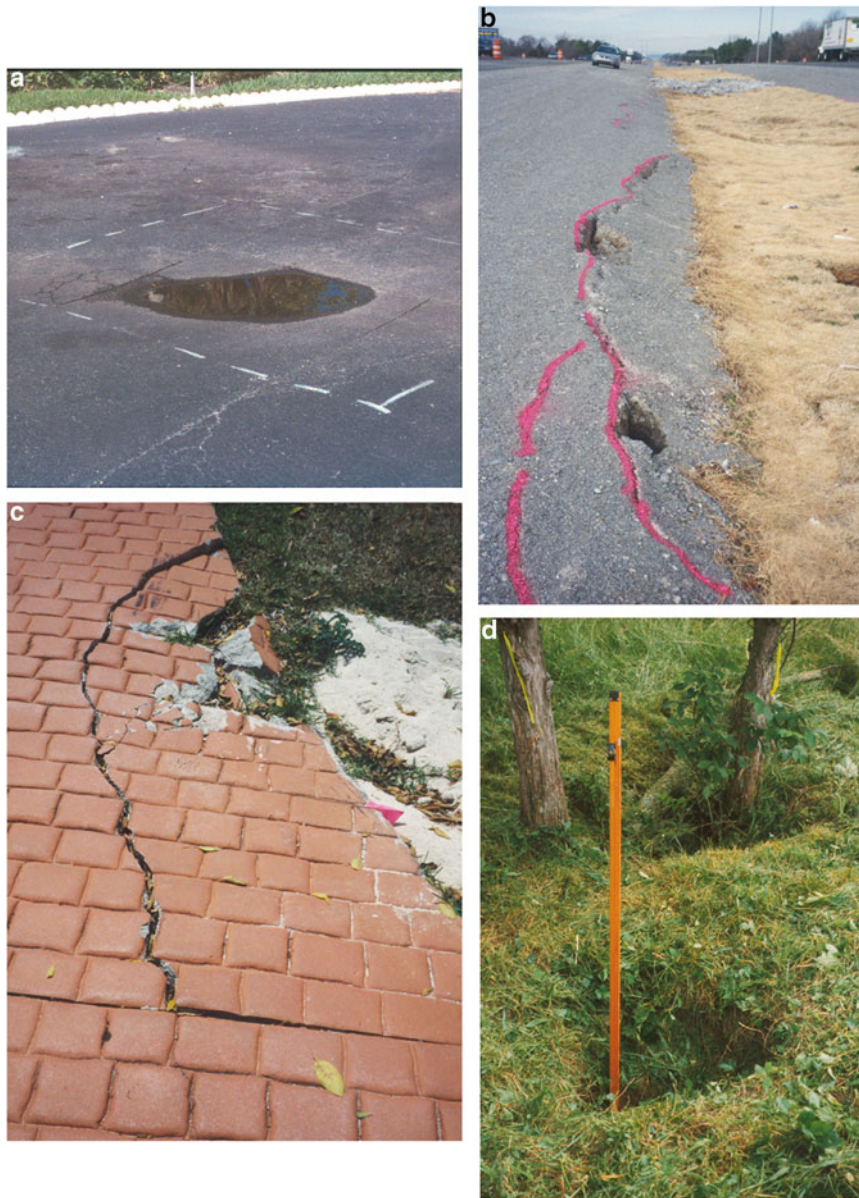
Fig. 15.10 Early subsidence is commonly indicated by the presence of circular depressions that retain water (a), cracks, fractures or local settlement in the soil (b), cracks in asphalt or concrete driveways (c) and localized depressions or drop-outs (d)

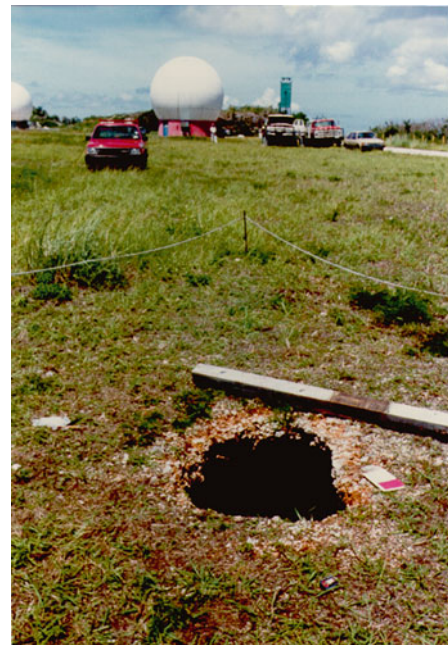
Fig. 16.21 One of many sinkholes at a military site on the northwest coast of Guam

A high security military facility was located on a cliff (almost 180 m high) on the northwest coast of Guam. The facility was experiencing localized sinkhole activity (Fig. 16.21). Areas of surface collapse were typically 1–2 m in diameter opening into small cavities within the limestone rubble fill used as soil cover. Concern arose regarding possible subsidence or collapse that could impact the critical military structures at the site. Radar was selected to survey the site using an 80 MHz antenna. The survey objectives were to identify cavities, joints and other areas of concern, which might impact the structures. The radar data quality was excellent and provided a depth of penetration to 24 m due to the dry, clean limestone conditions (Fig. 16.22a). However, the range was reduced to 12 m to provide higher resolution data within the shallower zone of concern (Fig. 16.22b). A series of parallel radar survey lines 7.5 m apart were run oriented perpendicular to the cliff.

Borings were then located based upon the cavities identified in the GPR data (hyperbola). Each air rotary boring was geologically logged then a borehole video system was used to investigate the vertical and lateral extent of any fractures or cavities encountered. Cavities encountered ranged from 1.8 to 3.6 m in diameter. Small joints (0.3–0.6 m wide) within the rock appeared to be allowing soil to migrate into the cavities, causing localized collapse features.

collapse to structures at the facility. The combination of radar data, borings and borehole video data provided increased confidence levels in the interpretation of subsurface conditions. A remedial program was designed and undertaken to stabilize the surface conditions by grouting within the upper 12 m.

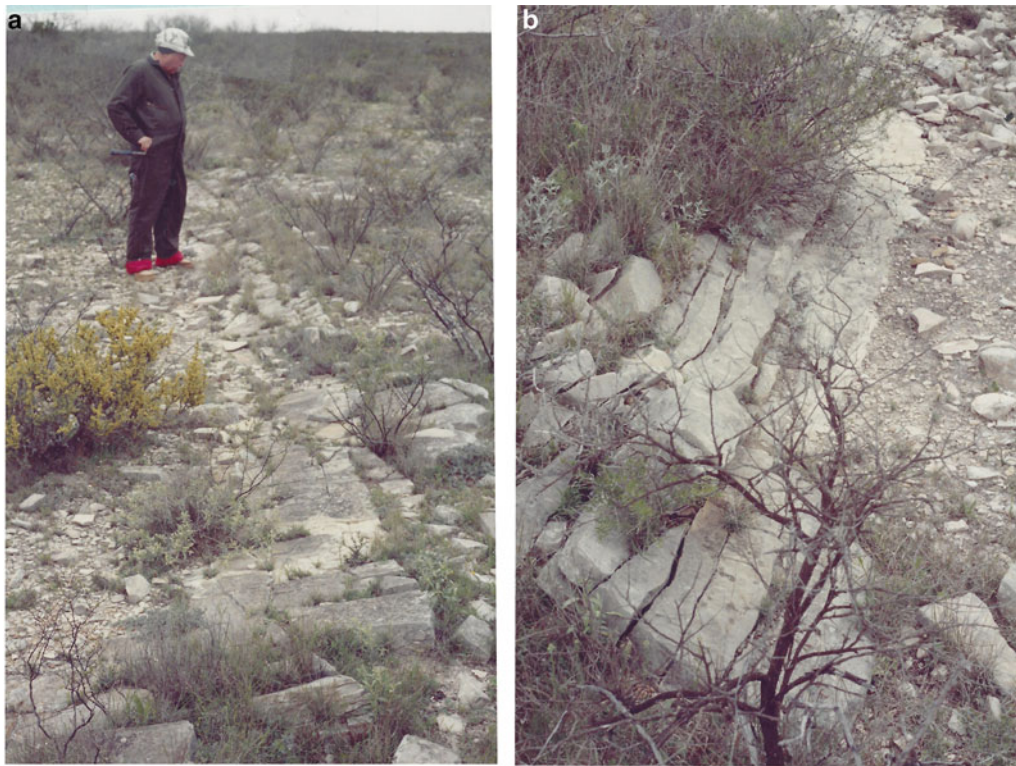
Fig. 16.30 Frank Woodward (a) observes edges of a paleocollapse feature defined by upturned rock (b)

the southeast of the site (Freeman 1968). These features were clearly identified by upturned rock around their boundaries (Fig. 16.30) and were as large as 450 m wide and 5 km long (Fig. 15.9).

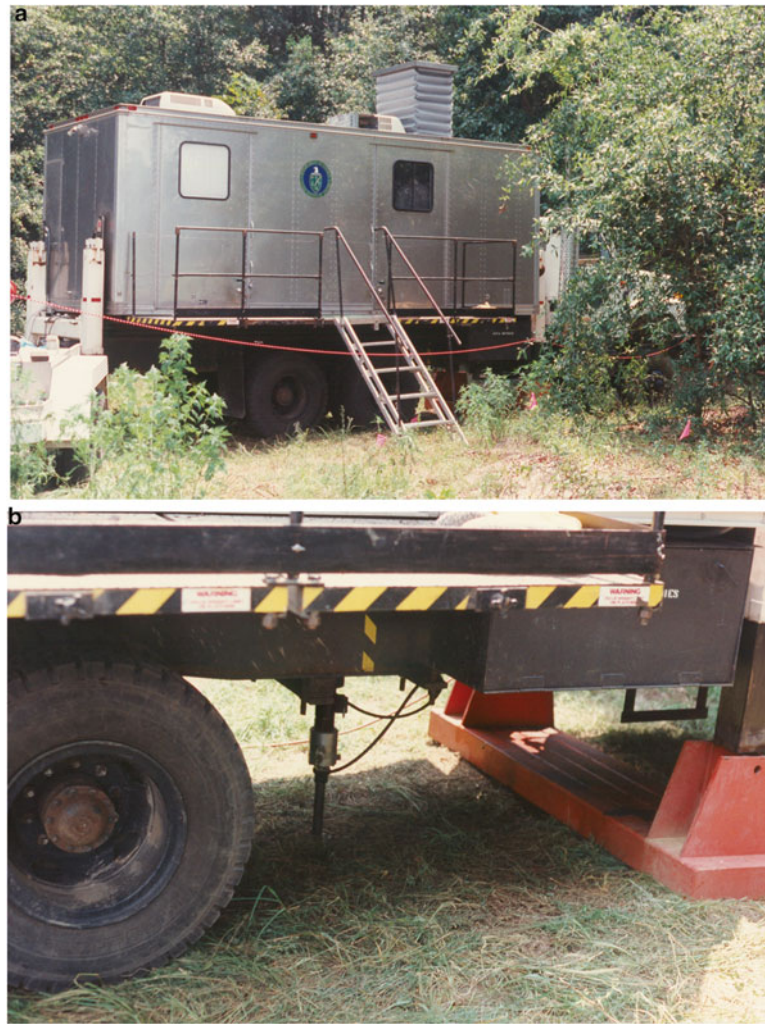
Fig. 17.5 A CPT rig is being used to evaluate soil conditions at a contaminated site in a karst setting (a) and a close-up of the probe beneath the truck (b)

At a site in west central Florida, CPT data was an integrated part of a site characterization. The site had a thick

cover of clean quartz sand that provided an ideal application for ground penetrating radar and CPT methods. The radar data provided a means of rapid cost effective site coverage to identify potential problem areas that showed signs of sink-hole activity or the presence paleokarst. A cone penetrometer was then used to further evaluate the potential problem areas by identifying loose materials, voids and changes in conditions.

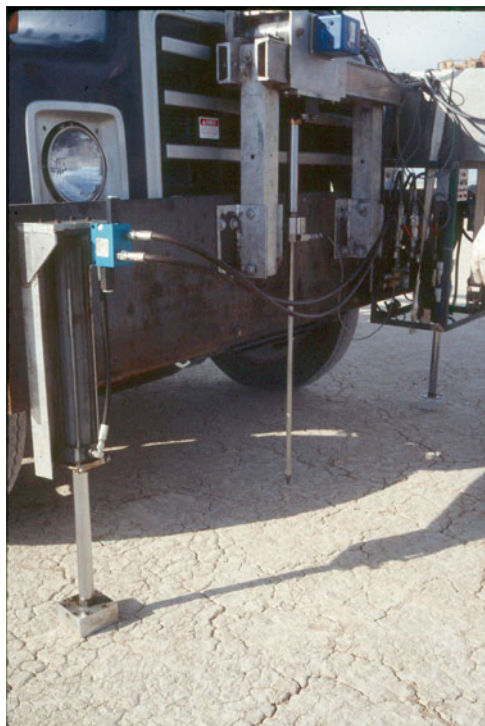
Fig. 17.8 Photo of the specialized shallow CPT system used to evaluate the fissures at Edwards Air Force Base (EAFB)

compacted. Khedr et al. (1985) provides details on this automated cone penetrometer system.

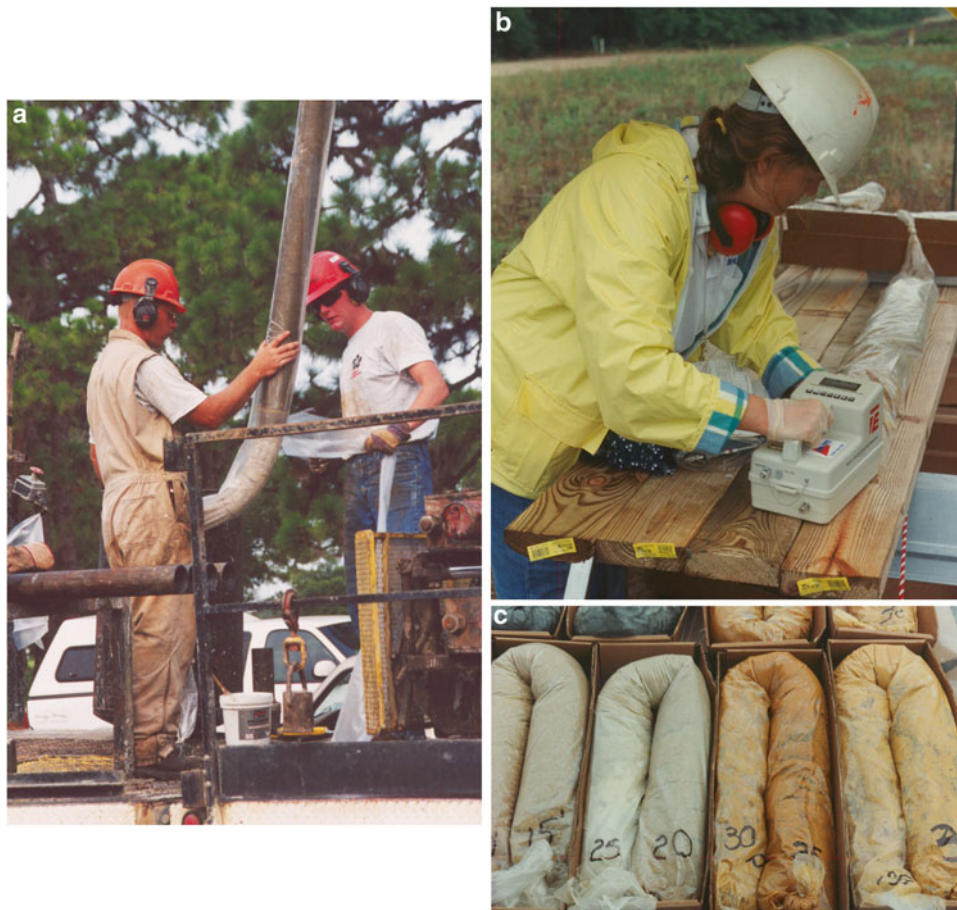
Fig. 17.12 A sediment sample from a roto sonic drill rig is being placed into a plastic sleeve (a), which is then monitored for radioactivity (b). The core is then labeled and stored (c)

Long continuous cores (typically 3 m) with core size of 7.5–25 cm can be obtained. The core sample is removed from the core barrel into a plastic sleeve or stainless steel tray with a minimum of disturbance. Samples may also be collected with clear plastic liners or stainless steel split liners inside of the core barrel. The unconsolidated sample may be somewhat disturbed (by vibration and handling) but are essentially continuous. Figure 17.12 shows a soil core being removed from the drill rig at the Savannah River Site (SRS), screened for radiation using a Geiger counter and then boxed for storage.

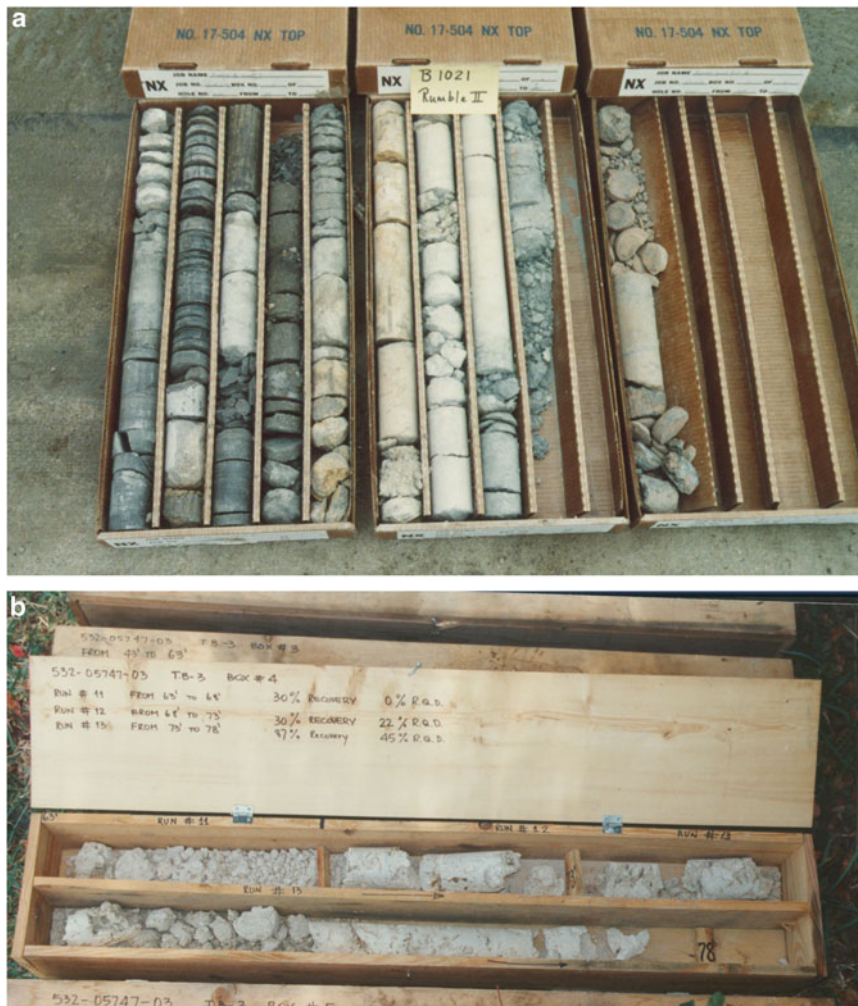
Fig. 17.14 Core samples from a Kansas site (a) indicate almost total core recovery while core samples from south Florida (b) indicate poor recovery and weather core

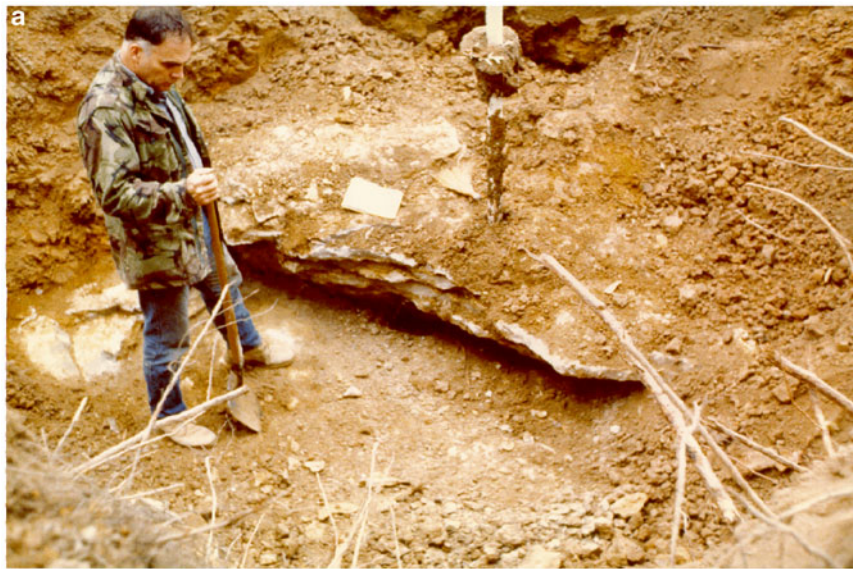
cross section through surface fissure and fractures
due to paleocollapse

Fig. 17.16 A fissure in the loess soil cover was excavated and exposed a major opening into top of rock (a). Two angle borings indicated fractures that would not retain water (b)

Angle borings were successfully used to confirm the presence and evaluate a fracture zone at a site in Kansas City, Kansas. A small soil piping feature was observed within a surface fissure in the loess soils at the site. The loess soils were removed revealing an obvious fracture zone in the rock (Fig. 17.16a). To evaluate the fracture zone, angle borings were made to intersect the fracture. Borehole video located fractures in the shale and large quantities of water (1,000 gal at 10 gpm) were poured into these two angle holes without being rejected (Fig. 17.16b). The exposed fracture was then used as an injection point for a dye trace to evaluate the connection of the fracture zone into the underlying mine. See the complete case history in Chap. 25.

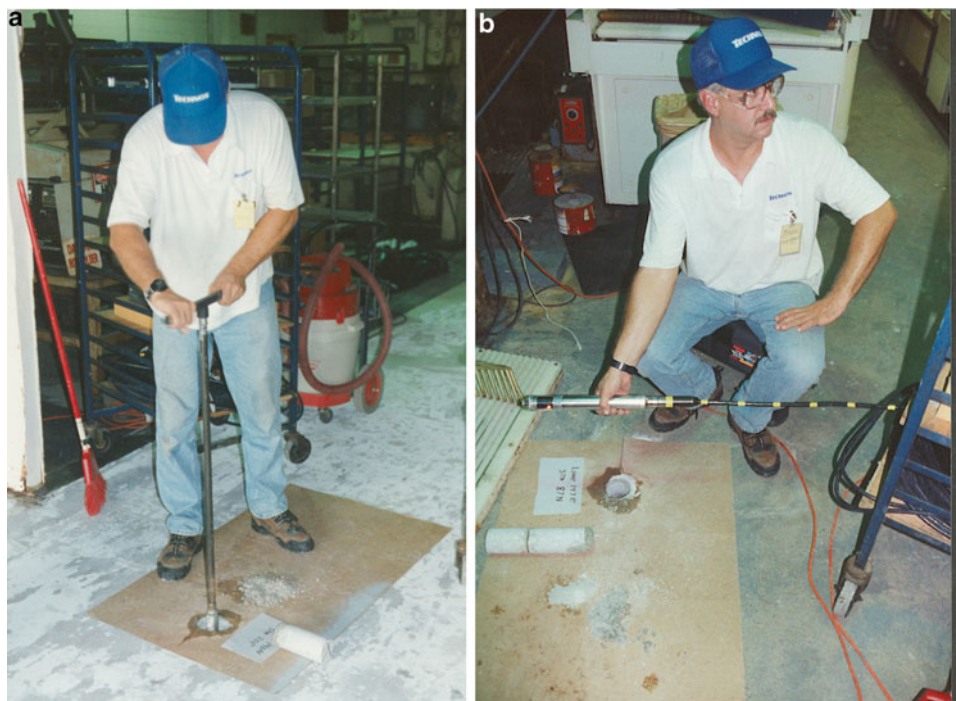
Fig. 17.19 A cored borehole was cut through the concrete floor of an electroplating plant to assess suspected voids under the floor and acquire samples (a). A borehole video camera was used to assess the extent of the void under the floor (b)

and the depth of the void could be directly measured. An auger was used to remove soil samples to test for the presence of acid (Fig. 17.19a). A side looking borehole video camera (Fig. 17.19b) was used to evaluate the lateral extent

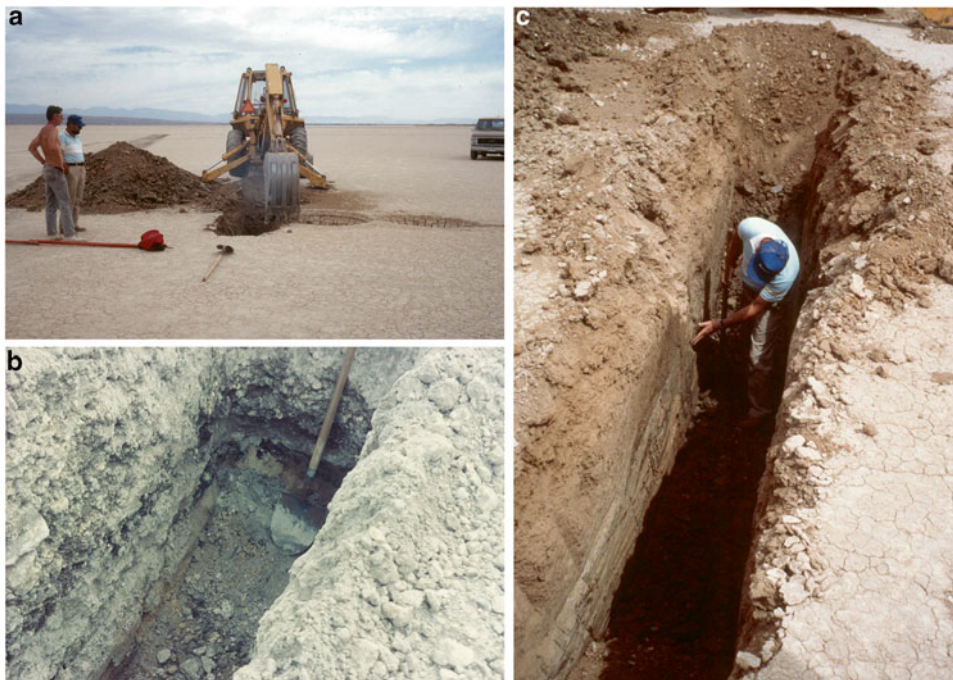
Fig. 17.21 Shallow trenches whether by backhoe (a and c) or dug by hand (b) can provide critical observations in the assessment of subsurface conditions

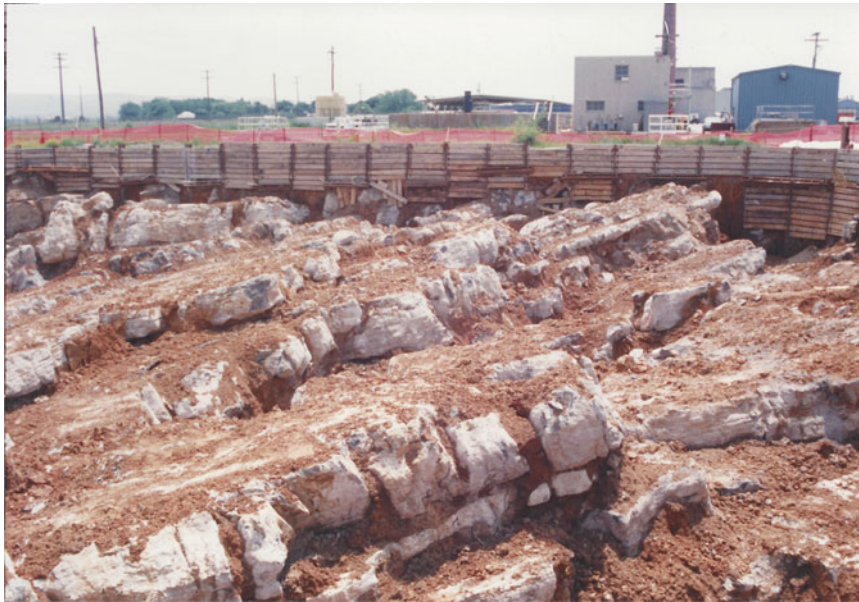
Fig. 17.23 An excavation clearly shows the complex nature of the top of limestone

At another site in Pennsylvania, excavations were utilized to assess the investigation of geologic pathways that might be controlling movements of organic contaminants from a military base. Excavation revealed the complex top of rock conditions (Fig. 17.23). The layers of limestone can be seen dipping which played an important part in controlling the movement of contaminants at this site.

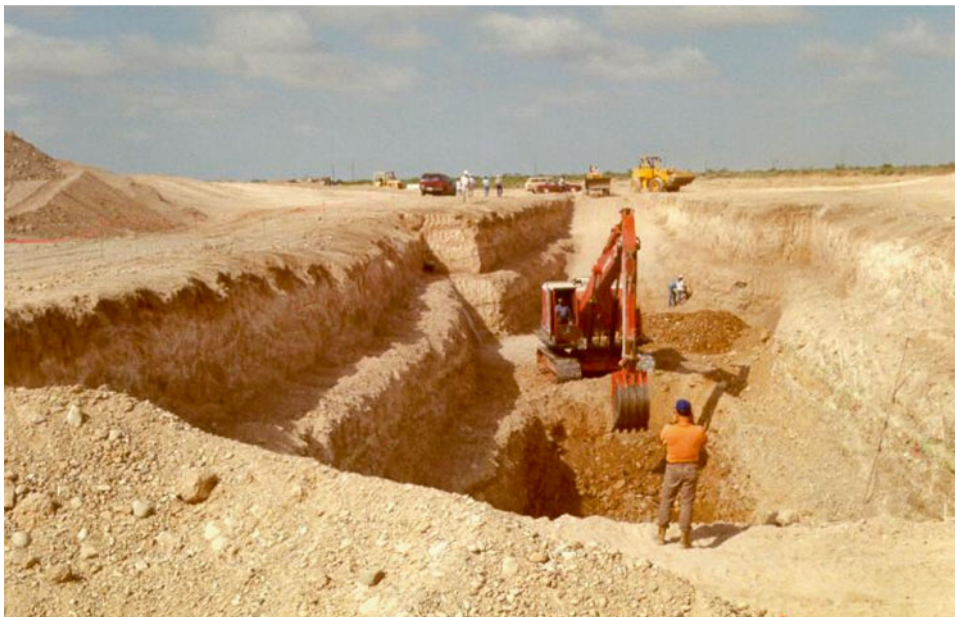
Fig. 17.24 A large trench is being excavated to expose the top of rock and assess possible buried channel or paleokarst conditions

An example of a very large trench is shown in Fig. 17.24. This is from a site being characterized for a proposed

hazardous waste facility in southwest Texas. The site had a thick alluvium over limestone. Some anomalous areas (possible buried channels or paleosinkholes) had been identified by surface geophysical measurements. This site was a large open area, and heavy excavating equipment was readily available on-site so trenching was an easy and effective option to provide more detailed data. This large trench was

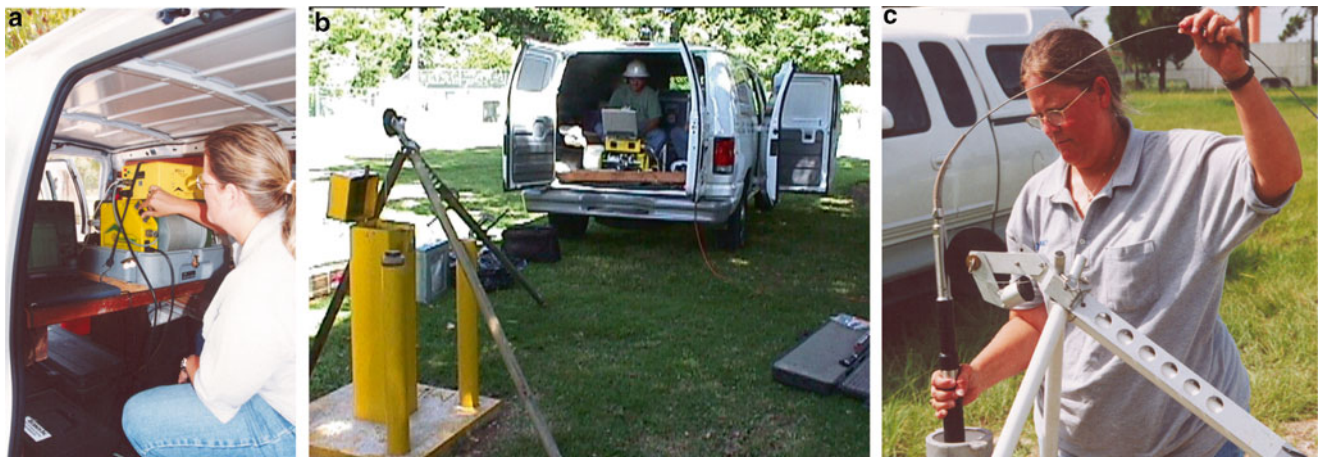
Fig. 18.2 Photos of typical logging system in operation. (a) Control unit, laptop and winch. (b) Tripod over well. (c) Probe being lowered into well

Figure 18.2 is a typical small logging system, from Mount Sopris, used for characterizing conditions within open boreholes and cased monitoring wells. The systems consist of a laptop computer, system control unit, winch (Fig. 18.2a), tripod over the borehole or well (Fig. 18.2b) and a variety of logging probes that are lowered into a borehole to acquire data (Fig. 18.2c). This system has been installed in a vehicle, however, some systems are small enough to be carried to remote locations. Most logs can be run in holes as small as 5 cm diameter and therefore can be run in most cased monitor wells. Logging is carried out by lowering or raising a logging

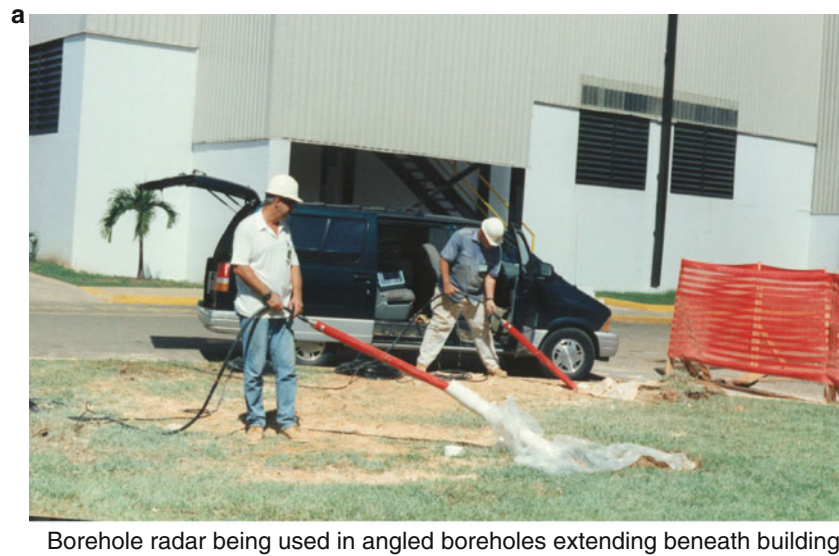
Example of 60 MHz borehole radar data showing planar fractures (Singha et al. 2000)

Fig. 18.19 Borehole radar data being acquired between two boreholes (**a**) and an example of radar data showing fractures (**b**) (Singha et al. 2000)

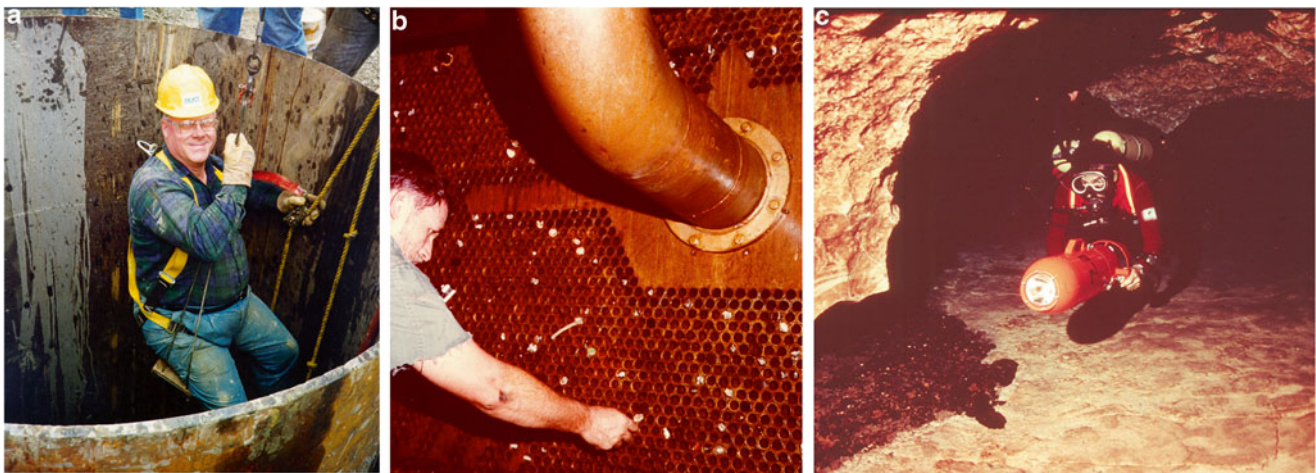
**Fig. 19.1** First-hand visual observations under unusual conditions. (a) Large borehole. (b) Intake pipe. (c) Underwater cave (Photo a courtesy of Dick Woods)

Visual inspections and observational skills have been stressed throughout the site characterization process. Here we are addressing more unique physical areas or conditions that require “thinking outside the box”. Figure 19.1 shows some of the unique conditions in which direct observations can be made in a borehole, water intake pipe to a nuclear power plant or underwater cave.

A new manufacturing facility was being constructed which was to contain vibration sensitive equipment. The design required 2.5 m diameter piers to be founded on unweathered shale to provide adequate stiffness. Surface wave seismic measurements indicated about 6–8 m of clay with nearly constant shear wave velocity over a thin stratum of weathered shale over intact shale. The precise depth and thickness of the weathered zone was not uniform over the site, so at each caisson, the quality of the rock needed to be determined. If the shale was not un-weathered or stiff enough, the caisson would be excavated deeper and the rock retested. Visual inspection and testing of the rock quality using a hand-held Housel Penetrometer was seen as the best option. Dr. Richard Woods was the vibration consultant to the owner and performed both the surface wave measurements and caisson rock testing. He is seen in the photo descending into a caisson for inspection of rock quality at the bottom of the borehole (Fig. 19.1a).

Sometimes site characterization is not a geotechnical issue. The 2.5 m diameter ocean water intake line at the St Lucie Florida nuclear power plant was being restricted by rapid barnacle growth. The ocean intake line was inspected using divers and photographs to monitor the rate of growth on different antifouling materials. The intake canal was inspected using an echo sounder and bottom sediment sampling, and the power plant intake was visually inspected and photographed including the grizzly intakes and piping up to the condenser (Fig. 19.1b) to evaluate both biofouling and corrosion.

While the authors were never directly involved with cave diving, many of their friends were, including Tom Mount, Steve Cawthon, Rick Freeze and Bob Friedmann. These early cave diving pioneers from the Miami area provided the authors with maps of many of the caves they explored in the late 1960s. Here Cawthon is making a reconnaissance inspection using an underwater scooter (Fig. 19.1c).

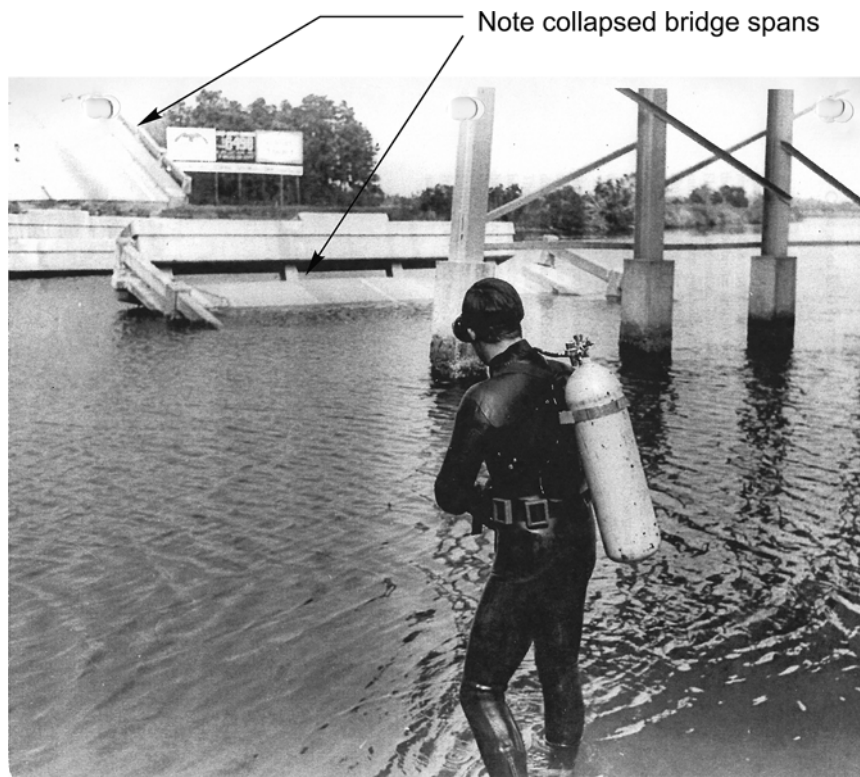
Fig. 19.2 A geologist prepares to make a dive to inspect conditions of a bridge collapse (Photo courtesy of Paul Beam)

Paul Beam, a young geologist, from the FDOT Research and Testing Laboratory supervised the investigation of the collapse. Three drill rigs (one on a barge) were used to sample subsurface conditions. After 4 weeks of subsurface core sampling by the three drill rigs, Beam reported that there was no evidence of sinkhole activity. Being professionally curious, Beam used SCUBA gear and an underwater camera to further examine the area (Fig. 19.2). The bridge pilings were steel H-beams with a concrete jacket around them to protect them from sea water corrosion. However, tidal action and river flow had scoured the river bottom beneath the concrete jacket allowing corrosion to occur on the now exposed H-beam piles. Mr. Beam discovered softball-sized holes in some of the pilings of the still standing sections of the bridge. Based upon drilling data indicating no sinkholes and his personal observations he concluded that the bridge collapse was not caused by sinkhole activity but by corrosion of the steel piles (Beam, 1984, personal communication).

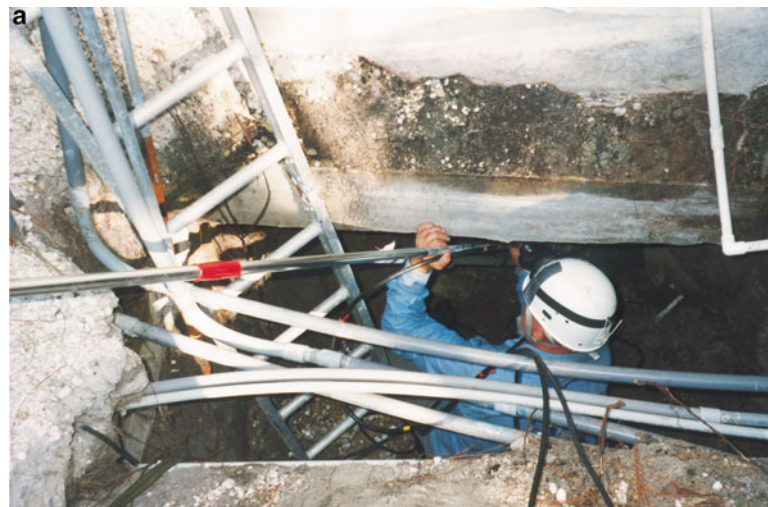
a
Downhole video camera mounted on pole being extended into collapse beneath home

Fig. 19.6 The video camera was attached to the end of a long pole in order to provide visual inspection of inaccessible areas (a). A light lowered into one of the boreholes provided a partial illumination of the larger portion of the cave (b)

and a few radar survey lines indicated a void from 3 to 4 m below grade in the area of the collapse. A borehole video camera was lowered down two of the boreholes, which had encountered a void and revealed the possibility of a small cave system extending away from the house. A local resident reported that that he and his friends used to play in this cave when they were kids many years ago. The entrance was in the neighbor's yard but had been filled with debris. The cave had gone unnoticed by the builder and the problem did not appear until a downspout at one corner of the house had focused enough run-off to erode sufficient material into the cave so that a local collapse occurred (Fig. 19.6a).

A light was lowered into one of the boreholes and it exposed the larger portion of the cave (Fig. 19.6b) in which kids had played. Then a video camera was then attached to the end of a long pole and from within the collapse area adjacent to the house (Fig. 19.6a) it was used to probe into areas that were physically inaccessible. The void extended under a portion of the house 0.3–1 m in height (estimated at about 45 m³) and under the swimming pool, but also expanded into a larger cave system away from the house where kids had played. This larger area was estimated to be about 3 m wide and 1–2 m in height and its volume was estimated to be (approximately 141 m³). A grouting program was then

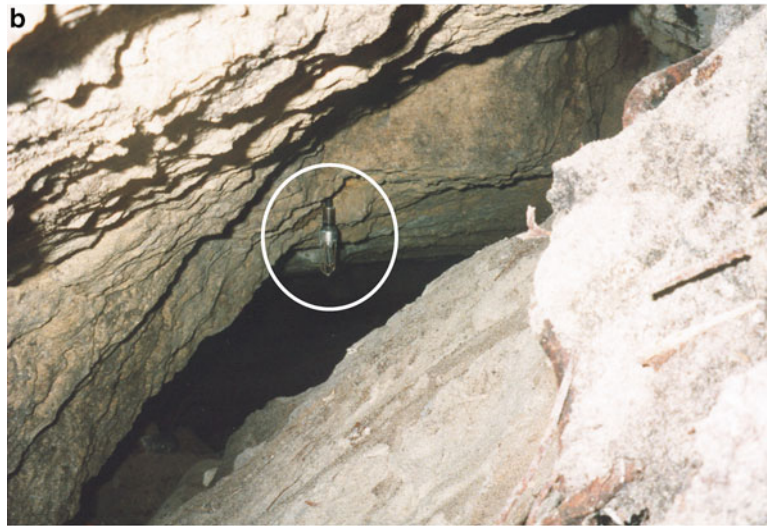
b
View from access point in (a) with additional lighting from adjacent borehole (circled) one could detect a larger cave in the distance

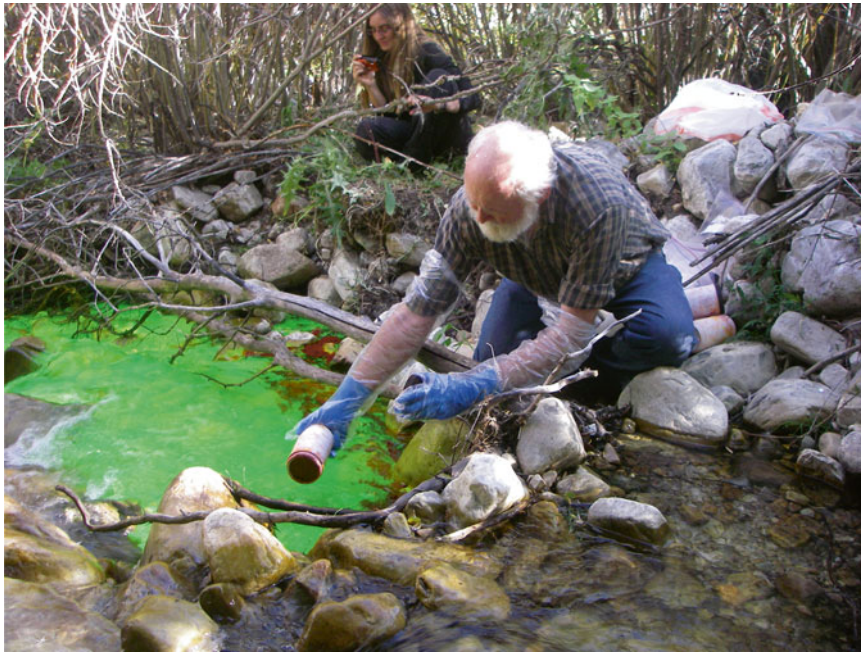
Fig. 22.1 Fluorescein dye being introduced by Tom Aley into a sinking stream in Nevada (Photo courtesy of T. Aley and G. Baker)

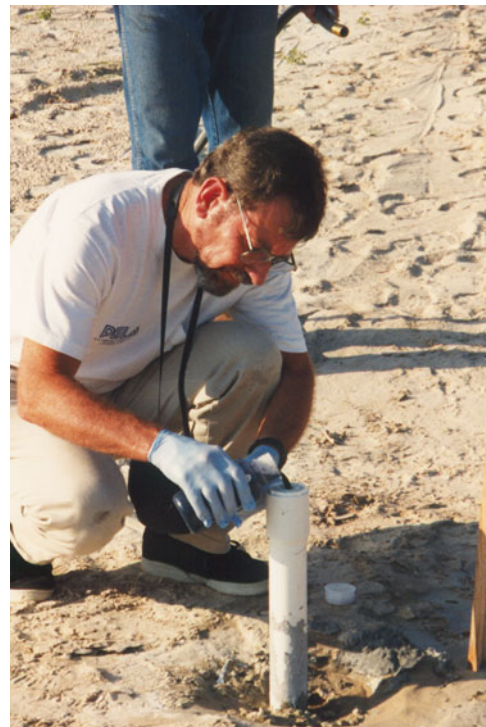
Fig. 22.2 Barry Beck introducing dye into a monitor well at a site in West Central Florida to determine its possible connection to a recent large sinkhole

Dye tracing is a point-to-point method that is dependent upon the location of the dye introduction and sampling points. This would typically require an inventory of karst features as well as other natural and man-made windows into the groundwater system. There are many different ways in which dyes can be introduced into the groundwater system. Sites for the introduction of dyes include; sinkholes, surface streams that sink into the subsurface (Fig. 22.1), and directly into cave streams. In some cases wells (Fig. 22.2), borings, trenches, or ditches along a road may be used.
