Site Characterization in Karst and Pseudokarst Terraines

Practical Strategies and Technology
for Practicing Engineers,
Hydrologists and Geologists

Richard C. Benson • Lynn B. Yuhr

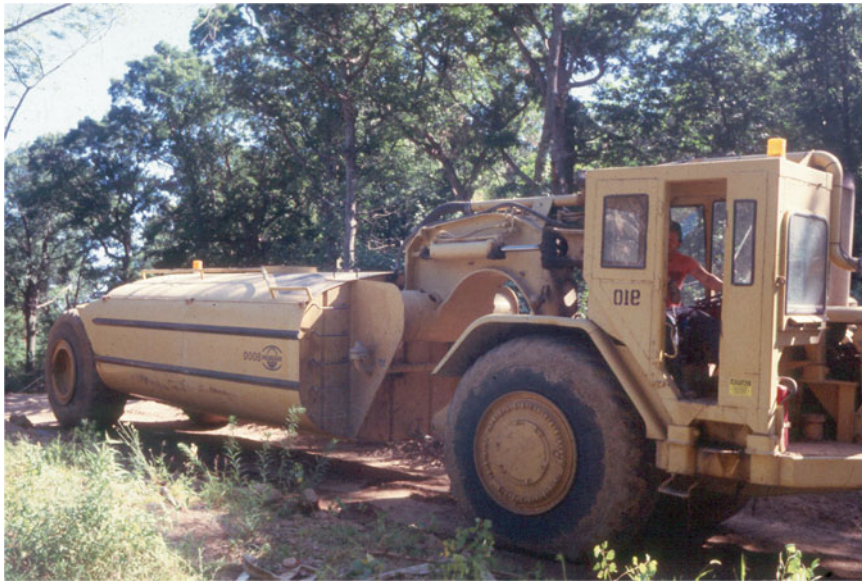
Fig. 22.3 A large water truck used to pre-flush and post-flush the dye introduction site in an unsaturated system

saturate the system. After the introduction of the dye, the system should be flushed again with large quantities of water to assist in flushing the dye through the fracture or karst system. This usually requires a large quantity of water. Figure 22.3 shows a water truck used for flushing dry systems.

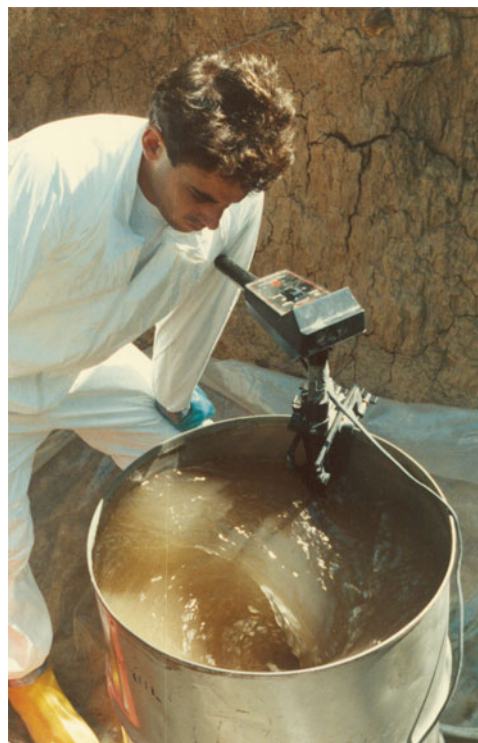
Fig. 22.4 Mixing of fluorescein dye prior to its introduction into a major fracture

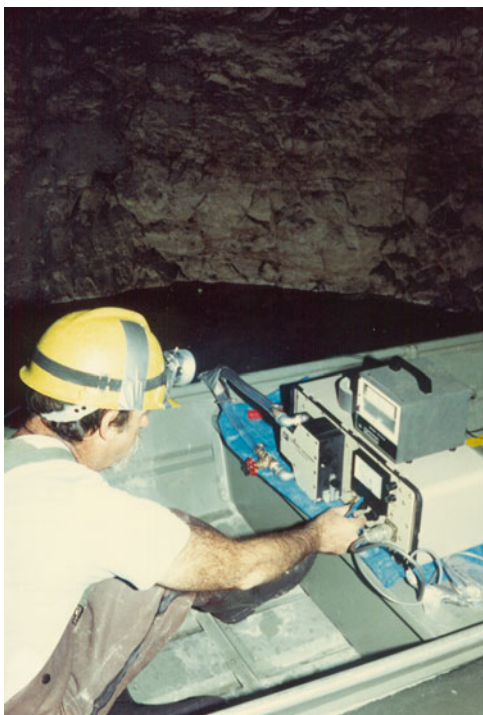
Fig. 22.5 A Turner fluorometer with water being continuously pumped through it to sample for the presence of any dye as the boat moves through the water within the Tobin mine. The results were recorded on a strip chart recorder

At this point in the site characterization, the mine had flooded to the point that movement within the mine was accomplished by small boat. Prior to injection of dye and during the first 10 days after injection of dye, sampling was carried out in the mine using a Turner portable fluorometer with continuous recording (Fig. 22.5). Water was pumped continuously through the fluorometer as the boat traversed through a common course within the mine passing by each charcoal bug sample station. No dye was detected by the Turner fluorometer during the first 10 days of sampling. The charcoal bugs in the mine were scheduled to be replaced and analyzed at approximately 1, 2, 5, 10, 20, 50, 100, and 500 days.

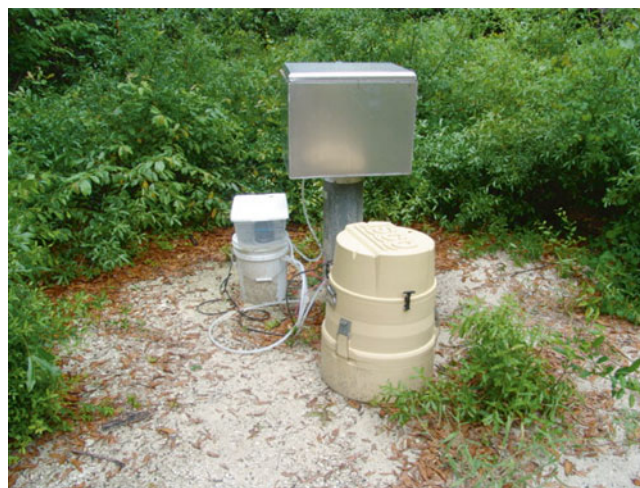
Fig. 22.7 An automated water sampler can be used to obtain discrete samples at programmable intervals

- In some cases the presence of dye can be determined visually and no sample is taken.
- Discrete water samples may be obtained at selected time intervals.
- Sampling and analysis can be done using a field fluorometer. This provides a means of obtaining a continuous sample and analysis in real time (Fig. 22.5).
- The use of charcoal packets, called 'bugs', are commonly employed to acquire an integrated water sample over a period of time (Fig. 22.6a). The bugs are removed and replaced at selected sample intervals.
- Automated water sampling can be used at selected intervals using an automated pump and sampler system (Fig. 22.7).

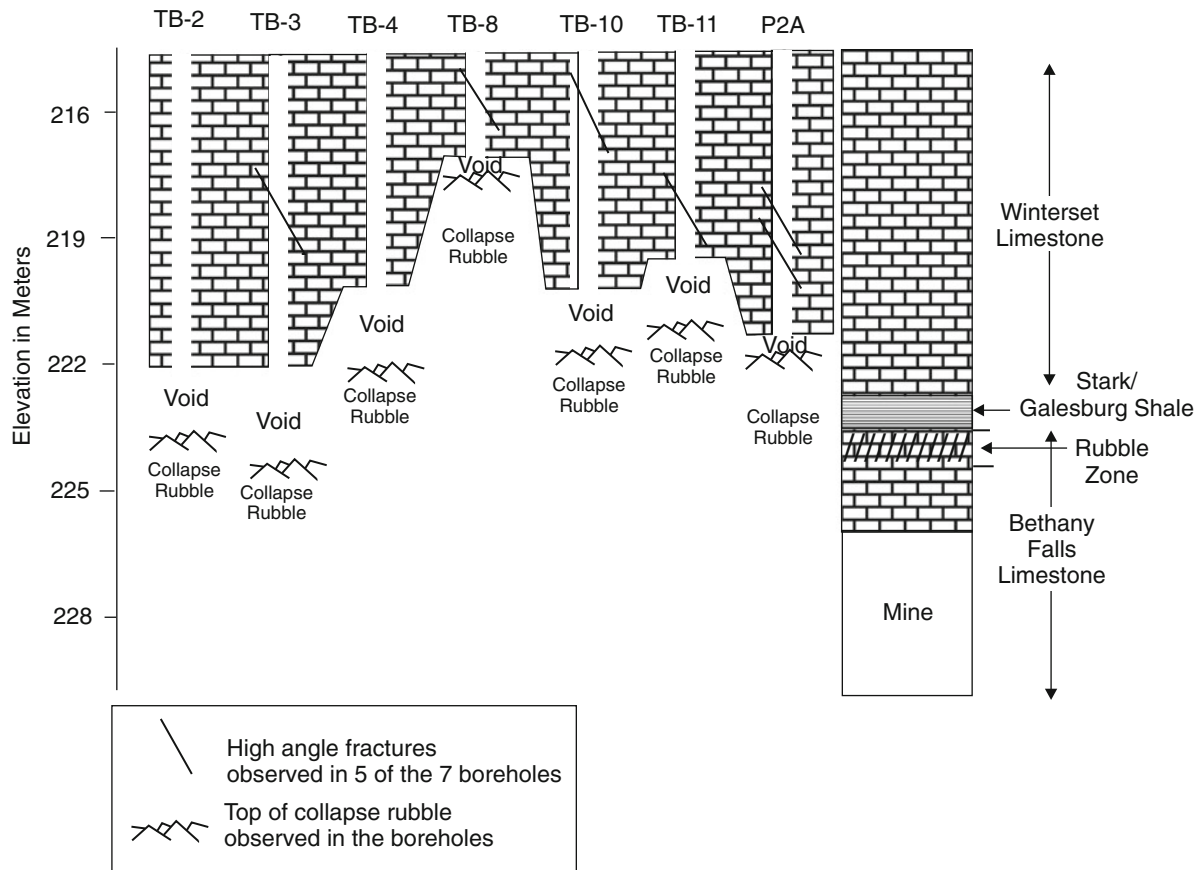
Fig. 25.22 Seven borings were used to evaluate the upward extent of collapse and bulking factor within the CCA. The results indicated an average bulking of 36 %

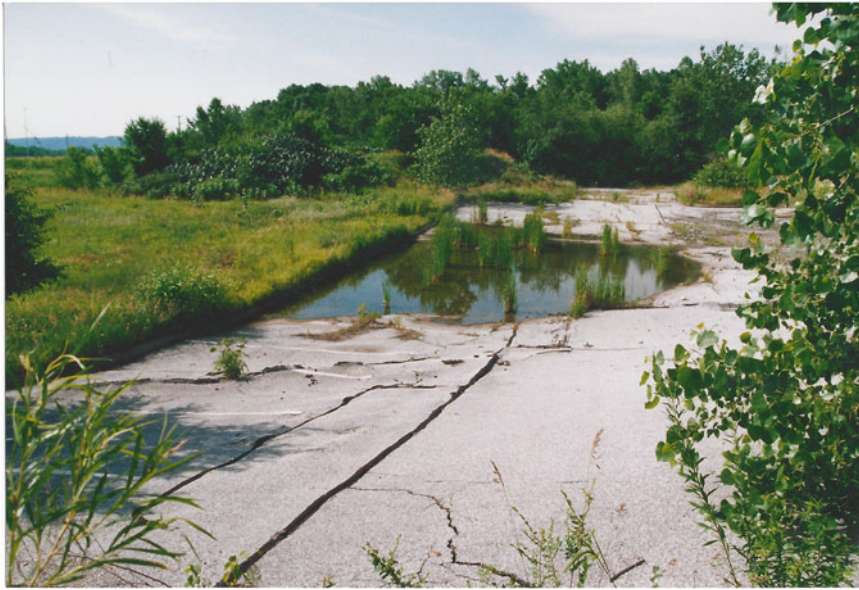
Fig. 25.23 Evidence of surface subsidence up to 2 m is seen in the paved parking lots of the two medical office buildings that were built over the easternmost extent of the Tobin Mine

a water problem. There had been a few small, localized roof collapse of Type A, similar to those in the western portion of the mine, but there was no large area of collapse such as the CCA. There was no reason to suspect surface subsidence would occur. However, subsidence did occur over much of the 1.6 ha, most obvious in the paved parking lots resulting in a undulating surface with as much 2 m of subsidence (Fig. 25.23). The medical offices were abandoned and removed.

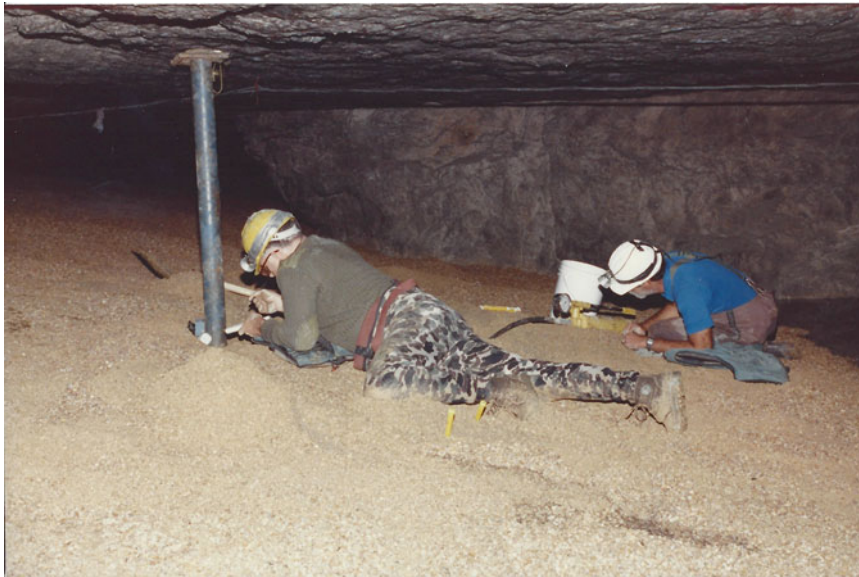
Fig. 25.24 In-situ compression tests were made on the crushed rock fill material

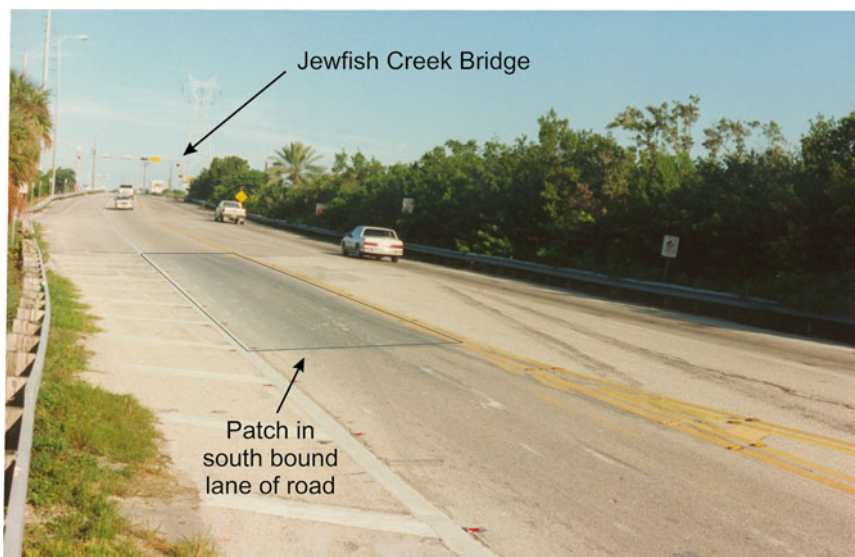
Fig. 26.2 A patch about 15 m long was noted in the southbound lane of US-1. The Jewfish Creek lift bridge is seen in the top of the photograph. The view is towards the northwest

When a karst feature does occur, it often can have significant impact upon structures. The area of concern extends from stations 1214+00–1226+00, which includes the location of the piers for the highest portion of the bridge over Jewfish Creek. Prior to this site characterization effort the only evidence of subsidence at the site was the small area of localized settlement seen on the southbound lane of US1 that required periodic maintenance (Fig. 26.2).

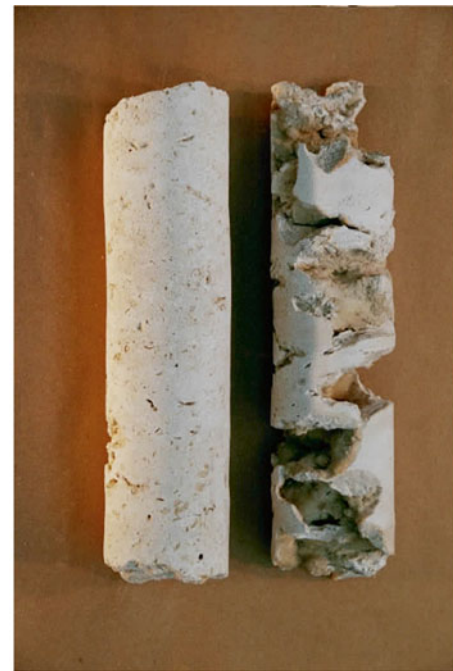
a Core from boring over Lake Surprise **b** Core from boring within the anomalous area

Fig. 26.13 A sample of limestone core outside of the anomalous area within Lake Surprise (a) and within the anomalous area (b)

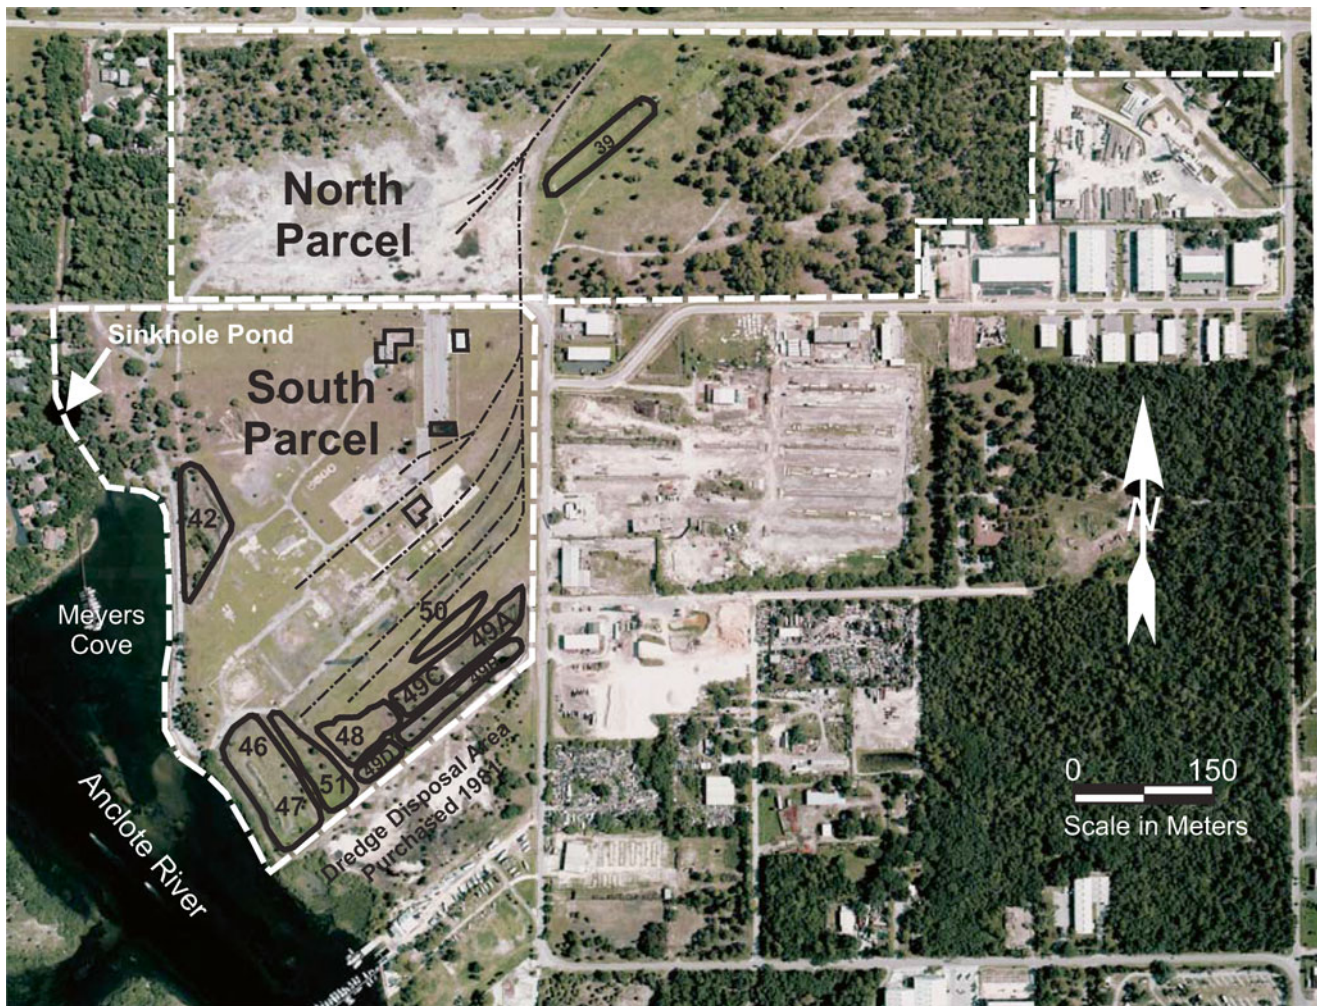
Fig. 27.2 Aerial photo of the site showing the North and South Parcels

The site is divided into two areas, a North and South Parcel (Fig. 27.2). The production facility, a series of settling and disposal ponds were located on the South Parcel. The North Parcel was used for slag processing, storage and a waste pond. Two byproducts came from the furnace: slag and ferrophosphorus. The calcium silicate slag was drained periodically from the furnace into the adjacent slag pit. The slag was then cooled and solidified prior to being trucked to the slag processing area in the North Parcel for crushing to produce aggregate that was sold and used off-site. The ferrophosphorus was also removed from the furnace as a liquid, allowed to cooled and solidified for sale to the steel industry. Some of the waste phosphorus was placed in drums and covered with water then disposed of in on-site ponds on the South Parcel.

After the plant was shut down in 1981, the plant production facilities and most of the buildings were decontaminated, demolished and removed from the site. The facility permanently closed in 1983. The only buildings remaining on-site at the time of this investigation were the main office building, an equipment building, a guard building, and a lunchroom building located on the northeast corner of the South Parcel (Fig. 27.2).
