Chemical Process Safety

Learning from
Case Histories

Third Edition

ROY E. SANDERS

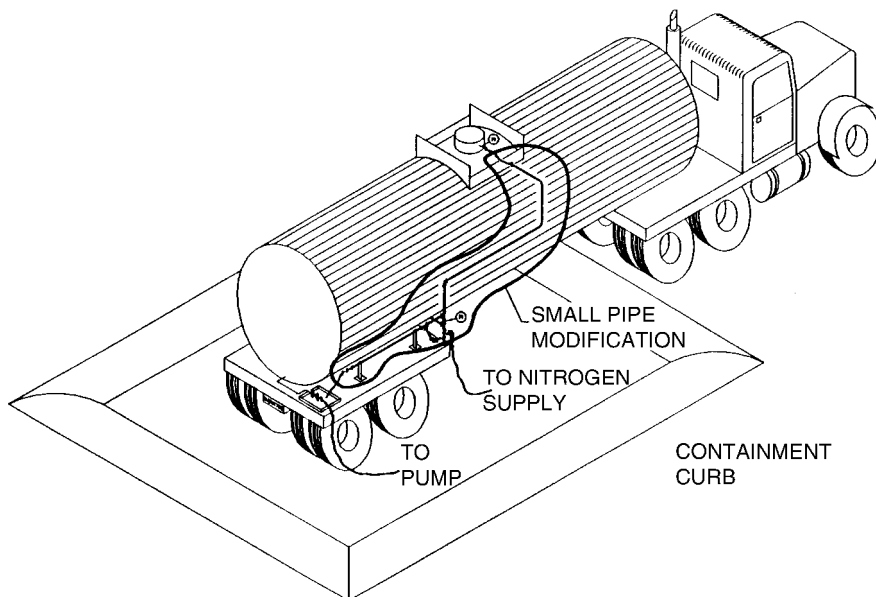
FIGURE 2–3 Tractor and tank truck ready to unload. Courtesy of Manuel David.

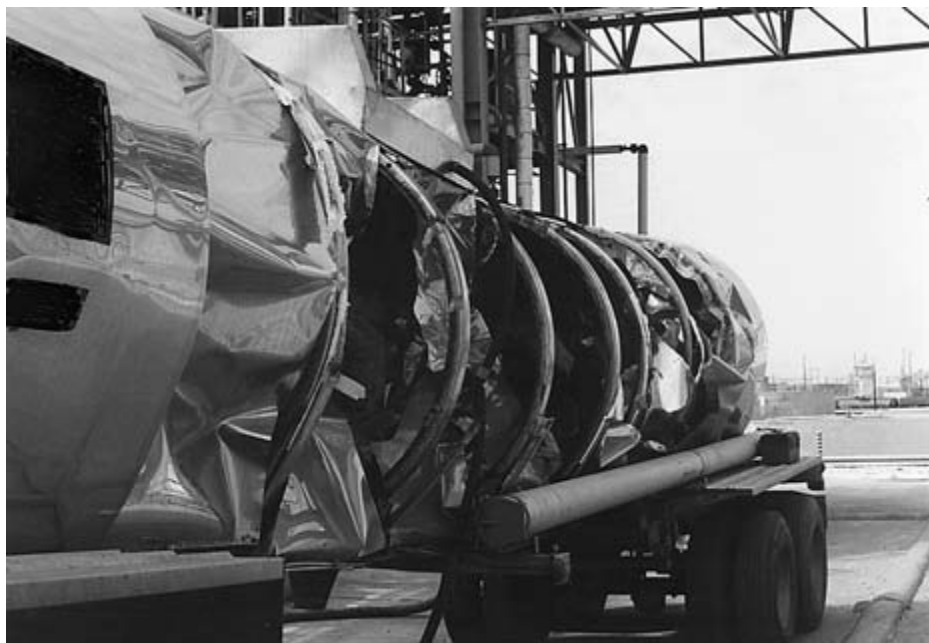
FIGURE 2-5 Close-up of tank failure and exposed ribs.

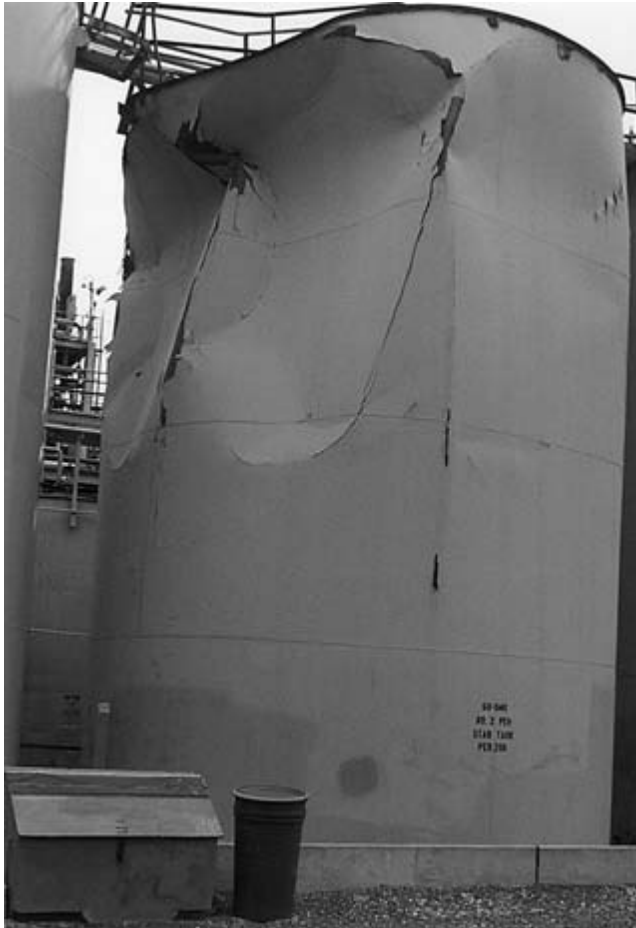
FIGURE 2-13 A 12-ft.-diameter tank ruined after vent system is improved.

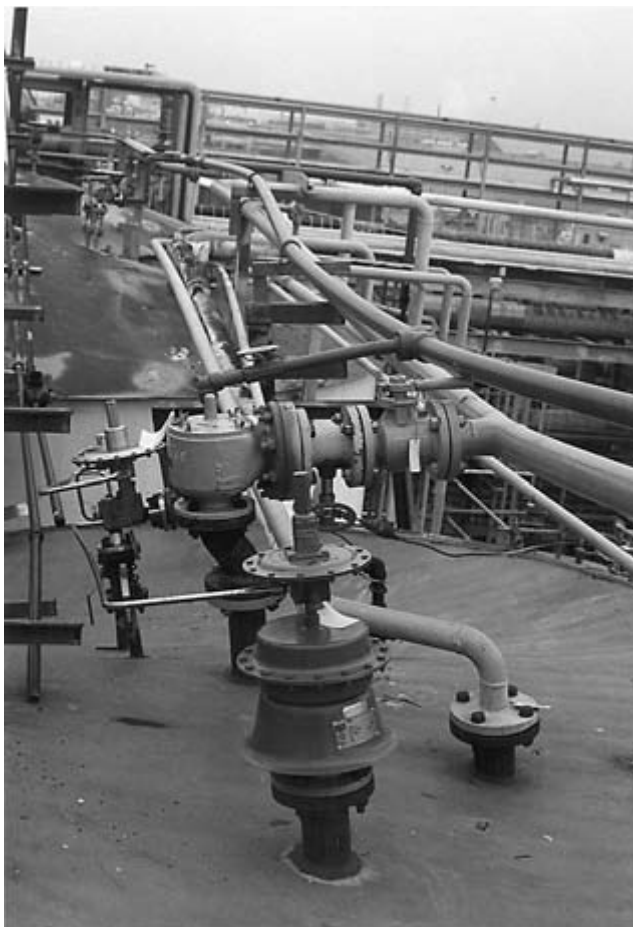
FIGURE 2-15 New but visually confusing piping system—after the incident.

With all due respect to the findings of the investigating team, the root cause appears to me to be a human factors situation. The new piping system looked simple but in fact this

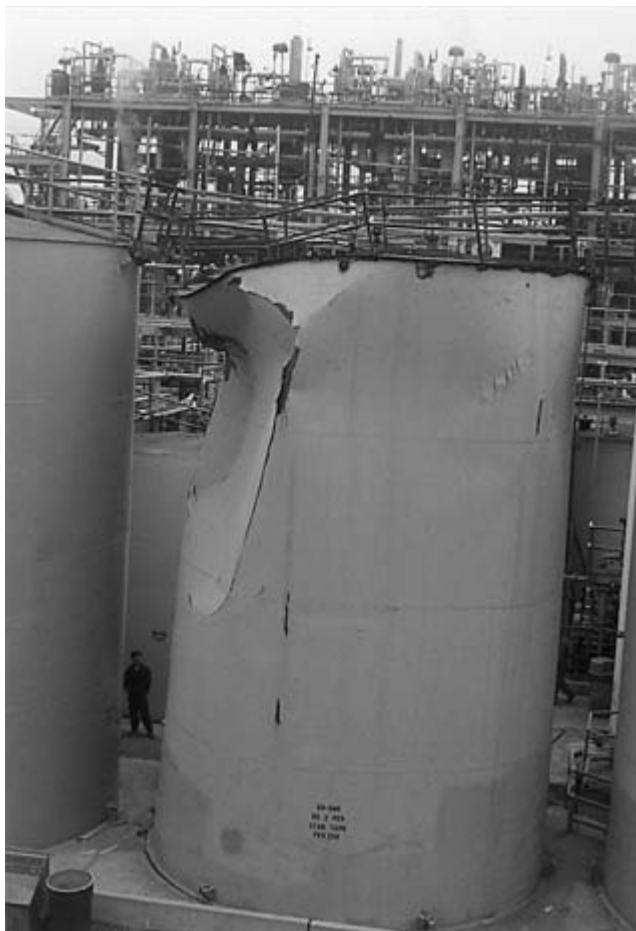
FIGURE 2-16 Crushed tank in the tank farm.

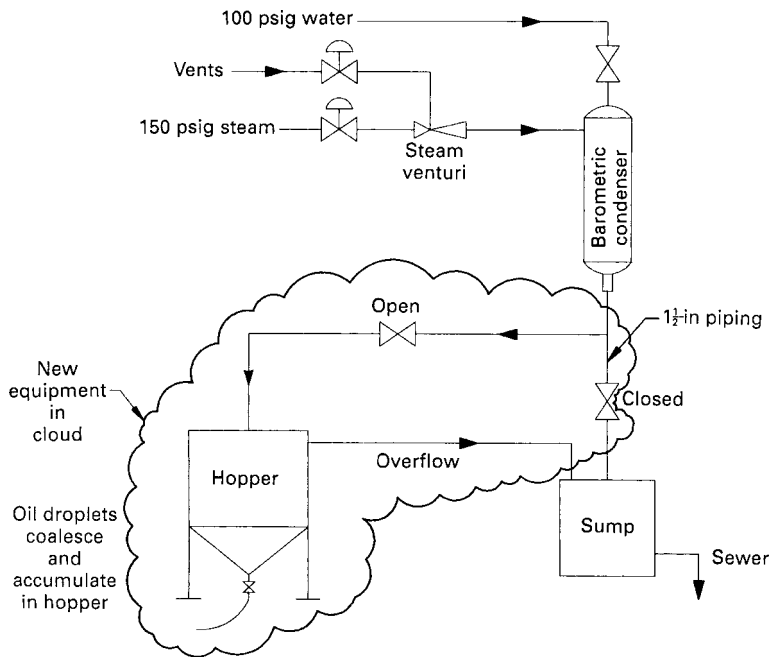
FIGURE 2–17 Modifications on water piping to reduce pollution potentials.
Courtesy of Jack M. Jarnagin.

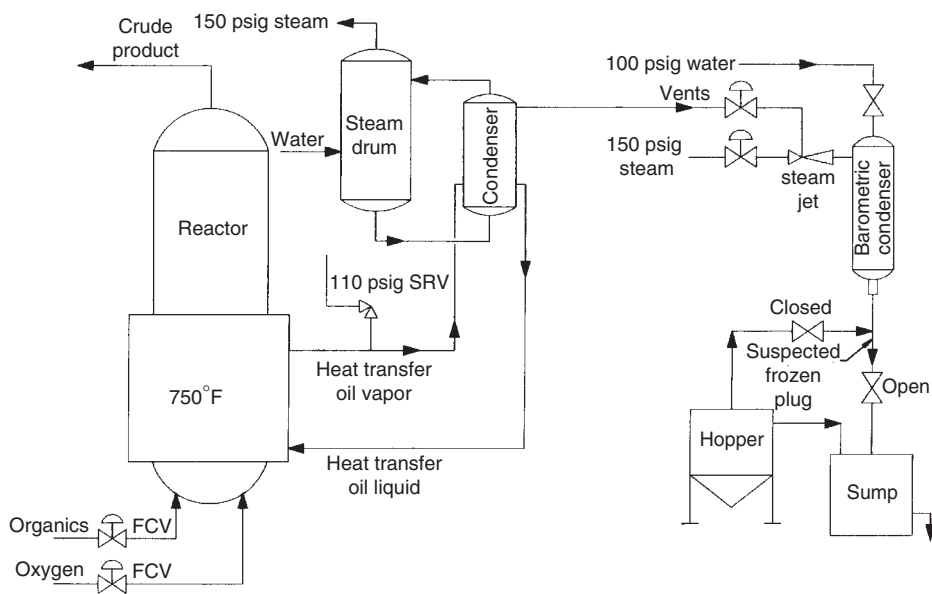
FIGURE 2–18 Solvents reactor system just before the explosion.
Courtesy of Jack M. Jarnagin.

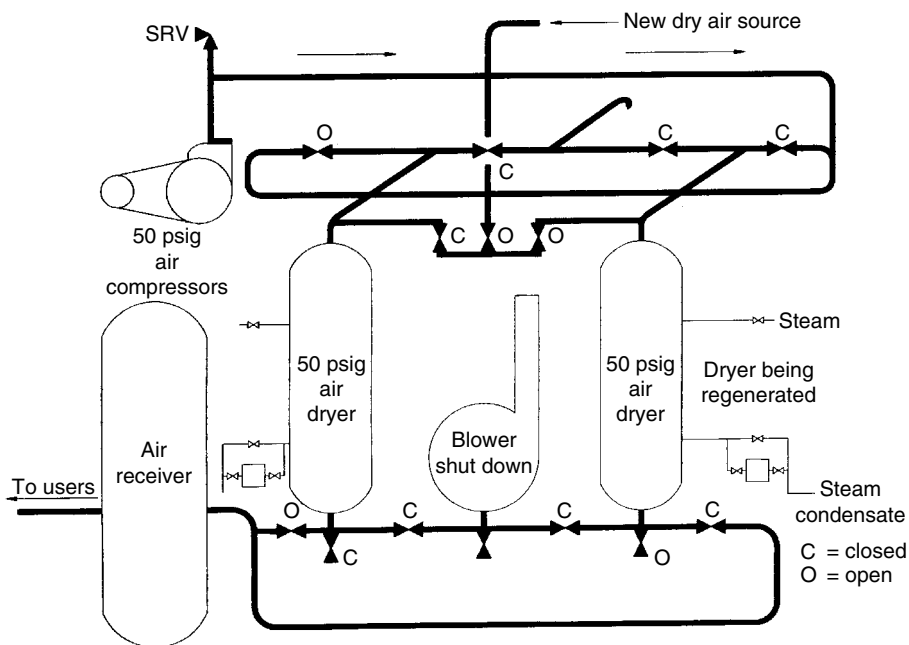
FIGURE 2-20 Modified dryer regeneration sequence at time of explosion.
Courtesy of J. M. Jarnagin.

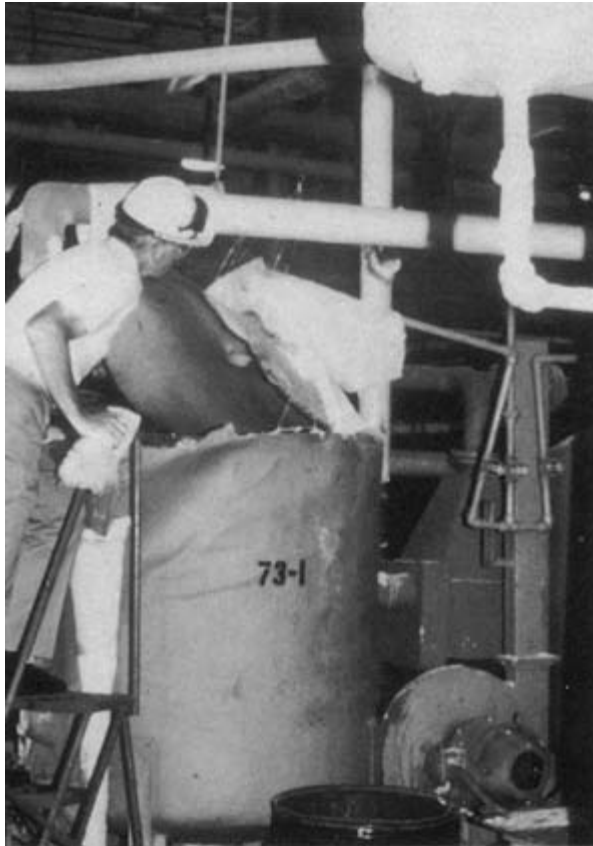
FIGURE 2-21 Employee examines the air dryer failure.

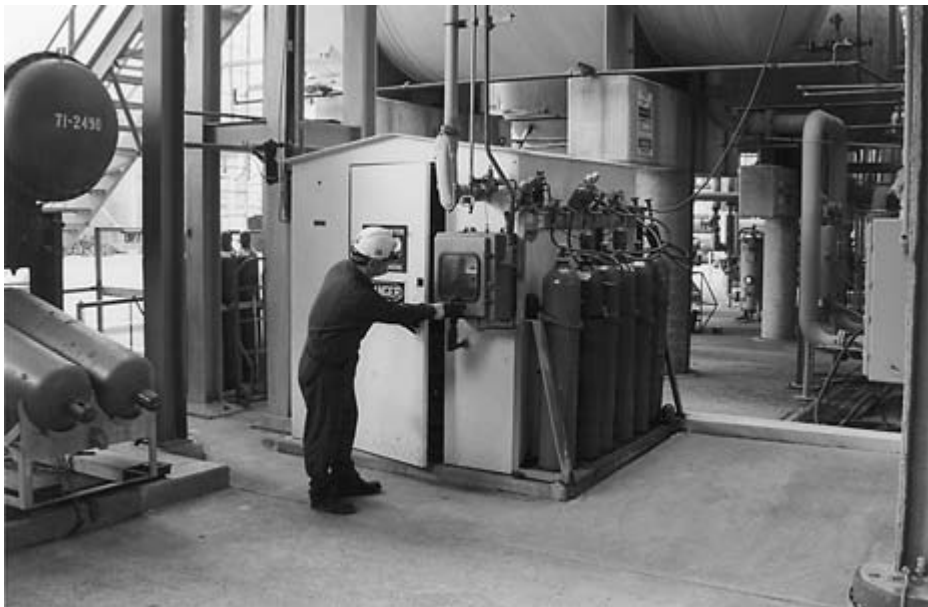
FIGURE 2–23 Typical pressurized and purged analyzer buildings found in chemical plants handling flammables.

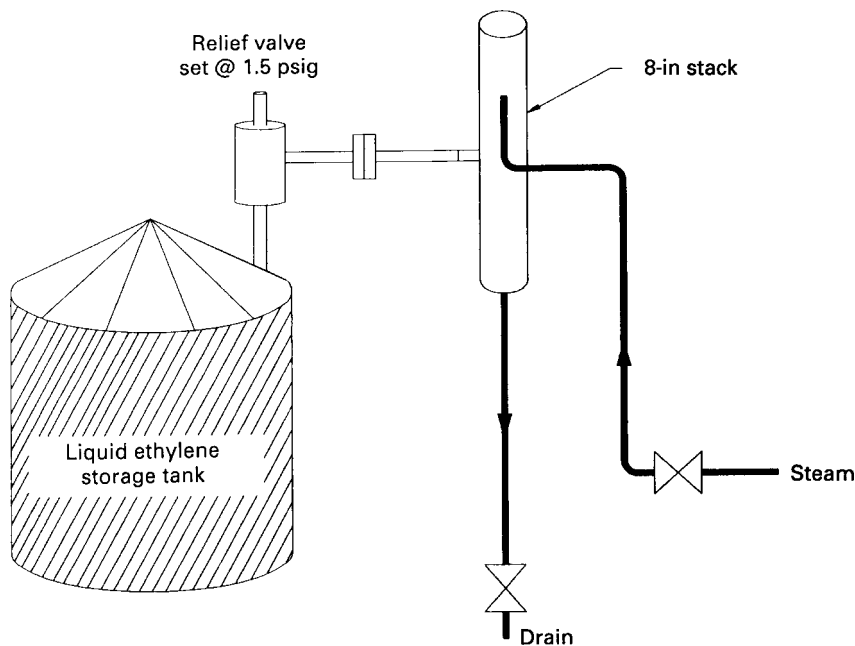
FIGURE 2–25 Well-intended vent modifications. Courtesy of T. A. Kletz.

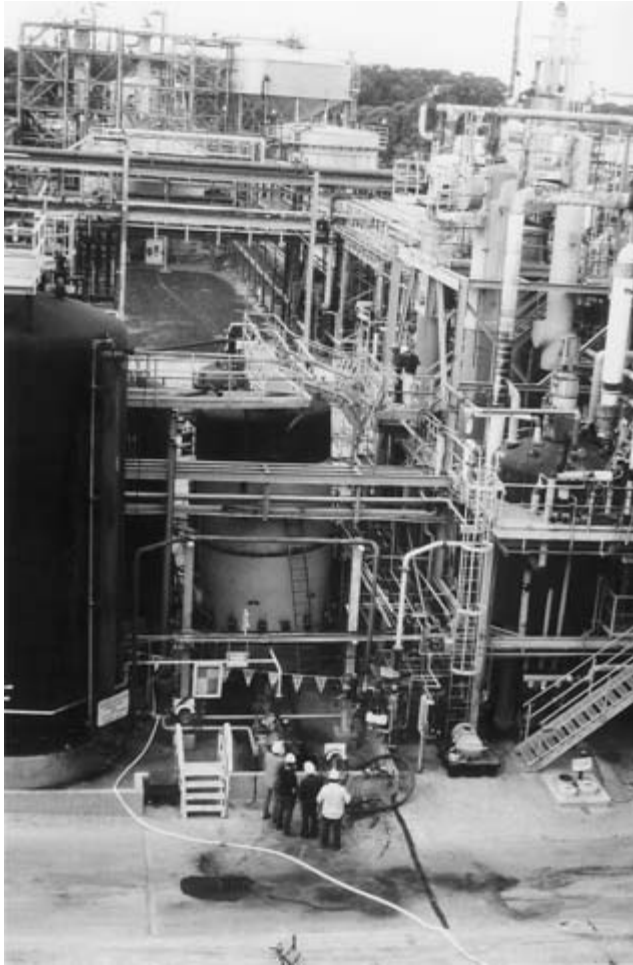
FIGURE 3-1 An API 620 tank is damaged during a hydrotest.

While preparing for the test, two mechanics blinded a six-inch (15 cm) pressure relief flanged top-mounted nozzle. The craftsman also capped two smaller nozzles on the tank roof with flanges. These smaller nozzles normally were equipped with a pressure gauge and

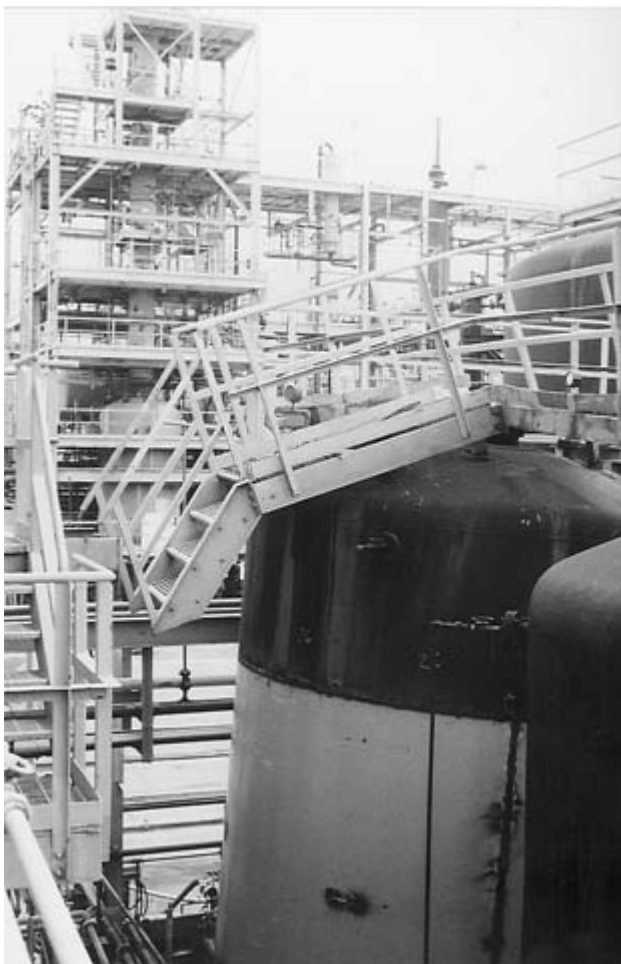
FIGURE 3-2 A closer look at the slightly leaning tank and the walkway that was torn off during the hydrotest.

When the maintenance crew returned to the job site a short time later, they observed a water stream forcefully squirting from the two 1/2-inch vents. They noticed this normally vertical tank leaning at a slight angle. The bottom bulged upward at the bottom-to-shell joint as much 8 inches (20.3 cm) above the foundation. Anchor nuts ripped through the anchor chairs, and catwalks attached to the tank roof had torn away from welded clips.

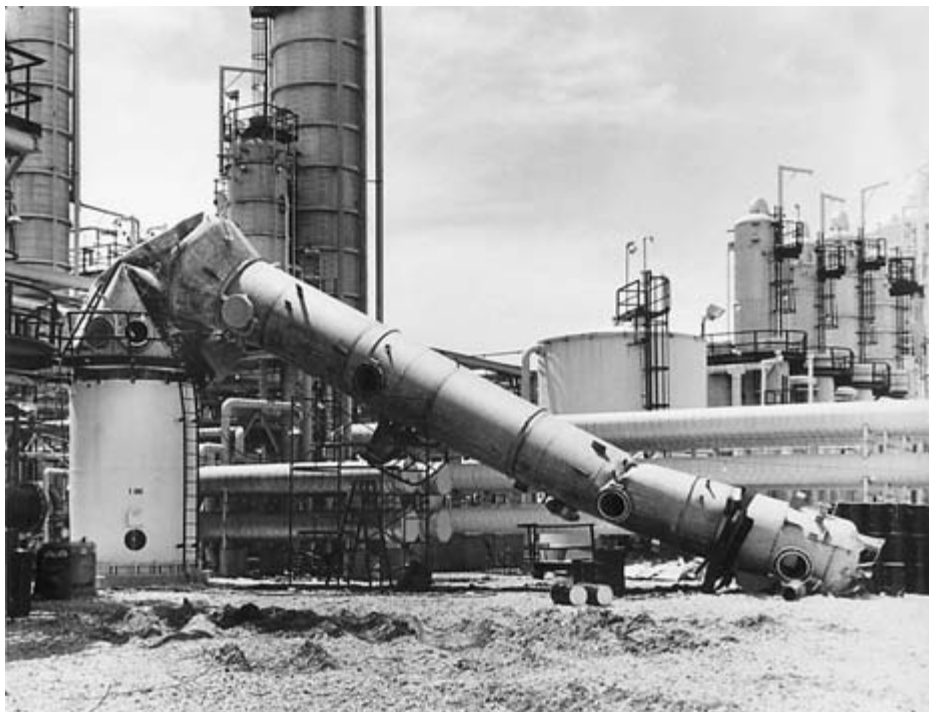
FIGURE 3-5 A stripper column collapses. Courtesy of Guido DeJesus.

At the time of the incident, the operating team was preparing to simulate operations by circulating water in the system. Shortly after midnight, operators noticed water coming from the reabsorber vent. Pre-op engineers concluded that water had flooded both the

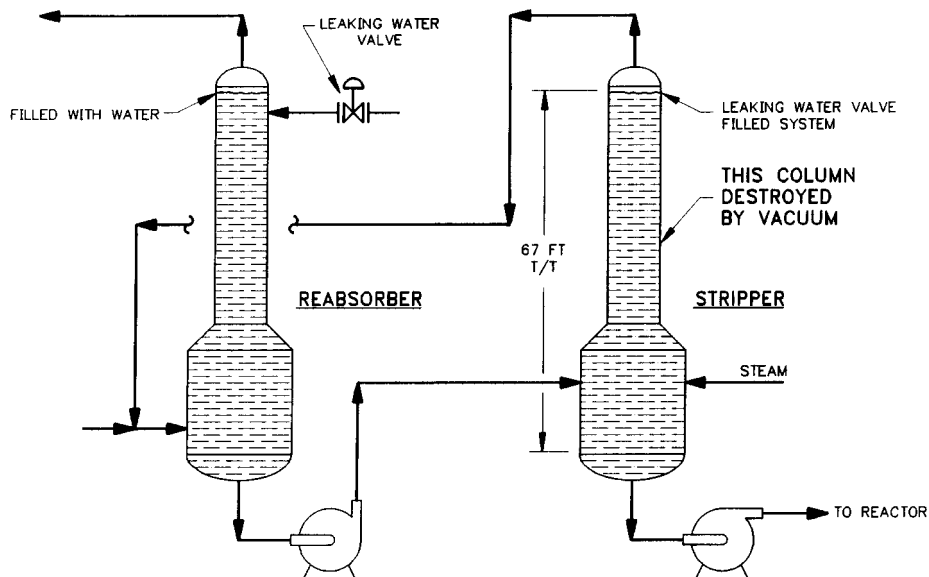
FIGURE 3-6 The design of the reabsorber/stripper system. Courtesy of Guido DeJesus and Warren Schindler.

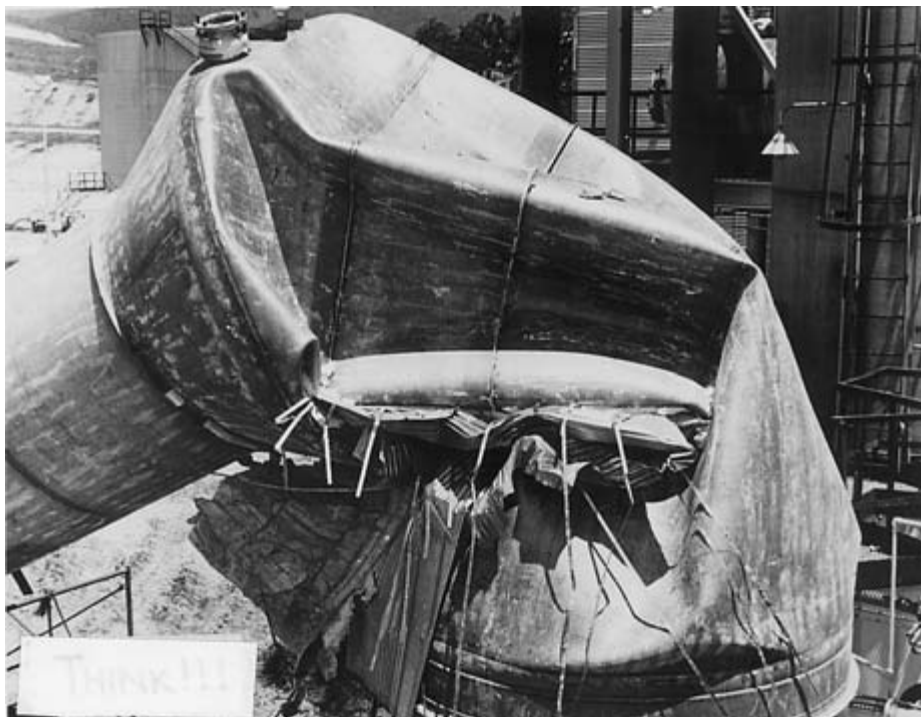
FIGURE 3-7 A close-up of a collapsed stripper column.
Courtesy of Guido DeJesus.

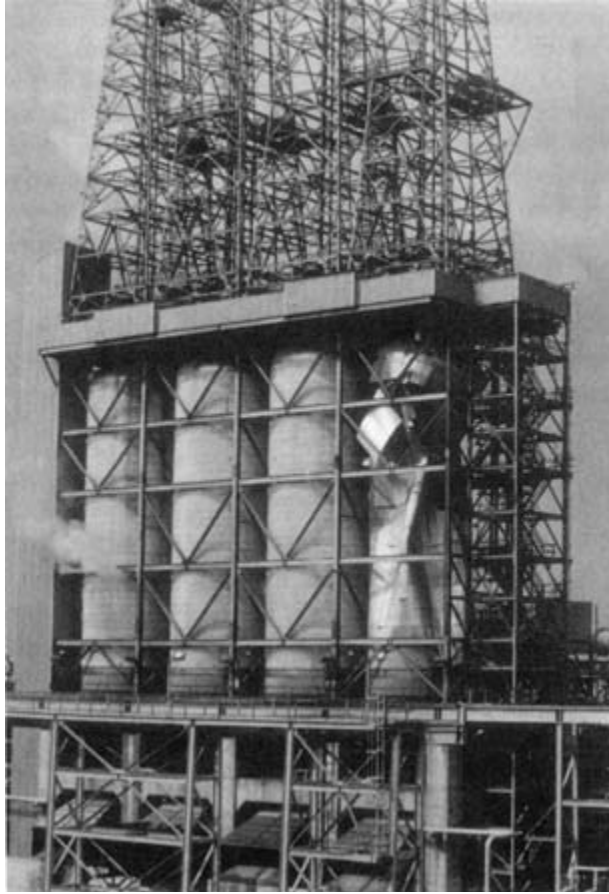
FIGURE 3–9 Collapsed coker drum in a refinery. Courtesy of S. O. Kapenieks.

These gigantic pressure vessels were over 100 ft. (30 m) high, 27 ft. (8.2 m) in diameter, and the main body was a straight side cylinder 74 ft. (23 m) long. The cokers were designed for 55 psig (380 kPa) internal pressure. The coker drum has a dome-shaped top

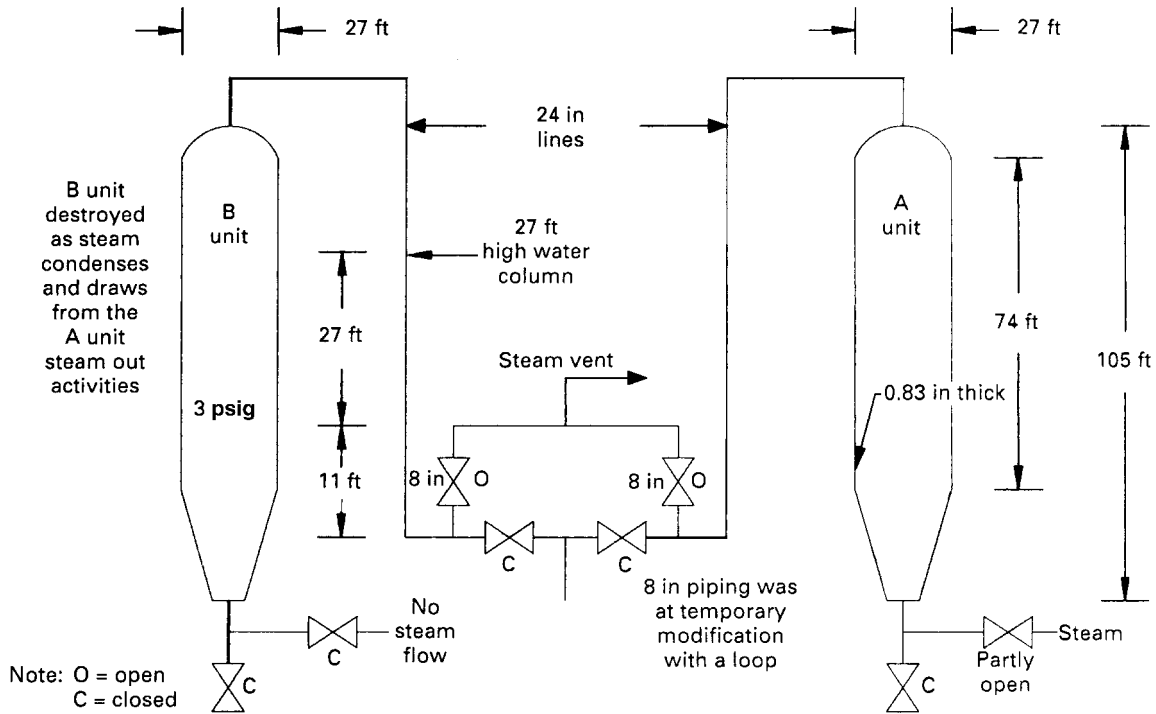
FIGURE 3-10 Conditions at the time of the failure of the coker drum.

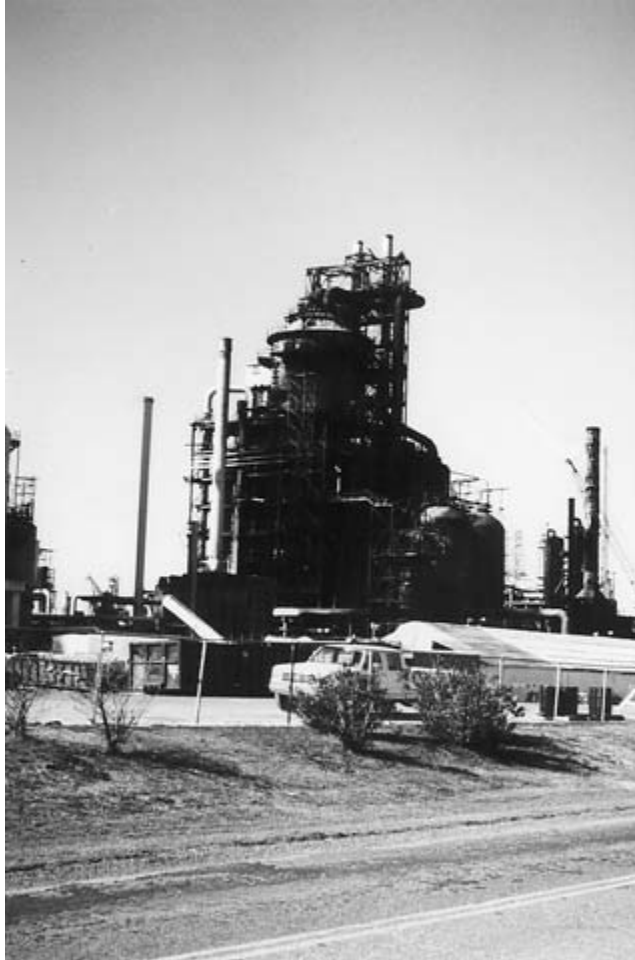
FIGURE 3–12 After the explosion, a charred multi-storied catalytic cracking unit.

In early July 1991, local newspapers provided detailed accounts of the vessel rupture mechanism. The large vertical pressure vessel that catastrophically ruptured was called an F-7 Slurry Drum, and its function was to separate heavy oil and catalyst dust. Newspapers

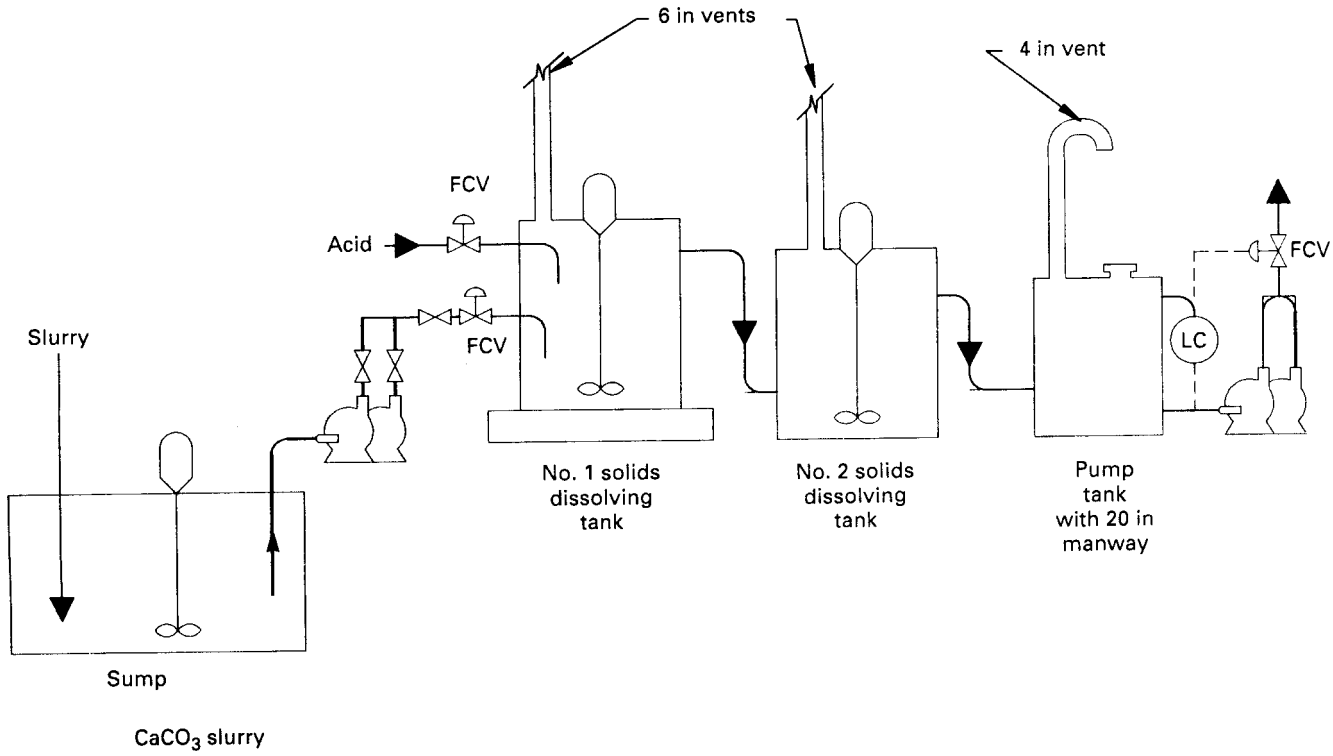
FIGURE 4-3 Slurry-dissolving system. Courtesy of J. M. Jarnagin.

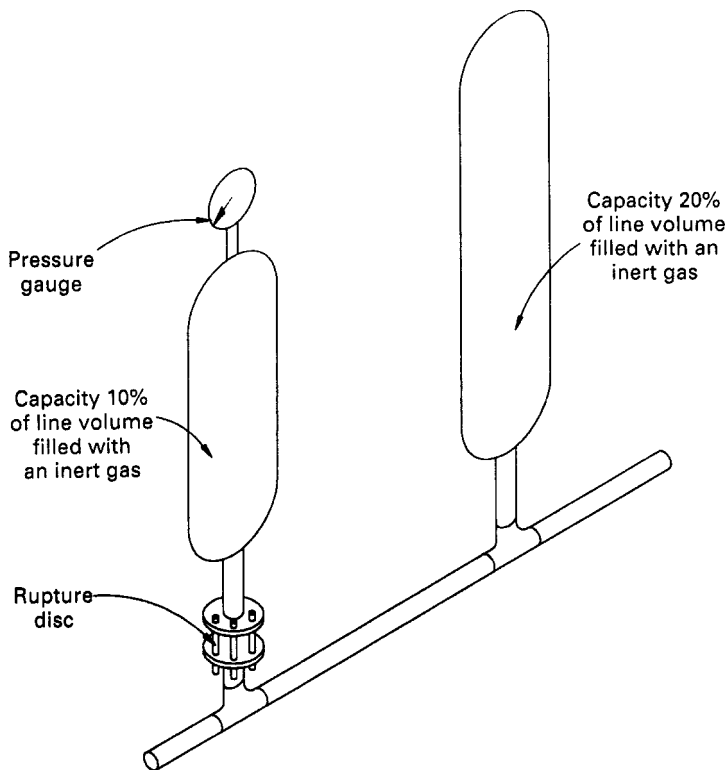
FIGURE 4-4 Expansion chambers for liquid chlorine pipeline protection. Courtesy of the Chlorine Institute, Inc.

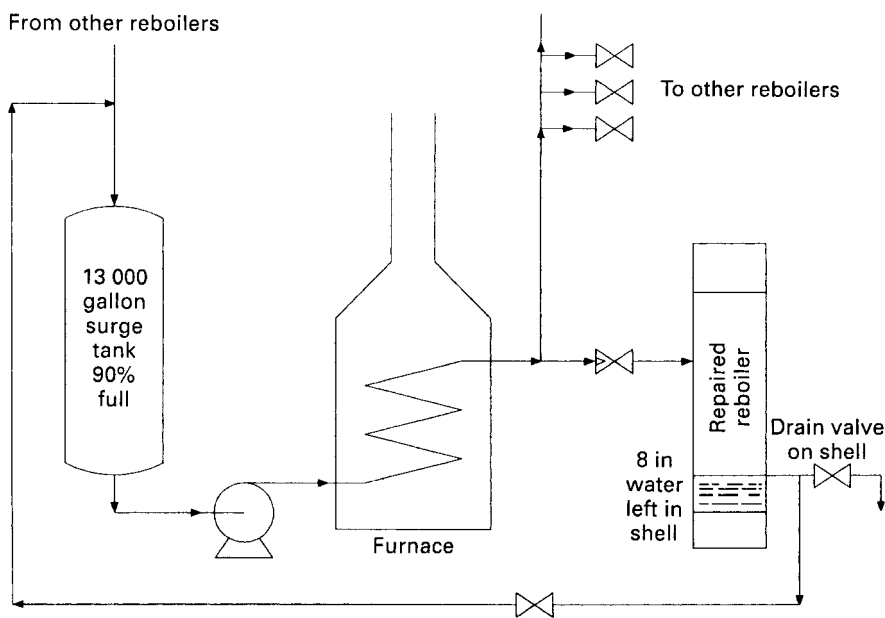
FIGURE 5–1 Residual, undetected water from a hydrotest explosively vaporizes and ruptures a surge tank. Courtesy of Trevor A. Kletz.

The repaired reboiler was mounted in the normal vertical position, when the employees decided to hydrostatically test the unit at the conclusion of the repairs. The mechanical integrity of the reboiler could be assured by a simple hydrotest. After the hydrotest pressure held and no leaks were detected, employees drained the water used to hydrotest from

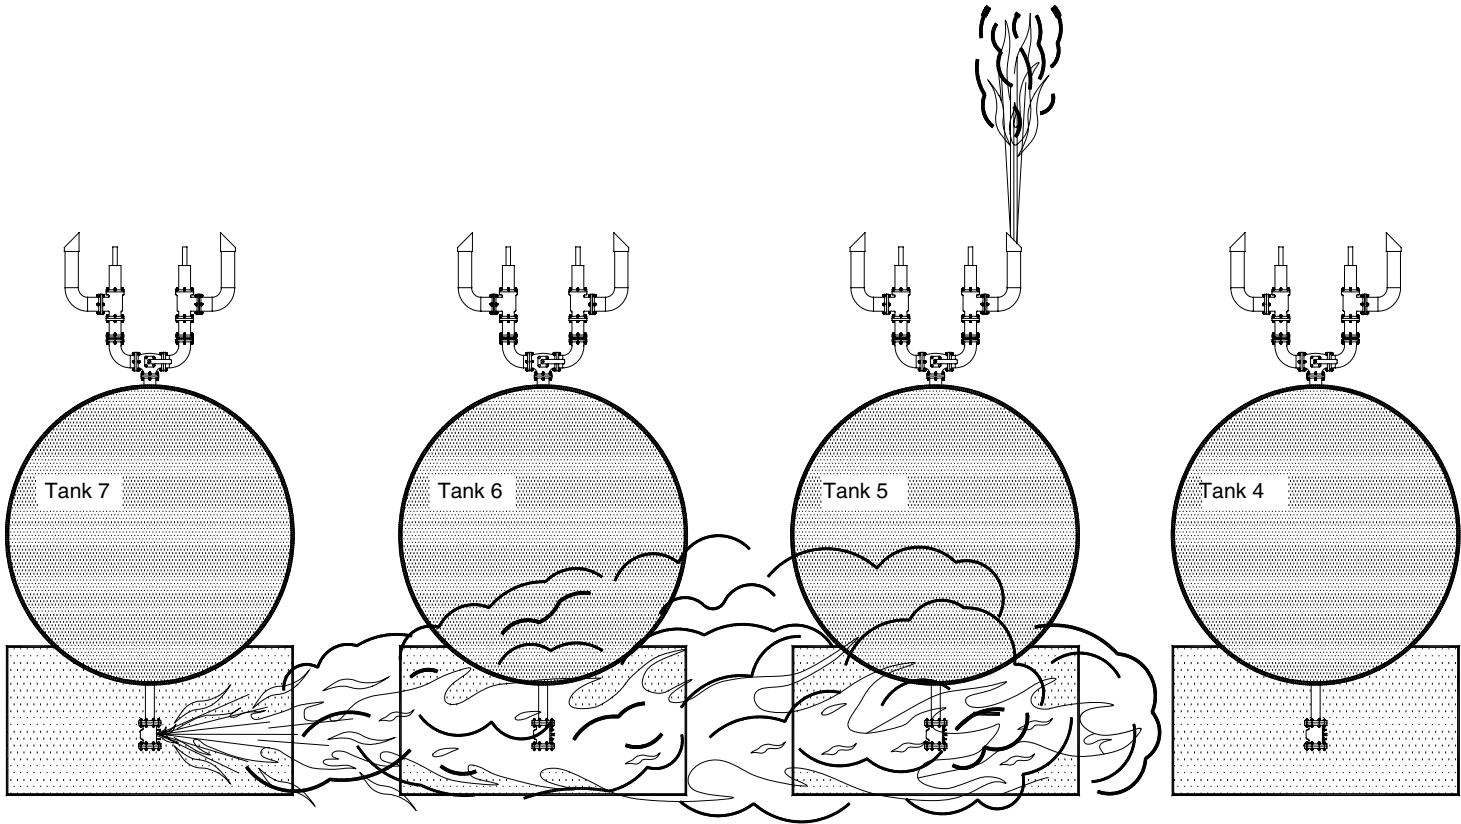
FIGURE 5-9 Flames Below the Vinyl Chloride Tanks—An Artist's Perception. Courtesy of Manuel David.

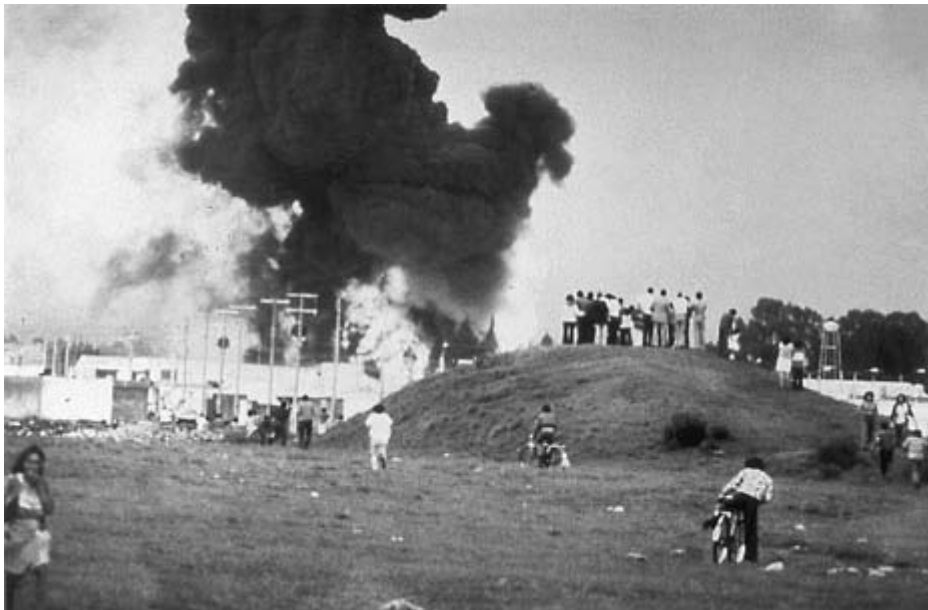
FIGURE 5-10 BLEVE of a vinyl chloride storage tank. Courtesy of the Institution of Chemical Engineers.

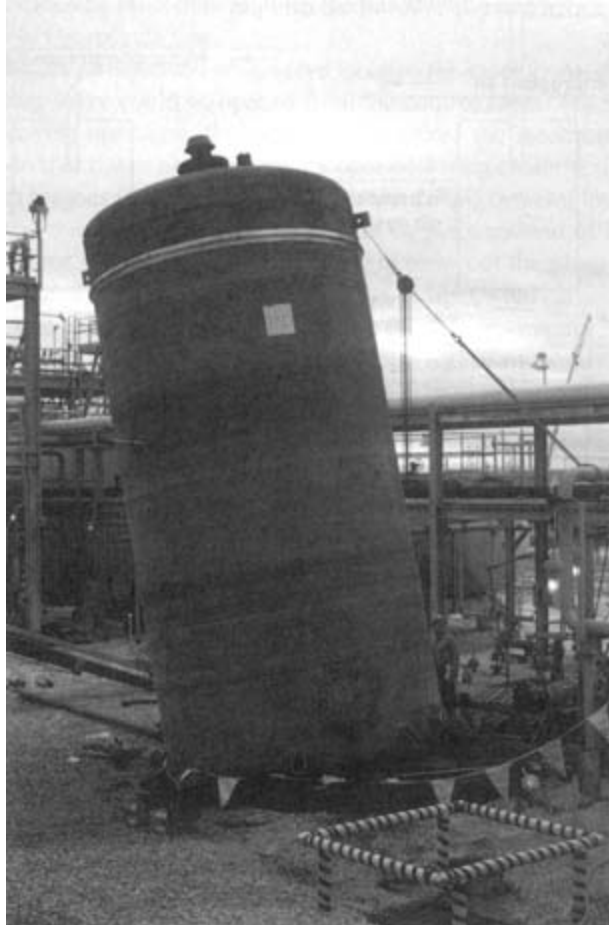
FIGURE 5-12 A large acid tank fails due to blocked vent and a blocked overflow line.

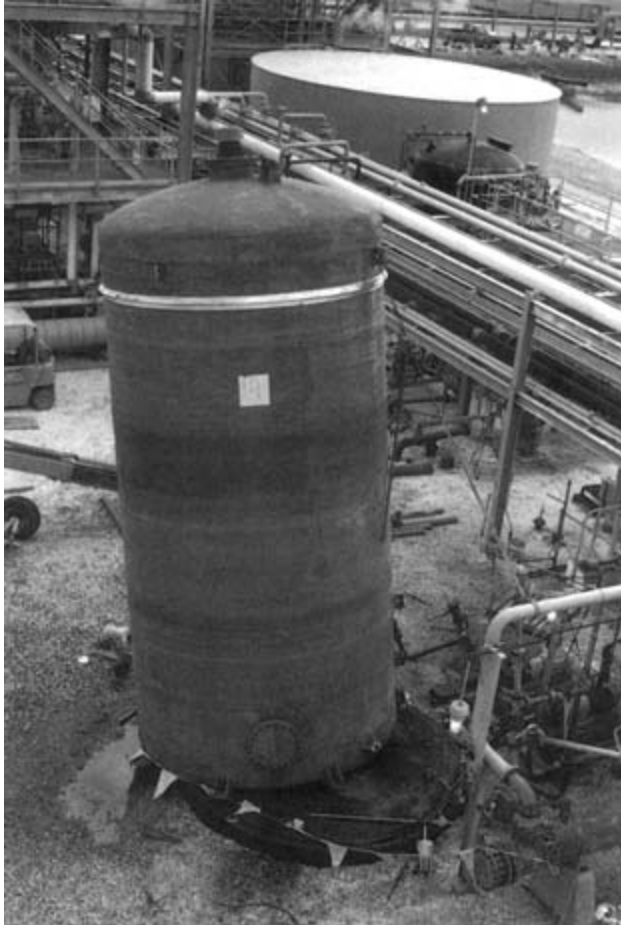
FIGURE 5-13 An aerial view of the tank failure.

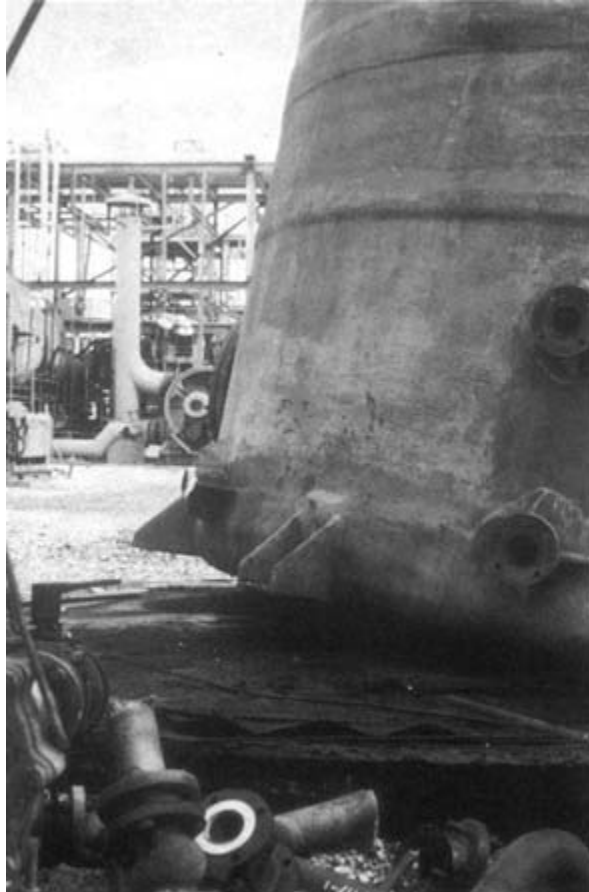
FIGURE 5-14 A close-up of the failed tank base.

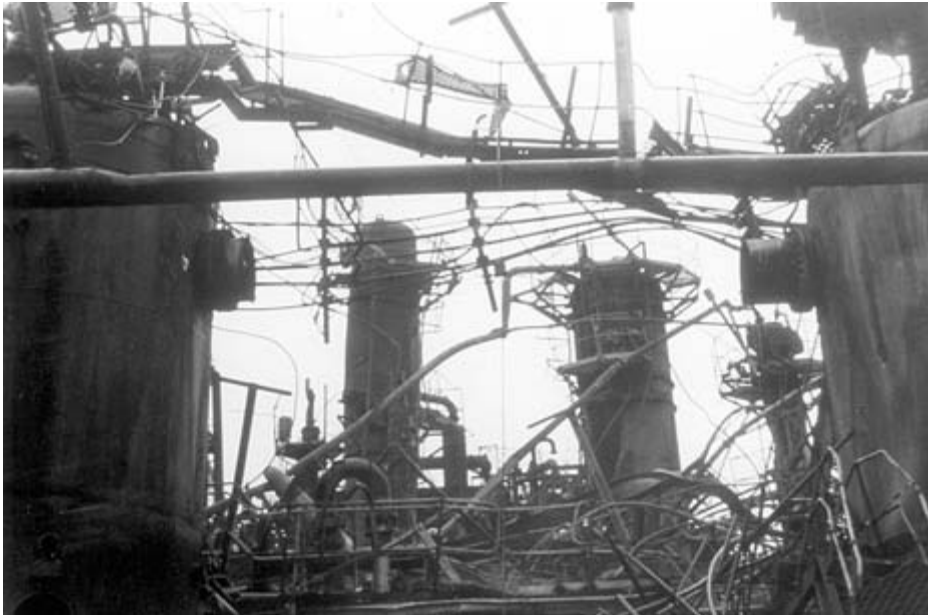
FIGURE 5-16 A Destroyed Section of the Flixborough Reactor System.
Photo courtesy of Trevor A. Kletz.

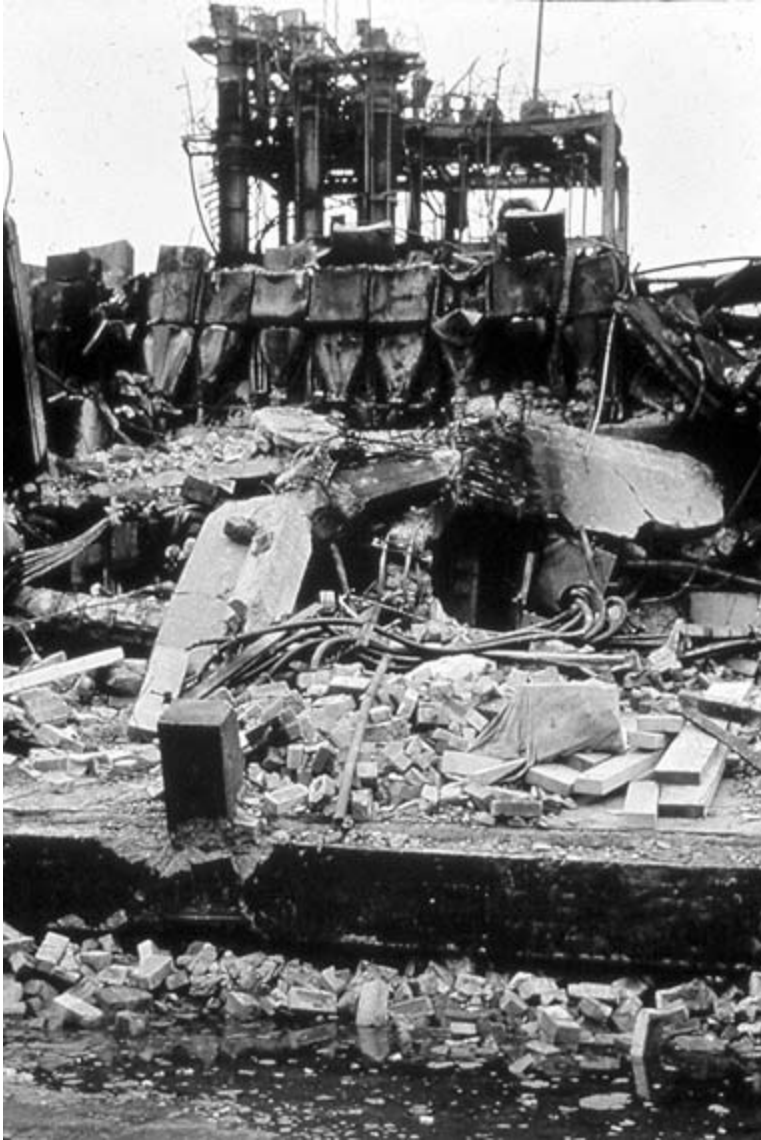
FIGURE 5-17 The rubble of the crushed control room at Flixborough. Courtesy of Trevor A. Kletz.

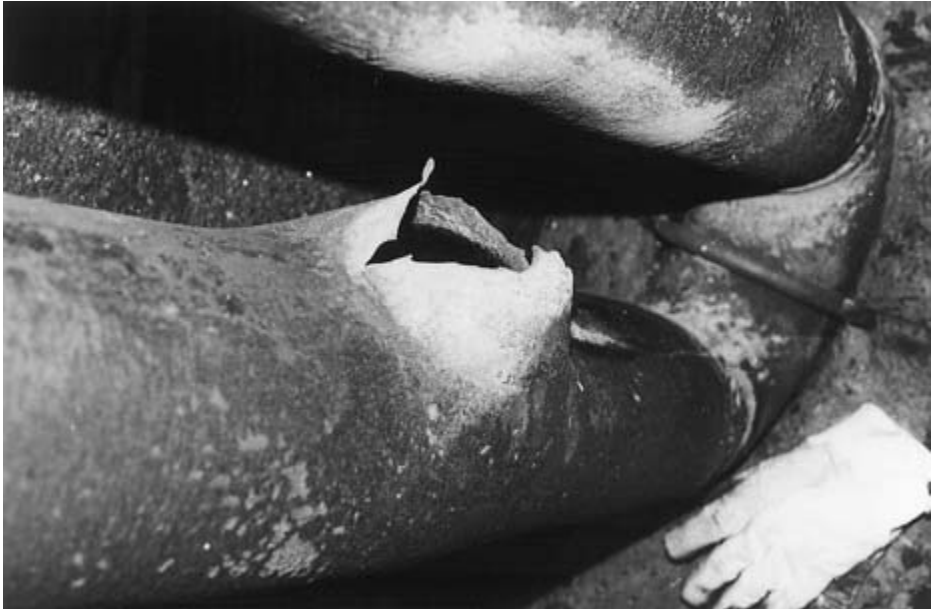
FIGURE 6-2 Tube rupture in a fired heater.

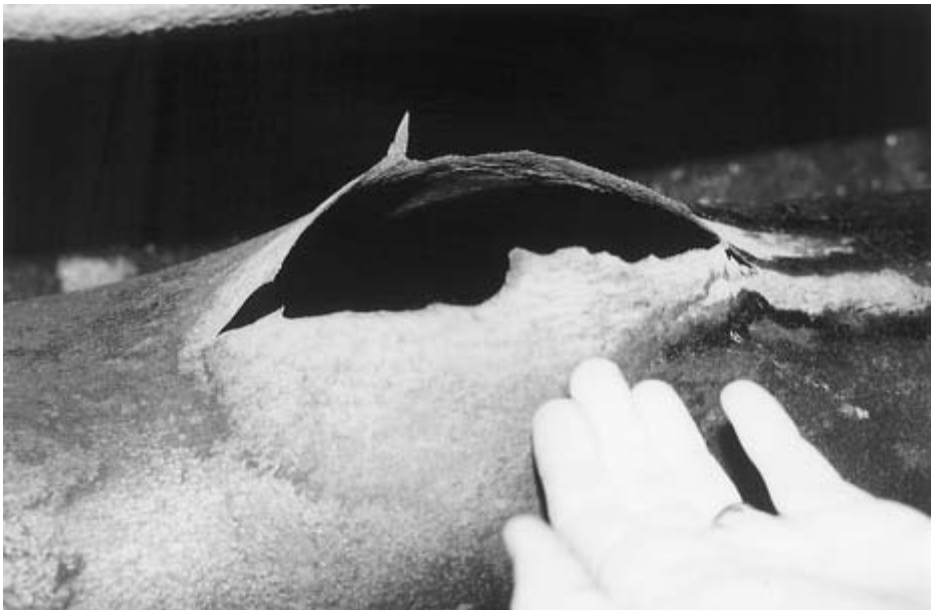
FIGURE 6-3 Close-up of the tube failure.

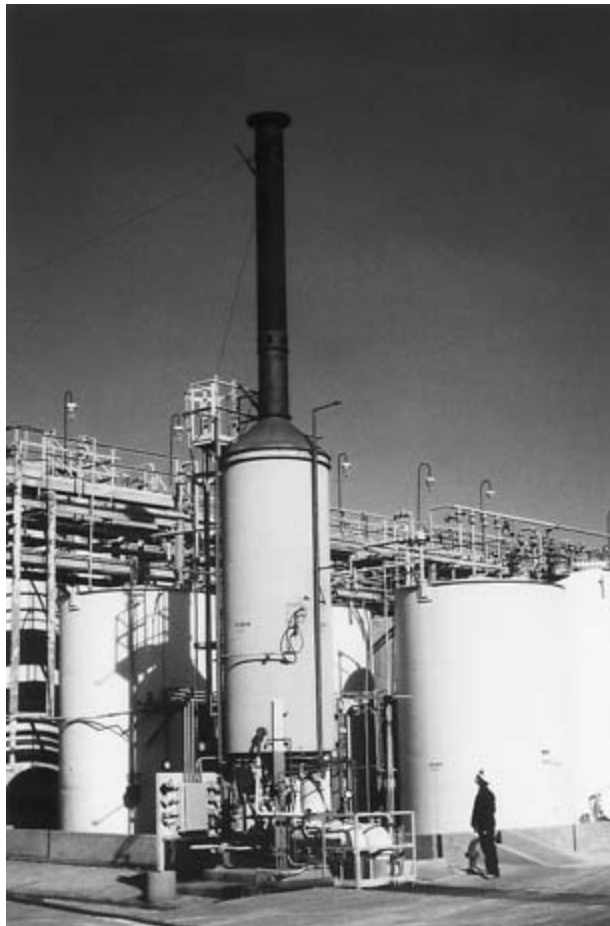
FIGURE 6-4 The rejuvenated and relocated gas-fired heater.

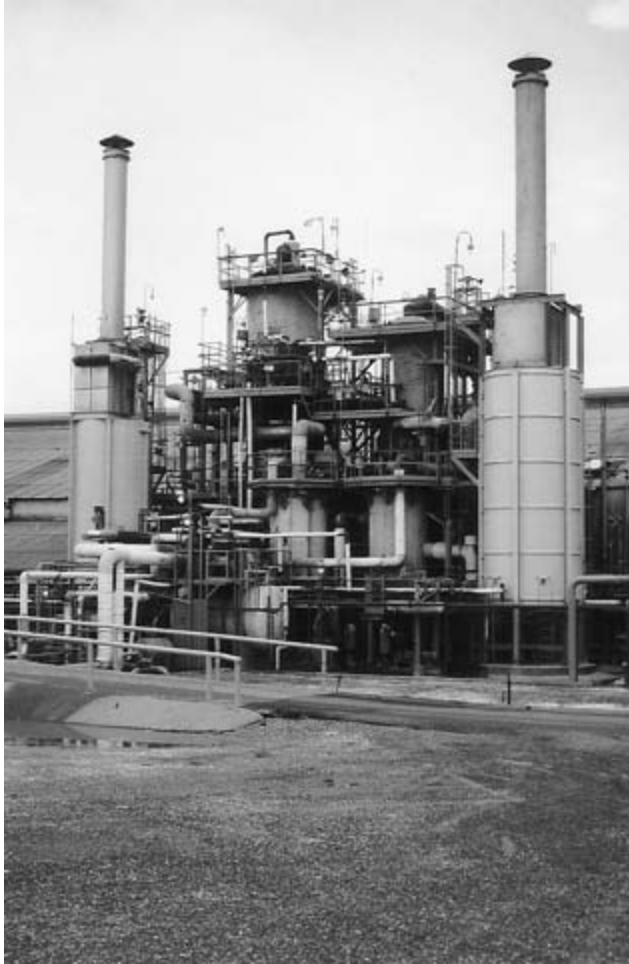
FIGURE 6-5 Well-maintained unit is troubled by a leak.

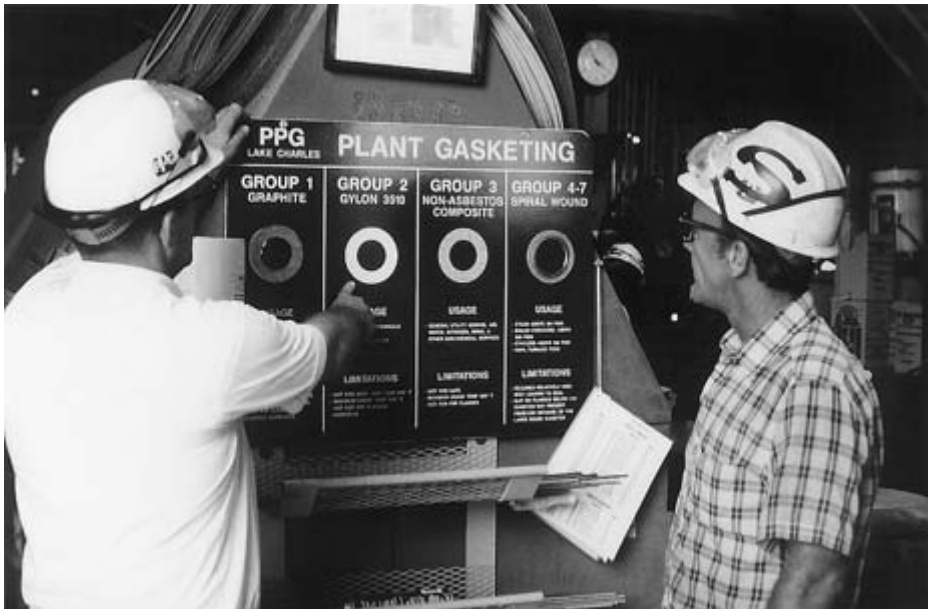
FIGURE 6-9 Choosing the proper piping gaskets with help from easy-to-understand gasket board.

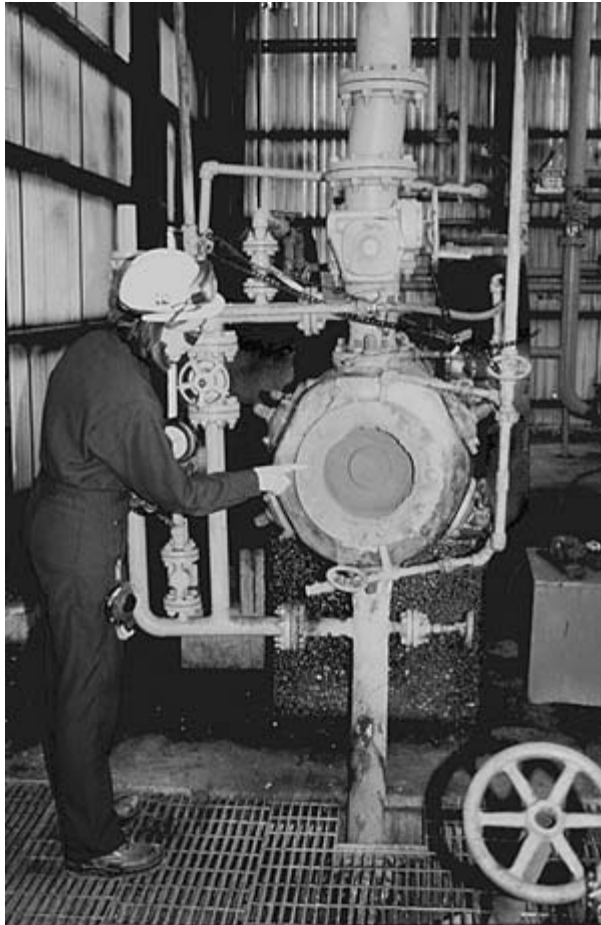
FIGURE 7-1 Reciprocating compressor with ruptured water jacket.
