Chemical Process Safety

Learning from
Case Histories

Third Edition

ROY E. SANDERS

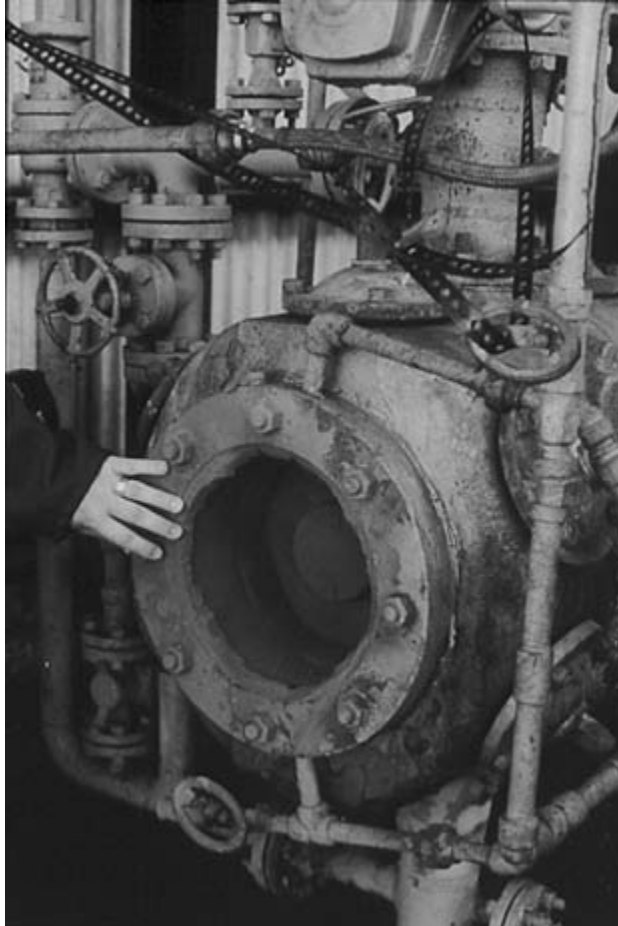
FIGURE 7-2 Close-up of ruptured water jacket on compressor.

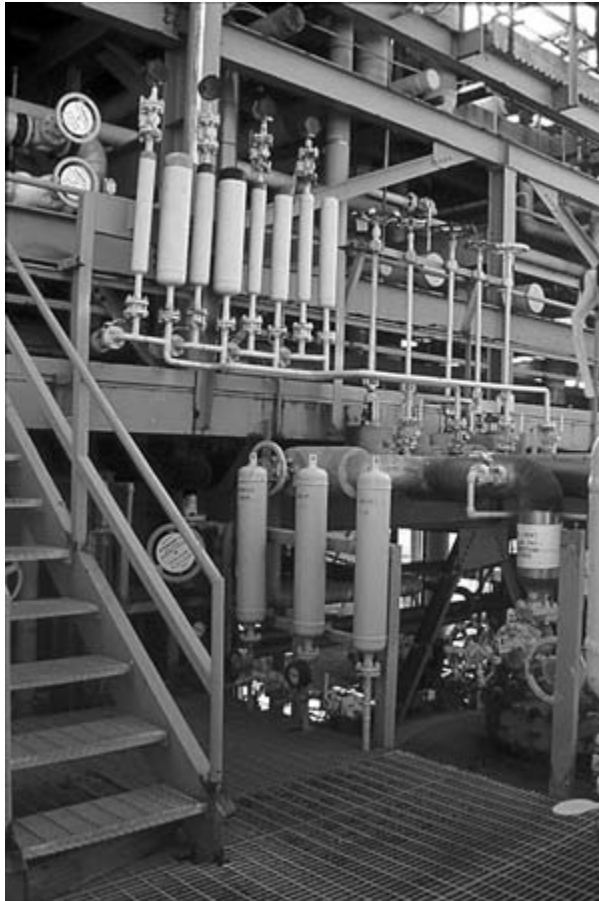
FIGURE 7-5 Expansion bottles protecting piping from overpressure.

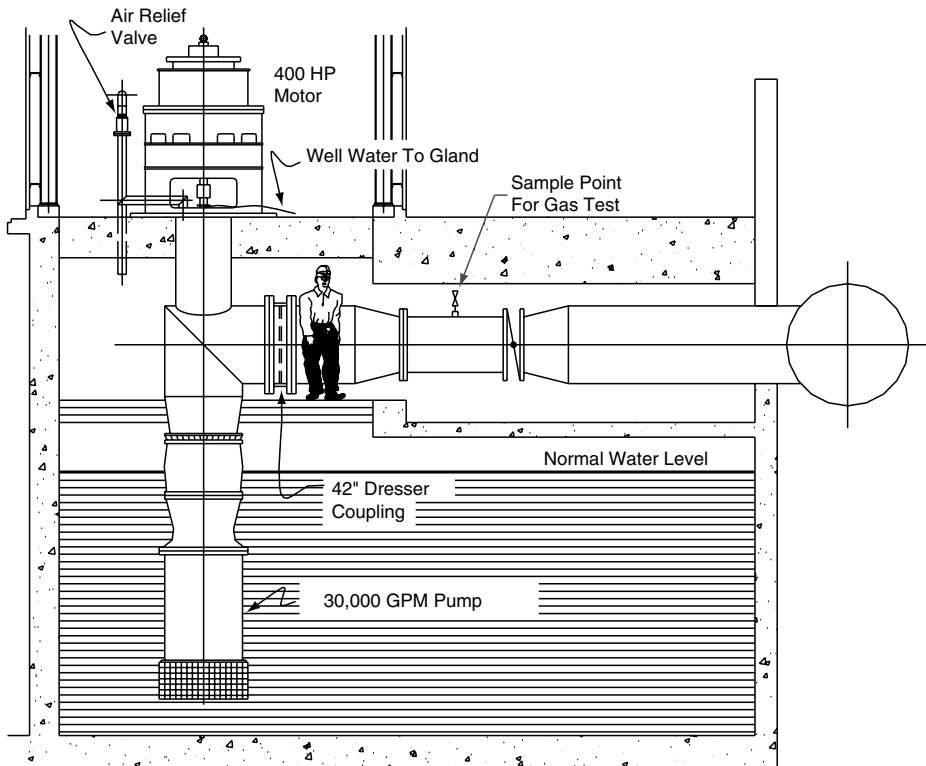
FIGURE 7-8 Sketch of the river water pump system at normal conditions. Courtesy of Manuel David.

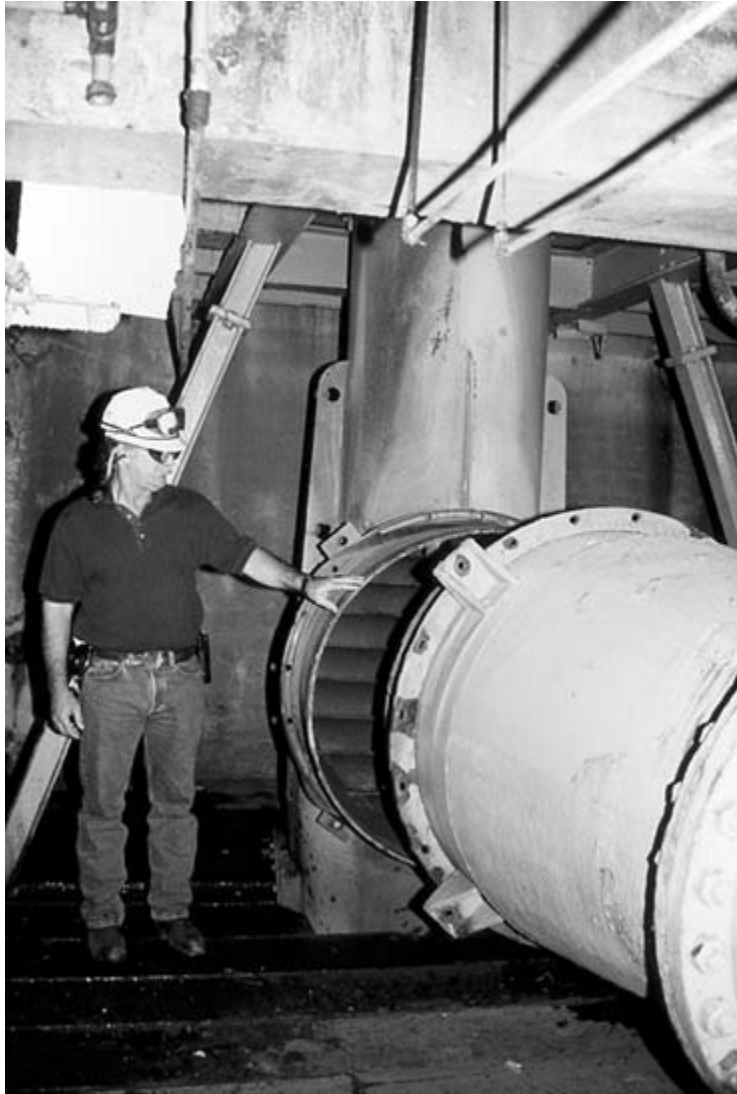
FIGURE 7-9 Photo of how the river water pump moved during the explosion.

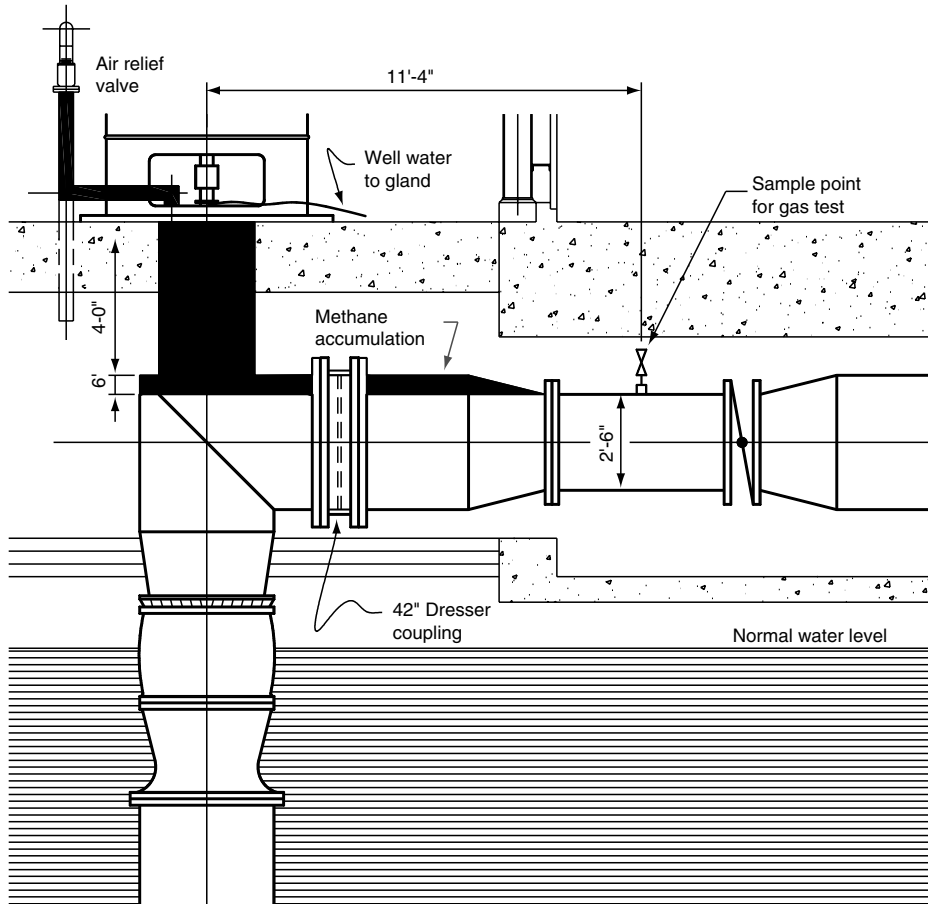
FIGURE 7-11 Sketch of how methane gas accumulated in the river water piping.

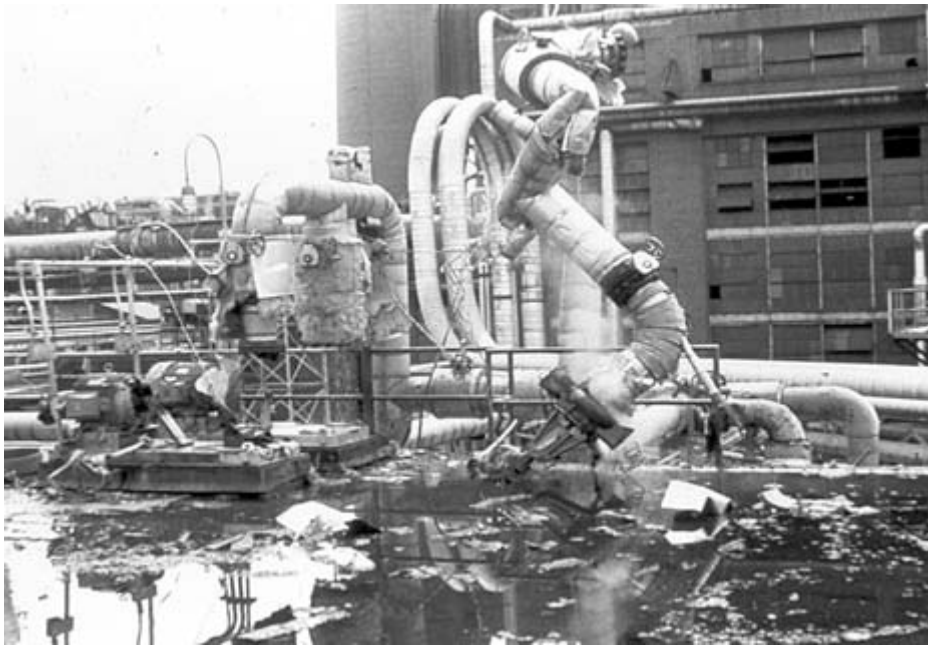
FIGURE 7-15 Heavily damaged condensate pump installation. Courtesy of Eastman Chemical Company.

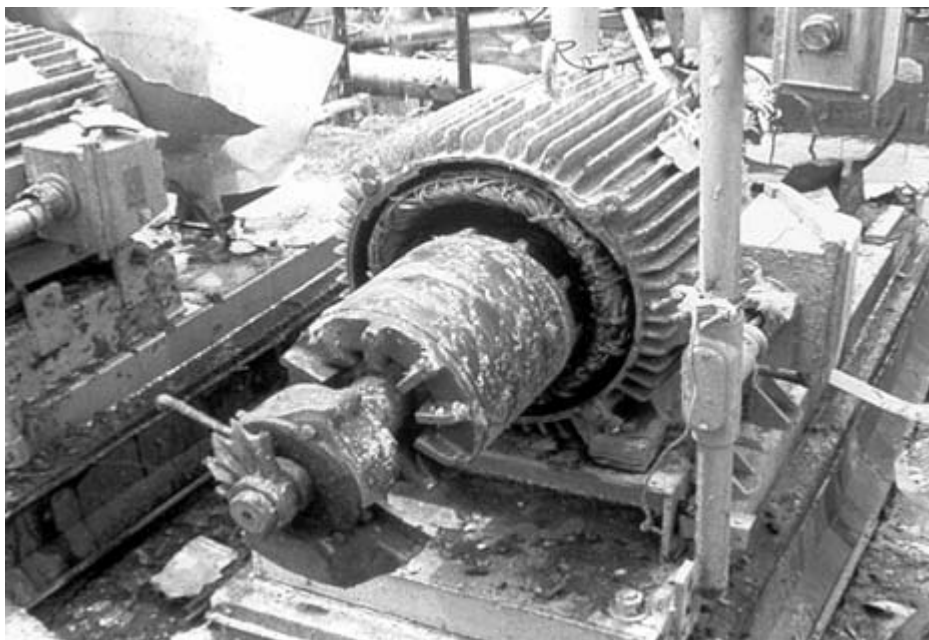
FIGURE 7-16 Explosion forces rotor out of condensate pump motor. Courtesy of Eastman Chemical Company.

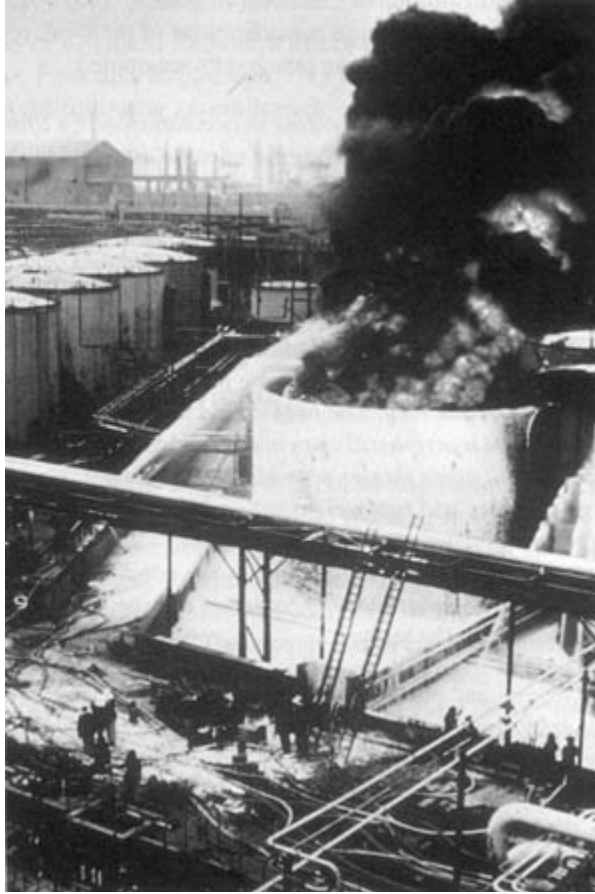
FIGURE 8-3 A fire in a giant floating roof crude oil tank. Courtesy of the Institution of Chemical Engineers. This photo can be found in Hazard Workshop Module No. 6, "Preventing Emergencies in the Process Industries, Volume 1."

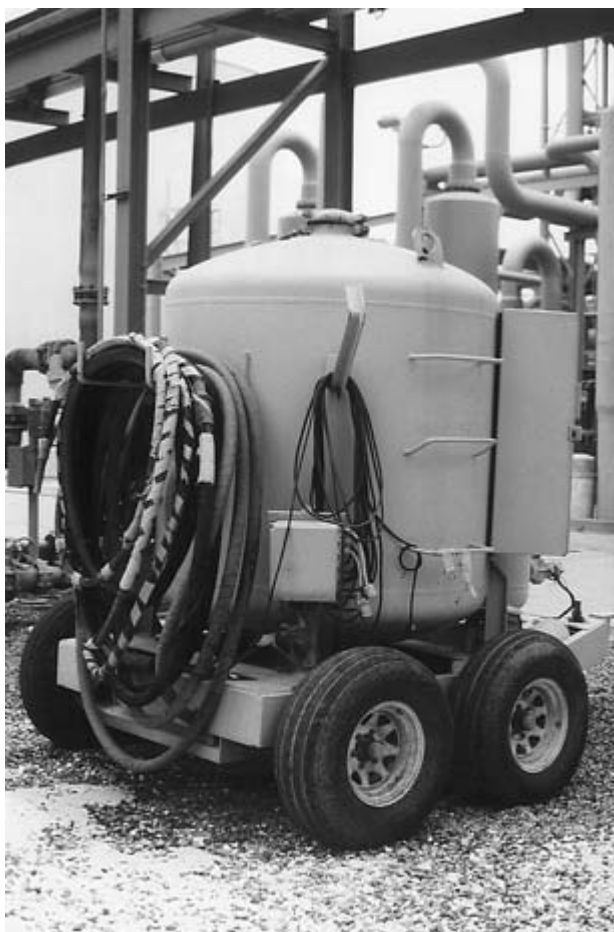
FIGURE 8-4 Repairs to a portable sandblast pot do not meet specifications and the lid flies off.

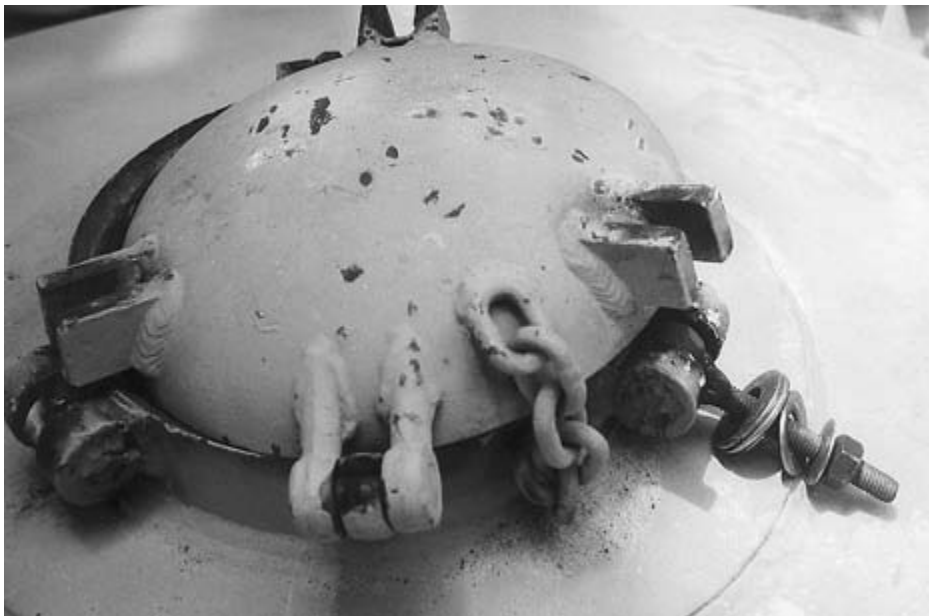
FIGURE 8-5 A close-up look at the quick closure bolts that failed on the sand pot.

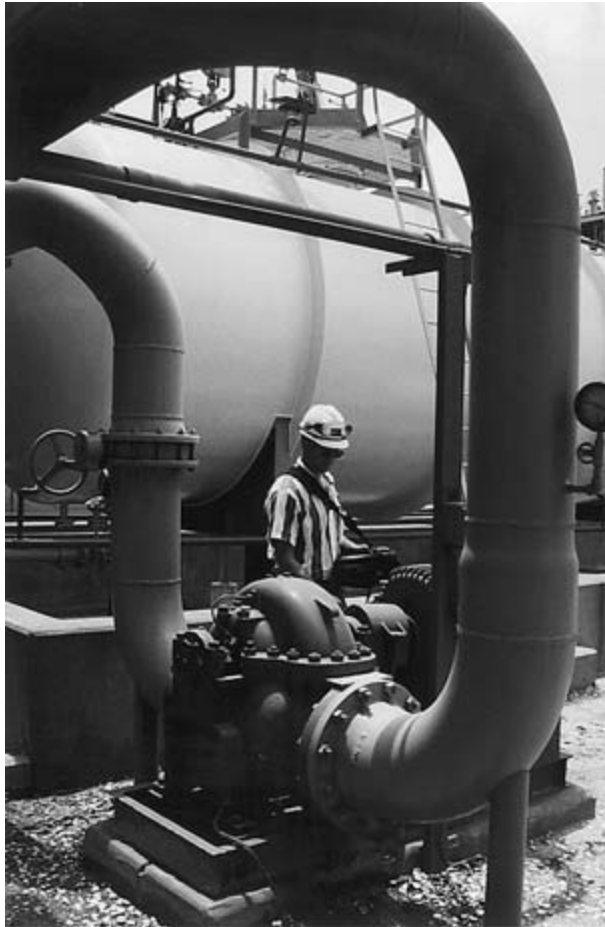
FIGURE 10-2 A vibration technician taking readings on a cooling water pump.

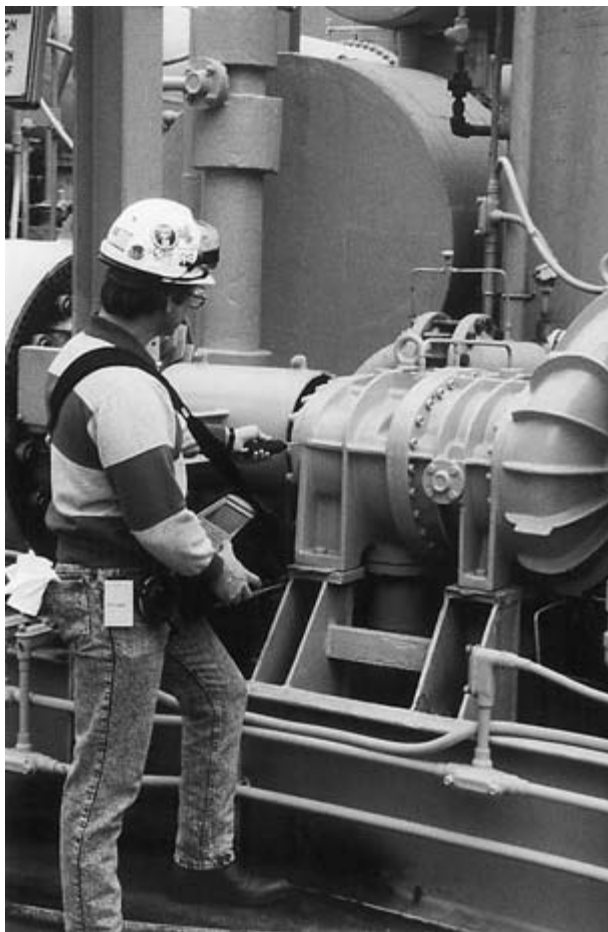
FIGURE 10-3 A vibration technician taking readings on a refrigeration compressor.

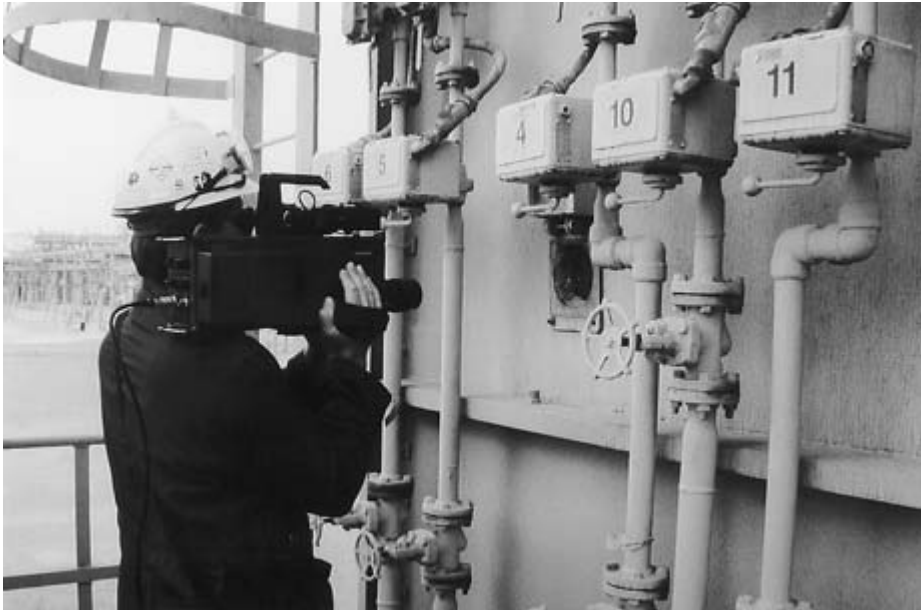
FIGURE 10-5 An inspector using an infrared camera periodically monitors furnace tube temperatures through the inspection port holes.

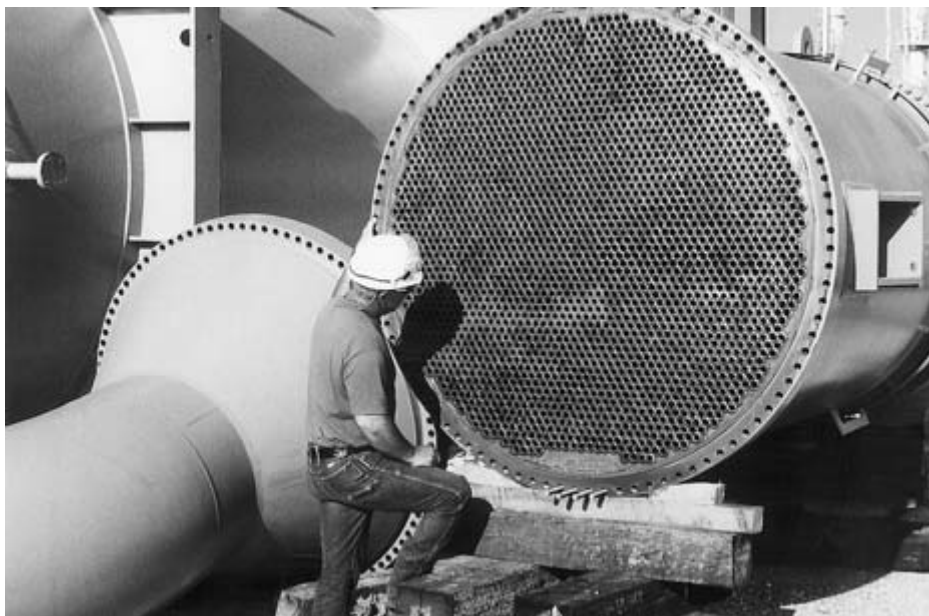
FIGURE 10–6 An inspector inspects new and repaired heat exchangers at the fabrication/repair shop and when they arrive at the plant site.

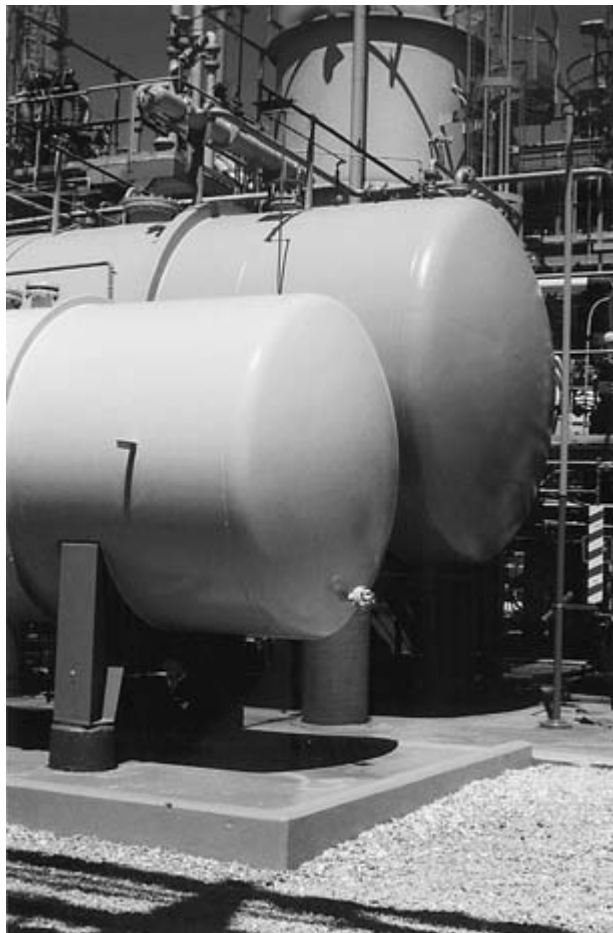
FIGURE 10–7 Well-maintained pressure vessels (over 30 years old) still safely handling hazardous materials.

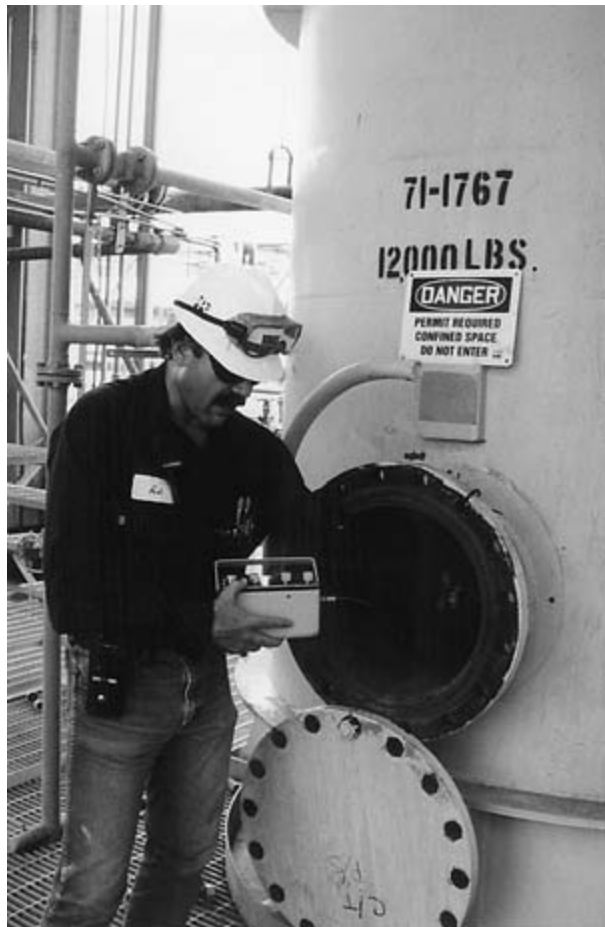
FIGURE 10-8 An operations foreman checks for blinding and samples the vessel's atmosphere before tank entry.

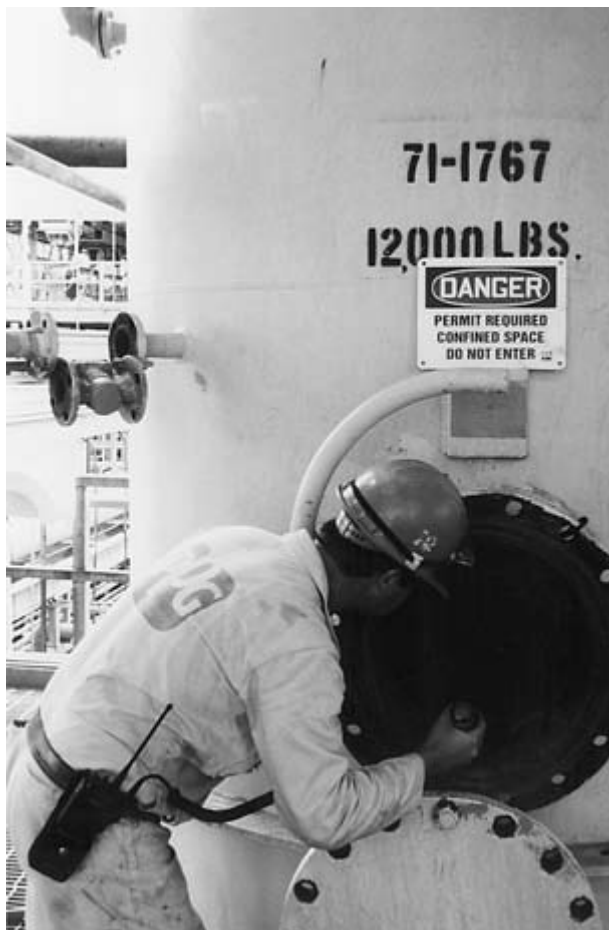
FIGURE 10-9 A pressure vessel inspector making an initial assessment of the vessel and determines any special inspection needs, such as ladders, scaffolding, or extra lighting.

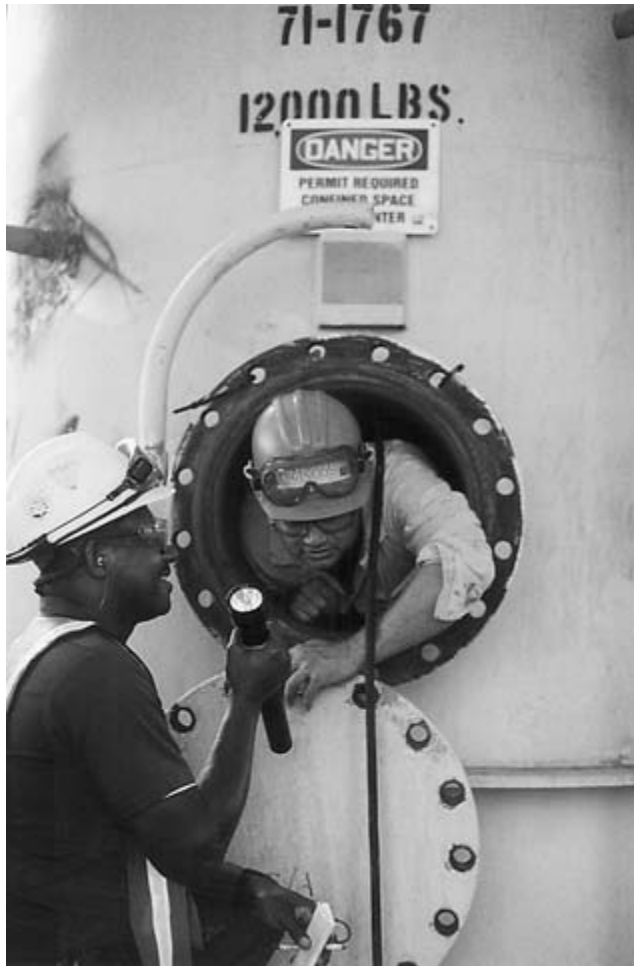
FIGURE 10–10 A pressure vessel inspector enters the confined space after the vessel is blinded, tested, and cleared, but still relies on a manway watch.

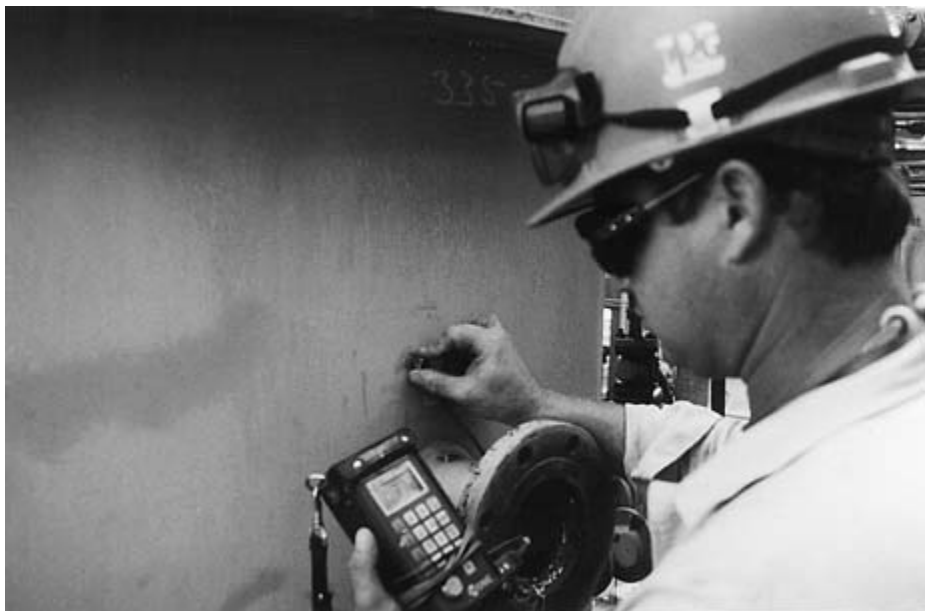
FIGURE 10–11 An inspector verifying wall thickness on a vessel near a nozzle that had experienced metal loss.

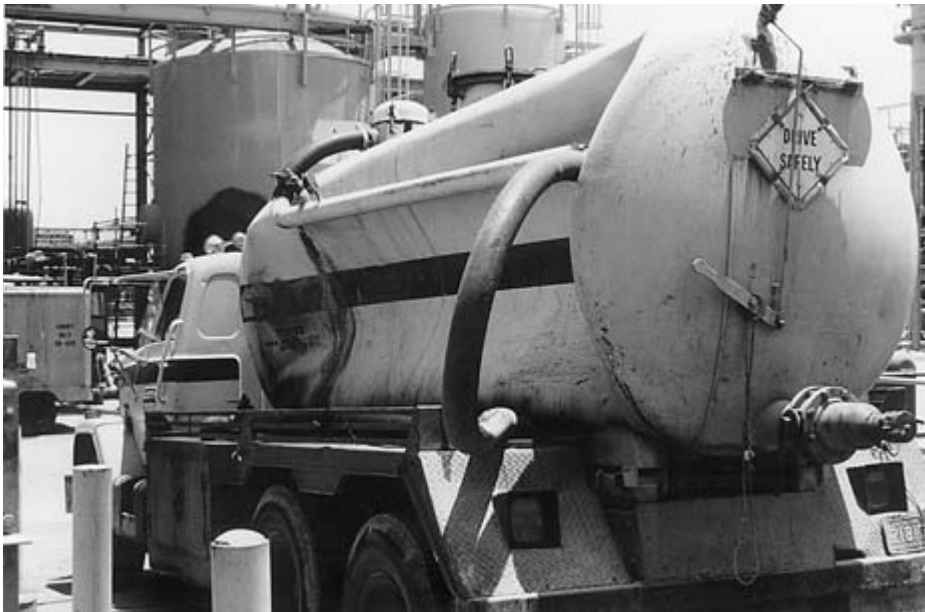
FIGURE 10–12 A collapsed service company vacuum truck signals an inadequate mechanical integrity program.

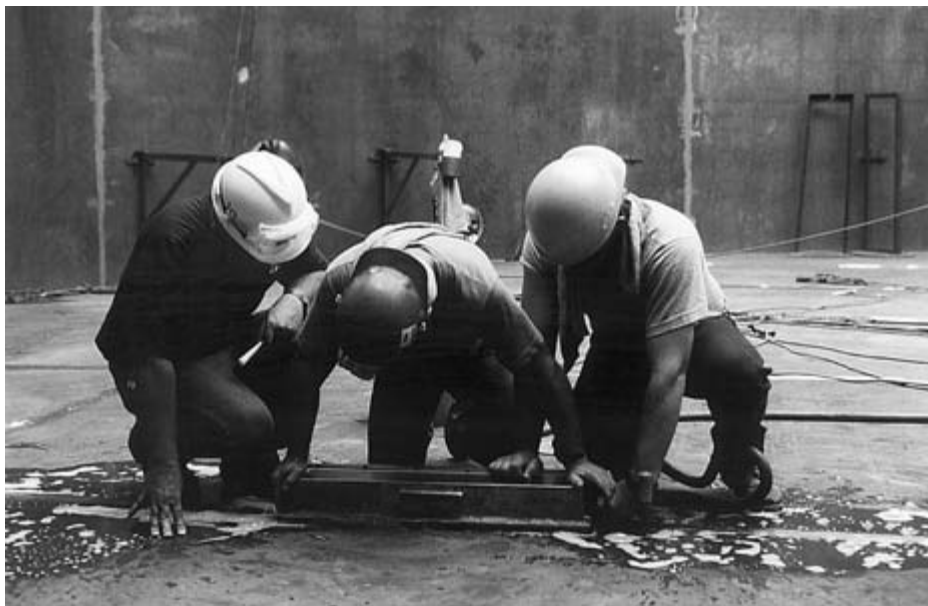
FIGURE 10–13 Inspectors using a vacuum box and soapy water to check for leaks in welds on the floor of low-pressure tanks.

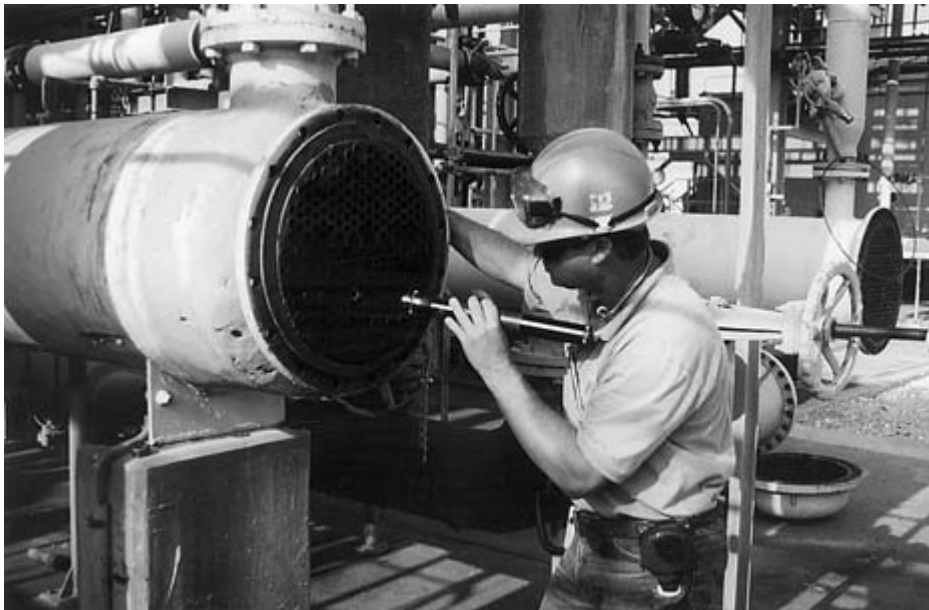
FIGURE 10-14 An inspector examines the condition of the tubes on a condenser. Water-side corrosion can occur if water treatment is insufficient.

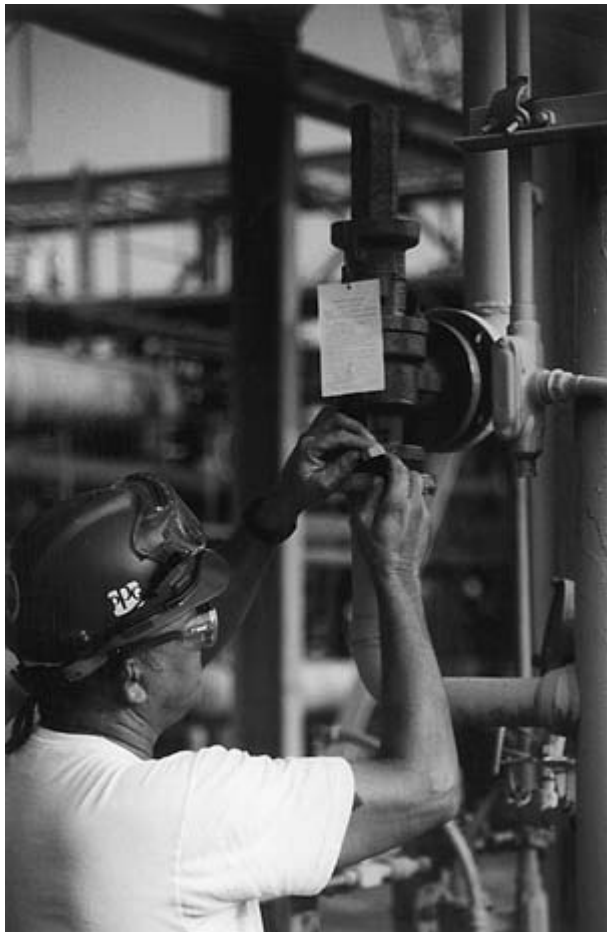
FIGURE 10–17 A mechanic is removing an SRV from a unit. The mechanic records the condition of the inlet and outlet piping components on the tag before the valve is sent for testing.

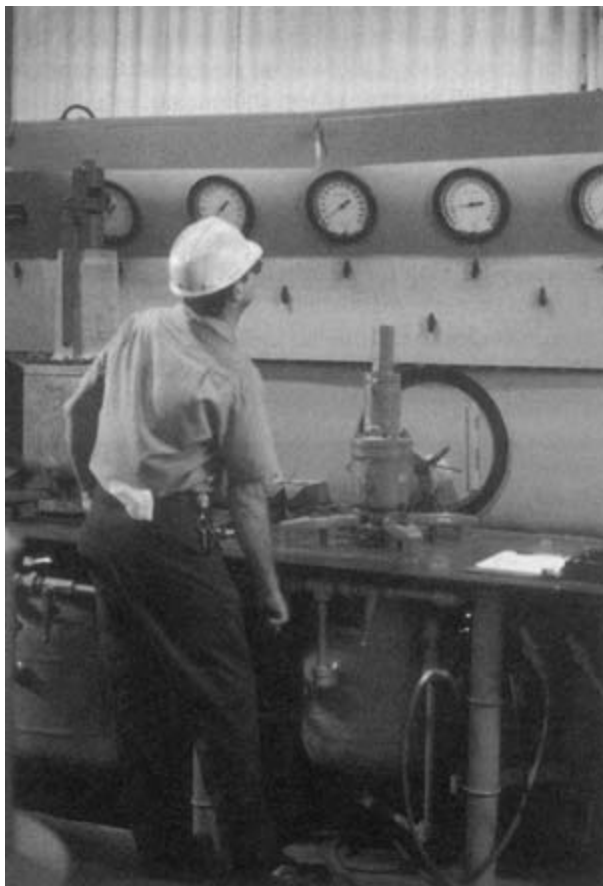
FIGURE 10-18 A well-trained mechanic testing a safety relief valve just as it is received from the unit.

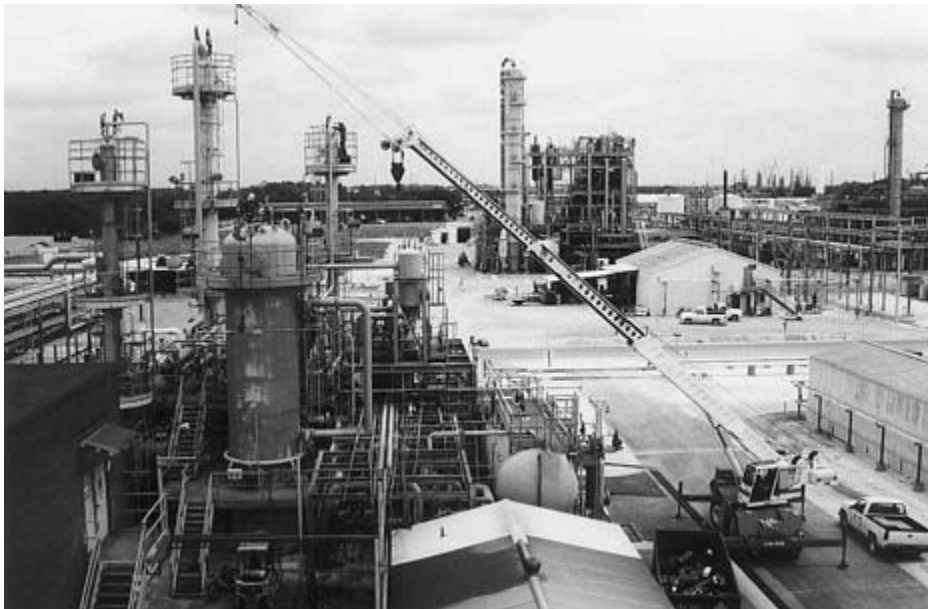
FIGURE 10-19 A crane is lifting a recently tested and reconditioned safety relief valve to reinstall on a reactor.

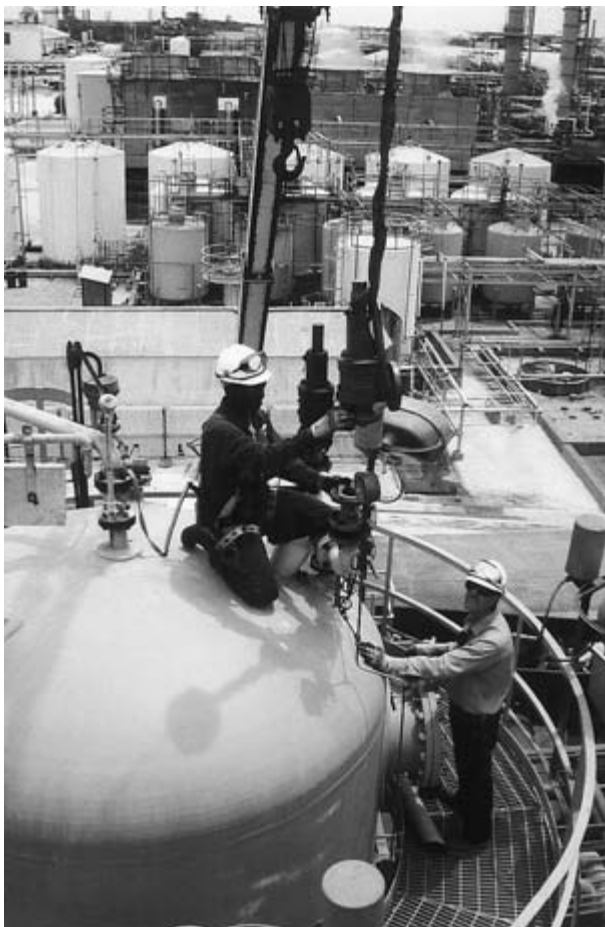
FIGURE 10–20 A mechanic is reinstalling an SRV after it was tested in the shop and raised into position by a crane.

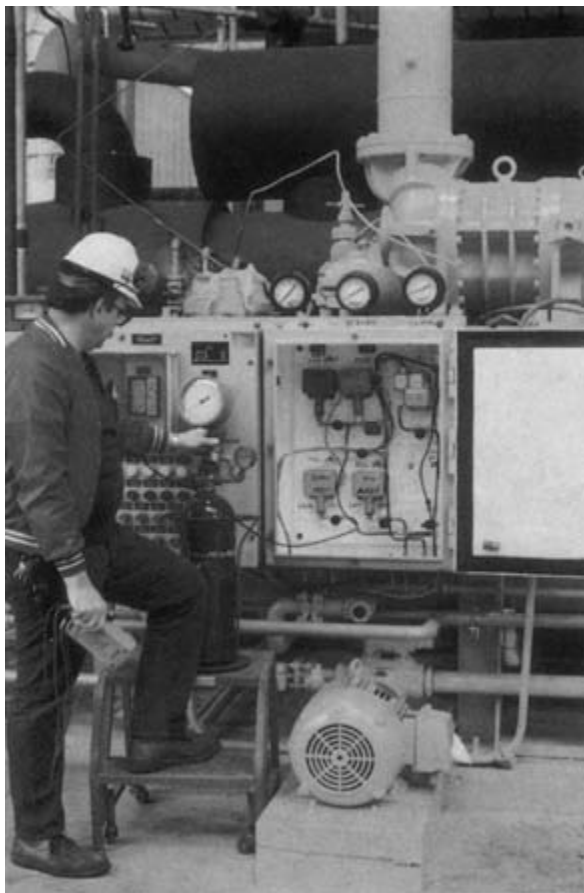
FIGURE 10–22 Prooftesting a high-pressure switch on a refrigeration unit.

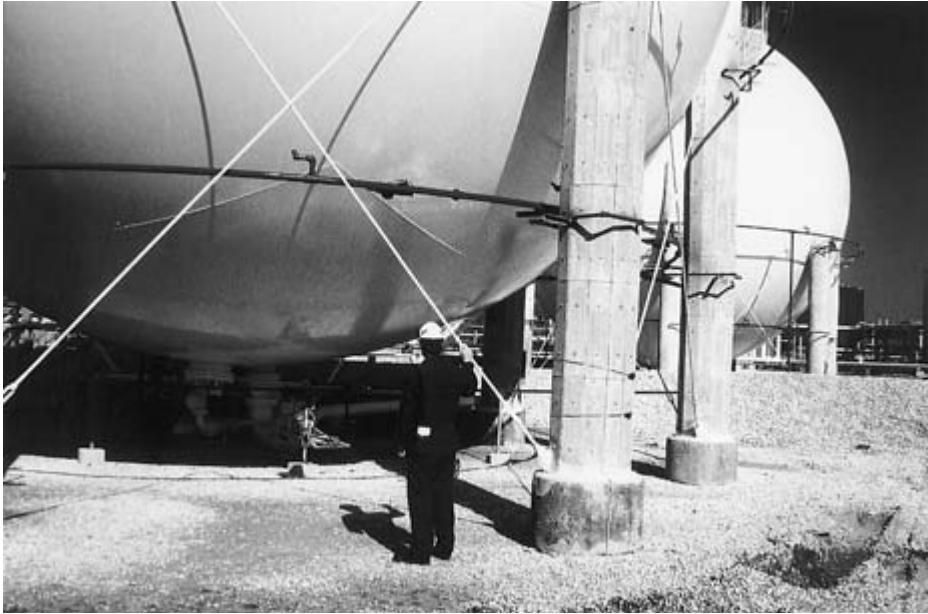
FIGURE 10-24 A chemical process operator witnesses the testing of an “Emergency Isolation Valve” below a sphere of flammable product.

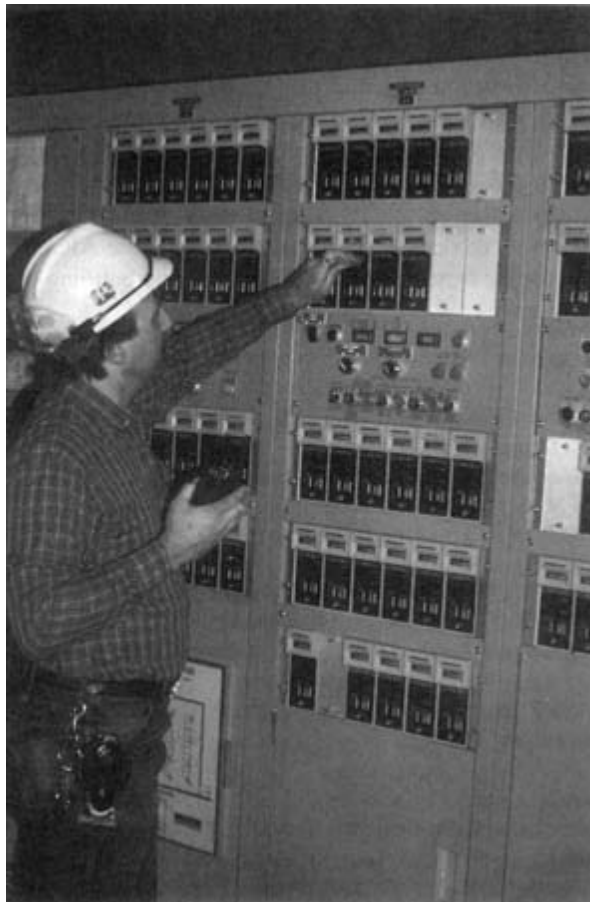
FIGURE 10-25 An instrument mechanic proof-tests a critical instrument panel.

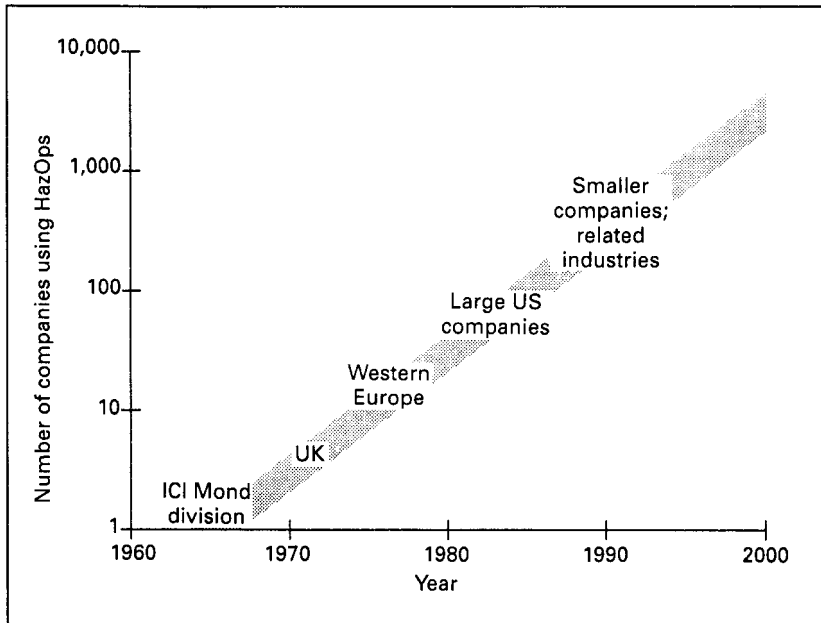
FIGURE 11-1 Estimate of the extent of HAZOP usage. Courtesy of R. W. Johnson, Battelle Memorial Institute.
