Natural and Artificial Rockslide Dams

The Formation and Behaviour of Natural and Artificial Rockslide Dams; Implications for Engineering Performance and Hazard Management

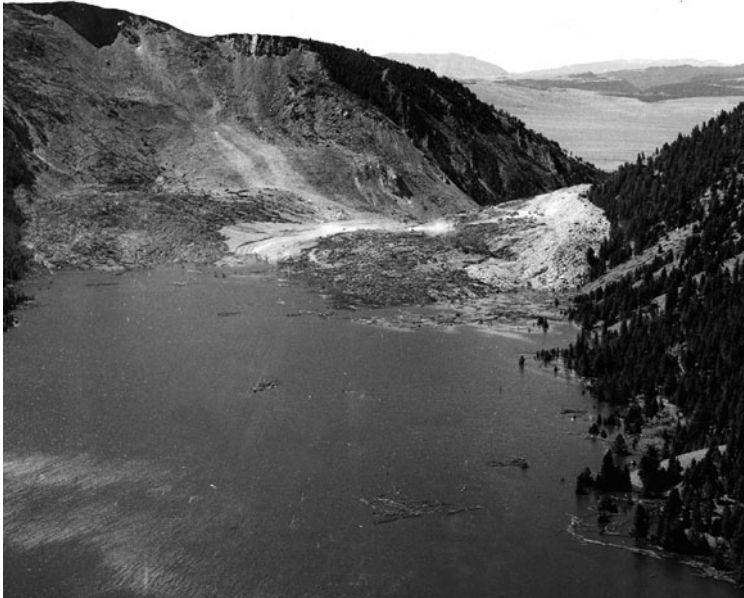
Fig. 1.2 Rockslide-dammed lake (Earthquake Lake) formed by landslide (est. vol. 20 Mm³) triggered by the M7.3 Hegben Lake earthquake, Montana, USA, August 17, 1959. Maximum volume of Earthquake Lake was 102 Mm³ [269]. Photograph was taken after construction of spillway (visible as a light area in the low centre of the debris) had begun (USGS photograph by John R. Stacy)

The best documented case of the construction of a spillway over a rockslide dam is the mitigation of the hazard of Earthquake Lake formed by the Madison Canyon rockslide ($44^{\circ}49'44''\text{N}$; $111^{\circ}25'39''\text{W}$) triggered by the M7.1 Hebgen Lake Earthquake on August 17, 1959 (Figs. 1.2, 1.27; [14, 111, 117, 269]) at an epicentral distance of 32 km. The source rock mass had an in-situ volume of between 21.4 Mm^3 [111] and 29.8 Mm^3 [269] bulking to between 28.3 Mm^3 [111] and 32.9 Mm^3 [269] respectively during emplacement. This corresponds to a bulking factor of between 10 and 32%.

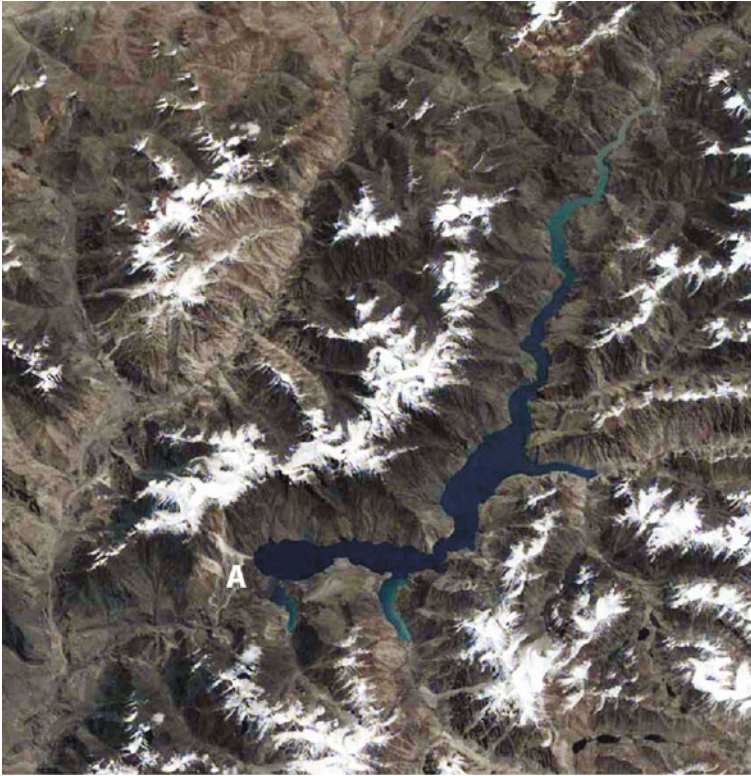
Fig. 1.3 Oblique photograph taken from International Space Station in September 2001 of Lake Sarez, Pamir Mountains, Tajikistan. Lake Sarez is a rockslide-dammed lake impounded by the 1911 Usoi rockslide (A) ([223]; Chap. 7 by Delaney and Evans, this volume). Lake Sarez has a length of ca. 60 km and a volume of ca. 17 Gm^3 (NASA photograph ISS002-E-7524)

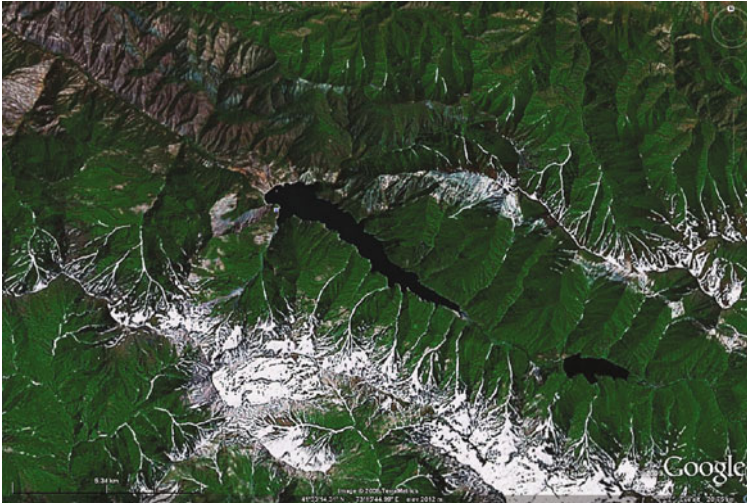
Fig. 1.4 Two rockslide-dammed lakes impounded by rockslides that have occurred along the linear trough marking the strike-slip Fergahna Fault, Kyrgyzstan (Google Earth image). The larger lake, Karasu Lake, is impounded by the Karasu rockslide (est. vol. 250 Mm^3), the slide from the south side of the trough, as described by Strom [257, 258]

Regional studies of rockslides, rockslide dams, and individual case studies of valley-blocking rockslides in the mountainous regions of the world indicate a significant rate of historical rockslide dam formation as well as the widespread distribution of prehistoric rockslide dams (Fig. 1.4). Such studies include work carried out in the Alps [2, 18, 49, 68, 122, 189], the Appennines [22, 26, 194, 216], Sicily [193], Central Asia, including Turkey ([61, 64, 71, 174, 224, 248, 258]; Chap. 7 by Delaney and Evans, this volume), the Himalayas [67, 131, 134, 135]; Chap. 7 by Delaney and Evans (this volume), New Zealand [4, 113, 156, 157, 191, 211, 281], China [30, 124, 172, 173], Japan [147, 179, 204, 245, 261, 262, 264], the North American Cordillera [42, 75, 169, 199, 207, 241, 260] (Figs. 1.2–1.6), Central America [190], the Caribbean [59], and the Andes ([12, 50, 83, 103, 129, 212, 217, 218, 289]; Chap. 5 by Hermanns et al., this volume).

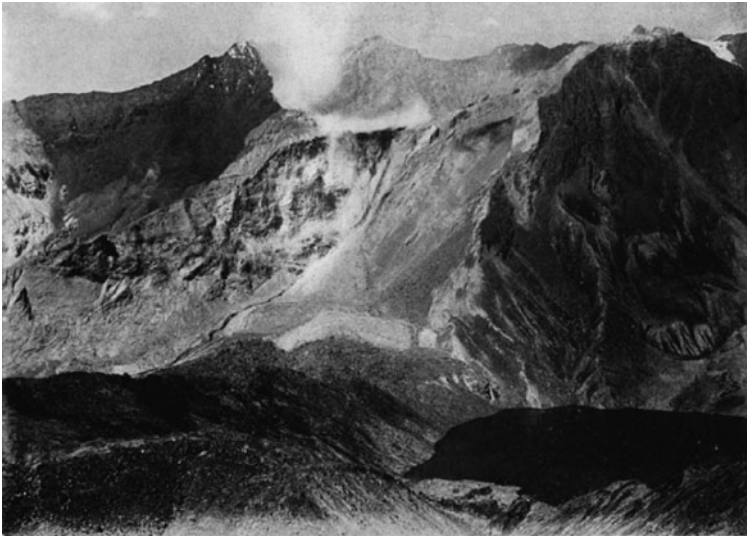
Fig. 1.5 View to northwest of Usoi rockslide scar and debris, Tajikistan, triggered by the 1911 Pamir Earthquake, taken by Sir Aurel Stein in August 1915 (reproduced from Fig. 1.24 in [255]). Clouds of dust are seen rising as rockfalls occur on the rockslide scarp. Rockslide debris (*bottom* foreground and *bottom left*) blocked the Murgab (Bartang) River and rockslide-dammed Lake Sarez can be seen forming at bottom right. At the time of Stein’s traverse over the rockslide, Lake Sarez was about 25 km long and was still “spreading up the valley” (Chap. 7 by Delaney and Evans, this volume)

A rockslide dam impounds one of the largest lakes on Earth, that being Lake Sarez in Tajikistan (Fig. 1.3). The lake is dammed by the 2.2 Gm³ Usoi rockslide (Fig. 1.5 [63, 79, 96, 236, 238]; triggered by the 1911 Pamir earthquake [203, 223, 255]; Chap. 7 by Delaney and Evans, this volume). Lake Sarez currently contains about 17 km³ of water behind the impounding rockslide [259].

As discussed in detail below, rockslide dams are commonly emplaced in major earthquakes (Fig. 1.5). Rockslide dams are also commonly associated with major mass movements on volcanoes (e.g. [23, 271, 280], Chap. 9 by Capra, this volume) when large-scale failures block surface drainage.

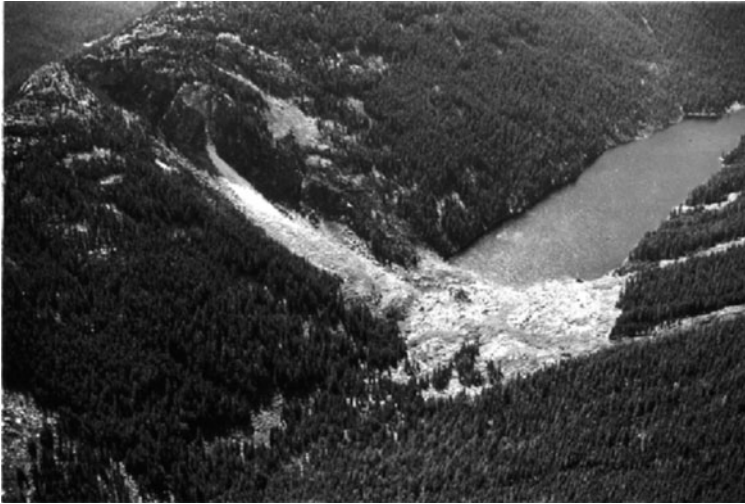
Fig. 1.6 Rockslide-dammed lake in the Coast Mountains of British Columbia formed where a rock avalanche of unknown age has blocked the Nahatlatch River ($49^{\circ} 53' 32''$ N/ $121^{\circ} 50' 19''$ W)

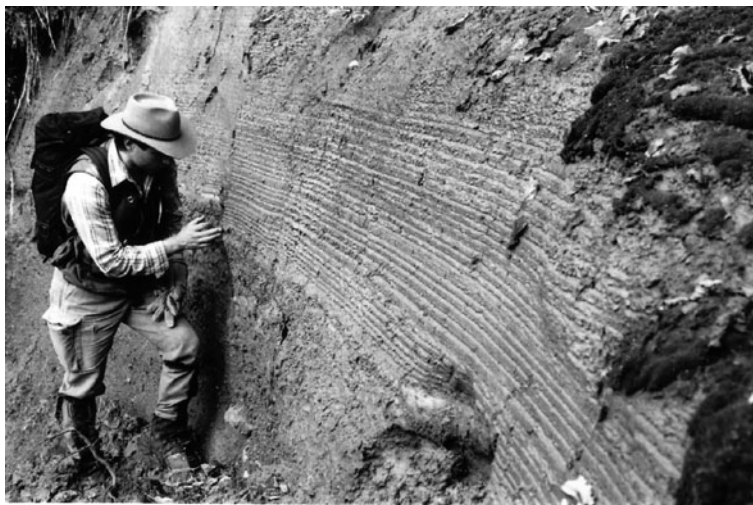
Fig. 1.9 Lacustrine sediments deposited in a lake formed when a flank-collapse of Mount Cayley volcano blocked the Squamish River, southwestern British Columbia. The impoundment was dated to ca. 4,800 y BP [19, 78]

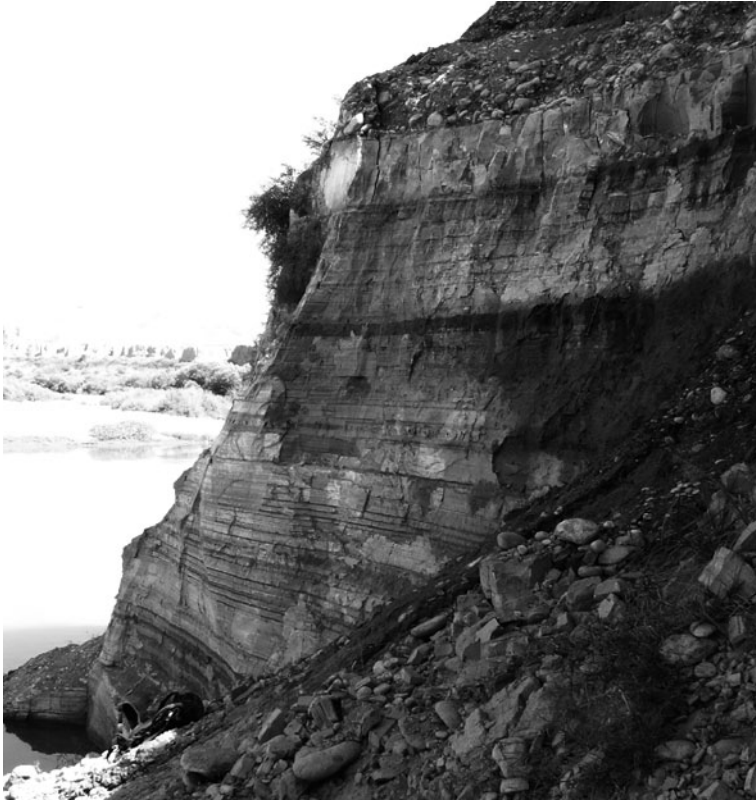
Fig. 1.10 Lacustrine sediments deposited in Saidmarreh Lake which was formed when the gigantic Saidmarreh rock avalanche blocked the Saidmarreh River, Zagros Mountains, Iran [118]. See Fig. 1.33. Photograph by N.J. Roberts, 2006

Cordillera [19, 78, 227, 230], the Zagros Mountains of Iran (Fig. 1.10; [118]), the Himalayas of Pakistan and India (e.g. [20, 85, 86, 87, 134, 135, 206, 214, 222]). These studies indicate that rockslide-dammed lakes can persist in the landscape to the extent that they become important sediment storage sites (e.g. [182]), and, as discussed below, impact on the geomorphic evolution of mountain landscapes (cf. [165, 166]).

Groeber [108] observed the loss of agricultural land downstream of the breach in areas “*where there was once fertile field there is today a rock-strewn wasteland*” (Fig. 1.10). He also predicted that the aggradation in the valley bottom below the rockslide dam would impede any agriculture in the area for decades afterwards, which unfortunately has turned out to be the case.

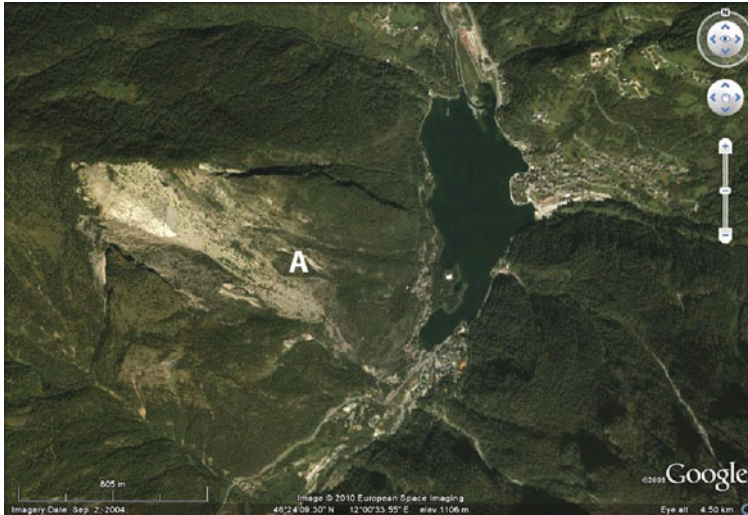
Fig. 1.11 Google Earth image of Alleghe Lake in the Italian Dolomites ($46^{\circ} 23' 56''\text{N}$; $12^{\circ} 00' 47''\text{E}$). Lake formed when rockslide (A) occurred on January 11, 1771 and blocked Cordevole River [68, 182]. Note location of community of Alleghe on rockslide debris

Rockslide dams and rockslide-dammed lakes can become integrated into both the geomorphic and socio-economic development of the landscape even though the rockslide damming event occurred relatively recently. Alleghe Lake (Fig. 1.11) was formed by a rock avalanche (est. vol. 20 Mm³) which blocked the Cordevole River

in the Italian Dolomites on January 11, 1771. A rockslide-dammed lake formed upstream flooding farmland and villages and still exists today (Fig. 1.11). Since 1771 the lake has decreased in areal extent, maximum depth and volume due to sedimentation [182]. Sediment deposition in the period 1933–2001 averaged $37,000 \text{ m}^3/\text{yr}$ [182]. In 1938 the lake was developed for hydro power and a spillway was constructed to regulate lake level. The lake has also developed as a tourist resource. To preserve the aesthetic and engineering potential of the rockslide-dammed lake local authorities have resorted to removal of sediment by dredging [182].

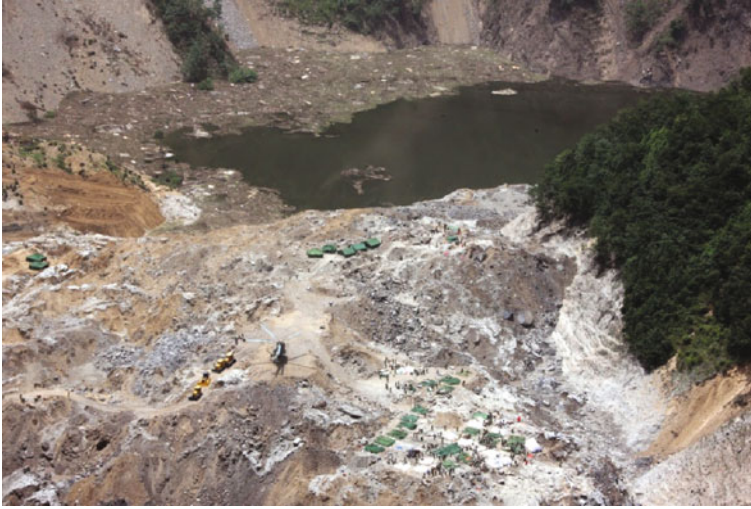
Fig. 1.20 Aerial view of Tangjiashan rockslide dam and lake forming upstream on May 28, 2010 (Day 16 of impoundment). Lake level was approximately 730 m a.s.l. and the lake volume was approaching 200 Mm³, approximately 81% of the maximum volume reached before controlled breaching on June 10, 2008 (photograph by Xinhua News Agency, China)

The largest barrier lake created was Tangjiashan Lake [36, 55] impounded by an earthquake-triggered rockslide at 31° 50′38″N, 104° 25′55″E, 4 km upstream of Beichuan county town on the Tongkou River, Sichuan Province (Fig. 1.20). The damming rockslide was ca. 24 Mm³ in volume and buried the village of Yuanheba

resulting in 84 deaths [177]. The height of the dam was approximately 100 m [142, 176] and the maximum possible reservoir storage capacity, determined by the elevation of the crest of the rockslide dam at 752.2 m a.s.l., was 320 Mm³ [176]. The filling of Tangjiashan Lake is summarised in Fig. 1.21. Tangjiashan Lake posed a significant hazard to communities downstream [176], including the possible flooding of parts of Mianyang, Sichuan's second largest city located 80 km down river. The maximum potential dam break flood was calculated by N. Lui et al. [176] as 46,000 m³/s.

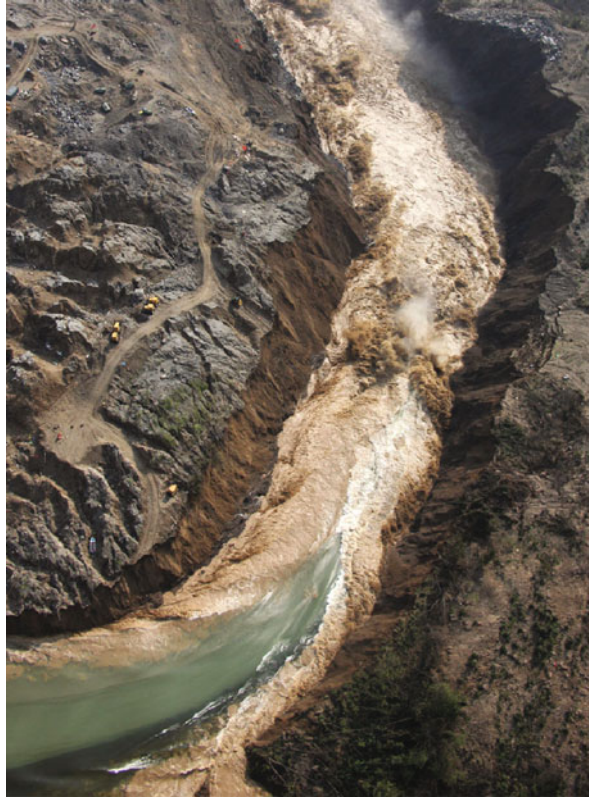
Fig. 1.22 Aerial view of flow in Tangjiashan spillway at about 9 a.m. June 10, 2008, during controlled partial drainage/breaching of rockslide dam. Discharge is approximately $2,000 \text{ m}^3/\text{s}$. Note effects of spillway erosion and construction machinery for scale (photograph by Xinhua News Agency, China)

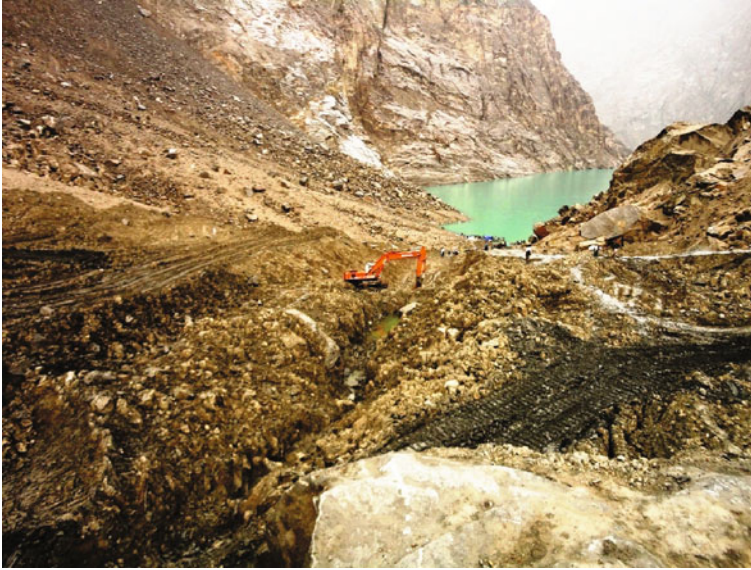
Fig. 1.24 Excavation of spillway in the debris of the Attabad rockslide dam, Hunza valley, northern Pakistan. The Hunza rockslide dammed lake is visible in the background. Photograph taken on April 18 (Day 102 of impoundment) when the lake level was at about 2,405 m a.s.l., 30 m below the eventual overflow elevation (*Pamir Times* photograph)

adjacent to the Hunza, and 22 km of the Karakoram Highway linking Pakistan and China disrupting road travel and commercial traffic between the two countries, as well as disrupting the lives of the inhabitants of the Hunza Valley and region. To achieve an eventual controlled overflow, Pakistan authorities began the excavation of a spillway over the debris on January 29 (Day 25) completing it around May 15 (Day 128) (Fig. 1.24). The excavation of the spillway lowered the effective crest of the dam by around 15 m.

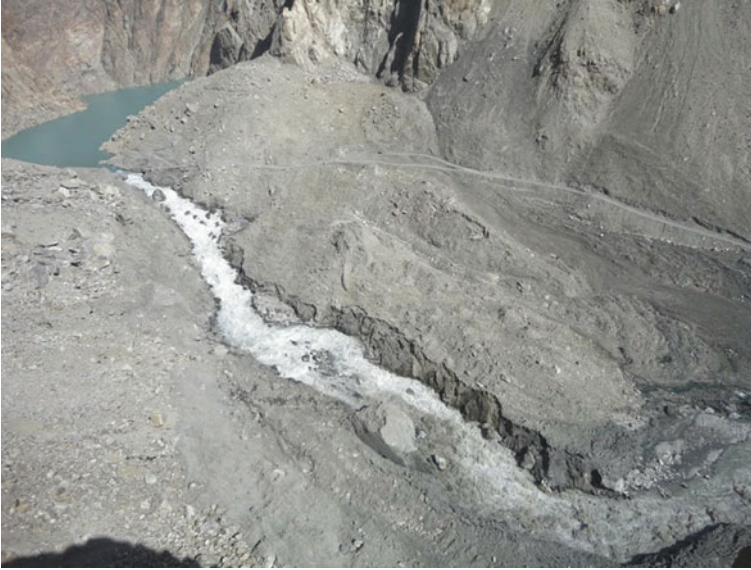
Fig. 1.26 View of spillway over the Attabad rockslide dam on June 14 (Day 159 of impoundment) as stable overflow continued after the May 29 overtopping. Hunza rockslide-dammed lake is visible in the left background (Photograph courtesy of Focus Humanitarian Assistance, Pakistan)

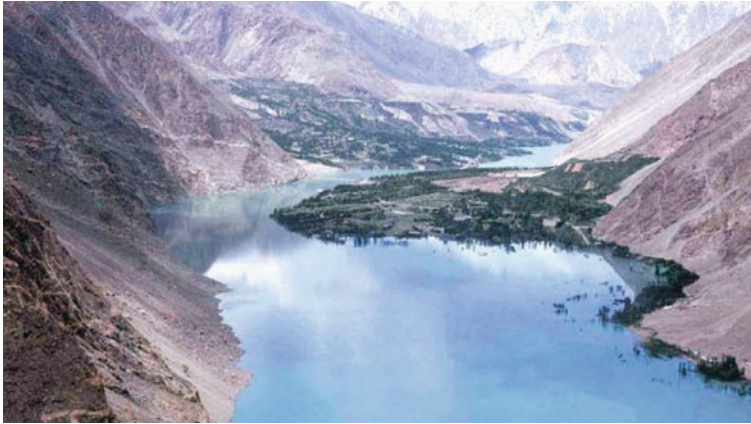
Fig. 2.1 Flooding in the Hunza Valley, northern Pakistan due to the filling of the rockslide-dammed lake impounded behind the Attabad rockslide which blocked the Hunza River on January 4, 2010 [23]. Lake waters submerged several villages, vast areas of agricultural lands adjacent to the Hunza, and 22 km of the Karakoram Highway. Photograph taken on May 28, 2010, a day before overtopping of rockslide dam (*Pakistan Tribune* photograph)

Landslide dams cause two types of floods: (1) upstream (backwater) flooding as the impoundment fills (Fig. 2.1), and (2) downstream flooding resulting from failure of the dam. Although less common than upstream flooding, downstream flooding is usually more serious and may be catastrophic. The world's worst landslide-dam disaster occurred when the 1786 Kangding-Louding earthquake in Sichuan Province, China, triggered a huge landslide that dammed the Dadu River [26]. After 10 days, the landslide dam breached, creating a flood that extended 1,400 km downstream and drowned 100,000 people. A similar disaster resulted from the 1513 failure of a rock-avalanche dam on a tributary of the Ticino River in southern Switzerland. The resulting flood engulfed the city of Biasca with a surge of debris and water that continued down the Ticino valley for 35 km, drowning about 600 people [31]. These are examples of extreme events that probably could not have been prevented even with modern technology. However, mitigative measures can prevent the failure of many landslide dams, or at least can reduce the severity of flooding by reducing the volume of water in the impoundment. These mitigative measures often are combined with hazard warning to downstream communities.

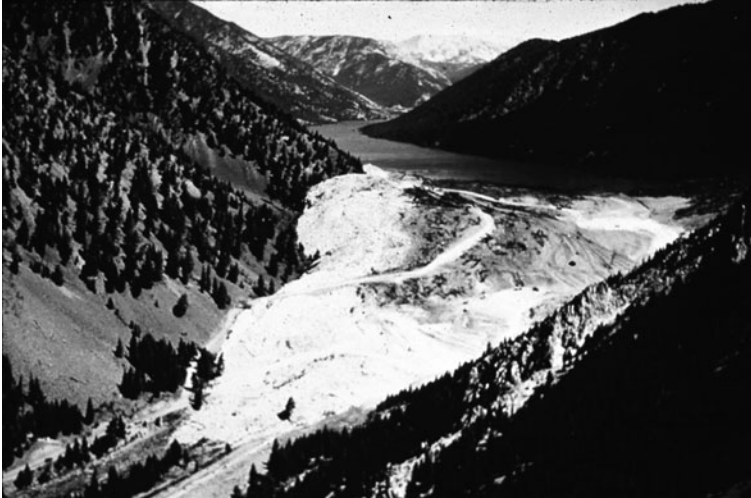
Fig. 2.3 The landslide dam formed by the 1959 earthquake-induced Madison Canyon rock slide, Montana, USA, and Earthquake Lake, which it impounded (Photo by J.R. Stacey, US Geological Survey)

In 1959, the earthquake-induced, 21 Mm³ Madison Canyon rock slide formed a 70-m-high blockage (Fig. 2.3) of the Madison River, southwestern Montana [17]. Fearing an overtopping failure of the natural dam, the US Army Corps of Engineers quickly constructed an open-channel spillway across the crest of the rock-slide dam. This 75-m-wide spillway was designed for a discharge of 280 m³/s and velocities that would only slowly erode the rock-fragment size that comprised the landslide dam [20; Chap. 1 by Evans et al., this volume]. In the 50 yrs since construction of the spillway, erosion has degraded the lake outlet only about 6–7 m.

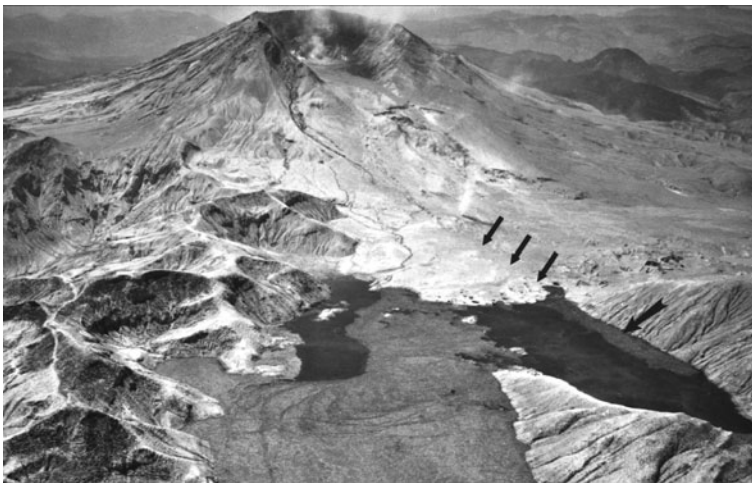
Fig. 2.5 View of Mount St. Helens and Spirit Lake a few days after the 1980 eruption. The crest of the debris-avalanche dam that impounds Spirit Lake (foreground) is indicated by the *small arrows*. The location of the intake portal for the diversion tunnel (Fig. 2.6) through the volcanic-rock right abutment of the dam is indicated by the single *large arrow* (Photo by R.M. Krimmel, US Geological Survey)

As Spirit Lake slowly rose, in November 1982 the US Army Corps of Engineers installed a temporary pumping system to prevent overtopping. The 20-pump facility, with a maximum capacity of $5 \text{ m}^3/\text{s}$, pumped water through a 1,112-m-long by 1.5-m-diameter buried pipe placed across the dam crest [34]. Four possible alternatives were considered for a permanent solution to the Spirit Lake hazard: (1) a permanent pumping facility (2) an open-channel spillway (3) a buried conduit, and (4) a diversion tunnel through the bedrock right abutment. Each alternative was evaluated in regard to (1) stability in relation to the debris avalanche (2) stability in case of volcanic or seismic activity (3) efficacy of construction (4) environmental disturbance of the site, and (5) cost. Based on these considerations, it was decided to maintain permanent lake level at elevation 1,048 m by means of a 2.59-km-long, 3.4-m-diameter tunnel (Fig. 2.6) through the volcanic-ridge right abutment immediately west of Spirit Lake.

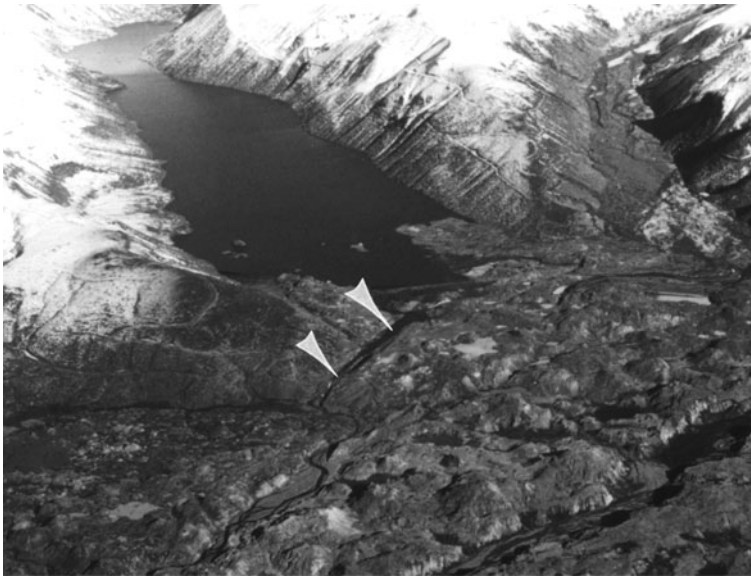
Fig. 2.8 Coldwater Lake and the debris-avalanche blockage of Coldwater Creek, near Mount St. Helens. Location of the excavated channel spillway across the right volcanic-bedrock abutment is indicated by the *white arrows*

Coldwater Creek, a tributary of the North Fork Toutle River, was dammed at its outlet by the 1980 Mount St. Helens debris avalanche (Fig. 2.8) [29]. If it had been allowed to overtop naturally, Coldwater Lake would have developed an estimated

maximum volume of 128 Mm^3 by late 1981 [34]. However, to prevent catastrophic breaching of the debris dam, the US Army Corps of Engineers constructed a permanent spillway for the lake across the erosion-resistant volcanic-bedrock right abutment. This spillway, which continues to function satisfactorily, has stabilized the volume of Coldwater Lake at 83 Mm^3 .

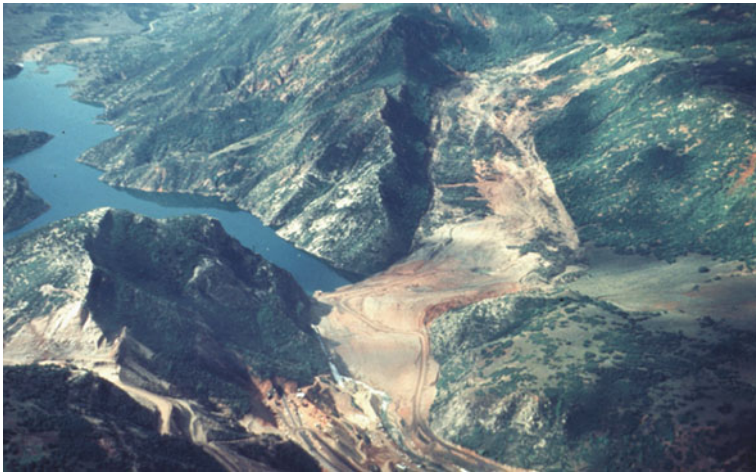
Fig. 2.9 The 1983 Thistle debris slide and its temporary impoundment, Thistle Lake. The lake was drained by a tunnel constructed through the mountain at the *lower left*

The April 1983 Thistle debris slide (volume: 22 Mm³) in central Utah was a reactivation of a prehistoric landslide in sedimentary rocks caused by above-normal spring snowmelt. The debris slide blocked the Spanish Fork River, forming 63-m-high Thistle landslide dam (Fig. 2.9), which impounded a lake with a volume of 74 Mm³ [19]. Upstream flooding submerged the village of Thistle, destroying 15 businesses, 10 homes, and railroad switching yards.

Soon after the landslide occurred, officials of the State of Utah decided to drain the lake to prevent overtopping and probable failure of the natural dam. A temporary 145-m-long, 2.4×3.0-m-diameter, drainage tunnel through the dam at the right abutment was completed on 4 May 1983 to prevent overtopping [5, 19]. Shortly thereafter, it was decided to drain the lake by means of a permanent diversion tunnel through the sandstone right abutment. The plan included (1) a 670-m-long, 4.25-m-diameter, horseshoe-shaped tunnel excavated through the right abutment at stream level, and (2) a 5- to 6-m-diameter vertical shaft from lake level to the upstream terminus of the tunnel. A lake tap was installed by excavating a channel between the lake and the shaft. This channel was deepened sequentially as lake level was lowered (Fig. 2.10).

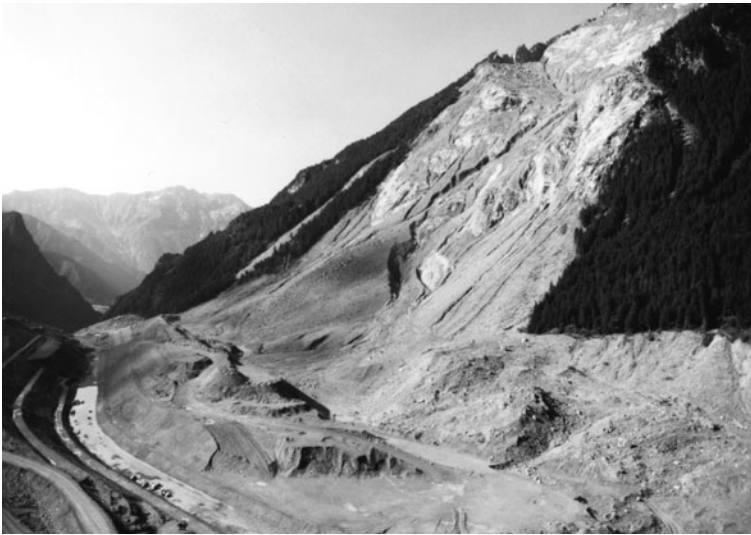
Fig. 2.11 Looking downstream across the 1987 Mount Zandila rock slide–rock avalanche and the Val Pola landslide dam. An open-channel spillway is under construction across the landslide dam. A twin-bore diversion tunnel (Fig. 2.13) passes through the granite bedrock valley wall on the lower left

On 28 July 1987, the 35 Mm³ Mount Zandila (Val Pola) rock slide–rock avalanche (Fig. 2.11) formed a natural dam 30–60 m high, 1,200 m long (normal to the river),

and 2,500 m wide on the Adda River in northern Italy [7, 16]. Because of the danger of breaching of the landslide dam upon overtopping, 80,000 people living downstream were evacuated during August, a 2-km-long open-channel spillway was dug across the crest of the dam, and check dams were constructed on the steeper parts of this channel (Fig. 2.12). As a temporary measure, pumps and siphons were installed to drain Lake Val Pola, a function that was completed by the end of 1987.

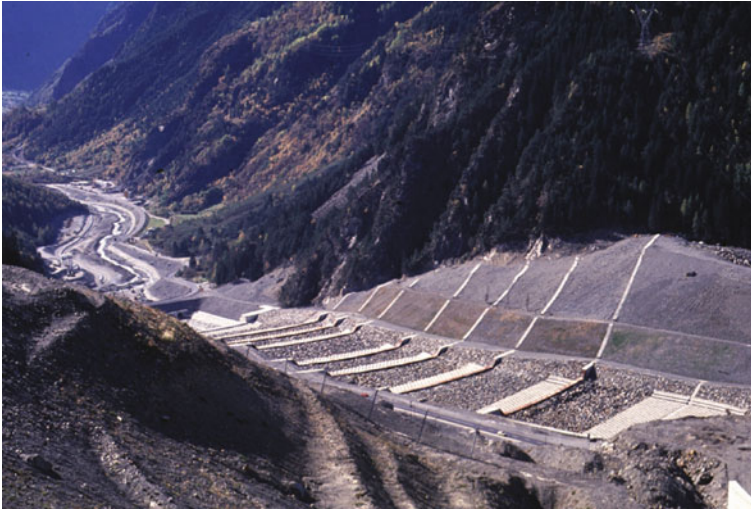
Fig. 2.12 Open-channel spillway, concrete sills, and a check dam under construction on the downstream slope of the Val Pola landslide dam

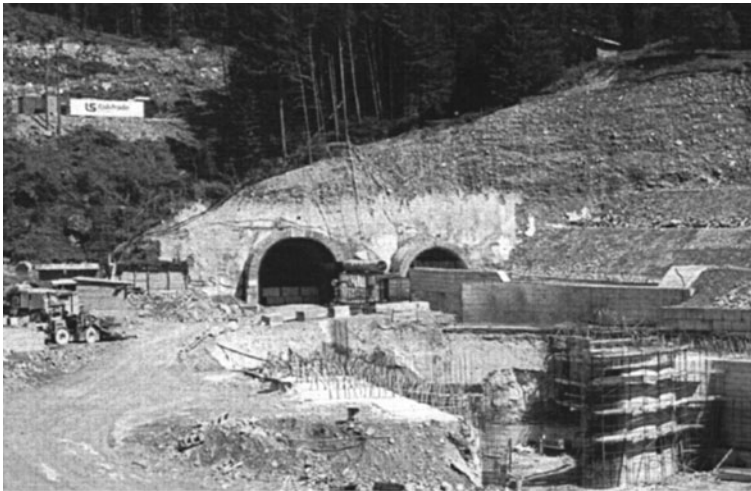
Fig. 2.13 Exit portals for the twin-bore diversion tunnel that carries the Adda River around the Val Pola landslide dam. The tunnel on the right was operational at the time of the photo, and the left-hand tunnel was near completion

Soon after the landslide occurred, construction by drilling and blasting began on two diversion tunnels through the granite left abutment. These tunnels (Fig. 2.13), with diameters of 5.0 and 4.2 m, are 3.5 km long and have a total discharge capacity of 540 m³/s [7]. Because Lake Val Pola had been drained by pumping and siphoning before tunnel construction began, no lake tap was needed. In addition, timing

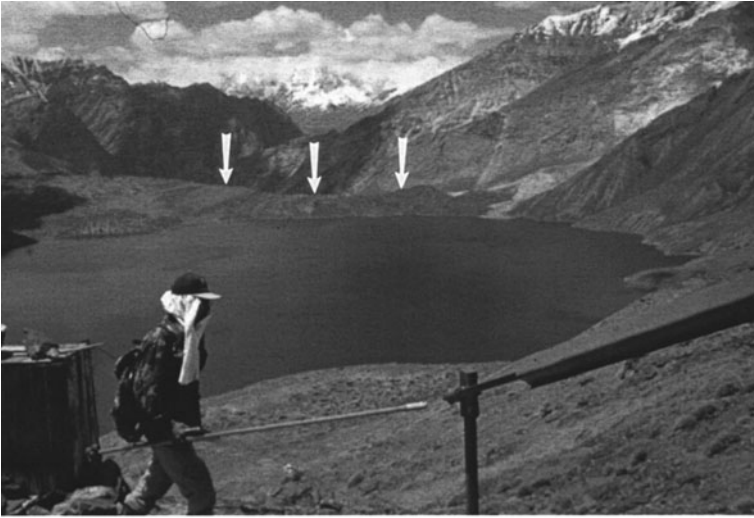
Fig. 2.17 View of the Ussoi rock-slide dam (*arrows*) and the downstream (west) end of Lake Sarez from the right (north) valley wall of the lake (1999 photo by J. Hanisch)

In 1911, the 2 km^3 earthquake-triggered Usoi rock slide blocked the Murgab River, southeastern Tajikistan, forming a still-existing 600-m-high natural dam (Figs. 2.16 and 2.17) – the highest dam, natural or constructed, in the world [2, 36, Chap. 16 by Ischuk, this volume]. Lake Sarez, impounded by this blockage, is 60 km long, with a maximum depth of 550 m and a volume of approximately 17 km^3 . This lake, which has never overtopped the dam, exits the downstream face as a series of large springs that regroup as the Murgab River. Freeboard between the lake surface and the lowest

point on the dam crest currently is approximately 50 m and the lake is rising at an average rate of 18.5 cm/yr. Although the possibility of dam failure is slight, it potentially could result from (1) seismic shaking (2) catastrophic overtopping caused by a landslide entering the lake at high velocity (3) surface erosion caused by natural overtopping by the rising lake (4) internal erosion (piping) (5) instability caused by lake pressure against the dam, or (6) slope instability of the dam faces.

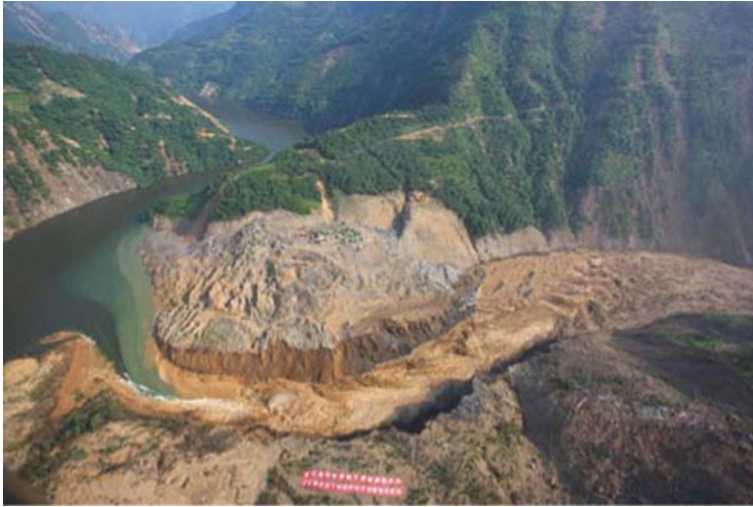
Fig. 2.18 Controlled breaching of Tangjiashan Lake, Sichuan, China taking place on June 10, 2008

The measure most widely adopted by Chinese authorities to reduce both outburst risk and the magnitude of the hazard was the excavation of spillways over the surface of the damming debris. In the case of Tangjiashan Lake, the largest of the rockslide-dammed lakes formed in the aftermath of the earthquake, a major civil engineering operation was involved in the excavation of a spillway. Construction lasted 7 days during which time 135,000 m³ of material were excavated to form the 425 m long spillway. On June 8, the lake reached the elevation of the spillway and overflow began [28]. The volume of the lake at overflow was 247.4 Mm³ compared to a maximum lake basin volume (without spillway) of 320 Mm³, a reduction in maximum lake volume of 23%. Flow in the spillway increased and a controlled partial breach occurred on June 10 involving a breached volume of 160 Mm³ and a maximum discharge of 6,500 m³/s (Fig. 2.18). During the controlled breaching, lateral and vertical erosion of the spillway occurred (Fig. 2.18) but complete catastrophic failure of the dam did not take place. The controlled partial breaching left a significant remnant lake with an estimated volume of 87 Mm³ [28].

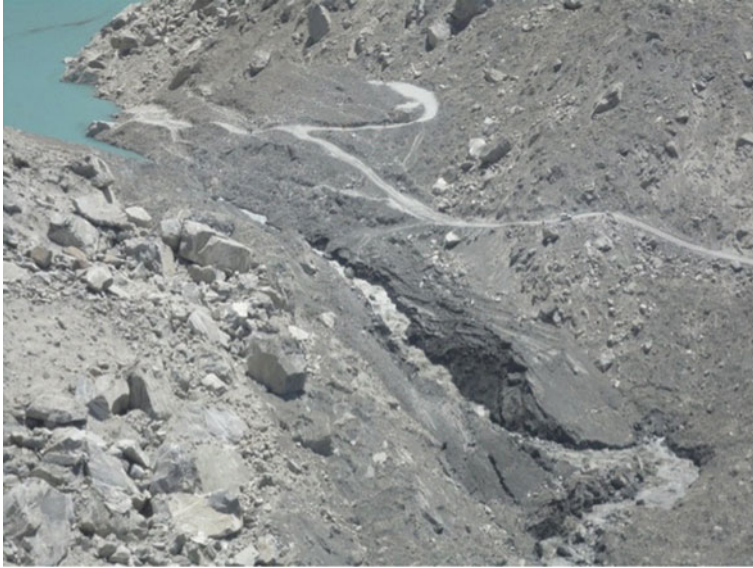
Fig. 2.19 Spillway in Attabad rockslide debris, shortly after overtopping began on May 28, 2010. Note vertical erosion of spillway and retrogression of “knickpoint”. As of July 25, 2010 (200 days after impoundment) stable overtopping continues with lake level more or less unchanged [Photograph courtesy of Focus Humanitarian, Pakistan]

Overtopping of the debris through flow in the spillway occurred on May 29 (Day 143 of impoundment) at an elevation of 2,435 m a.s.l. At this maximum pool elevation the lake area was 9.74 km² and its volume was 430 Mm³ [23, Chap. 7 by Delaney and Evans, this volume]. However, the lake level continued to rise a further 3 m in the 5 days up to June 3, since lake inflow exceeded lake outflow. By June 5, however, the lake level had stabilised (Fig. 2.19) as discharge in the spillway increased. Photographs published by the *Pamir Times* after overtopping show the enlargement of the spillway, first by deepening through headward erosion from the

lowest part of the spillway and then by widening through lateral undercutting and seepage erosion of the spillway walls. As of July 25, 2010 stable overflow through the spillway is continuing and lake level remains about the same as it was at the time of overflow. Whilst lake waters still submerge vast tracts of land in the Hunza Valley the stable overflow has thus far avoided a catastrophic draining/partial draining of Hunza Lake.

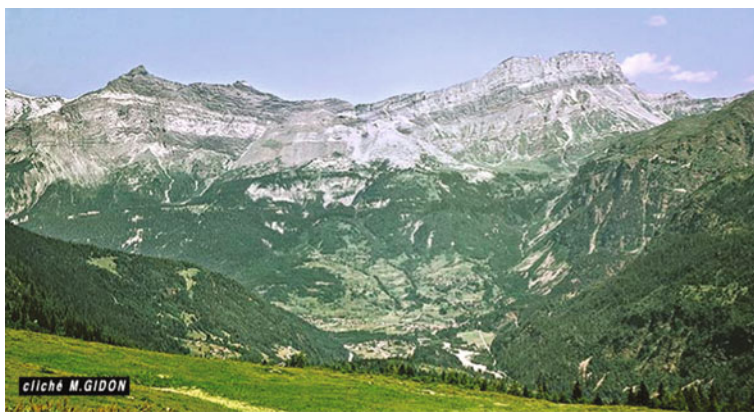
Fig. 3.2 Perspective view on the slides affecting the slopes of the Massif of Platé. The village of Servoz is shown by a star

One of the most ancient reported cases originated below the limestone Massif of Platé, near Mont-Blanc, some 1,500 m above the Arve River (Fig. 3.2). During the early Christian Era a large slide mass blocked the gorge of the Arve, an affluent of the Rhone River, impounding a lake which overflowed, not into the original gorge, but into a parallel gorge of Le Châtelard, some 500 m to the south. The lake seems to have persisted until the thirteenth century, that is more or less 1,000 years, which can be explained by the fact that the initial overflow did not occur on the slide mass itself. The failure of the landslide dam finally reestablished the old course of the river.

In February 1471 a part of the slope failed again, raising the water level some 150 m higher than the river bed, due to the narrowness of the gorge. Before the nearby village of Servoz was affected, its inhabitants excavated a ditch on the slide

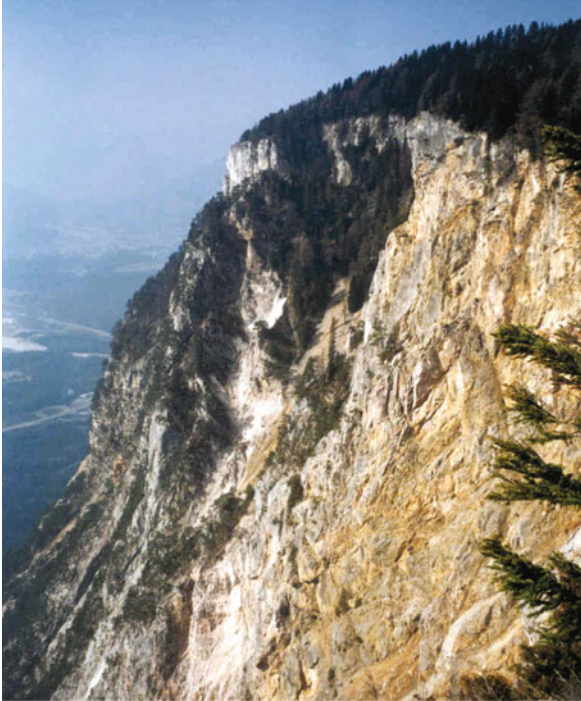
Fig. 3.3 View of the top scarp of the Dobratsch rockslide. Large fissures can be seen in the forest on the top

On January 25, 1348 a significant earthquake shook the Dobratsch massif (el. 2,000 m a.s.l.) and caused large rockslides, one of which, approx. 30 M m³ in volume, along a fault surface dipping 45° to the south, blocked the 2.5 km wide Gail Valley (el. 500 m a.s.l.) (Fig. 3.3). This valley, which corresponds to a major Alpine fault (Periadriatic Lineament) had already been affected by several rockfalls at the end of the last glaciation following the erosion of the toe of the north side of the valley. Several settlements were buried by the rockfall and flooded upstream, and a short time later the dammed lake burst across the dam and devastated the valley below. At present the hydraulic head created by the remaining debris lobe is used in a hydroelectric scheme and villages are developing in the valley despite risks related to the presence of large sinkholes and fissures behind the highest Dobratsch cliff face.

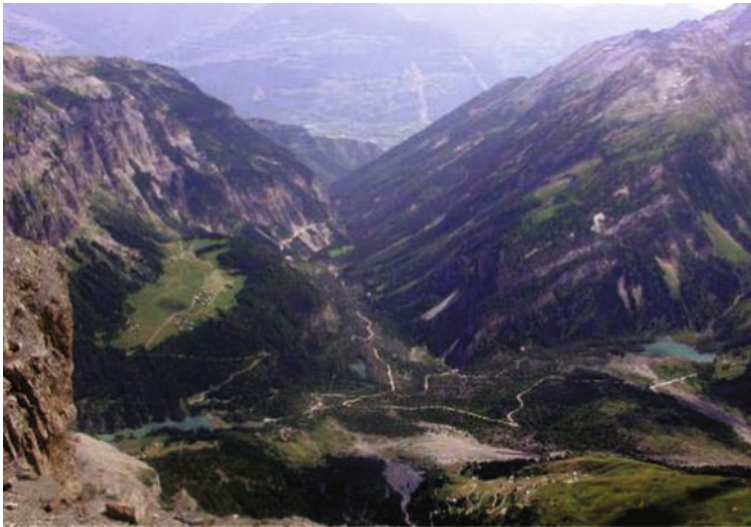
Fig. 3.5 Lower part of the Derborence rockslide as seen from Les Diablerets mountain. The major lake is visible on the right side of the photo

In the same area, a renewed larger failure of some 30 M m³ occurred on July 23, 1749, and moved over a total distance of 5 km, creating the Lake of Derborence at the outlet of a nearby creek called the Derbonne, the Lake of Godey in another creek, which has been raised by a dam built just on the side of the landslide mass, as well as three small lakes just on the side of the landslide mass itself which still exist [9]. The total landslide mass has been assessed by Heim [12] at 50 M m³. Smaller rockfall events occurred later but without major impact. The main natural

lake, still existing today, is now nearly filled with sediment and its depth does not exceed 3 m, so that it no longer represents a threat (Fig. 3.5).

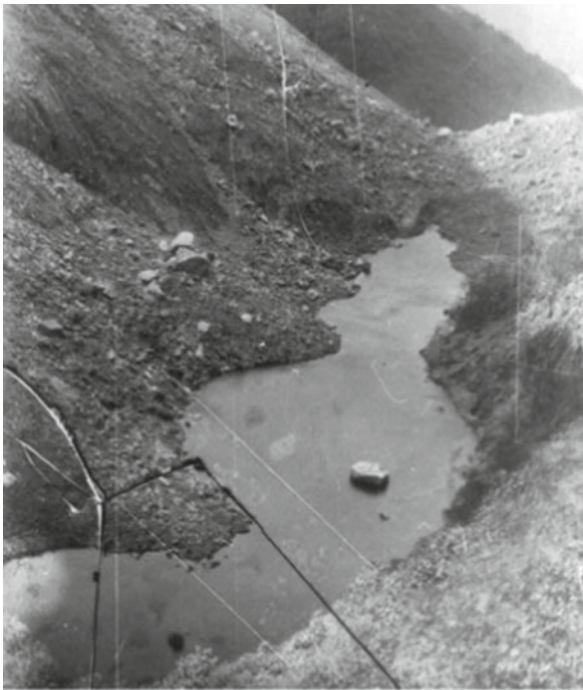
Fig. 3.8 View of the Motto d'Arbino rockfall dam in the Arbedo Valley, taken just after the event, in 1928

The first one refers to the Motto d'Arbino rockfall, located some 20 km south of the Buzza di Biasca (see above), which occurred in October 1928, when 30–40 M m³ of rock blocked the valley of Arbedo resulting in a small lake 1.5 km long (Fig. 3.8 and Case C in Fig. 3.1). Despite several debris flows which reached the village of Arbedo downstream, the gorge formed by the Traversagna torrent was not eroded. Between 1930 and 1950, a 30 m high debris retention dam was built so that the lake is now totally filled with sediments and the former debris course has been occupied by residential buildings. The most interesting aspect of this case is

that, since 1925, a routine triangulation survey on the Motto d'Arbino monument at the top of the mountain showed a clear preparatory movement, which was monitored in detail in 1927 and 1928, supplying the first scientific and duly measured evidence of the acceleration phase before the rockfall [8], allowing the evacuation of the 16 houses that were demolished by the rockfall.

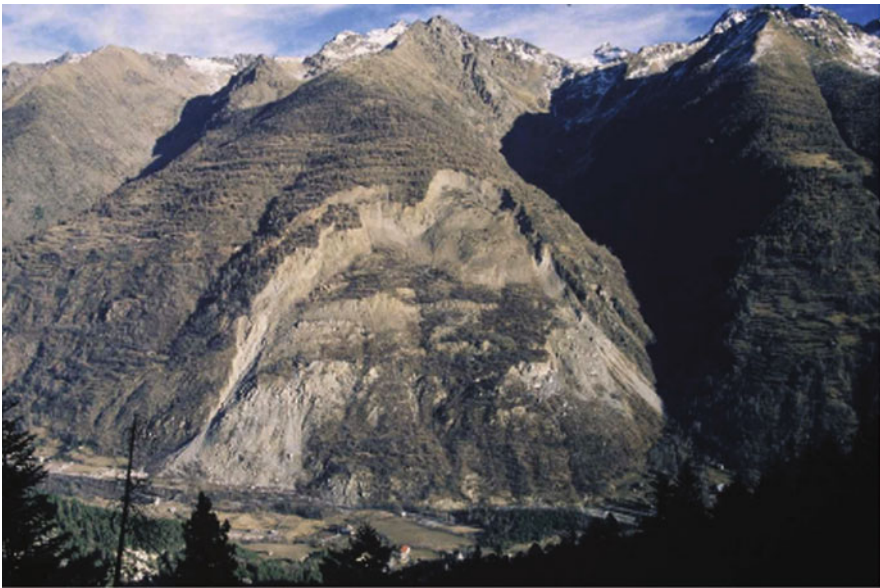
Fig. 3.9 Recent photo of the La Clapière rockslide which permanently threatens the Tinée Valley, north of Nice (photograph supplied by J.-L. Durville)

In the second case, the La Clapière rockslide in the south of the French Alps near the Italian border, the slope movement caused by a large toppling mechanism was first reported in 1976, but despite several critical periods of acceleration, in particular in 1987 and 2001 [Durville, 2002, personal communication, 19], the landslide mass displaced the river bed of the Tinée River towards the west, but never truly dammed it (Fig. 3.9). However, due to the high risks involved for the village of St. Etienne de Tinée immediately upstream and for the highly developed valley downstream, reaching the Mediterranean Sea in the outskirts of Nice, a diversion tunnel was built. The human aspects justified many preventive actions (sophisticated monitoring systems, significant modification of the access road, construction of a long diversion tunnel).

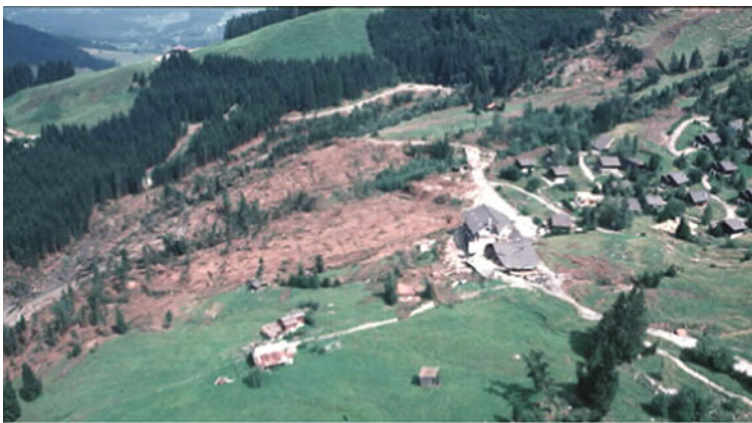
Fig. 3.10 Lower part of the Chlöwena landslide and the destroyed village of Falli Hölli. The lower part of the slide evolved in a mudslide to form a dam in the nearby river

The last recent case worth reporting occurred in August 1994, due to the Chlöwena Landslide [23] which dammed the Höllbach torrent, not far from the city of Freiburg, after a progressive acceleration phase which lasted at least 4 months (Fig. 3.10 and Case D in Fig. 3.1). Even though the lake was of very limited volume, the risk was high as the dam height reached nearly 40 m, as the torrent was known to experience violent floods (hence his name: Höllbach, i.e. Hell torrent) and as there were several industrial plants along the river downstream in the town of Marly.

Due to the progressive movement of the slide (a maximum displacement of 250 m was recorded) and the creation of the dam, time was available for the computation of the formation of the dam with a viscous mechanical model and for the execution of hydraulic model tests to check the overflow conditions. Finally, the flow found its way along the edge of the landslide mass without causing any damage up to the present.

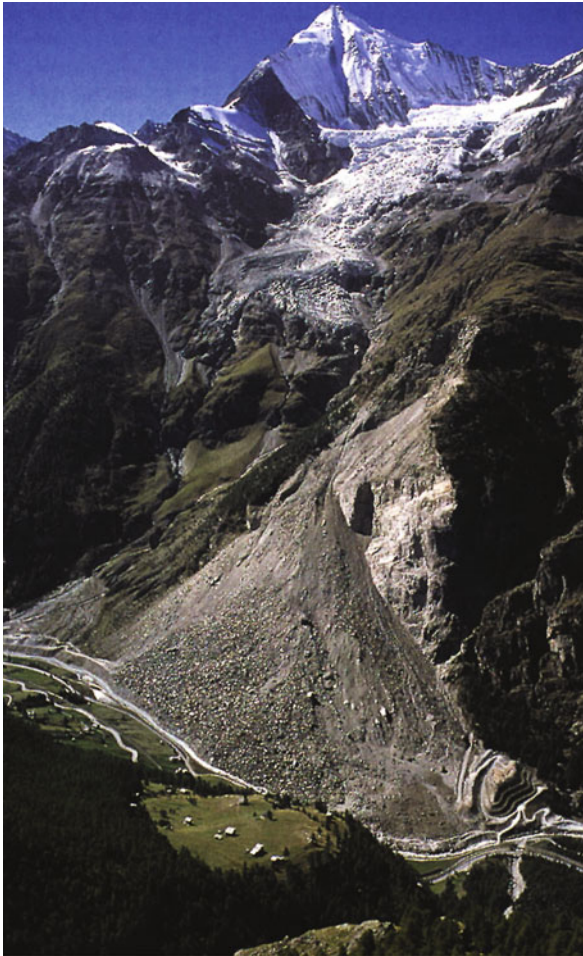
Fig. 3.11 General view of the Randa rockfall causing the damming of the Vispa River. The mitigation works have been already carried out

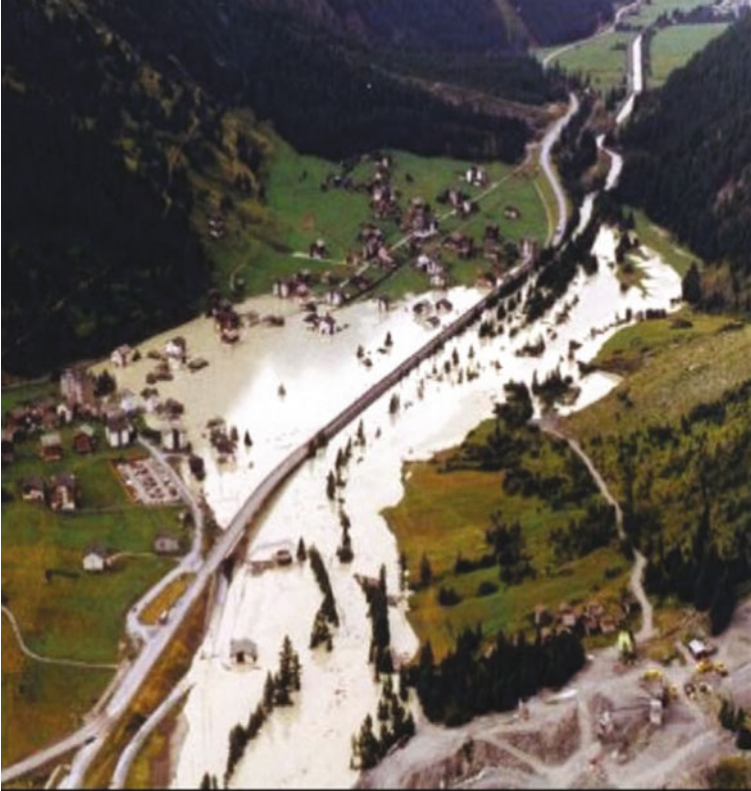
Fig. 3.12 Due to a debris flow which blocked the provisional excavation channel, the plain below the village of Randa was flooded for a short while. The road was maintained by a floating bridge set up by the Swiss army (photograph supplied by CREALP)

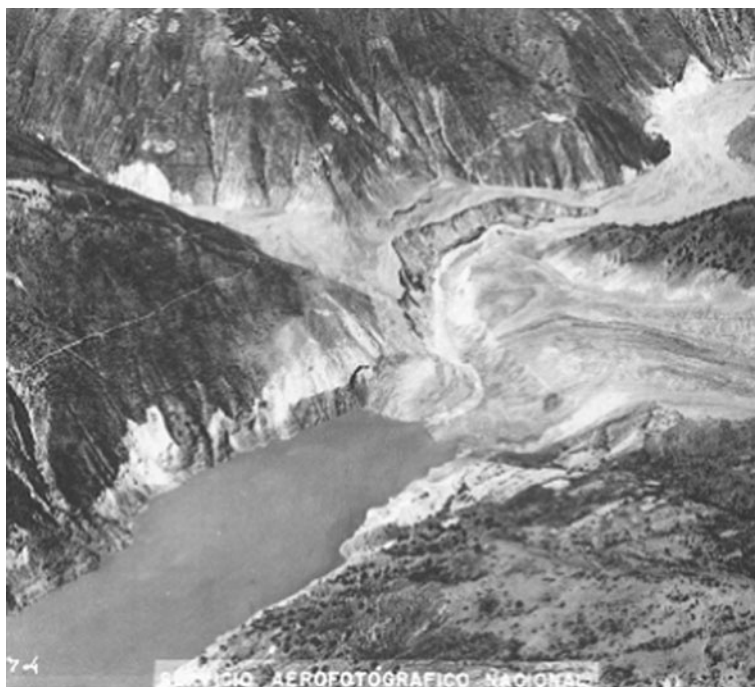
Fig. 3.13 Aerial view of the Mayunmarca landslide dam (from the Servicio Aerofotográfico Nacional del Perú)

The lake was rapidly filled to el. 2,625 m a.s.l. reaching a volume of 670 M m³ and extending about 30 km upstream from the natural dam. On June 8, 1974, 44 days after the rockslide, it breached (Fig. 3.13); the flow had passed first, during the previous day, through a shallow channel up to 3 m deep, which had been excavated by bulldozer over a length of 250 m. The maximum discharge is estimated between 7,000 and 15,000 m³/s, which eroded a deep gorge whose longitudinal profile had an inclination of not more than 1.5° (Fig. 3.14).

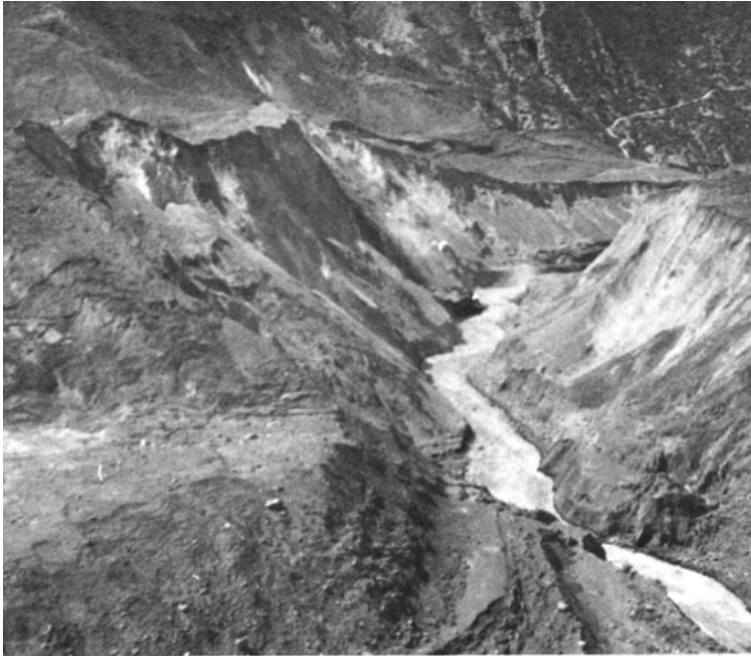
Fig. 3.14 Erosion gorge in the Mayunmarca Landslide dam after the outflow, more than 100 m deep
