Natural and Artificial Rockslide Dams

The Formation and Behaviour of Natural and Artificial Rockslide Dams; Implications for Engineering Performance and Hazard Management

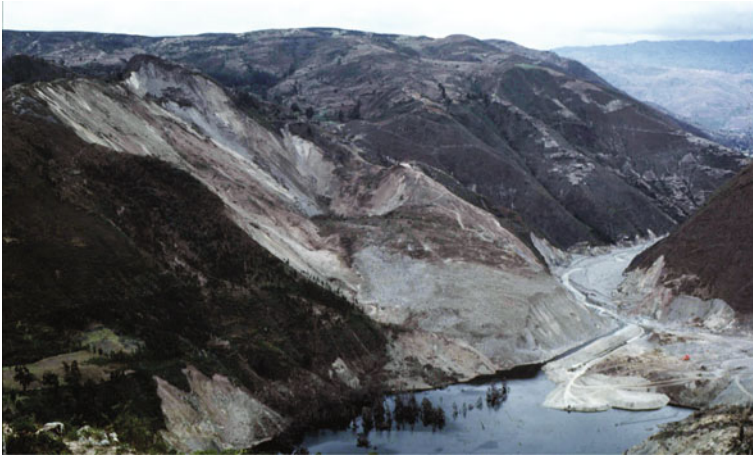
Fig. 3.15 View of the La Josefina landslide dam, some months after breaching. A deeper artificial channel was excavated to decrease the level of the residual lake

On May 1, 1993, the flow in the channel rapidly increased the erosion so that nearly 90% of the reservoir was emptied in 10 h with a maximum discharge of 8,000–10,000 m³/s, causing major damage to the communities of Gualaceo and Paute downstream, but no fatalities (Fig. 3.15). The most important hydro-electric plant of Ecuador, located downstream and which had been partially emptied during the month of April, was rapidly filled with water and sediments (equivalent to 1 year of normal siltation) and the spillway could safely evacuate some 4,500 m³/s at the maximum, saving the dam. The only major damage was the destruction of the platform in front of the entrance to the underground power plant, so that it was made inaccessible by vehicles.

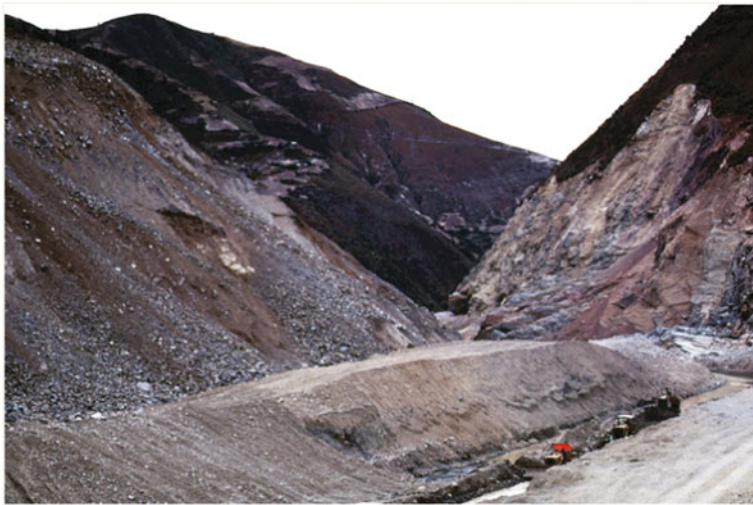
Fig. 3.16 Excavation of a new channel in the landslide mass after the May 1st, 1993 overflow. The unstable left slope that required a stabilizing scheme can be observed

the reconstruction and provide all the affected persons with partial help depending on the resources gathered through national and international assistance. One of the mitigation actions included the excavation of a new channel in order to decrease the level of the upstream residual lake and the stabilization of the river bed downstream to limit river erosion (Fig. 3.16). It was only after these preventive measures that the road in the valley could be rebuilt.

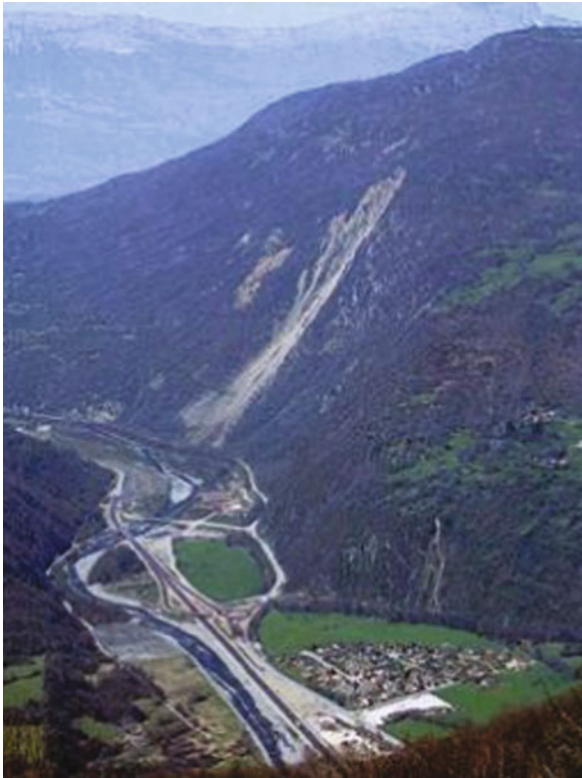
Fig. 3.17 Zone of impact of the Séchilienne rockfall

A good example of these preventive actions is given by the Séchilienne Landslide in the valley of the Romanche River as already mentioned above in Section 2.1 (Fig. 3.17). The evidence of increasing movements in the slope from 1985 perceived by the fall of individual blocks and the evolution of the morphology led the authorities to develop extensive monitoring systems, to change the layout of the exposed national road leading to important tourist resorts and to create a new river bed protected by a dam, to retain a limited volume of rockfall material [6]. As the monitoring results after some years led to the conclusion that the potential rockfall volume could be larger than expected, a tunnel was built to allow a partial diversion of the river flow in case of the formation of a landslide dam. Finally, detailed modelling of the formation of the dam, studied by two different dynamic approaches, allowed the determination of the dam height for several scenarios and thus the analysis of the flow conditions downstream. Other preventive measures are still being studied in order to limit the impact of the eventual flood wave on the city of Grenoble and its surroundings, where the presence of important industrial plants imply very high indirect risks.

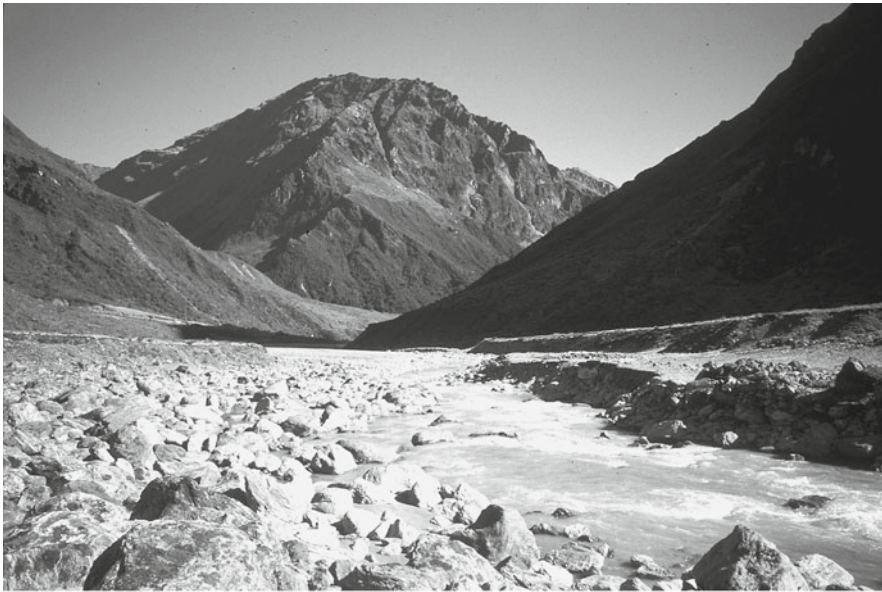
Fig. 4.8 Downstream view of remnant of deep-seated rockslide ($V_L \sim 22 \times 10^6 \text{ m}^3$) on Dart River near Dart Hut (#78, Fig. 4.2), ESA (February 2001). Repeated rock-slope failure at this site may have caused short-lived river blockage several times

Similar geomorphic impacts on river channels are common in the WSA, where large deep-seated rockslides have diverted river channels around their toes without creating persistent or well-defined blockage. At several such occlusion sites, fluvial trimming has oversteepened landslide toes, and triggered nested secondary rotational failures. Blockage of rivers by these secondary failures is interpreted to be mainly ephemeral and in close feedback with fluvial erosion, where no major obstructing deposits remain (Fig. 4.8).

III dams [4]; and (b) Deep-seated, low-displacement, suspended or chronic, often sackung-type failures causing river diversion and occlusion around their toe zones. This type of landslide-induced river occlusion not always forms cross-valley barriers, though may involve ephemeral blockage through nested secondary rockslides or large surficial debris flows (Fig. 4.8).

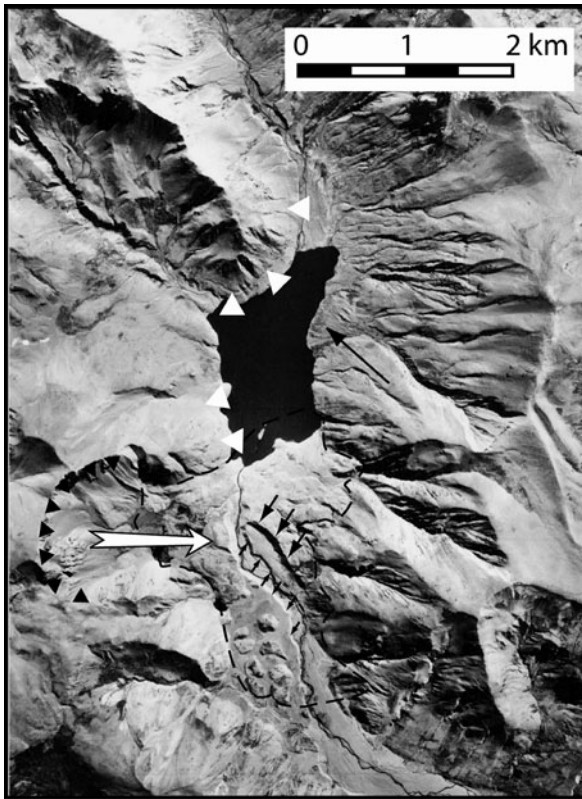
Fig. 5.13 Air photo with interpretation of Navarrete Lake and partially eroded rock avalanche dam (*dashed line*) after [31, 41, 42]. It is interpreted that the dam breached in a catastrophic event as indicated by the steep walled canyon eroded into the crown of the rock avalanche deposit (*large black arrows*) and the inundation surface spanning the entire width of the valley surrounding highest hummocks of the rock-avalanche deposit downriver the canyon, which in turn is cut by a steep walled gorge (*small arrows*). A palaeoshoreline surrounding the lake at a relative elevation of 40 m (*white triangles*) indicates that the lake level was stable for a long time before dam failure. A possible reason for failure is landsliding into the lake by a massive debris flow from the E-side of the lake (*large black arrow*), generating a displacement wave overtopping the dam crown and causing intensive erosion of the dam. This debris flow deposit appears to be young and does not show the palaeoshoreline; hence it was deposited simultaneously with or subsequently to dam failure

Miocene volcanic rocks and tephra deposits of basaltic to dacitic composition dipping with an angle of $\sim 5^\circ$ towards the valley [31, 41, 42]. The landslide dam is partially eroded and drainage of the lake occurs through a 40-m-deep steep-walled canyon. Below that canyon there is a flood surface spanning the entire width of the valley and covering also the down-valley part of the hummocky rock-avalanche deposit (Fig. 5.13). The inundation surface is dissected itself by a steep walled gorge. Lake Navarrete is surrounded by a palaeoshoreline 40 m above the present lake level indicating that the lake level was stable for a prolonged time at

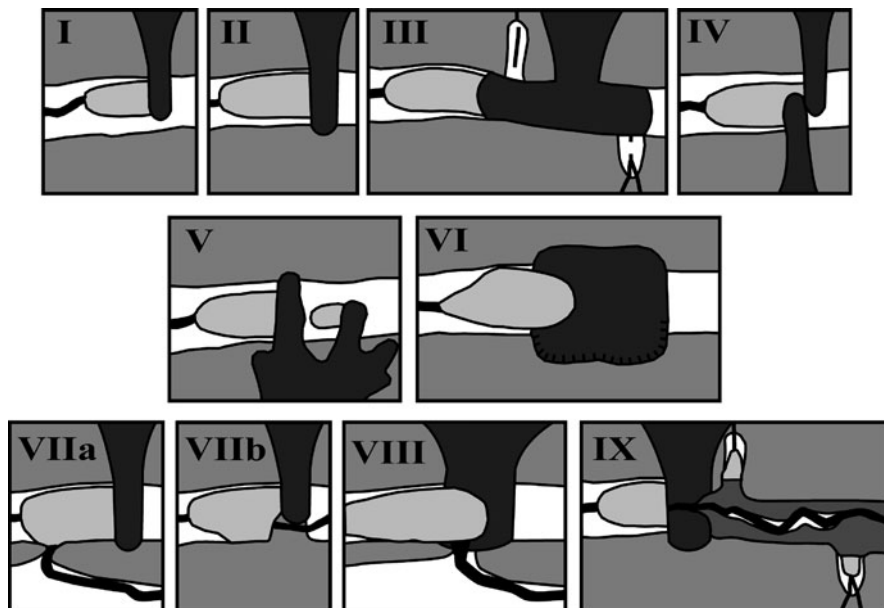
Fig. 5.19 Landslide dam types I–VI after Costa and Schuster [2] and new proposed dam types VIIa–IX

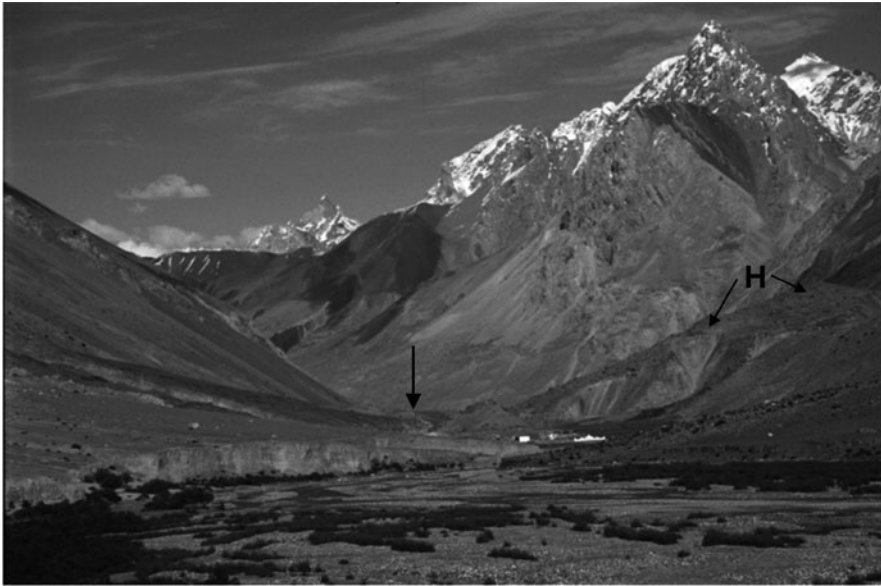
Fig. 6.2 Topographic interference and barrier form. A view looking downstream to the Ziarat rock avalanche barrier in Chapursan Valley, Hunza. The rockslide descended from the valley wall to the left of the photograph. Run up of some 150 m on the right, opposing flank, emplaced the bulk of the mass there ($H = \text{Hauptanglage}$). The flats around the white building, a shrine to a holy man, record the former lake bed. Overflow and breaching were in the lowest, proximal part of the barrier (*arrow*), below the source slope [29]

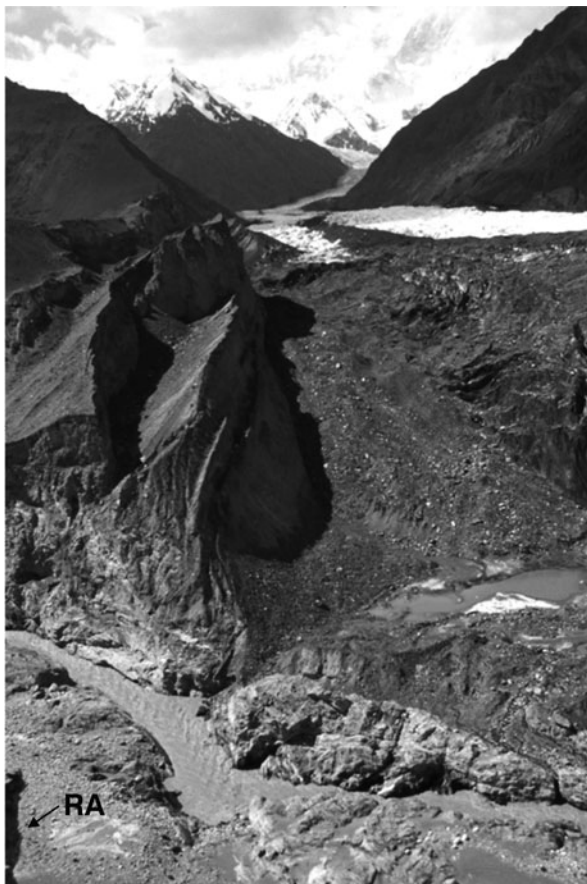
Fig. 6.3 A hybrid rock avalanche-glacier dam in Shimshal Valley. The view looks along the lateral moraine complex and ice of the Malangutti Glacier which extends across the main Shimshal River valley. The view is taken from remnants of the rock avalanche (RA), which descended from the rock slope behind to seal the dam. It spread over the ice, and moraines to the left of the picture. Remnants of extensive, deep lacustrine sediments occur upstream. In the foreground the Shimshal river is superimposed in bedrock within a complex pattern of overflow and breaching

avalanches were, however, decisive in sealing the dam and creating relatively long-lasting impoundments. This applies to the best-known cases at the termini of the Batura and Malangutti Glaciers in Hunza, although they have always been attributed solely to the glaciers. In each case the rock avalanches, descending from rock walls undercut by the ice tongue or river forced against them by the glacier and ice-margin deposition, sealed the narrows at the upstream flank of the terminus (Fig. 6.3).

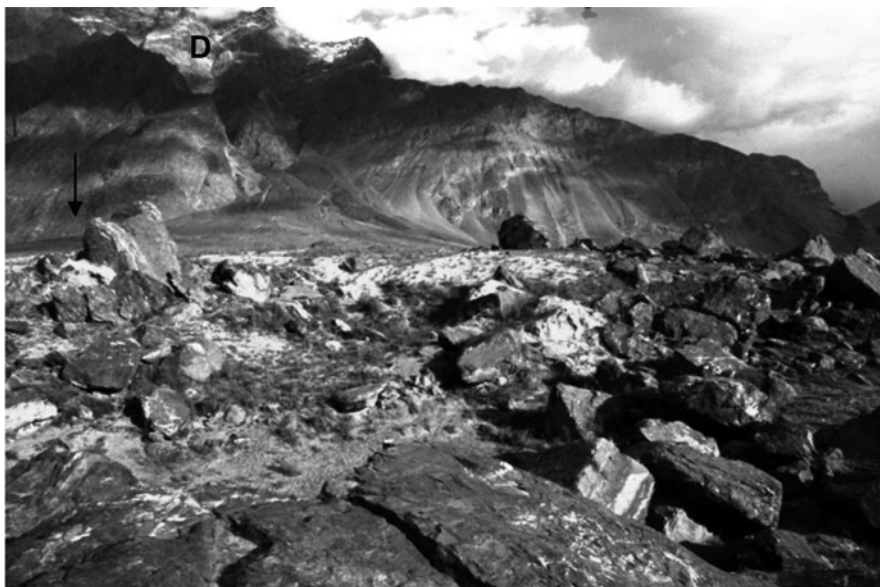
Fig. 6.4 The Yarbah Tsoh hybrid dam, Shigar valley, Baltistan. The view looks over the surface of the dam from the distal rim towards the detachment zone of the landslide on the distant Marshakala Peak (D). In the foreground is rock avalanche debris that skidded over or ploughed into (arrow) the fine-grained alluvium of the valley floor. Unseen parts of the rock avalanche sliced under the alluvium creating complex folding, thickening and transporting it in the direction of movement

In the wide, sediment-filled intermontane basins of Skardu and Shigar, Baltistan, ten rock avalanches are known that traveled into shallow lakes, over former lake beds, or extensive, braided river reaches [27]. Some descended over large, low-angle sediment fans and fan deltas. In fact, the visible valley fill was impounded behind other, older rock avalanches; in particular the Katzarah event blocking the exit from Skardu Basin. In each case there were complex interactions with, and transport of, deformable substrates [27, 29, 30]. As a result, thickened zones and transported substrate masses, were important elements of the cross-valley barriers (Fig. 6.4).

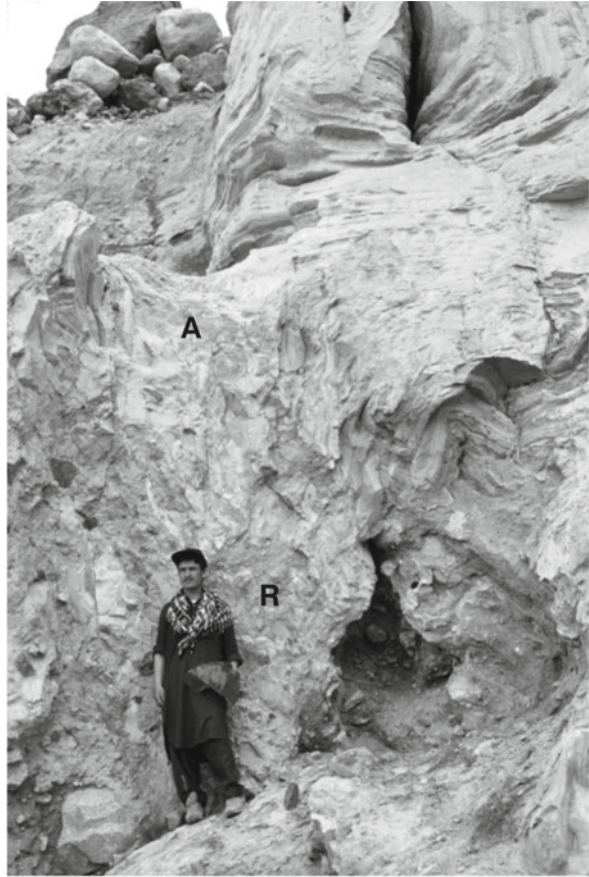
Fig. 6.5 Disturbed (“tectonised”) and transported valley fill alluvium (A), mixed with rock avalanche material (R). This is part of the former, Gomba Thurgon landslide barrier on the main Indus River in Skardu Basin [27]

In some cases, melange-like regions developed with rock avalanche and substrate materials chaotically interspersed and mixed (Fig. 6.5). The geometry, stability and fate of these barriers differ from those of rock avalanche materials alone (see below).

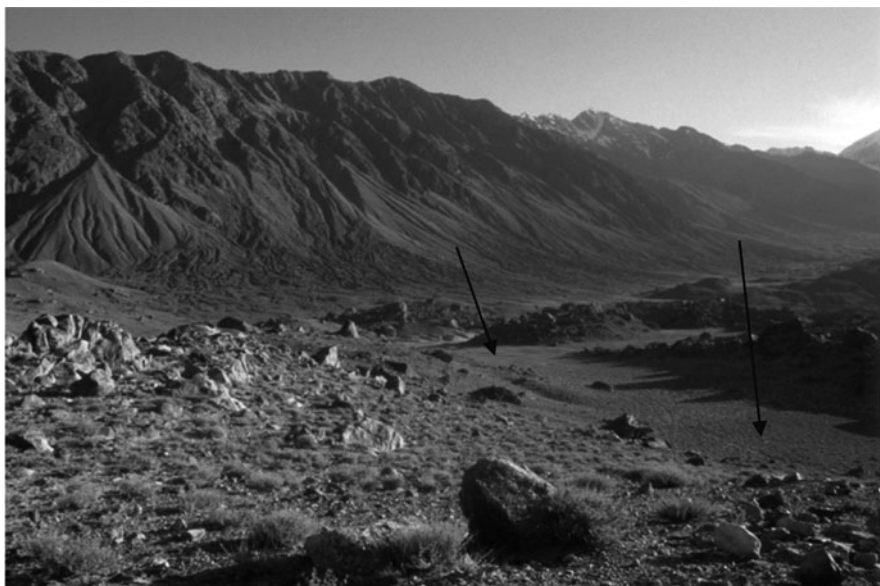
Fig. 6.8 Well-preserved initial overflow channel (*arrows*) of the Gakutch rock avalanche dam on the Gilgit River. Thick deposits of lacustrine sediments on the upvalley flank indicate the spillway operated for some decades at least. It was replaced by a breach against the proximal valley wall to the right of the photograph. The outflow is now in a rock gorge superimposed on a bedrock spur (see text Sect. 4.4.)

At first, overflow channels reflect dam morphology, generally where the lowest part of the cross-valley barrier lies, hence the importance of rock avalanche emplacement (Fig. 6.8). A number of the Upper Indus dams preserve evidence of initial drainage and breaching sequences; for example, the Litak, Gol-Ghone “B” and Haldi events in Baltistan, the Nomal and Gakutch events on Gilgit River, and Miragram-Parwak and Barok-Laspor in Chitral [25, 26, 29, 30]. Equally, however, the preservation of the spillways itself shows how, in the later stages of breaching, barrier surface morphology can become irrelevant. In each of the cases just cited, the main breach developed elsewhere, usually along one or other valley flank between the rock wall and rock avalanche debris. This applies quite widely and probably relates to the fifth possible path, seepage and piping through or beneath the barrier. Breaching, percolation or piping along one or other valley wall, or sapping and erosion of the down valley flank, which seem rare in early stages can become decisive later. They replace the initial, topography-related overflow channels, by a cut along either the proximal (e.g. Satpara Lake, and Gol-Ghone “B”) or distal rim (Dulung Bar-Darkot, Rondu Mendi). Water seeping along the bedrock-rock avalanche interface may reflect a less firm seal there. In several of these examples, erosion has

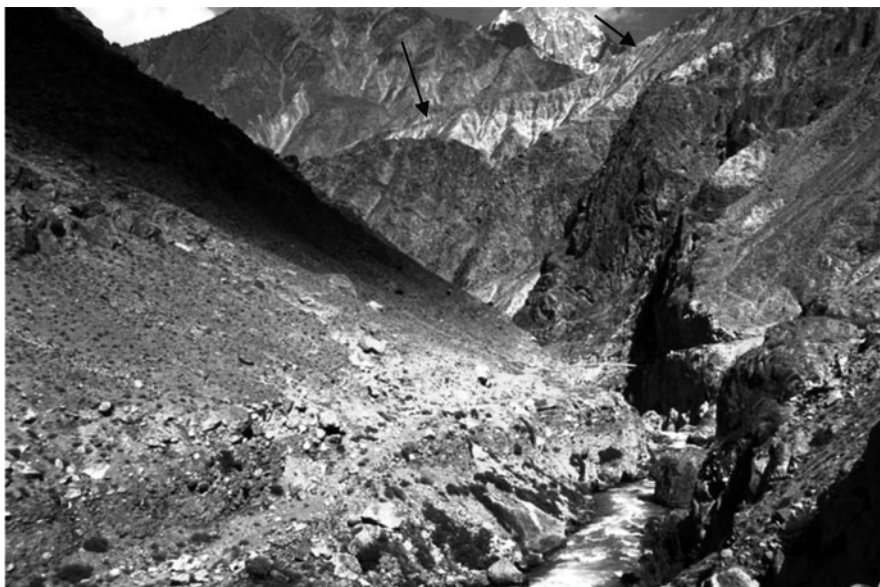
Fig. 6.10 Epigenetic gorge where the Naltar River was deflected and superimposed on bedrock of its left flank by the Nomal rockslide complex (*arrows*). The river makes a sharp turn to the left creating an anomalous junction, entering the main Hunza River facing upstream. Its original channel is buried under the landslide [28]

Another significant and not uncommon development involves spillways superimposed upon bedrock flanks or spurs of the pre-existing valley. The size and morphology of rock avalanche dams make it unlikely an overflow channel will exactly match the buried river's course. As a result, spillways can be let down on bedrock spurs to create superimposed or "epigenetic" gorges [26]. If this happens, rather than the landslide barrier, the bedrock gorge comes to control lake drainage, the trenching and movement of upstream sediments (Fig. 6.10). Some 45 of these epigenetic gorges have been identified with rock avalanche dams (Table 6.1).

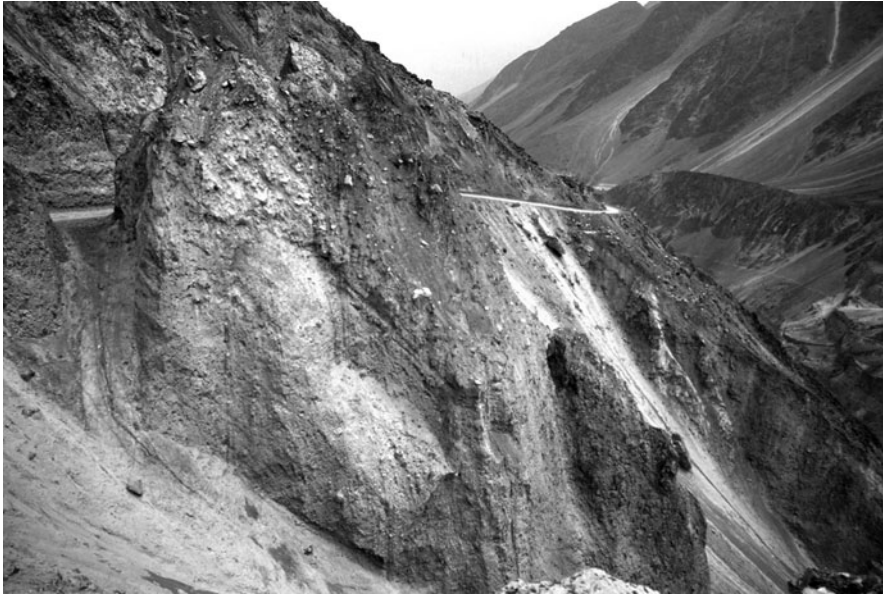
Fig. 6.11 Mountain road cut through a rock avalanche, the Bilchar event, in Bagrot valley, Gilgit District. The vertical cuts testify to the strength and compaction of the rock avalanche material, but rainfall and snowmelt can generate sudden collapses or debris flows at the surface. The landslide once formed a dam on the Bagrot River [28]

Major significance has been accorded to the hazards of slope instability and mass movements along highways [41]. However, past hazard assessments had also missed the role the degraded rock avalanches and related features as sources of these problems, notably unstable material contributing to debris flows (Fig. 6.11).

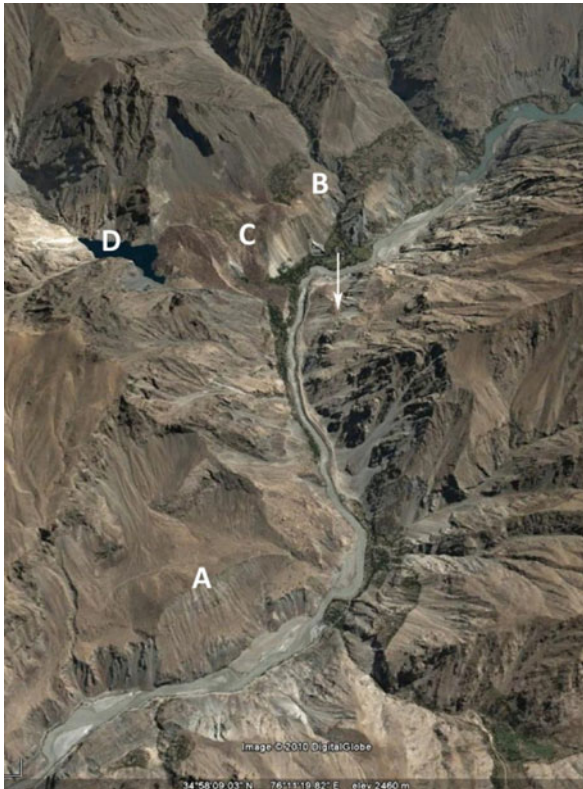
Fig. 7.5 Typical example of complex valley fill deposits in the Upper Indus basin, northern Pakistan. Previously unmapped deposits include (1) older rockslide deposits at A and B that both dammed the Indus River, (2) younger rockslide deposits (C) that have dammed a tributary forming a rockslide-dammed lake at D and ran up the opposite valley slide to a limit indicated by *vertical arrow*. This rockslide also dammed the Indus. Length of Indus (flowing from top *right* to bottom *left*) seen in image is 13 km. *Google Earth* image at $34^{\circ} 58' 09''\text{N}/76^{\circ} 11' 19''\text{E}$, 65 km SW of Skardu. Locality is indicated in Fig. 7.3

The deep valleys of the northwestern Himalayas and the adjacent Pamirs frequently contain complex valley fills characterised by chaotic rubbly debris (Fig. 7.5) as well as stratified silts (e.g. [10]). The interpretation of these deposits as remnant rockslide debris and lacustrine sediments deposited in rockslide-dammed lakes only became established after work by M. Fort and co-workers [24, 25] and K. Hewitt

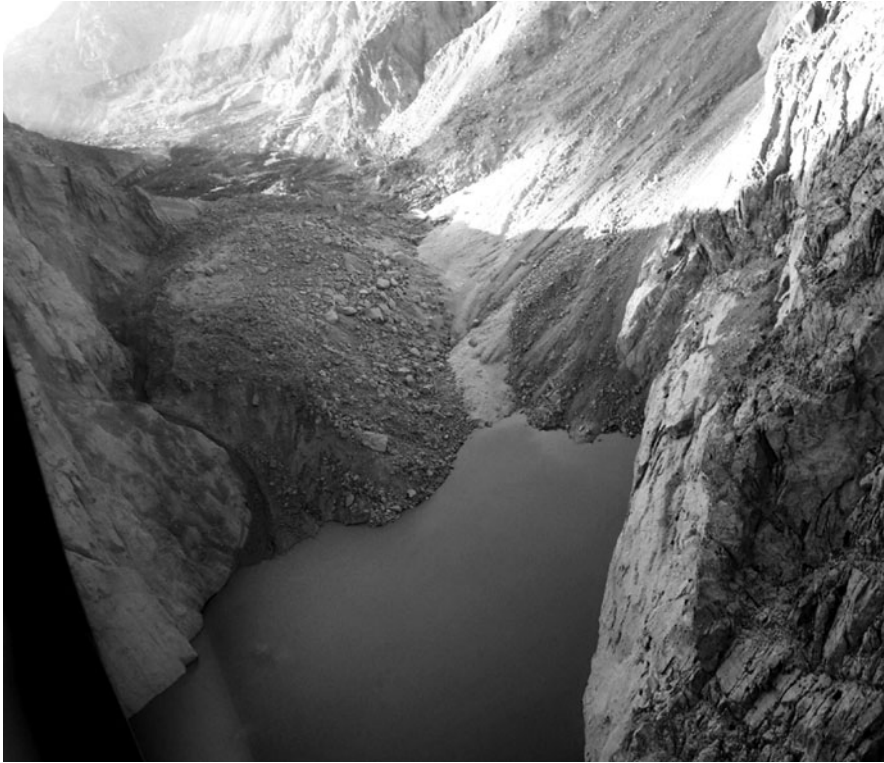
Fig. 7.11 Aerial view of Attabad rockslide (est. vol. 55 Mm^3) that blocked the Hunza River, northern Pakistan on January 4, 2010. Rockslide slid from right. Rockslide-dammed lake is filling behind the debris on January 17 (Day 13 of impoundment). View is downstream. [*Pamir Times* photograph]

A second major rockslide (the Attabad rockslide) blocked the Hunza River [47] at about 13:00 h on January 4, 2010 at a location ($34^\circ 18' 24''\text{N}/74^\circ 49' 17''\text{E}$) (Figs. 7.1 and 7.11) only 2.5 km upstream of the 1858 blockage described above. In 2010 the rockslide originated on the north side of the Hunza valley and the volume of the debris is estimated to be in the order of 55 Mm^3 . The rockslide mobilised valley fill sediments from the valley floor of the Hunza that liquefied and travelled as a rapid mudflow over the valley floor up to a distance of 2.7 km downstream. Part of the mudflow debris swept up the valley side overwhelming part of a village downstream of Attabad, killing about 20 people (Fig. 7.1). The rockslide blocked the Hunza River and a rockslide-dammed lake (Lake Gojal) immediately began to form upstream. The elevation of the Hunza River at the blockage site is estimated from our SRTM-3 DEM at 2,325 m a.s.l. The minimum height of the dam is estimated as ca. 125 m for an overflow crest elevation of about 2,450 m.a.s.l.

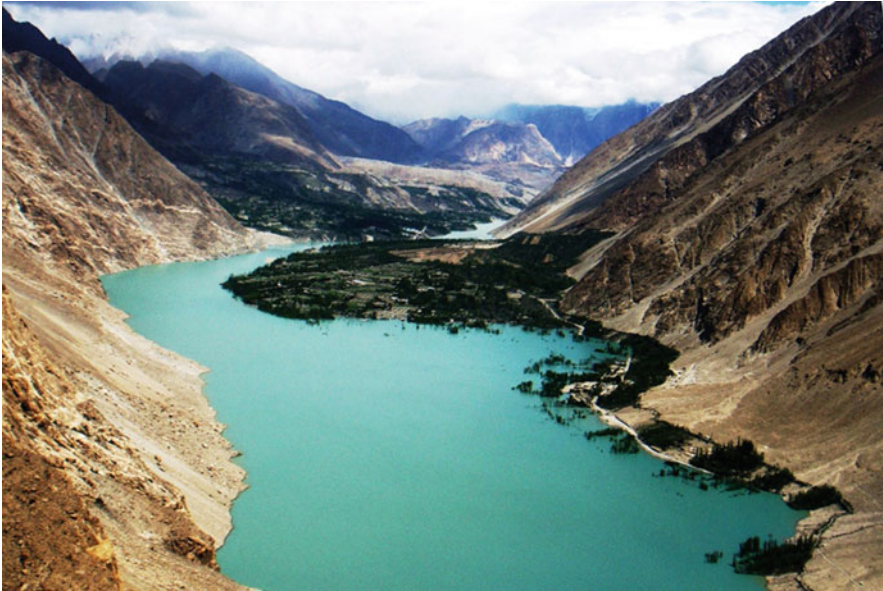
Fig. 7.12 Aerial view of 2010 Hunza rockslide-dammed lake in northern Pakistan. At the time of the photograph (May 13, 2010; Day 127 of impoundment) lake waters are still rising (pool el. 2,423 m a.s.l.), filling the Hunza Valley. View is upstream. Lake would rise another 12 m before overtopping on May 29, 2010 (*Pamir Times* photograph)

As the waters of the lake rose they flooded several villages, large tracts of agricultural land adjacent to the Hunza, and 22 km of the Karakoram Highway linking Pakistan and China, disrupting road travel and commercial transport between the two countries (Fig. 7.12).

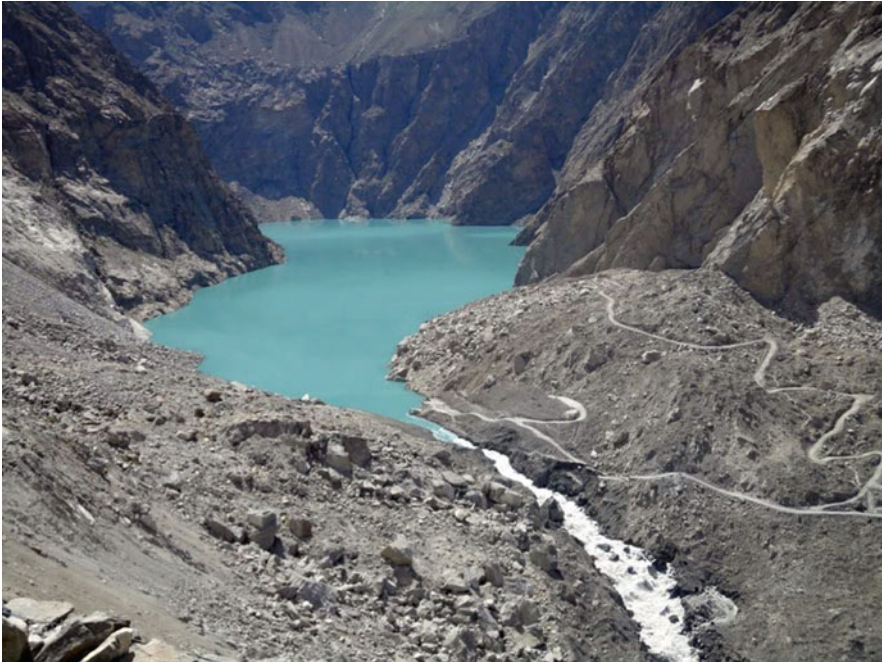
Fig. 7.15 View of overflow of 2010 Attabad rockslide dam and the Hunza rockslide-dammed lake in the background. Date of photograph is June 10, 2010 12 days after overtopping on May 29 (143 days after impoundment). Volume of lake is ca. 430 Mm³. Note limited erosion of spillway. Photograph by Focus Humanitarian Assistance, Pakistan

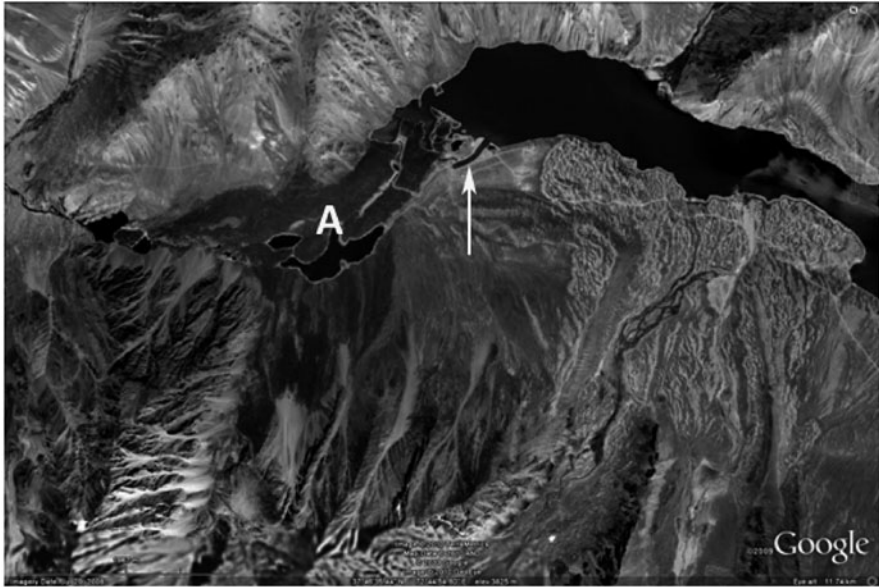
Fig. 7.17 Google Earth image of Lake Yahilkul in the Pamir Mountains of Tajikistan ($37^{\circ} 47' 37''\text{N}/72^{\circ} 45' 06''$). The lake is formed by rock avalanche debris (A) which has been dated to ca. 4,400 yr. [81]. Note spillway (white arrow) that forms part of civil engineering works to regulate lake level and outflow in Lake Yashilkul

The largest rockslide-dammed lake in the Gunt River basin is Lake Yashilkul, located at $37^{\circ} 47' 07''\text{N}/72^{\circ} 44' 47''\text{E}$ in southwestern Tajikistan; the lake was formed when a rock avalanche from the steep southern slope of the Gunt River valley blocked surface drainage to form the 20 km-long rockslide dammed lake (Fig. 7.17).

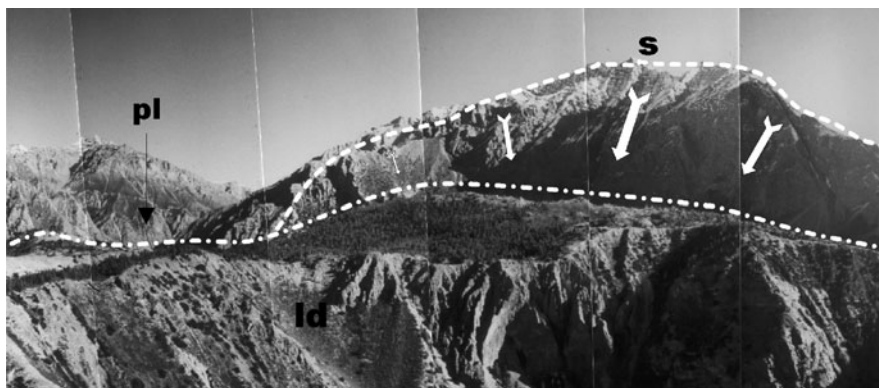
Fig. 8.9 S-N view towards the Ringmo rockslide area (*ld*); *s* = scarp, ↓ = direction of movement, *pl* = position of Phoksundo Lake. Photograph by H. J. Ibetsberger 1995

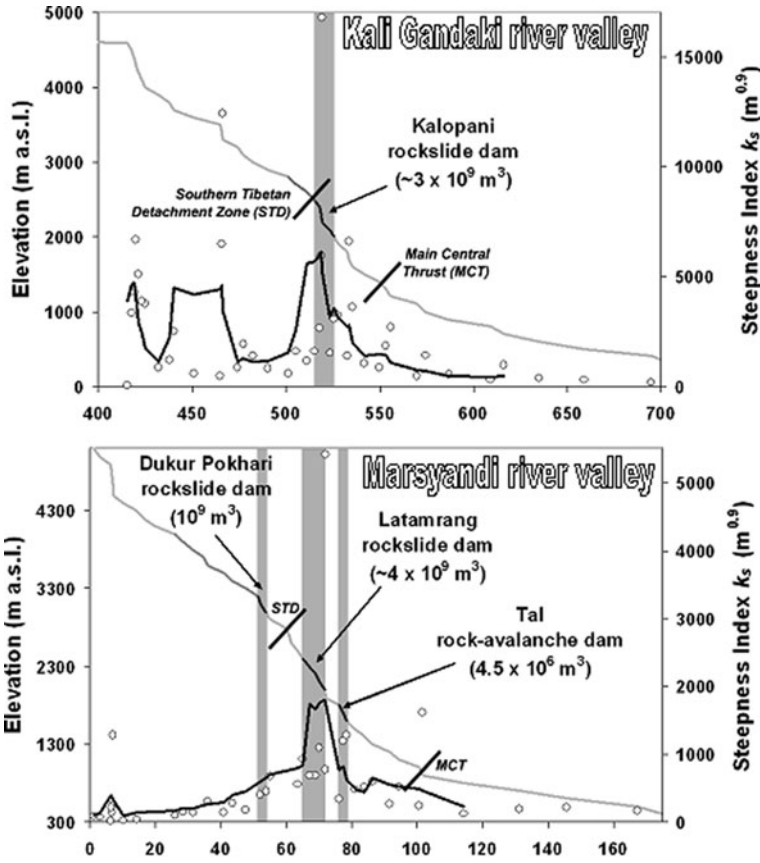
Fig. 8.11 River long profiles (grey lines) with variation of the Steepness Index k_s (white dots) and its 5-point running mean (black lines) for fixed Concavity Index (= 0.45) show spatial coincidence between high values of k_s and deposits of large rockslides (grey shaded boxes) (after [29])

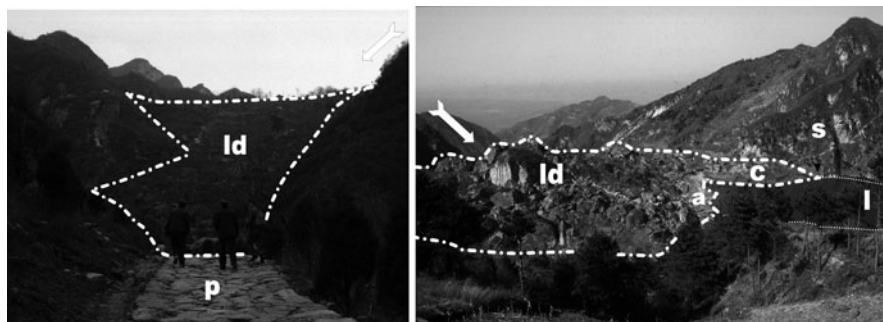
Fig. 8.21 *Left:* view from the pathway (*p*) towards SSE, to the dam of Cui Hua rock avalanche (*ld*); ↓ = direction of movement. *Right:* Chui Tsho Tshe village (*c*) on top of Cui Hua rock avalanche (*ld*); *s* = spillway of Tianchi Lake (*l*) regulated for agriculture; *a* = artificial sealing of lake

The upper surface of Cui Hua rock avalanche – a giant fan-like cone up to the main scarp in the west – exhibits extremely huge blocks and boulders (Fig. 8.21). Instead of piping inside the rock avalanche, seeping waters have given a stabilizing input by filling voids between the blocks with fine-grained sediments. Nevertheless, in

the upper part of the deposit (carapace) water can still easily flow through the big boulders and the coarse-grained material. That is why the northern shore of Tianchi Lake has been sealed by the locals with artificial cementation, preventing the water from seeping through the material of the rock avalanche.

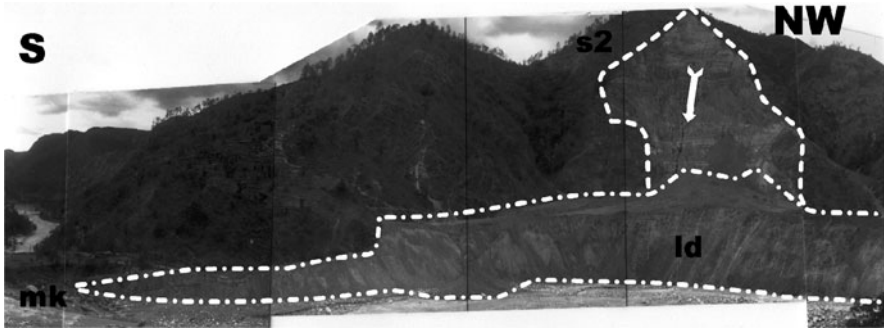
Fig. 8.26 Panoramic view over the remnants of DhARBANG landslide dam (*ld*): Note the morphology of the cone of landslide debris); *s2* = scarp (1988), ↓ = direction of movement, *mk* = Myagdi Khola River

Because of the rapid breaching of a natural rock blockage, the Dharbang landslide of 1988 maintains an extraordinary position among all those investigated in the Himalayas so far. The source landslide material was saturated during the monsoon season before the event. Heavy rainfalls during late September caused the rock failure resulting in the rapid filling of a lake. Morphology and internal structure of the remaining deposition area after the lake's outburst (Fig. 8.26) show that the movement of the slide was an in-situ collapse due to increasing pore water pressure.

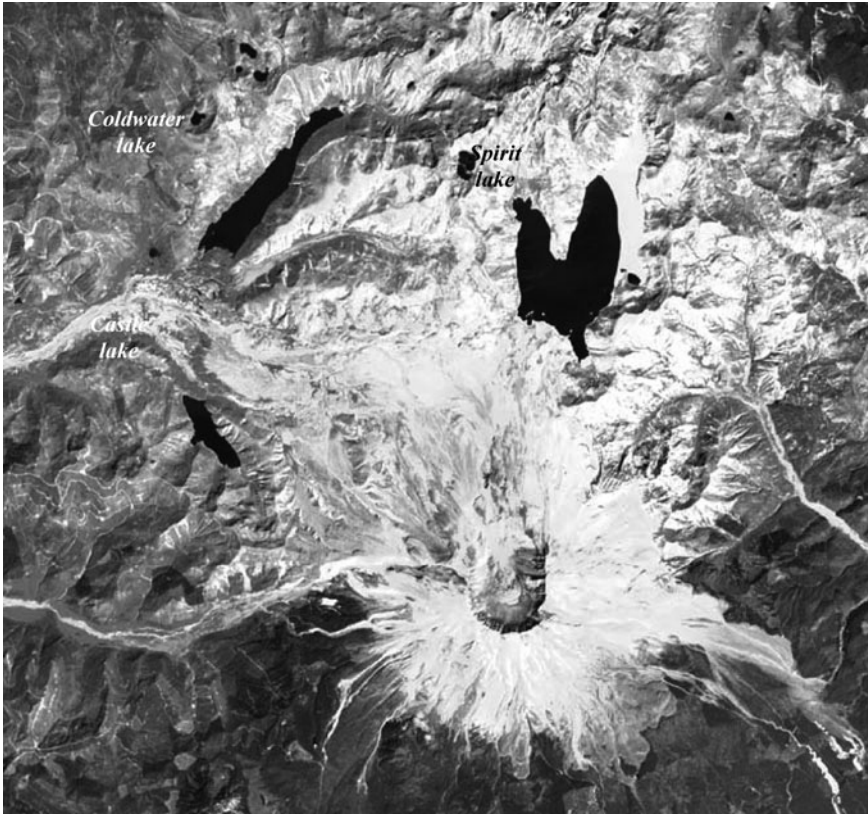
Fig. 9.1 ASTER image of Mount St. Helens showing the two new lakes (Coldwater and Castle) formed by the emplacement of the debris avalanche deposit during the May 18, 1980, eruption. The pre-existing Spirit Lake underwent an increase in water level of approximately 60 m

Valley morphology is fundamental in determining the formation and dimension of natural dams. As noted by Costa and Schuster [10] volcanic natural dams correspond to type III of Swanson et al. [43] where the dam fills the valley from side to side and fills considerable distances upvalley and downvalley, blocking other tributary rivers to the main valley. Natural dams generated by volcanic collapses are some of the most voluminous, with a reservoir capacity that may range from $30 \times 10^6 \text{ m}^3$ to 1.2 km^3 (Table 9.1). Different geometries of the reservoir are possible. In most cases, volcanoes are surrounded by deep valleys and high relief, favouring the formation of deep lakes, and elongated along river drainage (e.g., Mount St. Helens, Nevado de Colima and Volcán de Colima; Figs. 9.1 and 9.3).

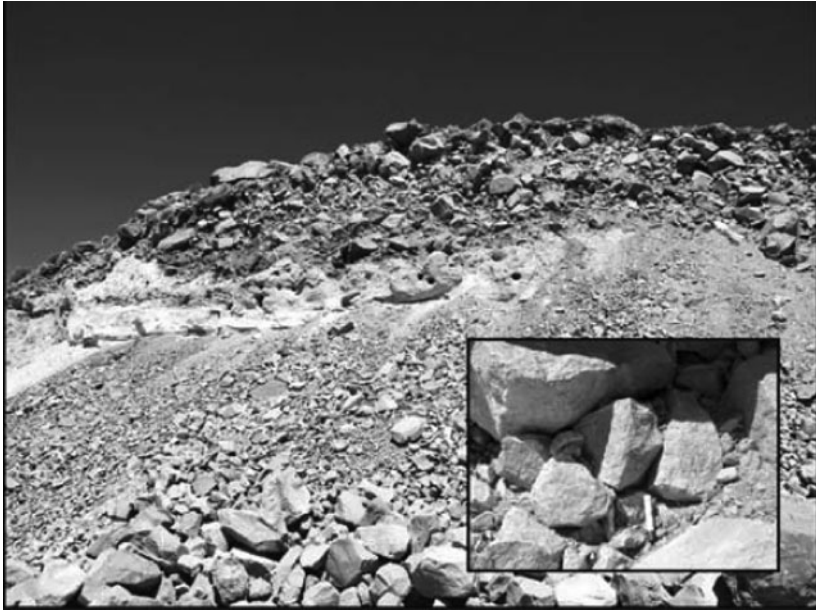
Fig. 9.6 Picture showing the texture of the block facies of a debris avalanche deposit, Parinacota volcano, Chile (Photo by L. Capra)

This may also be explained by the relatively high permeability of the debris due to the absence of matrix, and the low internal and/or superficial erosion because the fragments that constitute the deposit surface are too large (10–100 m in diameter) to be removed by water. Figure 9.6 shows the texture of the Parinacota debris avalanche where it is possible to observe a large number of voids between blocks. This texture gives a high permeability to the material, leading to establishment of a hydrological balance between the infilling rate and outflow via a natural spillway.

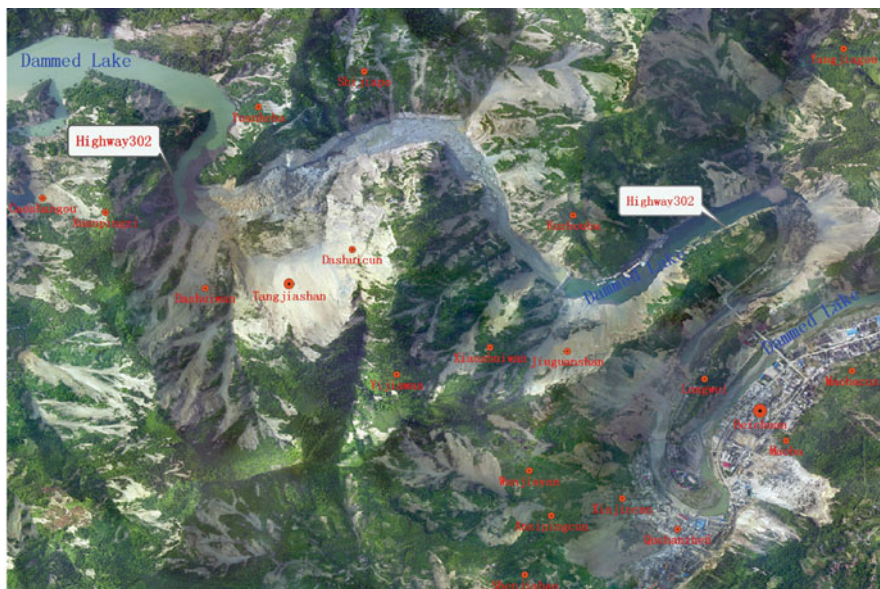
Fig. 10.6 The cluster of landslide dams along the major Tongkuo River Valley upstream from Beichuan County to the Tangjiashan rockslide dam. From *left to right* are the Tangjiashan dam, the Kuzhu landslide dam and the New – Street village landslide dam (Image from the Chinese Mapping Bureau)

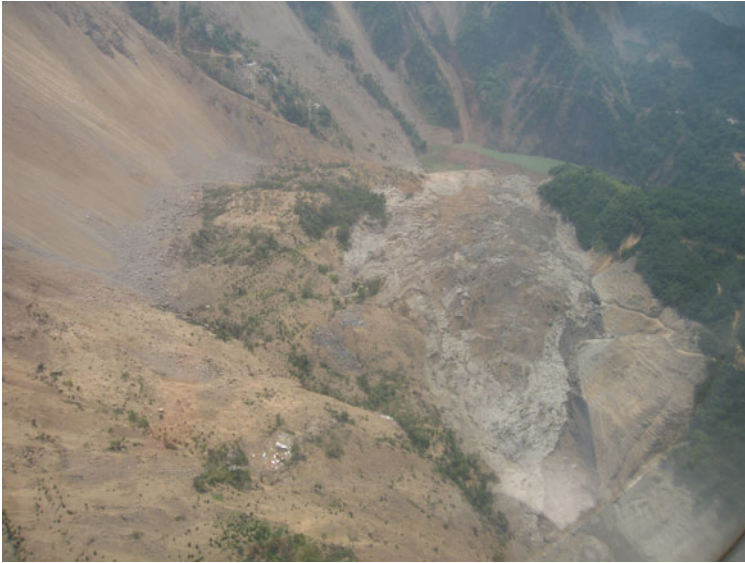
Fig. 10.7 The Tangjiashan landslide dam (Provided by Water Resources Bureau of Mianyang city)

The sluiceway was designed to make use of the low point on the upper right side of the dam, in a curve with the convexity facing the right bank (Fig. 10.9; also refer to Fig. 10.7). The designed channel has a trapezoid section with slope of 1:1.5 on both sides, the bottom is 8 m wide, the elevation of the entrance was 742 m a.s.l. and the length is 695 m. The channel gradient is 0.6% in the upper part; and it is 24 and 16% in the middle and the lower part respectively (Fig. 10.10).

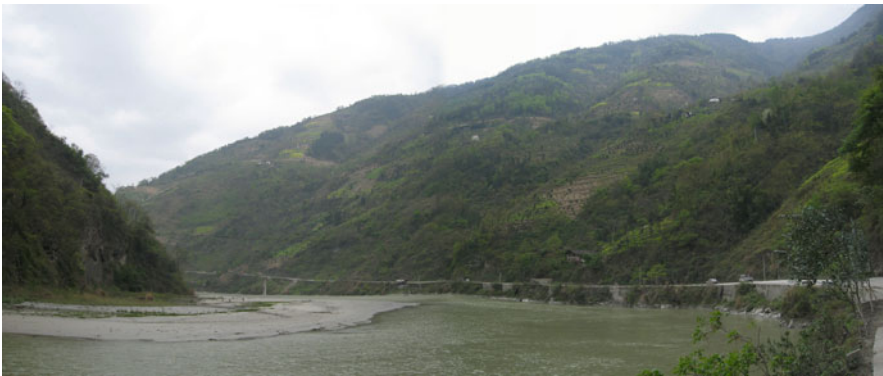
Fig. 10.8 The landform of Tangjiashan before Wenchuan Earthquake (Provided by Water Resources Bureau of Mianyang City)

Tangjiashan rockslide dam stands at 6 river-km upstream from the Beichuan township along the Tongkou River and 3.2 km in a direct line [4, 10]. The dam, 803.4 m long and 611.8 m wide, possessed a maximum possible reservoir capacity of 315 Mm³ before the excavation of the sluiceway described below. The drainage area of 3,550 km². The elevation at the highest point of the landslide dam was 793.9 m a.s.l. and 669.5 m a.s.l. at the lowest. Weakly weathered base rock is present at the level of 638.0 m a.s.l. The maximum height of the dam was 124.4 m and lowest point of the dam surface being 82.7 m high (Fig. 10.7). The dam was formed in what was an asymmetrical V-shaped valley before the landslide, with the right bank steeper (60°) than the left (30°) (Fig. 10.8).

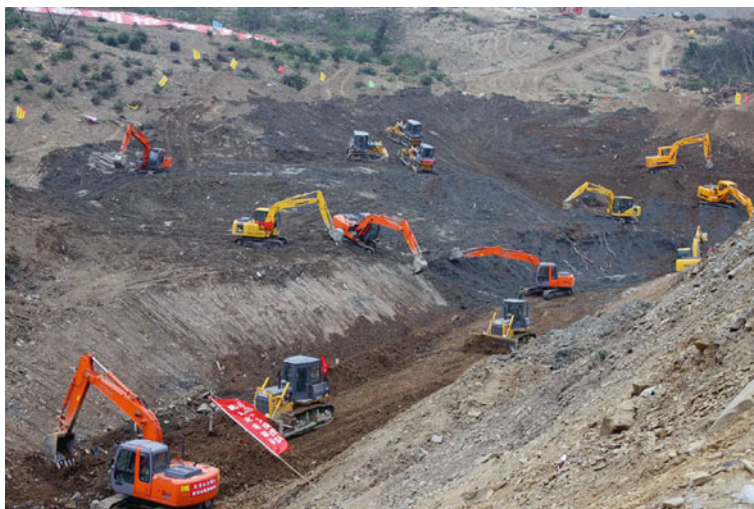
Fig. 10.11 The Tangjiashan sluiceway under construction (Provided by Water Resources Bureau of Mianyang city)

After 6 days of construction from May 26 to May 31, a channel with trapezoid cross sections had been created on the surface of the rockslide dam (Figs. 10.11 and 10.12). Before drainage took place, the sluiceway was 50 m wide, the base of the inlet was 7 m wide, and increases up to 10 m at the outlet; the maximum depth was 13 and 12 m on average. The sluiceway channel was 475 m long, the highest elevation at the base of the entrance was 740 m a.s.l. (2 m lower than designed) and the outlet was 739 m a.s.l. The total excavated debris was 135,550 m³ in volume and 4,200 m³ of stone-filled gabions were placed to stabilize the channel. The project also included 17 km of road construction and 35,000 m³ of wood clearance.

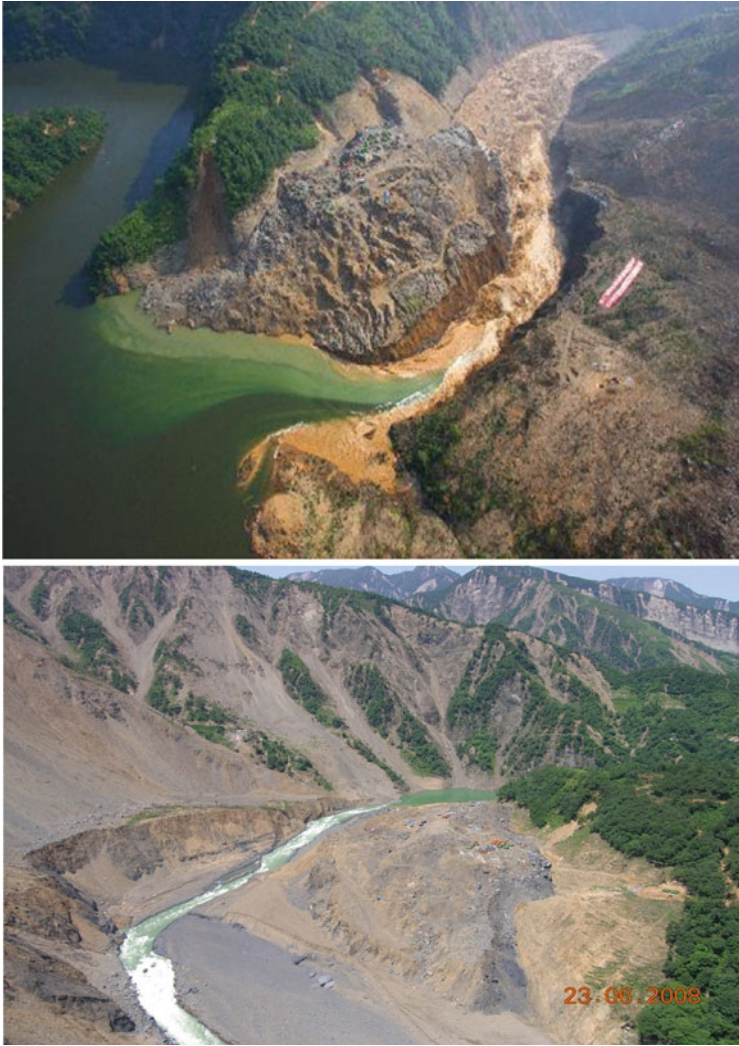
Fig. 10.14 Tangjiashan rockslide-dammed lake during and after partial drainage on June 10, 2008. *Upper picture* (view downstream) shows the incised channel over the debris caused by water release from Tangjiashan lake through the sluceway (photograph from Prof. Liu Ning). *Lower photograph* (view upstream) is an overview of new channel after water release from Tangjiashan landslide lake (photograph is provided by Water Resources Bureau of Mianyang city)

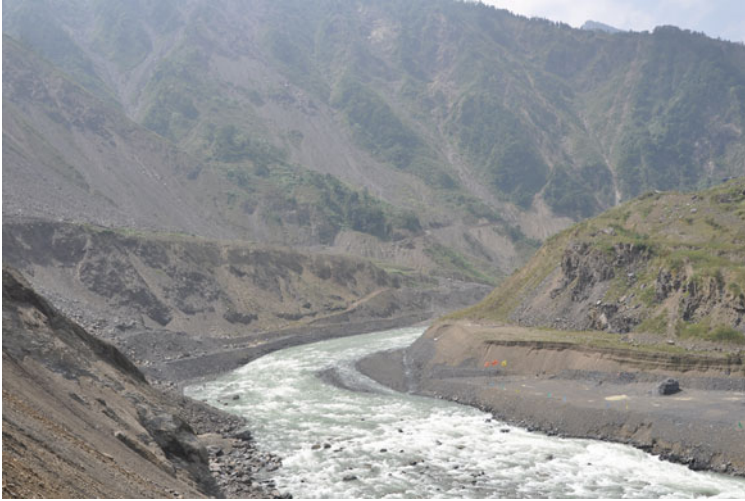
Fig. 10.15 Tangjiashan Lake: upstream view of the armoured spillway channel bed 15 months after risk reduction operation (Photograph taken on September 22, 2009)

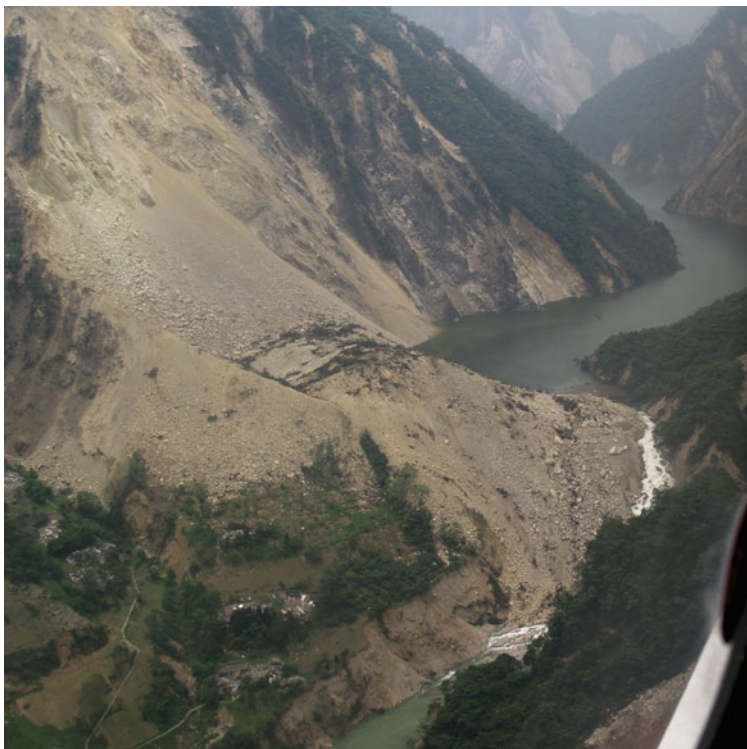
Fig. 10.16 Aerial view of Xiaogangjian #1 rockslide dam. View is upstream

The dam blocking the Mianyuan River is formed by a rocky landslide that slid from the right bank. The top surface of the dam is lower on the left and higher on the right. The left side of the dam is 50 m wide with a surface slope is $2-5^\circ$. Near the left cliff there is an eroded 5 m wide channel at an altitude of 884.7 m a.s.l. in the middle, the dam is 120 m wide and the surface slope is $0-5^\circ$. The right side consists of stones and bedrock fragments. The surface slope of the rockslide dam parallel to river flow is between $25-30^\circ$. The dam is 250 m wide across the river, 300 m long along the thalweg, and 62–120 m high above the streambed. The total volume of the rockslide is $2 \times 10^6 \text{ m}^3$. The maximum volume of impounded water is about $1.050 \times 10^7 \text{ m}^3$. The normal discharge of Mianyuan River in June is about $15 \text{ m}^3/\text{s}$ at Qingping.

Boulders in the dam are as large as 10 m diameter and 2–4 m on average, accounting for 50% of the debris; rocks 0.3–0.6 m in diameter account for 25%; gravels are 0.1–0.2 m in diameter for 10%; soils make up the rest of the debris (15%). Isolated
