Natural and Artificial Rockslide Dams

The Formation and Behaviour of Natural and Artificial Rockslide Dams; Implications for Engineering Performance and Hazard Management

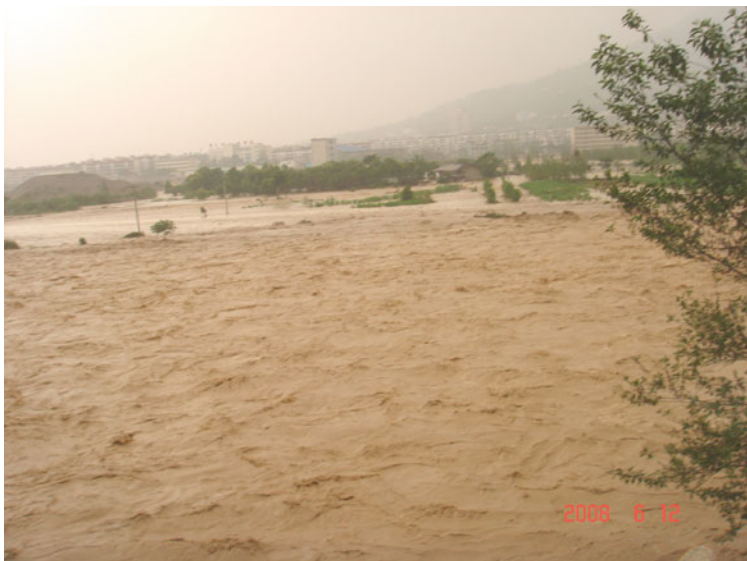
Fig. 10.19 The peak discharge of the spillway flood from Xiaogangjian #1 rockslide-dammed lake passing the Hanwang township, Mianzhu city (Provided by Chen Zuyu)

The sluiceway is designed to reduce the risk [7, 9]. The channel is 25~30 m wide so as to lower and maintain the water level down to elevation 842 m a.s.l. (Figs. 10.17 and 10.18). Explosions were used to dig the channel because of the inaccessibility of the site to engineering machinery. The sluiceway discharge reached 1,300 m³/s, which is equal to a flood with a 10-year return period (Fig. 10.19).

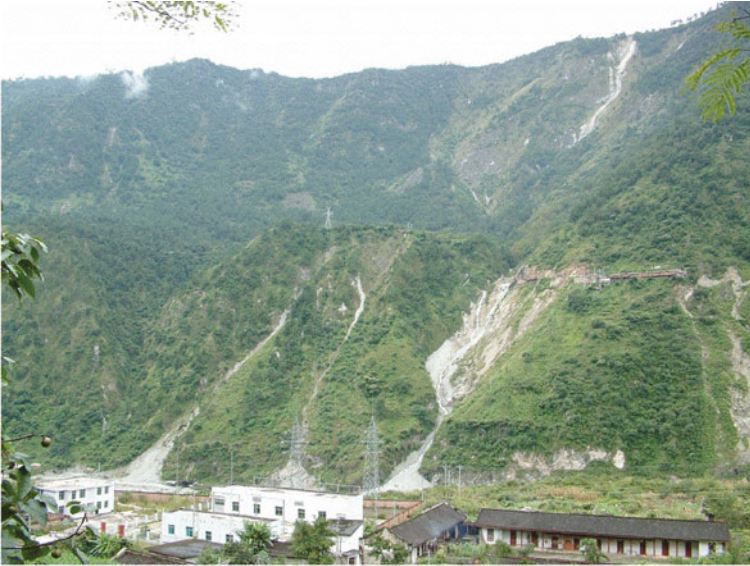
Fig. 13.5 Photograph showing the location which was interpreted as the landslide site by Institute of Geophysics at the National Seismological Bureau and Institute of Chinese Historic Geography at Fudan University [16]. (View is to the west). The location of the site is shown in Fig. 13.7

We then checked all other possible locations, conducting a walkover survey from Lengqi to Qianwan along the Dadu River (Fig. 13.4). We found that, although numerous small-scale rockfalls and landslides could readily be observed on both banks of the Dadu River, a site on the right bank (Fig. 13.6) was the only sizable landslide that could dam the Dadu River. This landslide is adjacent to the site in Fig. 13.5 and lies within the MMI zone IX of the 1786 earthquake.

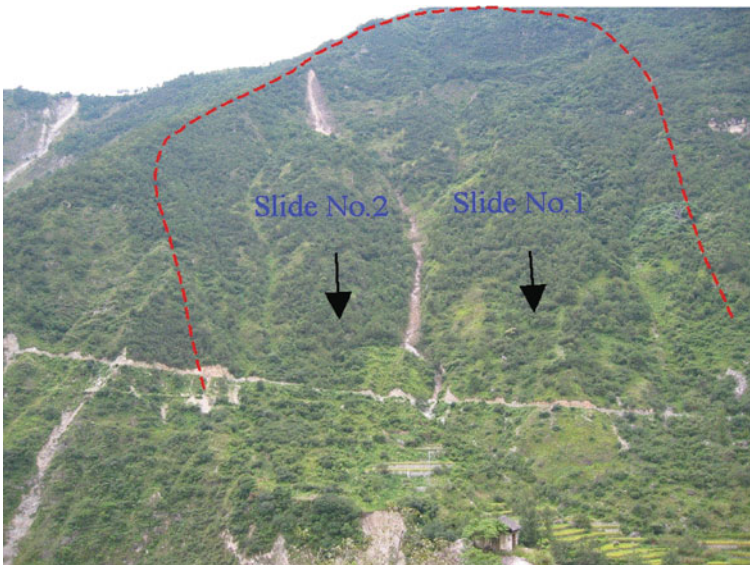
Fig. 13.6 Photograph showing the landslide site (view is to the west). The failure main scarp is marked with a *dashed line* and the location of the site shown in Fig. 13.4

into two parts by a drainage line along which the recent debris avalanche moved downslope (Fig. 13.6). It can be observed that the loose materials deposited along the drainage line were entrained during debris movement, exposing the underlying bedrock. It may be reasonable to divide the landslide into Slide No. 1 and Slide No. 2 as possibly two phases of movement (Fig. 13.7), because both slides are inferred to have a deep shear surface from the geomorphic features of the main landslide scar and the exposed bedrock on the drainage line. At the back of the landslide mass, a huge displaced rock block was sandwiched between these two slide masses. Apart from the minor erosion scar that constitutes the source area of the recent debris flow, no scarp shows evidence of active slope movements.

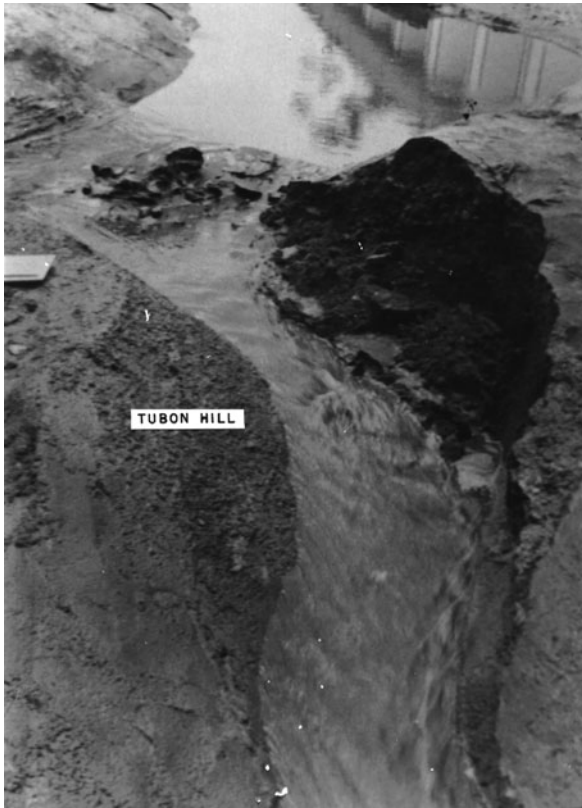
Fig. 14.9 Erosion in the physical scale model, view upstream, tested by EPN technical team [28]

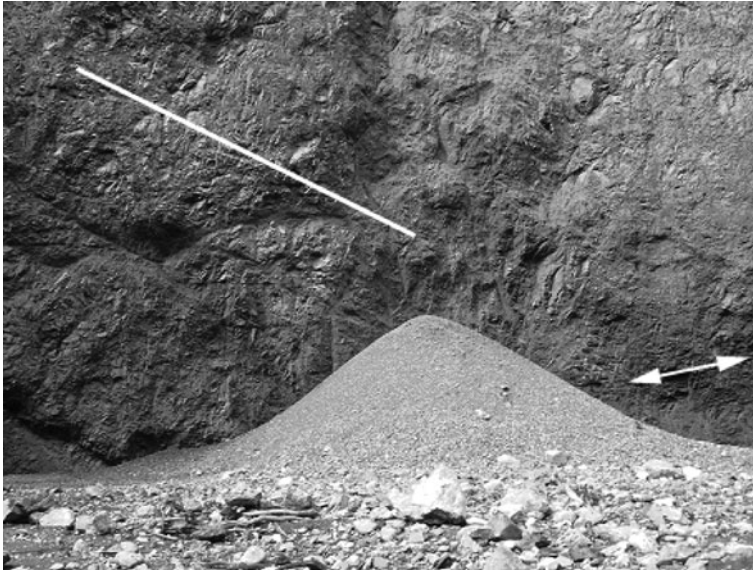
Fig. 15.2 Rockslide material in “three-dimensional jigsaw-facies” in the Rabiusa gorge. The direction of movement was from *right to left*. At the *right* margin sub-horizontal former bedding is visible (parallel to the *white arrow*). Important deformation plains cross-cut it and follows upward ramps (*white line*)

In many places a small-scale three-dimensional jigsaw has been produced, still preserving the original structure (Fig. 15.2). This general structure is cross-cut, more or less densely, by deformation planes and zones. Along these zones the limestone has been crushed to fine gouge. In some places these planes are sub-parallel to the former sedimentary layering as indicated by Pollet [13]. It seems that even more important are ramp-like deformation planes, cross-cutting the bedding and mostly dipping northward.

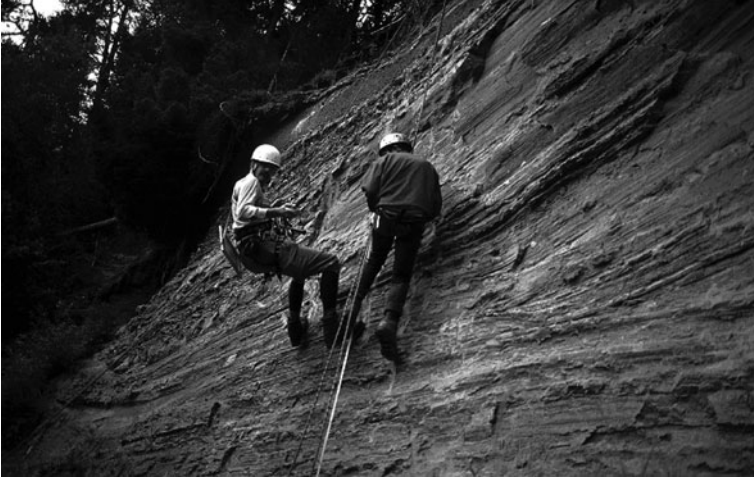
Fig. 15.4 Sediments of Lake Ilanz near Schiedberg. The clearly and regularly layered silts and sands show a horizontal bedding surface. The origin of the bedding might have been seasonal changes, but, also, repeated single heavy rain events

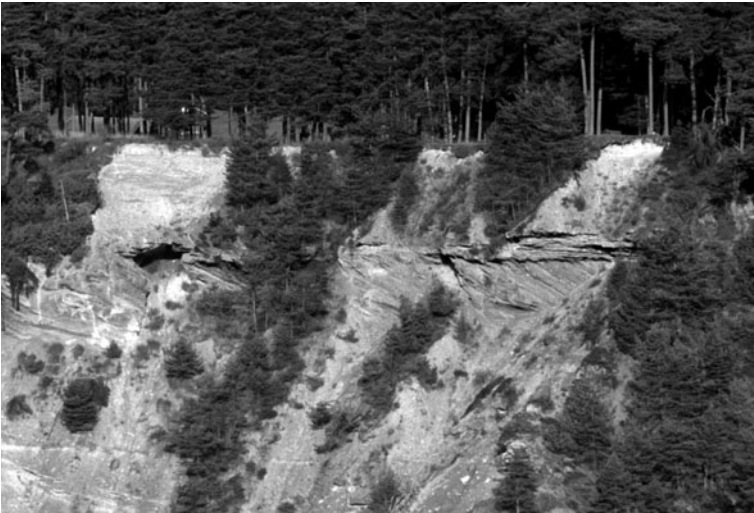
Fig. 15.5 Delta sediments of the Laaxerbach at Planezzas south of Laax with topset and foreset beds. The top of the foreset beds has an elevation of about 820 m

and can only be assumed. It is evident that it was significantly higher than 820 m a.s.l., because the large flood plain must have been created by a large amount of water. It also obvious that the lake level did not exceed 936 m a.s.l. At that elevation, a morphological depression on the right bank near Carnifels – Erlacresta (Figs. 15.1 and 15.5) shows clearly that no important overflow has ever taken place. So, the

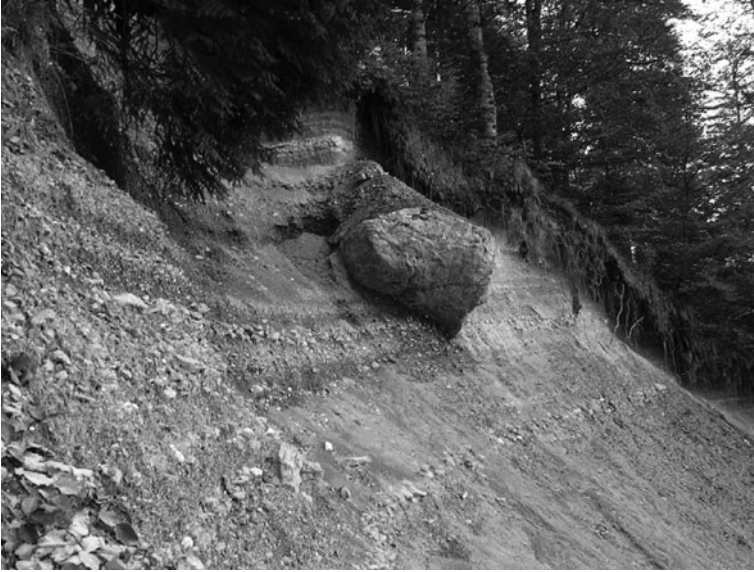
Fig. 15.8 Sediments of the Ilanz outbreak flood at Zault showing clear layering. The fragments consist of angular rockslide material (limestone). In some layers the particles have the size of coarse gravel, in some they consist of sand or even silt only. Around the single large block no disturbance of the bedding is apparent

In several erosion gullies the vertical structure of the flood deposits is well exposed (Fig. 15.8). The rockslide deposits are covered by gravel sediments that have been bulldozed by the rockslide from their former situation in the valley floor to an elevated position [14, 15, 16]. Accordingly, they are part of the rockslide event, forming together with the rockslide debris an undulating surface. This relief was filled up by outbreak sediments. NW of Zault the sedimentation of the flood starts with a typical debris flow deposit, dominated by coarse, slightly rounded blocks. These blocks are concentrated in several layers, separated by finer material. This blocky sediment is about 15 m in thickness. Above it, gradually finer sediments (medium gravel size) occur, showing a layering (Fig. 15.8). The sequence of the layered gravel attains about 10 m in thickness, each single layer about 5–15 cm. All constituents are angular fragments of the rockslide. Some layers contain only sand or even silt. At first sight, the layered gravel indicates a low energy environment. However, single large blocks within these layers (Fig. 15.8) led to questions of origin. Manville (personal communication, 2004) has suggested that, a “hyperconcentrated flow”, as described in Pierson and Costa [12], might be the origin for this sediment. A giant flood as assumed to have happened could have induced such a process of transport. Its deposition was the last phase of the flood event. The layered gravel beds with few boulders are parallel to the surface of the inclined floodway. After this sedimentation, the floodway was incised by fluvial erosion.

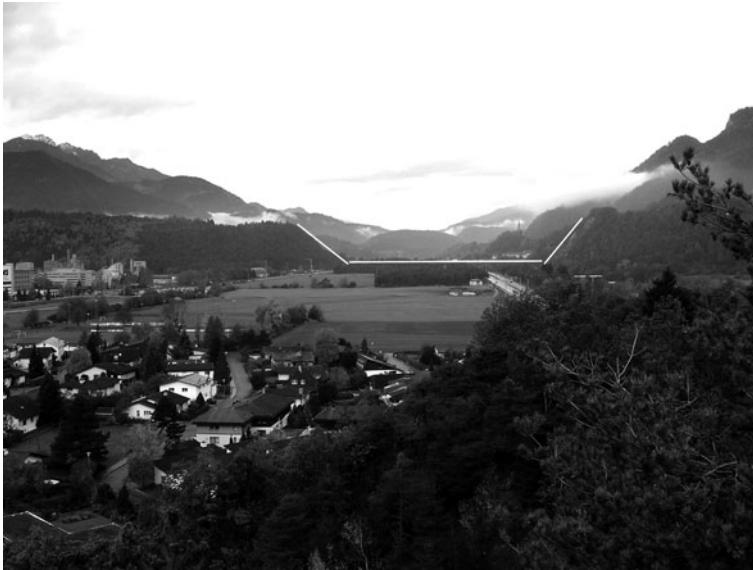
Fig. 15.9 The Tamins rockslide deposits, seen from the Toma hills of Domat-Ems (looking towards West). The slide mass forms a straight barrier across the Rhine valley. A distinct breach (*white line*), caused by the outbreak of Lake Bonaduz, was partly filled later by the outbreak sediments of Lake Ilanz. The inclined flood plain in the centre of the photo has a direct extension to that of Zault. Within the breach in the background the Flims deposits are visible

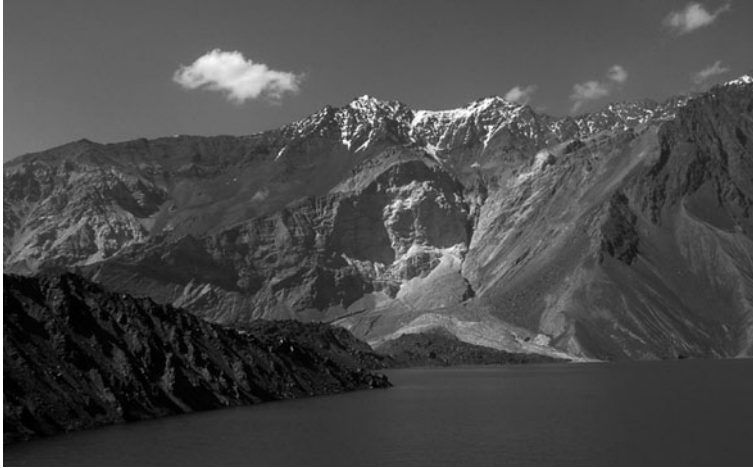
Fig. 16.2 Scar of the Usoi landslide. View from the south (photo A. Ischuk, 2004)

The Usoi landslide occurred on the southern slope of Muzkol Ridge. The landslide scar (Fig. 16.2) is cut into the Permo-Triassic deposits (dolomite, limestone, gypsum, anhydrite) in its upper part, while its main portion is in terrigenous-carbonate deposits (sandstone, schist, quartzite) of the Carboniferous Sarez Formation. These two units are divided by the Usoi Thrust dipping 60° to 80° towards SE. There is one more shear zone dipping 50° towards NW at the eastern part of the scar. Large-scale slope failure was caused by the collapse of the wedge delimited by these two fault planes. The bedding plains dip mainly 30 to 45° towards NNW, but with marked local variations due to local folding and faulting. A high degree of fracturing has led to the practically permanent occurrence of rock-falls and talus formation along the slopes on the right flank of Murgab Valley. The talus slopes have a surface angle between 35 and 40° and form rock glaciers in the upper part of the slopes (above 4,000 m. a.s.l.).

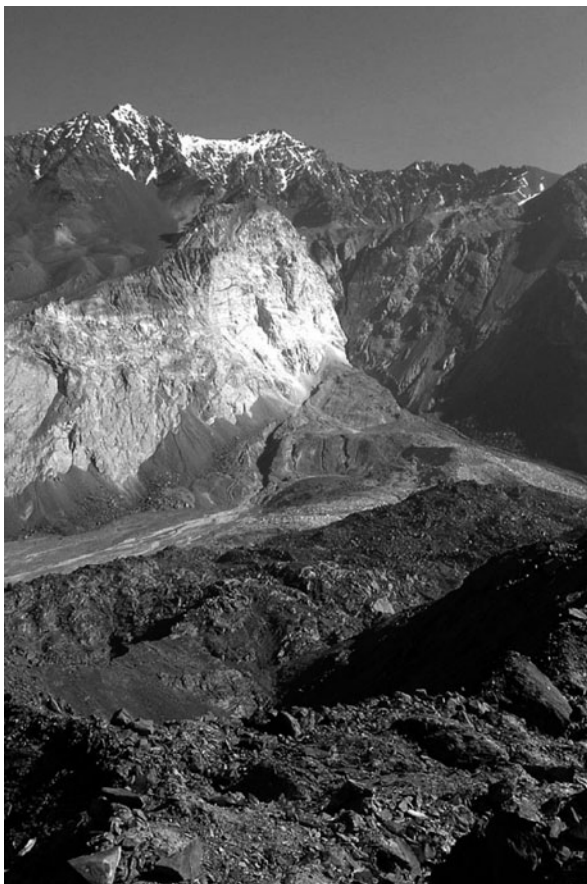
Fig. 16.5 Helicopter view of the scarp of the Usoi landslide from the highest point of the dam (photo A. Ischuk, 2004)

The northern part of the dam (see Fig. 16.5) is the lowest part with a minimum freeboard of approximately 38–45 m. This part is covered by large blocks of sandstone and schist from 2 to 20 m in size without fines on the surface. The part that abuts the right flank of the Murgab River valley is covered by secondary debris flows

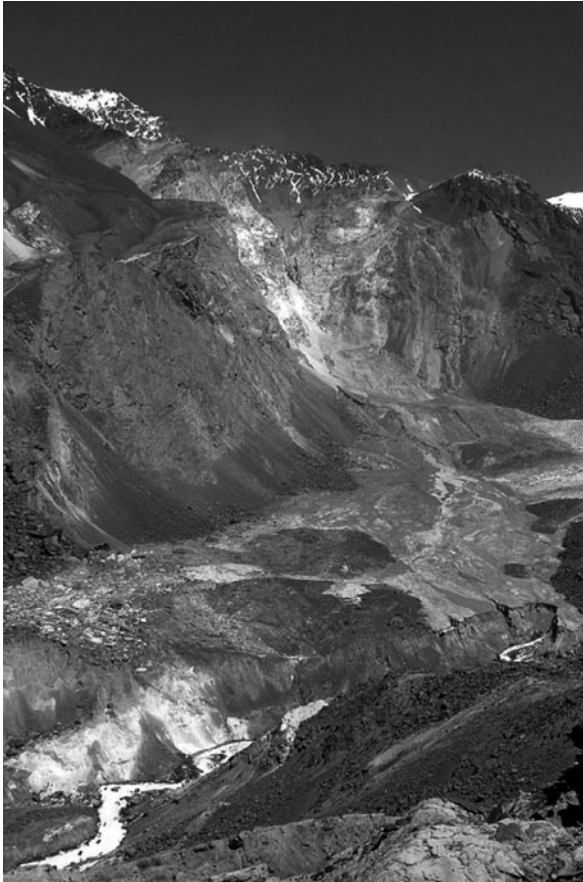
Fig. 16.6 Helicopter view of the downstream side of the Usoi Dam, debris flow and canyon (photo A. Ischuk, 2004)

and mudflows deposits (Figs. 16.5, 16.6, 16.7 and 16.8) composed of limestone, marble, gypsum debris and fines from moraine deposits that rest in the upper part of the scar and in the glacier zone above it. Mudflows from the Usoi Landslide scar passed towards the downstream face up to 1949 when their direction was changed by rockfall from the headscarp wall. After that they have flowed towards the lake (see Fig. 16.3). The volume of sediments from these mudflows is not too big and does not influence the seepage flow through the dam due to void space clogging [9].

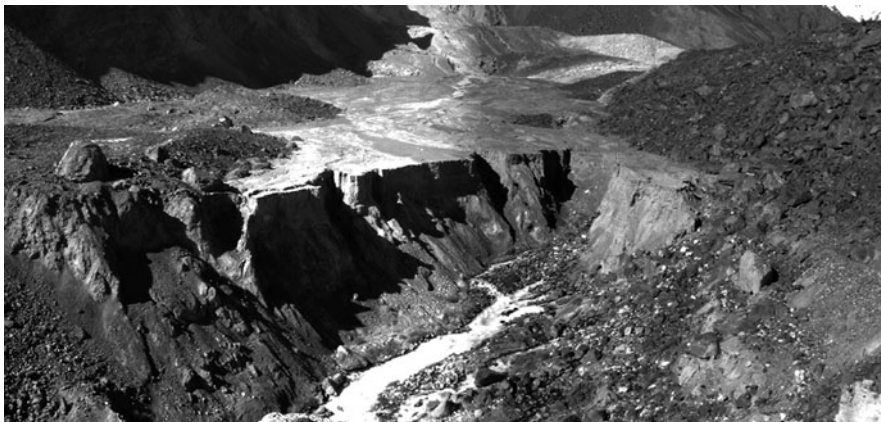
Fig. 16.9 The downstream canyon (photo A. Ischuk, 2002)

57 springs on the downstream slope of the dam are all located in the canyon at the nearly the same level – about 3,100 m. a.s.l., 140–150 m below present Lake level (Figs. 16.9 and 16.10). Seepage started when the Lake level rose to 3,050 m a.s.l.; indicating that the dam below this elevation is impervious. The cumulative discharge of all springs is 35 m³/s in winter and 75 m³/s in summer (season variation) and depends on the lake level, which varies annually ± 6 m on average.

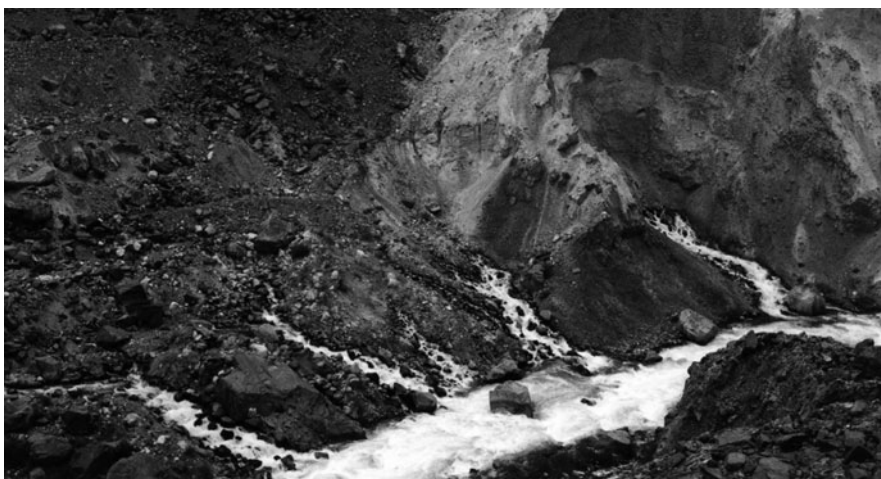
Fig. 16.10 Springs in the downstream canyon (photo A. Ischuk, 1999)

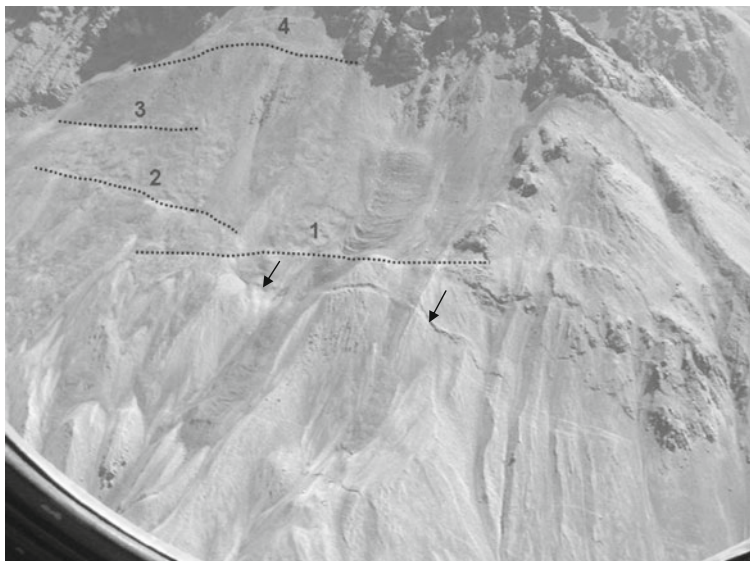
Fig. 16.16 Linear features on the upper part of the RBL. *Dotted lines 1–4* mark along-slope traces of contacts between glacial body and valley slope, *arrows* mark landslide crack

According to [1, 9] the biggest landslide crack is located in the upper part of the slope. However, most likely it is not a fracture but traces of contacts between glacial body and the valley slope located at 4 levels (Fig. 16.16).

These 4 terraces were erroneously interpreted as a 2 km long sliding surface crack with 200 m difference of the elevation between its headcrown (corresponding to line 4 on Fig. 16.16) and top of sliding block (corresponding to lines 1 and 2). However it seems to be incorrect, though there are some fractures associated with landslide (arrows on Fig. 16.16).

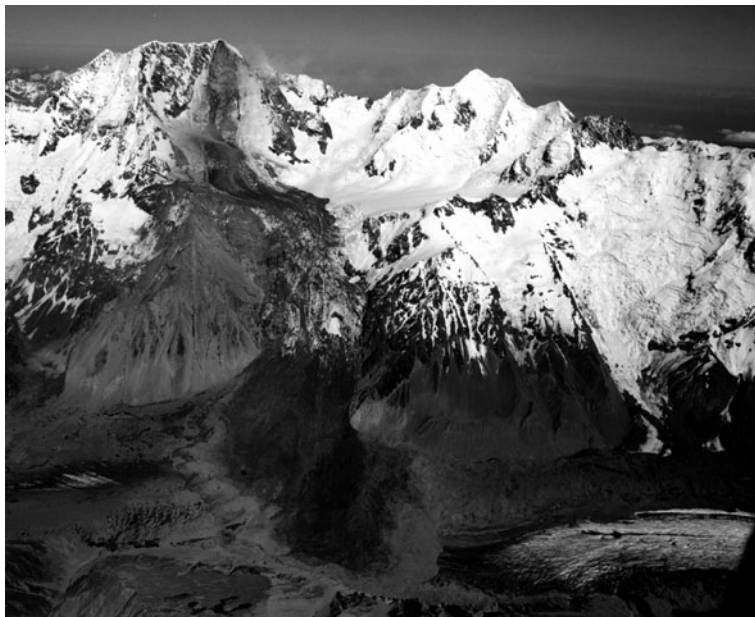
Fig. 17.3 The east face of Mount Cook collapsed in December 1991 releasing an avalanche of $12 \times 10^6 \text{ m}^3$ of rock and ice. Based on seismogram (Fig. 17.4) interpretation, the bulk of the rock mass broke from the source in the first 20 s of the rapidly escalating collapse, and almost all of the mass was in simultaneous motion. Photo by Lloyd Homer

Many rock avalanches in New Zealand’s Southern Alps fall without recognized triggers, or prior warning. One at Mt Cook (Fig. 17.3) [14], two at Mt Fletcher [14], and one at Mt Adams [10] appear to be induced by static gravitational stress in the mountain rock mass. Seismic records indicate that the bulk of the energy from the release at Mt Cook in December 1991 dissipated in 2 min [14, 17] (Fig. 17.4 top). Witnesses describe the main release as over in 15 min, but the roar of falling rocks continued for an hour and a half, and tremor from falling rocks was recorded for most of the day.

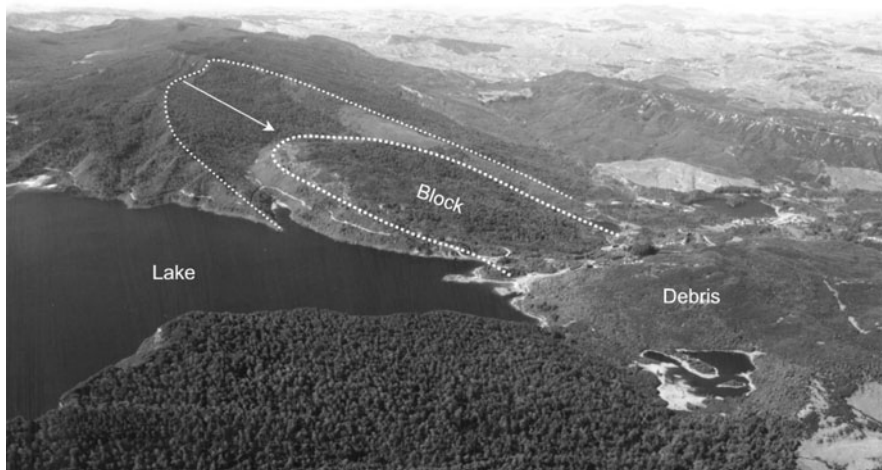
Fig. 17.12 Waikaremoana blockslide and landslide-dammed Lake Waikaremoana. Photo by Lloyd Homer

A remarkable prehistoric landslide deposit at Waikaremoana, North Island, New Zealand is interpreted as a low-angle rapid blockslide [1, 5], in which a 1.2 km^3 intact block of sandstone moved about 2 km on a sandstone surface sloping at about $6\text{--}8^\circ$ to the horizontal at a speed of up to $30\text{--}50 \text{ ms}^{-1}$ (Fig. 17.12). The long, accelerating travel on a very low-angle surface requires that there was very low frictional

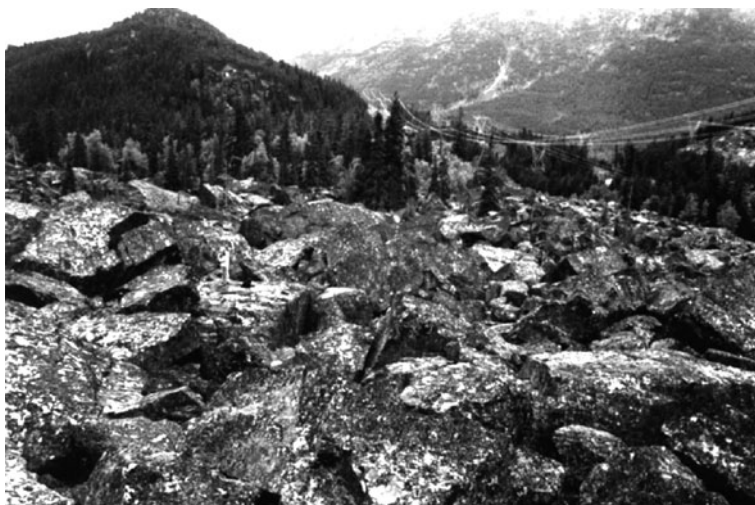
Fig. 17.14 Mystery Creek (Green River) rock-avalanche deposit, British Columbia, Canada showing uniformly large surface clasts forming a carapace on the rock avalanche. The carapace is formed by collapse of the rock mass along joints. Its mass is its only contribution to the dynamics of the rock-avalanche runout process. Note figure, trees and power pylons for scale

Fragmented rock-avalanche debris dominates the material properties of landslide dams, and the dams' ability to resist failure due to overtopping, slope failure or piping. A large rock-avalanche deposit is a relatively unstructured mass of all grain sizes, apart from the top several metres, which has a higher proportion of larger clasts. The surface layer of large clasts often gives rock-avalanche deposits an appearance of being comprised completely of angular boulders (Fig. 17.14).

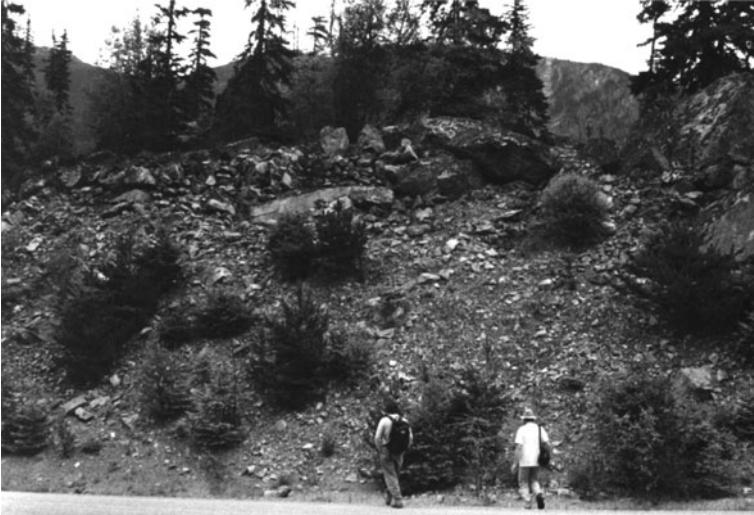
Fig. 17.15 Section through Mystery Creek (Green River) rock-avalanche deposit, showing the finely crushed interior. Dynamic grain fragmentation in the failure of grain bridges is the cause of the comminution. Grain fragmentation imparts a dispersive stress of the magnitude of the Hugoniot elastic limit of the rock material appropriate for the local strain rate and confining stress

However, the material beneath the boulder carapace is finely fragmented (Fig. 17.15), and matrix – rather than clast-supported. If the carapace is disrupted by water flow, the interior is highly erodible. The finer subsurface material, however, is likely to be of low permeability due to its wide grading and consequent very small average void size. It is therefore likely that seepage rates will be low following emplacement of the dam. Slumping of the downstream dam face due to daylighting of the phreatic surface is likely to require a long time to occur, making this mode of failure relatively unlikely prior to overtopping. This was the case with the Poerua landslide dam in Westland, New Zealand [10, 11]. Piping failure also has a lower likelihood than overtopping, because the widely graded material of the dam acts as an efficient filter. Even when seepage has developed it is unlikely that void spaces will be sufficiently large to allow particle migration.

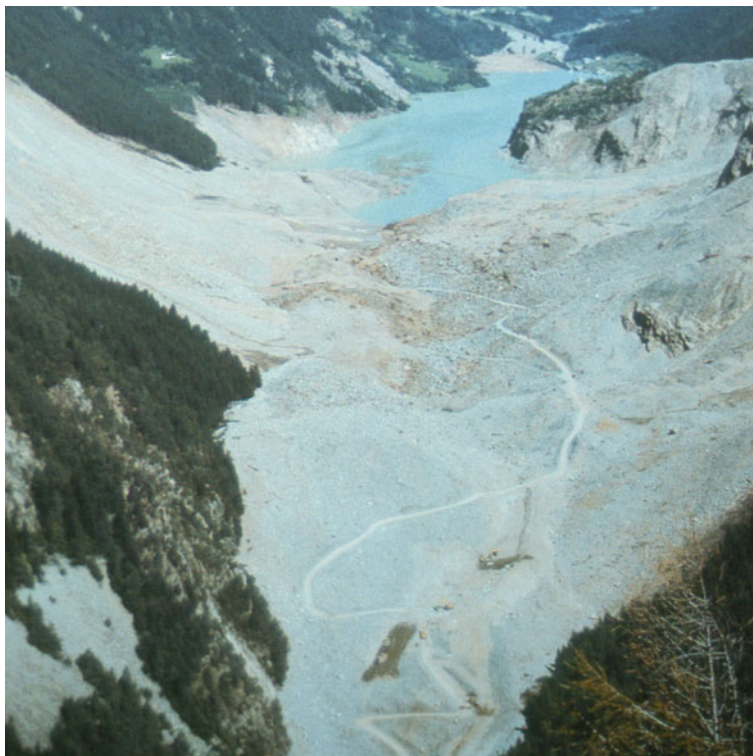
Fig. 18.3 The Val Pola slide deposit. Note substantial runoff on the right-hand slope opposite the source slope (Photo: Banco Popolare Sondrio)

Three-dimensional solutions are preferred for dam geometry predictions, as there is often a large degree of lateral spreading. A sample back-analysis was carried out of the 1987 Val Pola Slide in Valtellina, Northern Italy (Fig. 18.3). The analysis, carried out using the DAN 3D model described by [11, 16] is shown in Fig. 18.4. The analysis uses the frictional model with pore pressure. The basal frictional resistance is characterized by a single parameter, the “bulk friction angle”, defined by [7]:

the failure, as well as a realistic velocity profile (cf [9]). Each of the three rheologies produces a different distribution of debris across the valley floor. The frictional run produced runup onto the bench on the opposite side of the valley, followed by a fall-back, leaving a small part of the deposit on the bench. The Voellmy deposit is similar, but more compact at the front, so that the bench crest was reached, but no deposit was left. The Bingham result left a large part of the mass on the proximal slope and did not predict any fall-back. Its deposit is of a fairly uniform (“critical”) thickness. The Voellmy model yields the best comparison with the actual distribution of deposits, both in terms of the maximum thickness of the debris and the shape of the “dam” crest (compare with Fig. 18.3).

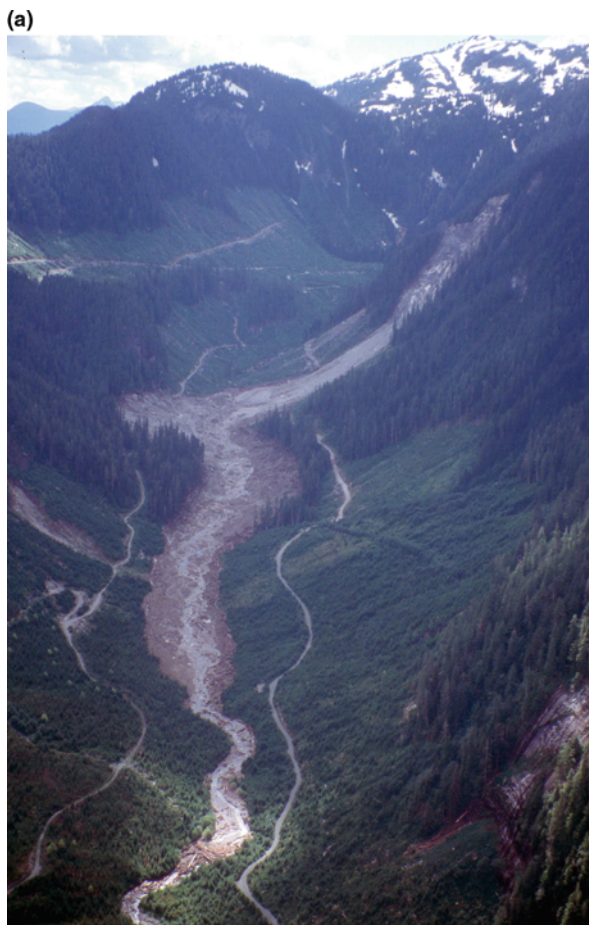
Fig. 18.11 Analyses of the Nomash River rock slide debris avalanche using the program Dan3D [17]. (a) An aerial view of the slide. (b) Analysis using the Voellmy fluid model as described by Hungr and Evans [10]. (c) Analysis using the frictional model, with a bulk friction angle of 20° . The depth contour interval is 2 m. The thin line is the actual path outline. Time intervals 25 s

Figure 18.11b shows a dynamic analysis of the landslide produced using the model DAN 3D [17]. The input parameters are equivalent to those used in a 2D DAN analysis by [10]. The initial slide is frictional and dry, with a friction angle of 30° . The slide entrains the requisite amount of material from the path in accordance with Fig. 18.10. At the same time, the rheological model is changed to Voellmy, with a friction coefficient of $f = 0.05$ and $\xi = 400 \text{ m/s}^2$. These are the same parameters as used in the 2D analysis and the resulting distribution of debris is also very similar, corresponding approximately to the actual distribution observed in the field. Thus,

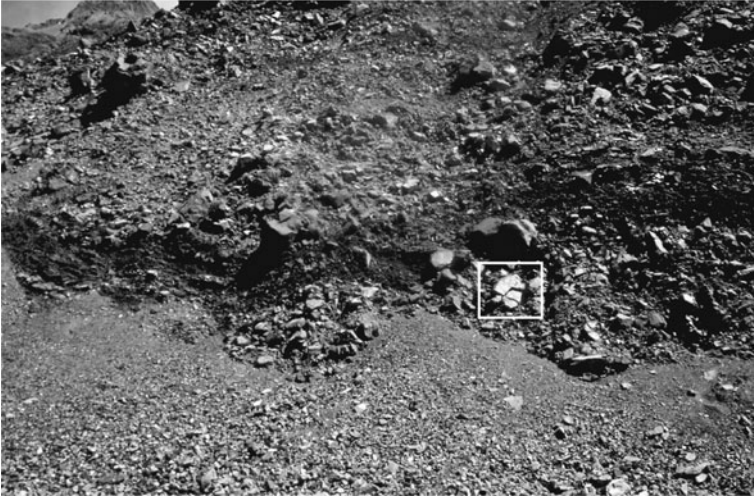
Fig. 19.1 Preserved banding sub-facies at the Falling Mountain rock-avalanche deposit consisting of highly fragmented, angular, fine, bands of dark argillite and highly fragmented, angular, coarse, light coloured greywacke. Highly fractured but relatively undisaggregated clasts are common; a large greywacke example is highlighted. The boundaries between bands are sharp with no evidence of mixing. Height of river-cut exposure is approximately 4 m

It appears that as with the mechanisms of motion for rock avalanches, landslide-dam stability study has much to gain from studies of the sedimentology of the resulting deposits. The current state of knowledge adheres to commonly described features; crude inverse grading [5, 13], highly fractured but relatively undisaggregated clasts (Figs. 19.1 and 19.2) [6], preservation of source stratigraphy in the final deposit (Fig. 19.1), and, interaction with the deposit substrate [16].

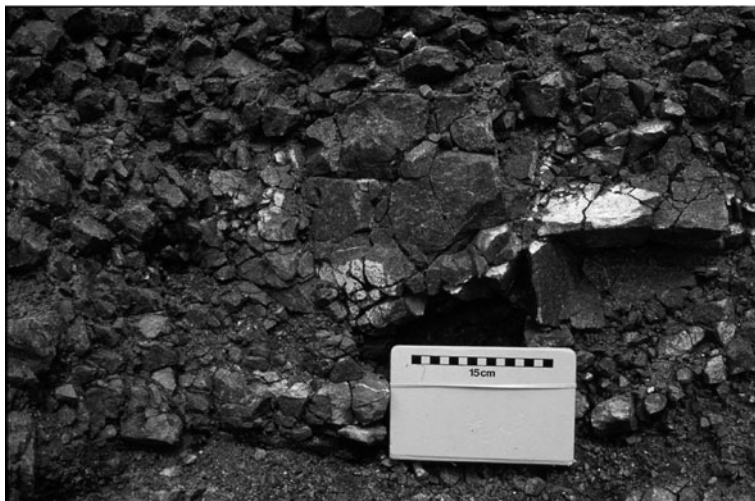
Fig. 19.2 Close up view of a highly fractured but undisaggregated greywacke clast at the Falling Mountain rock-avalanche deposit. Distinct “impact” marks are preserved with fractures radiating away from them. These features must have either been transported without the fractures opening and allowing matrix infill and further fracture as observed in Fig. 19.1; or, this represents a fracture event immediately before the cessation of motion of the rock avalanche

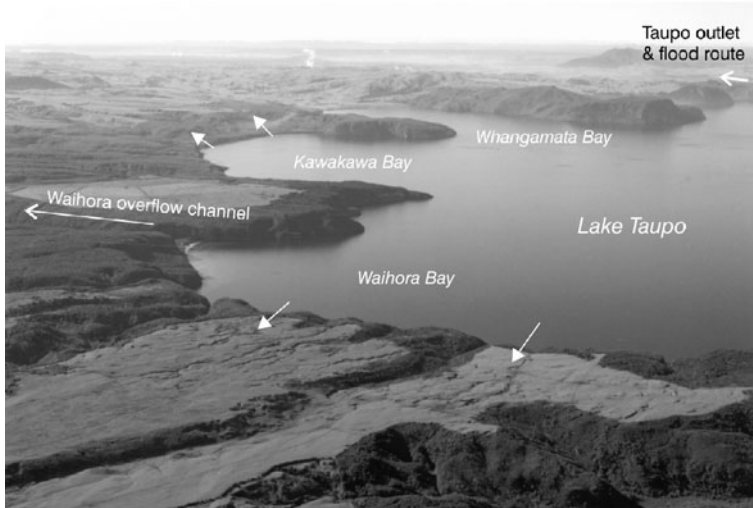
Fig. 21.2 Post-Oruanui shoreline terraces in the Western Bays of Lake Taupo (photo L. Homer, GNS)

before the ignimbrite barrier was eventually compromised near the present outlet in the Taupo area (Fig. 21.2).

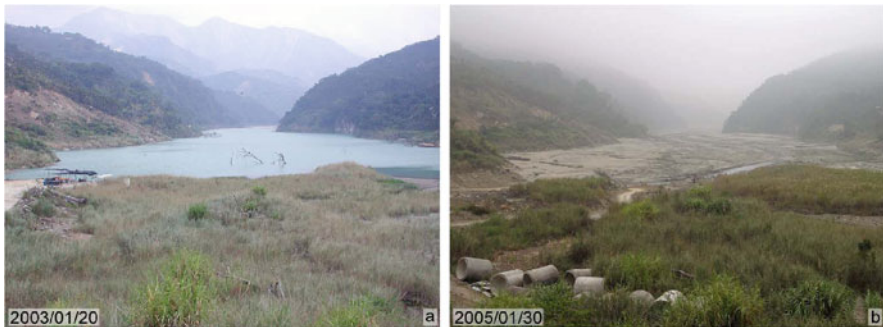
Fig. 23.11 The rockslide-dammed lake before and after Typhoon Mindulli on July 2–4, 2004. The dates of the photos are marked on the *lower-left* of each image

The Chi-Chi earthquake had triggered many smaller landslides in Chingshui basin, upstream of the Tsao-Ling rock avalanche. The debris of these upstream landslides was transported in typhoons into the rockslide-dammed lake. During the threat of the Typhoon Mindulli on July 2–4, 2004, the rockslide-dammed lake was filled completely, as shown in Fig. 23.11b. The filled material was composed of fine debris, sands and vegetation (e.g., tree trunks). Figure 23.11a,b were taken before and after the 2004 Mindulli events. Soon after the lake was filled, small river channels developed on the surface of the sediment and became incised. Figure 23.9b demonstrates the power of river incision which affected the filled lake, with a river channel deeper than 50 m. It is worth noting that a flat river terrace was generated by the incised river course. The formation of the river terrace as part of the evolution of a landslide dam is thus different from the general concept related to tectonic uplift.

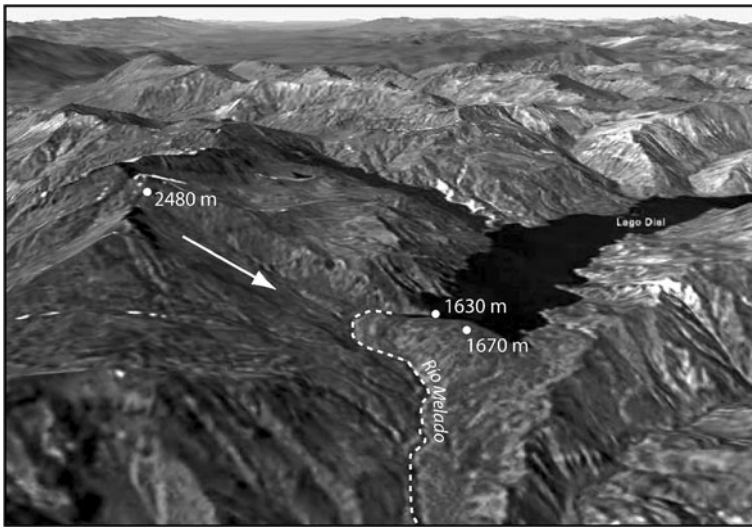
As an example (Fig. 24.8) the rockslide dam forming the Laguna Dial in southern Chile, this dam would be classified as a type IIa/ii/2 rockslide dam.

Fig. 24.8 Oblique view of the rock-avalanche deposit impounding Laguna Dial, Chile ($36^{\circ} 25' 14'' S / 70^{\circ} 55' 28'' W$; Google Earth). This rock avalanche forms a single dam in a stretched valley (type II). The cross valley profile has asymmetric distribution of the landslide deposit overlying an apparent symmetric valley floor (type ii). This is a narrow mountain valley and direction of landsliding is normal to the thalweg, the dip of the thalweg is minor, therefore the run out is restricted and the landslide forms a massive thick deposit (type 2)

Our classification system is not meant as three independent classifications considering the plan view, the cross valley and along-valley profile. These morphologic characters are intrinsically linked to each other (Fig. 24.8) and depend on the relative relations of rockslide volume, valley size and morphology and rockslide mobility. For example, a relatively small rockslide impacting at a right angle to

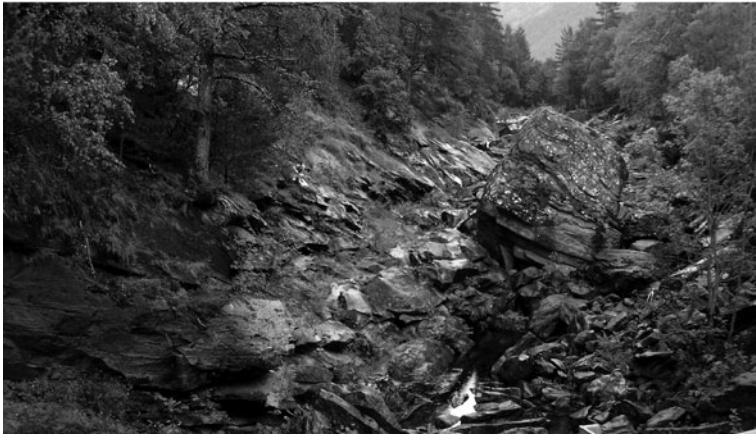
Fig. 24.9 Photo of the base of the breach of the dam of Onilsavatnet [27] at the southern tip of Tafjord, Norway, showing that the breach cut down to the bedrock (*centre and left*) leaving the rock avalanche deposits only at the margin of the breach (*right*)

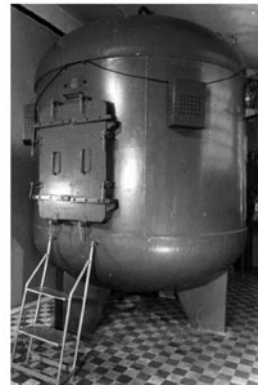
Fig. 25.1 Scheme of modeling equipment. 1 – Vacuum chamber (see on the right); 2 – Explosions simulators; 3 – Vacuum pump; 4 – Compressor; 5 – Vacuum-meter; 6 – Thermocouple vacuum-meter; 7 – Oil vacuum-meter; 8 – Differential valve; 9 – Mercury gage; 10 – Control and detonation device; 11 – Electromagnetic valve; 12 – High-speed camera

The principal element of the equipment is a steel cylindrical vacuum chamber 2.3 m in radius, 3 m high and 12 m³ in volume (see Fig. 25.1). A model of the corresponding rock mass is created in the chamber and relevant explosion simulators are placed inside. The equipment is supplied with detonating instruments, experiment control devices and recording tools. Up to 10 such simulators can be placed inside the model and detonated with desired time delays. Modelling of known industrial explosions has shown that the discrepancy between actual results and modelling does not exceed 5–10% [4–5].

Since 1972 all large industrial explosions, including those designed for blast-fill dams construction have been tested in the special simulator developed in our Institute (Fig. 25.1) [1, 3–4, 5, 7–10]. This equipment allows us to simulate the explosion site morphology at a scale from 1:100 to 1:1,000 and to evaluate optimal detonation scheme, shape and weight of charges, their positions, and time delays, necessary for construction of a desired dam configuration even in complex relief. It is based on the following modelling principles:

described above (Fig. 25.1). Modeling had been performed when charge chambers (Figs. 25.8 and 25.9) had been already driven. Different variants of charge masses, of the detonation order and of delay time had been tested to find the optimal one.

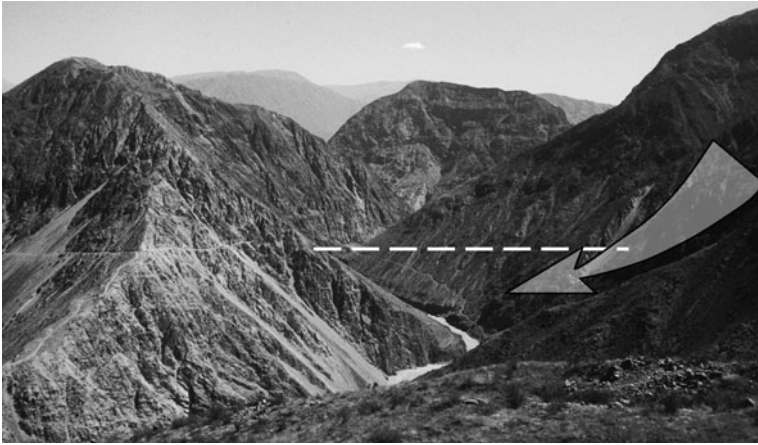
The scheme of detonation of three groups of charges at the Kambarata-1 dam site (Fig. 25.20) that should cause slope collapse has been designed on the basis of the Burkykia and Uch-Terek experimental explosions (Fig. 25.21).

Fig. 25.20 The Kambarata-1 dam site. *Dashed line* corresponds to the designed dam crest; *arrow* shows the direction of rock sliding

The total amount of explosives should be 217.5 kilotons. To prevent spreading of debris along the river valley groups of charges No 1 and 3 should be detonated first and the main group No 2 later. In its turn, to reduce the seismic effects, each charge within these groups should be detonated successively from the lower one to the upper one. The resulting dam is designed to be 270-m high, 2,200-m wide, and about 200 Mm^3 in volume. However, after the breakdown of the USSR this project has not been completed as yet. However, construction of Kambarata-2 on the Naryn

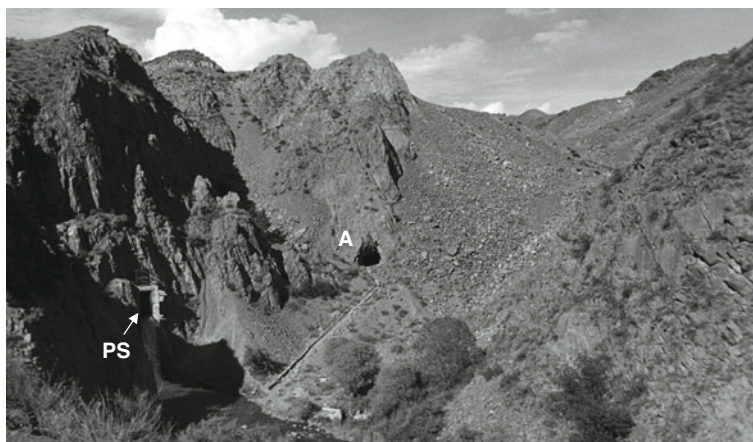
Fig. 26.1 The Burlykia experimental blast-fill dam. A – adit at the base of the right slope that was made to investigate seismic effect of the explosion on the underground structures. PS – permanent spillway. View from downstream

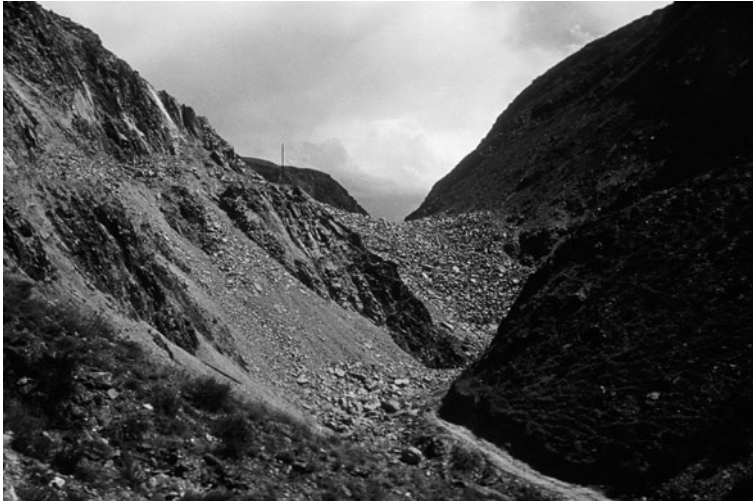
Fig. 26.2 The Uch-Terek experimental dam immediately after its creation. View from downstream

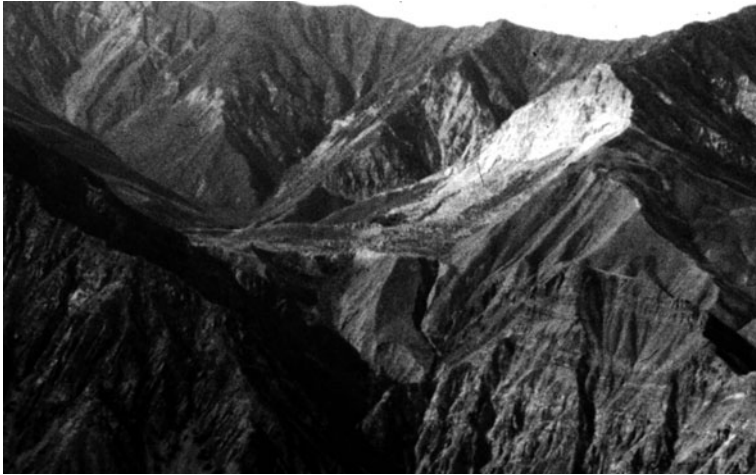
Fig. 26.10 The Aik-kiol rockslide that had formed natural dam with a nearly even crest

The across-valley debris distribution ideal for dam construction corresponds to the case when its crest is flat without prominent rise or lowering (Fig. 26.9A). However this is a rather rare case for natural blockages. We could find few examples of such natural dam morphology including the Ak-Kiol (Fig. 26.10) and the Southern Karakuney rockslides (Fig. 26.11) in the Kokomeren river basin (Central Tien Shan) [39], and the Rio Toro rockslide in Costa Rica [30].

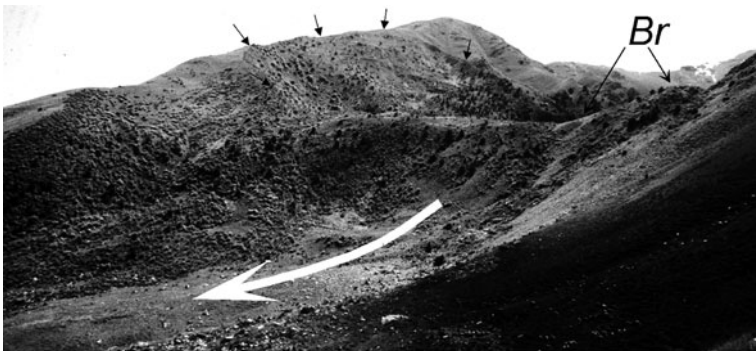
Fig. 26.11 The Southern Karakungey rockslide scar (marked by *small arrows*) and a 120-m high dam with nearly horizontal crest and expressive *brandung* (*Br*). Concave shape of its downstream slope reflects presence of a secondary scar above long runout rock avalanche that had moved in direction marked by *white arrow*

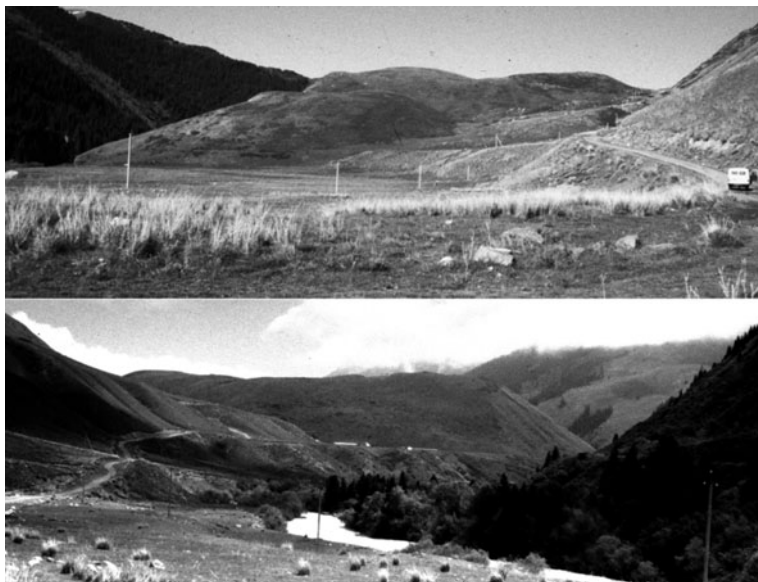
Compact blockages are characterized by rather wide crests and steep up- and downstream slopes dipping $30\text{--}35^\circ$ that corresponds to the angle of repose of rockslide debris. They can be exemplified by the Aksu and Djashilkul (Fig. 26.12)

Fig. 26.12 Up- and downstream views of the Djashilkul rockslide about $2 \times 10^8 \text{ m}^3$ in volume that had formed 200-m high compact dam on the Chon-Kemin River with steep slopes

It should be pointed out that even in those cases where a descending rock mass hits the opposite slope almost at a right angle, either compact blockages with steep up- and downstream slopes form (Fig. 26.12), or km-long spreading of debris incorporating significant part of the entire rockslide may occur (Figs. 26.13, 26.14).
