CISM COURSES AND LECTURES NO. 435
INTERNATIONAL CENTRE FOR MECHANICAL SCIENCES

REFURBISHMENT OF BUILDINGS AND BRIDGES

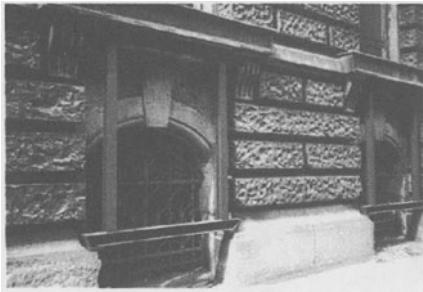
Figure 4. Provisional reinforcement by means of steelworks (Berlin)

What needed are constructional systems which offer flexibility of execution and ease of erection. For this purpose, steel provides “ad hoc” solutions under the classical form of scaffoldings or in more sophisticated and personalised versions of steelwork (Fig. 4). Scaffoldings can be used to create a provisional protection of the site during restoration operations (Fig. 5).

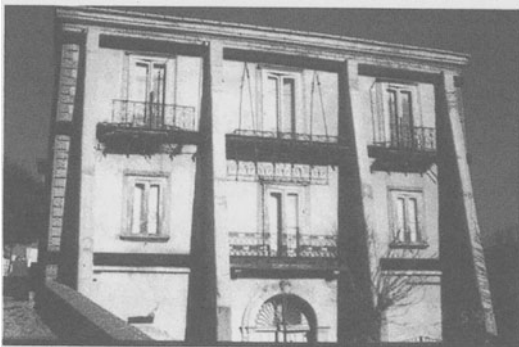
Figure 8. Provisional reinforcing system for a damaged building (Campania, Italy)

In the same period other damaged buildings were provisionally consolidated by means of steelworks and stone barbicans (Fig. 8).

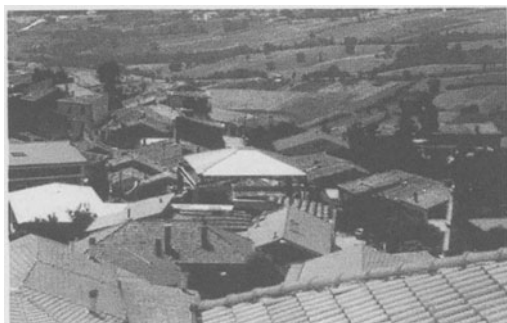
Figure 29. The roof structure of the Sacrarium of Morra de Sanctis (Avellino – Italy)

The new steel roof is inserted inside of the perimetral masonry ruins, in order to cover the internal space as a sacrarium consecrated to the memory of the victims of the earthquake (Fig. 29). Another example is the church in Quebec city (Canada); which was partially destroyed by a fire and now is restored by means of some simple steelworks inside, remembering the old features (Fig. 30).

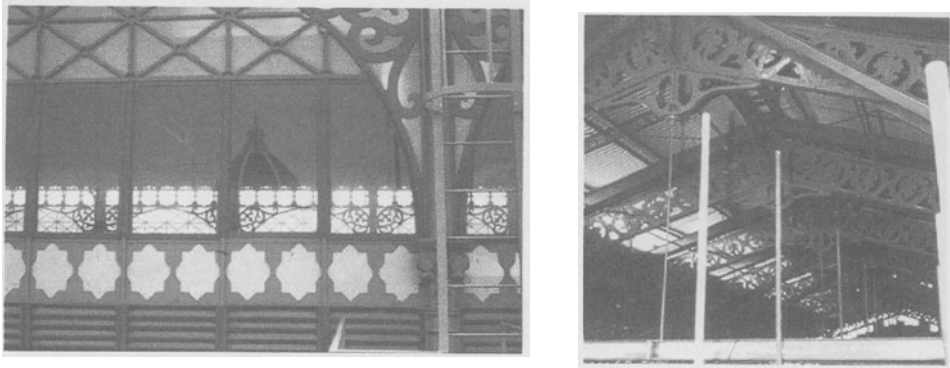
Figure 33. The St. Lorenzo market in Florence (Italy)

Particular attention must be paid to the connection between the old and the new steel in relation with the state of conservation (see Section 3.5). In many cases welding is not advisable due to the unpure composition of the old material and the use of bolting is therefore suggested. From the structural point of view it must be observed that the old steel schemes are usually well conceived for carrying vertical loads, but they are weak for horizontal actions and therefore require the integration with new bracing systems. These problems have been faced during the restoration of the St. Lorenzo market in Florence (Fig. 33).

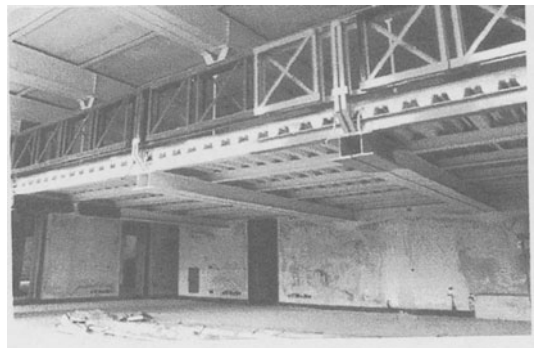
Figure 44. Insertion of mezzanine in the Ducal Palace of Genoa (Italy)

Many steel structures have been inserted under form of mezzanine made of steel supported by the existing masonry and partially suspended to upper new steel beams (Fig. 44). They are connected by many elicoidal staircases, whose banisters have a structural role. There is an amphitheatre, whose gradine is made of heavy curved double T sections (Fig. 45).

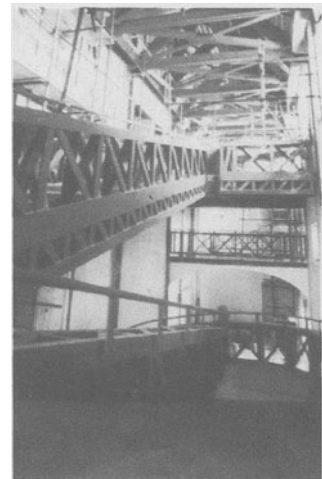
Figure 46. Insertion of a suspended ramp in the Ducal Palace of Genoa (Italy)

The most interesting insertion is a steel ramp, which is suspended to a steel umbrella created on the top of a r.c. core (Fig. 46). The curious reason, why a ramp not a stair has been designed, is due to the fact that the Duke was used to go to bed riding on horseback and the bedroom was at the second floor.

The structural restoration concept of the Ducal Palace of Genoa is characterised by a massive use of steelwork, whose dimensions are very impressive. In the suspended ramp the huge dimensions of the steel structure probably want to simulate the same sizes of the previous old wooden structure.

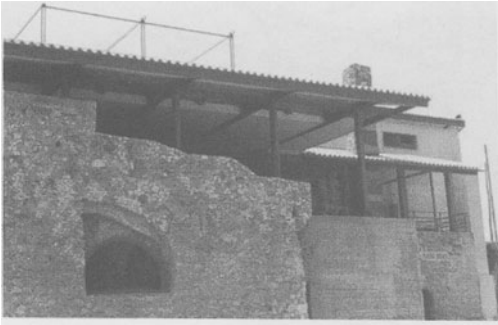
Figure 55. Vertical addition in a restored building in Briatico (Calabria, Italy)

An old industrial building in Briatico (Calabria, Italy), which was active in different productions (sugar, wool and soap) from fifteen to seventeen centuries, has been retrofitted and re-used as a sport club (Fig. 55). After consolidation of masonry, a new level has been created by means of a steel framed structure (Matacena & Mazzolani, 1981, 1986).

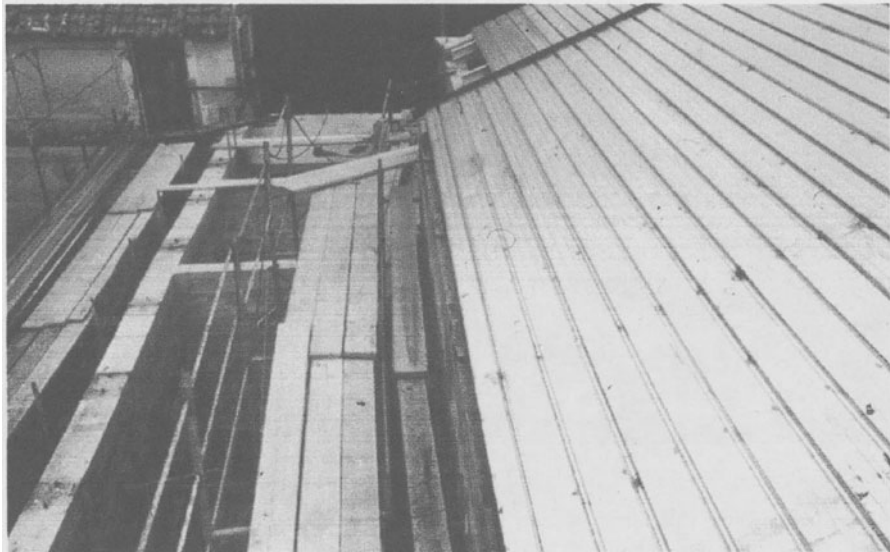
Figure 59. Corrugated sheeting for a new steel roof

drastically, lightening interventions are considered all operations substituting floors, roofs or other structural elements with lighter materials. In fact, the substitution of heavy wooden and masonry floors with light steel I-sections and corrugated steel sheets as well as the complete remaking of roofs with steel trusses are very common (Fig. 59).

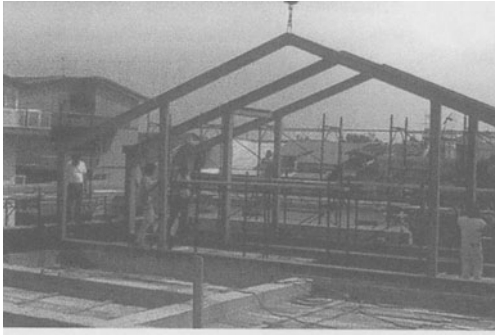
Figure 61. The new light structure for the roofing of a building in Succivo (Caserta, Italy)

An interesting example of lightening has been done in Succivo (Caserta) near Naples. It is a masonry building belonging to the municipality, whose roof structure made of heavy masonry tympanums and wooden beams has been completely demolished. The new structure consisted of light steel frames (Fig. 61) with four columns, completely prefabricated in workshop, transported, erected and completed with trapezoidal sheeting, giving rise to a new volume, like a penthouse, where the cultural center of the village has been located (Fig. 62).

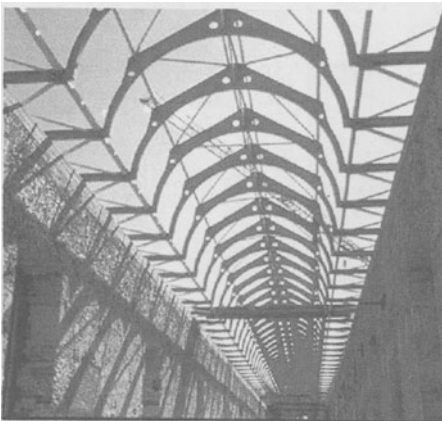
Figure 63. A light steel roof (courtesy V. Nascè)

A very light steel roof has been built to cover the gallery of the Museum of Contemporary Art in the Rivoli Palace near Turin (Italy) (Fig. 63).

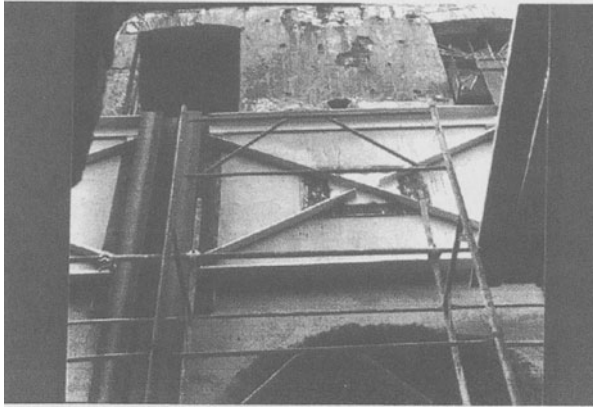
Figure 66. Steel braces on the masonry wall of the Montemarano church (Avellino, Italy)

In case of masonry structures two significant examples are: the electrical power station near the Balaton lake in Hungary (Fig. 65) and the church of Montemarano near Avellino, Italy (Fig. 66).

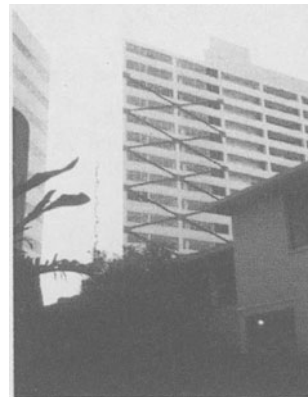
Figure 72. Steel cross braces in a building of St. Monica, Los Angeles (California USA)

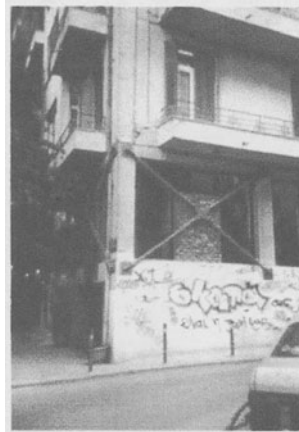
Figure 73. Steel cross braces in a building of Tessaloniki (Greece)

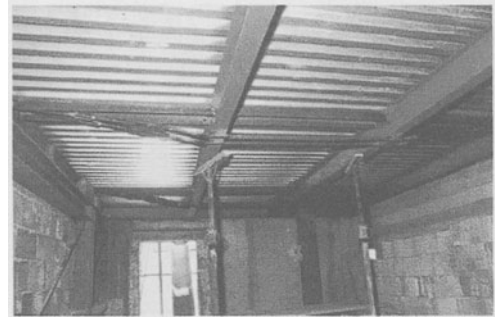
Figure 78. The new floor structure of the Capodimonte district (Ancona, Italy)

- constructing roof structures with trusses and purlins and finishing off with the existing covering of roof tiles (Fig. 77);
- from the top floor, demolition of internal walls and the corresponding floor and reconstructing the new floor with main and secondary beams, corrugated steel sheets and casted concrete (Fig. 78);

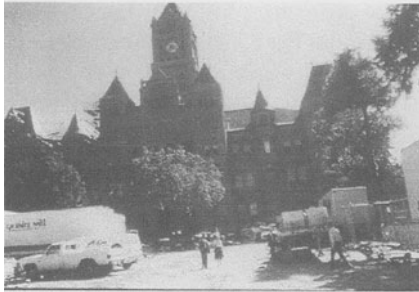
Figure 80. The first application of “base isolation” in a historical building: The City and Country Hall of Salt Lake City (USA)

The first historical application of the base isolation technique has been experienced in 1989 on the City and County Hall in Salt Lake City (USA): hundred years old masonry building which has been located on about 200 cylindrical rubber paths at the foundation level (Fig. 80).

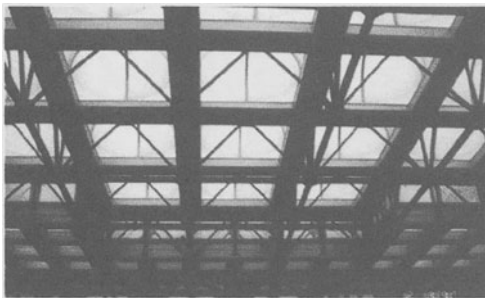
Figure 94. Support structure of the dome skylights

- The beams supporting the dome skylights (Fig. 93) which illuminate the inner courtyard rest on the upper truss nodes of the inner box walls (Fig. 94)
- The cantilever beams which cover the zone outside the perimeter defined by the four towers are connected to the lower truss nodes of the outer box walls

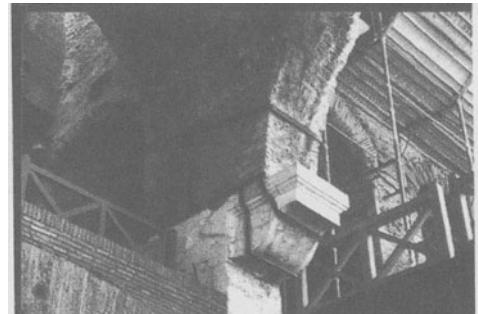
Figure 106. Detail of the support of the vault impost and of the previous reinforcement

The effectiveness of the reinforcing system is today very poor owing to both the absence of internal ties and the rupture of some elements.

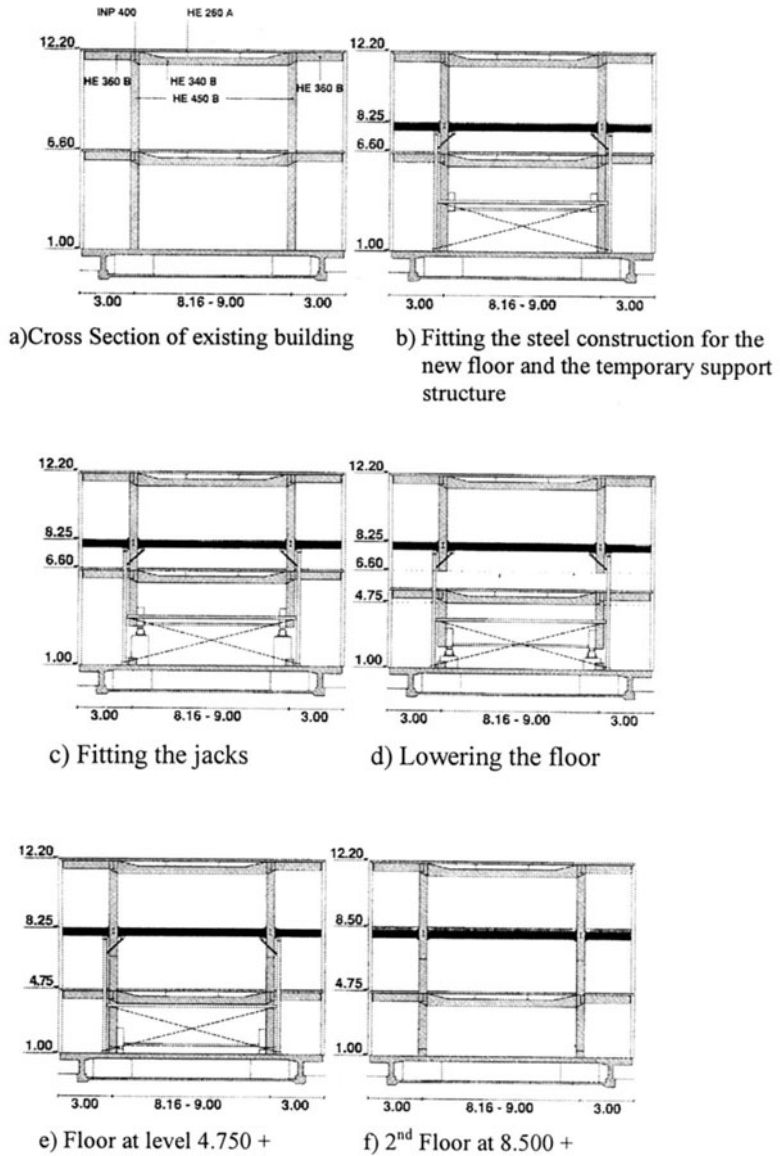
Figure 113. The operational phases in the transformation of a building in Amstelveen (Netherlands)

- Fit a steel construction for the new floor at 8.25 m;
- Assemble the temporary support construction under this;
- Shorten the bottom columns by 1.85 m and keep these column sections;
- Put the jacks in place;
- Release the column division and allow the floor to be lowered by 1.85 m;
- Replace the column sections and weld the whole structure together.

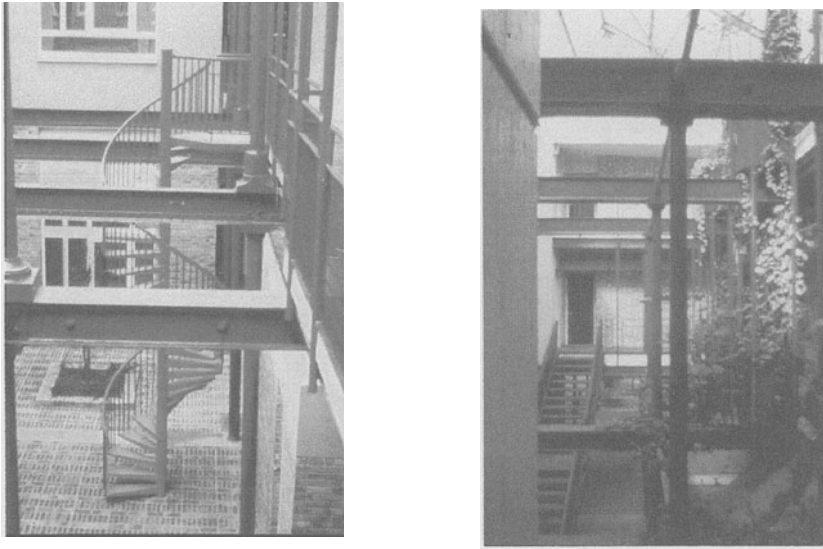
Figure 116. The original columns made of cast iron

The internal columns supporting the floors are of cast iron construction on a structural grid measuring 4m by 4m. Where the new arrangement created small loads, the columns were left in their original condition (Fig. 116).

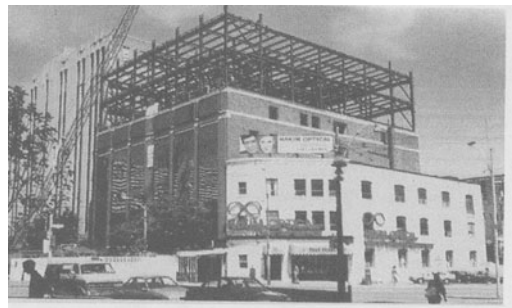
Figure 119. The additional floors under construction

Contrary to the initial choice, it was later decided to use steel for the additional structure (Fig. 199). Thank to this choice, instead of four stories, it was possible to add new eight stories (Fig. 120). Therefore, at the end the super-elevated building is now composed by fourteen stories, instead of ten, with an important increase in volume (Fig. 121) with respect to the initial forecast.

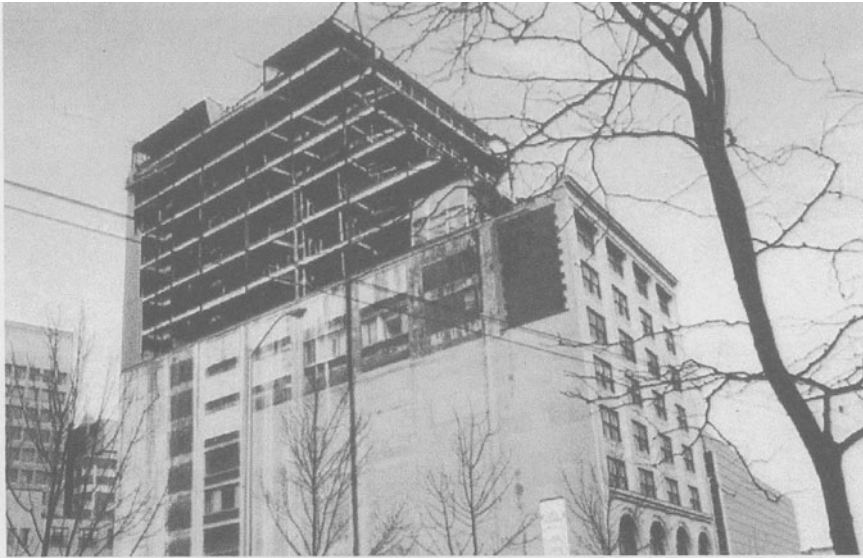
Figure 120. Eight additional floors made of steel frames

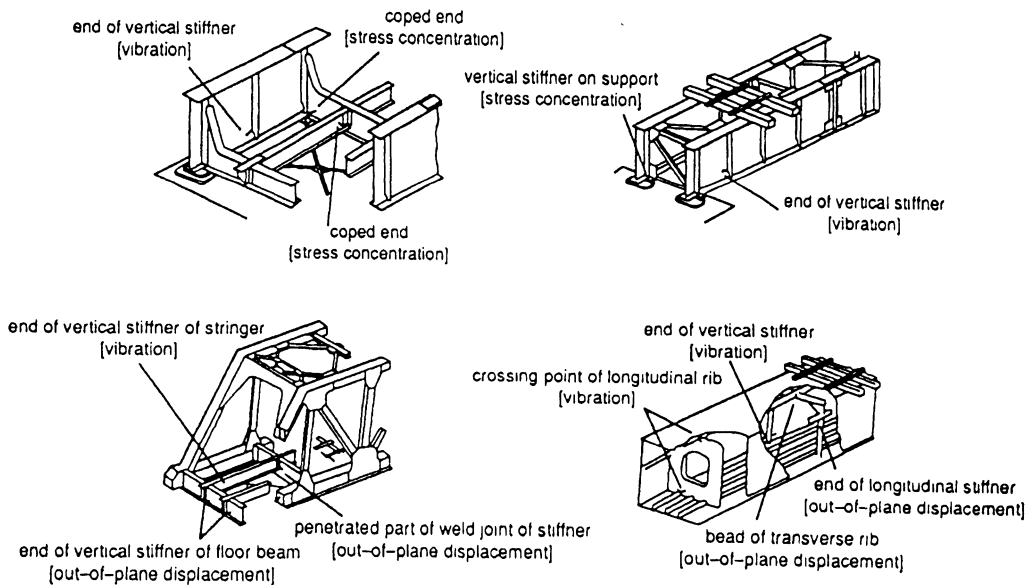
Figure 3.31 Fatigue damage in steel bridges

Concerning steel bridges, several types of fatigue damage have been observed as shown in Fig. 3.31 [Isoura, 1989]. These types of damage began to be observed in about 8 years after the opening of service. Some types of fatigue cracks are comparatively rare in the conventional railway system. They are in many cases caused by stress concentrations due to structural details of members, by out-of plane displacements occurring between perpendicularly crossing members such as main girders and cross beams or cross beams and stringers, and by vibration due to distortion under high-speed operation of trains peculiar to bullet train system.

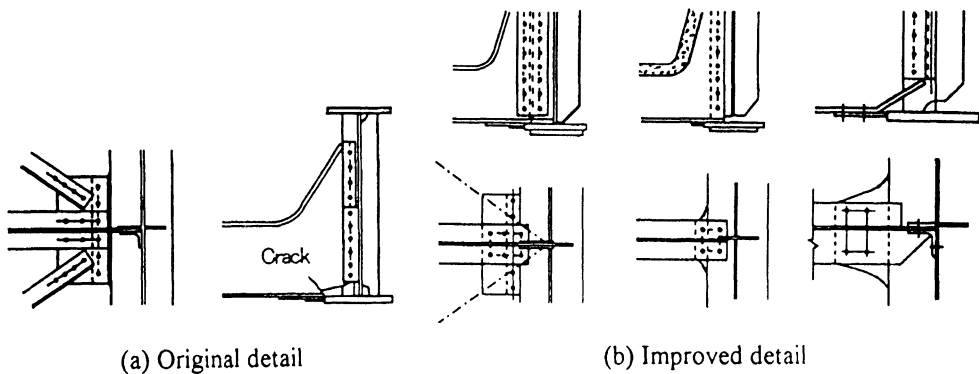
Figure 3.32 Improvement of details of cross beam

1. The main cause of this fatigue crack was that the end of lower flange of the cross beam was coped to connect with main girder and this induced stress concentration.
2. The measured stress becomes higher in the case of normal shoe seat than in the case of damaged shoe seat. Thus, the settlement of supporting point was also one of the causes.
3. In the retrofiting, additional plates were applied to web plate in order to increase the loading capacity. A sufficient reinforcing effect was obtained.
4. The details of the currently designed bridge was improved as shown in Fig. 3.32.

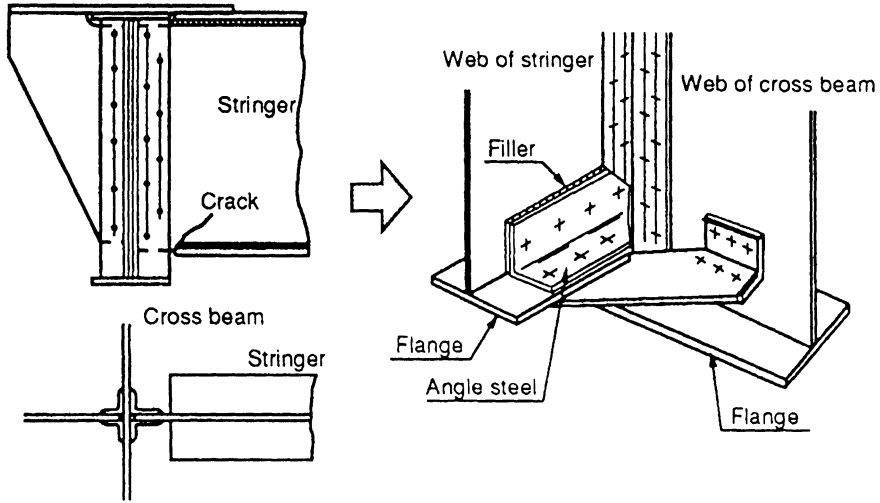
Figure 3.33 Damage of coped stringer

improving the lateral rigidity or keeping the stress flow as continuous as possible. However, in some bridges the lower flanges of stringer were not connected to the cross beam. This caused the stress concentration at the cope combined with it and led to cracking. With regard to the repair, the lower flange was connected with the cross beam web plate by extending it to the stringer end.

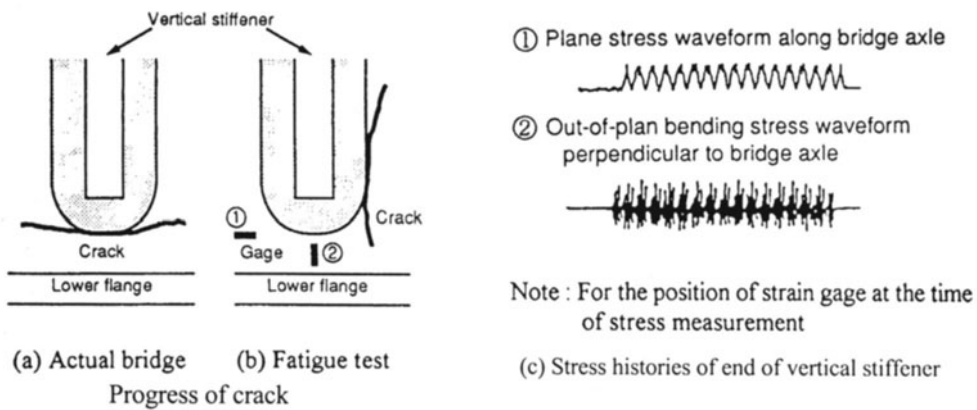
Figure 3.35 End of vertical stiffener in web plate

(e) End of Vertical Stiffener in Web Plate. Many fatigue cracks were observed at the lower ends of the vertical stiffeners attached to the web plates of stringers of truss girders or box-section deck girders. This type of fatigue damage was discovered in about 10 years after the opening of service, being hardly observed in the bridges in the conventional railway systems. The crack originates primarily at the toe or the root of fillet weld around the lower end of the vertical stiffener and develops horizontally into the base metal of the web plate. Such a crack may sometimes propagate along the weld toe, and progress in the direction horizontal to the base metal with some length. On the other hand, in the fatigue tests of beam specimen under in-plane bending, cracks usually progress in the perpendicular direction along the toe of weld as cruciform joints. These are shown in Fig. 3.35.

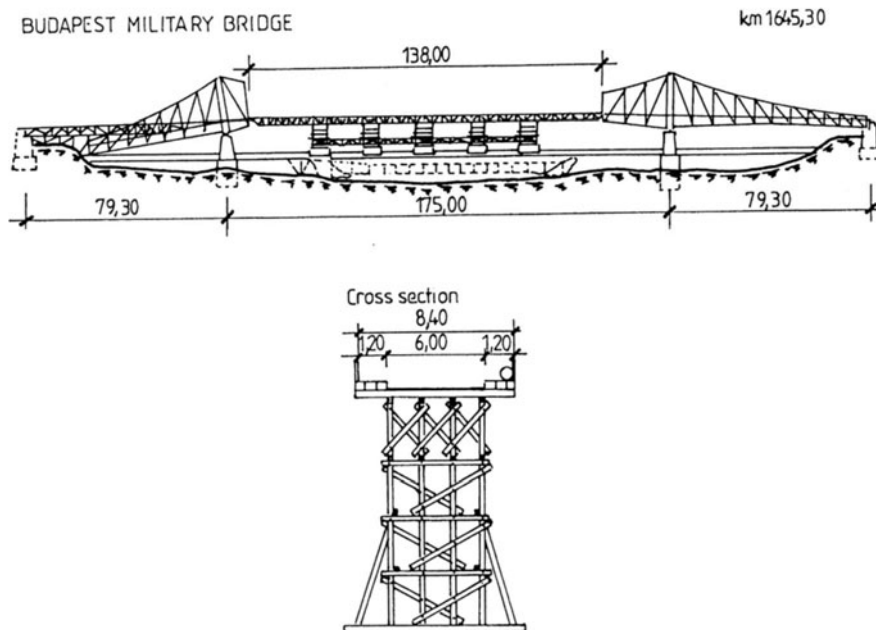
Figure 5.6 Provisory bridge in January 1946

A provisory bridge was built in the mid-span on five barges and on the wrecks of the Buda span from 15. March 1945, but it was drifted by an ice-flow in 10 January 1946 (Fig. 5.6).

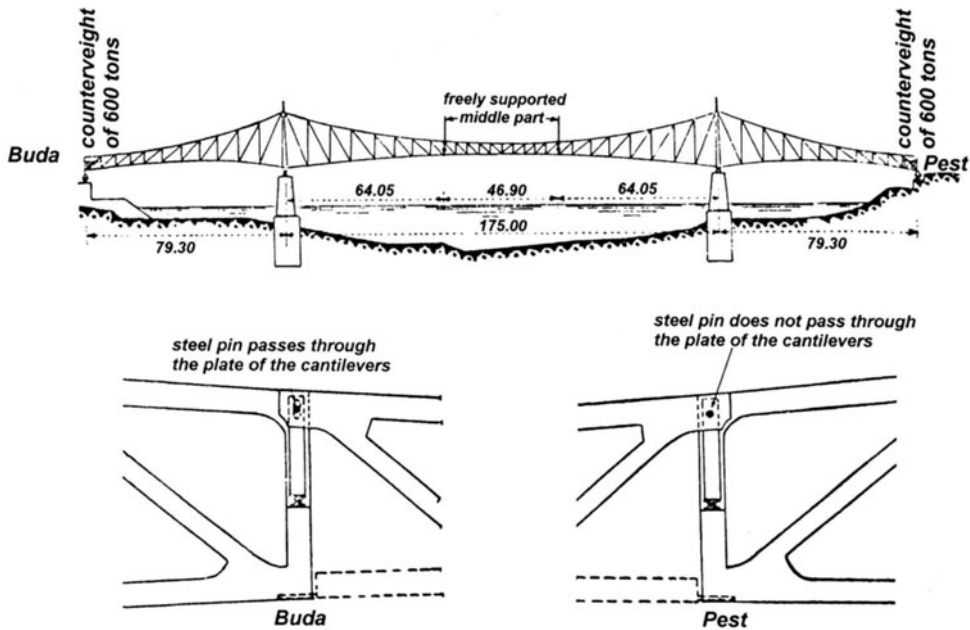
Figure 5.7 The cantilever type main girders

The main girders of this steel bridge are of the cantilever type running over three spans (Fig. 5.7.) [Haviár, 1947].

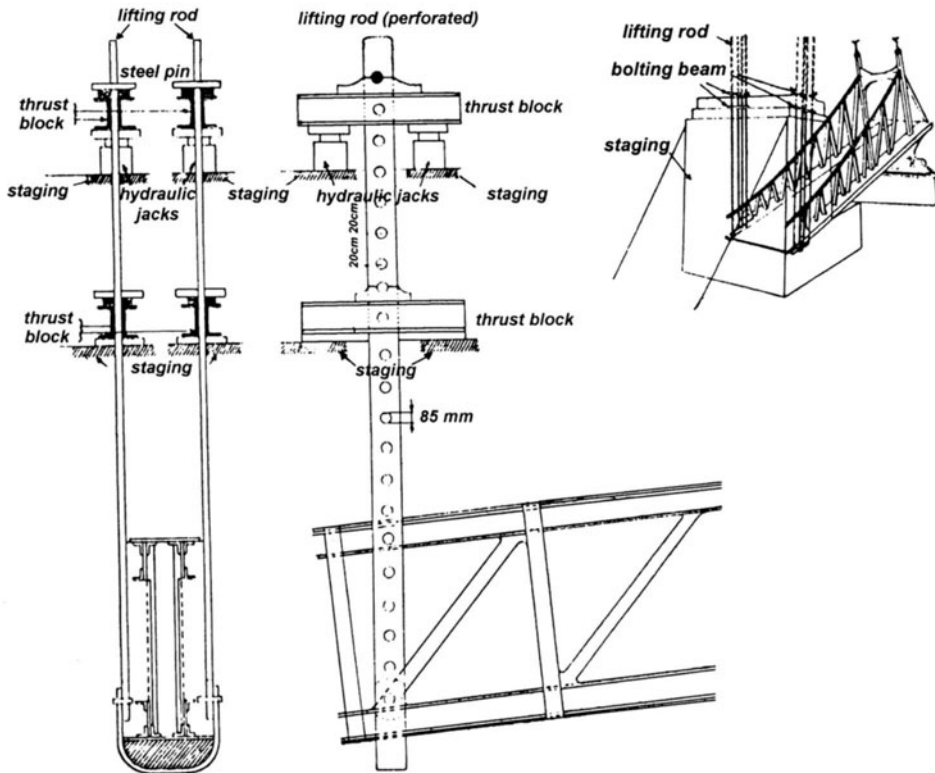
Figure 5.8 The bridging scheme

transferred temporarily to the pin passed through these additional cross blocks. For transmitting the load the jacks were emptied, the upper thrust blocks and pin were lowered down by 20 centimetres and the hydraulic jacks with pistons in the initial position could raise the structure by another 20 centimetres. The height of lift was altogether 9 metres 30 centimetres and by such steps of 20 centimetres all the work was done within four days.

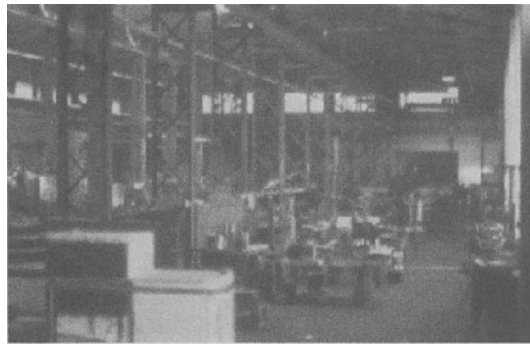
Figure 2. Service enterprise in Braunschweig.

insulation was installed. The heating was not situated - as is usual - under the truss. The reason was **not to disturb** the slender view of the truss. The heating is now situated on the top of the lower chord of the truss.

Even the overhead travelling crane was not changed (hand-operated) and it's still used for transport. The floor was carefully changed because of pollution level.

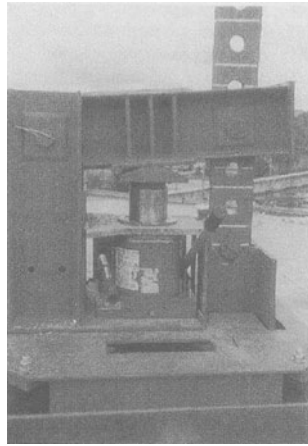
Figure 19. The lever attachment.

The procedure of hoisting the roof is finished (Fig. 19, 20). The first roof raised up to its final position (Fig. 21, 22).

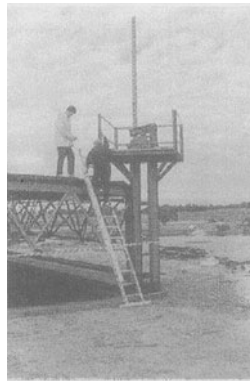
Figure 20. The lifting system of the hall roof after the placement of the first roof section to its new position.

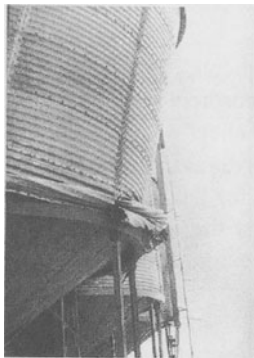
The next picture (figure 16) presents a silo with a volume of 200 m^3 . The silo wall is made of corrugated sheet and the hopper of flat sheet. The filling of this silo was grain.

Figure 16. Failed silo with corrugated sheet.

Along the vertical shell wall, longitudinal stiffeners are arranged in small distances. They are on the inside of the cylinder. In the last example, the longitudinal stiffeners were on the outside. These longitudinal stiffeners carry the whole load, which appears between the shell wall and the bulk material. The longitudinal stiffeners are placed on a ring stiffener, which is supported on 4, 6 or 8 columns.

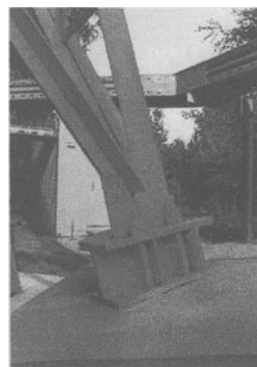
Figure 14. Foundation.

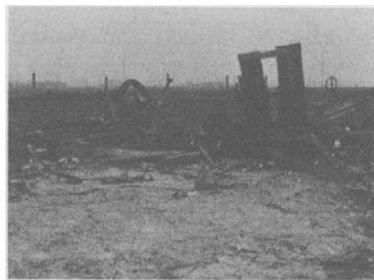
Figure 17. Collapse.

The list of collapses starts in 1911 with a mast that was situated west of Berlin near a town called Nauen. The poor quality of the photos can be attributed to the year of their taking (1911). At this time, the relation between wind forces and the height of a building or construction was still unknown. Therefore, the reason of the collapse of the 200m mast was the underestimation of the wind loading (Figure 16 and 17).

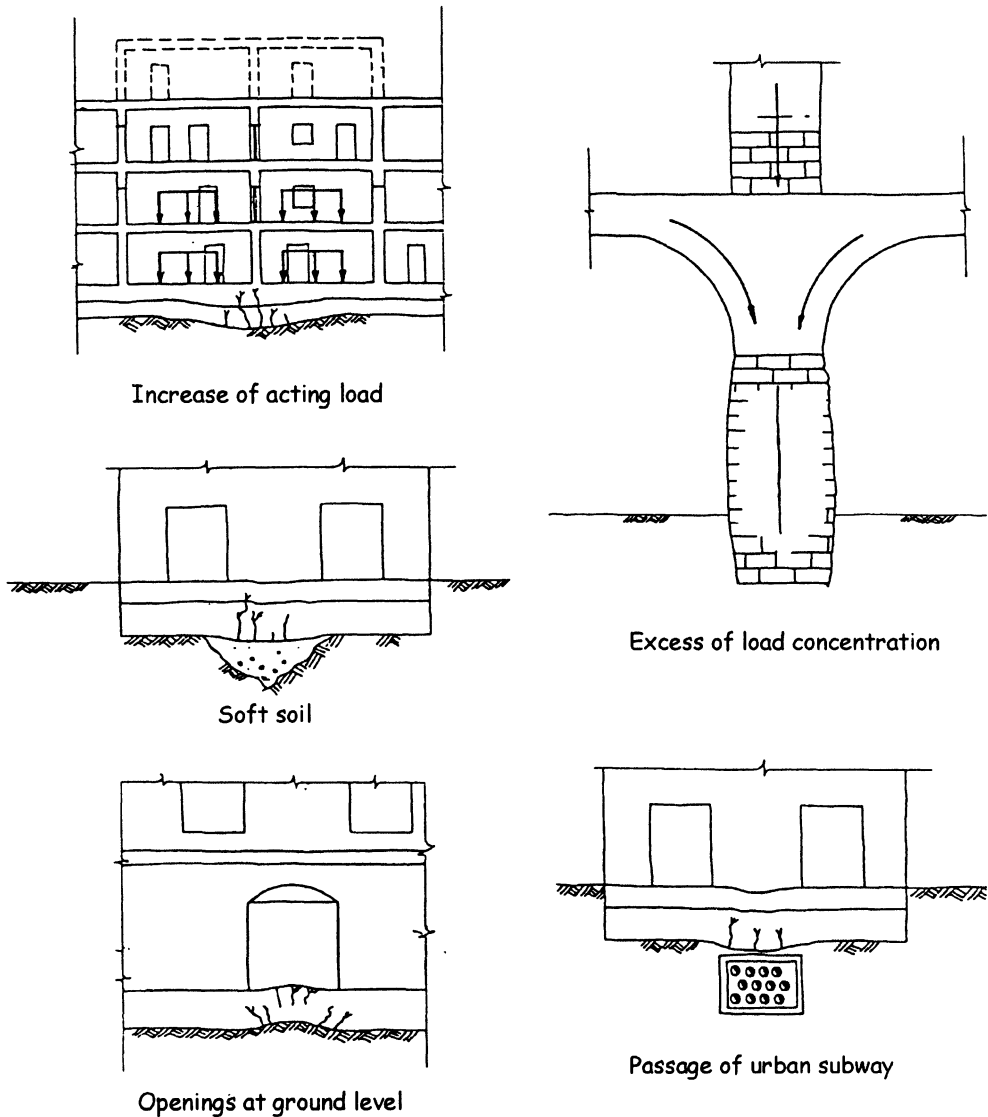
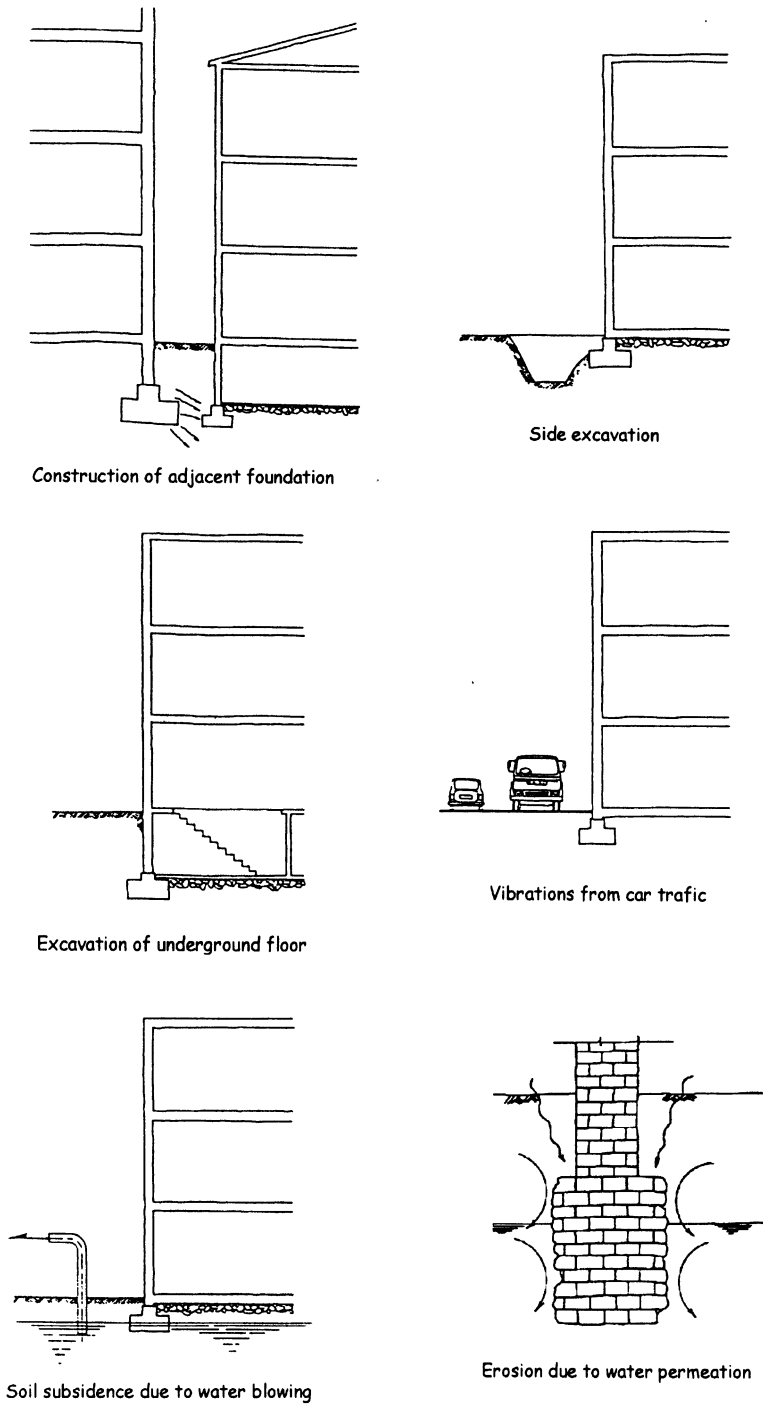
Figure 1. Causes of foundation damage.

In the first case current provisions for repairing and strengthening of masonry and reinforced concrete structures can be applied, which is why this aspect is dealt with in the following. The second case is concerned with a lack of foundation soil, which can be involved either by inherent poor soil properties, or by inadequate design. This may happen quite often in old masonry or r.c. buildings, which in most cases have been built without specific account for geotechnical problems. Most of times, damage of foundations arise as a consequence of soil settlements, that is of displacements which may occur across the whole lifetime of the building. Such displacements, either absolute or differential, can be due to (Figure 1):

Figure 1 (ctd). Causes of foundation damage.

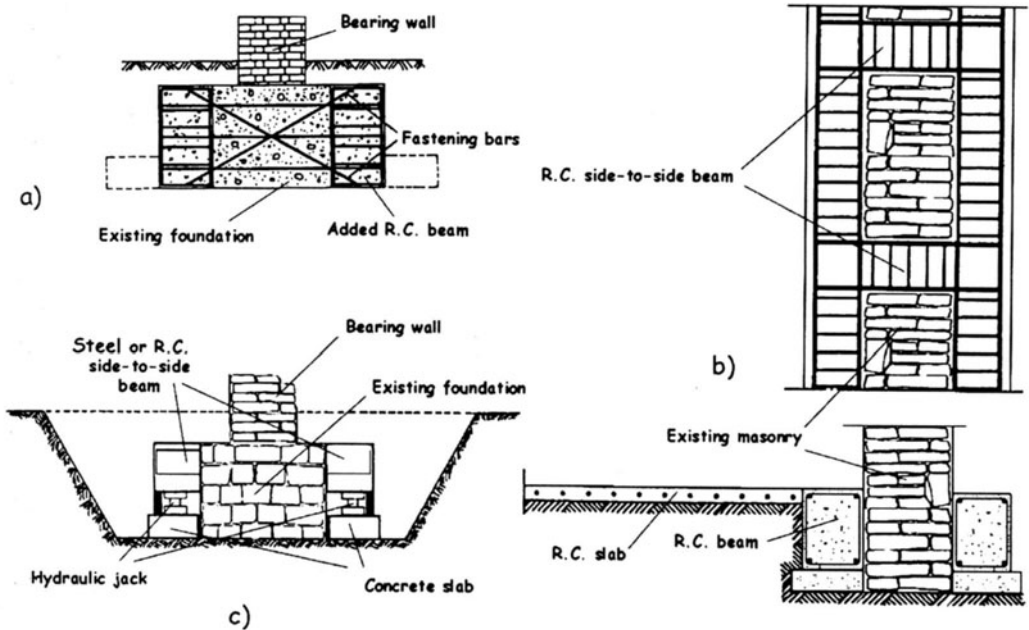
Figure 3. Cases of passive (a, b) and active (c) base enlargement.

As new elements are cast aside the existing base, they will be enforced only by loads applied after their construction. Thus, in order to make these elements effective, additional displacements are needed, which can cause possible damage in the superstructure. Such risk can be reduced by trying two solutions. The first one is to eliminate all live loads from the building and, if possible, also a part of dead loads (e.g. furniture, partition walls or even floor structures, if their eventual substitution is planned), before laying down the base enlargement. In this way, all loads applied later will insist on the enlarged foundation acting as a whole, that is on both existing and new elements. The second way is to adopt active methods in order to apply a given preload to additional elements, for example by means of hydraulic flat jacks placed as shown in Figure 3c. In this case the value of the force acting on the new elements can be adjusted so as to meet the specified design requirements. In addition, preload can also be applied at different construction stages, depending on the planned load application procedure. In particular, some existing damage in the superstructure can be also partially or totally recovered by means of such active devices.

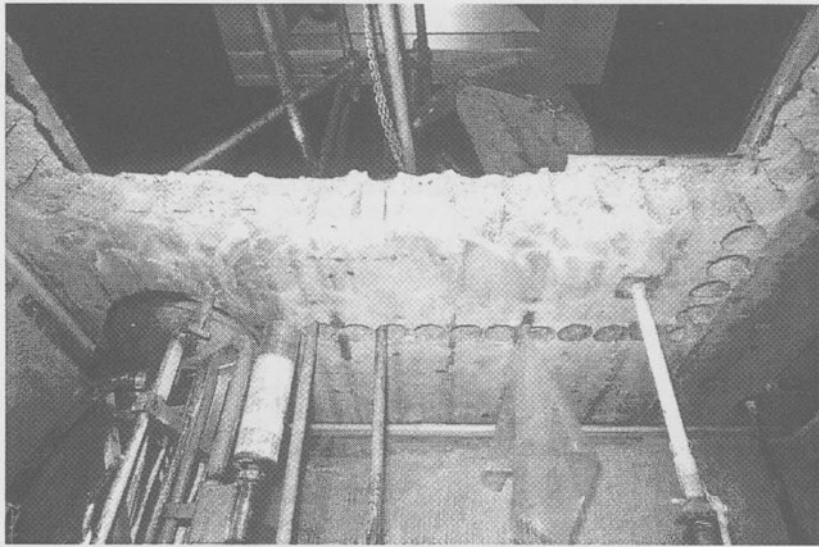
Photo 7. Drilling of an opening in a concrete floor, with a diamond core (Courtesy Zschokke)

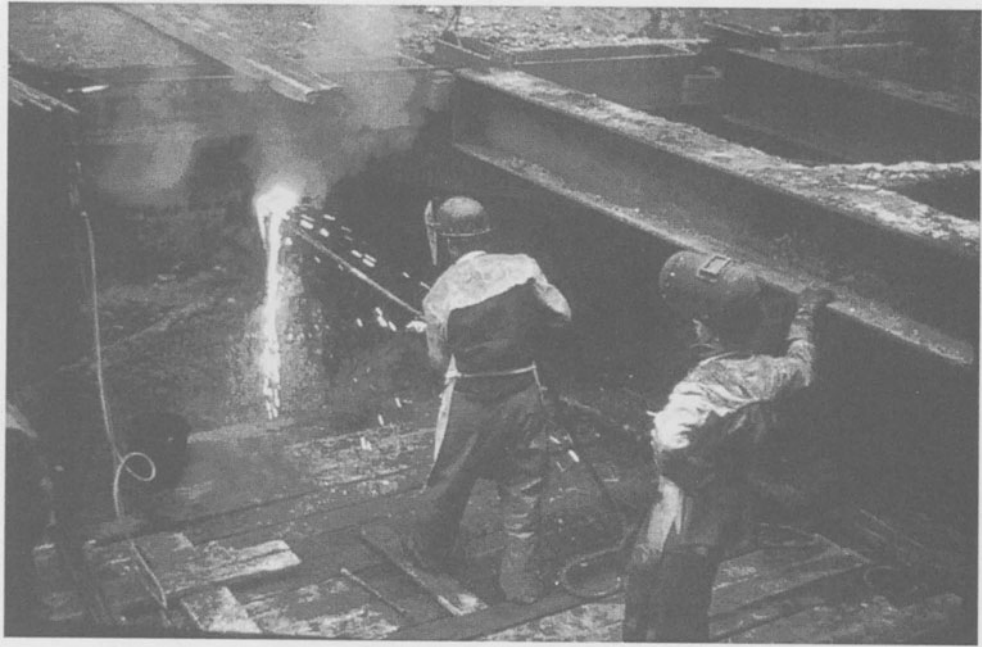
Photo 9. Thermic lance cutting (Courtesy Zschokke)

The most common lances are 3 to 4 m long with diameters equal to 13, 17 or 21 mm. The bored holes have diameters between 30 to 60 mm.

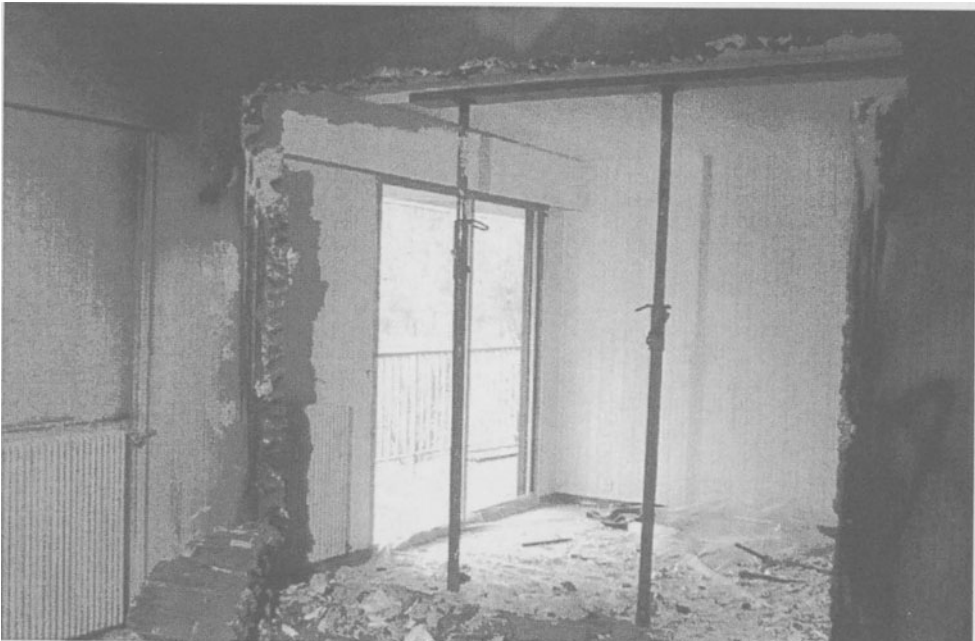
Photo 10. Result of an opening cut with a thermic lance (Courtesy Zschokke)

This technique is very attractive in the field of partial demolition (photo 10). No noise, no impacts, no vibrations are produced. It does not create cracks in the surrounding concrete. This is a fast process, usable in urban sites without problem. It allows large thickness of material to be bored. It is to be noted that this technique can also be used under water.

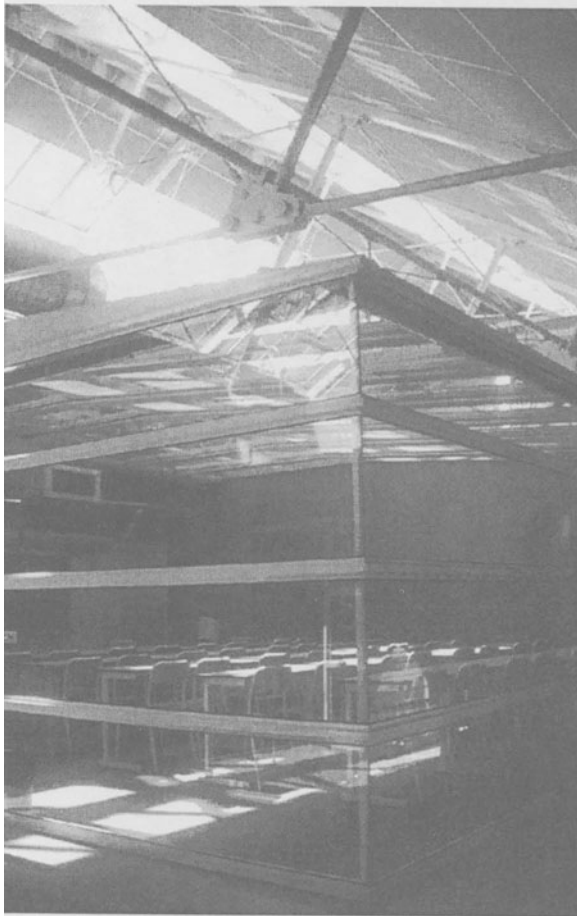
Photo 14. Internal view of the "Polonceau" trusses and upper teaching rooms.

A catwalk was created at the level of the main tie of the "Polonceau" truss and was hung from it. It supports the services including ventilation and smoke extractors. It allows the roof windows

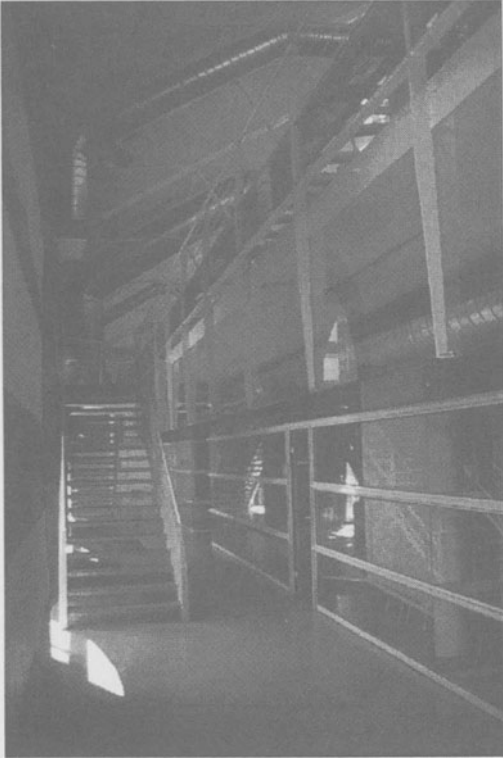
Photo 15. Stairs and lower level.

Internal light steel stairs disposed close to the external walls permit the passage from one level to the other one. Balustrades fabricated in glass panels framed with steel tubular sections are provided, keeping clear the required transparency (photos 15 and 16).

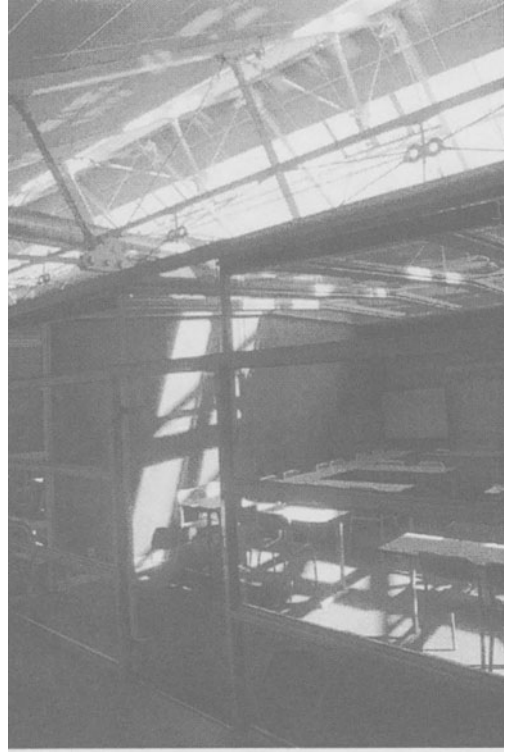
Photo 16. The upper level

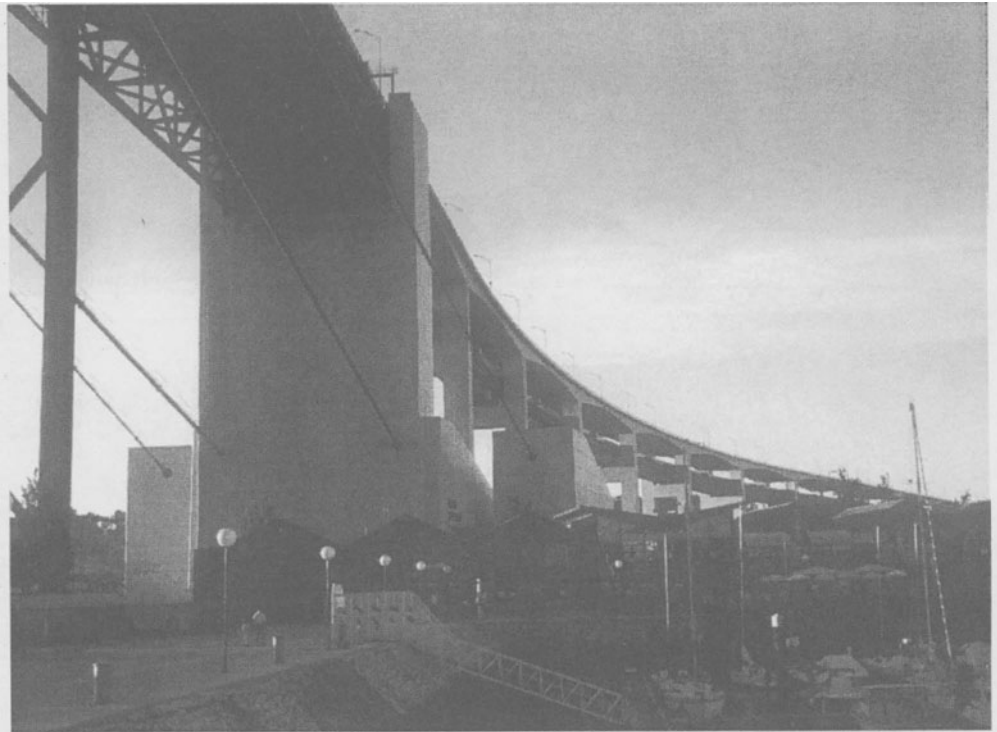
Photo 26. North bank anchorage blocks

The new anchorage, made of separate concrete blocks, have been located close to the existing ones (Photo 26).

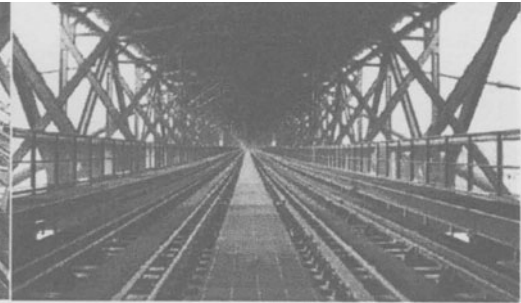
Photo 34. Railway tracks after completion

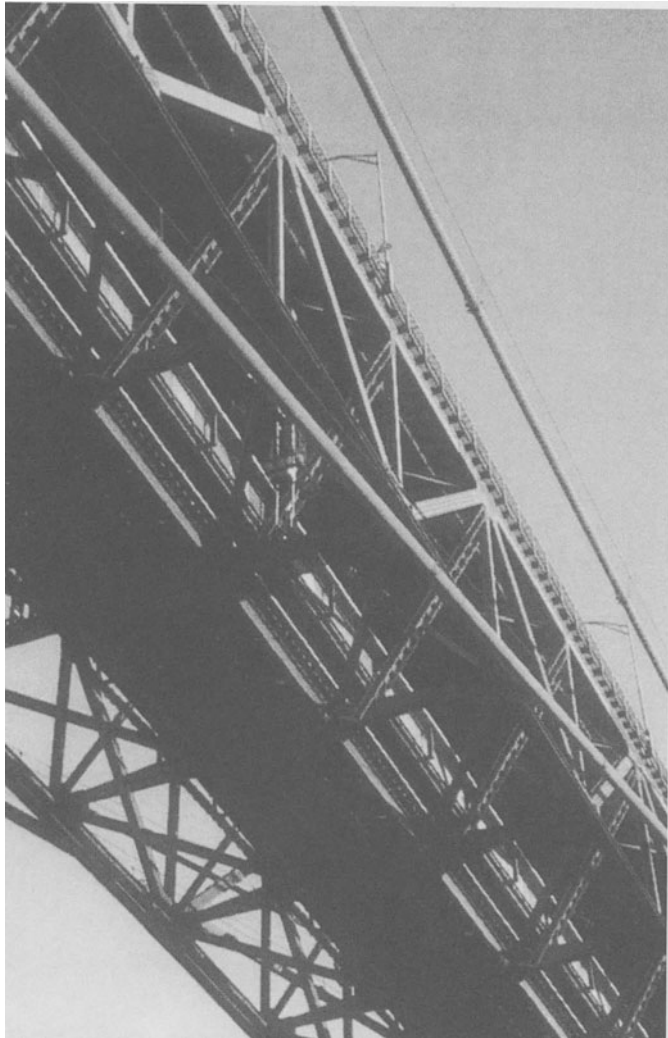
Photo 36. Downside view of the truss girder after completion of the improvement

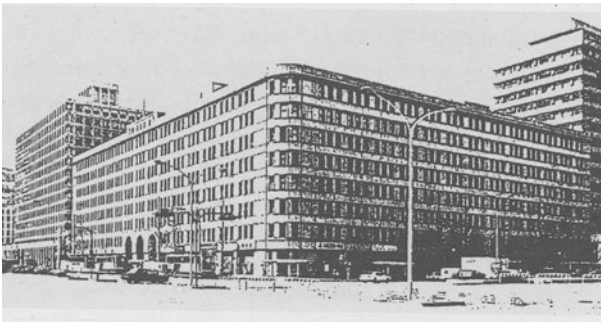
Fig.5.1 Marunouchi Building

Site	2-4-1 Marunouchi, Ciyoda-ku, Tokyo
owner	Mitsubishi Estate Co. Ltd
Main purpose	Office, Retails
Total floor space	Approx. 650357 square feet
Floors	1 floors below ground, 8 floors above ground, 1 floors penthouse
Height	Approx. 102 feet
Structure	Steel frame reinforced concrete Steel frame brick built (original)
Completion	February 1923

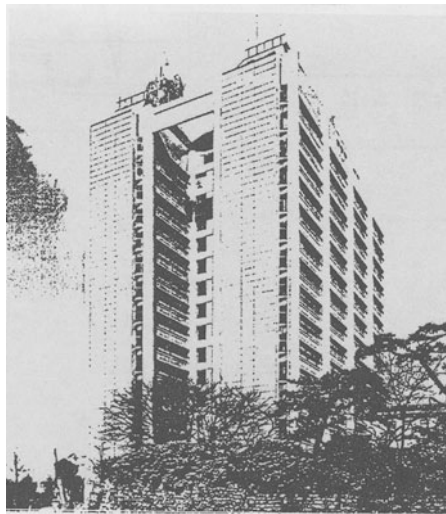
**Fig.5.16 Original Steel Framed Reinforce Concrete Building**

Structure:	Steel framed reinforced concrete
Height:	64 m Structure
Completion:	1970
Target	Structural safety for earthquakes
of Design:	with ground velocity of 70 cm: Story drift angle less than 1/100~1/150
Designer:	Nikken Sekkei Ltd
