# WHY BUILDINGS FALL DOWN

How Structures Fail

MATTHYS LEVY  
and  
MARIO SALVADORI

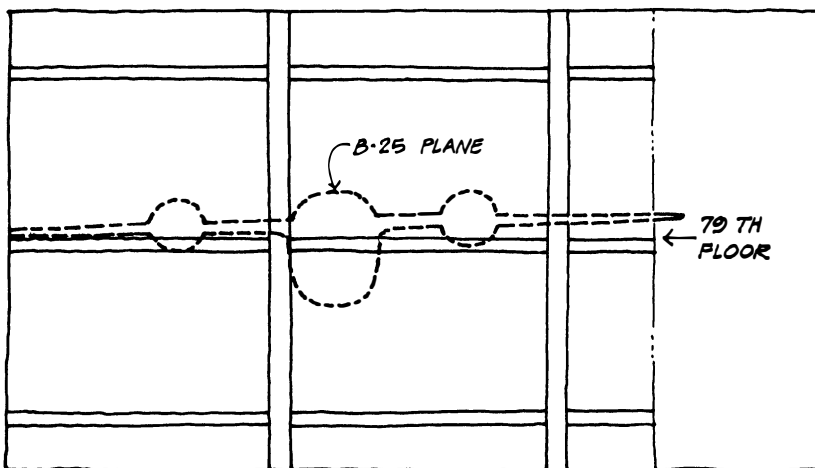
## 2.4 B-25 Straddling Column

The center of impact aligned almost exactly with a column on the face of the tower. The right motor passed on one side of the column and the left motor on the opposite side (Fig. 2.4). The column itself was barely damaged, although a steel beam supporting

the masonry wall struck by the right motor was torn out, and a second beam supporting the floor slab was bent back 18 in. (450 mm). The plane apparently struck the seventy-ninth floor dead-on, which explains the lack of damage to the column. Had the plane been just a bit higher or lower, it might have struck and bent the column, and then . . .

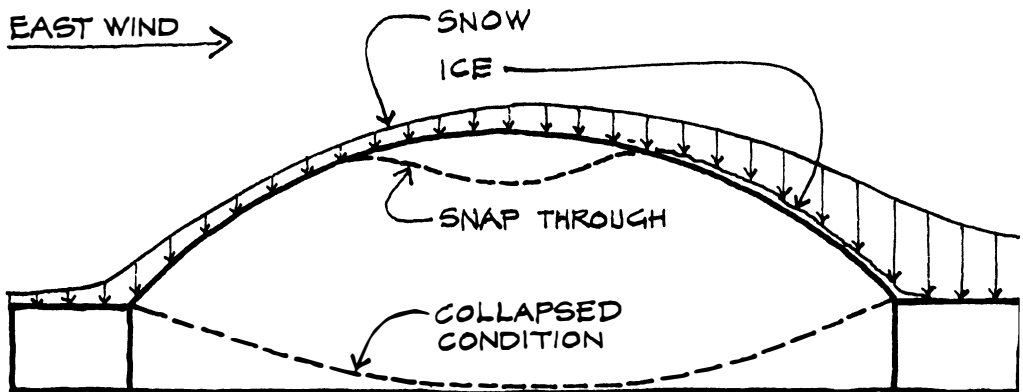
### 3.12 Stages of Collapse of C. W. Post Dome

Between 2:00 and 3:00 A.M. on Saturday, January 21, 1978, the center dome suddenly caved in under mounds of snow and ice. “It looks like a giant cracked eggshell,” commented Officer Stephen Chand of the Old Brookville Police Department (Fig. 3.12). Only four days earlier the 360 by 300 ft. (110 × 90 m) *flat* steel roof of the Hartford Civic Center Arena had collapsed under similar conditions (see p. 68), and one could have heard then the “amateur structuralists” comment on the traditional strength of the dome, the prototypical “form-resistant” structure: “They should have used a dome instead of a flat roof. It would have been stronger and cheaper!” But now. . . ?

Three days later Nicholas W. Koziakin, a structural engineer with the renowned New York City office of Mueser, Rutledge, Johnston and DeSimone, inspected the site and, after numerous additional visits, presented on May 10 his thorough but qualitative report. He concluded mainly that the dome had been underdesigned by a simplified theory *inapplicable* to the reticulated dome structure, based on the assumption of *uniform* dead and live loads, and that the nonuniform snow blown on the dome by the wind, and the ice found under the snow the day of his first visit, may well have stressed the structure above allowable limits (Fig. 3.12). He advised that a more realistic model of the reticulated dome should be analyzed by a rigorous theory to check the design. Weidlinger Associates was entrusted with this analysis, and its report of May 1979 proved Mr. Koziakin's conclusions to have been entirely correct. As in some other structures, for the reticulated dome of the C. W. Post center "less was more." A snow load of only *one-fourth* the load required by the code but concentrated over a sector *one-third* of its surface was bound to collapse the dome! Indeed, that had been the story on the night of January 21, 1978, when a load of snow blown by an east wind had lodged onto the *leeward* side of the dome.

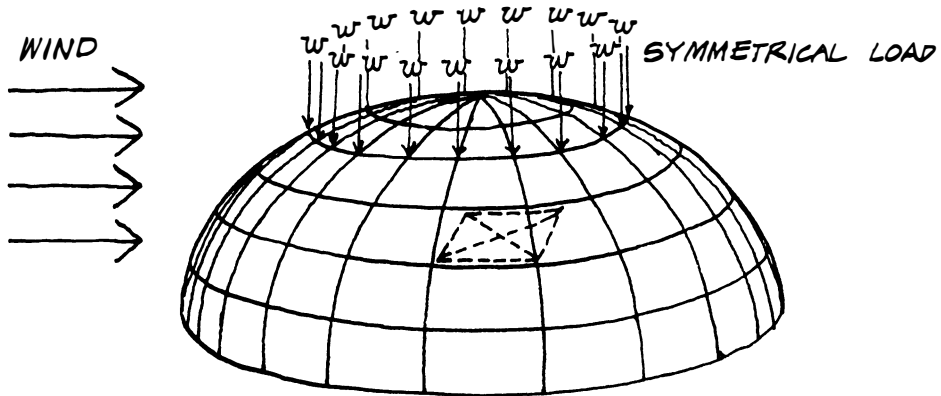
### 3.14 Skewing of Radial Ribs Caused by Wind

But perhaps the most dangerous consequence of using membrane theory in the design of shallow reticulated domes is that under symmetrical gravity loads its meshes *shrink* (slightly) on all four sides, *remaining square*, while under wind loads they become skewed (Fig. 3.14) and require diagonals to be stable. Finally, since most of the bars of the mesh are compressed, reticulated domes must be checked against the dangerous phenomenon of *instability in buckling as a whole*, which causes the dome to invert or *snap through*. (You may easily check instability in buckling by pushing down on a thin metal or plastic ruler that will bend out at right angles to its thin surface and lose all capacity to resist compression higher than a small push [p. 289, Fig. D4].) Rather unwisely the

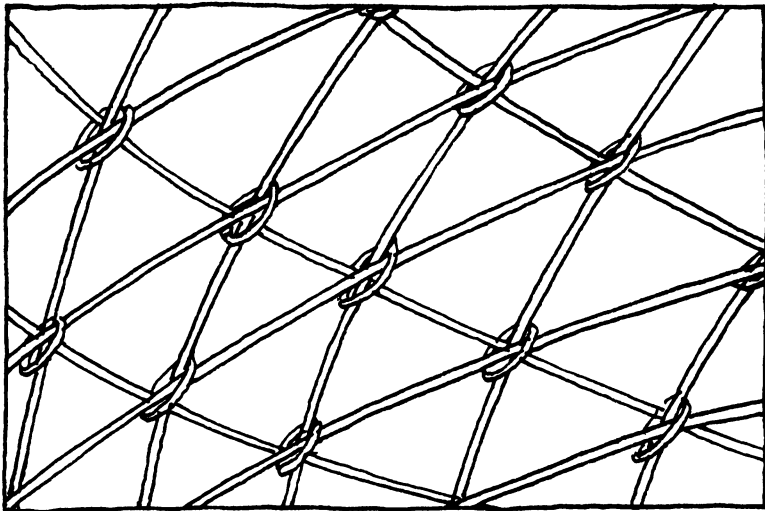
3.16a Bar Arrangement in Bucharest Dome

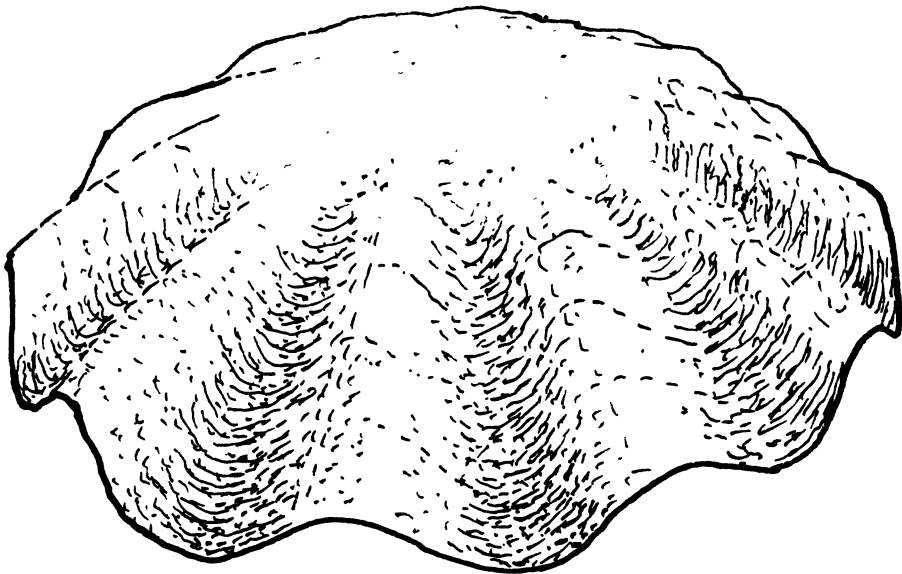
**3.17** Local Radial Buckling of a Dome

Soare also remarked later that the bridle node connections had been entirely unable to prevent the relative sliding of the pipes meeting at the nodes. Rigid connections at the nodes of a reticulated dome are essential to maintain unchanged the geometry of the dome and to prevent bending deformations at the joints; no

light reticulated dome can be self-supporting without the satisfaction of these two conditions. Thus a probably minor saving in the cost of the connections may well have been a major contributory cause of the collapse.

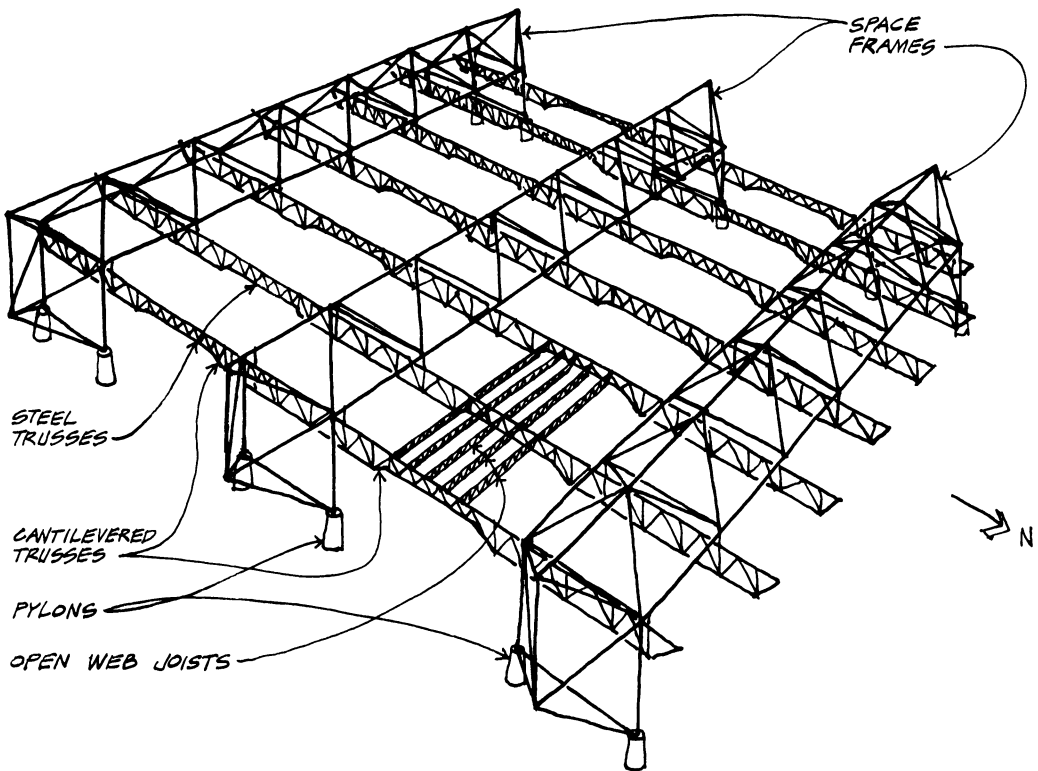
4.4 Diagrammatic Layout of Structure of the Kemper Arena

The basic structural elements supporting the loads of the roof itself and those acting on it, as well as the weight of the upper part of the walls of the arena, were three external space frames spaced at 153 ft. (46 m) in the north-south direction in the shape of rectangular portals, 360 ft. (108m) long in the east-west direction, and 81 ft. (24 m) high (Fig. 4.4). The horizontal element, or beam, of the portals consisted of a *space frame* of steel tubes with an equilateral

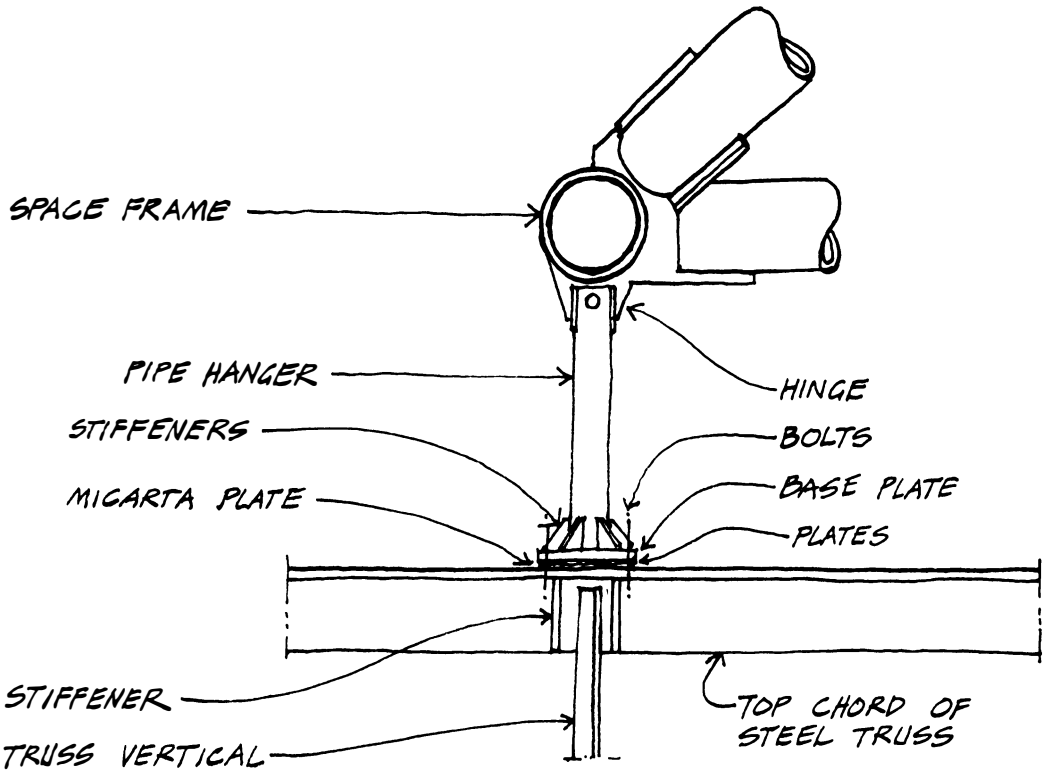
#### 4.6 Components of the Hanger Assembly

The hanger assembly, because of its two essential functions, does not consist of a simple rod as the word "hanger" may have implied to the reader (Fig. 4.6). Since the weight of the roof itself is 26 psf (1.3 kN/m<sup>2</sup>), or about 1,500 tons, and since the roof was designed to carry 25 psf (1.25 kN/m<sup>2</sup>) of additional load caused by rain, the load of the mechanical systems, and other hanging loads (or about

another 1,500 tons), then each of the forty-two hangers was to support in *tension* 140,000 lb. (622 kN). Moreover, they had to resist the horizontal, variable wind forces (exerted on the roof and on the upper part of the walls hanging from it), which tended to move the roof horizontally as a gigantic pendulum. For this purpose six of the hangers were hinged both at their top and about halfway down their length, while the remaining thirty-six were hinged only at the top and connected (almost) rigidly to the top chord of the large trusses. While the two-hinge hangers allowed the roof to move as a pendulum, the single-hinge hangers limited the horizontal roof motions to the *bending* deflections of these hangers (Fig. 4.7).

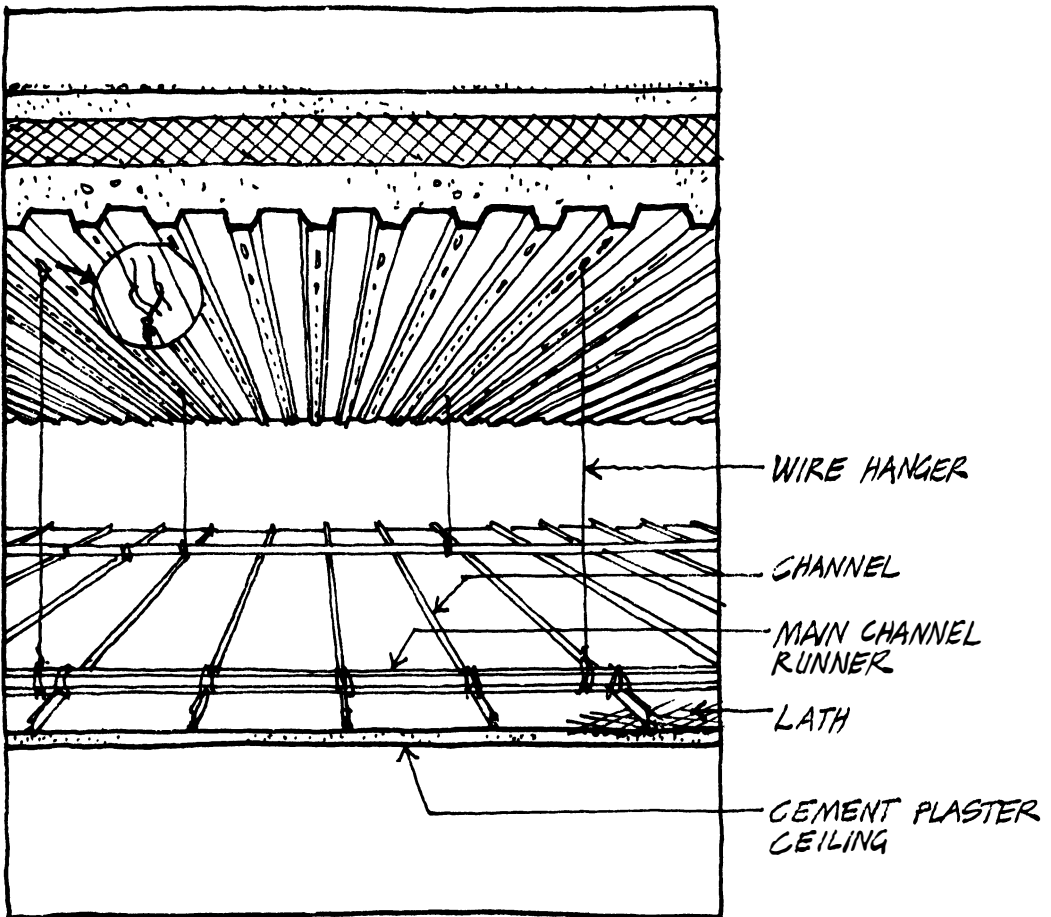
4.9 Components of the PATH Railroad Station Ceiling

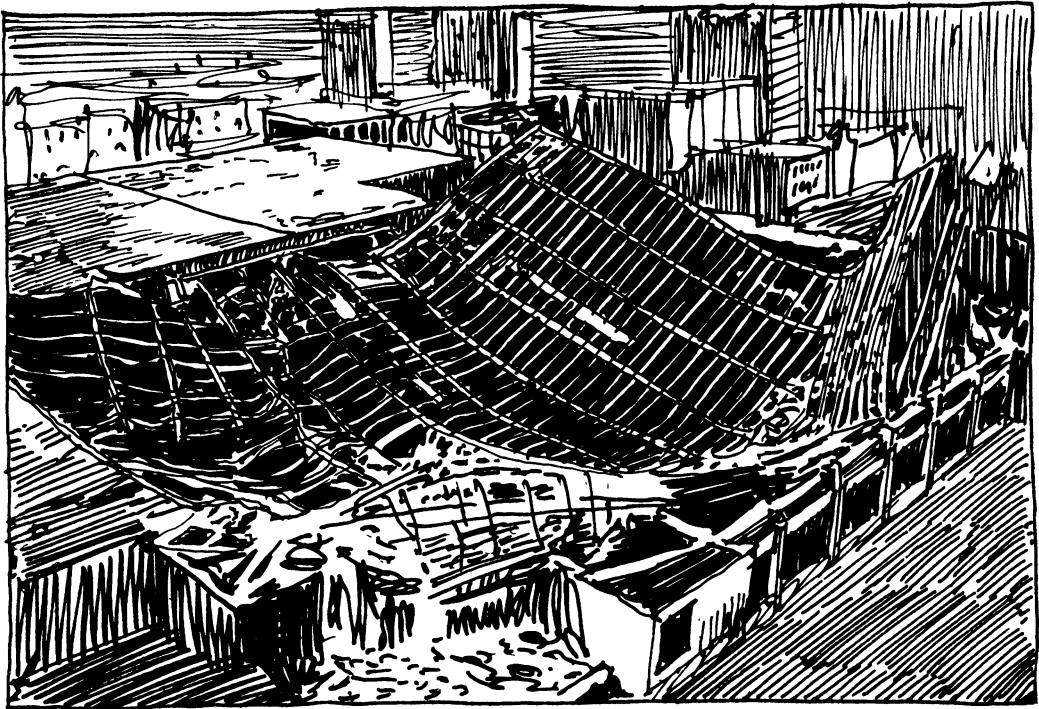
4.10 Hartford Center Roof: after the Collapse

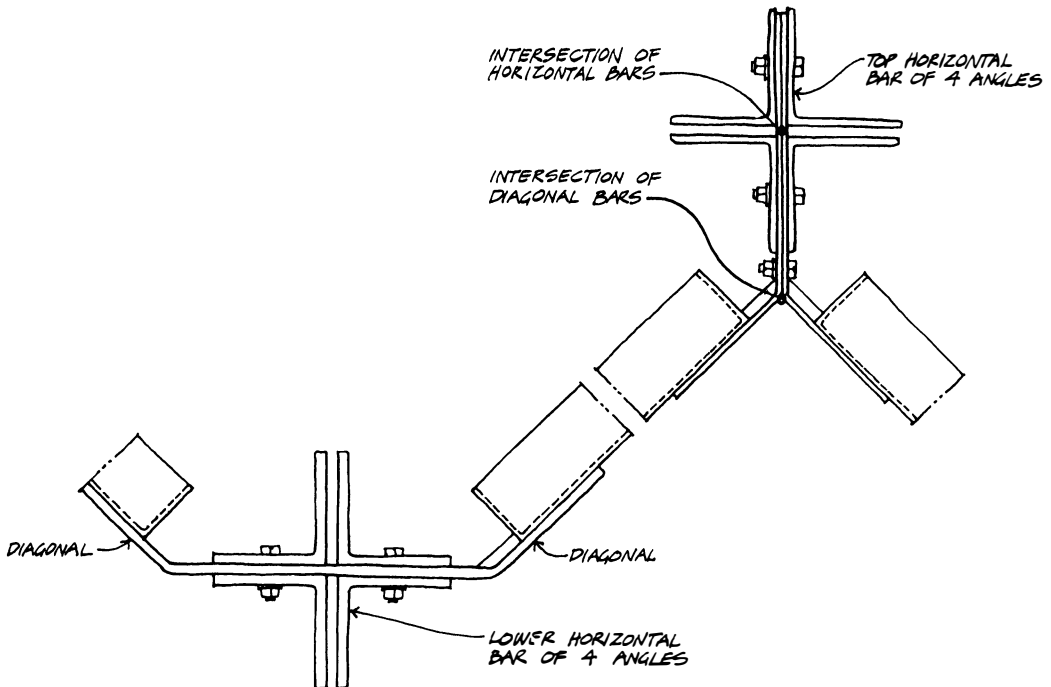
**4.13 Diagonals Eccentrically Connected to Cross-Shaped Chords**

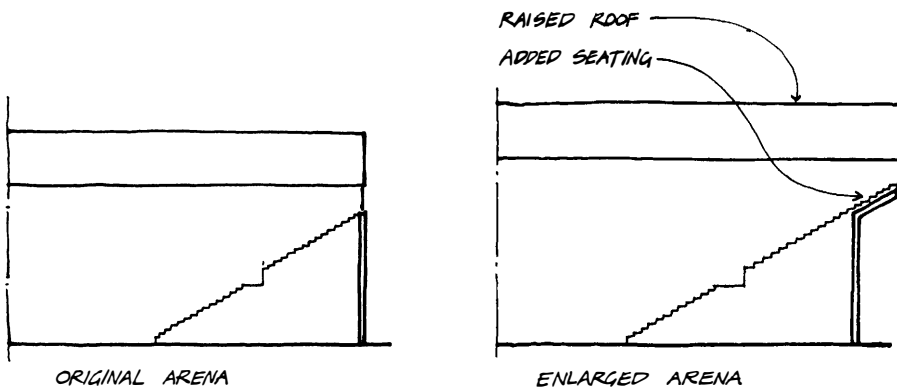
4.15 Section through Original and Enlarged Arena

Once the wreckage was cleared away, the firm of Ellerbe Architects of Minnesota began planning for a new arena. True to the promise of the city fathers, it was bigger, seating four thousand more spectators than the old one. Its roof was simpler, with two ordinary parallel vertical trusses sitting on the same four pylons raised up 12 ft. (3.6 m) to fit the grander facility (Fig. 4.15). Secondary trusses were framed into these primary trusses at six locations, and tertiary trusses framed into the secondary ones, resulting in a grid of trusses bearing a family resemblance to the original roof. The revamped coliseum began to take shape sixteen months after the collapse and by the spring of 1980 was ready to receive its first guests, the fans of a local hockey team that had been homeless for over two years.

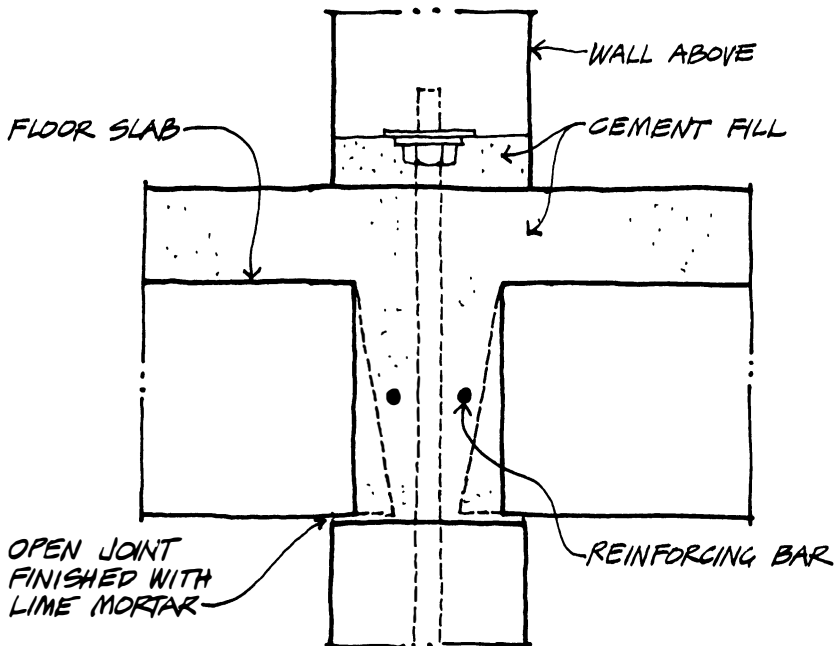
### 5.3 Joint between Interior Wall and Floor Slabs

push a wall panel off the floor. Since the explosion in Miss Hodge's apartment did not damage her eardrums, it was deemed to have caused a pressure against the wall panels of less than 10 psi (0.07 N/mm<sup>2</sup>). Yet tests showed that this pressure, equivalent to that felt when one swims under only 10 ft. (3 m) of water, was high enough to cause the failure of a reinforced concrete wall either by bending it or by overcoming the friction resulting from the gravity loads and kicking it out. Tests conducted by experts from the tribunal established by the government to determine the cause of the collapse showed that the wall panel would slide out against the floor panel at a pressure of 2.8 psi (0.02 N/mm<sup>2</sup>), less than one-third that of the explosion. A witness in a nearby factory reported seeing the wall of Miss Hodge's living room "come out as if pushed sideways and then fall," which is consistent with the fact that the strength of the wall panel in bending was greater than the resistance of the joint in friction. Had the explosion occurred on a lower floor, the loads compressing the wall panels and the resulting friction might have been large enough to have prevented a failure of the wall by sliding.

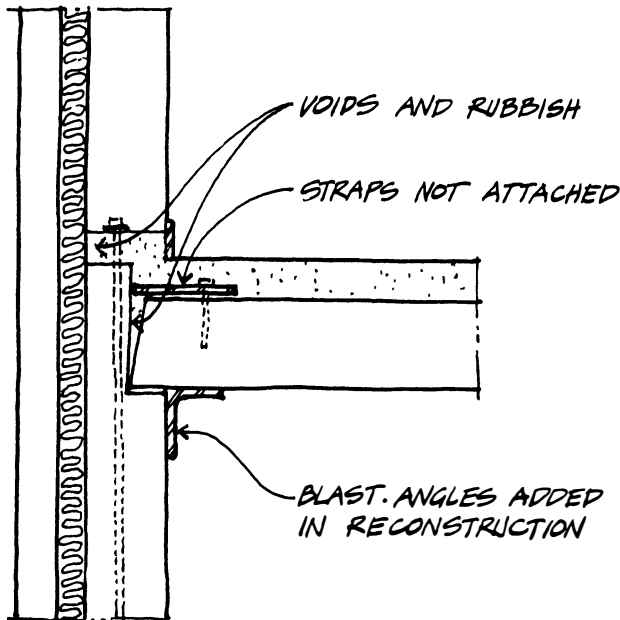
**5.4 Joint between Floor Slab and Outside Wall—Reinforced after the Blast**

The need to strengthen Ronan Point was obvious, but discussions about what to do and who should pay for the remedial work moved the matter into the sociopolitical arena. Within a year of the disaster the debris was cleared away, and the wing rebuilt with a *blast angle*, a reinforced joint detail preventing the separation of the wall from the floor. The tower was reoccupied; but in 1984 cracks began appearing in other walls, and the entire tower was evacuated. Eventually, in May 1986, the building, which the press had dubbed the “Infernal Tower,” was swathed in a coat of reinforced polystyrene to contain the dust of demolition, and the tower was demolished, floor by floor, in a procedure that reversed that used in construction. Forty-one weeks later only the foundations remained, a monument to a failed dream of industrialized construction gone only eighteen years after its erection. Since it would have cost six times more to strengthen the tower in accordance

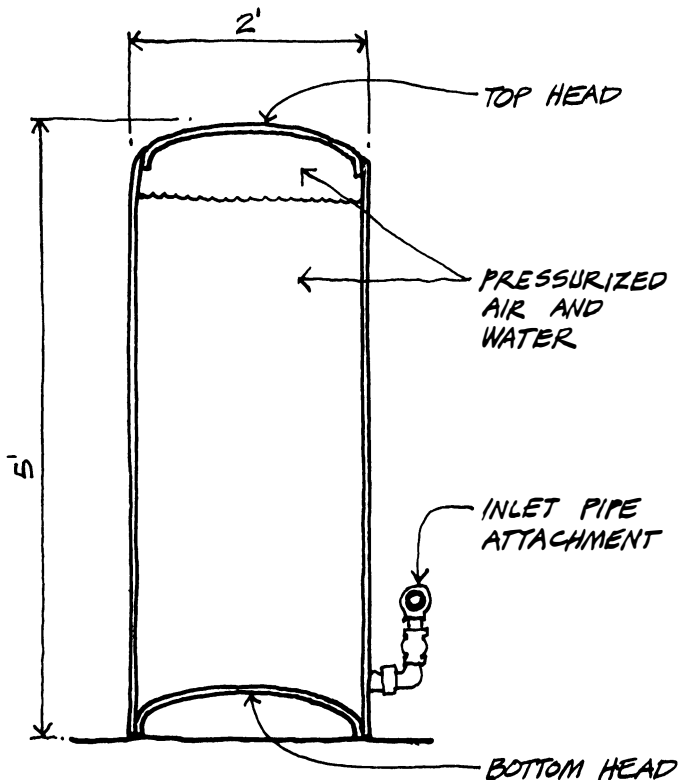
## 5.5 Hydropneumatic Tank

Very early on the morning of the blast an employee of the photo lab went to the basement and closed the safety switch on Tank No. 2, instantly starting the pump, but when he returned to the lab on the sixth floor, he noticed that the pressure gauge there showed almost no pressure in the system. He went right back to the basement to check the problem and found Tank No. 2 lying on its side on the floor and water flooding the area from a broken pipe that had been connected to the tank. He also smelled gas. He left immediately to call for help, but before he could reach the lobby, a powerful explosion engulfed him in dust and flying debris.

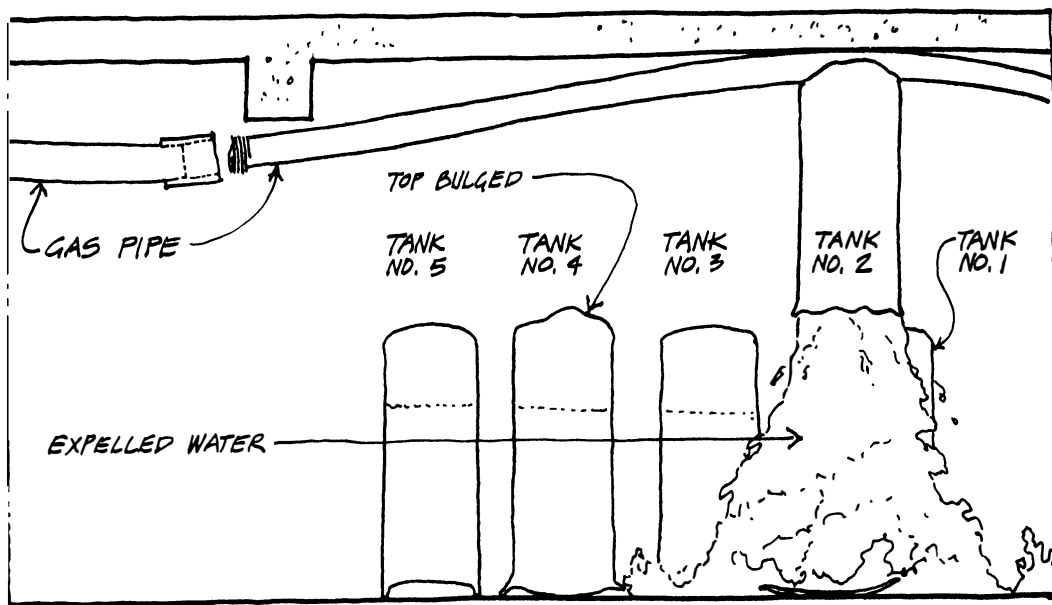
5.6 Ruptured Tank Striking the Gas Pipe

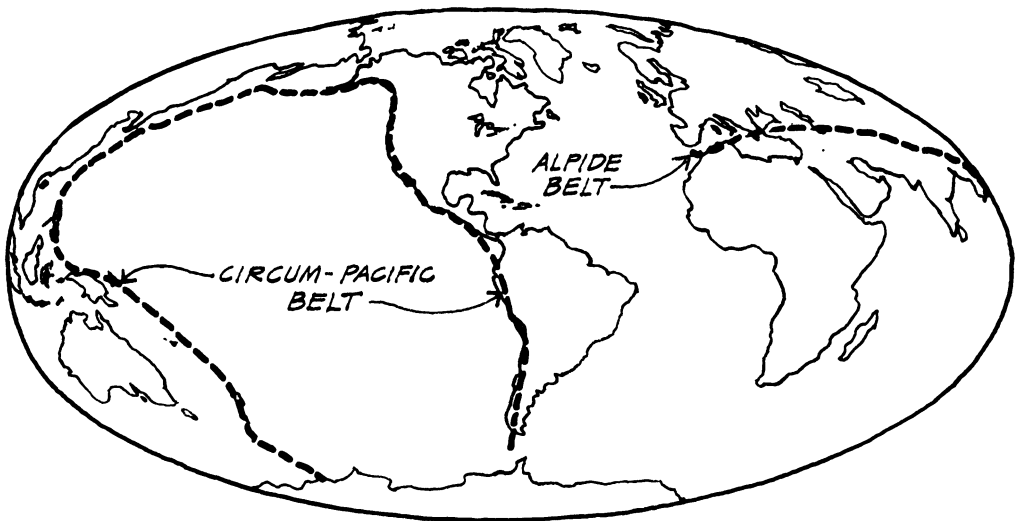
6.1 World Seismic Bands

The earth's crust is like a broken eggshell floating on the viscous inner magma of melted rock. Plate tectonics, the recently developed theory of movements of the earth's crust, offers the most plausible explanation for the existence of bands all over the globe along which most earthquakes occur. These bands contain *fault lines* or cracks that are, in fact, the edges of the tectonic plates and, as correctly observed by Strabo, occur primarily along continental coasts (Fig. 6.1). These giant plates move relative to one another

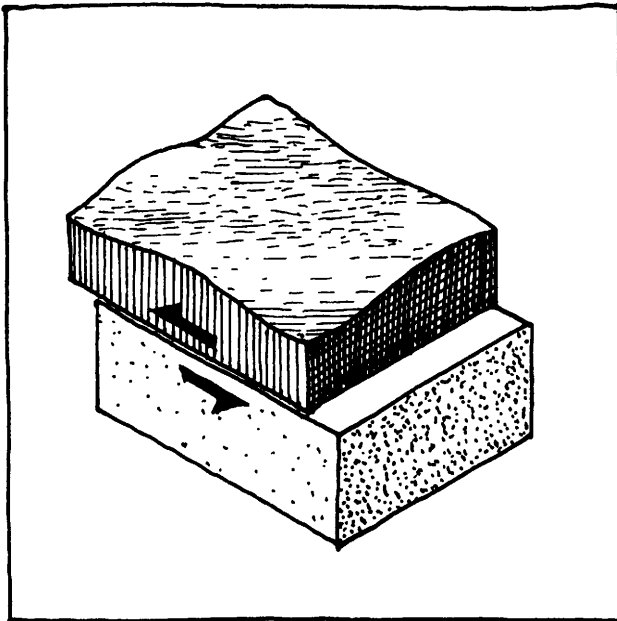
6.2c Subduction/Thrust

about as fast as one's fingernails grow, grind against each other both vertically (thrust) and horizontally (slip), and sometimes try to climb one above the other (subduction) (Fig. 6.2). Since the plate boundaries are not smooth, the movements are inhibited by friction, resulting in the storage of energy caused by the unreleased movement, somewhat like that in a stretched rubber band. Over time this energy accumulates until the frictional resistance generated by the roughness of the plate boundaries is overcome and the pent-up energy is suddenly released (the rubber band snaps), causing an earthquake. Predicting where, when, and how violently this event will take place is the major goal of geologists concerned with seismology (from *seismos*, Greek for "earthquake"). They are beginning to be quite successful in answering the questions of where and how violently, but not yet of when. They have correctly predicted the location and energy content of the last twelve major earthquakes in the world, but time uncertainty, despite rapid improvement, is still within thirty years.

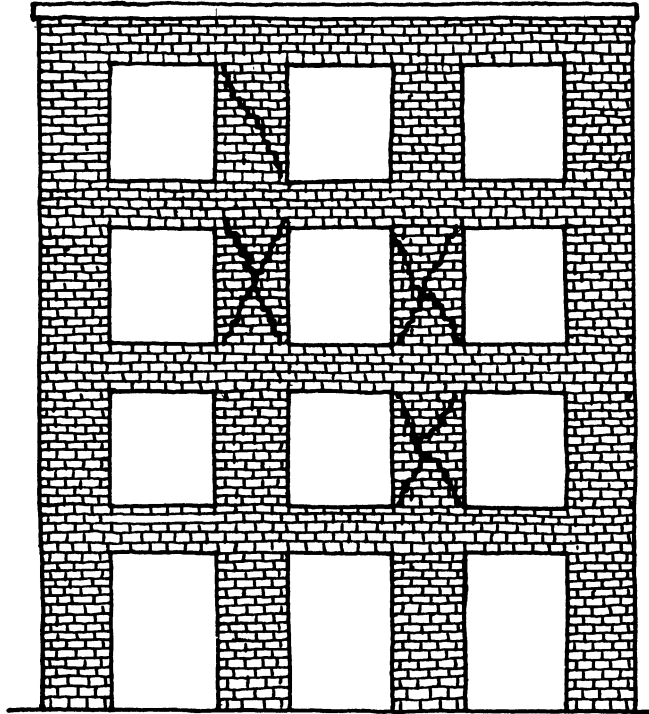
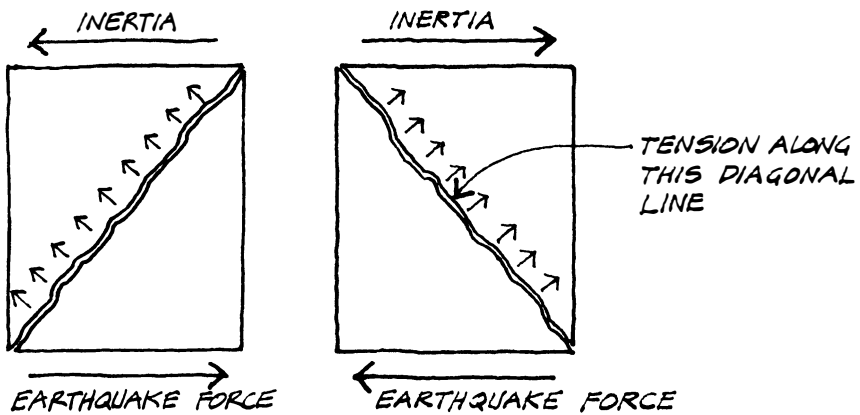
#### 6.4 Diagonal Cracking of Masonry Wall

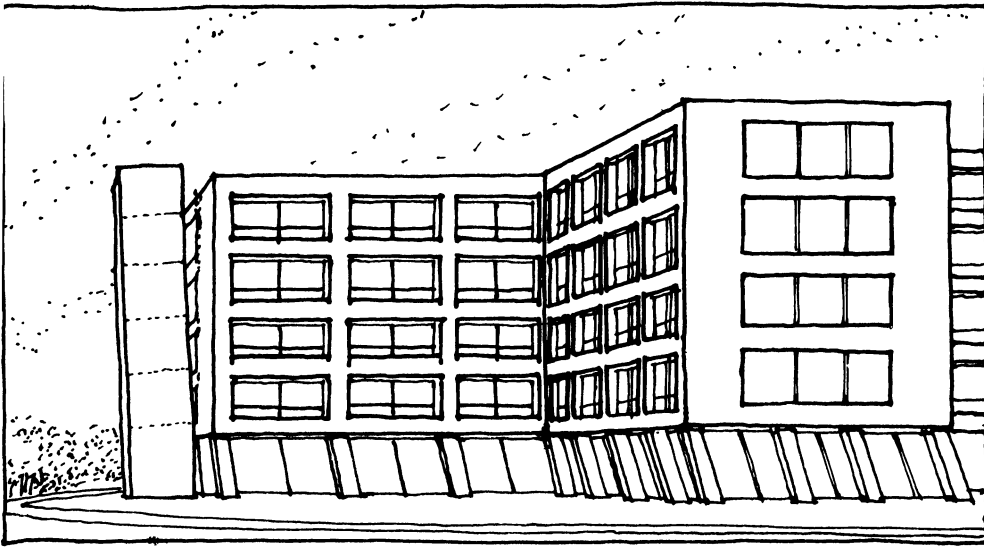
## 6.5 Olive View Hospital: After the Earthquake

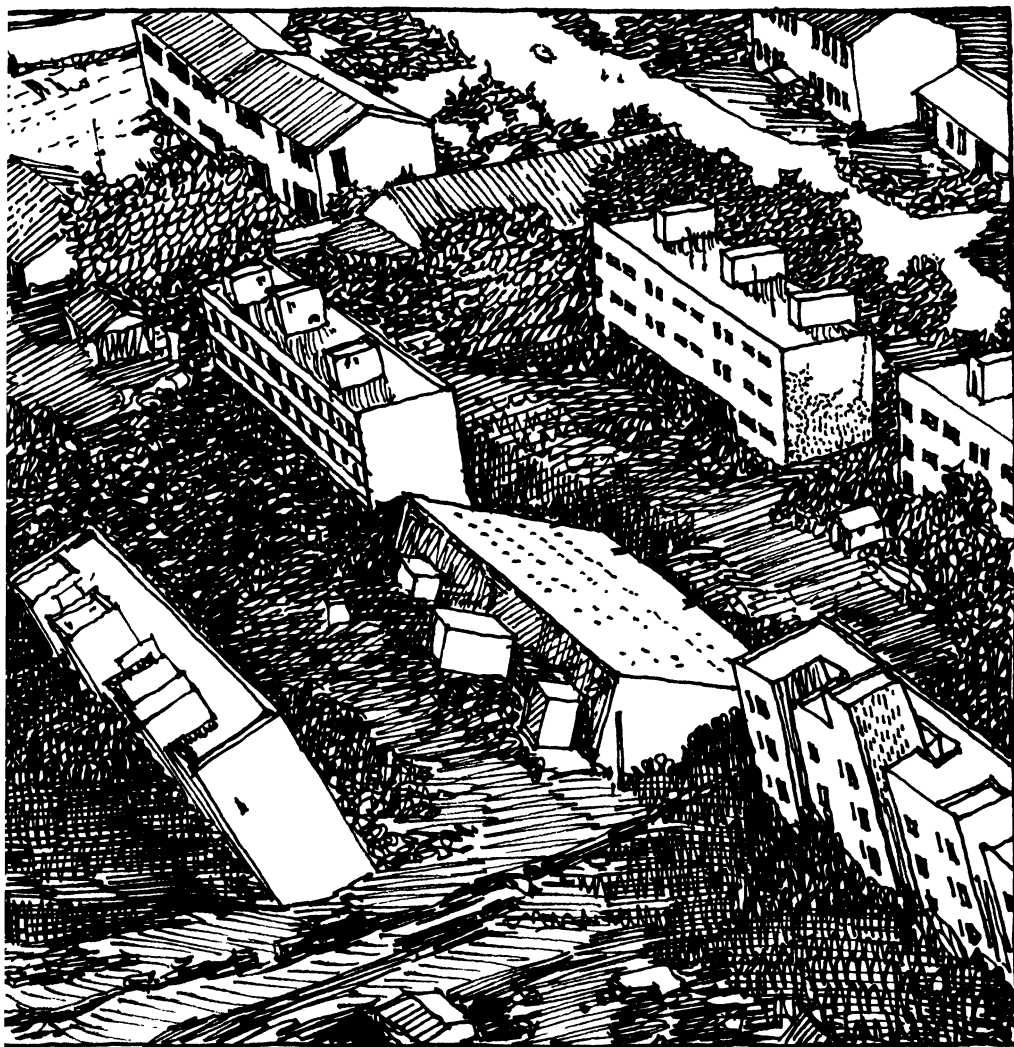
6.6 Niigata Apartment Buildings: After the Earthquake

urated with water that suddenly become liquid when subjected to shaking from the quake. To demonstrate this action, place a weight on a pot full of sand to which water has been added almost to the top. Shaking the pot will cause the sand-water mixture to liquefy and the weight to sink and/or tilt. This is precisely what happened in Niigata, Japan, in 1964, when an apartment building tilted through an angle of  $80^\circ$  from the vertical without breaking up, so that after the movements stopped, the occupants were able to walk to safety down the face of the building (Fig. 6.6).

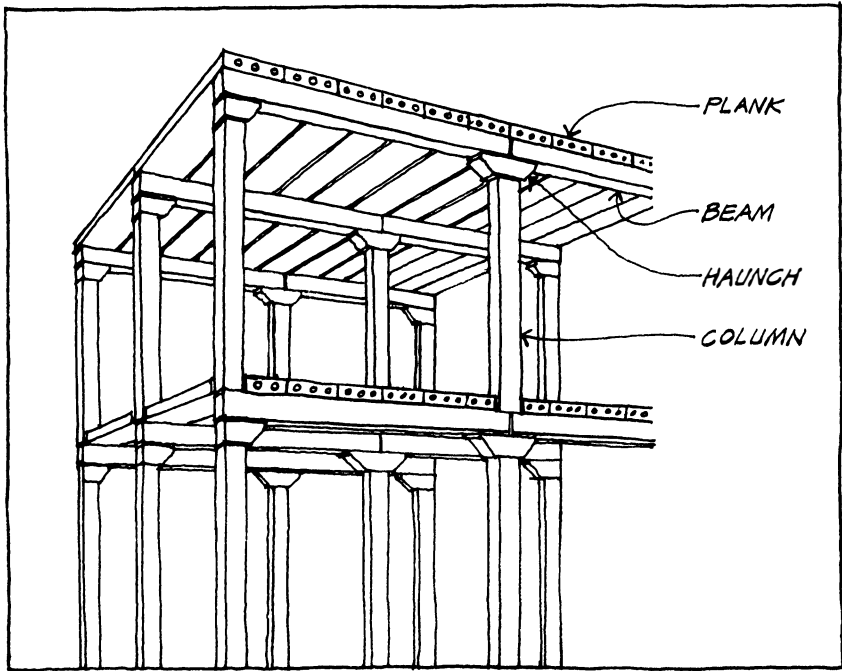
**6.7 Precast Concrete Frame Construction**

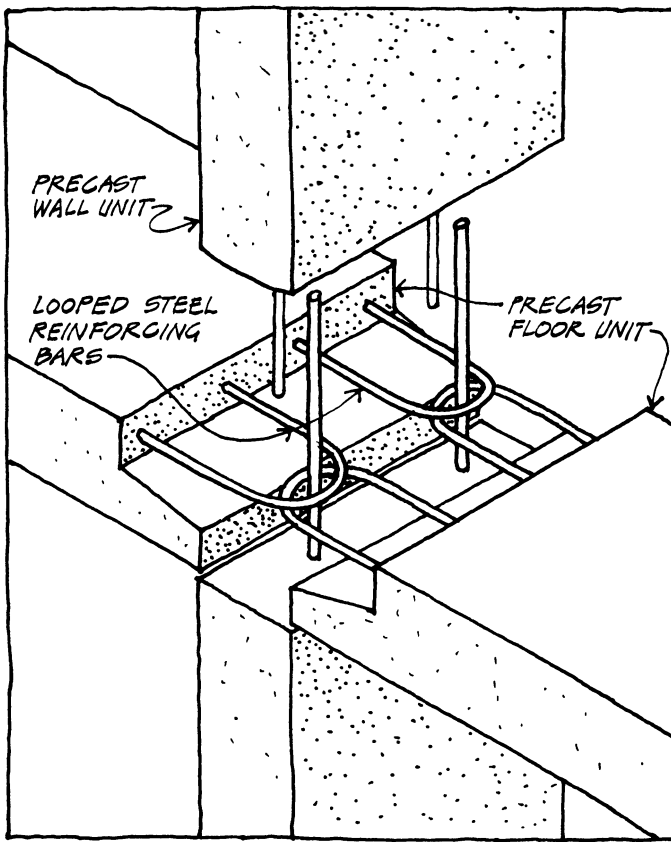
### 6.9 Detail of Joint between Precast Concrete Wall and Floor Panels

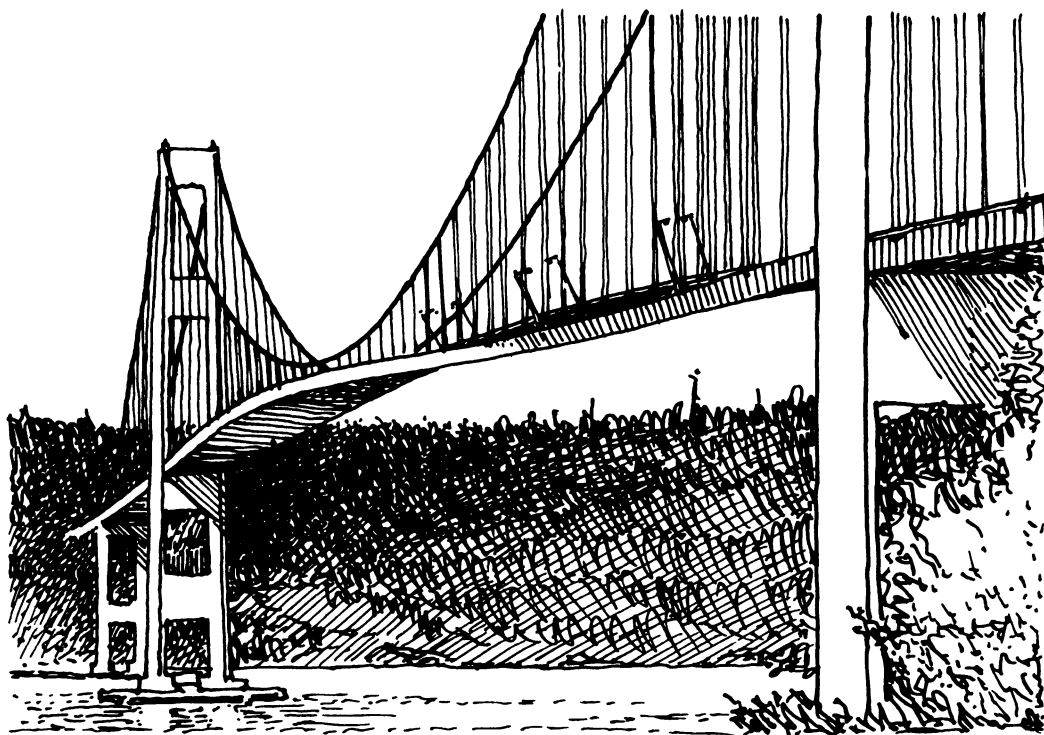
7.3 Twisting Motion of Tacoma Narrows Bridge

circular arc. Shortly before 10:00 A.M. Arkin again checked the wind velocity and saw that it had increased to 42 mph (67 km/h) and that the movement of the bridge deck had heightened dramatically; by his count, the deck rose and fell at the center of the bridge 38 times per minute with a 3 ft. (0.9 m) amplitude. Greatly concerned, Arkin halted all traffic, and Professor Farquharson, who happened to be at the site that day, observed that the up-and-down motion of the center span consisted of at least nine vertical undulations while the bridge was also deflecting laterally by as much as 2 ft. (60 cm). Suddenly the bridge started twisting violently, and the nine-wave motion changed to a two-wave motion while the bridge deck near the Tacoma side appeared to twist to an almost  $45^\circ$  angle (Fig. 7.3).

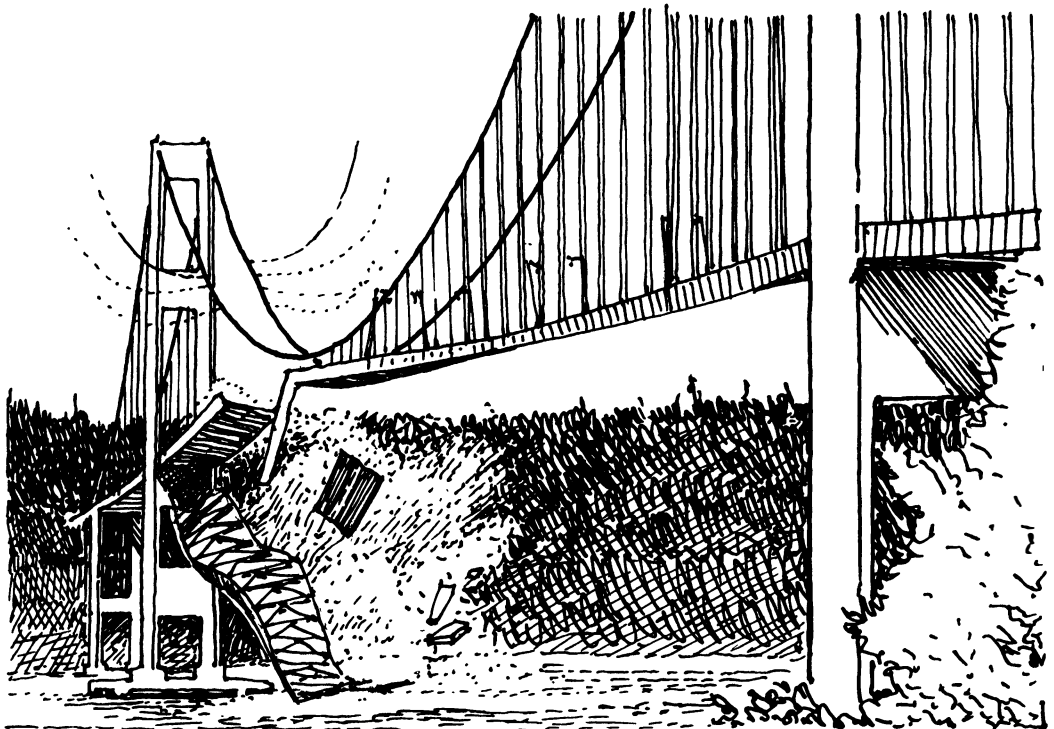
7.4 Tacoma Narrows Bridge at the Moment of Collapse

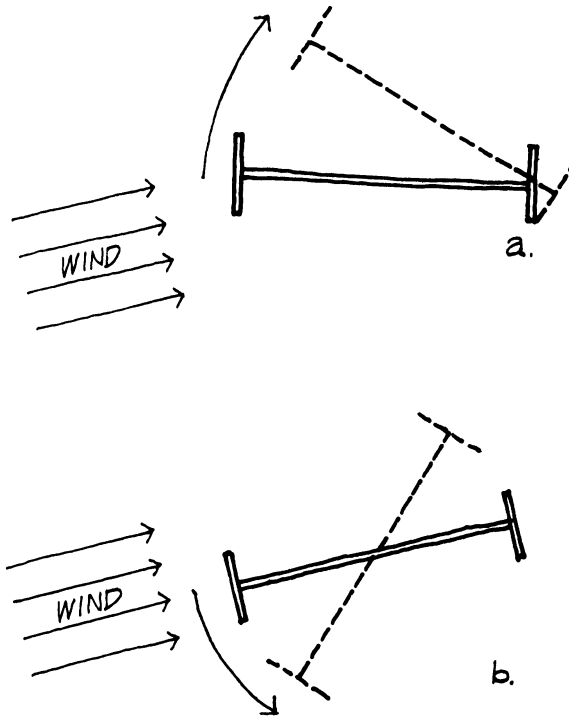
### 7.6 Wind-Induced Twist

\* Recent (1991) studies suggest that the cause may be attributable to vortex shedding, a phenomenon first described by Theodor von Karman. Spiraling vortices can be seen in the wake of a ship moving through water, and similar, though invisible, vortices trail an airplane wing in flight. Two kinds of vortices were shed by the twisting Tacoma Narrows deck. The first is called a Karman vortex street because the periodic shedding creates a continuous pattern of alternating vortices. However, these vortices were out of sync with the natural frequency of the bridge and therefore could not contribute to a buildup of motion. The second was a flutterlike complex pattern of vortices with a frequency coincident with the bridge’s natural frequency that rapidly reinforced the destructive torsional oscillations. It is difficult to state whether the twisting oscillations of the deck caused these vortices or whether the vortices caused the deck oscillations, but at the present time this new assumption must be considered the best interpretation of the cause of the collapse.

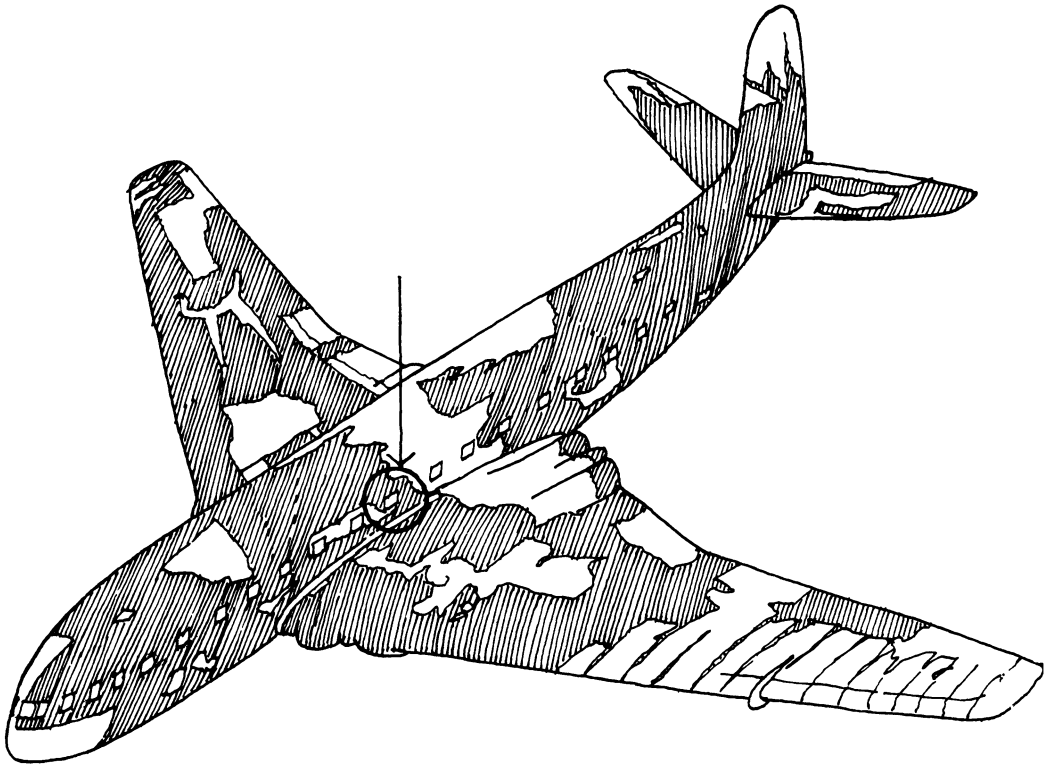
8.1a Comet Airliner with Recovered Sections Shown Shaded

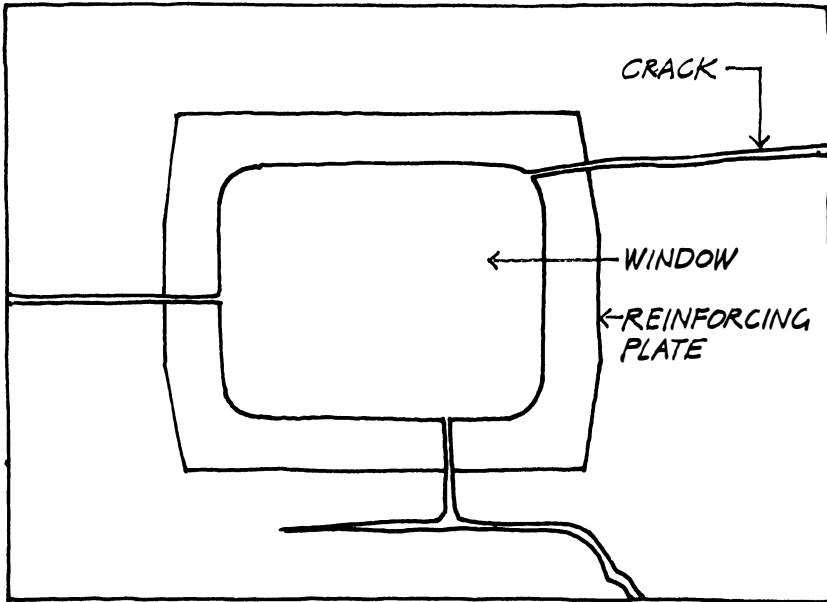
8.1b Cracks around Window

De Havilland had tested samples of the corner panel and an entire fuselage section of each plane, concluding that in terms of fatigue the cabins were good for a service life of about ten thousand flights or ten years. After the accident a test performed by the RAE showed failure after only three thousand cyclic load applications. This result, although only one-third of de Havilland's estimate of the fuselage's fatigue life, was still three times larger than the thousand-load applications experienced by the last two crashed Comets. Why this incompatible difference? Because, first, the de Havilland test did not accurately represent the actual cabin since complete windows were not fitted into the test section. Then there

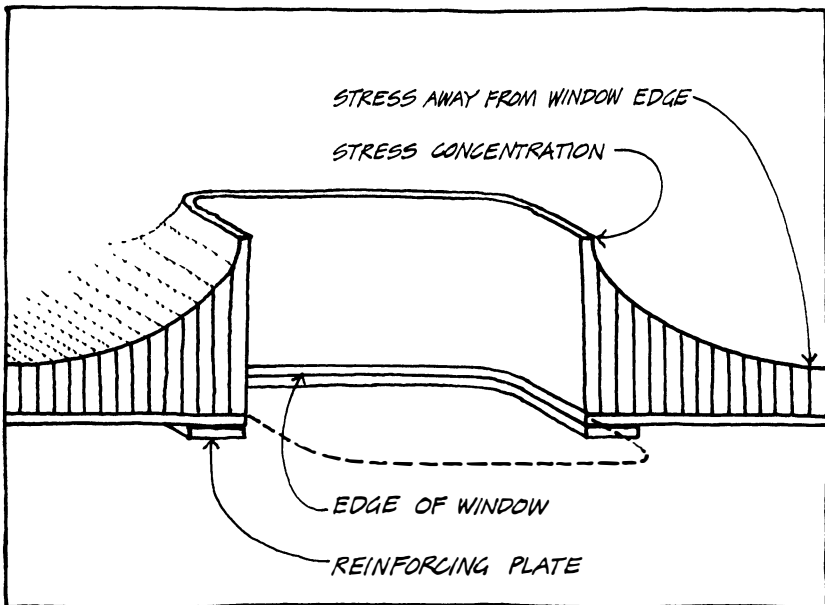
8.2 Stress Concentration at Window's Edge

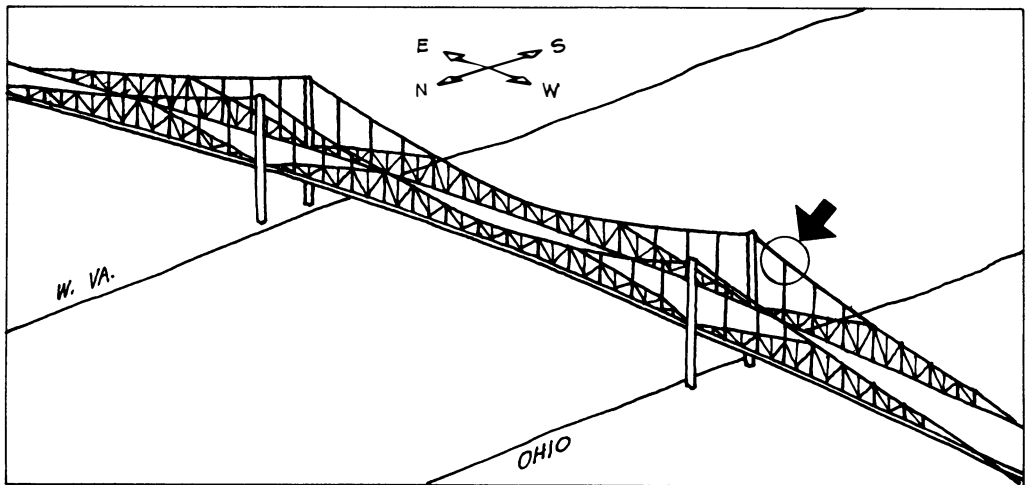
### 8.3 Point Pleasant Bridge

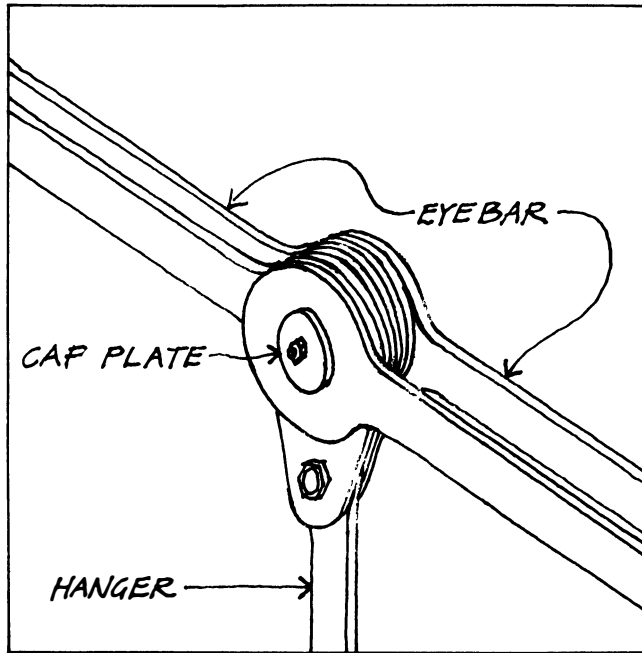
**8.4 Typical Eyebars Joint**

Modern suspension bridges use steel cables introduced by French engineers around 1830, but the Point Pleasant Bridge, like other U.S. suspension bridges of the time, was supported by two steel chains, each consisting of 50 ft. (15 m) long *links* with *two* parallel forged steel eyebars each. (A cable today generally consists of thousands of individual wires.) An *eyebars*, as the name implies, is an iron or steel bar with enlarged ends pierced by holes; a pin through the holes of adjoining links, 12 in. (300 mm) in diameter in the Silver Bridge, connects them to make a chain and is held in place with bolted cap plates (Fig. 8.4). The Silver Bridge had a central span of 700 ft. (213 m), with two 380 ft. (116 m) side spans, and approach spans supported by piers at either end of the bridge leading to the anchorages for the eyebar chains. As originally built in 1928, the two-lane bridge had a timber deck and two sidewalks. For added durability, the roadway was replaced in 1941 with a
