# WHY BUILDINGS FALL DOWN

How Structures Fail

MATTHYS LEVY  
and  
MARIO SALVADORI

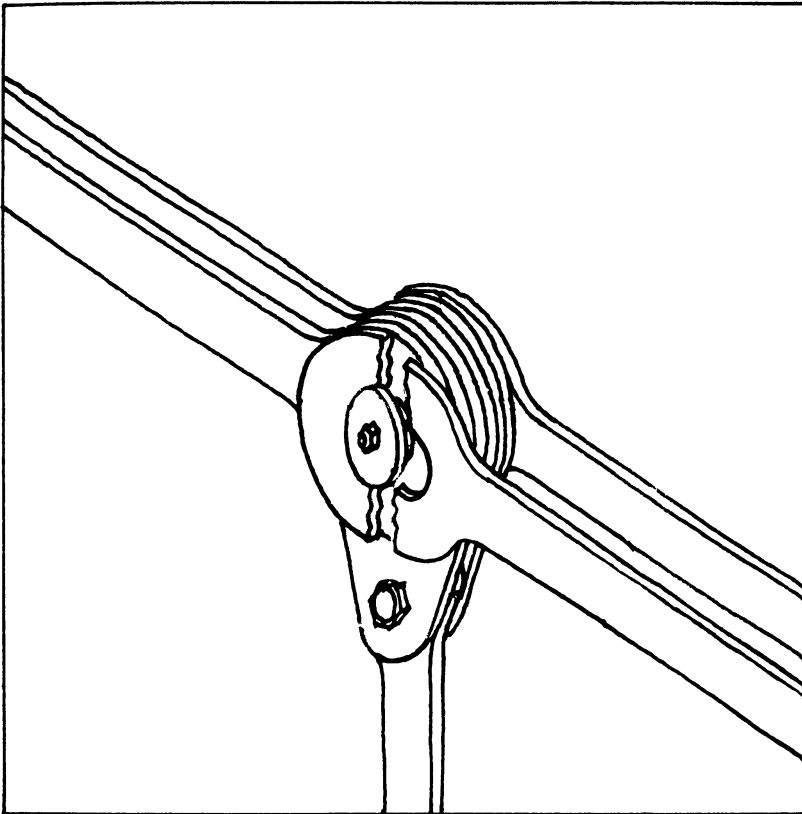
**8.7 Cracked Eyebar**

The need to discover the cause of the Point Pleasant failure led to the decision to salvage and store as many elements of the fallen spans as possible. Fractured, bent, and rusting segments were reassembled into a giant jigsaw puzzle on a 27 acre (10.9 ha) field near the banks of the Ohio. The inquiry panel and its consultants, some of the best bridge engineers and scientists in the country, had the task of locating the bar that broke first. Laboratories were engaged in the conduct of microscopic examinations of the steel in

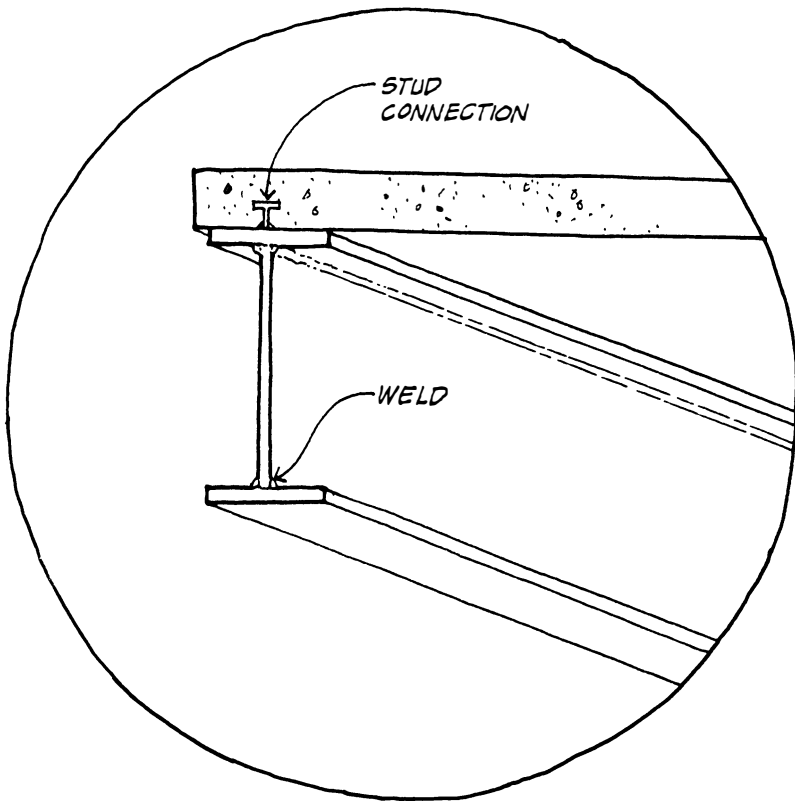
## 9.1 Typical Welded Bridge Girder

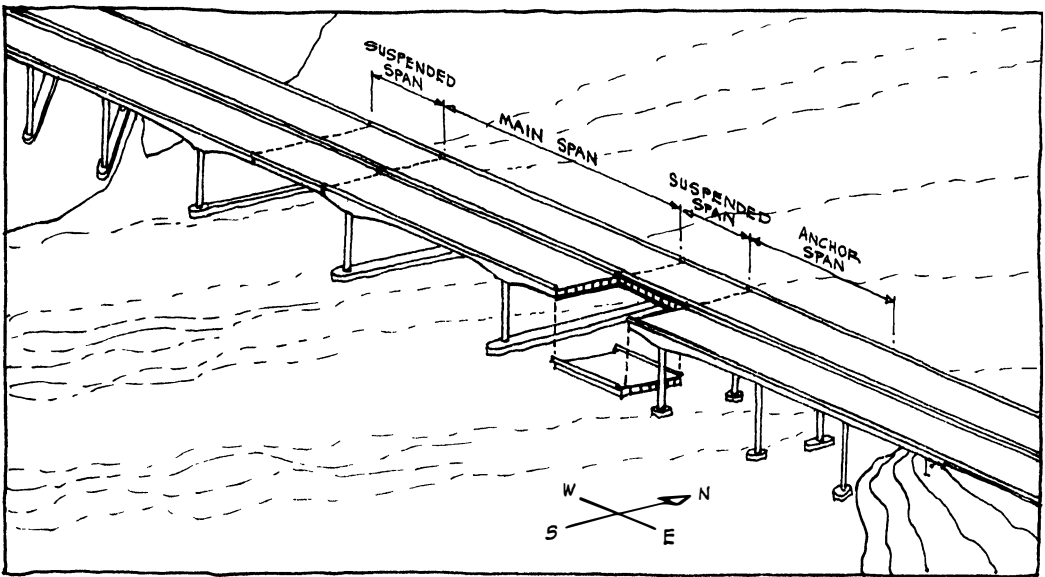
## 9.2 Mianus River Bridge, Showing Collapsed Section

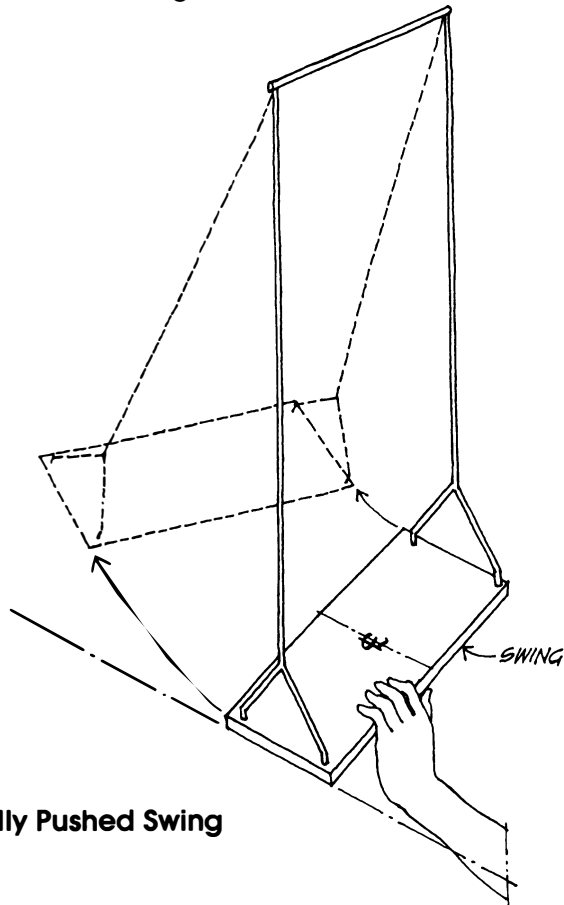
## 9.5 Eccentrically Pushed Swing

The unusual amount of rust found in the Mianus Bridge hanger assembly led the investigators to look for the source of the water responsible for it. It was discovered that ten years before the accident the drains on the roadway had been paved over, allowing water, salt, and dirt to flow through the joint between the cantilevered and suspended spans, dropping directly onto the hanger assembly and causing accelerated rusting of its steel.

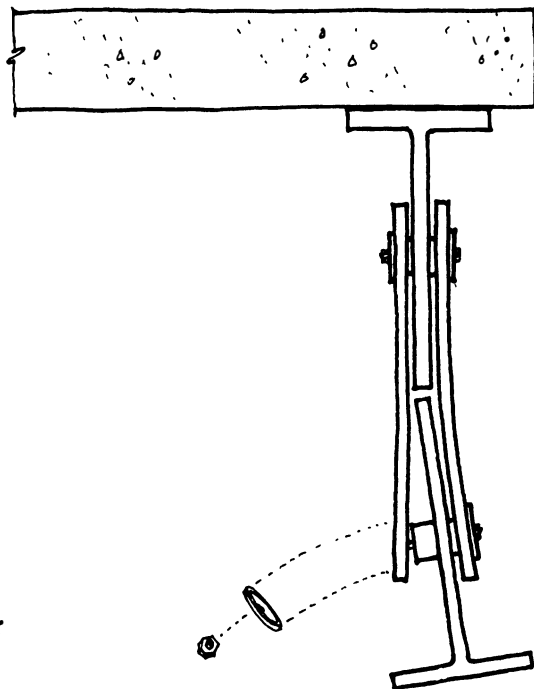
9.6 Failure of Hanger

We can now reconstruct the events leading to the collapse of the Mianus Bridge. Over the bridge's twenty-five years, corrosion builds up between the hanger plates and the pins because of the constant wetting action of rain, brought on by the paving over of the floor drains. Each time a car or truck passes over the bridge, the skew effect imposes a lateral force on the hanger plates, contributing to the tendency of the hanger plates to be pushed off the pin. At the southeast corner of the suspended span, the force of corrosion, aggravated by the skew effect, is so large that it causes the restraining pin cap to dish out and possibly pop off. Sometime before the collapse, hours or days earlier, the bottom of the inside hanger plate slips off the pin (Fig. 9.6), causing a transfer of the

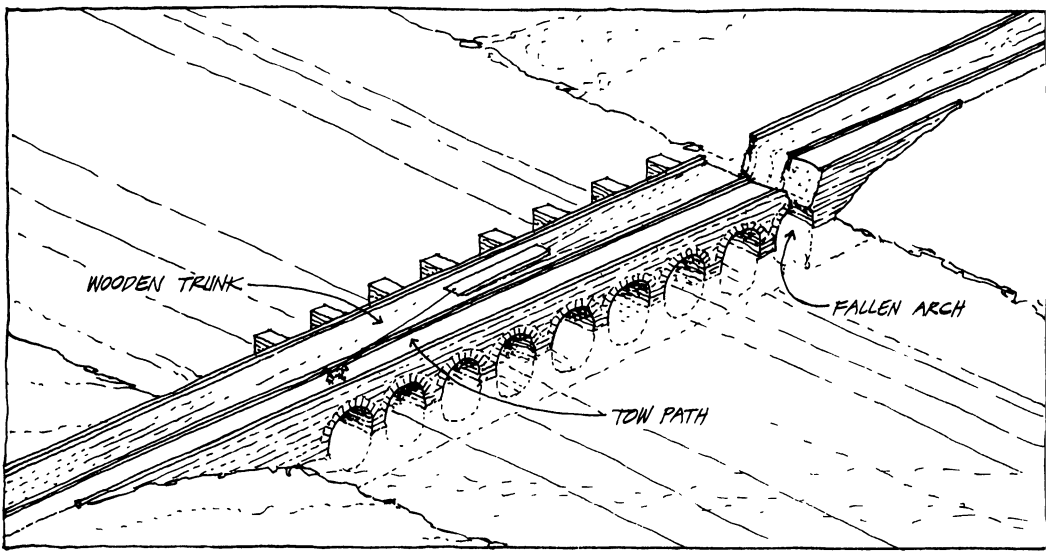
9.7a Schoharie Creek Aqueduct

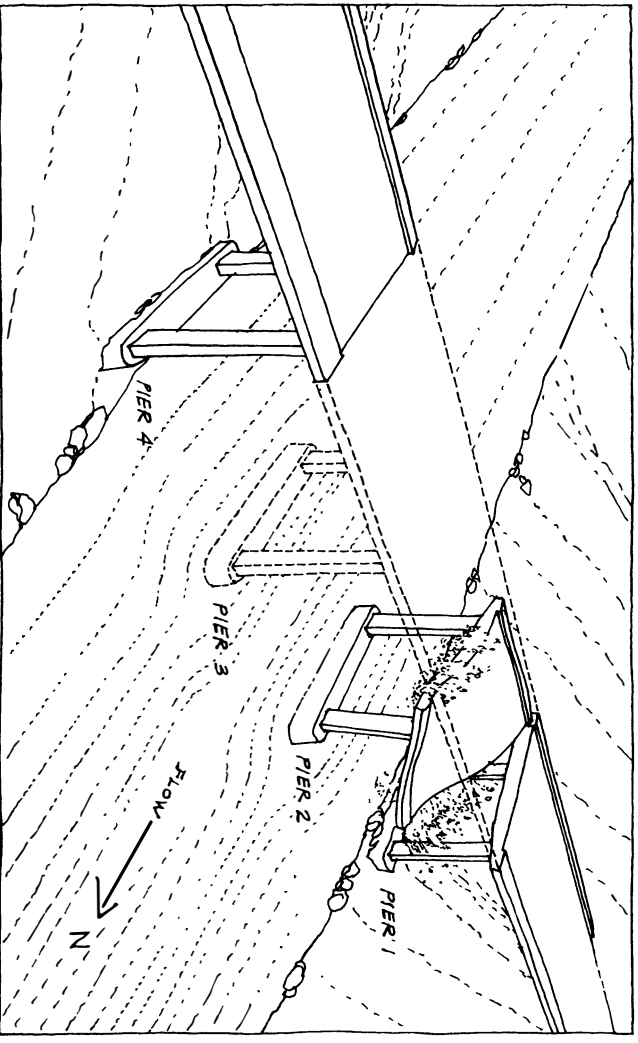
9.9 Collapsed Schoharie Bridge

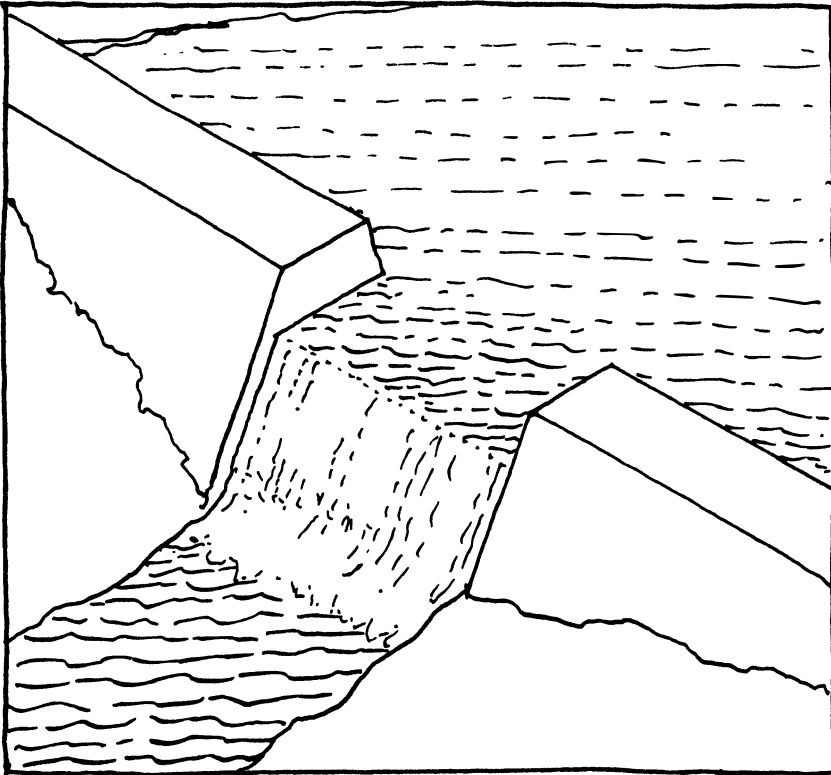
**11.1 South Fork Dam: Original Construction**

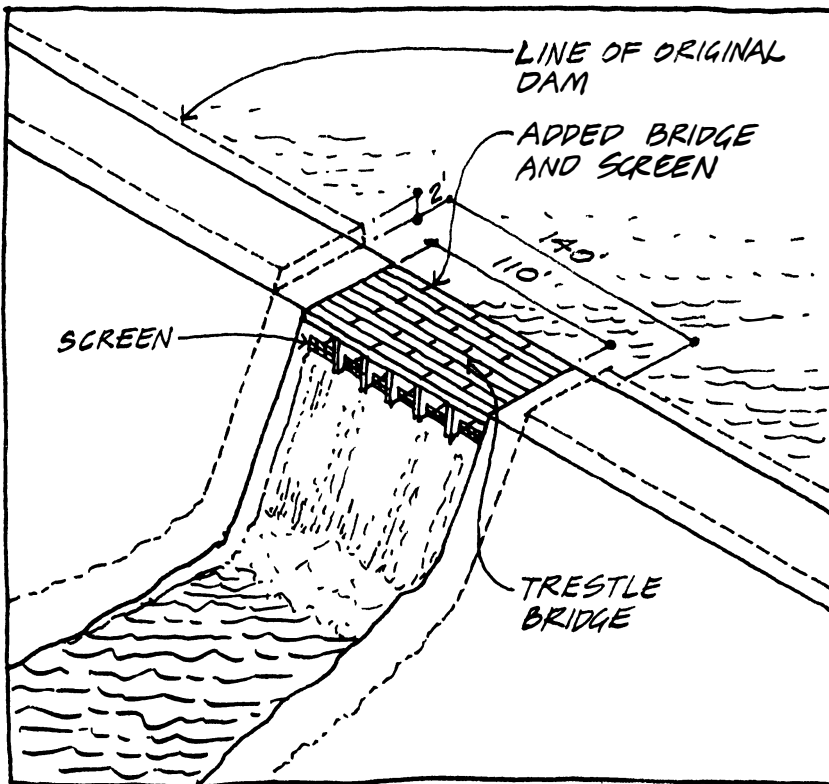
11.2 South Fork: Modified Dam and Spillway

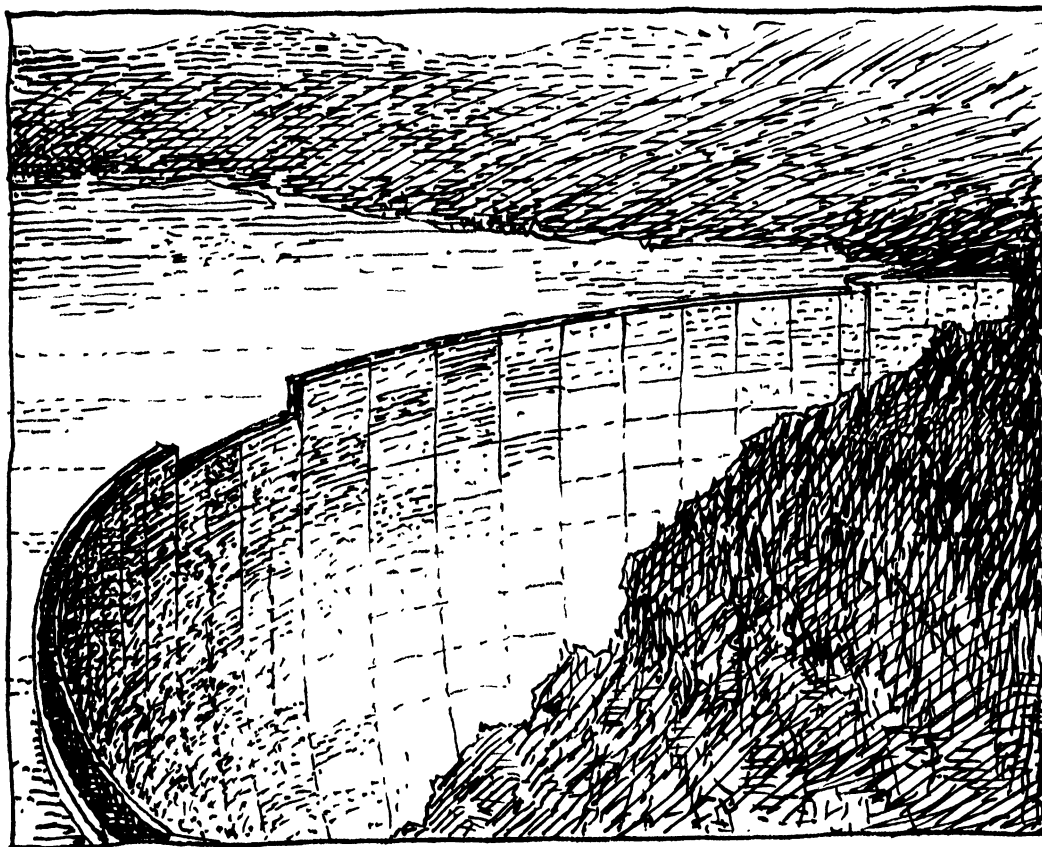
### 11.3 Malpasset Dam

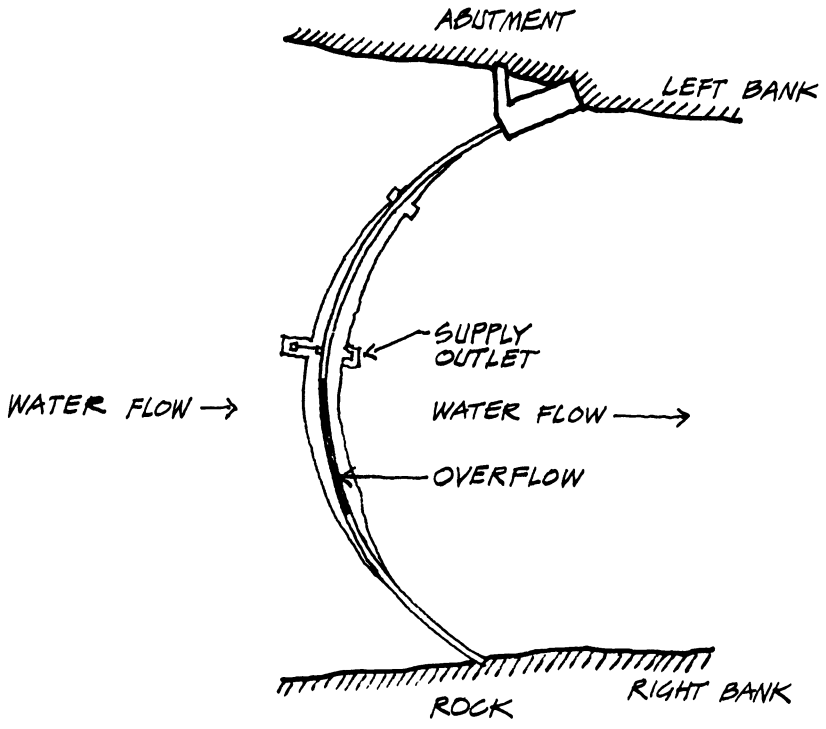
11.4 Plan of Malpasset Dam

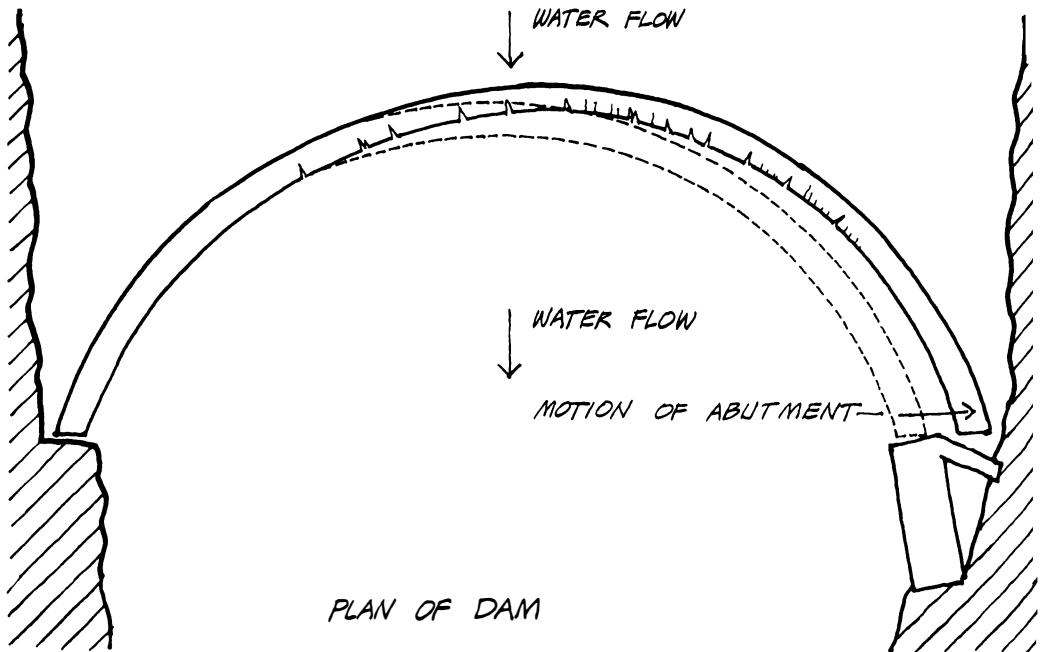
**11.6 Failure of Arch Owing to Displacement of Abutment**

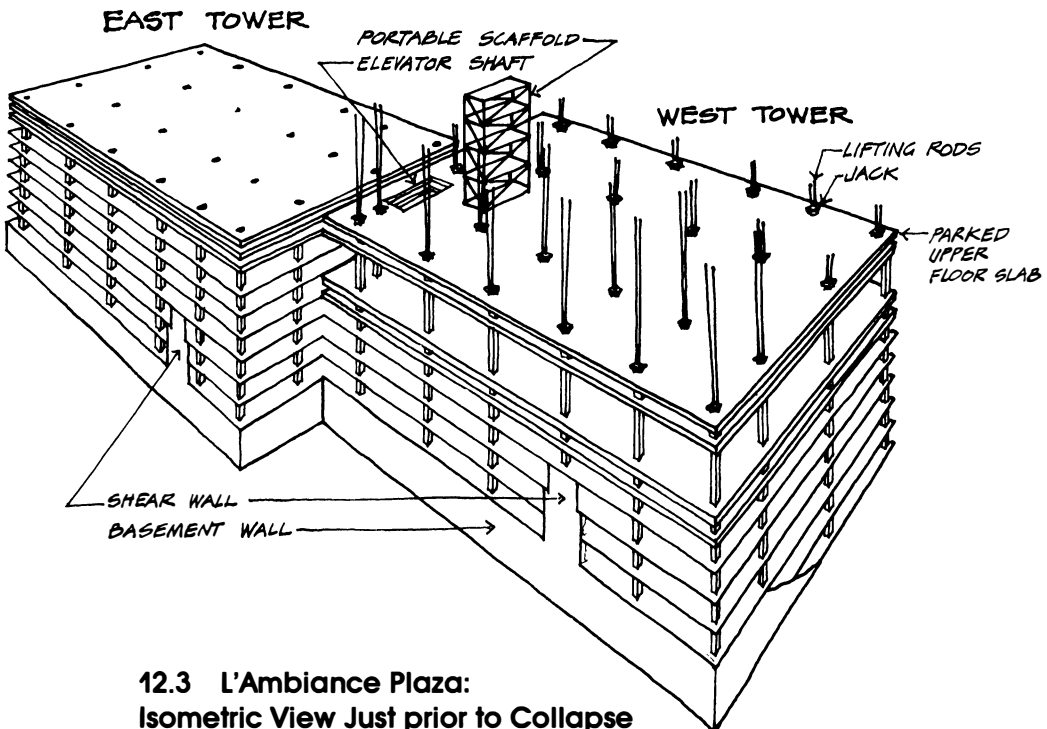
**12.3 L’Ambiance Plaza:  
Isometric View Just prior to Collapse**

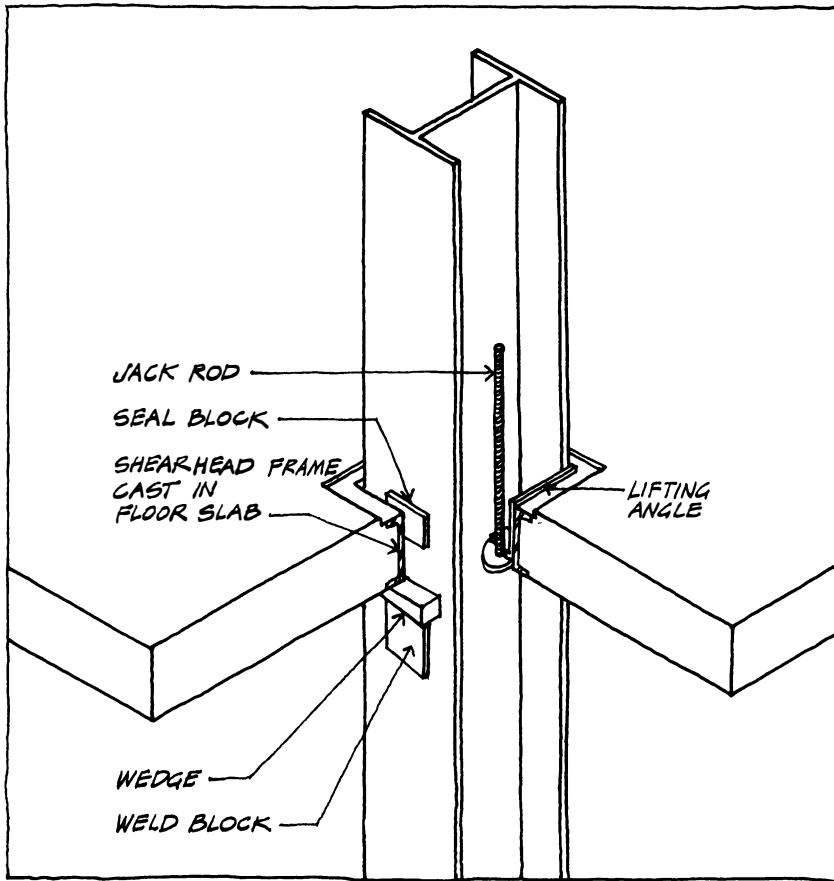
## 12.4 Typical Shearhead Arrangement

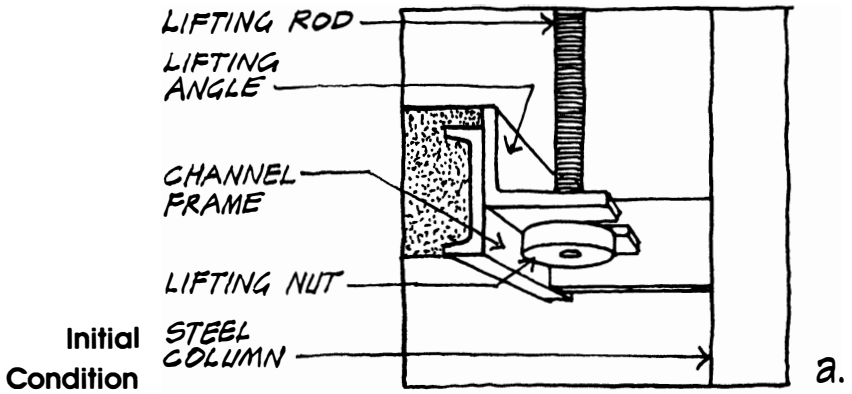
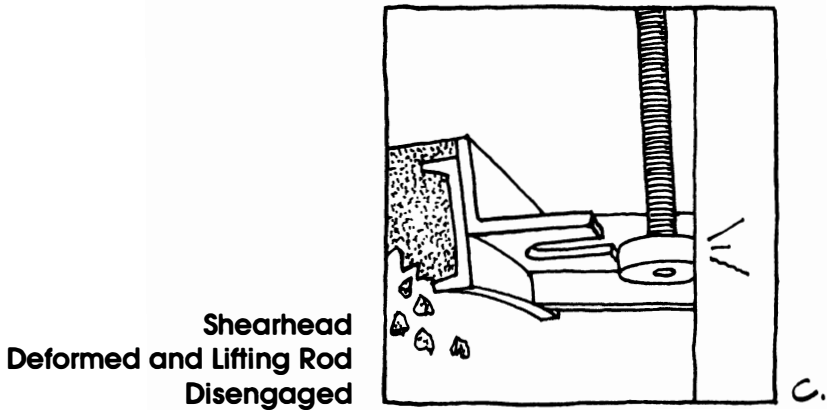
12.7 Failure Sequence

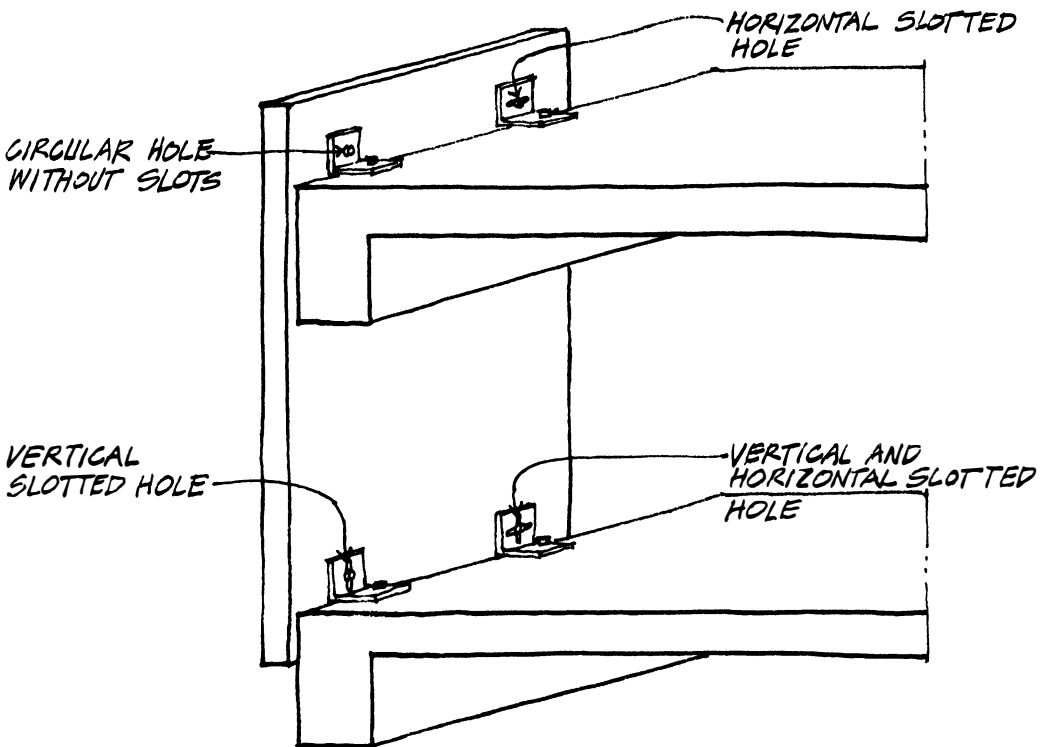
13.1 Attachment of Precast Panel

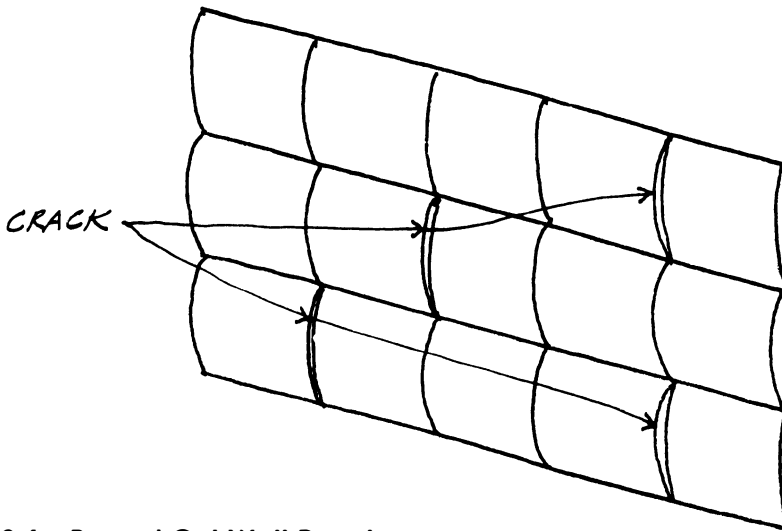
**13.6 Bowed-Out Wall Panels**

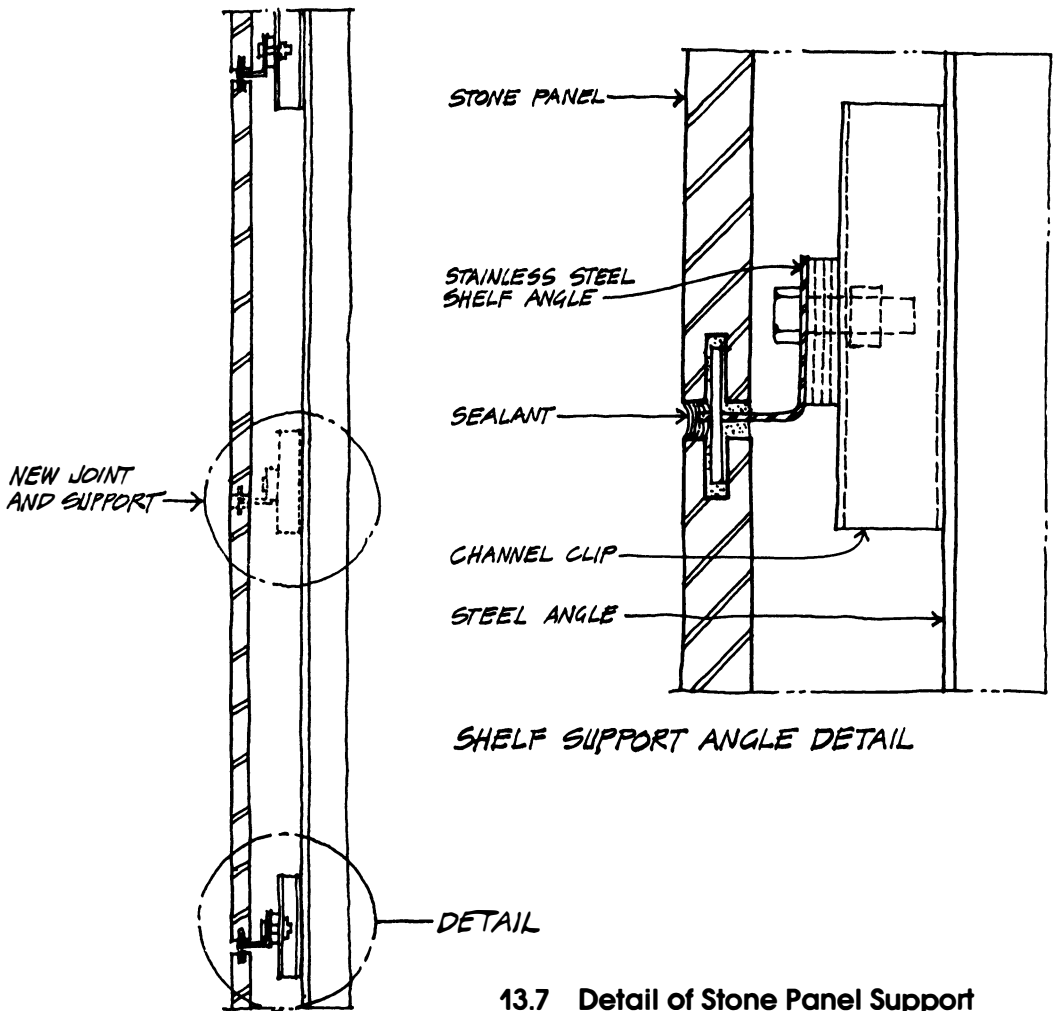
### 13.7 Detail of Stone Panel Support

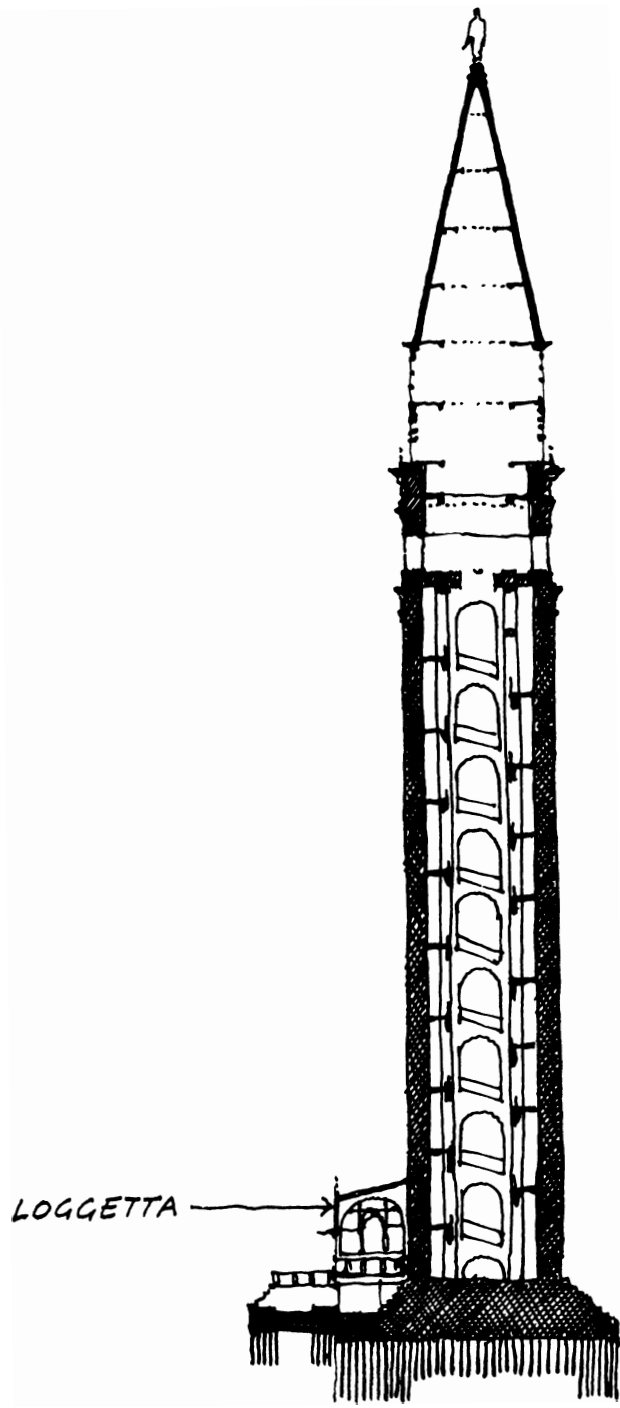
14.2 Section through Campanile of San Marco

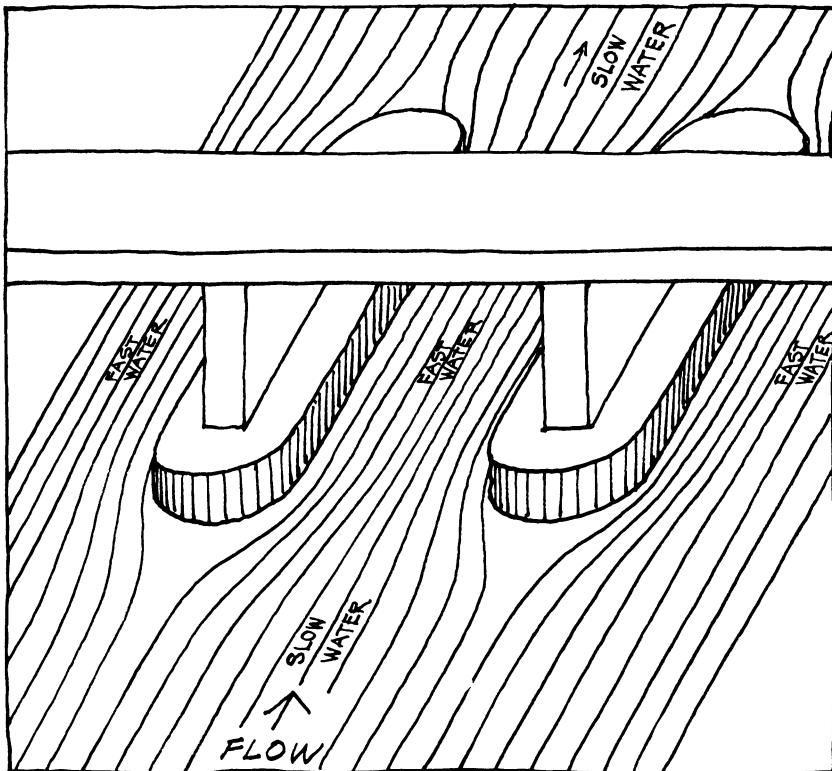
14.5 Flow of Water around Bridge Piers

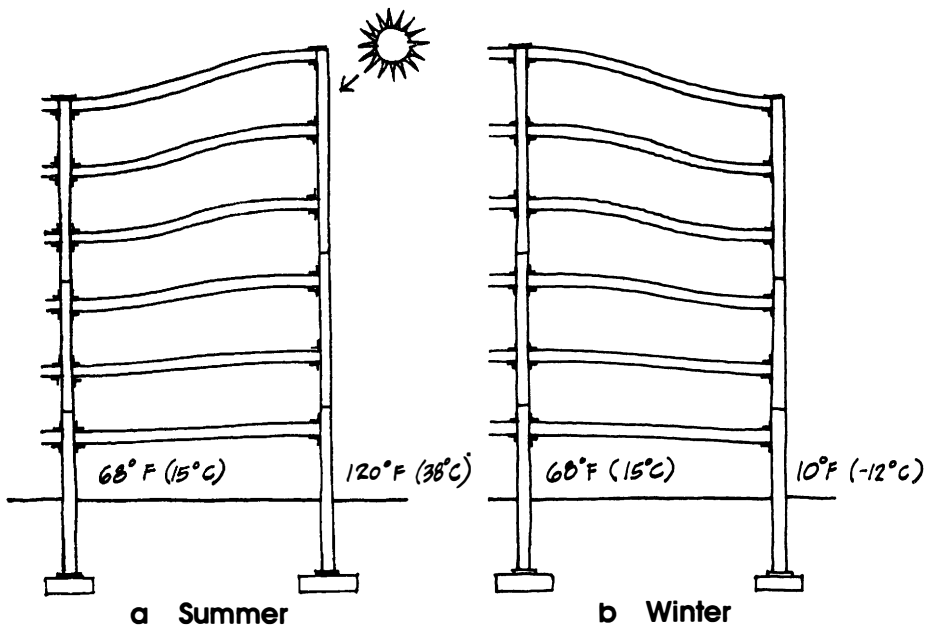
### A3 Thermal Bending of Frame Beams in:

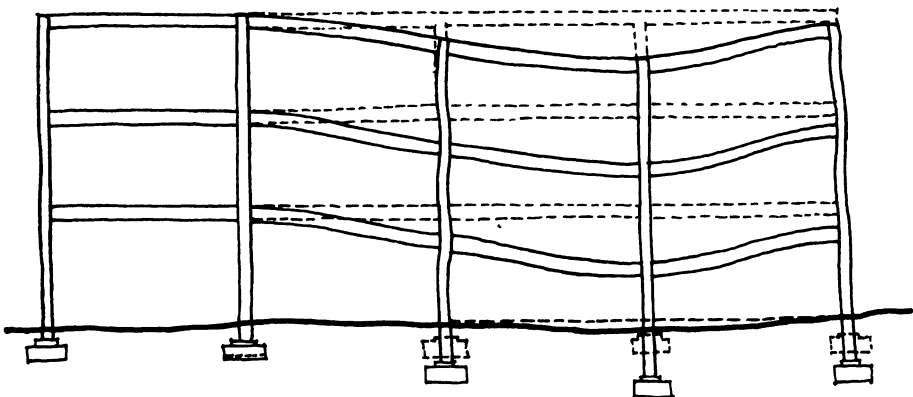
**A4 Uneven Settlement of Building Foundation, Causing Bending of Beams**

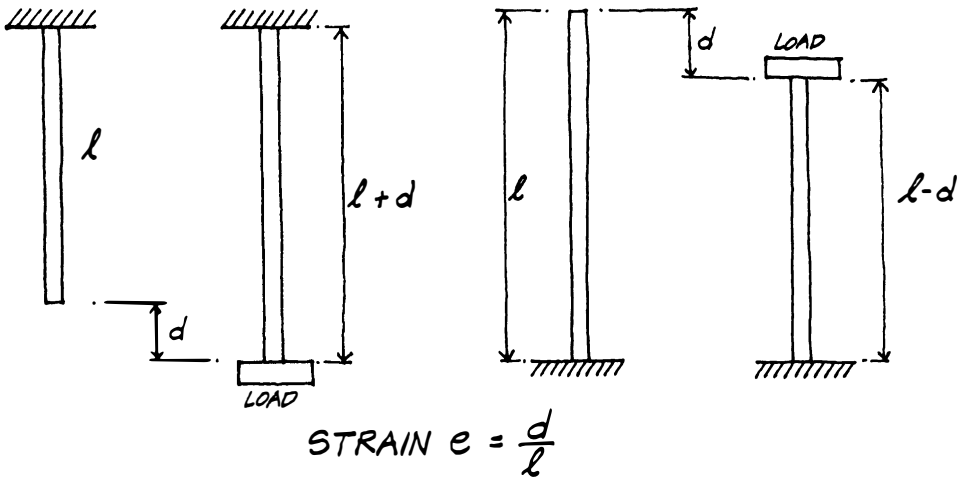
**B1 Stress**

**a Caused by Tension**                      **b Caused by Compression**

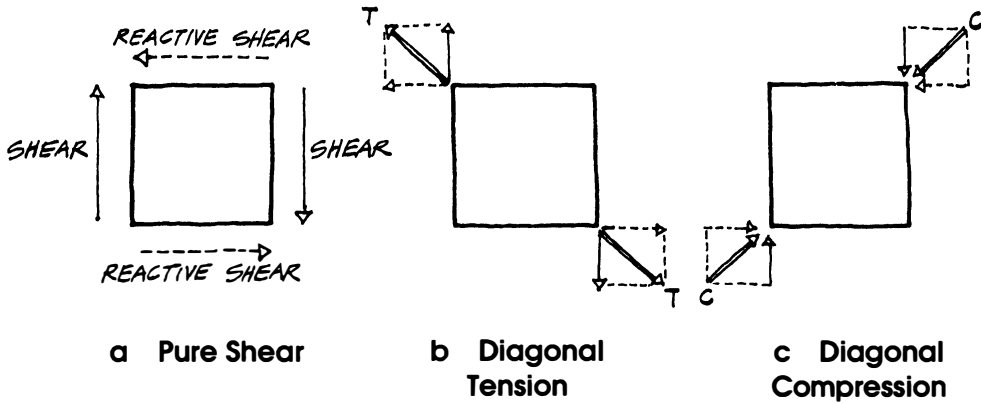
### D12 Shear Equivalent to Tension and Compression

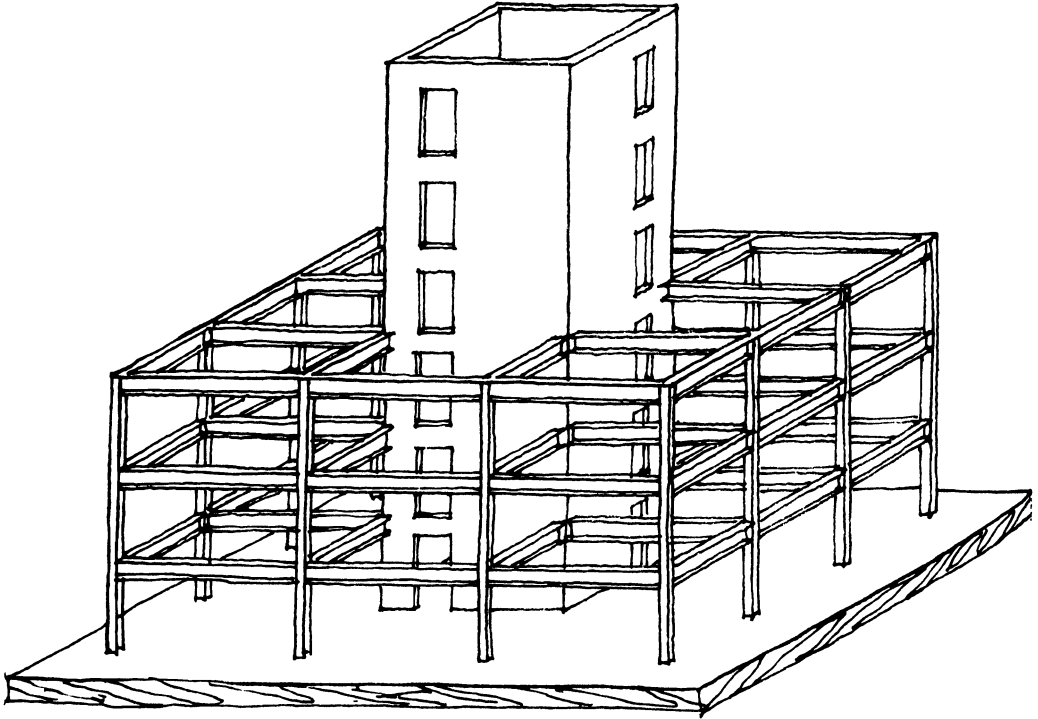
### D24 Steel Frame with Concrete Core

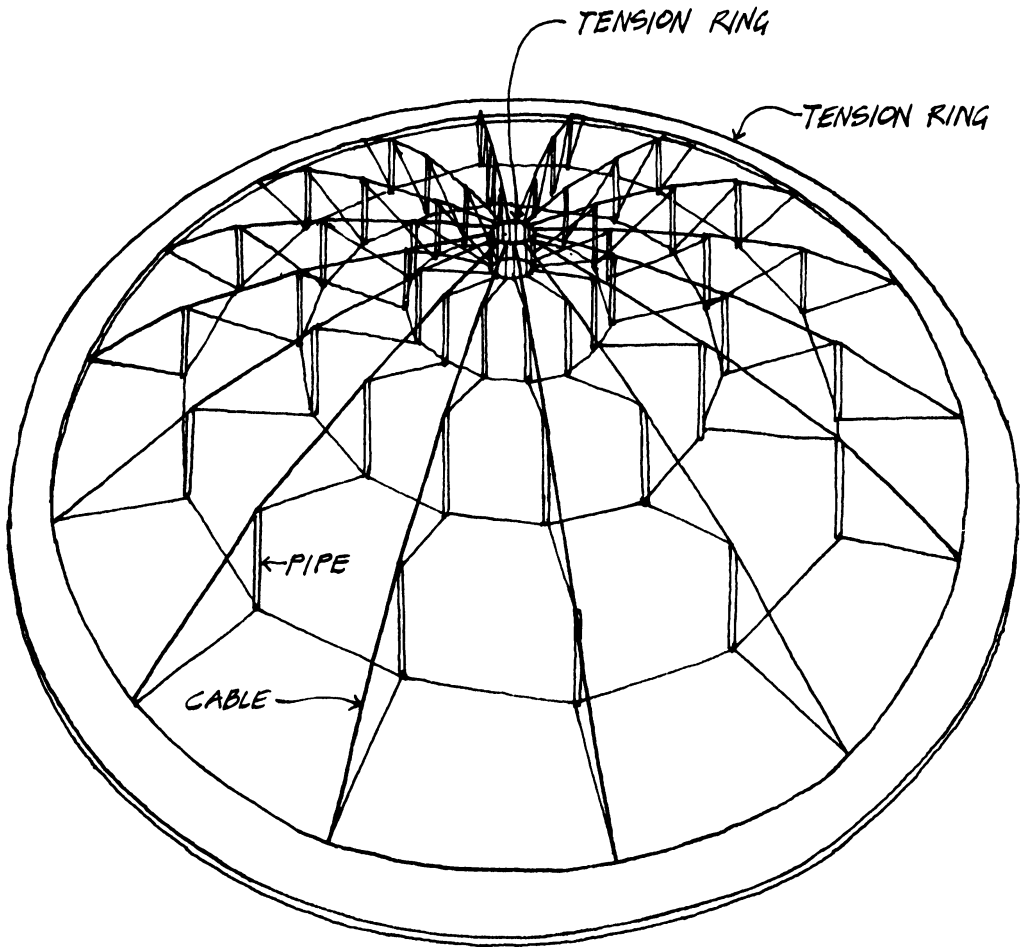
#### D34 Tensegrity Roof of Suncoast Dome, St. Petersburg, Florida

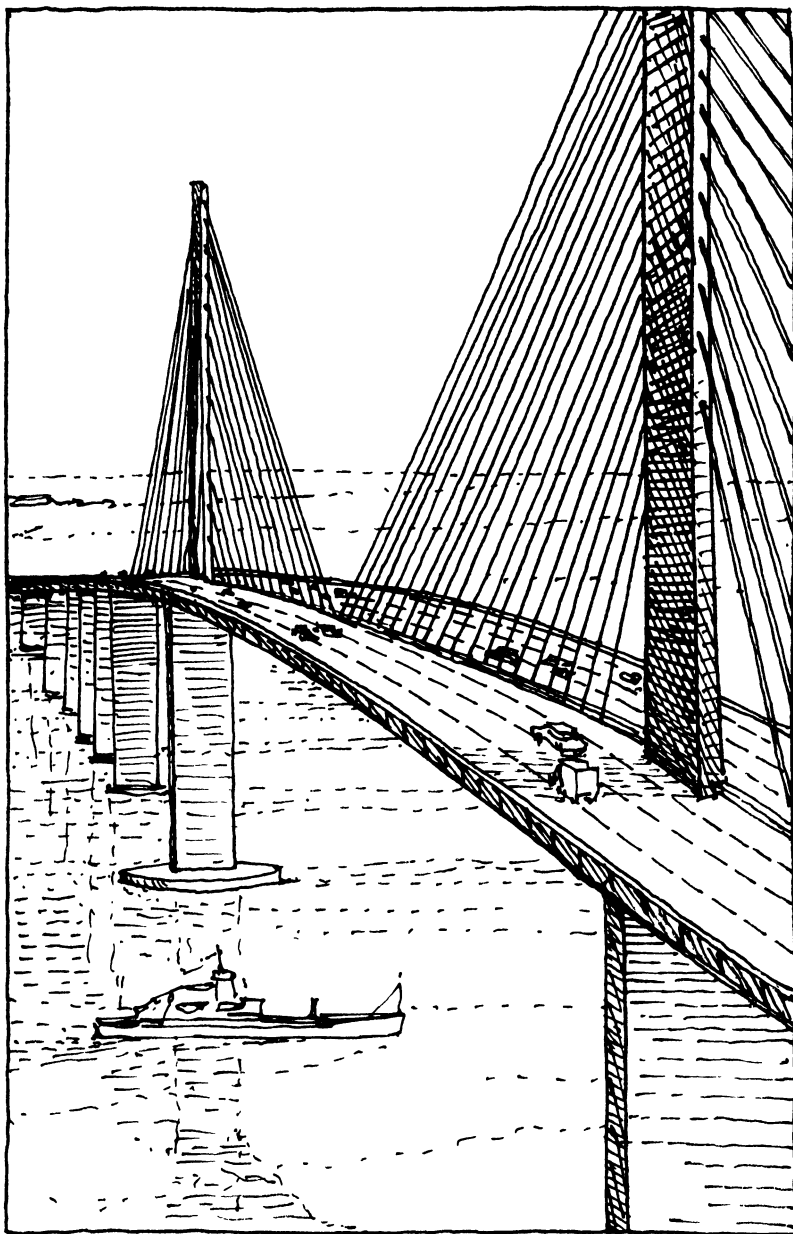
D37 Cable Stayed Bridge, Sunshine Skyway, South of St. Petersburg, Florida
