**Emergency repairs  
for  
historic buildings**

Eleanor Michell

*commissioned by the Historic Areas Division of English Heritage*

1988

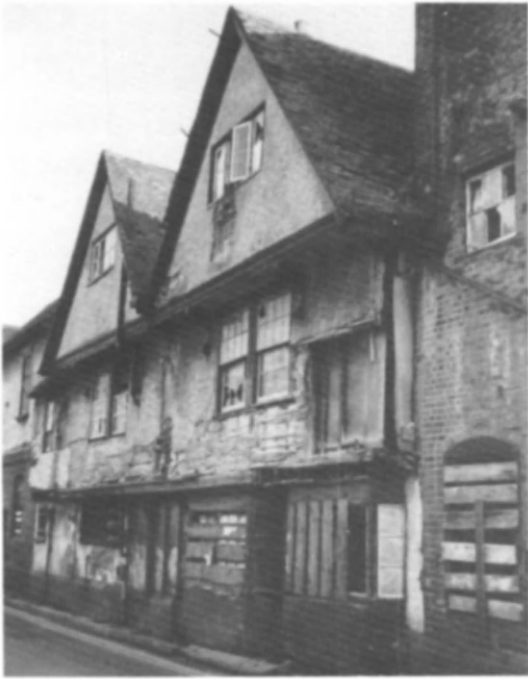
During this time it became what was described as 'a dangerous eyesore'. The slates on the High Street side began to slip and were a danger to passers-by. The jettied first floor of the Jacobean range was damaged by high-sided vehicles because of the very narrow footway below.

Fig 42 The Lamb Inn, Wallingford: the sixteenth-century range in 1976 (photo: Colin Bridger)

new bricks for reconstruction. The Jacobean range was repaired and its future integrity protected by the construction of a wide pavement with a higher kerb. The structural members which had been severed to make way for the internal shores were replaced by huge oak beams craned in through the roof, which then required complete reconstruction.

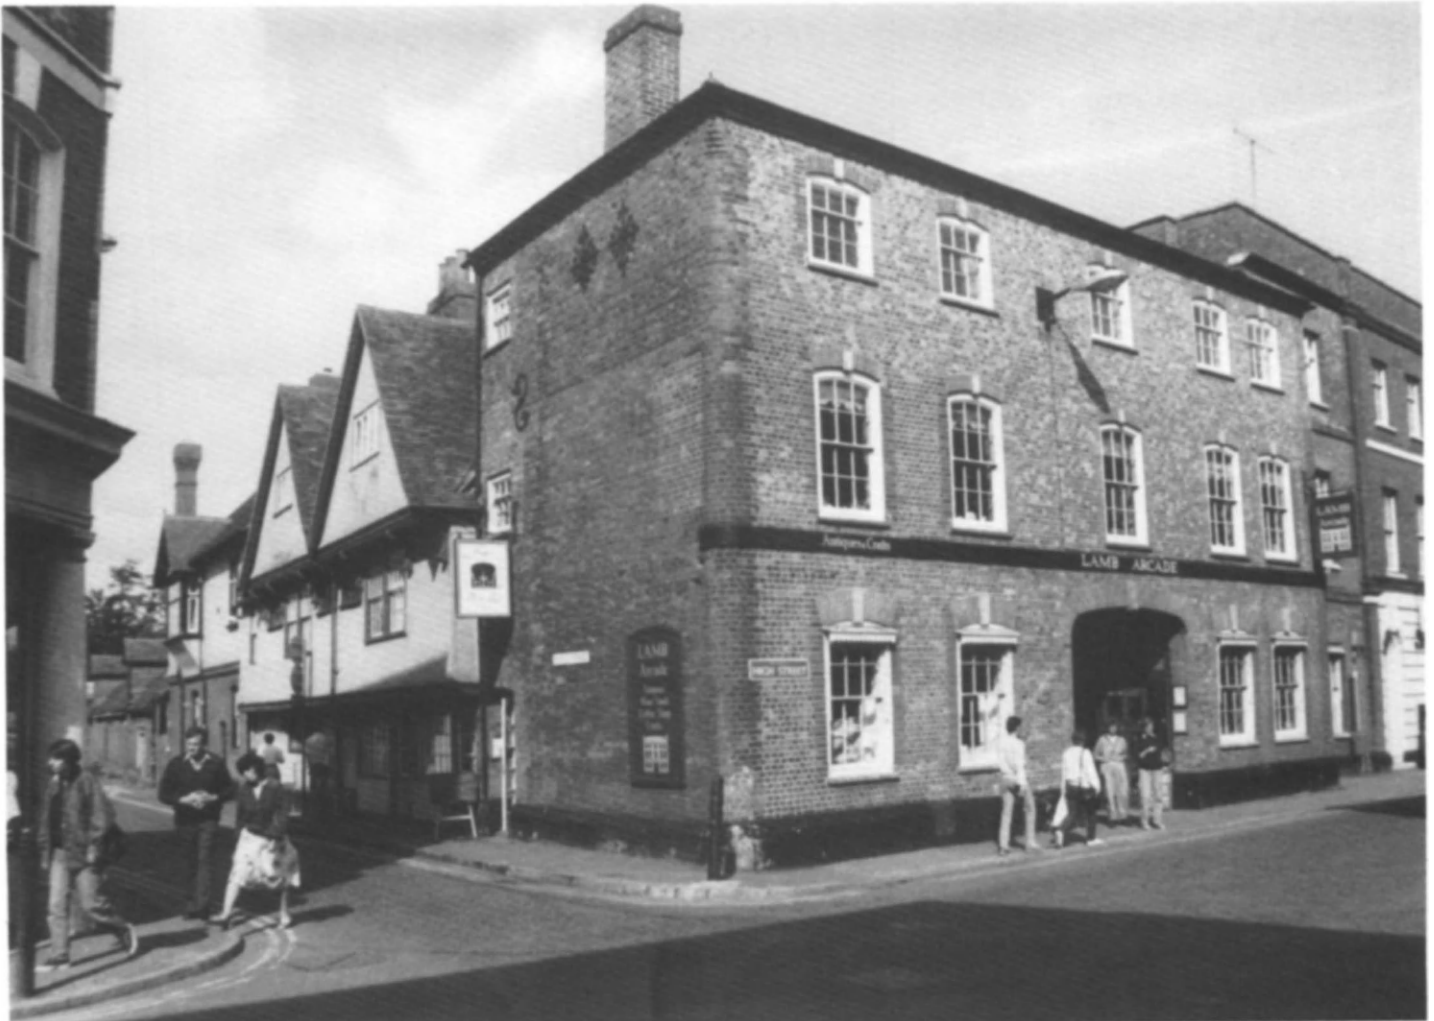
Fig 43 'The Lamb Arcade' in 1987

At last a company was formed locally on the initiative of Ann and Colin Bridger to repair the Lamb and to convert it to a two-level arcade for antique shops with a furniture repair workshop, a cafe, a basement wine bar, and flats on the upper floors. This scheme succeeded through the determination of local people to save a central symbol of their town and through their continuous detailed involvement in the process of conservation and conversion.

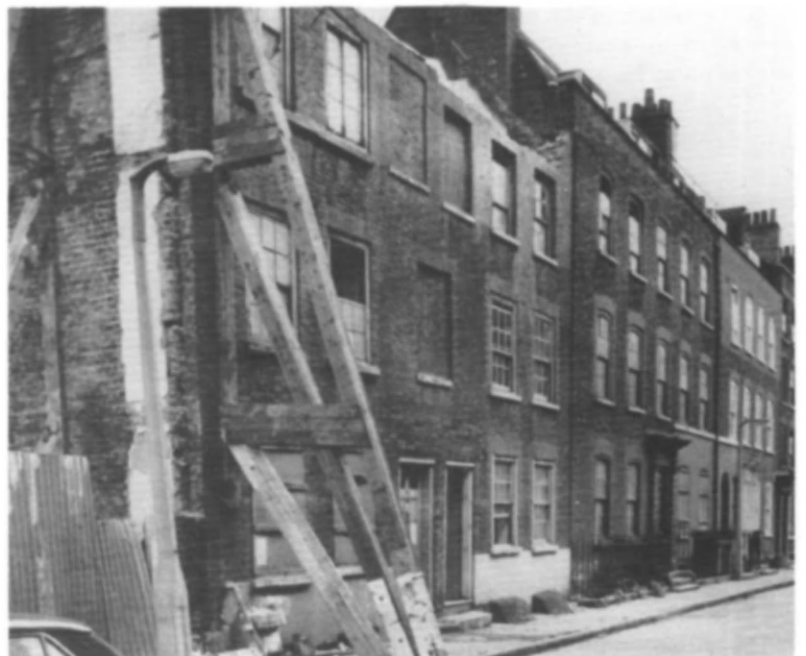
Tarpaulins were immediately hired to cover the roof while preparations were made for scaffolding. The front elevation was leaning out by 123mm and settling at the sides; it was secured by a scaffold tied through the windows from front to back. The windows and shutters which had to be removed for this purpose were stored. The scaffold was extended to support a temporary corrugated iron

Fig 48 5-7 Elder Street, Spitalfields: tarpaulins are being replaced by a protective scaffolding (photo: Julian Harrap Architects)

roof with a reinforced polythene skirt. The whole temporary structure was tied down with *in situ* concrete pads on the pavement and at the rear.

The scaffolding was hired for ten months. It allowed the structure to dry out during the pre-contract period and arrested the deterioration of the walls. It was known that the upper parts of the walls would have to be rebuilt, but it was argued that, if deterioration had been allowed to continue during the waiting period, lower levels of masonry would have become saturated and weakened and demolition would have become cumulative.

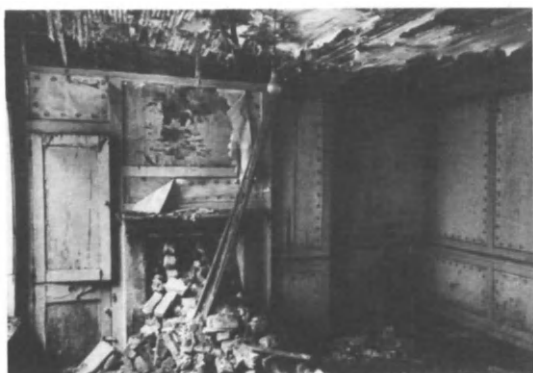
Fig 49 5-7 Elder Street, Spitalfields: an example of the condition of the original panelling which was saved as part of the emergency repairs (photo: Julian Harrap Architects)

After removing rubbish, disconnecting mains, securing the building, and pumping out the basements, a thorough conservation programme was undertaken. The panelling, shutters, and historic joinery were carefully removed and dried. A very detailed survey was made of the unstable and fractured brickwork of the facade; this made it possible to produce contour drawings revealing the pattern of movement. An eighteenth-century leaded light weaver's window was discovered, half complete under layers of hardboard and felt; this was removed for conservation.

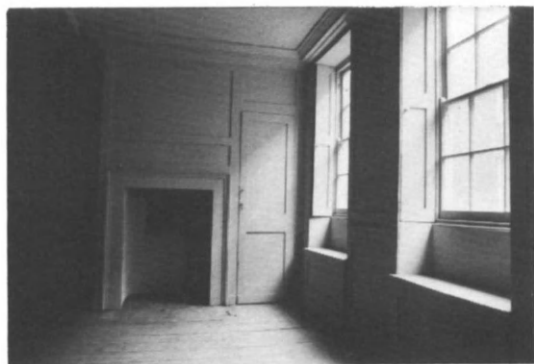
Fig 50 5-7 Elder Street, Spitalfields: repaired panelling (photo: Julian Harrap Architects)

Owing to the temporary restraint and the detailed surveying, only limited areas of the brick facades had to be rebuilt. All the conserved panelling and joinery were repaired and reinstated, a most painstaking process which was probably more expensive than making new work

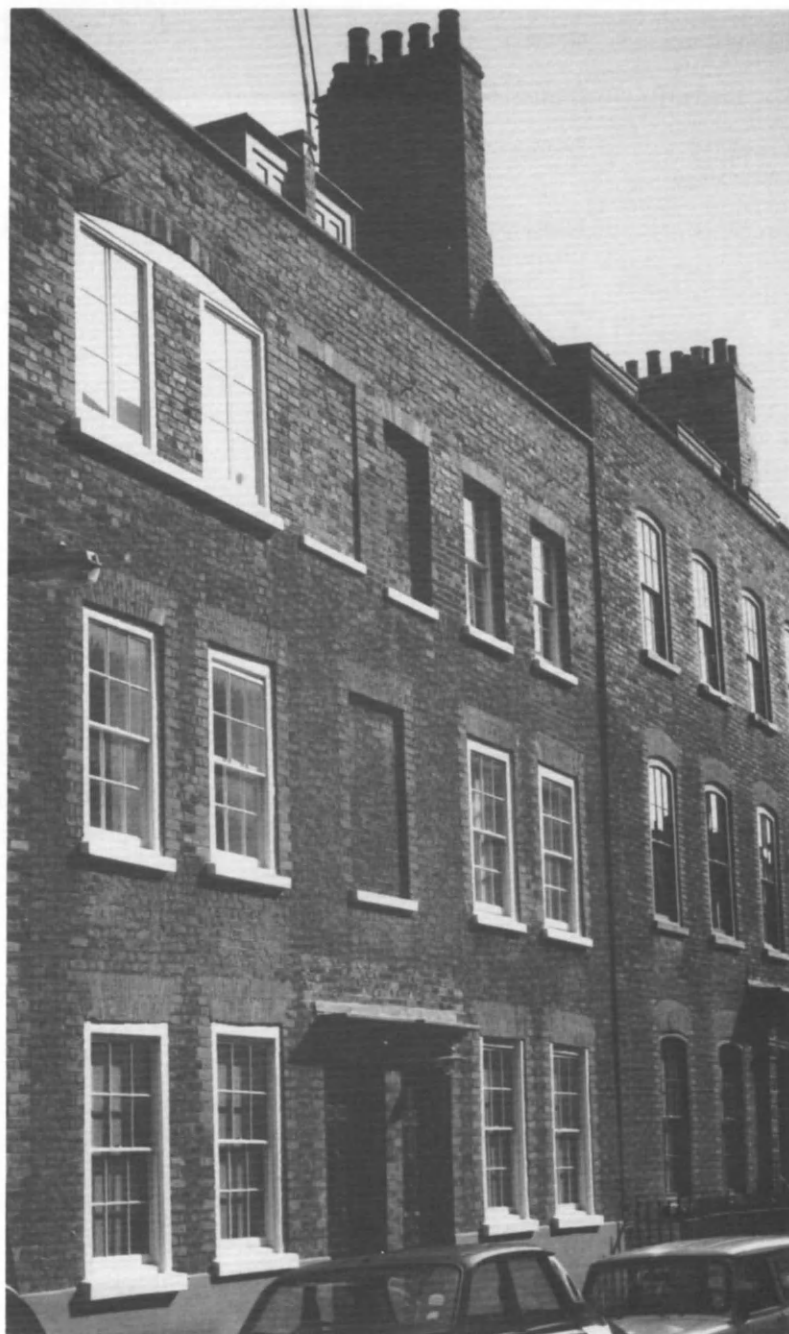
**Fig 51** 5-7 Elder Street, Spitalfields: the unusual roof formation giving rear light to the weaver's loft, rebuilt with original pantiles (photo: Julian Harrap Architects)

to match. However, the old work has the patina deriving from 250 years of continuous use and it gives the houses their historic domestic character. The weaver's window was reinstated. The part-framed floors were repaired rather than replaced.

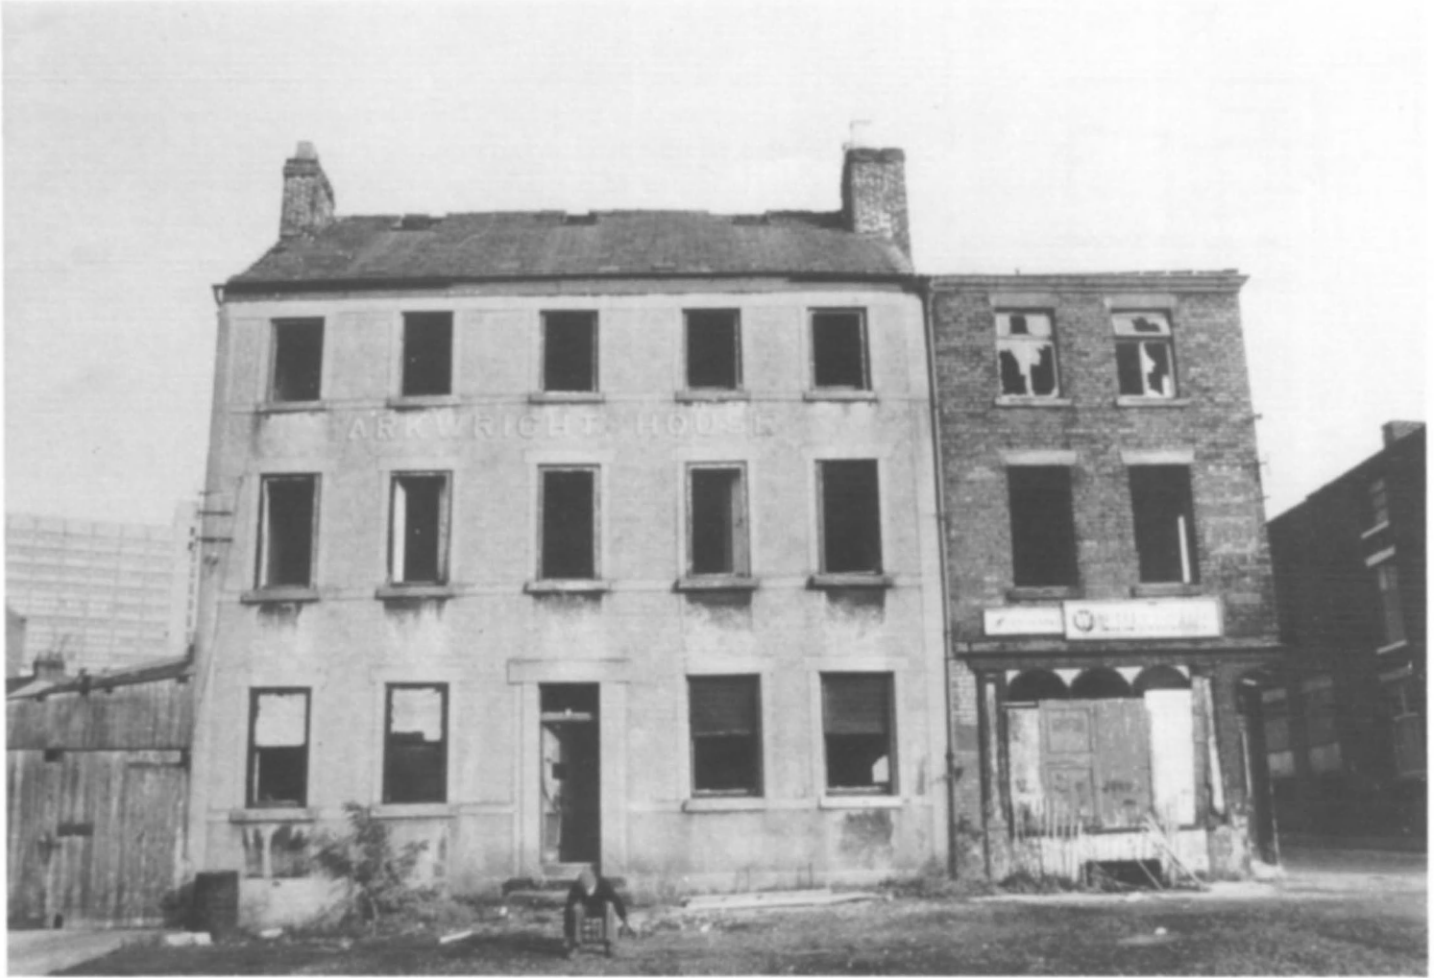
25 years; it had reached the state where much of the roof structure was collapsing and allowing severe water penetration. The twentieth-century timber beams replacing the cross walls had rotted through their bearing ends, leaving the east wall with no lateral support. In the original section of the building timber binders built into the walls had rotted, causing settlement.

Fig 57 Arkwright House open to vandals in 1978 (photo: Architectural Heritage Fund)

- Sealing the rooflights with polythene sheets.
- Covering the damaged areas of roof with tarpaulins, which was done by pushing them through the roof lights and over the ridge and tying them down at the eaves on the opposite side.
- Removing to a secure place valuable items such as stair balusters, damaged panelling, and joinery sections.
- Clearing out rubbish and debris to allow the fabric to dry and to improve its appearance.
- Sealing upper floor windows with polythene fixed with battens to frames.
- Sealing ground floor windows with plywood and corrugated iron.
- Propping two beams in the nineteenth-century part using baulks of timber already on site.

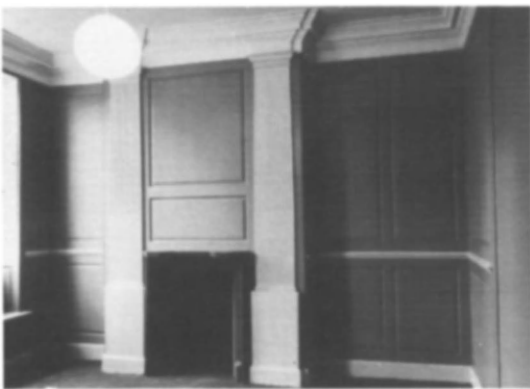
Fig 58 Arkwright House, Preston: meticulously repaired panelling and a newly designed fire surround (photo: Architectural Heritage Fund)

The Friends of Arkwright House commissioned an ambitious scheme for the complete repair and conservation of the building for museum and educational uses. A new extension was built for workshops and storage; facilities were provided for adult education conferences and lectures. Panelling and staircase details were meticulously repaired; new work was designed to be identified both in planning and detailing by a diamond theme. Tie rods, with commemorative tie plates, were installed to stabilise the east elevation. The forecourt garden and railings were recreated.

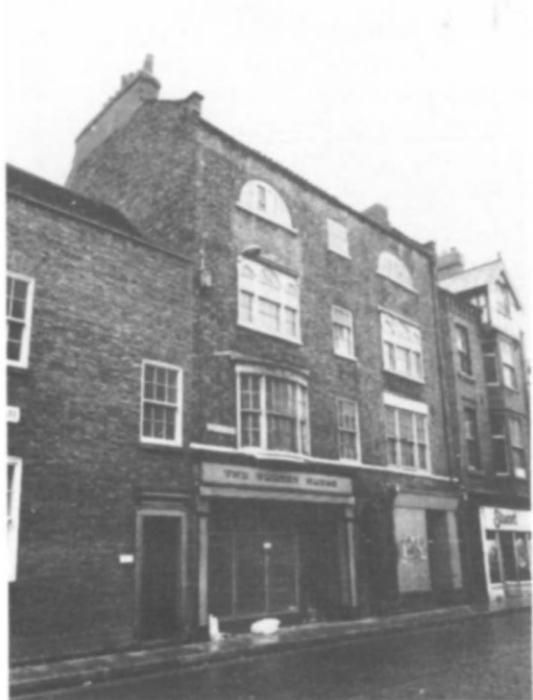
Fig 63 Gillygate, York: numbers 3 and 5 before repair (photo: York City Council)

These comprise the first pair on the west side. They have a very interesting upper elevation, now painstakingly restored to an original design of 1797. They were built by Thomas Wolstenholme, a prolific maker of composition ornaments with which he lavishly decorated the interiors. The emergency repairs were just in time to ensure their survival and to check destruction by squatters who were burning stair balusters for firewood. The pair of houses has been converted horizontally into three flats with two shops below. The second staircase has been retained as a required alternative means of escape from the upper floors. Nothing survived of the original ground floor facade and this is now a new design.

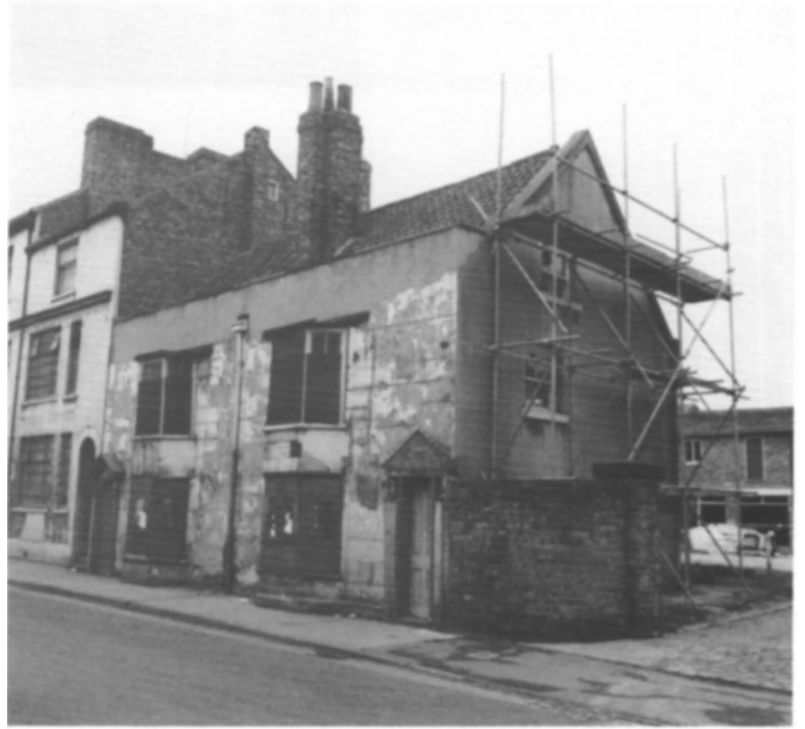
The last of the group on the west side was an eighteenth-century house remodelled around 1800 as two dwellings with double height bay windows and timber door cases with reeded columns and open pediments. These were among the earliest to be bought by the city council for clearance and they were designated derelict in 1970. They were made watertight by emergency repairs in 1976 and the windows were boarded up.

However, a repair scheme was not approved until 1982 and six years of waiting proved to be too long; one of the door cases disappeared and the boarding was not fully effective in keeping out intruders. The emergency repairs prevented total loss but they did not enable the architecture to play its part in upgrading the street during the waiting period.

Fig 65 Gillygate, York: numbers 23 and 25; work beginning in 1982 after six years of temporary repair (photo: York City Council)

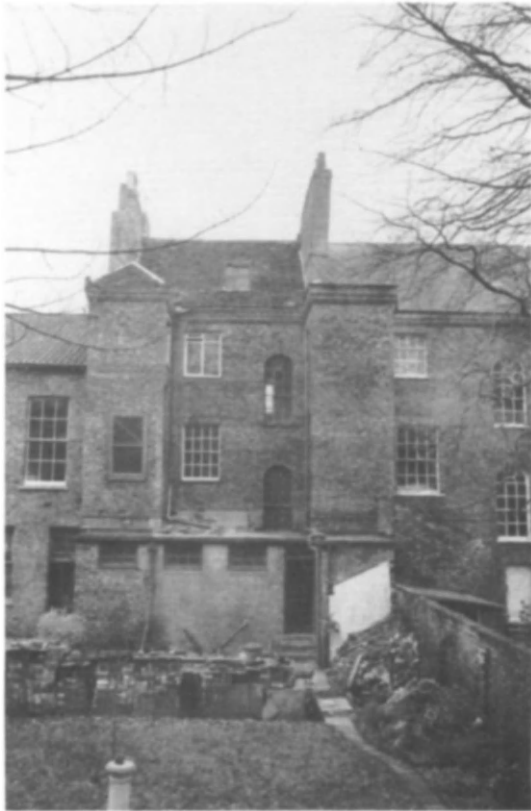
Fig 67 Gillygate, York: number 26 in 1980 (photo: York City Council)

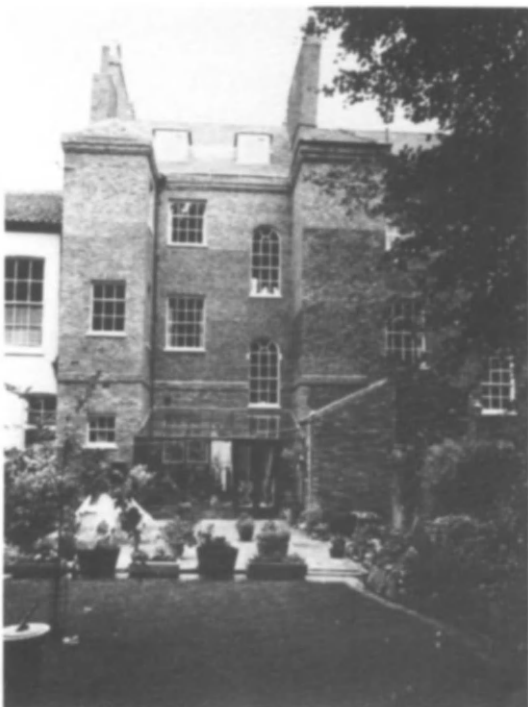
Fig 68 Gillygate, York: the back of number 26 as seen from the city wall in 1980 (photo: York City Council)

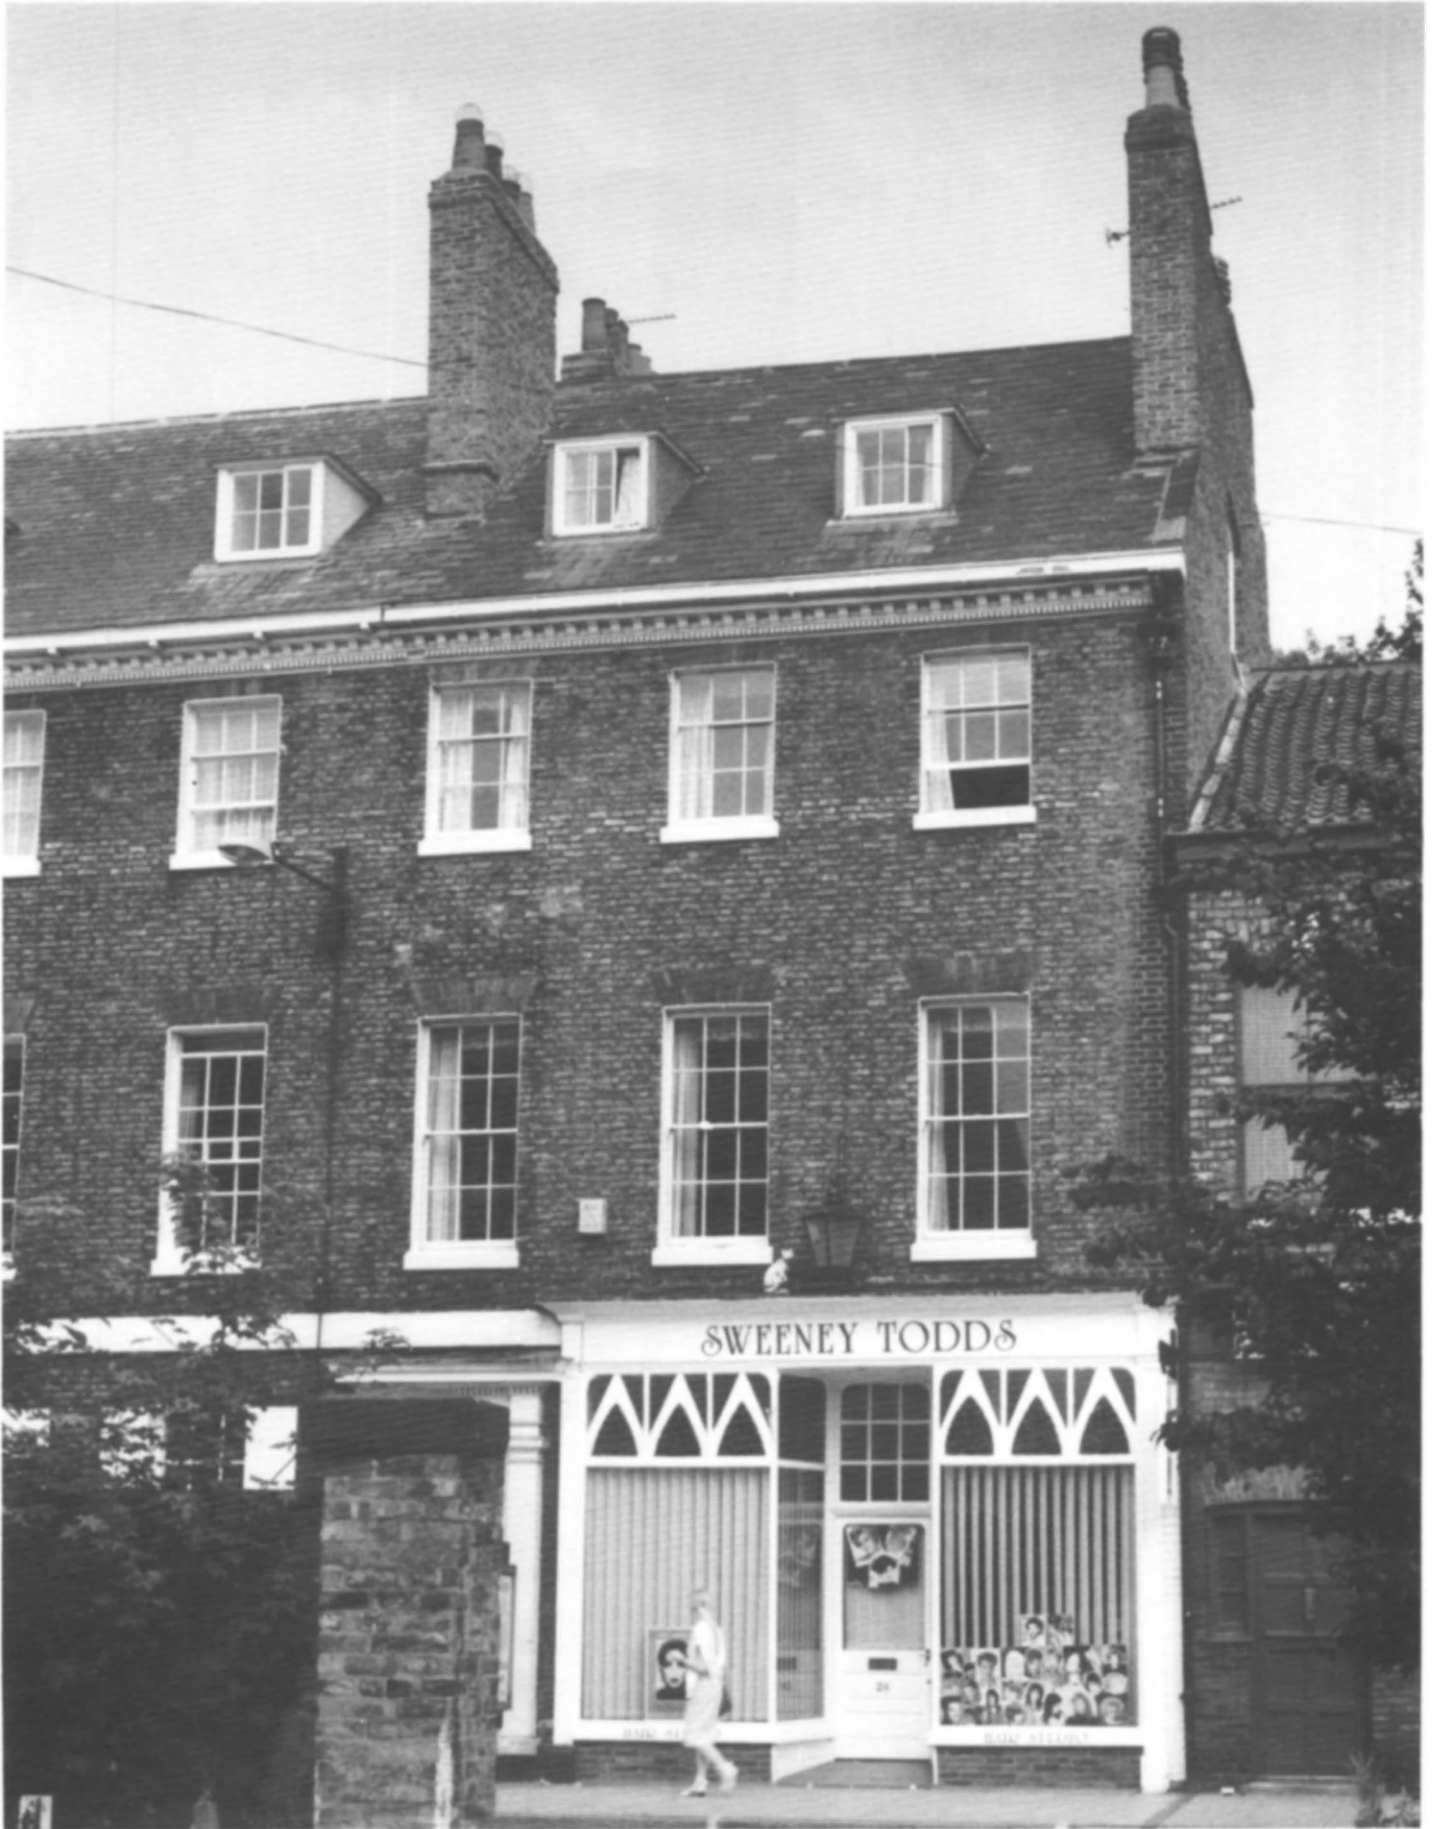
Fig 70 Gillygate, York: number 26 in 1987

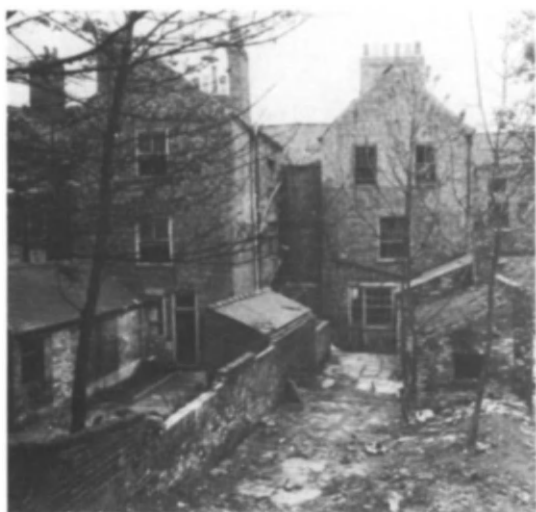
This block was the main problem of the street; the houses were owned by the city council and became so poor in condition that only the existence of the Town Scheme tipped the balance against demolition. Initially emergency repairs were mainly dry rot treatment by a specialist firm. A great deal of timber was removed and the houses became virtually gutted and roofless with floors and staircases removed and outer walls deprived of restraint. A second stage of emergency repairs was needed in 1982 due to the threatened collapse of half the front elevation. An inner structure was then built to which the elevation was tied.

**Fig 72** Gillygate, York: the backs of numbers 16–20 seen from the city wall in 1977 (photo: York City Council)

In their gutted condition no one would buy the houses except for demolition and rebuilding, but the council was still determined that the original fabric should remain, equal importance being attached both to the back and to the front. Therefore they carried out permanent emergency repairs to roof and external walls and the group was bought by a builder who converted it into shops and flats.

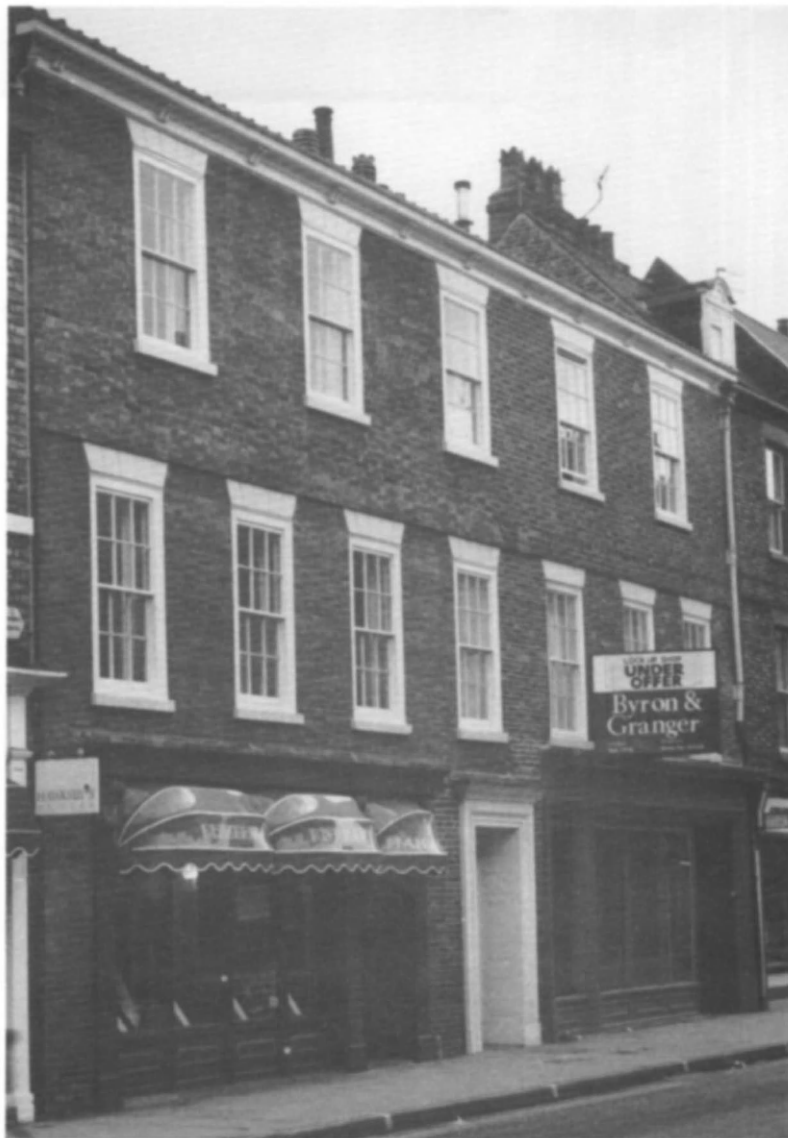
Fig 73 Gillygate, York: numbers 16–20 in 1987, with the seven first floor windows showing the extent of the original early eighteenth-century house

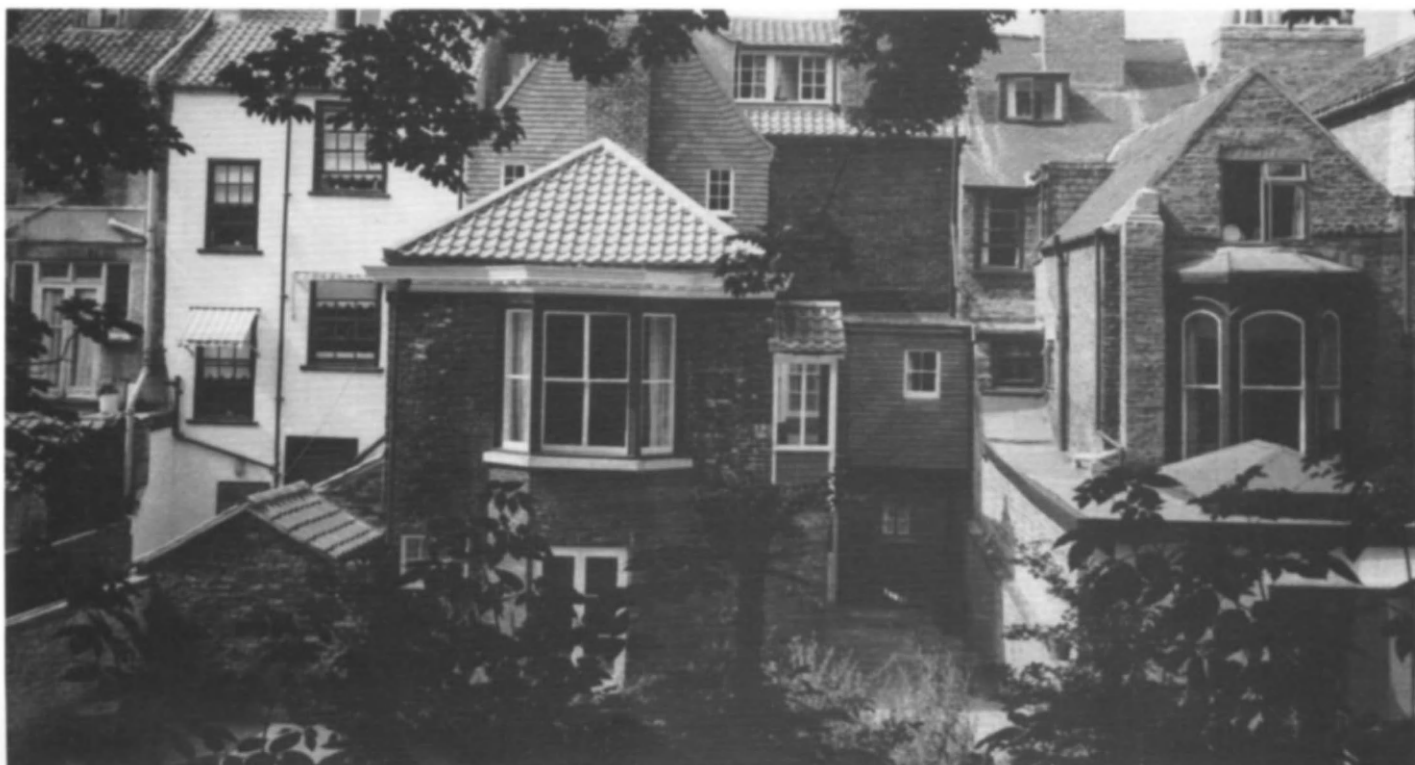
Fig 74 Gillygate, York: a view from the city wall in 1984 after repairs (photo: York City Council)

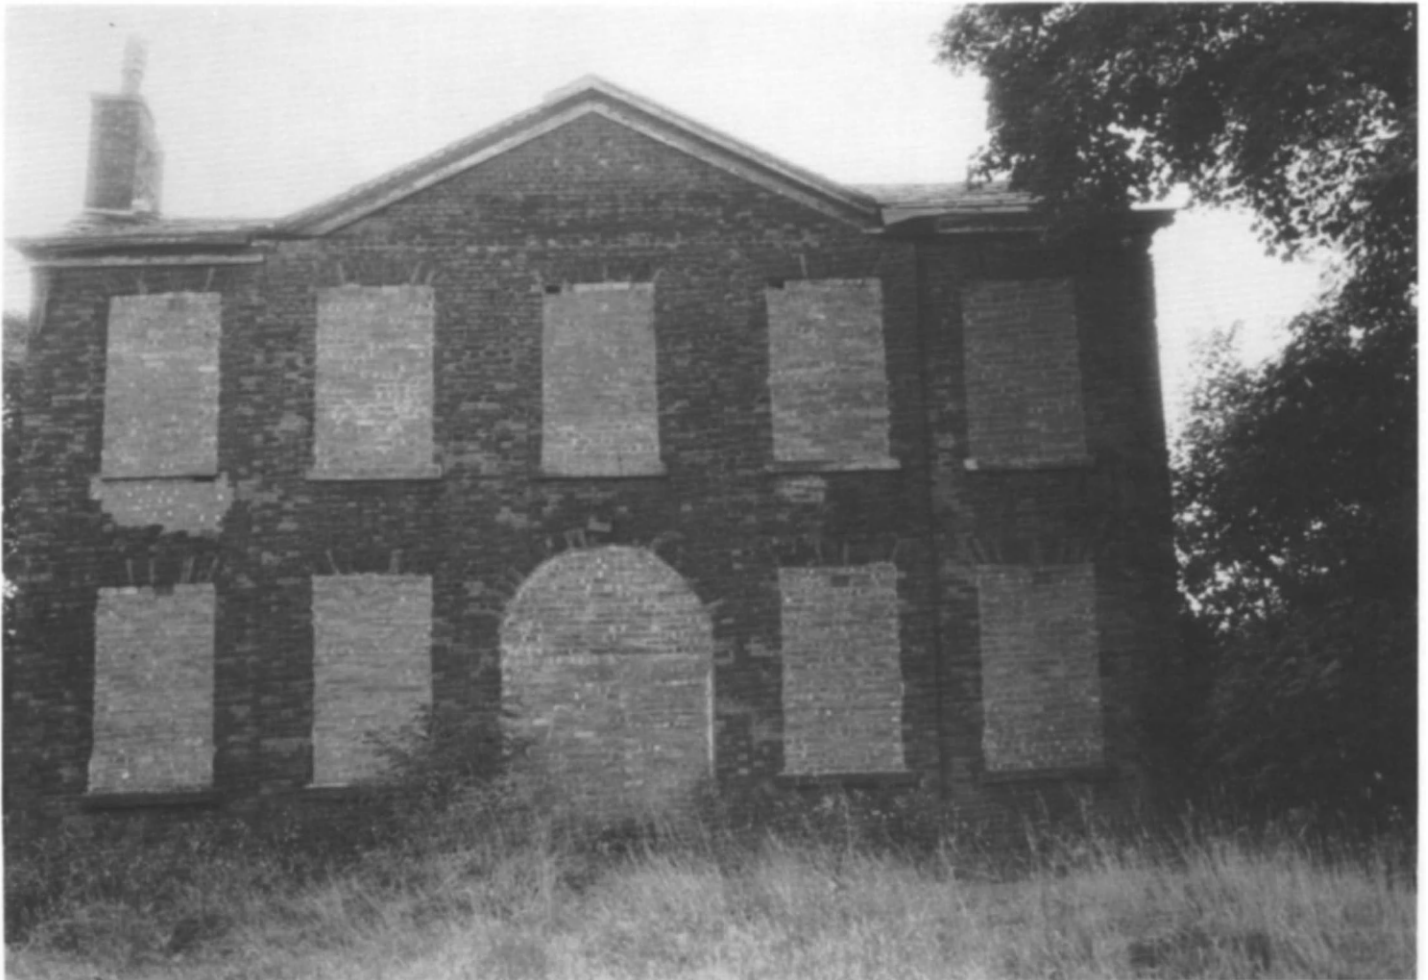
Several repair operations took place during this time, including patching the roof and mending the gutters. The windows and doors were infilled with brickwork which was not entirely successful; it was penetrated at least once by vandals in spite of the use of a strong mortar, which damaged the arrises of the reveals when it was removed. A structural survey revealed an urgent need to take down a dangerous chimney stack.

**Fig 80** Rock Hall under emergency repair  
(photo: A J Pass)

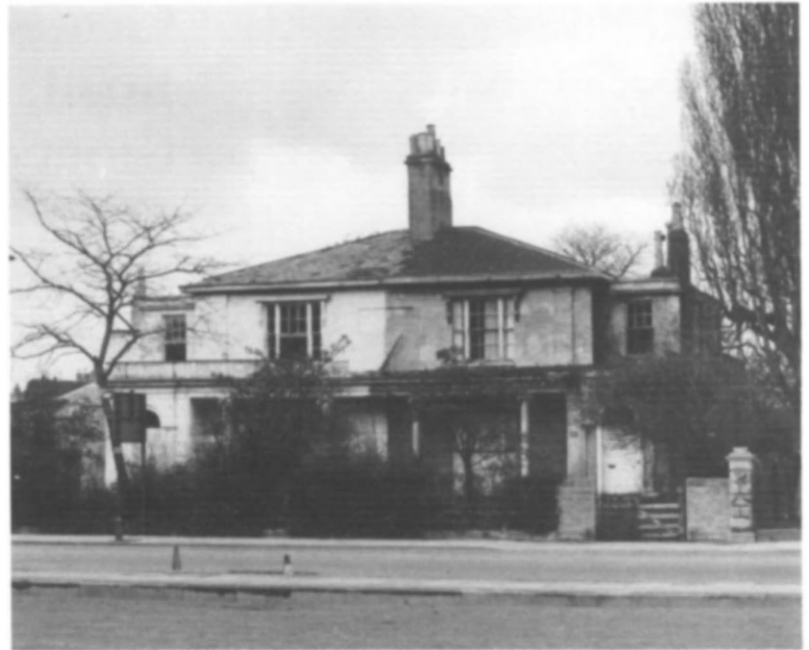
Fig 84 113-115 Bath Road, Cheltenham in 1975 (photo: Cheltenham Borough Council)

An architect's survey in 1975 recorded a long catalogue of defects including numerous attacks of dry rot, theft of lead ridges and hips, missing rainwater goods, structural cracks, leaning chimneys, settlement, rotted windows, smashed glass, missing rendering and copings, collapsed timber lintels and ceilings, saturation of walls, vandalised joinery details, and, worst of all, damage to the Ionic columns and the front door stonework of number 113 whose stone balustrade was completely missing. The stonework of number 115 had not fared much better as it had been treated with a cement paint and the leadwork of the balcony above had been removed.

These were carried out by the owner as the result of a Section 101 notice. Temporary repairs included felt covering to gutters and balcony, boarding up of windows, clearing of debris and vegetation, spraying of dry rot with fungicide, and patch repair of some of the subsidiary roofs. Permanent emergency work comprised reslating the main roof.

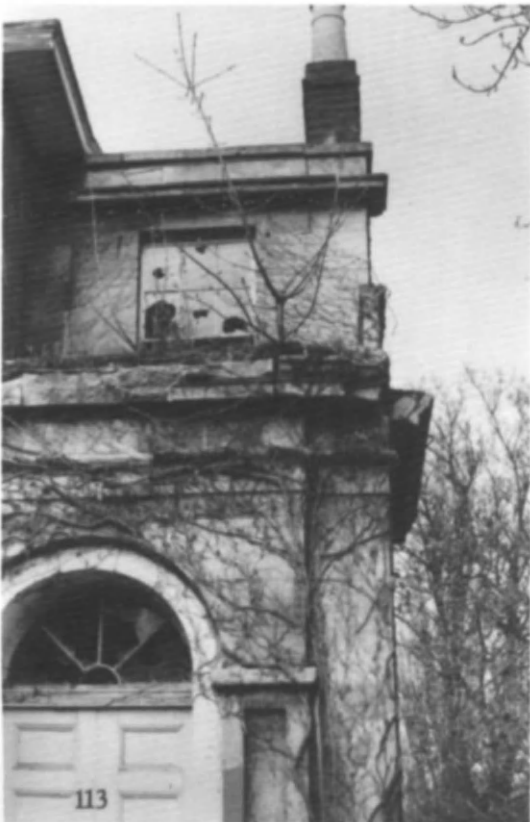
**Fig 85 Bath Road, Cheltenham: the stonework of number 115 had been covered with cement paint (photo: Cheltenham Borough Council)**

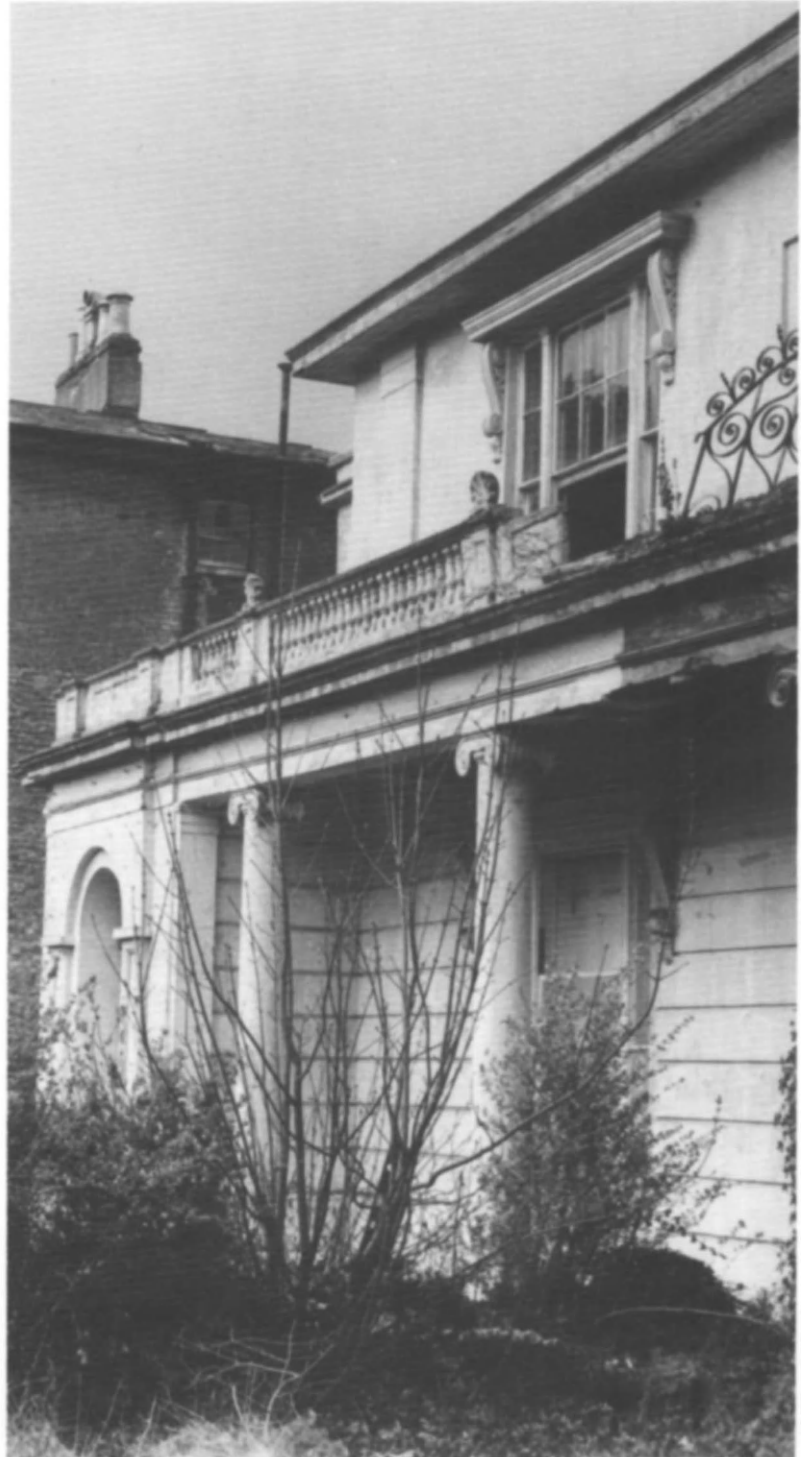
**Fig 86 Bath Road, Cheltenham: number 113, overwhelmed with vegetation, and progressively losing the finely detailed stonework (photo: Cheltenham Borough Council)**

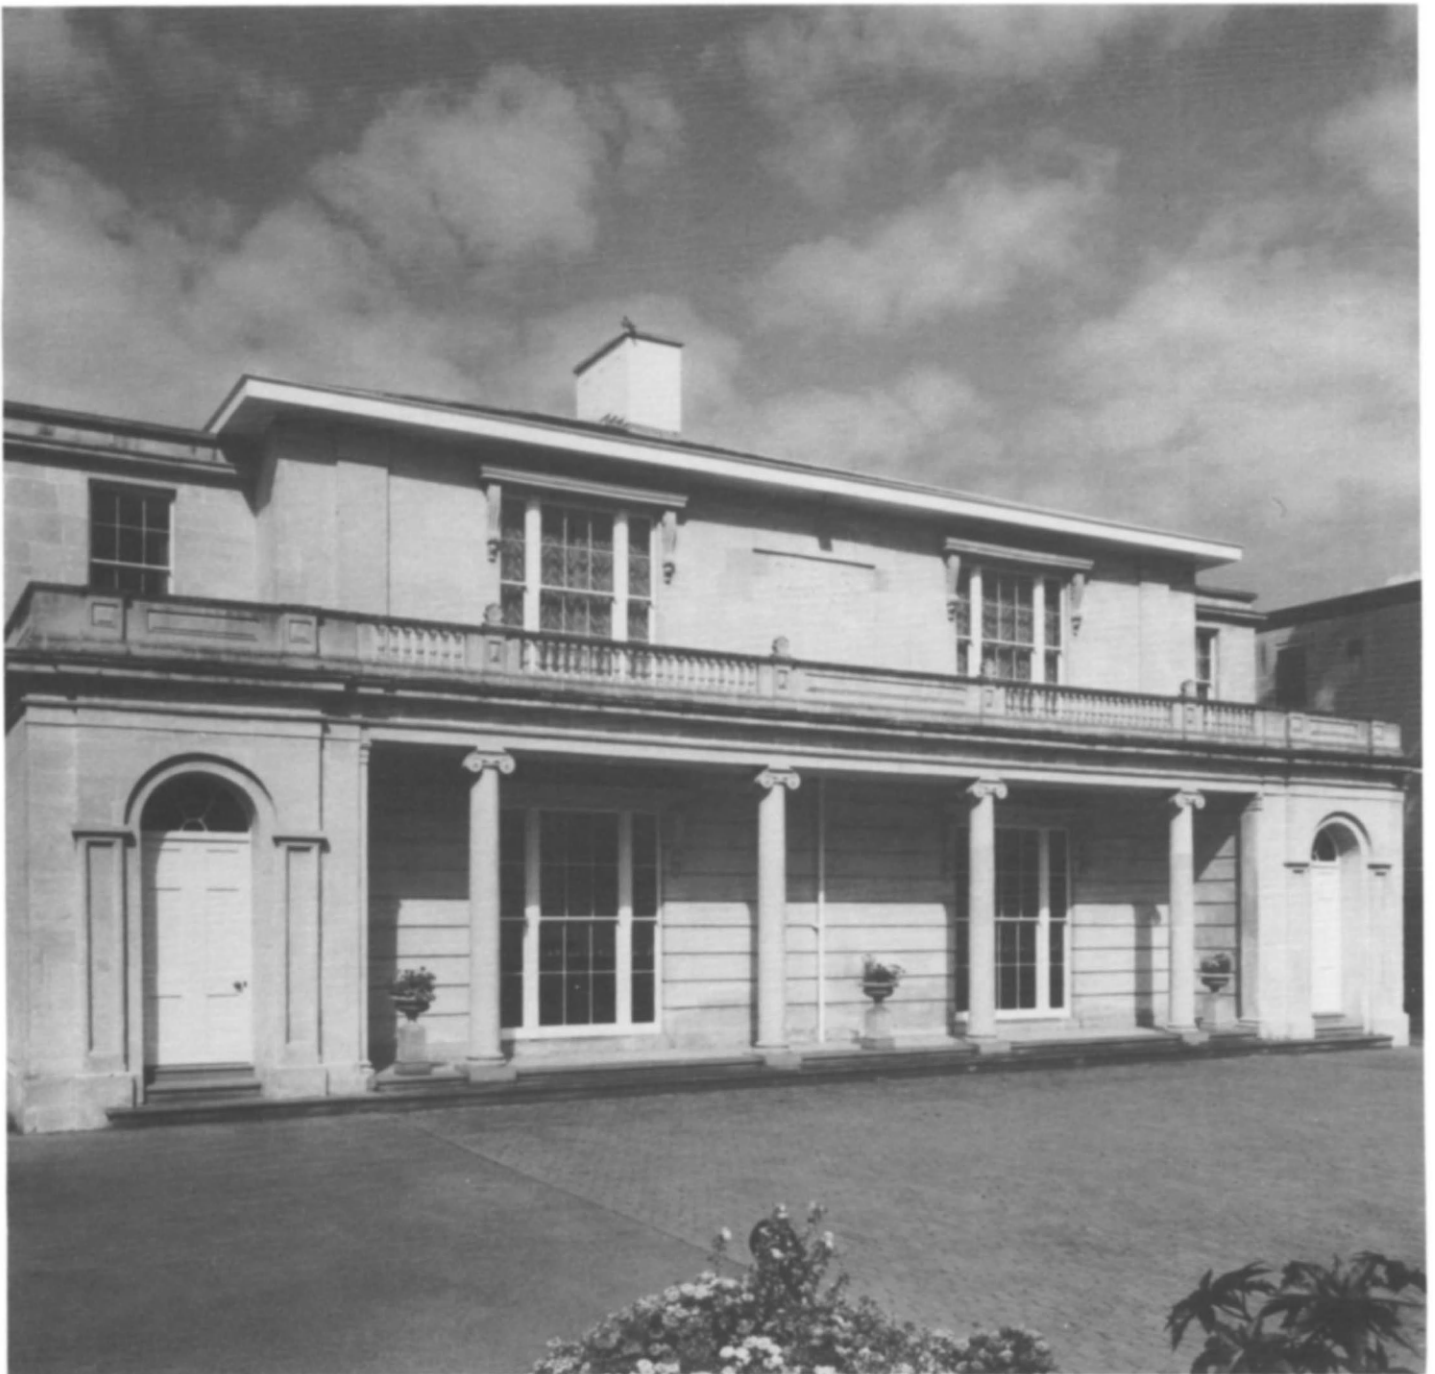
Nothing actually remains of the original pair of villas except the main structural brick walls and the facade which is largely recreated. The emergency repairs were too late and too ineffectual; nevertheless, without them the building might well have been demolished and commercial buildings would have pressed further into Regency Cheltenham.

**Fig 87** 113–115 Bath Road, Cheltenham: the restored elevation in 1988 concealing the large office extension behind it (photo: English Heritage)

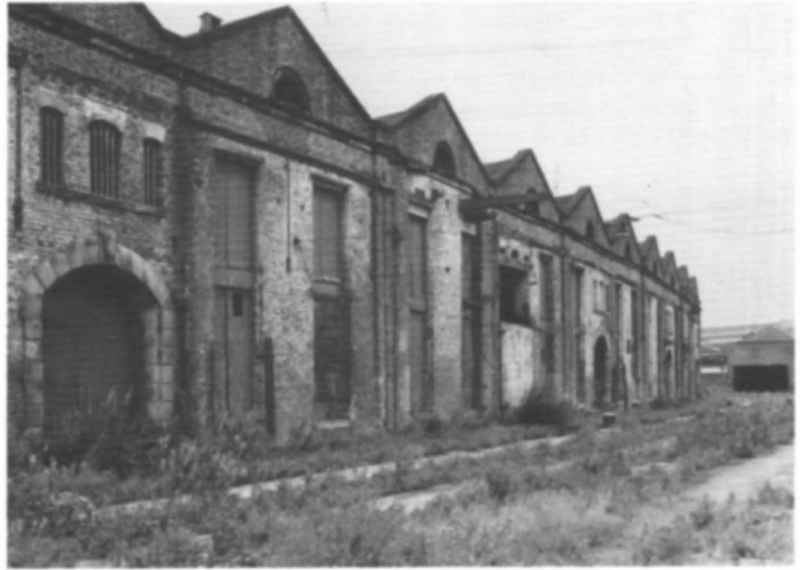
British Rail stopped using the warehouse in 1976 but two years passed before it was actually bought by the Greater Manchester Council. It was in a deplorable condition with a very poor appearance; the condition of the slates was too bad for eventual reuse, the valley gutters leaked, the stone gable copings were seriously damaged, and the brickwork was disfigured with deteriorating paint. The worst result of these external defects was deterioration of the timber structure due to water penetration.

**Fig 91 Warehouse, Liverpool Road Station, Manchester: the south side in 1978 before emergency repairs (photo: Greater Manchester Council)**

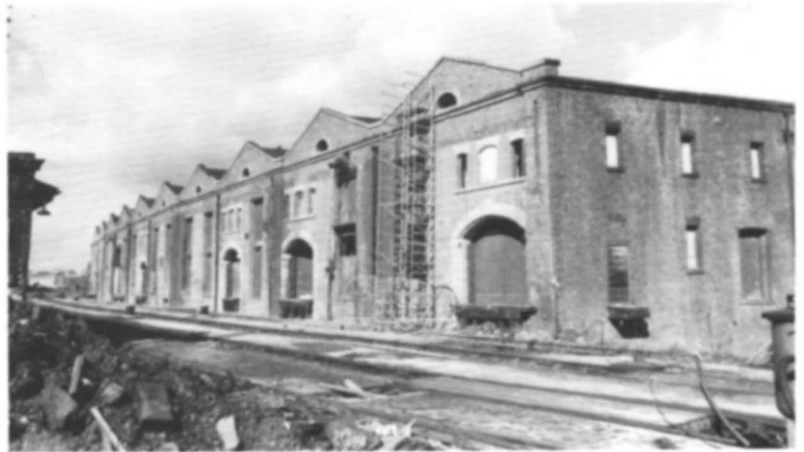
**Fig 92 Warehouse, Liverpool Road Station, Manchester: after emergency repairs in 1979 the appearance of the warehouse, and its prospects, were much improved (photo: A J Pass)**

only because the ventilation was good and the slates would, in any case, have to be written off. The gable coping was temporarily patched with brickwork. The most conspicuous elevations were cleaned and repointed. The improved appearance enhanced the building's prospects and brought support from those who had previously failed to appreciate its architectural value. The emergency measures as a whole represented a commitment to full repair in due course.

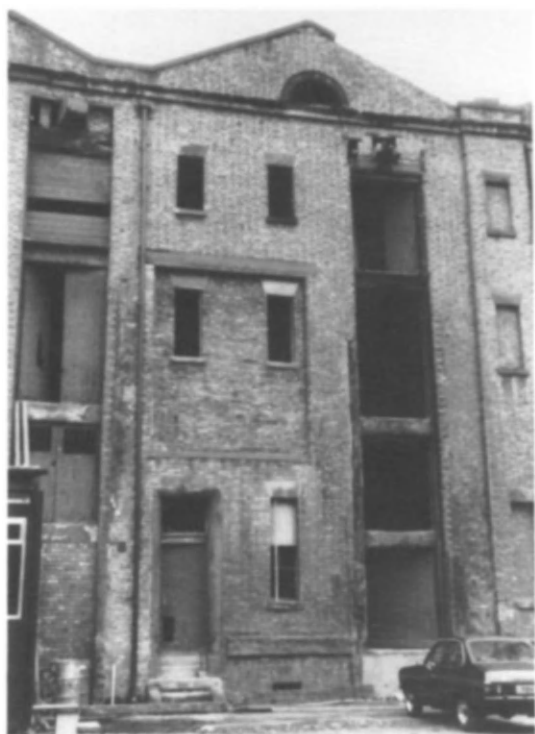
**Fig 95 Warehouse, Liverpool Road Station, Manchester: a typical bay of the yard elevation appeared to be once more at risk in 1987**

Action came in 1988 when a detailed structural survey was followed by the repair of eight local collapses. The roofs and flashings were entirely retreated and the rainwater pipes reconnected; copings were rebbed on the north side. This work was designed to preserve the structure intact for a further five years.

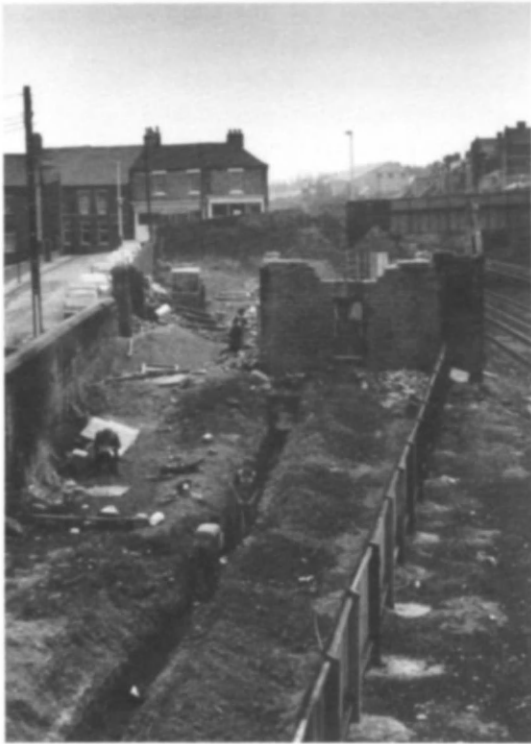
**Fig 104** Brandling Station, Felling, empty but intact in 1987
