**Emergency repairs  
for  
historic buildings**

Eleanor Michell

*commissioned by the Historic Areas Division of English Heritage*

1988

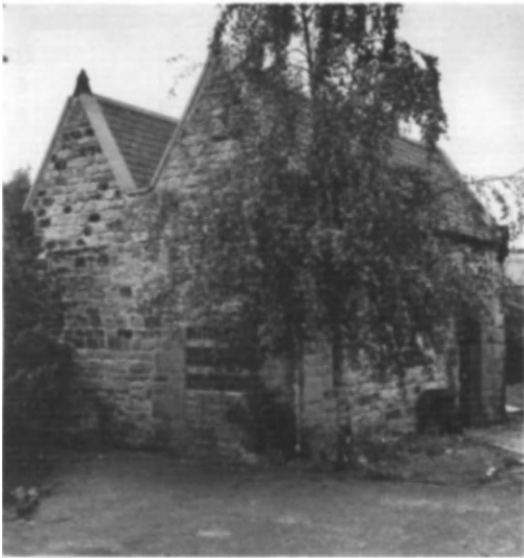
Fig 106 Brandling Station, Felling: the entrance side in 1987 with the side window shuttered and padlocked; beside the entrance door stood the bold and heavy finial which together with its missing partner should have crowned the rear roof

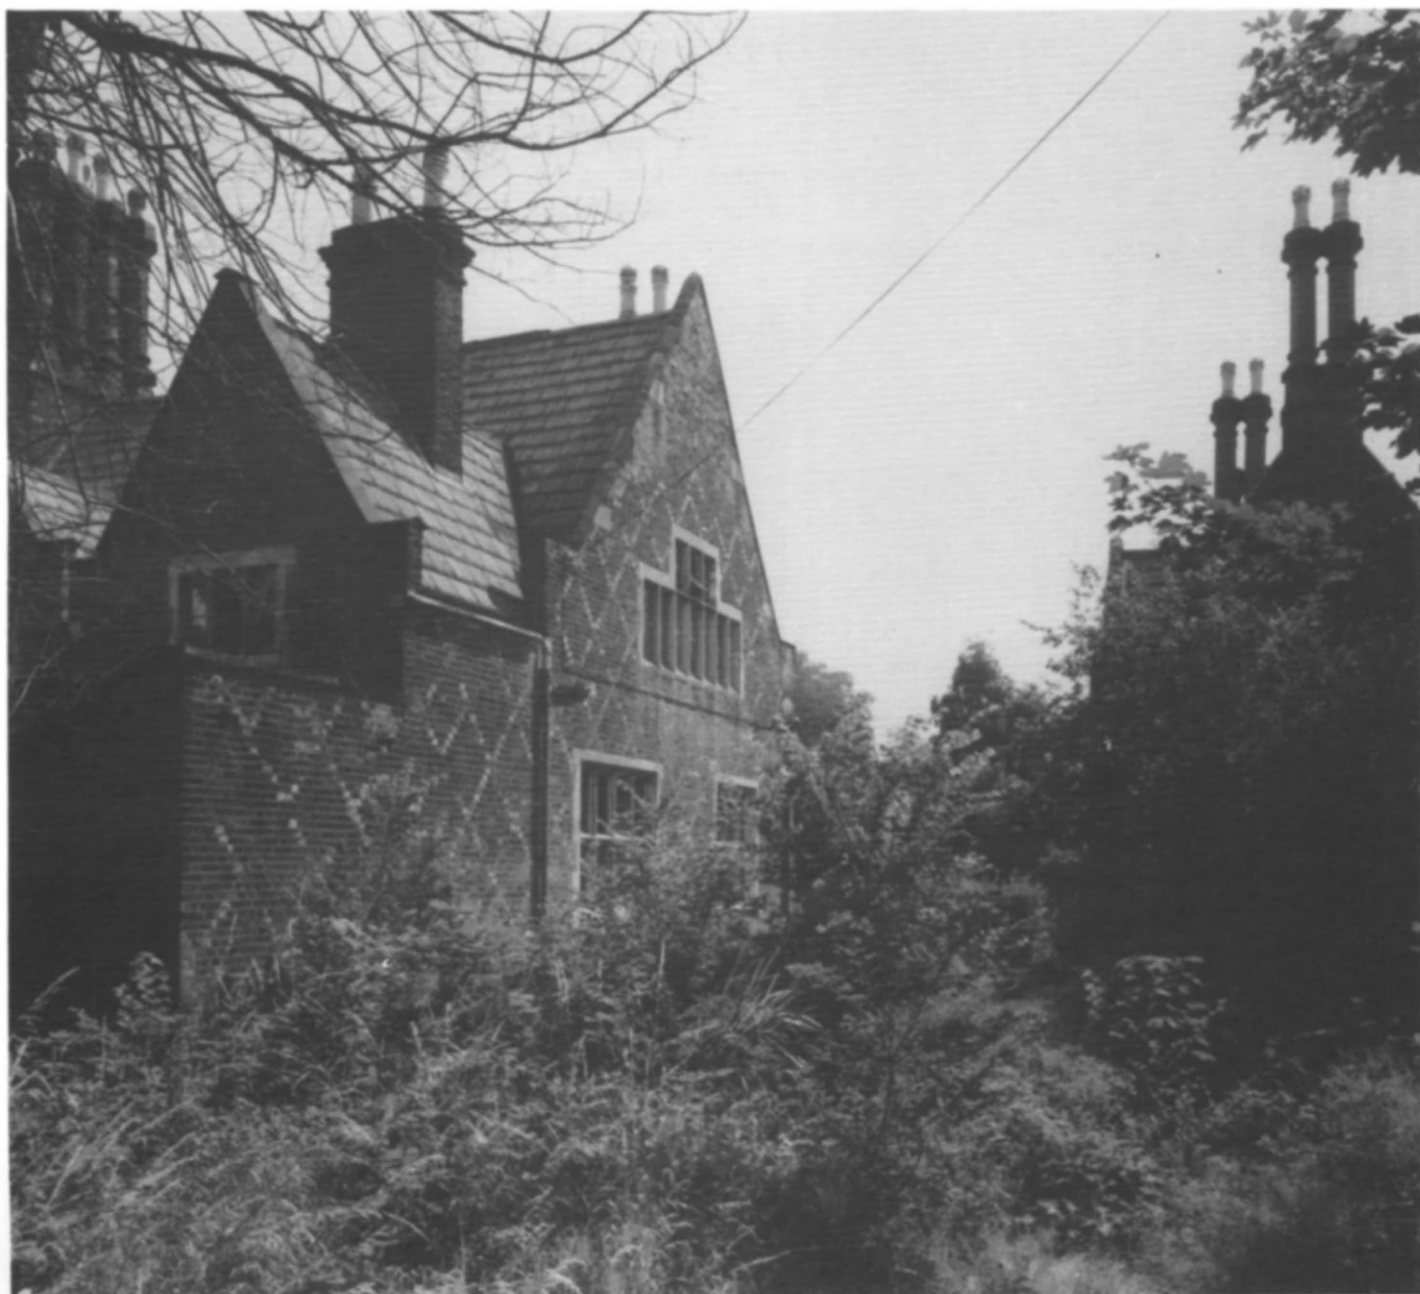
Philip Hardwick designed the elaborate roofs to discharge water into numerous separate pockets bounded by parapets, with small, and sometimes tortuous, outlets. As the garden trees grew larger, there were more leaves to block the internal gutters. Unseen from the ground, the water built up and penetrated the attics. The chimneys were designed as separate slender octagonal stacks, each cluster joined at the top by a huge brick crown, some of which had begun to separate dangerously.

**Fig 111 The Royal Naval Asylum, Penge: the gable of the central block and the linked chimneys of the south block in 1974 (photo: Greater London Photograph Library)**

repairs. They repaired the gables, reslated the roofs with Westmorland slates, overhauled the rainwater system, renewed the flashings, and treated numerous outbreaks of dry rot. The chimneys were repaired by tying the crowns together and strengthening the stacks with reinforced concrete poured from above around new five-inch flue liners.

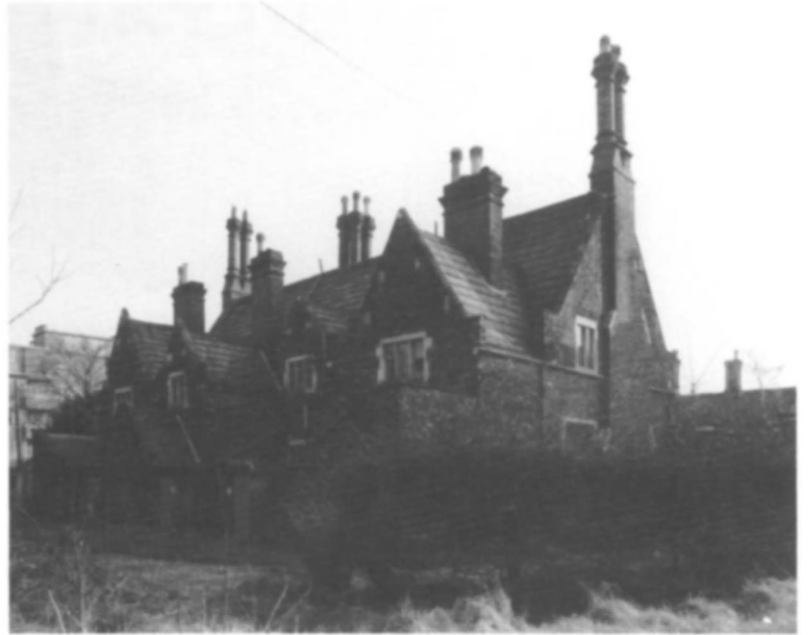
**Fig 112** The Royal Naval Asylum, Penge: the back of the north block in 1974 (photo: Greater London Photograph Library)

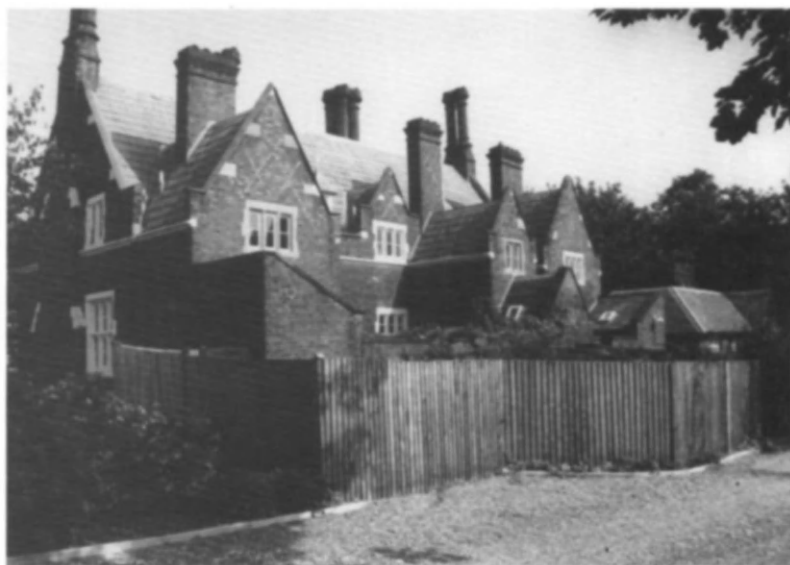
**Fig 114** King William IV Gardens, Penge: the back of the south block in 1987; the compact consistency of Philip Hardwick's design, with yard walls linking rear extensions, is now obscured by fencing to extend the private areas

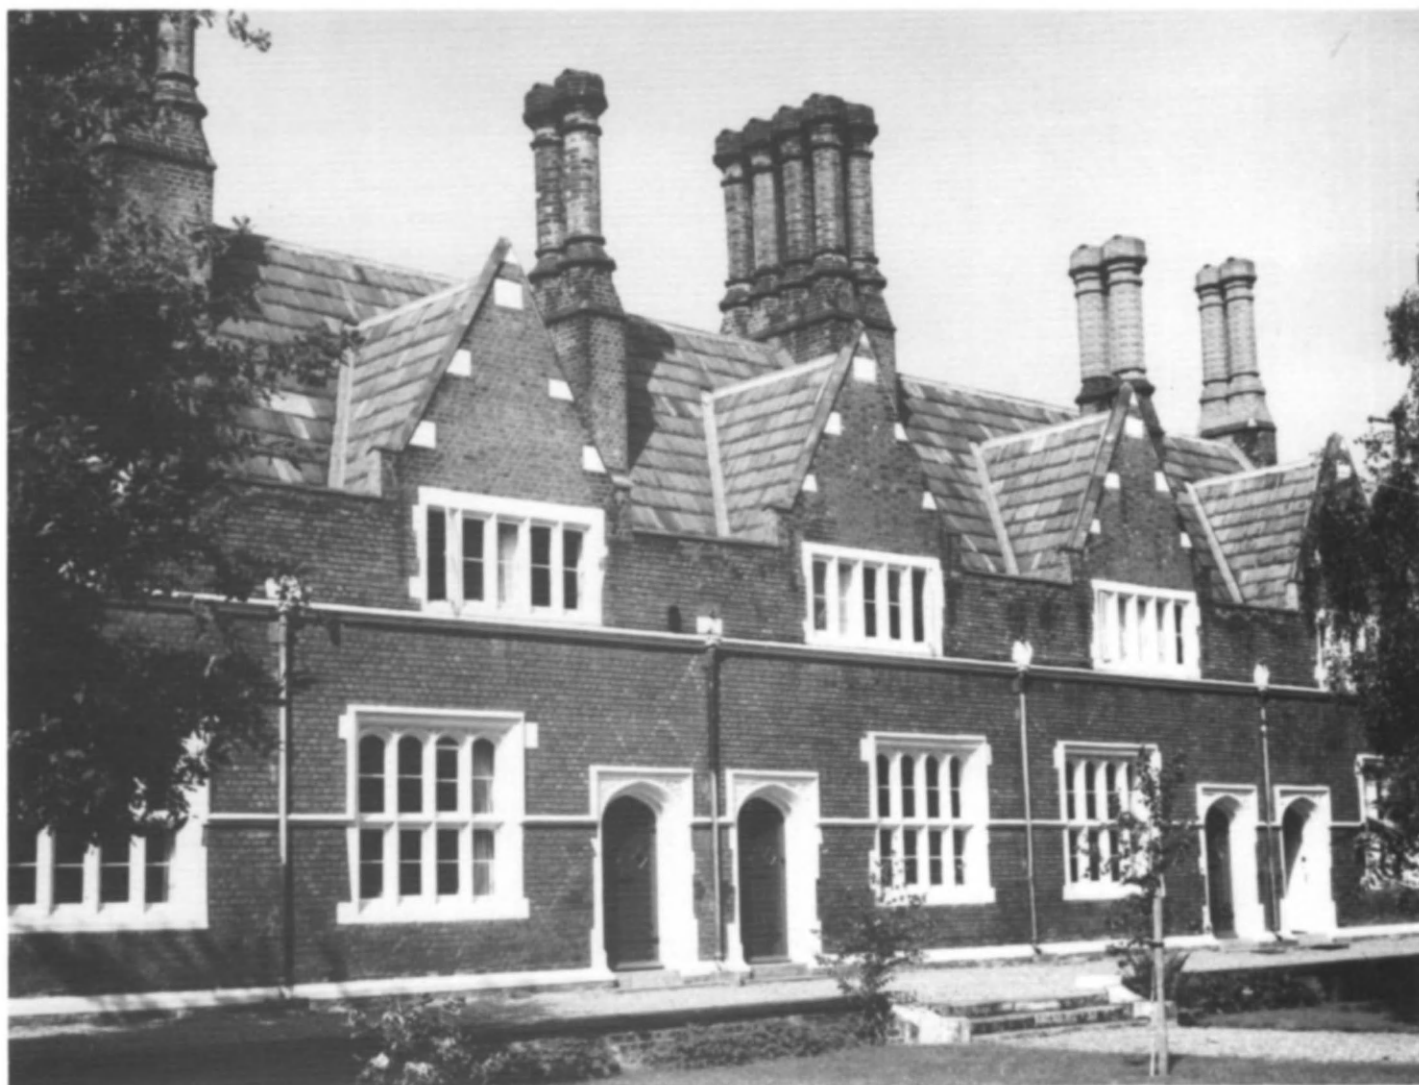
**Fig 115** King William IV Gardens, Penge: the central block in 1987, wholly repaired and completely unchanged; the two rebuilt chimney stacks can be seen on the right

The ownership of the buildings was transferred to the London Borough of Bromley which invited tenders for the purchase of a long lease at a peppercorn rent. They stipulated a high standard of renovation, including the rebuilding of two chimney stacks, stone repairs, and the renewal of rainwater heads in the original foliage design. The successful development company, relieved of the great expense of the emergency work, carried out the renovation and sold the houses within a year. The site was divided up into saleable parcels, vehicular access and car parking were provided, and the name was changed to King William IV Gardens. The central landscaped garden was retained.

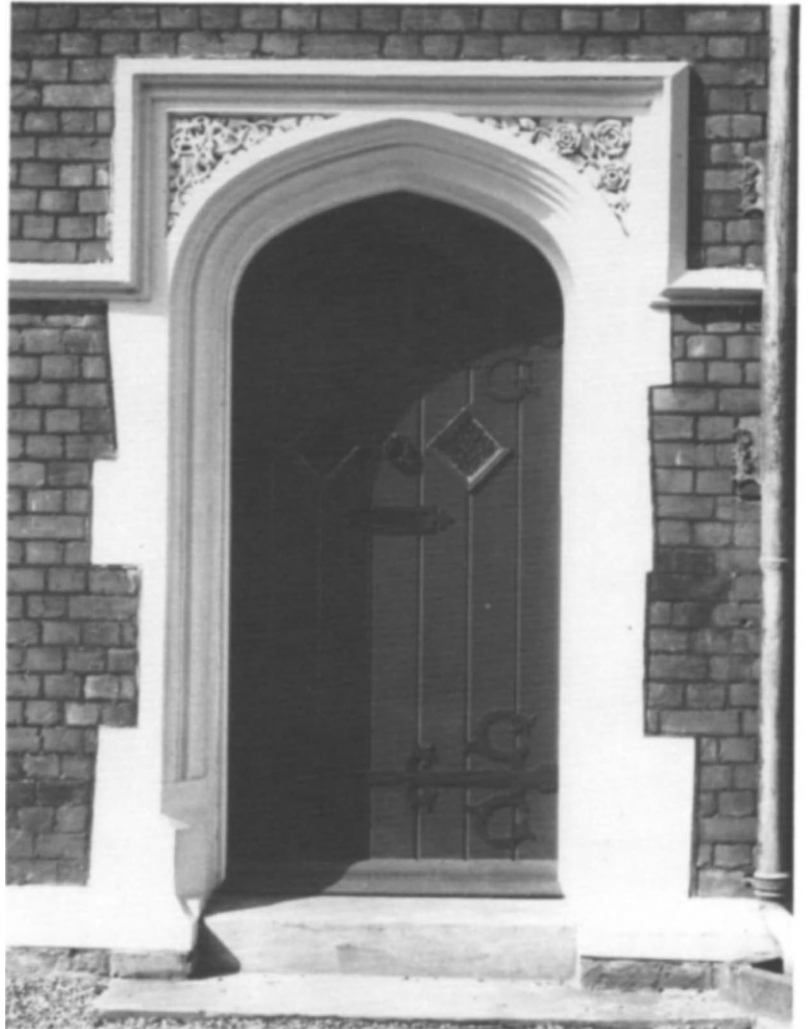
**Fig 117 King William IV Gardens, Penge:** typical front door and rainwater pipe; the lead pipes were not stolen during the waiting period because the GLC removed them to safe storage

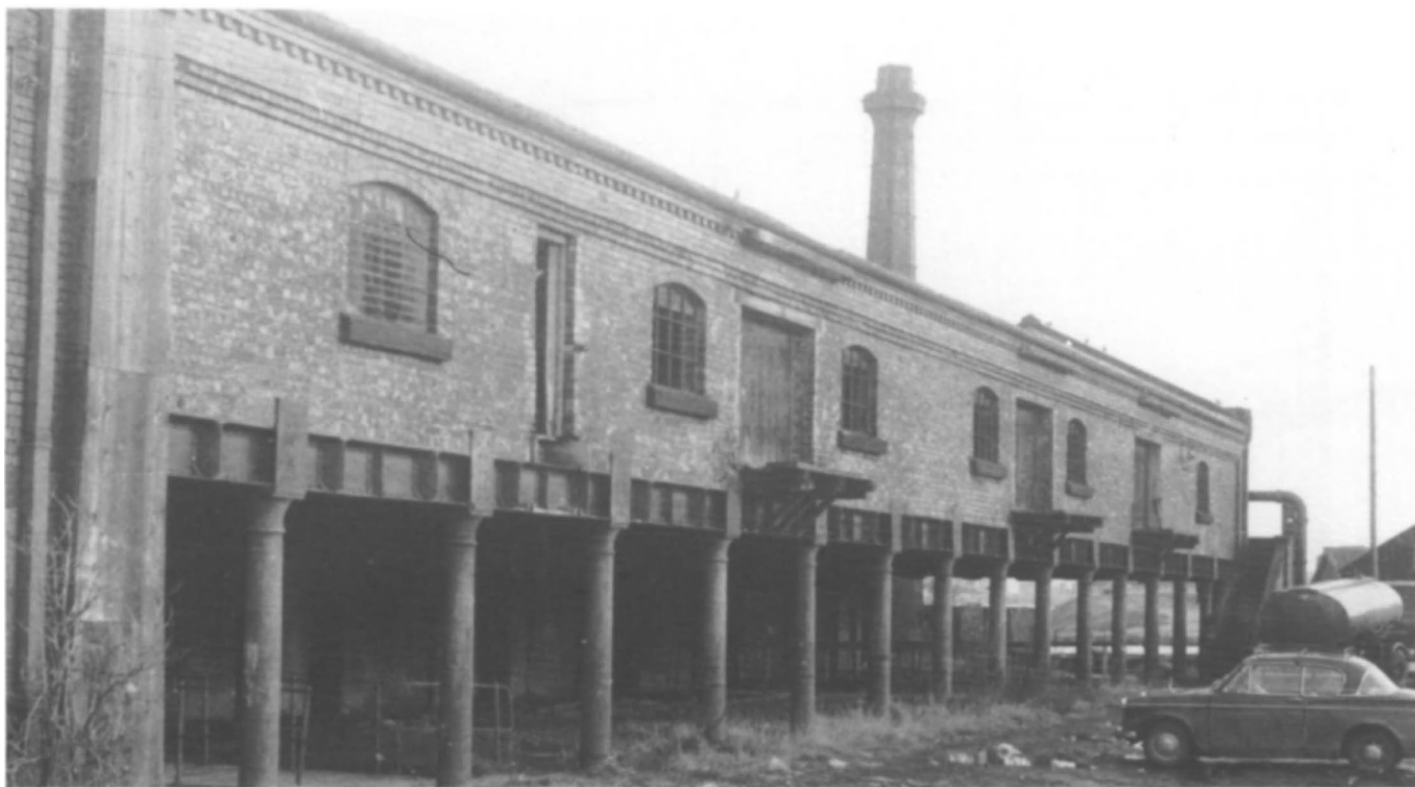
**Fig 120** Island Warehouse, Ellesmere Port: in 1974 the building was open to vandals and the canal arm filled with debris (photo: The Boat Museum Trust)

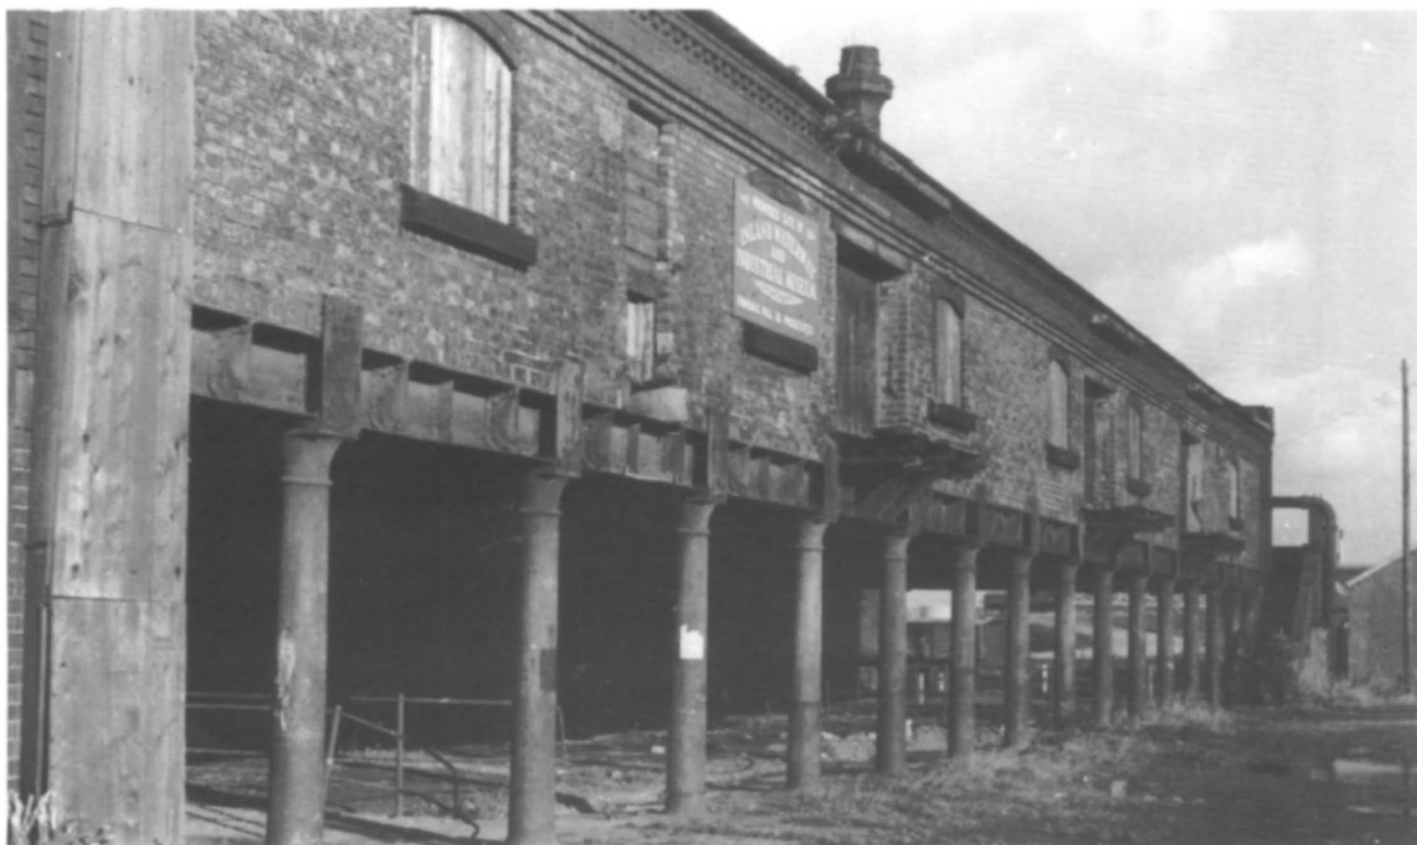
**Fig 121** Island Warehouse, Ellesmere Port: in 1975 clearance was beginning and the windows were boarded; a large and attractive sign declares the future use of the building and that vandals will be prosecuted (photo: The Boat Museum Trust)

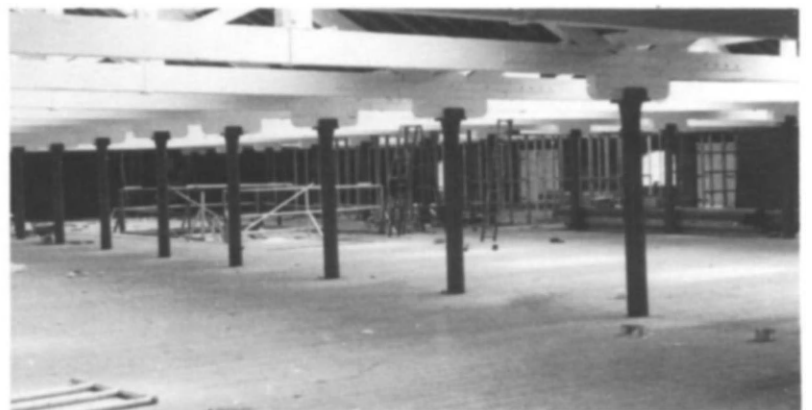
**Fig 124** Island Warehouse, Ellesmere Port: the first floor under conversion to the exhibition area in 1980; the trusses were all taken down and repaired, and rotten timber was replaced and plated at the feet of almost every truss (photo: The Boat Museum Trust)

with felt but this was not successful in protecting the feet of the trusses (when the main repairs were carried out almost all the ends of the trusses had to be replaced). The work cost very little as labour was voluntary, and materials such as concrete blocks and timber were given by the Ship Canal Company and others. It was thus the volunteers themselves who secured the building for the future by their own work.

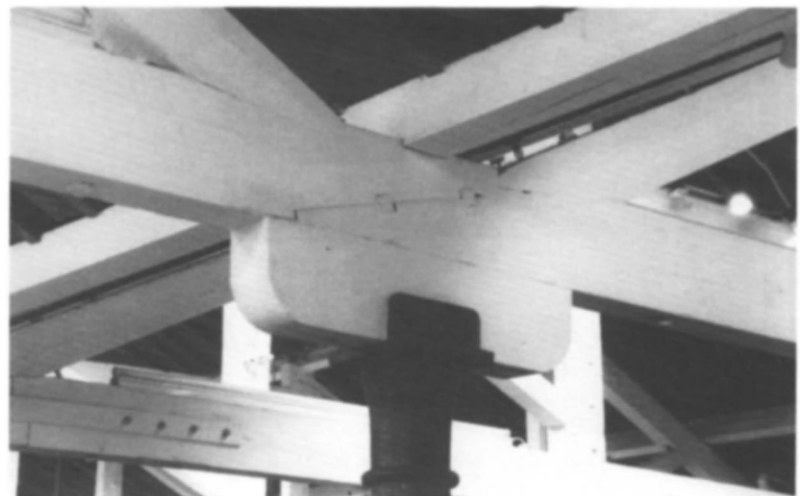
Fig 125 Island Warehouse, Ellesmere Port: one of the few original joints where the feet of the trusses remained sound

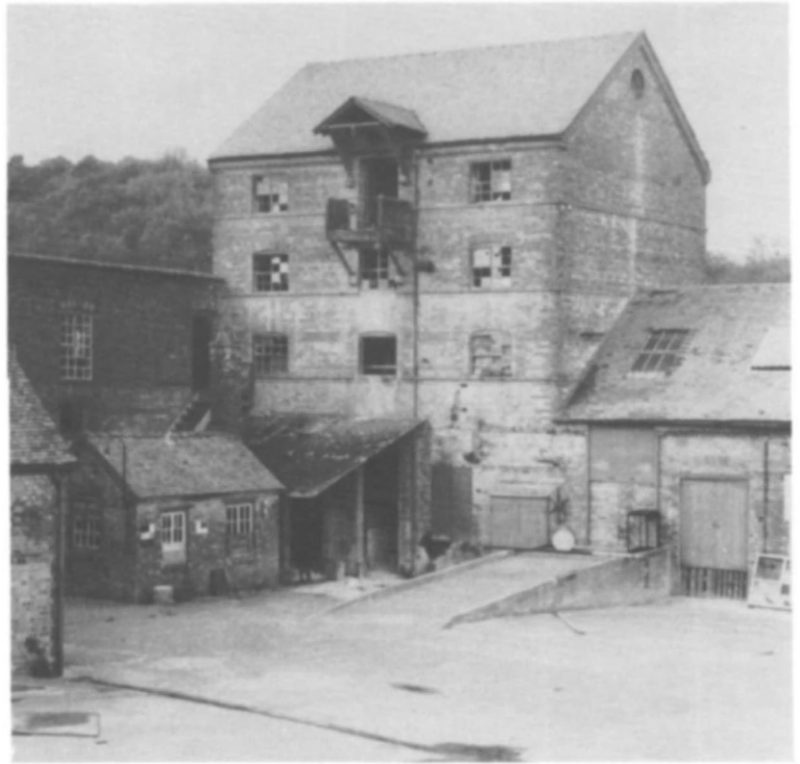
**Fig 128** Maw's Tileworks, Ironbridge: the Mill building in 1973 closely surrounded by unwanted buildings (photo: A T Herbert)

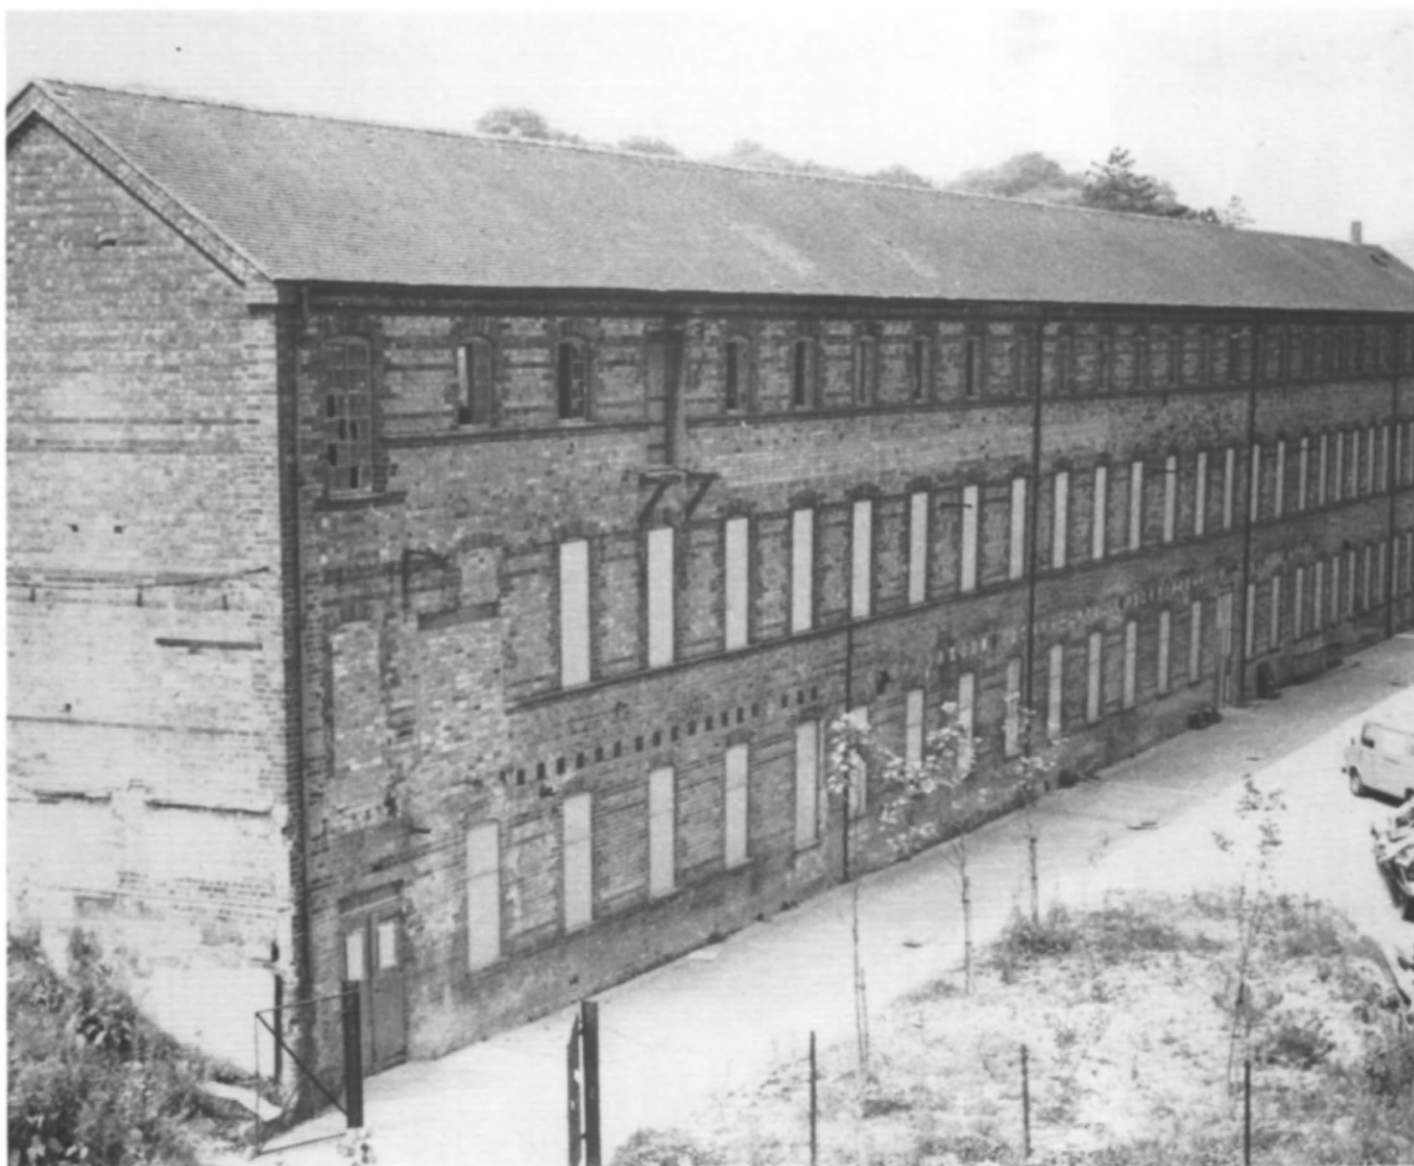
**Fig 130 Maw's Tileworks, Ironbridge: the huge 'biscuit' warehouse under emergency repair in 1979 with the windows well protected; the galvanised sheeting was never penetrated and lasted here for twelve years; in some unused parts of the complex the sheeting is still in place after 17 years (photo: A T Herbert)**

the fabric. Rotten skylights were removed and replaced by patch repairs of roof tiles. The building was secured against vandals by nailing plain galvanised iron sheeting to the outsides of all the lower windows, using galvanised clout nails at about 100mm centres. This was very strong indeed, especially as the sheeting was backed all over by small-pane wood window frames. It kept the vandals out but inevitably caused some damage to the windows. It totally blocked the ventilation and thus made it more difficult to arrest the dry rot.

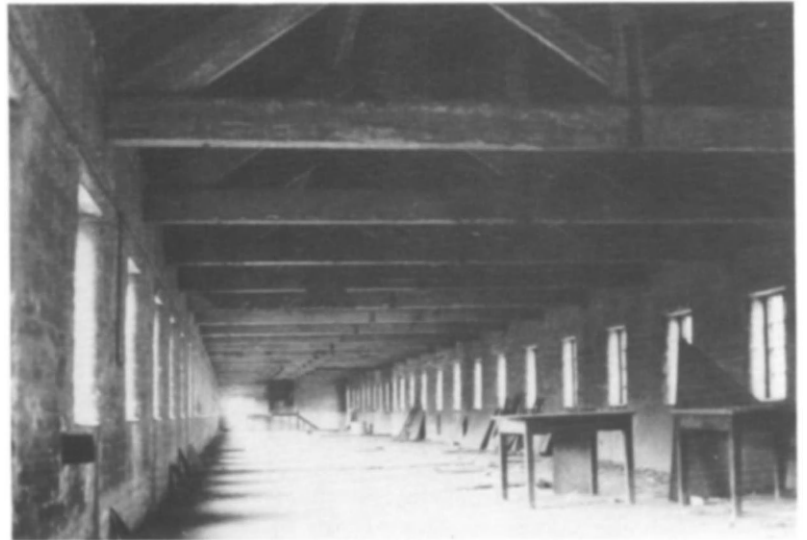
**Fig 131 Maw's Tileworks, Ironbridge: the top floor of the 'biscuit' warehouse in 1973, formerly used for the mosaic department; the building was strengthened in 1982 by building crosswalls to form individual dwellings and workshops (photo: A T Herbert)**

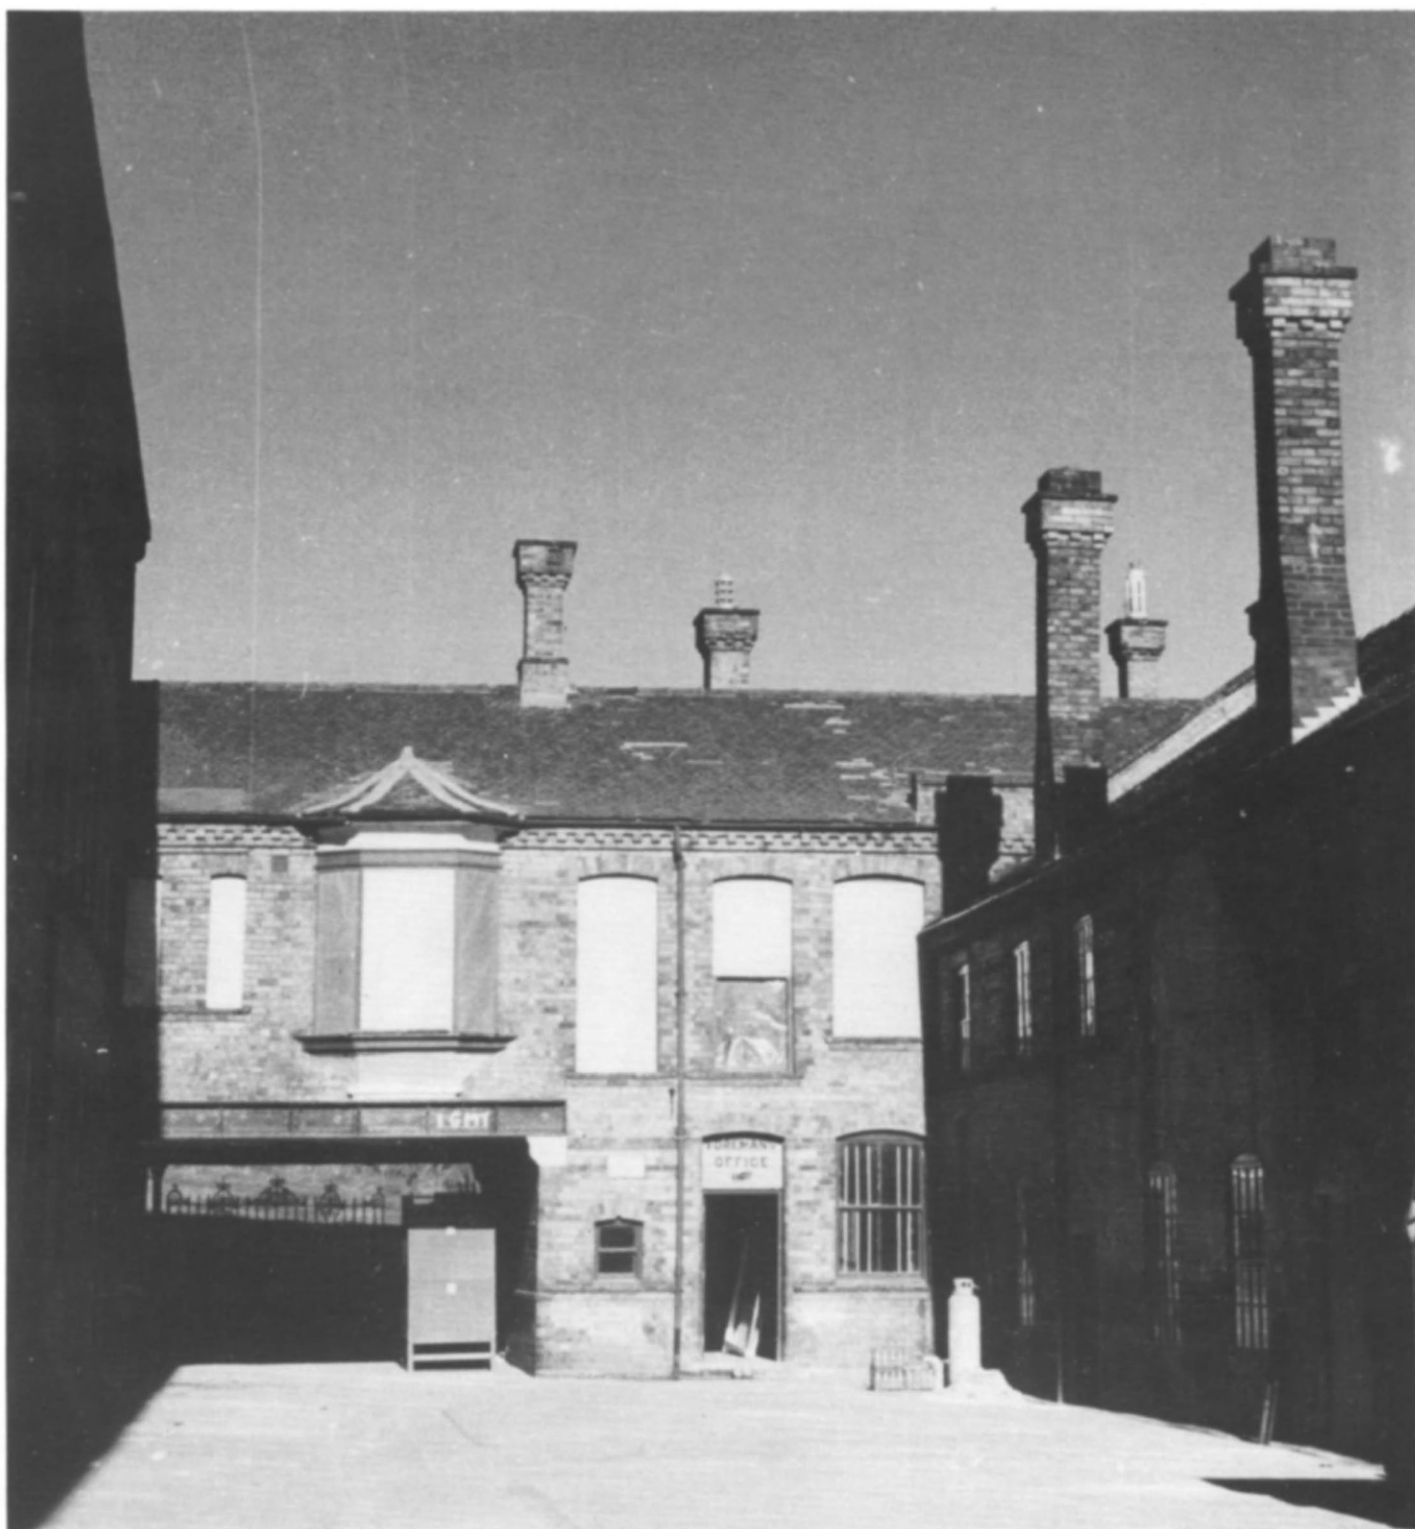
Fig 133 Maw's Tileworks, Ironbridge: the office building under emergency repair (photo: A T Herbert)

The third stage of emergency repairs in the early 1980s included permanent work to the office building. The timberwork of the bay windows was completely renewed; the roof and bell tower were repaired; the original main entrance and iron gates leading into the courtyard were repaired and painted; the windows were repaired and glazed, thus letting light into the interior. This work has helped to give the whole group a more promising appearance and highlighted

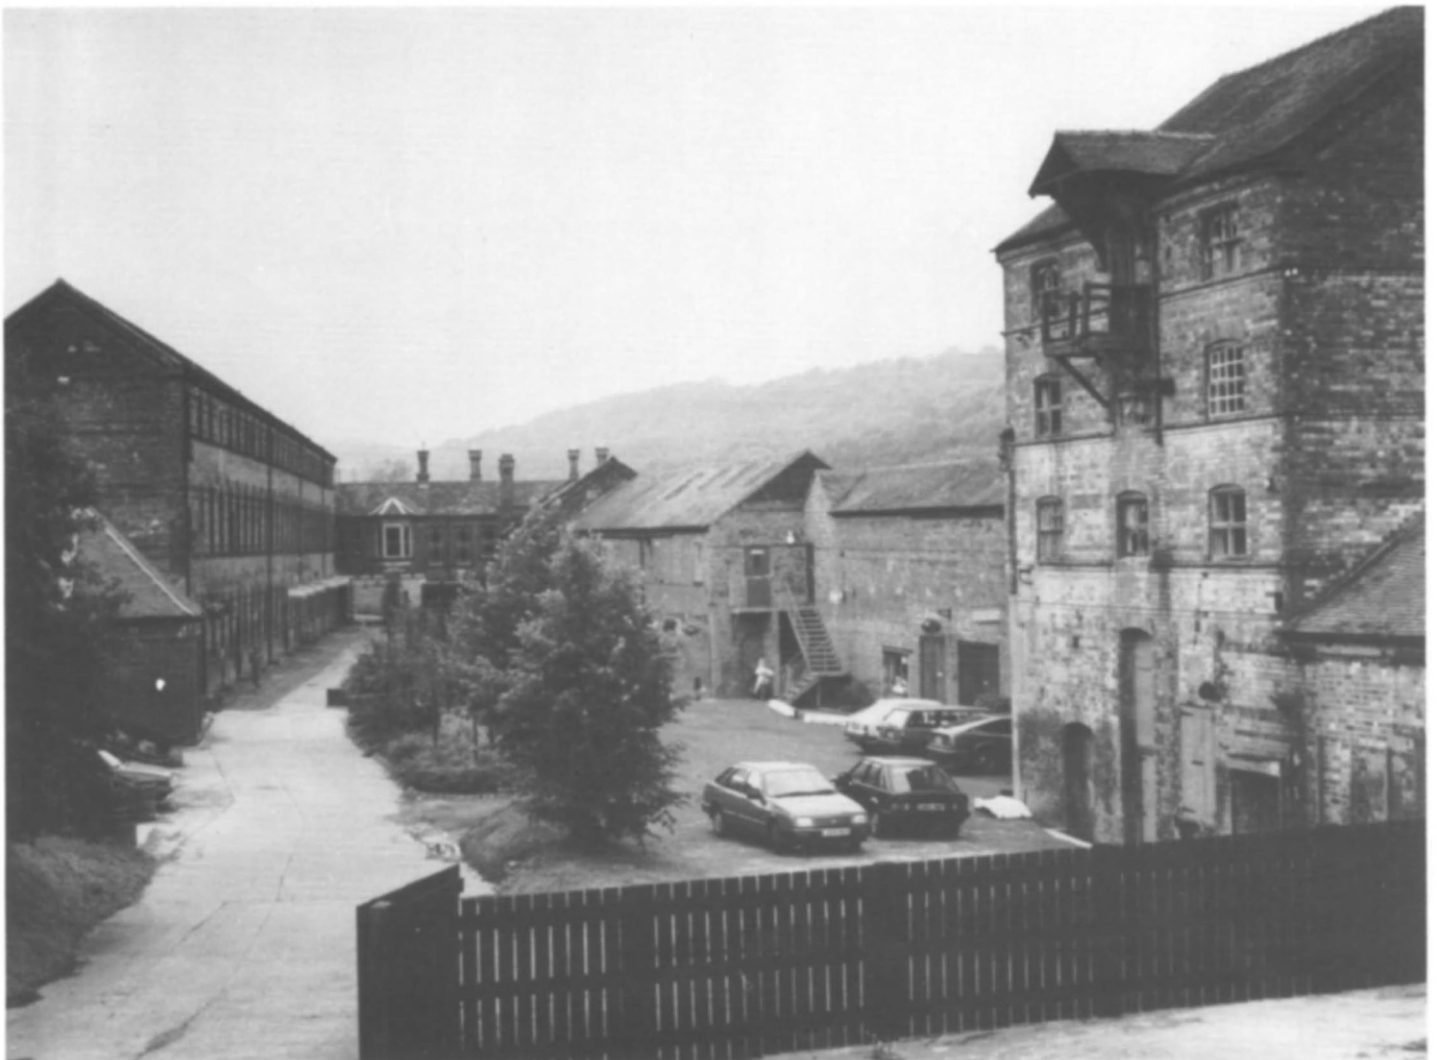
**Fig 134** Maw's Tileworks, Ironbridge: the courtyard in 1987; the 'biscuit' warehouse on the left was in full use as workshops with dwellings above; the office building at the end had received permanent repairs to the outside only; the mill building on the right was deteriorating and at risk

vulnerable. The original galvanised sheets are still effective in the lower windows but the polythene protection to the upper windows has become degraded and torn and now admits rain and birds. The pointing has been washed out of the large buttresses on the lower side and the sloping surfaces support a vigorous growth of vegetation. This is a difficult building with very low beam heights, but it makes an immense architectural contribution to the group.

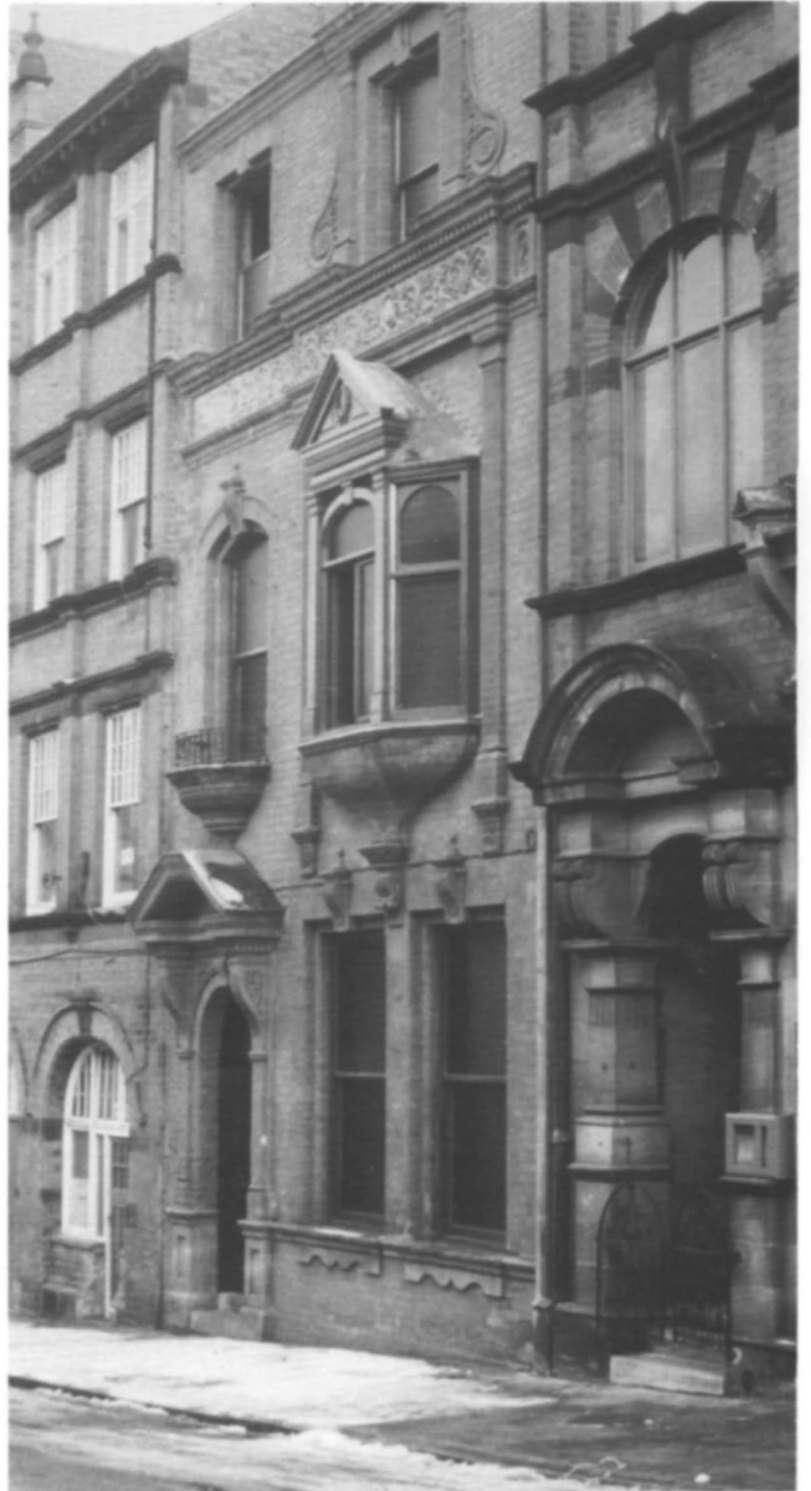
The work included eradication of dry rot, replacement of rainwater goods, and repairs to the roof and staircase. The front elevation was carefully cleaned, revealing the details of the brickwork. Decaying joinery in the bay window and the front door frame was replaced, and all the woodwork on this elevation was repainted. The windows were not boarded up, but the sashes were infilled with a matt black, vandal-resistant sheet material instead of glass.

**Fig 138** 32 Heathcoat Street, Nottingham, after emergency repair in 1978; the brickwork was conspicuously attractive, the joinery repaired and painted, and the windows infilled with sheet material instead of glass (photo: Nottingham City Council Planning Department)

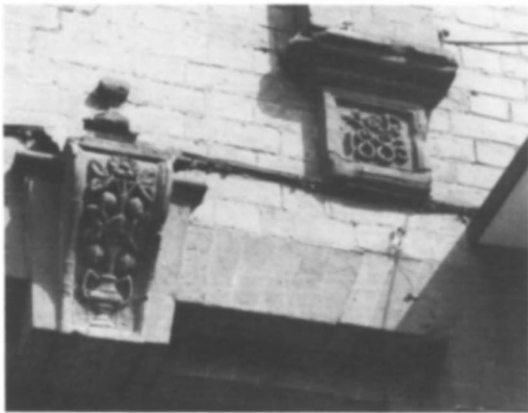
Fig 140 32 Heathcoat Street, Nottingham: a detail showing the fine quality of the brickwork in 1987
