WENCHUAN, SICHUAN PROVINCE, CHINA, EARTHQUAKE OF 2008

Lifeline Performance

Technical Council on Lifeline Earthquake Engineering
Monograph No. 39

Earthquake Investigation Committee of the
Technical Council on Lifeline Earthquake Engineering

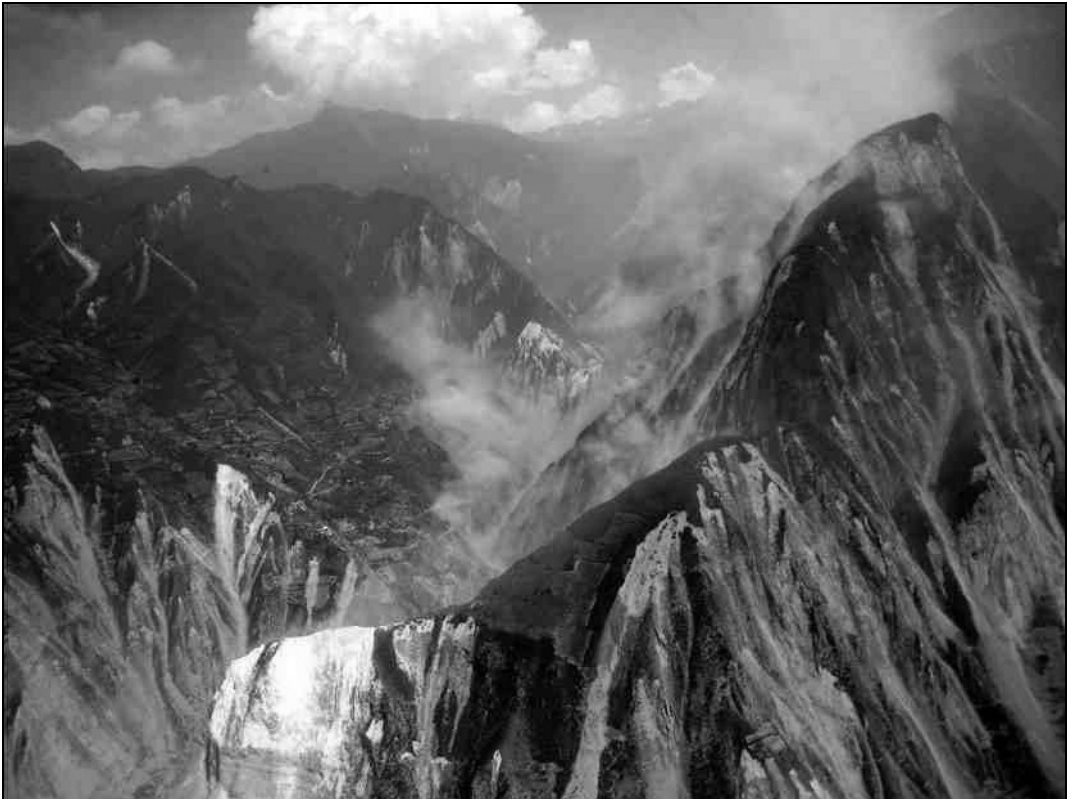
Figure 2.23 shows the dust created by the landslides within a minute or two of the earthquake.

Fig. 2.23. Landslide dust (Courtesy IEM)

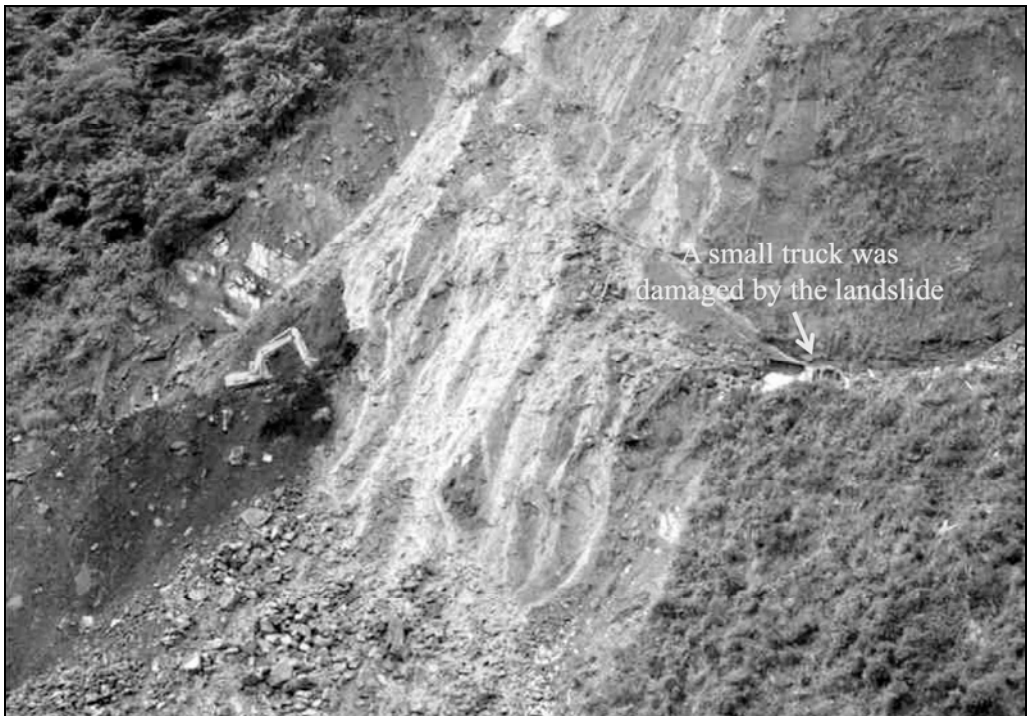
Figure 2.24 shows a road cut into a hillside that was destroyed by a landslide. This was a common occurrence; essentially all roads leading from the Sichuan plain towards the Tibetan plateau, subjected to $PGA > 0.30$ g, were cut by such failures.

Fig. 2.24. Failed roadway due to landslide

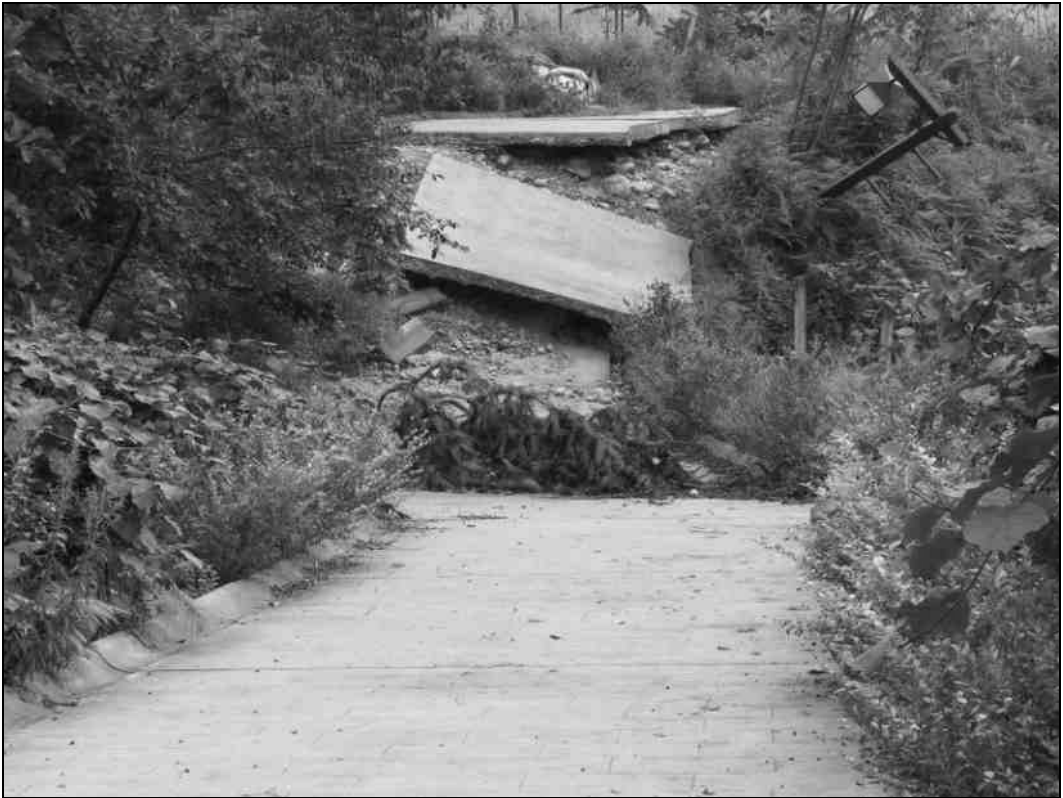
Figure 2.26 shows about 10 ft. of uplift along a concrete road.

Fig. 2.26. Surface faulting through road at Gaoyan Village

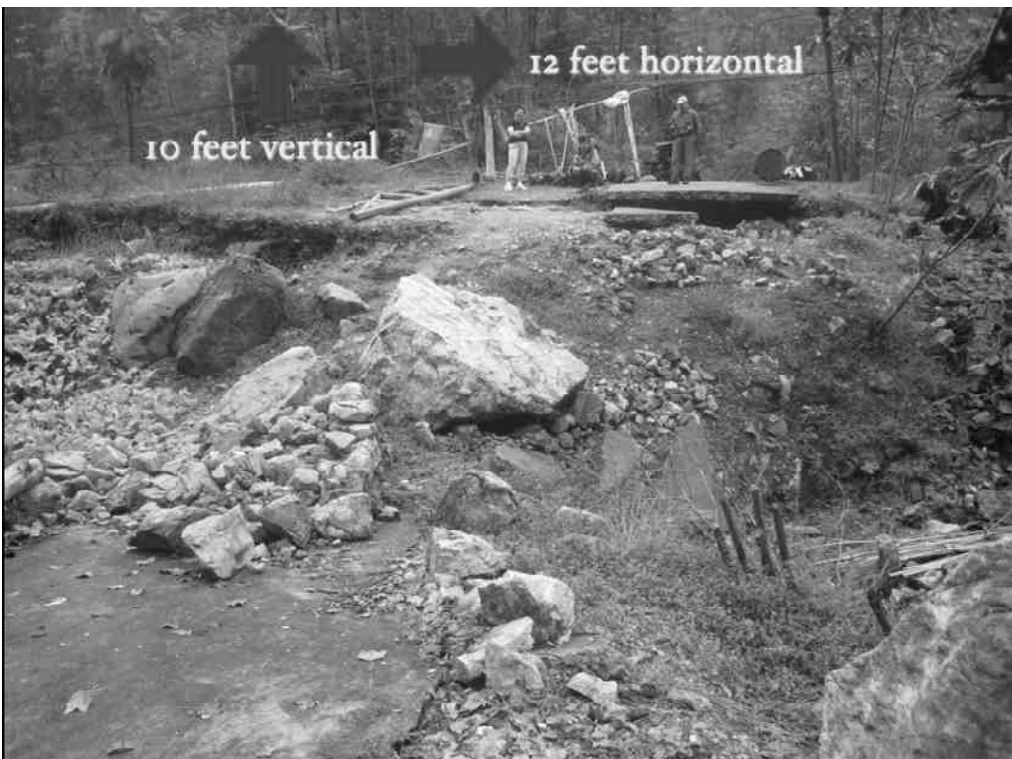
Figure 2.27 shows 10 ft. of vertical upward thrust and 12 ft. of horizontal offset right at a road in Shenxigou Village. There was evidence of 1 ft. of offset at a few other locations within about 300 ft. of this location. Note that the offsets shown were observed in late October 2008; other investigators reported offset at 4.5 m vertical and 4 m horizontal at this site, but we would have to interpret those larger values as including the effects of subsidiary and secondary offsets.

Fig. 2.27. Surface faulting through road at Shenxigou Village

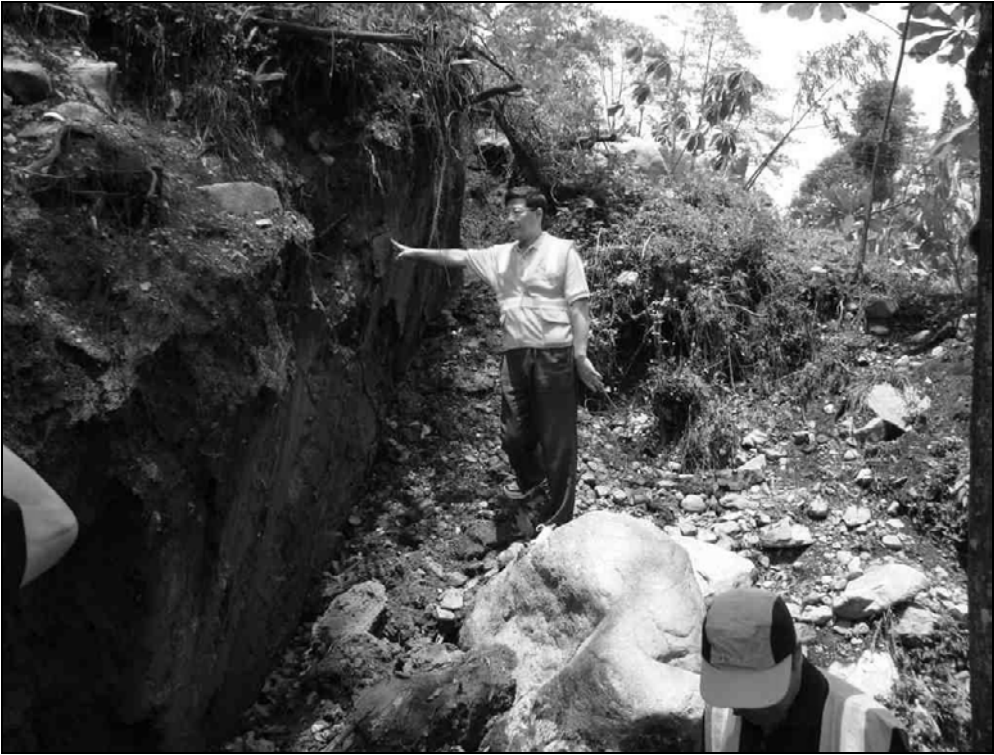
About 6 km away also in Hongkou vicinity, Prof. Manchao He lead us to a surface fault shown in Figure 2.28. This faulting had a maximum vertical uplift of about 2 m with a length of about 30 m. It went through a house that collapsed (Fig. 2.29).

Fig. 2.28 Surface fault in Hongkou, Prof. He pointing at the smooth surface resulted from the uplift.

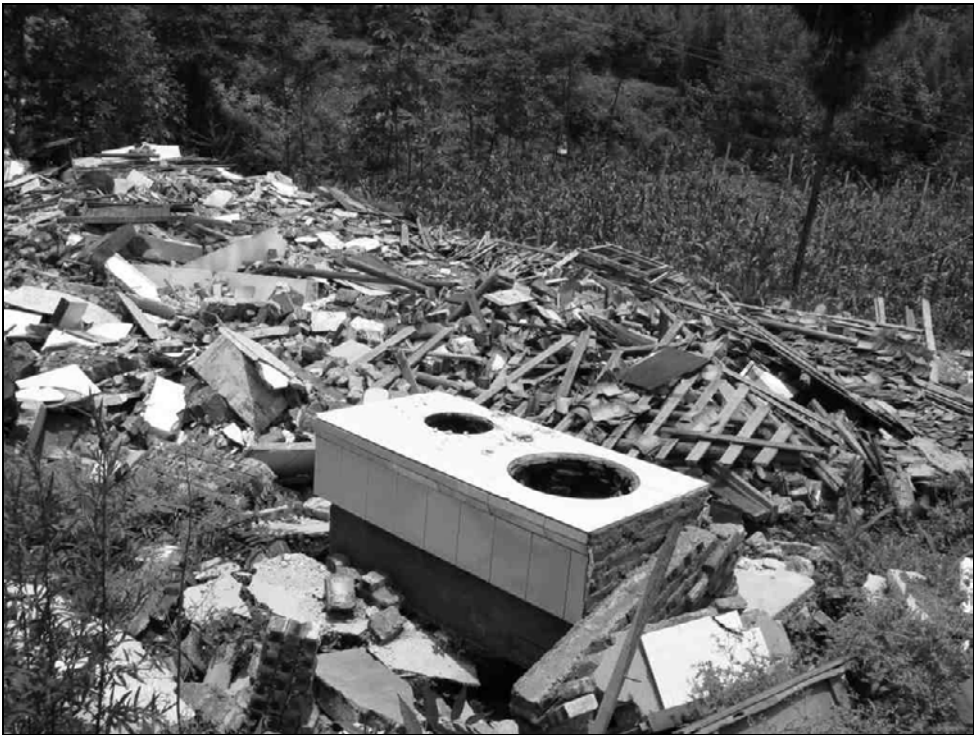
Fig. 2.29 This house was about 30 m from the surface fault show in Fig. 2.28. The stove at the back of the house was the only recognizable appliance.

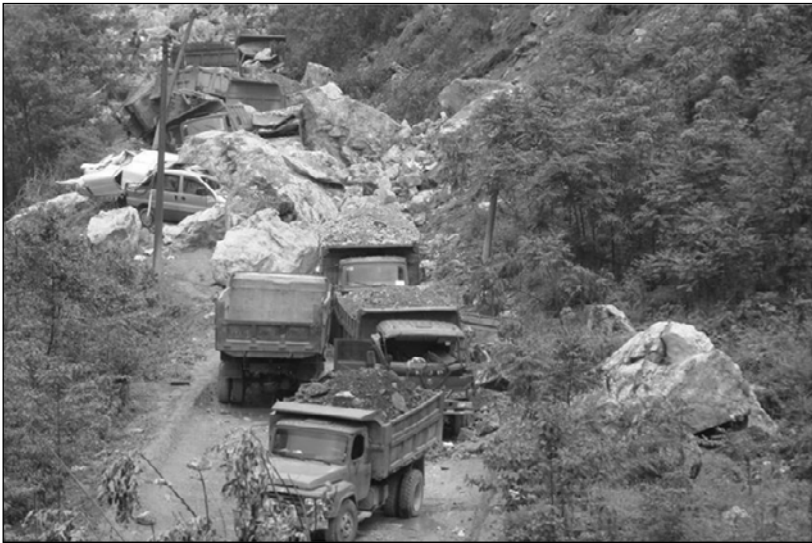
During the May 12 earthquake, thousands of large rocks that had precariously balanced on mountainsides fell onto roads killing drivers, damaging the roadbed, and closing the roads until heavy equipment could be sent to clear the site (Fig. 3.3). This occurred at hundreds of locations through the mountains. Some of the rocks weighed more than 3000 tons and were difficult to move. Fortunately, the PLA had several Russian-made MI-26 helicopters capable of a 20-ton payload and was able to bring earth moving equipment to hundreds of sites. The damaged roads prevented food and water from getting to many mountain communities. The residents of many villages had to hike (or be carried) out of the mountains to survive.

Fig. 3.3. Rock slide in Gaochuan, Anxian County

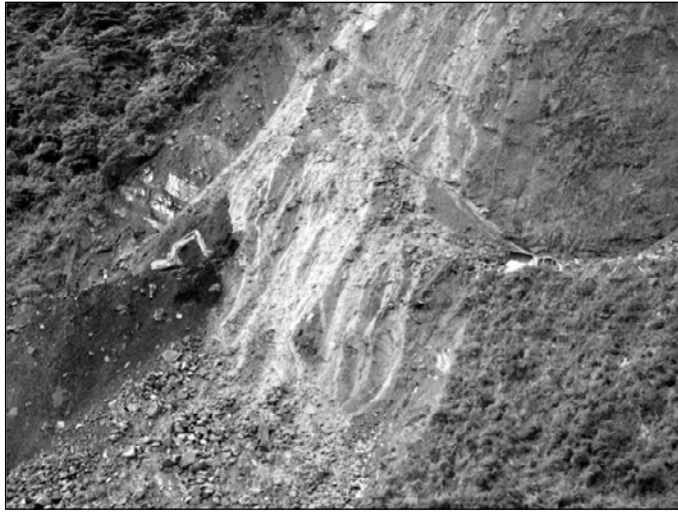
Thousands of landslides denuded mountainsides and damaged roads. Sometimes the slope above a road slide down and covered the roadway with tons of material to be cleared away (Fig. 3.4). Equally common, the slide carried the roadway downhill (Fig. 3.5). These landslides not only affected roads, bridges were also vulnerable (Fig. 3.6).

Fig. 3.4. Landslides blocked many roads

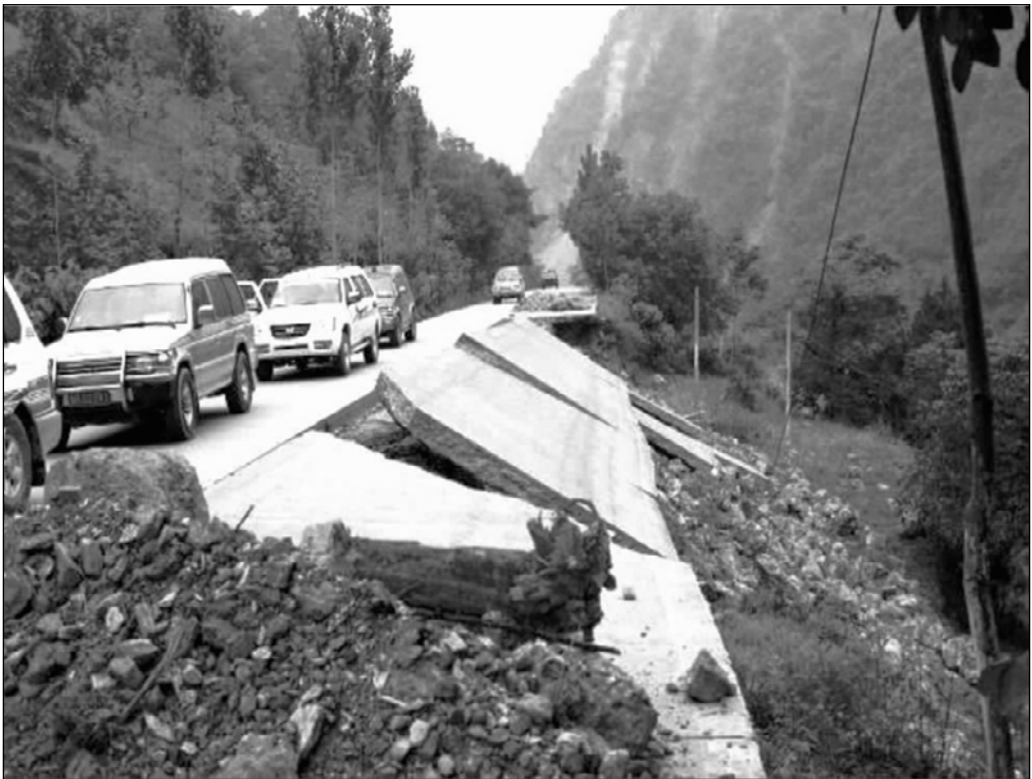
Fig. 3.5. A landslide carries a roadbed downhill near Pengzhou

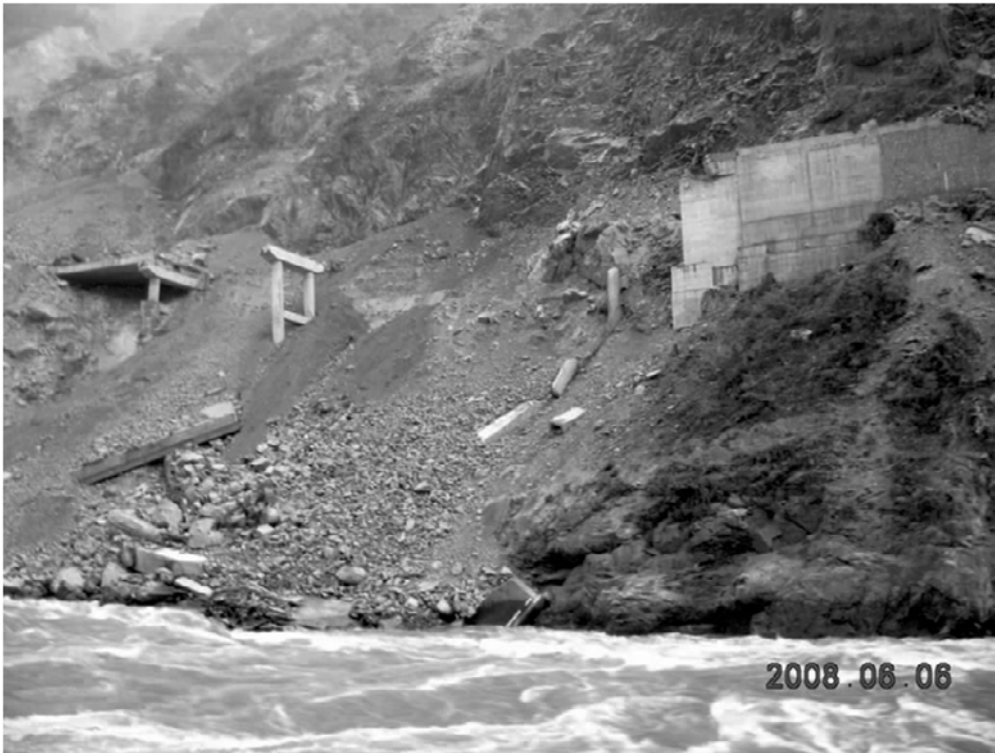
Fig. 3.6. Landslide destroyed a bridge on Duwen Road

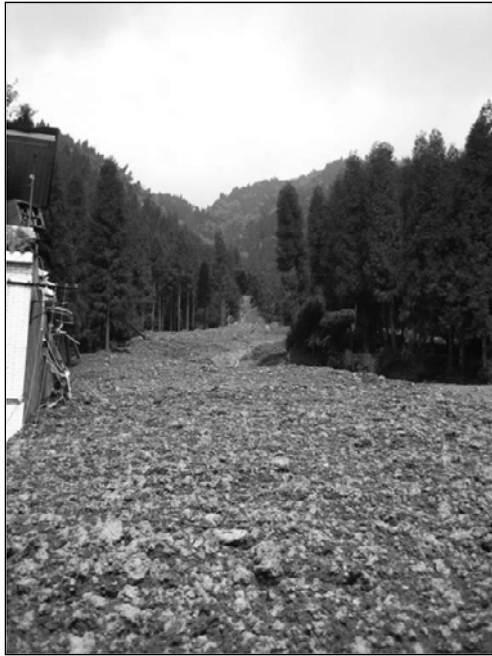
Mud flows occurred during the earthquake and in the following weeks and months. As a result, many quake lakes were formed by mud-flow created dams during and after the earthquake. Rocks, soil, and other debris loosened by the strong ground shaking during was prone to form mud flows. Heavy rainfall on the evening of August 7, 2008, caused a mud flow in Pengzhou that lasted about 40 minutes. The mud flow had ceased by the following day, but the debris—boulders up to 1.5 m in diameter, tree trunks up to 30 cm in diameter, and a sand/silt clay matrix with a very high moisture content—was still in a very fluid state with low bearing capacity, as evidenced by individuals sinking to their knees as they traversed it. This mud flow covered the roads and prevented transportation into and out of the area (Fig. 3.7 and 3.8).

Fig. 3.7. Mud flow in Pengzhou

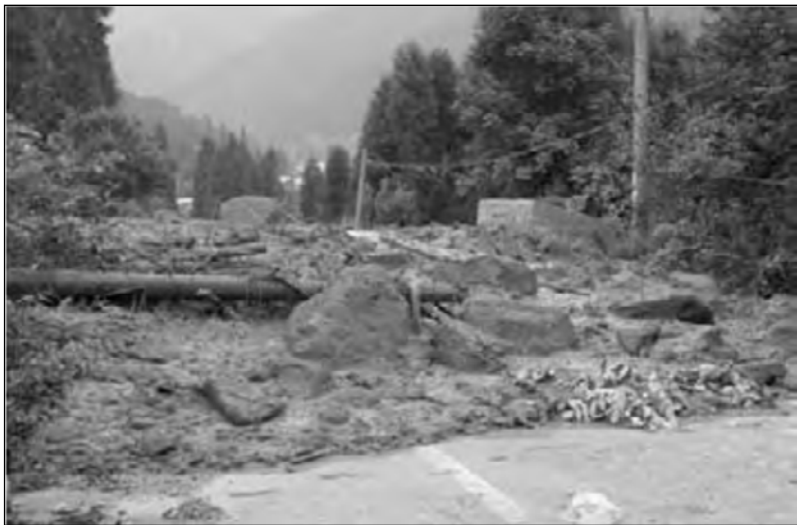
Fig. 3.8. Mud flows covered several roads

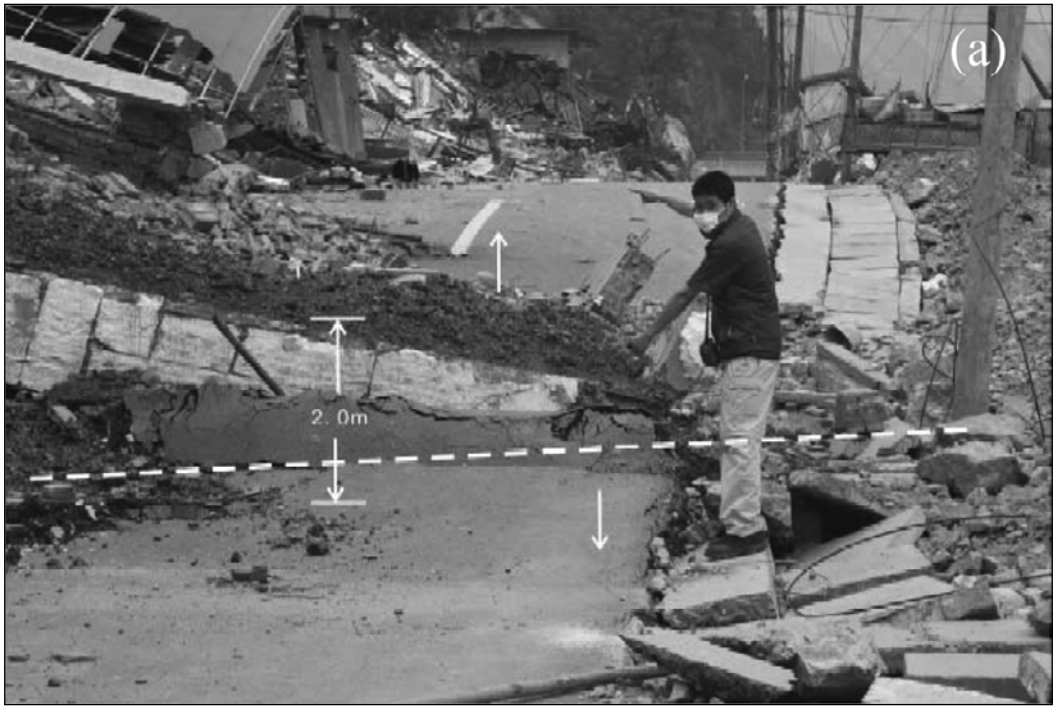
The observed surface rupture along the Yingxiu-Beichuan segment was about 210 km, and the vertical offset varied from about 1.0 to 2.0 m near its southern end to 5.0 m in its center (south of Beichuan) to 1.0 to 2.0 m near its northern end. Figure 3.10 shows an example from Yingxiu Town near the southern end, with a vertical offset of about 2 m and right-lateral offset of about 0.5 m (location a in Figure 3.9). Collapsed buildings can be seen on the hanging wall in Figure 3.10. Location b in Figure 3.9 is near the segment's center. Pintong Town of Pinwu County (location c in Figure 3.9) is near the northern end of the segment. A surface rupture of about 70 km was also observed between Wafeng Town of Dujiangyan and Hanwang Town of Mianzhu along the Dujiangyan-Jiangyu segment (location d in Fig. 3.9).

Fig. 3.9a Yingxiu Town near the southern end, with a vertical offset of about 2 m and right-lateral offset of about 0.5 m

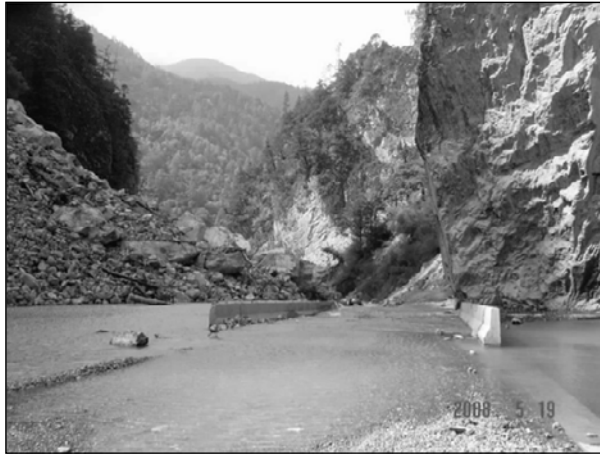
Tangjiashan Lake was formed when a landslide dammed the Jian River (Fig. 3.11). Its name comes from the nearby mountain Tangjiashan. On May 24, 2008 the water level reached a depth of 23 m (75 ft.) covering roads and washing away several bridges (Fig. 3.12). Soldiers used digging equipment, explosives, and missiles to blast channels in the dam. The flow from the resulting channel caused flooding in the evacuated town of Beichuan and overtopped several dams.

Fig. 3.12. Quake lake closed roads and damaged bridges

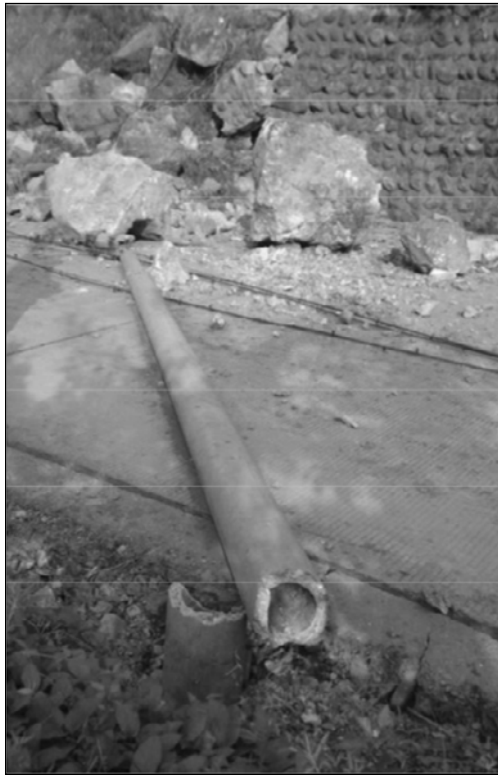
Fig. 3.13. Colocation damage, such as the retaining wall and telephone pole blocking access to the roadway, is very common after earthquakes

Colocation damage is caused by the failure of a structure or a lifeline affecting an adjacent lifeline, such as a retaining wall, utility line, or building failing closing a road (Fig. 3.13 and 3.14).

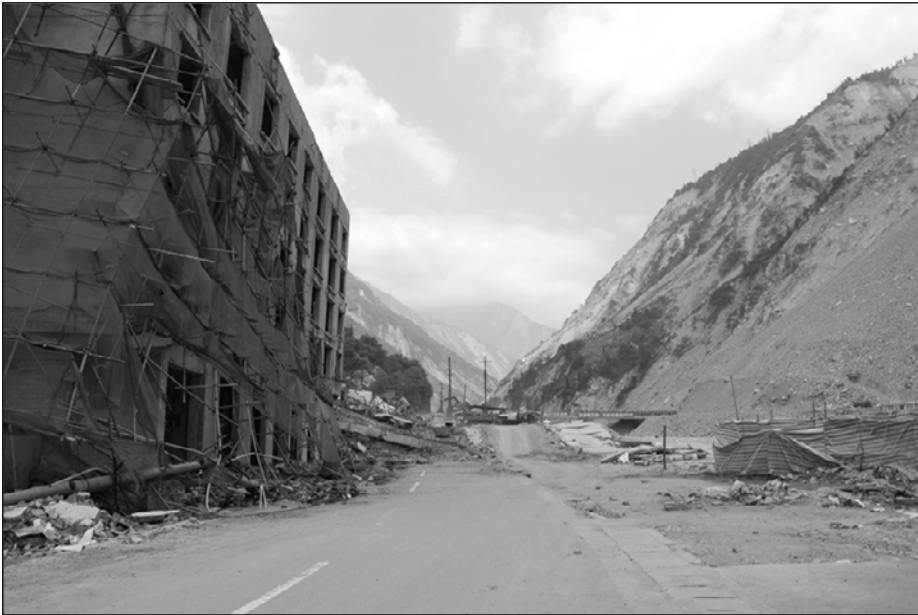
Fig. 3.14. Colocation damage due to collapses buildings blocking roads in Yingxiu

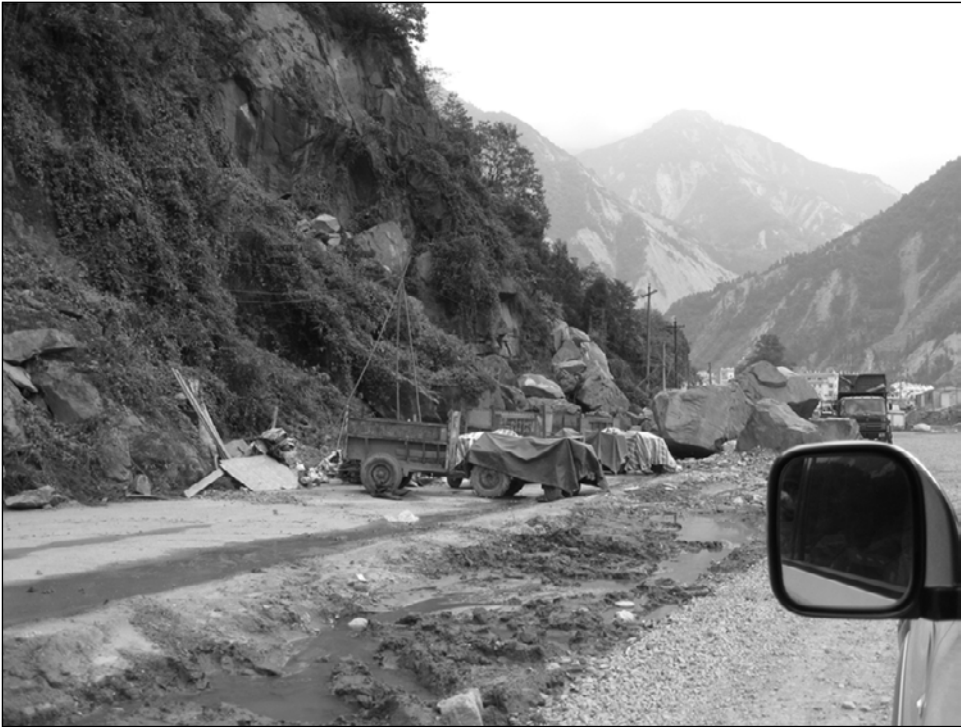
When the investigation team toured the area in July, existing Route 213 had been regraded, but it was still an unpaved one lane road that had no traffic control and was continually washing out due to heavy rains. There was still evidence of rockfalls and landslides everywhere (Fig. 3.15 and 3.16). As we drove into Yingxiu Village, there was so much rubble from damaged buildings that it felt like driving through a huge maze. Many of the bridges had been damaged, but the road remained opened because either the ground was graded alongside of the bridge or the bridge was held up by shoring.

Fig. 3.15. Fallen rocks on Route 213 after the May 12 earthquake

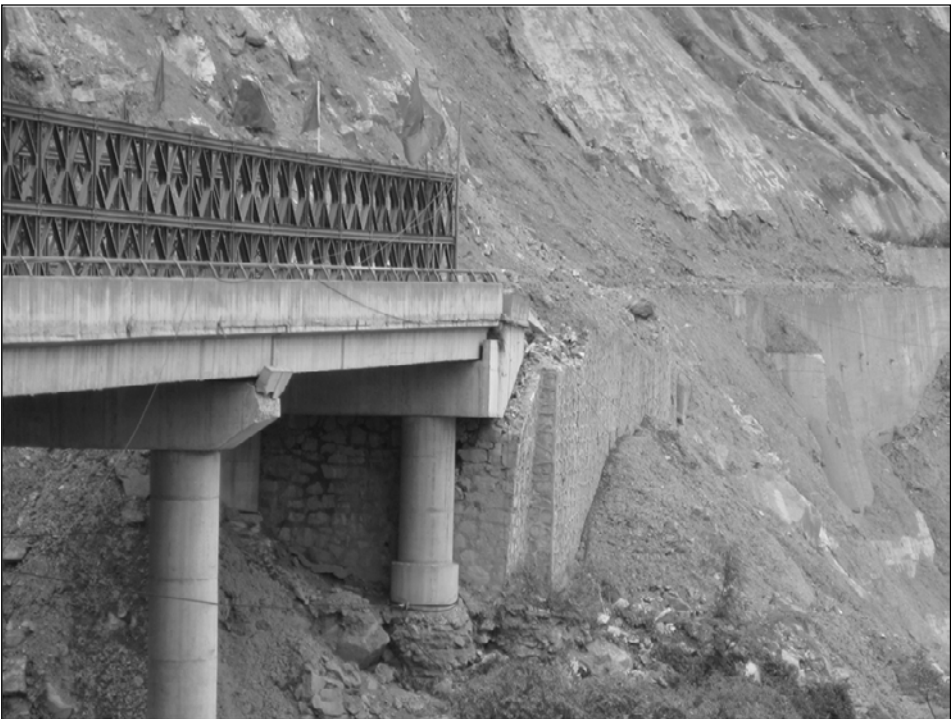
Fig. 3.16. Landslide and ground shaking damage at Zhonghi Bridge near Yingxiu

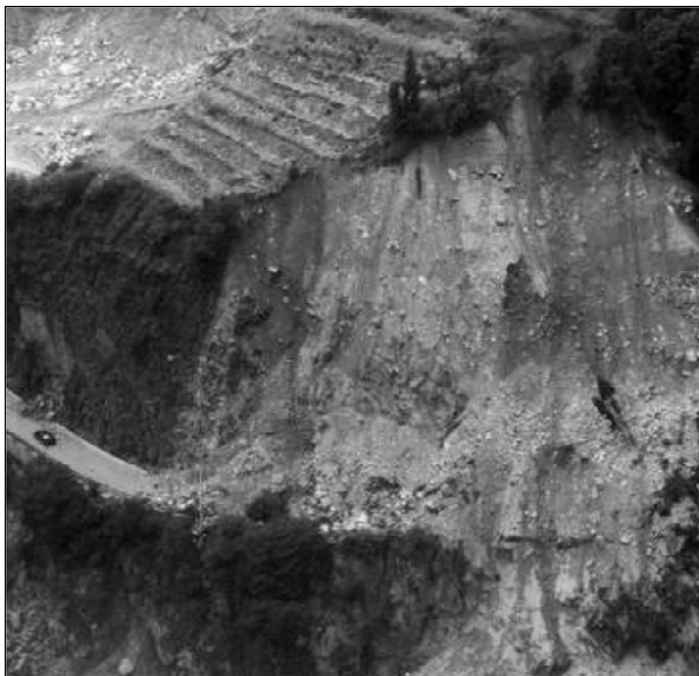
In the 20-km-long highway from Yingxiu to Wenchuan, 340 landslides and rockfalls occurred, and the highway was blocked for six months (Fig. 3.17). At the time of the earthquake, traffic density was at its yearly peak due to the sightseeing traffic to and from the Jiuzhaigou Valley UNESCO World Heritage site. According to the numbers of destroyed buses and cars, it is estimated that there were more than 1,000 deaths on the road. The damage was not caused by surface faulting because the adjacent Wenchuan Maoxian fault didn't rupture to the surface during this earthquake.

Fig. 3.17. Landslide on Route 213 between Yingxiu and Wenchuan

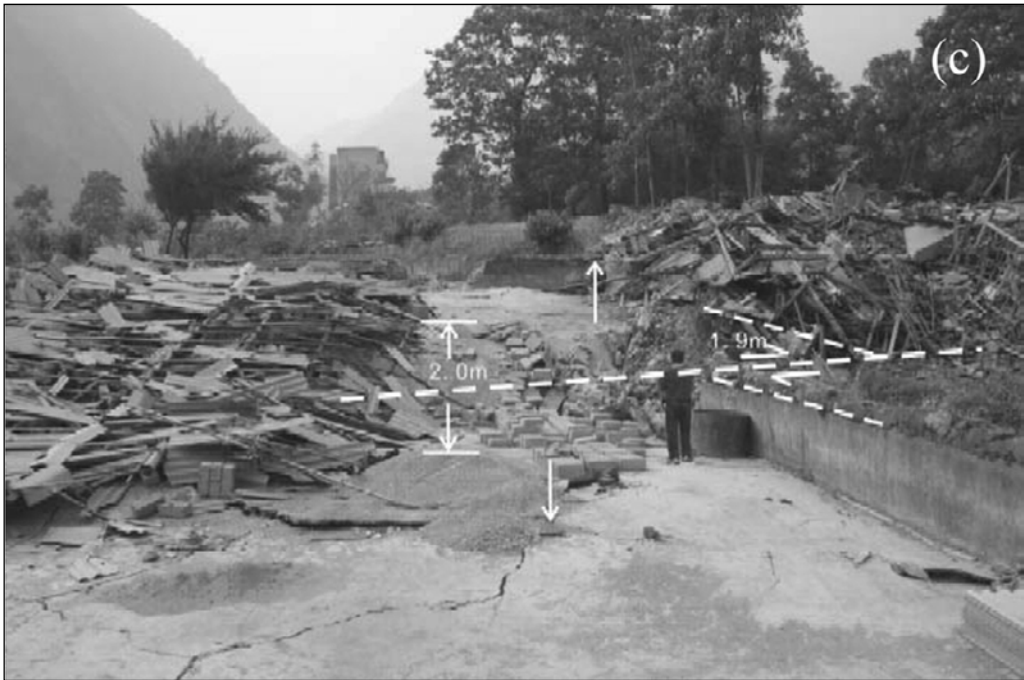
Fig. 3.18. Surface fault damaged a road between Beichuan and Nanba

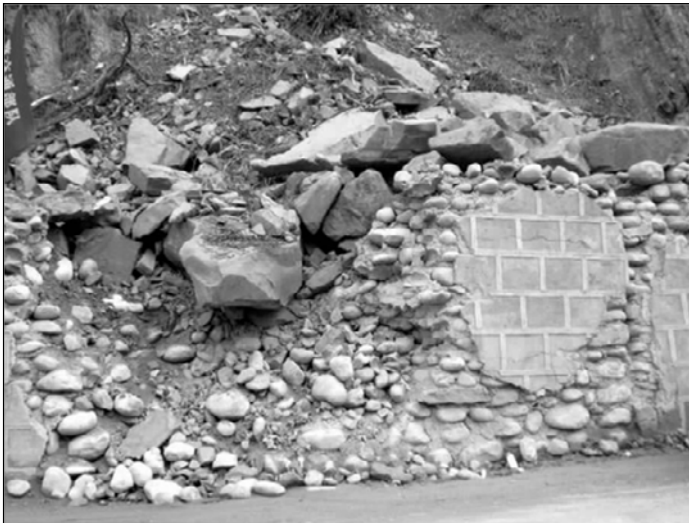
Fig. 3.19. Typical retaining wall failure along roads in Sichuan

It is difficult to retain downward sloping material excited by ground motion greater than a few tenths of a g. Moreover, most of the retaining structures were made of unreinforced concrete filled with cobbles and were barely adequate for non-seismic loads (Fig. 3.19). Surprisingly, many of these structures we saw very close to the fault were undamaged (Fig. 3.20). This illustrates the spatial variability of the ground motion rather than indicating the remarkable strength of the unreinforced stone masonry retaining walls.

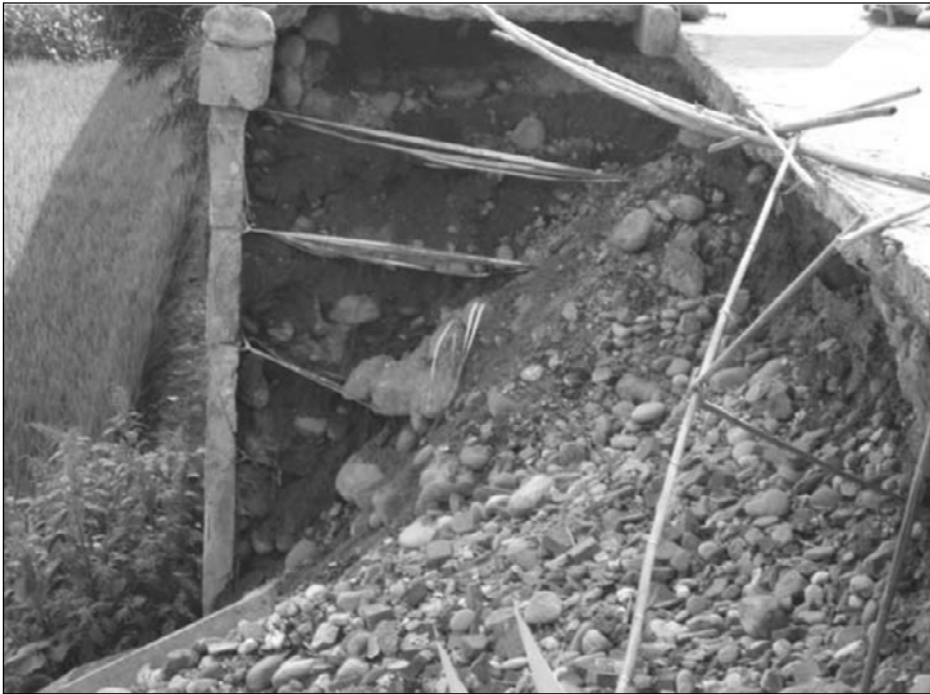
Fig. 3.21. Failure of MSE wall supporting a roadway

Mechanically stabilized earth (MSE) retaining systems were inadequately anchored into the surrounding material and failed (Fig. 3.21). We have seen good seismic performance from MSE walls during previous earthquakes when they were adequately designed.

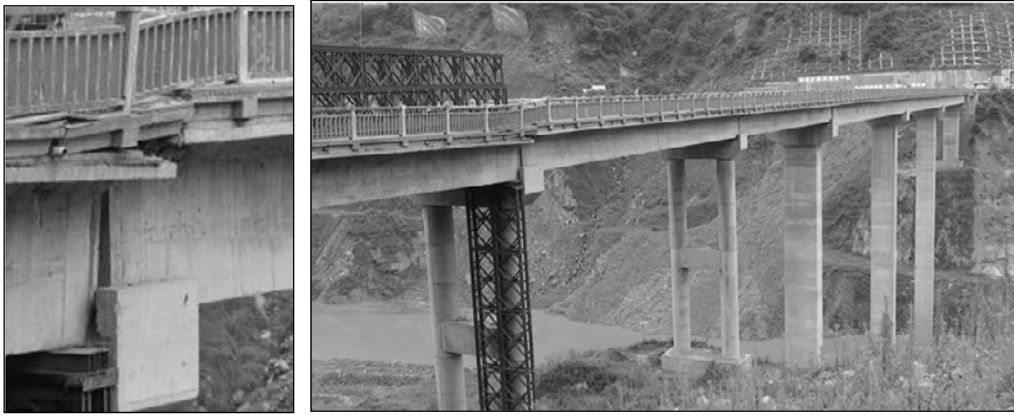
The Shoujiang Bridge is as an eight-span, 280-m-long, T-girder bridge supported on very tall two-column towers and pier walls. The tallest piers were approximately 60 m high, the approach spans were 30 m long, and the four main spans were 40 m long. Both the towers and the pierwalls were supported on pile foundations (see Fig. 3.24). The north span almost fell off the north tower and was supported by a temporary steel tower (Fig. 3.25). A Bailey bridge had been launched over the north span to carry the traffic. The north approach embankment showed evidence of ground failure, and there was a shear failure of the north abutment (Fig. 3.26). It appeared that too much movement of this very tall structure pushed the girders of the first span into the approach and almost unseated it from the tower. It is unclear if the hazard was faulting, a landslide, or ground shaking. The most serious vulnerability was the short seat that could not accommodate the resulting movement at Bent 2.

Fig. 3.25. Photos of dropped span at Bent 2 of Shoujian Bridge

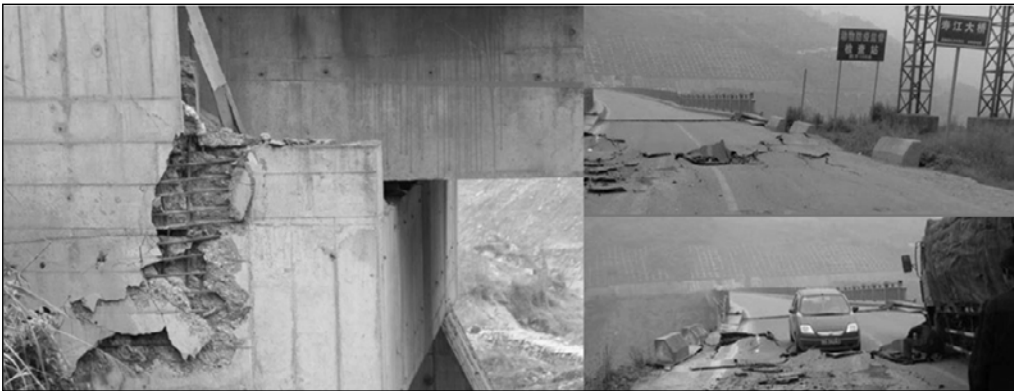
Fig. 3.26. Photos of damage at the north abutment

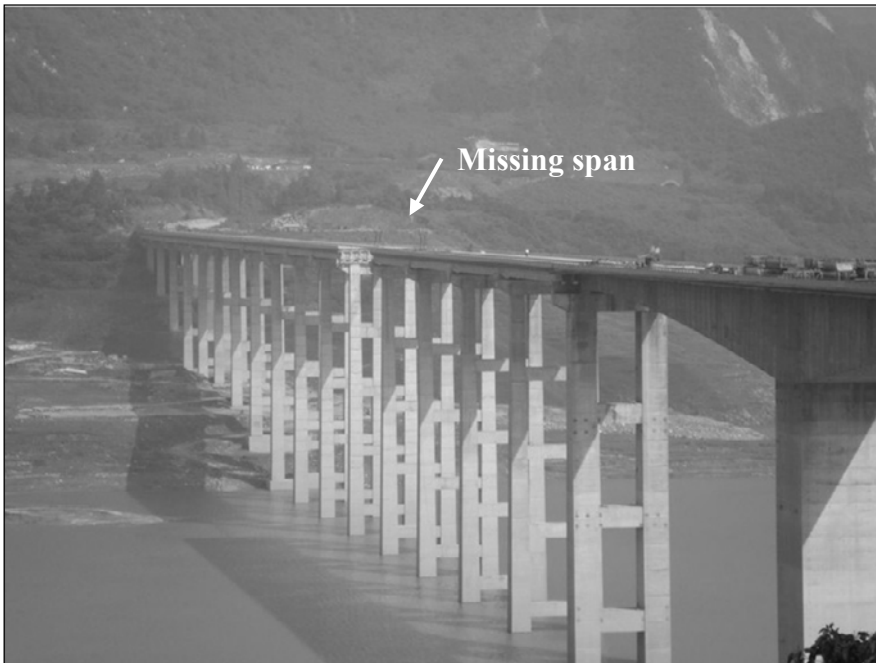
The bridge over Zipingpu reservoir had one collapsed span and many other spans with displaced girders. The construction of this bridge started in 2007, and it was scheduled to open in June 2008. The main span (right side of Fig. 3.27) is a continuous rigid frame; the remaining approach spans are a simply supported girder-type. Figures 3.28 and 3.29 provide details of the bridge with the missing span.

Fig. 3.28. Miaoziping Bridge with Missing Span (13th span), many other spans shifted (taken in July 2009)

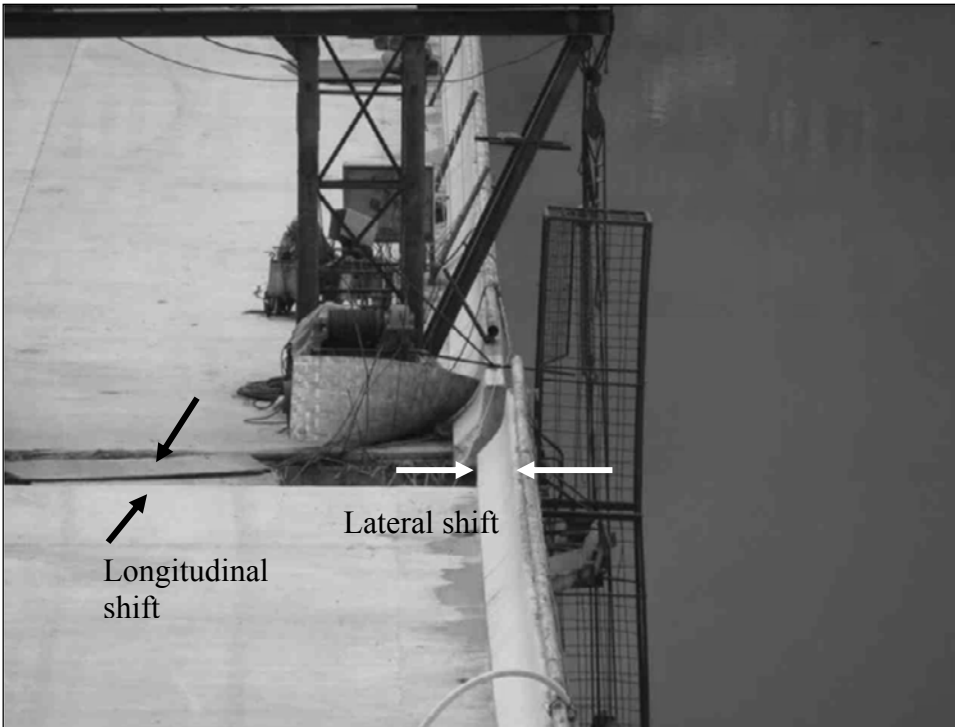
Figures 3.30 and 3.31 show some of the other spans on this bridge. A few lateral shear keys sustained larger cracks. This type of shear key design was used for many bridges in the area and was also observed in bridges in Beijing. It is apparent that it has insufficient lateral strength (or ductility) to withstand high loads from the bridge deck associated with strong inertial shaking.

Fig. 3.31. Miaoziping Bridge with a permanent displacement of about 20 cm after the earthquake

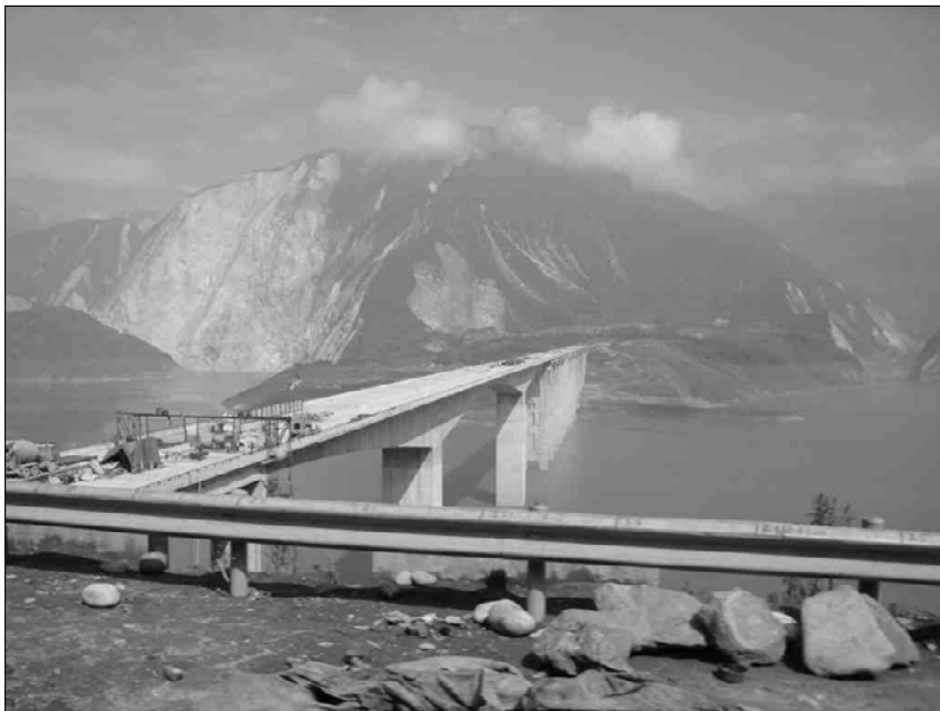
Fig. 3.32. Miaoziping Bridge, heavy equipment on the bridge making repairs

The team visited the Miaoziping Bridge a second time on October 17, 2008 (158 days post-earthquake). There was still considerable heavy equipment on the bridge making repairs (Fig. 3.32 and 3.33). The missing span was replaced. Note that the conduit along the side of the bridge deck carries electric power lines. Figure 3.34 provides the plan and elevation views of the bridge; note that the bridge enters tunnels at both ends.

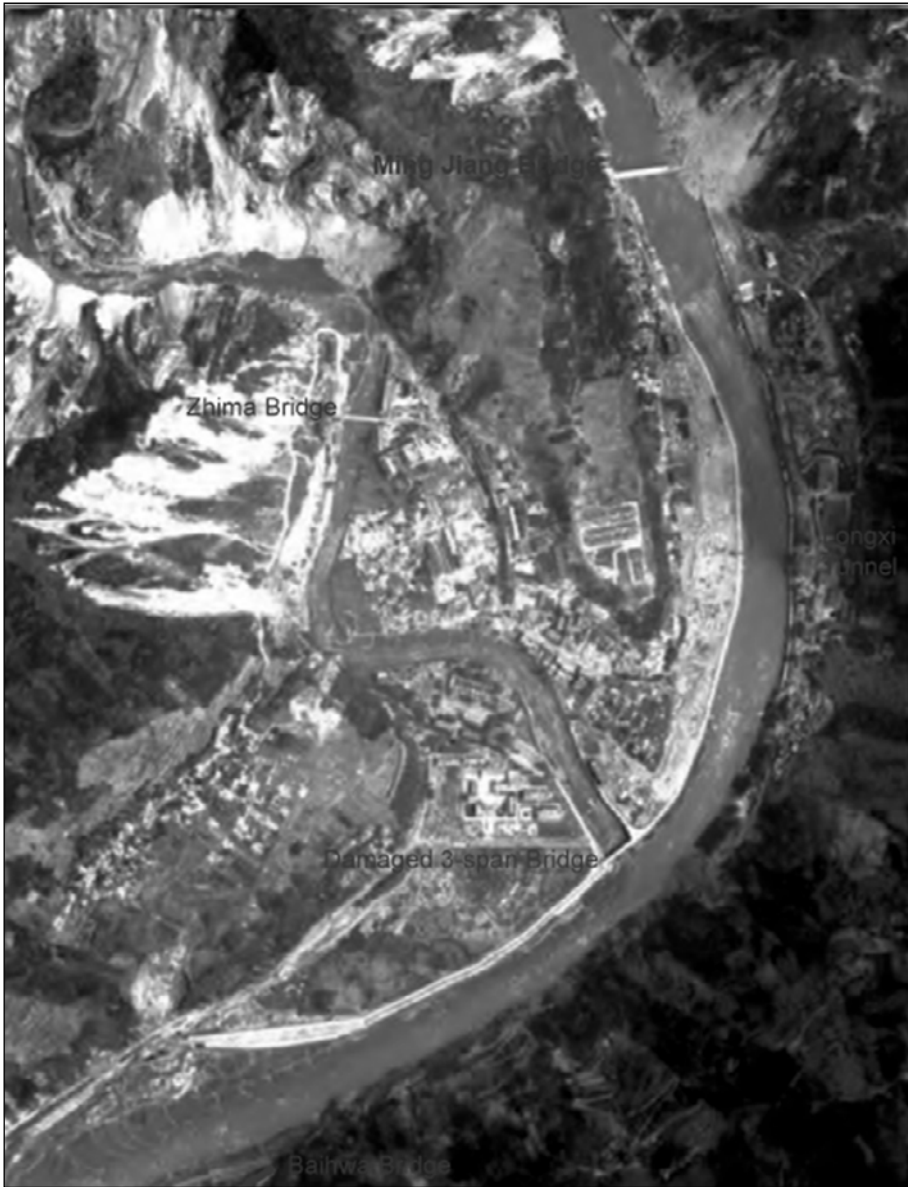
The Ming Jiang Bridge at Yingxiu is located a few hundred meters north of the Beichuan Yingxiu fault and was very close to the epicenter of this earthquake. This area suffered intense ground shaking, landslide, and surface faulting damage (Fig. 3.36).

Fig. 3.36. Aerial view of structural damage in Yingxiu Village (Deren Li, 2009)

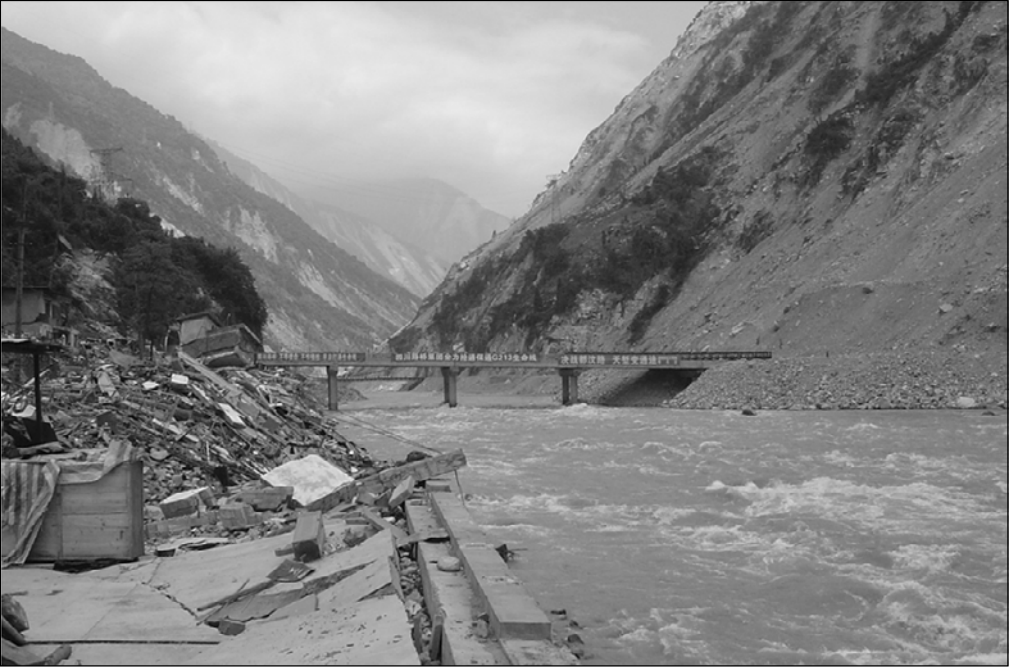
The Ming Jiang bridge was built in 2007. It is a T-girder structure with two-column bents that are supported on pile shafts and a span arrangement of 4-25m + 1-27m (Fig. 3.37). The Sichuan Province government built a Bailey bridge to carry vehicles over the its east span, which was damaged by a landslide. Several other structures in the vicinity were damaged, including an elevated viaduct, the Longxi Tunnel, and a levee, along with most of the village.

Fig. 3.37. Landslides, surface faulting, damaged Ming Jiang Bridge, and other structural damage in Yingxiu Village

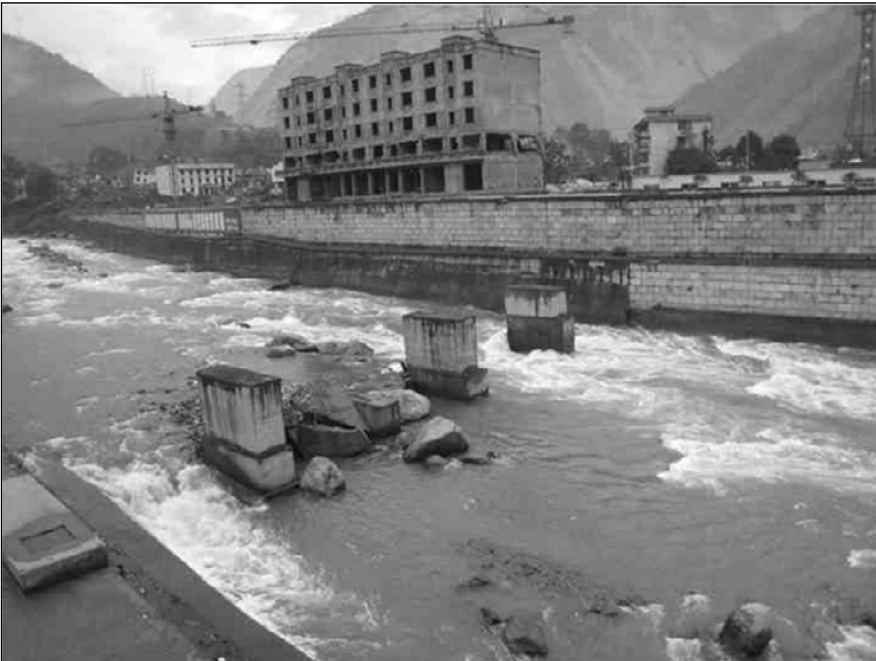
Figure 3.38 shows the remnant piers of a collapsed four-span bridge in Yingxiu. A nearby three-span bridge remained in service, despite moderate spalling damage at the shear keys, damaged bearings atop the piers, and moderate approach settlement damage at the abutments (Fig. 3.39 and 3.41). A newly built temporary water pipeline as well as new fiber optic cable and low-voltage power cable were supported on the bridge.

Fig. 3.38. Collapsed four-span bridge at Yingxiu

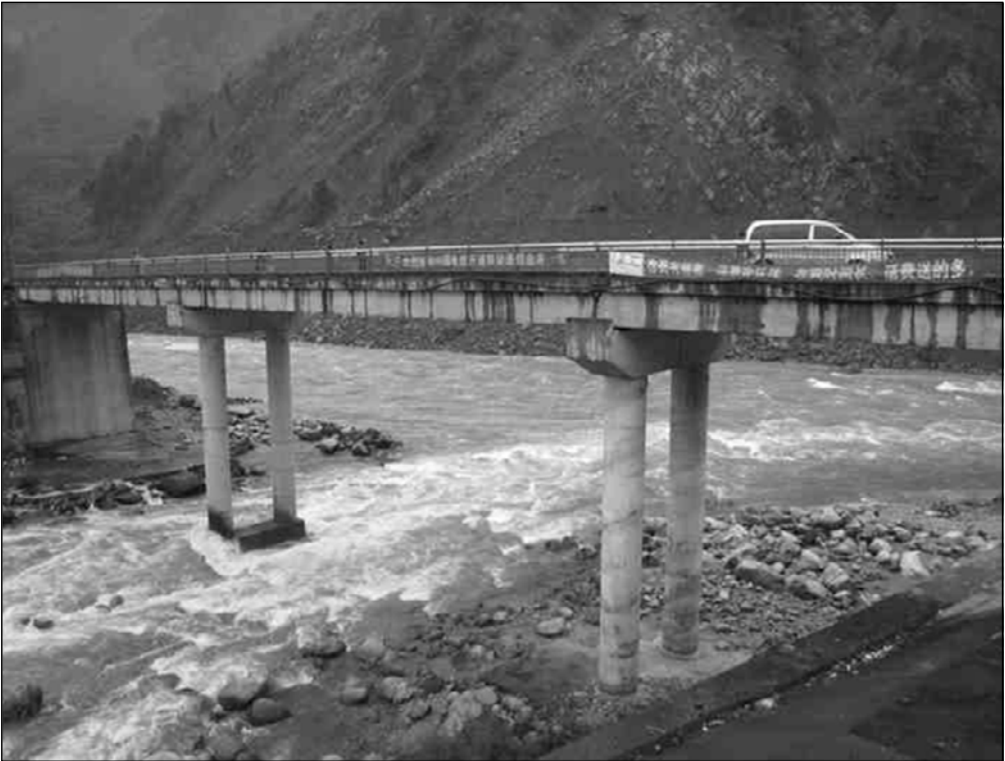
Fig. 3.39. Damaged but in-service three-span bridge at Yingxiu
