WENCHUAN, SICHUAN PROVINCE, CHINA, EARTHQUAKE OF 2008

Lifeline Performance

Technical Council on Lifeline Earthquake Engineering
Monograph No. 39

Earthquake Investigation Committee of the
Technical Council on Lifeline Earthquake Engineering

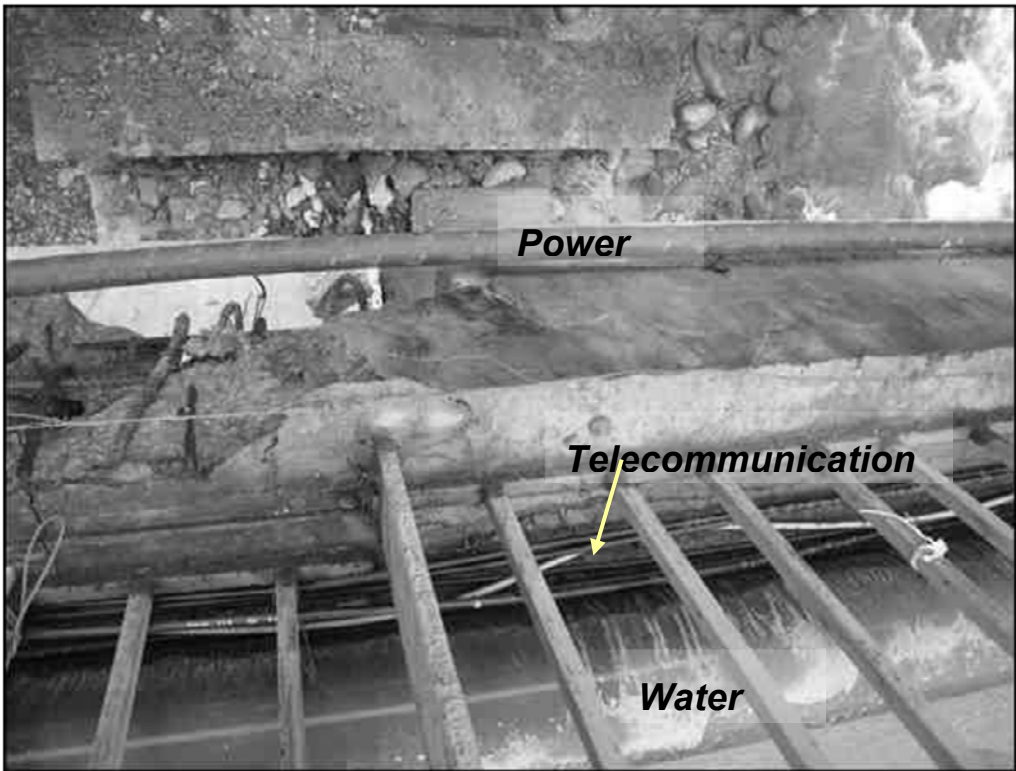
Fig. 3.40. Spalling on this slightly damaged three-span bridge in Yingxiu

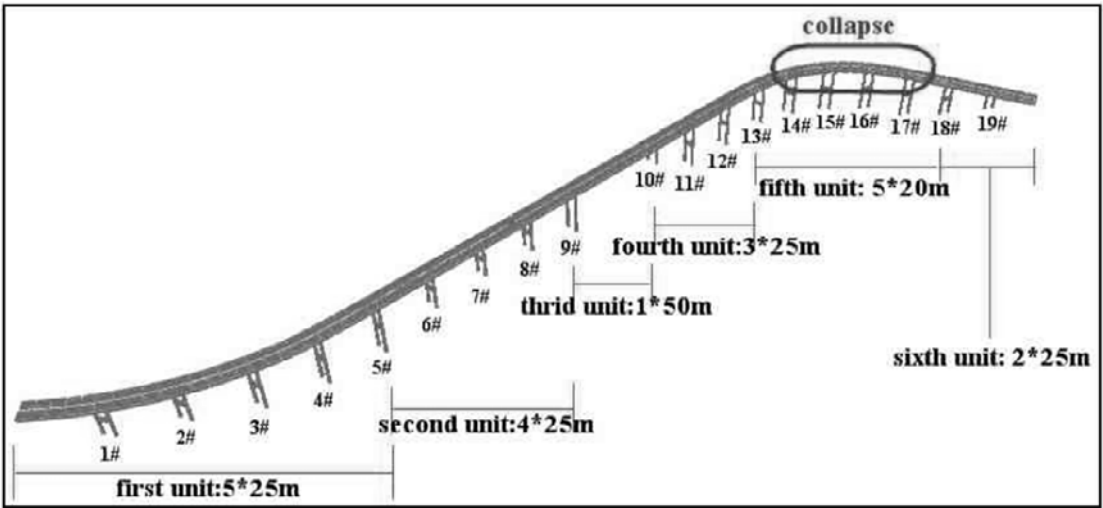
As shown in Figure 3.43, the bridge is an 18-span, reinforced concrete structure with a total length of 450 m. The bridge superstructure was supported on two-column bents of varying heights as it climbs over the hilly terrain. The tallest bents have one or two struts to provide transverse restraint between the columns. The bridge has both straight and curved spans. For convenience, the bridge structure can be divided into six sections as summarized in Figure 3.43. The superstructure was a prestressed box girder with a drop-in T-girder span between Bent 9 and Bent 10. There were expansion joints at Bents 2, 6, 9, 10, and 14, and at the two-seat-type abutments. The bridge deck of the drop-in span just rested on the bent cap at its both ends.

During the earthquake, the more highly curved section of the bridge completely collapsed as illustrated in Figure 3.43. The rest of the bridge suffered varying degrees of damage, including shear cracks and failure at columns and struts, shear key failure, and bearing failure for Bents 3, 9, 15, and 18, respectively. At Bent 3, typical spalling and crack damage occurred between the strut and columns. At Bent 9 with expansion joints, the superstructure had significant transverse displacement, knocking off the shear key. At Bent 15, the bridge section was completely collapsed due likely to the shear and flexural failure of columns. At Bent 18, in addition to cracks between column and strut, significant spalling occurred underneath the bridge deck.

Fig. 3.43. Schematic view of Baihua Bridge before the earthquake

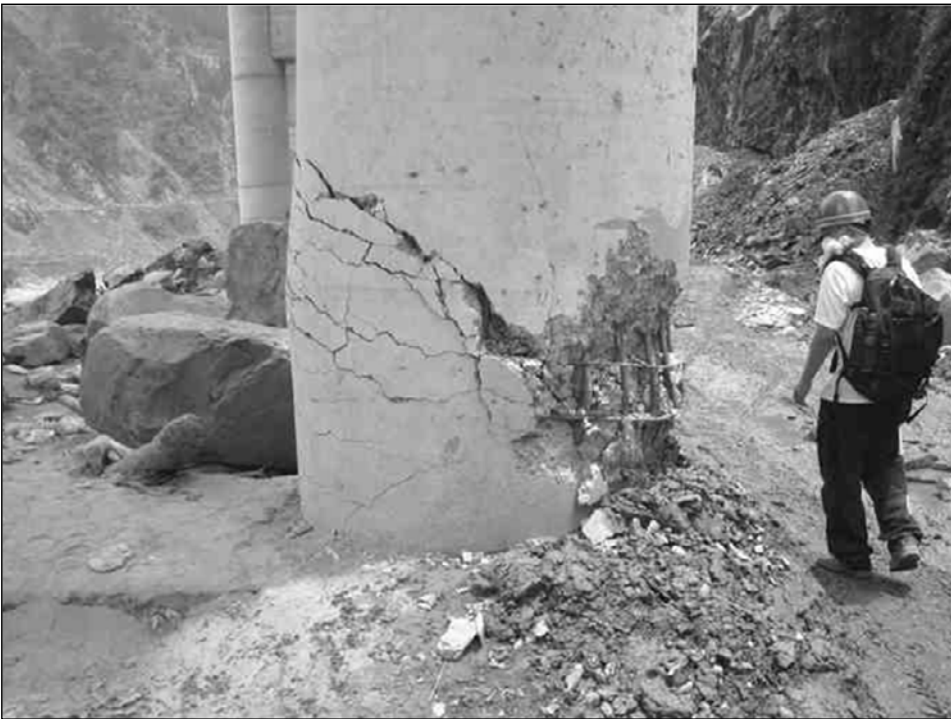
Figure 3.44 shows the failed base of a pier column, the transverse reinforcement seemed to undersized and widely spaced. The Ministry of Transportation told us that this bridge had been privately constructed to transport workers to a nearby power plant. Because the bridge collapse blocked access for vehicles, the bridge was dynamited and a road was graded alongside of it.

Fig. 3.44. Circular column with hinge (widely-spaced hoop steel) for Baihua Bridge

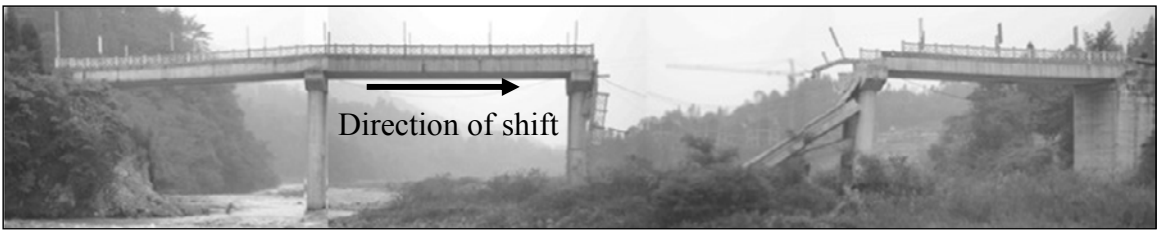
It is speculated that the failure of the Gaoyuan Bridge was caused by a large velocity pulse that pushed the left abutment towards the right and soil compressive loading that punched out the unreinforced abutment side wall (seen on left side of Figure 3.45), resulting in sliding of the unrestricted concrete span girders towards the left. Some observers suggested the damage was due to fault offset, but we did not observe this as a likely failure mode. The unreinforced masonry damaged abutment is seen on the left of the photo (Fig. 3.45). The collapsed span reflects unseating due to

Fig. 3.45. Gaoyuan Bridge near Hongkou

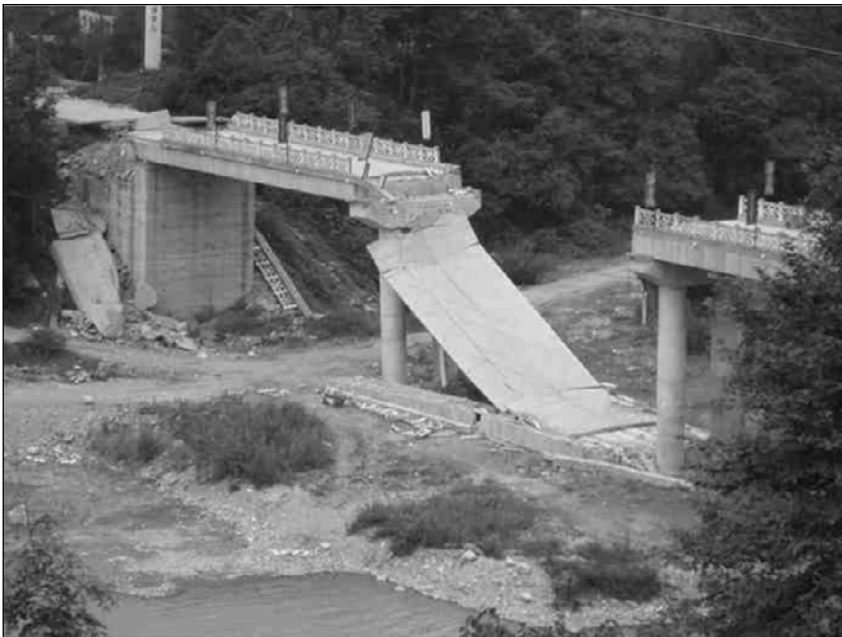
excessive motion along the long axis of the bridge. We examined this span (Fig. 3.46) and found that every one of the concrete girders sits without any form of positive attachment to the pier caps. Other spans were shifted but did not move off the pier cap to fall. The concrete girders included no steel or any other positive attachment to the abutments or the bent caps. The small sign in Figure 3.47 under the remaining supported span reads, “do not dally under this bridge.” It was sound advice, as the remaining girders would likely become unseated should a small aftershock occur. The side shear keys on this bridge showed evidence of substantial lateral shifting of the girders (Fig. 3.48), indicating that they were grossly underdesigned for the actual seismic lateral loads. Additionally, the keys were completely destroyed to the extent of having almost no residual capacity at the center pier cap (Fig. 3.48).

Fig. 3.46. Failed span of the Gaoyuan four-span bridge (Hongkou)

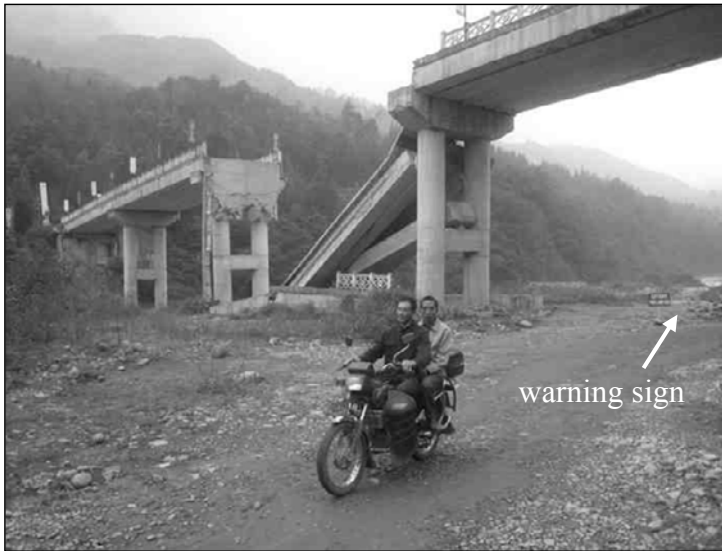
Fig. 3.47. Gaoyuan four-span bridge (Hongkou)

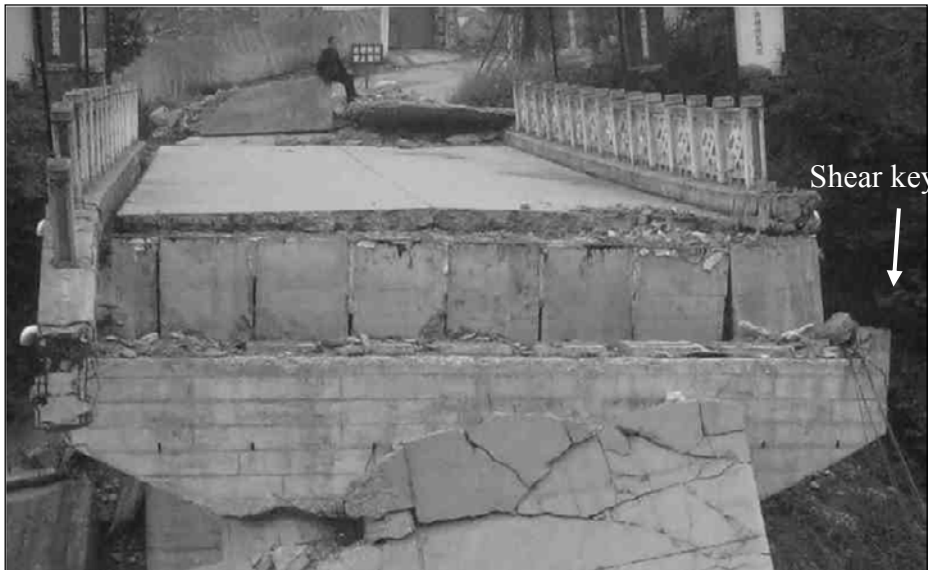
Fig. 3.48. Close up view of Gaoyuan Bridge's failed span (Hongkou)

This bridge supported a series of low-voltage distribution cables, as can be seen hanging from the right side in Figure 3.48. While we could observe no clear break in these cables, a new power line had been erected, suggesting that the old sagging lines faulted.

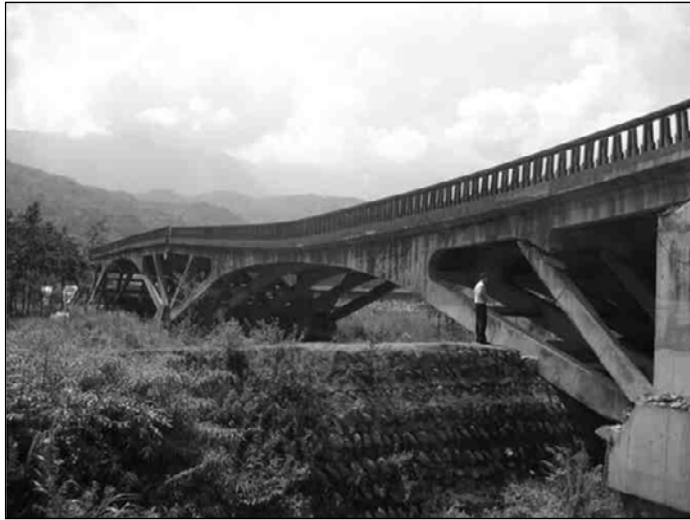
The collapsed Xiayudong Bridge was constructed in 1998 (Fig. 3.49 and 3.50). The bridge is 187 m long and 23 m wide, with four arches and a main span of 40 m. The bridge is near a fault rupture zone. Figure 3.49 shows two damaged but standing spans; Figure 3.50 shows two adjacent collapsed spans.

Fig. 3.49. Damaged Xiaoyudong Bridge (Longmenshan town and Xiaoyudong town)

The eastern most span also suffered significant damage. Shear failures were observed on the top end of the struts and on the bottom end of the arches. The shear key on the east abutment was damaged. At the top end, each strut seems to be reinforced with 15 #25 bars (Metric unit). Some were fractured.

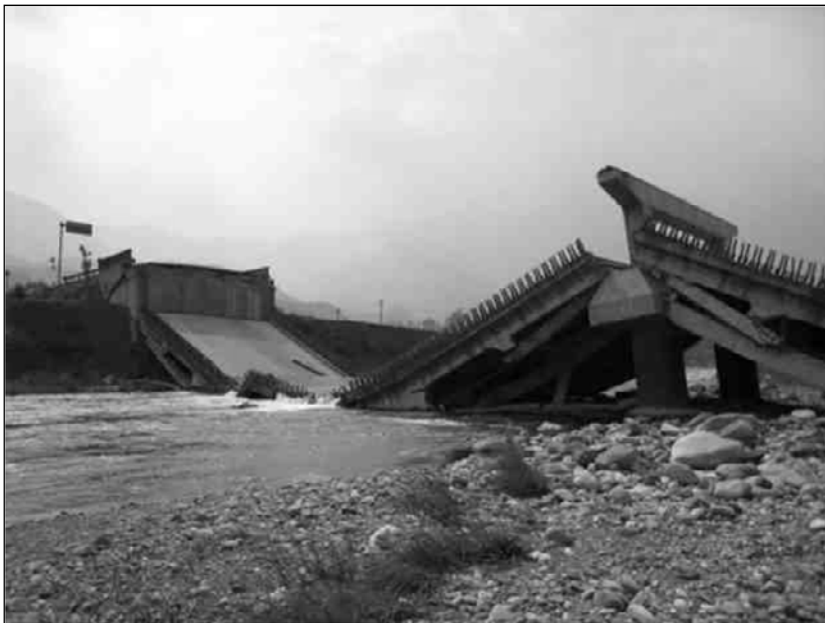
Fig. 3.50. Collapsed Xiaoyudong Bridge span (Longmenshan town and Xiaoyudong town)

The two spans on the west side of the bridge had collapsed (Fig. 3.50), and the eastern most span was severely damaged (Fig. 3.49). The remaining span suffered little damage. The central bent is located in the middle of the river with the longest pile shafts exposed above the ground. This central bent was significantly tilted while the other intermediate bents appeared to have little rotation. The difference in the stiffness of the various bents most likely contributed to the collapse of the two western spans. Under severe shaking around the bridge, the central bent rotated, unseating the two spans. The bent cap was approximately 850 mm across; the seat length of each girder was approximately 300 mm, which is very limited for strong shaking at the bridge site.

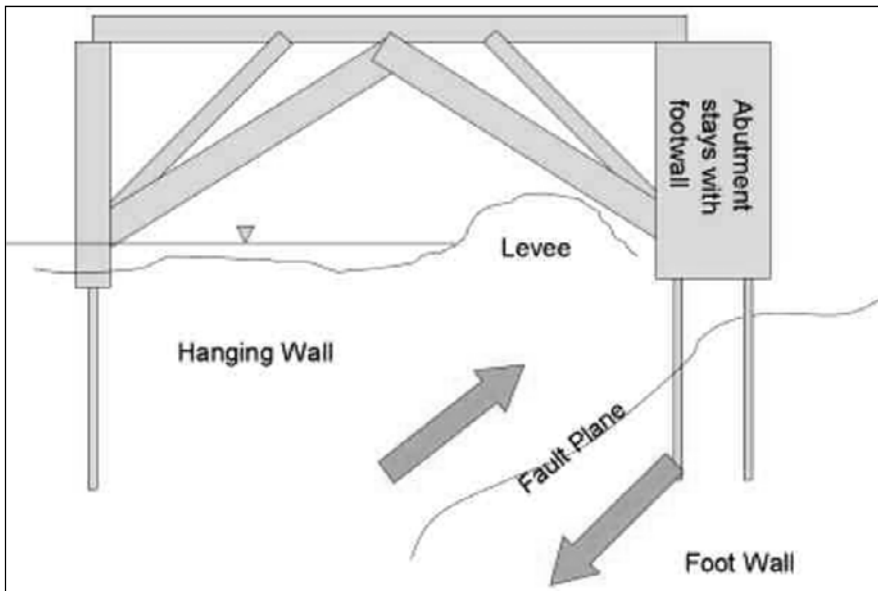
The damage to the eastern most span was likely caused by the surface fault near the east abutment. Figure 3.52 presents a schematic view of fault rupture versus the location of the east abutment of the bridge. When the hanging wall of the thrust fault moved up right relative to the foot wall that supported the east abutment, the levee began to bear on the arches and added significant shear forces and bending moments especially at the east ends of the arches. Designed for axial forces, the arches sheared at their east ends. The top end of the arches remained intact due mainly to its larger section. Because of the shear failure in the arches, the east span deflected downward significantly and added more load to the strut, resulting in its shear failure as well. At the same time, Span 4 pushed toward Bent 4 and caused flexural cracks at the pile shaft.

Fig. 3.52. Surface faulting and interaction with bridge

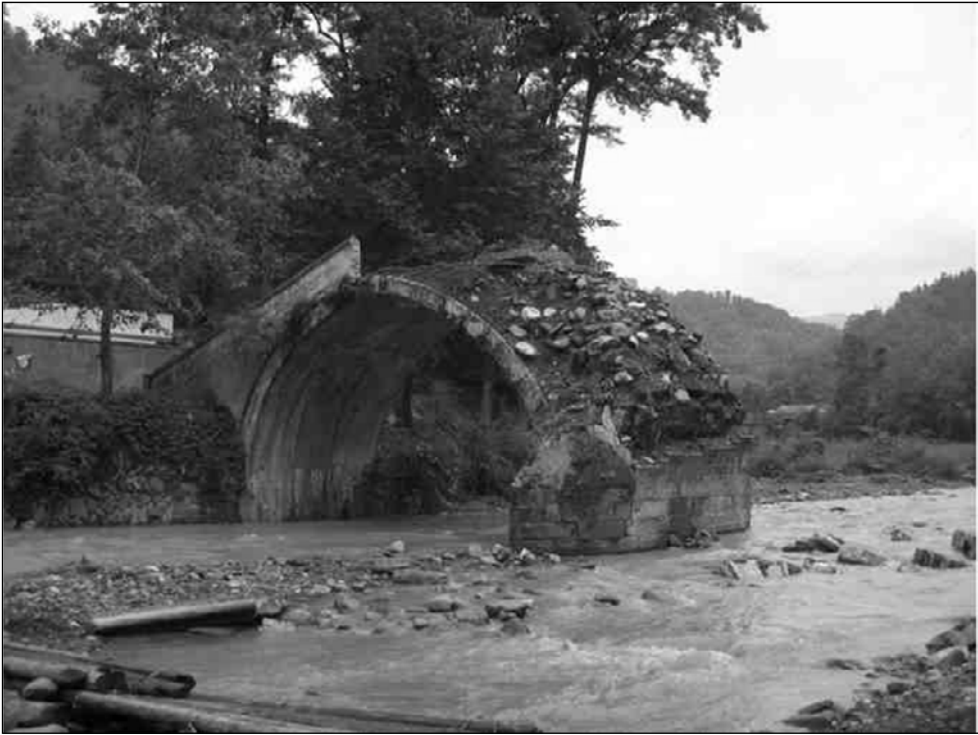
Figure 3.53 shows a collapsed stone-and-earthen arch bridge (also called the Sino-French Bridge). One span collapsed into the river (right side of figure), the other side remains standing. The commonly expected failure mode for unreinforced masonry arch bridges occurs when the seismic inertial loading is high enough to cause an opening in the arch's stonework (overcoming gravity compression); we would not be surprised if this failure mode occurred for this bridge.

Fig. 3.53. Collapsed stone-and-earth bridge (Bailu town of Pengzhou City)

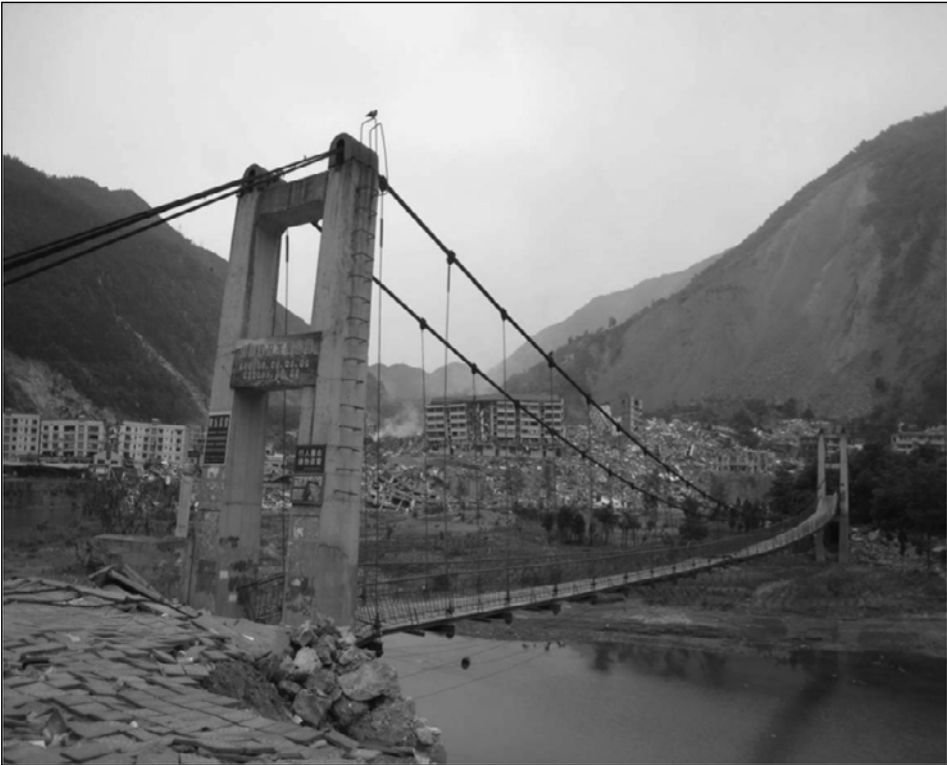
Figure 3.55 shows a pedestrian suspension bridge over the Yu River in Baichuan County. The main span of the bridge was approximately 130 m long and 2.5 m wide. The 10 cm diameter suspension cables were supported by large, stiff, reinforced concrete towers. The deck suspenders were 2 cm in diameter. The superstructure consisted of two steel pipe girders and a wooden deck. Suspension bridges typically perform well during earthquakes. These long-period structures are strong and flexible and usually have little damage except to the deck, which can get banged around during an earthquake. During this earthquake, at least one of the towers moved toward the river either due to lateral spreading or from a surface offset (Fig. 3.55). The three enormous slides in Beichuan destroyed a significant portion of the building stock in the city as well as other bridges.

Fig. 3.55. Beichuan Bridge after the Wenchuan Earthquake

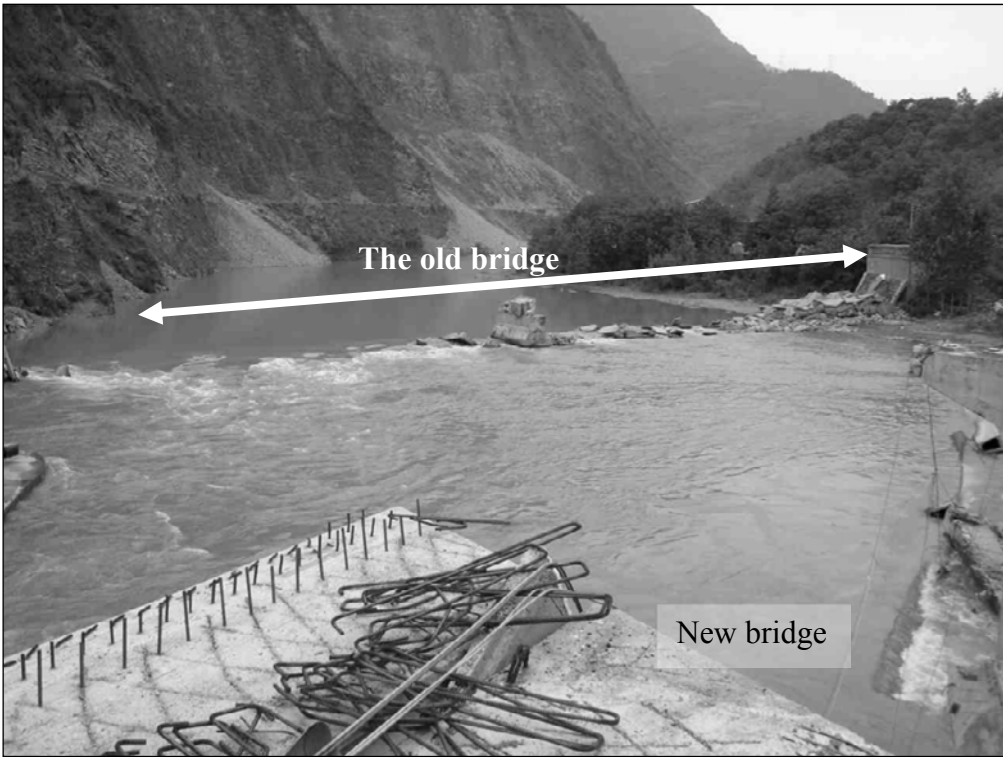
An old bridge in Nanba collapsed (Fig. 3.56) along with a new bridge under construction just west of the old bridge (Fig. 3.57). A temporary bridge (Fig. 3.58) was constructed by the PLA to provide supplies to the communities in the mountainous region. A sign posted on the approach read “one car at a time”; however, it seemed that no one had the patience to wait (Fig. 3.59).

Fig. 3.56. The old Nanba bridge collapsed leaving only part of its mid-pier standing in the middle of the river

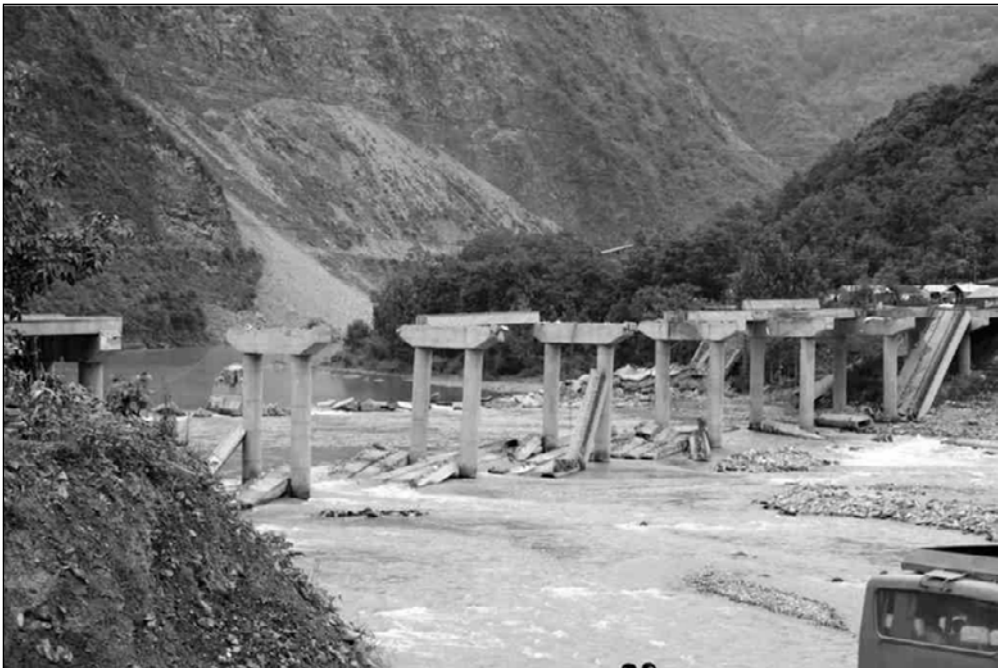
Fig. 3.57. All spans of this partially completed nine-span bridge fell into the river except the two spans on abutments

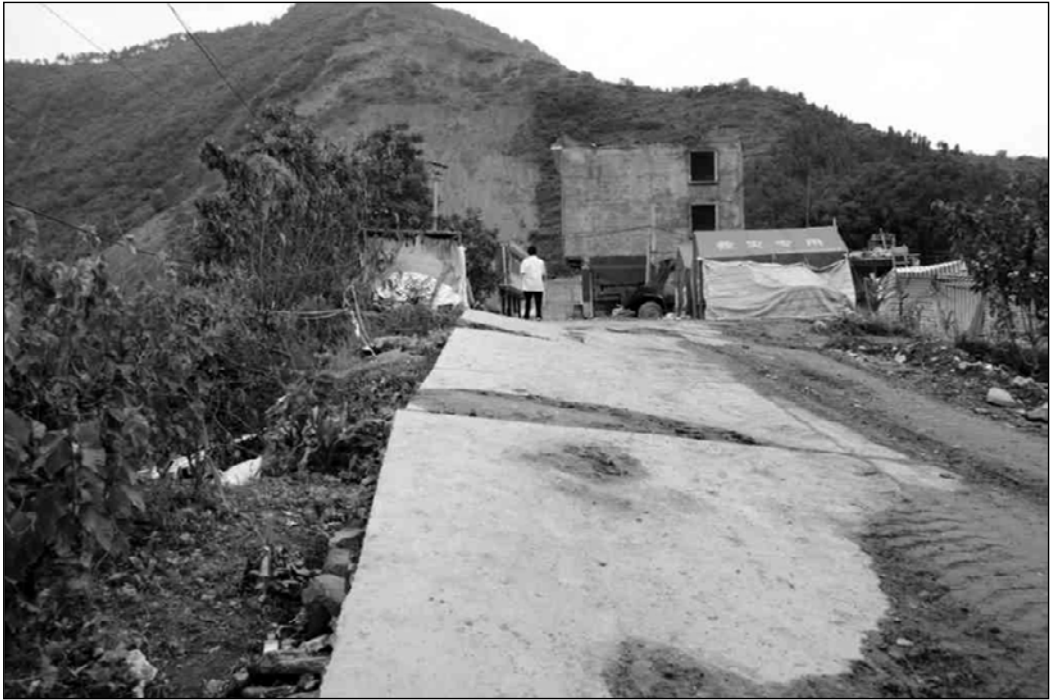
Surface faulting occurred in Hejiaba (Fig. 3.60), just east of Nanba across the river. An old bridge between Nanba and Hejiaba collapsed (Fig. 3.76). A temporary wooden bridge for foot traffic (Fig. 3.62) was constructed by the PLA, and military guards were posted to ensure no vehicle used the bridge. Along with traffic closure, the collapse also damaged a fiber optic cable on the bridge; a temporary cable was supported by a tripod made of wooden sticks (Fig. 3.63).

Fig. 3.60. Surface fault in Hejiaba; the road used to be level and a few houses on the right of the photo collapsed

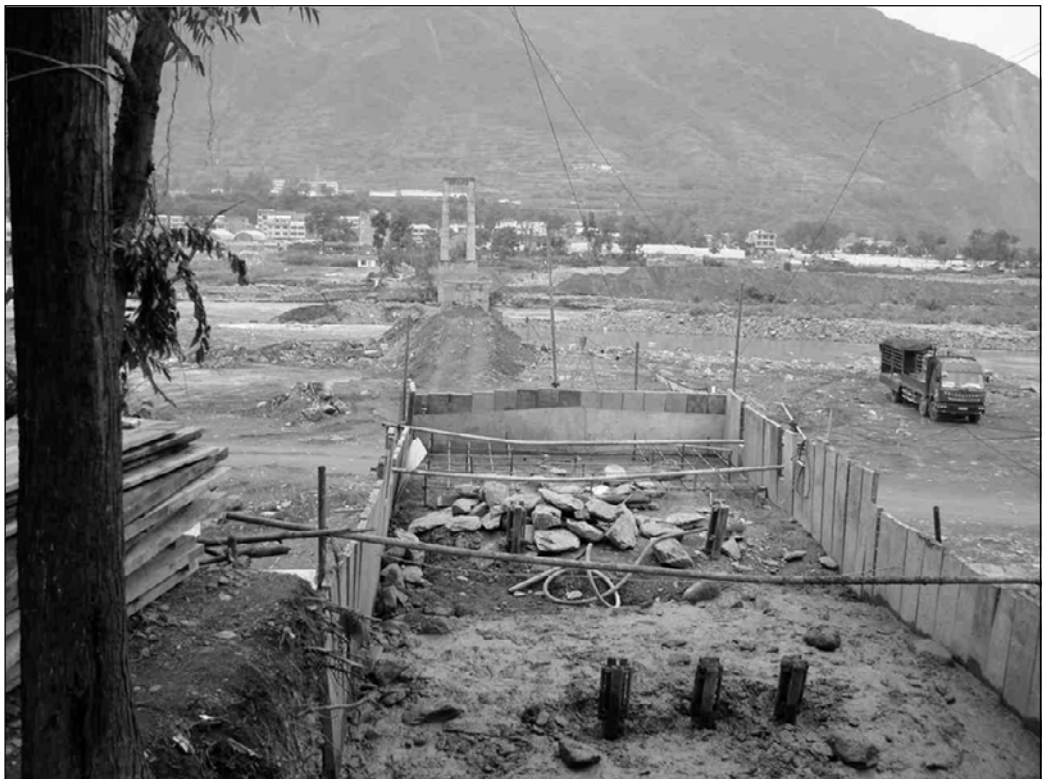
Fig. 3.61. View from Hejiaba towards Nanba of collapsed bridge and construction of new abutment

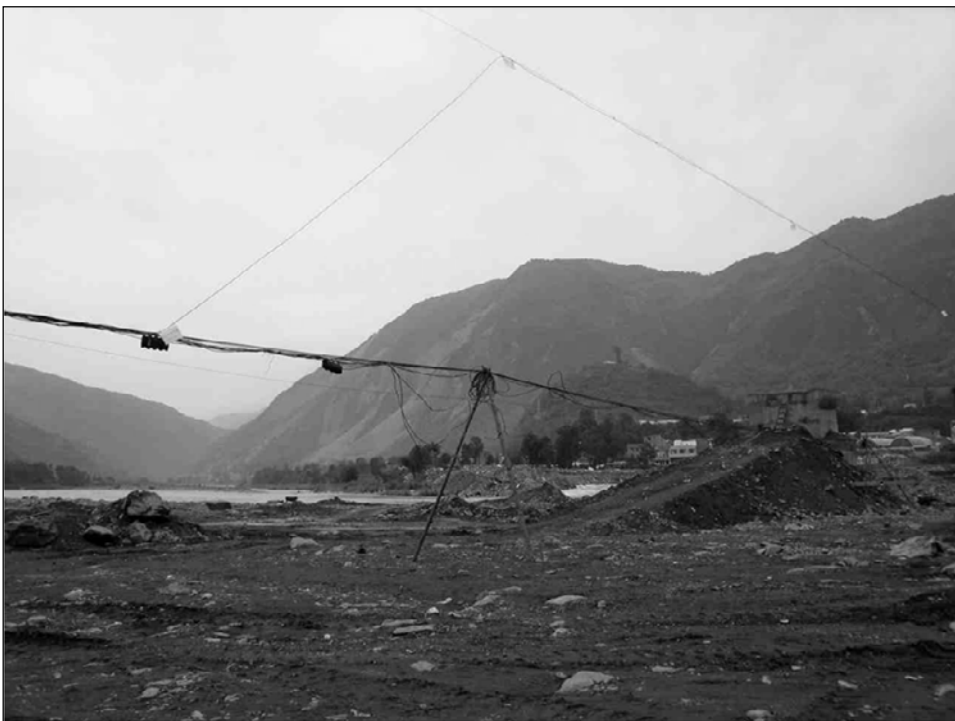
Fig. 3.63 Temporary fiber optic cables for telecommunication were installed to replaced the damaged cables due to bridge collapse (Fig 3.76)

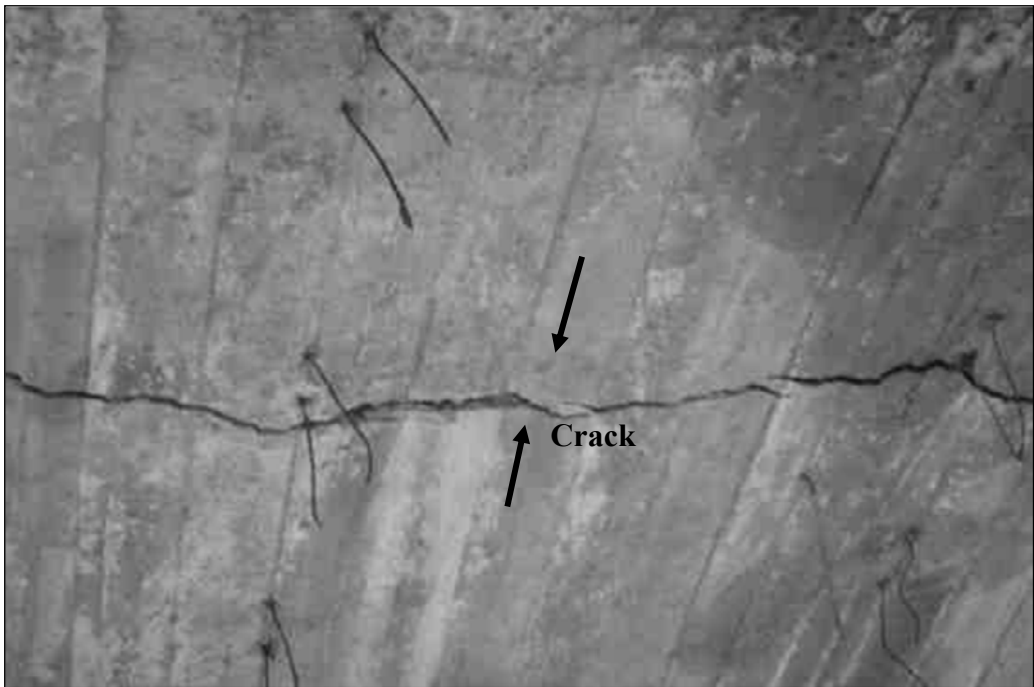
The arch bridge in Zhongba showed evidence that the ground shaking was sufficient to open cracks in the arch (Fig. 3.64 and 3.65).

Fig. 3.65. The crack under the arch bridge was about 15 mm wide

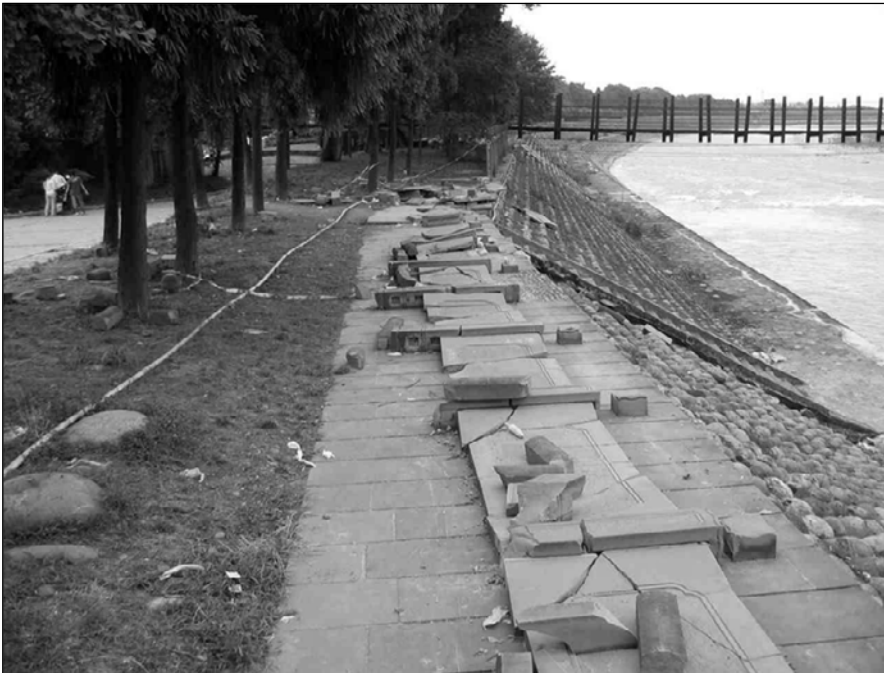
Damage to the stone railings demonstrated strong shaking in this area (Fig. 3.68).

Fig. 3.68. The poles of the stone railing close to the flexible pedestrian bridge were sheared off the stress riser close to the base

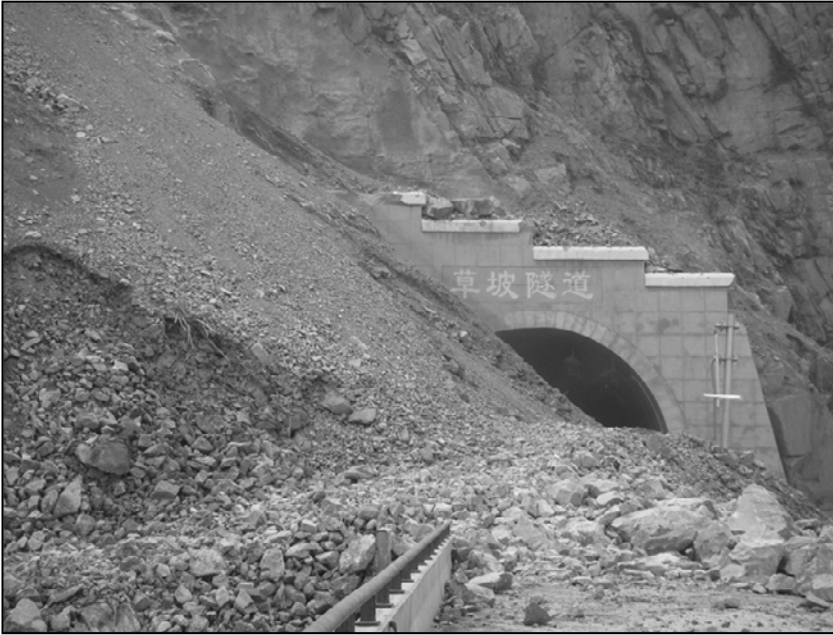
Fig. 3.70. Portal landslide, Caopo Tunnel in Duwen (Courtesy CRSWRI)

A landslide at the portal blocked the tunnel and the road leading to it (Fig. 3.70). The slope in front of the tunnel was not designed to prevent landslide as result of earthquake.

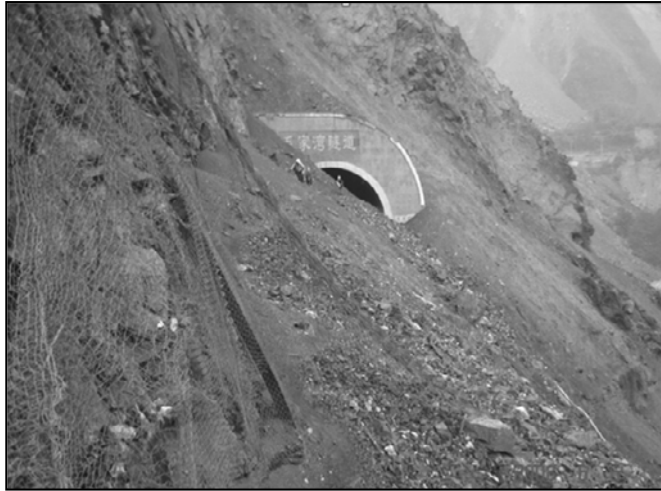
The rock fall in front of the portal blocked the tunnel and covered the road leading to it. Accessing the tunnel was nearly impossible (Fig. 3.71); note that the reconnaissance team had to scale the slope to get to the tunnel. Although meshed wired net was used to prevent rock falls, it was not strong enough to keep the rocks from covering the road and the portal area.

Fig. 3.71. Portal landslide, Maojiawan Tunnel in Duwen (Courtesy CRSWRI)

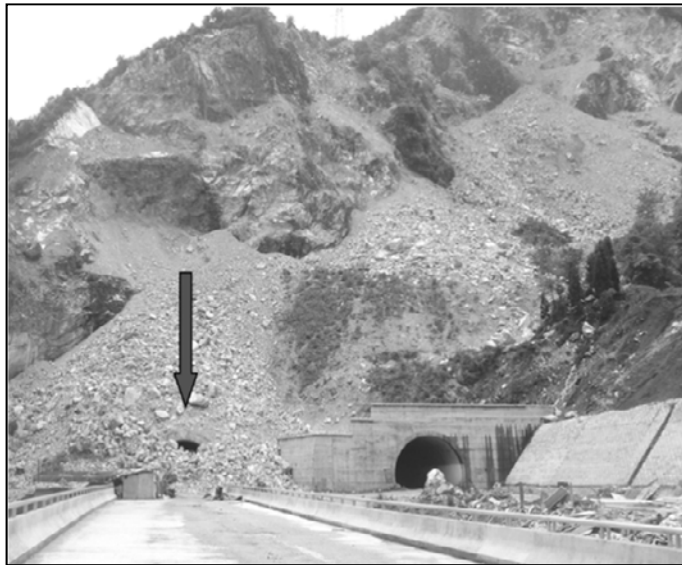
As shown in Figure 3.72, the left portal of the Longdongzi tunnel is almost entirely covered by a landslide, which fell from above the portal.

Fig. 3.72. Portal landslide, Longdongzi Tunnel in Duwen (Courtesy CRSWRI)

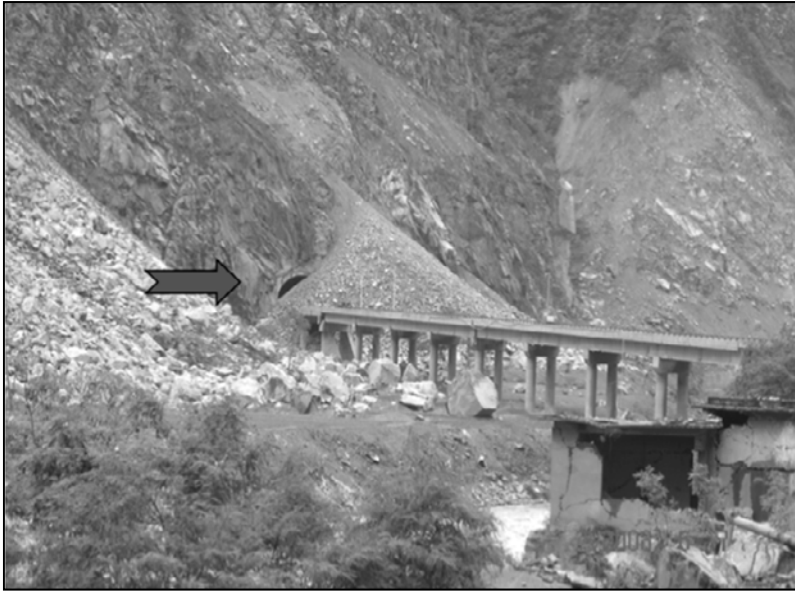
This portal area was also covered by the landslide. The first two spans were also covered by the landslide (Fig. 3.73).

Fig. 3.73. Portal landslide, Futang Tunnel in Duwen (Courtesy CRSWRI)

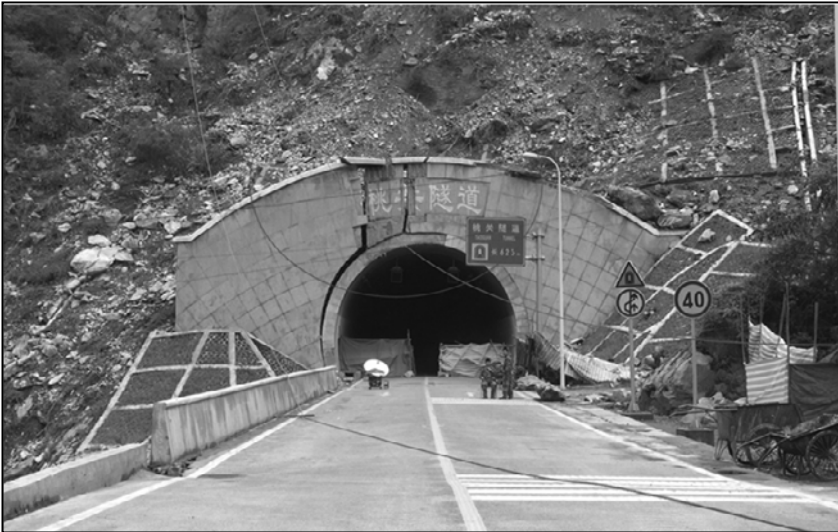
The cracking of the portal wall was caused by the landslide above it (Fig. 3.74). Note that there were crib walls used to protect the road and the tunnel from landslide.

Fig. 3.74. Cracking of Taoguan Tunnel in Duwen (Courtesy CRSWRI)

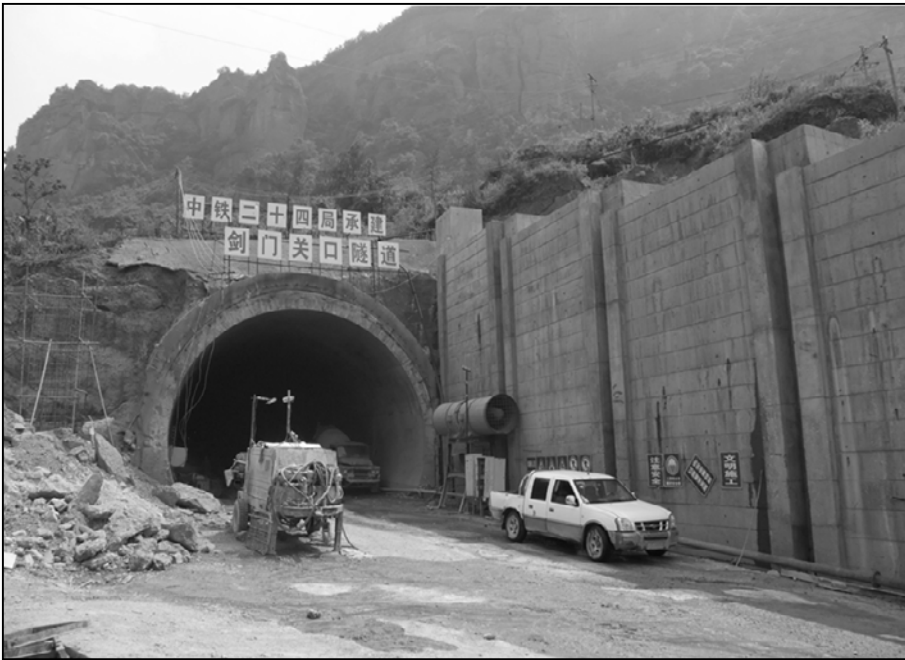
The concrete structural wall (right side of Fig. 3.75) provided protection against landslide. The damage on the left side seemed to be fascia that had fallen off, most likely because it lacked adequate anchoring capacity. Fault offset within tunnels caused some relatively modest damage. The exhaust fan was used to circulate air for the repair crews inside.

Fig. 3.75. Damage to portal of the Jianmenguankou Tunnel (left side of photo) (Courtesy CRSWRI)

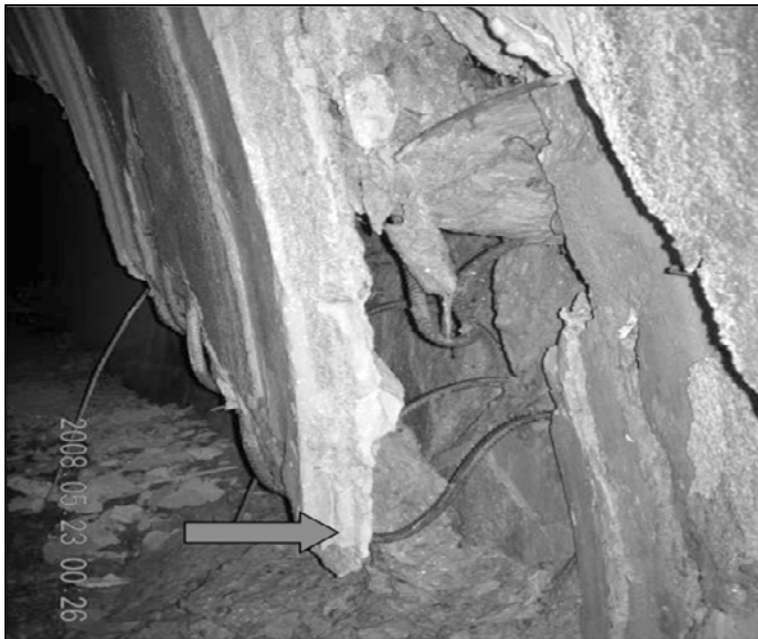
Figure 3.76 shows the liner damage close to the foot.

Fig. 3.76. Damage to liner, Baiyunding Tunnel (Courtesy CRSWRI)

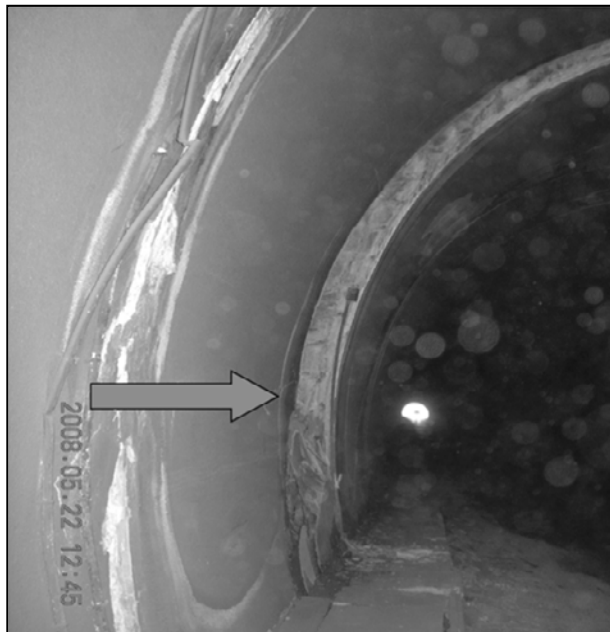
Figure 3.77 showed damage to tunnel liners.

Fig. 3.77. Damage to Liner, Youyi Tunnel (Courtesy CRSWRI)

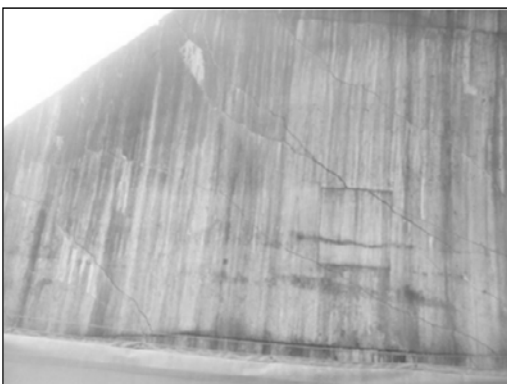
The Longxi Tunnel runs along the Duwen highway, a cut-and-cover construction road. Figures 3.78 to 3.84 show cracking to the tunnel liners and upheaval of road surface.

Fig. 3.78. Damage, Longxi Tunnel approach (Courtesy CRSWRI)

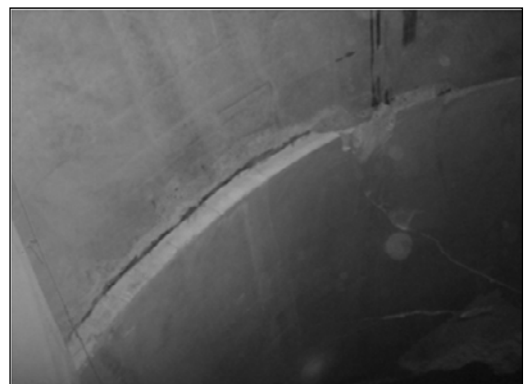
Fig. 3.79. Liner damage, Longxi Tunnel (Courtesy CRSWRI)

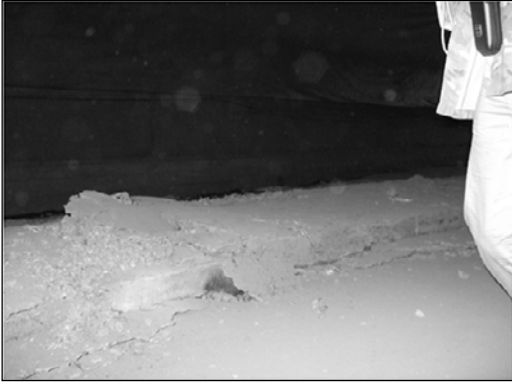
Fig. 3.80. Upheaval damage by 70 cm (Courtesy CRSWRI)

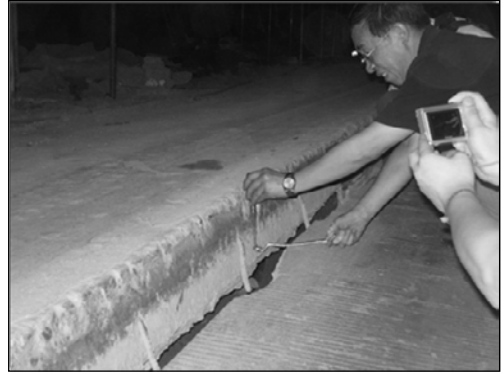
Fig. 3.81. Upheaval damage by 70 cm (Courtesy CRSWRI)

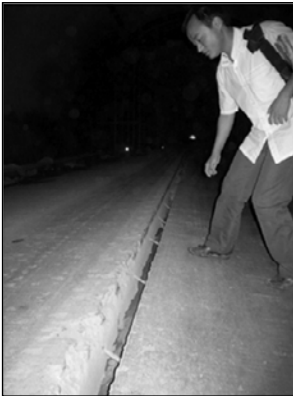
Fig. 3.82. Vertical movement damage to road surface in the tunnel (Courtesy CRSWRI)

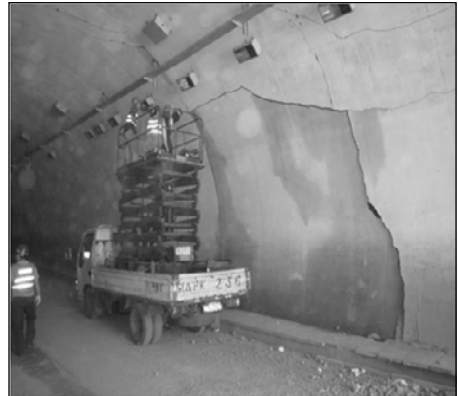
Fig. 3.83. Repairing liner damage (about 15 cm) (Courtesy CRSWRI)

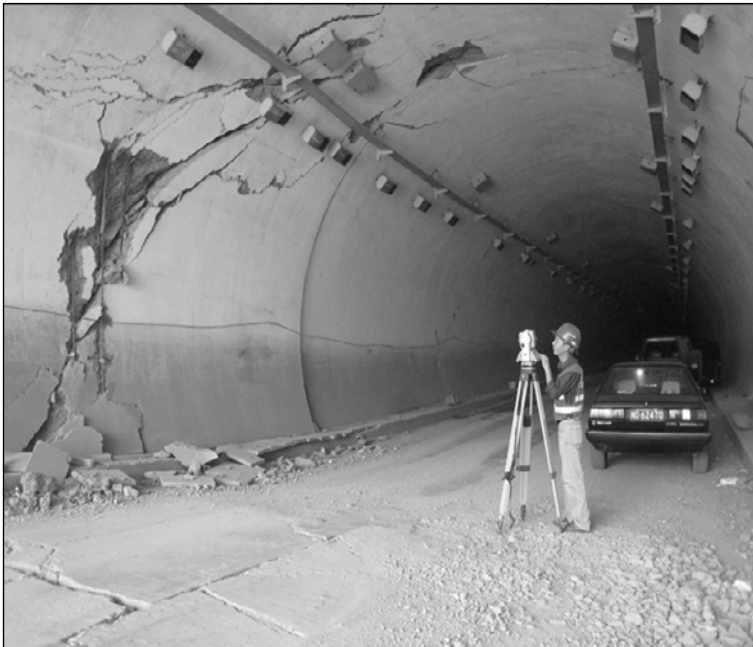
Fig. 3.84. Liner damage (Courtesy CRSWRI)

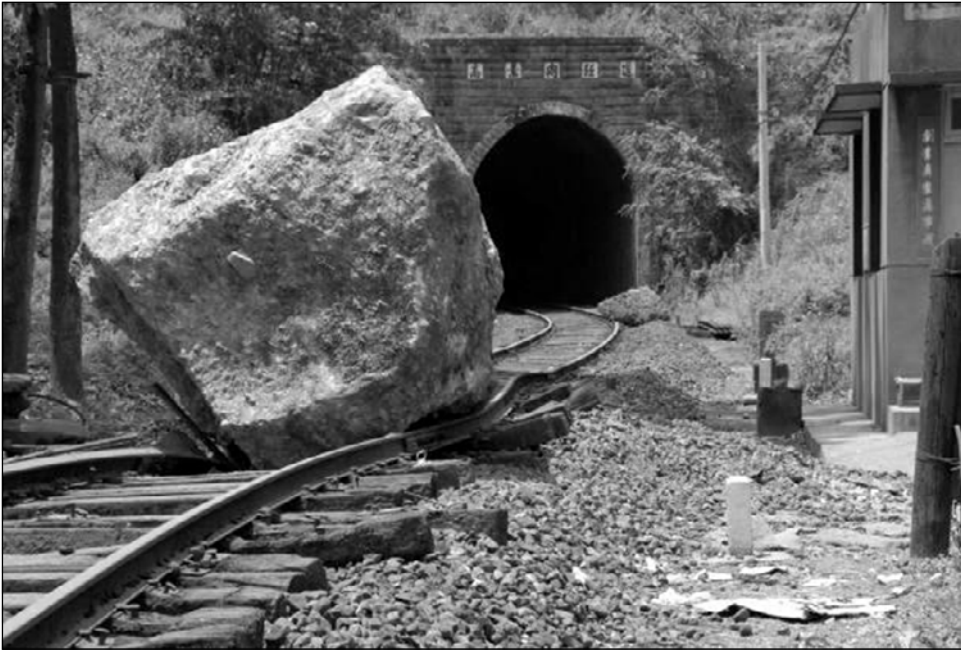
Fig. 3.85. Rockfall on railroad tracks (Courtesy of Prof. Mei and Dr. Zhang)

Landslide damage to roads during earthquakes is considered inevitable in mountainous areas and apparently was not properly addressed by seismic criteria. Building mountain roads in tunnels and using more rock anchors could possibly reduce their vulnerability during large earthquakes. Protecting tunnels from landslides and fault offsets must be part of the design and construction criteria. In California, modern tunnels are designed and constructed for landslides and fault offset.

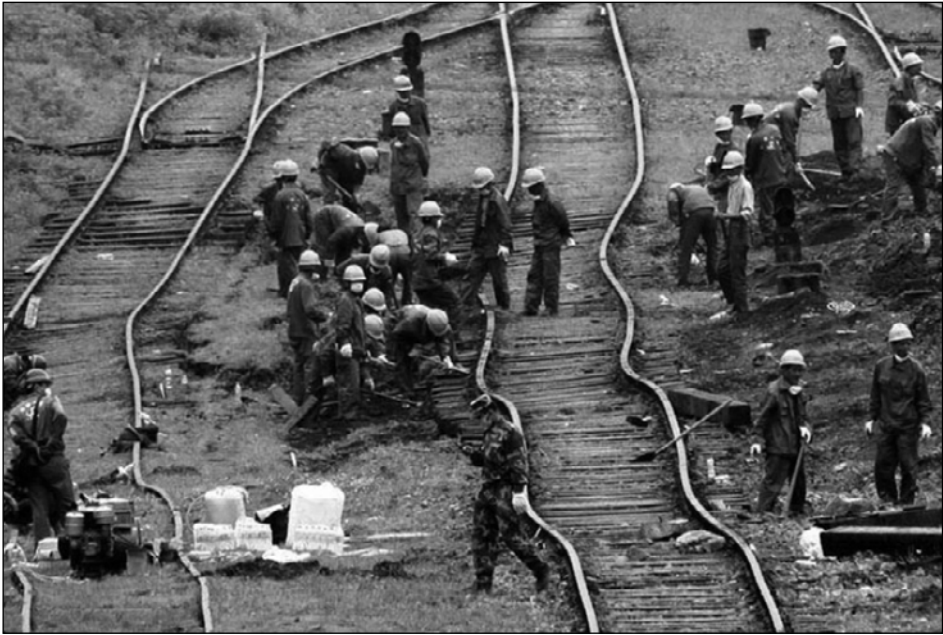
Fig. 3.86. Soil liquefaction damage to tracks (Courtesy of Prof. Mei and Dr. Zhang)

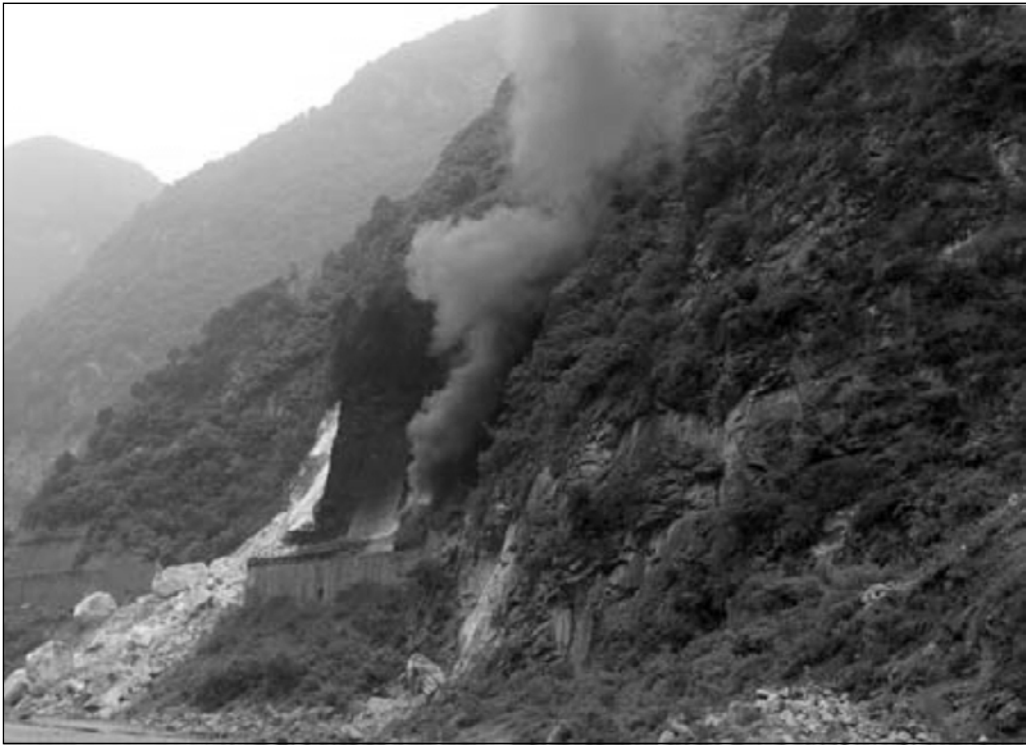
The railway system also experienced extensive damage at four places in Baocheng, four in Chengkun, and seven in Chengyu. Additionally, a number of railway branches in Guanyue sustained various degrees of damage. A freight train from Baocheng to Yuguan derailed in tunnel 109 and was trapped. Another freight train in Xuixian County in Gansu Province derailed in a tunnel, and a freight car carrying flammable liquid caught fire in the tunnel. Rockfalls caused problems for railways just as they did for highways (Fig. 3.85). There was also damage to tracks due to liquefaction (Fig. 3.86), damage to railway bridges due to ground shaking (Fig. 3.87 and 3.88), and damage to railway tunnels due to landslides and fault offset (Fig. 3.89).

Fig. 3.89. Gasoline tanker train derailed in a tunnel in Xuixian County in Gansu Province and caught fire (Courtesy of Prof. Mei and Dr. Zhang)
