WENCHUAN, SICHUAN PROVINCE, CHINA, EARTHQUAKE OF 2008

Lifeline Performance

Technical Council on Lifeline Earthquake Engineering
Monograph No. 39

Earthquake Investigation Committee of the
Technical Council on Lifeline Earthquake Engineering

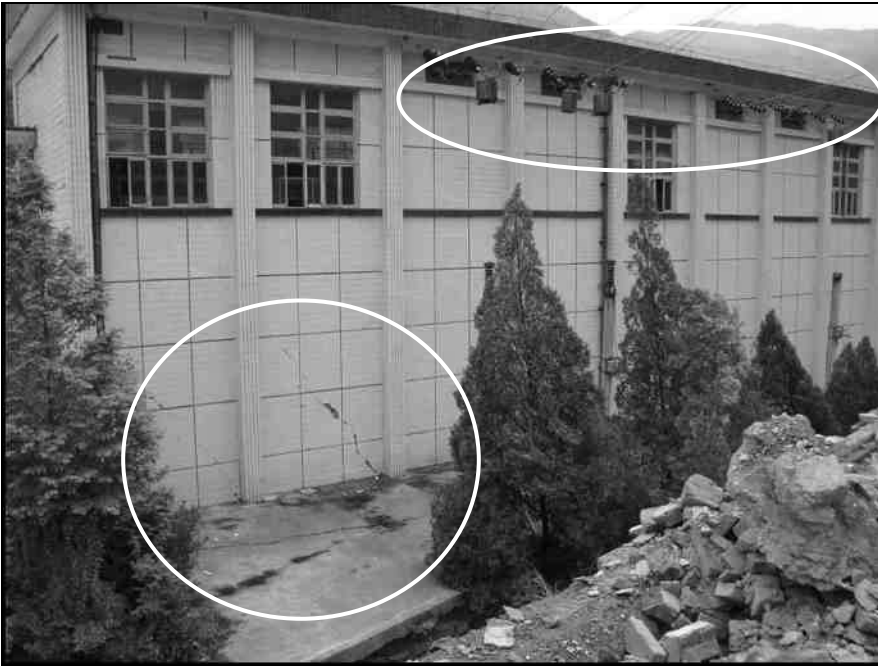
- 76 percent fossil fuel (coal);
 - 7 percent hydro (dams);
 - 3 percent nuclear; and
 - 14 percent wind, solar, geothermal, and such.
- A hydroelectric power plant near Nanba was out of service. Figure 4.3 shows the damage (large diagonal cracks) in exterior structural walls (also note the collapsed fence in the foreground). Permanent ground deformations of perhaps a few inches of settlement were prevalent around the building. Figure 4.4 shows the substation at the power plant; note the circular concrete-style dead-end towers over a step-up

Fig. 4.3. Hydroelectric power plant building (Nanba)

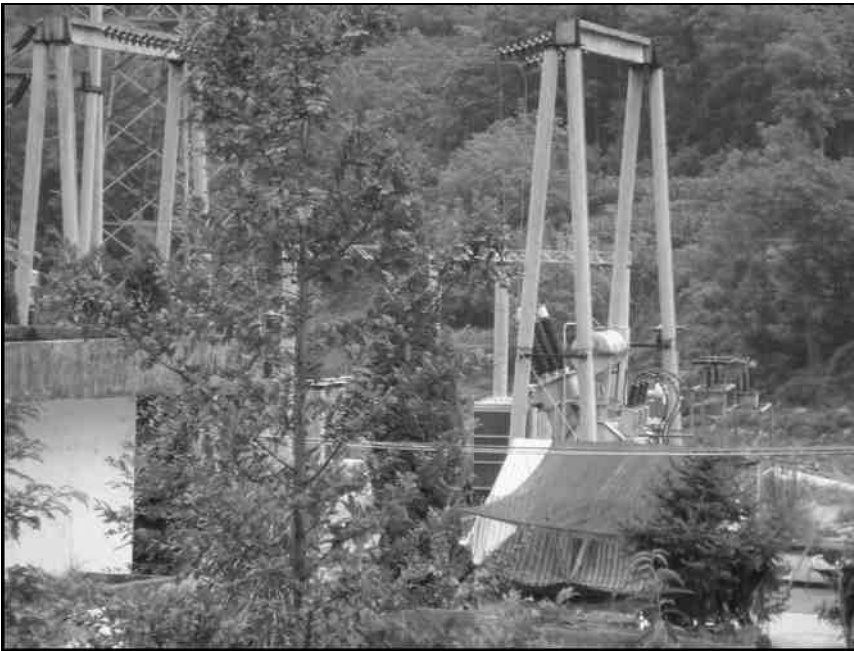
Fig. 4.4. Substation at hydroelectric power plant building (Nanba)

transformer. The high-voltage bushings on the transformer appeared new, but we were not able to enter the site for closer inspection. At 220 kV substations that experienced higher levels of ground shaking ($PGA > 0.4$ g), these types of dead-end towers collapsed, resulting in gross damage to equipment below. Within 150 m of the power plant was a newly constructed 115 kV transmission tower, suggesting that a landslide had failed an earlier tower near the plant.

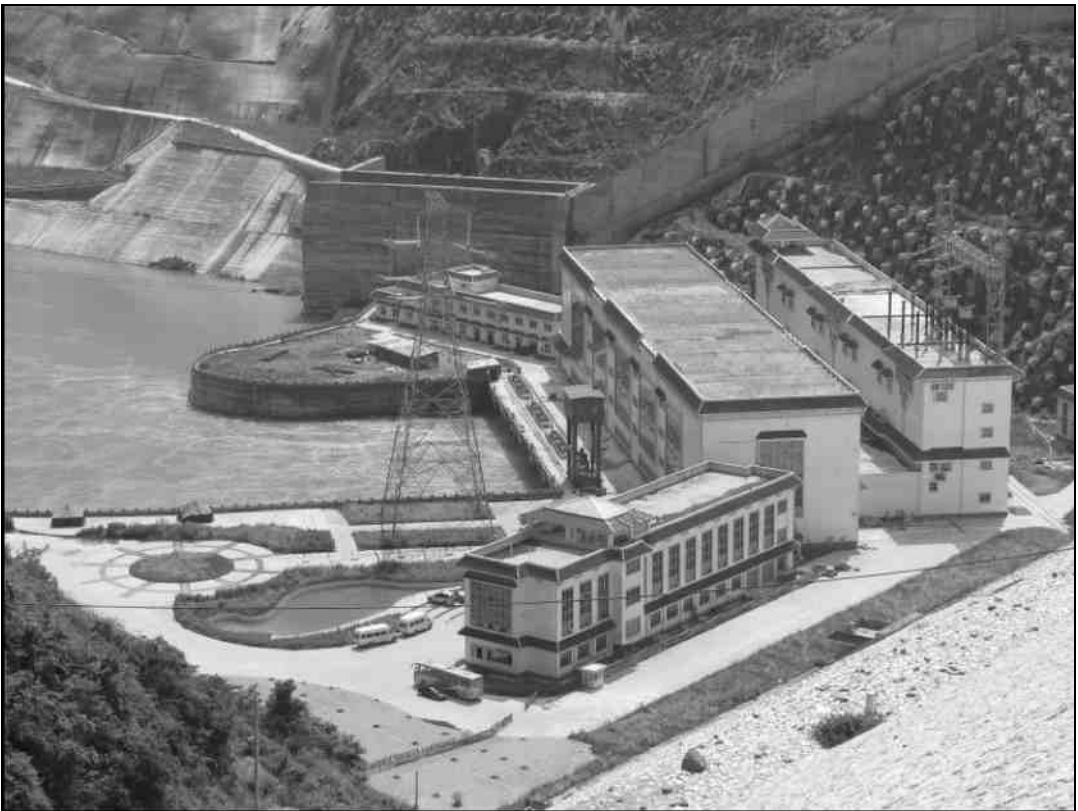
Figure 4.5 shows the powerhouse, substation and control building at the base of the Zipingpu Dam. ASCE team investigated these buildings. We estimated that at the base of the dam, ground motions were about $PGA = 0.2g$. There are four three-phase 500 kV transformers, all unanchored; one slid several inches and broke its 500 kV side riser (gas insulated). The 500 kV gas-insulated indoor substation performed well. One 500 kV lightning arrester and one 500 kV CVT (Current Voltage Transformer) on the roof of the substation building broke. The building structures at the base of the dam performed well, with minor structural damage. The four 190 MW turbines (total 760 MW) all had various forms of damage and each had to be overhauled in the year after the earthquake.

Fig. 4.5. Hydroelectric power plant buildings (Zipingpu Dam) (Courtesy of IEM)

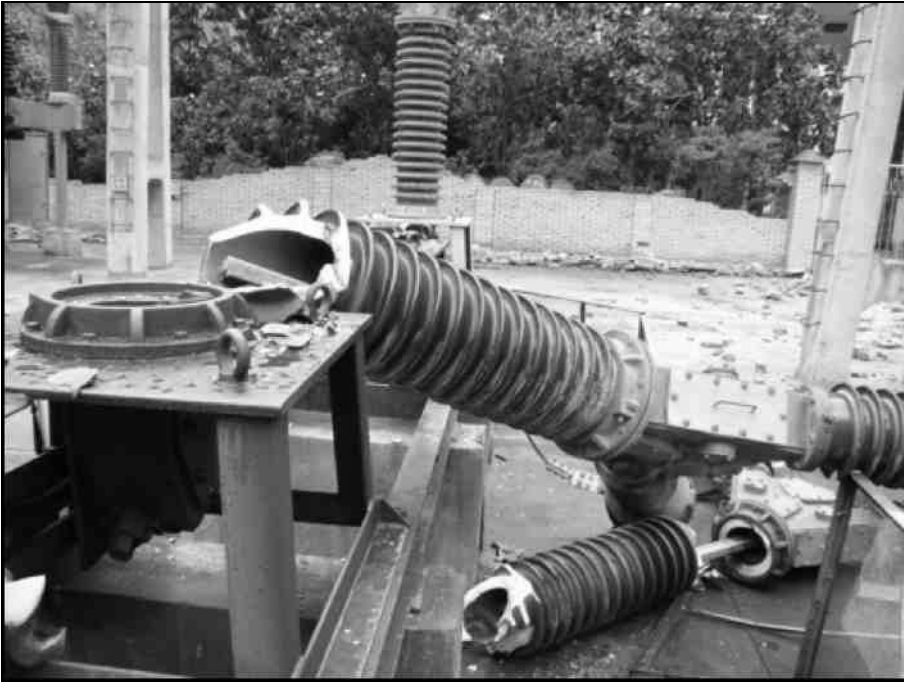
Figure 4.6 shows some typical damage to a live tank circuit breaker. In this case, the initial damage is concentrated at the base of the porcelain, where it is connected to a flange with only a shallow embedment. In Figure 4.7, the porcelain failure is at the top of the bottom porcelain unit. The primary weaknesses of this type of circuit breaker are either excessive bending moments on the porcelain or weak porcelain-to-flange fittings.

Fig. 4.6. Close-up of damaged live tank circuit breaker (110 kV)

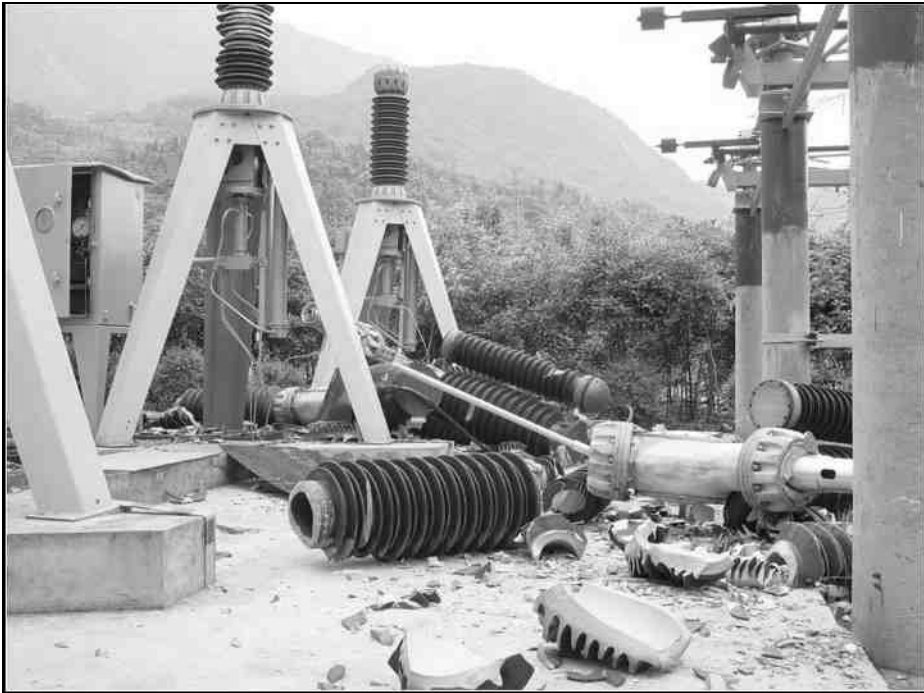
Fig. 4.7. Damaged live tank circuit breaker (220 kV)

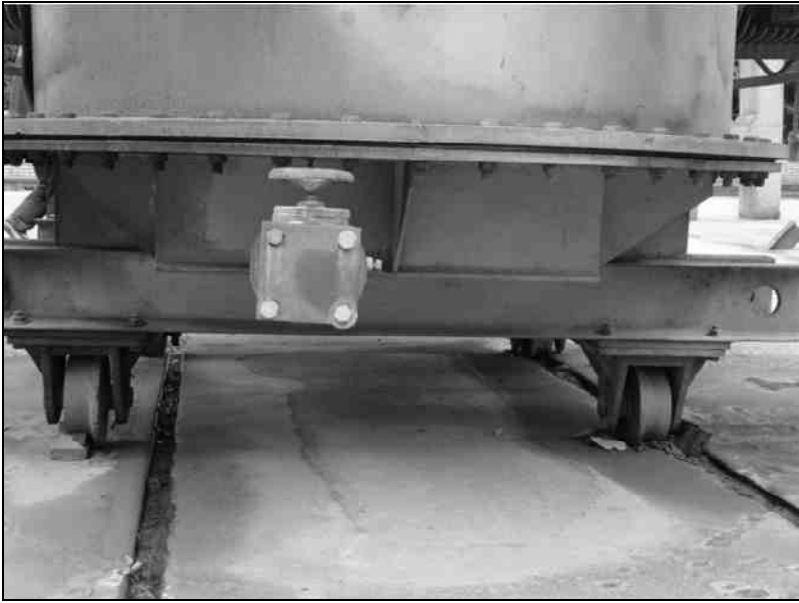
Figure 4.10 shows a transformer on wheels that jumped its tracks. This type of damage has been observed in almost every corner of the world when ground motions exceed $PGA = 0.25$ g or so. This type of weakness is relatively easy to mitigate, and we would recommend that every wheel-mounted transformer in China where the 475-year earthquake PGA level is estimated to be 0.15 g or larger should be properly anchored. This is a prudent upgrade priority.

Fig. 4.10. Wheel-mounted transformer

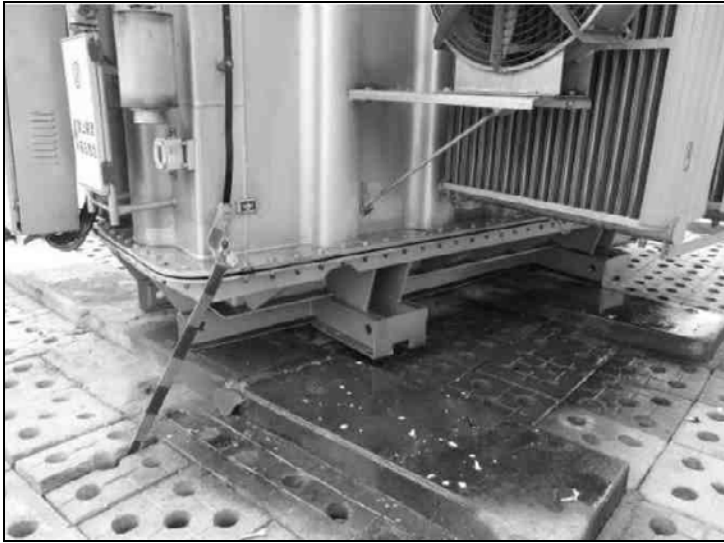
Figure 4.11 shows a slid 110 kV transformer at Chuanxindian in Shifang. The sliding exceeds 1 ft. for a steel-on-concrete installation. The staining on the concrete reflects that there was a large oil leak here (see Chuanxindian 110 kV Substation and Fig. 4.52 through 4.54).

Fig. 4.11. Skid-mounted transformer

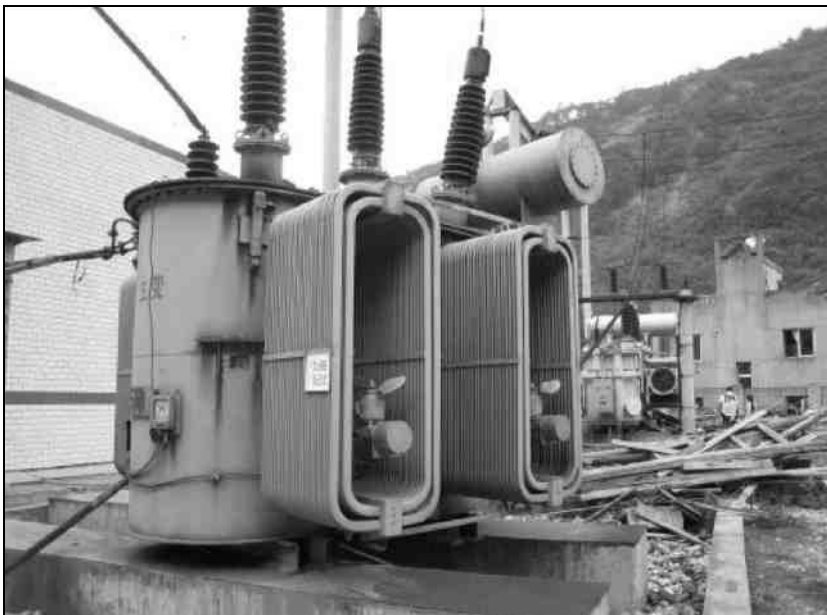
Figure 4.12 shows the sliding of a 110 kV transformer at Beichuan substation ($PGA > 0.3 g$). It leaked oil, most likely due to radiator pipe damage. While the two radiators are tied to each other, there appears to be no lateral support for the radiator other than the pipe connections. The State Grid reported many oil leaks due to pipe failures of radiators.

Fig. 4.12. Skid-mounted transformer

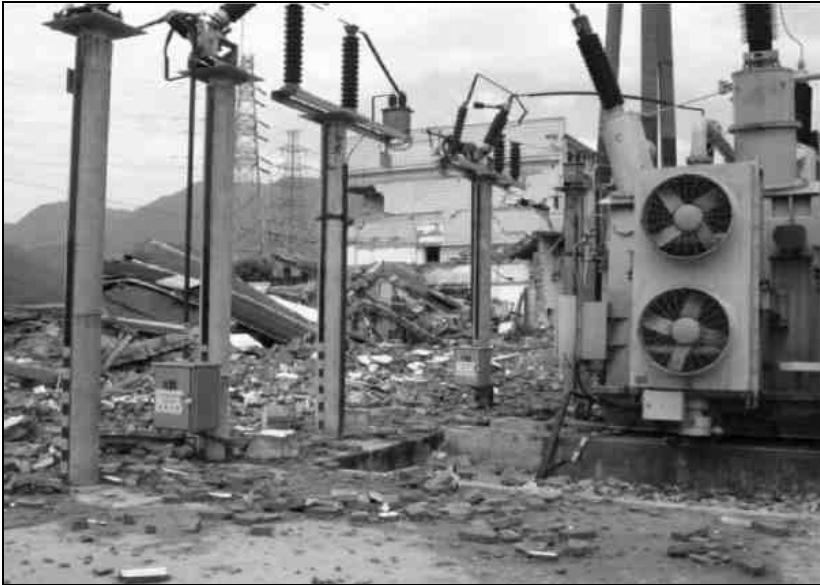
Fig. 4.13. Collapsed control building

Figure 4.13 shows a collapsed control building at Anxian. The transformer on the right also slid, damaging grounds and likely imparting pull-down loads on adjacent disconnect switches.

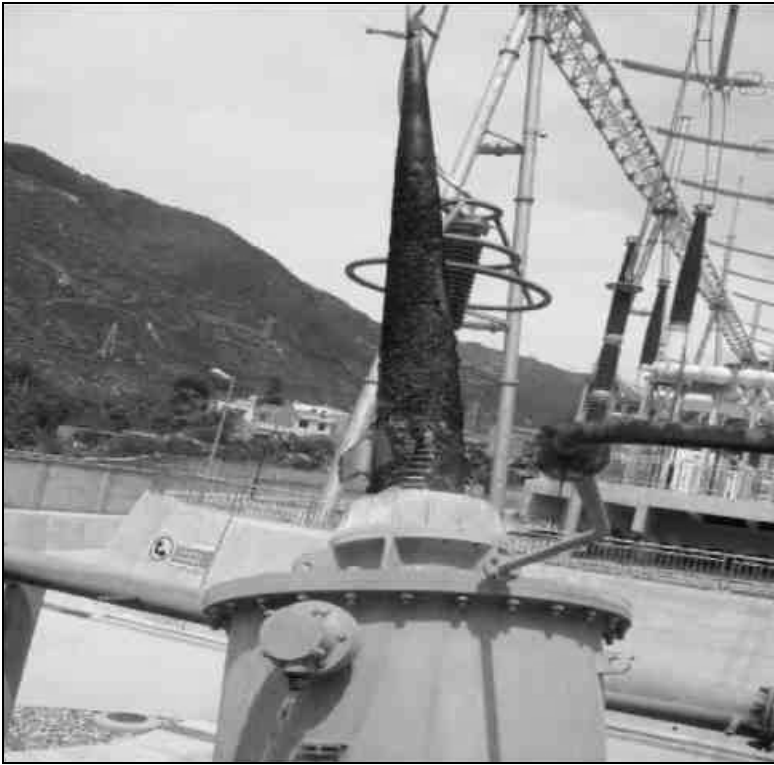
Figures 4.14 and 4.15 show the damage to two bushings on a 500 kV transformer at Maoxian. The Phase C bushing caught fire. The Phase B bushing had total failure of its porcelain. These appear to be grouted bushings, which are rarely used in the United States. The adjacent surge arrestors had good slack and appeared unharmed.

Fig. 4.14. Bushing, 500 kV transformer (Phase C burned)

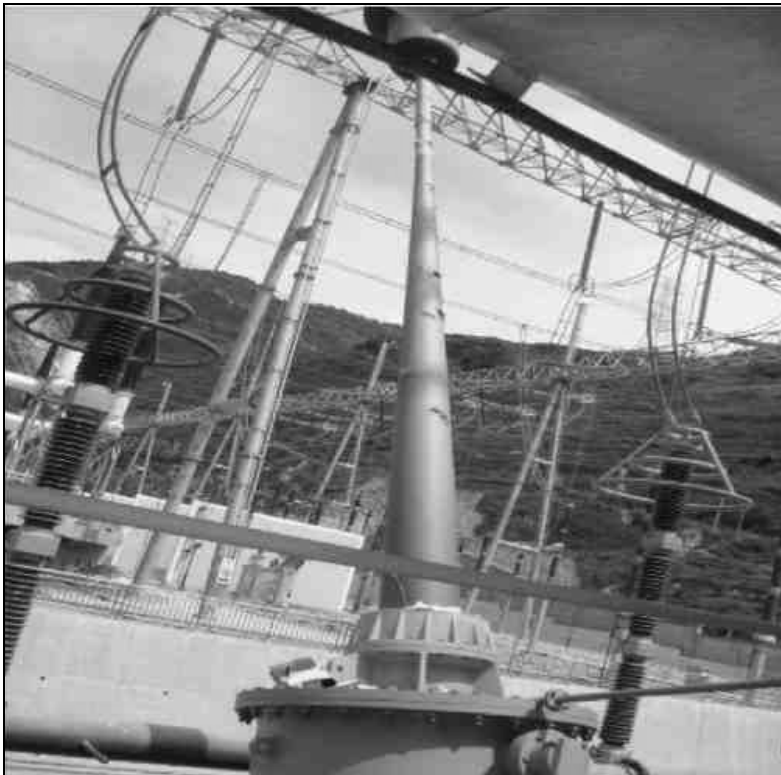
Fig. 4.15. Bushing, 500 kV transformer (Phase B lost porcelain)

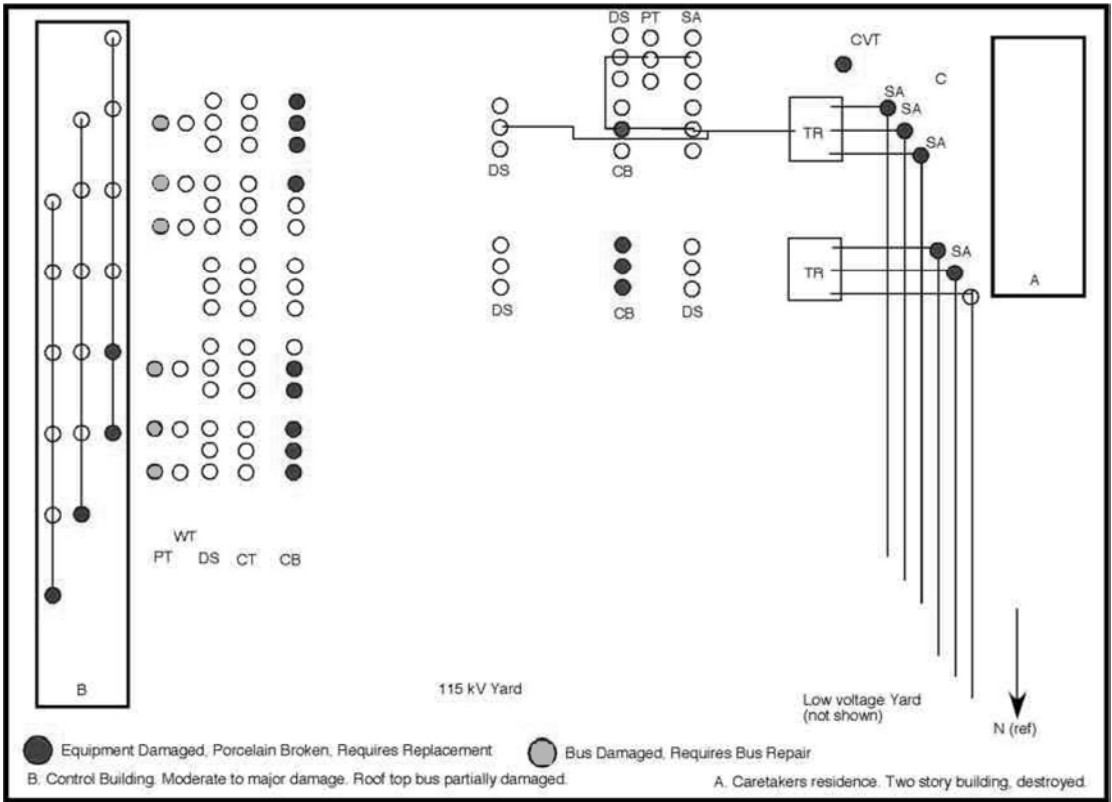
Figure 4.16 shows a schematic of the substation. We were not allowed to enter the substation, so all observations were made from outside the boundary fence. We estimate that we were able to observe about 80 percent of all equipment damage. The yard equipment damage is shown as dark gray dots (completely destroyed, requires replacement) or light gray dots (minor repair work to re-install the bus). The State Grid transmission company had not begun repair work as of 160 days after the earthquake, and there were weeds growing in many areas reflecting the lack of maintenance at the yard for more than 5 months. Most likely reason for the lack of repair is that the factories within a mile or so of the yard were heavily damaged, with no repair efforts ongoing, resulting in loss of load.

Fig. 4.16. Diagram of Yingxiu 110 kV substation

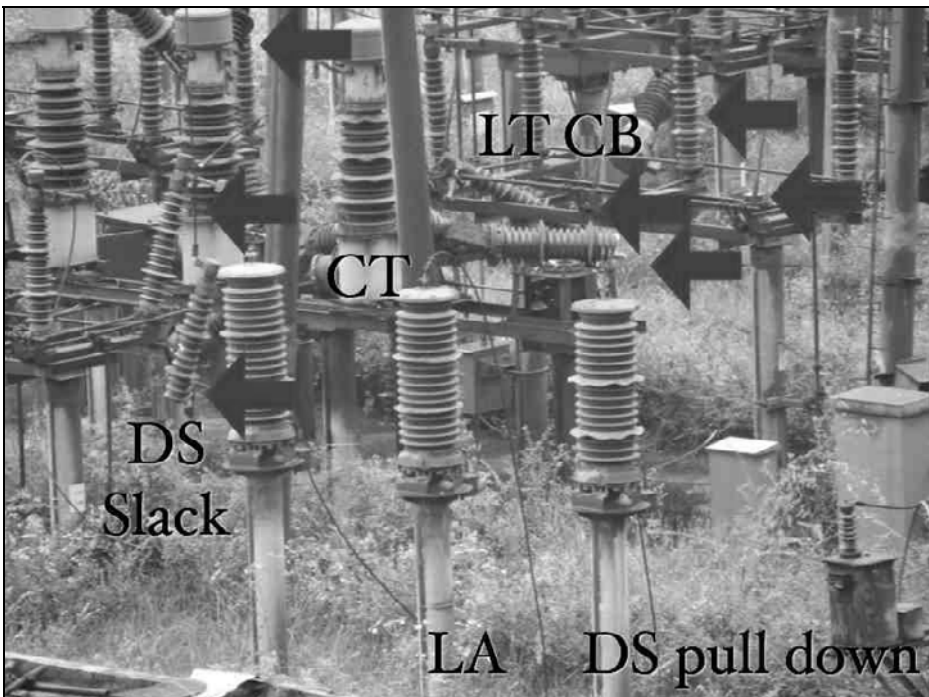
Fig. 4.17. Examples of damage to yard equipment, Yingxiu 110 kV substation

We observed gross failure of at least 13 of 21 live tank circuit breakers. It is possible that all were damaged, but we could not gain close enough access to verify each individual breaker. This type of breaker was used at many substations (see also close ups in Fig. 4.6 and 4.7). The commemorative mural at the Beichuan 220 kV substation (Fig. 4.36) highlights this particularly weak breaker.

Figure 4.17 shows a different view of the damaged circuit breakers (CB) than Figure 4.16. The inertial failure of the live tank CBs grossly damaged the adjacent disconnect switch (DS) about 15 percent of the time but never visually damaged the adjacent current transformer (CT). The CT has a larger post than the DS, so it is relatively more strength than the DS to support the weight of the failed and collapsed live tank circuit breaker (LTCB).

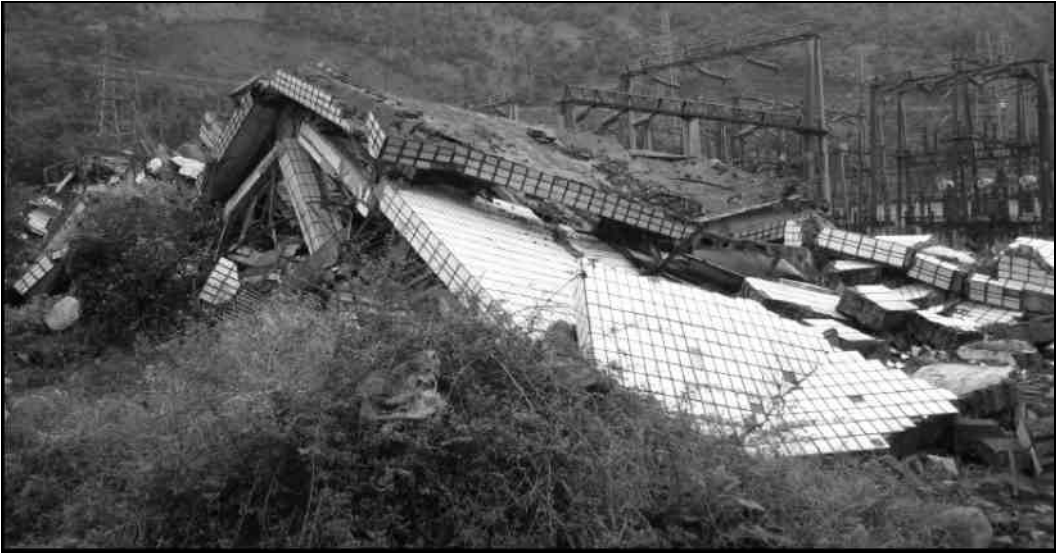
Fig. 4.18. Collapse of caretaker's two story URM residence

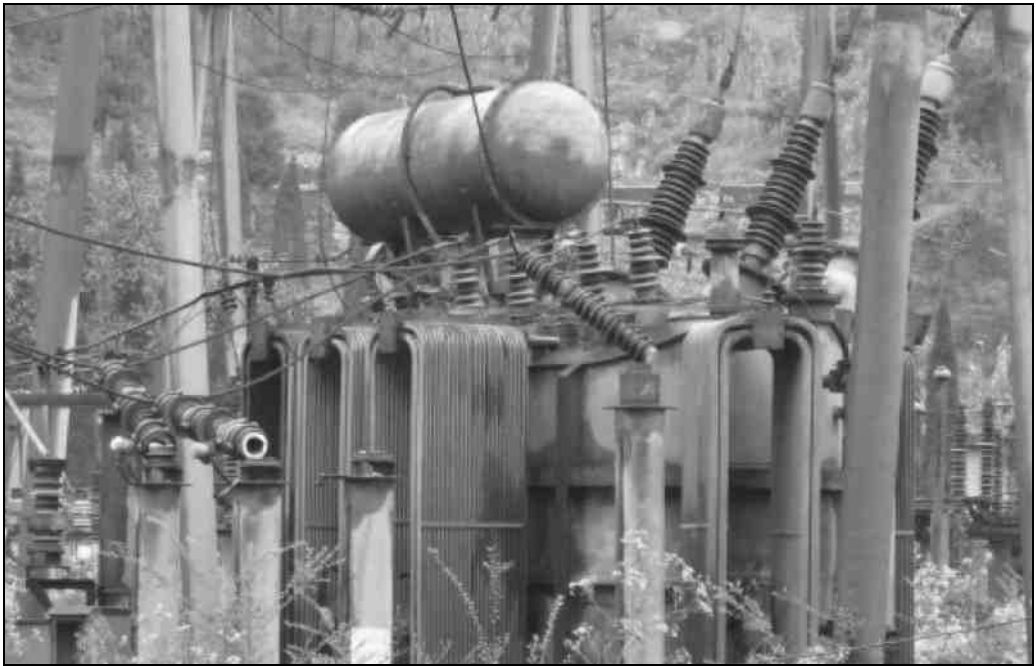
Fig. 4.19. Damage to current voltage transformer (CVT) and three lighting arrestors

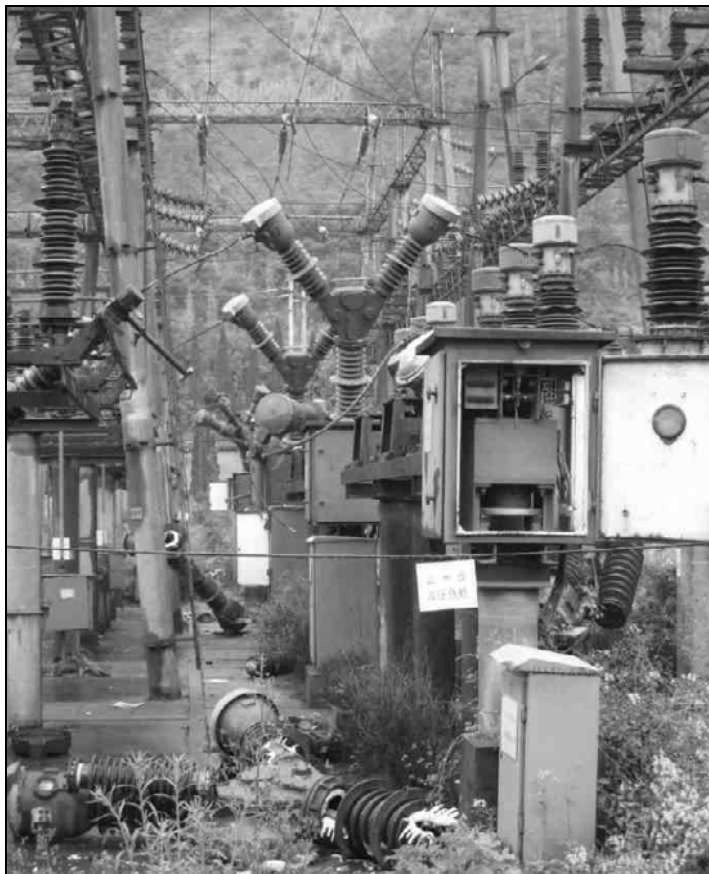
Fig. 4.20. Damage to live tank CBs; pull down of some adjacent DS

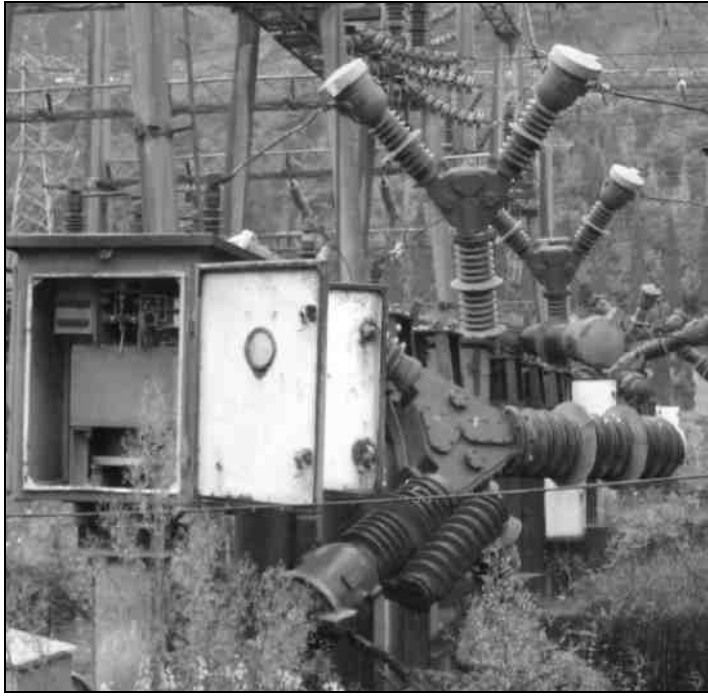
Fig. 4.21. Damage to live tank CBs

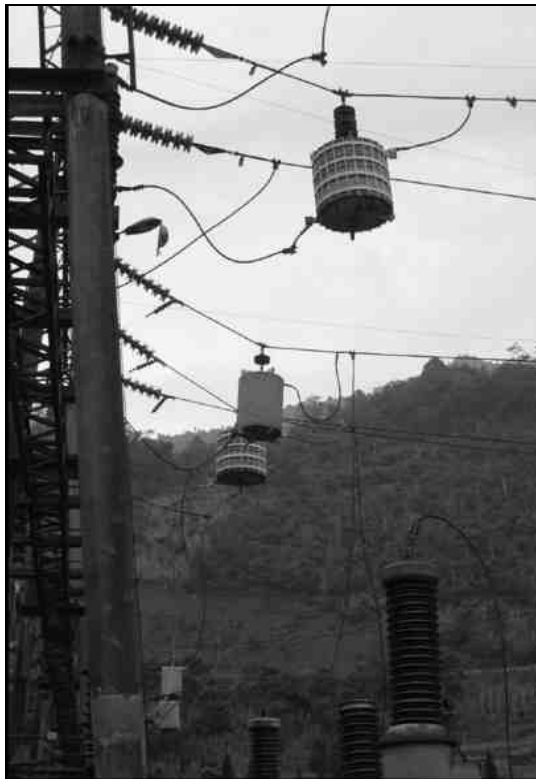
There were six hanging wave traps; none visually appeared to be damaged. Five wave traps (WT) are shown in Figure 4.22. In Figure 4.22, all three bus drops to the three power transformers (PT) were broken, probably due to large movements of the hanging WTs and insufficient slacks that impacted the drop. Though less likely, it may also have been caused by cable dynamics.

Fig. 4.22. Hanging wave traps and damage to bus connections to PTs. 15 percent of DS adjacent to hanging WTs were damaged due to pulldown

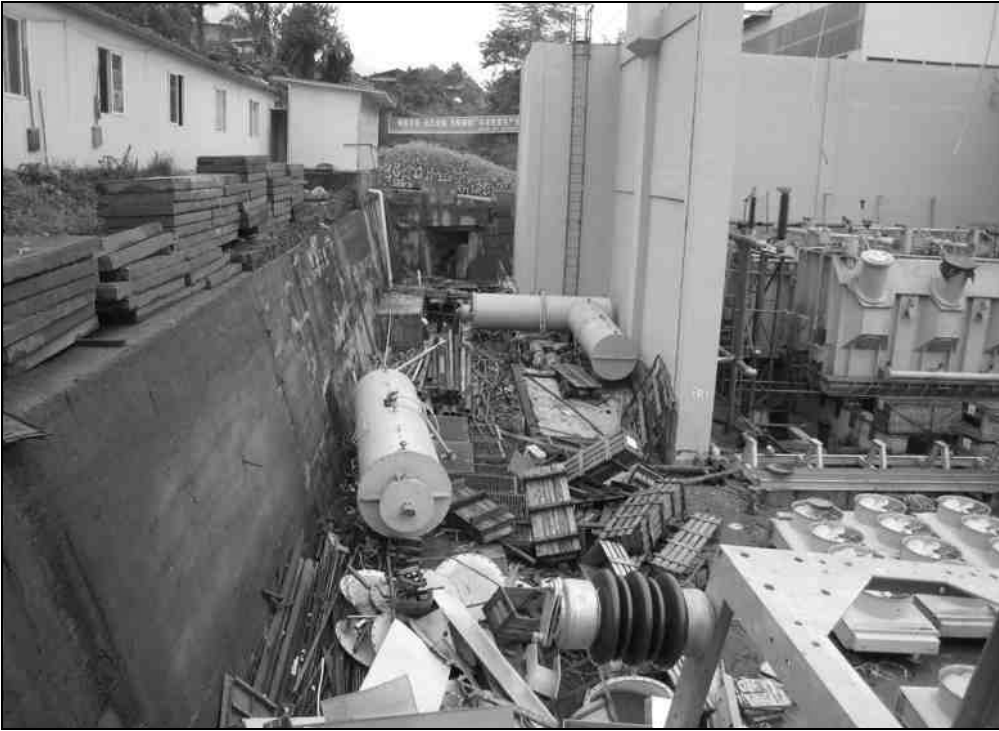
We observed that 15 220 kV and 15 110 kV bushings and all radiators had been removed. At least three of the 10 oil conservators had been removed as well (Fig. 4.25). From the “boneyard” (Fig. 4.28, and 4.29), at least one 220 kV bushing was damaged beyond salvage (gross broken porcelain), and the porcelain of one other 220 kV bushing had apparent slippage from its metal support structure (Fig. 4.29).

Fig. 4.25. Oil conservator tanks

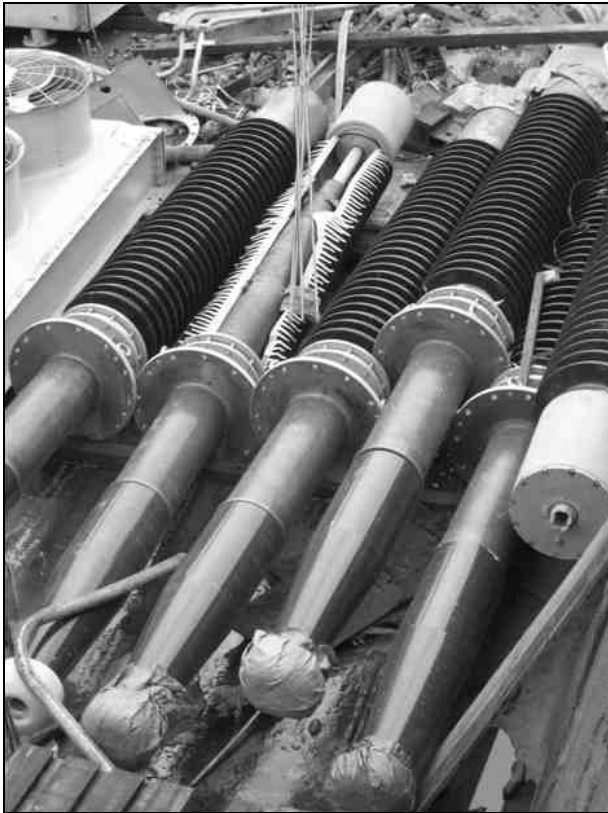
Fig. 4.28. "Boneyard" with damaged 220 kV bushings

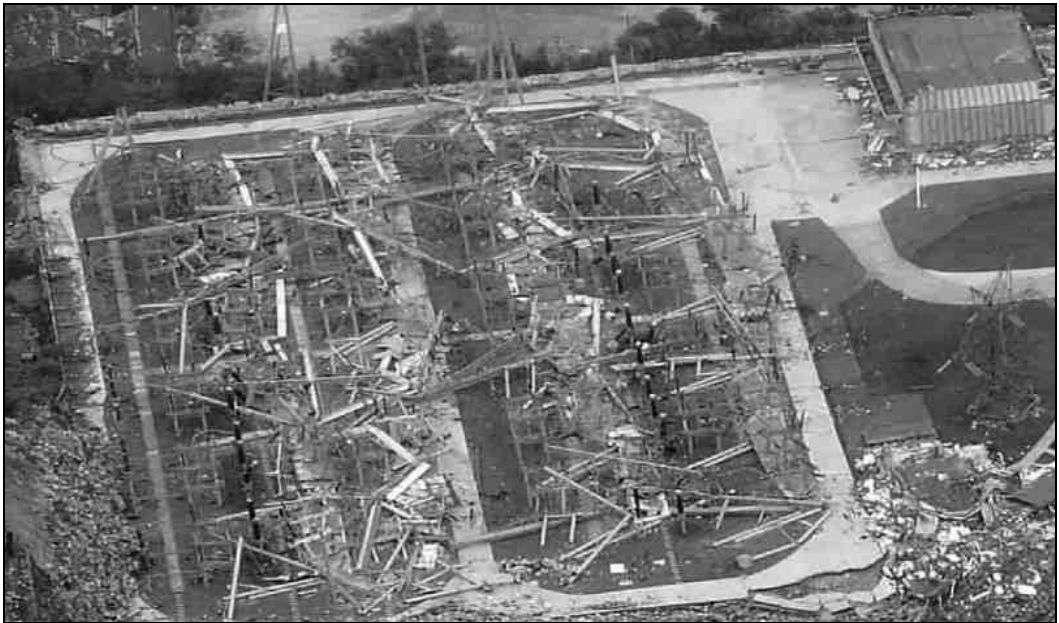
Figure 4.30 shows an aerial view of the destruction of Ertaihan substation in Yingxiu. The primary cause of the damage is inertial induced destruction of concrete dead-end structures, resulting in collateral damage to transformers and circuit breakers.

Fig. 4.30. Destruction to Ertaihan Substation, 220 kV, Yingxiu

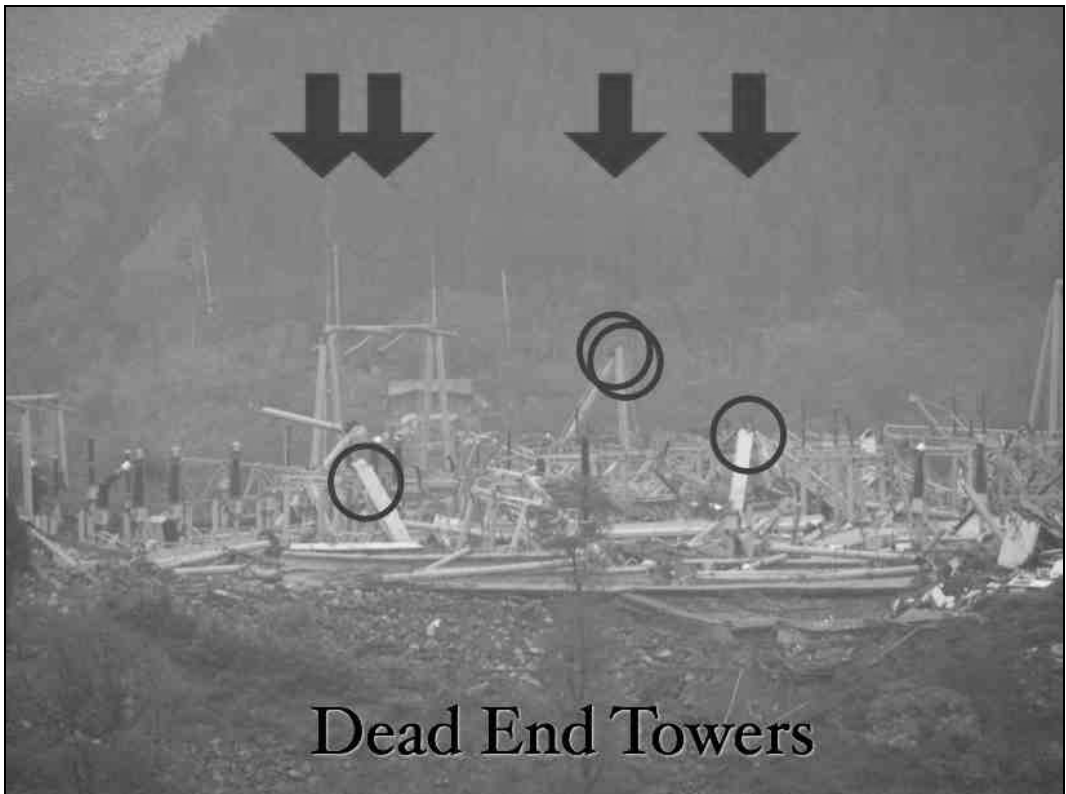
Fig. 4.31. Destruction to dead-end towers, Ertaihan Substation

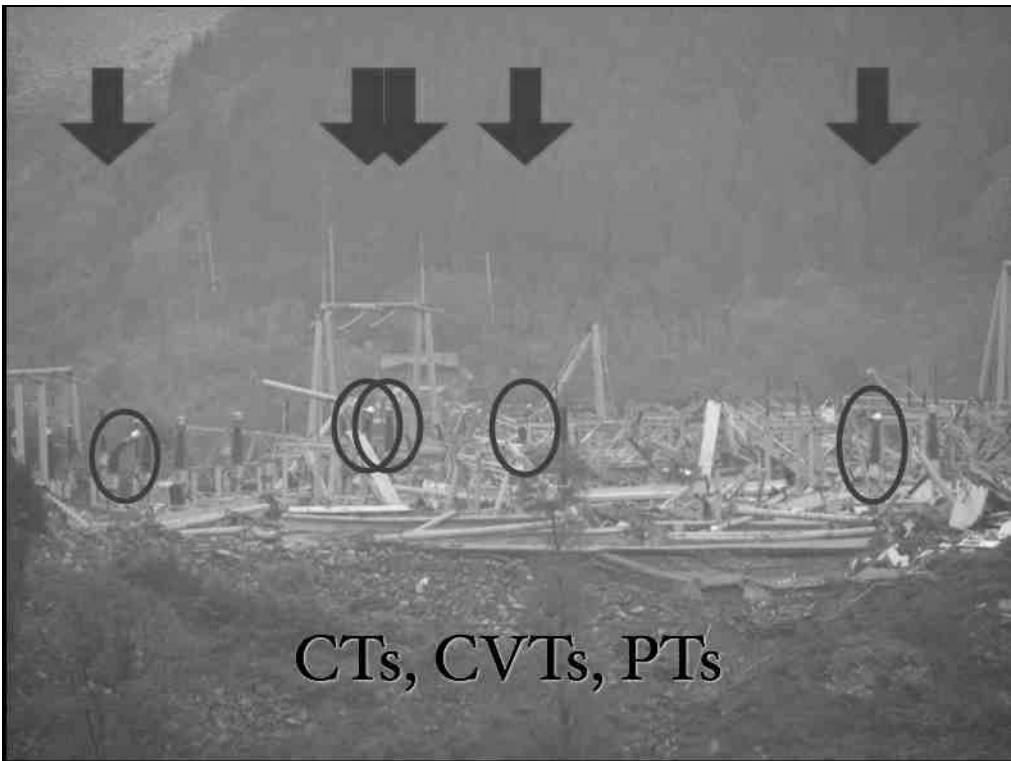
Fig. 4.32. Destruction to yard equipment, Ertaihan Substation

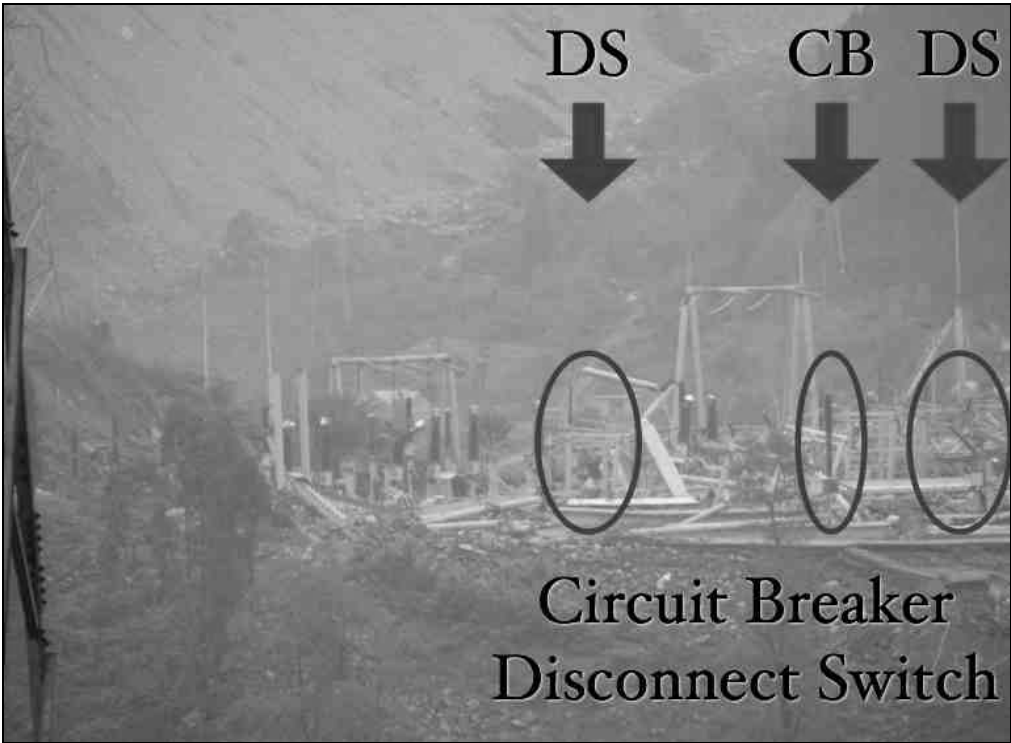
Fig. 4.33. Destruction to yard equipment, Ertai Shan Substation

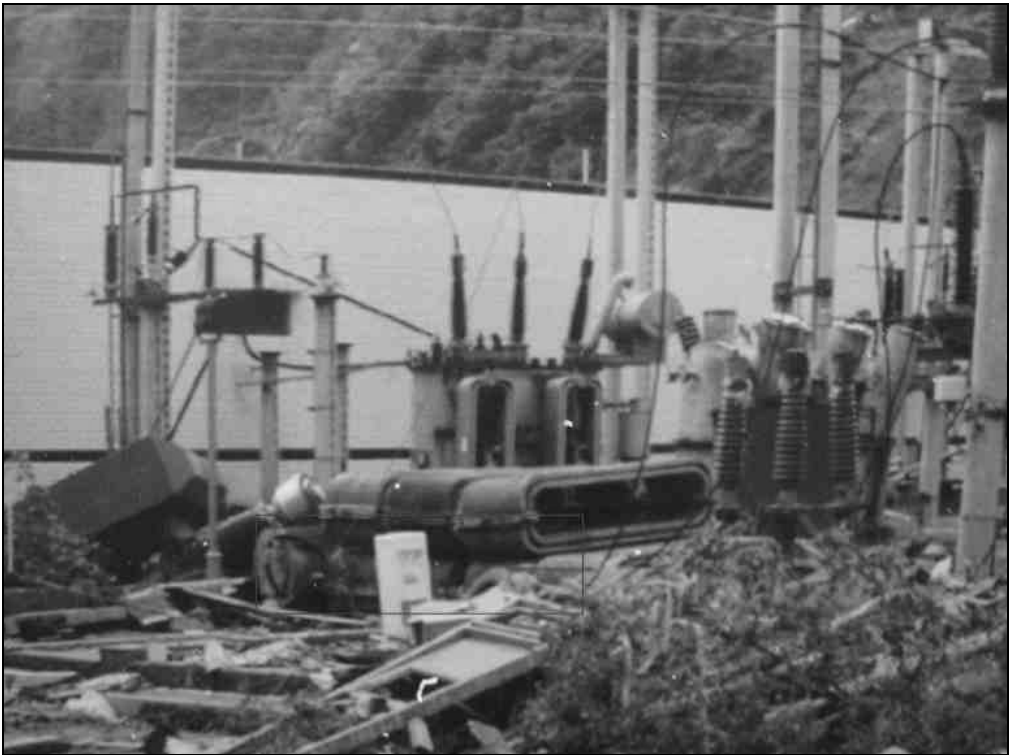
Fig. 4.34. Damage to Beichuan substation, 110 kV (May 2009 photo)

Figure 4.34 shows damaged transformer radiators (left) and a collapsed dead-end tower (pole lying down to right).

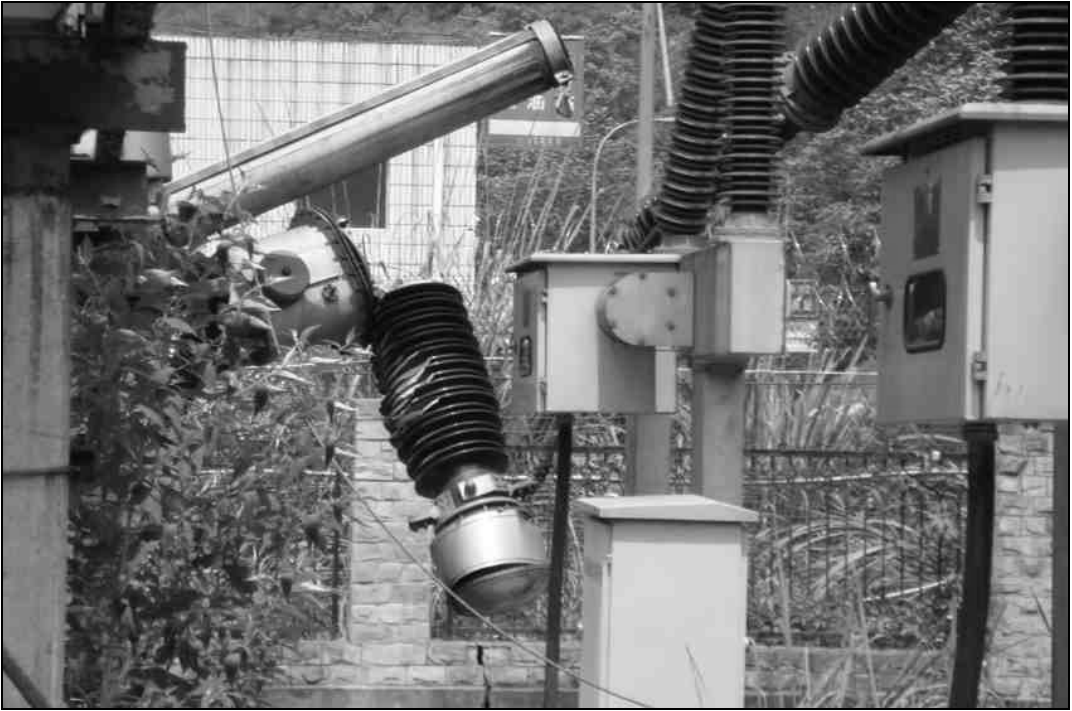
Figure 4.35 shows a collapsed current transformer that appears to have been impacted by the collapse of the top beam and masts of a dead-end structure (Fig. 4.36). Dead-end structures collapsed at several substations: one at this substation, one or more at the Beichuan 220 kV substation, three at Ertaishan 220 kV substation, and one at Yinxing substation (likely impacted by landslide). The cause(s) of these collapses remains speculative and might have been resulted from any of the following:

Fig. 4.35. Damage to Beichuan substation, 110 kV (May, 2009 photo)

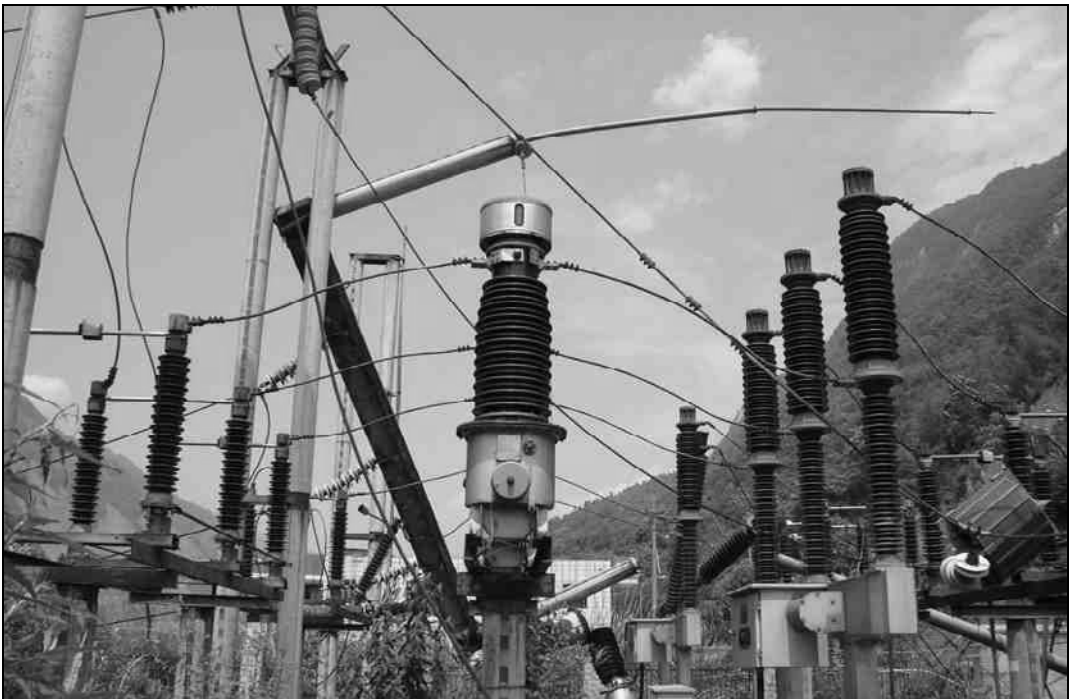
- inertial overload on the dead-end structure;
- pull-down forces caused by falling substation equipment with attached bus to the dead-end structure;
- collapse of other nearby items (possibly light poles and such) that might have impacted the dead-end structure; and
- impact from landslide.

Normally in the United States, these dead-end structures have been assumed to be seismically-robust in that they were elastically designed for unbalanced line loads plus wind and ice loads, which in almost every instance exceed the loads from even the largest earthquakes. Certainly, these collapsed dead-end structures in China should be further investigated to determine the cause of failure, as their impacts on nearby substation equipment resulted in substantial damage.

Fig. 4.36. Damage to Beichuan substation, 110 kV (May 2009 photo)

- Every dead-end tower in China within substations should be evaluated and, where necessary, rebuilt using materials (either steel or reinforced concrete) that can sustain the worst case loading of wind + ice + line loads or $\text{PGA}=0.5$ g without damage (keep stresses in steel below $0.96 F_y$). All such structures that currently use under-reinforced concrete tubes should be replaced in a 5- to 10-year effort. Impact of the dead-end towers by adjacent under-designed items (like light poles) must be avoided; whenever possible relocate these items. The replacement of dead-end structures program should start with the critical nodes (substations) first.

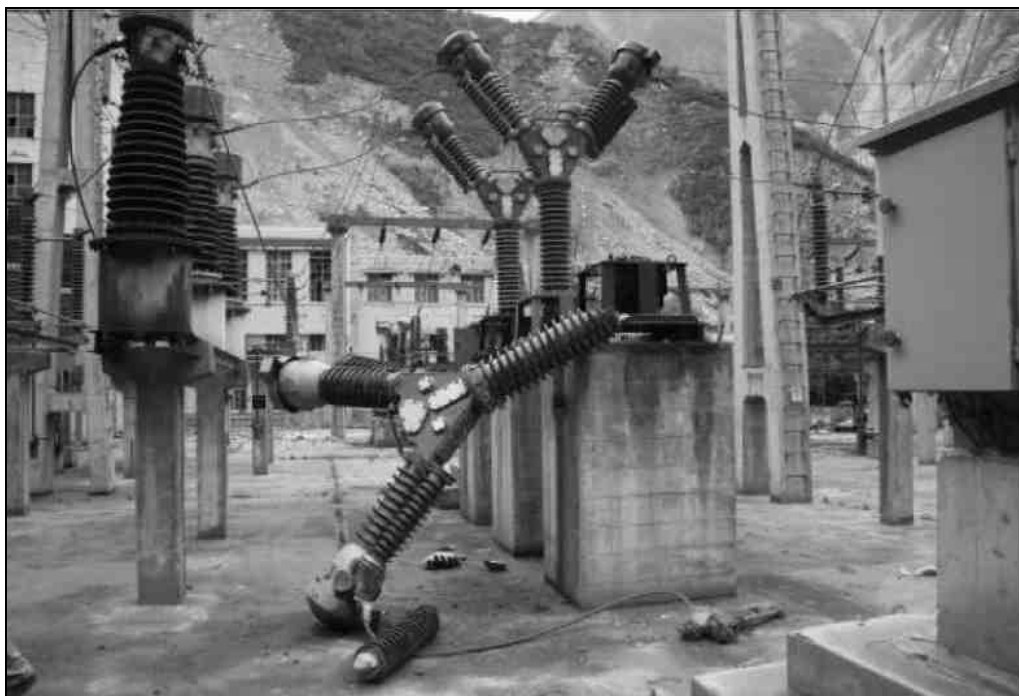
Figure 4.38 shows a damaged live tank circuit breaker at the Caopo power plant. The current transformer to the left of the broken breaker has a taugh cable holding up the broken breaker, and the discoloration of the CT shows oil leakage, likely due to the high load. On the other side, the breaker is attached to the remnants of a broken disconnect switch, likely broken due to pull-down.

Fig. 4.38. Circuit breaker with damaged adjacent current transformer and disconnect switches due to pulldown

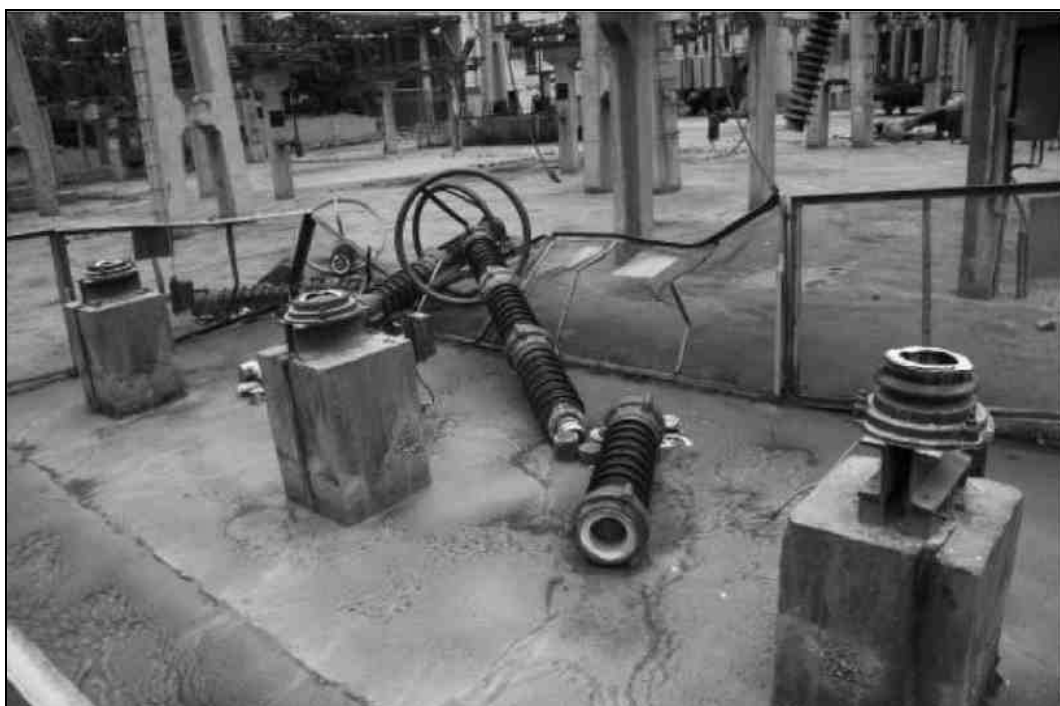
Figure 4.39 shows damage to CVTs at the Caopo power plant.

Fig. 4.39. CVT damage

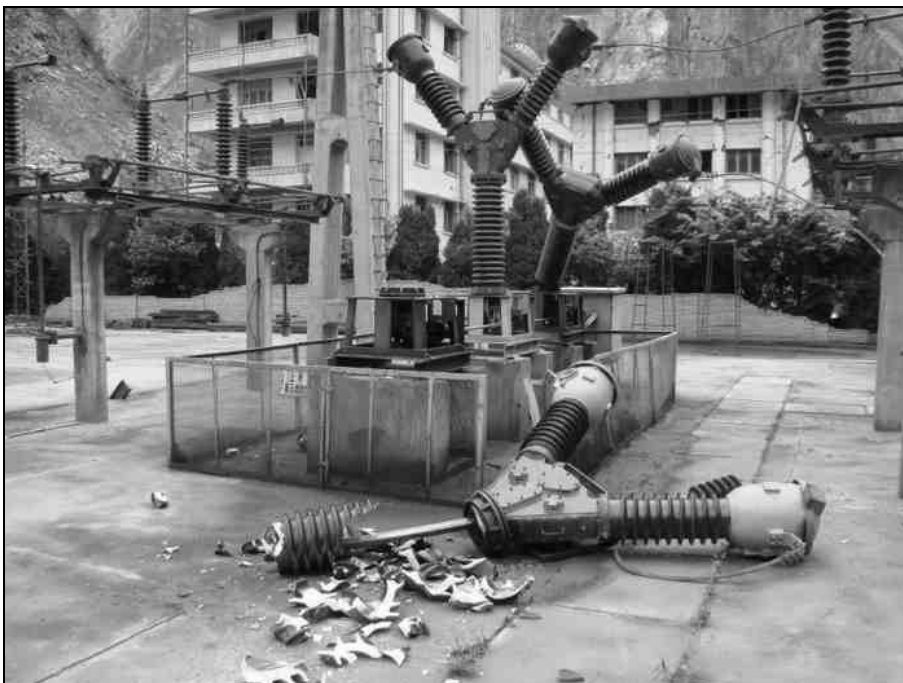
Figure 4.40 shows damage to the 110 kV live tank circuit breakers. These types of breakers have been damaged in past earthquakes around the world. They were prevalent in China and were damaged at many different substations. The damage to the horizontal break disconnect switches to the left of the breakers is most likely caused by pulldown of the failed breakers. The influence of the tight (little to no slack) bus in the failure of the breaker is uncertain, but once the breaker fails, the pulldown of the adjacent switch is not uncommon. Figure 4.40 shows a close up of the porcelain column for one of the damaged breakers. Notice the failed URM brick wall in the background, from which we assume that the local PGA must have been at least 0.30 g. The background of Figure 4.40 shows x-cracks in non-ductile concrete frame columns, further illustrating that the ground motion at this substation was likely in excess of $PGA = 0.30$ g.

Fig. 4.40. Damage to live tank circuit breakers, Caopo Power Plant

- Live tank circuit breakers should be replaced for all critical circuits using either dead tank bulk oil (older style) or dead tank SF6 (newer style); all equipment must be adequately anchored. For areas of the country where the 475-year PGA exceeds 0.30 g, bushings for high-voltage transformers (200 kV and higher) should be seismically qualified (IEEE 396).
