WENCHUAN, SICHUAN PROVINCE, CHINA, EARTHQUAKE OF 2008

Lifeline Performance

Technical Council on Lifeline Earthquake Engineering
Monograph No. 39

Earthquake Investigation Committee of the
Technical Council on Lifeline Earthquake Engineering

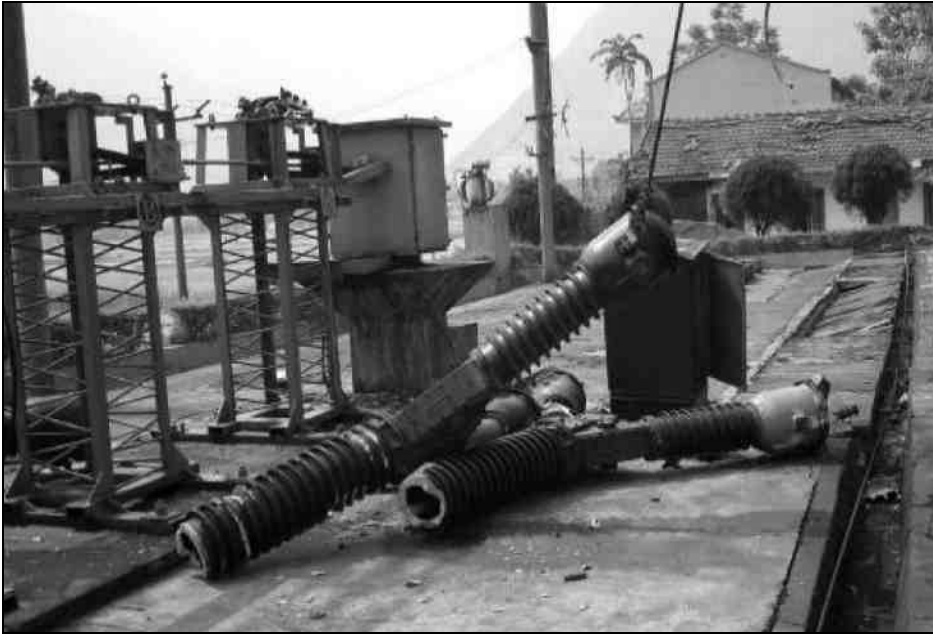
Figure 4.41 shows broken live tank circuit breakers at the Yuanmenba substation. These types of breakers had a very high failure rate (likely exceeding 75 percent) whenever exposed to a $PGA > 0.35$ g or so.

Fig. 4.41. Live tank breaker damage, Yuanmenba Substation

- Live tank circuit breakers should be replaced for all critical circuits using either dead tank bulk oil (older style) or dead tank SF6 (newer style); all equipment must be adequately anchored. For areas of the country where the 475-year PGA exceeds 0.30 g, bushings for high-voltage transformers (200 kV and higher) should be seismically qualified (IEEE 396).

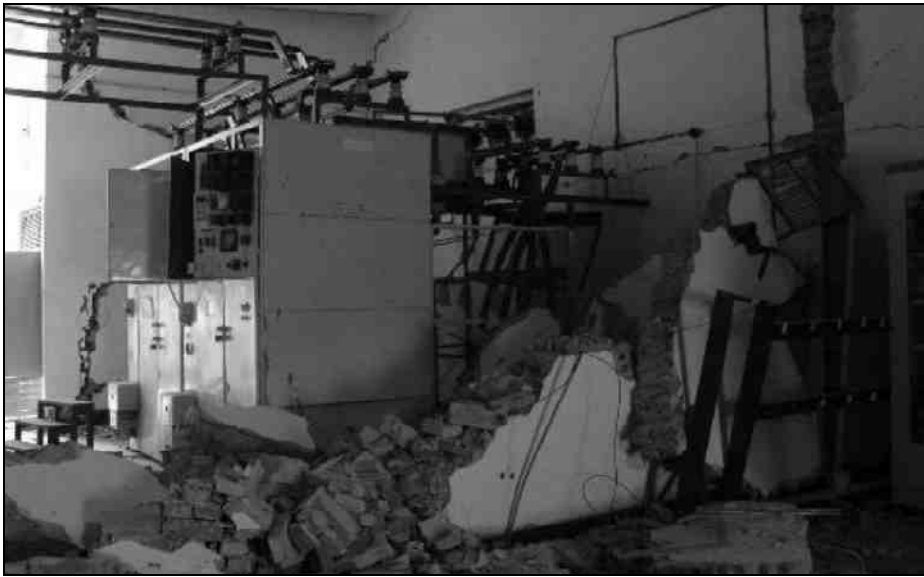
Collapse of control buildings led to the damage of low-voltage switchgear equipment within. Figure 4.42 shows the partially collapsed URM control house at Yuanmenba substation.

Fig. 4.42. Control Building Equipment Damage, Yuanmenba Substation

While costly, seismic improvement should be made for existing substation control buildings. Most if not all of the failures of the substation control houses could easily have been mitigated had China rigorously adopted and implemented a higher seismic standard for critical facilities. Upgrading substation control houses requires a long-term mitigation plan, but it is necessary because of the vulnerability of these buildings and the risks they present to the post earthquake performance mitigation program.

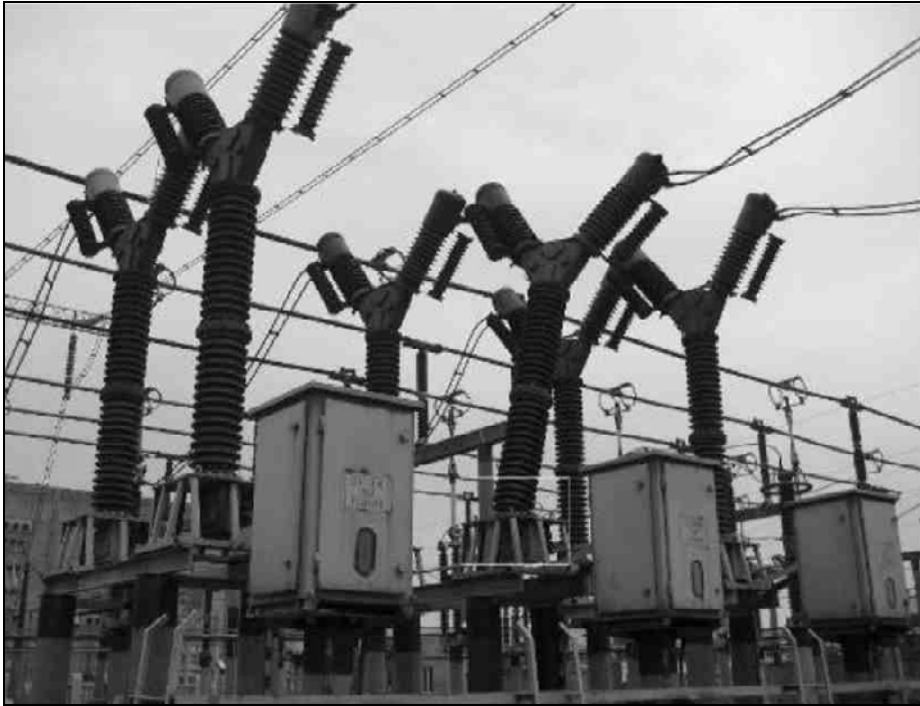
Fig. 4.43. 220 kV live tank circuit breaker damage, Yongxing Substation, Mianyang

Figure 4.43 shows damage to 220 kV circuit breakers. Note the extra height of the porcelain required for higher voltage installations as compared to the 110 kV installations. The taller height leads to higher overturning moments, and the larger diameter porcelain is still insufficient to resist the applied loads. The level of ground shaking at this location was likely under $PGA = 0.15$ g.

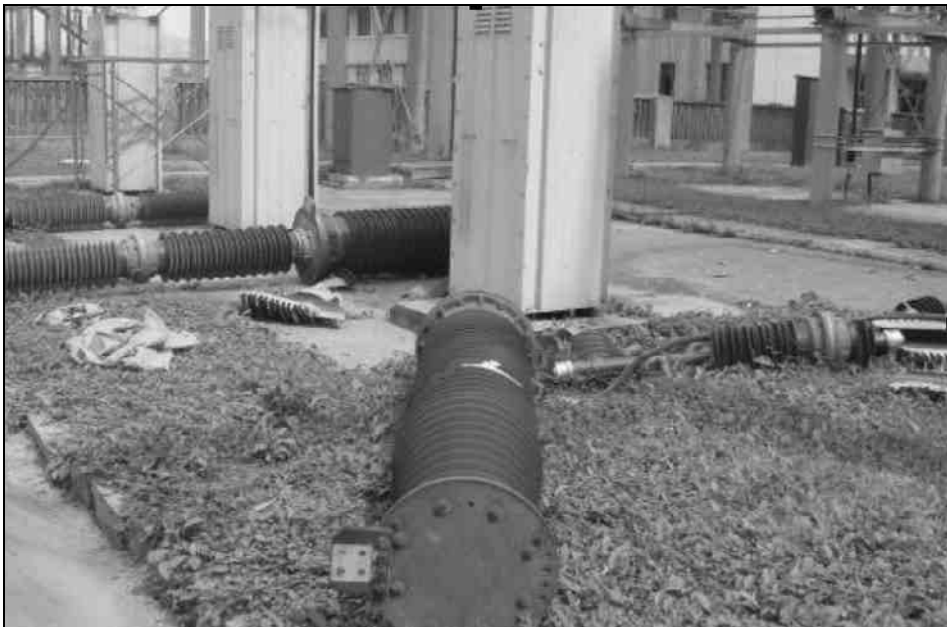
Figure 4.44 shows damage to ABB candlestick-type 220 kV circuit breakers.

Fig. 4.44. Live tank breaker damage, Jiangyou Power Plant

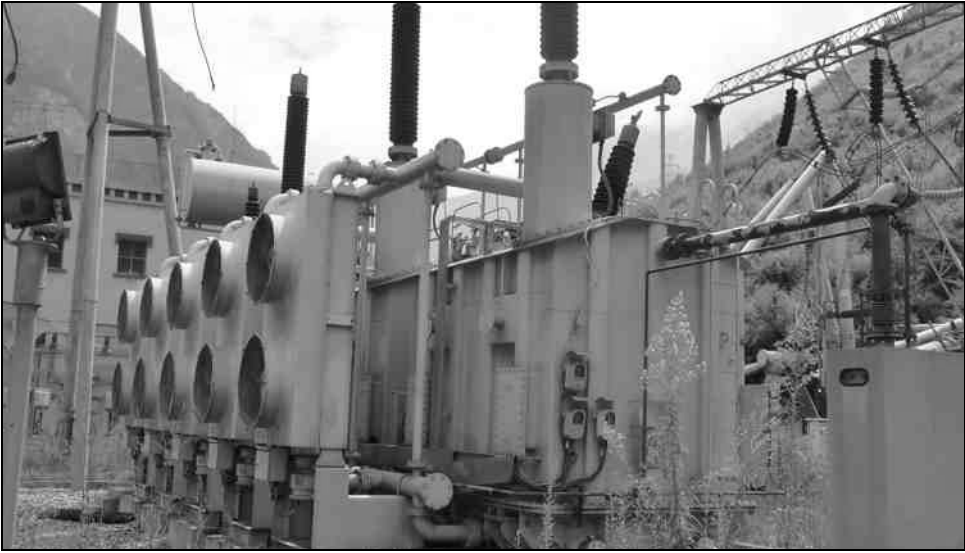
The 220/110kV transformer banks were supported on concrete grade beams and had welded anchorages to embedded steel. The high- and low-side bushings of the remaining bank appeared to be intact (Fig. 4.45), but surge arresters were damaged. Damaged 220kV bushings from the bank that had been removed were left in the yard, and cracked cast aluminum flanges were visible (Fig. 4.46).

Fig. 4.45. 220/110kV transformer

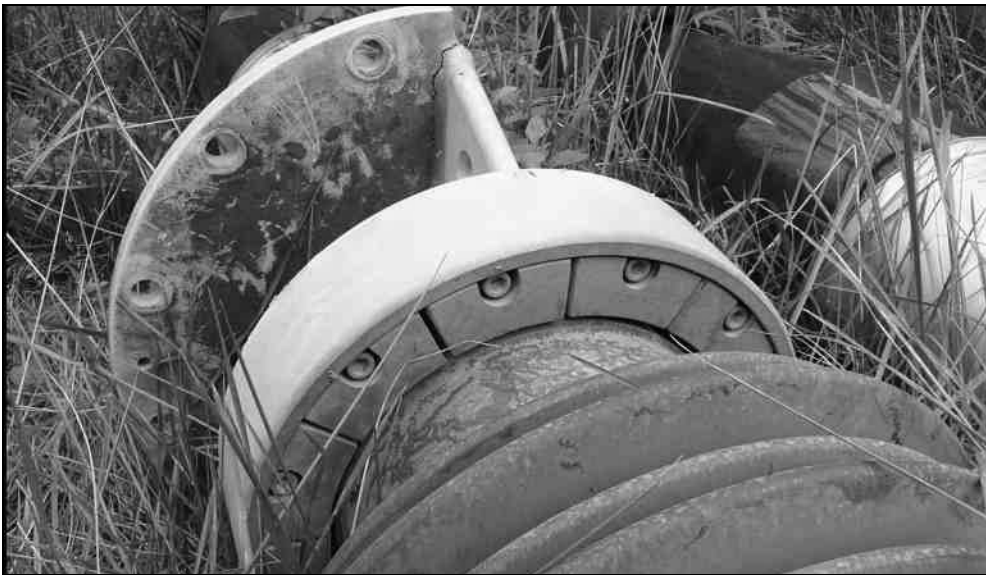
Fig. 4.46. 220kV bushing with cracked flange

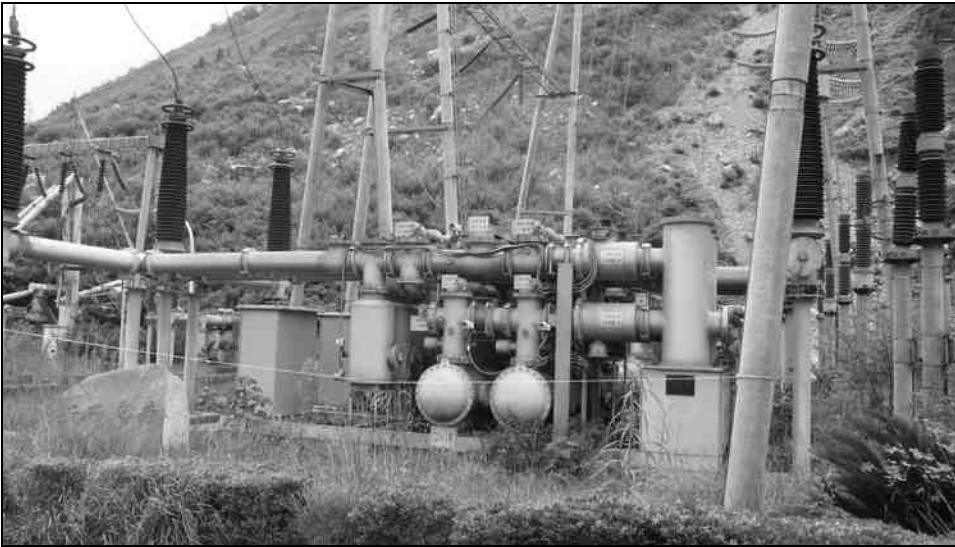
The 220kV GIS equipment (Fig. 4.47) did not appear to be damaged, but it is unknown whether gas leaks or internal damage occurred. The 110kV GIS equipment (Fig. 4.48) was located at the back of the station against the slope and was destroyed in the landslide.

Fig. 4.47. 220kV GIS equipment

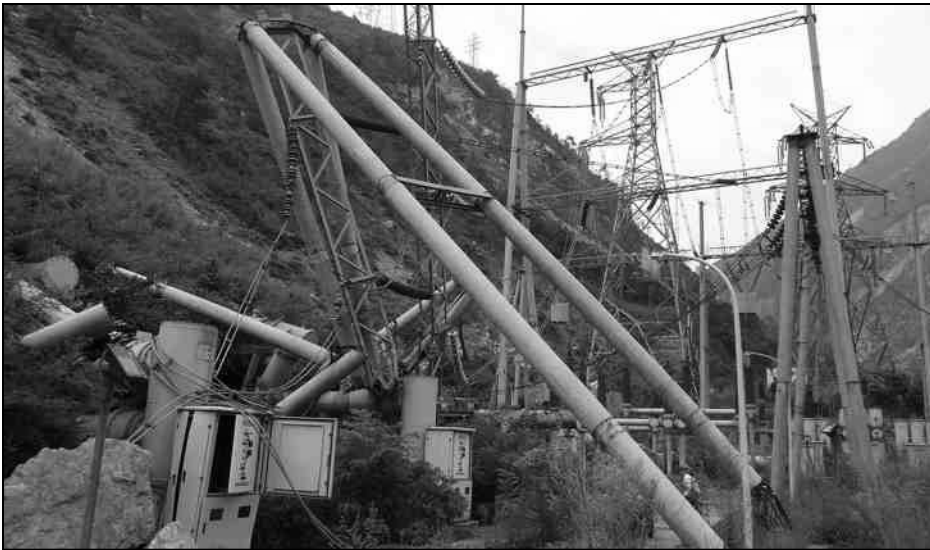
Fig. 4.48. Tubular concrete dead end structure and 110kV GIS were damaged by the landslide

The landslide collapsed several A-frame type bus supports and dead-end structures at the rear of the station. The details of these structures are of some interest because of the failures observed in other stations, presumably from inertial or conductor pull forces. The precast concrete tubes have an outer diameter of about 40 cm (16 in.) with 6 cm (2.5 in.) wall thickness and are reinforced with 18 smooth reinforcing steel bars (about 12 mm [$\frac{1}{2}$ in.] in diameter) and a smooth wire spiral shear reinforcement (Fig. 4.50). The bars are anchored by welding to the interior wall of a steel sleeve at each end. To create a longer section of tube, two or more sections are joined together by welding one sleeve to another. Light-weight welded steel trusses, consisting of angle chords and bar web members, span the A-frames so that conductors or suspended

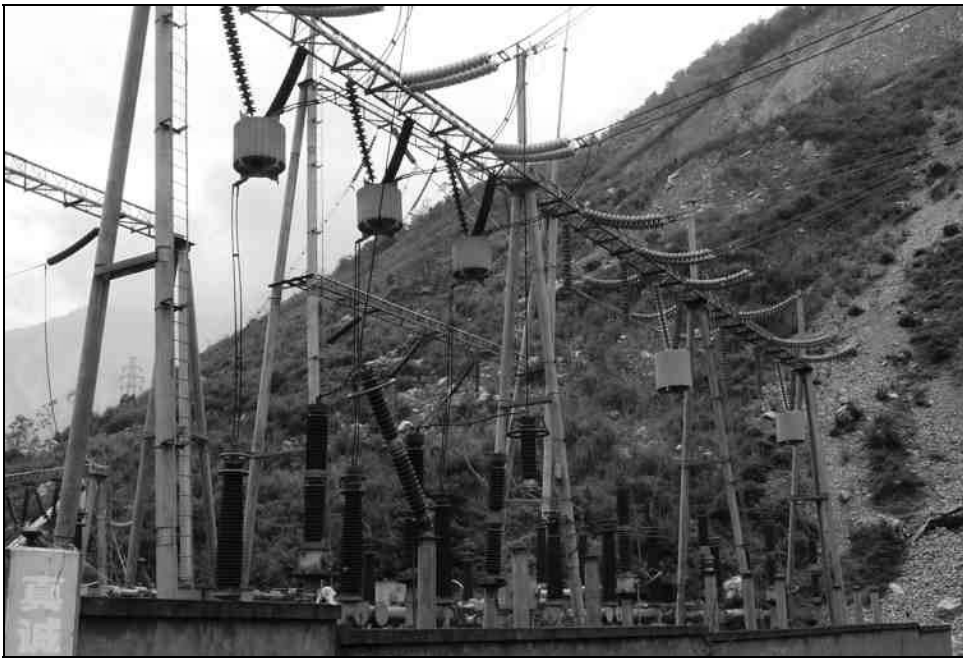
Wave traps were suspended from the dead-end structures with no lateral restraint; however, no damage conclusively attributed to this arrangement was observed. One of the wave traps was noted to be missing and may have fallen. All the surge arresters in Figure 4.49 were observed to have fractured, possibly caused by inertial overload on the surge arrester directly or induced by conductor loading effects (nine of nine surge arresters appear to have failed).

Fig. 4.49. Suspended wave traps, arrester damage (July 2009)

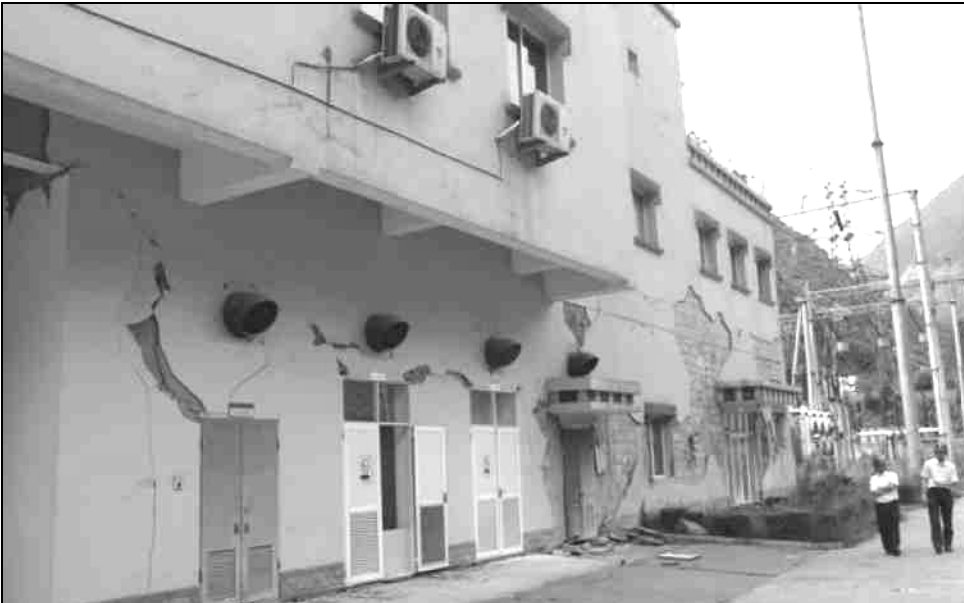
The two-story control building shown in Figure 4.51 had significant damage to its stucco finish and portions of its infill. The infill consisted of concrete blocks and bricks in some places. The moment frame did not appear to be distressed. A single-story building at the site exhibited only minor damage to the stucco finishes. The perimeter brick with stucco finished substation walls had some cracking and spalling, but did not collapse.

Fig. 4.51. Control building damage

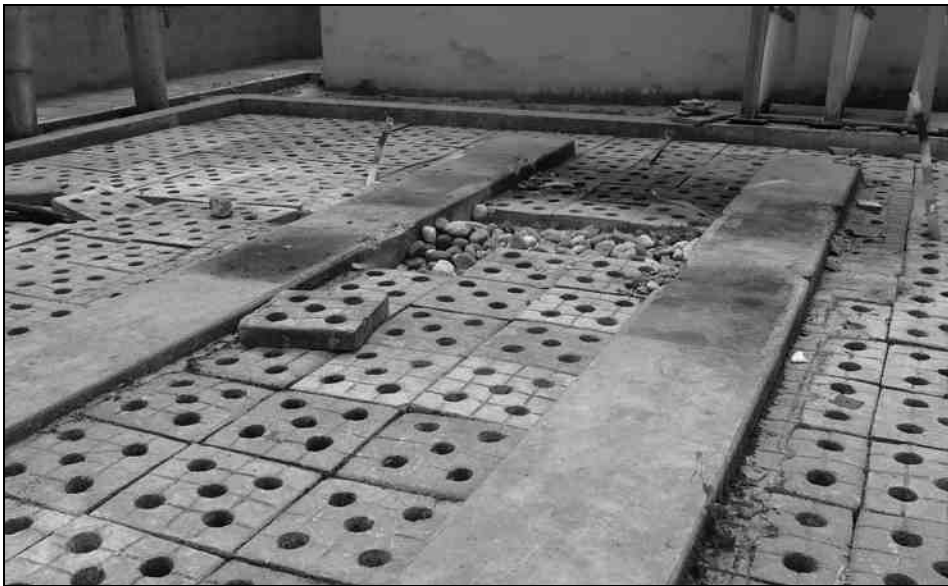
The substation perimeter walls (unreinforced brick) collapsed during the earthquake and had been rebuilt. The 110/10kV transformer was unanchored and had slid off of its foundation (Fig. 4.11). Additionally, some oil leaks were evident (Fig. 4.52). The substation buildings had only minor exterior damage; however, suspended lighting and ceiling tiles fell during the earthquake, as shown in Figure 4.53.

Fig. 4.52. Unanchored transformer slid off this foundation, later relocated.

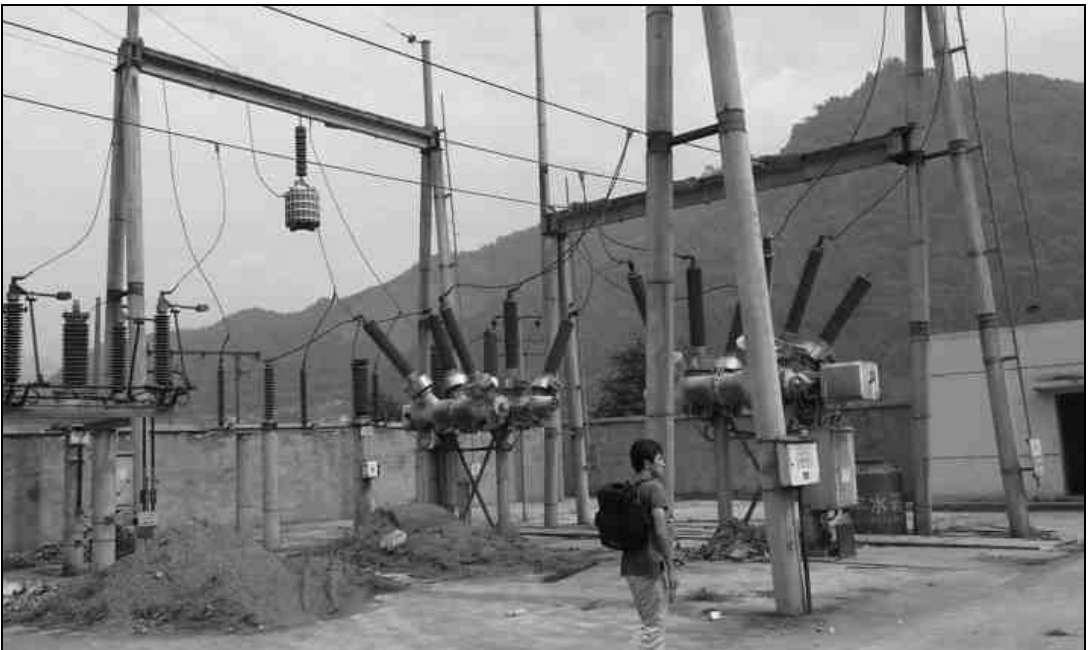
Utility representatives stated that the 110kV SF₆ dead tank circuit breakers were undamaged. This type of breaker is generally considered to be seismically rugged and is used in many high-seismic regions of the United States. No visible damage was observed in the disconnect switches or other structures, including the dead ends, which were constructed of the typical A-frame precast concrete tube columns. As shown in Figure 4.54, the A-frame structures used concrete beams instead of the light steel trusses. As seen in Figure 4.54, the potential for the hanging wave trap to swing apparently did not damage the bushing on the SF₆ circuit breaker.

Fig. 4.54. Disconnect switch, bus supports, and SF₆ circuit breakers

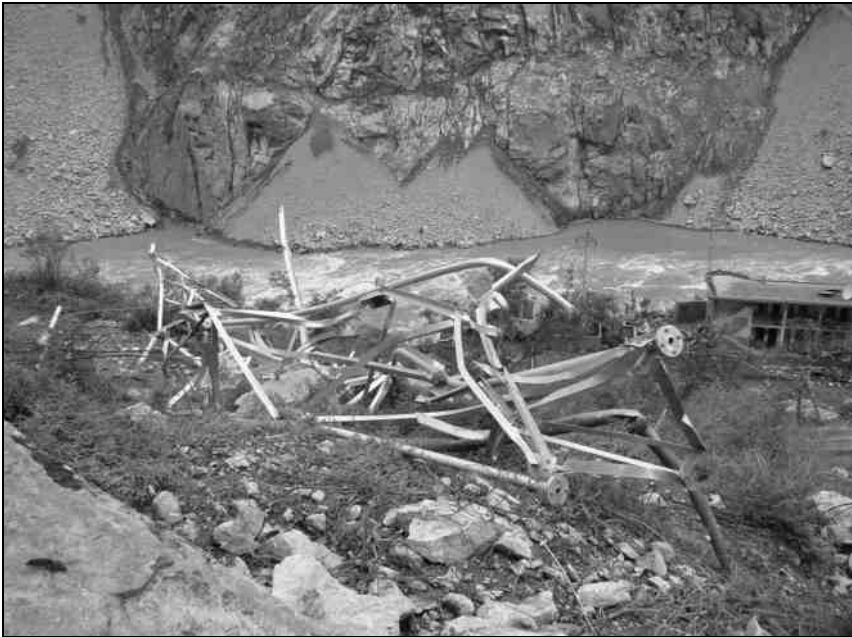
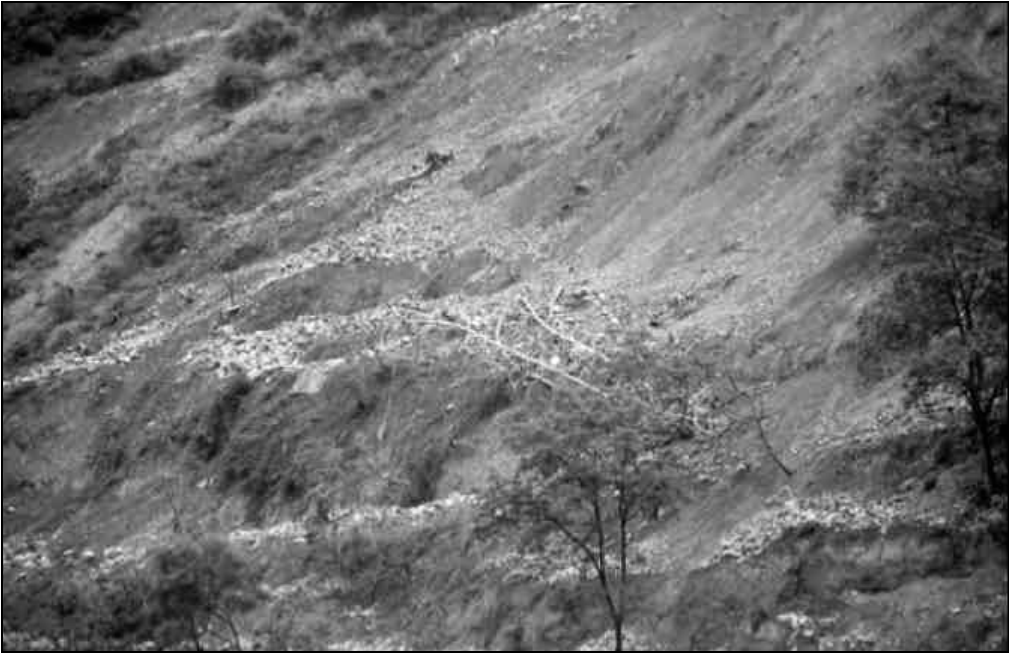
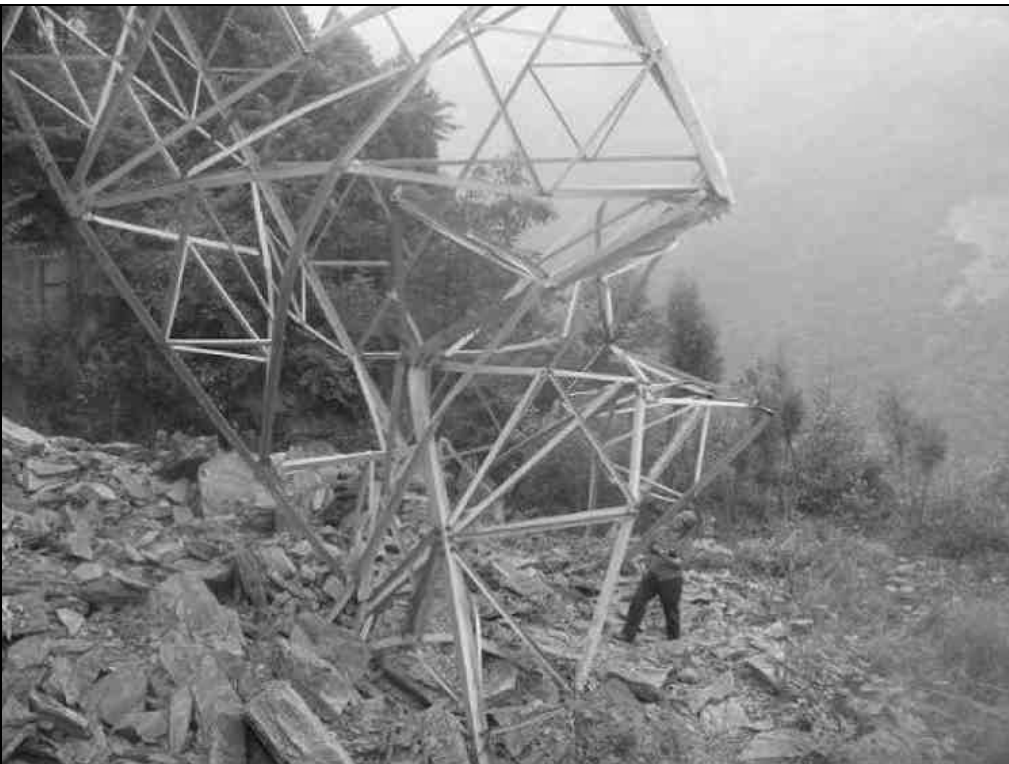
Figures 4.55 to 4.58 show collapsed towers, apparently due to landslide. Figure 4.59 shows a transmission tower that remains standing despite debris flows on either side of its four legs, but the lattice steel arm on the ground use to be atop the tower. The damage to the arm might have resulted from inertial loads or pulldown loads.

Fig. 4.55. Collapsed tower

Fig. 4.56. Collapsed tower

Fig. 4.57. Collapsed tower

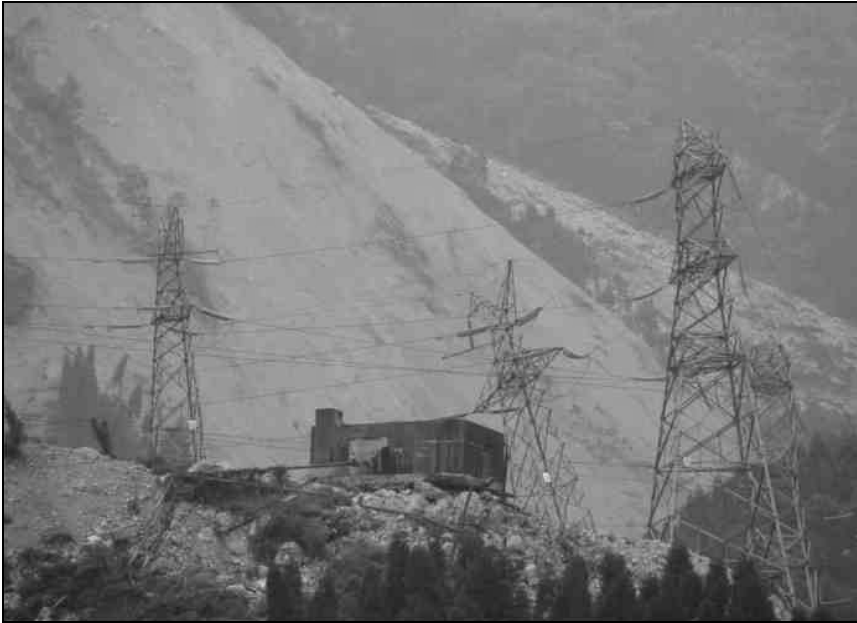
Fig. 4.58. Tilted transmission tower, possibly due to landslide (Yingxiu)

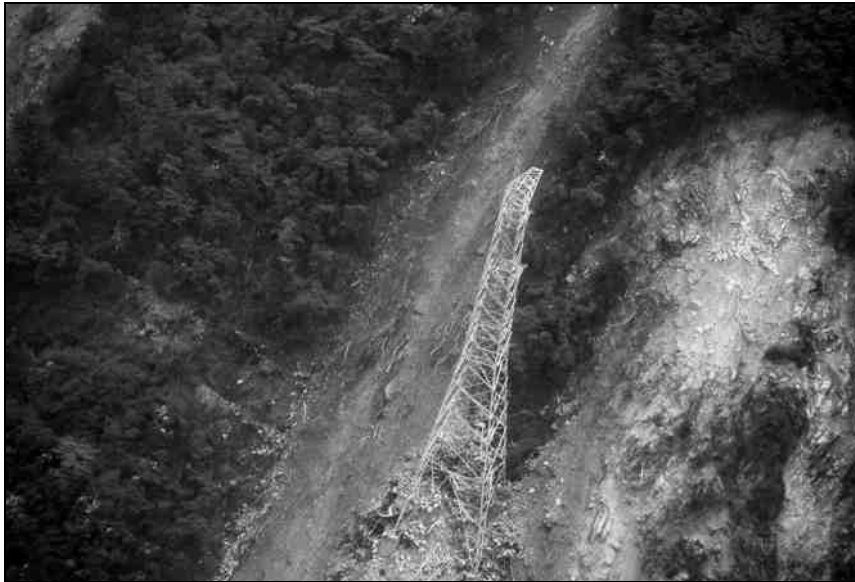
Fig. 4.59. Tower with damaged arm

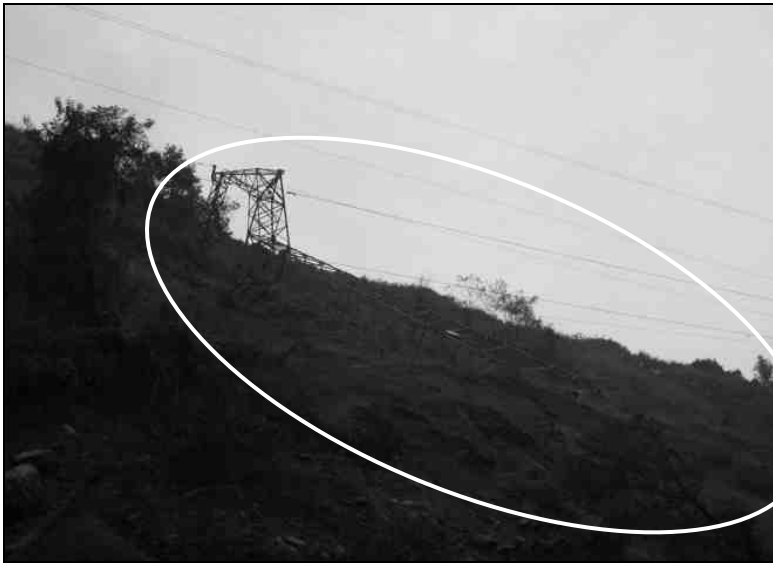
Figure 4.60 shows a collapsed 220 kV suspension tower. PLA guards prevented us from climbing up to examining the foundation, but from viewing the overall transmission line, a landslide failure of an adjacent tower (not shown) might have resulted in pulling this tower down.

Fig. 4.60. Collapsed 220 kV transmission tower

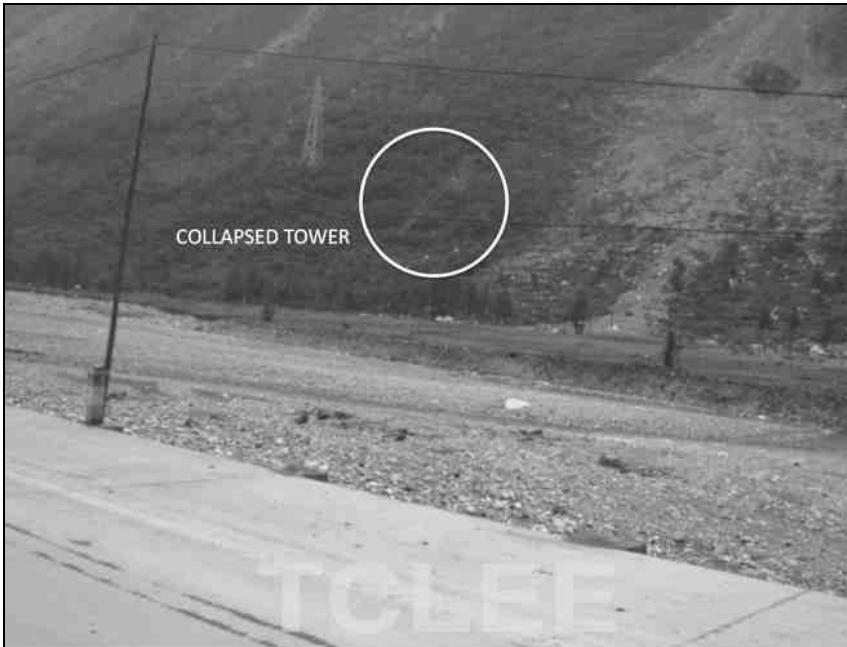
Figure 4.61 shows a reconstructed 220 kV tower, and Figure 4.62, a collapsed 110 kV tower. The two towers are located within 1 km of each other, adjacent to landslides on a mountain slope near Beichuan. We surmise that the 110 kV tower was pulled down by the landslide that affected the nearby tower. While the original tower locations remain

Fig. 4.62. Collapsed 110 kV tower

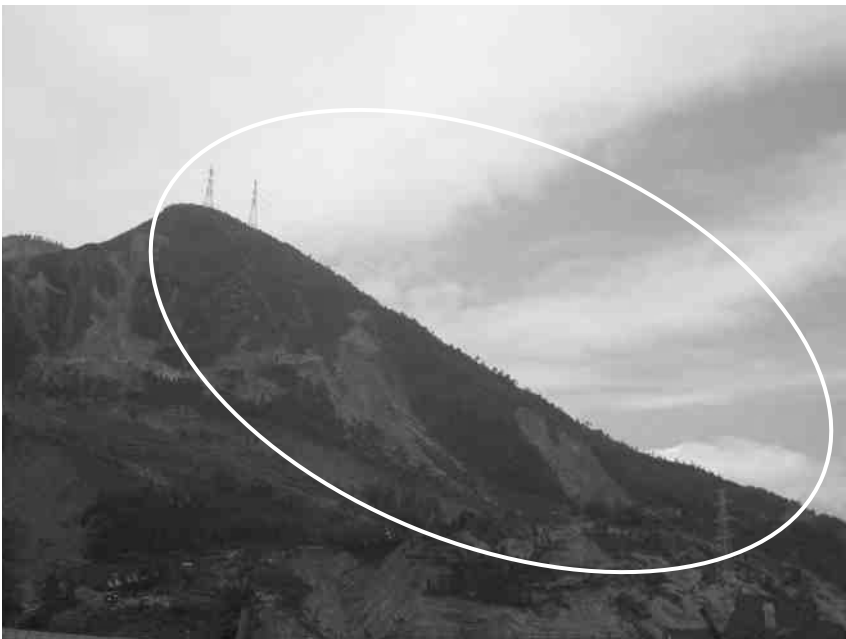
Figure 4.63 shows a collapsed low-voltage line that heads up the mountain. It is hard to see the tower poles in this photo; they were pulled down by a deep-seated landslide. The location is about 10 km west of Beichuan with estimated $PGA = 0.3 g$. The 220 kV towers at the ridge crest were unaffected by the landslide. Figures 4.64 through 4.70 show additional damaged transmission towers.

Fig. 4.63. Collapsed 10 kV line

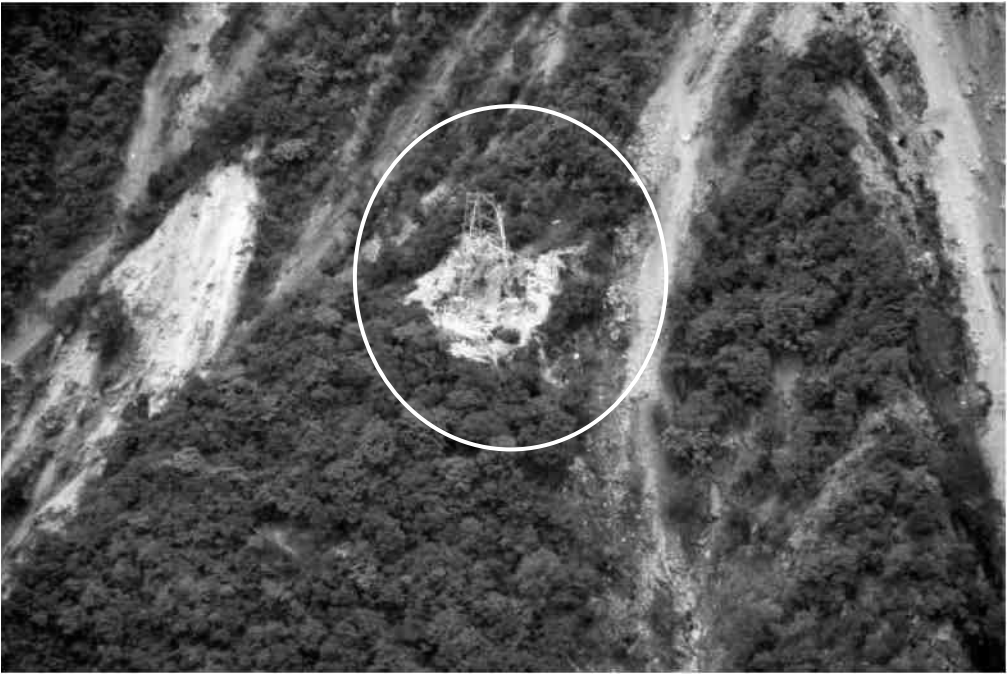
Fig. 4.64. Collapsed tower

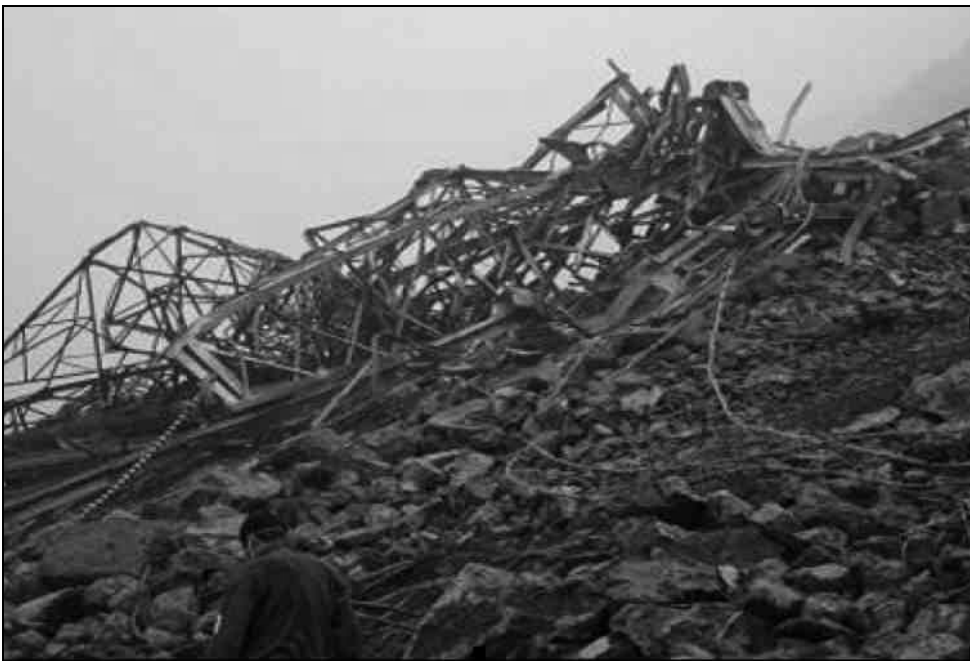
Fig. 4.65. Collapsed tower, #123, 500 Maotan line

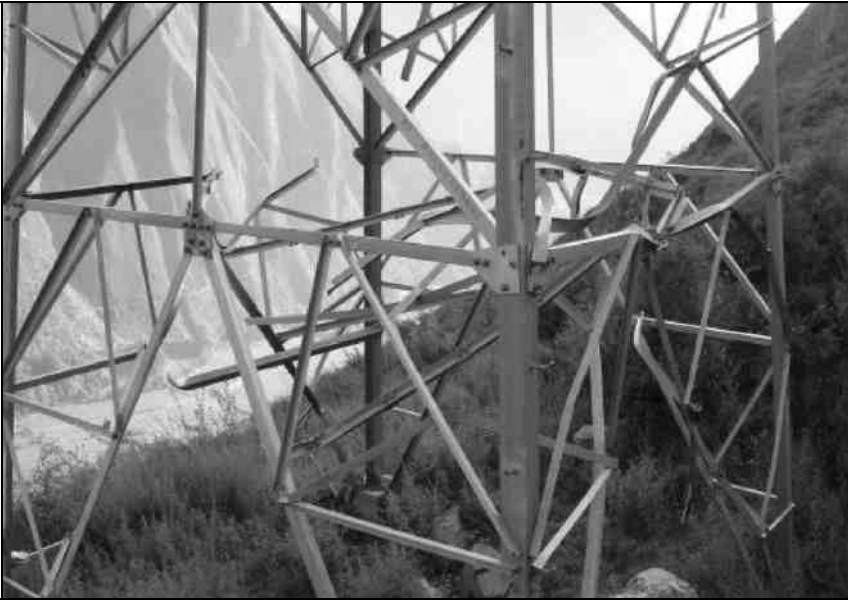
Fig. 4.66. Rack fall-impacted tower, #123, Hongxue line of Yingxiu Town

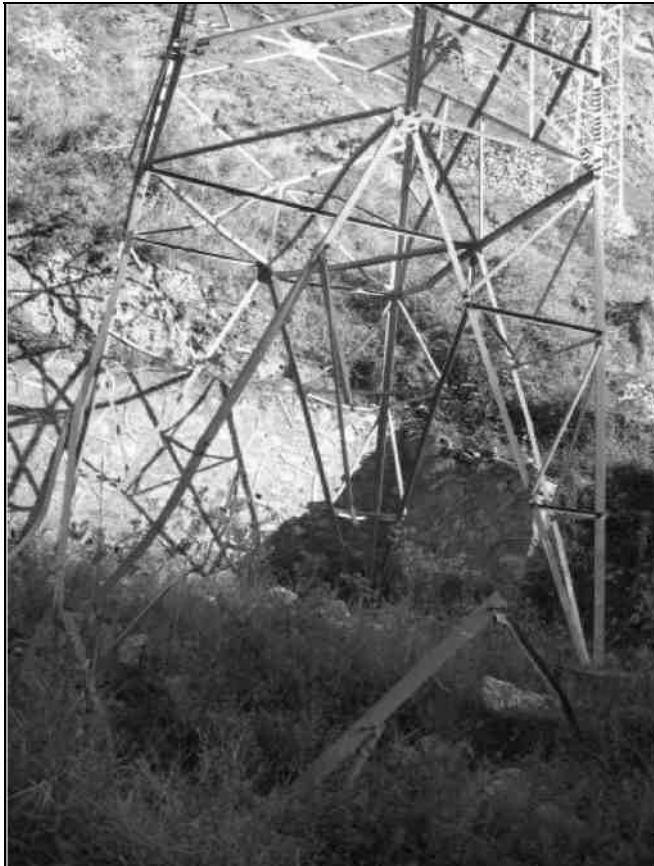
Fig. 4.67. Rock fall-impacted tower, #79, Zhouman line

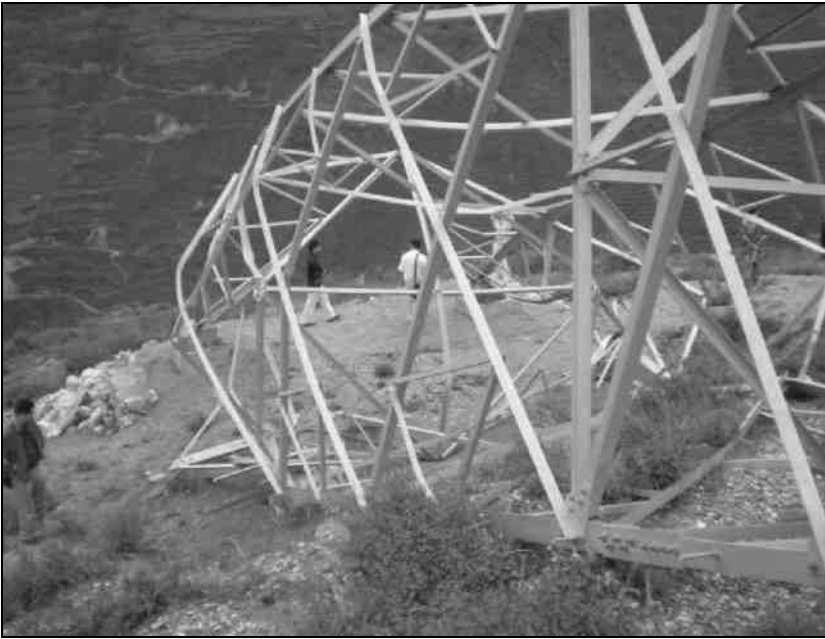
Fig. 4.68. Collapsed Tower, #13, Jiangsang line

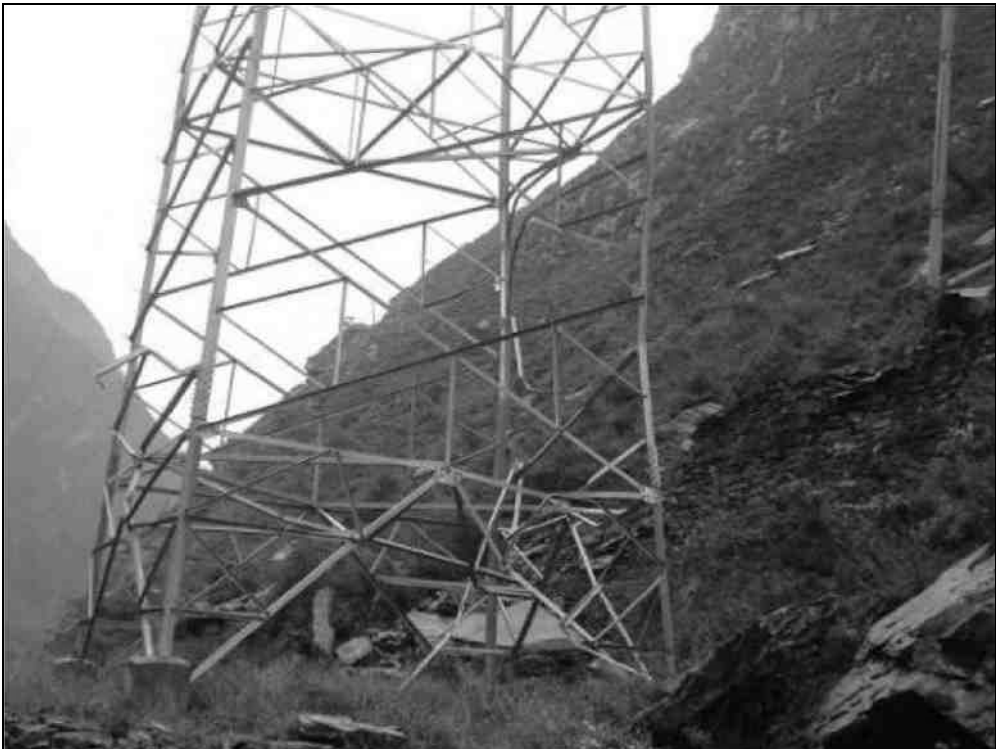
Fig. 4.69. Rockfall impacted tower, #14, Tianjin line, Jinlong Lake area, Wenchuan

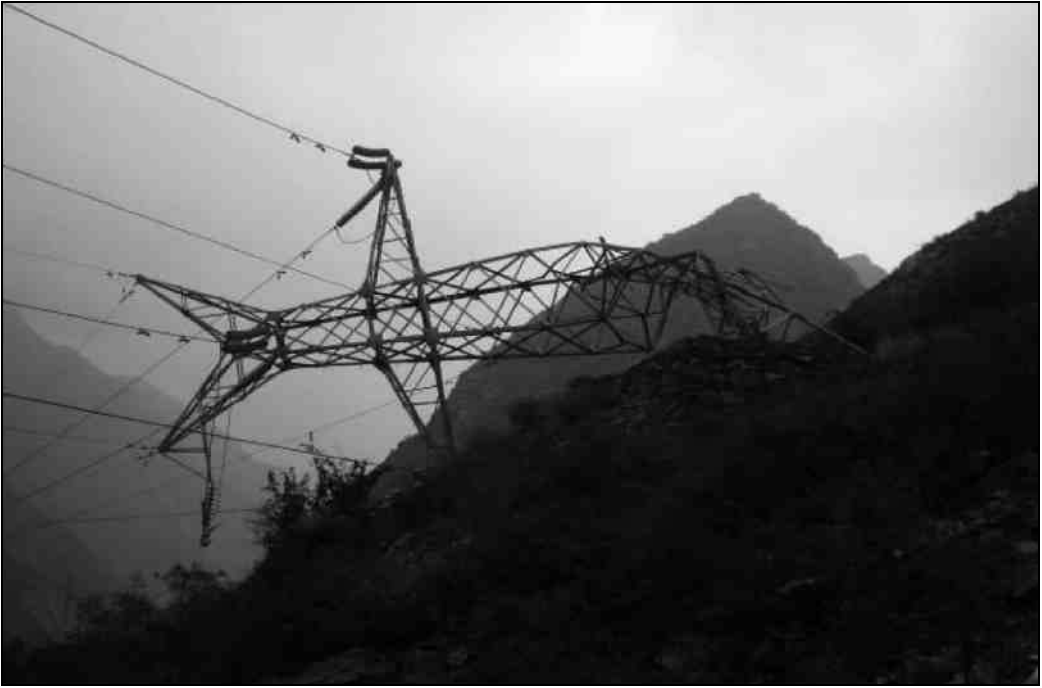
Fig. 4.70. Collapsed tower, #11, Tianjin line, Jinlong Lake Area, Wenchuan

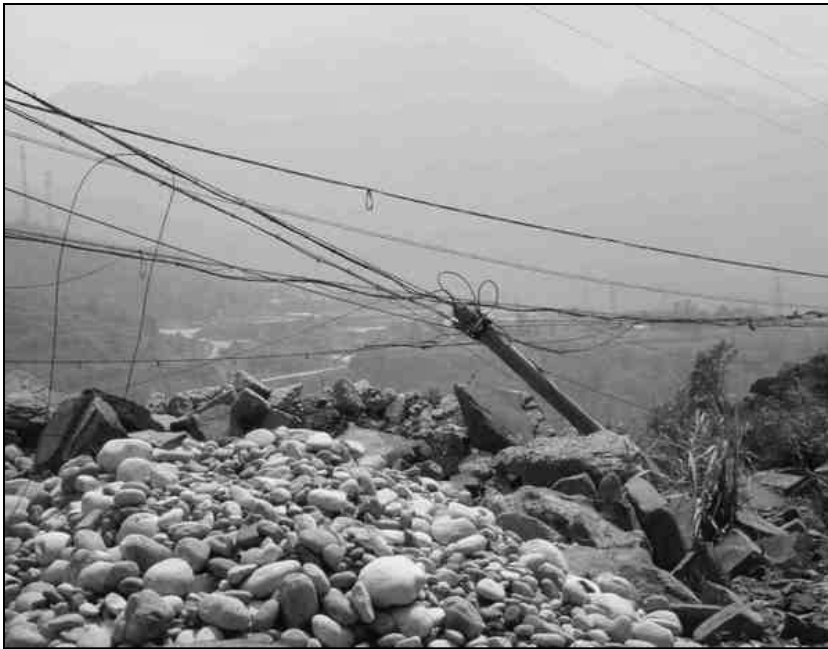
Landslides and rock falls caused loss of poles in many areas (Fig. 4.72).

Fig. 4.72. Pull down of power and telecom distribution due to landslide

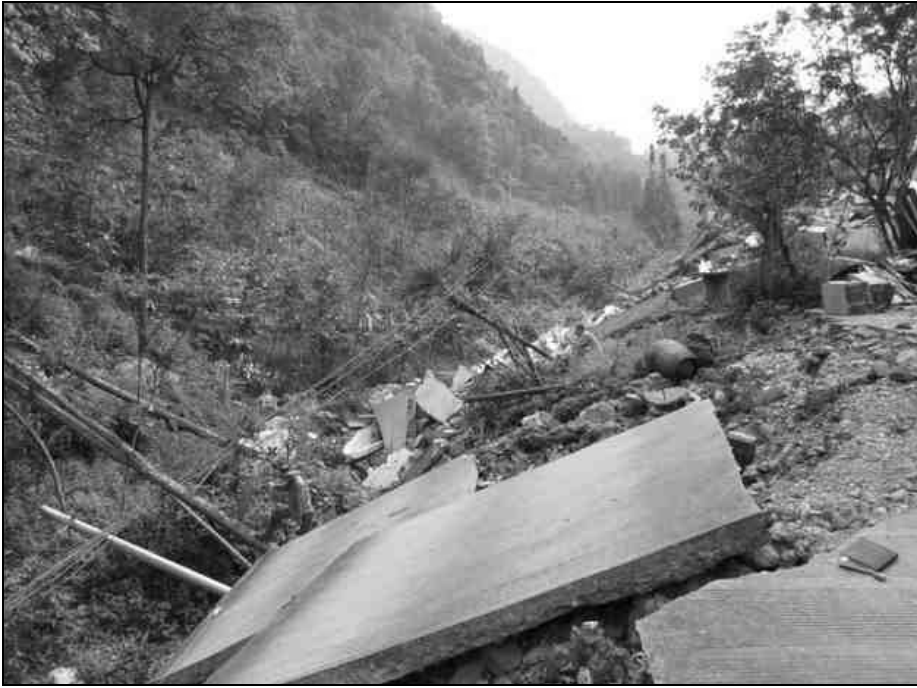
At Shenxigou village, we observed rockfalls that were likely triggered by the first rupture, followed by surface faulting of more than 3 m thrust upwards and 4 m lateral (some of this might have been induced landslide) that toppled power poles and caused power lines to come to rest atop the rock fall debris.

Fig. 4.73. Surface faulting uplift of about 3 m and lateral shift of about 4 m with damaged road and tilted distribution poles

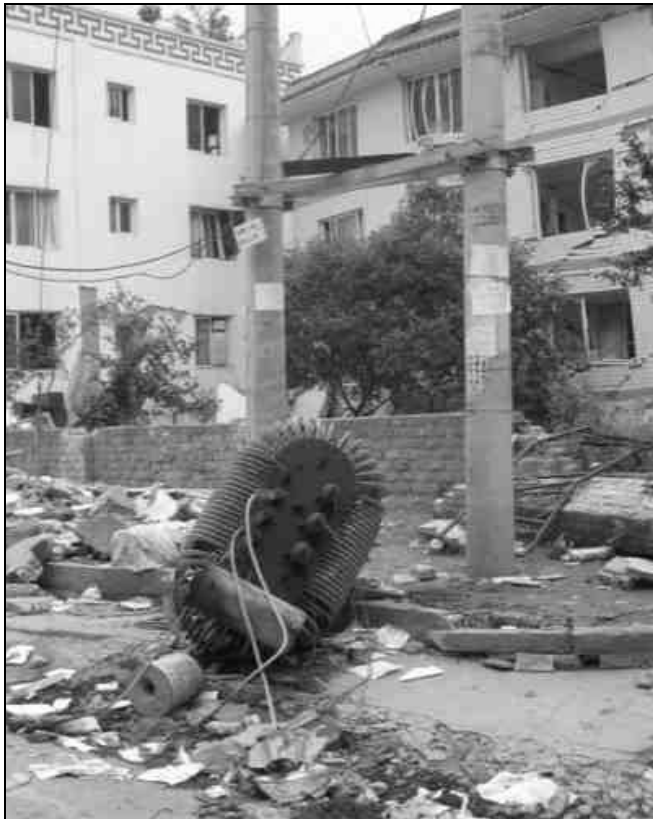
Platform-mounted transformers were observed. Figures 4.74 and 4.75 show two such examples. This type of damage was observed in a California earthquake in 1952, and since then, power distribution companies in California have all but eliminated the placement of unanchored transformers on elevated platforms for new installations. We recommend similar retrofits be adopted in China as a high priority in all high-seismic regions of the country.

Fig. 4.74. Fallen distribution transformer

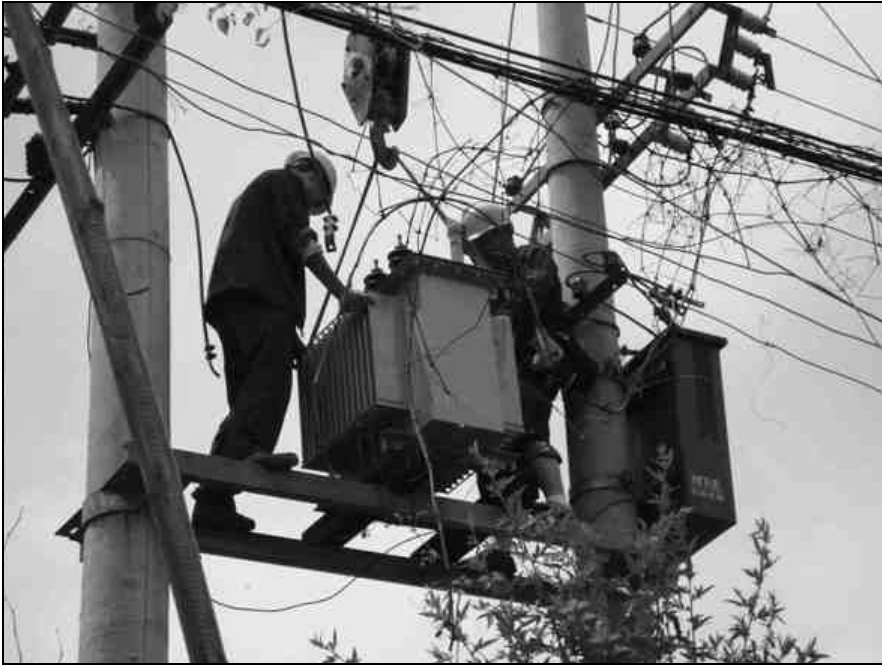
Fig. 4.75. Distribution system transformer (10 kV) being replaced (Hongkou), July 16 2008

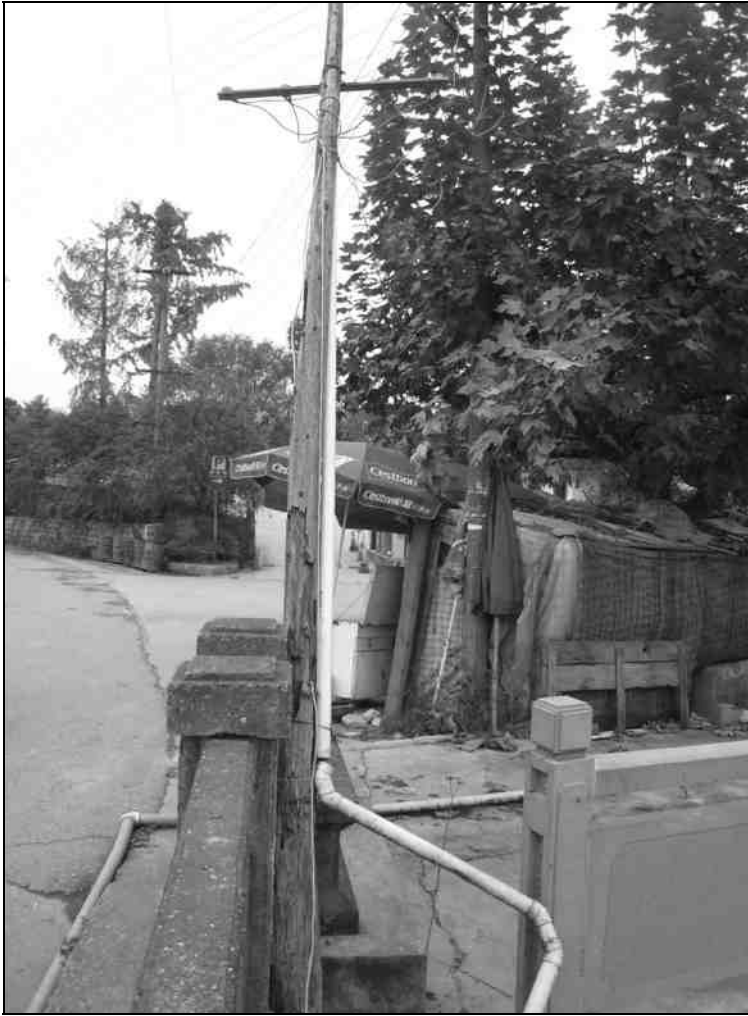
Figure 4.76 shows the failure of a low-voltage (10 kV) power cable crossing a bridge at Dujiangyan. The movement of the bridge embankment by a few inches resulted in the non-ductile failure of the PVC pipe at two locations and one location at the other abutment. It is likely that the power remained in service because it appears that the cables did not break at the PVC failure points and there was no new power line observed.

Fig. 4.76. Damage to low-voltage power conduit at bridge abutments

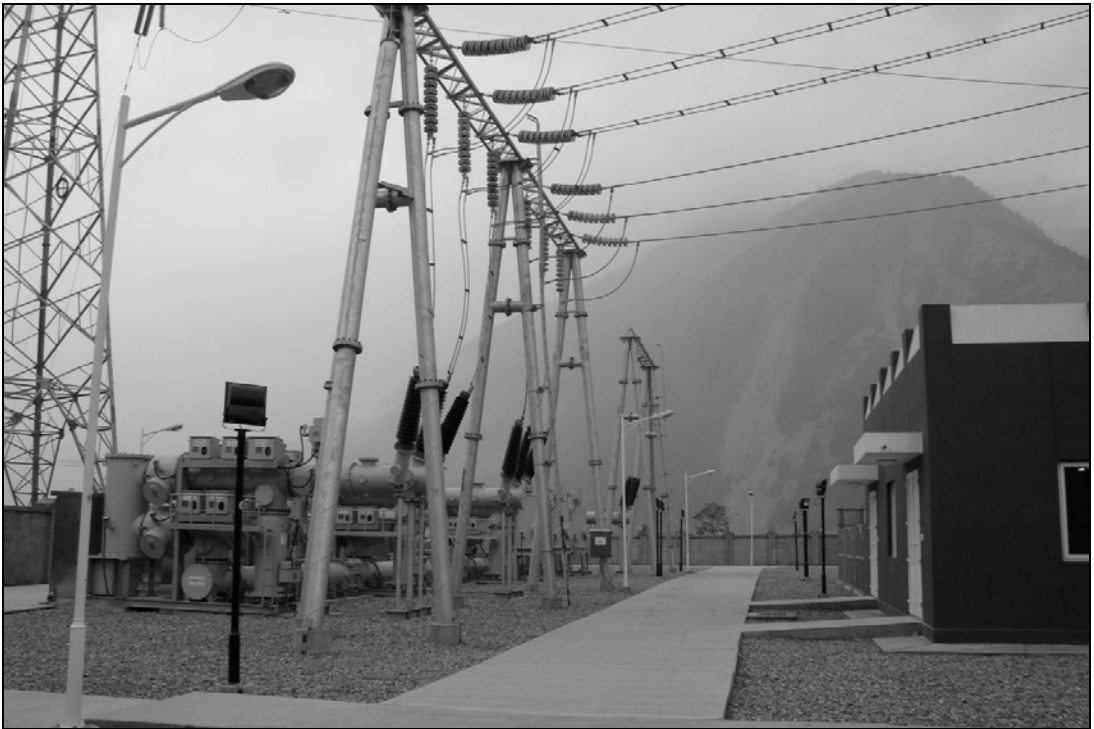
Fig. 4.78 Yingxiu, Ertaihan 220 kV substation rebuilt with one line working.
