WENCHUAN, SICHUAN PROVINCE, CHINA, EARTHQUAKE OF 2008

Lifeline Performance

Technical Council on Lifeline Earthquake Engineering
Monograph No. 39

Earthquake Investigation Committee of the
Technical Council on Lifeline Earthquake Engineering

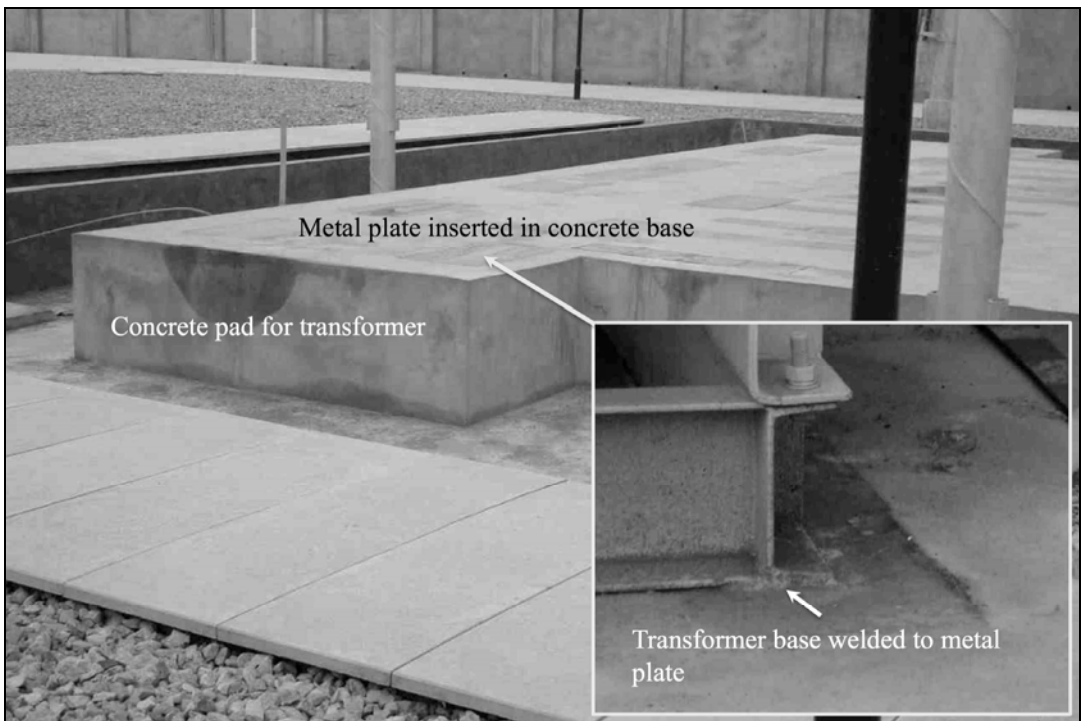
Fig. 4.79. The concrete platform with metal plates inserted for transformer anchoring shows one good seismic protection improvement

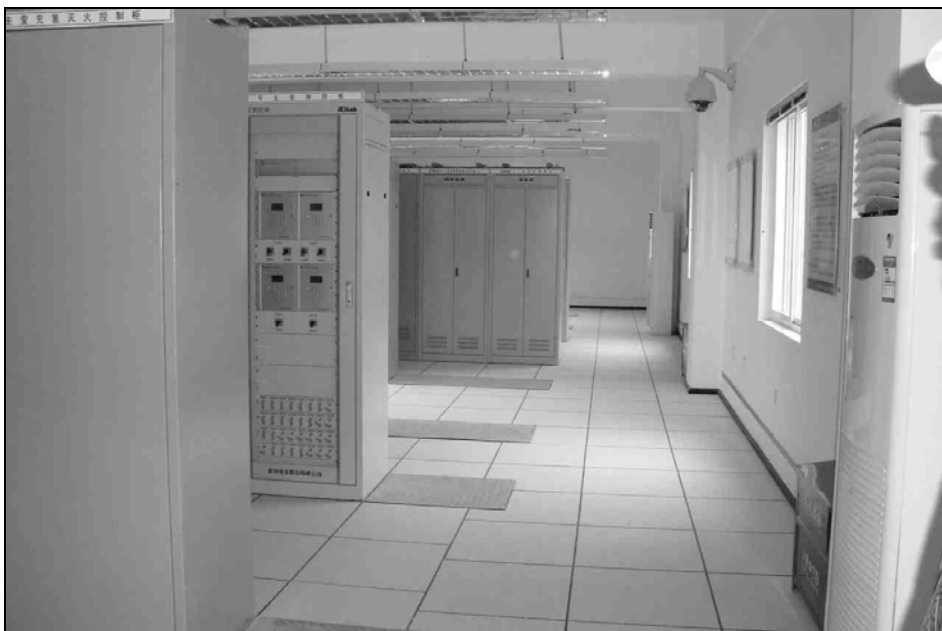
Fig. 4.80. The control room is built with a raised floor. It is not clear whether the equipment on the raised floor is anchored or not.

While costly, seismic improvement should be made for existing substation control buildings. Most if not all of the failures of the substation control houses could easily have been mitigated had China rigorously adopted and implemented a higher seismic standard for critical facilities. Upgrading substation control houses requires a long-term mitigation plan, but it is necessary because of the vulnerability of these buildings and the risks they present to the post earthquake performance mitigation program.

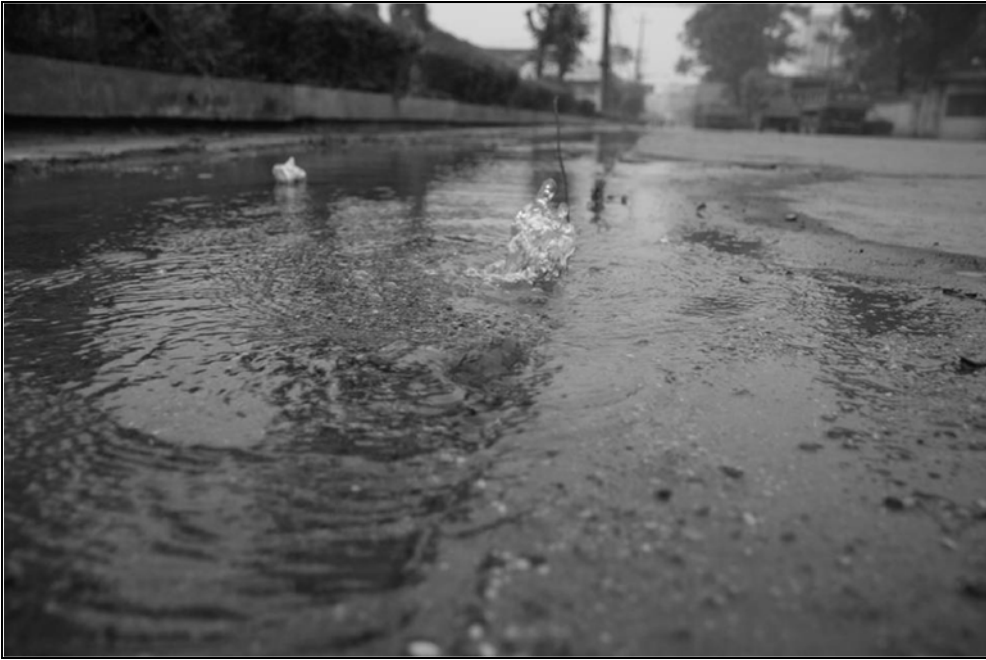
Fig. 5.2. Water leak under road

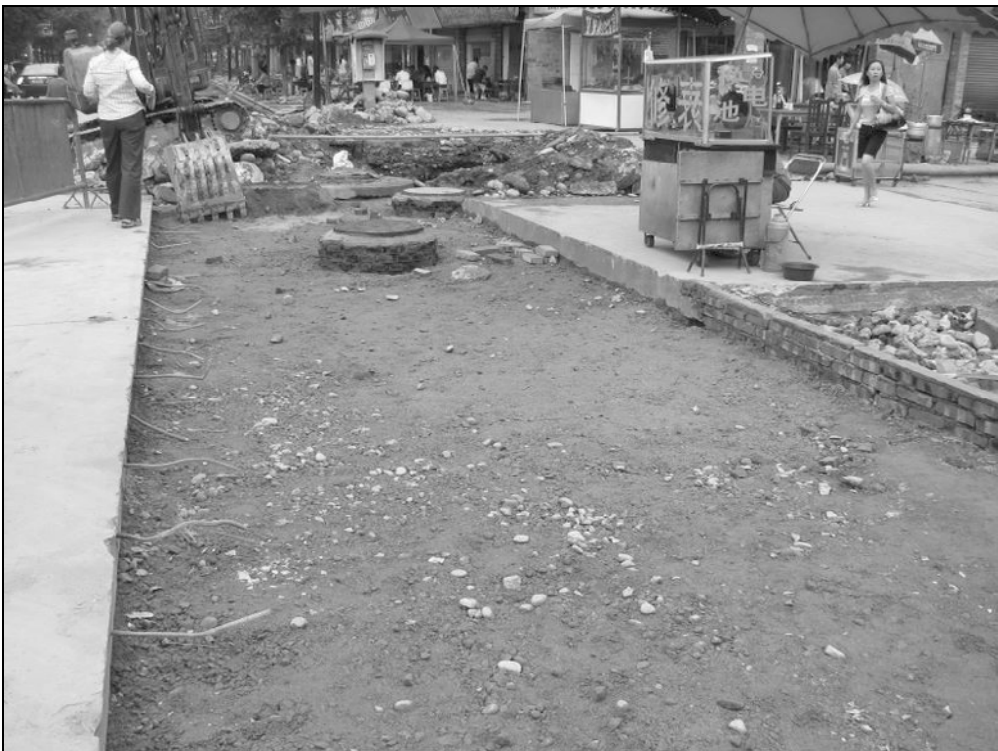
Fig. 5.3. Repair to water and sewer pipes in Dujiangyan

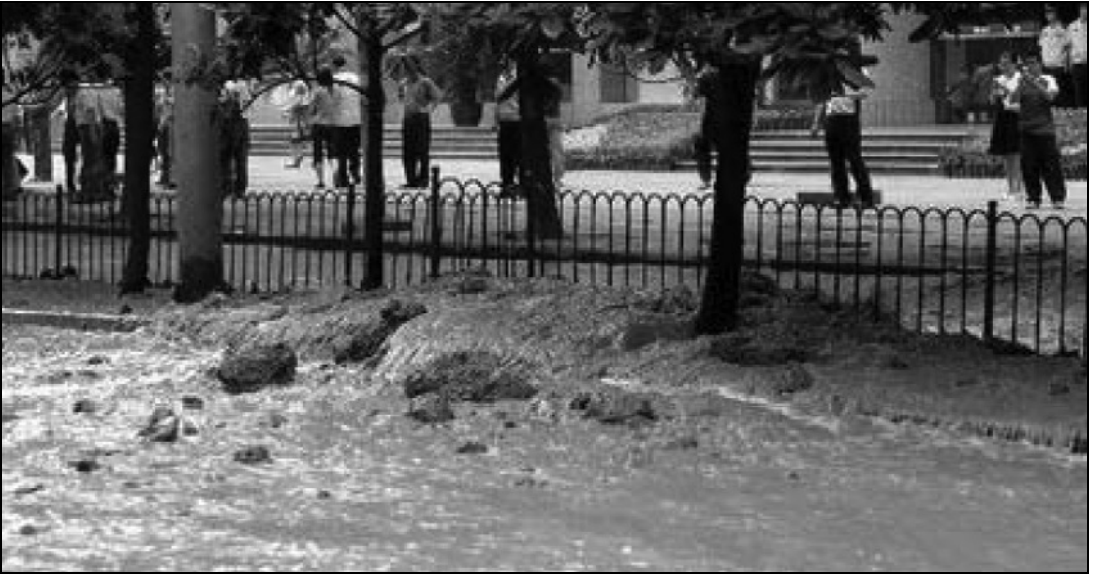
Fig. 5.4. Broken water pipe in Chengdu City

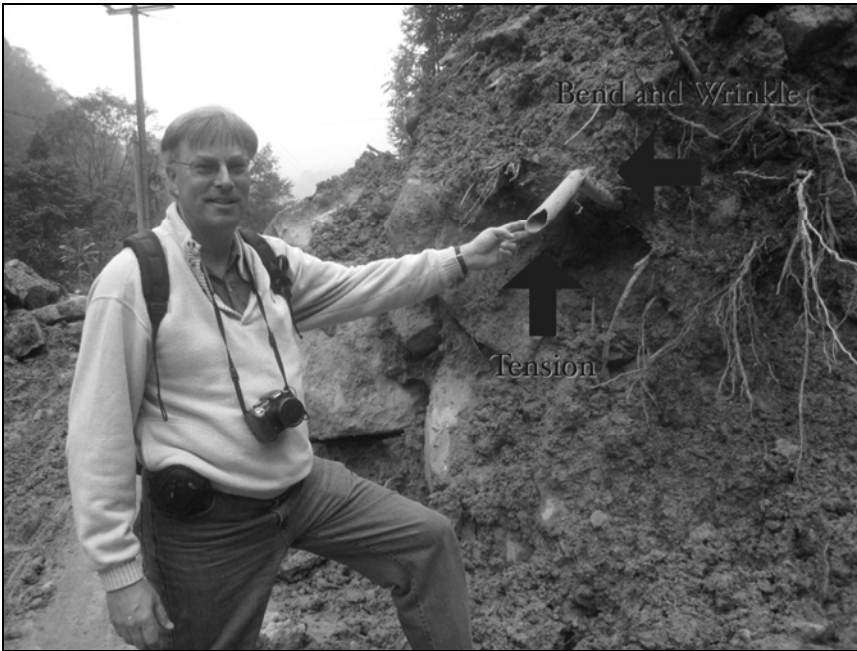
In large landslide areas, existing buried pipe were destroyed over the width of the landslide zone (commonly 50 to 200 ft. wide), and as a rough estimate, there might have been 300 of these instances throughout the earthquake zone. The team observed several of them. Local surface faulting broke some pipes (about 50 to 100 repairs), and liquefaction damaged some pipes² (about 200 to 300 repairs), therefore the first-order-magnitude number of water pipe repairs would be about 1,925 to 2,225. The damage to service laterals of collapsed buildings in Mianzhu alone were reported to be 700; thus, the region-wide damage to service laterals would be several thousand. In towns such as Beichuan that were subjected to massive landslides, the number of broken water pipes remains unknown.

Fig. 5.6. Damage mechanisms to water pipes at one side of a landslide, Shenxigou Village

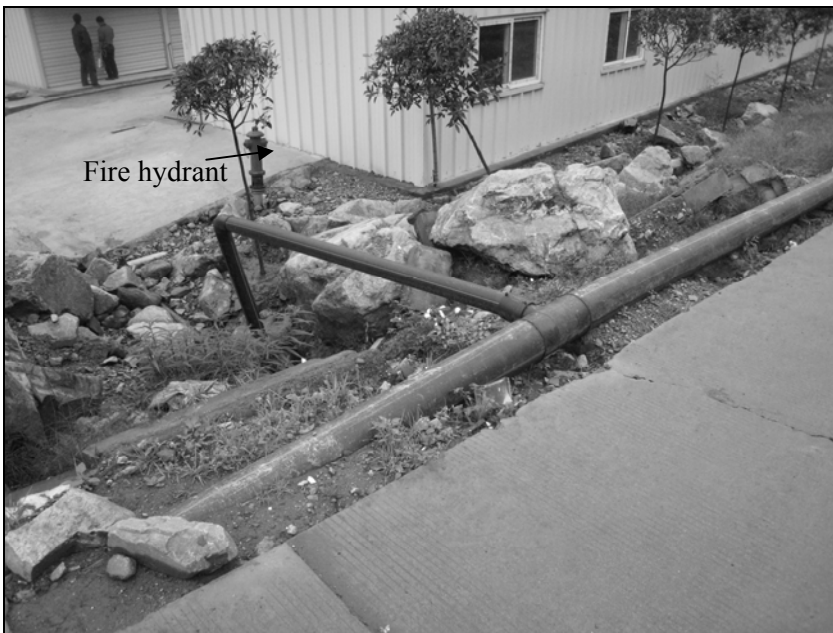
Figure 5.7 shows a 6-in. diameter, fusion-welded HDPE pipe in Yingxiu 160 days after the earthquake. As essentially all of the residential buildings were destroyed or rendered uninhabitable in this town, the remaining population was relocated into temporary shelter buildings, as seen in the background in Figure 5.8. All of these buildings had branch pipes leading to them, allowing residents to obtain water via outdoor hose bibs; it is unclear if cold weather in winter will lead to pipe freeze.

Fig. 5.7. Temporary above ground water pipe in Yingxiu for temporary shelters

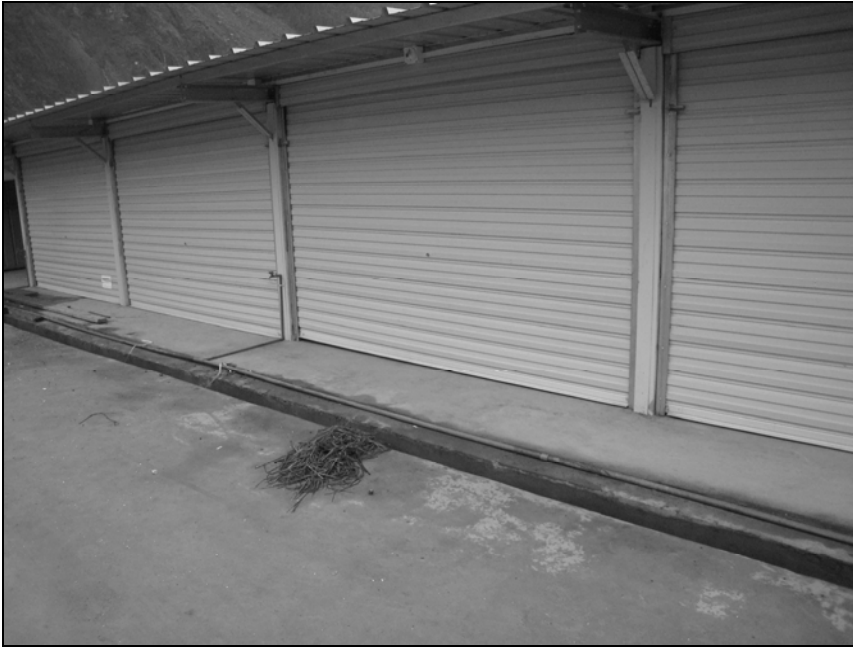
Fig. 5.8. Temporary above ground water pipe with hose bib to temporary housing in Yingxiu

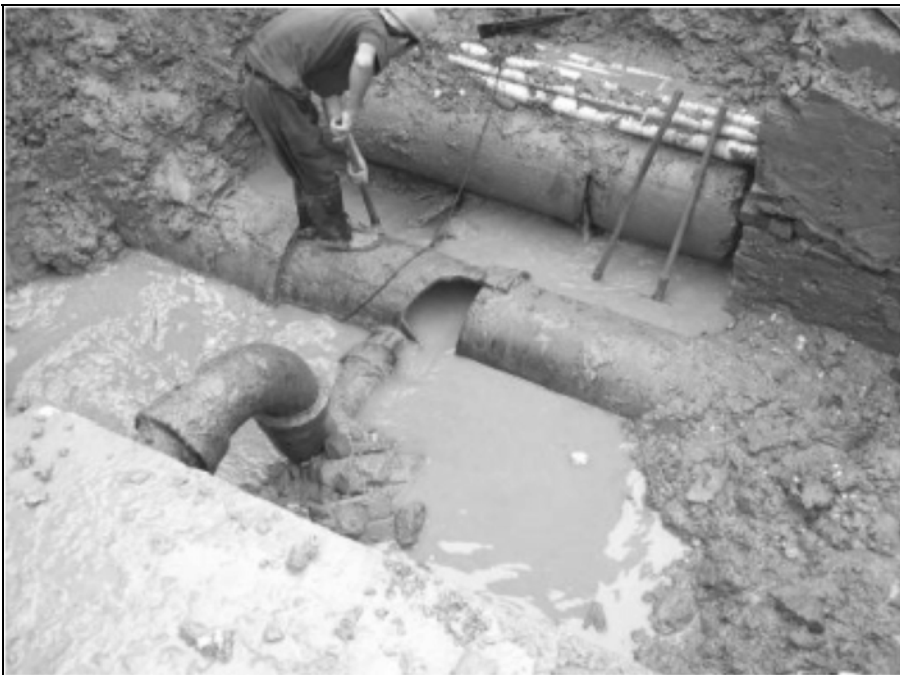
Fig. 5.9. Damaged cast iron pipe, Mianzhu

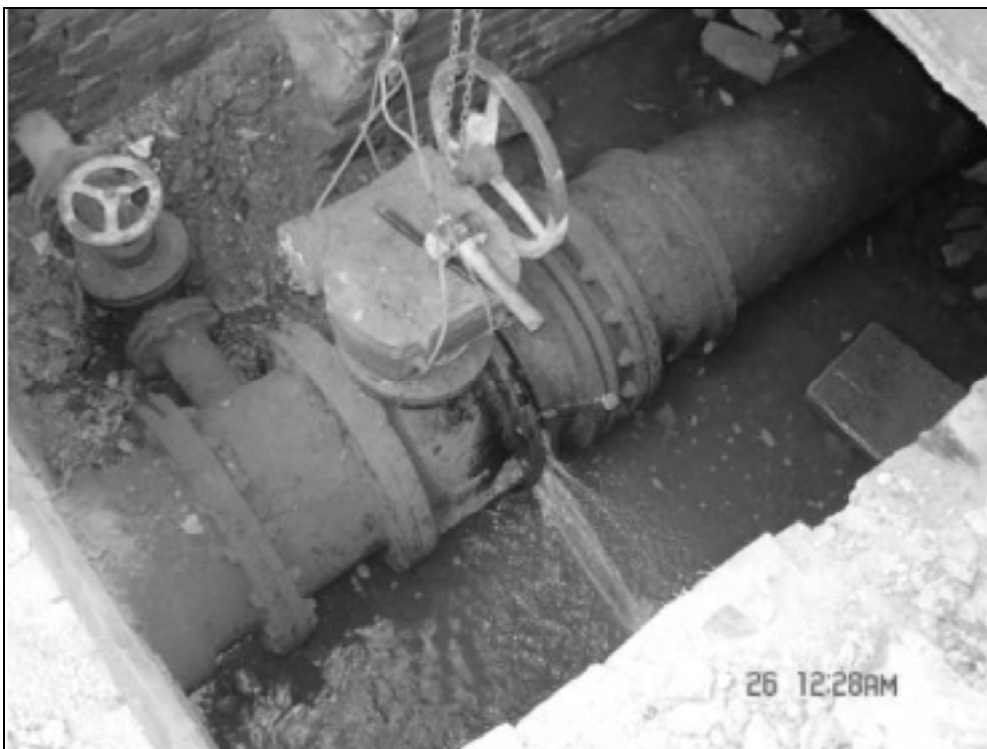
Fig. 5.10. Damaged cast iron pipe, Guangyuan City

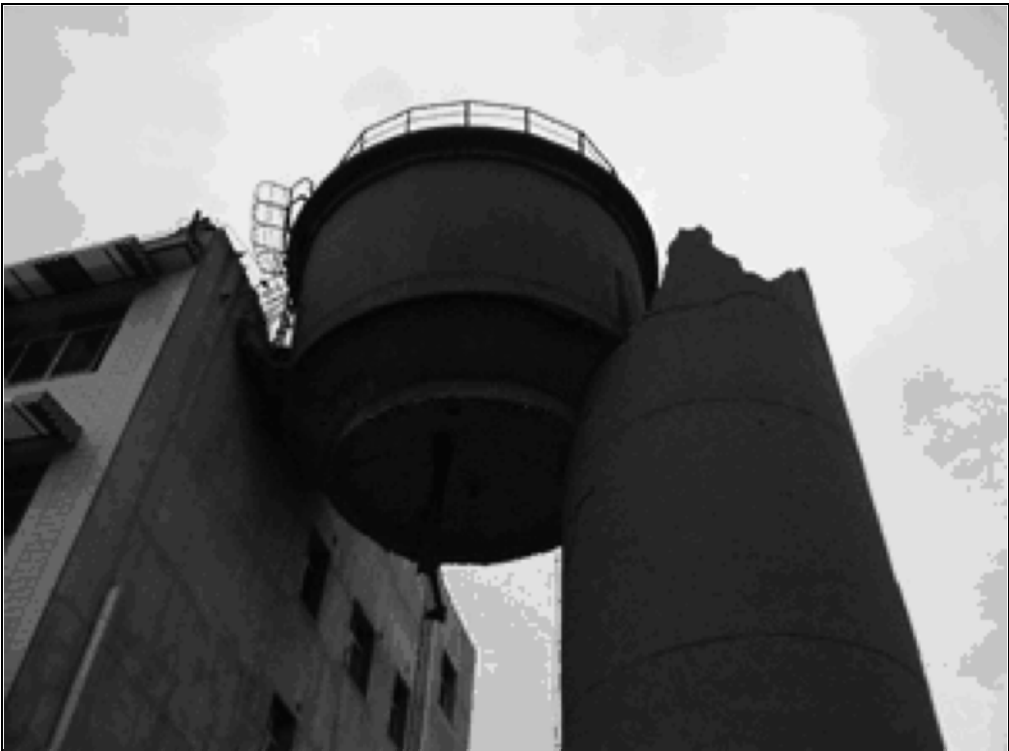
From our observation, more than than 95 percent of the elevated cast-in-place concrete water tanks performed well and remained functional (leak tight). These were located in areas with estimated PGA < 0.30 g. However, some of the water towers (assumed to be URM) sustained heavy damage, ranging from outright collapse (Fig. 5.11) to severe damage (Fig. 5.12, large x-cracks in the supporting structures) to no apparent damage (Fig. 5.13). We did not observe this style of tank construction in the mountain towns and villages, so it is uncertain how the tanks would have fared when subjected to PGA > 0.4 g. In the mountain town of Yingxiu (PGA between 0.4 g to 0.7 g), a rectangular concrete tank failed (Fig. 5.15).

Fig. 5.11. Collapsed elevated concrete water tank

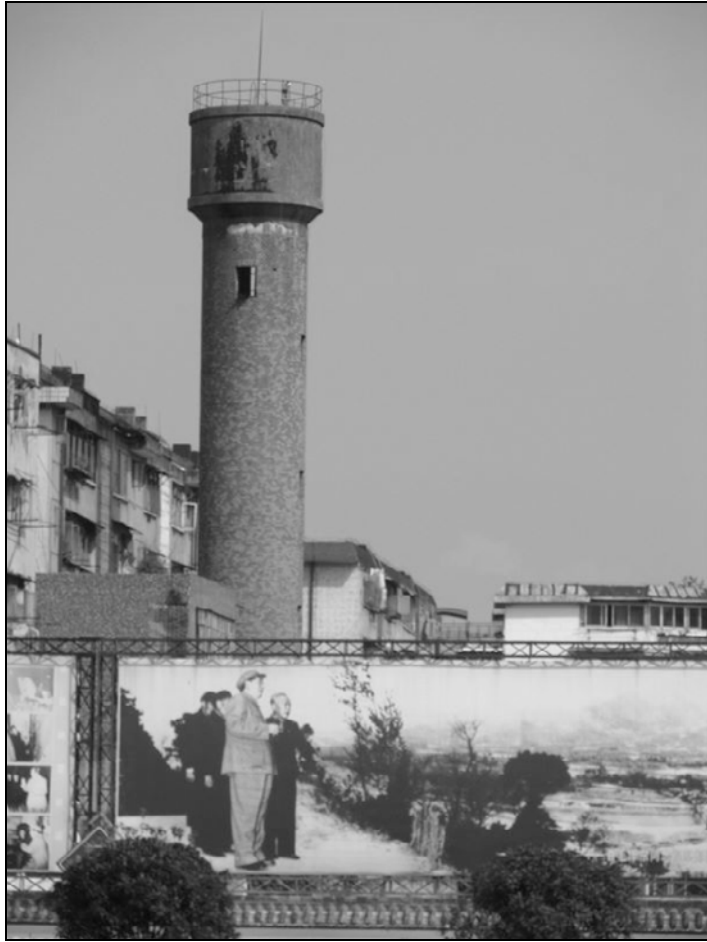
Fig. 5.13. Water tower in Dujiangyan, no apparent damage from exterior view

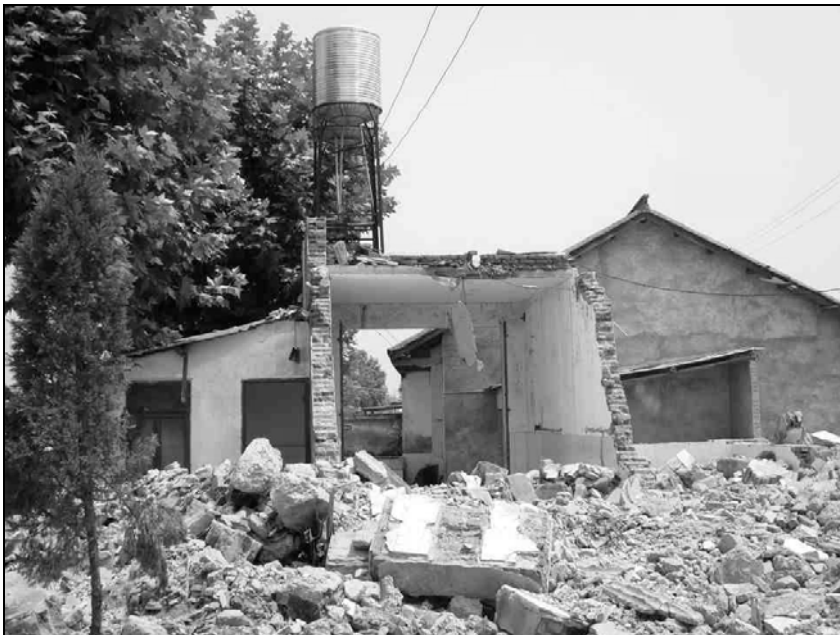
The local water supply distribution system in some areas is unable to keep up with peak water demands, which is not uncommon in developing nations. In some smaller towns, some individual buildings have their own wells and small roof-top storage tanks. These owner-installed water tanks are filled with local well water (or town-supplied water when system-demand is low), and then used for building-specific purposes. One such tank (Fig. 5.14) survived, although supported atop a collapsed brick building.

Fig. 5.14. Local storage tank atop damaged URM structure (Shifang)

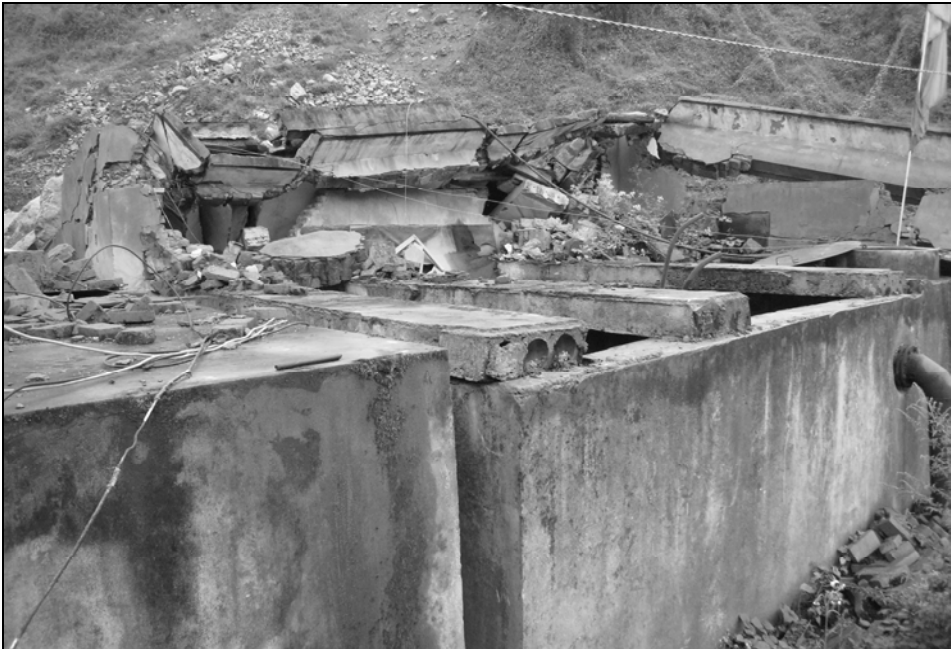
Figure 5.15 shows a damaged reinforced concrete rectangular water tank. The roof of the tank was unanchored and composed of precast concrete slab elements; several of these slab elements slid sideways (at Yingxiu, ground motions likely exceeded 0.4 g) with some dropping into the tank. There had been no attempt to repair the tank 160 days after the earthquake.

Fig. 5.15. Local storage tank (Yingxiu)

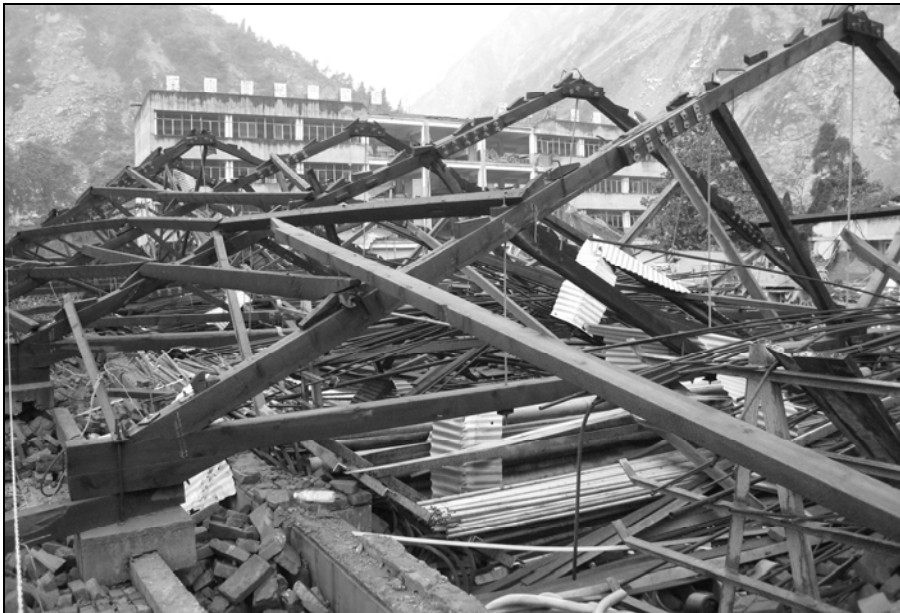
Fig. 5.16. Storage building (Yingxiu)

Figure 5.16 shows the ruins of the wood post-and-beam maintenance facility with infill brick walls of a water and local power distribution company, which was located adjacent to the water tank (Fig. 5.15).

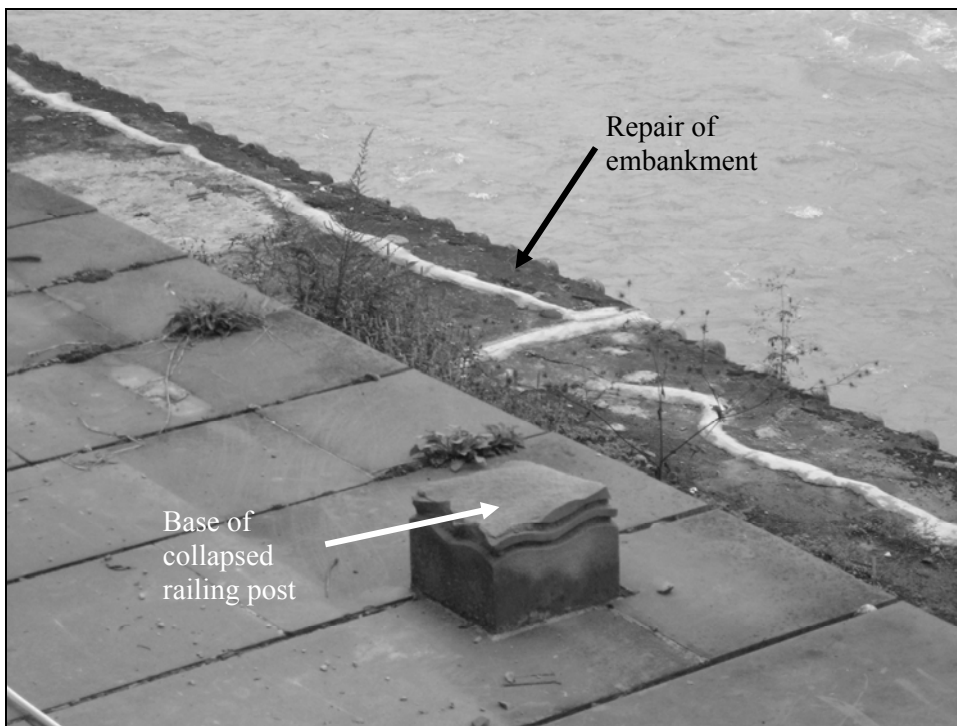
Figure 5.21 shows repairs to the embankments (background), denoted by the light-colored material. The cracks at this location were commonly 2 to 4 in. wide, running over a few thousand feet of river side. Higher up the embankment, there were clearly observed settlements of 2.5 to 5.0 cm (1 to 2 in.) and lateral spreads of 2.5 to 5.0 cm (1 to 2 in.).

Fig. 5.21. Repair of embankment (background) and base of collapsed masonry railing wall (foreground)

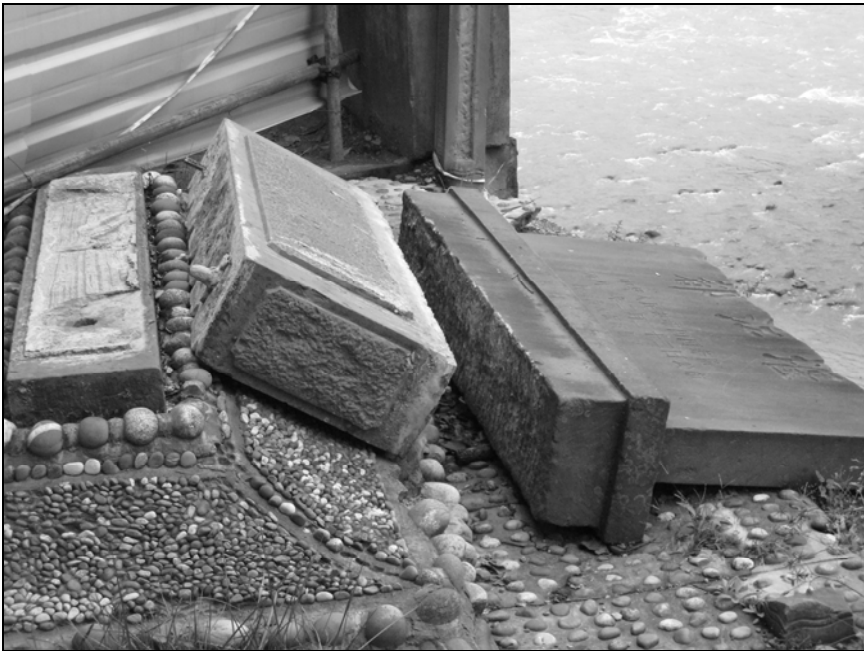
Tall under-reinforced (or unreinforced) monuments toppled at this site (Fig. 5.24). Note the steel pull out and concrete failure for the two rebar-held connections for the bottom portion and the non-reinforced connection for the top portion. Upon toppling, the top of the monument snapped.

Fig. 5.24. Toppled monument

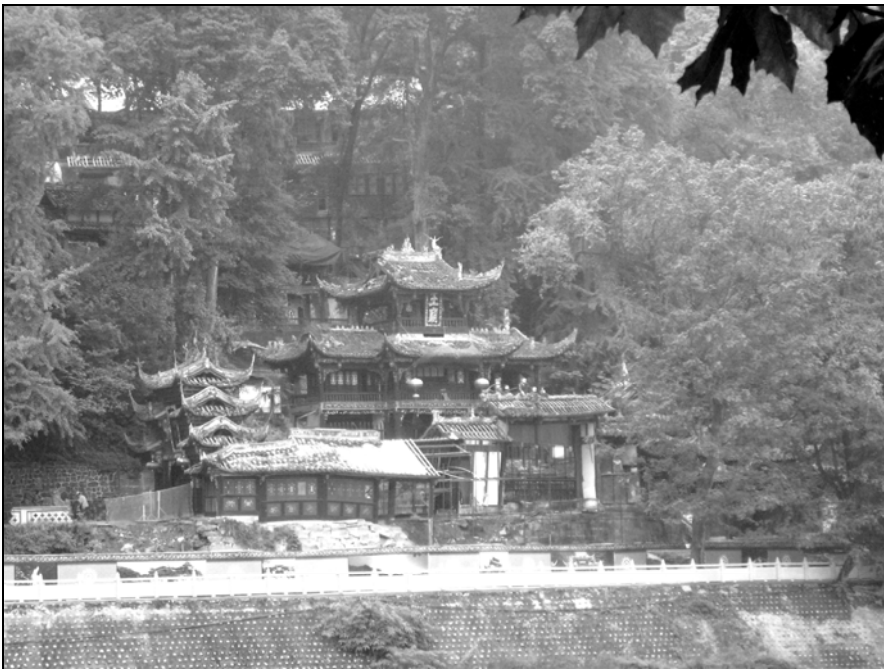
Figure 5.25 shows two wooden temples built to honor Li Bing. On the left side, the top two floors collapsed. These temples were closed to the public due to the damage. Because this site is a major tourist attraction, this hurts the local economy due to a reduction in tourism and a loss of a cultural artifact representing one of the most famous engineering flood control achievements in Chinese history.

Fig. 5.25. Collapsed and heavily damaged temple of Li Bing and his son.

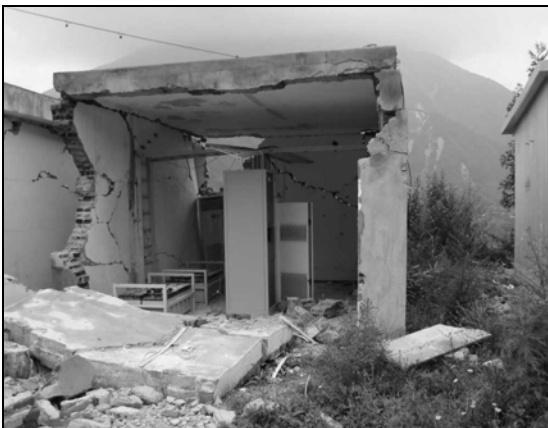
Both buildings and the equipment inside them sustained extensive damage. It was noted that the equipment was not anchored. In addition to the telecommunication equipment and batteries, the air conditioning units were also damaged (Fig. 6.2 to 6.5). A portable power generator indicated that power was out at this site (Fig. 6.6). A 10-kV pole mounted transformer not far from this site was damaged and was being replaced during the team's July 17 visit (Fig. 6.7). China Telecom built a new building to house the equipment (Fig. 6.8).

Fig. 6.2. The unreinforced masonry (URM) building was damaged and almost collapsed

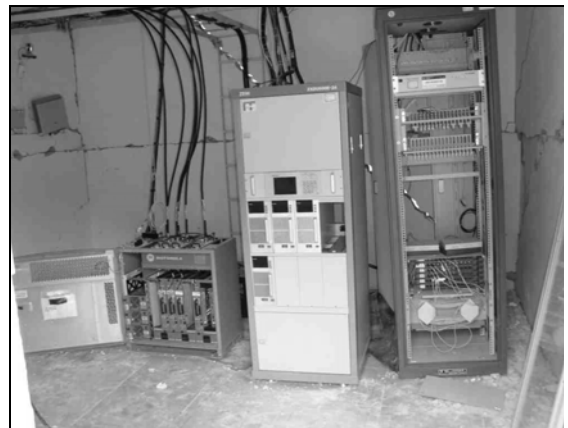
Fig. 6.3. New equipment was temporarily installed to restore service

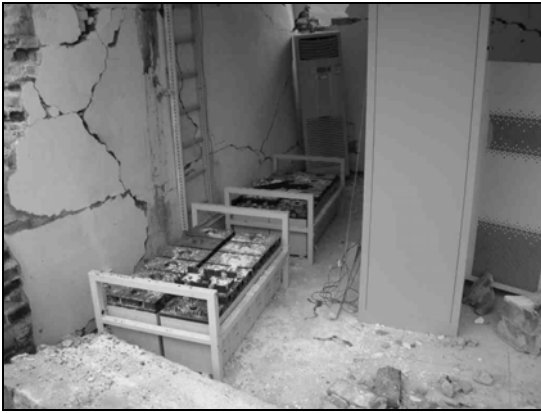
Fig. 6.4. Damaged batteries due to building damage

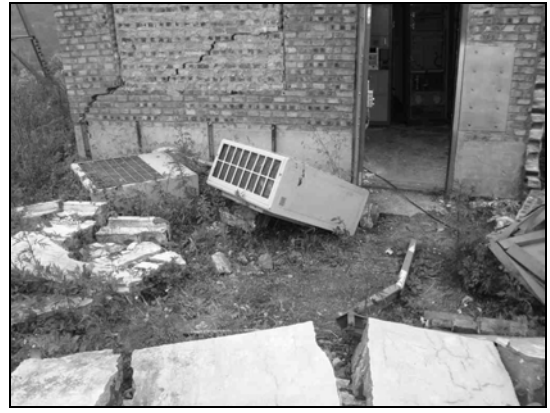
Fig. 6.5. Air-conditioning units were damaged; note the building debris in the foreground

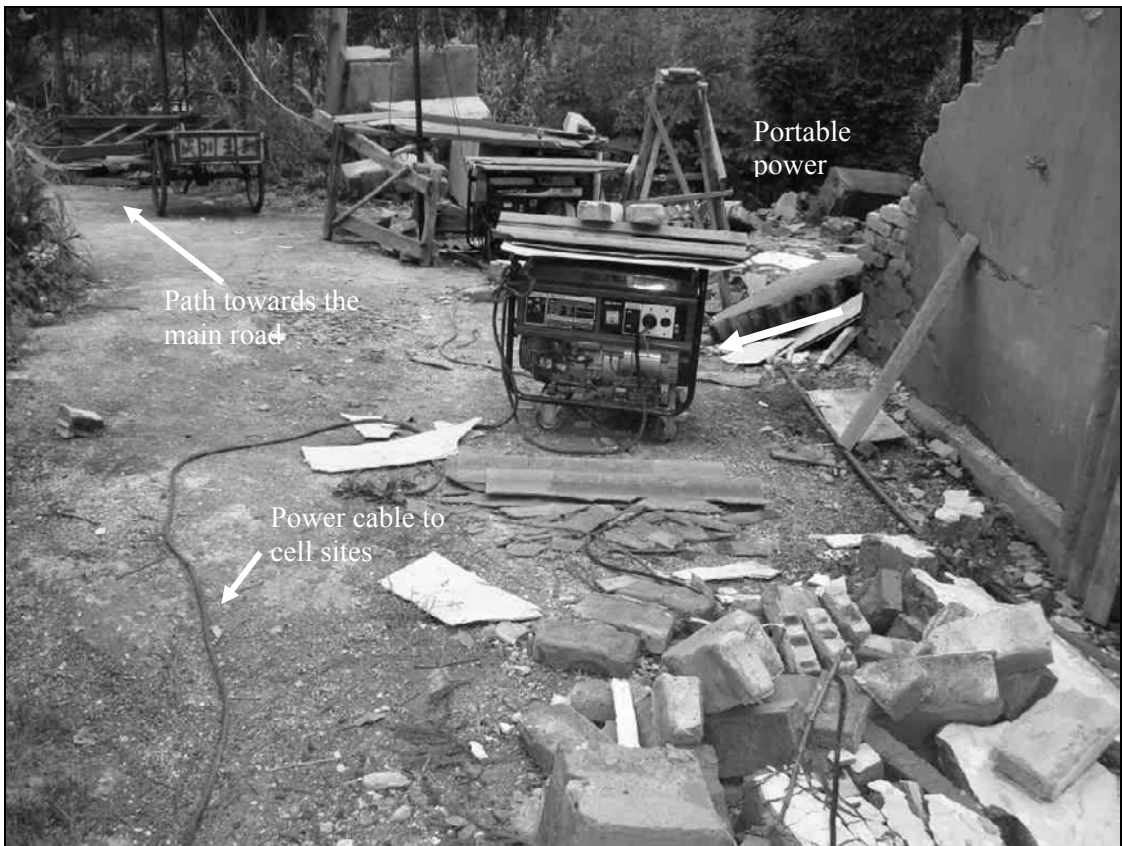
Fig. 6.6. A portable power generator was used to power the cell sites after emergency recovery at Hongkou. This photo was taken in front of the damaged cell site building on the pathway leading to the main road.

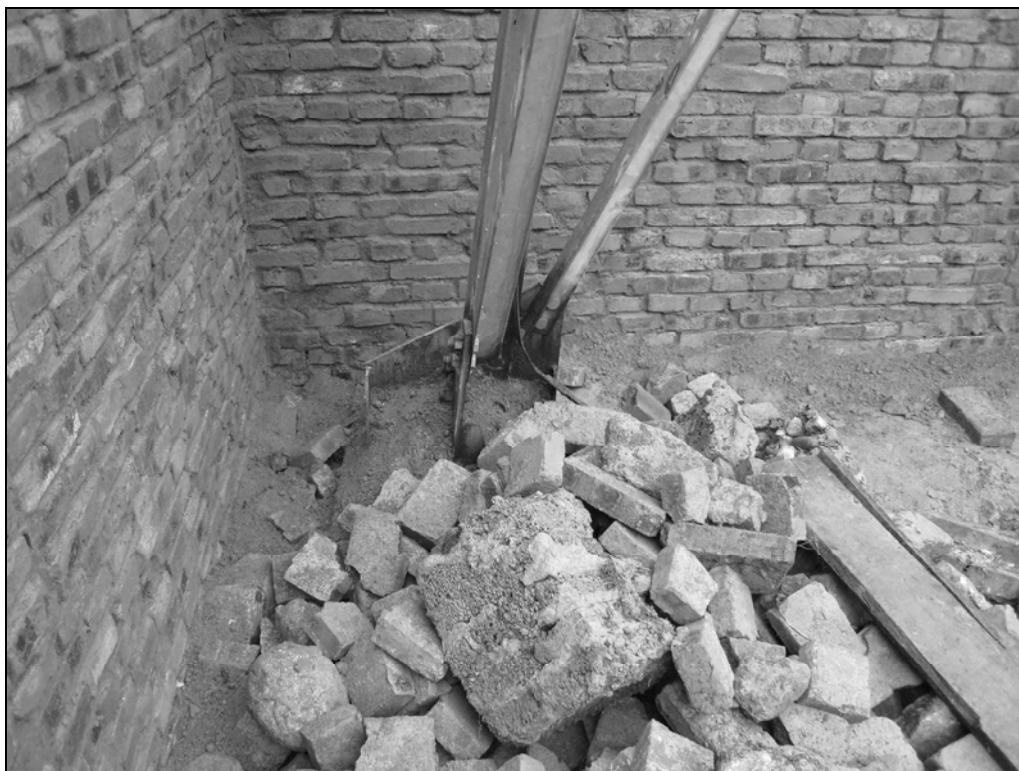
Fig. 6.10. Bricks from the damaged wall all over the yard under the tower

The local people told us that some of the antennae had dropped and the top part of the tower was damaged. The brick wall around the cell site collapsed and was rebuilt during our visit in October. The equipment building inside the brick wall seemed to be quite new with no obvious signs of damage. We believe that repairs were made prior to installing new equipment to restore this cell site.

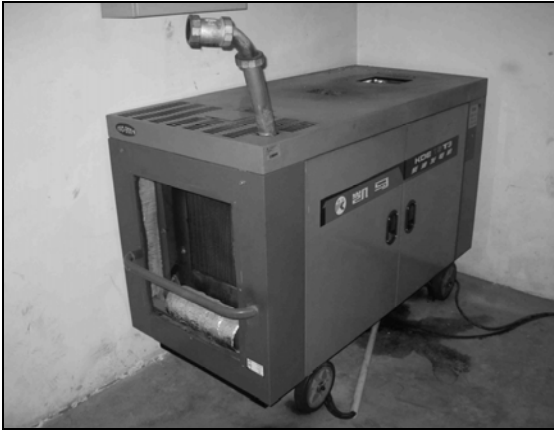
Fig. 6.15. This new power generator for the cell site was not anchored. The exhaust pipe was not connected to the outside.

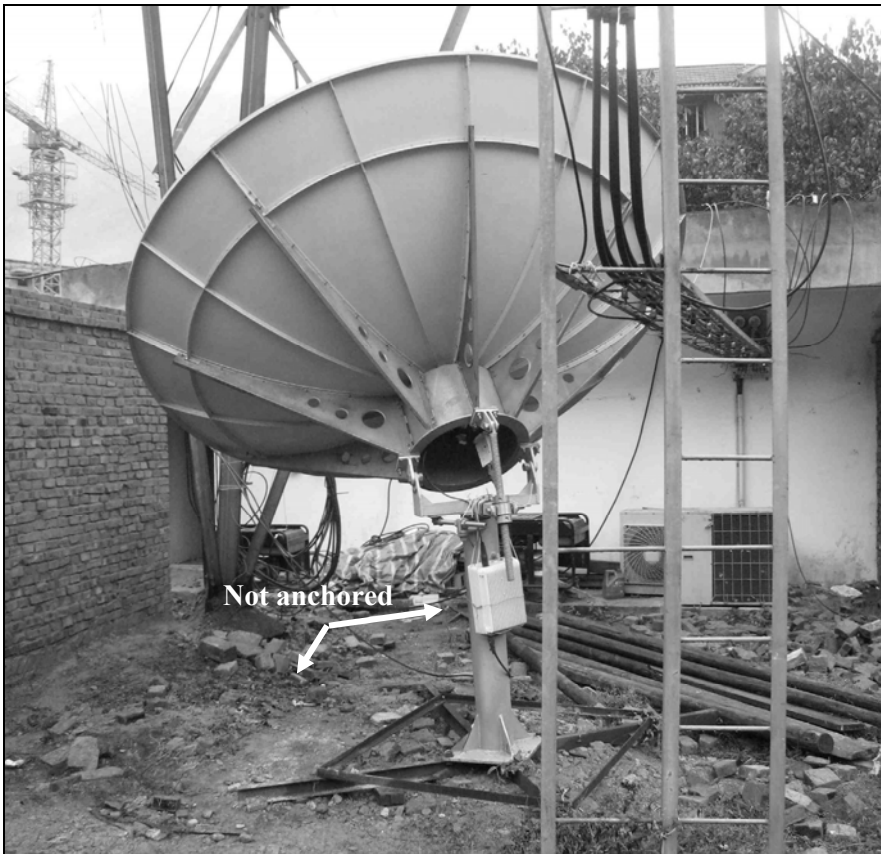
Fig. 6.17. A temporary satellite dish was used to communicate with other nodes in the network. Note that there were two portable power generators and a new air conditioning unit on the outside of the equipment building. This equipment was brought in after the building was repaired.

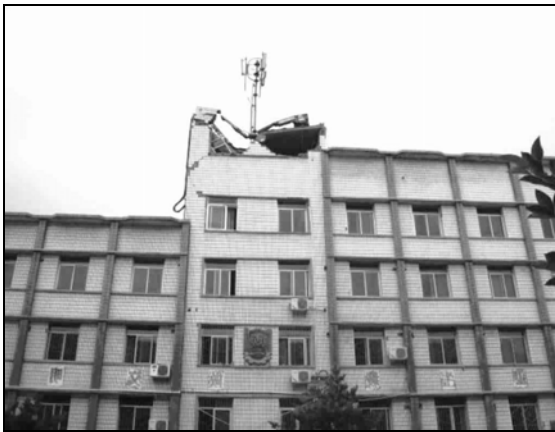
Fig. 6.22. The walls and part of the roof of this cell site in Mianzhu on the top floor of this commercial building collapsed and damaged the equipment inside. (Courtesy of IEM)

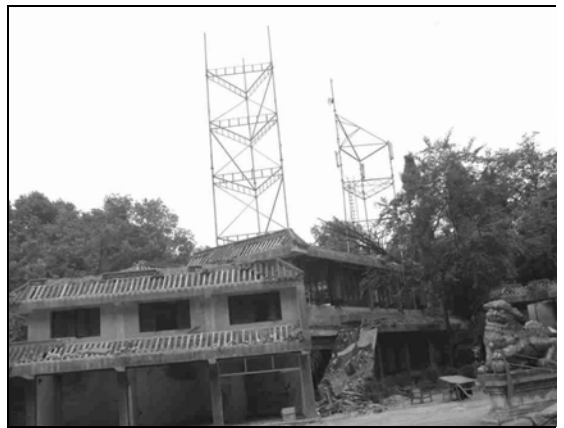
Fig. 6.23. A damaged cell site in Dujiangyan (Courtesy of IEM)

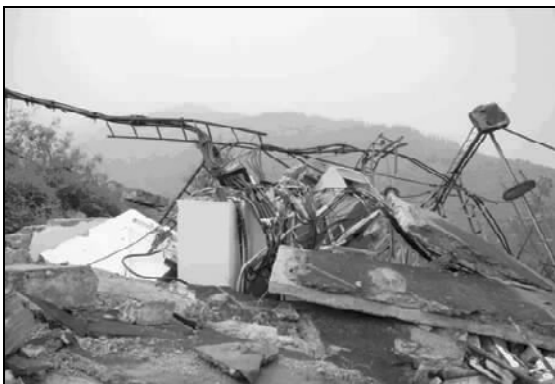
Fig. 6.24. This cell site building in Jianshi, Shifang, collapsed and damaged all the equipment inside. (Courtesy of IEM)

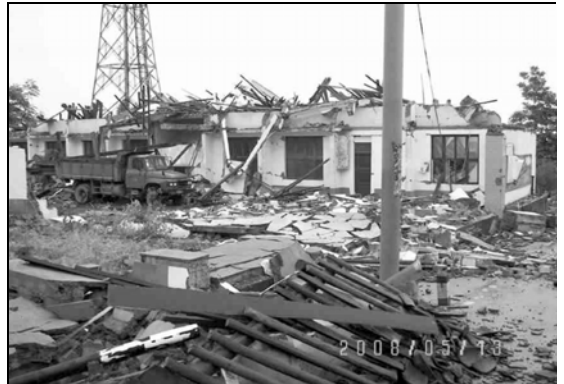
Fig. 6.25. The roof of this cell site building in Wudu, Shifang, collapsed on the equipment inside. (Courtesy of IEM)

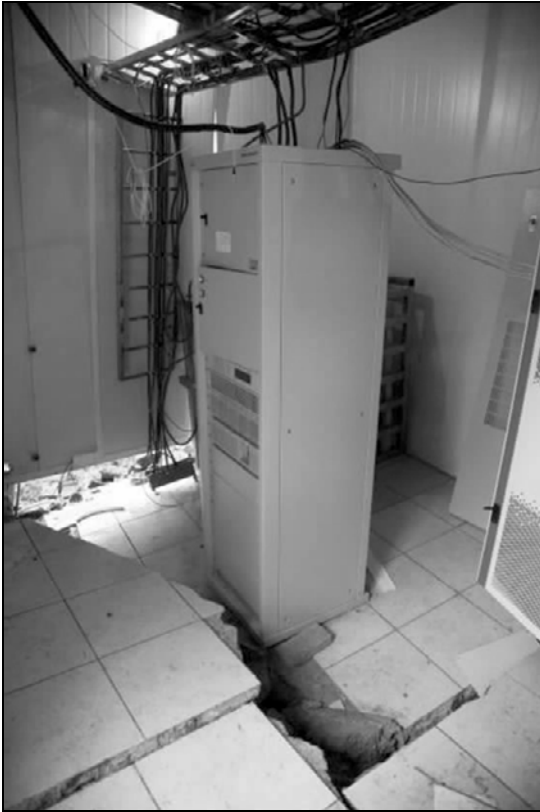
Fig. 6.26. The concrete floor of this cell site in a metal panel building in Dujiangyan cracked causing equipment failures. (Courtesy of IEM)

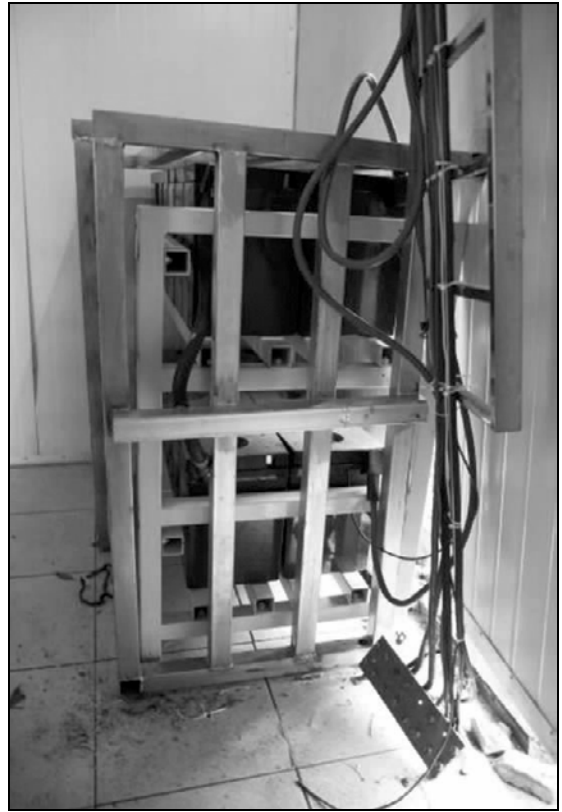
Fig. 6.27. The battery bank in the same building escaped damage, but the ground plate was pulled from its mounting location. (Courtesy of IEM)

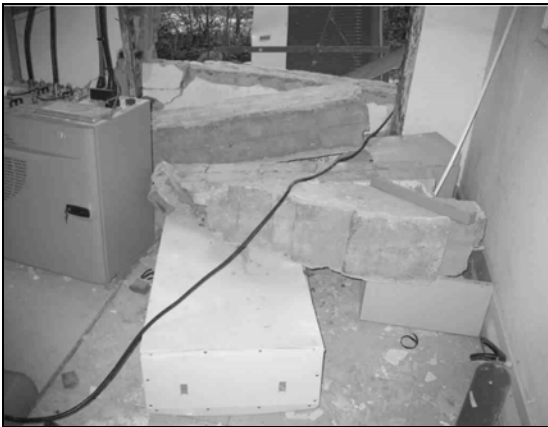
Fig. 6.28. The walls of this cell site building in Dujiangyan collapsed and damaged the equipment. (Courtesy of IEM)

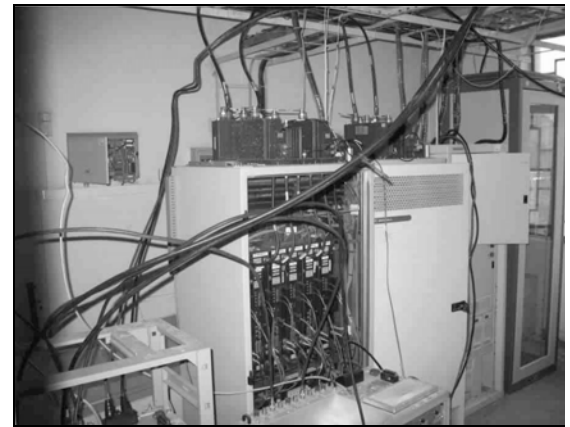
Fig. 6.29. The cables in the other room of the building came off the cable rack above. The collapsed wall is on the left in this photo. (Courtesy of IEM)

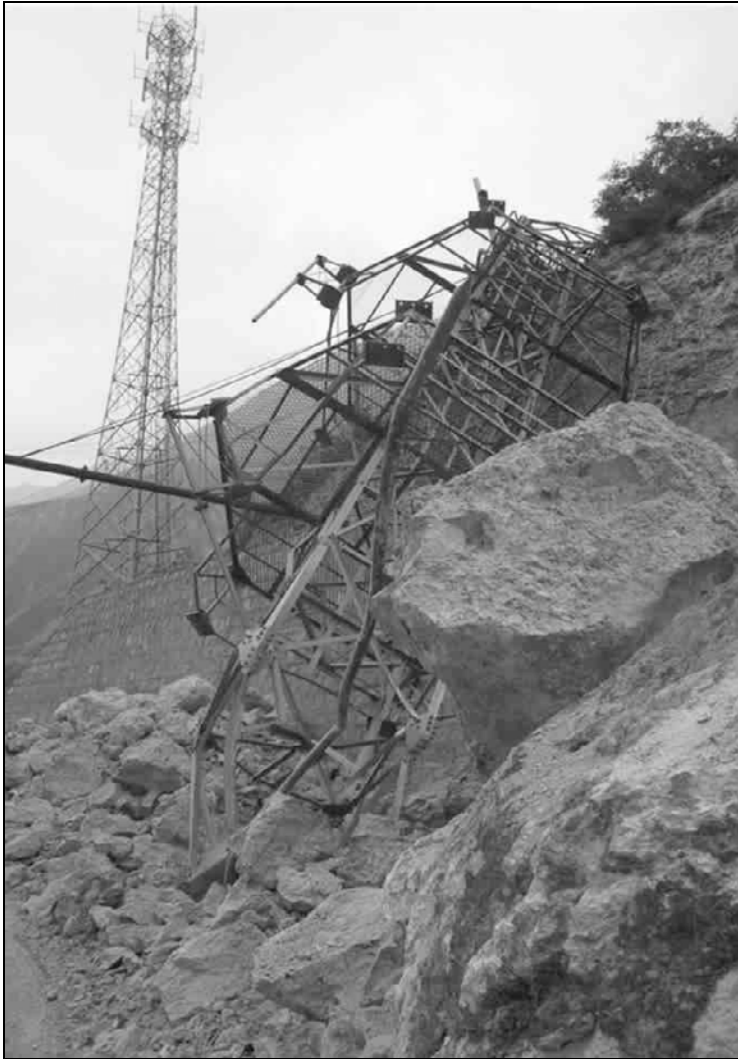
Fig. 6.30. A collapsed cell tower in Mianchi, Shifang. This tower was damaged by the rock fall. (Courtesy of IEM)

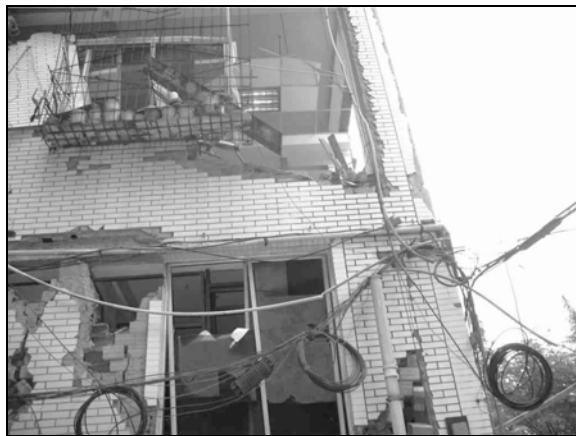
Fig. 6.31. The walls of this cell site building collapsed damaging the equipment inside. (Courtesy of IEM)

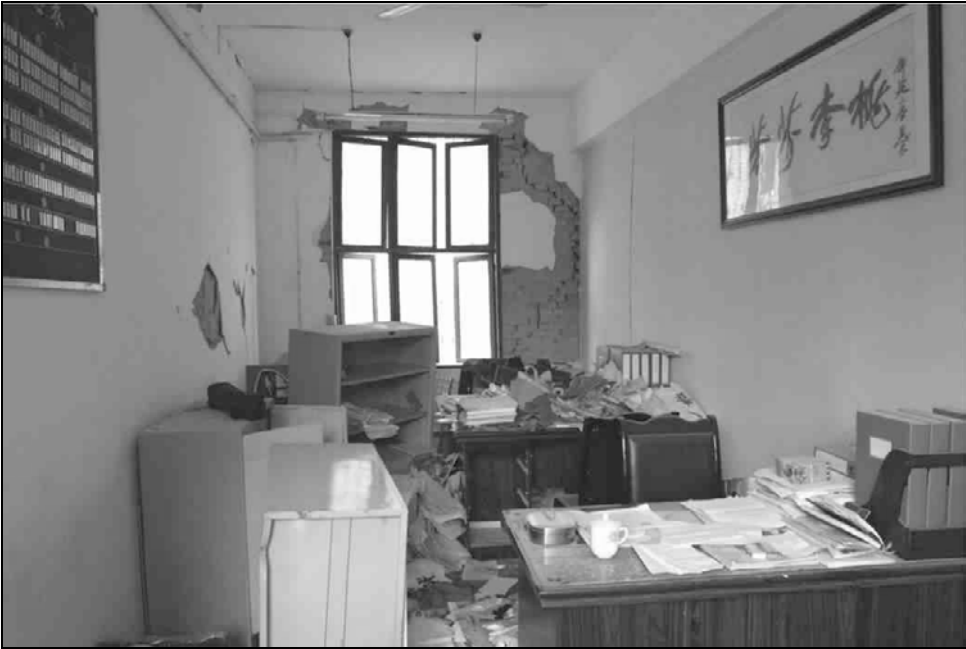
Fig. 6.32. Inside a cell site administrative office, book cases and file cabinets and documents were scattered on the floor. (Courtesy of IEM)

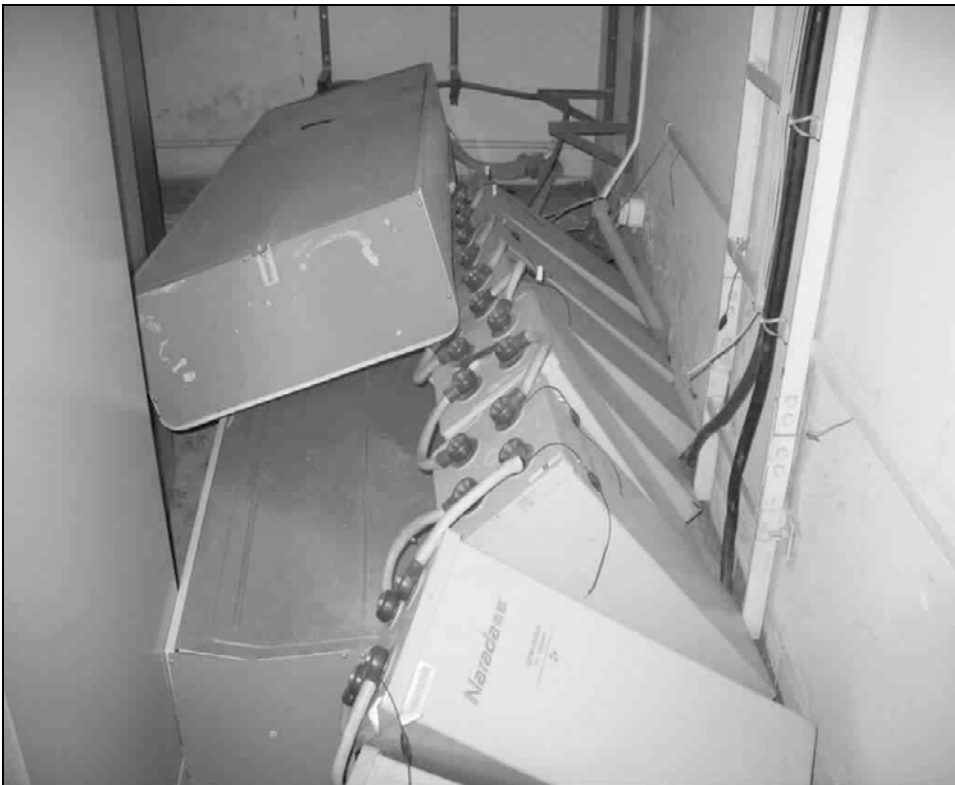
Fig. 6.33. Battery damage caused by fallen cabinets in a switching office in Dujiangyan (Courtesy of IEM)

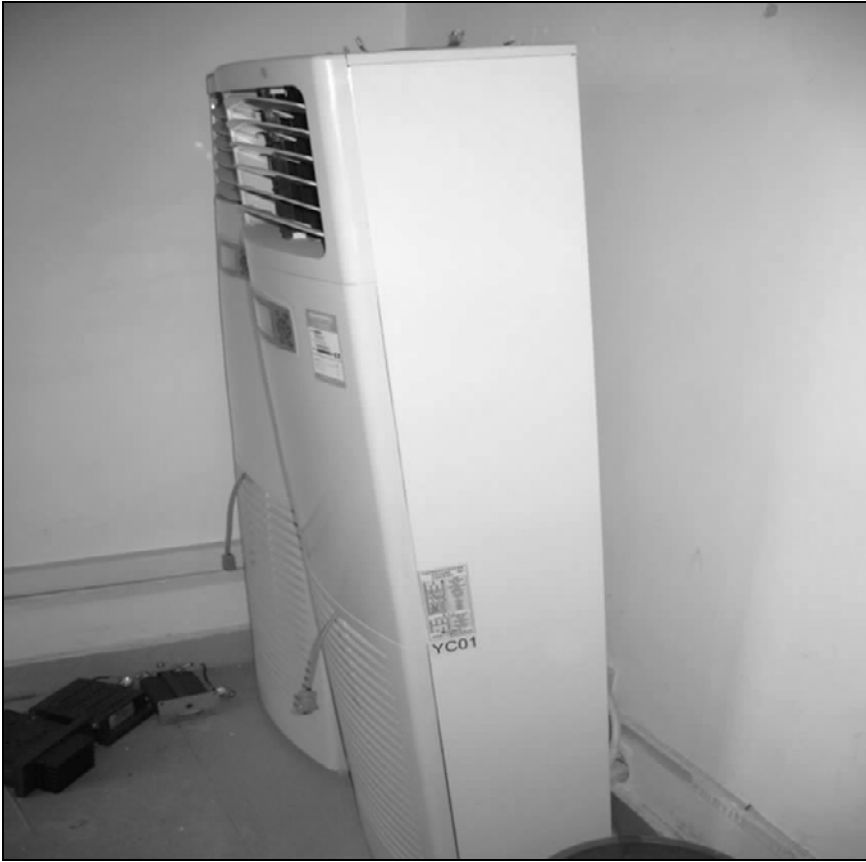
Fig. 6.34. Damaged air conditioning units. The small equipment fell from the top of the units onto the floor. (Courtesy of IEM)
