WENCHUAN, SICHUAN PROVINCE, CHINA, EARTHQUAKE OF 2008

Lifeline Performance

Technical Council on Lifeline Earthquake Engineering
Monograph No. 39

Earthquake Investigation Committee of the
Technical Council on Lifeline Earthquake Engineering

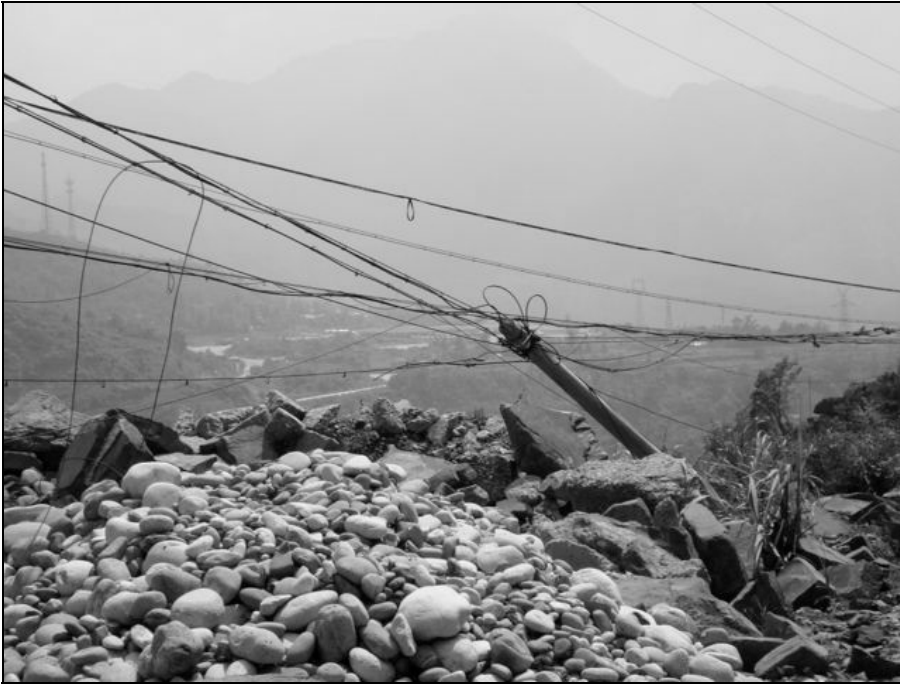
Fig. 6.35. Damaged utility pole on the road to Yingxiu and a close look at the cables, which are all optic fiber cables.

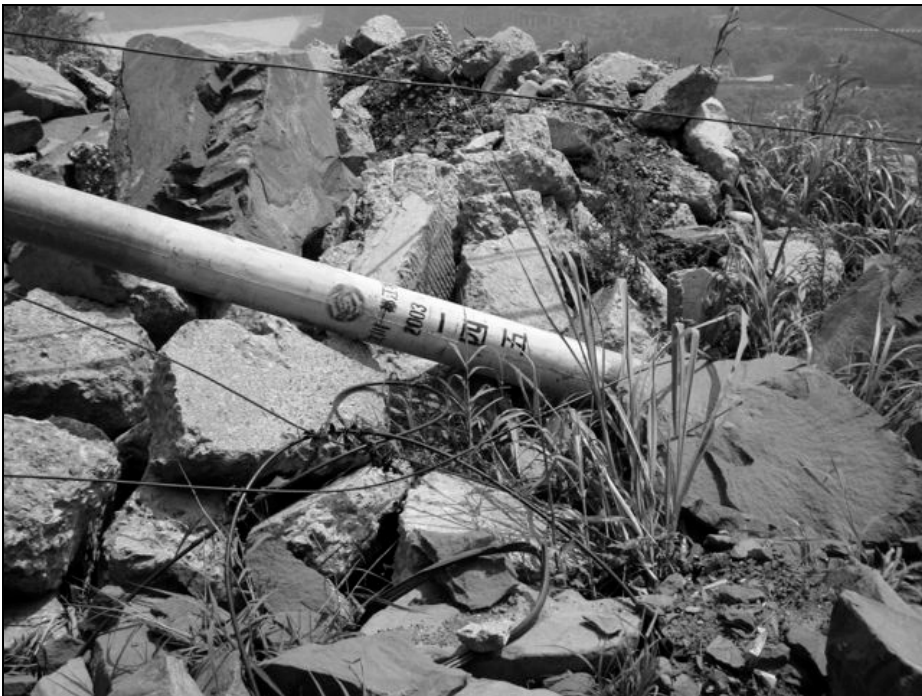
Fig. 6.36. Damaged pole due to rock falls

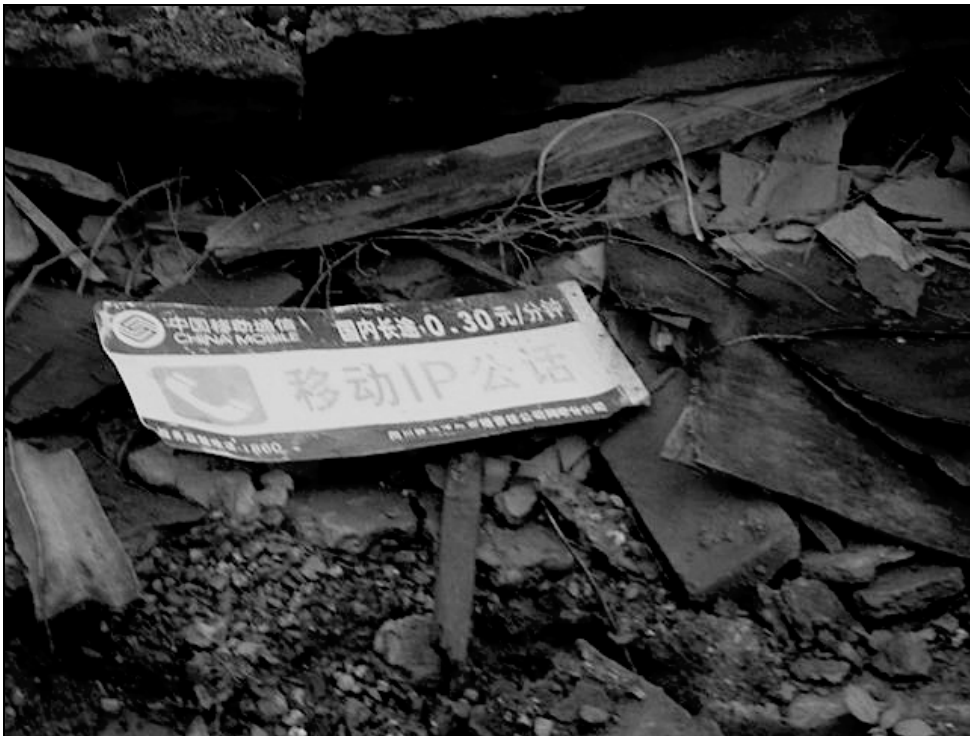
A telephone booth at Yingxiu was totally damaged, leaving a sign on the side of the road (Fig. 6.38).

Fig. 6.38. A public telephone booth sign left on the side of the road near the damaged phone booth

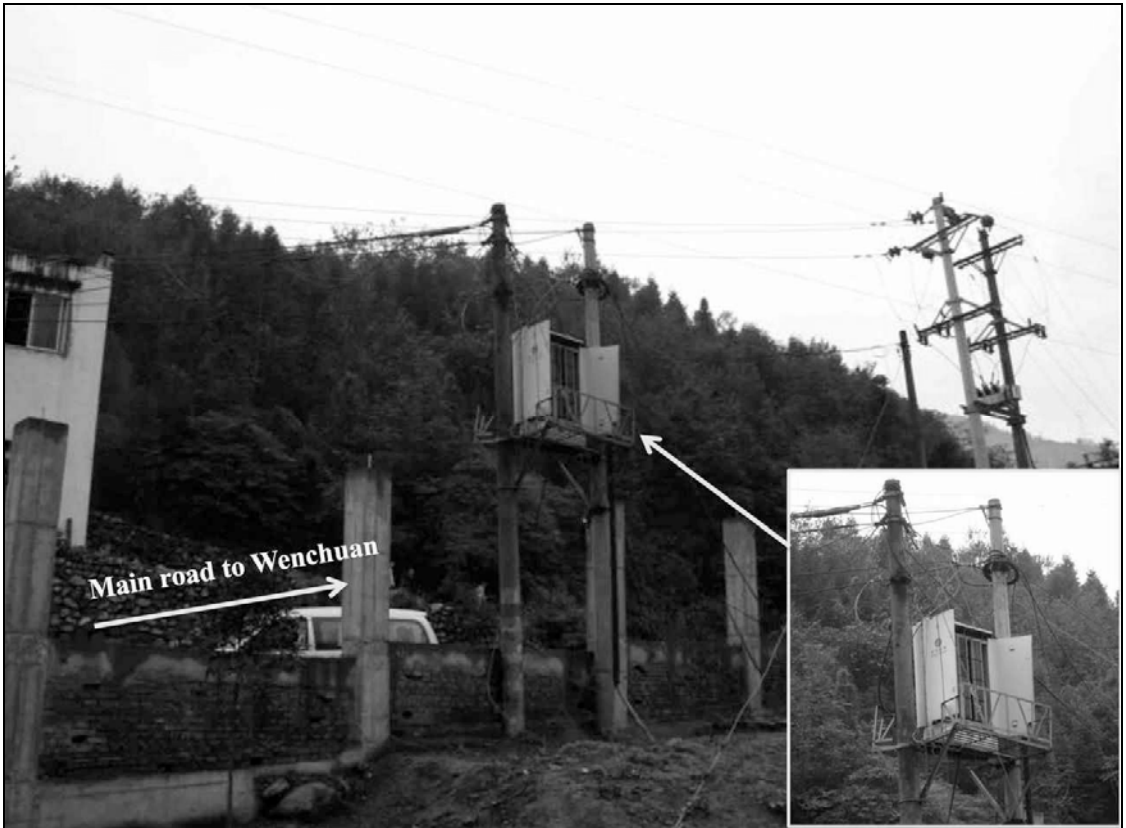
Fig. 6.39. A cross connect box mounted between the utility poles was opened to allow the service crew to remove connections and connect telecommunication service to temporary shelter areas.

Due to the large number of building collapses, the cross connect box for the neighborhood was opened to allow the service crew to remove unwanted connections (Fig. 6.39). The strong shaking in this area did not damage poles. Most likely the platform joining the two poles together provided added strength and also it is not in the landslide area.

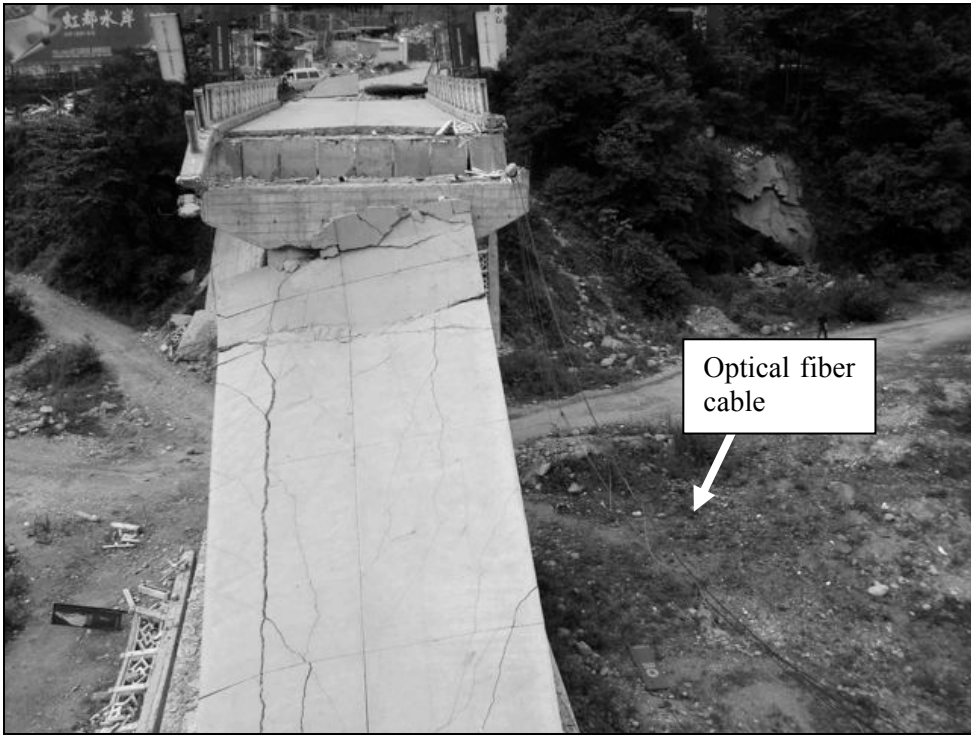
Colocating lifelines creates collateral damage. When this bridge span collapsed (Fig. 6.44), the telecommunication cable alongside was also damaged.

Fig. 6.44. The telecommunication cable on the right side of the collapsed span was damaged.

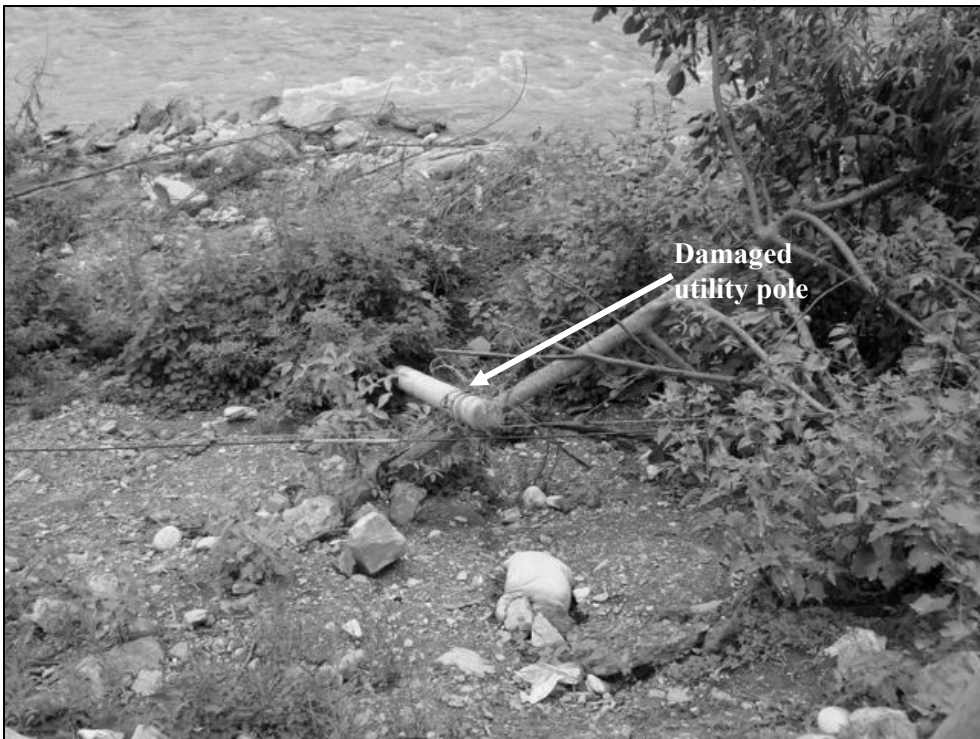
Fig. 6.47. Extensive landslides along the steep slopes of riverbank toppled many utility poles

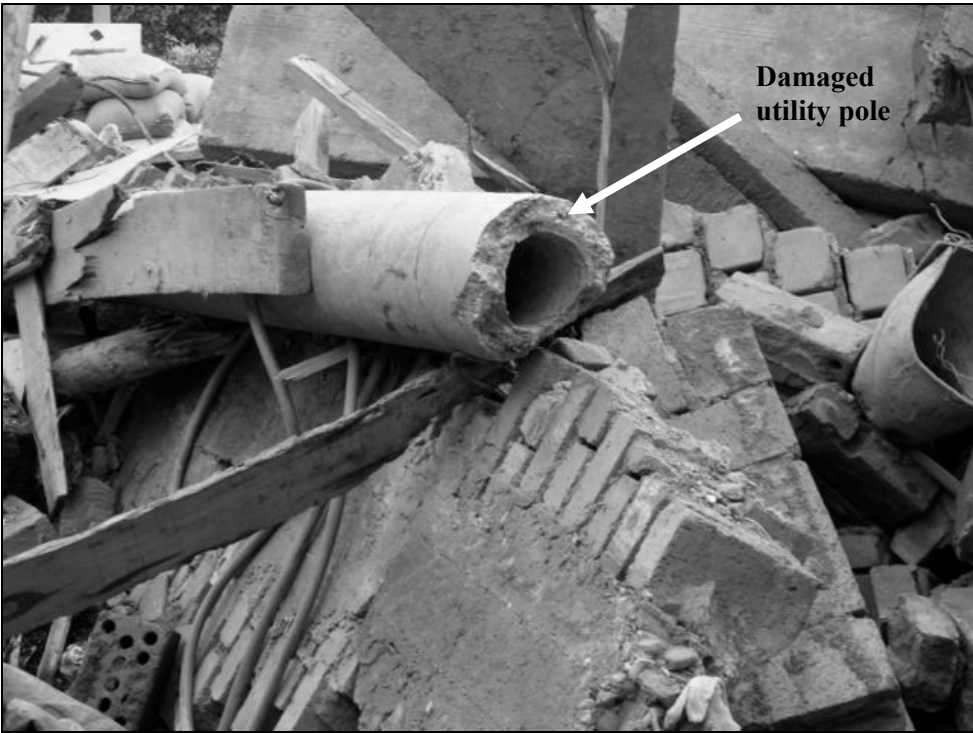
Fig. 6.48. Utility pole damaged by collapsing building

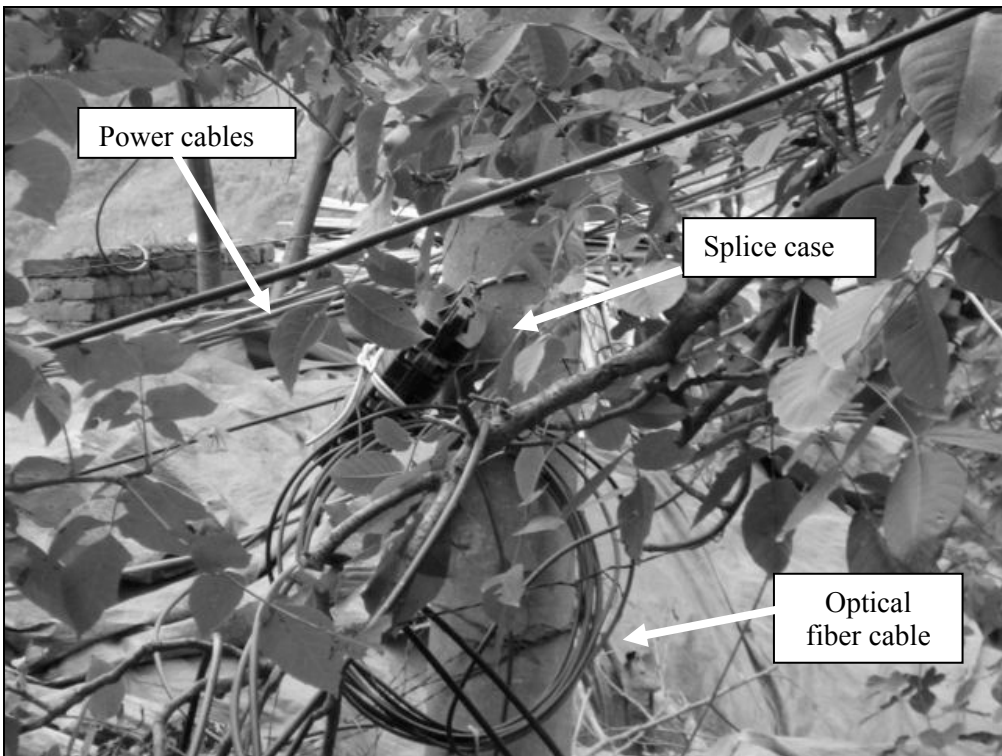
Fig. 6.49. Temporary repair of the landline with splice case tied to the pole by a piece of cable. Note the temporary power cables also shared the same pole here in Hejiaba.

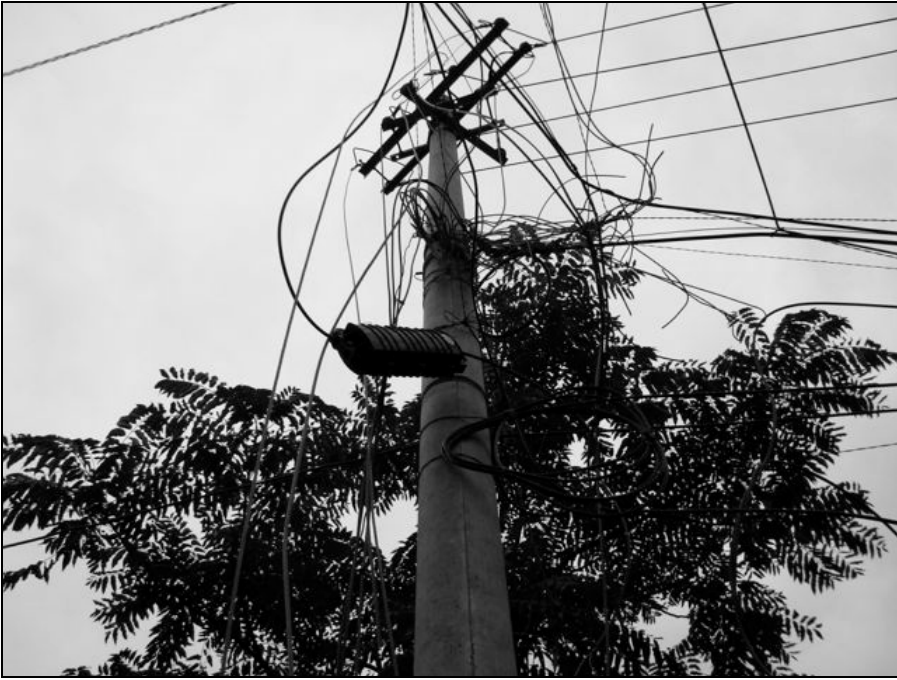
Fig. 6.50. The power lines on the top portion of this pole were not energized. Note the temporary telecommunication cables and the splice case mounted at about mid-height of this pole.

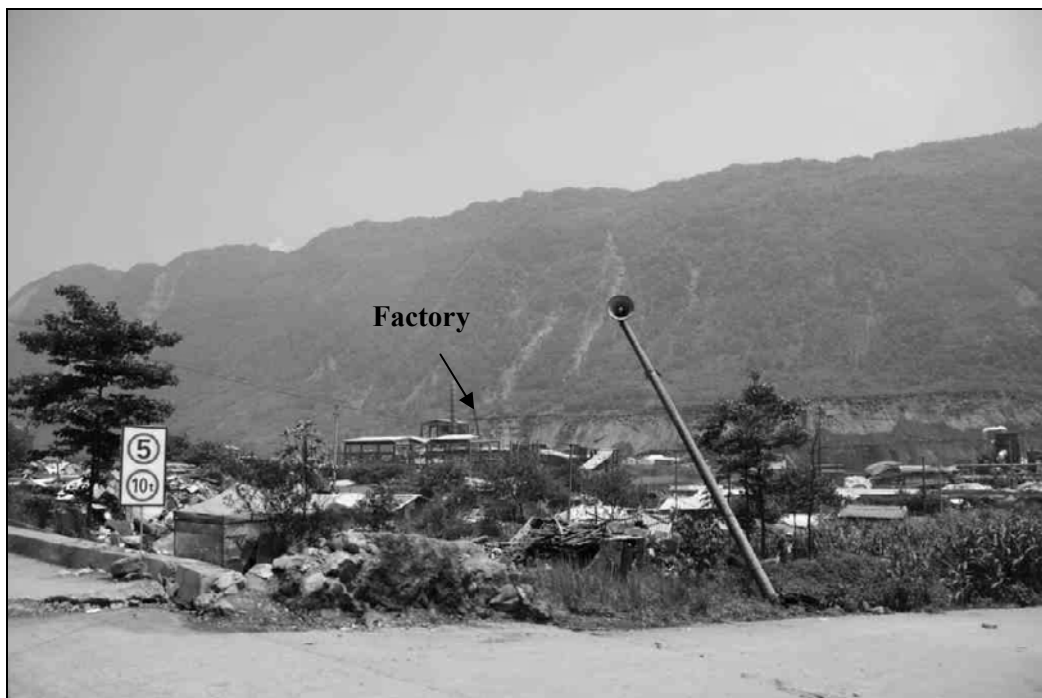
Fig. 6.52. This utility pole was damaged, and the cables were removed. On the left of the pole in the background is a chemical factor that sustained extensive damage.

Figure 6.52 shows a utility pole slanting about 35° from its vertical position due to ground movement and potentially shallow embedment. In the background is a chemical factor producing fertilizer. This factory sustained extensive damaged to its old structures.

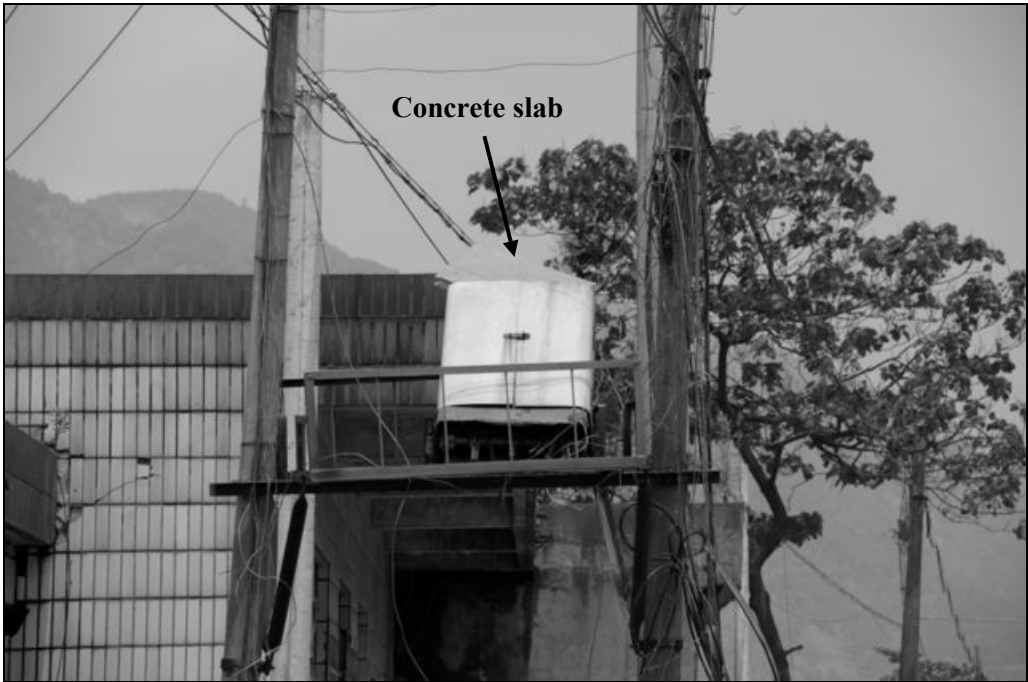
A pair gain unit mounted between two utility poles was damaged by a piece of fallen concrete from the nearby building (Fig. 6.53). Fortunately, the unit did not fall off its mount.

Fig. 6.53. Note the concrete slab on top of the pair gain unit on the platform between the poles.

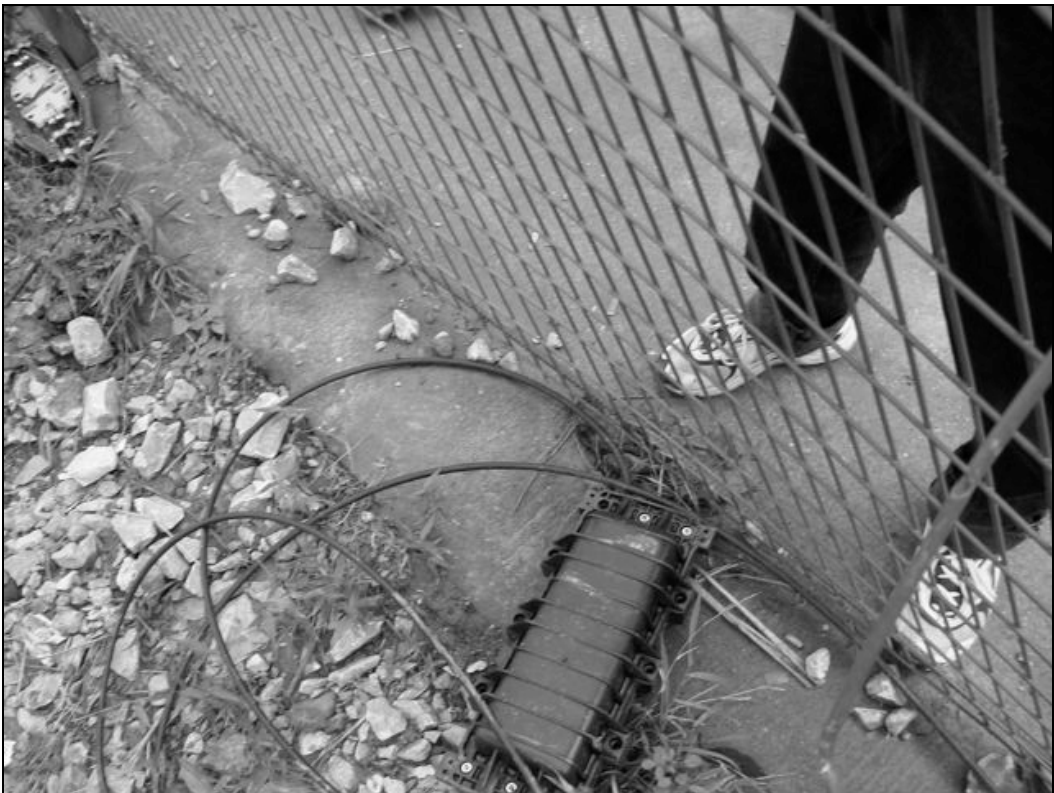
Fig. 6.56. A splice case for a temporary optical fiber cables was placed on the side of the road.

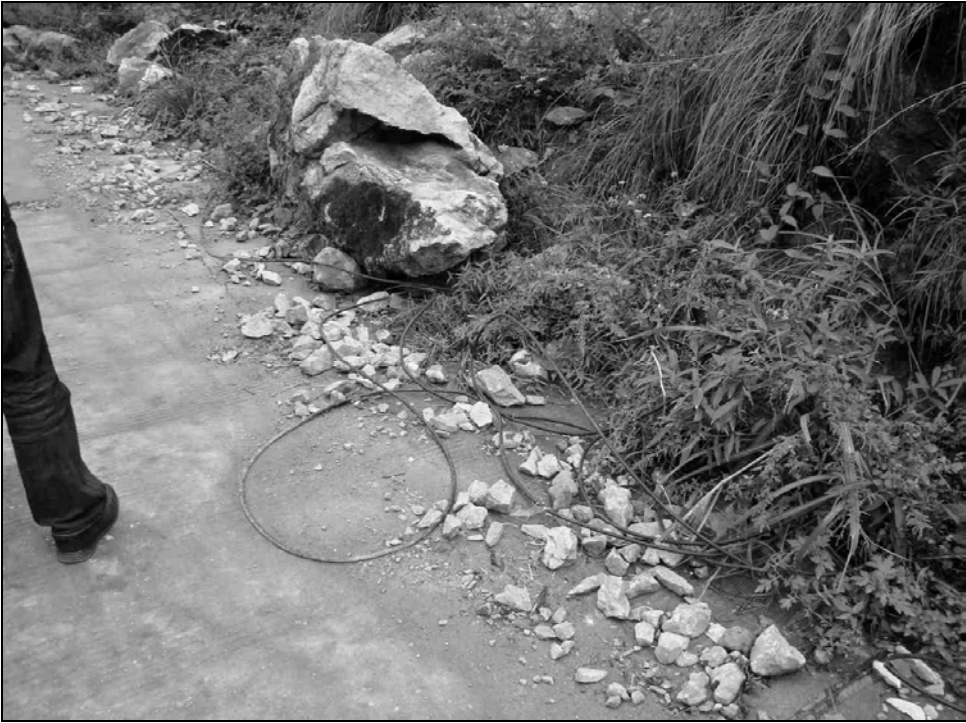
Fig. 6.57. Severed optical fiber cables were left on the side of a road. Note the size of the rock that rolled down the slope above, some cable was under it.

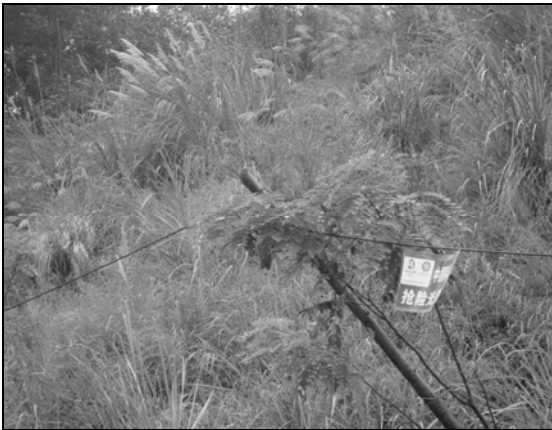
Fig. 6.58. The temporary emergency cable was wrapped around the pole with a very tight bend radius.

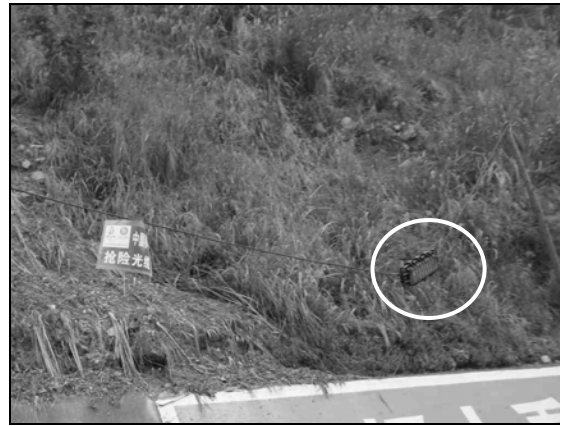
Fig. 6.59. The temporary emergency cable was hanging quite low, with the splice case supported by the cable instead of a guide wire between the poles.

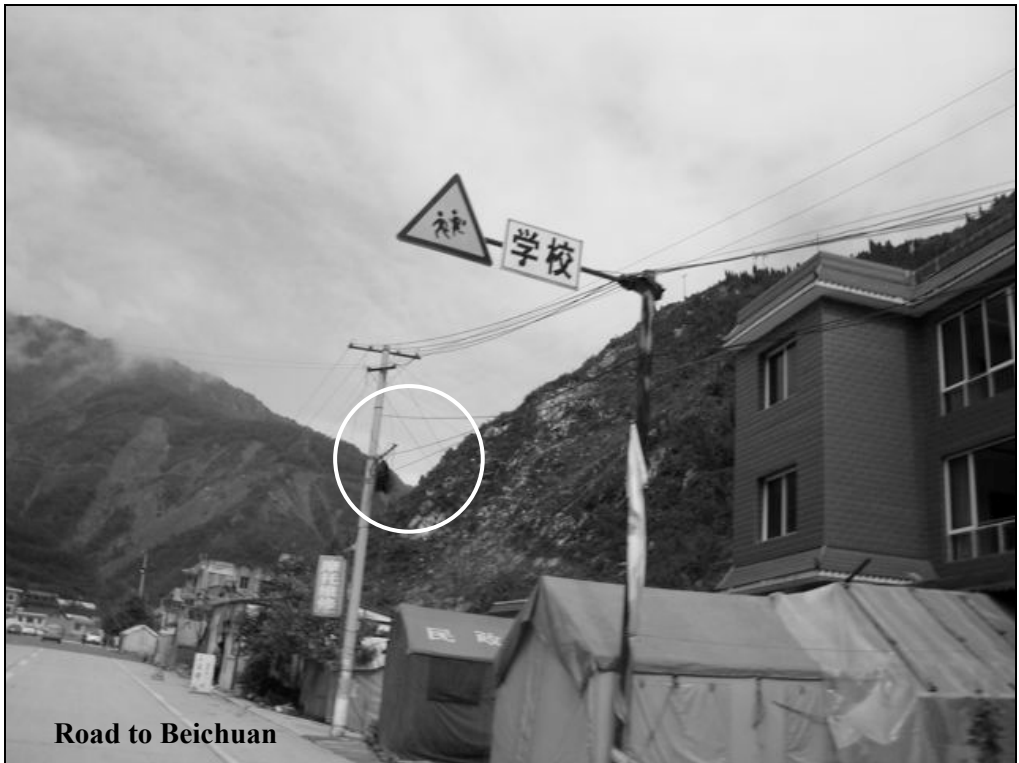
Fig. 6.61 Optical fiber cables (in the circle) for emergency repair were bundling up on the pole.

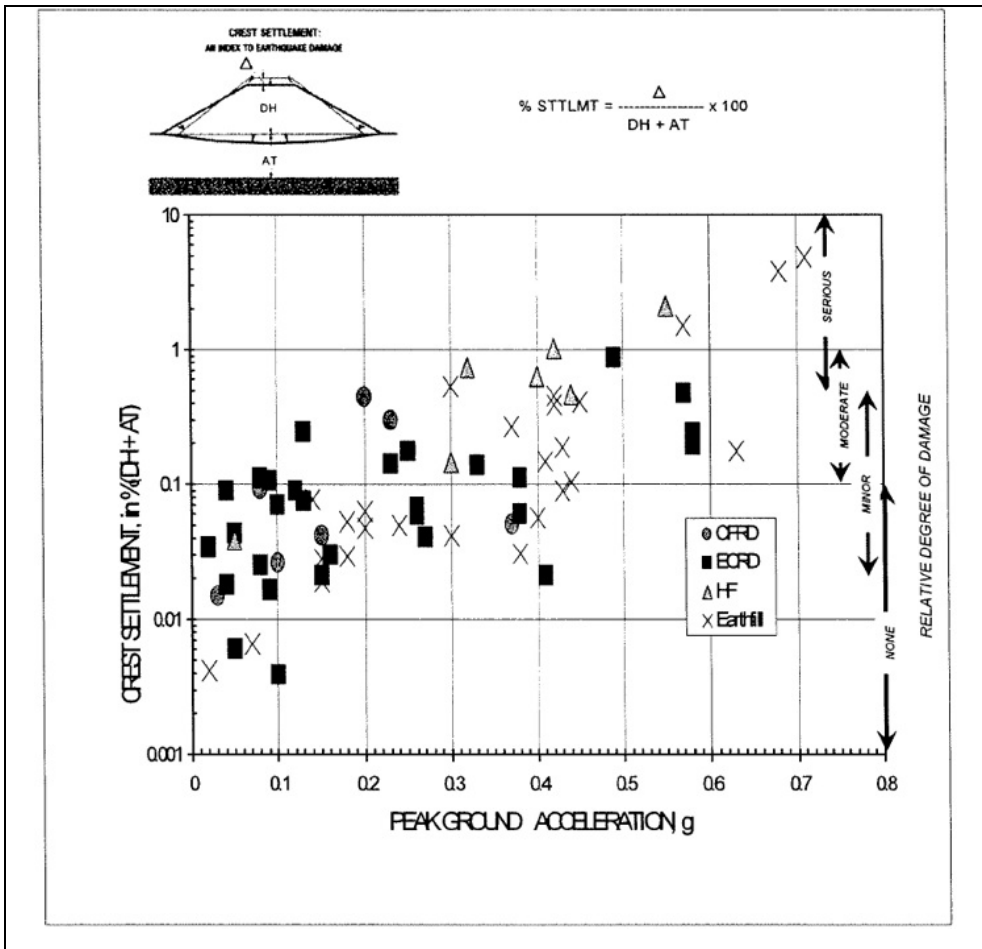
The original design of Zipingpu Dam anticipated maximum ground accelerations of 0.26 g, and at the crest, these estimates were exceeded by nearly an order of a magnitude. Nonetheless, the observed damages—especially the crest settlement and lateral displacements—were within tolerable limits. Properly designed and constructed rockfill dams are inherently robust structures and capable of remaining stable under extreme flood and earthquake loading conditions. When subjected to

Fig. 8.4. Actual crest settlement vs. PGA (from Swaisgood)

At Zipingpu this translates to a predicted crest settlement, using the Swaisgood methodology of between 1.56 m and 7.8 m. Actual settlements were approximately 0.5 percent of the dam's height, less than half of the lowest predicted settlements, so it can be concluded that overall the Zipingpu Dam performed well given the violent shaking it experienced.

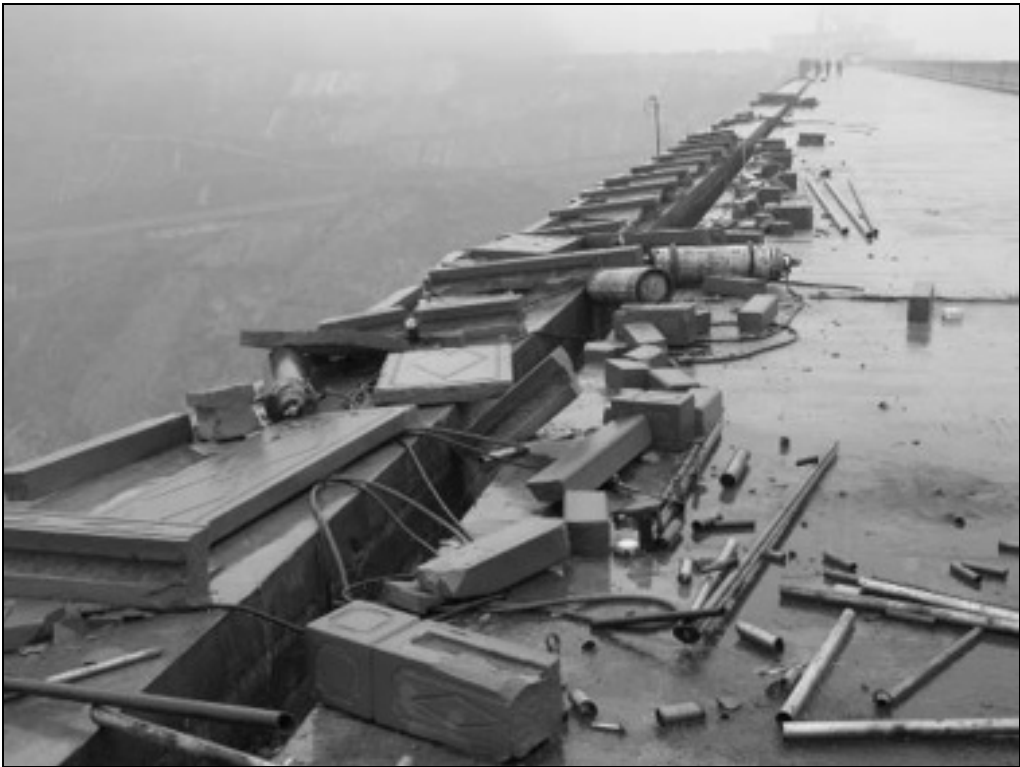
Fig. 8.7. Collapsed guardrail on dam top (Courtesy IEM)

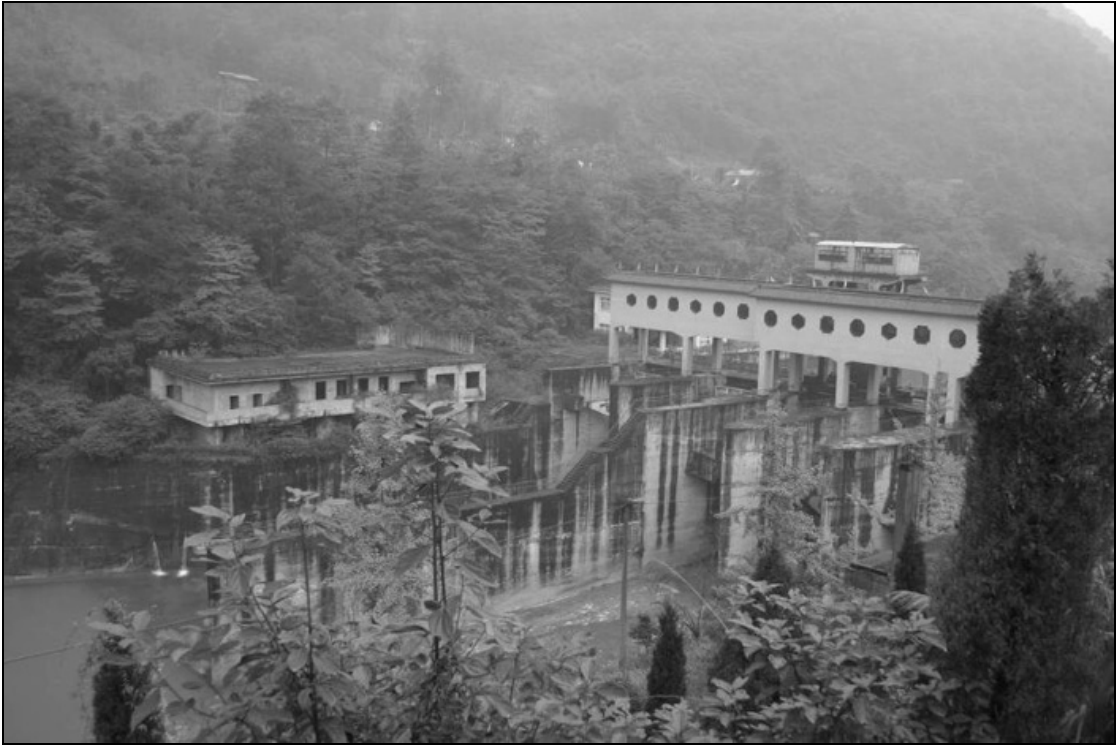
Fig. 8.9. Hongkou Dam after the Wenchuan earthquake

Minor cracking was observed at the main dam, but it was not clear if this cracking occurred before or after the Wenchuan earthquake. However, significant seepage is occurring around the right abutment through weep holes in a long retaining structure as well as through uncontrolled seepage zones further downstream. The total quantity of this seepage was estimated to be in excess of 0.03 m^3 per second (1 ft.^3 per second). It is believed this seepage predated the Wenchuan earthquake, but it is uncertain if seepage rates increased, decreased, or remained unchanged after the earthquake. No seepage measurement weirs, other monitoring, or instrumentation were noted during the inspection.

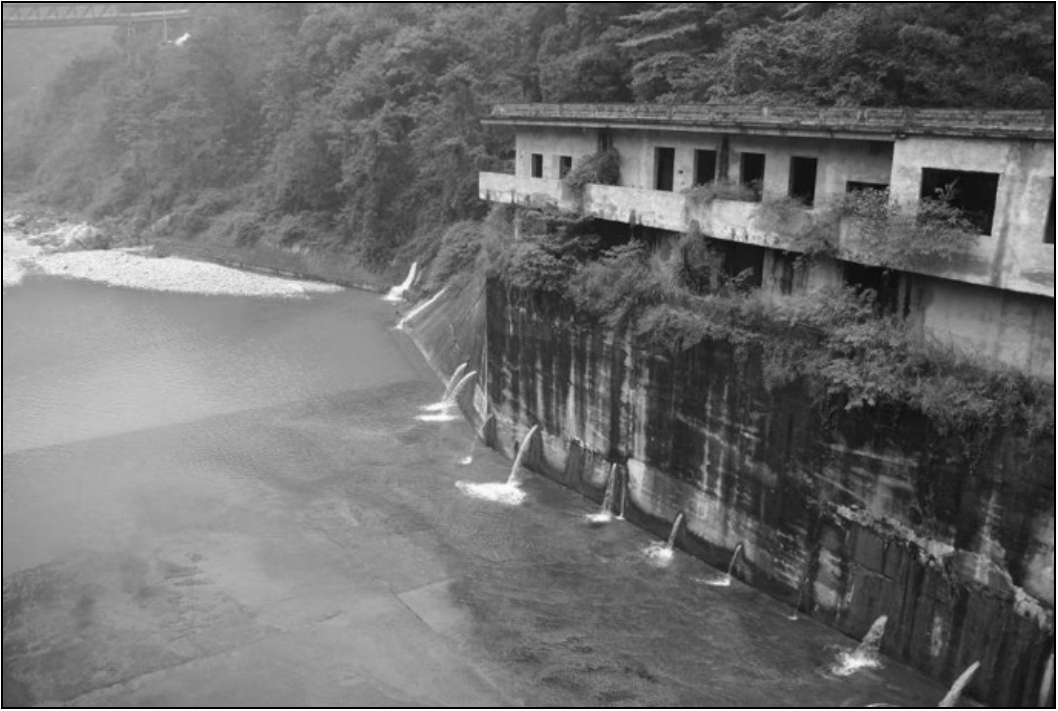
Outcrops of poor quality rock were noted on the right abutment, and it was surmised that seepage forces were flowing through this media with very little inhibition. While it is impossible to visually determine the stability of a dam, high rates, seepage, and their associated pressures are typically regarded as a destabilizing influence for most dams. High rates of seepage flows will eventually erode away the material they flow through. When this happens, catastrophic failure in the form of an uncontrolled reservoir release can occur more rapidly than repairs preventing it can be implemented.

Fig. 8.10. Hongkou Dam right abutment seepage

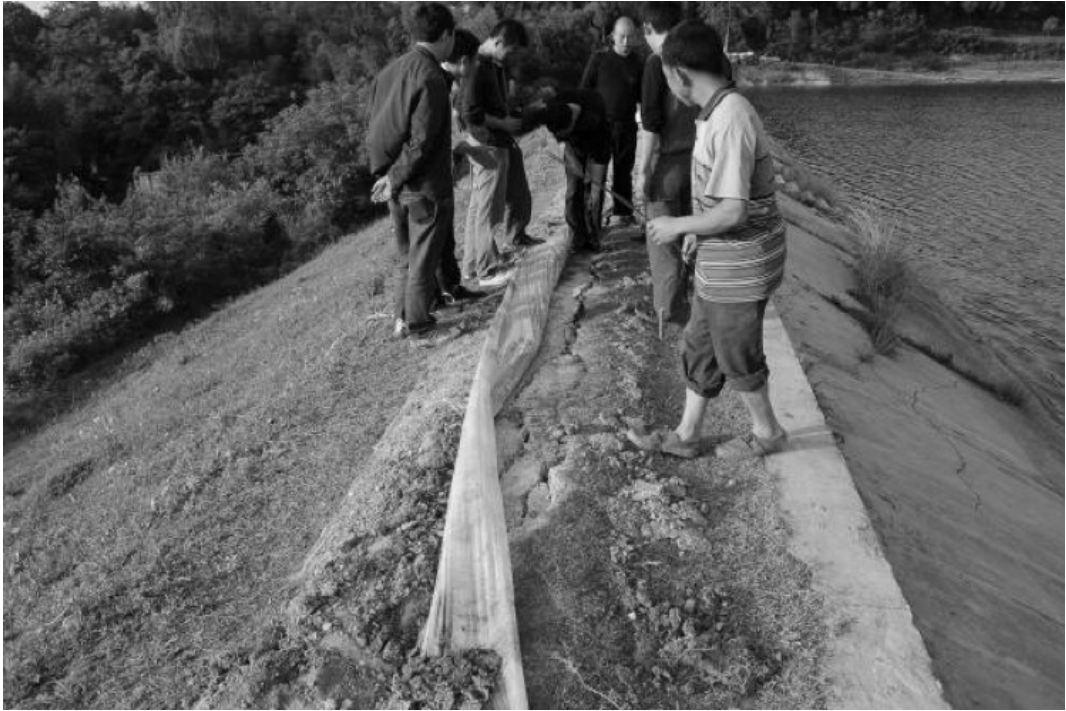
Numerous earthen dams were damaged as a result of the earthquake with the vast majority of these occurring longitudinally and parallel to the dam crest. In isolated cases transverse cracking was also noted but was not a predominate form of observed distress. Longitudinal cracking was observed mainly at the crest and on the upstream slope of the dam. Figures 8.11 to 8.16 show several earthen dams damaged in the earthquake.

Fig. 8.11. Longitudinal cracks at crest of newly constructed earthen dam, Fenggu Town, Mianyang City (Courtesy IEM)

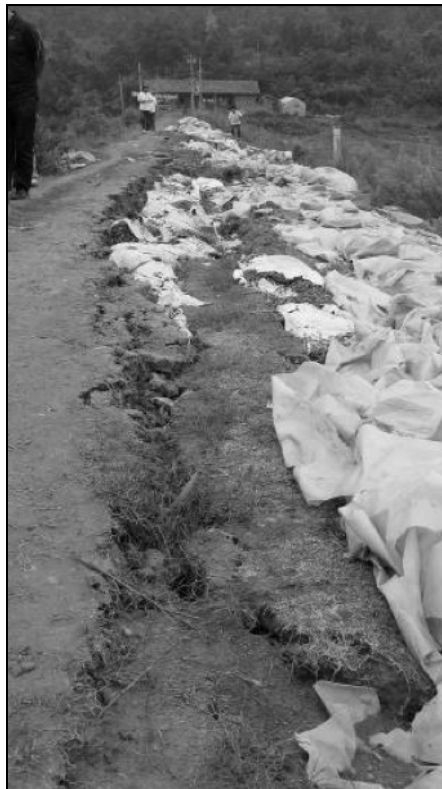
Fig. 8.12 Longitudinal cracks at crest of earthen dam, Changdaogou Reservoir, Mianyang City (Courtesy IEM)

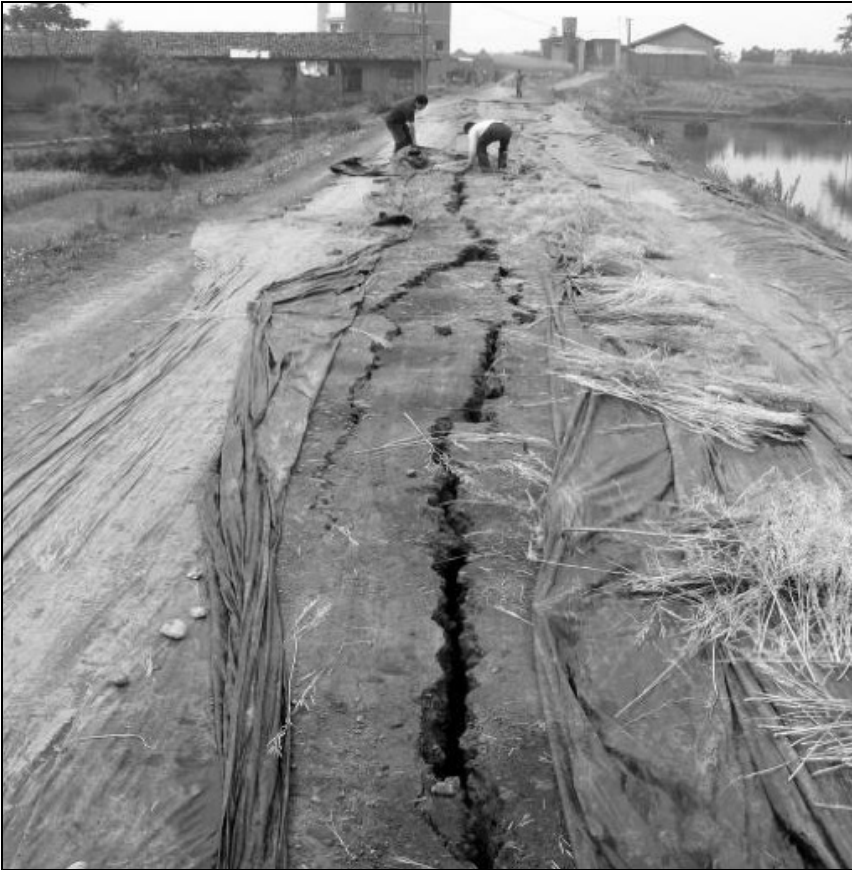
*Fig. 8.13. Longitudinal cracks at crest of earthen dam, Dasongshu Reservoir
(Courtesy IEM)*

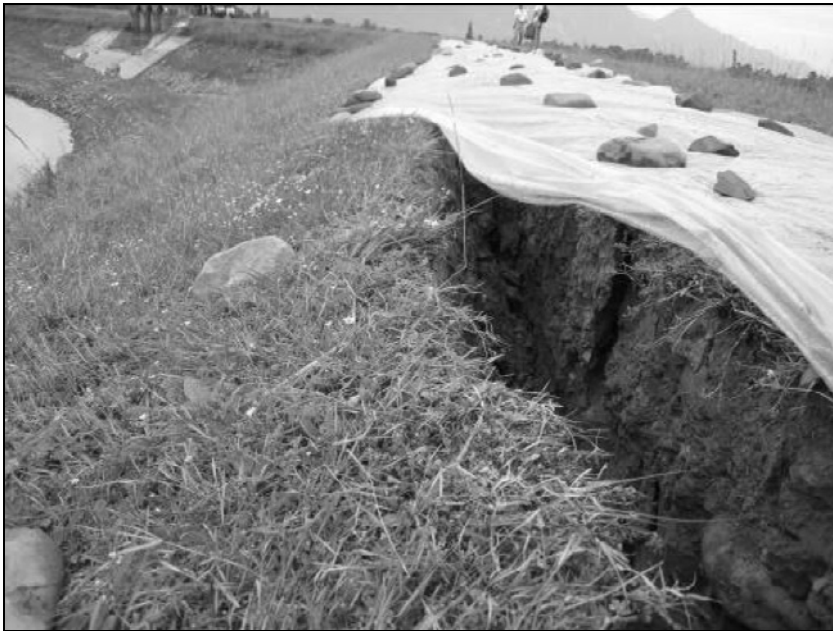
*Fig. 8.14. Upstream slope movement of earthen dam, Bailin Reservoir,
Hanwang Town, Mianzhu City (Courtesy IEM)*

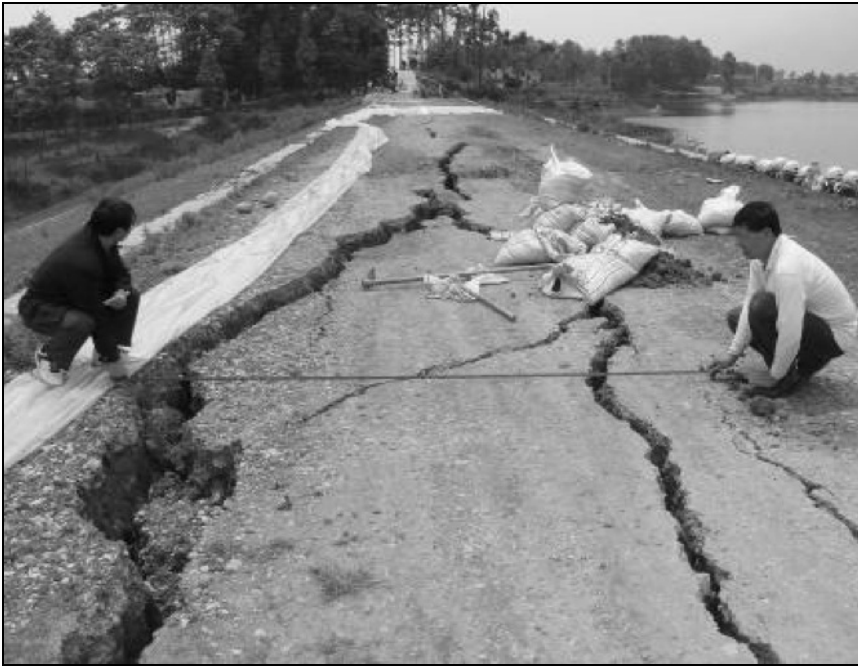
Fig. 8.15 Longitudinal cracks at crest of earthen dam, Fengshou Reservoir, Anxian County (Courtesy IEM)

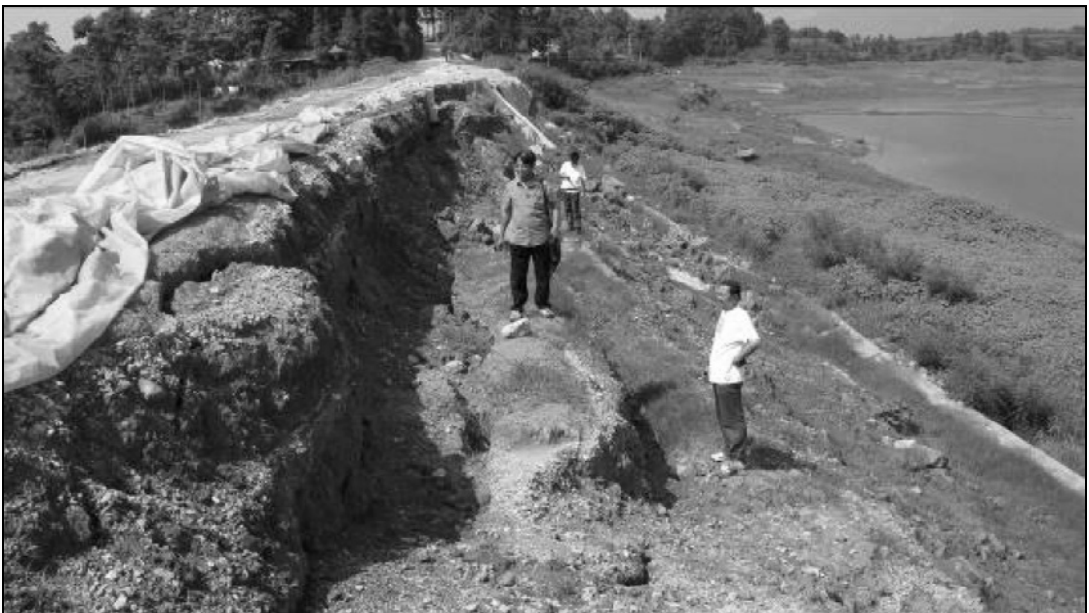
Fig. 8.16. Upstream slope movement of earthen dam, Fengshou Reservoir, Anxian County (Courtesy IEM)

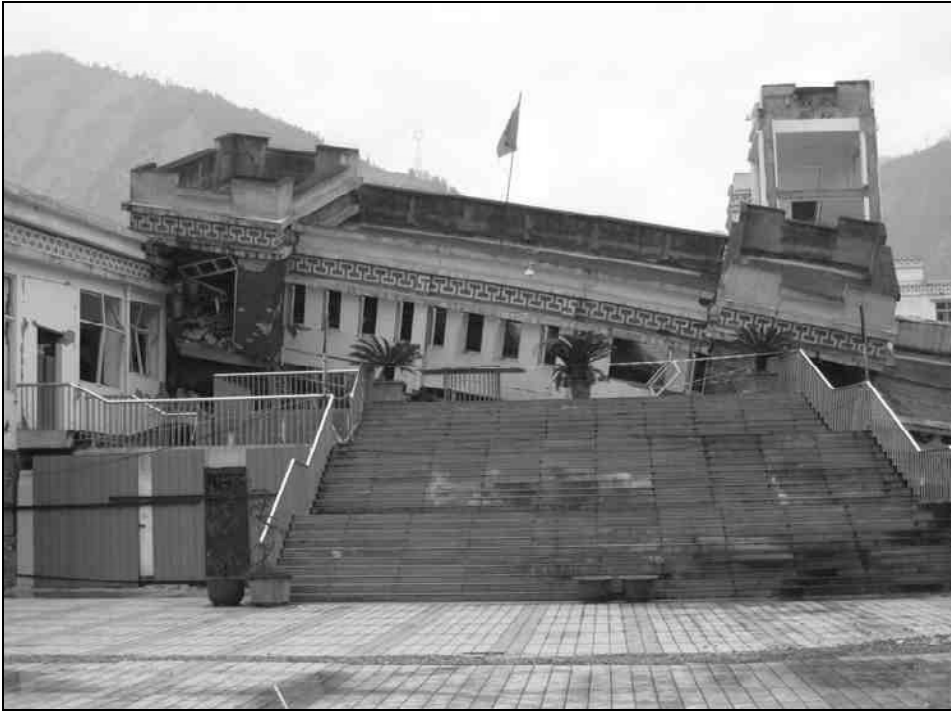
Figure 9.1 shows the collapse of main building at the entrance of Xuan Kou (漩口) High School in Yingxiu. This school has many buildings on its campus, and except for the student residence, most had collapsed or partially collapsed. The damage to school buildings, however, was not obviously better or worse than collapses to the general building stock nearby.

This school is a relatively new building. The most important cause of failure is the seismic zoning criteria; it is low compared to the history of strong ground shaking in this province. In addition to this low requirement, the absence of importance factors in the building code of critical structures is also key. Without the original structural building plan, it was impossible to evaluate quality and workmanship of the construction. Based on the ruins, the quality of construction was not substandard. The failed building figures shown in this section reveal the inadequate design of basic load transfer elements and load bearing capacity. This is a hard lesson and will be remembered for years.

Fig. 9.1. Partially collapsed Yingxiu, Xuan Kou High School.

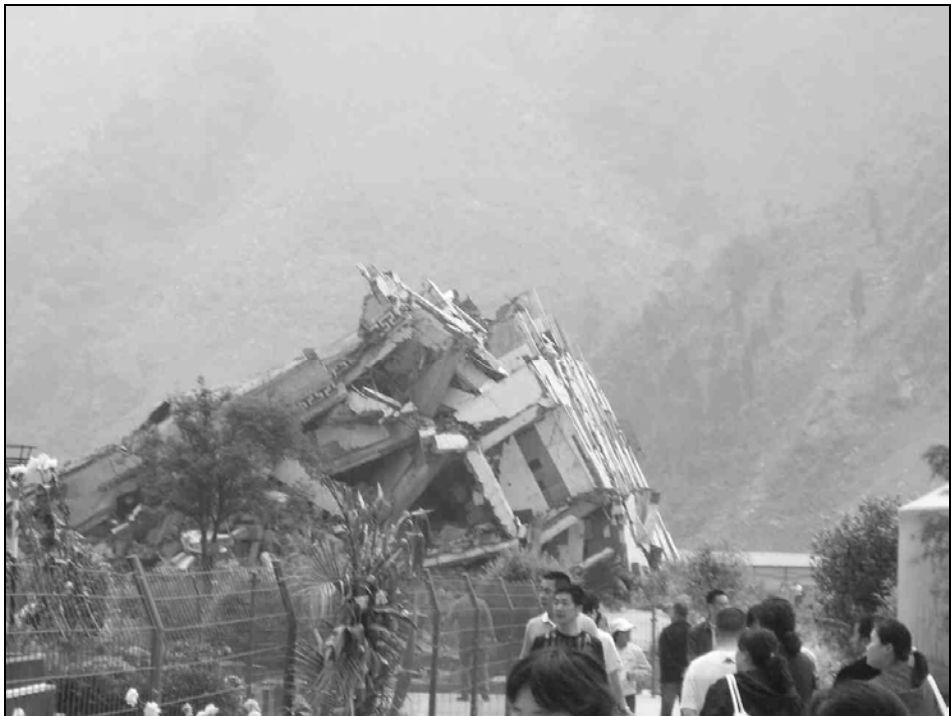
Fig. 9.2. Totally collapsed building Yingxiu, Xuan Kou High School.

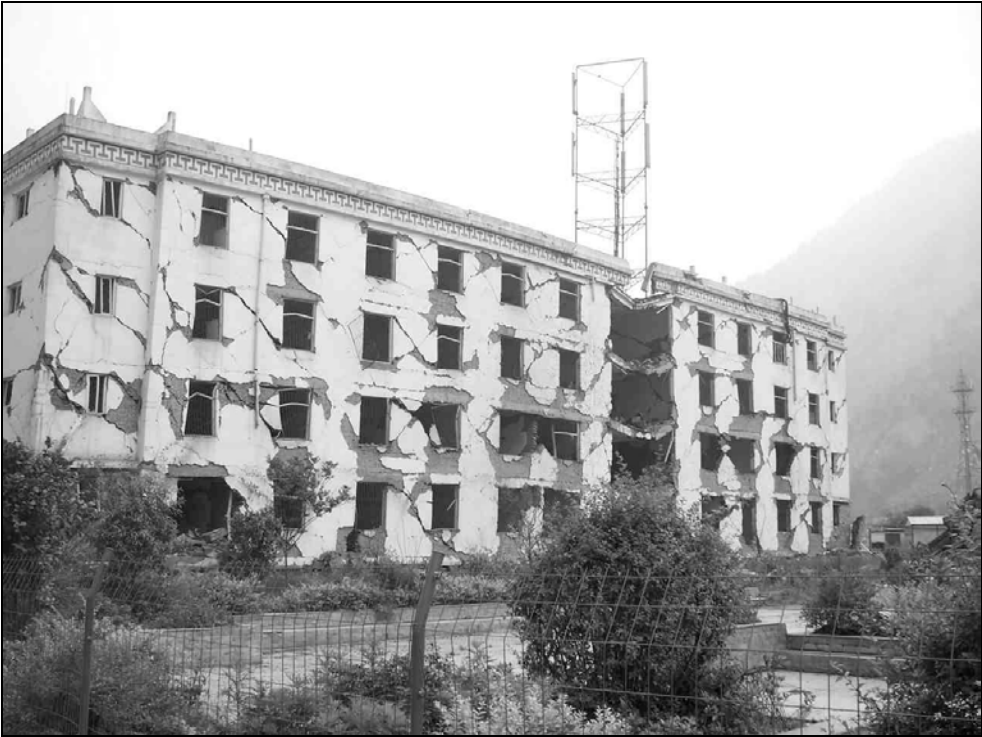
Fig. 9.3. Yingxiu, Xuan Kou High School student residence was heavily damaged but did not collapse.

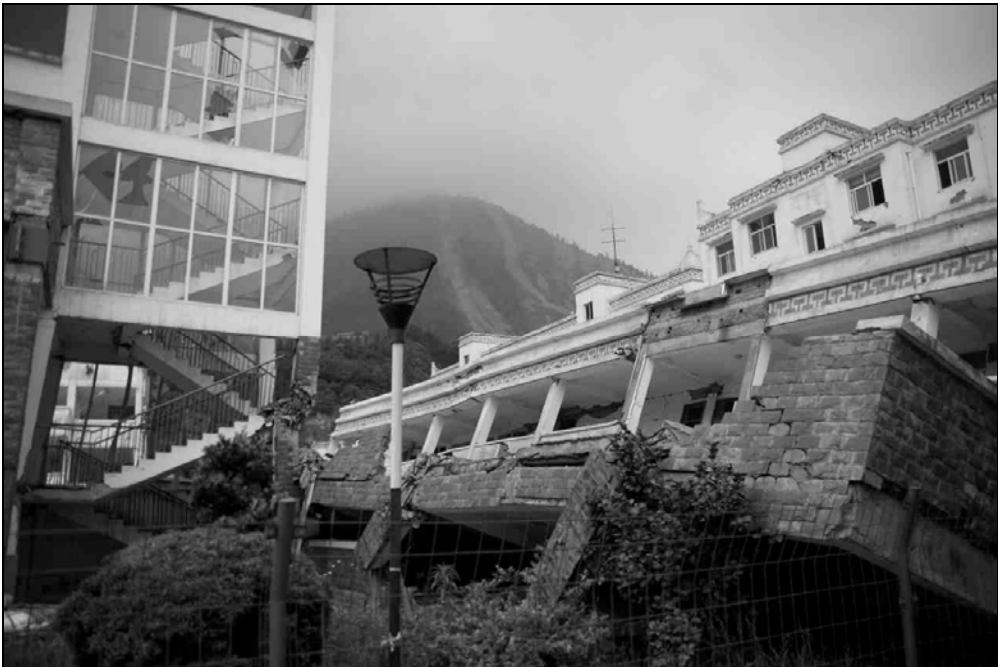
Fig. 9.4. Other building within the school campus sustained extensive structural damage. Many students were injured and killed.
